# Reconnaissance Level Fish and Fish Habitat Inventory in the Bulkley T.S.A.

*(Working Unit #4 - Boucher)*

**Pacific Inland Resources (FRBC)**

April 1998

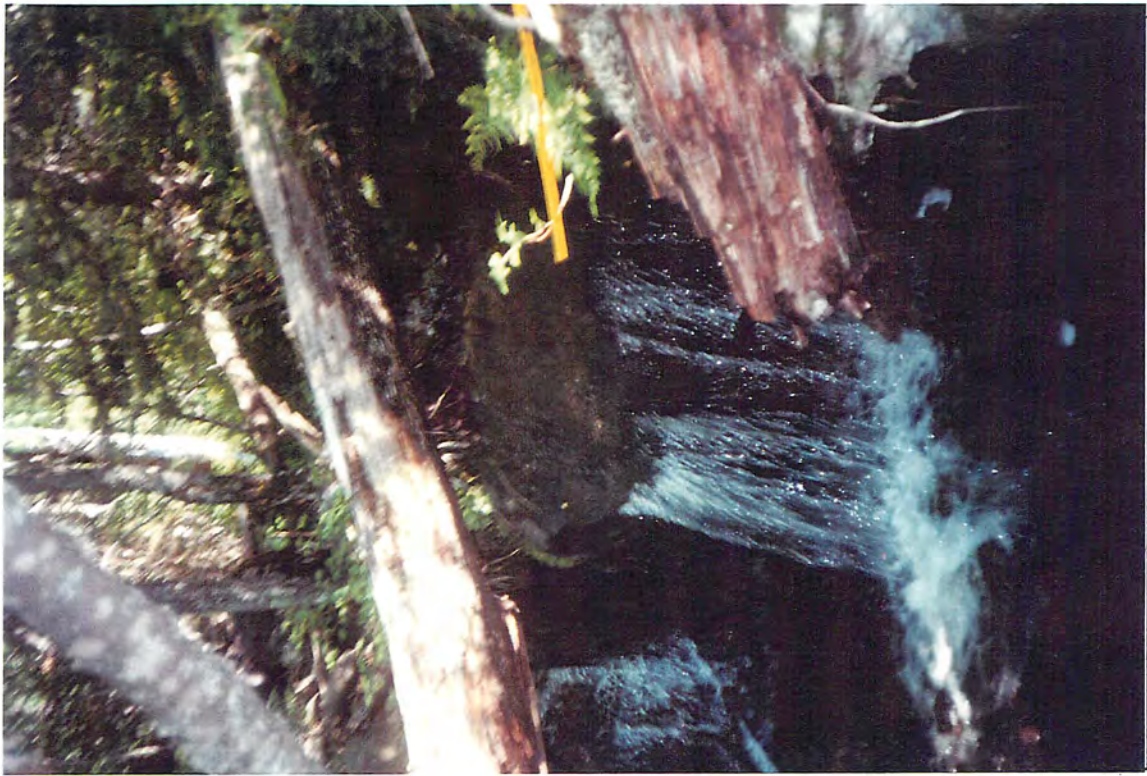
Photo #: J-1-23, 1996/07/26

- C1: S6  
C2: LS=60%, RS=60%  
C3: No fisheries sensitive zones were noted.  
C4: No electroshocking was carried out at this site as the gradient was deemed too steep to accommodate fish.  
C5: Lat N 55 30' 47.2", Long W 126 30' 48.8"  
C6: No additional bank texture information.  
C7: DO, pH, conductivity were not measured at this site. The water was clear to the bottom. The mean air temperature on this day was 18.8°C  
C8: No spawning, rearing or overwintering habitat occurs at this site. Steep gradient and a series of cascades and step pools were observed close to the mouth. The gradient increases upstream. The steep gradient, 2 meter cascade and lack of suitable fish habitat noted by the crew have resulted in a non fish bearing classification for this tributary.

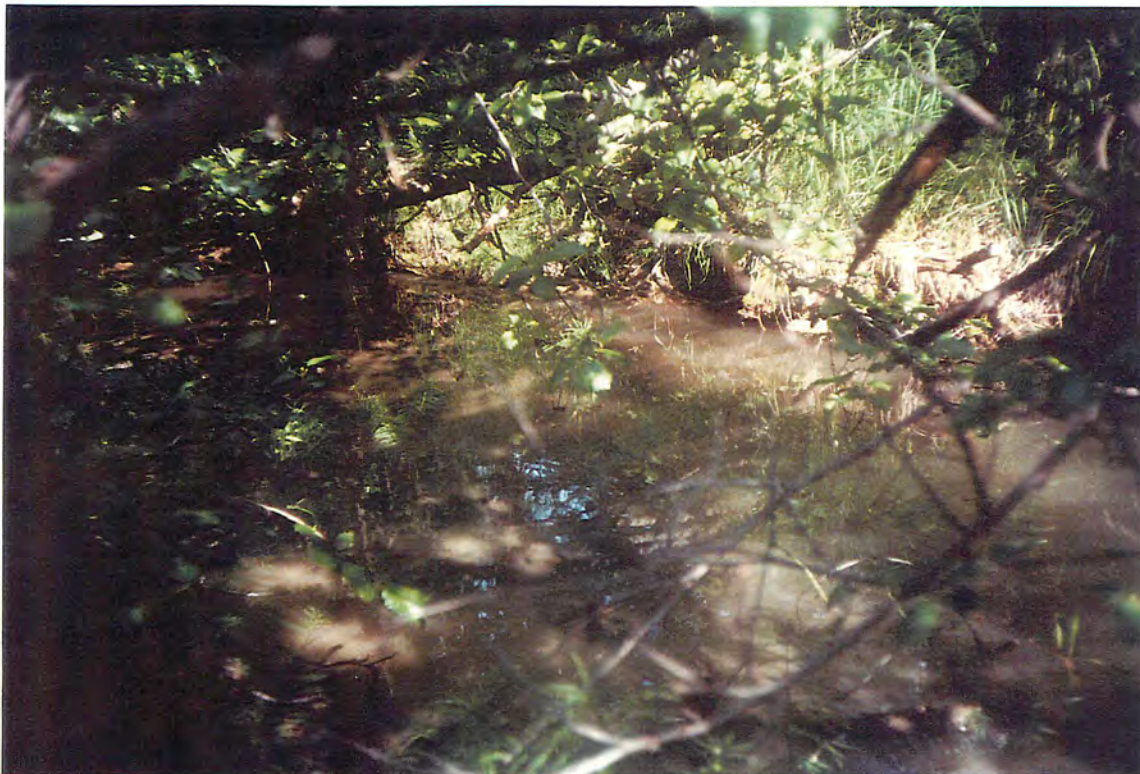
Photo #: J-1-24, 1996/07/26

C8 An aerial reconnaissance carried out above a small beaver dam, revealed a cascade/falls above the dam and no access to, or overwintering habitat in that area.

Site #: J18, Looking cross-stream, clay substrate.

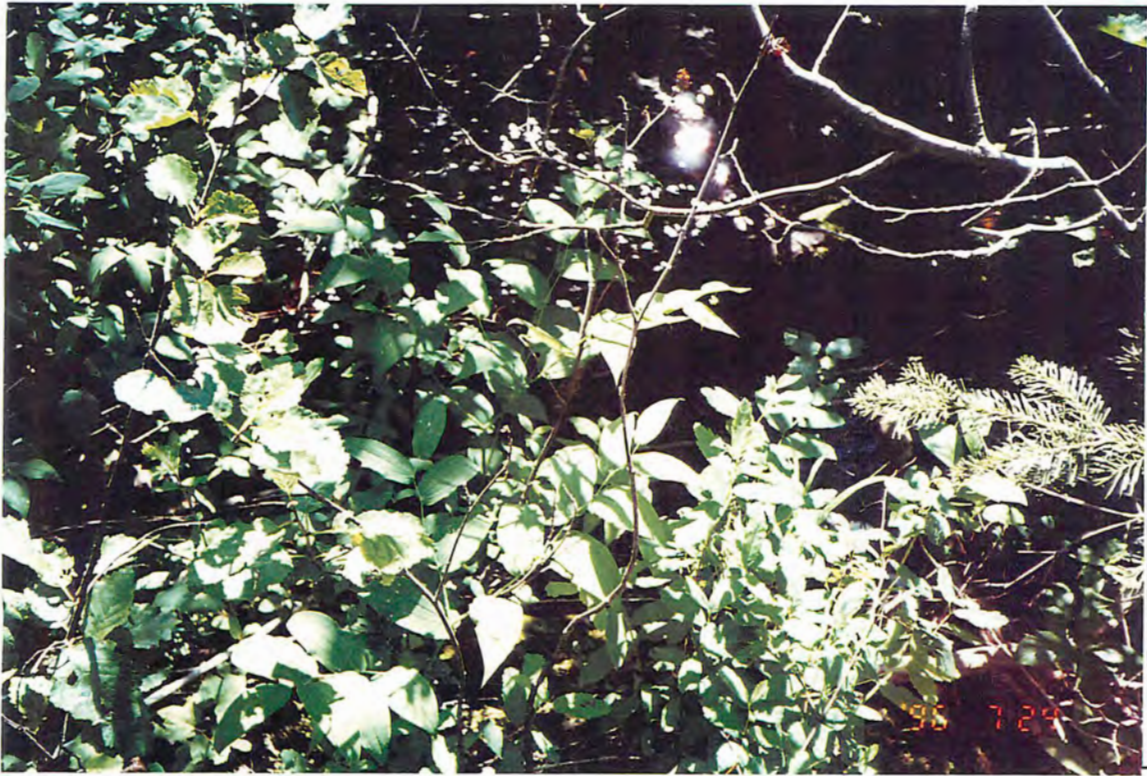
Photo #: J-1-2, 1996/07/24

Site #: J3, Looking upstream through alder and dogwood.

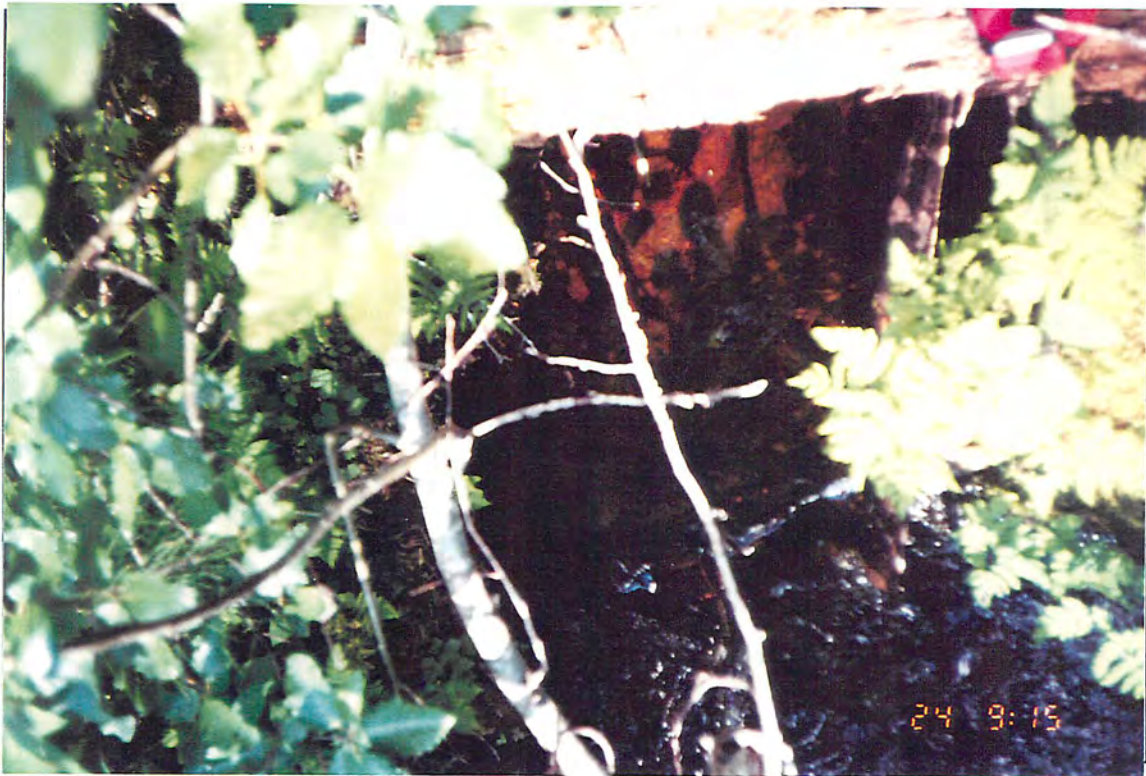
Photo #: J-1-3, 1996/07/24  
Site #: J4, Looking upstream.

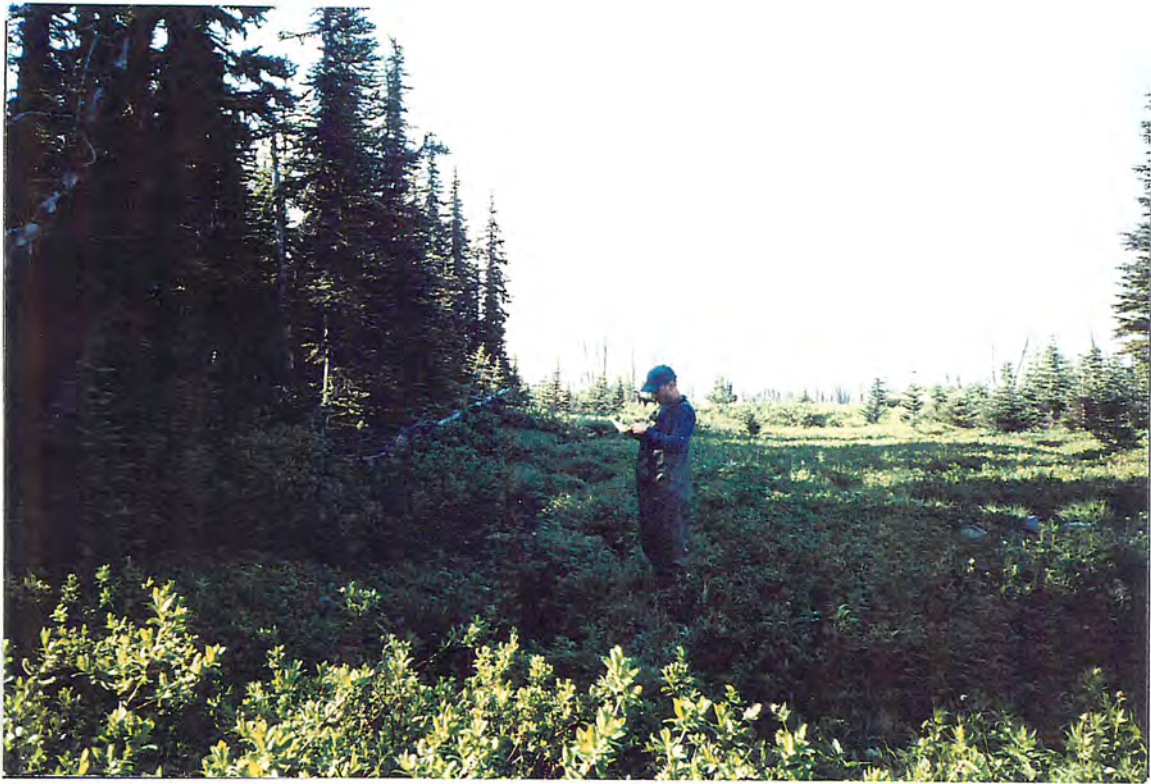
Photo #: R-1-2, 1996/07/25  
Site #: R1, Looking downstream.

C8: Some excellent fish habitat was observed at this site but the 3m cascade downstream prevents fish passage upstream.

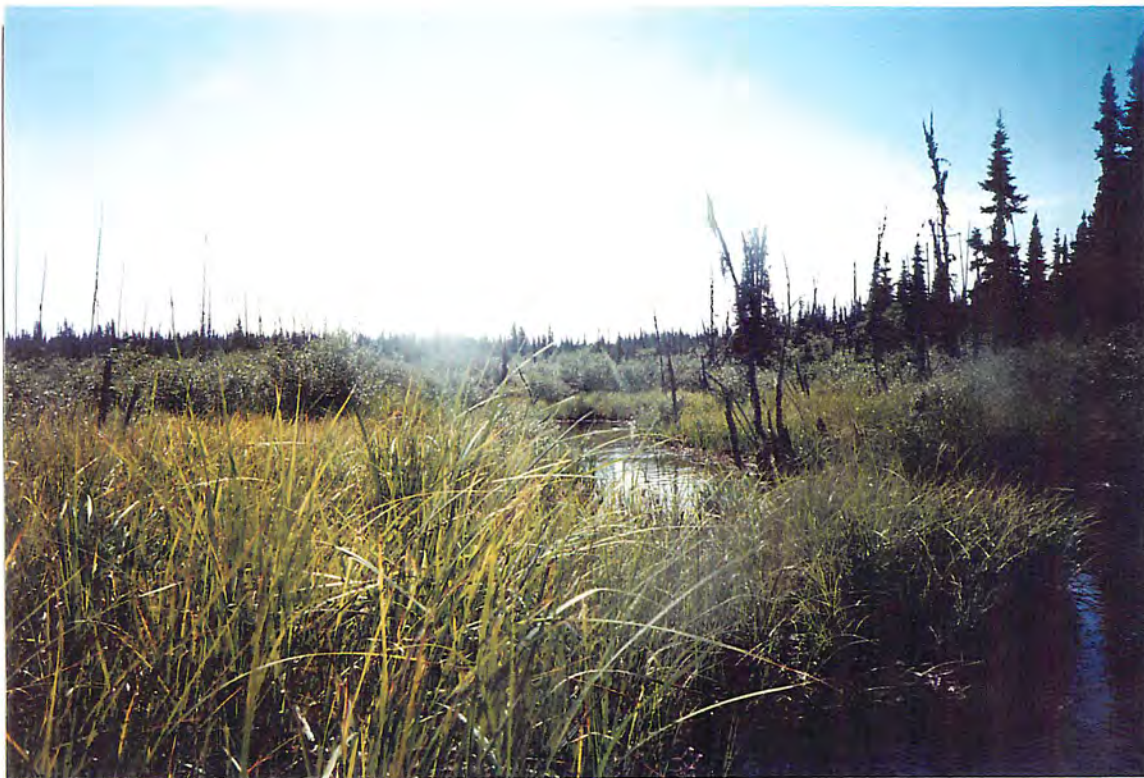
Photo #: R-1-9, 1996/07/26

Site #: R11, Looking upstream, marshy area.

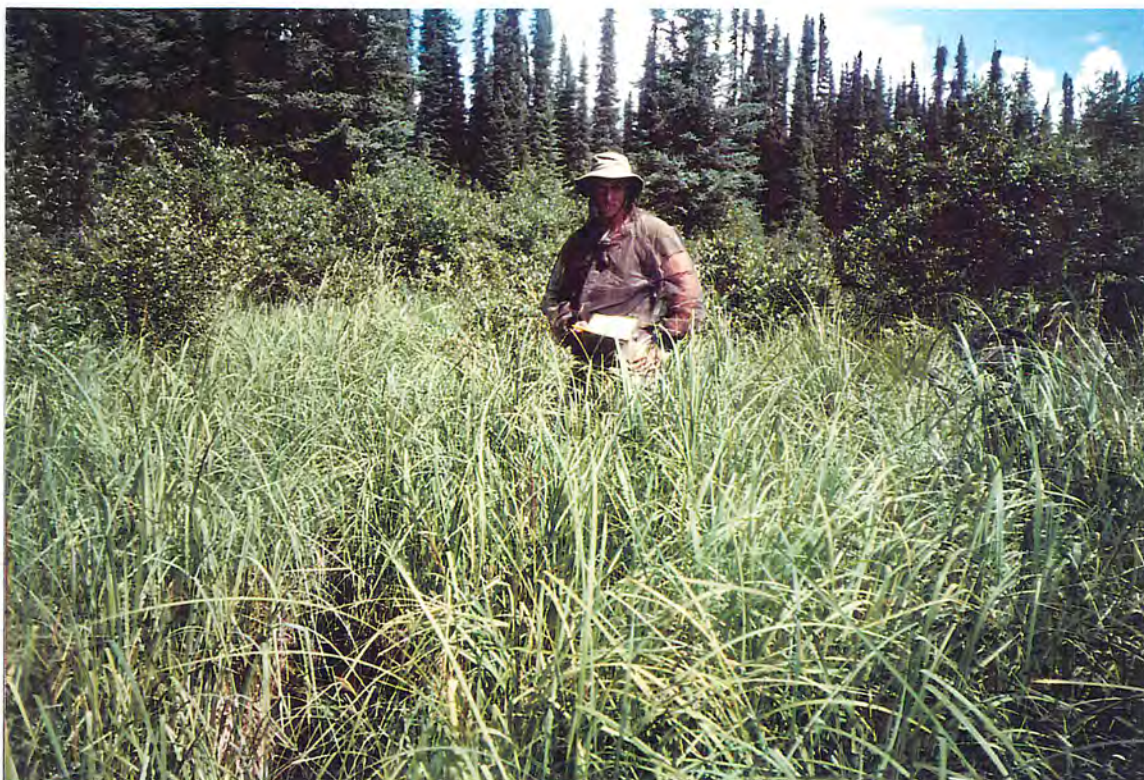
Photo #: R-1-10, 1996/07/26

C8 This site has some good rearing habitat.

Site #: R12, Looking upstream, channel through grassy area.

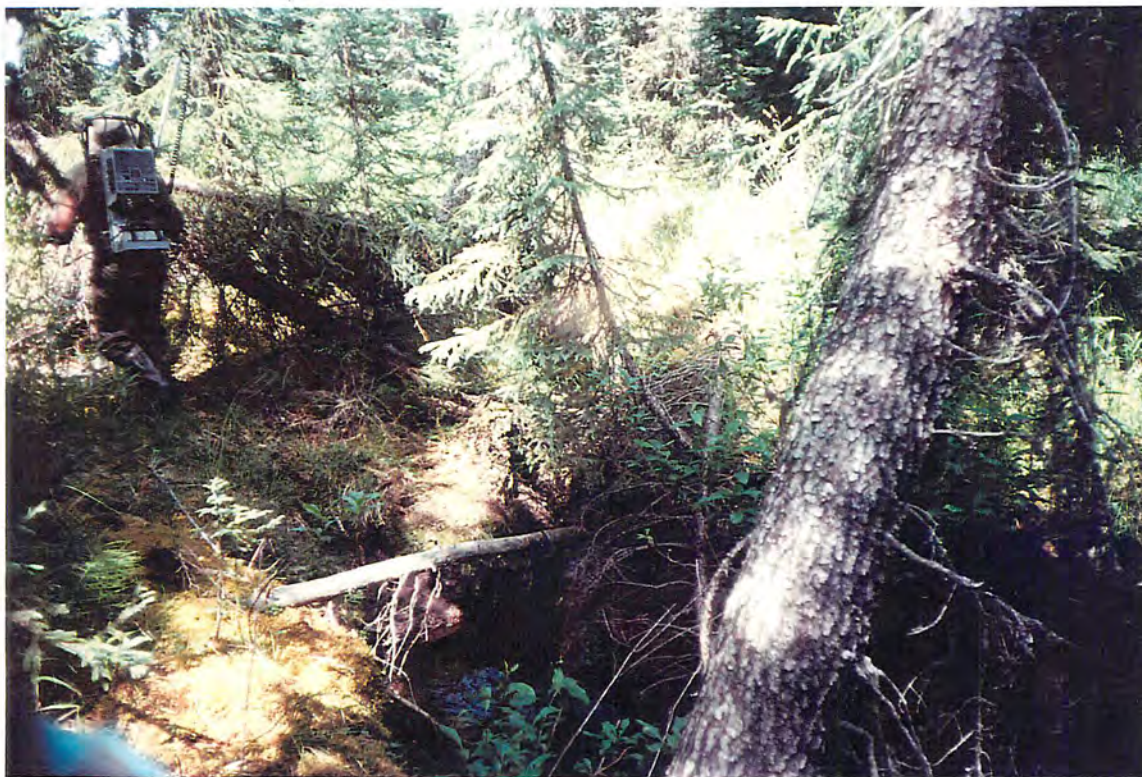
C8: This site has some good fish habitat.

Photo #: R-1-11, 1996/07/26  
Site #: R13, Looking upstream.

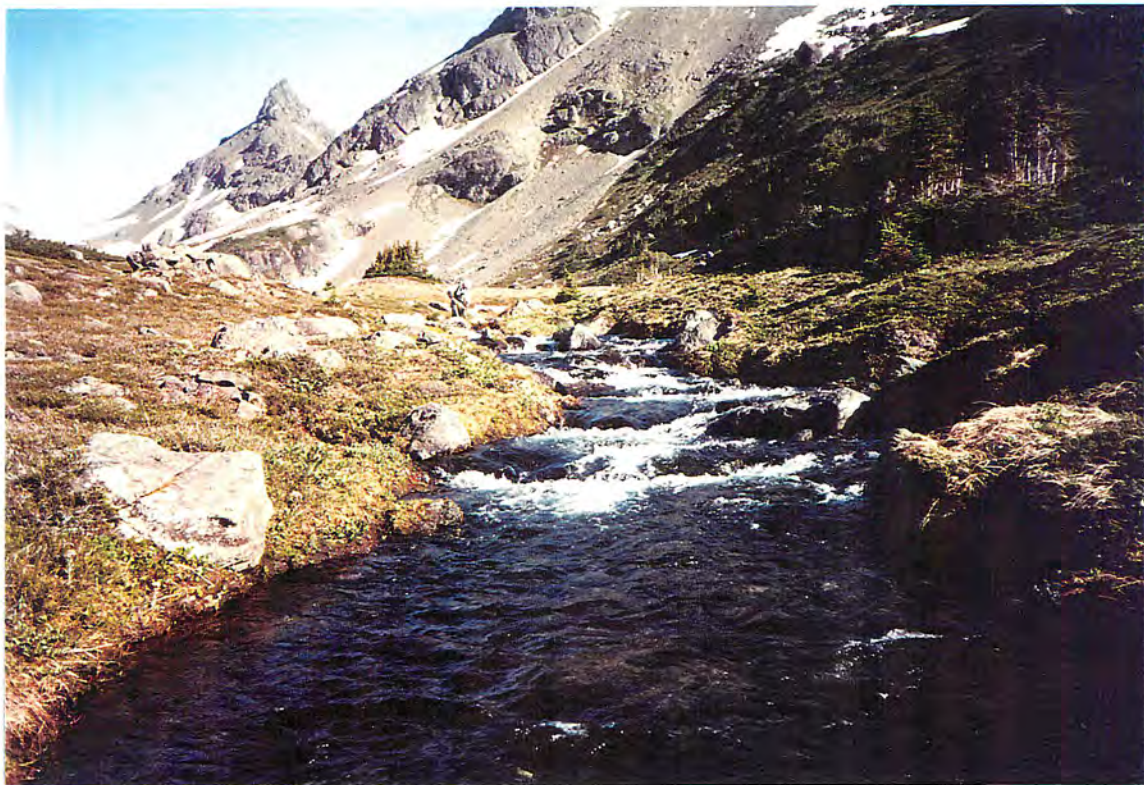
Photo #: J-1-4, 1996/07/25

Site #: J5, Looking upstream, cascade and pool habitat.

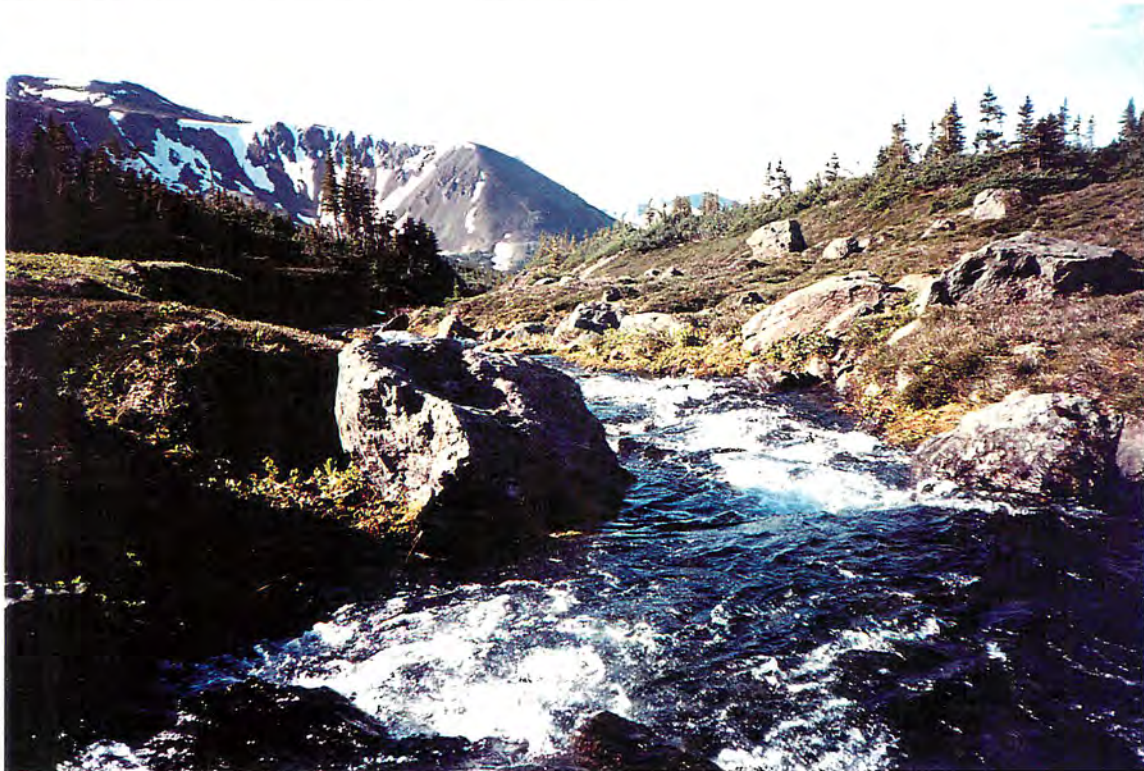
Photo #: J-1-5, 1996/07/25

Site #: J5, Looking downstream.

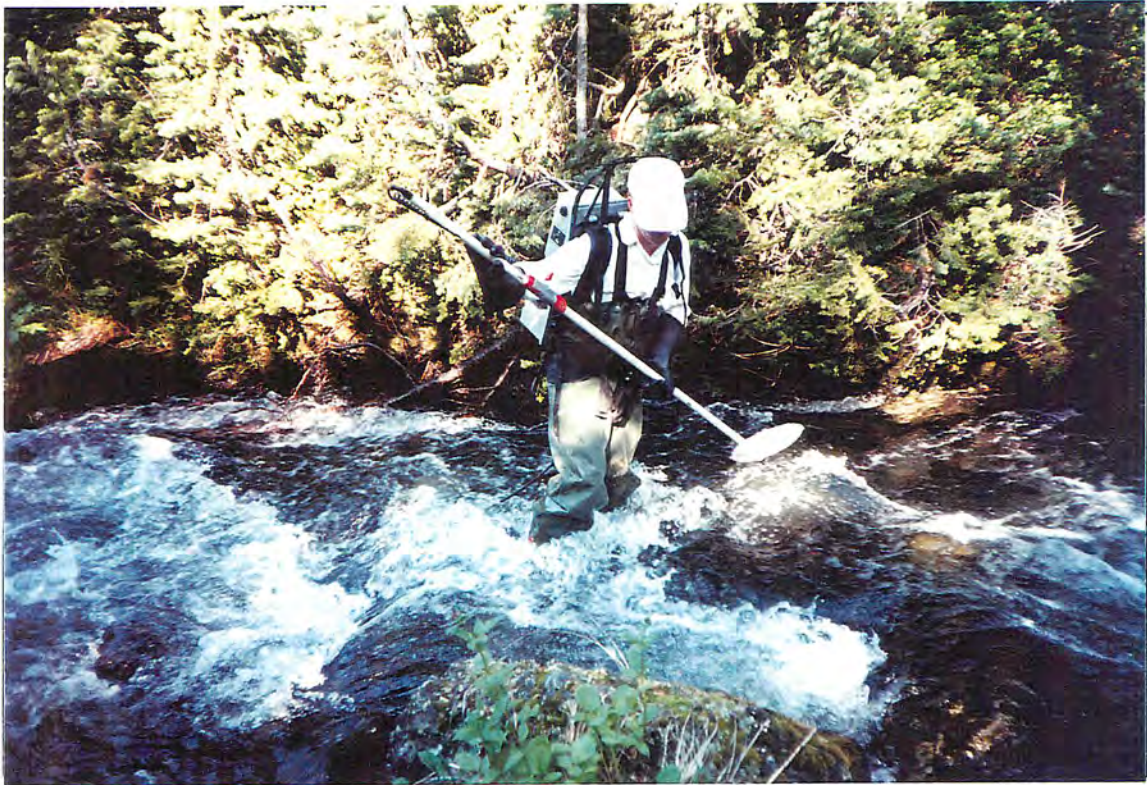
Photo #: J-1-6, 1996/07/25  
Site #: J6, Looking cross-stream.

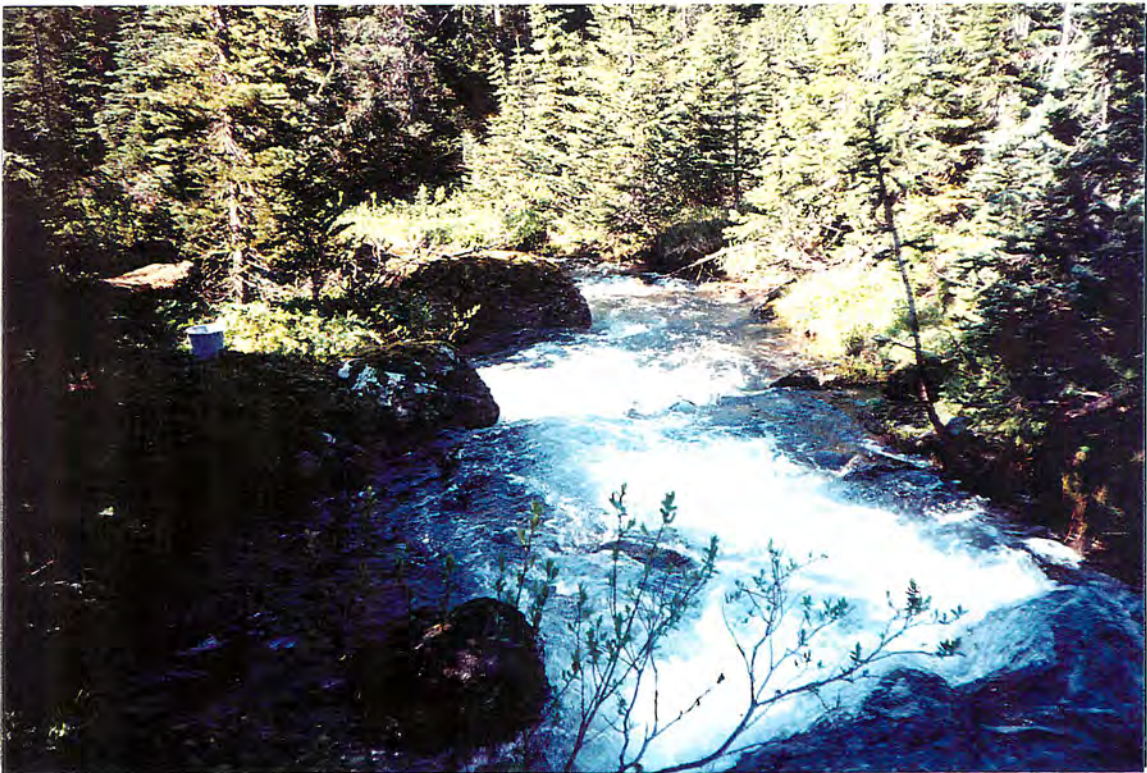
Photo #: J-1-7, 1996/07/25  
Site #: J6, Looking downstream.

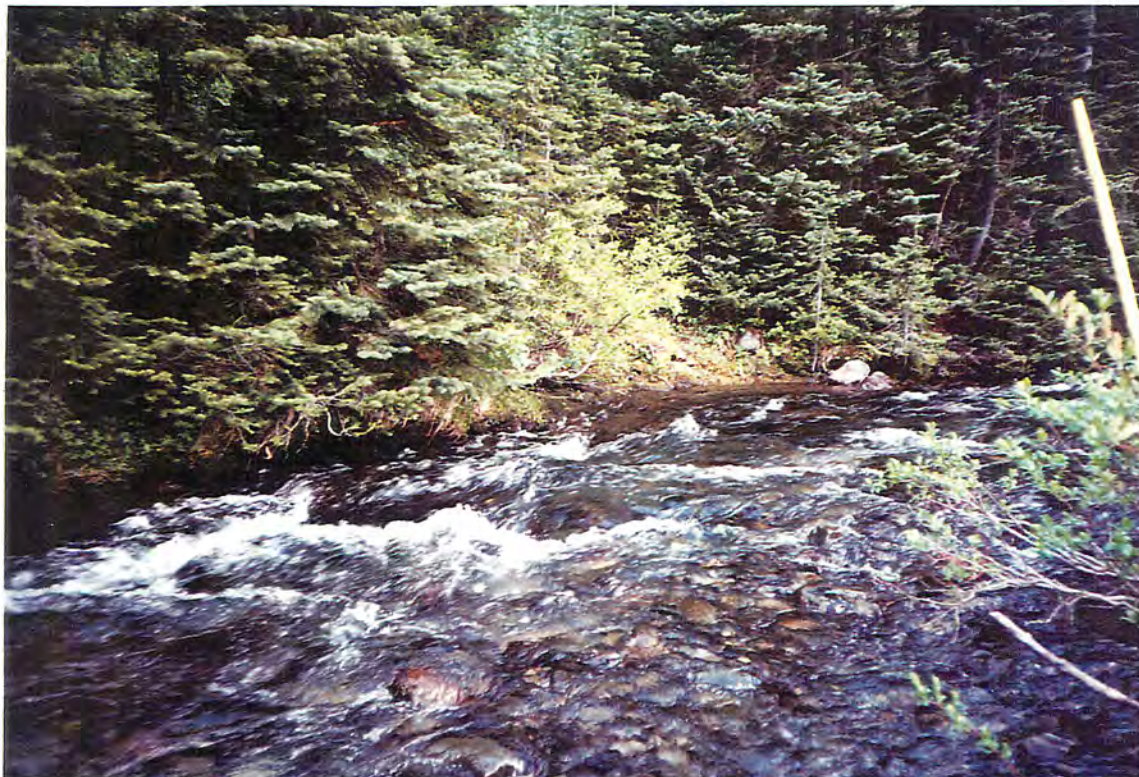
- C1 S5  
C2 LS = 15%, RS = 15%  
C3 No fisheries sensitive zones were noted at this site.  
C4 The electroshocking effort, using a 12 B POW model, was 771 seconds over 100 meters.  
C5 N 55 34'46 W 126 25'22  
C6 No additional bank texture information.  
C7 No pH, DO or conductivity tests were carried out. The water was clear to bottom. The mean air temperature on this day was 19.2°C  
C8 Large pools, caused by avalanche activity, were sampled at this site. Some good habitat under log jams was shocked extensively but no fish were caught. Steep Gradient was observed downstream of this site, which is located roughly 500 meters above an 8 meter falls. The gradient and falls barriers downstream of the sampling area have resulted in a non fish bearing classification for this reach.

Photo #: J-1-8, 1996/07/25  
Site #: J7, Looking upstream.

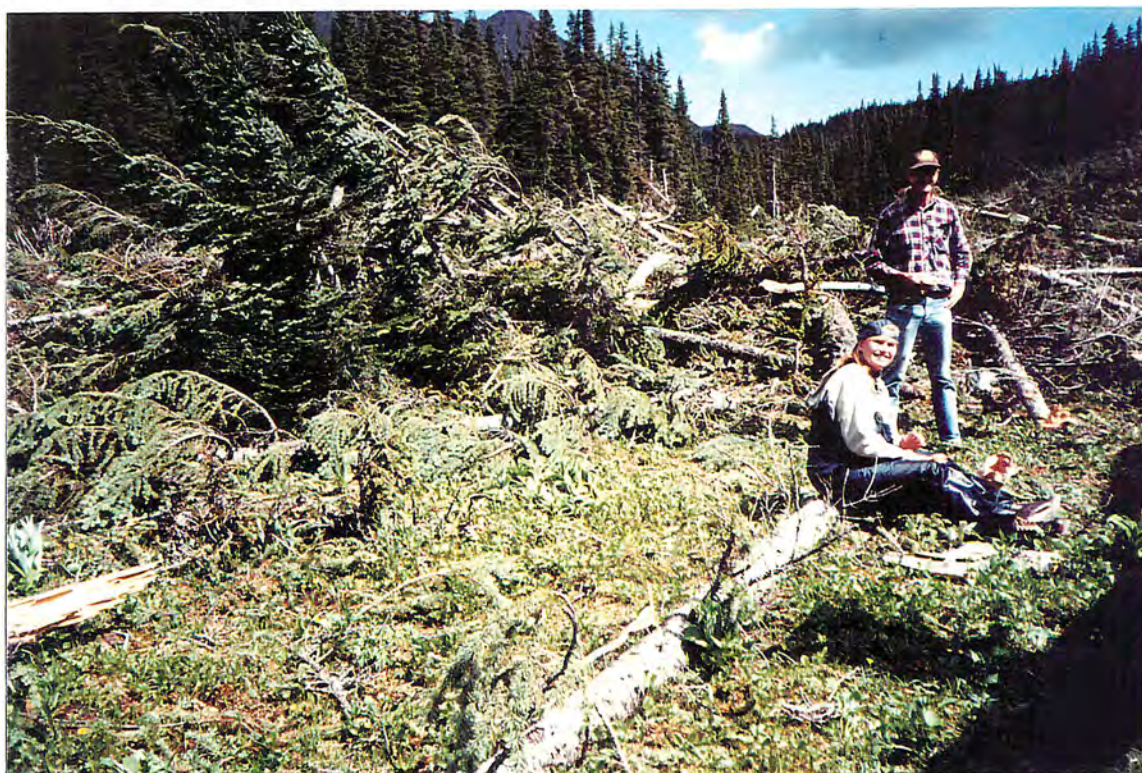
Photo #: J-1-9, 1996/07/25  
Site #: J7, Avalanche site at site J7

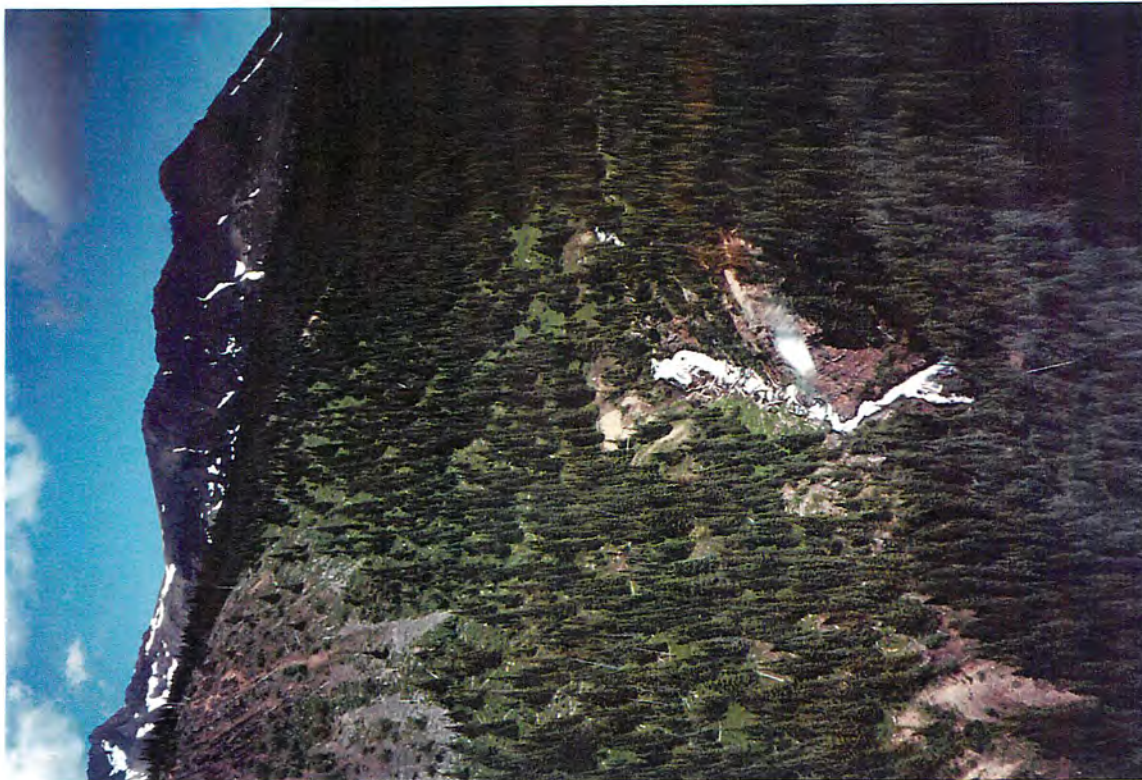
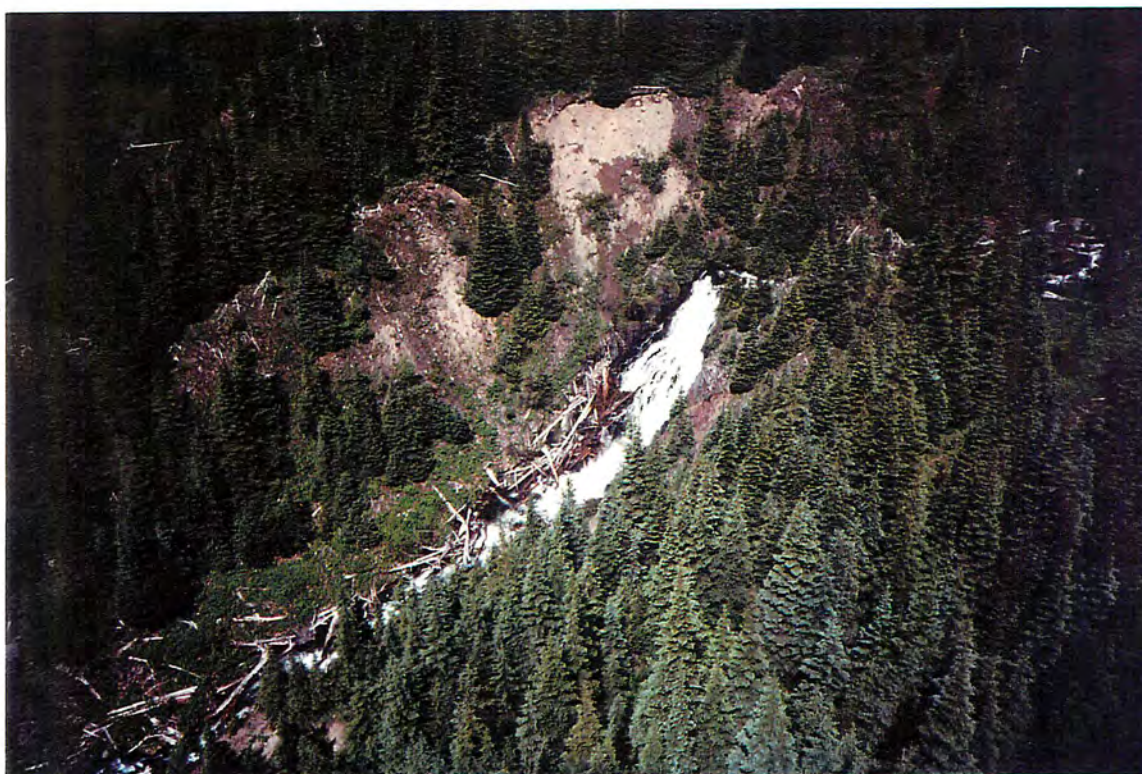
Site #: d/s J7, Barrier downstream of site J7.

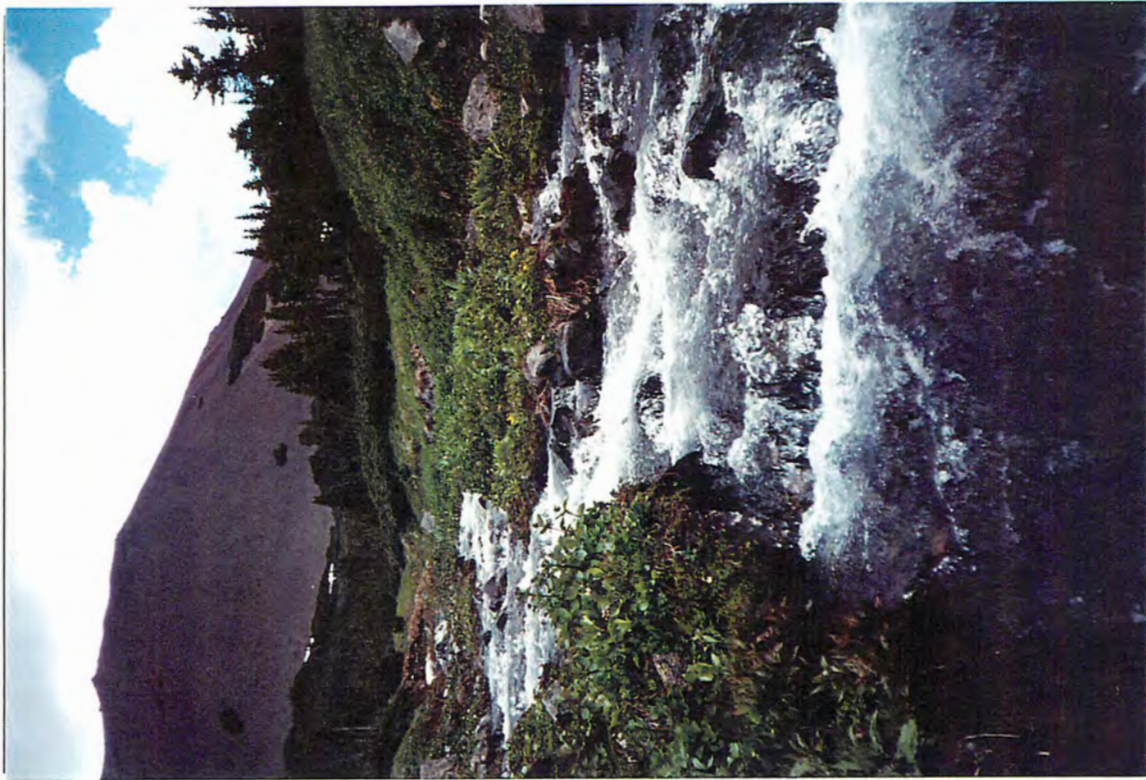
Photo #: J-1-13, 1996/07/25  
Site #: J8, Looking upstream.

C8 This site was evaluated on the ground and from the air. A steep gradient barrier was observed downstream of the sampling area, and has resulted in a non fish bearing classification for the reach.

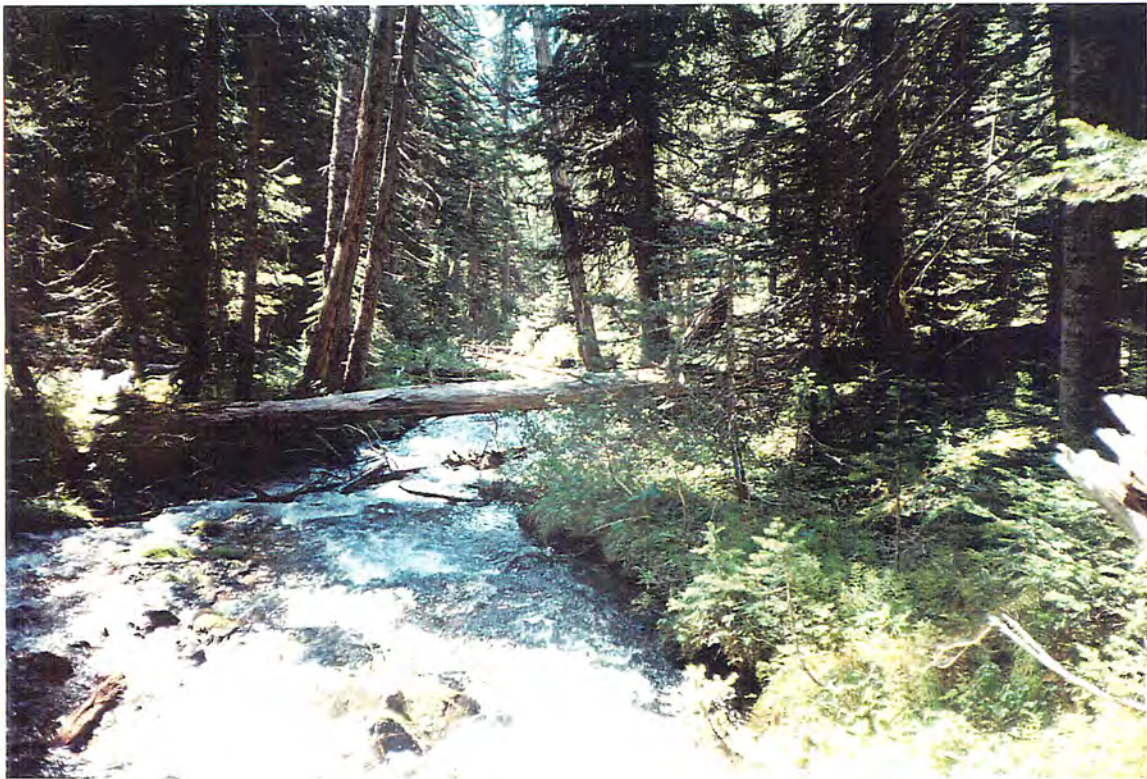
Photo #: R-1-4, 1996/07/25  
Site #: R3, Looking downstream.

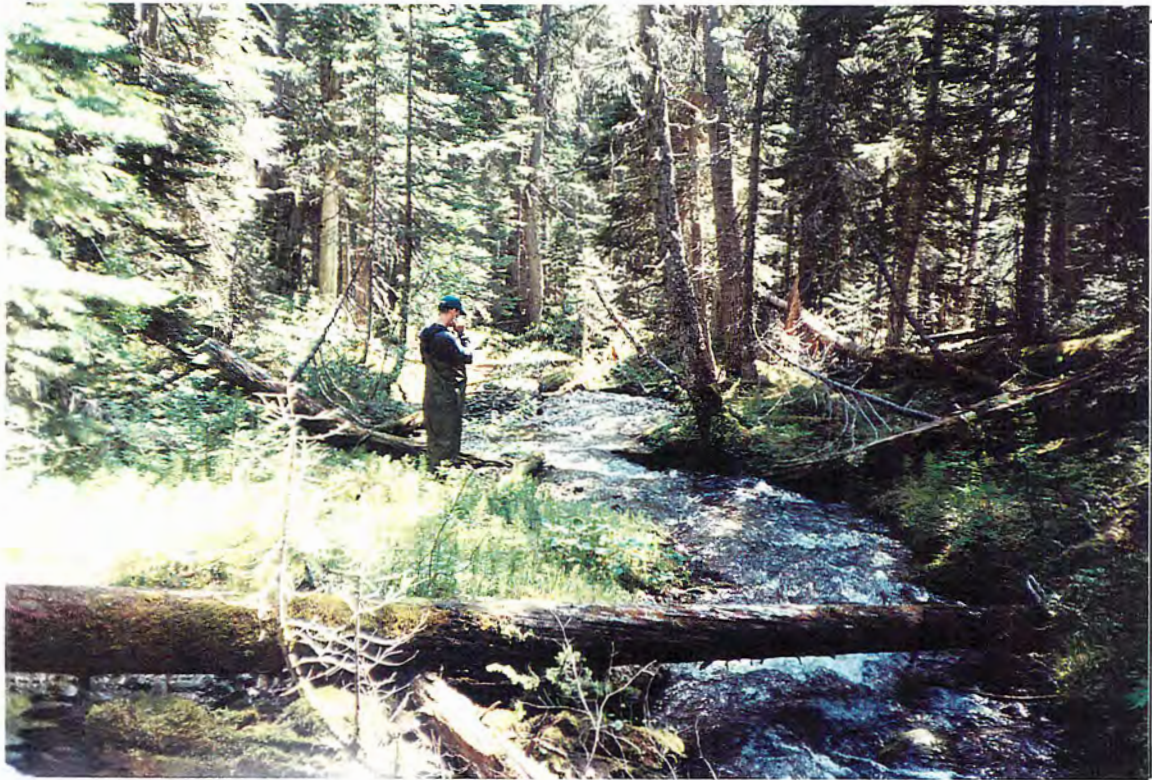
- C1 S3  
C2 LB - 12% RB - 28%  
C3 No fisheries sensitive zones were noted at this site.  
C4 This site was not electrofished a a Dolly Varden was caught at the junction of this tributary and the one sampled at R3.  
C5 Lat N 55 32' 55", Long W 126 28' 09"  
C6 No additional bank texture information.  
C7 DO, pH and conductivity were not measured at this site. The mean air temperature on this day was 19.2°C  
C8 Deep pools and overstream vegetation comprise most of the cover for fish at this site.

Photo #: R-1-5, 1996/07/25  
Site #: R4, Looking downstream.

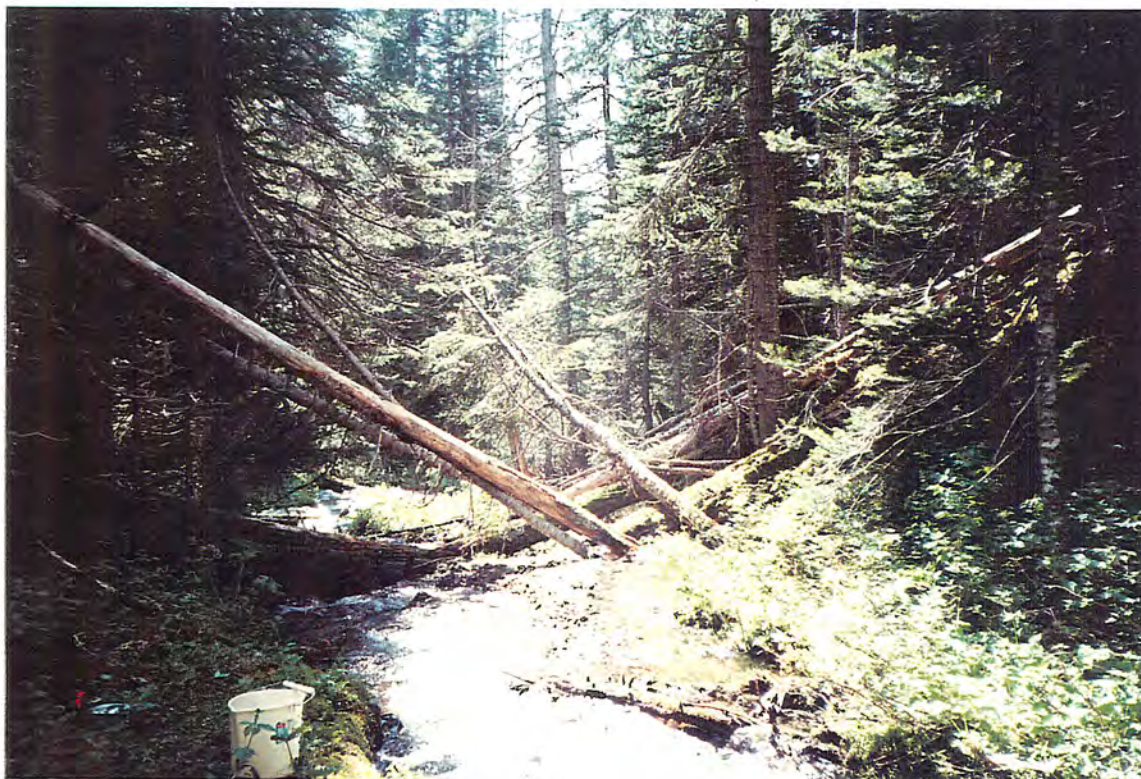
C8 A large falls, located 200 meters downstream from the confluence of the tributary sampled at R5 and the one sampled at R6, prevents fish passage upstream.

Photo #: R-1-6, 1996/07/25  
Site #: R5, Looking downstream.

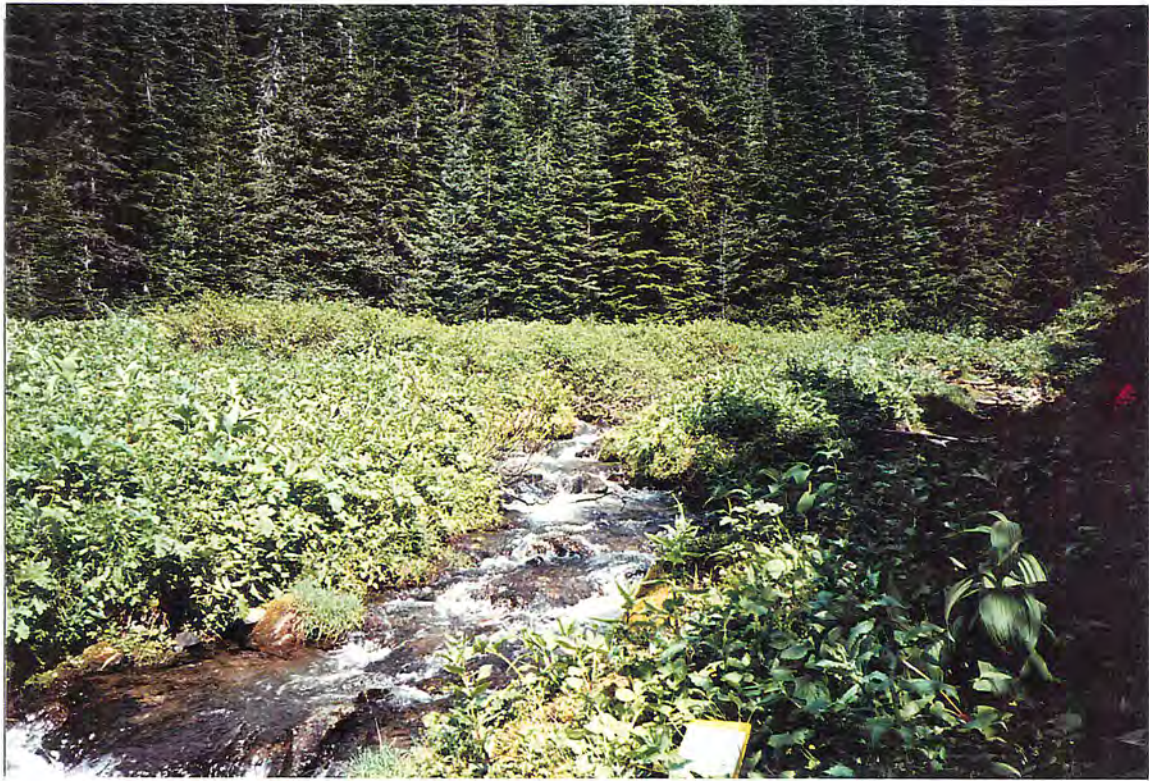
Photo #: R-1-7, 1996/07/25

Site #: R6, Looking upstream, channel through meadow.

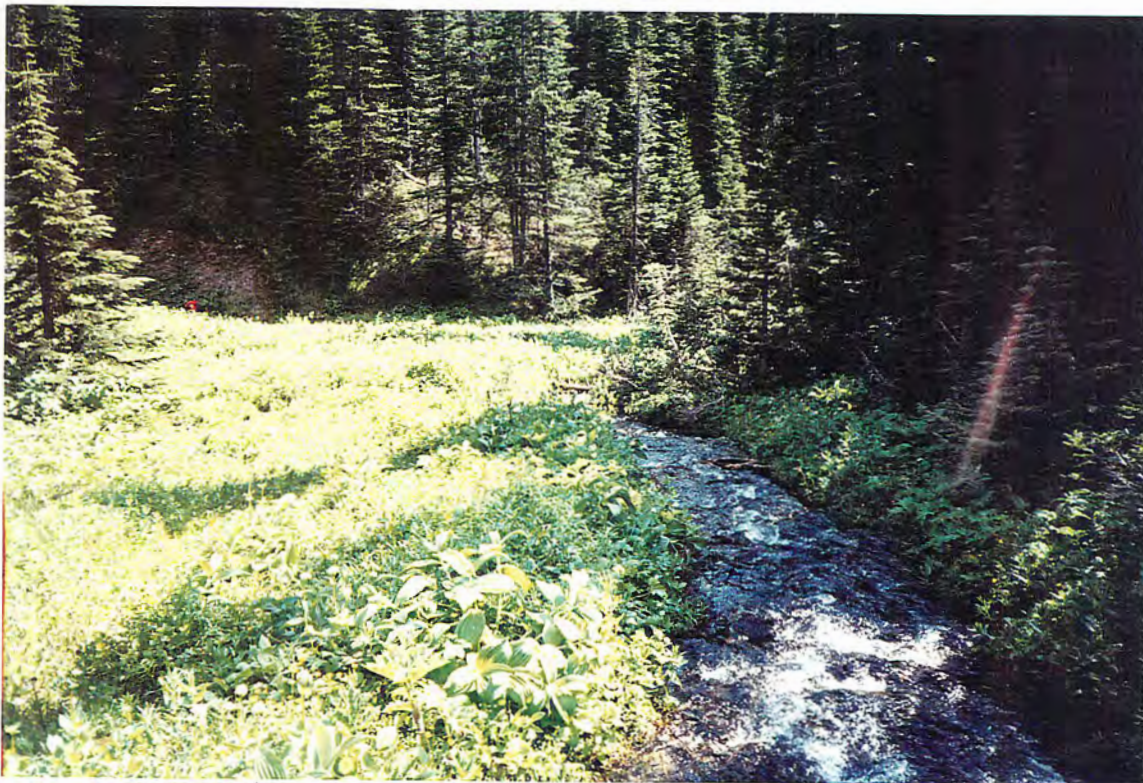
Photo #: R-1-8, 1996/07/25  
Site #: R7, Looking downstream.

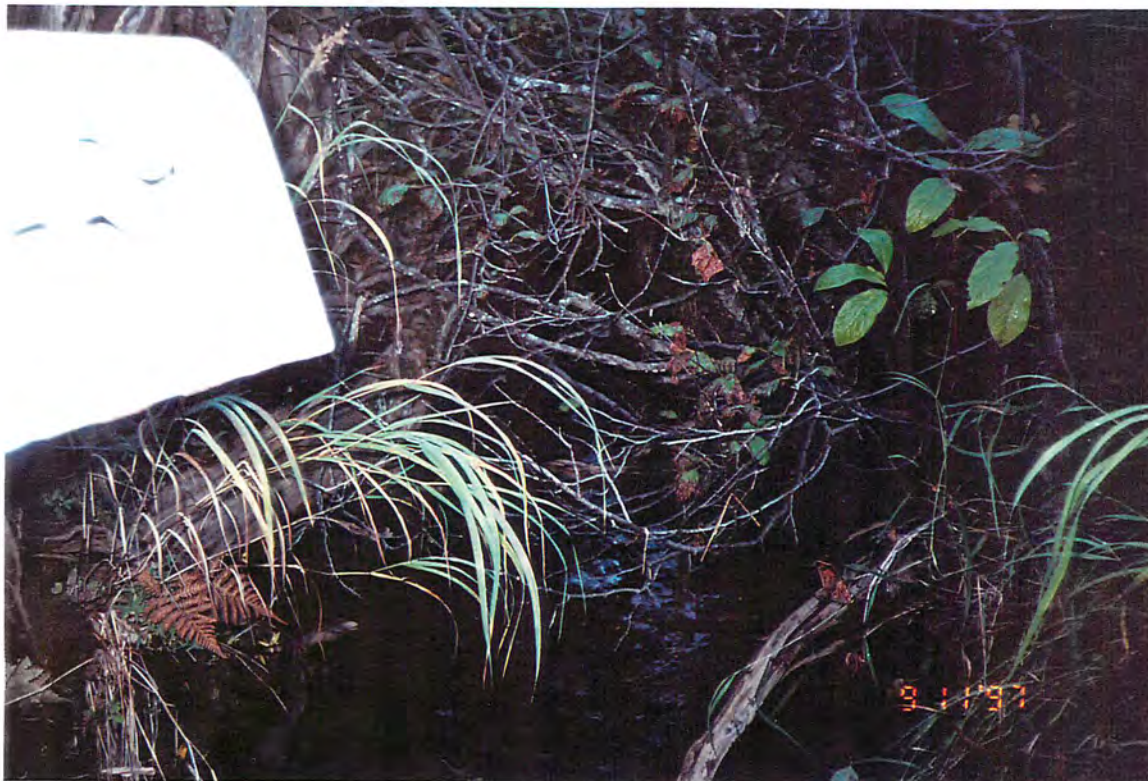
Photo #: E-28-7, 11-Sep-97

C7 This reach moves through an old burn. Rearing habitat is provided by deeply undercut banks, pools and LOD. Some spawning gravels were also noted.

Site #: E293, Looking upstream at the channel

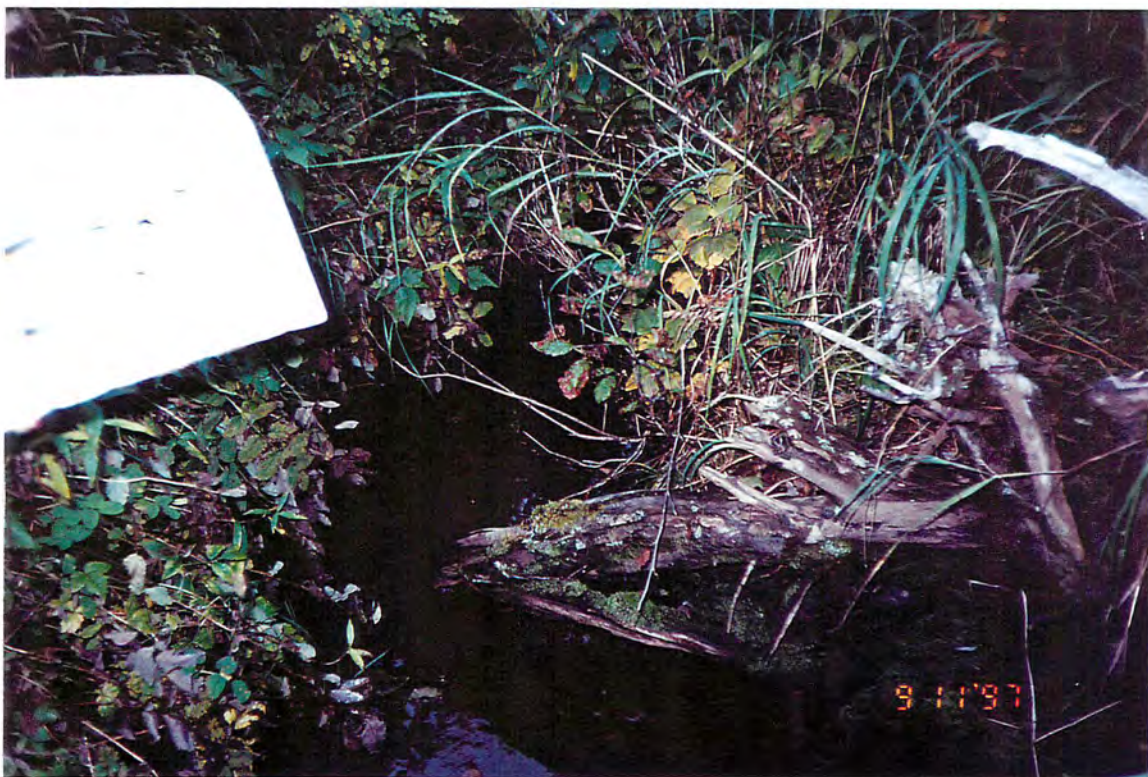
Photo #: E-28-8, 11-Sep-97

Site #: E293, Looking downstream at the channel
