# Reconnaissance Level Fish and Fish Habitat Inventory in the Bulkley T.S.A.

*(Working Unit #4 - Boucher)*

**Pacific Inland Resources (FRBC)**

April 1998

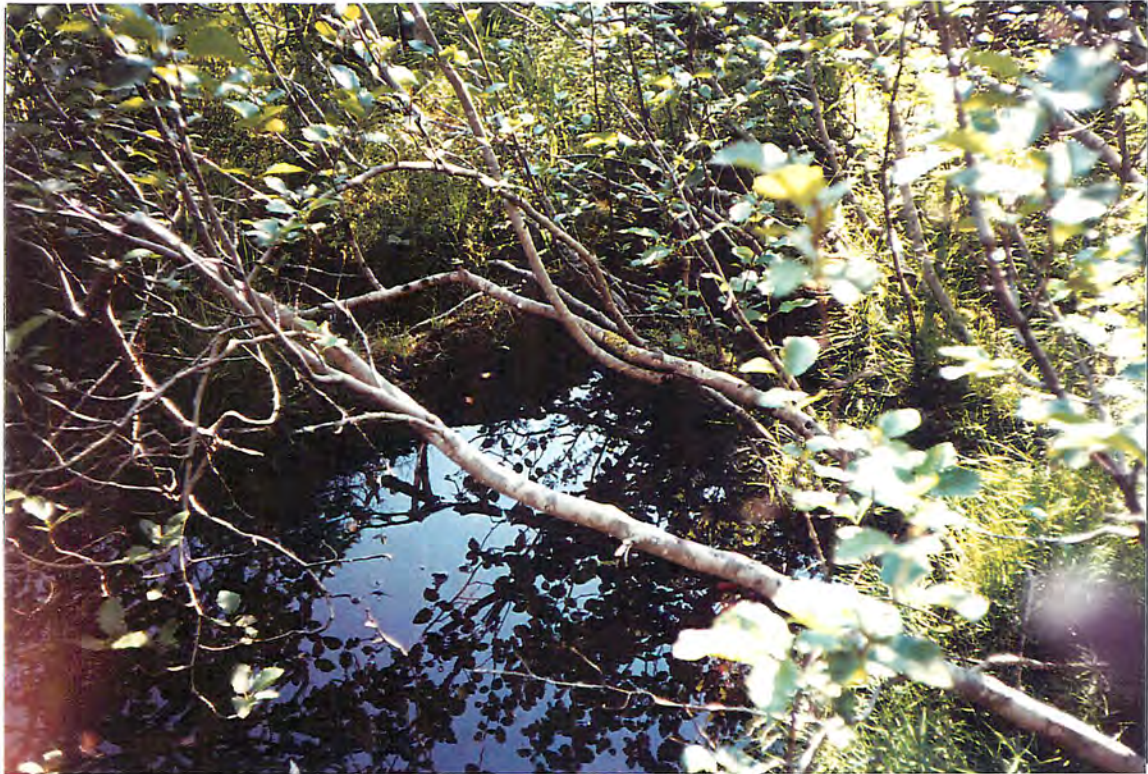
Photo #: J-1-25, 1996/07/27

- C1 NC  
 C2 LS=15, RS=15  
 C3 No fisheries sensitive zones were noted at this site.  
 C4 This site was not electrofished.  
 C5 Lat N 55 29' 40", Long W 126 33' 40"  
 C6 Bank texture not applicable.  
 C7 DO, pH, conductivity and turbidity were not measured at this site.  
 C8 No defined channel was observed at this site. The banks are not defined, this is an alder swale.

Site #: J19, Undefined channel, alder swale.

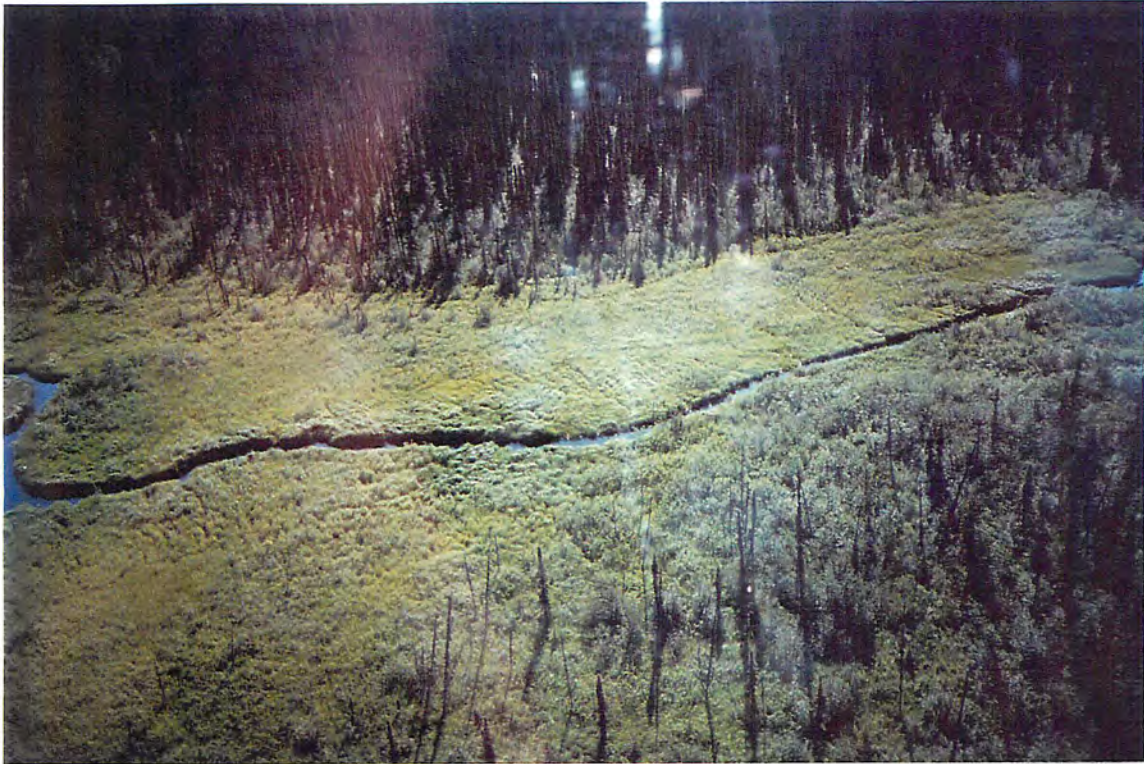
Photo #: J-1-26, 1996/07/27  
Site #: J20, Aerial photo of site J20.

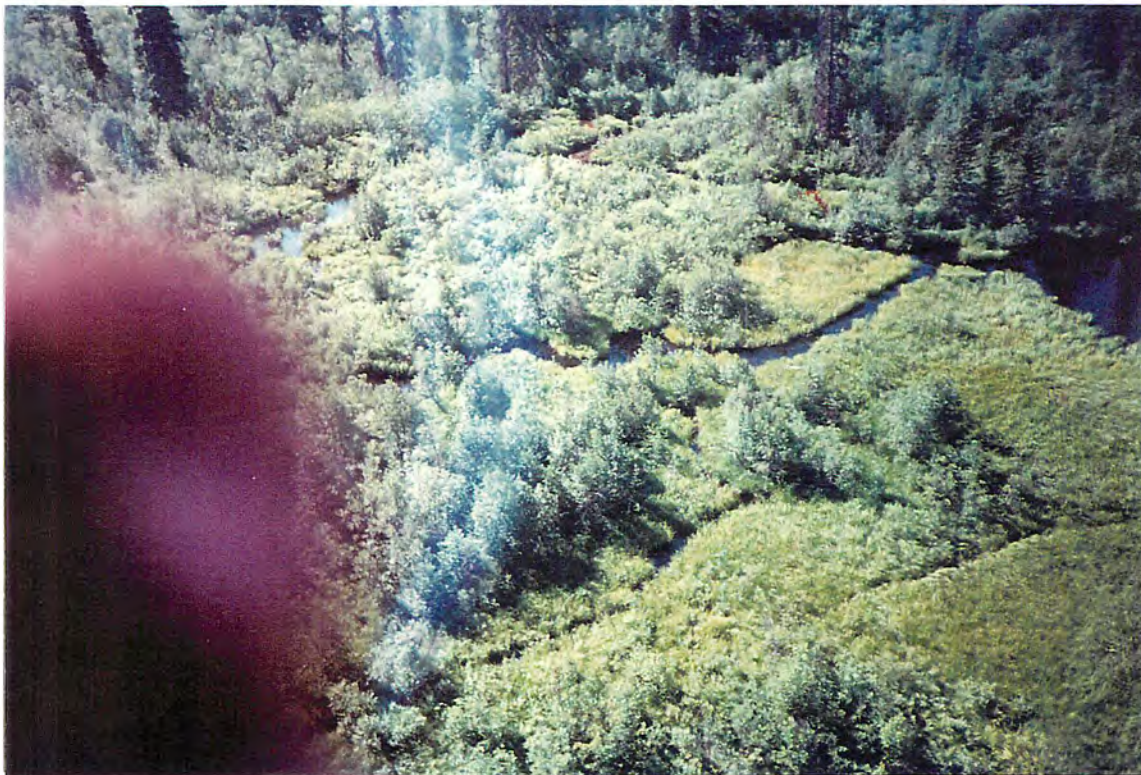
Photo #: J-2-1, 1996/07/27  
Site #: J21, Aerial photo of site J21.

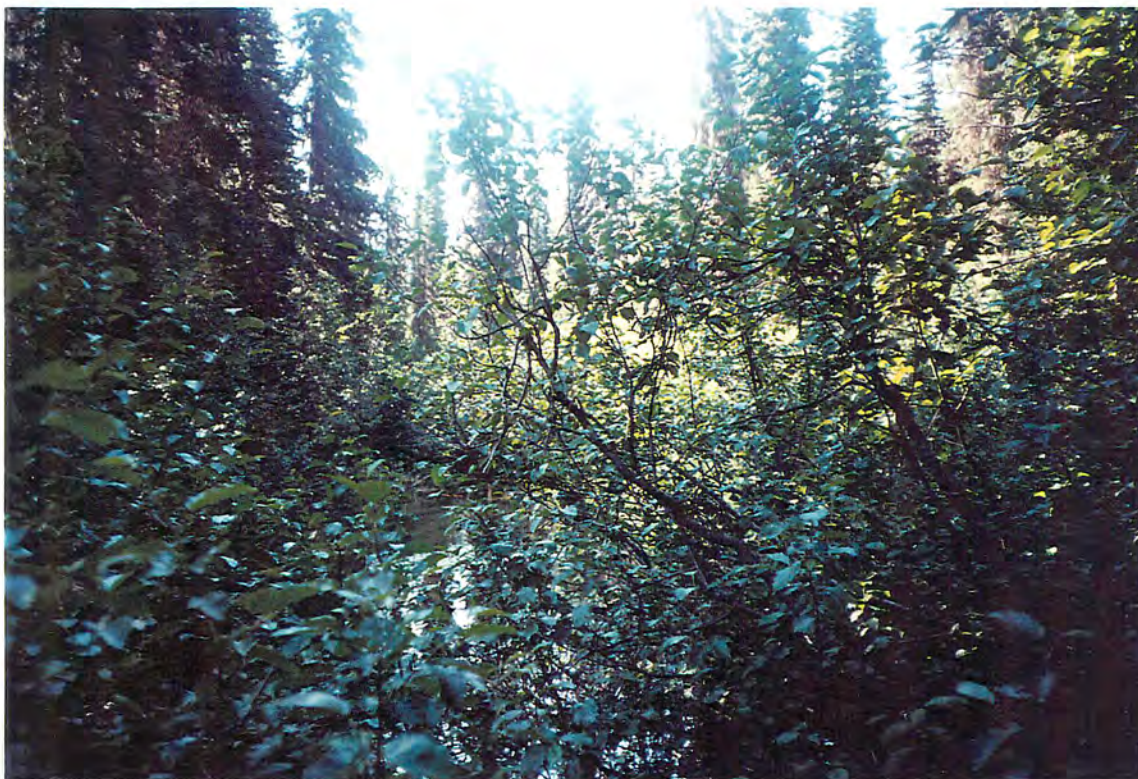
Photo #: R-1-13, 1996/07/27

C8: This site provides rearing habitat for rainbow trout.

Site #: R16, Looking downstream through alder.

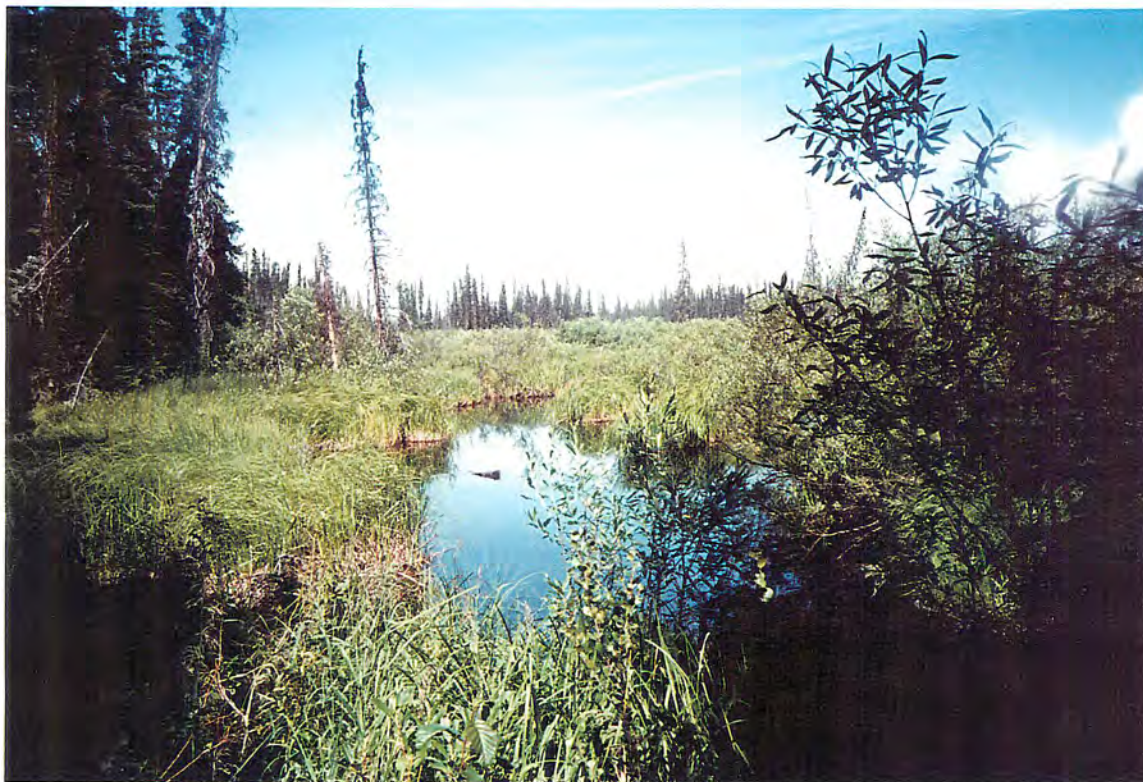
Photo #: R-1-14, 1996/07/27

Site #: R17, Looking upstream through marshy area.

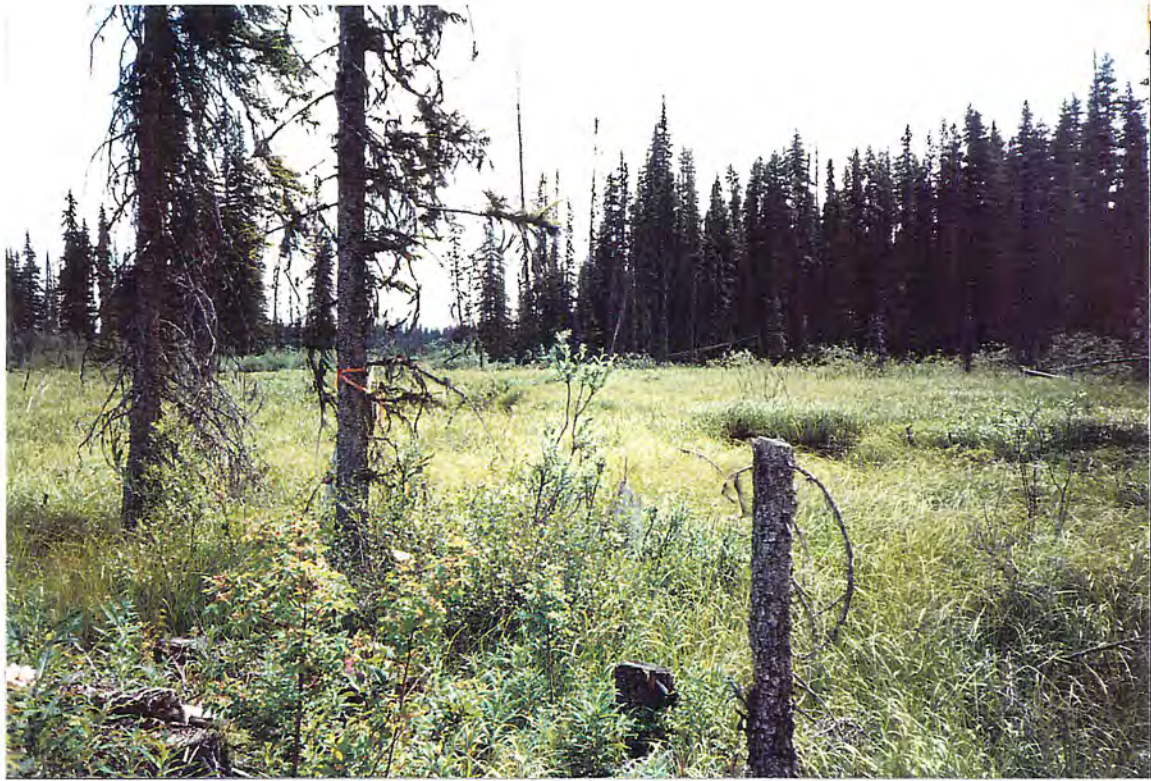
Photo #: R-1-15, 1996/07/27

C8: This site could provide rearing habitat for rainbow trout.

Site #: R18, Looking cross-stream through meadow.

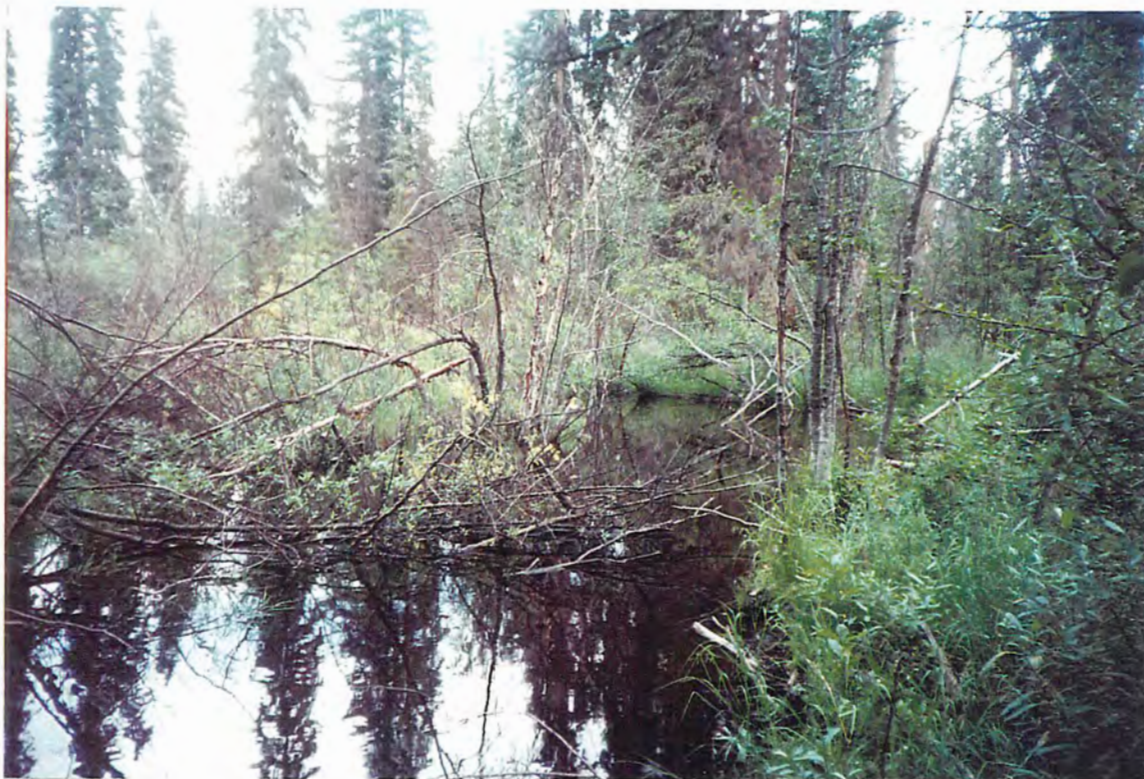
Photo #: R-1-16, 1996/07/27  
Site #: R19, Beaver dam.

- C1 S3. A defined channel was not observed at this site, however, a fish bearing classification has been applied because it is a part of a large area of interconnected swamps, supporting rainbow trout and sucker sp.
- C2 The side slopes were not measured at this site.
- C3 This site is associated with an extensive marsh.
- C4 This site was not electrofished. Bank instability and deep water made electroshocking dangerous.
- C5 N 55 27' 28" W 126 35' 49.4"
- C6 No additional bank texture information.
- C7 DO, pH and conductivity were not measured at this site.
- C8 No defined channel was observed in the sampling area, however, this area is associated with some extensive marsh and no barriers were noted to channels nearby. As such this site has been classified as fish bearing.

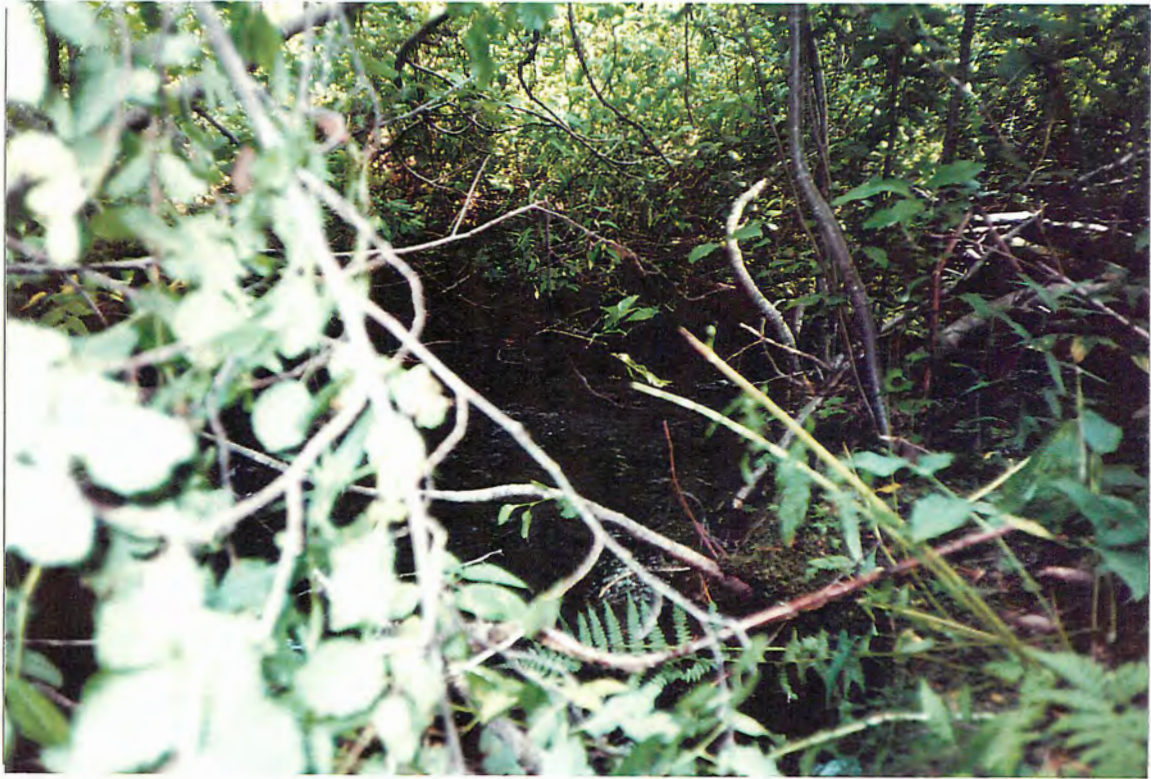
C8 Overstream vegetation and boulders provide most of the cover for fish at this site. A large amount of LOD was noted.

Photo #: J-2-6, 1996/07/27  
Site #: J26, Channel through alder.

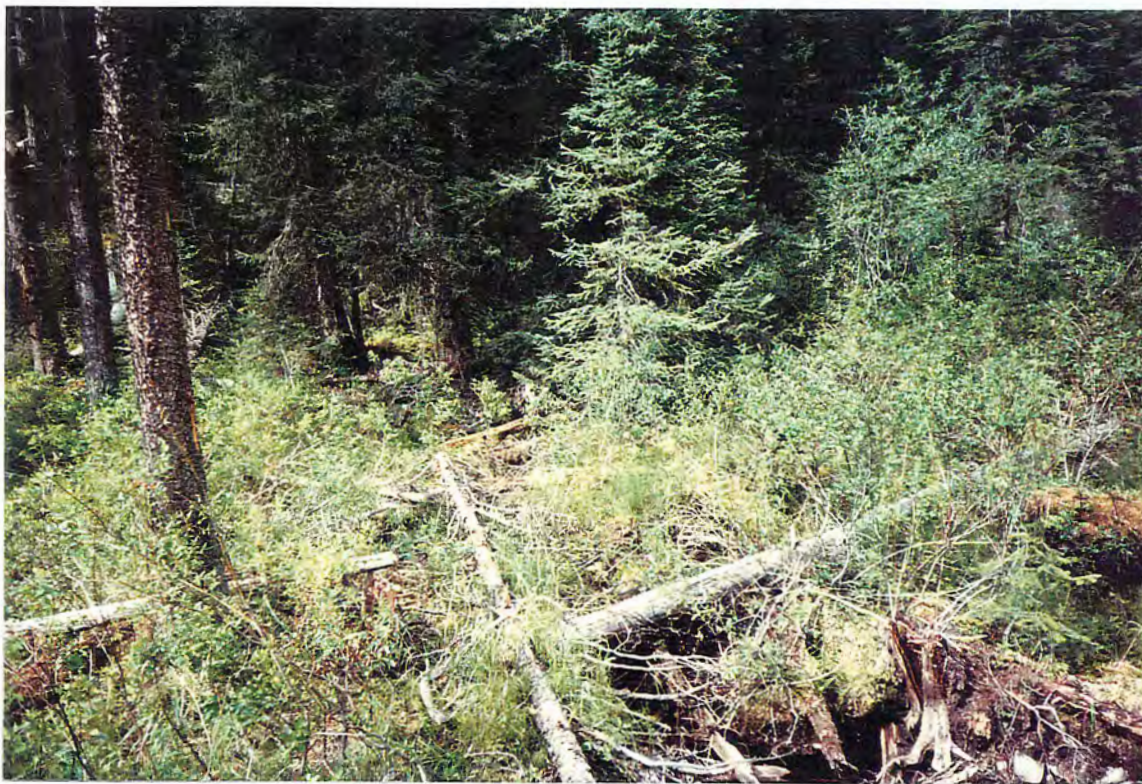
Photo #: R-1-17, 1996/07/27

C8 This site has some fair rearing habitat. The culvert would be a barrier to fish passage at low water.

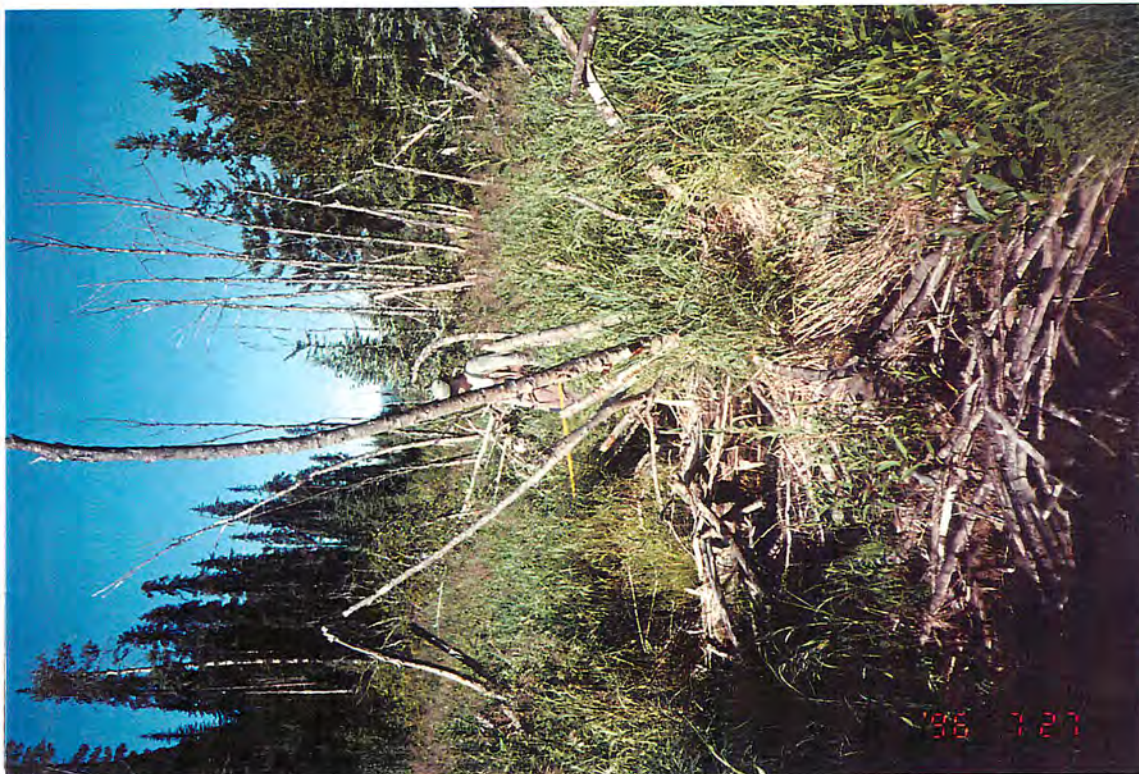
- C1: S4
- C2: LS=1, RS=2
- No fisheries sensitive zones noted.
- C4: The electroshocking effort, using a Smithroot 15 A model was 523 seconds over 150 meters. This site was also minnow trapped.
- C5: Lat N 55 25' 34.4", Long W 126 42' 57.3"
- C6: No additional bank texture information.
- C7: DO, pH and conductivity were not measured at this site. The mean air temperature on this day was 19.8°C
- C8: This site has some excellent rearing cover. LOD is particularly abundant.

Photo #: H-1-8, 1996/07/27  
Site #: H7, Looking upstream.

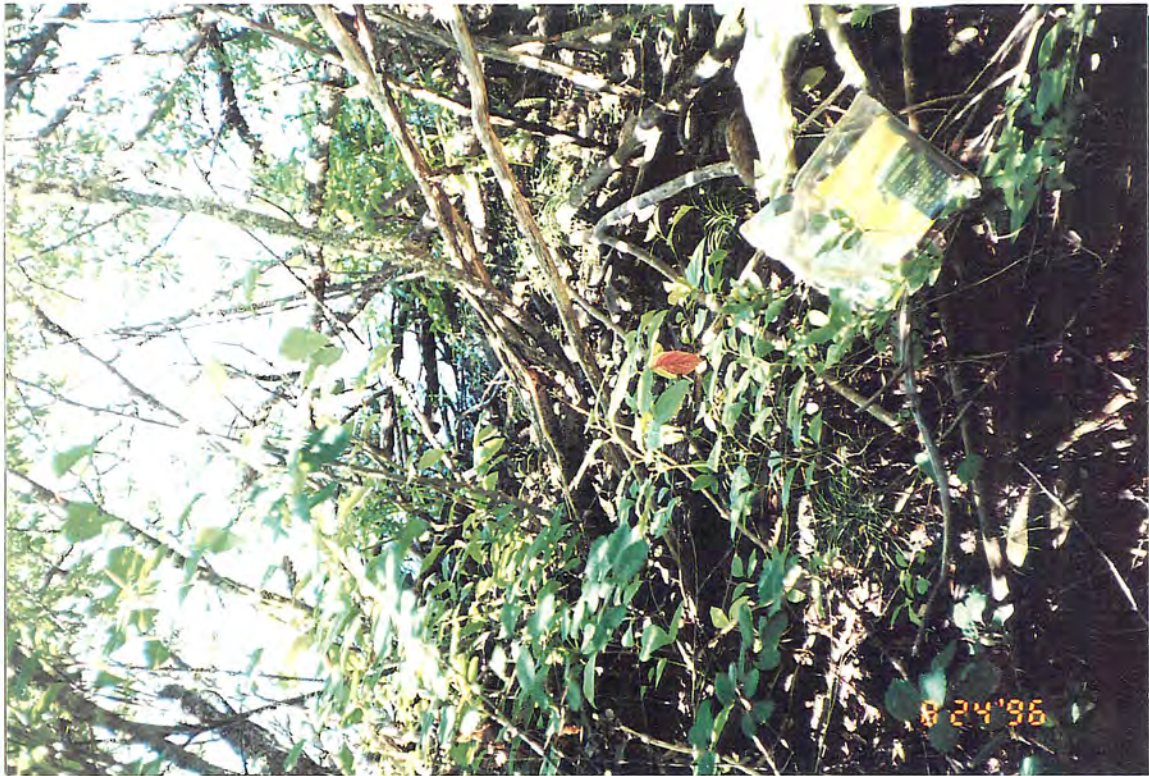
Photo #: P-10-19, 1996/08/24  
Site #: P110, Downstream view.

- C1: S4  
C2: LS - 45% RS - 70%  
C3: No fisheries sensitive zones noted.  
C4: This dry site was not electrofished.  
C5: Lat N 55 19' 34" Long W 126 37' 43"  
C6: No additional bank texture information.  
C7: Water quality not applicable. The mean air temperature on this day was 12.5°C  
C8: This site is accessible to fish and could provide seasonal rearing. Future sampling is recommended.

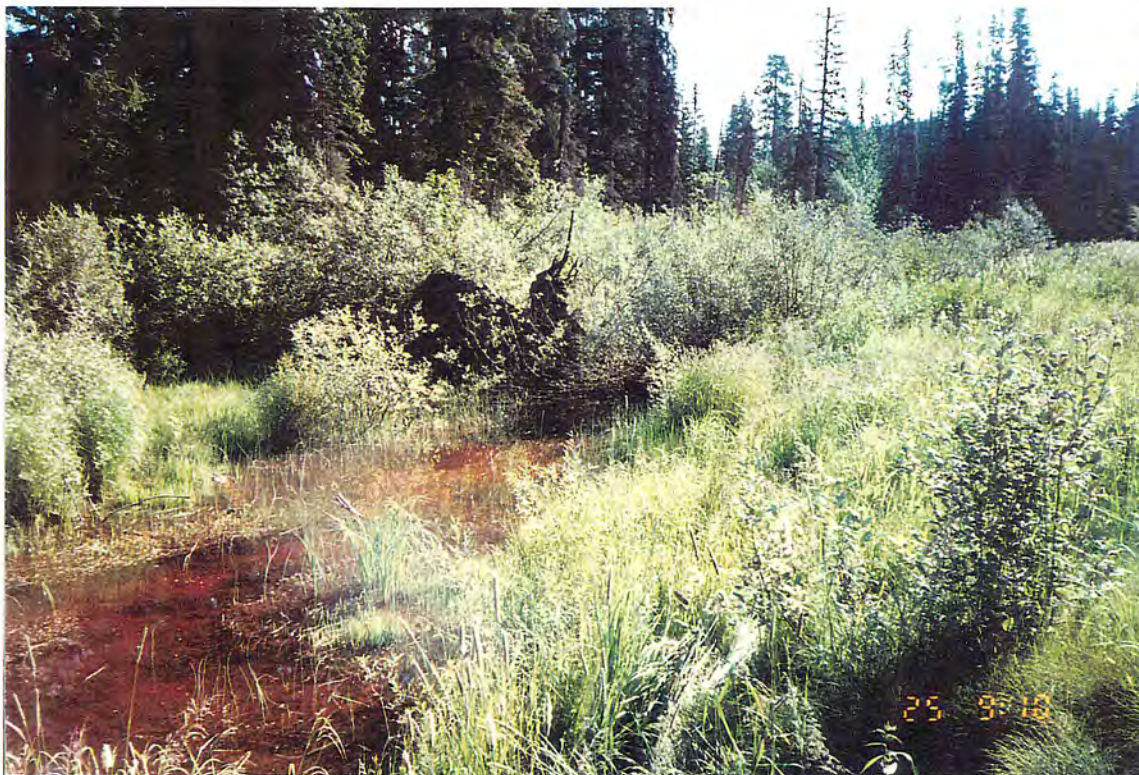
Photo #: T-1-4, 1996/07/25  
Site #: T2, Channel.

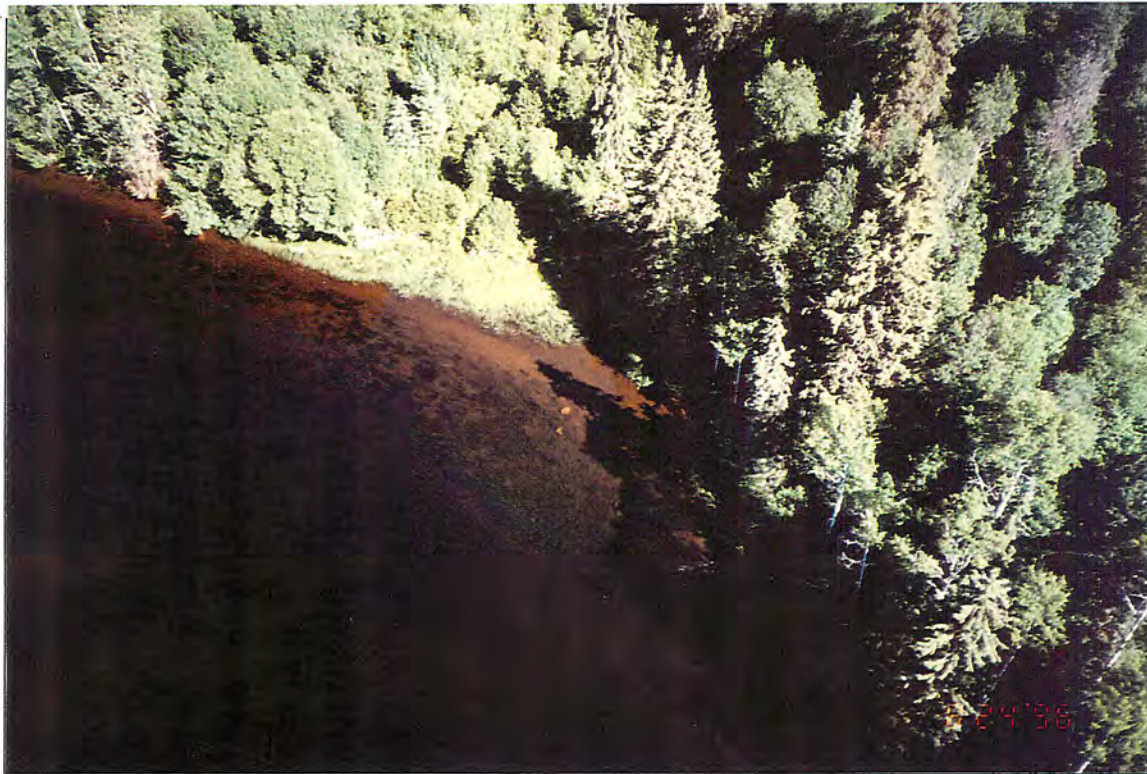
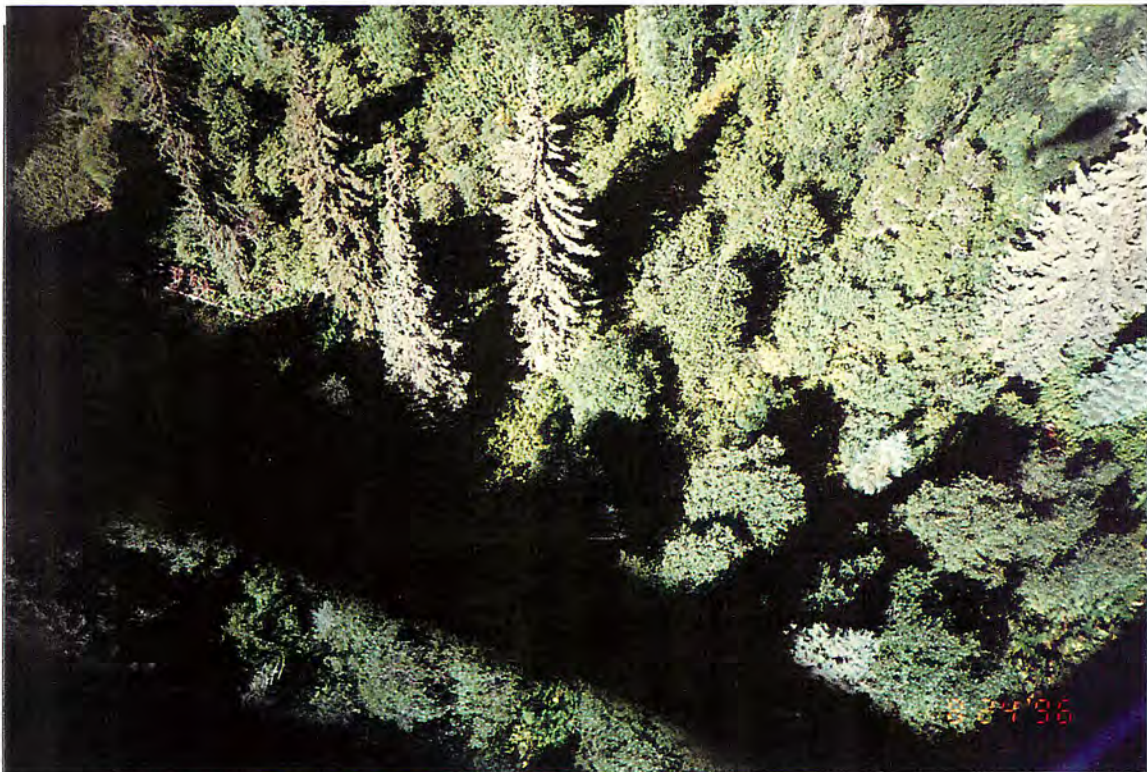
- C1 S4  
C2 LS - 30% RS - 30%  
C3 No fisheries sensitive zones noted.  
C4 This site was not electrofished.  
C5 Lat N 55 20' 20" Long. W 126 38' 00"  
C6 No additional bank texture information.  
C7 Water quality not applicable. The mean air temperature on this day was 12.5°C  
C8 This site has very bad access. A small dry channel may extend 200 meters upstream. Then the drainage becomes an alder swale with no defined channel.  
C9 Gravel deposits were not observed near the mouth. The entire area would be vulnerable to siltation. Adult salmon were observed in the Babine River.

Photo #: J-10-19, 1996/08/24  
Site #: J156, Aerial photo of J156.

Photo #: J-10-20, 1996/08/24  
Site #: J156, Aerial photo of J156.

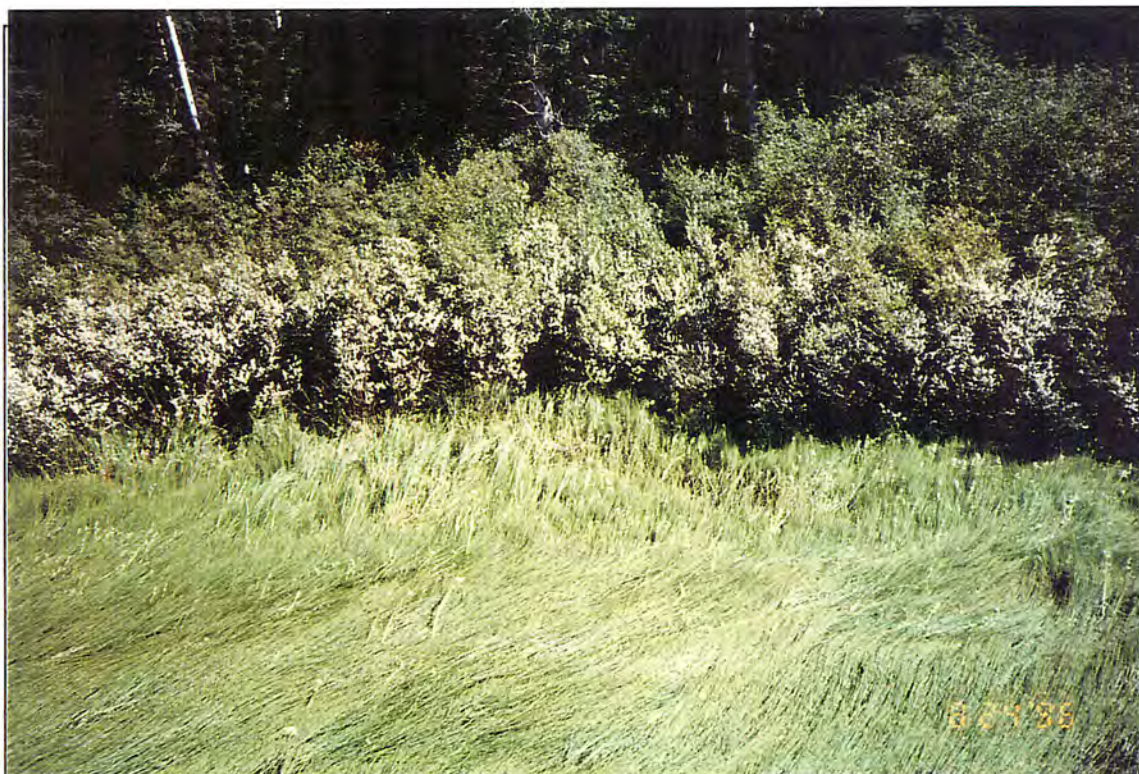
Photo #: J-10-21, 1996/08/24

Site #: J157, Photo taken from helicopter at ground level.

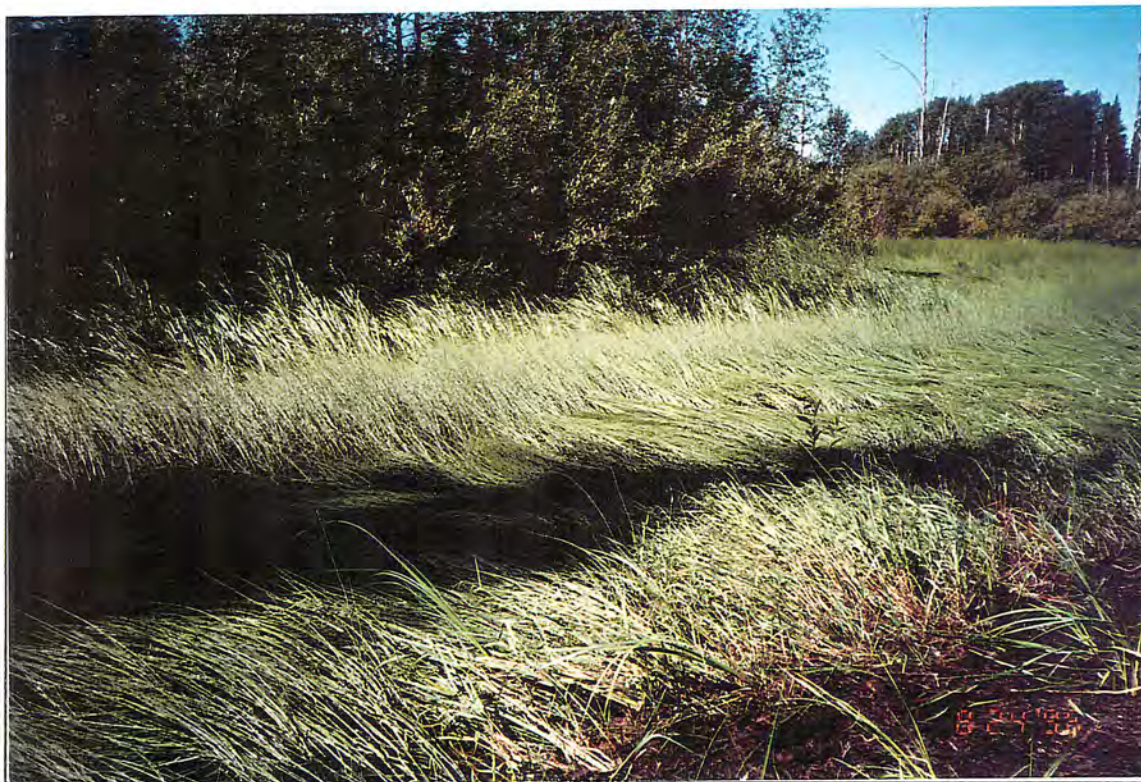
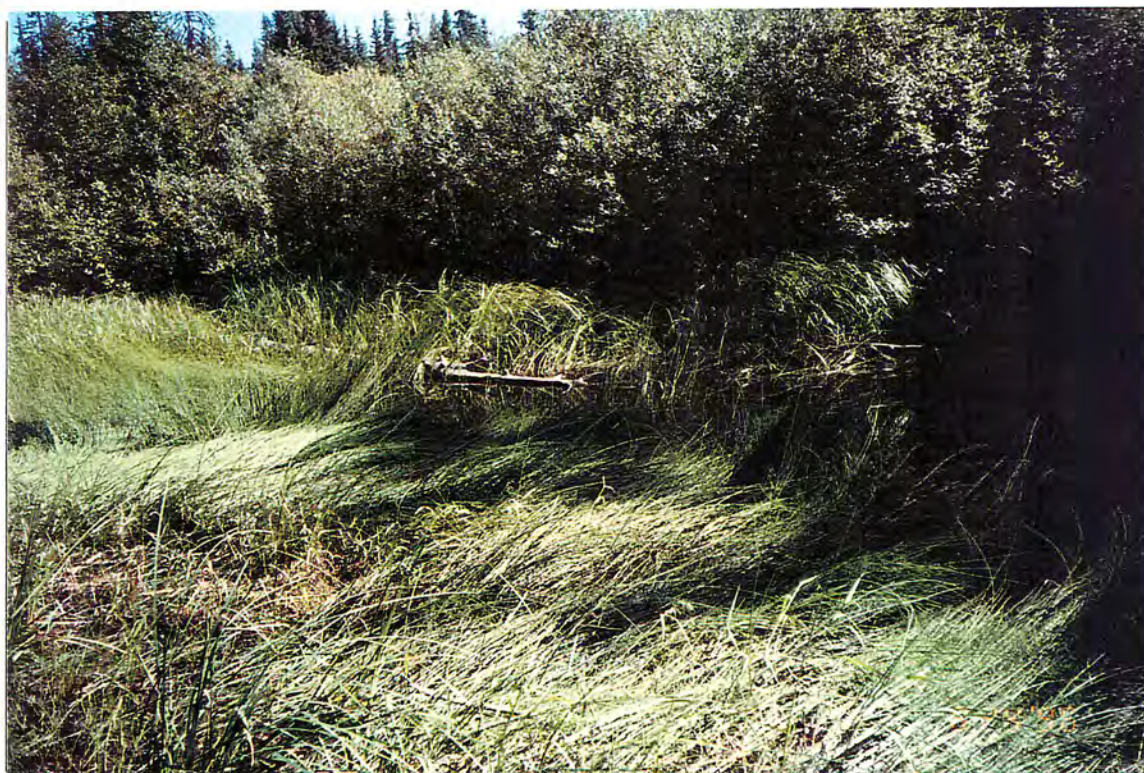
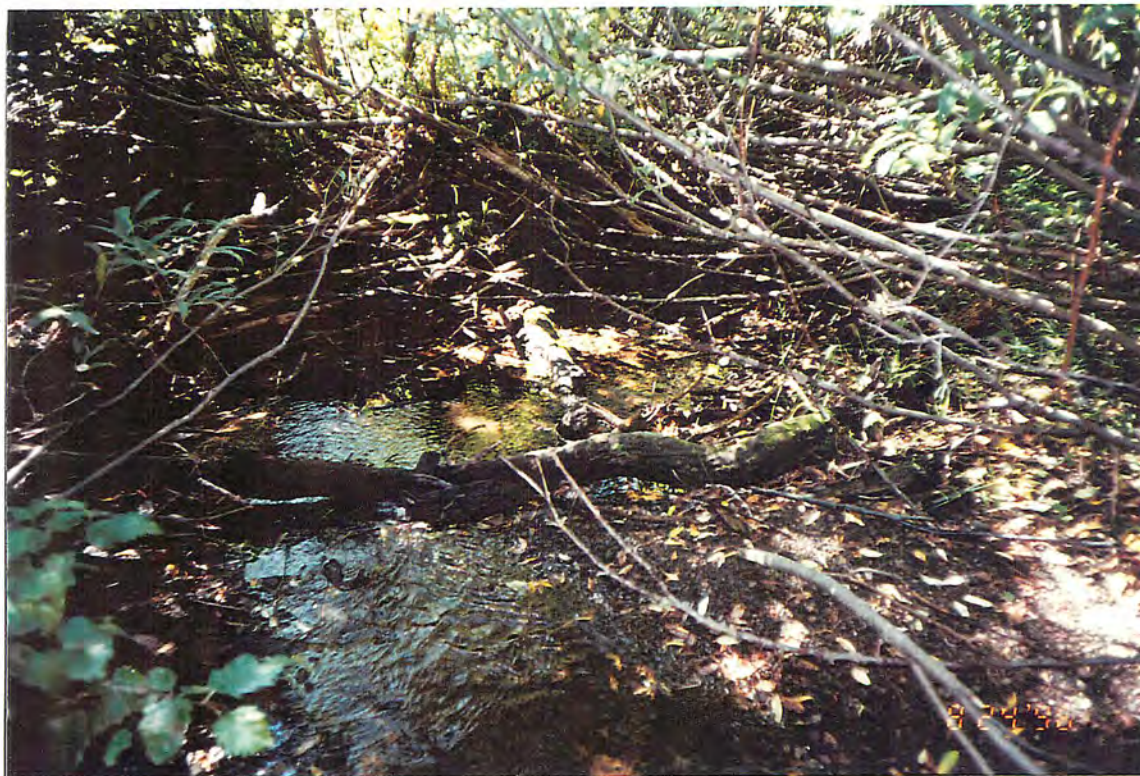
- C1 S3 \* An S2 classification is recommended for this highly productive site.
- C2 LS- 3% RS - 3%
- C3 No fisheries sensitive zones noted.
- C4 The 200 mm fish caught at this site was suspected to be a rainbow trout. The fish were visually observed as the shocking conditions were poor at this site.
- C5 Lat. N 55 21' 01.2" Long W 126 38' 13.1"
- C6 No additional bank texture information.
- C7 DO, pH and conductivity were not measured. The mean air temperature on this day was 12.5°C
- C8 This site has some excellent rearing habitat.

Photo #: J-10-22, 1996/08/24  
 Site #: J158, Photo taken from helicopter at ground level.

Photo #: J-10-23, 1996/08/24  
 Site #: J158, Looking downstream, channel through grassy area.

Site #: J158, Looking downstream toward grassy area.

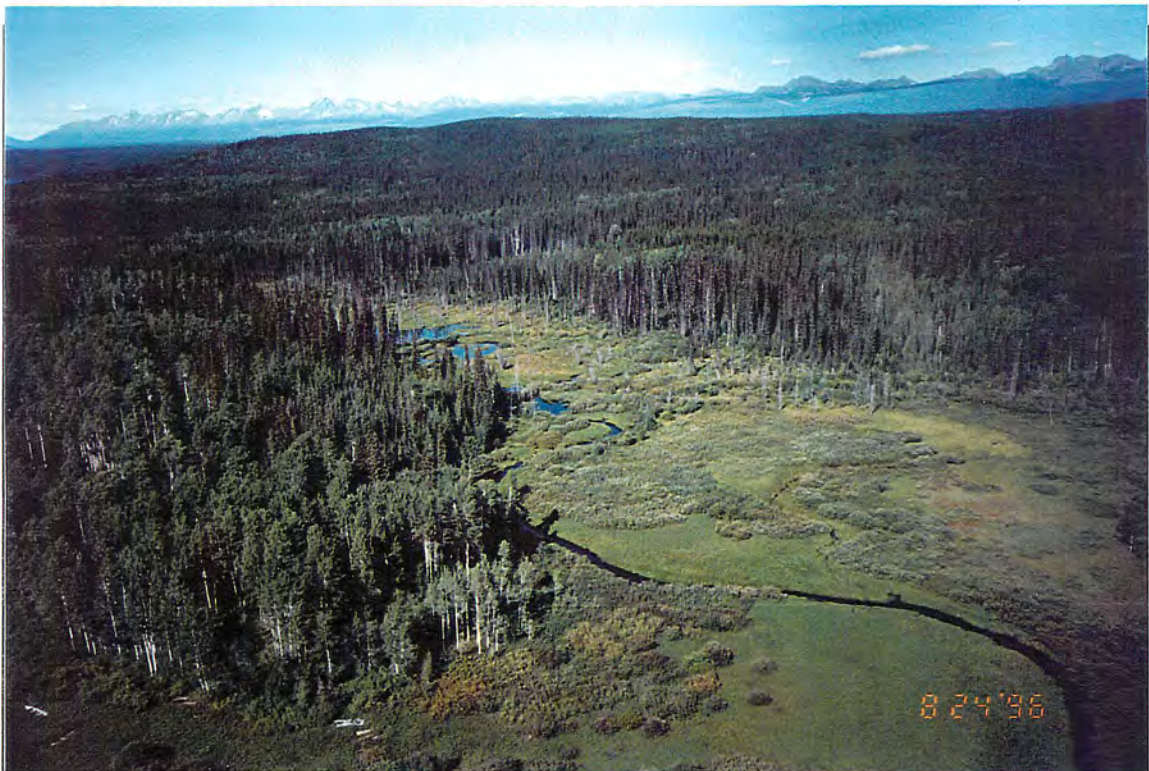
- C1: S3  
C2: LS -0% RS - 0%  
C3: No fisheries sensitive zones noted.  
C4: This site was not electrofished.  
C5: Lat. N 55 29 53.1, Long W 126 31' 37.8"  
C6: No additional bank texture information.  
C7: Water quality was not evaluated. The mean air temperature on this day was 12.5°C  
C8: This site could provide rearing habitat for rainbow trout. The channel drains through grasses and horsetails. No spawning gravel was observed near the mouth.

Photo #: J-11-2, 1996/08/24  
Site #: J161, Aerial photo, channel through meadow.

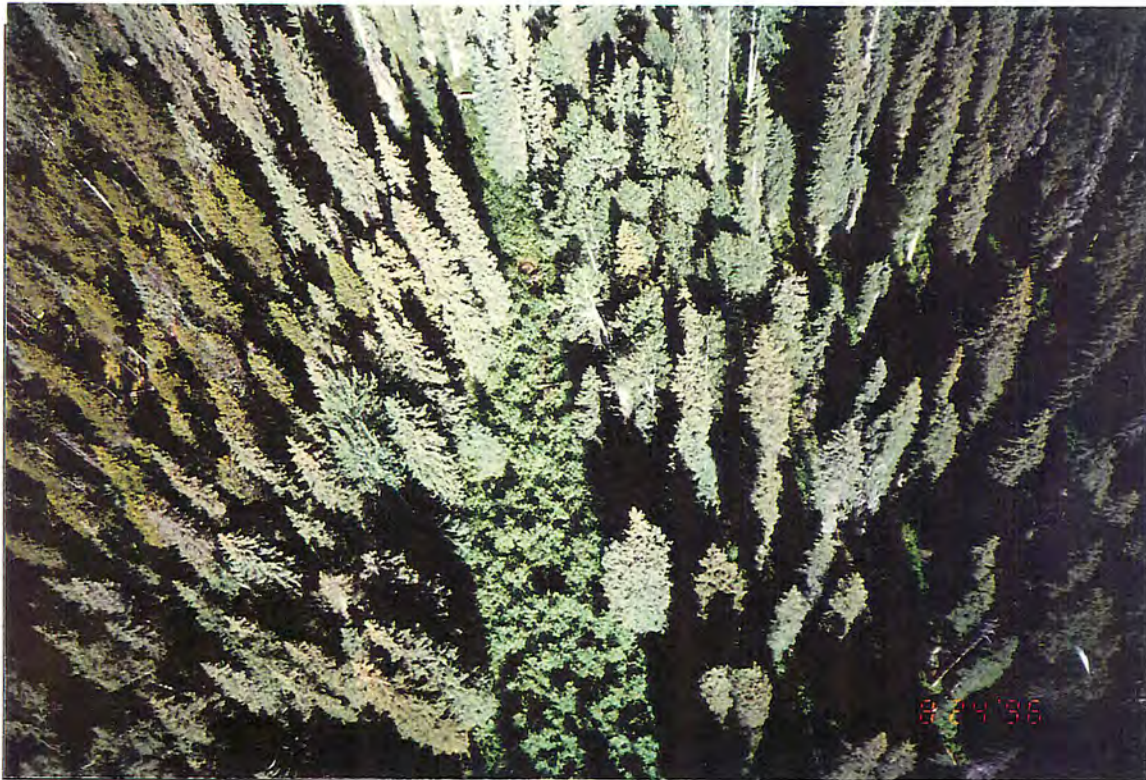
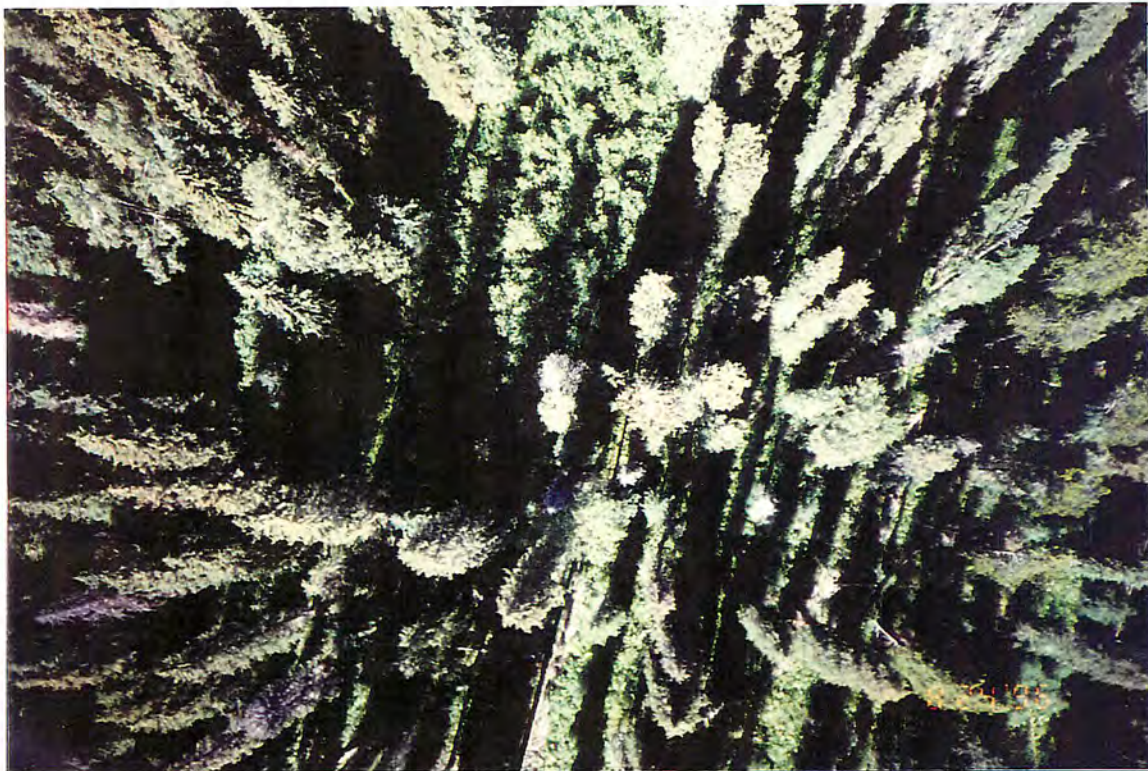
- C1 S3  
C2 LS -20% RS -20%  
C3 No fisheries sensitive zones noted.  
C4 This site was not electrofished.  
C5 Lat. N 55 21' 37" Long. W 126 37' 50"  
C6 No additional bank texture information.  
C7 Water quality was not evaluated The mean air temperature on this day was 12.5°C  
C8 This site could provide rearing habitat. The creek is heavily overgrown with willow and alder. It is a slo very similar to that of J158, so the same discharge measurements were used. This area was very difficult to access and is connected to the Nilkitkwa by a beaver pond.

Site #: J162, Aerial photo, alder choked channel through mature spruce.

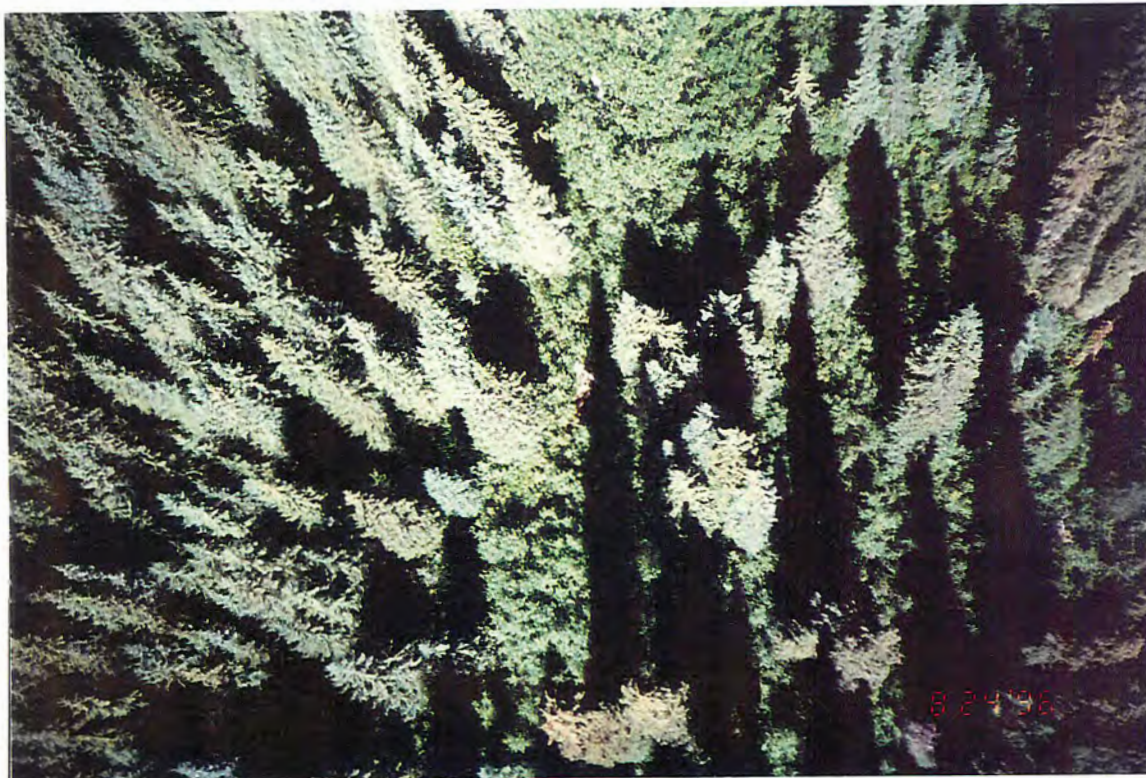
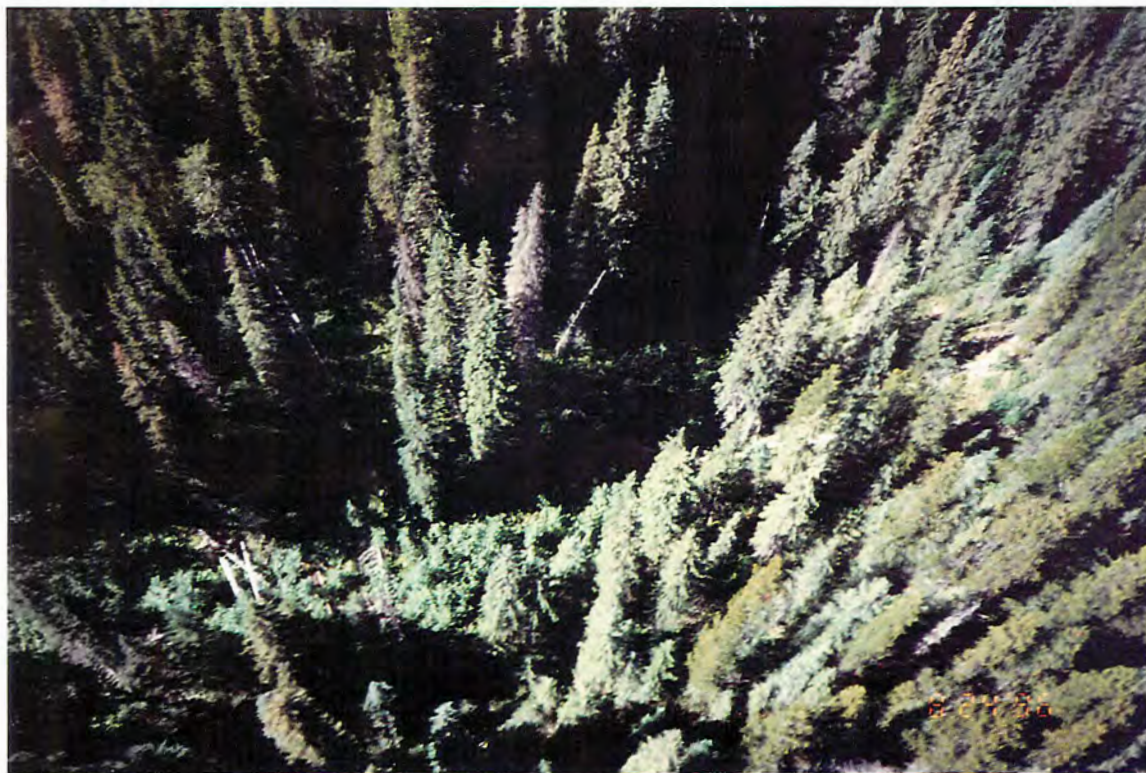
Site #: J163, Aerial photo, alder choked channel through mature spruce.
