# Reconnaissance Level Fish and Fish Habitat Inventory in the Bulkley T.S.A.

*(Working Unit #4 - Boucher)*

**Pacific Inland Resources (FRBC)**

April 1998

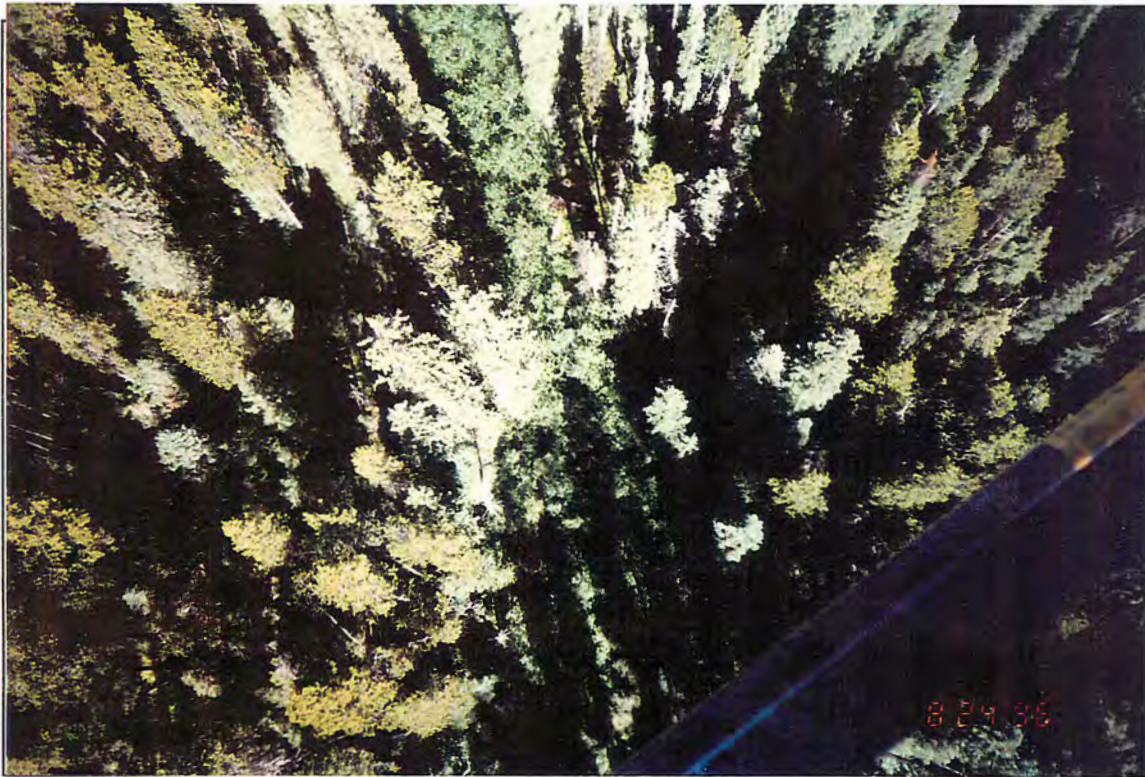
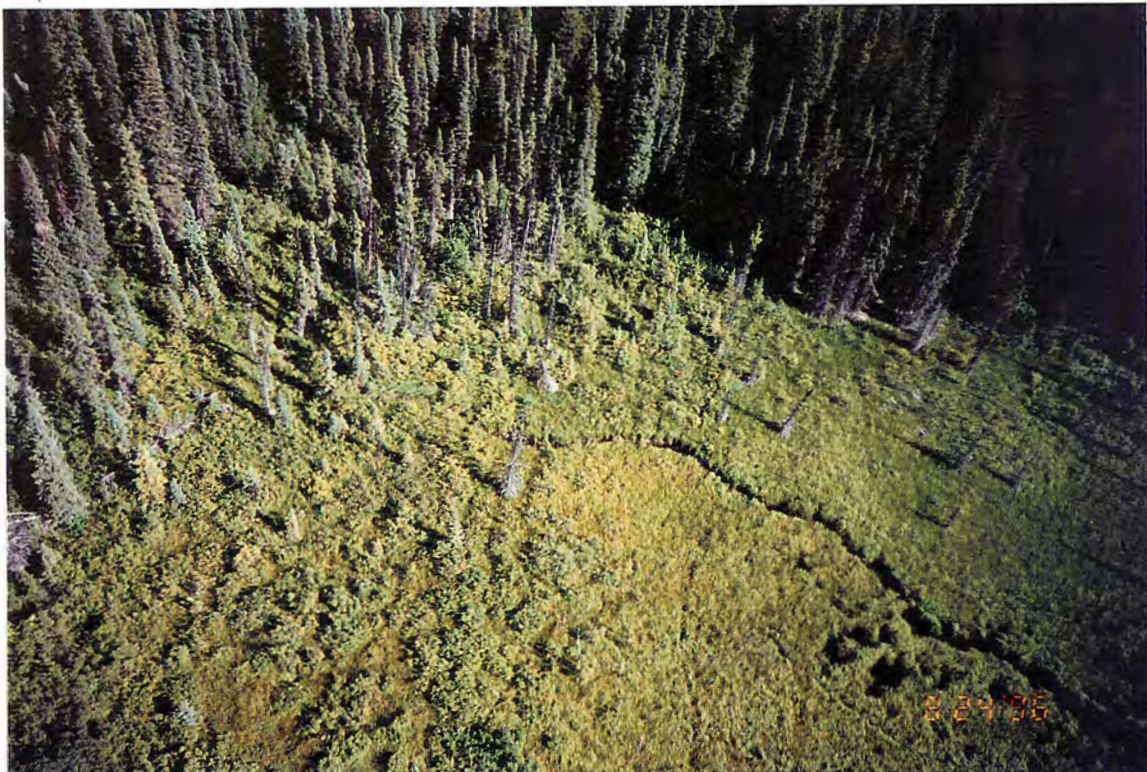
- C1: S3  
 C2: LS -5% RS -5%  
 C3: No fisheries sensitive zones noted.  
 C5: Lat N 55 22' 33" Long W 126 36' 41"  
 C6: No additional bank texture information.  
 C7: Water quality not evaluated. The mean air temperature on this day was 12.5°C  
 C9: The habitat noted here may be suitable for rearing rainbow trout. Approximately 200 m upstream the creek becomes undefined. Only the first 200 meters, which are connected with a beaver dam, are accessible to fish.

Site #: J164, Aerial photo, alder choked channel through mature spruce.

Site #: J164, Aerial photo, channel through opening in spruce stand.

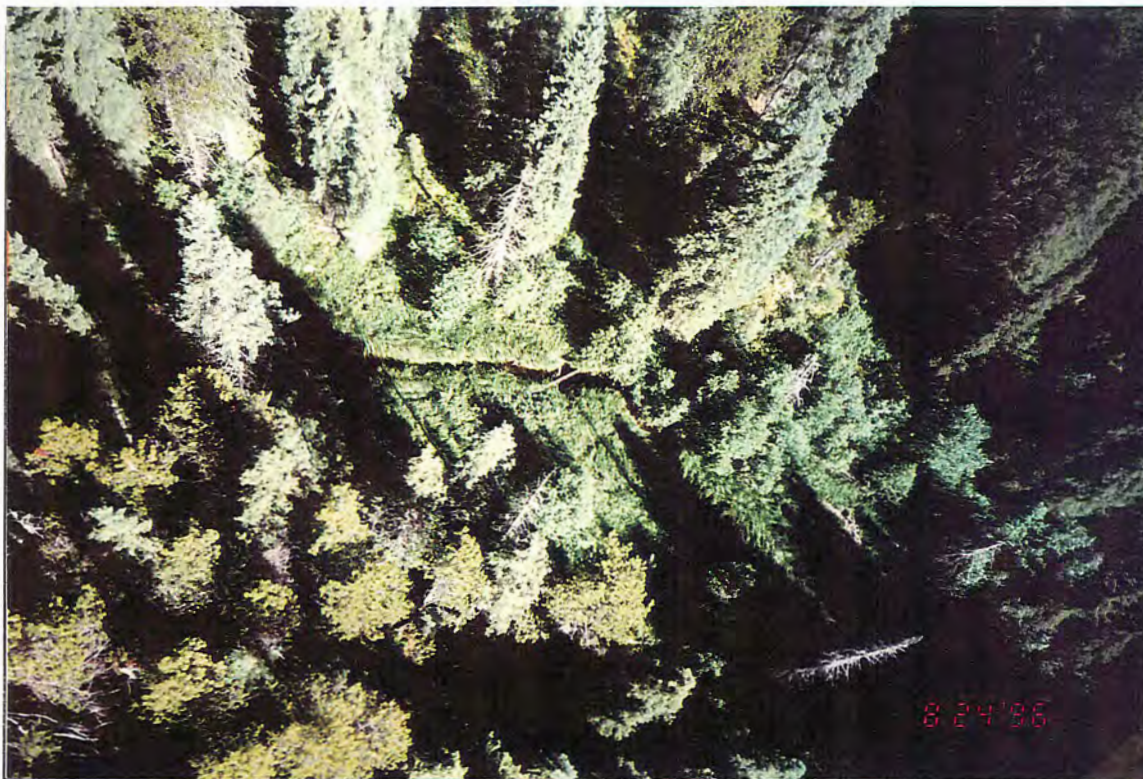
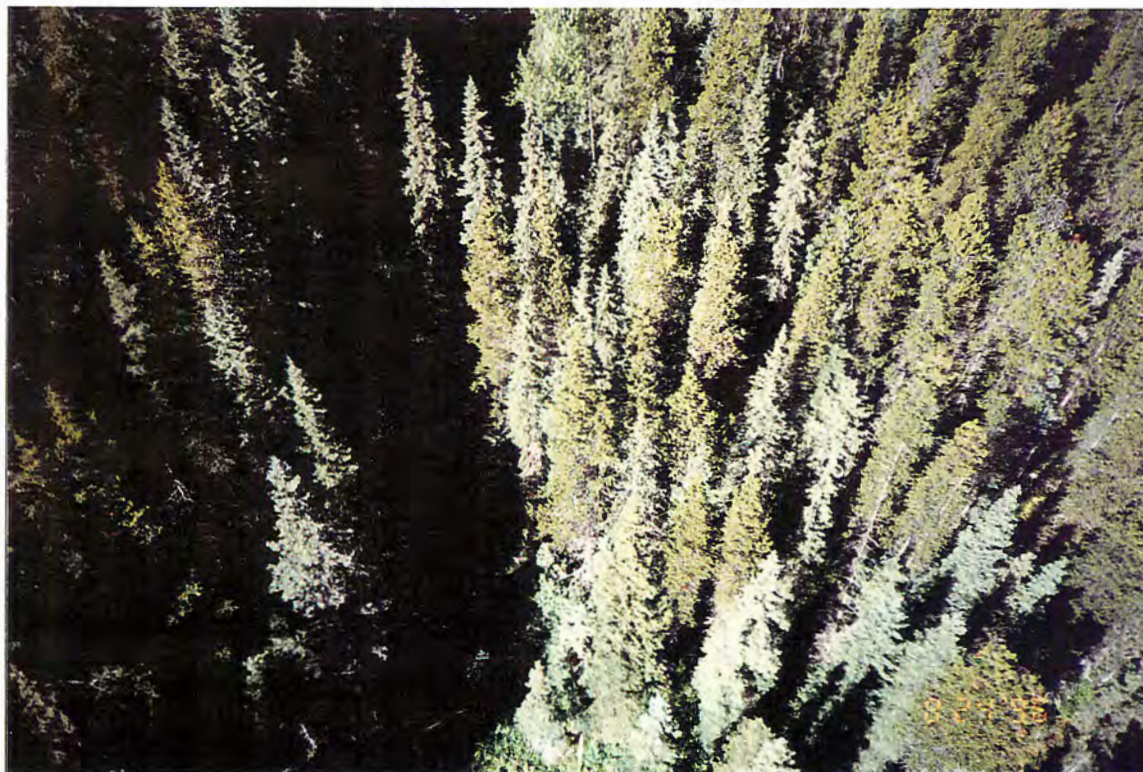
C8: This site is in between two known fish bearing areas and may be suitable for rearing. No spawning gravels were evident. Beaver dams are present both up and downstream.

Site #: J165, Aerial photo, alder choked channel through mature spruce stand.

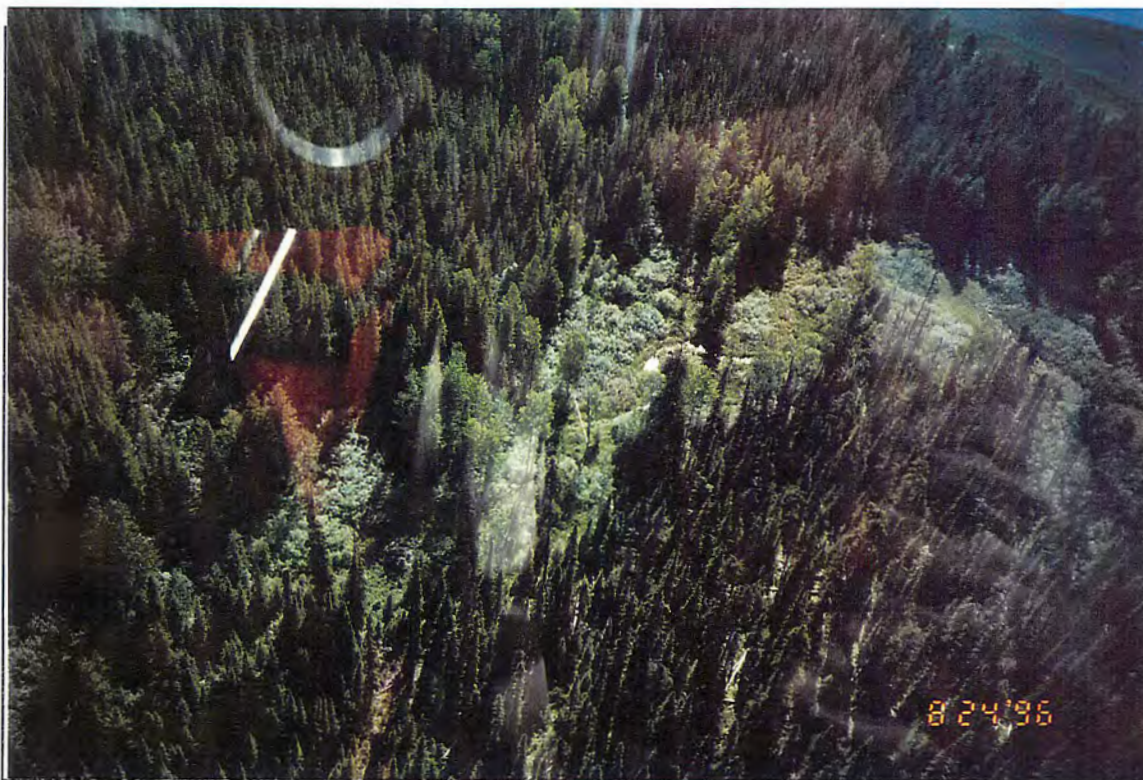
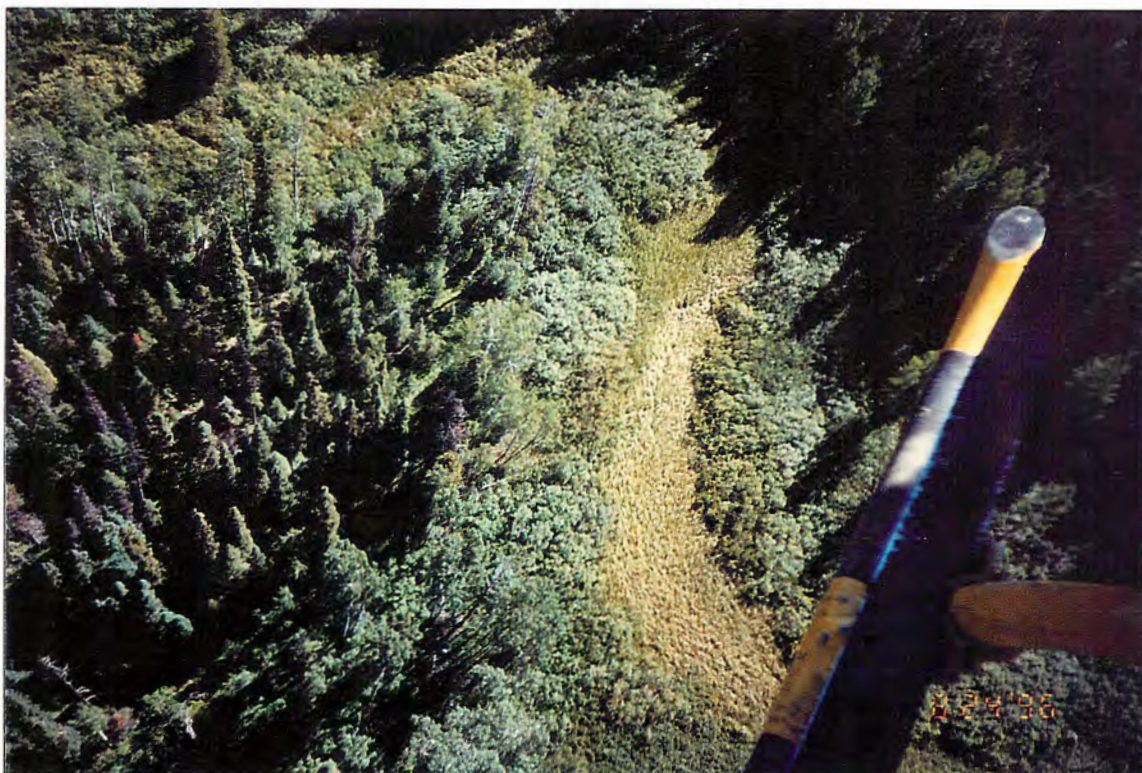
- C1 S3  
C2 LS - 5% RS - 5%  
C3 No fisheries sensitive zones noted.  
C4 This site was not electrofished.  
C5 Lat. N 55 21' 54" Long. W 126 38' 27"  
C6 No additional bank texture information.  
C7 Water quality was not evaluated. The mean air temperature on this day was 12.5°C  
C8 The channel is defined in the lower 300 m which directly connect to the lake. It then moves through a grassy area and into an alder swale, which was dry. No road or helicopter access was noted in this area.

Site #: J166, Aerial photo, alder choked channel through mature spruce stand.

Site #: J166, Aerial photo, channel in narrow winding meadow.

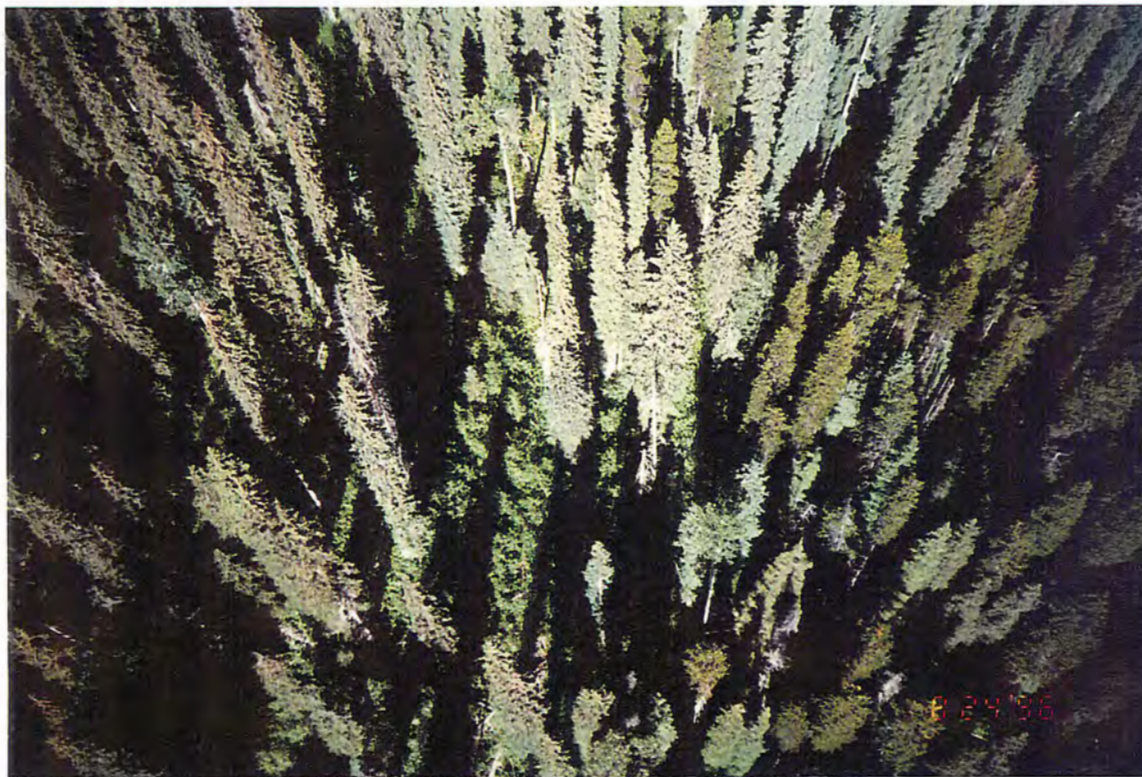
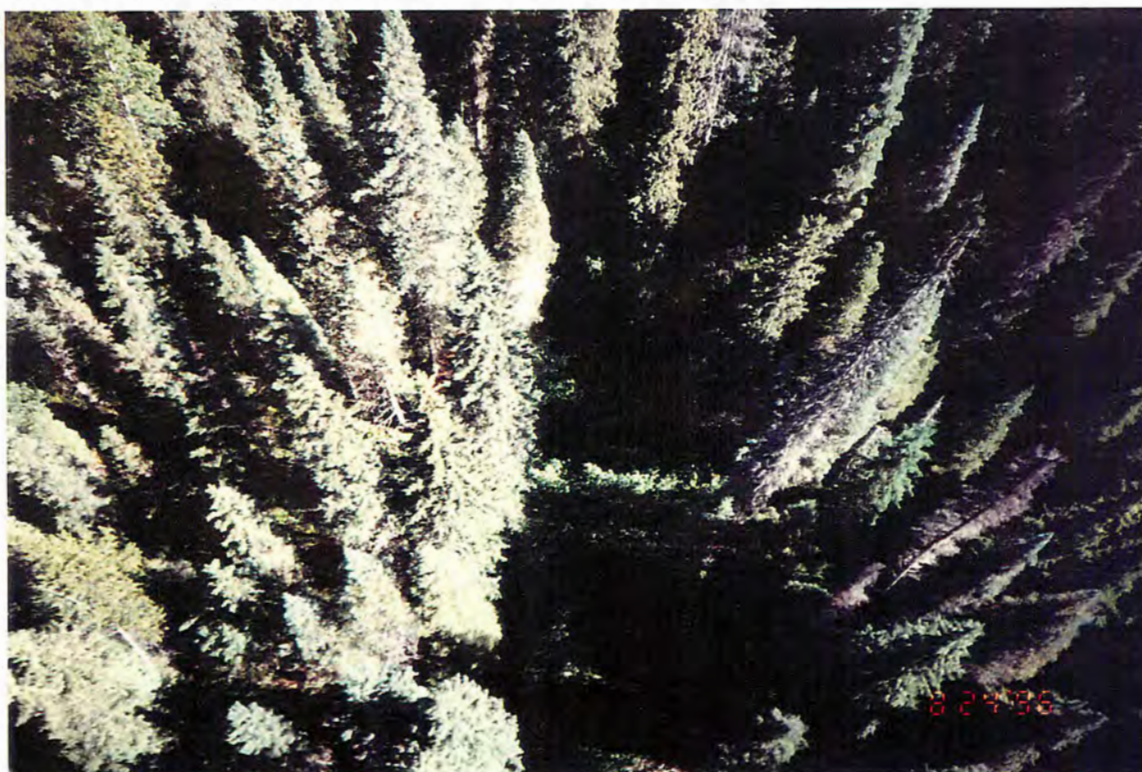
C8: This site may be used for rearing. The channel connects directly to Nilkitkwa lake. No barriers were observed but the channel may not be continuous.

Site #: J169, Aerial photo, alder choked channel through mature spruce.

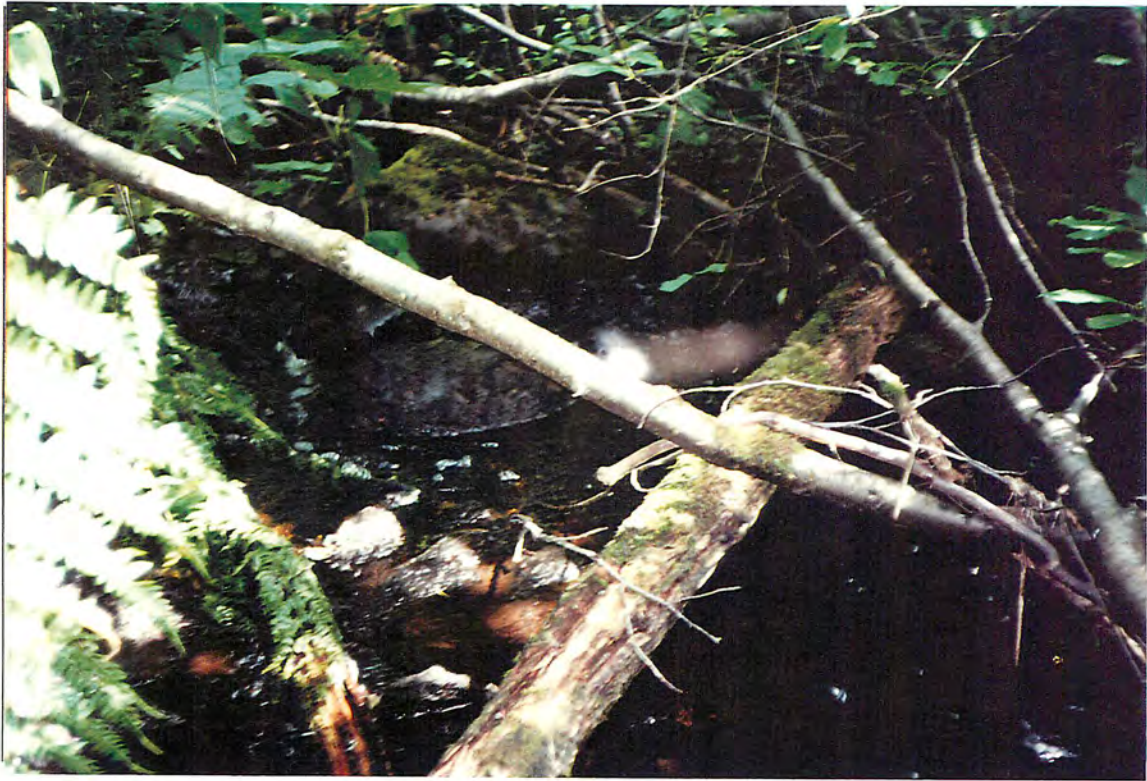
C8: This creek is the outlet of a small lake. The vegetation is dense in this area making access to the creek difficult.

Photo #: J-2-5, 1996/07/27  
Site #: J25, LOD in channel through alder.

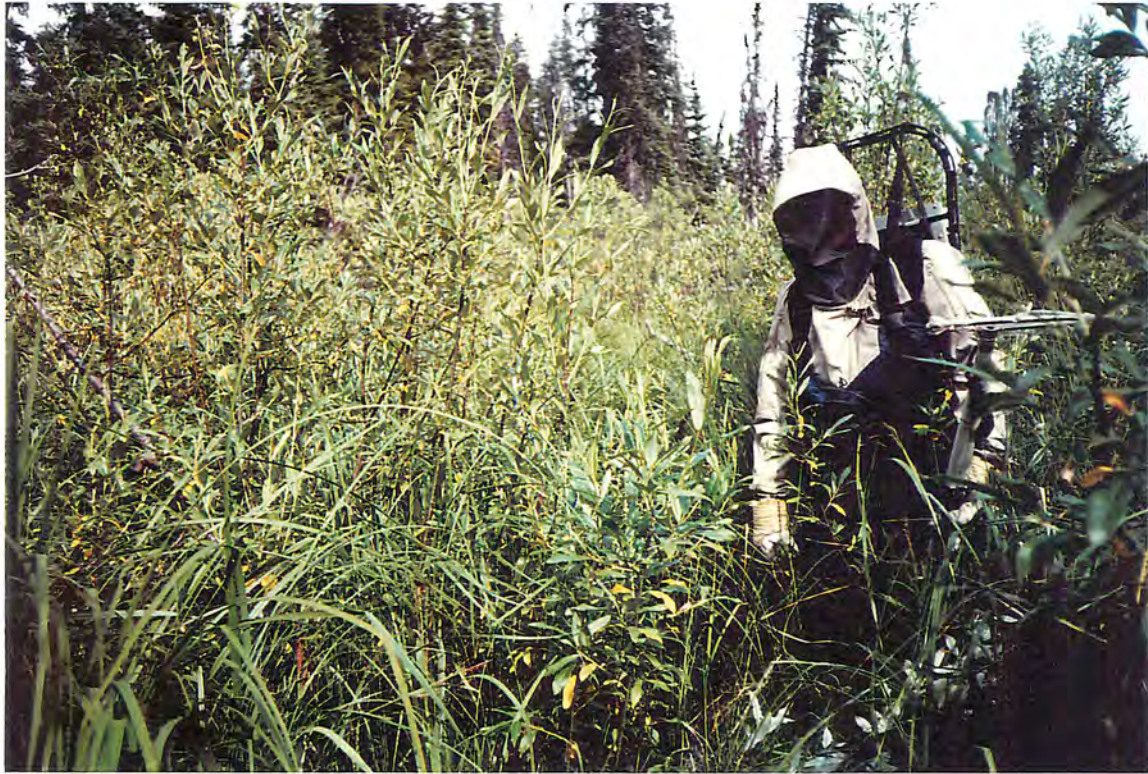
Photo #: J-2-7, 1996/07/27

- C1: S3  
C2: LS = 0%, RS = 0%  
C3: No fisheries sensitive zones noted.  
C4: The conditions were dangerous at this site, so it was not electrofished.  
C5: Lat N 55 23' 21", Long W 126 35' 52"  
C6: No additional bank texture information.  
C7: DO, pH, conductivity were not measured at this site. The mean air temperature on this day was 19.8°C  
C8: Instream vegetation provides most of the cover for fish at this site. Potential rearing habitat was found at this site. No obstructions were noted during the aerial reconnaissance in which the entire creek was flown.

Site #: J27, Channel through grass and willows.

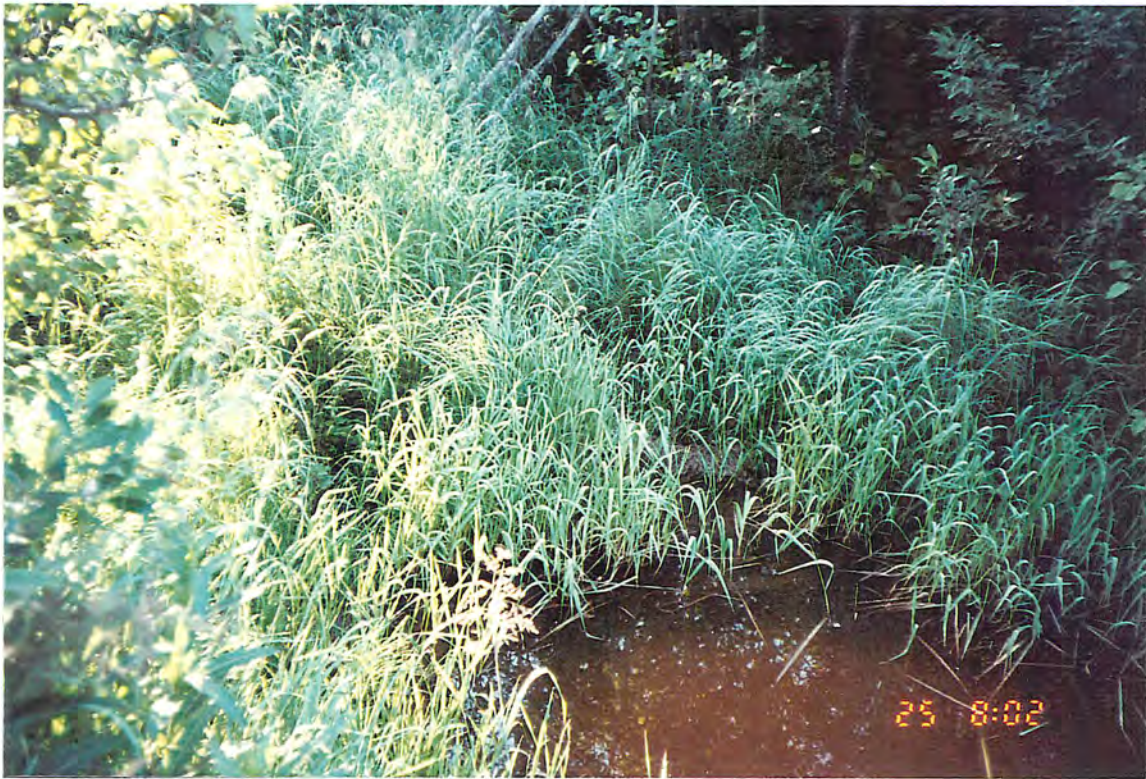
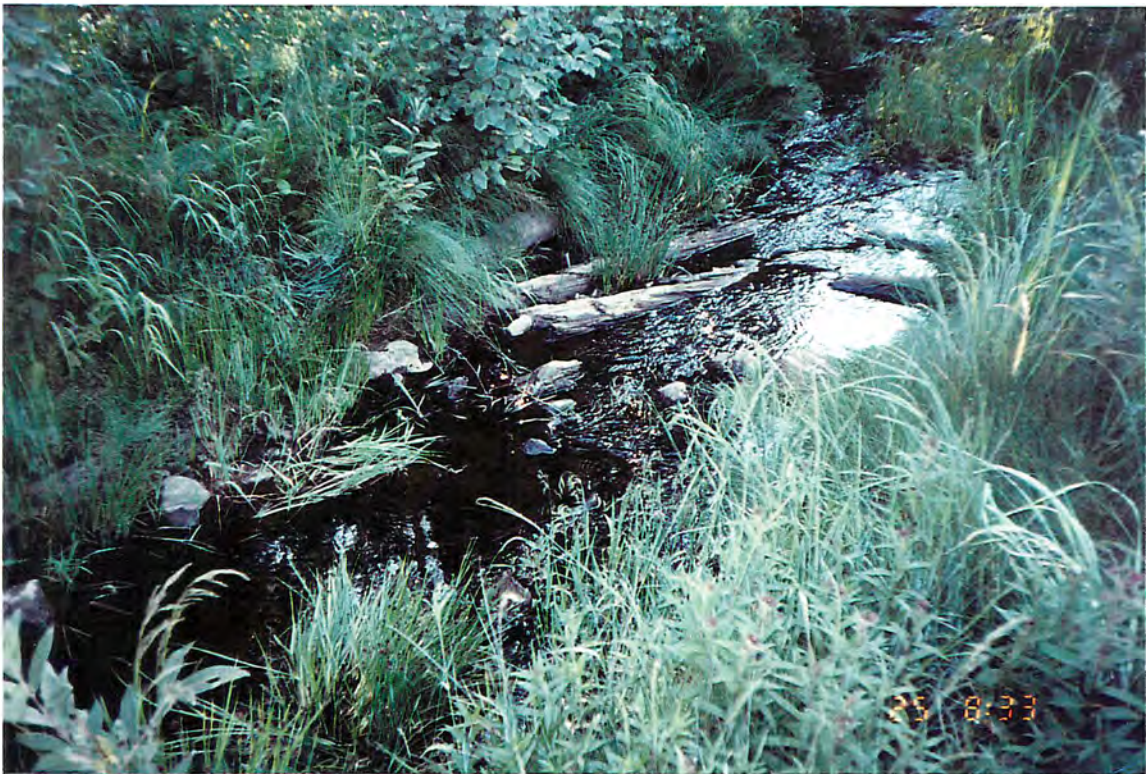
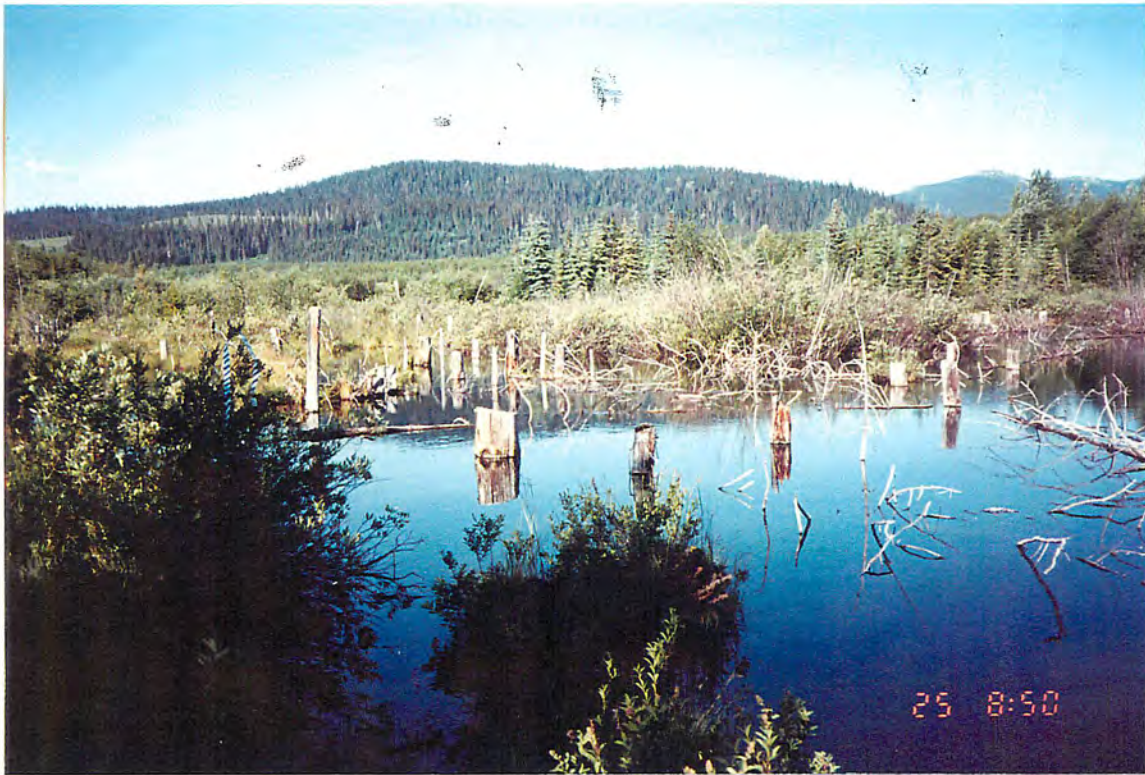
- C1: S6  
C2: LS = 12%, RS = 23%  
C3: No fisheries sensitive zones noted.  
C4: The electroshocking effort, using a Honda Mark 10 model was 231 seconds over 200 meters. Minnow traps were also set in the beaver ponds 70 meters upstream of the road.  
C5: Lat N 55 23' 665. Long W 126 41' 609  
C6: No additional bank texture information.  
C7: DO, pH and conductivity were not measured. The mean air temperature on this day was 17.5°C  
C8: Beaver ponds were noted upstream of the road crossing. This reach was sampled downstream of the road crossing, where potential habitat was found.  
C9: Tadpoles were caught in the gee traps set at this site.

Photo #: T-1-1, 1996/07/25  
Site #: T1, Channel.

Photo #: T-1-2, 1996/07/25  
Site #: T1, Downstream view.

Photo #: T-1-3, 1996/07/25  
Site #: T1, Upstream view of beaver pond.

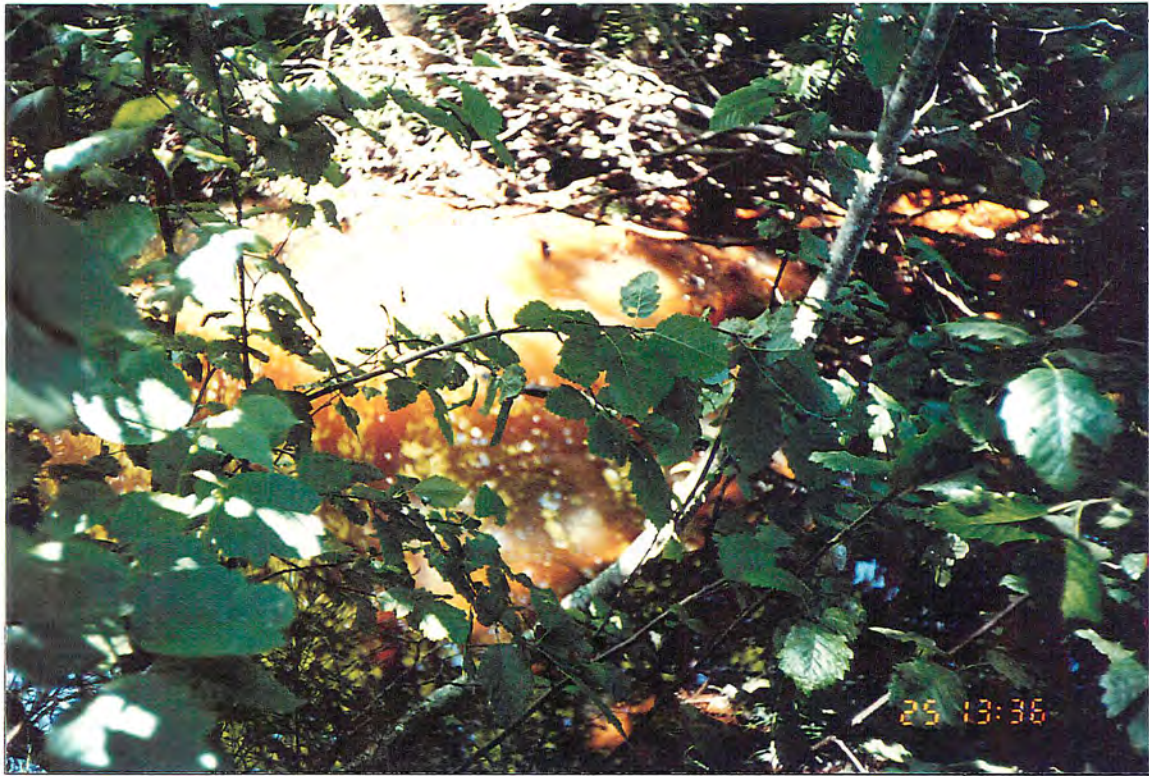
- C1: S6  
 C2: The side slopes were not measured.  
 C3: No fisheries sensitive zones noted.  
 C4: The electroshocking effort, using a Honda Mark 10 model, was 229 seconds over 100 meters.  
 C5: Lat N 55 20 059, Long W 126 39 516"  
 C6: No additional bank texture information.  
 C7: DO, pH and conductivity were not measured. The mean air temperature on this day was 19.2°C  
 C8: This site does not contain suitable fish habitat. The substrate contains mostly fines.

Photo #: T-1-7, 1996/07/25  
Site #: T6, Channel.

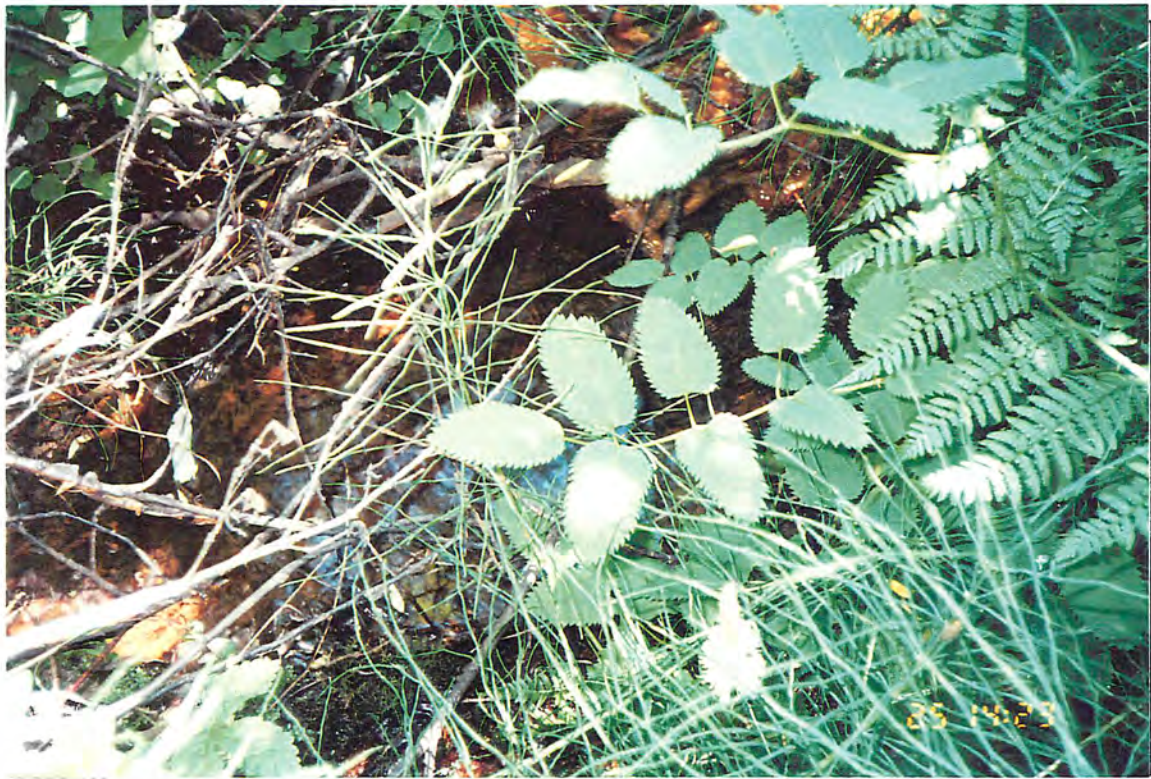
Photo #: T-1-8, 1996/07/25  
Site #: T7, Channel.

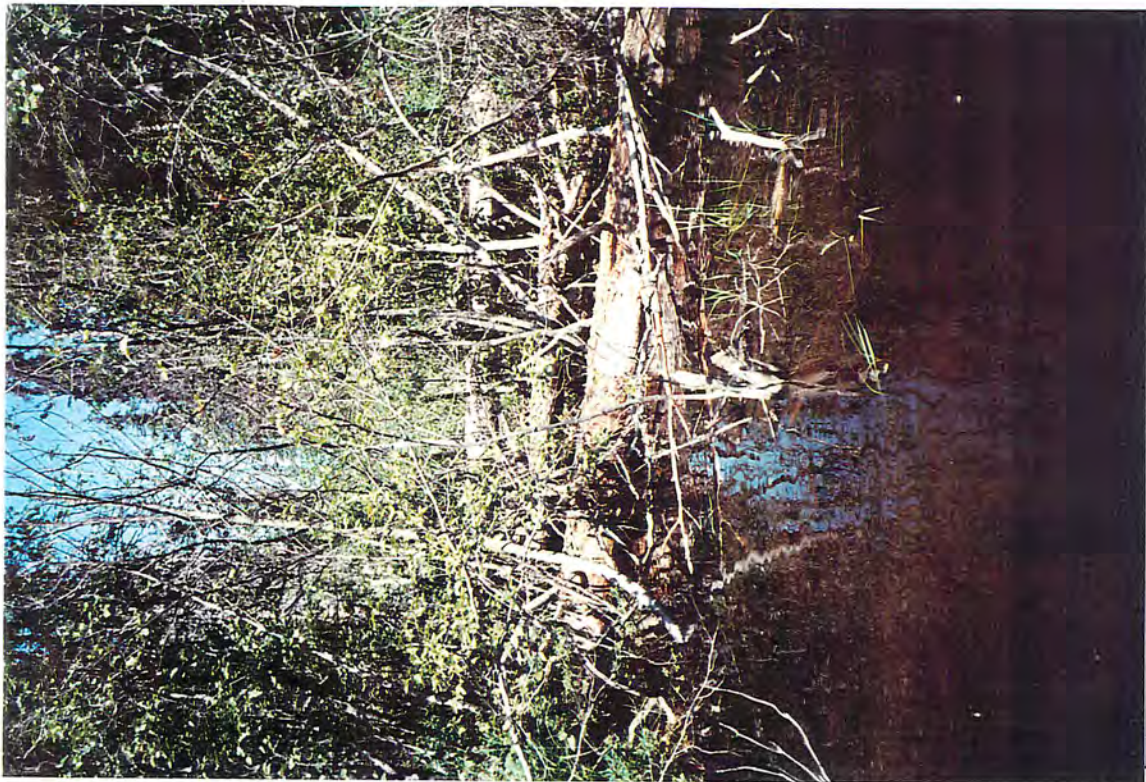
Photo #: J-2-4, 1996/07/27

- C1: S3  
 C2: LS=13 RS=15  
 C3: A large swampy area associated with the lake occurs at this site.  
 C4: This site was not electrofished due to bad access.  
 C5: Lat N 55 22' 39.6", Long W 126 34' 21.3"  
 C6: No fisheries sensitive zones noted.  
 C7: DO, pH and conductivity were not measured at this site. The mean air temperature on this day was 19.8°C  
 C8: This creek connects two lakes. No barriers to fish passage were observed. Several debris jams and beaver dams were noted. The fish were visually observed upstream.

Site #: J24, Small creek connecting 2 lakes.

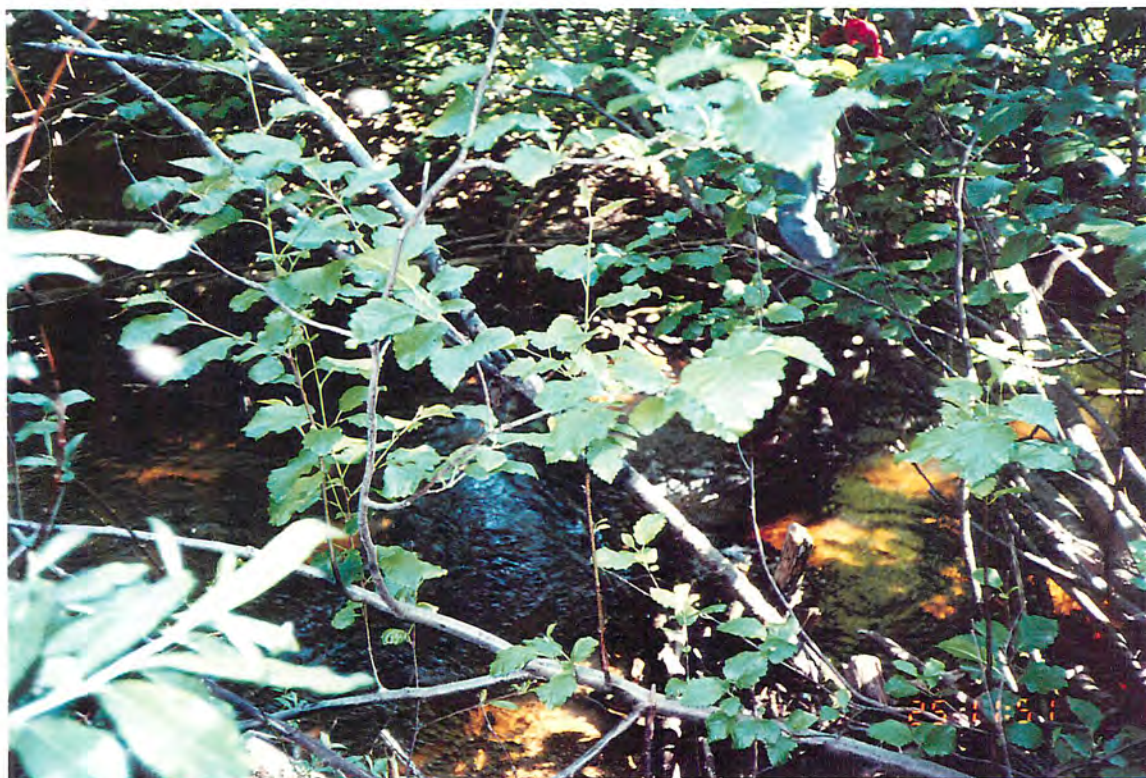
- C1: S3  
C2: LS = 18%, RS = 25%  
C3: No fisheries sensitive zones noted.  
C4: The electroshocking effort, using a Honda Mark 10 model, was 36 seconds over 20 meters.  
C5: Lat N 55 20'.544", Long W 126 39'.182"  
C6: No additional bank texture information.  
C7: DO, pH and conductivity were not measured at this site. The mean air temperature on this day was 19.2°C  
C8: This site has some good rearing habitat. Overstream vegetation provides most of the cover.

Photo #: T-1-6, 1996/07/25  
Site #: T5, Channel.

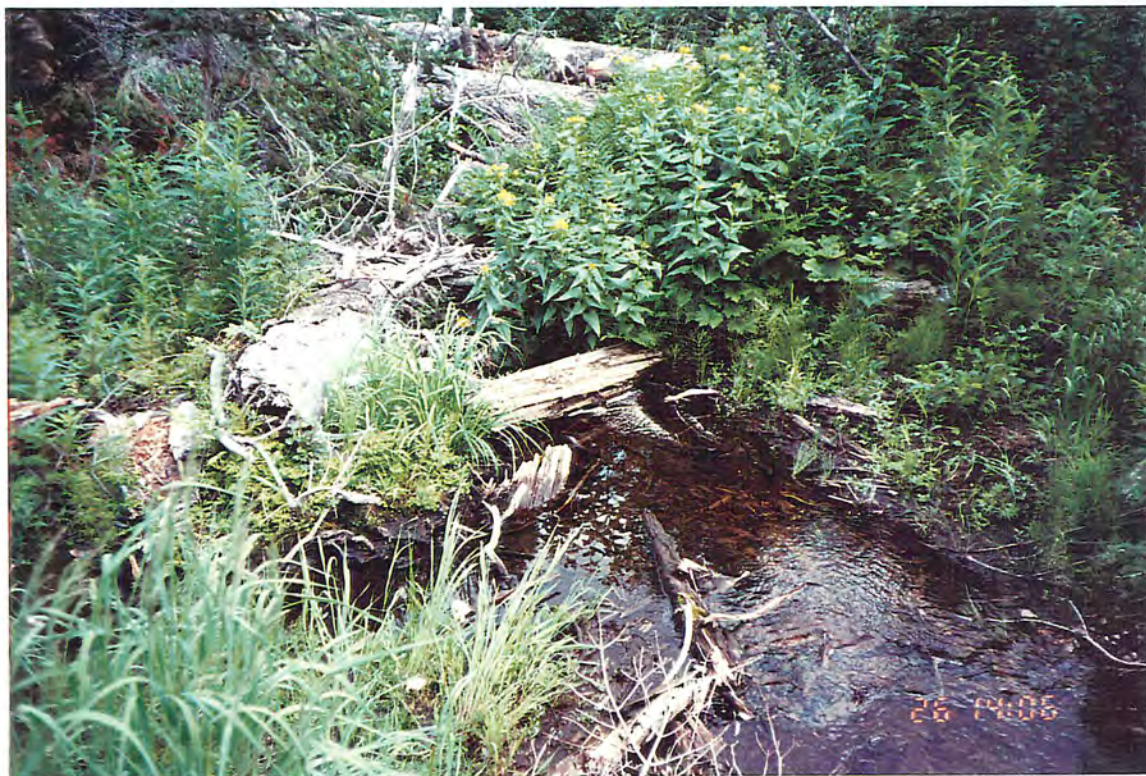
- C1: S3  
C2: The side slopes were not measured at this site.  
C3: No fisheries sensitive zones were noted at this site.  
C4: The electroshocking effort, using a Honda Mark 10 model was 162 seconds over 40 meters.  
C5: 55 20" 40.3' 126 44" 05.3'  
C6: No additional bank texture information.  
C7: DO, pH and conductivity were not measured at this site. The mean air temperature on this day was 18.8°C  
C8: This site may provide rearing cover. The stream moves through a cutblock for 1 km then enters a wooded area.

Photo #: T-1-10, 1996/07/26  
Site #: T10, Channel.

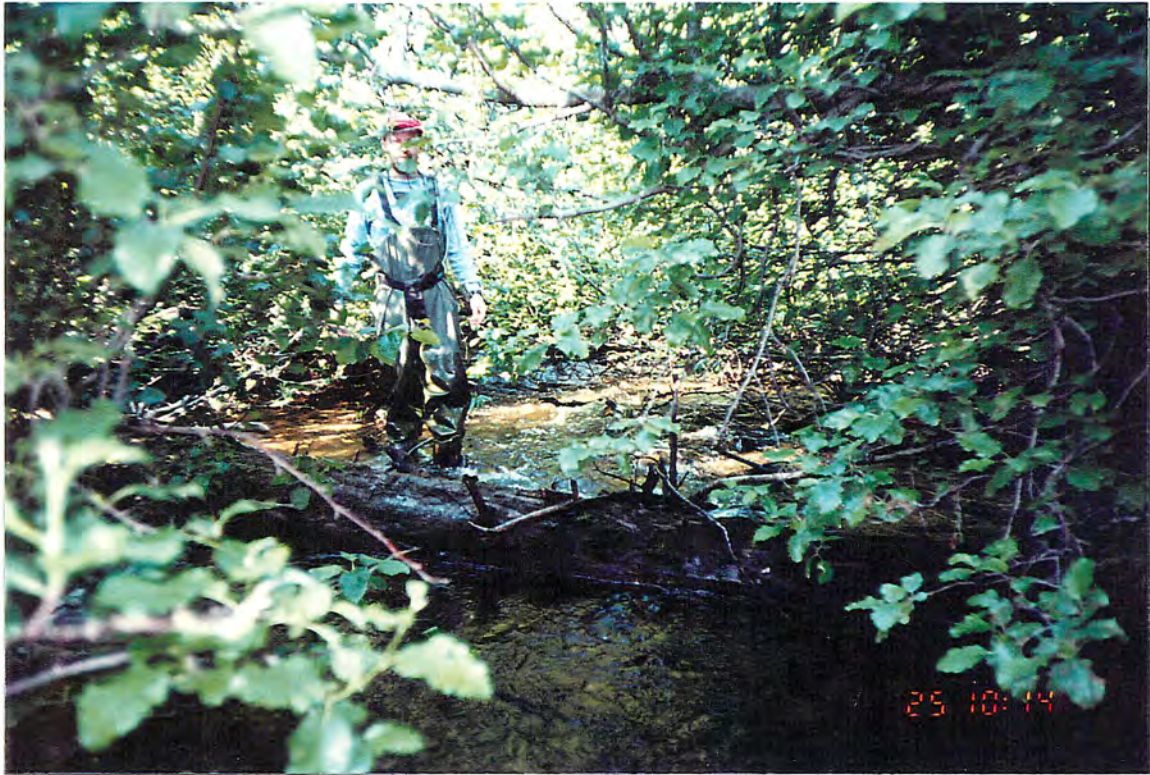
- C1: S2  
C2: The side slopes were not measured.  
C3: No fisheries sensitive zones noted.  
C4: The electroshocking effort, using a Honda Mark 10 model, was 101 seconds over 50 meters.  
C5: Lat N 55 22.241', Long W 126 40.127'  
C6: No additional bank texture information.  
C7: DO, pH and conductivity were not measured at this site. The mean air temperature on this day was 19.2°C  
C8: This site provides some rearing habitat.

Photo #: T-1-5, 1996/07/25  
Site #: T4, Downstream view.

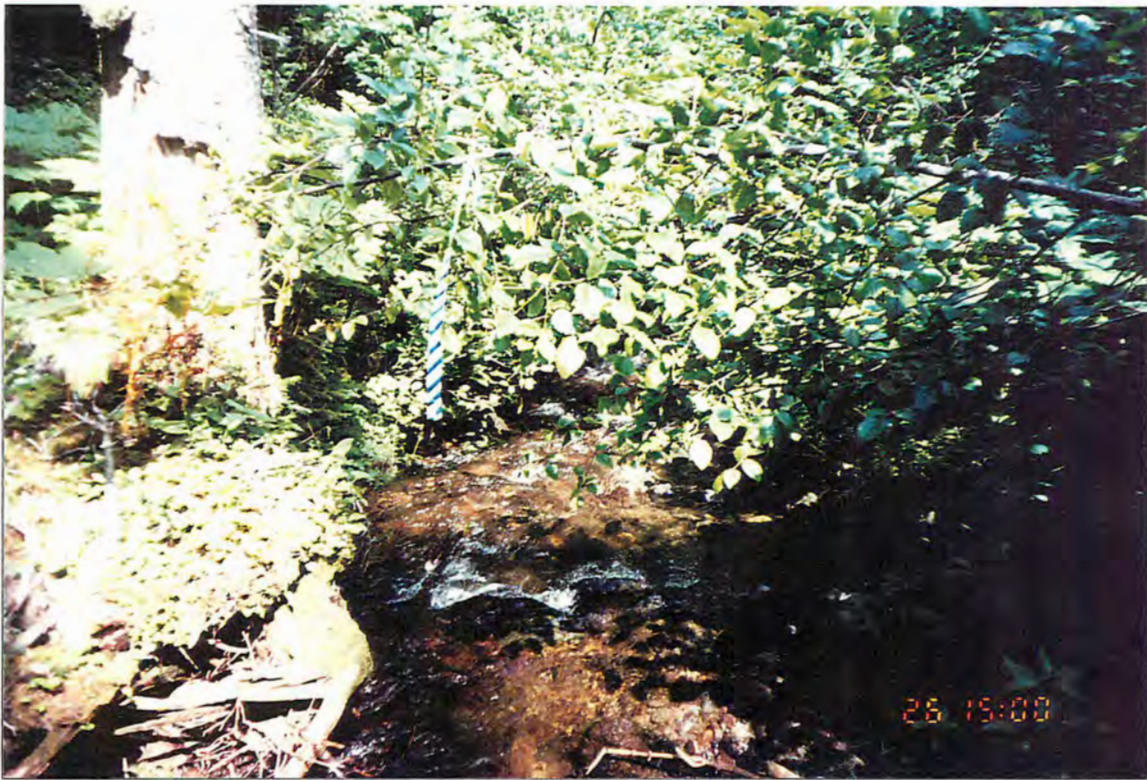
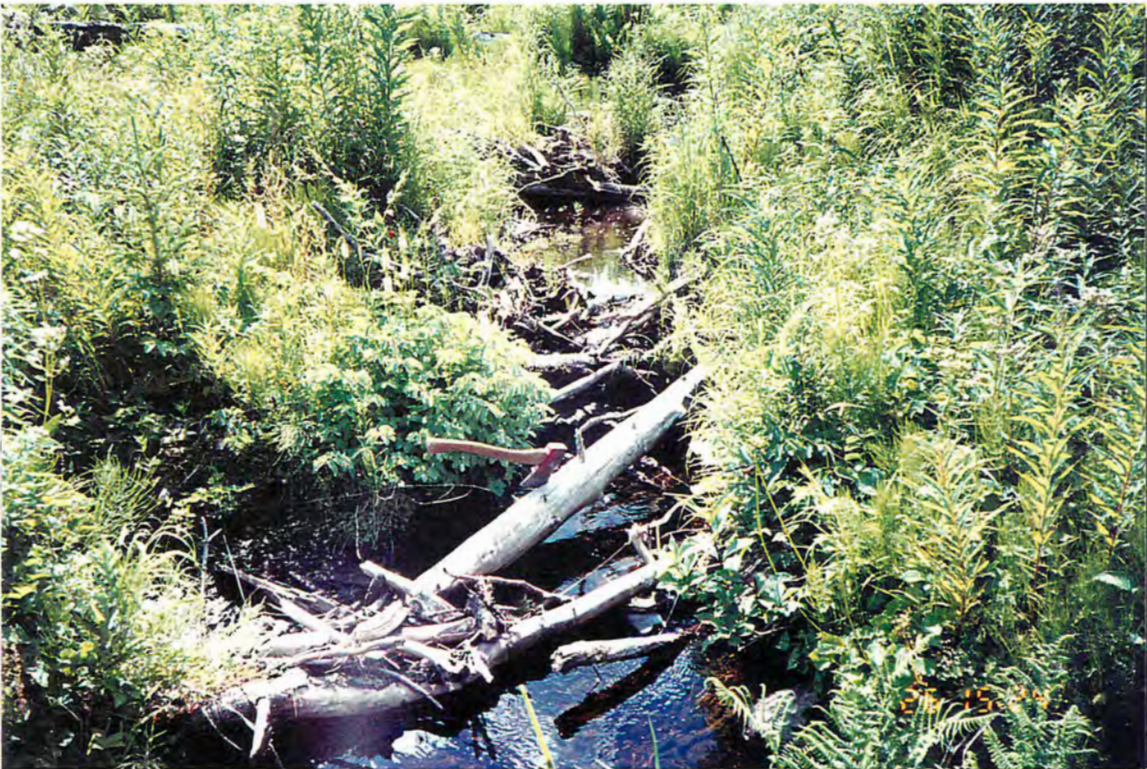
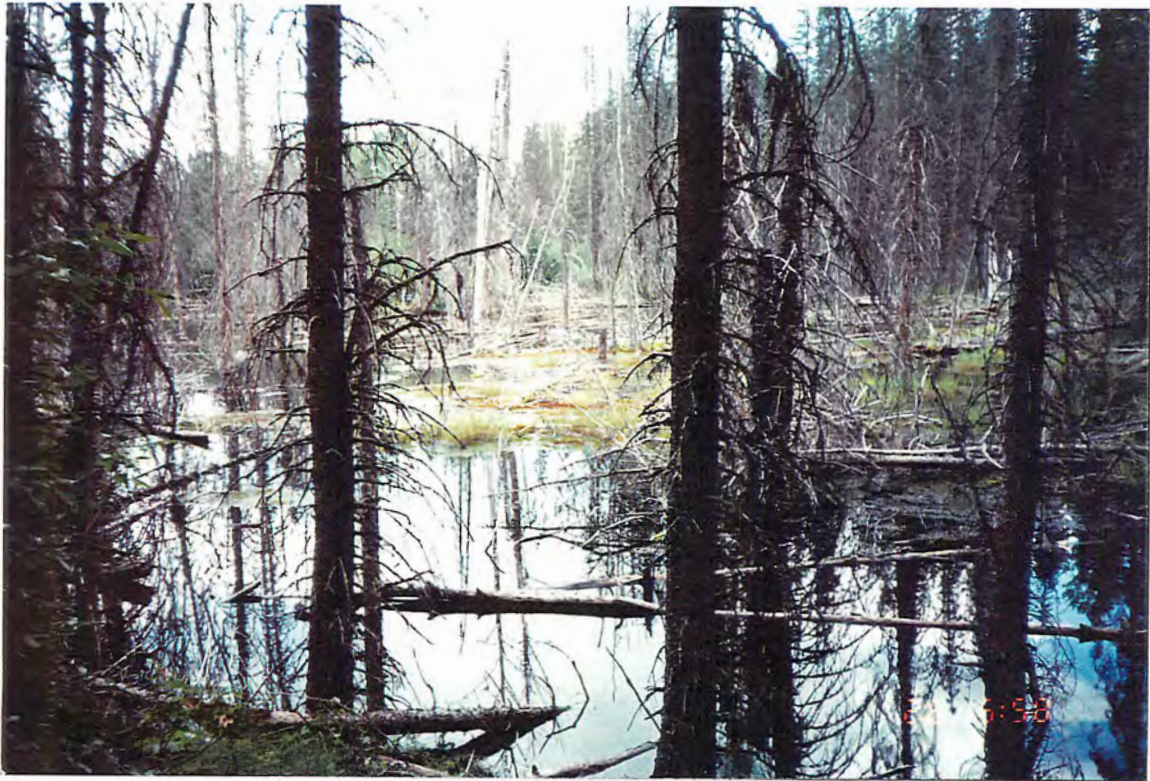
C8: This site has some good rearing habitat.

Photo #: T-1-11, 1996/07/26  
Site #: T11, Downstream view.

Photo #: T-1-12, 1996/07/26  
Site #: T11, Upstream view.

Site #: T11, Dead standing timber in pond.

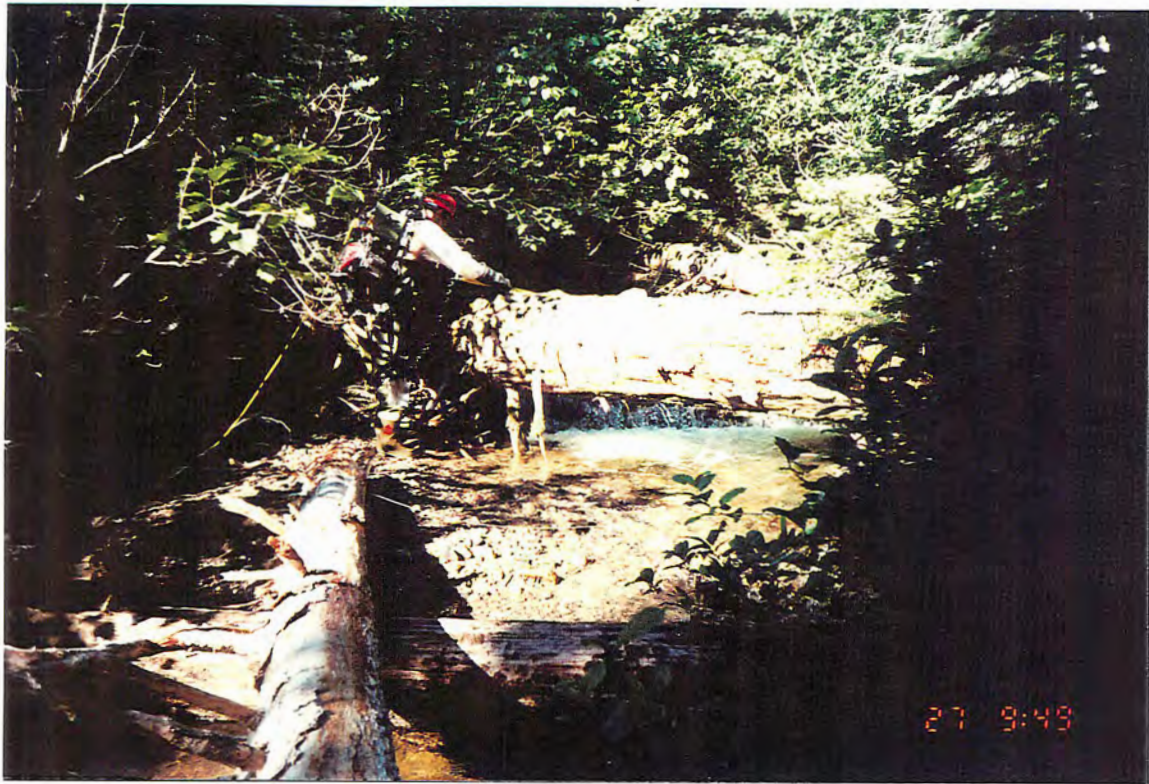
C8: This site has some good rearing habitat. LOD cover is particularly prominent.

Photo #: T-1-15, 1996/07/27  
Site #: T12, Upstream view.

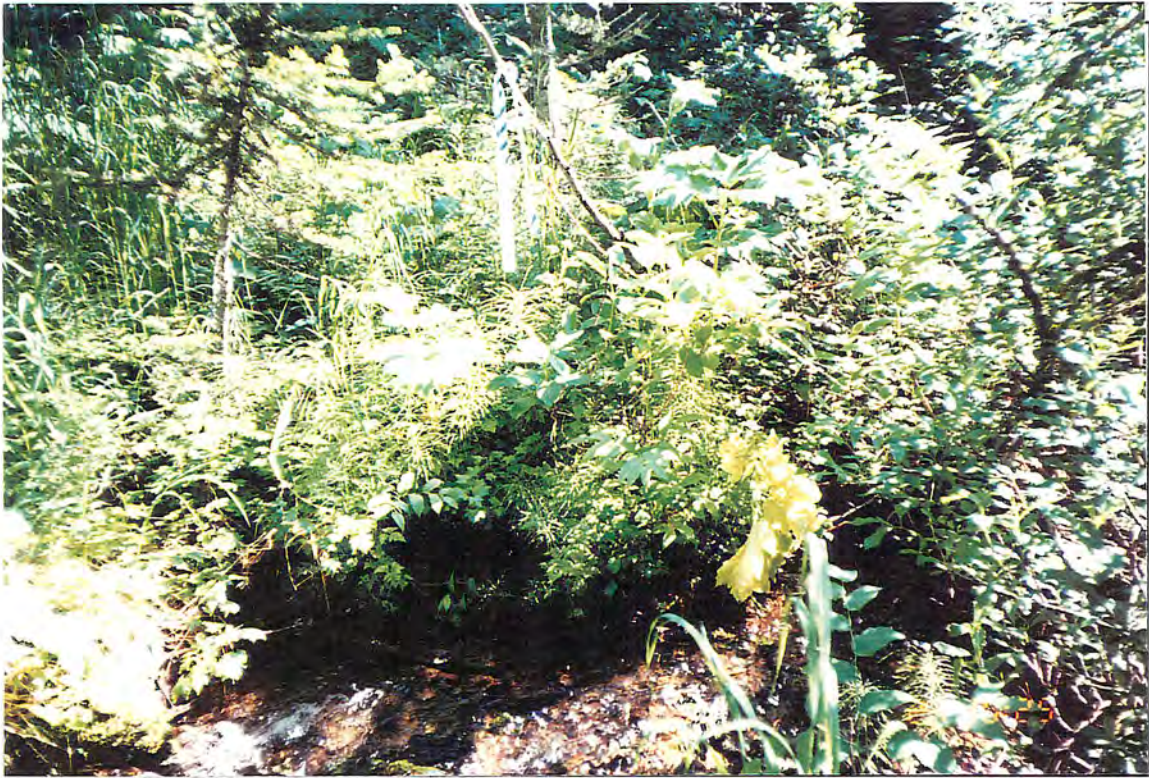
Photo #: T-1-16, 1996/07/27  
Site #: T13, Upstream view.
