# Reconnaissance Level Fish and Fish Habitat Inventory in the Bulkley T.S.A.

*(Working Unit #4 - Boucher)*

**Pacific Inland Resources (FRBC)**

April 1998

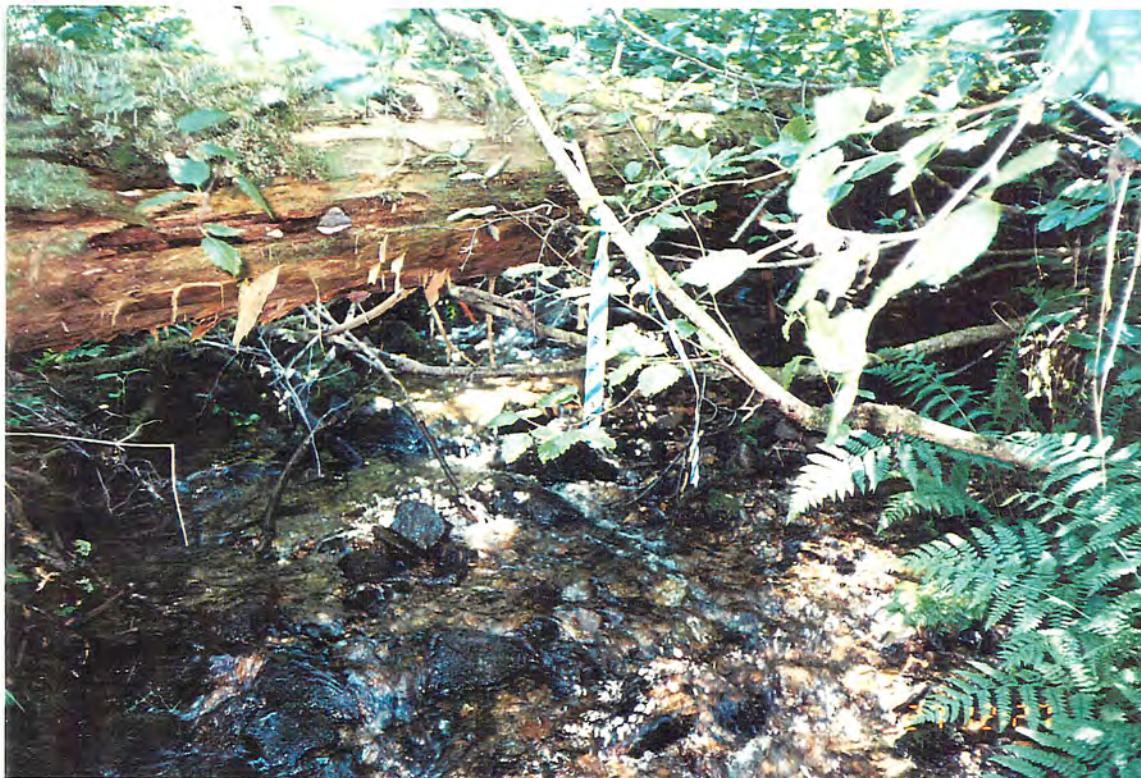
C8 This site provides rearing habitat.

Photo #: T-1-17, 1996/07/27  
Site #: T14, Upstream view.

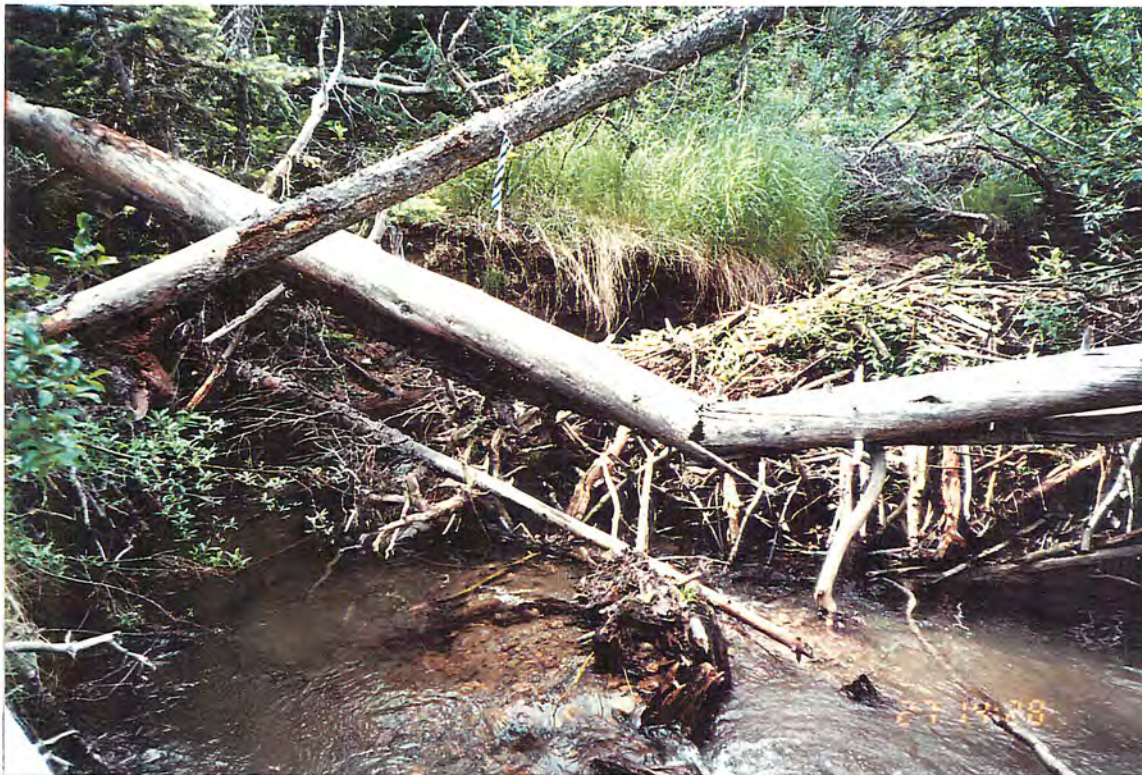
- C1: S3  
 C2: LS=1 RS=38  
 C3: No fisheries sensitive zones noted.  
 C4: The electroshocking effort, using a Honda Mark 10 model, was 449 seconds over 100 meters.  
 C5: N 55 22' 12.3" W 126 44' 25.7  
 C6: No additional bank texture information.  
 C7: DO, pH and conductivity were not measured. The mean air temperature on this day was 19.8°C  
 C8: This site has some great rearing habitat.

Photo #: T-1-18, 1996/07/27  
Site #: T15, Upstream view.

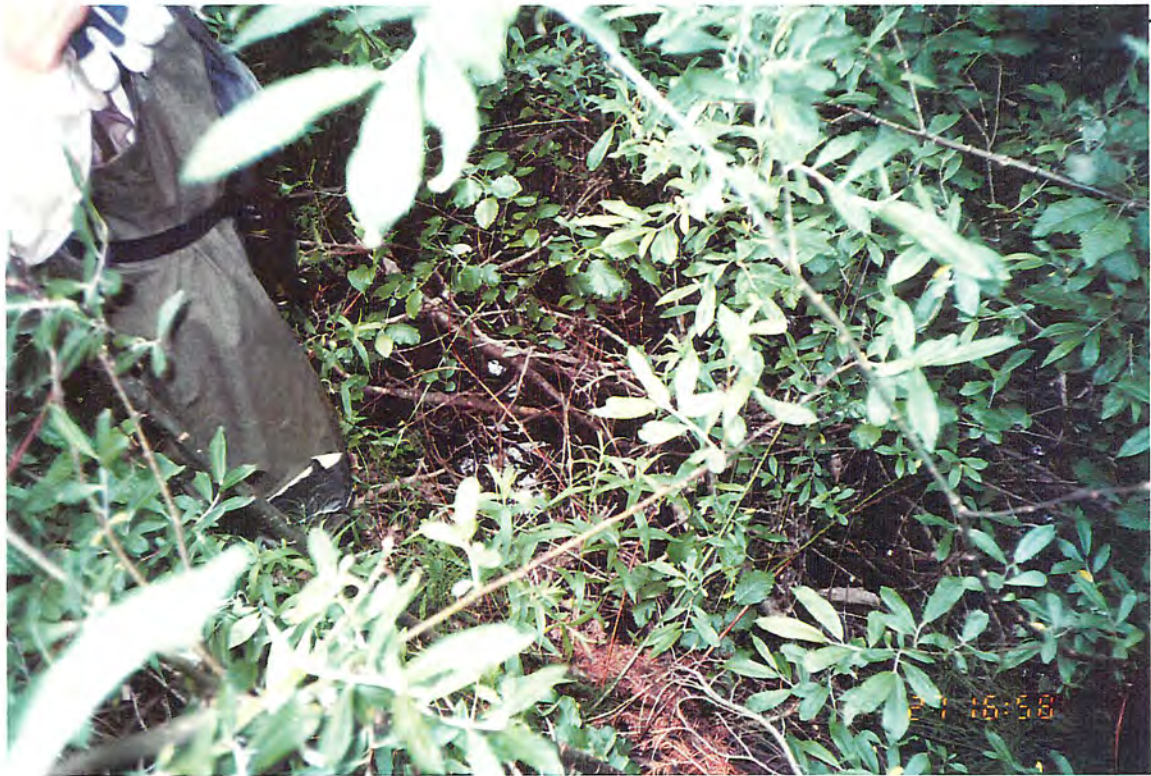
- C1 NC  
C2 Side slopes not applicable.  
C3 No fisheries sensitive zones were noted.  
C4 This site was not electrofished.  
C5 Lat N 55 22 22.6, Long W 126 42 39.3  
C6 Bank texture not applicable.  
C7 Water quality not applicable.  
C8 No fish habitat was observed at this site, which is an alder swale.

Photo #: T-1-19, 1996/07/27  
Site #: T16, Not a creek.

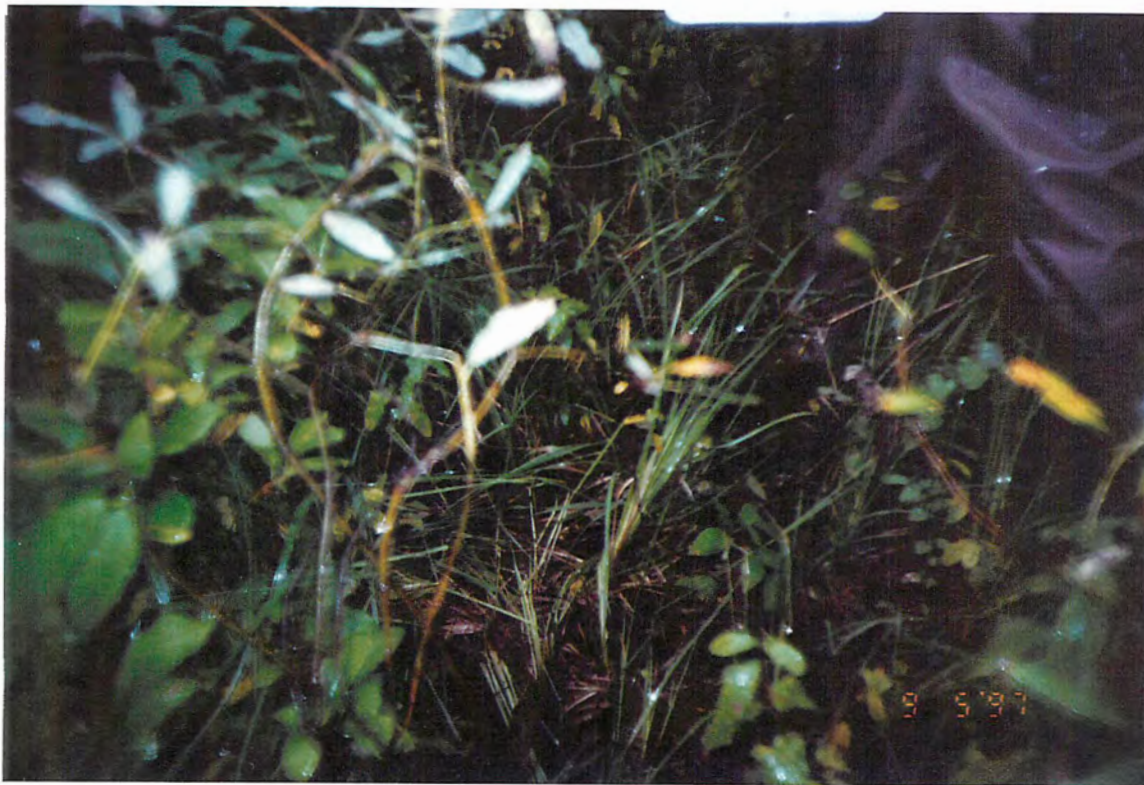
Photo #: E-24B-11, 05-Sep-97  
Site #: E256, Looking at an "NC"

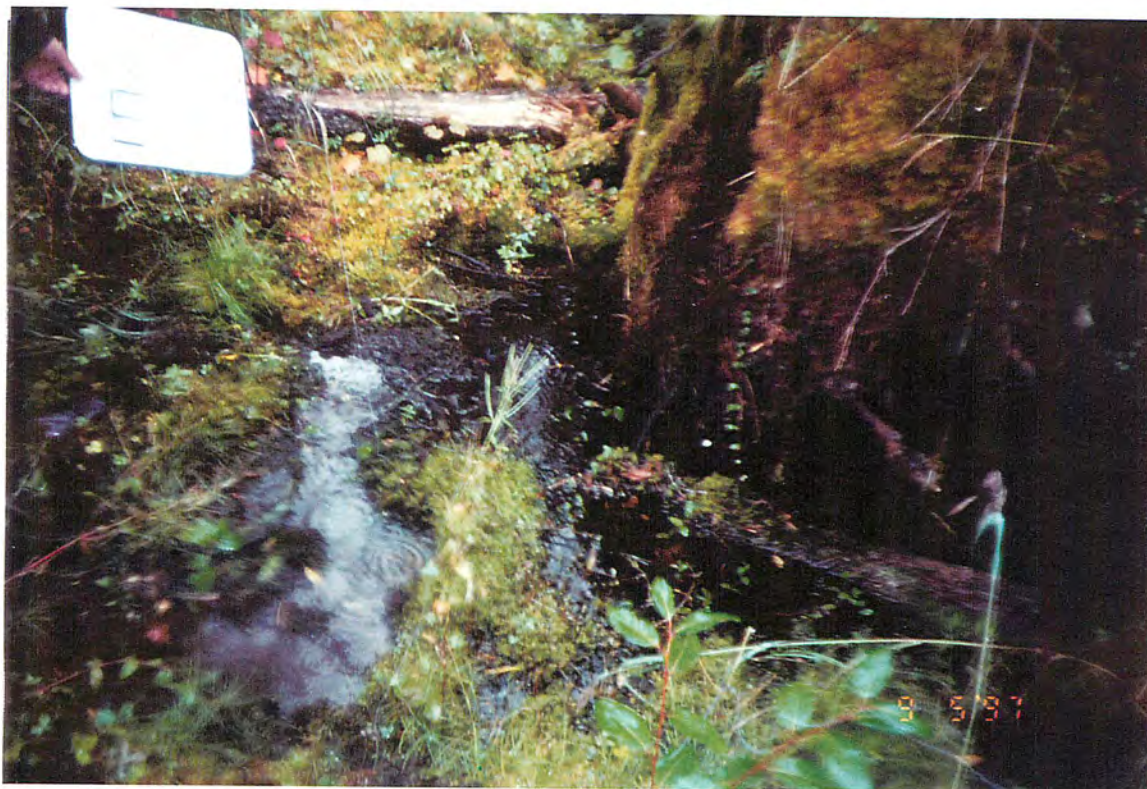
- C1 NC  
C2 Side slopes not applicable.  
C3 No fisheries sensitive zones present.  
C4 This site was not electrofished.  
C5 Bank texture not applicable.  
C6 Water quality was not evaluated at this site.  
C7 No defined channel was observed in the sampling area. A boggy swale with isolated pools was found.

Photo #: E-24B-12, 05-Sep-97  
Site #: E257, Looking at an "NC"

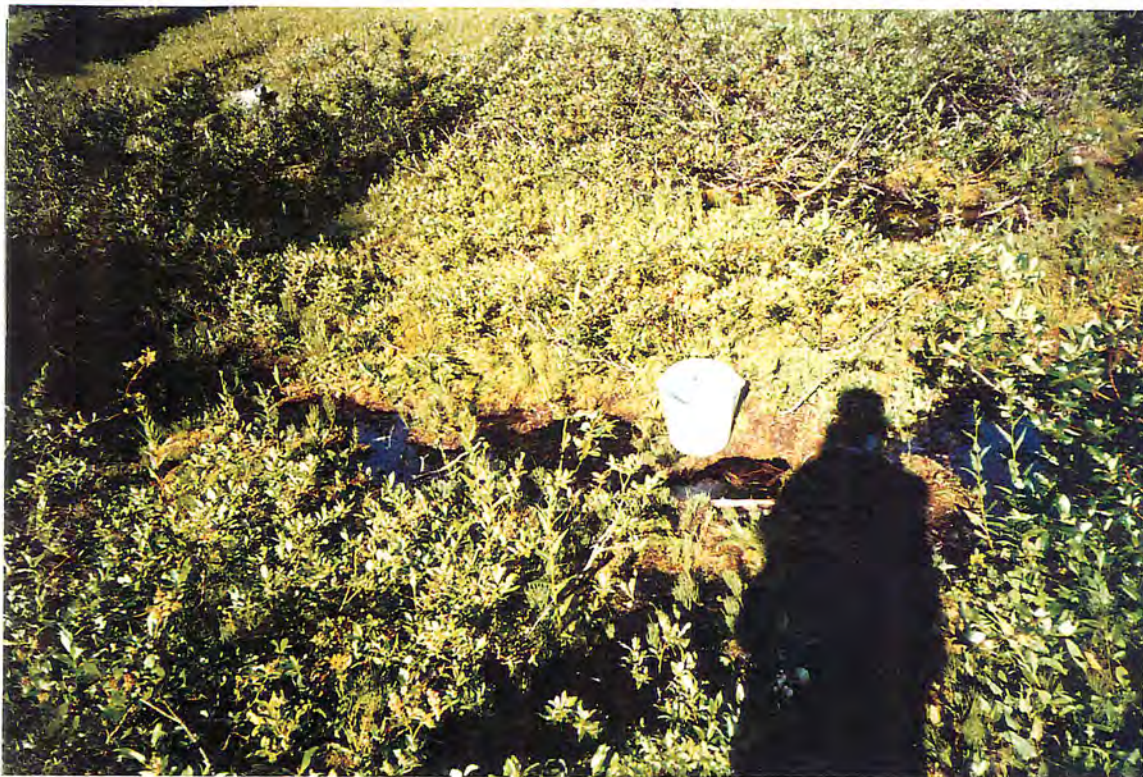
- C1: NC  
 C2: LS = 3%, RS = 3%  
 C3: No fisheries sensitive zones were noted at this site.  
 C4: The electroshocking effort, using a Smithroot 12 B POW model, was 185 seconds over 80 meters at 200V. The machine shorted out at a higher voltage.  
 C5: Lat N 55 32' 47", Long W 126 26' 55"  
 C6: No additional bank texture information.  
 C7: DO, pH, conductivity and turbidity were not measured at this site. The water was clear to the bottom.  
 C8: The crew walked down to the bottom of drainage, to discover that it disappears underground. It is not suitable for overwintering, spawning or rearing and is not a creek by definition. It connects with Boucher Creek through groundwater only and its banks are not continuous and well defined. Finally, the substrate is 100% organic matter.

Photo #: J-1-17, 1996/07/26  
Site #: J12, Not a creek.

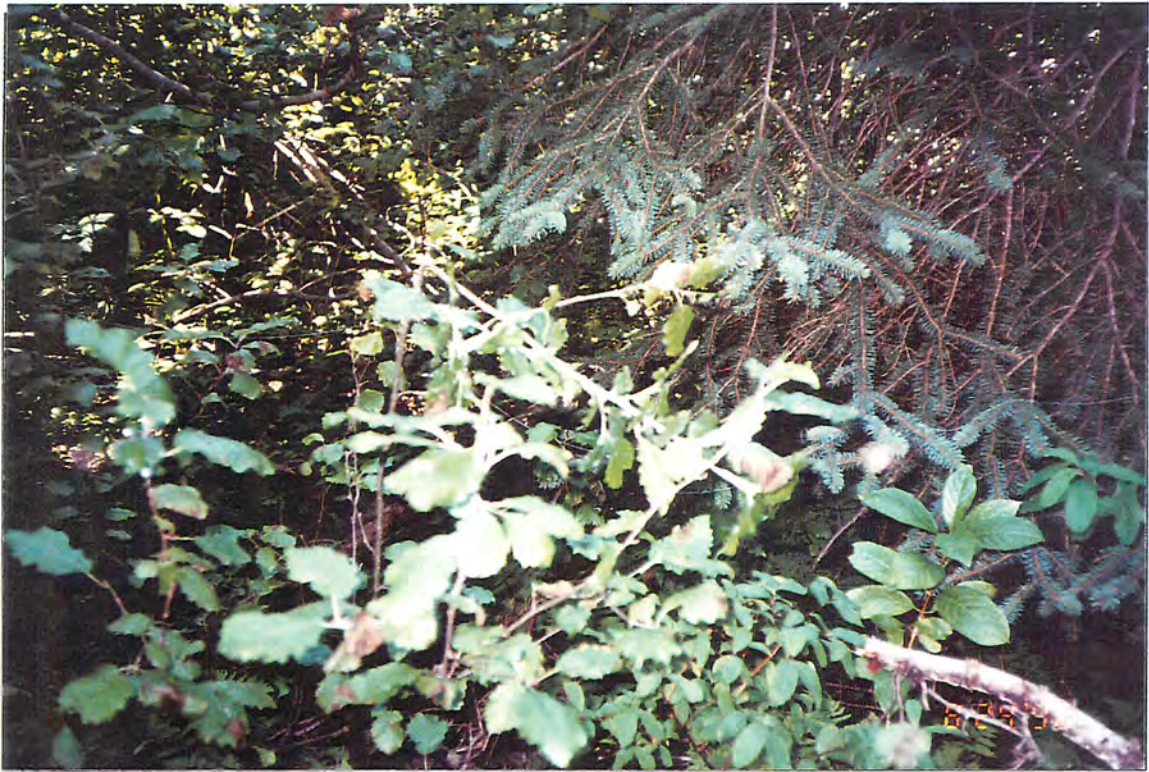
- C1 NC  
C2 LS - 2% RS - 2%  
C3 No fisheries sensitive zones noted.  
C4 This site was not electrofished.  
C5 Lat N 55 21' 08.7" Long 126 37' 50.3"  
C6 Bank texture not applicable.  
C7 Water quality not applicable.  
C8 The crew hiked up 743 meters from the mouth of the creek at (J158) and did not find a defined channel.

Photo #: J-10-25, 1996/08/24  
Site #: J159, Not a creek.

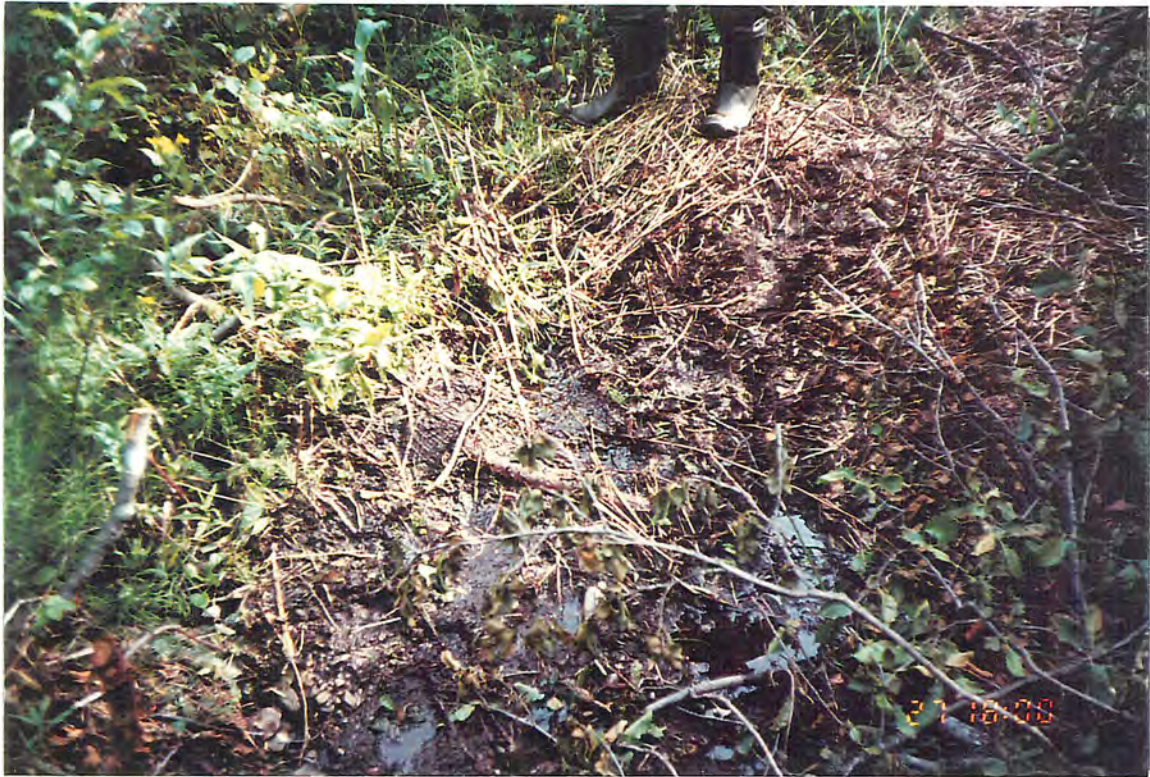
- C1: NC  
C2: Side slopes not applicable.  
C3: No fisheries sensitive zones were noted.  
C4: No electroshocking was carried out.  
C5: N 55 23 57.2 W 126 44 38.2  
C6: This is an alder swale, not a creek.

Photo #: T-1-20, 1996/07/27  
Site #: T17, Not a creek.

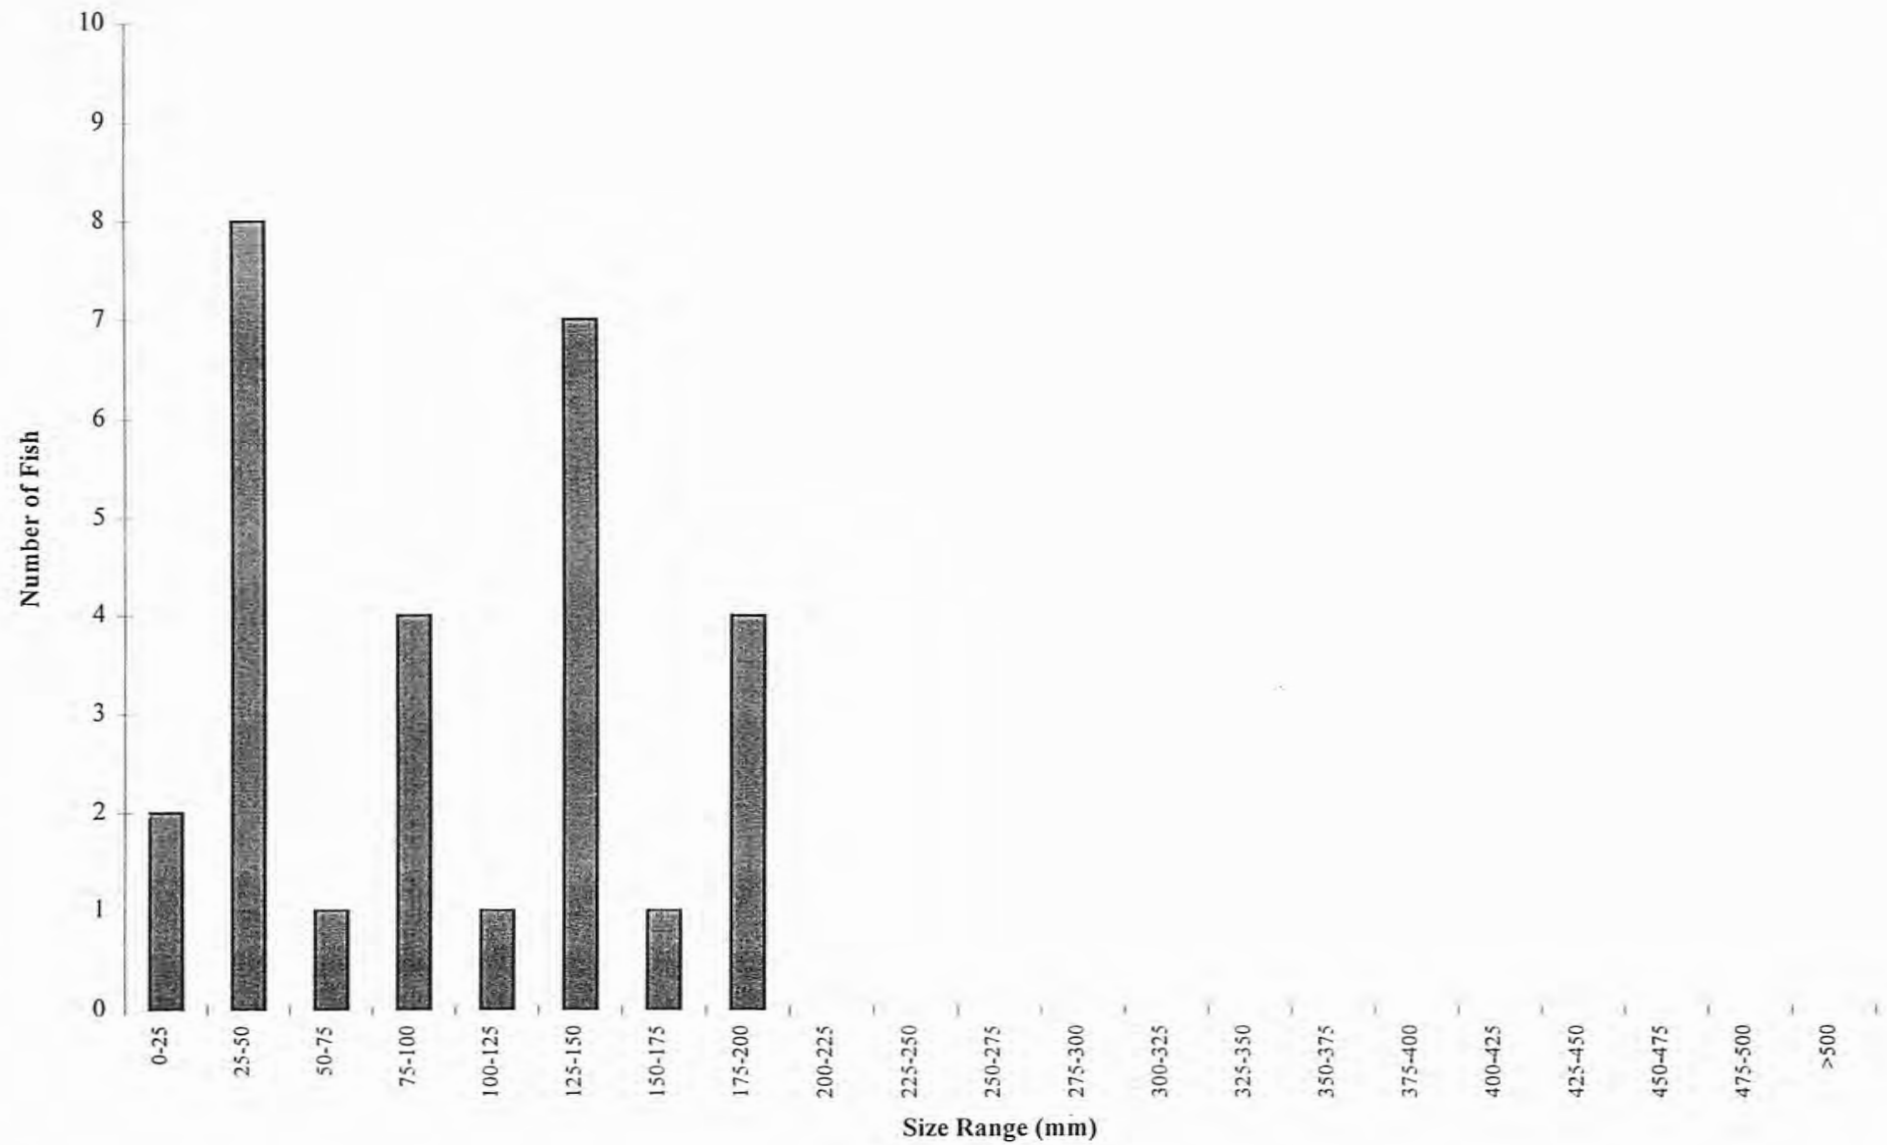
## Working Unit 4 - Dolly Varden

The survey took place between July 25 and October 2, 1996 and July 7 and September 20, 1997. A total of 91 sites were sampled, 10 of which were classified as "Not a creek" due to the absence of a defined channel. Fish were caught by electrofishing at 23 sites, by minnow trapping at 3 sites and were visually observed at 8 sites. The species sampled include Dolly Varden, rainbow trout, northern squawfish, red sided shiner, coho, an unidentified sucker species and an unidentified chub species. A total of 14 sites have been classified as non fish bearing, due in part to the presence of barriers preventing access upstream. A list of barriers identified in working unit 4 is provided in **Table 3**. The summary information for all sites in working unit 4 is listed in **Table 4**. This table is organized alphabetically, by sub-basin and includes fish data, stream classifications and methods of sampling. The stream cards and accompanying photos are in alphabetical, sub basin order and the appropriate cards and photos appear in this report after each sub-basin description. A summary of non fish bearing classifications established in this working unit are listed in **Table 5** and a summary of the sites for which future sampling is recommended is provided in **Table 6**. A summary of wildlife and wildlife signs observed in unit 4 is provided in **Table 7**. Individual fish data for this working unit have been summarized in Appendix 2. Fish catch data were compiled for all records that contained a discrete size measurement. These data were summarised and plotted in histograms by species, the results are presented in Figures 2a through 2g.
