**1999 NORTH COAST STREAM INVENTORY PROJECT (NCSIP)**

***FINAL WATERSHEDS REPORT***

FOR SELECTED WATERSHEDS IN DFO AREAS 3, 4, 5, 6 & 7

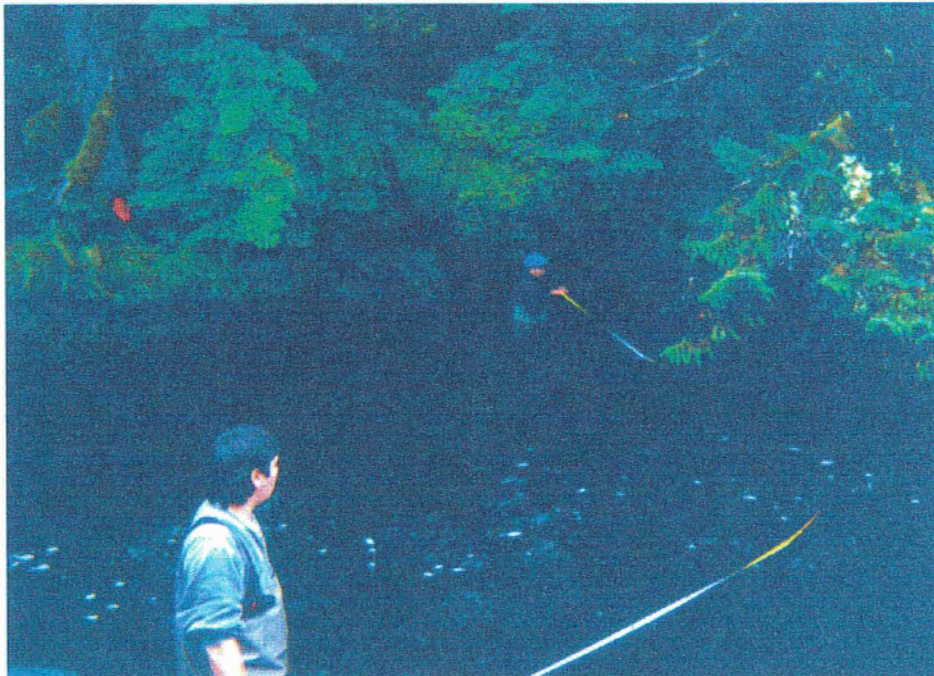
**ALVIN BOLTON AND BRAD LEIGHTON TAKING STREAM MEASUREMENTS IN SWAMP ISLAND CREEK DURING 1998 NCSIP**

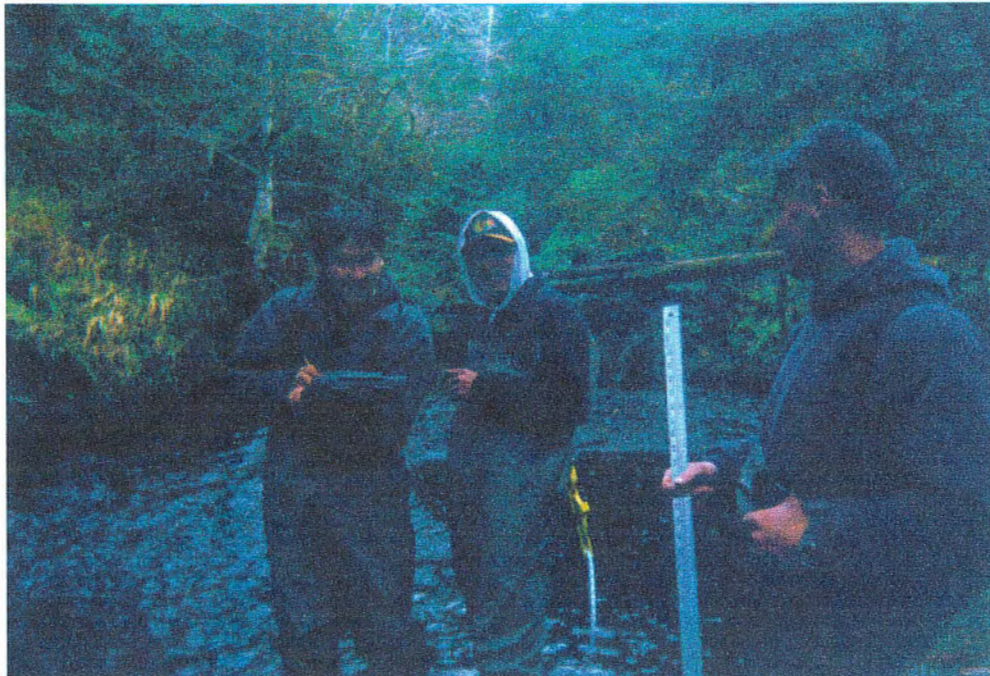
**DEPTH MEASUREMENTS IN SLIPPERY ROCK CREEK**

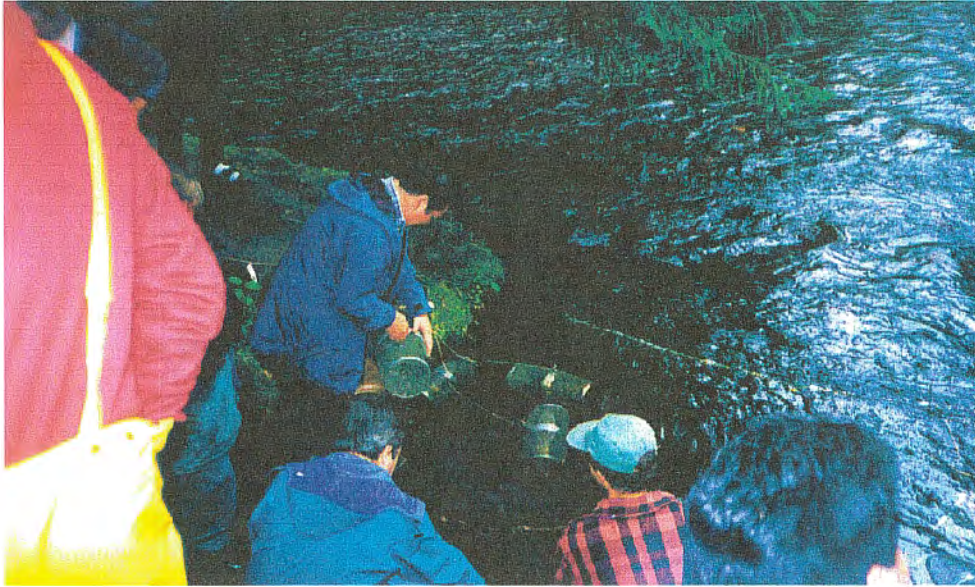
**Fig 9 Taking the juvenile salmonids out of the trap for sampling**

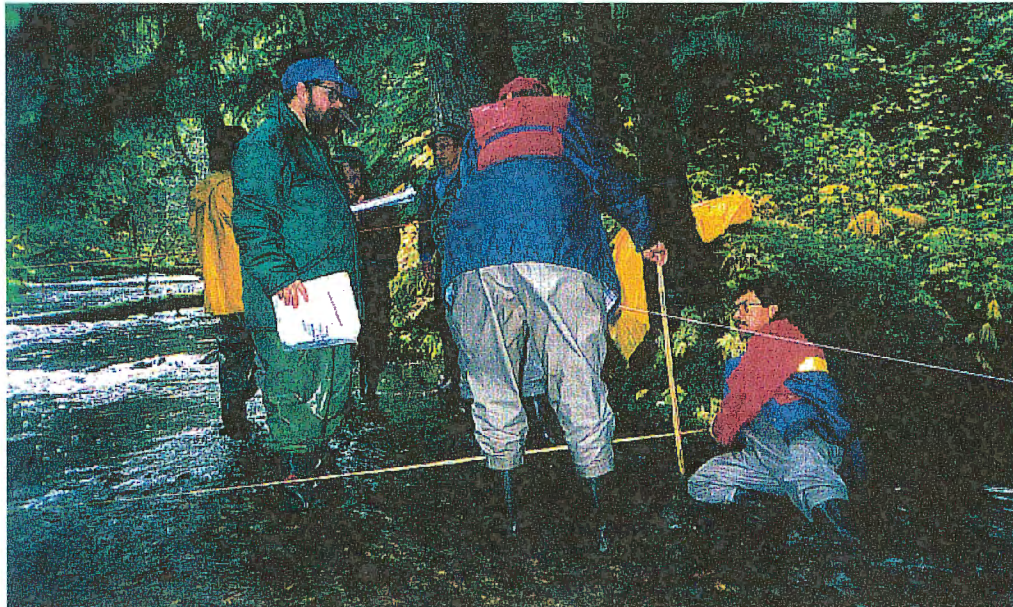
**Fig 10 Taking channel depth measurements in training session**

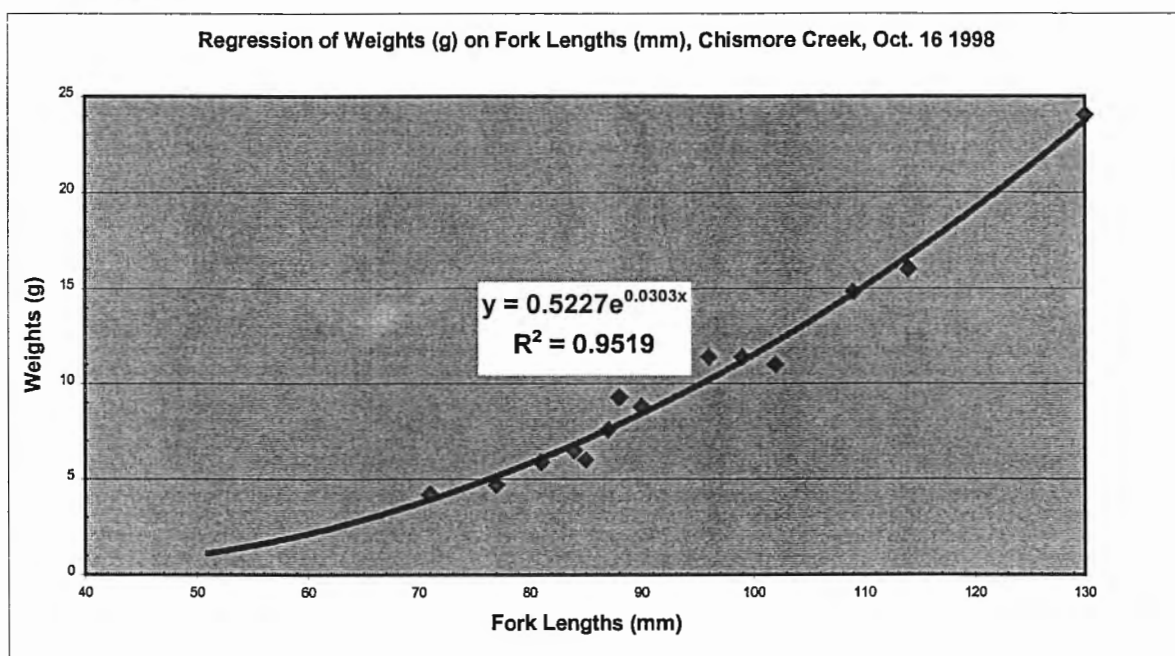
Figure 4 - Regression of Coho Fry Weights on Fork Lengths - Chismore Creek

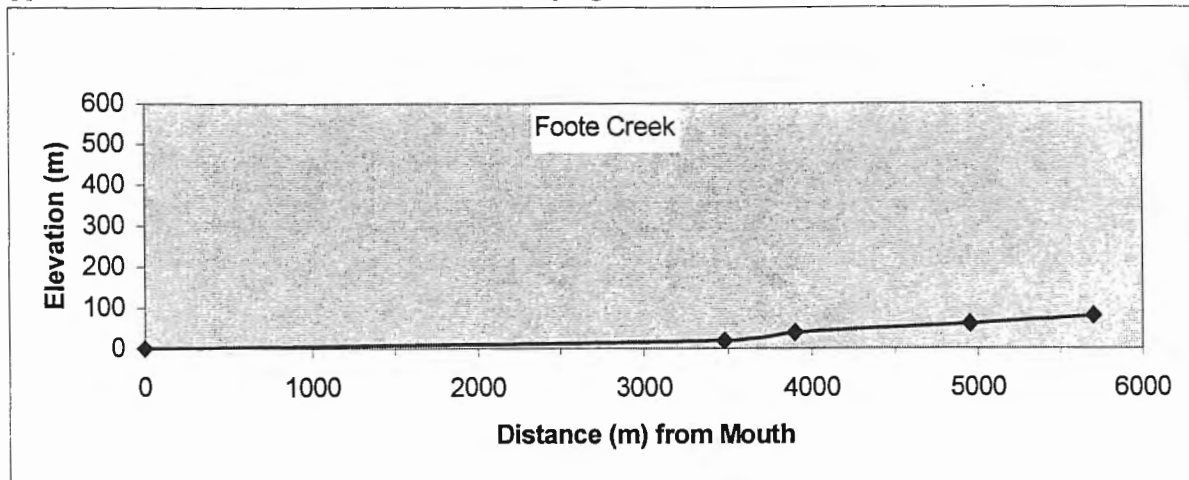
Foote Creek (DFO Watershed Code 97-9300-430), located on the north of Porcher Island, flows southeast to Salt Lagoon (Figure 6). It is a third order stream, 5.7 km in length, draining an area of 9.2 km<sup>2</sup>. Foote Creek is a low gradient stream with an overall gradient of approximately 0.5% for the first 3.5 km, and an overall gradient of 1.5% to its' termination at 5.7 km (Figure 5). There is a short, higher gradient section between 3.5 and 3.9 km of ~5%, the next section between 3.9 and 5.0 km having a gradient of 2%, and the uppermost section between 5.0 and 5.7 km having a gradient of 2.5%.

**Figure 5 - Gradient Profile for Foote Creek**

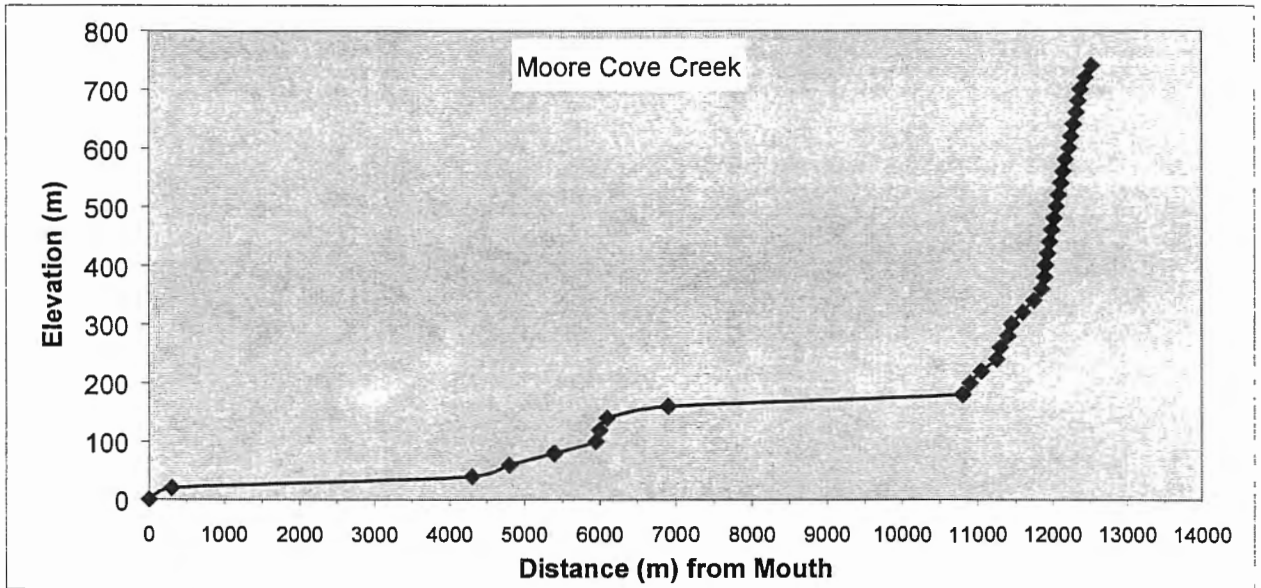
Moore Cove Creek has a short 300 m section at the mouth with 7% gradient, an overall gradient of ~0.5% for the next 4.0 km, a higher gradient section of 4% for the next 1.7 km, a short high gradient section of ~27% at ~6.1 km, a lower gradient section of ~1% between 6.1 and 10.8 km containing a lake, ending with a high gradient of ~33% to its' termination at 12.5 km (Figure 17).

Figure 17 - Gradient Profile for Moore Cove Creek

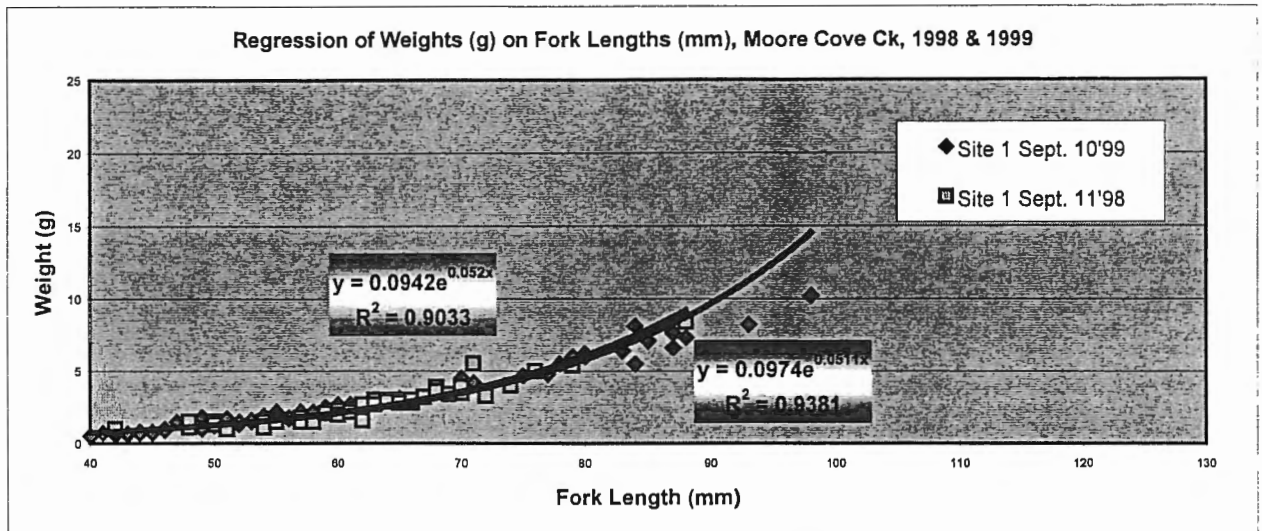
**Figure 25 - Regression of Coho Fry Weights on Fork Lengths - Moore Cove Creek**

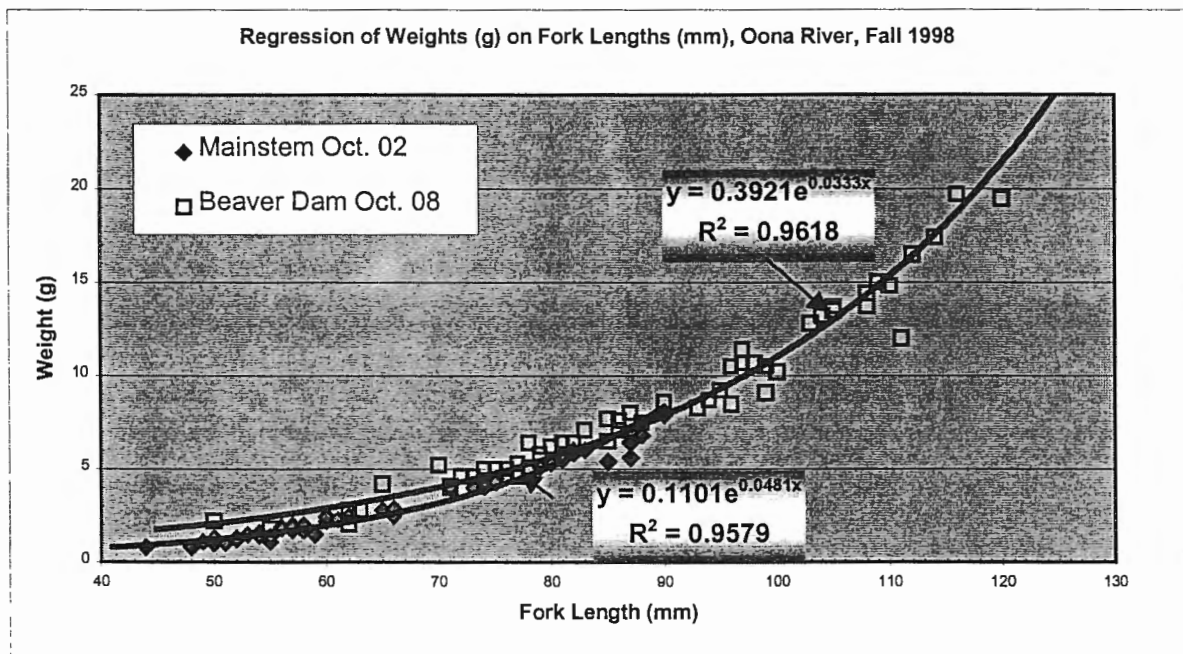
Figure 34 - Regression of Coho Fry Weights on Fork Lengths - Oona River

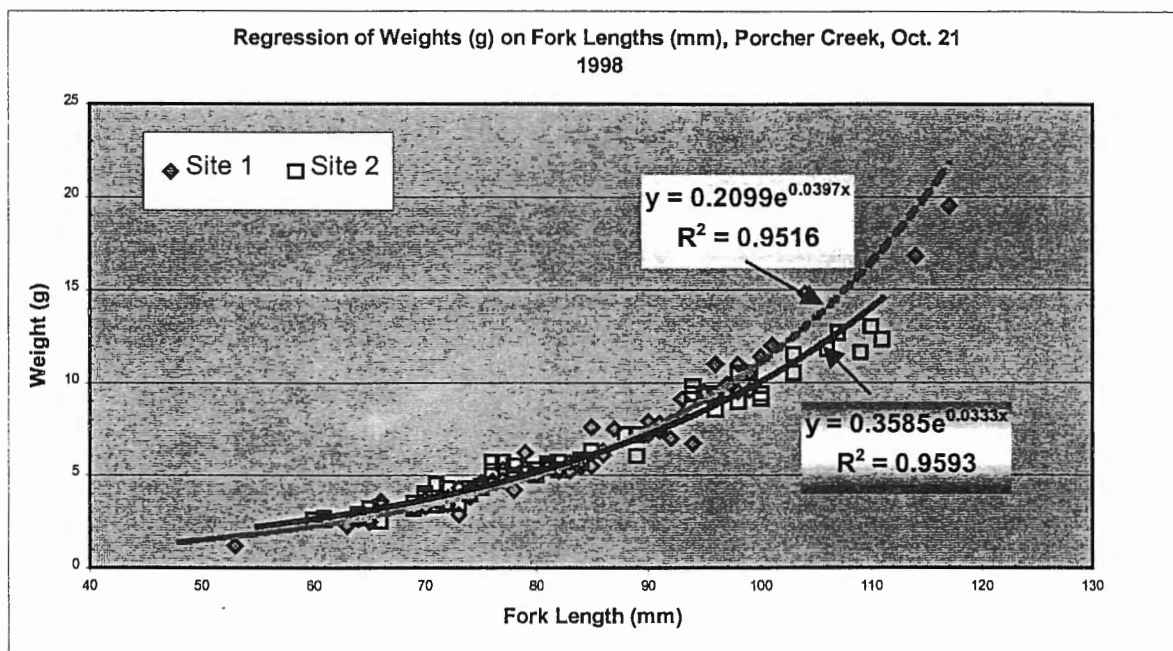
Figure 41 - Regression of Coho Fry Weights on Fork Lengths - Porcher Creek
