MAXAN CREEK AND BULKLEY RIVER HISTORICAL AIR PHOTO ANALYSIS

APPENDIX 1 - MAXAN CREEK APPENDIX 2 - BULKLEY RIVER

November 2021

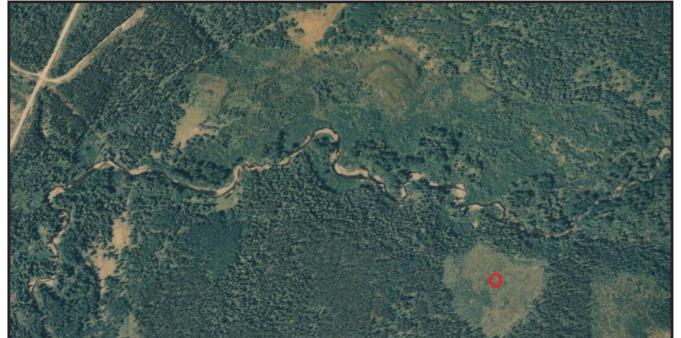
(vi)

Date: August 1, 1998 30BCC98021 #45

- Clearing O.
- Enlarged instream sediment accumulations throughout this section (need to extend the analysis upstream to better evaluate the impportance of local bank erosion versus upstream sediment sources).

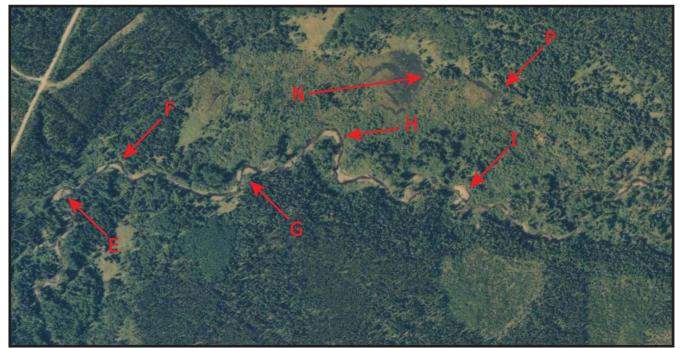
(vii)

Date: August 10, 2005 30BCC05065 #112

- Continued progressive bank erosion **E**, **F**, **G**, **H** & **I**.
- Limited vegetation development on exposed bars.
- Enlarged wetlands associated with beaver dams N & P.

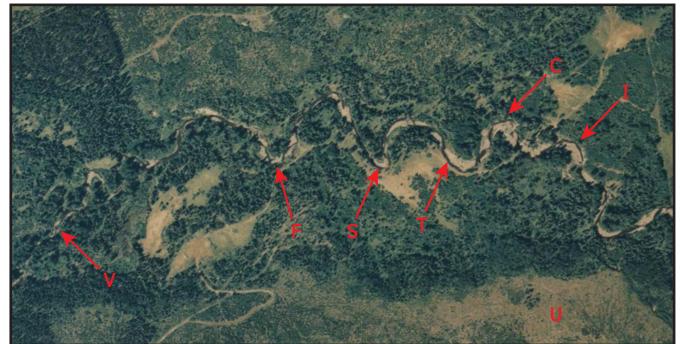
(vi)

Date: August 1, 1998 30BCC98021 #66

- Cutblock U.
- Channel shifting in the vicinity of S, T, C & I and cutoff V.
- Enlarged instream sediment accumulations throughout the section (suggesting channel shifting rather than upstream sediment production as the source).

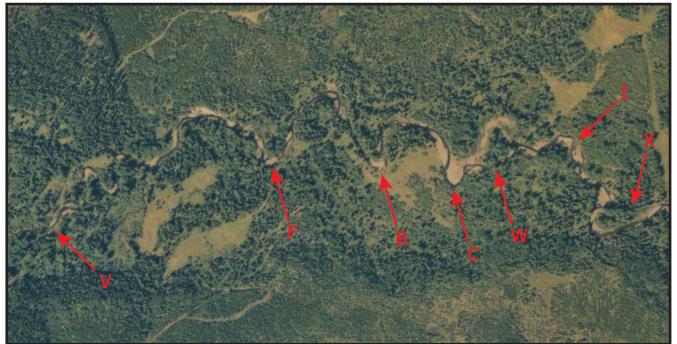
(vii)

Date: August 10, 2005 30BCC05065 #112

Continued channel shifting V, F, B, C & I and cutoff channels W & X.

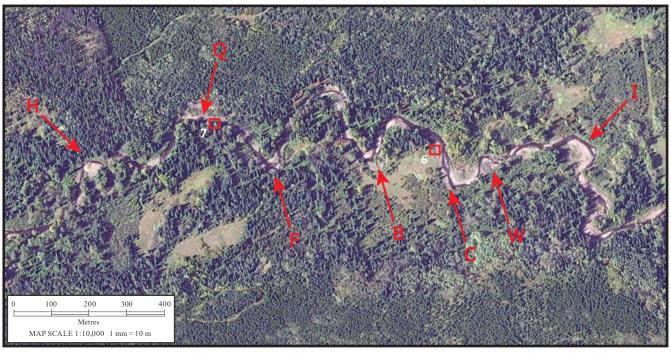
(viii)

Date: September 10, 2016 Google Earth Imagery

- Widespread cutblock revegetation.
- Channel relocation at Q.
- Continued progressive channel erosion H, F, B, C, W & I.
- Widespread enlargement of partially vegetated bars.

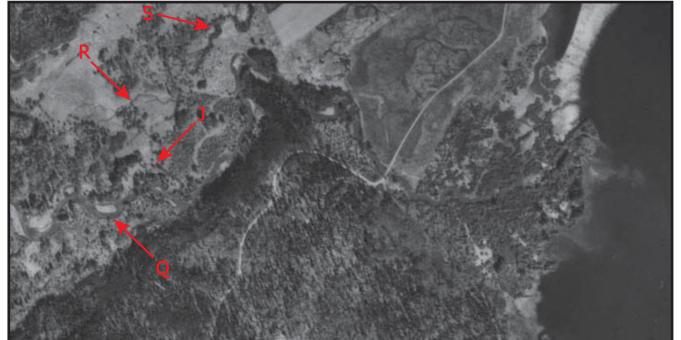
(iii)

Date: June 5, 1971 BC5420 #95

- Channel shifting Q.
 - Wetted channel traces $\bf J, R \& S$ indicate the importance of channel shifting, and possibly beaver dams, in maintaining hydrologic connectivity to the flood plain.

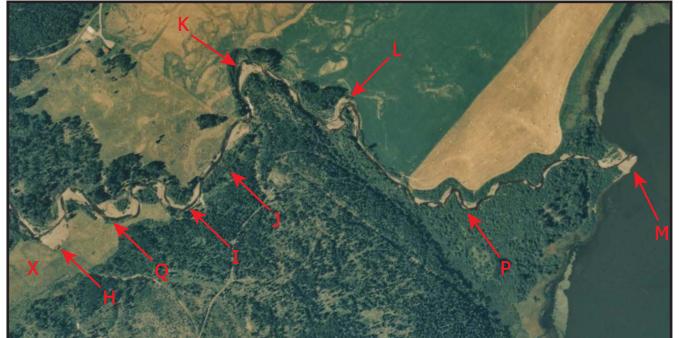
(vi)

Date: August 1, 1998 30BCC98022 #15

- Clearing X with no riparain reserve.
- Widespread channel shifting and enlarged unvegetated instream sediment accumulations associated with cleared channel banks H, Q, I, J, K, L & P.
- Progradation of delta M.
