**A Survey of Day Lake
and its
Inlet and Outlet Streams**

**Ron Saimoto
Regina Saimoto**

**B.C. Fish and Wildlife Branch
Smithers, B.C.**

October, 1993

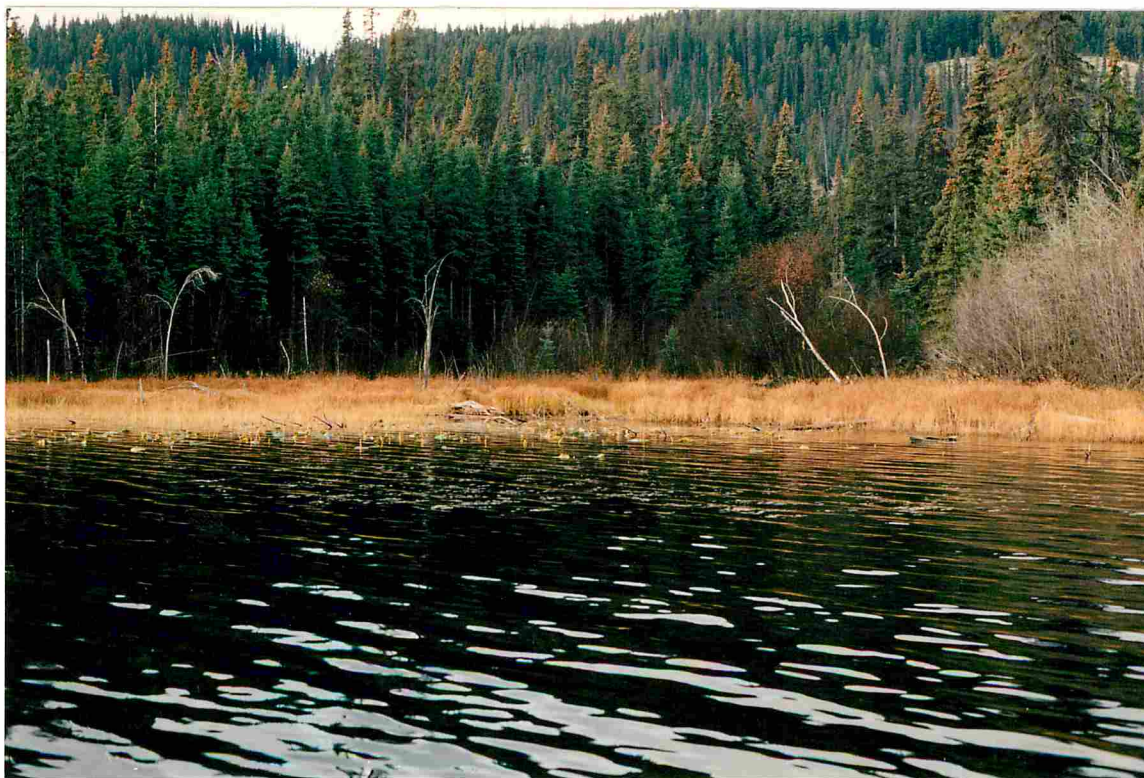
This inlet is the smaller of the two inlets draining into Day Lake (Figure 2). The inlet stream bed was dry, although the substrate was still muddy at the time of the survey (Figure 3). The stream bed was 1 m wide for the initial 30 m above the lake, beyond which it widened into a pool. The stream bed was

Figure 2. The southwest inlet of Day Lake, looking upstream from lake.

The inlets surveyed at this lake presented no useable rearing or spawning habitat for rainbow trout. Enhancement at either of these streams to improve the quality of the habitat for rainbows would not be constructive or essential.

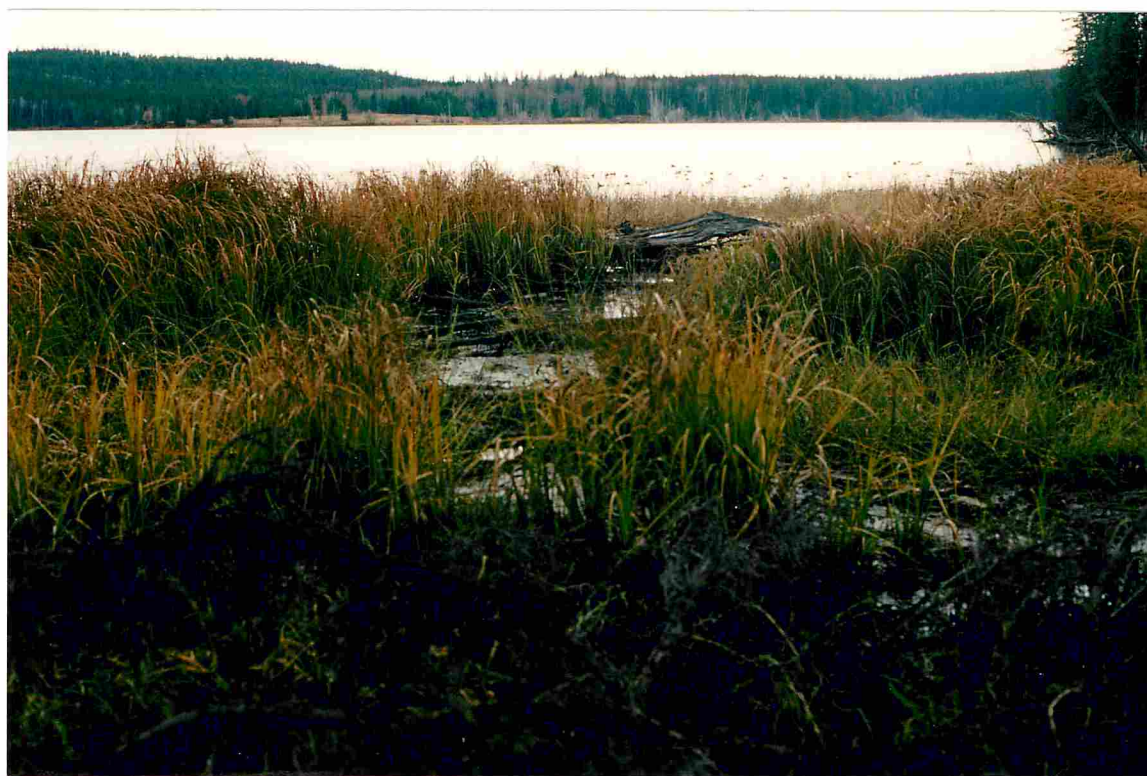
Figure 3. Southwest inlet of Day Lake looking downstream.

surrounded by a marsh for the initial 20 m above the lake, and there was negligible cover. Cover increased to 90 %, primarily from trees, above this point. The pool still contained some water, and the substrate was muddy. Above the pool, the stream bed was 1 m wide and remained dry for at least an additional 200 m. No signs of beaver activities were noted. Due to the temporary nature of this stream, it is unsuitable for rainbow trout spawning and rearing.

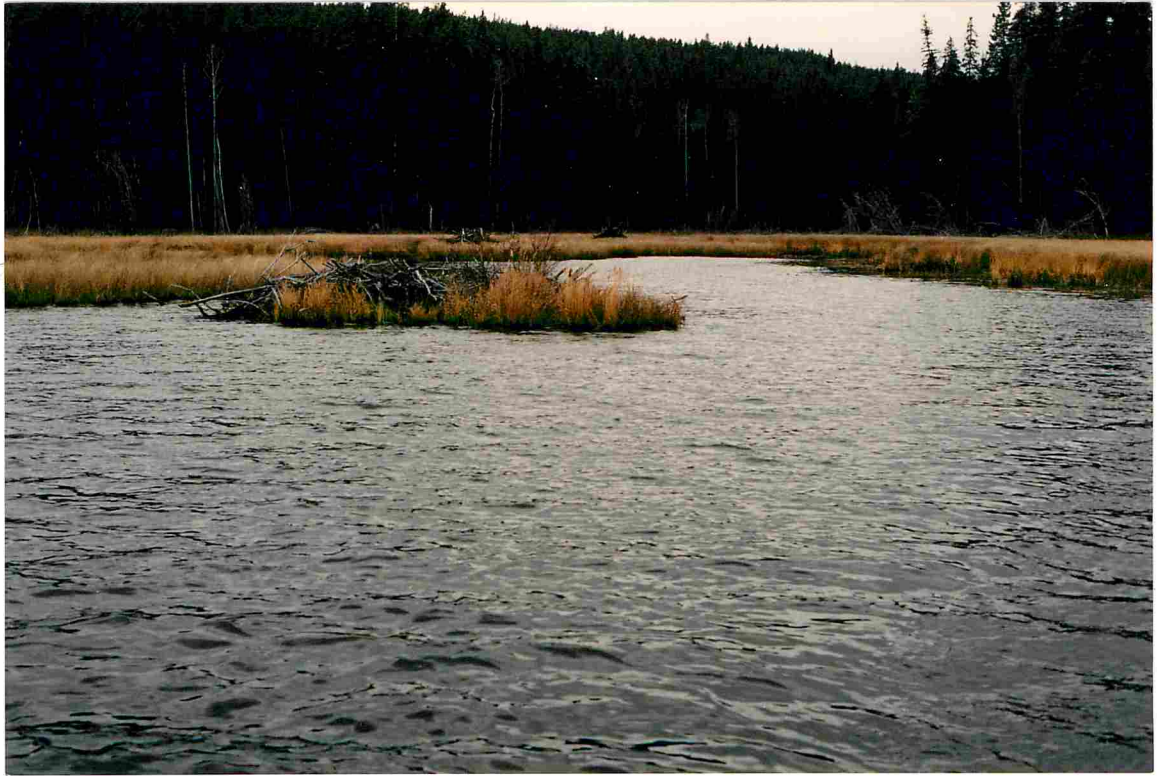
Several beaver houses are located near the inlet at the west arm of the lake (Figure 4). The inlet stream ranged in width between 10 and 20 m, exhibited no flow, and the substrate was very muddy (Figure 5). It was impossible to hike along the shore of the stream, which resembled a swamp at this point. Judgment of distance was therefore difficult. Approximately 1 km above the lake, the stream was blocked by an impassable beaver dam. The dam appeared old, but solid and was overgrown with terrestrial vegetation (Figure 6). For 100 m downstream of the dam, the inlet stream narrowed to 4 m, and had minimal habitat for rainbow trout spawning. Cover increased from almost 0 % to 75 % just downstream of the dam. The dam was approximately 40 m long, and was impassable to fish. Water level on the upstream side of the dam was 1 m higher than below the dam. Some seepage of water through a small hole recently repaired was noted. The inlet consisted of a large, stagnant pool above the dam, with a width of 30 m at its narrowest point.

Figure 4. Inlet at the west arm of Day Lake, including three beaver houses.

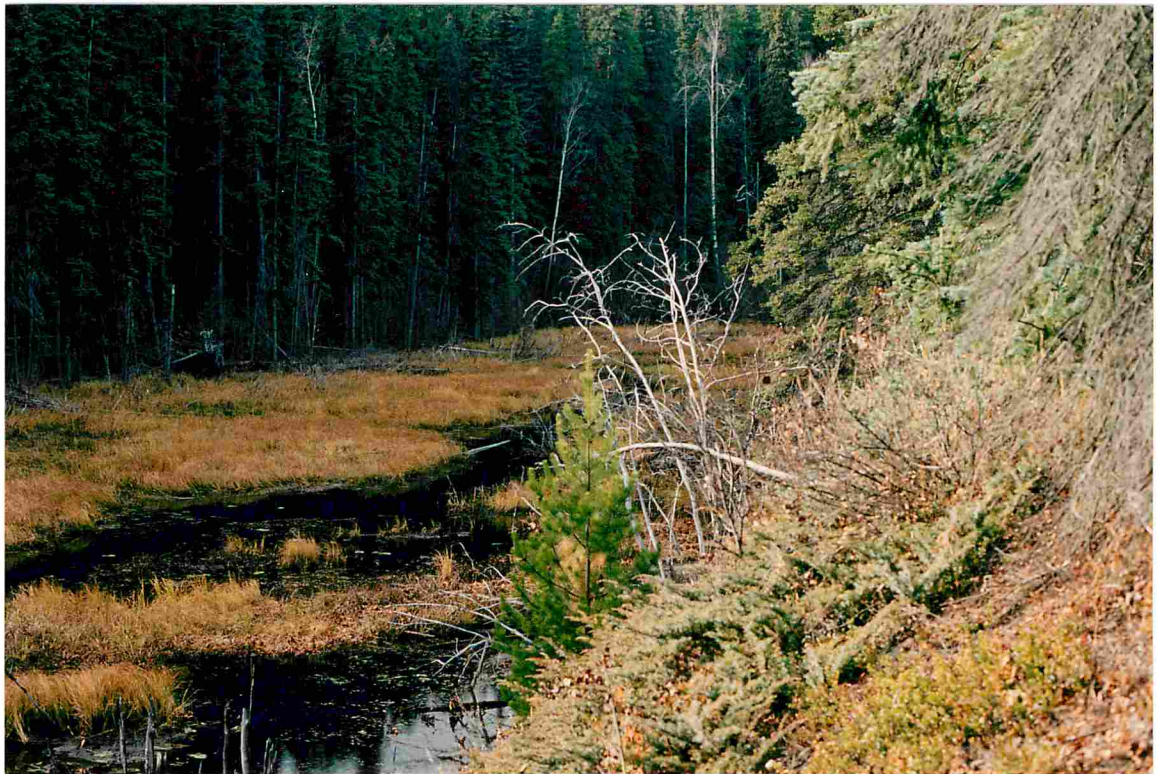
Figure 5. West arm inlet of Day Lake, looking upstream from 300 m above lake.

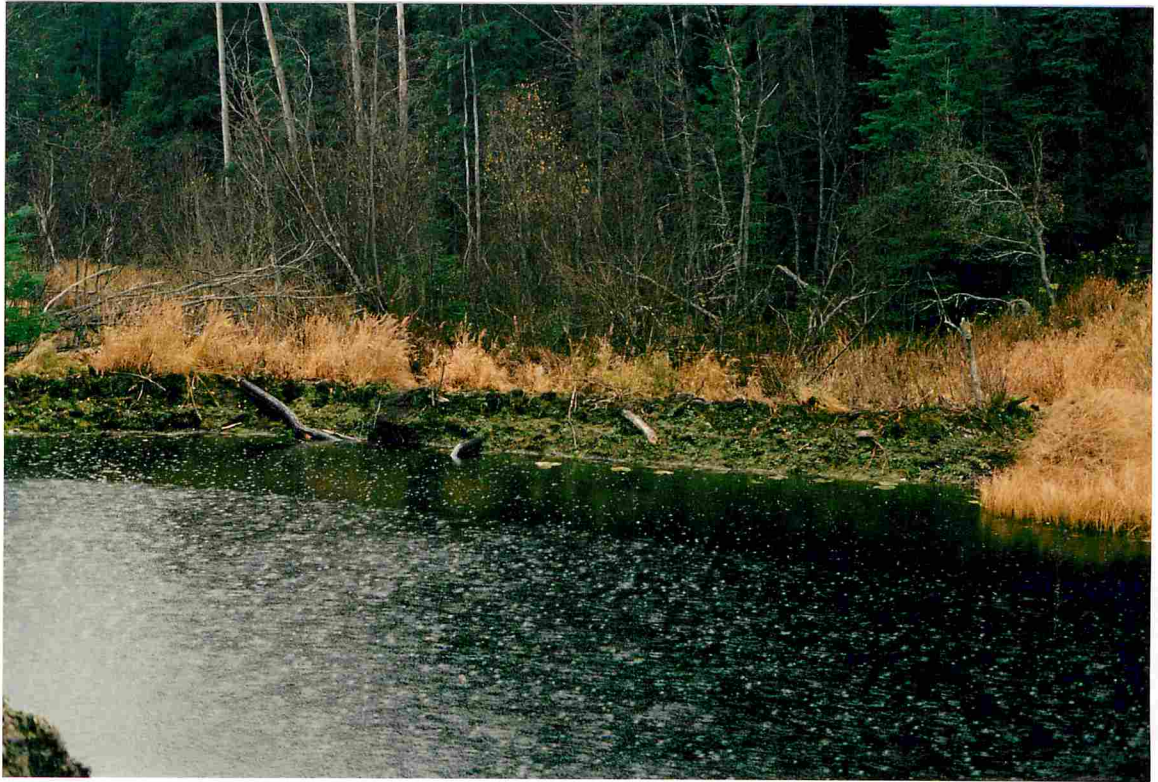
Figure 6. Looking downstream at beaver dam at west arm inlet approximately 1 km above the Day Lake.

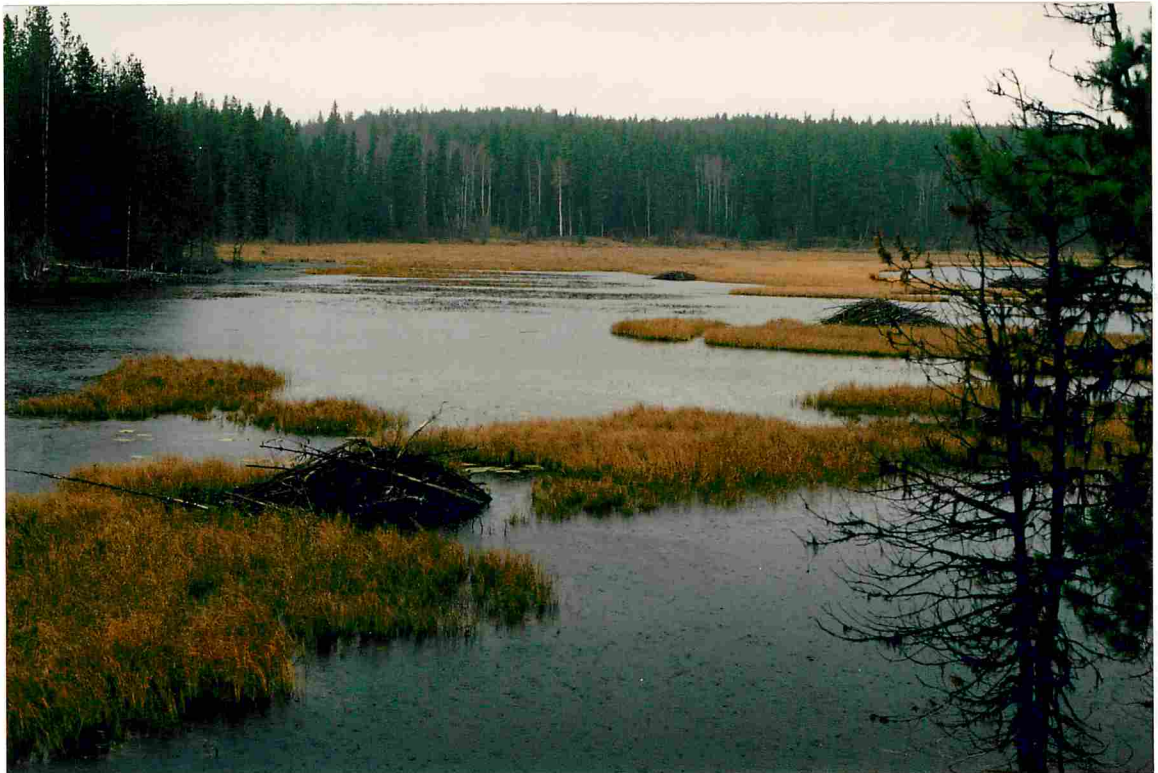
Figure 7. Looking upstream at small lake above beaver dam of west arm inlet.

The transition between this pool and a small lake just above it was indistinguishable (Figure 7). Six beaver houses were seen from the shore of this small lake. No fish were observed and no traps were set in this location.

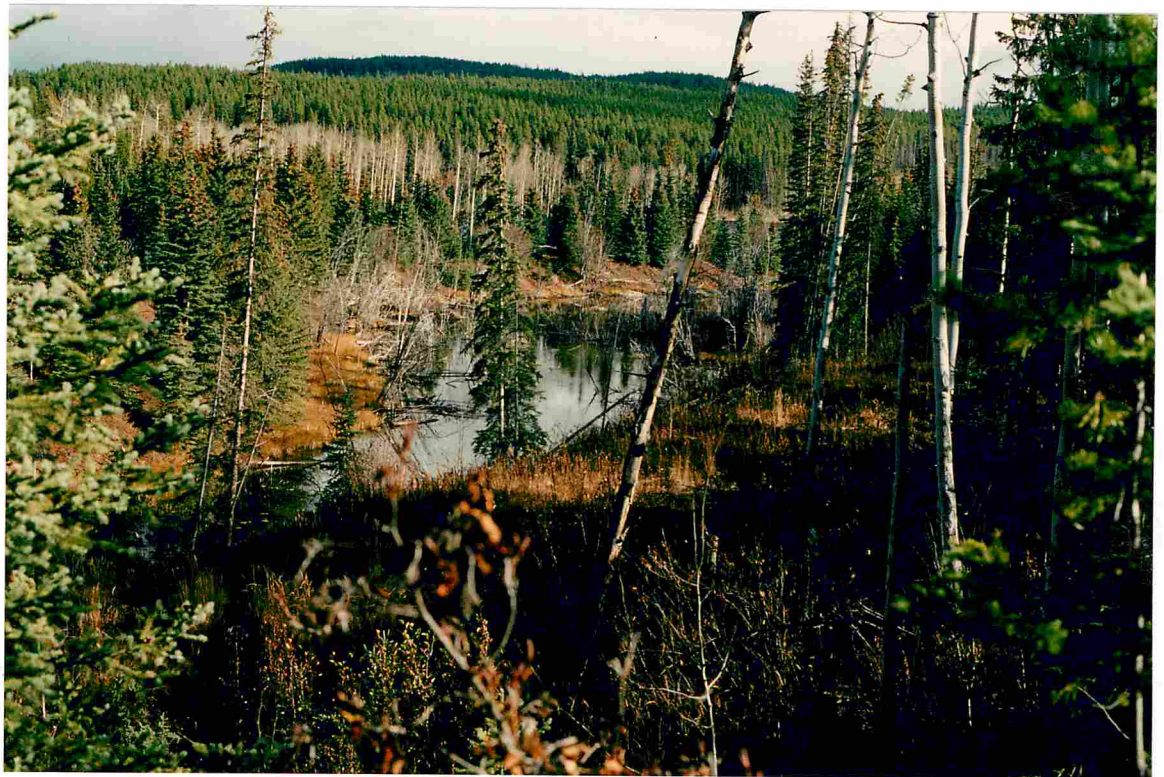
The Day Lake outlet drains Day Lake into Elwin Lake (Figure 8). The outlet was dammed 500 m downstream from the lake. The section of the outlet stream above the dam consisted of a large pool (20 - 30 m wide, 40 cm deep) (Figure 9), with a deep channel, about 5 m wide and 120 cm deep, in the centre of the pool. It was possible to navigate the boat to the dam from the lake through the deeper section of the pool. The substrate above the dam consisted primarily of sand and mud and was not suitable as rainbow trout spawning habitat. Dead willows and aspen were found in the marshy area around the pool, as well as in shallow sections. The beaver dam was approximately 20 m across, and 1 m high (Figure 10). A recent break through the dam was repaired. A pool below the first beaver dam stretched to the second beaver dam. This pool was about 10 m long, 15 m wide and 1 m deep in the centre. Substrate in the pool was muddy and sandy. The second dam was 15 m long, and the top of the dam was level with the water on the upstream side of the dam. The water level on the downstream side of the dam was 1 m lower. The outlet narrowed to 1 - 2 m wide and 10 cm deep below the second beaver dam, and the substrate consisted of a mixture of sand and gravel. This stretch of stream remained relatively consistent

Figure 9. Looking upstream from beaver dam in Day Lake outlet stream.

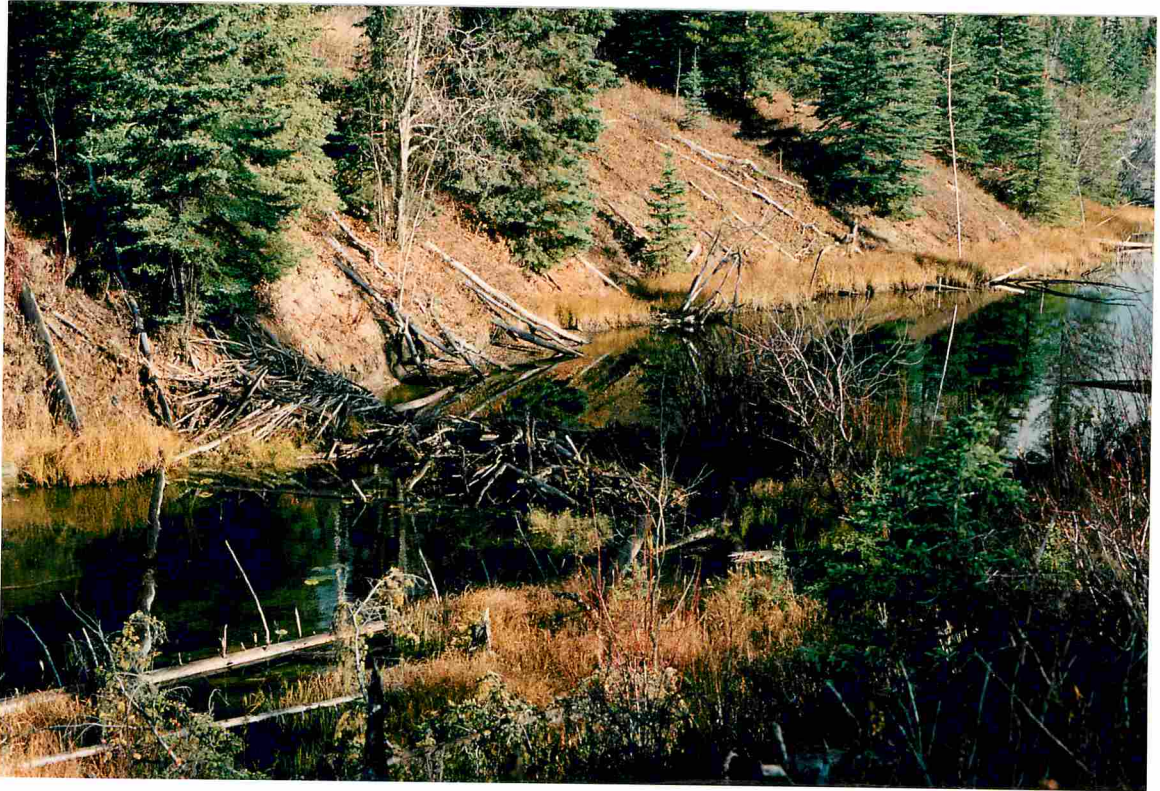
Figure 10. First beaver dam at the outlet of Day Lake.

Spawning and rearing habitat were found in the Day Lake outlet stream. The presence of rainbow parr indicates that this stream is being utilized by rainbow trout. It is unclear whether the beaver dams upstream of the spawning and rearing habitat are passable by fish. A visit to this stream during spring flooding would be valuable to assess this possibility. In addition, previous logging practices appear to have left the stream vulnerable to siltation and predation. The fisheries values of streams and lakes should be impressed upon the logging company responsible for these practices. Removal of beavers and/or their dams is a short term solution to a recruitment problem. However, riparian restoration should lead to a long term improvement in the quality of spawning and rearing habitat in the stream.

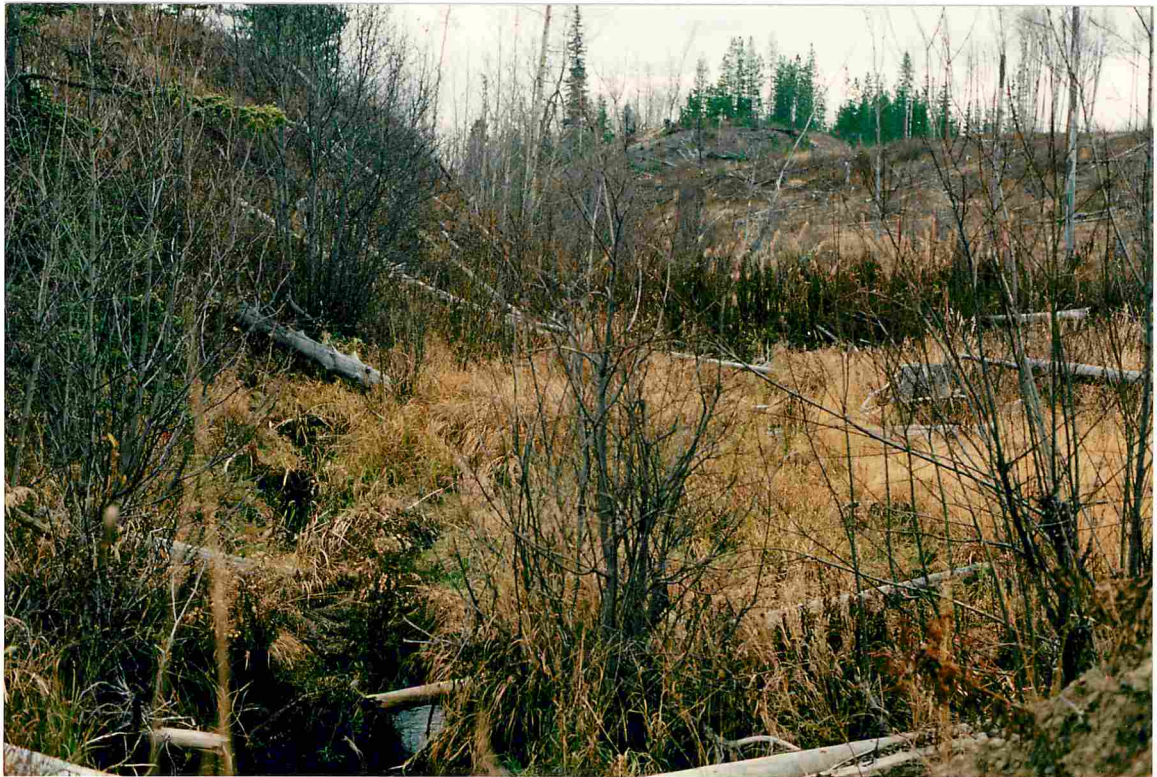
Figure 11. Day Lake outlet looking upstream from logging road.
Note the clear cut to the edge of the stream.

for the next 300 m, to the logging road crossing. Overhanging shoreline grass and abundant organic debris provided cover for this section of the stream 100 m below the dam. However, most of the stream has been logged to the edge, with little terrestrial vegetation remaining at the edge of the stream. A steep slope, which has also been logged and not satisfactorily replanted, formed the north bank of the stream, where erosion and run off are likely serious problems (Figure 11). The flow below the second dam was good (about 1 m/sec), and there was adequate spawning habitat for rainbow trout. However, both beaver dams were impassable to up migrating fish at the time of survey. It is likely that downstream migration is possible during higher water levels. 250 m below the dam, the width of the stream varied between 1 and 3 m, and depth was between 40 and 50 cm. Cover consisted of large organic debris (10%) and overhanging grass (10%). Flow was variable, with faster flows in riffles (1m/sec) and slower flows in pools. The sandy component of the substrate increased, and grasses grew in shallower sections of the stream. Habitat was primarily suitable for rearing rather than spawning, although the lack of cover may jeopardize juvenile survival. A culvert under the logging road allowed for migration of fish (Figure 12). The stream was again logged right to the edge below the culvert. The substrate below the culvert consisted of 60 % rock, 30 % gravel and 20 % sand. The section of stream 10 m immediately below the culvert contained suitable spawning habitat in some places. The next 150 m of the stream was similar to the section

5.2 The outlet of Day Lake has been logged to the edges of the stream in the section where most of the valuable spawning and rearing habitat exists. It is important that this section be replanted as soon as possible to prevent further siltation and erosion and to increase cover for the stream.

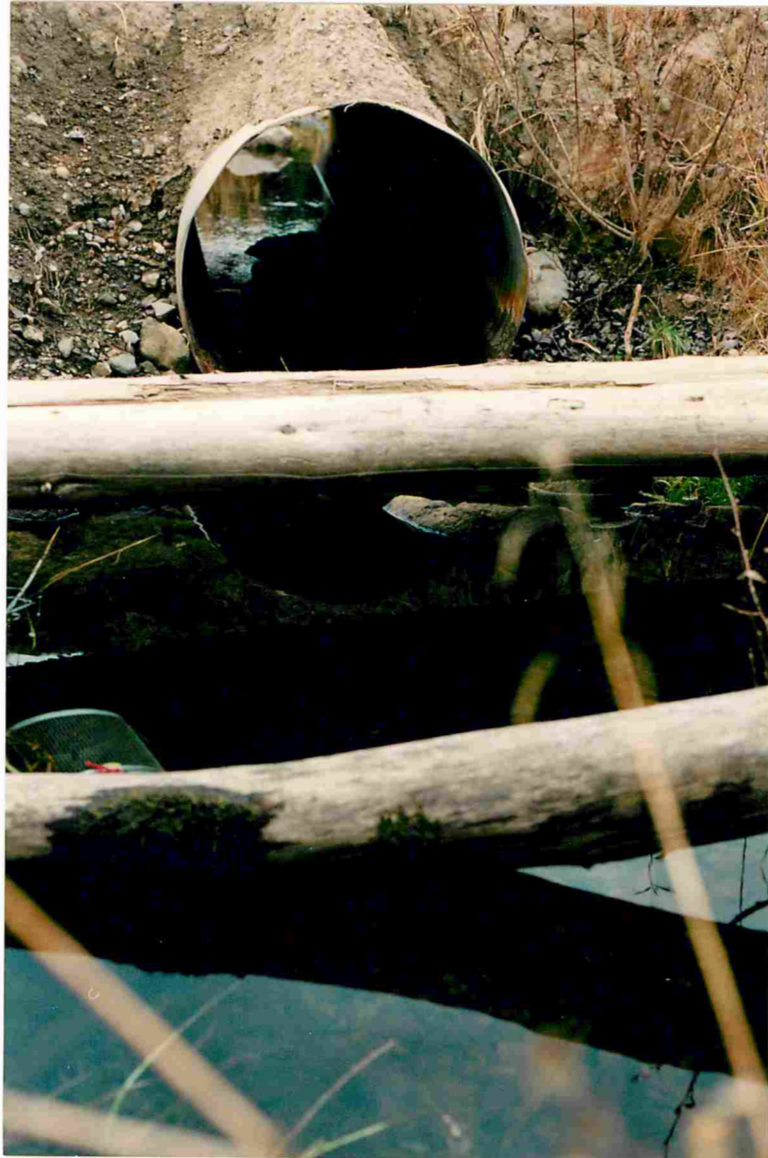
Figure 12. Culvert under the logging road at the Day Lake outlet stream.

just above the culvert, and was suitable for rainbow trout rearing habitat. An old, broken through beaver dam was found 25 m above the culvert, and was passable to fish at the time of the survey. The lower parts of this outlet are described in more detail in the Elwin Lake survey (Saimoto 1993). However, no
