# FDIS Site Card

Project Name: NTL 2010 Field Work  
 Stream Name (gaz.): BELL-IRVING RIVER Project Code: 20255  
 Project Watershed Code: 560-000000-00000-00000-0000-0000-000-000-000-000-000-000

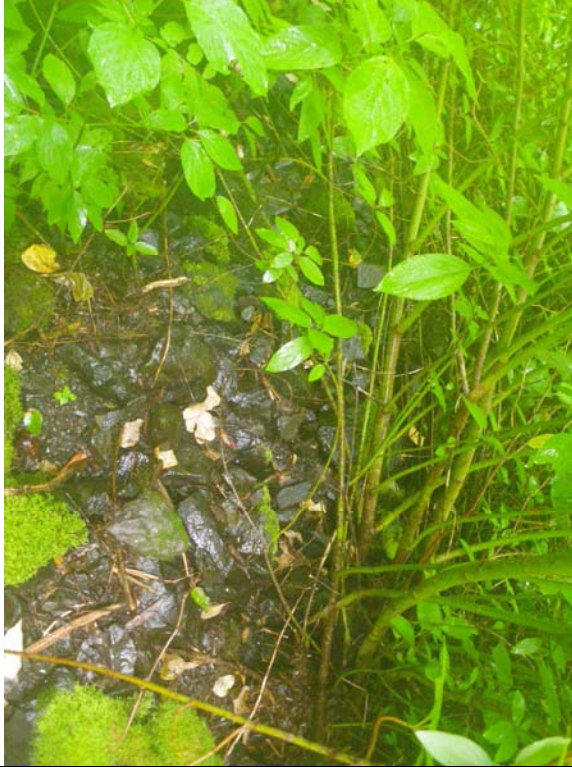
Stream/ILP: 7017 Image: 0357 Comment: Downstream, . 8/23/2010.

Section	Comments
CHANNEL	NCD - 45% slope, dry but looks like water flows off of hillslope in spring

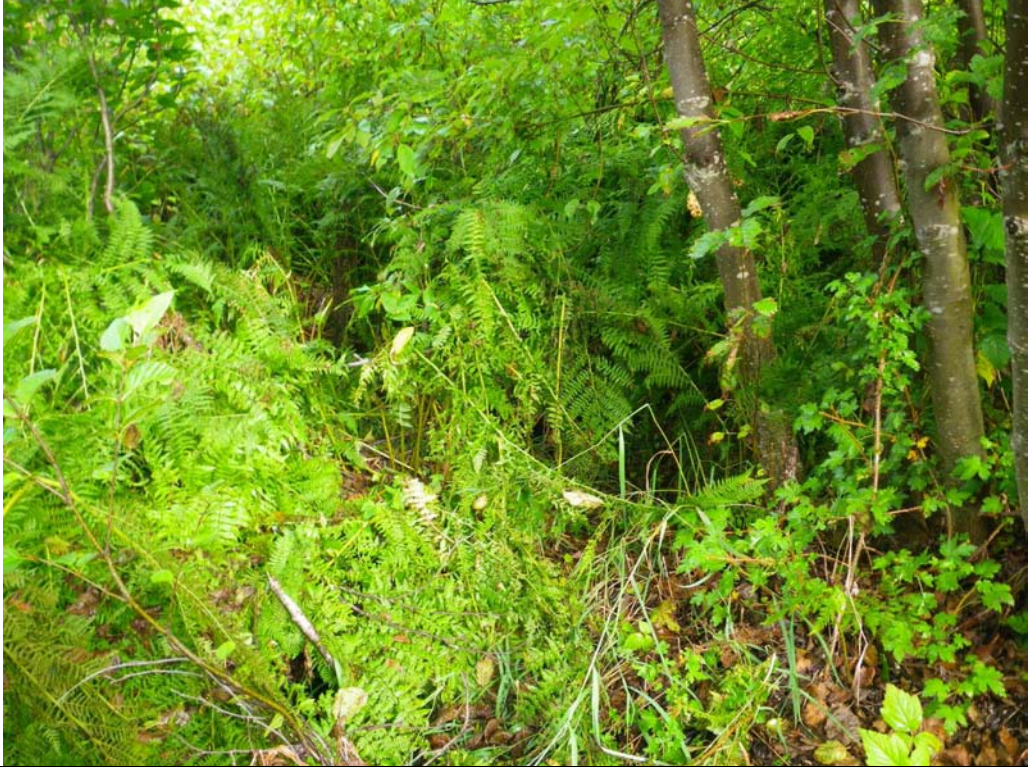
Stream/ILP: 7021 Image: 0396 Comment: Upstream, . 8/26/2010.

Section	Comments
CHANNEL	NCD

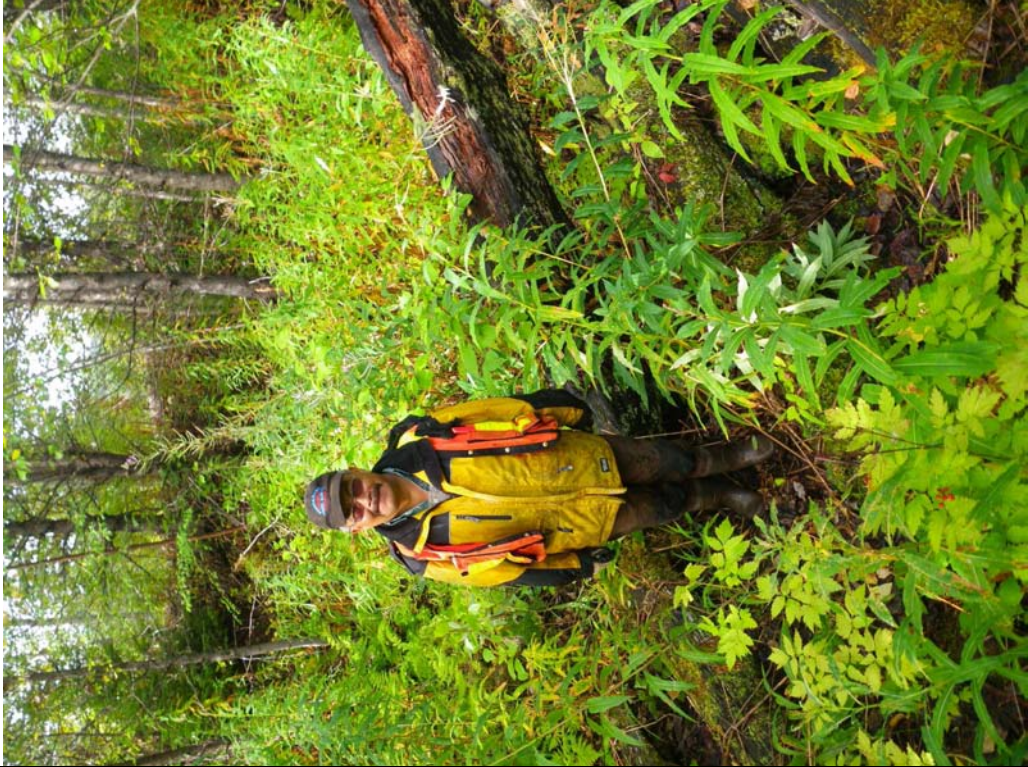
Stream/ILP: 7022 Image: 0398 Comment: Downstream, With assistant. 8/26/2010.

Section	Comments
CHANNEL	NCD - No culvert at road crossing. Drainage must pool up above road and soak thru rock/gravel below

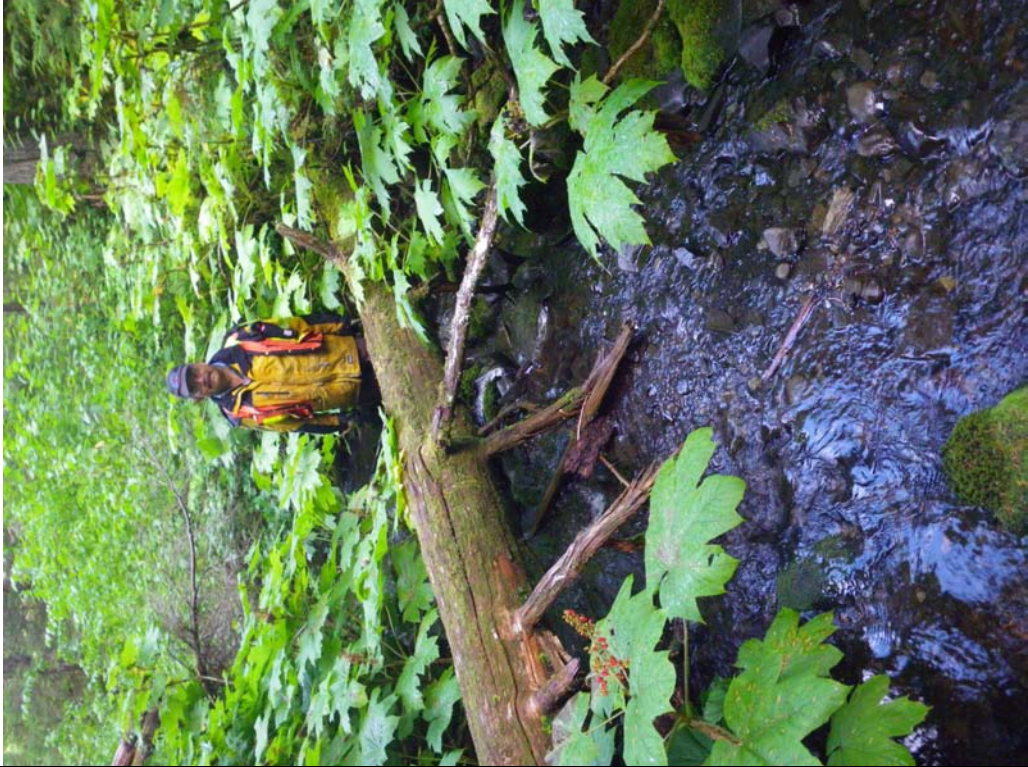
Stream/ILP: 7024 Image: 0405 Comment: Downstream, With assistant. 8/26/2010.

COMMENTS	
Section	Comments
CHANNEL	S3 - Default. Road crossing old log crib bridge no barrier to fish. Suspect down stream gradient barrier possibly at mainstem confluence.

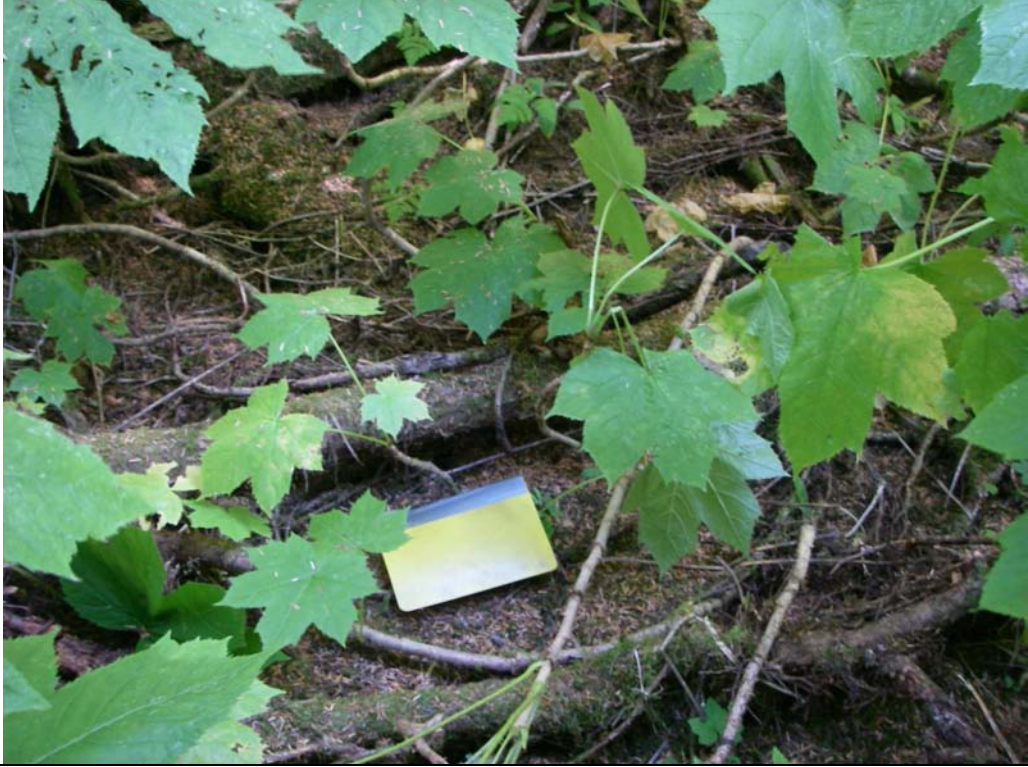
Stream/ILP: 8001 Image: 2520 Comment: Across, Book for scale. 8/20/2010.

Section	Comments
CHANNEL	NCD - Seepate through swale - NFH

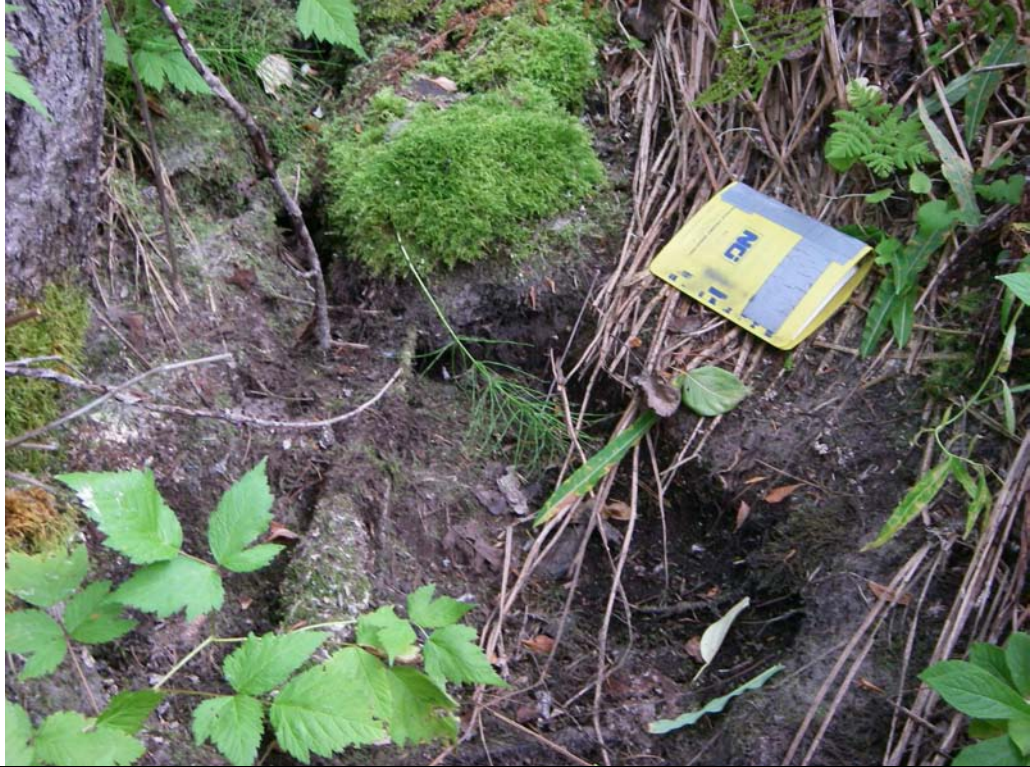
Stream/ILP: 8005 Image: 2532 Comment: Upstream, Book for scale. 8/21/2010.

PHOTOS				
Photo		Foc Lg	Dir	Comments
R: 8005	F: 2534	STD	U	Book for scale
COMMENTS				
Section		Comments		
CHANNEL		NCD - No continuous scoured channel bed or fluvium upstream of cascade barrier. Potentially useable pools below steps by CT are inaccessible for seasonal use. Drainage becomes a stream downstream of cascade.

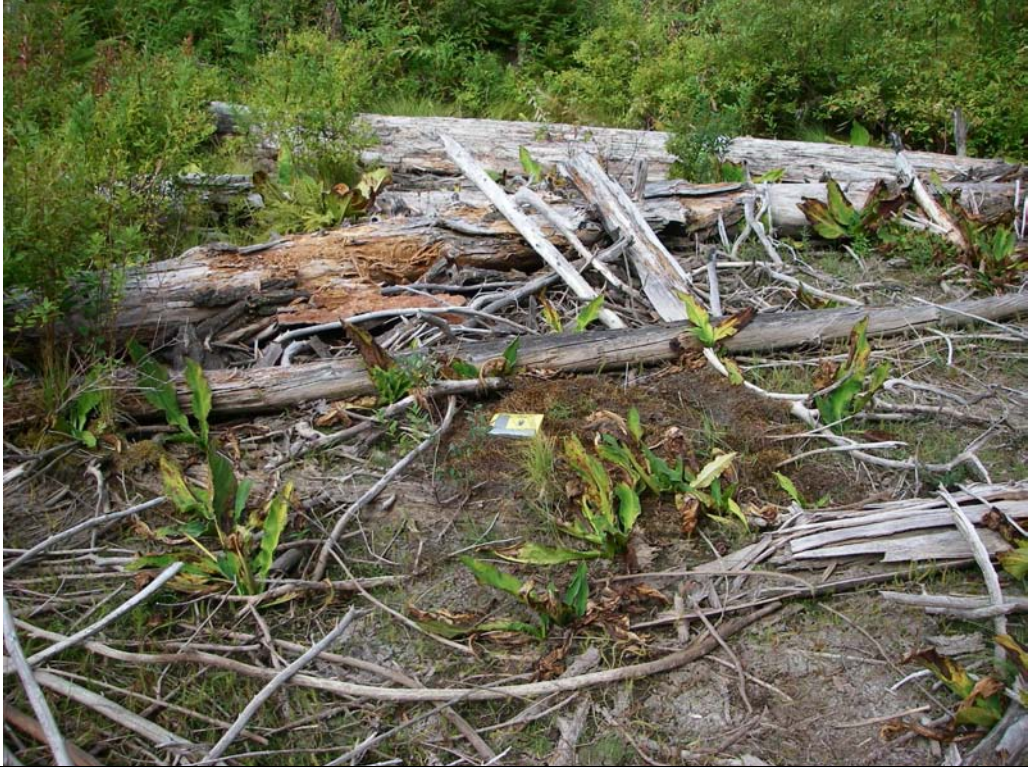
Stream/ILP: 8006 Image: 2536 Comment: Across, Book for scale. 8/21/2010.

Section	Comments
CHANNEL	NCD - Gully draw with seasonal water collection puddles, no scour, no fluvium = not a stream. Drainage parellels NTL in SE-NW direction. Crosses at NTL UTM - 501883 6197955, 2 ribbons hang with ILP as it is the same drainage.

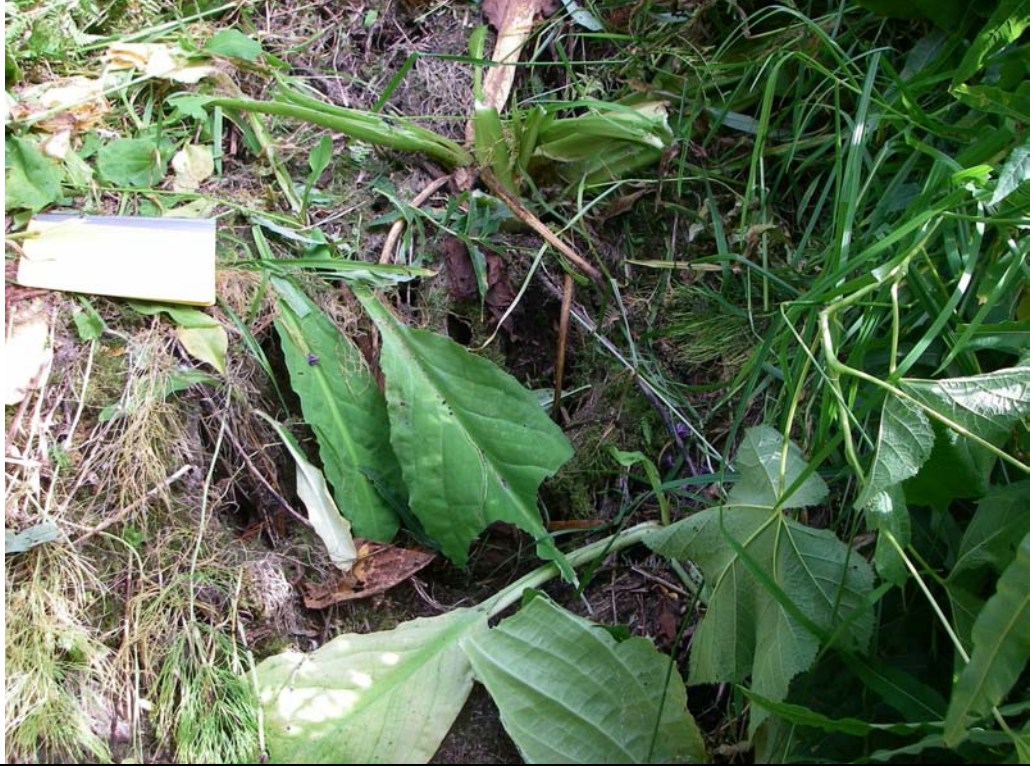
Stream/ILP: 8007 Image: 2539 Comment: Across, . 8/21/2010.

Section	Comments
CHANNEL	NCD - Seasonal drainage with no fluvian or scour, descends at NTL at 30% down to other trickle

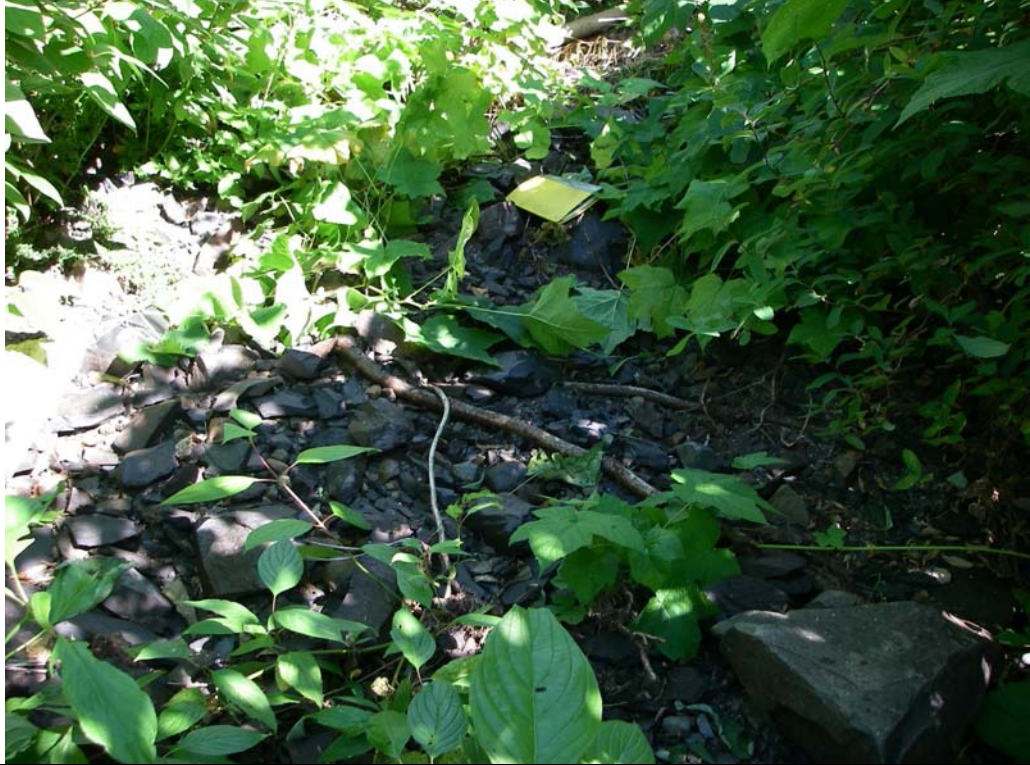
Stream/ILP: 8009 Image: 2545 Comment: Upstream, Book for scale. 8/21/2010.

FEATURES													
NID Map	NID	Type	Hgt	Method	Lg	Method	Photo			AirPhoto		UTM (Z/E/N)	Method
103P.096	80012	CV	1.0	MS	16	MS	R: 8009	F: 2544	L:		#:	9.501024.6199757	GP3
Comments:		Impassable at all flows											
HABITAT QUALITY													
Name		Comments											
OverWinter Habitat		POOR - Two suitable pools and lack of flow @ LF, likely will freeze up.											
Spawning Habitat		NONE - Anuglar and mixed substrate											
Rearing Habitat		POOR - Stream dewatered from end of July											
PHOTOS													
Photo		Foc Lg	Dir	Comments									
R: 8009	F: 2543	TE	X	Site card									
R: 8009	F: 2544	STD	U	CV									
R: 8009	F: 2545	STD	U	Book for scale									
R: 8009	F: 2546	STD	D	No scale									
R: 8009	F: 2547	STD	U	Cascade									
R: 8009	F: 2548	STD	U	Cascade 2									
COMMENTS													
Section		Comments											
CHANNEL		S3 - CV perched EMP 800, 16 M water percolates through road fill. Water droms 1 m away from pool. Debris pile accumulated near CV. Water percolates under fluvian @ low flows - dewatered none. Very unlikely fish use. Stream entrenched u/s at xing

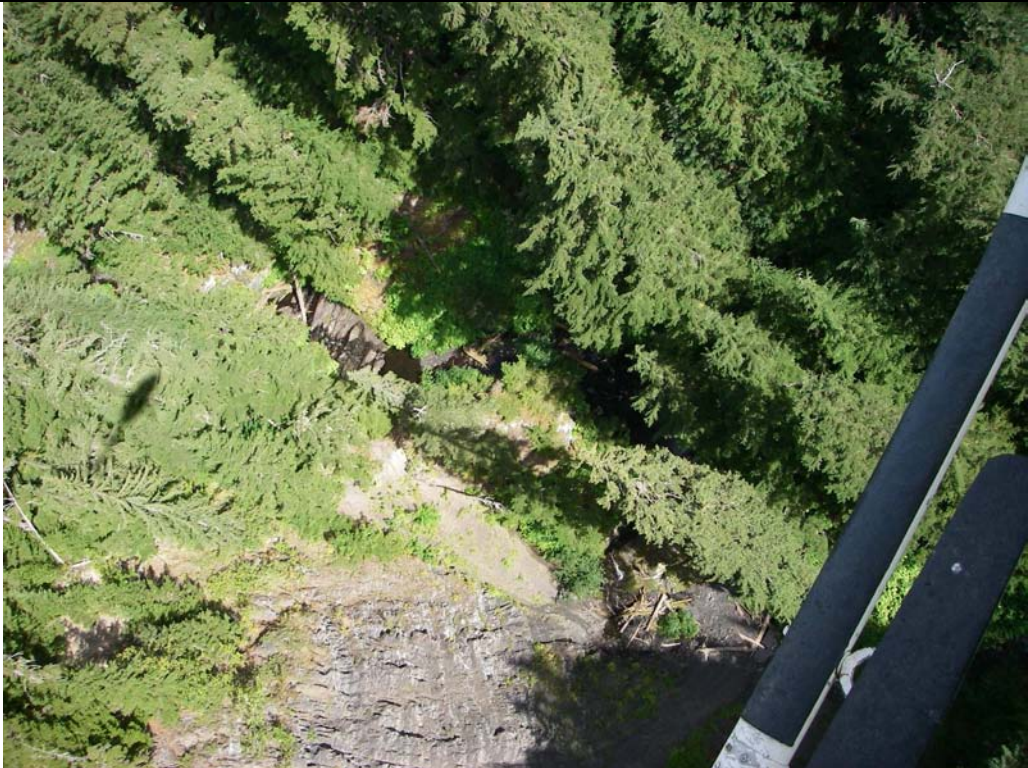
Stream/ILP: 8012 Image: 2570 Comment: Across, . 8/22/2010.

Section	Comments
CHANNEL	S2 All values estimated. Creek inaccessible due to 20 m high vertical canyon severed falls observed.

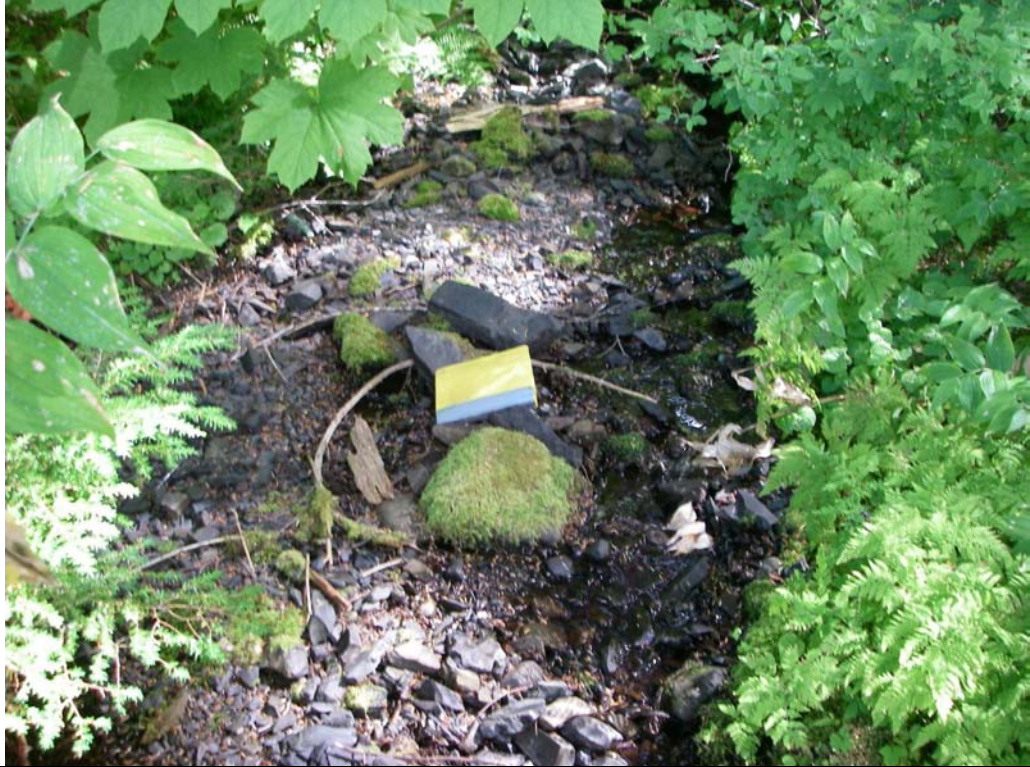
Stream/ILP: 8013 Image: 2559 Comment: Upstream, Book for scale. 8/22/2010.

COMMENTS	
Section	Comments
CHANNEL	S6 - Normal erosion nothing excessive BC but overall stable stream flowing through mature forest

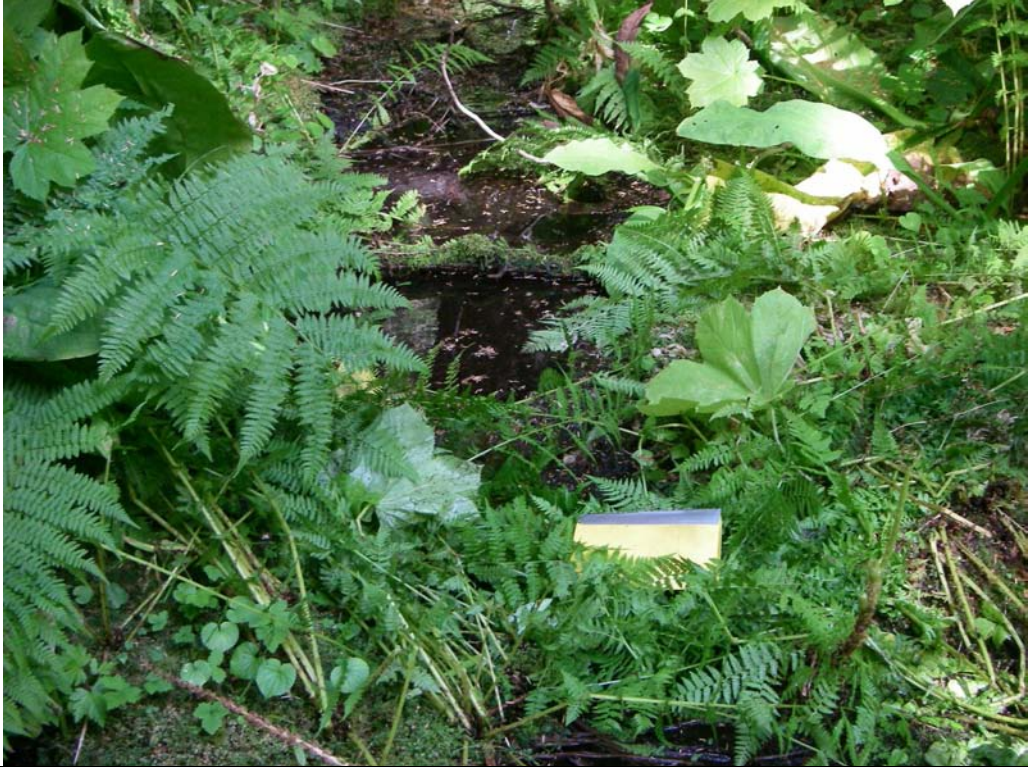
Stream/ILP: 8014 Image: 2562 Comment: Upstream, Book for scale. 8/22/2010.

Section	Comments
CHANNEL	NCD - No fish habitat, seepage, no scoured channel bed or fluvium, isolated and disconnected potholes

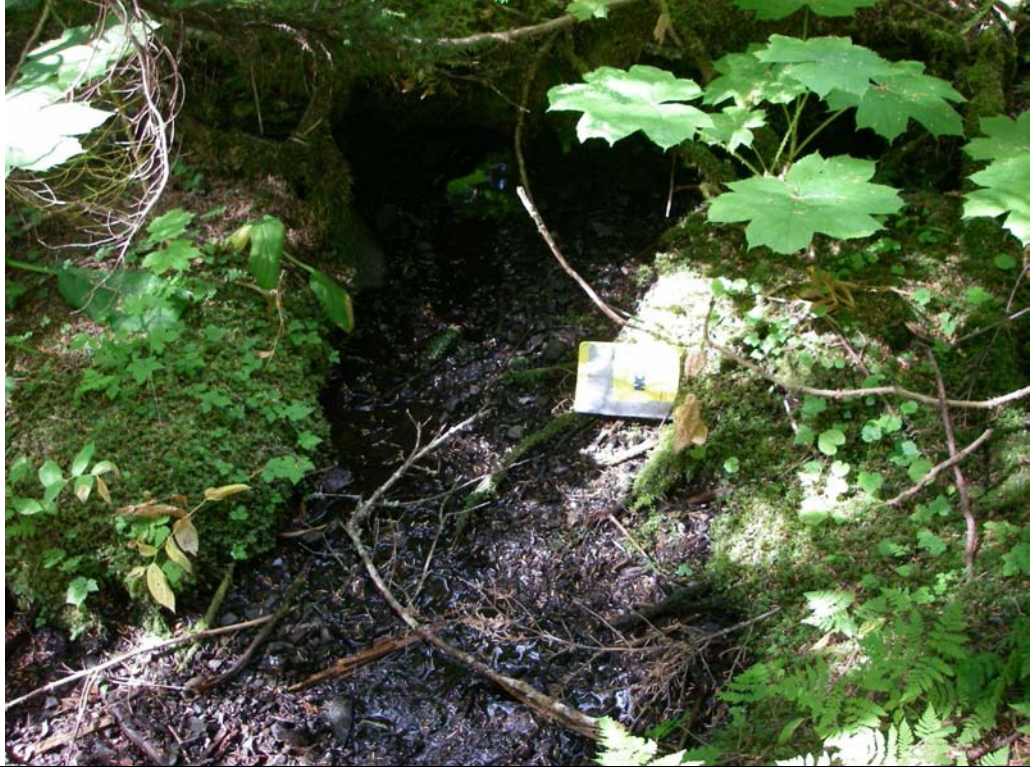
Stream/ILP: 8015 Image: 2563 Comment: Upstream, Book for scale. 8/22/2010.

PHOTOS				
Photo		Foc Lg	Dir	Comments
R: 8015	F: 2565	TE	X	Site card photo
COMMENTS				
Section		Comments		
CHANNEL		S6 - LWD from mature forest, SOD deciduous and conifer, Stable banks, regular erosion, some gravels.

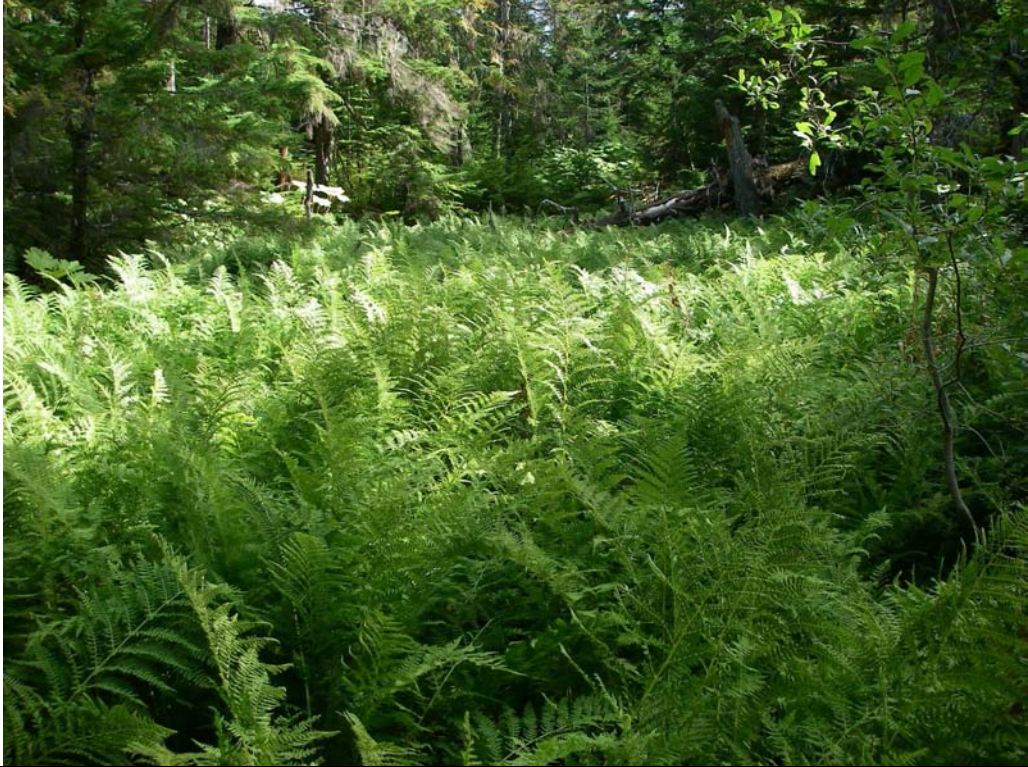
Stream/ILP: 8016 Image: 2567 Comment: Across, No Scale. 8/22/2010.

Section	Comments
CHANNEL	NCD - No fish habitat, seepage/small wetland - no fluvian, no scour.

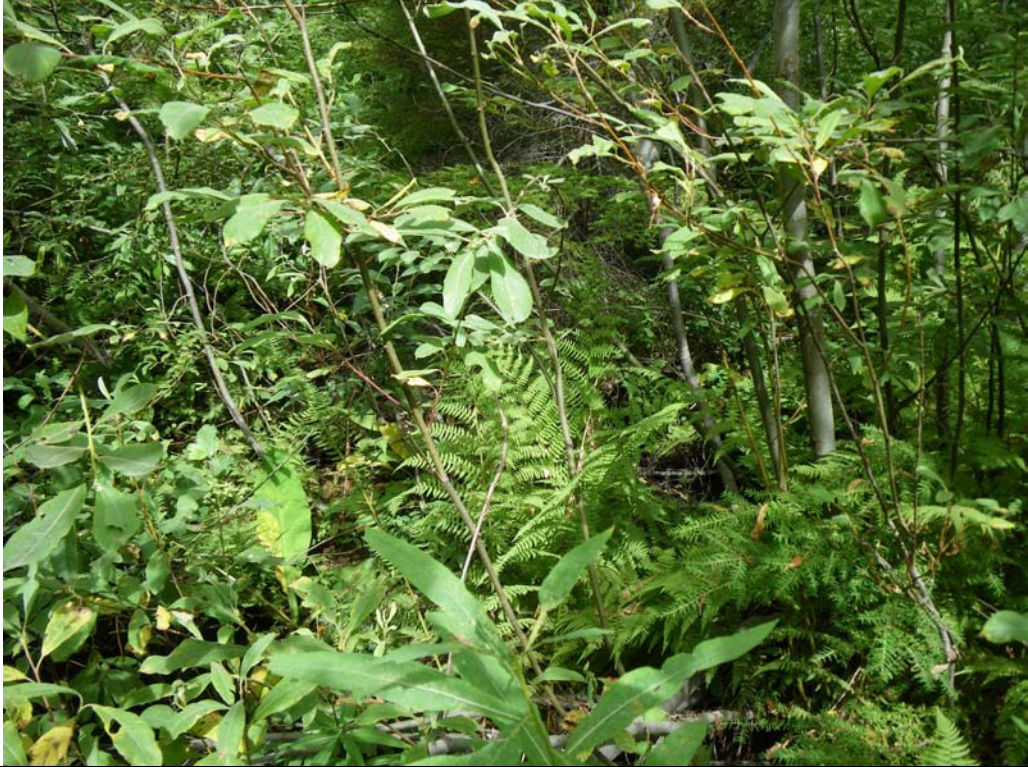
Stream/ILP: 9005 Image: 391 Comment: Upstream, Brush. 8/20/2010.

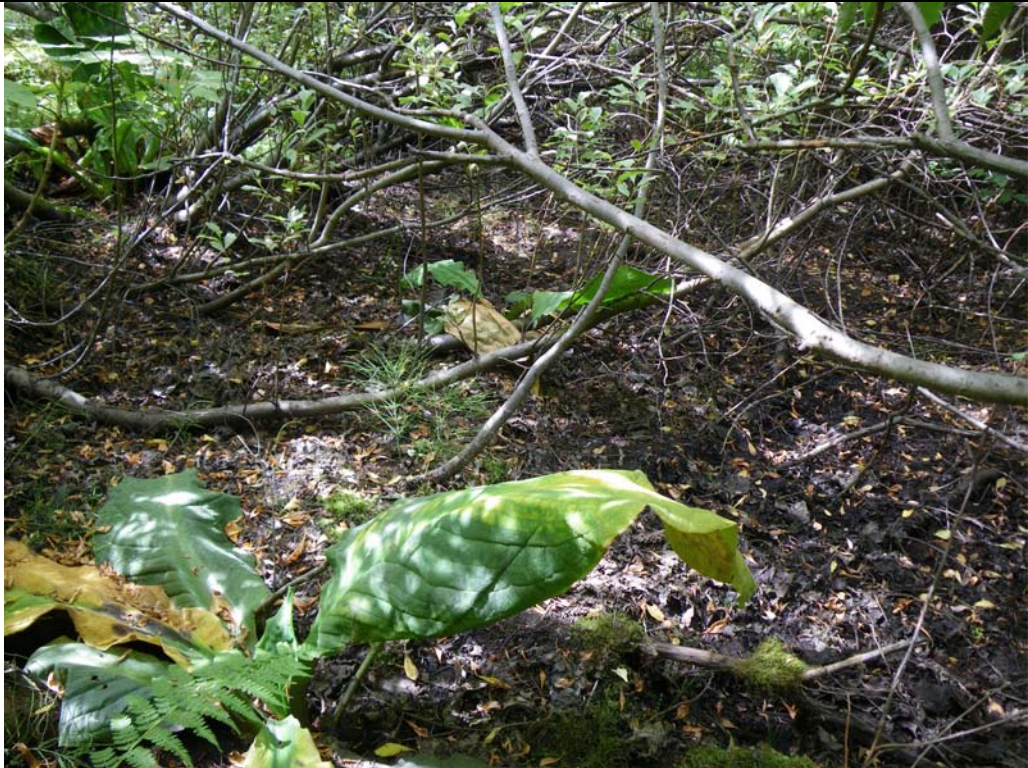
Stream/ILP: 9005 Image: 392 Comment: Downstream, Organics. 8/20/2010.

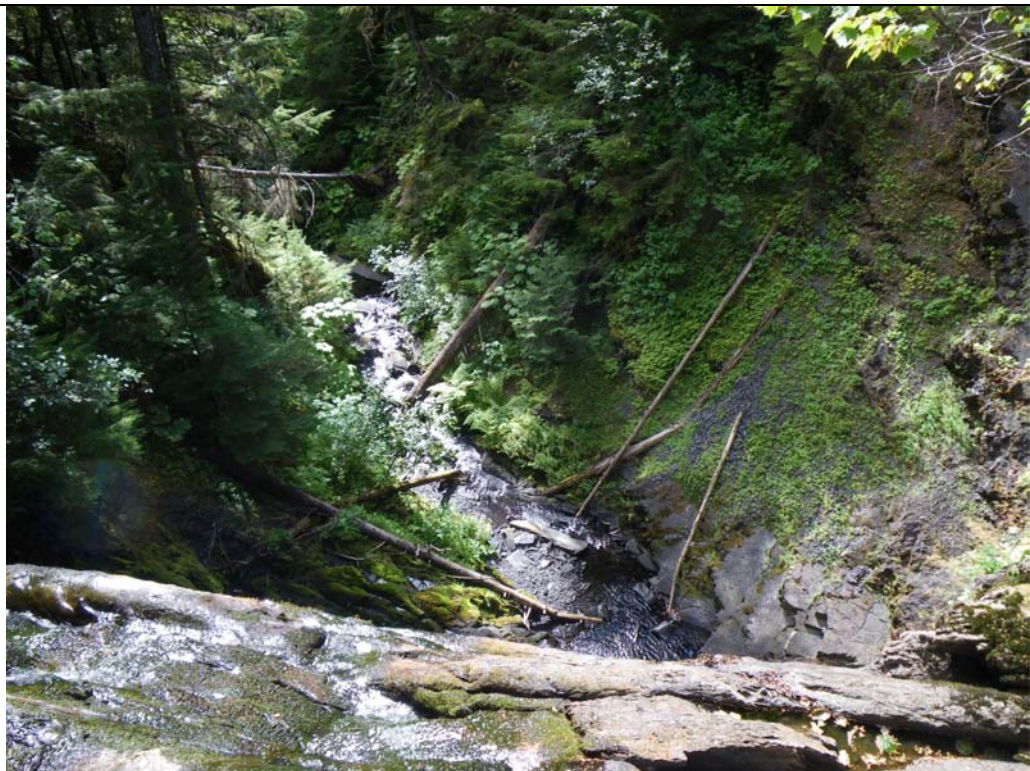
Stream/ILP: 9006 Image: 395 Comment: Downstream, Looking Down 25 m high falls. 8/20/2010.

A. GEAR SETTINGS														
Site#	MTD/NO	H/P	Date In	Time In	Date Out	Time Out	Comment							
1	EF	1	2010/08/24	15:15	2010/08/24	15:38								
C. ELECTROFISHER SPECIFICATIONS														
Site#	MTD/NO	H/P	Encl	Sec	Length	Width	Voltage	Frequency	Pulse	Make	Model			
1	EF	1	1	O	515	200.0	4.0	500	60	5	SR	12B		
COMMENTS														
Section			Comments											
WATERBODY			Nice creek. Good perennial habitat. Good overwintering spawning relatively poor. Spawning gravel in patches, related habitat due to falls downstream.

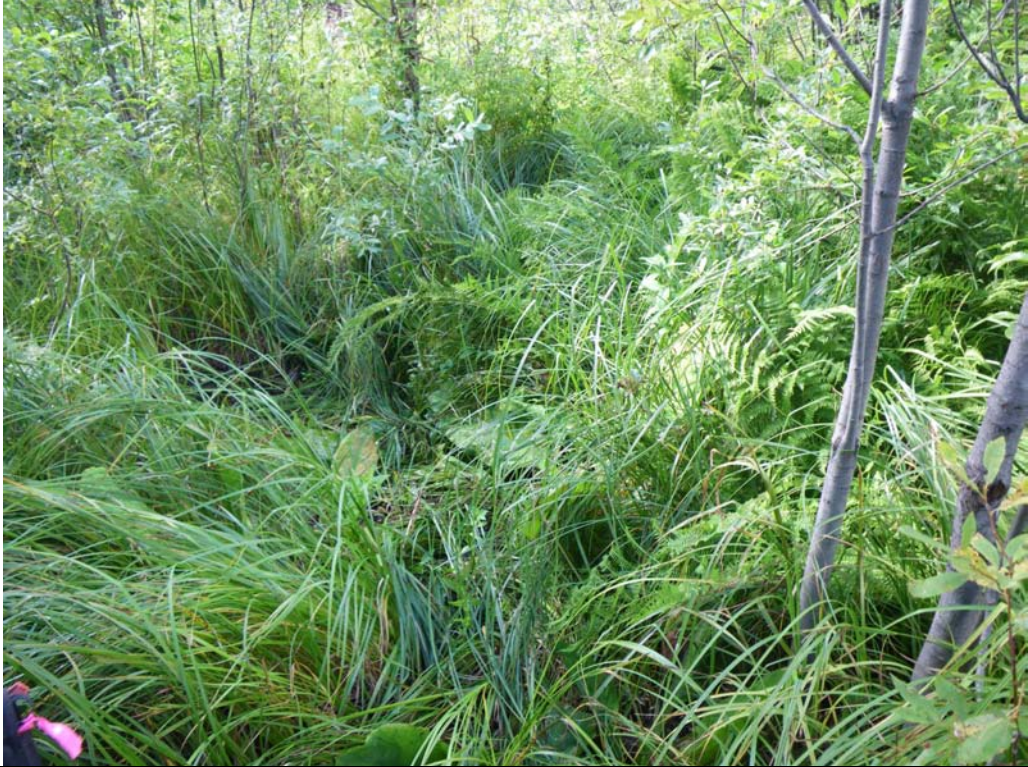
Stream/ILP: 9007 Image: 398 Comment: Across, Swale, grass, no channel. 8/20/2010.

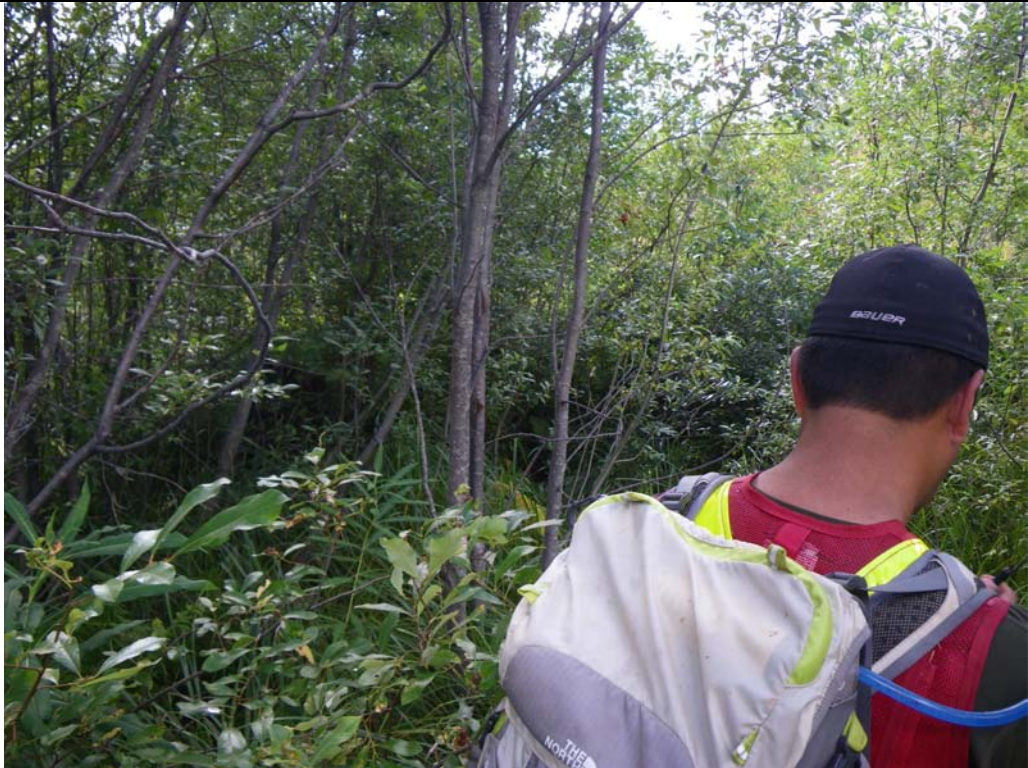
Stream/ILP: 9007 Image: 399 Comment: Across, Swale, grass, no channel. 8/20/2010.

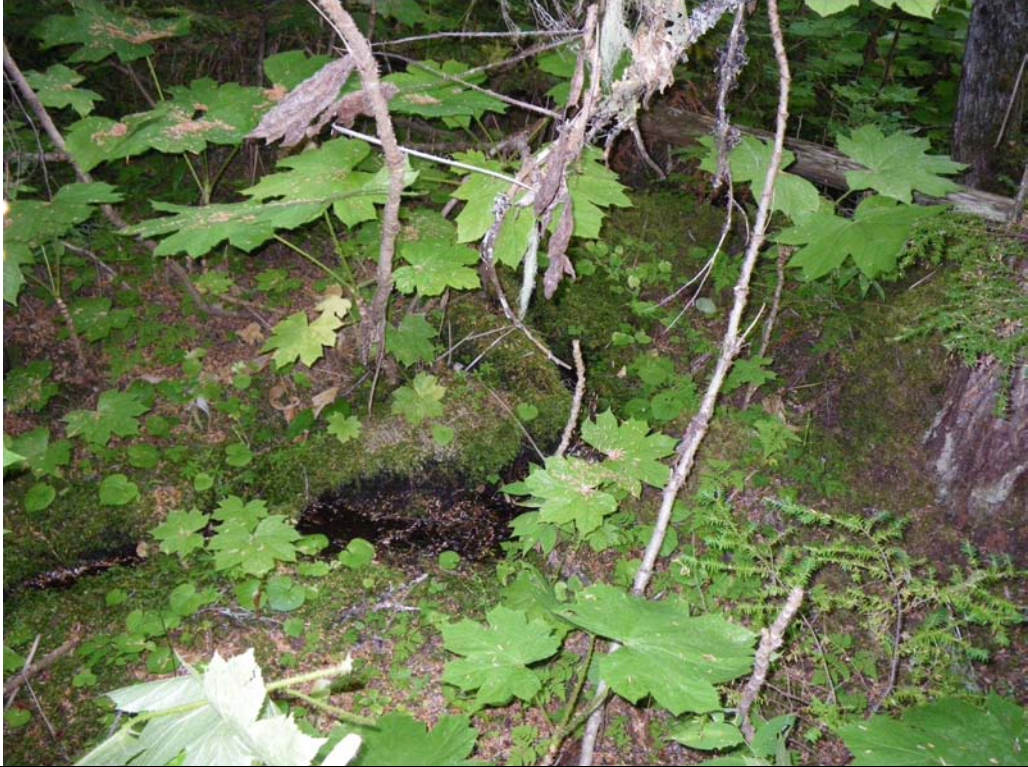
Stream/ILP: 9008 Image: 402 Comment: Upstream, Devil club vegetation. 8/21/2010.

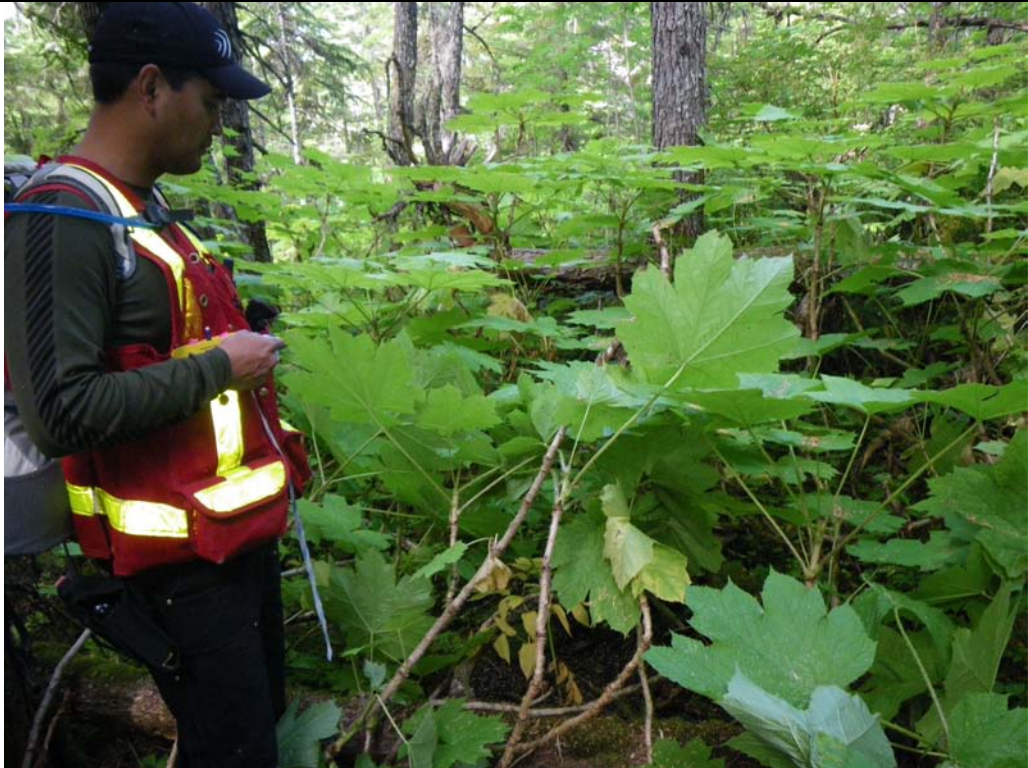
Stream/ILP: 9008 Image: 403 Comment: Downstream, Assitant and dry swale. 8/21/2010.

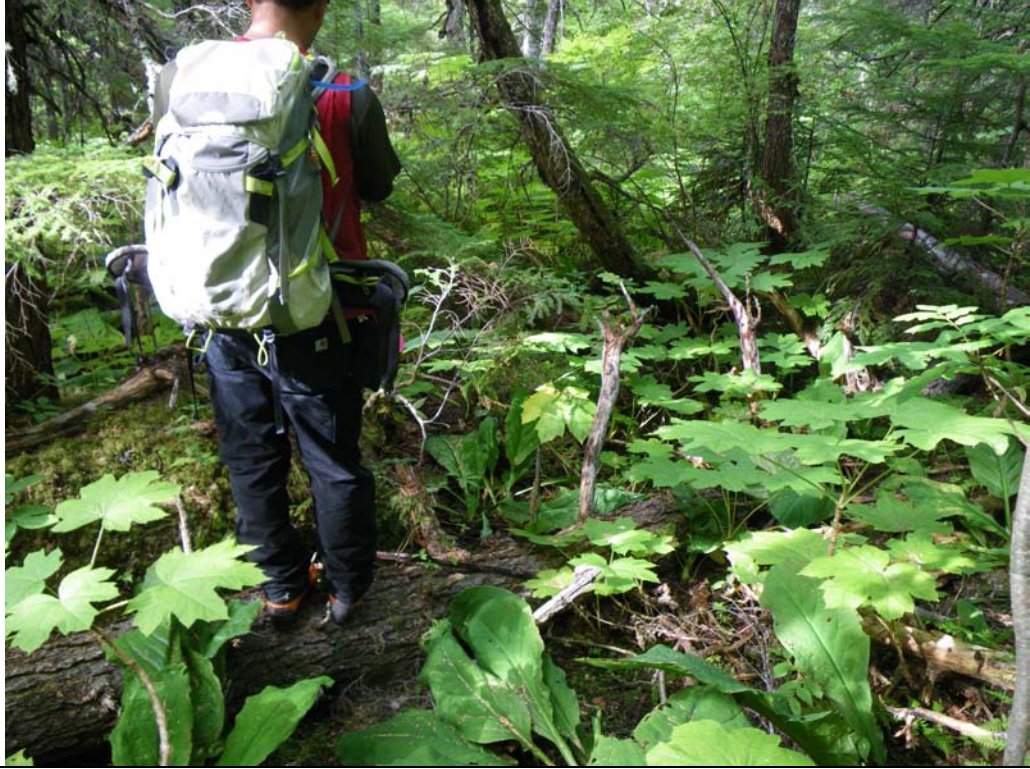
Stream/ILP: 9009 Image: 405 Comment: Upstream, With assistant and vegetation. 8/21/2010.

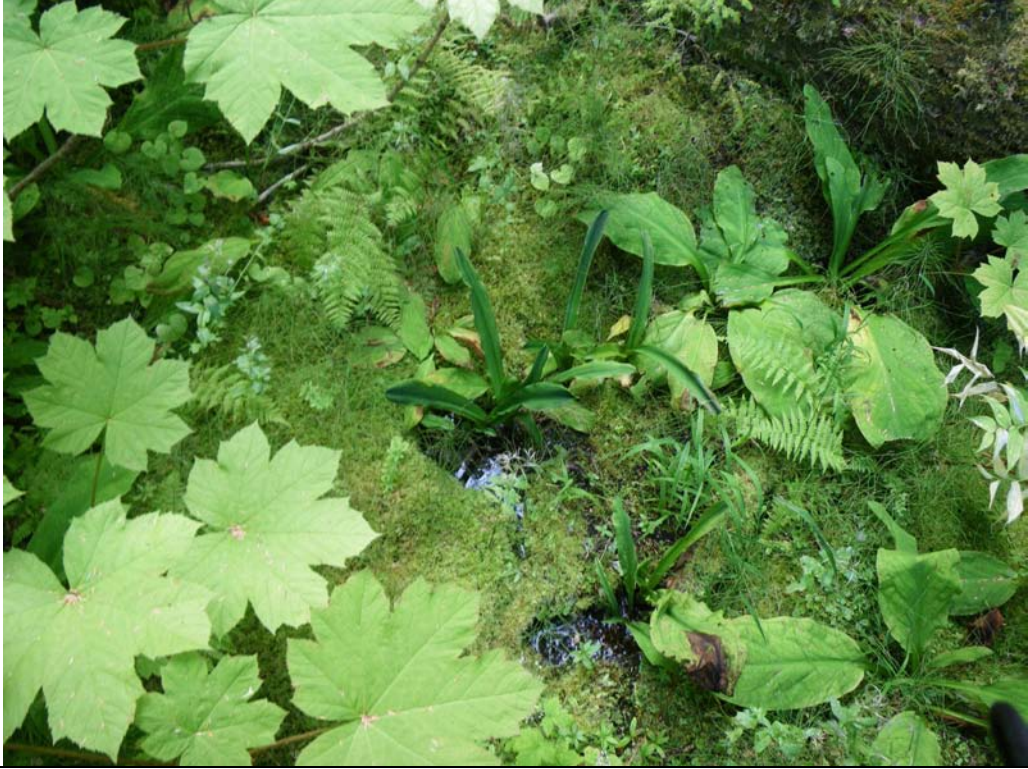
Stream/ILP: 9010 Image: 407 Comment: Upstream, Stagnant Pool. 8/21/2010.

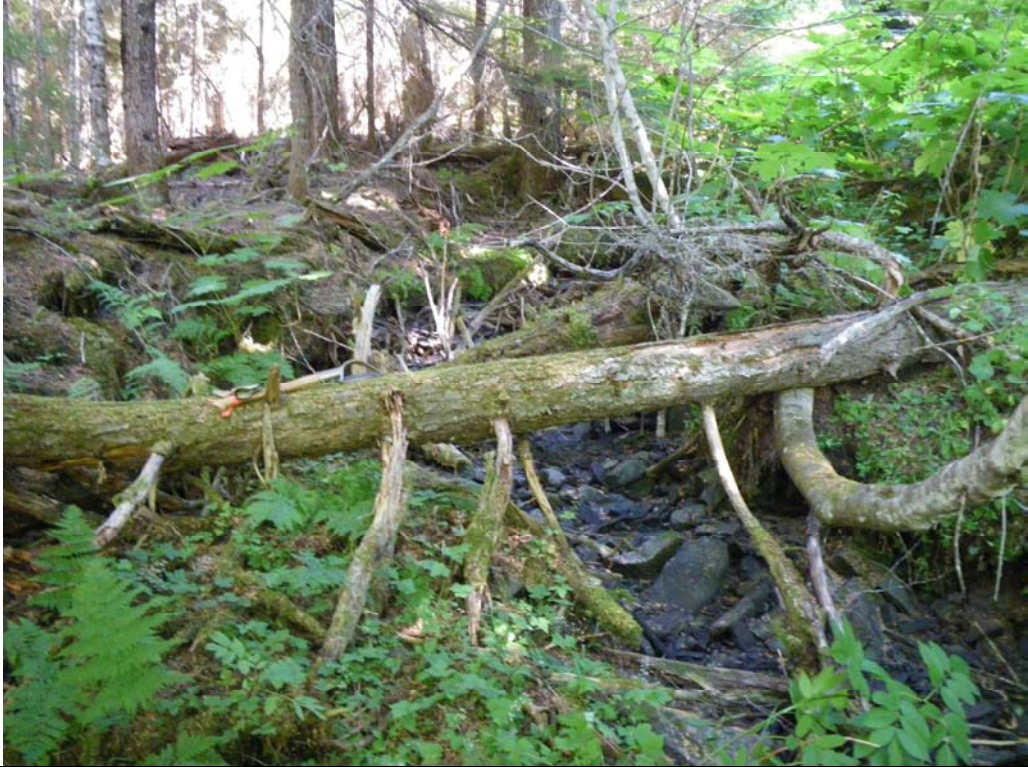
Stream/ILP: 9011 Image: 410 Comment: Upstream, Dry channel. 8/21/2010.

PHOTOS				
Photo		Foc Lg	Dir	Comments
R: 9011	F: 412	STD	X	Dry
COMMENTS				
Section		Comments		
CHANNEL		S3 - Have to assess downstream for barriers at the road and further downstream. If barrier falls present than change to confirmed non-fish since dry up stream of barrier now. Just downstream from ROW xing creek enters big alder swale - unique alder pat

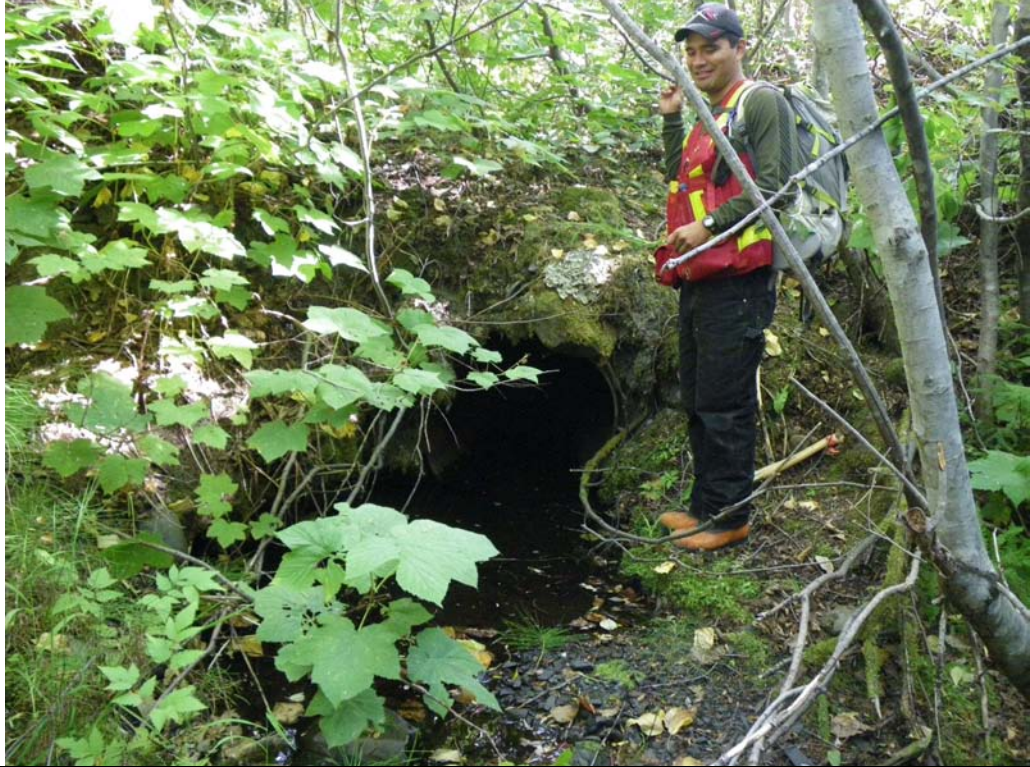
Stream/ILP: 9012 Image: 414 Comment: Upstream, Culvert at outlet. 8/21/2010.

PHOTOS				
Photo		Foc Lg	Dir	Comments
R: 9012	F: 413	STD	X	Site Card
R: 9012	F: 414	STD	U	Culvert at outlet
R: 9012	F: 415	STD	U	
R: 9012	F: 416	STD	D	
COMMENTS				
Section		Comments		
CHANNEL		S3 - Trickle flow, culvert blocked with debris, channel upstream of culver better habitat, nearly dry, not likely to support fish
