AQUATIC RESOURCE BASELINE STUDIES

TELKWA COAL PROJECT

DAVID BUSTARD AND ASSOCIATES LTD.

MANALTA COAL LTD.

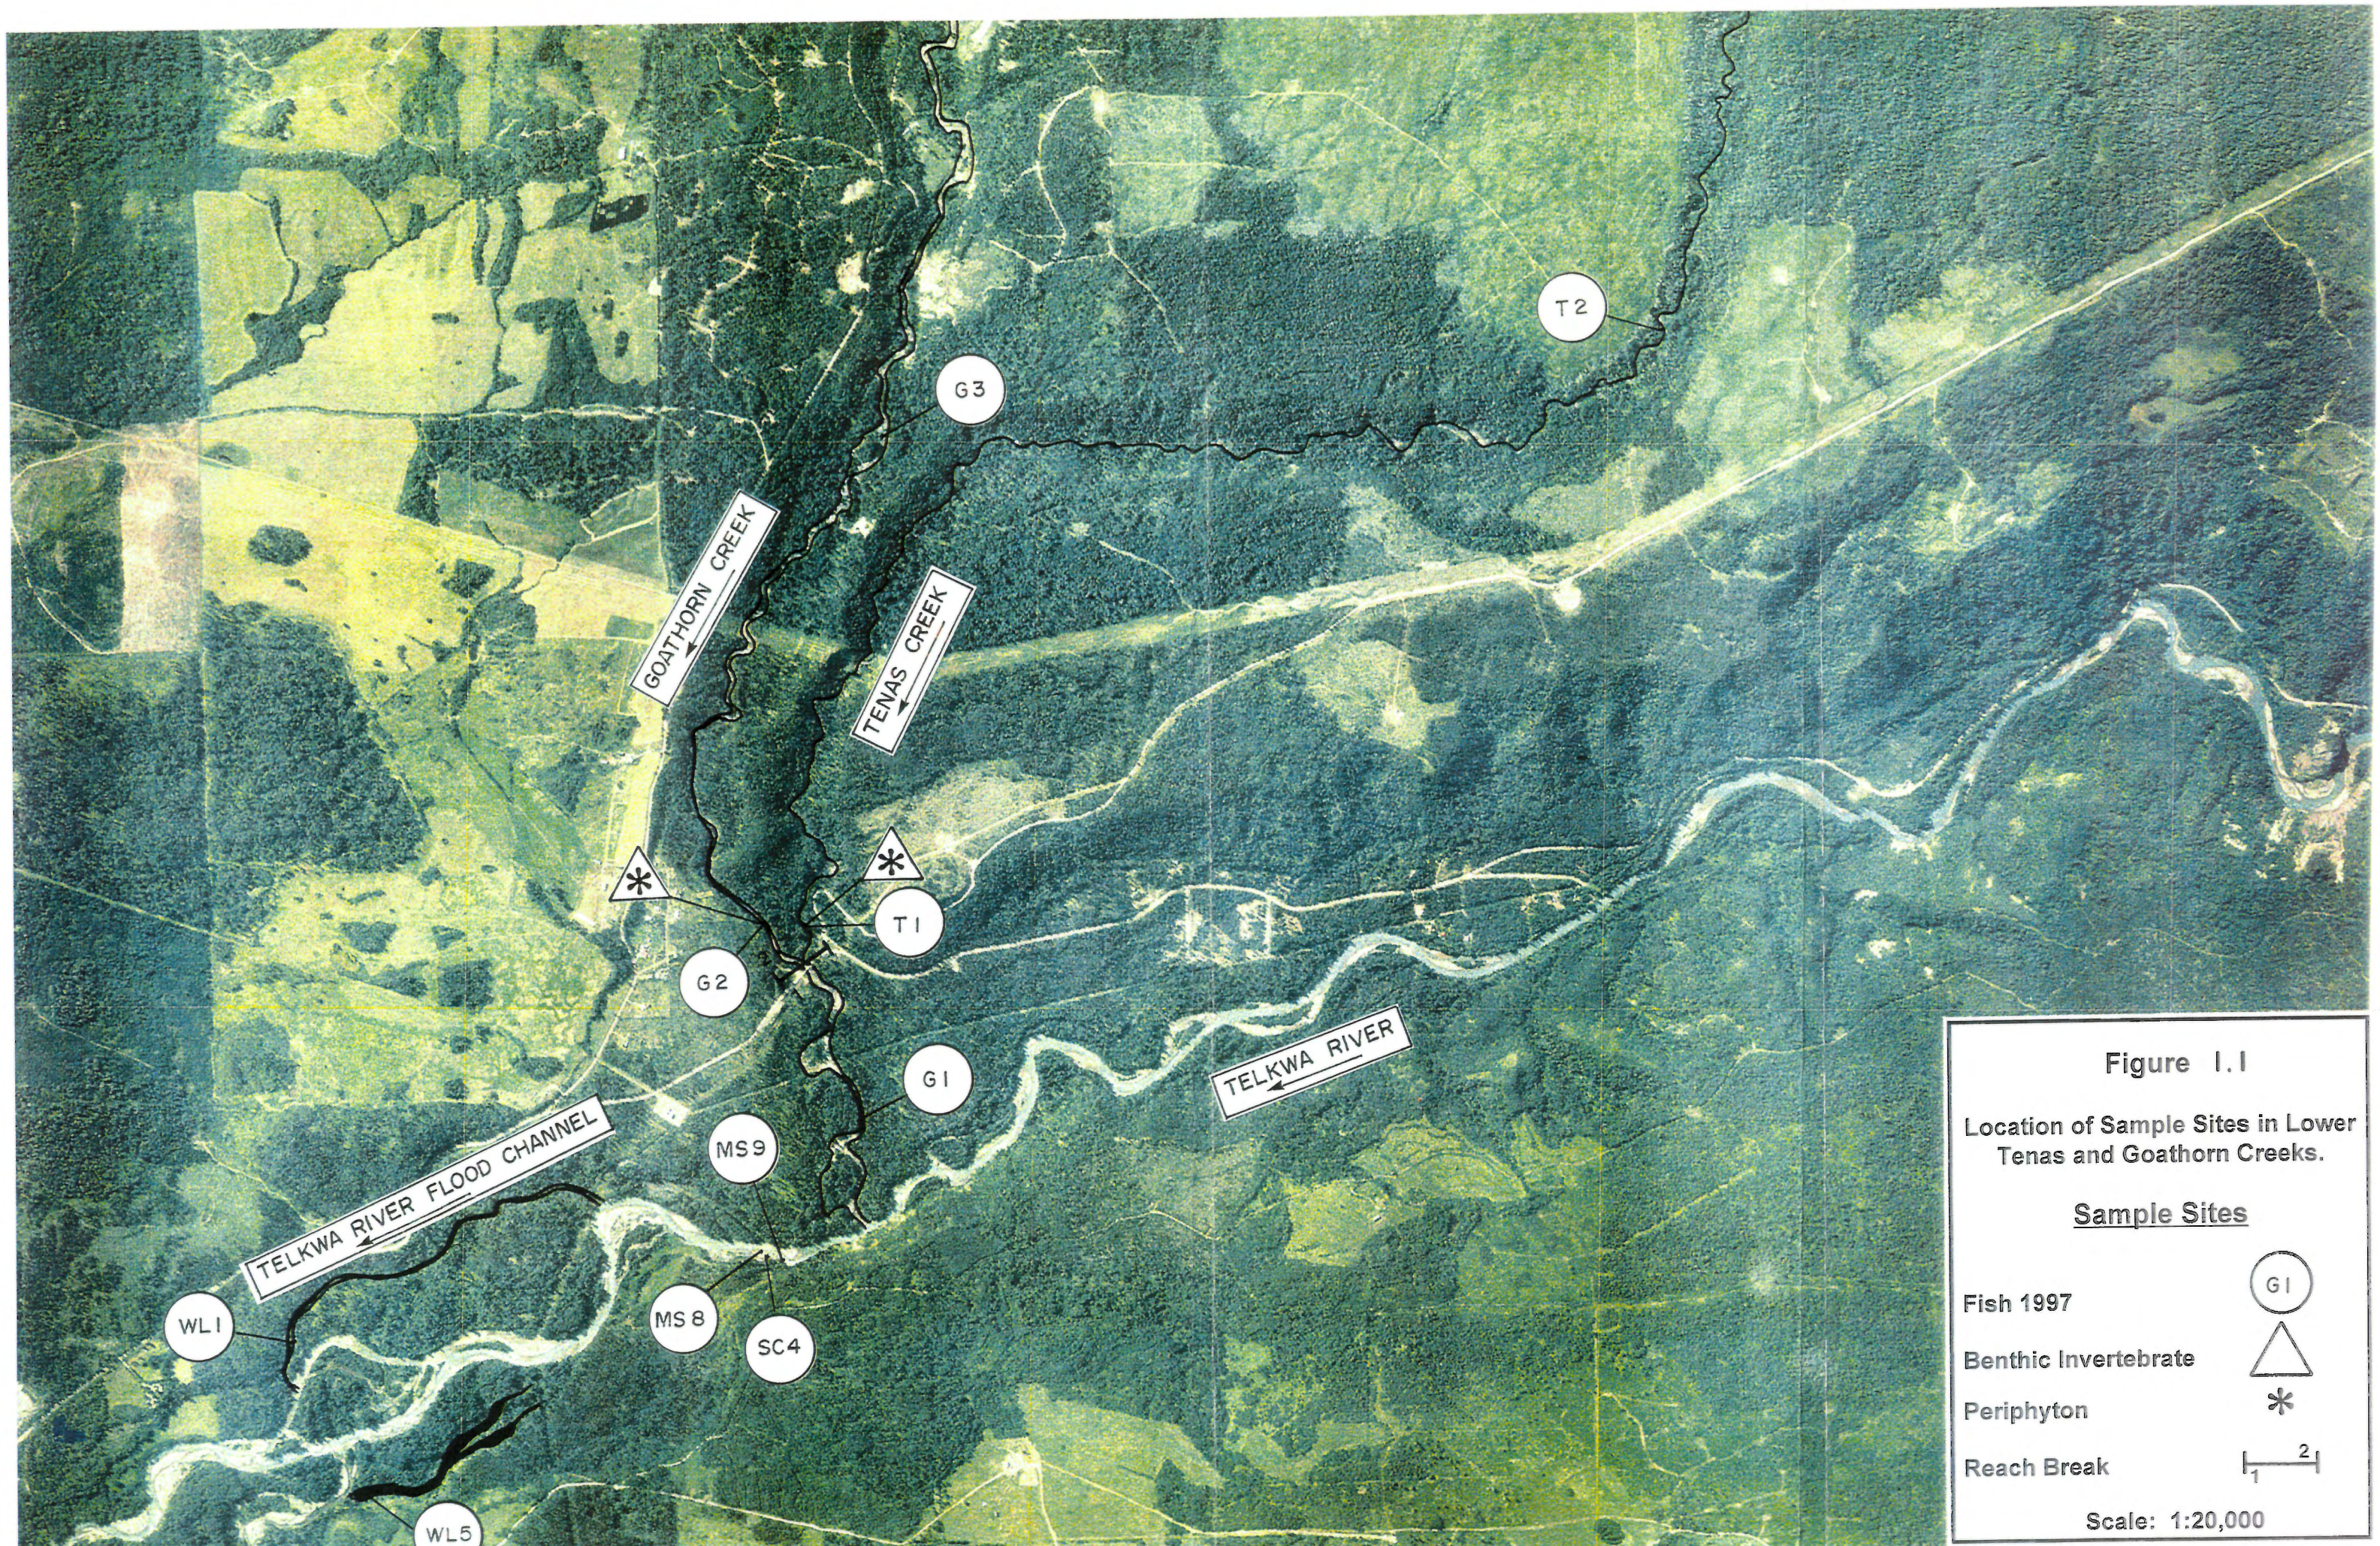
Figure 1.1

Location of Sample Sites in Lower
Tenas and Goathorn Creeks.

Benthic invertebrates were sampled at four locations - two sites in Goathorn Creek and two site in Tenas Creek (Figures 1.1 and 1.2). Site G5 in Goathorn and T3 in Tenas Creek were upstream from the proposed mine operations and they served as controls. Sites G2 and T1 were in the stream sections that may be affected by mine operations.

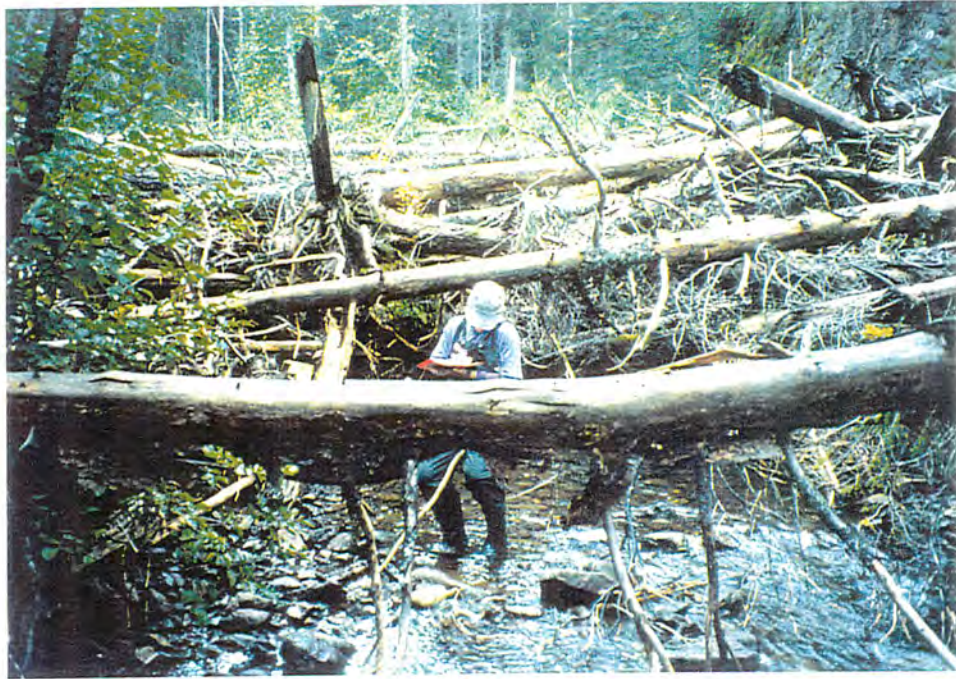
Photo 1. Goathorn Creek upstream from the Cabinet Creek confluence is characterized by several large debris jams and associated sediment wedges. A debris jam located 0.5 km upstream from Cabinet Creek is presently the upstream limit for steelhead and bull trout moving upstream from the Telkwa and Bulkley rivers.

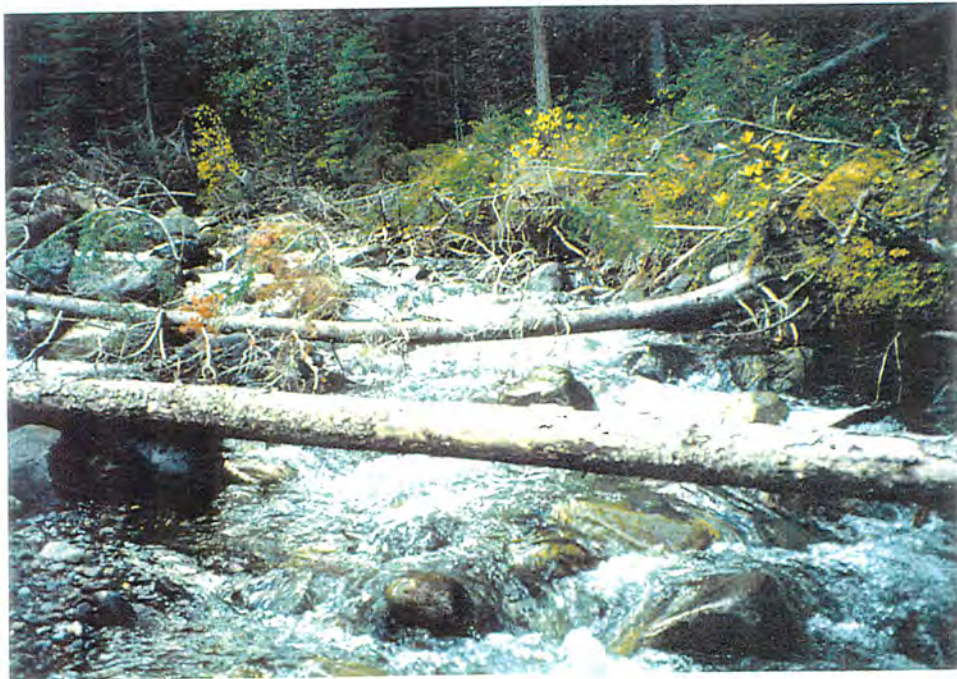
Photo 2. Cabinet Creek upstream from the Webster Creek confluence is comprised of a series of stepped pools and heavy debris accumulations. This section is accessible for 1.4 km and is utilized by resident Dolly Varden.

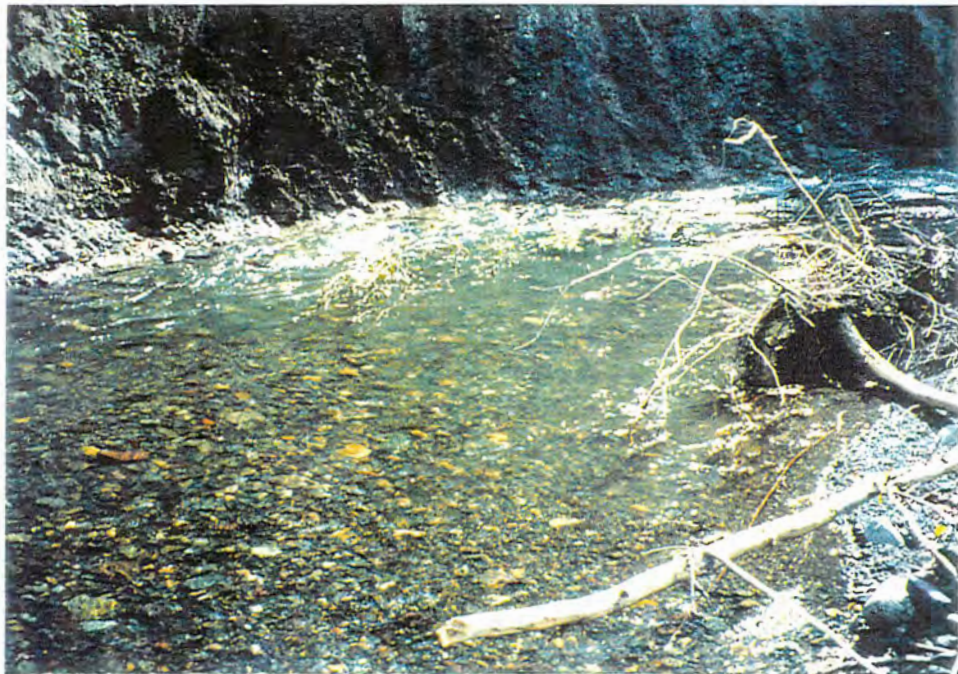
Photo 3. This good potential bull trout spawning habitat was located in the mid-reaches of Goathorn Creek. Most bull trout spawning occurs upstream from the proposed mine project.

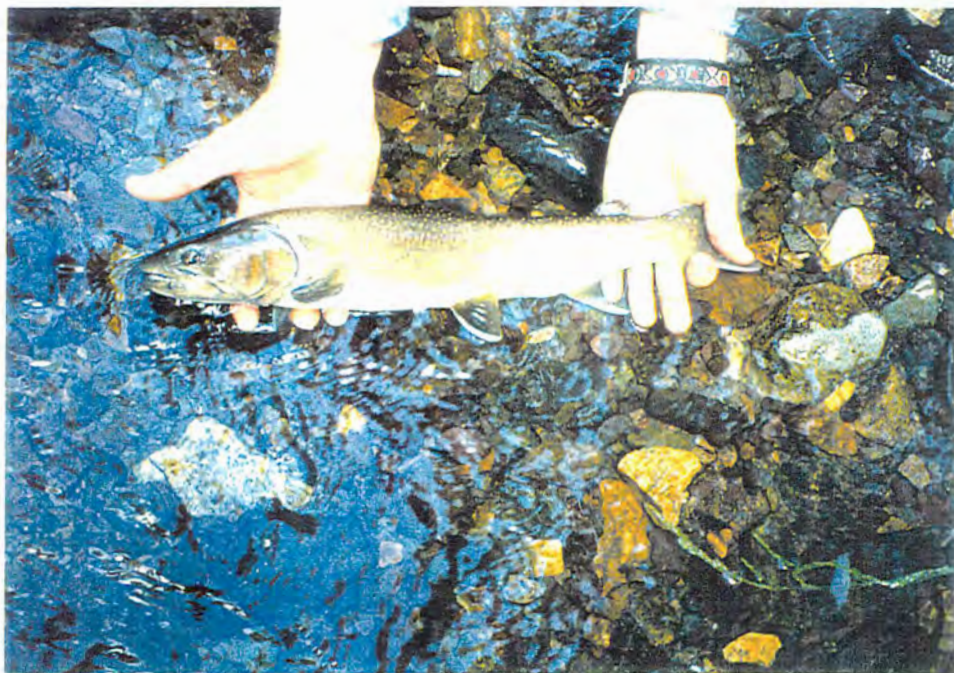
Photo 4. This female bull trout was tagged at a redd site in Webster Creek in early September. It was recaptured by an angler in the Telkwa River three weeks later.

It is interesting to note that a female bull trout that was tagged at a redd site 3.8 km upstream in Webster Creek on September 4 was recaptured by an angler in the Telkwa River upstream from Goathorn Creek approximately 3 weeks later (Photo 4). This was the only bull trout tagged during the study, and suggests that Goathorn Creek bull trout spawners are probably very vulnerable to angling in the Telkwa and Bulkley rivers.

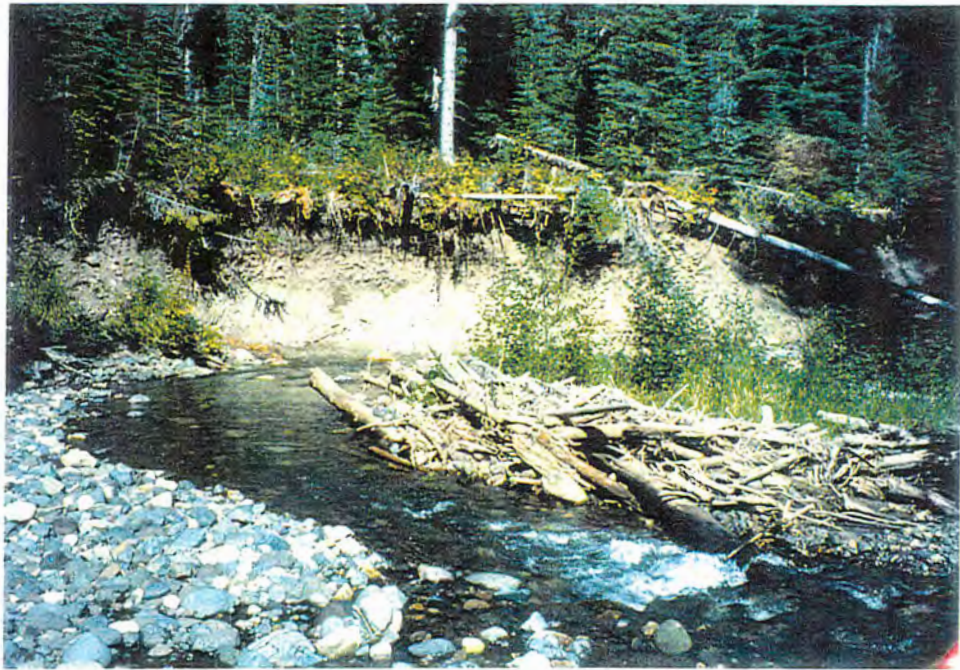
Photo 5. Naturally unstable silt banks were common along Tenas Creek. This site is located near the top end of Reach 1, the main steelhead spawning and rearing section of Tenas Creek.

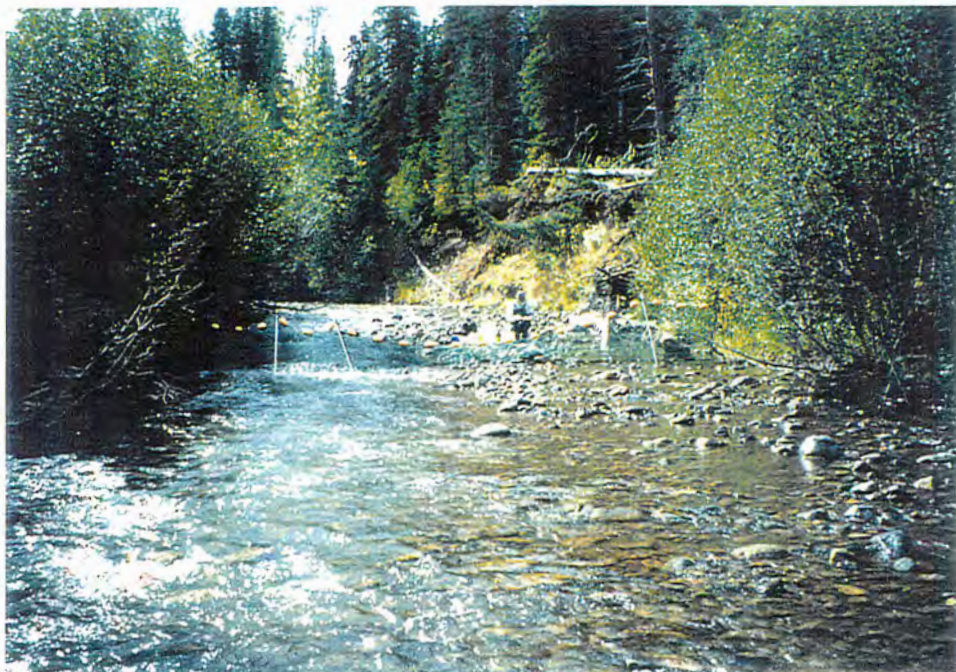
Photo 6. The lower 9 km of of Tenas Creek is heavily utilized by steelhead. The shallow cobble sections are ideal for steelhead fry and parr rearing.

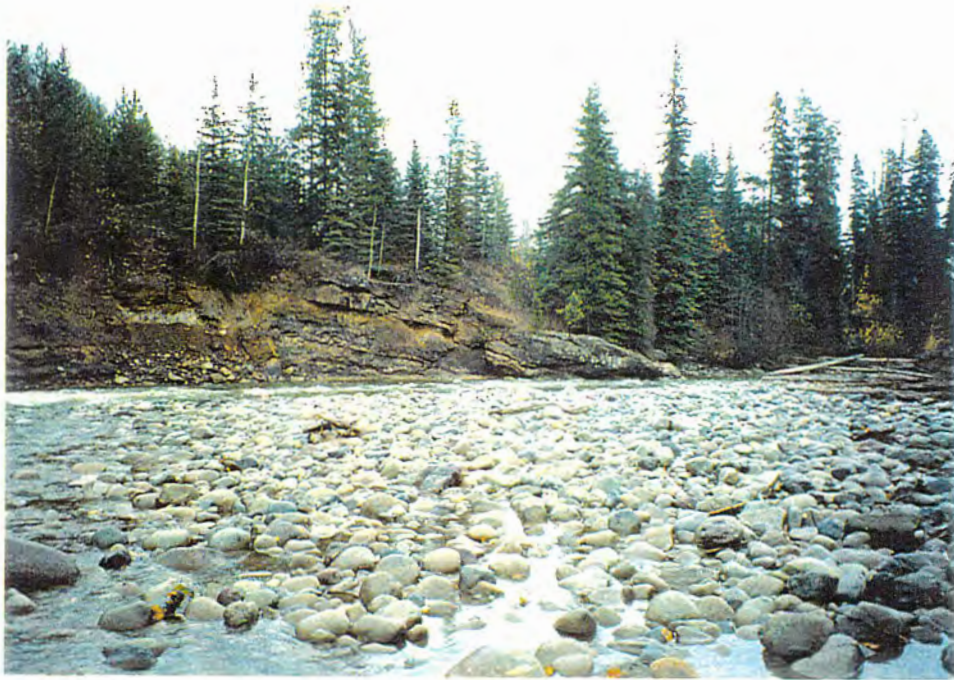
Photo 7. Telkwa River mainstem looking downstream at the proposed bridge crossing site. The crossing site is at the lower end of a confined section, just upstream from where the floodplain widens.

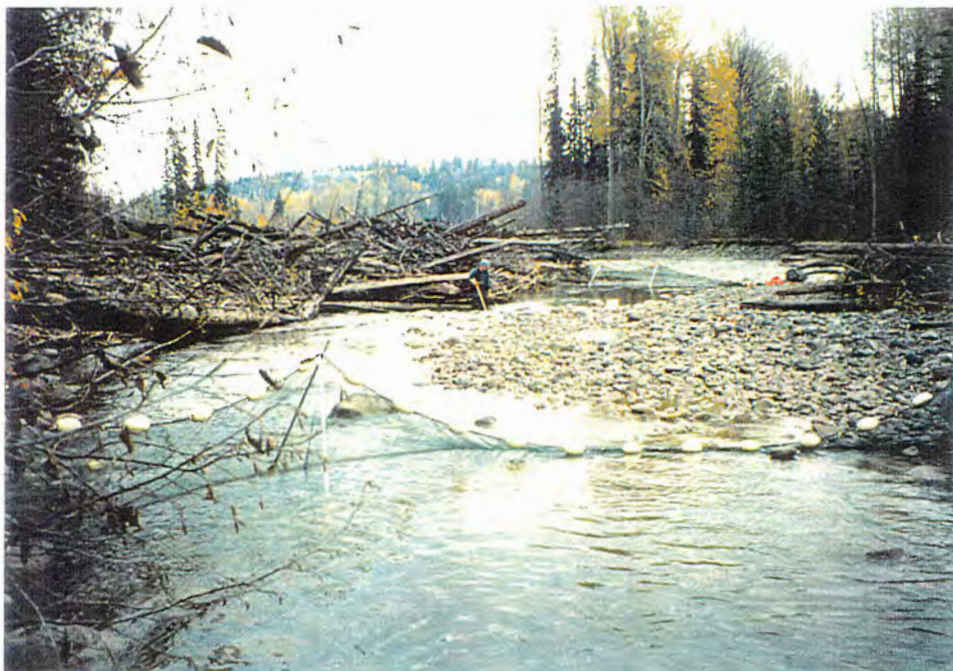
Photo 8. Sidechannel SC4 located at the proposed bridge crossing site. This channel was used by both steelhead fry and parr.

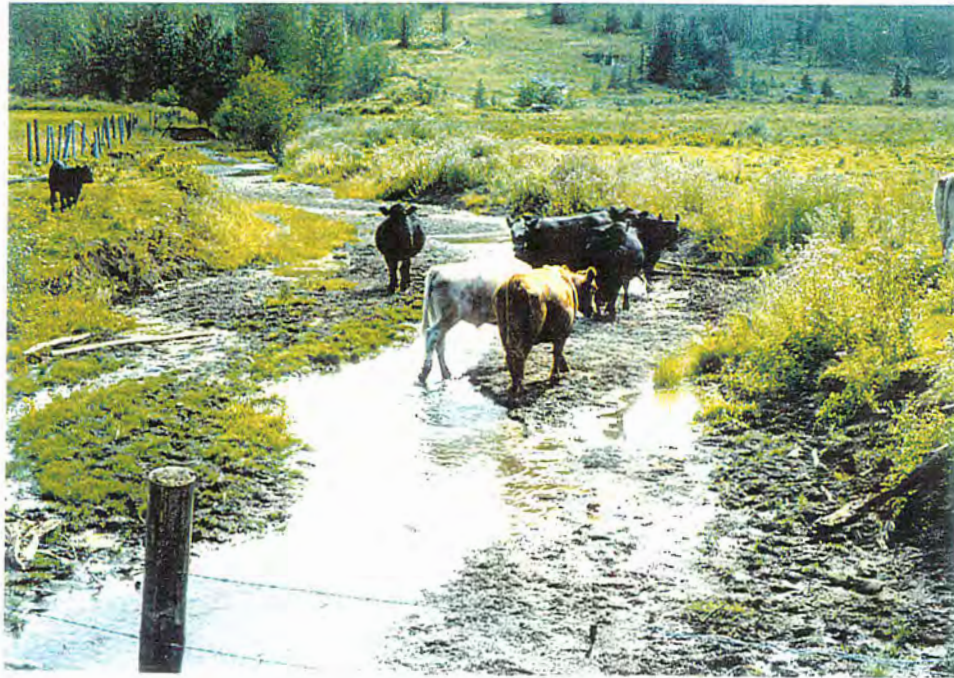
Photo 9. Sections of Helps Creek have been severely degraded by agricultural clearing, diversions, and livestock use. The loss of a riparian zone along this section has resulted in channel widening and infilling, resulting in loss of surface flows and high water temperatures in a formerly productive stream section.

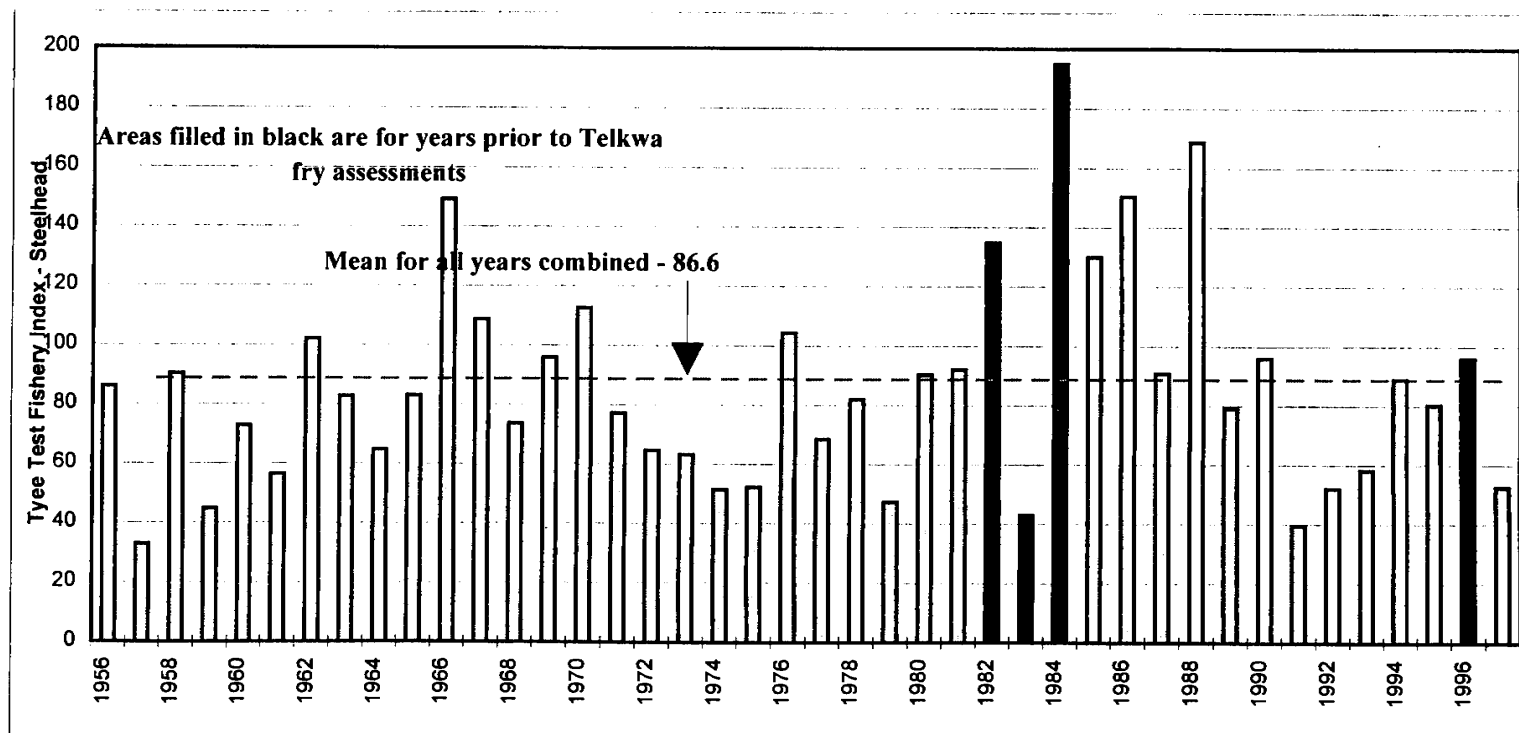
Appendix 13 Figure 1. Tyee Test Fishery Index of Skeena steelhead run strength for period of record highlighting years prior to Telkwa juvenile assessments.
