# **Zymoetz Watershed Restoration Program**

## **Aquatic Habitat Rehabilitation Works 1998/99**

*3-Km Side Channel (Site 9)*  
*16-Km Side Channel (Site 54B)*  
*Thomas Creek (Site 236B)*  
*Simpson Creek (Site 253)*

Prepared by  
Terrace Salmonid Enhancement Society

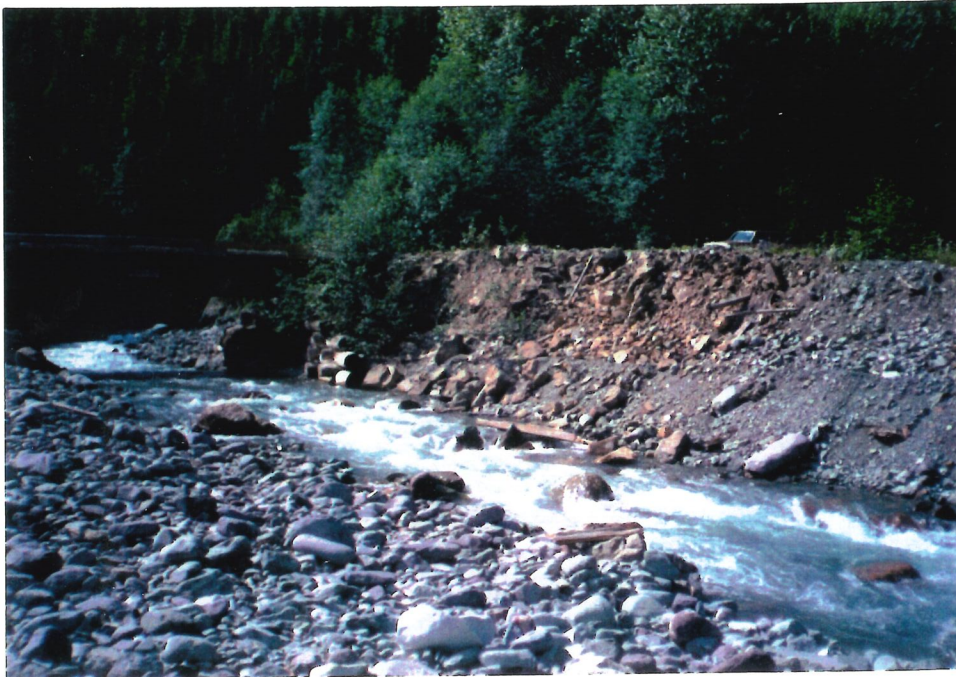
**Photo 1. Looking upstream Simpson Creek before installation of vees began in 1997.**

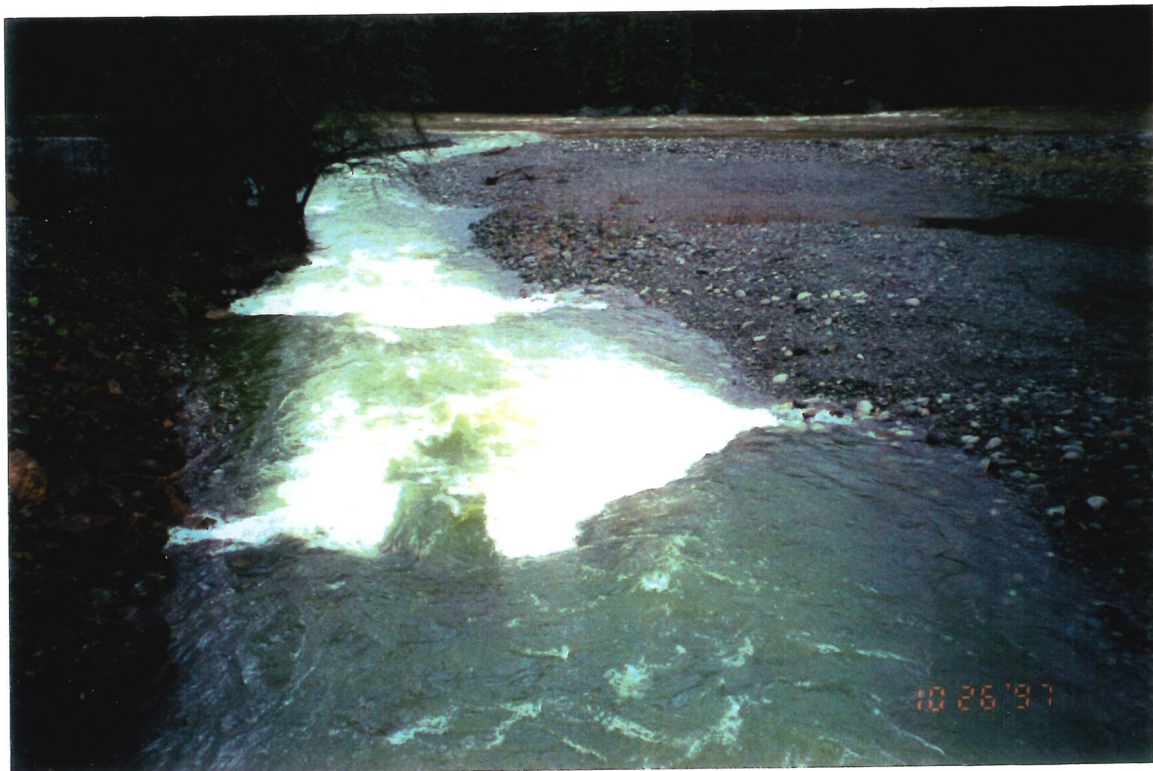
**Photo 2. Downstream Simpson Creek after rock vee installation (10-26-97)**

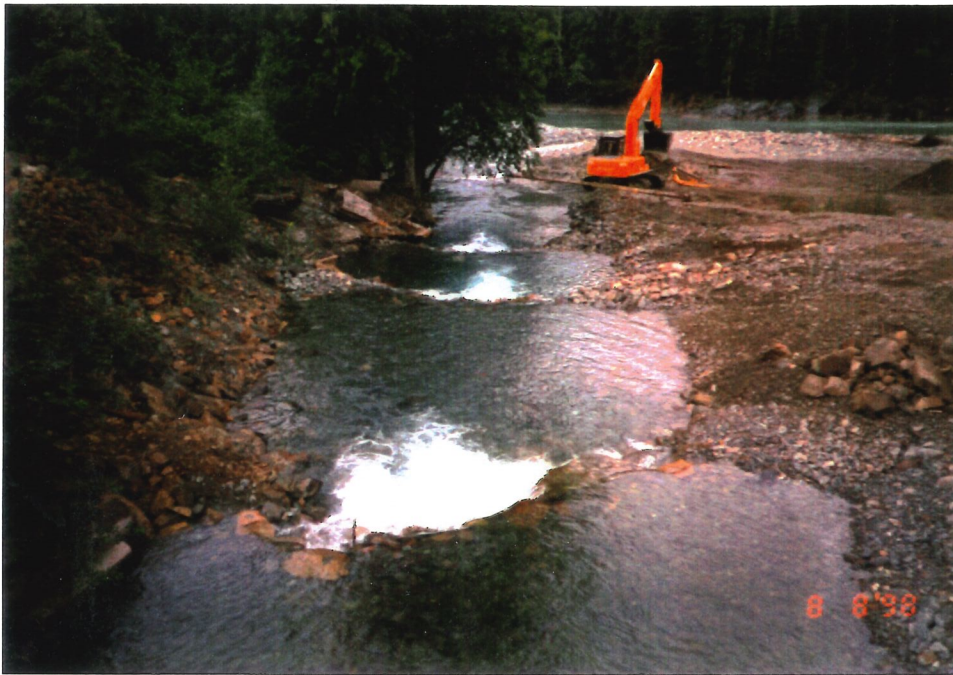
**Photo 3. Excavation of lower rock vee (8-8-98).**

The two new rock vees were constructed as proposed in the prescription downstream from the bridge across Simpson Creek on August 8, 1998 (Photo 3). The following steps were taken:

- A Hitachi EX60 excavator was used to dig openings in the substrate that were 60cm to 120cm diameter which the anchor rocks were set into. The depth of each anchor hole was about half the diameter of the rock that was placed into the excavation. All rocks used were taken from the base of the rock walls along the road above Simpson Creek and a few in Simpson Creek were moved into the vees;
- Once each anchor rock was secure, smaller rocks were fitted into the openings between the larger rocks;
- Spawning gravel between 2cm and 8cm in diameter was placed above each vee to a thickness varying from 30 to 60 cm;
- A 10m section of dike using rocks 30 to 90cm in diameter was constructed along the right bank, adjacent to the third and bottom vee.

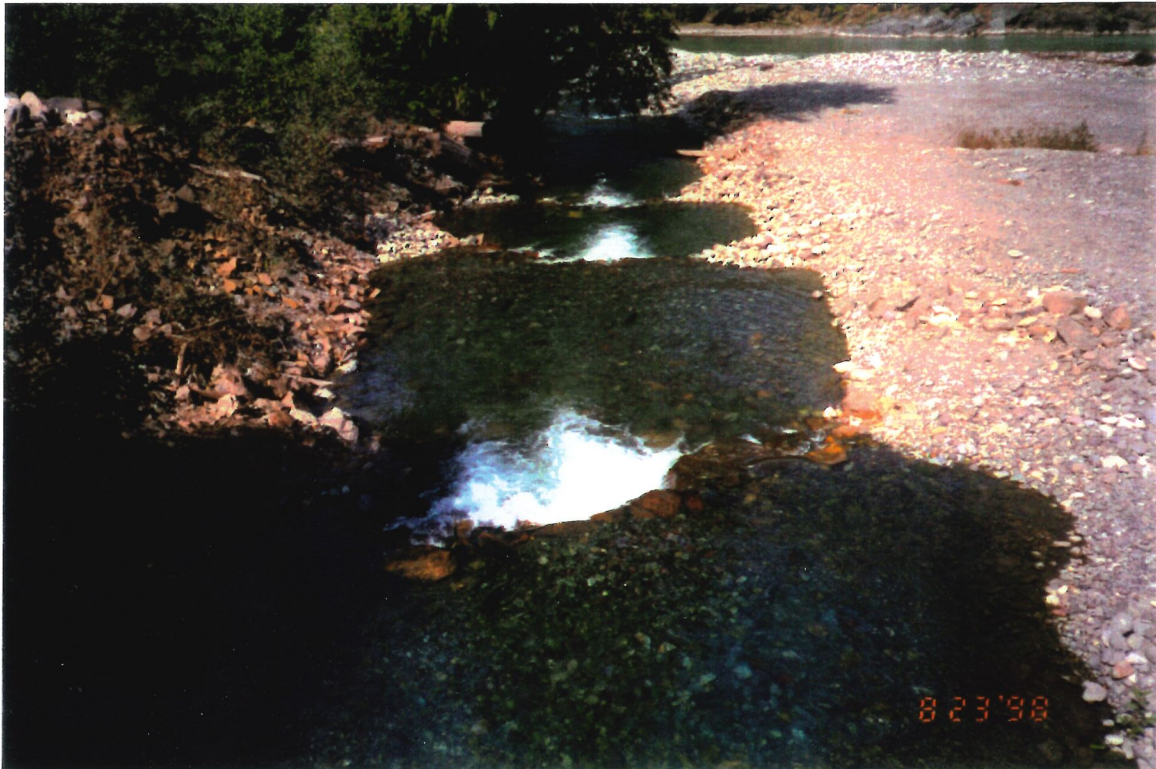
**Photo 4. Spawning chinook in Simpson Creek after rock vee completion (8-23-98).**

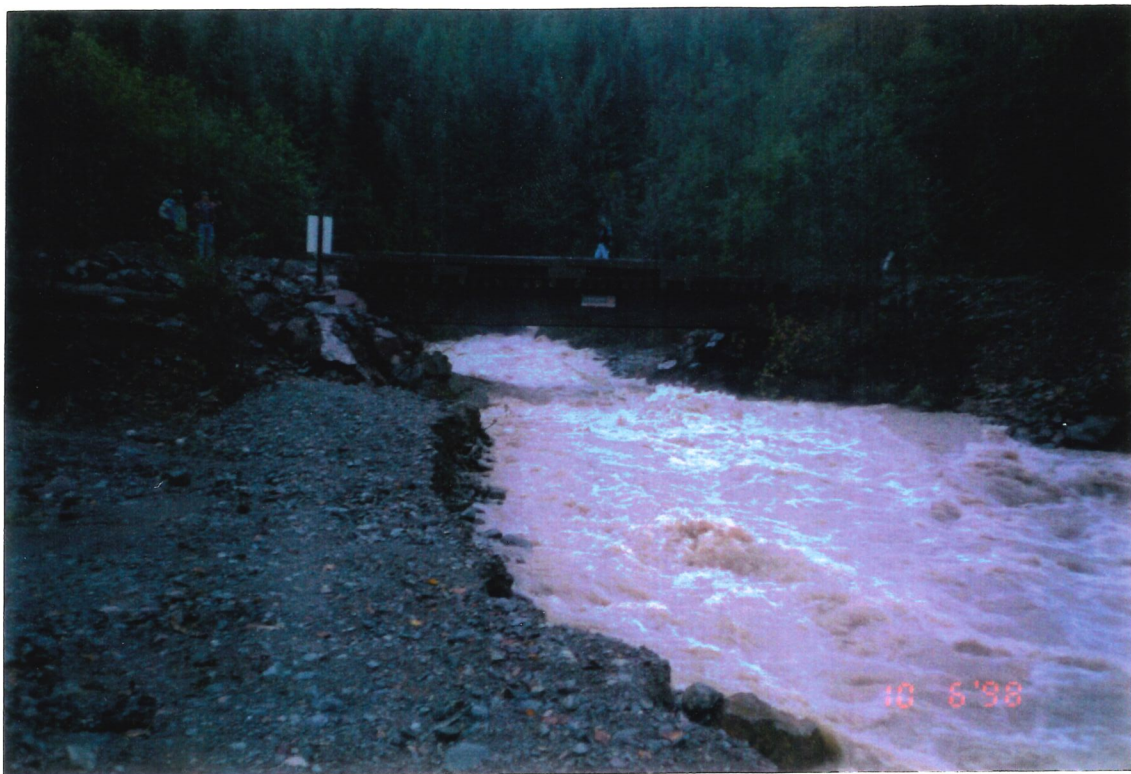
Type II works involving the addition of one rock weir proposed for Simpson Creek was completed in August 1998. On October 6, 1999, a large flood severely damaged all works completed in Simpson Creek in 1997 and 1998 after water flow broke around the outside of the vees and completely ripped out the top vee and the third vee.

**Photo 5. Upstream Simpson Creek during the flood of October 1998 (10-6-98).**

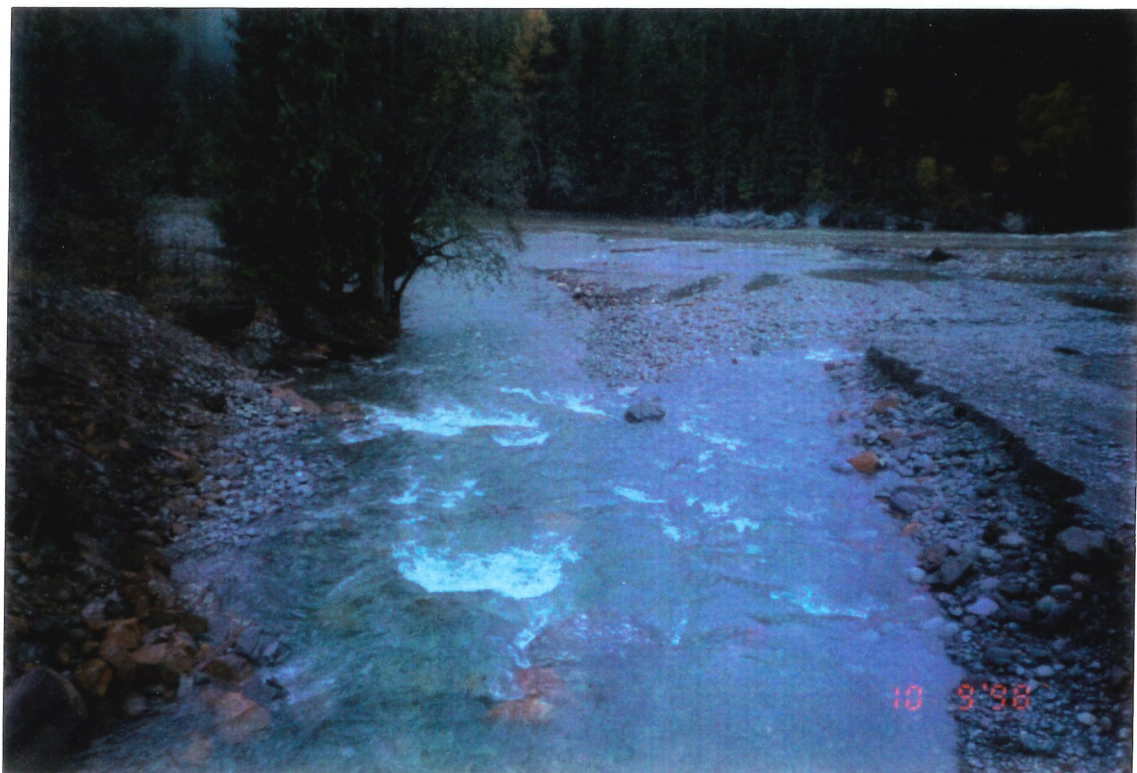
**Photo 6. Damage caused by flood in Simpson Creek (10-9-98).**

A very heavy rainfall in the mid-Zymoetz watershed on October 6, 1998 caused an extreme flood in Simpson Creek and other streams close by. This resulted in the entire first and third rock cluster and 1/3 of the second vee to be washed out. Likely in part as a result of the reduced velocity of the flood flow at the third vee, and because of the construction of the berm the vee appears to be in tact, but buried under a huge amount of gravel that was moved downstream. One more effort is proposed to rehabilitate the Simpson Creek habitat downstream from the bridge. Adam Engineering Ltd. was contracted to carry out an engineered plan to mitigate the damage (WRP Site Survey and Design report). The reclamation works are scheduled to begin in early August of 1999. Highlights of the proposed plan include the:

- Use riprap armouring sized to be stable during an extreme flood event.
- Stream banks will be armoured and a low-level dike that floodwaters can pass over will prevent channel breakout.
- The upper or first vee which was the second vee will be reconstructed to create a pool and spawning area and what is now the second or lowest vee if not intact will be reconstructed or modified.
- Install instream boulders at the downstream end of the creek below the second vee to create scour pools and provide a stable creek bed.
- Periodic maintenance to monitor the condition of the substrate after flood events.
- A MELP and DFO preliminary review of the engineering plan are critical to determine if the new plan will have the ability to achieve the desired results. Further meetings will be held between the interested parties to try and find a solution.
