**Survey of Watson Lake  
and its  
Outlet Stream**

**B.C. Fish and Wildlife Branch  
Smithers, B.C.**

**October, 1993**

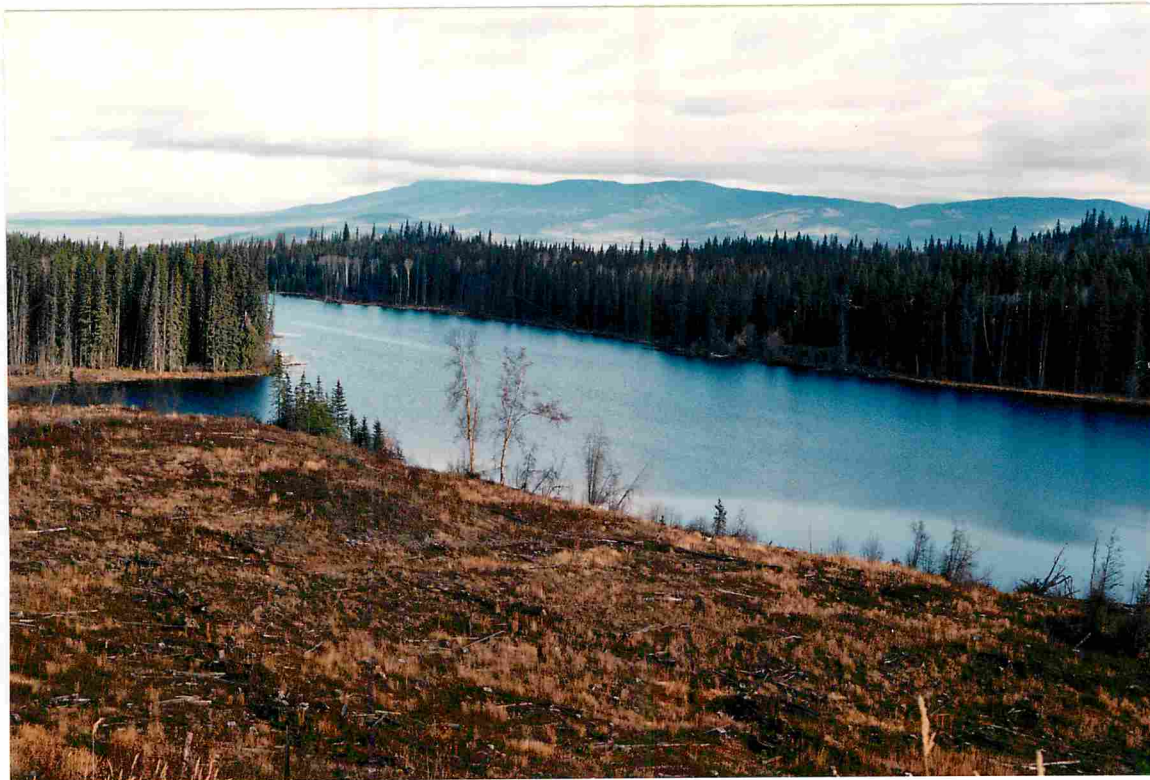
and 150 m wide. The southwest shore of the lake has been clear cut in an area that includes the steepest banks at Watson Lake. No fringe of vegetation was left to prevent runoff and erosion. Figure 2 illustrates that large proportions of this logged area that have not been sufficiently replanted. The actual shore of the lake was shallow and muddy and vegetation consisted of water lilies and *Equisetum*.

**Figure 2.** View of Watson Lake, looking northeast.

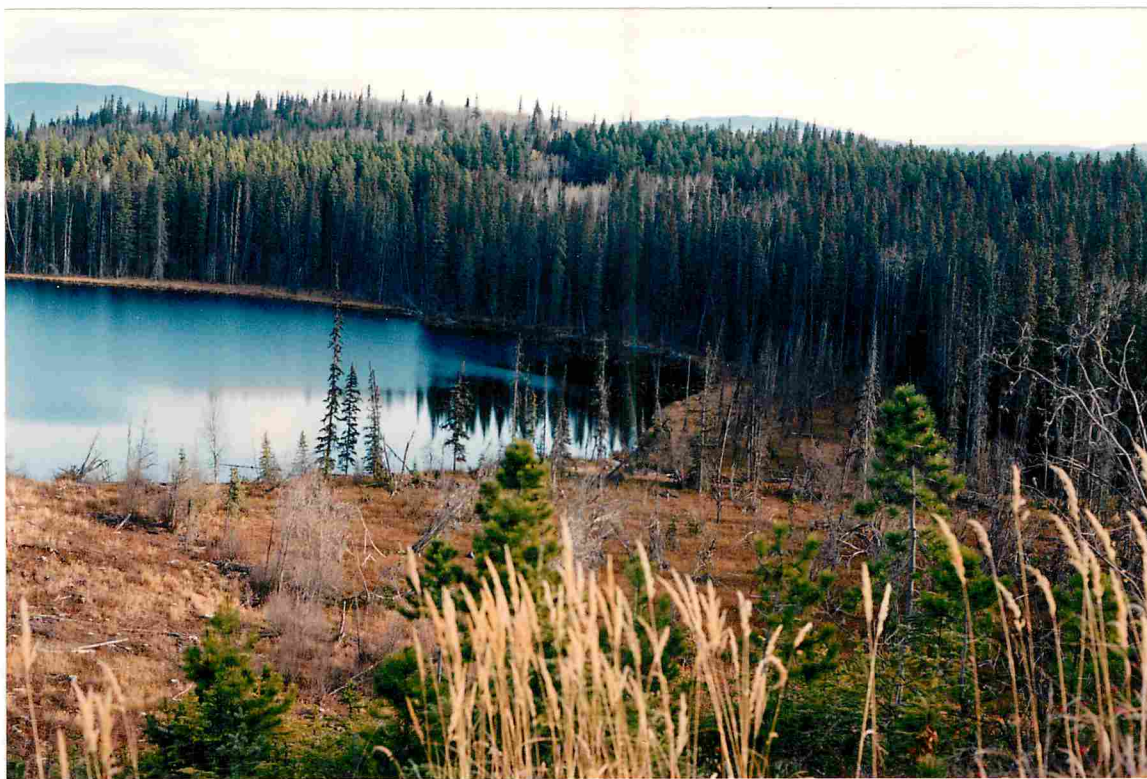
The outlet of Watson Lake is located at the south end of the lake (Figure 3). The depth at the outlet is shallow, with lilies reaching 20 - 30 m into the lake. The outlet stream is 4 m wide, approximately 50 cm deep, and has a mud substrate. This initial stretch of stream has good cover from fallen debris (Figure 4). A beaver dam 60 m below the lake is presently impassable to fish. The creek has no identifiable flow for the stretch upstream of the dam. The dam is approximately 20 m long and 0.75 m high and has been well maintained for several years (Figure 5). There was very little water seeping through the dam. The habitat of the outlet stream was observed for an additional 100 m below the dam and no suitable spawning or rearing locations for rainbow trout were evident.

**Figure 3.** View of the outlet at the south end of Watson Lake.

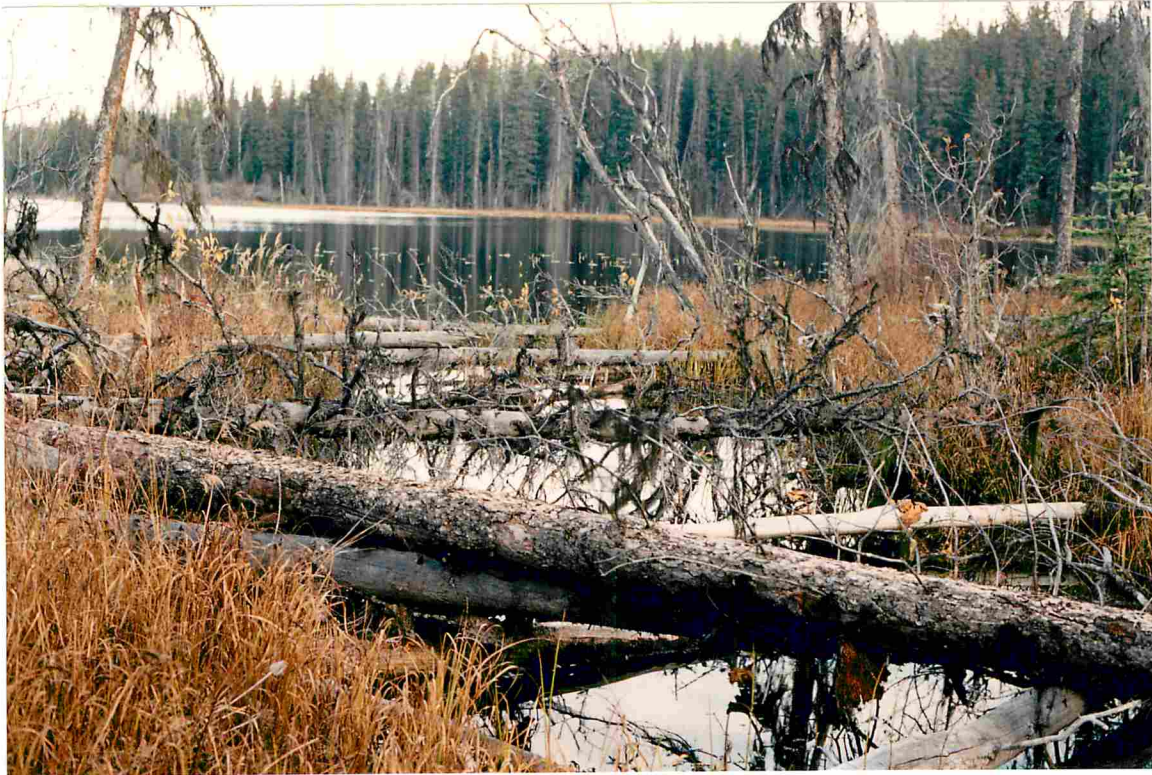
**Figure 4.** Looking up the outlet creek into Watson Lake.

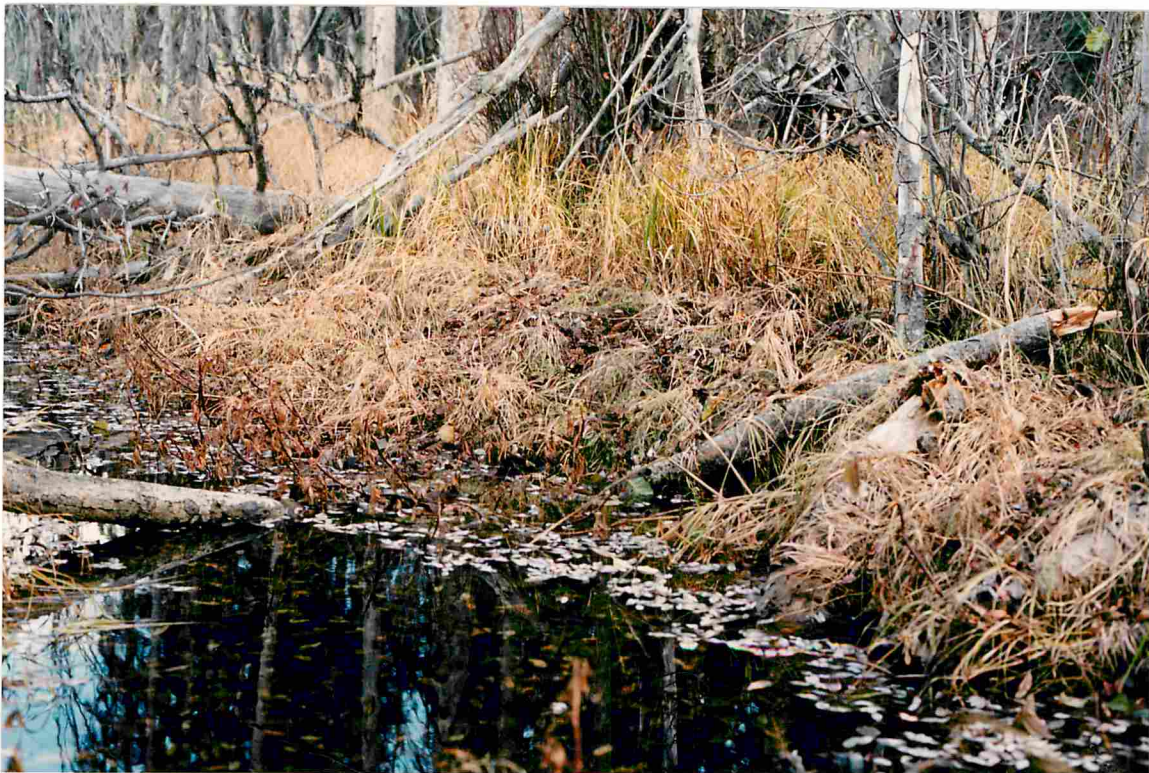
**Figure 5.** Photograph of the beaver dam that blocks the Watson Lake outlet stream about 60 meters downstream from the lake.

The only stream at this lake is completely blocked by a beaver dam and no suitable spawning habitat for rainbow trout was observed. It is difficult to predict the advantages or benefits that would be achieved by removing the beaver dam from the outlet stream. With no permanent inlet streams at Watson Lake, it is likely that the outlet would be subject to temporary drying. Presently, this lake is not an ideal location for a self-sustaining stock of rainbow trout.
