Dahlie Creek
Salmonid Overwintering and Water Quality Studies: Interim Report

Prepared for:
The Town of Smithers, B.C.
and
The Bulkley Morice Salmonid Preservation Group

June 2000

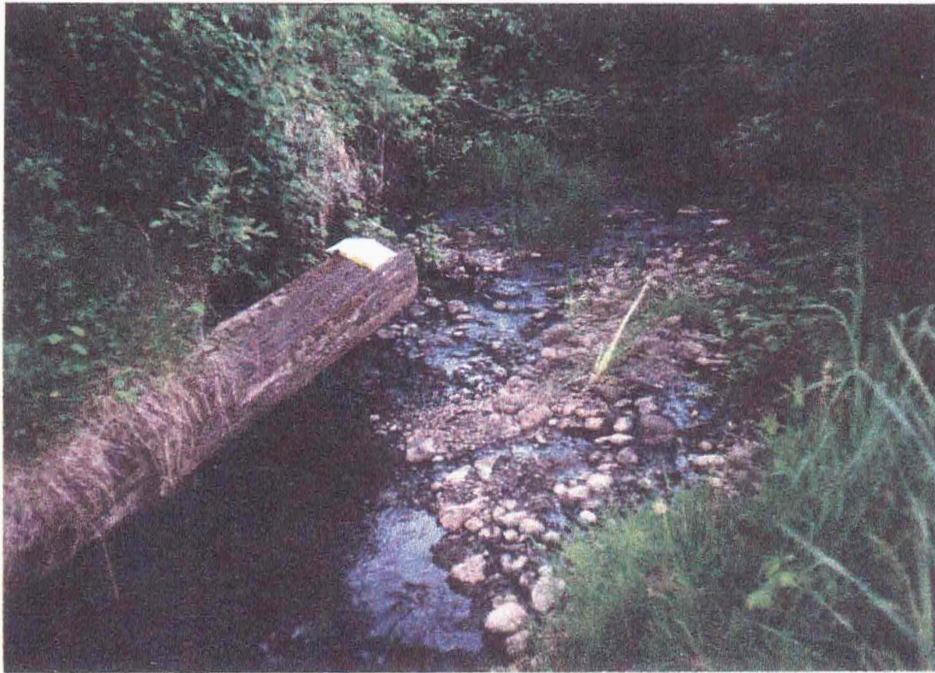
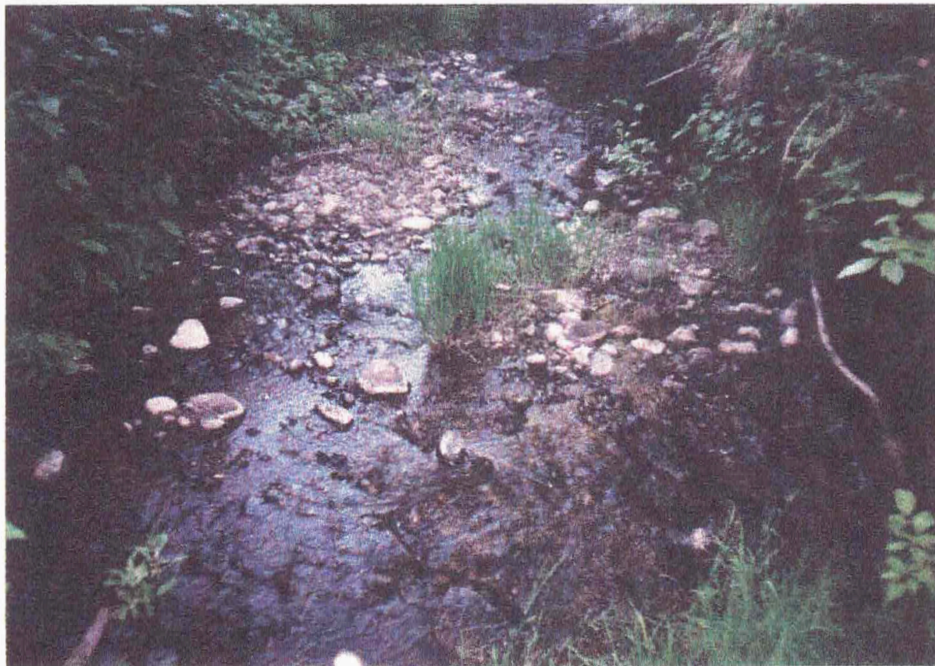
Dahlie Creek Site DAH 1

Plate 1. Reach 2 – DAH 1. Upstream view (above) and downstream view (below).

Overhanging vegetation also provided some cover at this site, which may be important even in winter due to incomplete ice cover. While site DAH 1 also has moderate in-stream cover, the majority of this site consists of riffle habitat (50%). Water depth at site DAH 1 was lower than at sites DAH 2 or DAH 3 during both winter sampling events (Appendix 1) and during habitat assessments conducted on June 26th 2000 (Appendix 1). Water depth at this site may be insufficient and water velocities in riffle habitat too high to allow fish to overwinter at this location. Site DAH 1 is located in the lower section reach 2 of Dahlie Creek, which was noted to be aggraded with minimal pool area (Tamblyn and Jessop 1999). Pools in this reach are generally small and shallow (Tamblyn and Jessop 1999), leaving little water during winter low flows and maximum ice thickness as observed at site DAH 1. Sedimentation was noted in this reach in the fall of 1999 (Tamblyn and Jessop 1999) and during our study, particularly at site DAH 2. Increased sediment input leads to increased embeddedness which has been documented to be detrimental to overwintering fish (Hillman *et al.* 1987), since salmonids are often associated with interstitial spaces in winter (Bustard and Narver 1975, Swales *et al.* 1986, Cunjak 1988, Reihle and Griffith 1993). It is interesting that no fish were captured at site DAH 2 during the overwintering study, since catch per unit effort at this site was highest during minnow trapping in November (Tamblyn and Jessop 1999). Fish habitat in reach 3 consists primarily of glides, as the channel is essentially an old ditch, and exhibits few meanders (Tamblyn and Jessop 1999). Habitat sampled at site DAH 3 appears to be representative of habitat characteristics described for reach 3 by Tamblyn and Jessop (1999), since the site consisted primarily of glide/pool edge habitat (60%) with 20% pool and 20% glide. We also noted trash at the sample site, as described by Tamblyn and Jessop (1999). Data collected during this study, and information summarized by Tamblyn and Jessop (1999) indicate that reach 3 offers some suitable overwinter habitat, but that overwinter habitat quality and quantity in reaches 1 and 2 are very low to non-existent due to the lack of deep pools and in-stream cover elements.

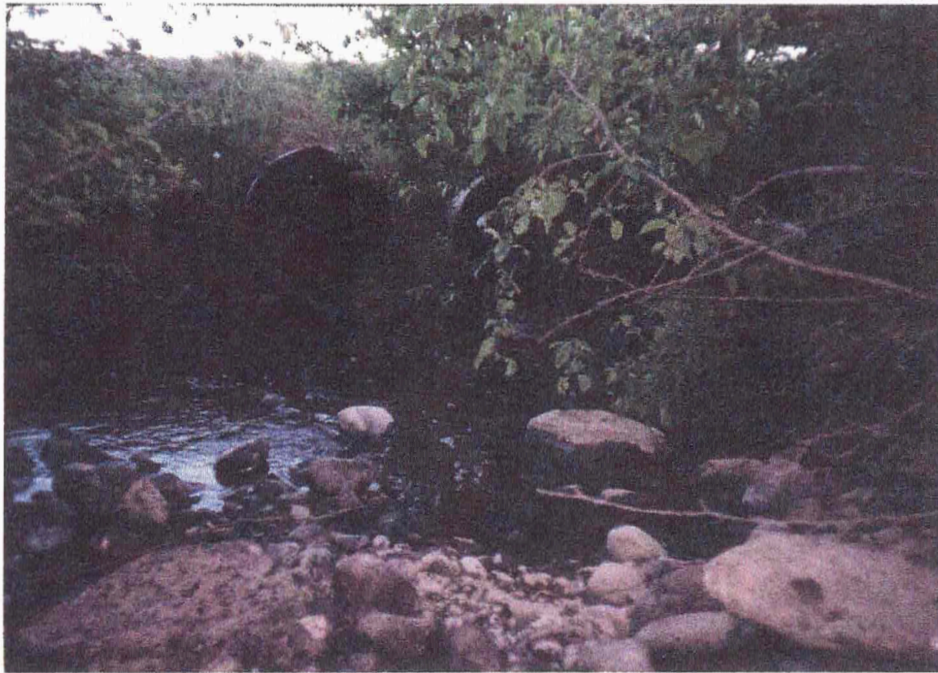
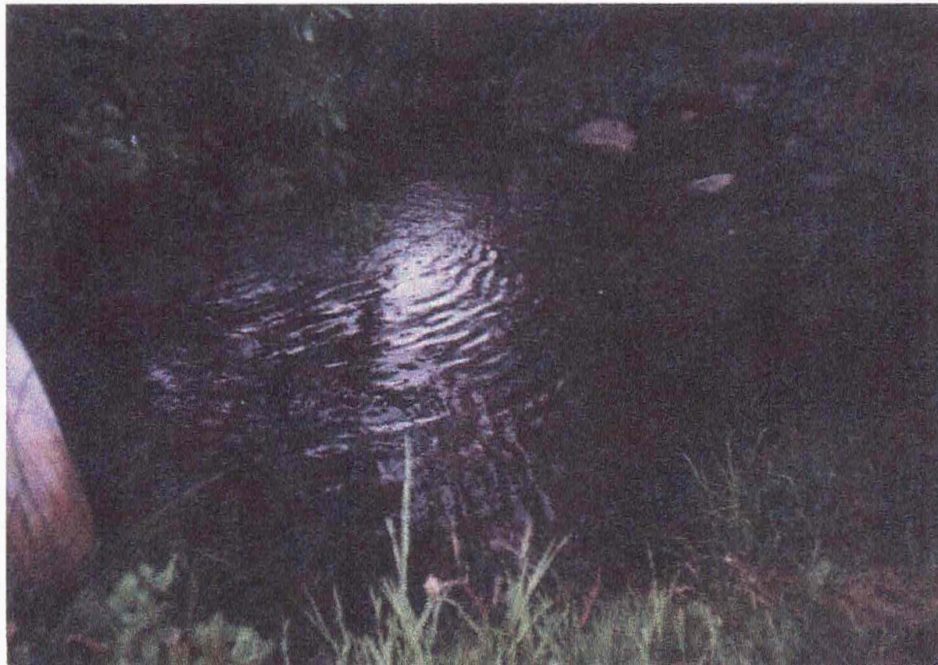
Dahlie Creek Site DAH 2

Plate 2. Reach 3 – DAH 2. Upstream view (above) and oblique view (below).

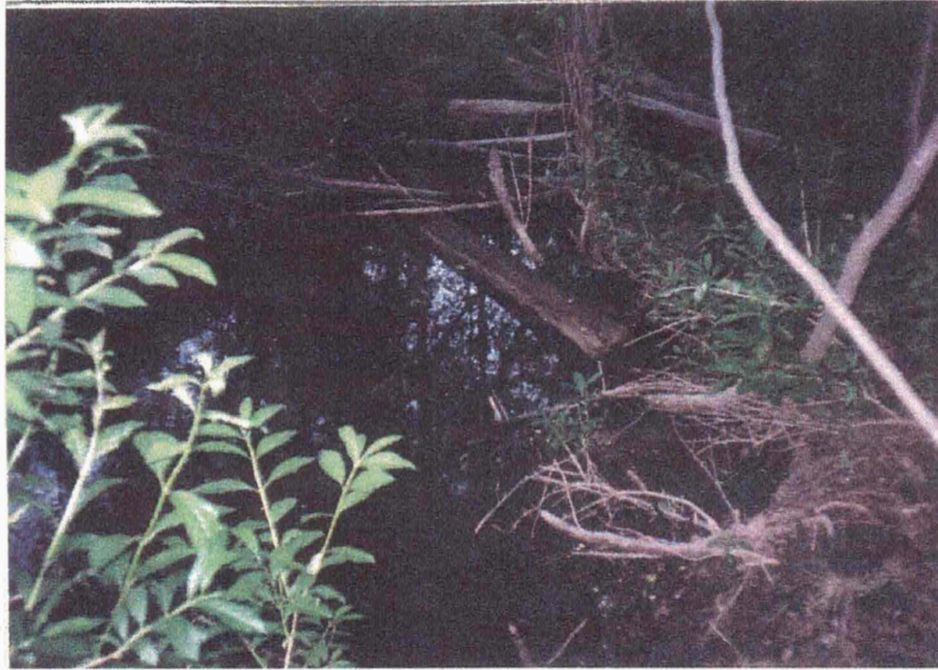
Dahlie Creek Site DAH 3

Plate 3. Reach 3 – DAH 3. Downstream view of site (above) and upstream view of culverts under Railway Avenue (below).

Of the sites sampled, site DAH 3 was located furthest upstream. Site DAH 3 is located upstream of known barriers to fish passage the highway 16 crossing, and upstream of the Willowvale subdivision as well as the location of the proposed Ducks Unlimited Stormwater Detention Project (Ducks Unlimited Canada 2000). Winter water temperatures appear to be consistently higher at this site than at the other sites sampled. During February sampling period, water temperature at sites DAH 1, DAH 2, and DAH 4 ranged between 0.2 and 0.5°C, while water temperature at site DAH 3 was 0.9°C. Similarly, water temperatures on March 15th 2000 ranged was 1.2°C and 1.1°C at sites DAH 1 and DAH 2, respectively, while temperatures at site DAH 3 was 2.3°C. This may indicate groundwater influence, or warm water inflow at this location. However, the difference in water temperature is not statistically significant ($t=6.314$, $p=0.46$), probably due to the low sample size. Site DAH 3 also had more open water than the other sites sampled in the study. Lack of ice cover allows for re-oxygenation of the water (Schreier *et al.* 1980, Chambers *et al.* 1997), and may prevent declines in oxygen concentrations to critical levels (6 ppm) (Davis 1975, Canadian Council of Ministers of the Environment 1991). Oxygen concentrations were well above critical levels at all sites sampled (10.8 ppm – 14.5 ppm). Winter observations at site DAH 3 indicate that this site had the highest potential for migration of fish. Limited ice cover and moderate water flow resulted indicated that fish were able to move in and out of the site freely. While some researchers indicate that fish move little during winter (Envirocon 1986, Heifetz *et al.* 1986, Dolloff 1987, Swales *et al.* 1986, Giannico and Healey 1998), others report extensive movements of salmonids during winter (Cunjak 1996, Heggensen *et al.* in prep). In the upper Bulkley, coho density indices appear to be higher at sites with a greater potential for migration, while rainbow trout density indices are lower at sites with a greater potential for migration (Donas and Saimoto 2000). Similarly, coho catch per unit effort appears to be greater, and rainbow trout catch per unit effort lower, at sites with a greater potential for migration in the Morice River than sites with a lower potential for migration (Wet’suwet’en and Saimoto 2000). Ability to migrate to and from sites may be important for overwinter survival since entrapment in unsuitable habitat can be avoided (Bustard 1986, Cunjak 1996). Catch per unit effort may be higher at open sites since a wider range of habitat can be effectively sampled than in closed sites. In open sites, fish from outside the immediate sampling area may access the trap during the sampling interval.

Percent pool and substrate composition as well as organic cover have been identified as important components of overwinter habitat (Bustard and Narver 1975, Swales *et al.* 1986, Saimoto and Donas 2000). Pool depth has been identified as an important factor for overwintering habitat suitability in several studies (Bustard and Narver 1975, Swales *et al.* 1986), however, Cunjak and Power (1987) suggest that water depth only becomes important where it provides cover, or is associated with low flows. Site DAH 2 had the highest proportion of pool habitat (60%), while site DAH 3 consisted primarily of pool/glide edge habitat (60%). Instream cover provided as site DAH 2 was rated as trace, however, and may limit the suitability of this habitat for overwintering. In-stream cover was rated as moderate at site DAH 3, and consisted primarily of small and large woody debris, with some undercut banks.

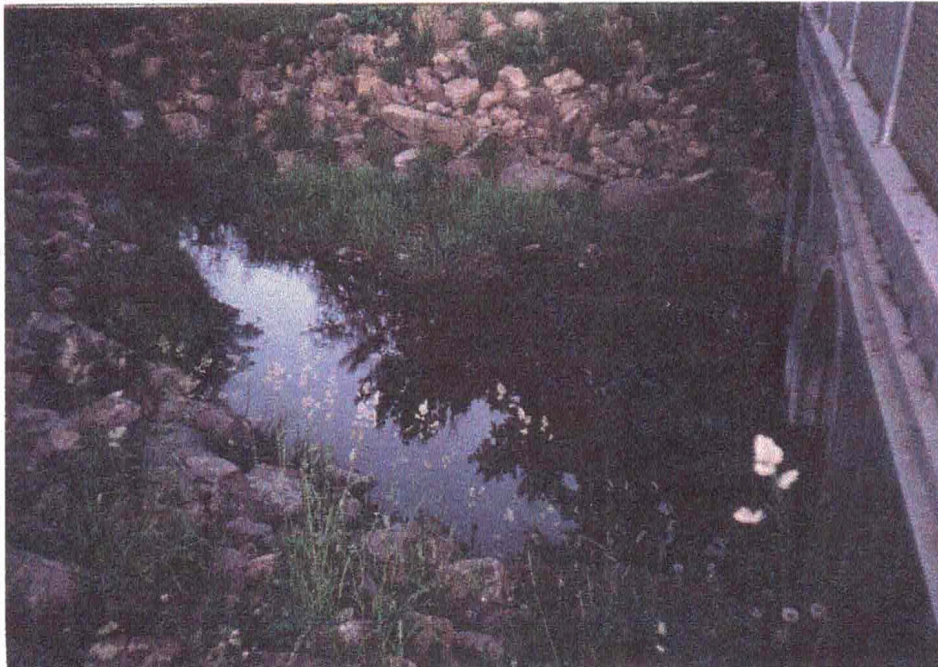
Dahlie Creek Site DAH 4

Plate 4. Reach 3 – DAH 4. Upstream view of culverts (above) and oblique view (below).

some instream rock placement to create pools was observed upstream of culverts

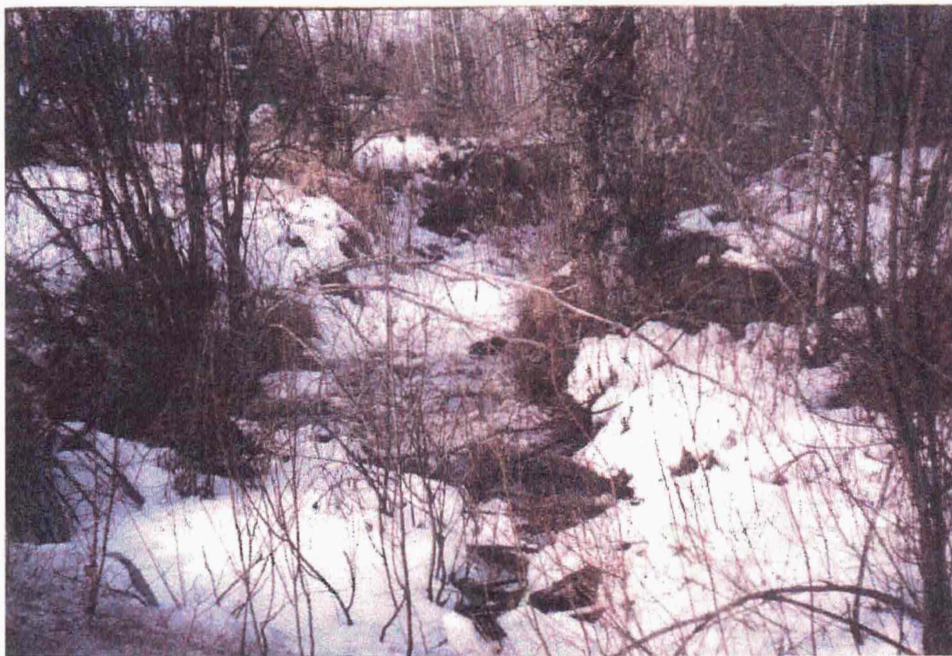
Dahlie Creek Site DAH 1

Plate 5. Reach 2 – DAH 1. Upstream view on February 9th 2000 (above) and downstream view on March 15th 2000 (below).

-fish habitat appeared to be good except for sediment
 -excellent trap setting in deep slow flowing water but no fish captured or observed

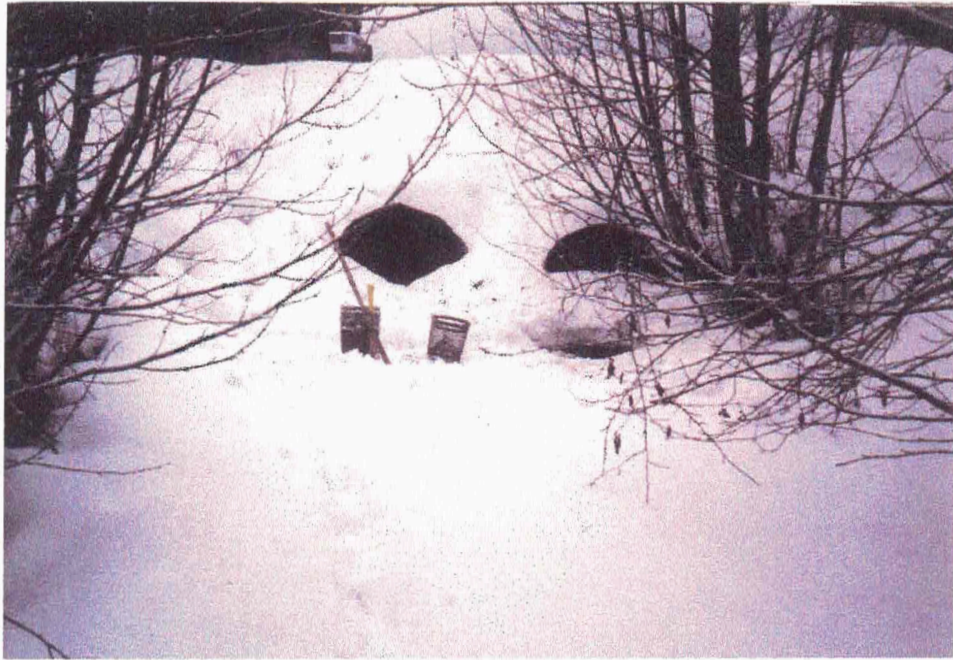
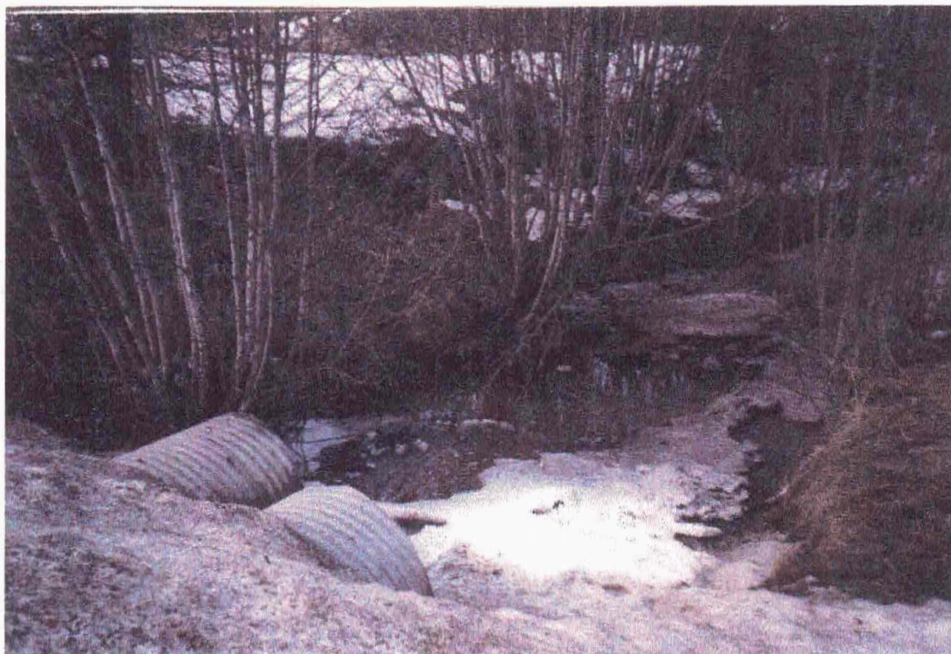
Dahlie Creek Site DAH 2

Plate 6. Reach 3 – DAH 2. Upstream view on February 9th 2000 (above) and downstream view on March 15th 2000 (below).

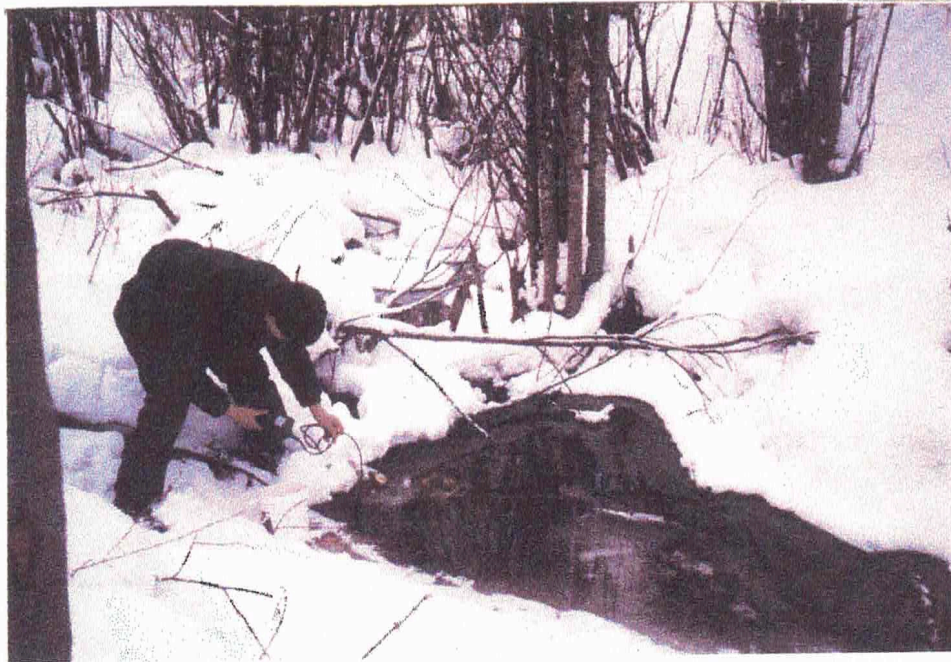
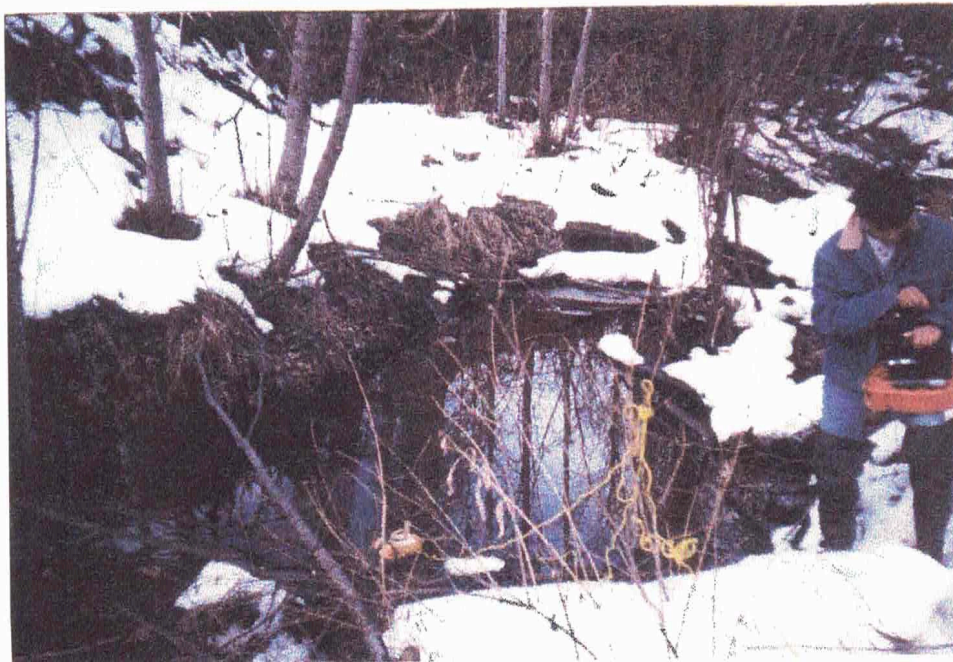
Dahlie Creek Site DAH 3

Plate 7. Reach 3 – DAH 3. Upstream view on February 9th 2000 (above) and downstream view on March 15th 2000 (below).

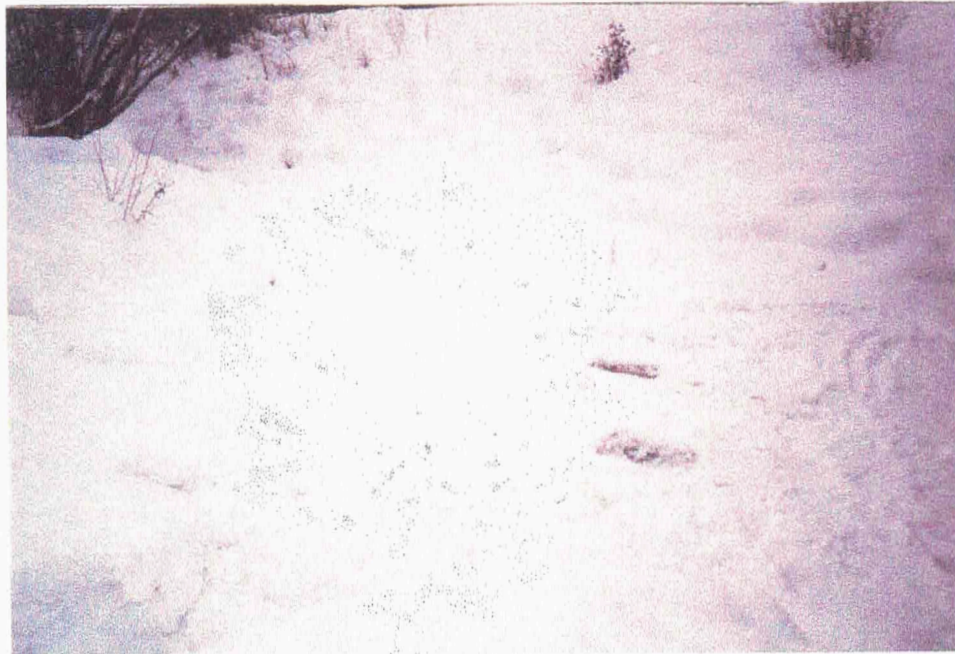
Dahlie Creek Site DAH 4

Plate 8. Reach 3 – DAH 4. Upstream view (above) and oblique view (below) on February 9th 2000.
