**Snowflake Lake
(180-374000-95200-41400-5280-7330-01)
02387FRAN**

**SECONDARY LAKE INVENTORY
1997 STUDIES**

**Ministry of Environment, Lands and Parks
Project No. IVBVS622 (FRBC)**

APRIL 1998

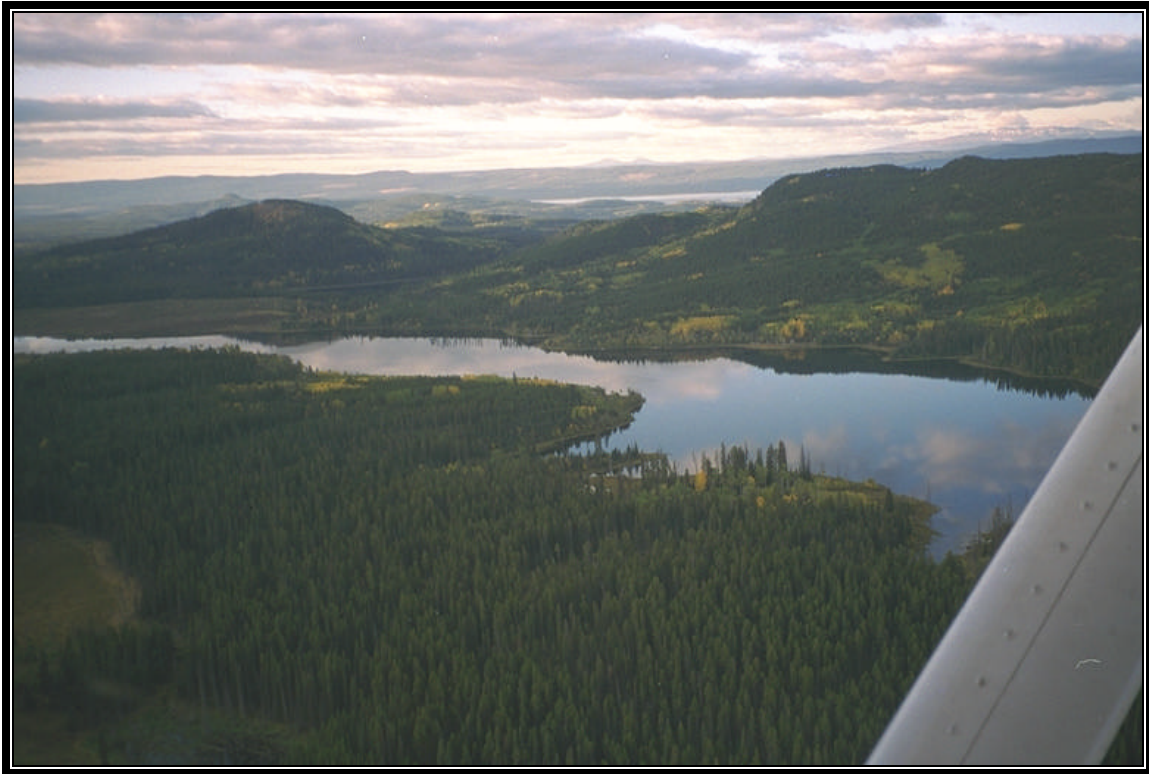
Plate 1 Aerial view of lake looking southwest.

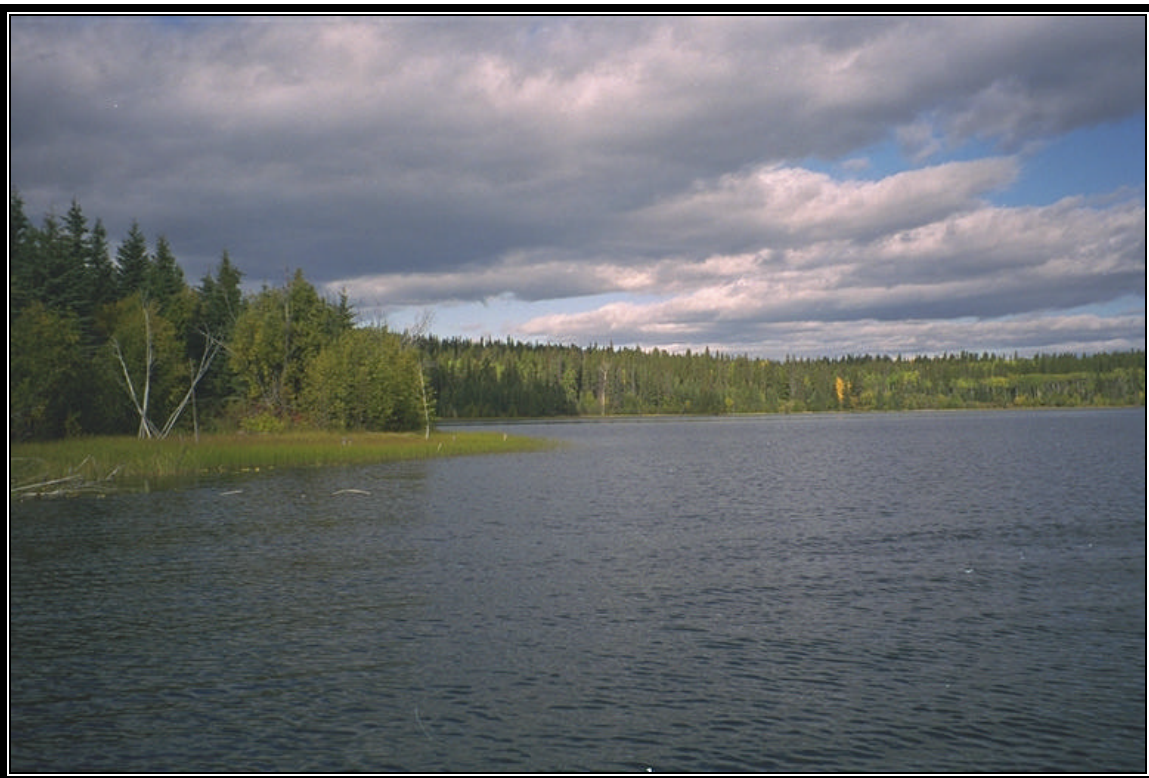
The shoreline is comprised of 75% marsh and 25% sand/gravel beach. Shoreline vegetative cover is moderate and consists primarily of grass and low-lying

Plate 2 View of southwest shoreline from near lake centre.
