**Reconnaissance (1:20,000)
Fish and Fish Habitat Inventory of
Selected Inlet Streams to the
East Shore of the Northwest Arm of Babine Lake**

Watershed Code: 480-000000

SKR Consultants Ltd.

March 31, 2001

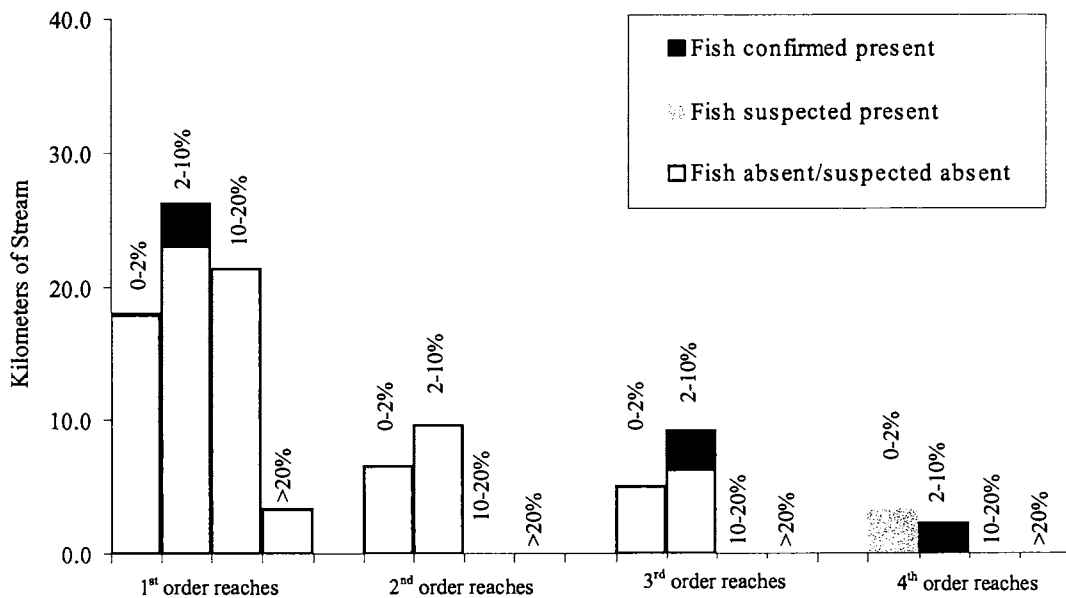
Figure 2. Distribution of fish presence in different order and gradient classes of stream reaches within Sub-basins IV and V in the study area along the northeast shore of Babine Lake. Data labels represent the gradient classes (%) within each stream order.

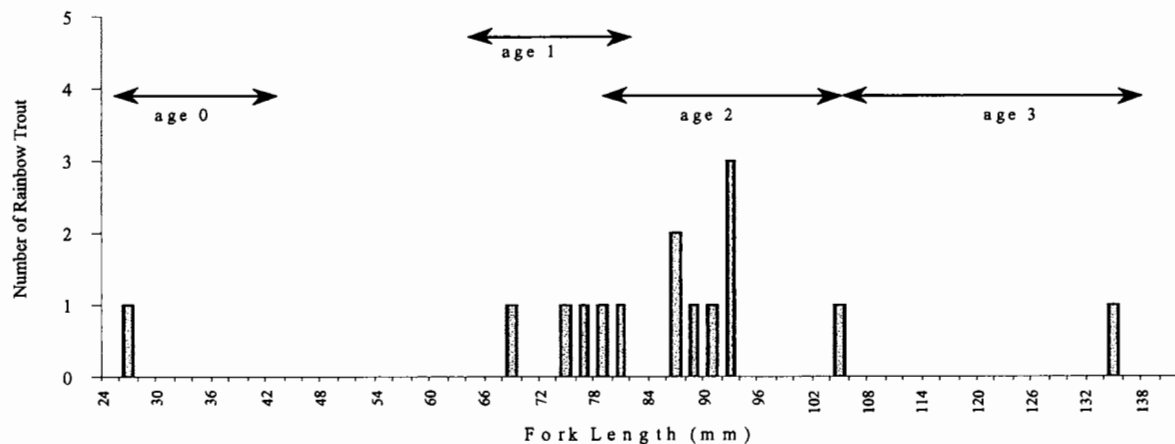
Note: Age classes were estimated based on ages obtained from 11 scales samples.

Figure 3. Length frequency histogram of rainbow trout captured in the inlet streams to the east shore of Babine Lake (N=15) on July 7th and 26th 2000.

In total, 15 rainbow trout were captured in streams sampled in Sub-basins IV and V. The largest rainbow trout (136 mm fork length) was estimated to be 3 years old by scale aging. Fork lengths of rainbow trout captured in stream reaches ranged between 67 and 134 millimeters (mean = 84.80, SD = 22.25). Fork length frequency distribution (Figure 3) suggests that four age classes are present in the sample of rainbow trout obtained from the streams sampled. The low abundance of fry indicates that they were just beginning to emerge from the gravel at the time of survey in mid July which is not uncommon in this region (Scott and Crossman 1973). Rainbow trout captured in the study area likely exhibit a lacustrine-adfluvial life history, as suggested by the juvenile age classes and the proximity of capture locations to Babine Lake.

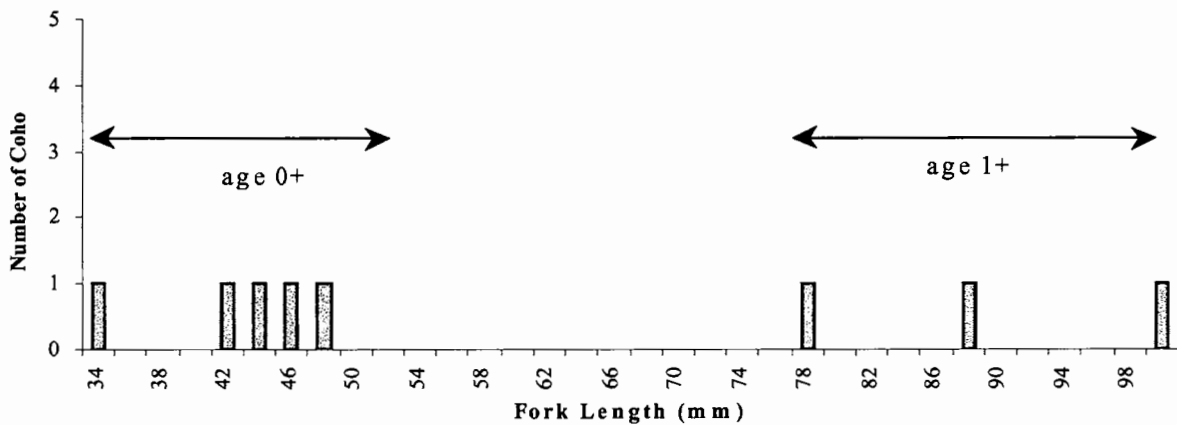
Note: Age classes were estimated based on ages obtained from 3 scales samples from fish >75 mm.

Figure 5. Length frequency histogram of coho captured in the inlet streams to the east shore of Babine Lake (N=8).

Fork lengths for eight coho that were captured in inlet streams to the northeast shore of Babine Lake were documented. In addition, 15 coho fry (35-40 mm) were identified and released without accurate measurements to reduce handling. All of these fish were captured in close proximity to Babine Lake. Fork length frequency distribution (Figure 5) and length at age data reported in the literature (Sandercock 1991) suggests that the coho captured are age 0+ and 1+ years. Fork length of fry ranged between 35 and 49 millimeters and fork length of 1+ year old juveniles ranged from 79 and 100 millimetres. All coho captured in the inlet streams to the northeast shore of Babine Lake exhibit an anadromous life history, and the lack of coho older than 1+ suggests that juvenile coho from this stream may smolt at age 2.

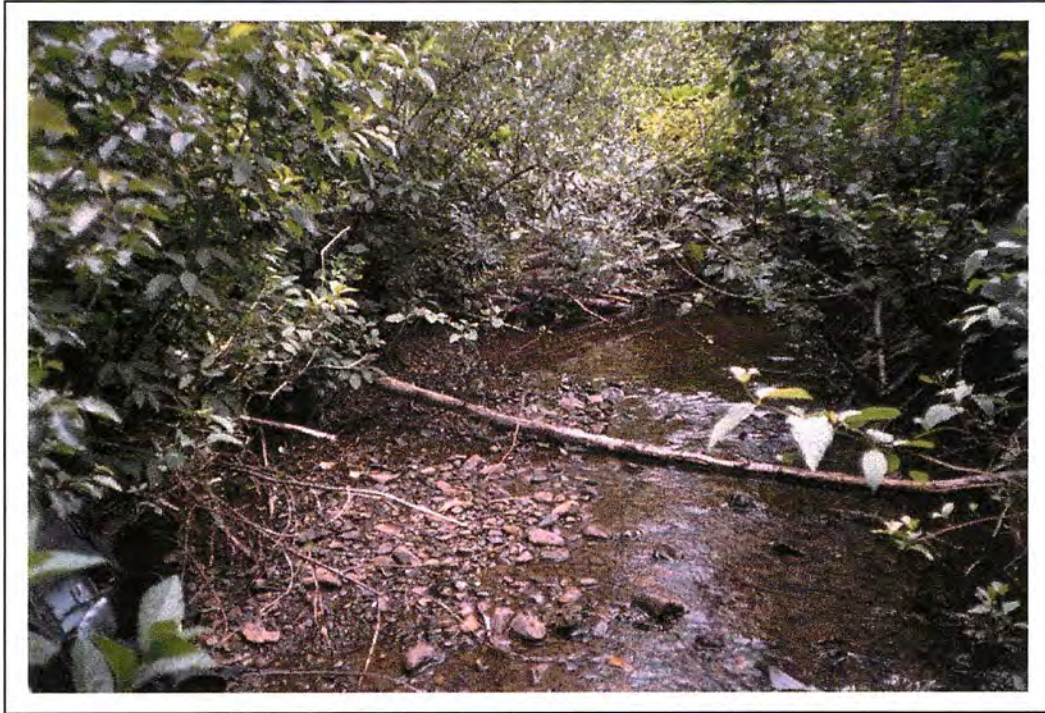
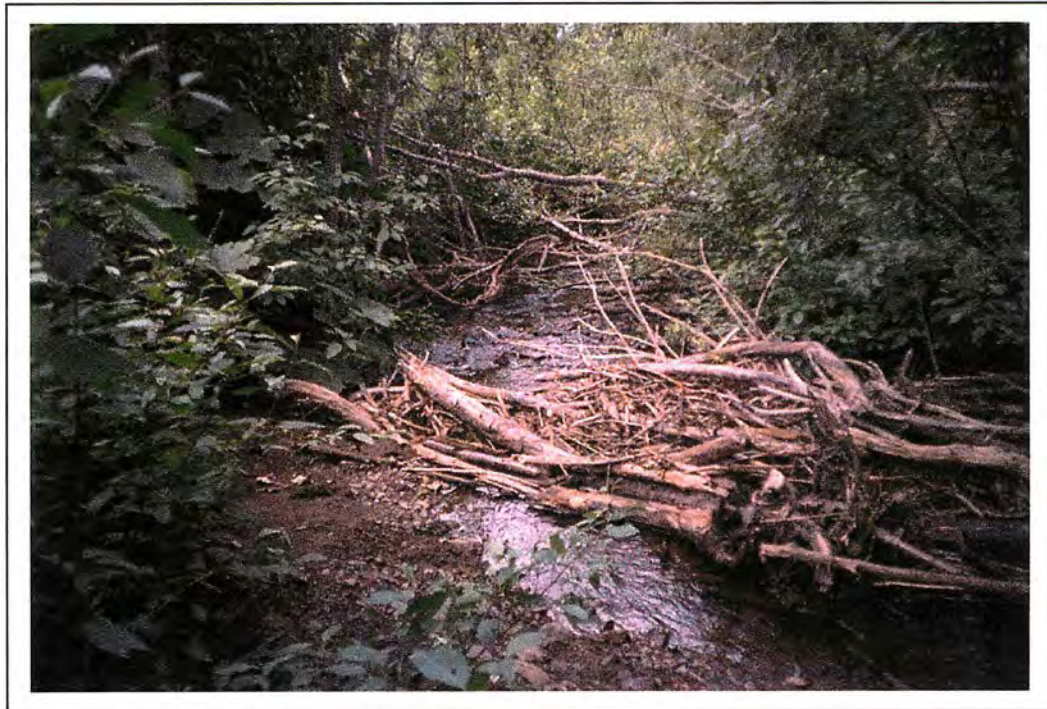
Reach 1

Upstream view (above) and downstream view (below)

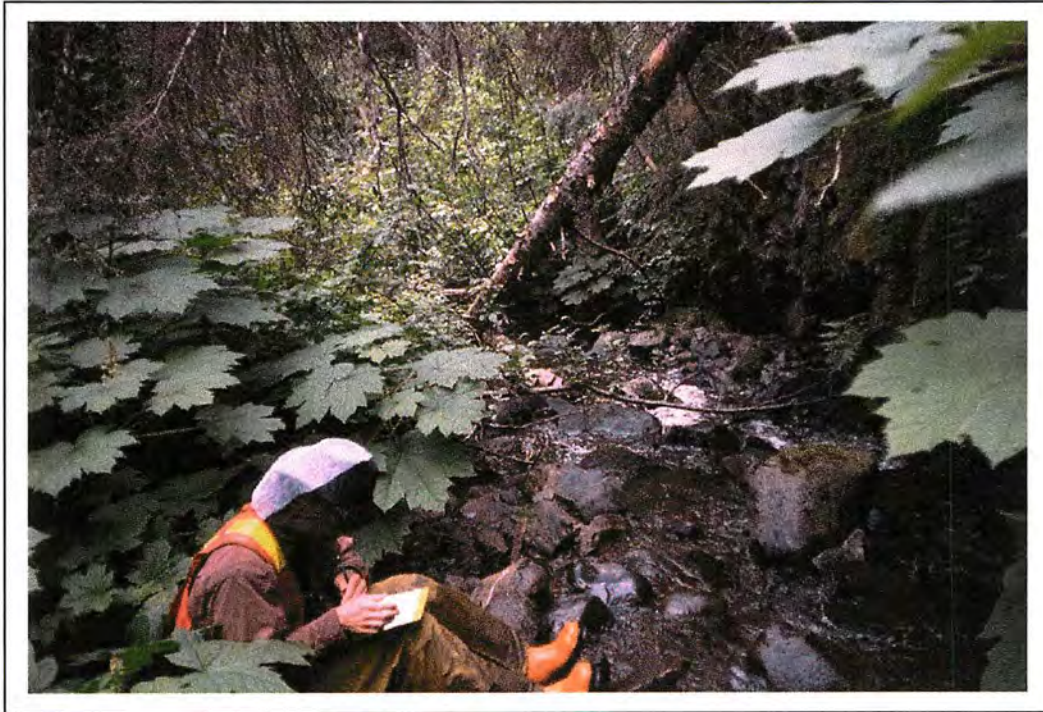
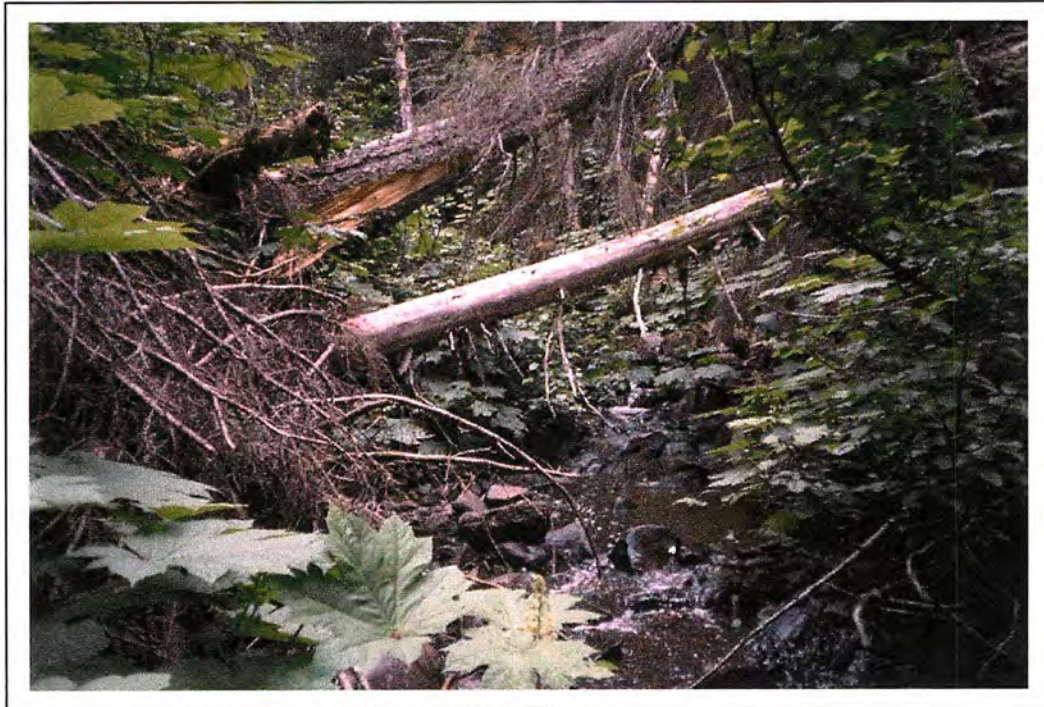
Reach 2

Upstream view (above) and downstream view (below)

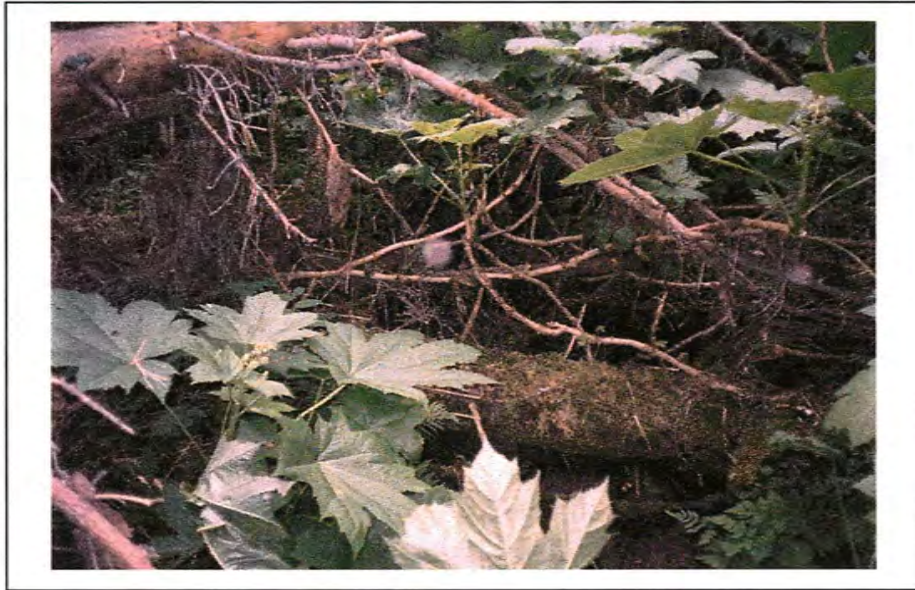
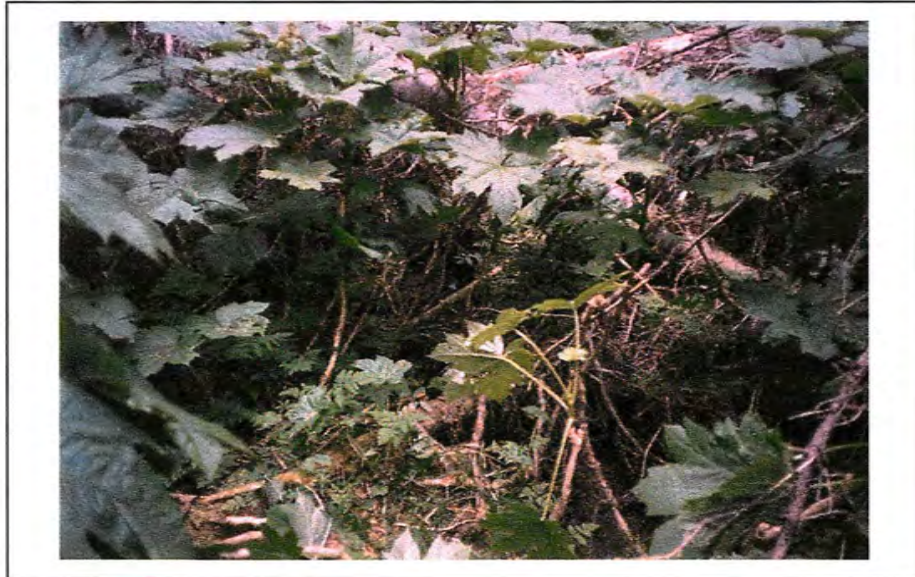
Reach 1

Upstream view (top left) and downstream (bottom left) of site; upstream view of 42% gradient barrier (above).

| Sample Site # | ILP | Reach | TRIM Map # | Gradient (%) | Electrofishing Specifications | | | | | | | | Proposed Riparian Class. | Comments |
|---|---|---|---|---|---|---|---|---|---|---|---|---|---|--|
| 3 | 10364 | 1 | 093M.028 | 12.5 | 0.9 | 100 | 377 | 40 | 11 | L | C | 07/11 | S6 | The initial 60 metres of this stream has 42% gradient and was identified in the field as a barrier to fish migration. No perennial fish habitat was identified upstream of the barrier due to no overwintering habitat in this small stream (max. pool depth observed was 5 cm) or its tributary (see site 5). In addition, no fish were captured in all available habitat in a 100 metre section upstream of the barrier. |

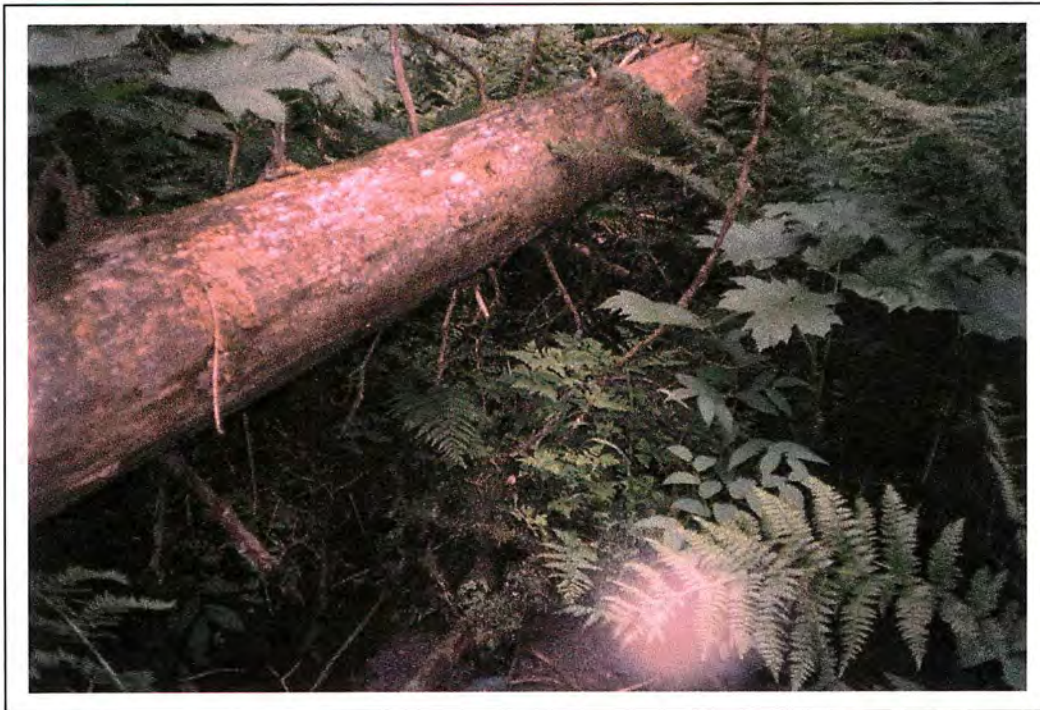
Reach 2

Upstream view (above) and downstream view (below)

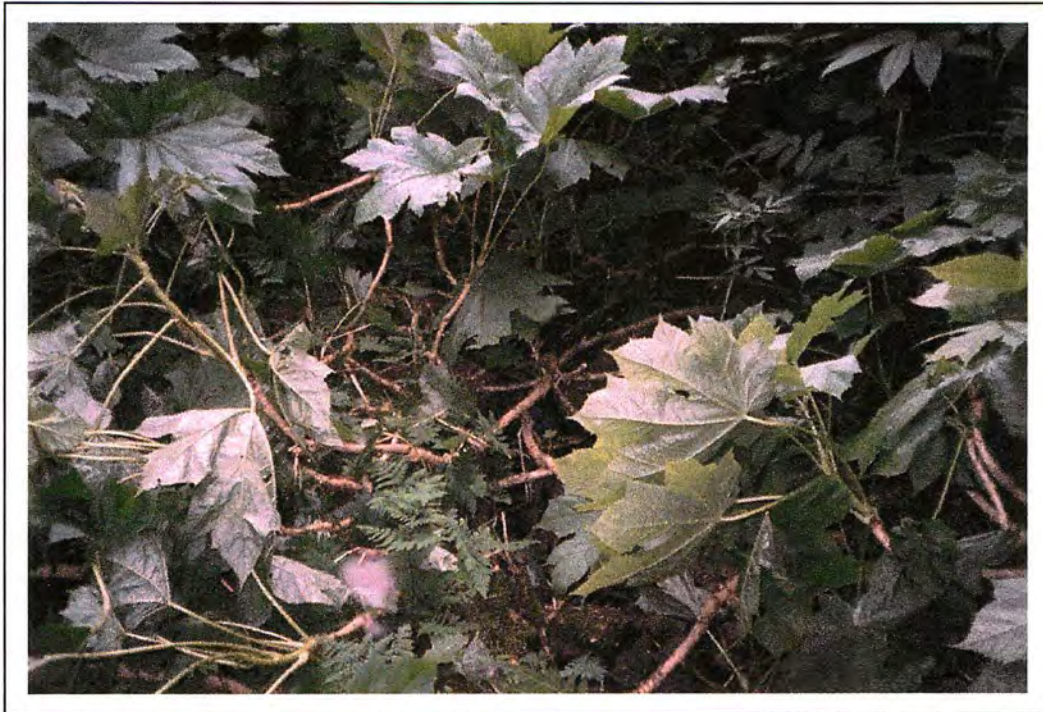
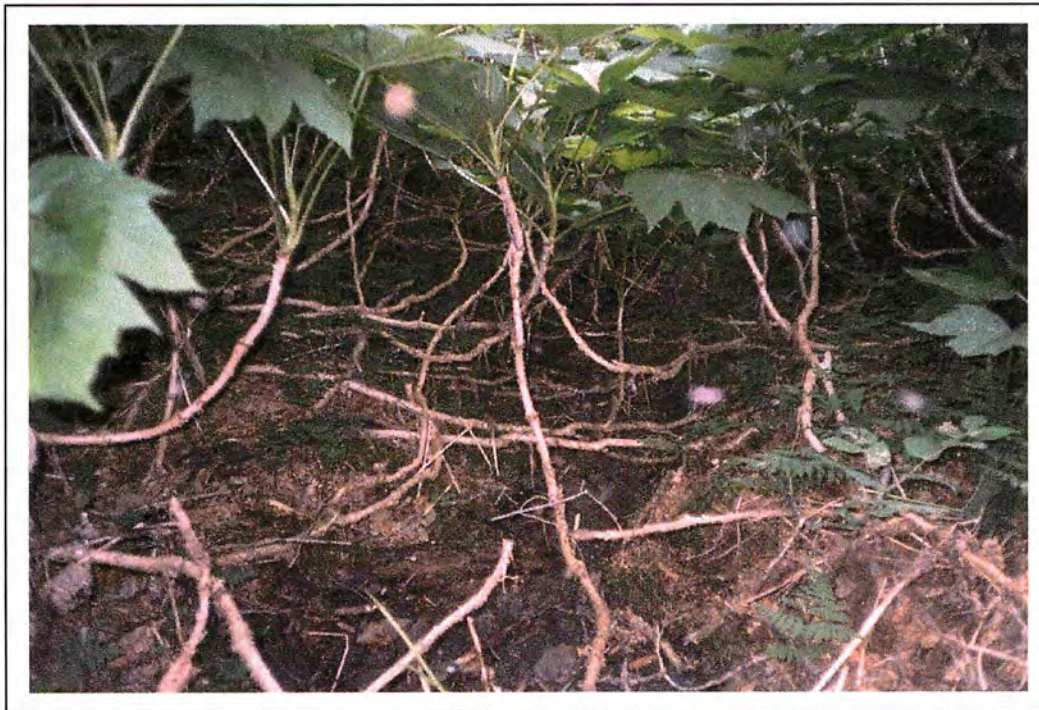
Reach 1

Upstream view (above) and downstream view (below)

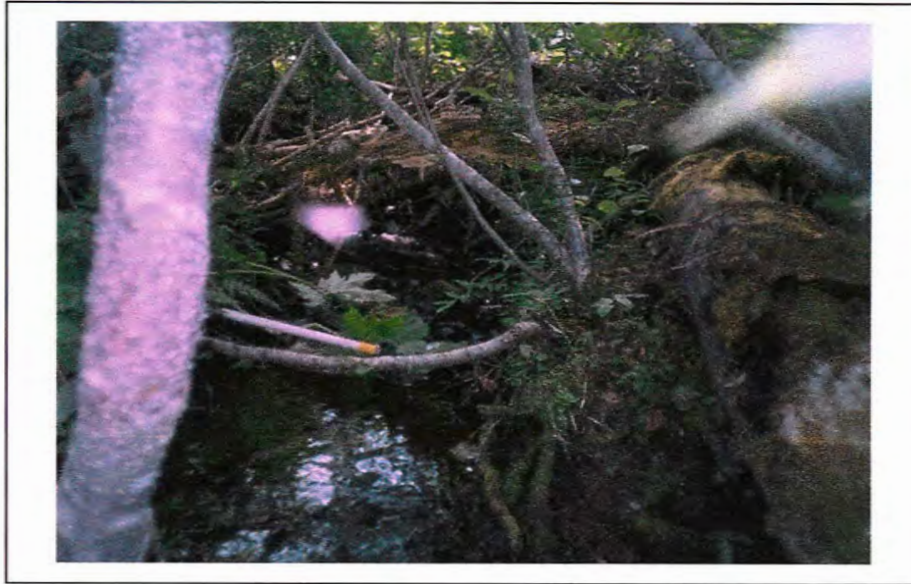
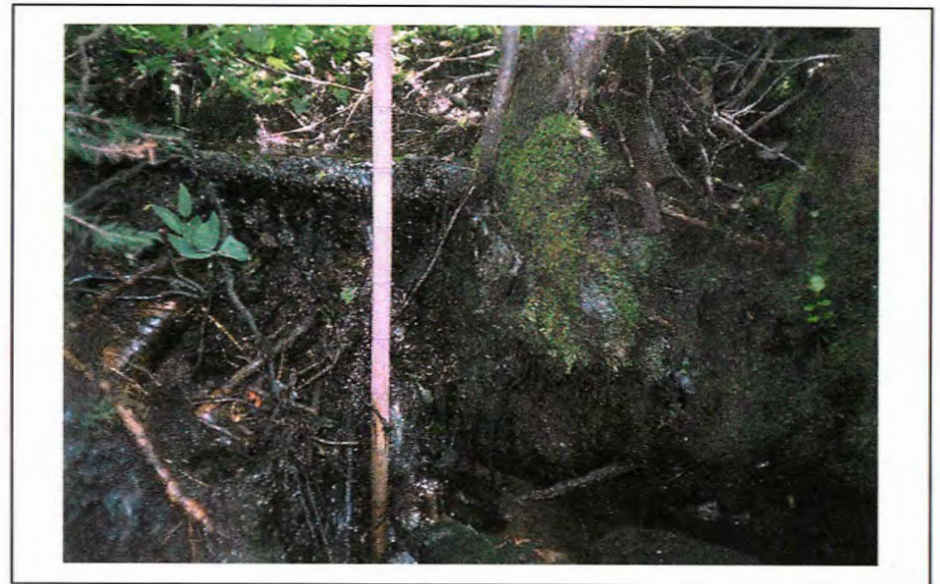
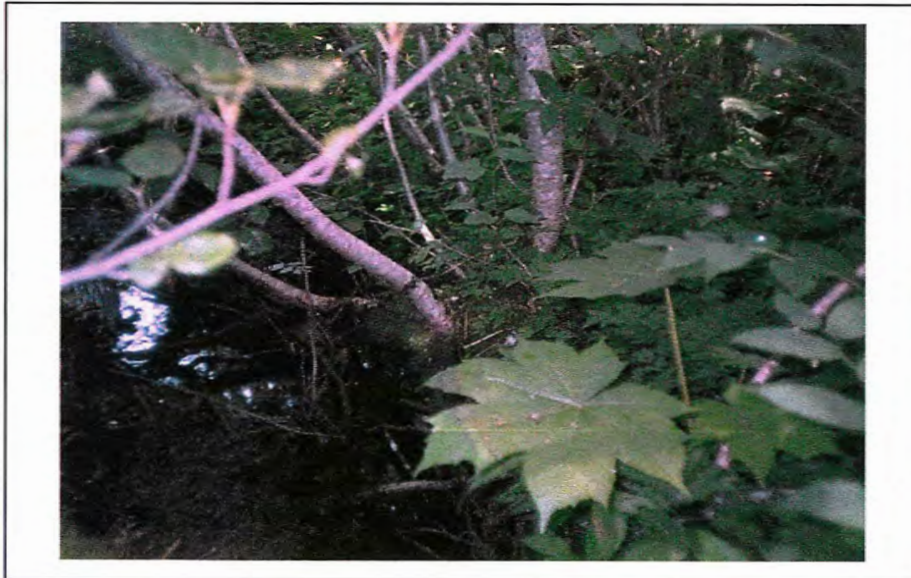
Reach 2

Upstream view (top left) and downstream view (bottom left) of site; upstream view of an 0.8m step within this reach (above).

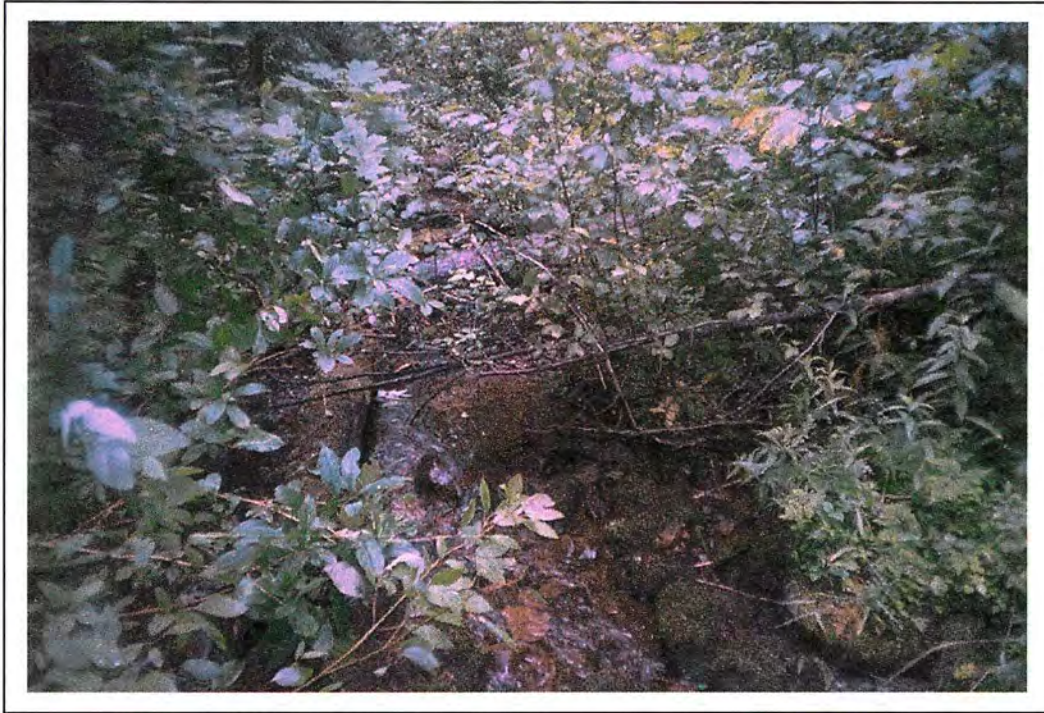
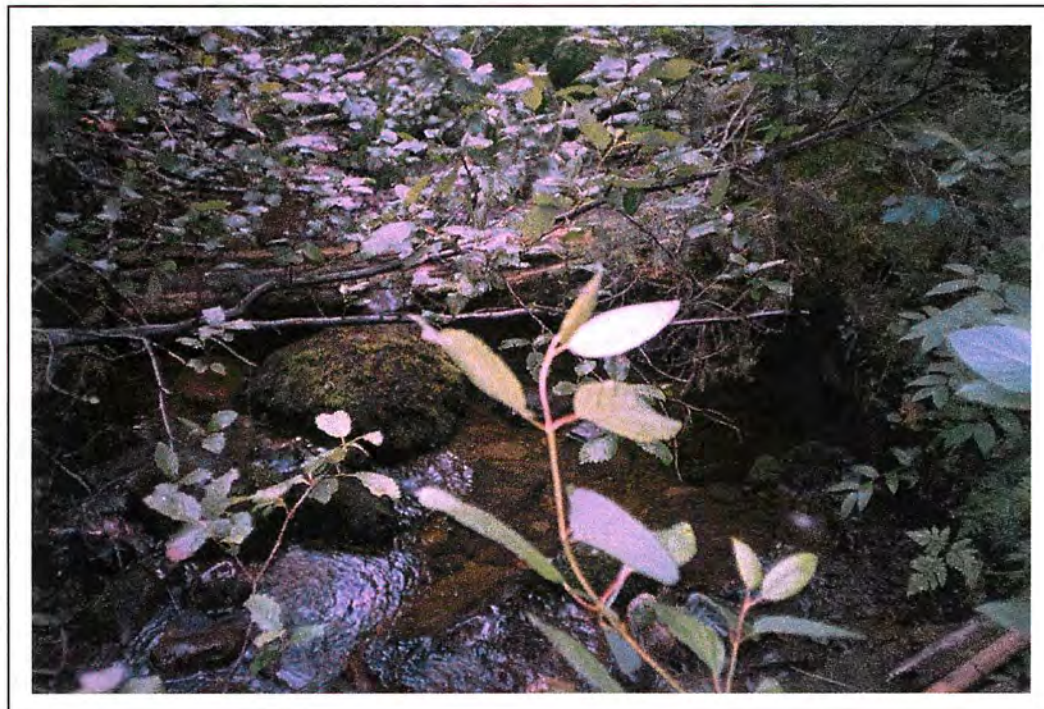
Reach 1

Upstream view (above) and downstream view (below)

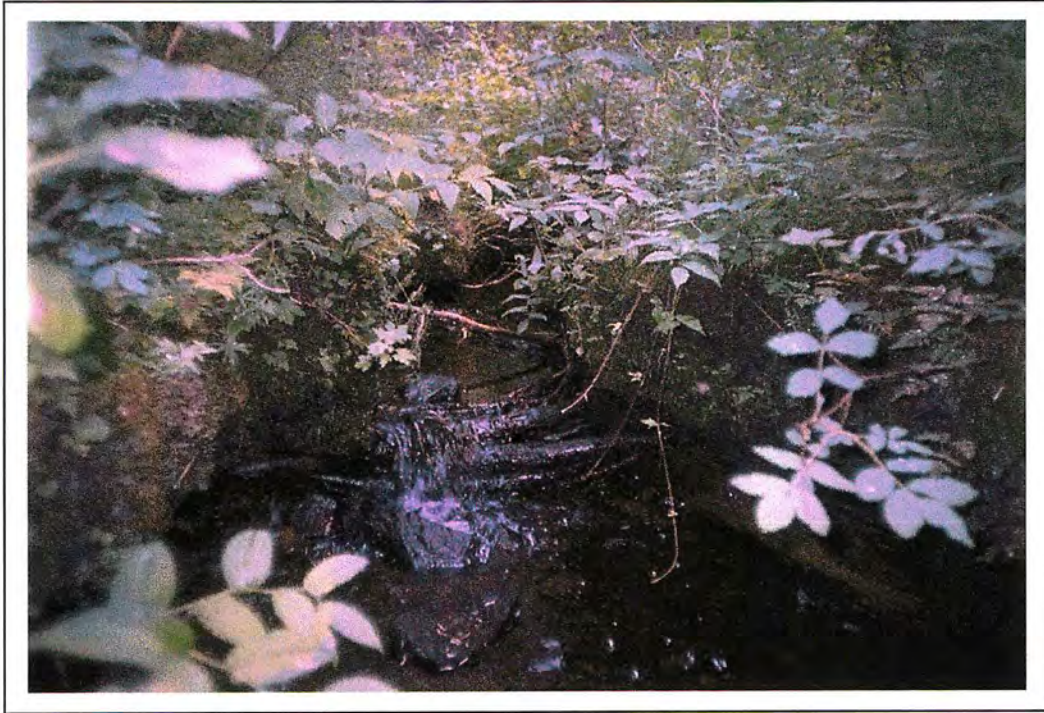
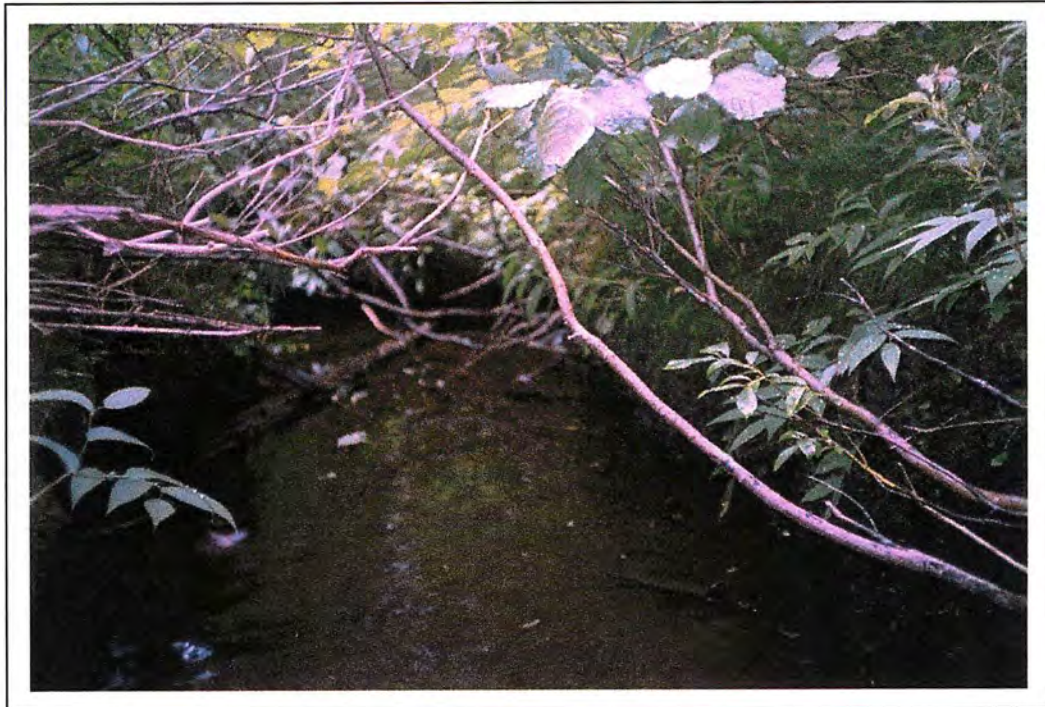
Reach 1

Upstream view (above) and downstream view (below)

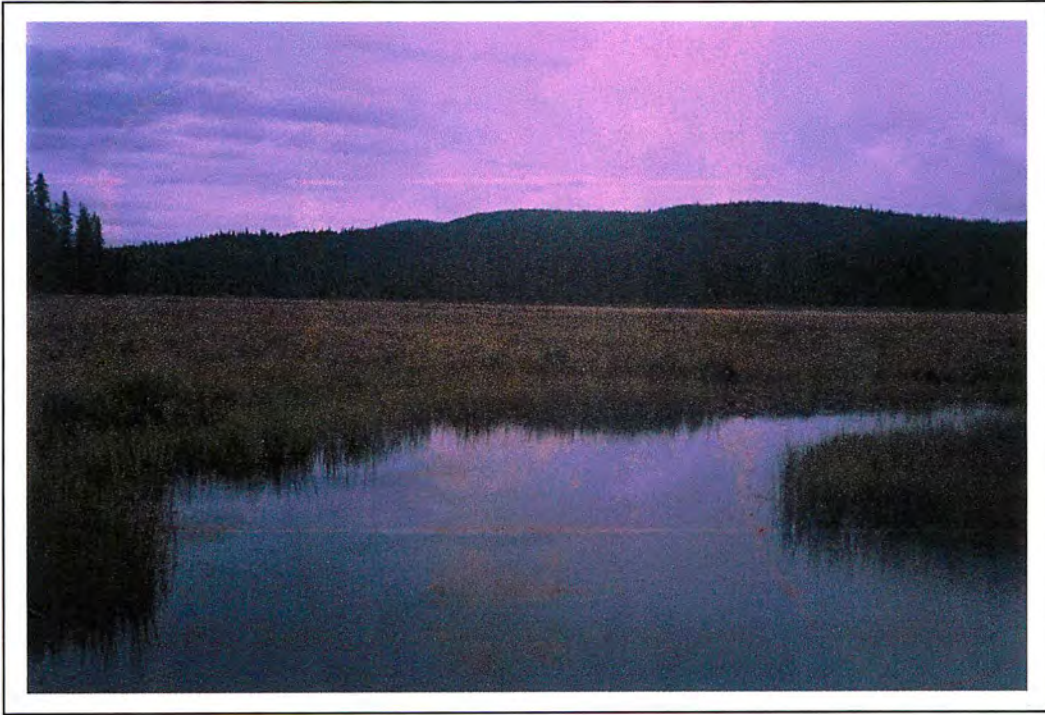
Reach 3

Upstream view (above) and downstream view (below)

| Sample Site # | ILP | Reach | TRIM Map # | Gradient (%) | Electrofishing Specifications | | | | | | | | Proposed Riparian Class. | Comments |
|---|---|---|---|---|---|---|---|---|---|---|---|---|---|--|
| 9 | 10187 | 3 | 093M.018 | 0.5 | 3.7 | 100 | 522 | 100 | 16 | M | C | 07/26 | S5 | Fish absence was confirmed upstream of a 5 metre waterfall at reach 2/3 of the mainstem (ILP 10864) of this stream due to no fish captured during a secondary lake inventory (SKR 2001b) and previous stream sampling upstream of the falls (SKR 1997, 1998a). In addition, no fish were captured or observed during electrofishing at this site. |

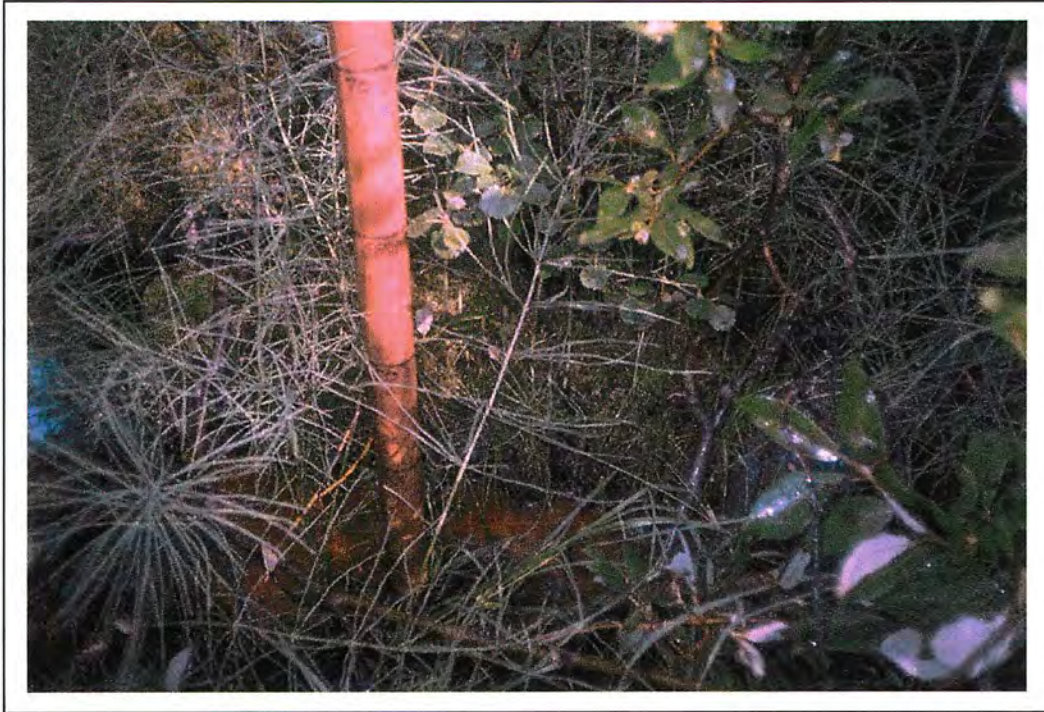
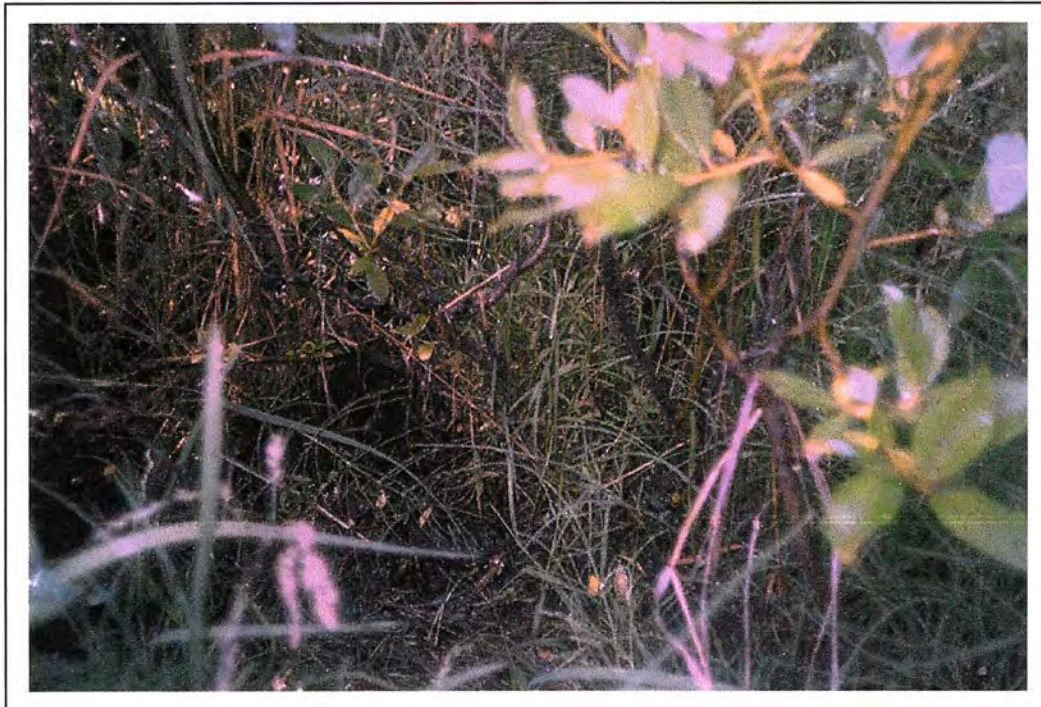
Reach 1

Upstream view (above) and downstream view (below)
