**Unnamed Lake
(480-697200-25400-53200-01)
01529BABL**

**SECONDARY LAKE INVENTORY
1997 STUDIES**

**Ministry of Environment, Lands and Parks
Project No. IVBVS622 (FRBC)**

APRIL 1998

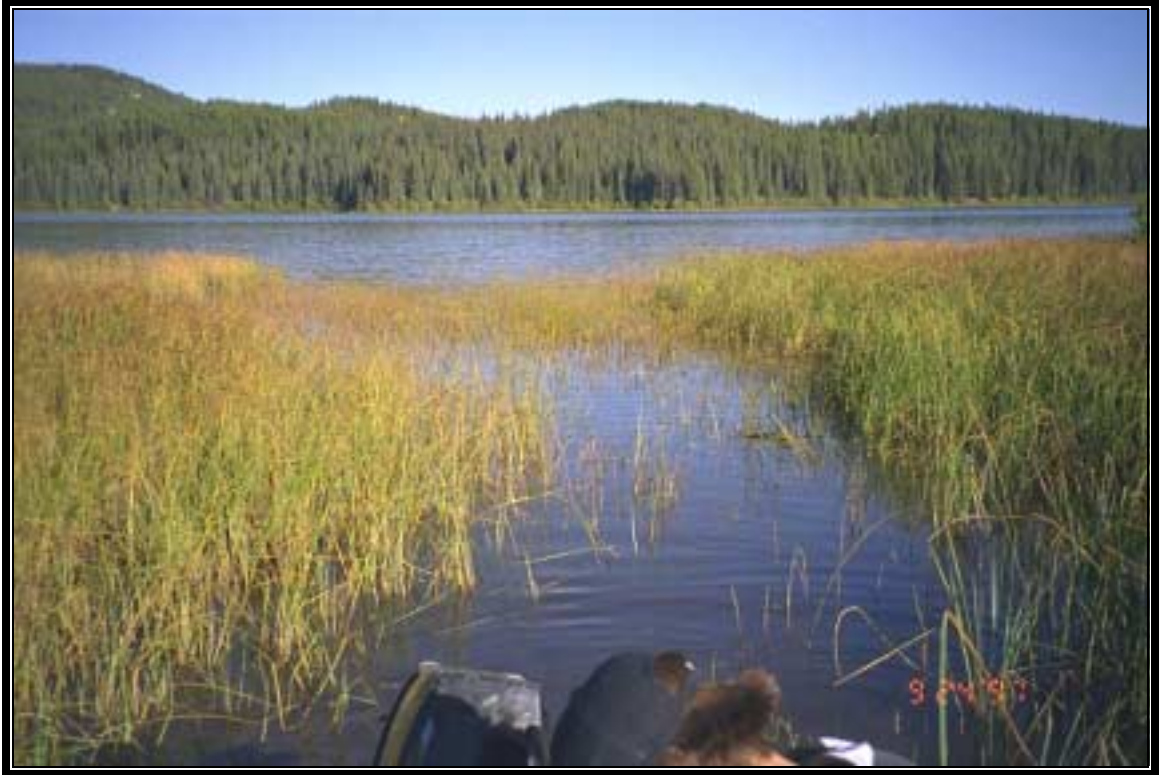
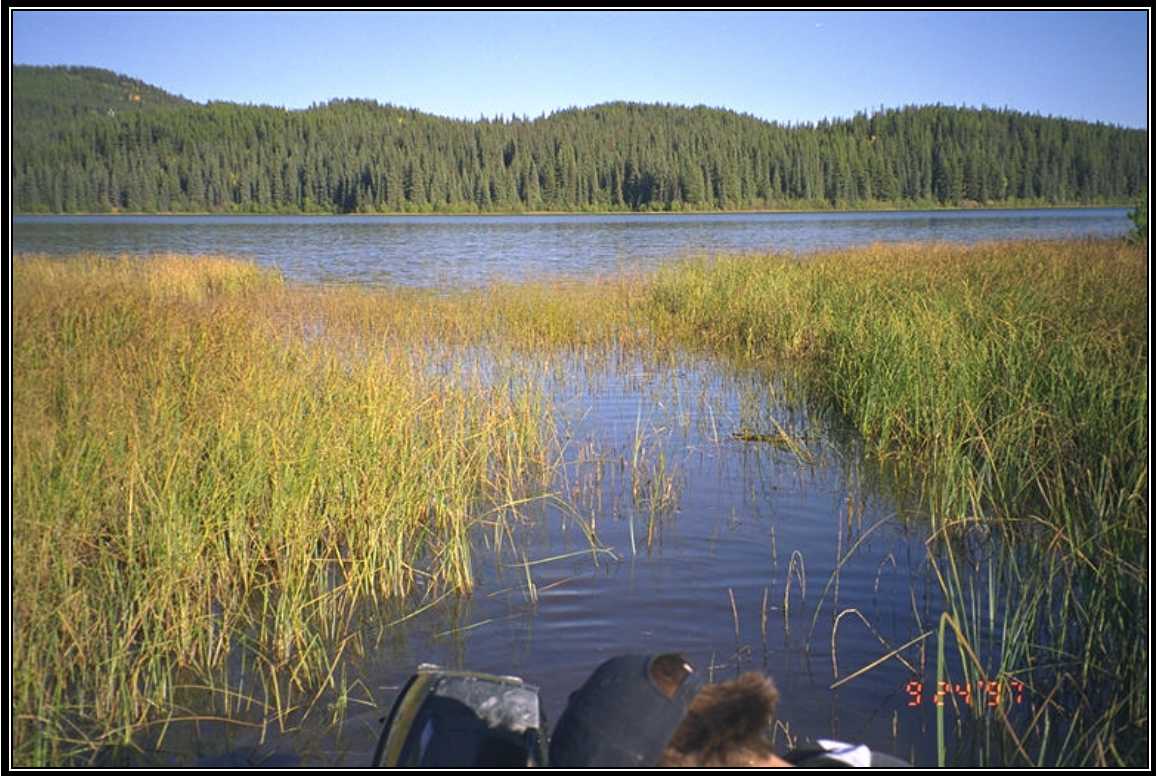
Plate 1 View looking east from lake outlet.

The shoreline is comprised of 65% rocky substrate and 35% marsh. Large and small cobbles were observed throughout the shoreline, with gravel present intermittently. Shoreline gravel was observed in greater abundance on the southwest shore as well as at the head of the outlet channel, and may provide potential spawning habitat. Shoreline vegetative cover is sparse and consists

primarily of grass. No recreational features (i.e. resorts, campsites, boat launches) were identified.

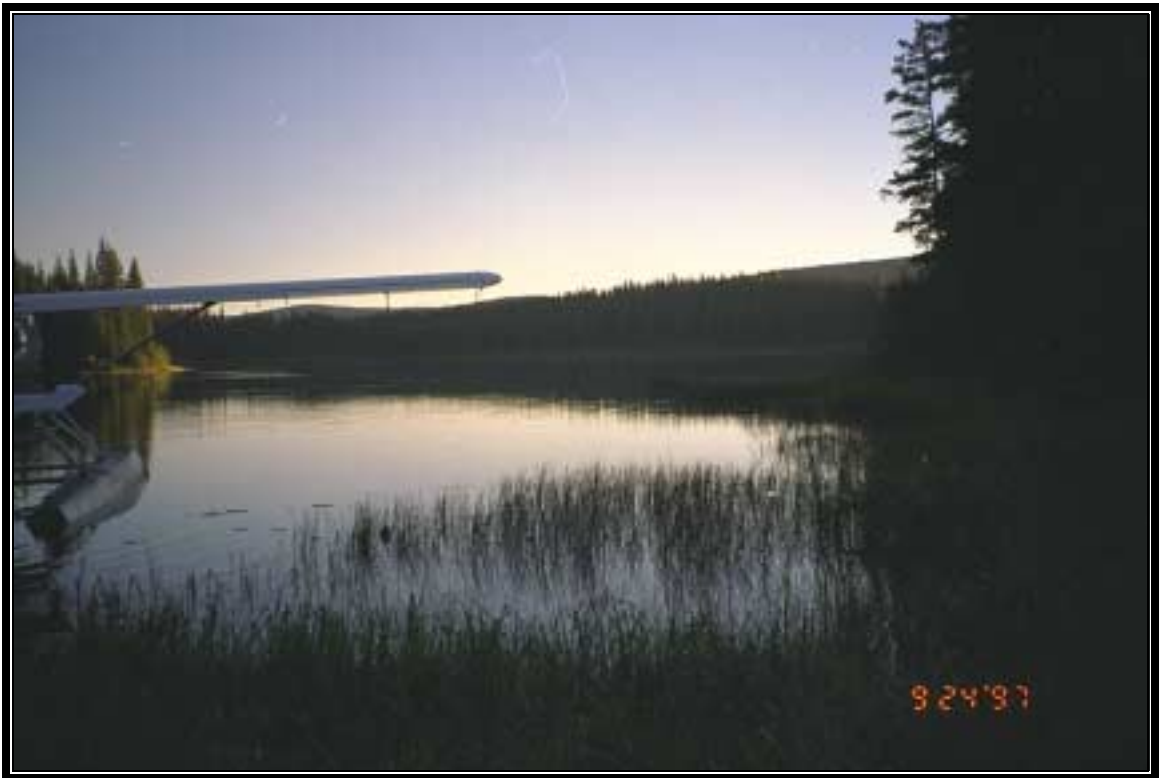
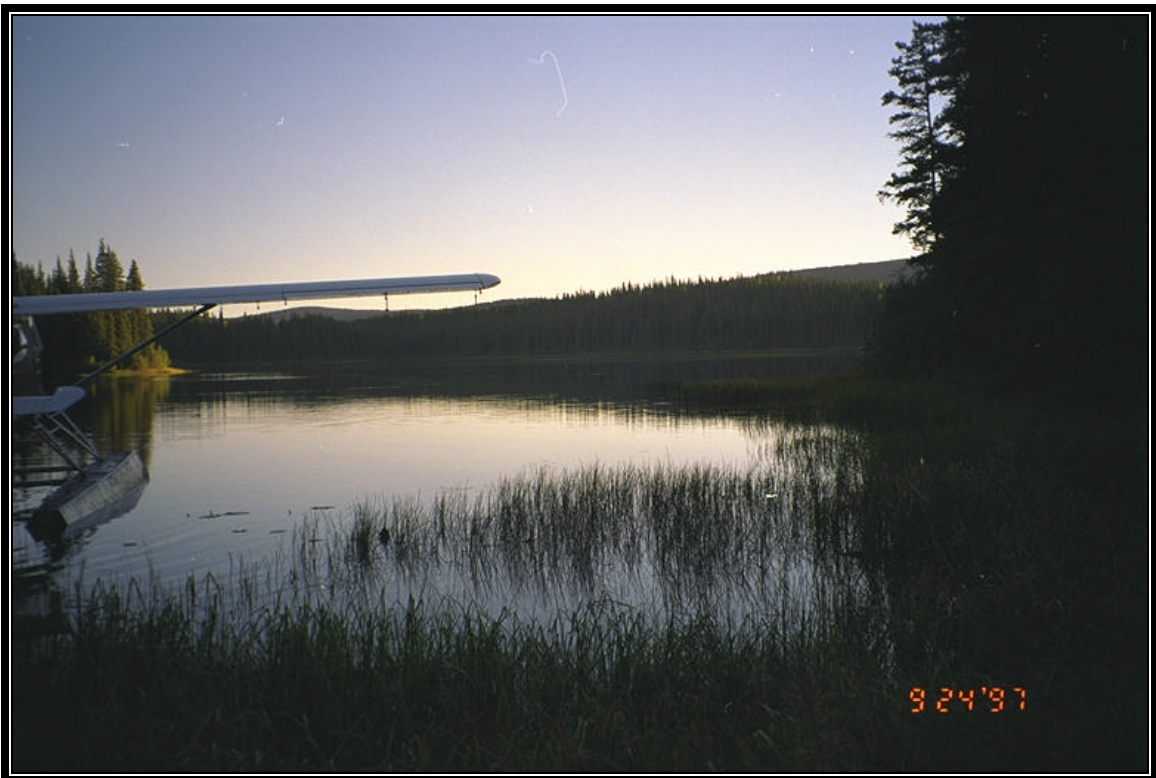
Plate 2 View from north end of lake looking southwest.

The lake is shown in Plates 1 and 2.
