Seymour Lake Treatment Excerpts from Targeted BC Aquatic Invasive Plant Inventories

Prepared by Chris Harkness, 2019

Prepared for the Ministry of Forests, Lands and Natural Resource Operations

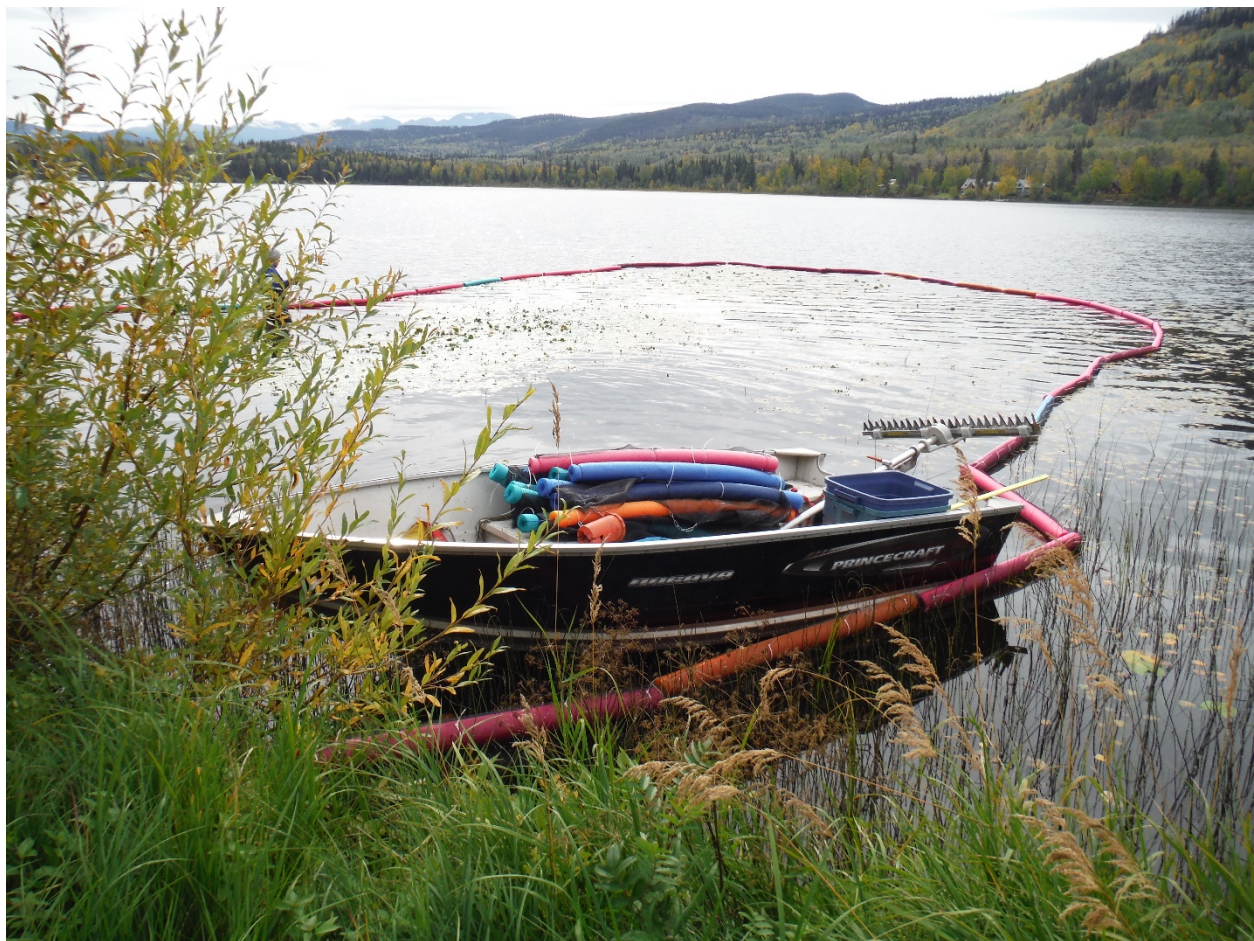
constraints each site was only treated once. At this site pathways were cleared from the shoreline access point to open water approximately 8-10 m wide. Due to time constraints sites were only treated once. Where the water depth was less than a meter hand pulling was employed using care to remove the stolon and minimize fragmentation of the roots. A combination of mechanized boat cutters and a throw scythe was used in areas where the water depth exceeded 1m. In all cases a containment boom was deployed and all material was collected and disposed of on shore. Initially a forty foot long oil containment boom that was purchased was used. This boom proved to be insufficient for a number of reasons. It was difficult to manoeuvre the boat within the confines of this boom. It became evident that a great deal of time was used in moving the boom to a new section within the treatment site. After a day of use the areas where section of the boom were attached began to sag, compromising the effectiveness of its containment. For these reasons four 50 – 70 foot booms were constructed using pool noodles, rope, zip ties and window screen as the suspended curtain (see figure 1.). This allowed for

Figure 1. Containment boom and boat with mechanized cutter

a much larger area to be contained, with much greater manoeuvrability of the watercraft. Depending on the size of the treatment site any number of sections of boom could be deployed with a total length

of over 200 feet. In treatment sites where a vehicle could access the shoreline, the boom was positioned with a small path to shore and plant material was hauled directly into a truck and tarped for disposal. This greatly reduced the time for plant material removal and disposal. Where accessibility was an issue, plant material was placed in a canoe and towed to a private homeowner's property. Material was then wheelbarrowed up to a disposal site.
