**Unnamed Lake  
(460-750400-02)  
00845BULK**

**SECONDARY LAKE INVENTORY  
1997 STUDIES**

**Ministry of Environment, Lands and Parks  
Project No. IVBVS622 (FRBC)**

**APRIL 1998**

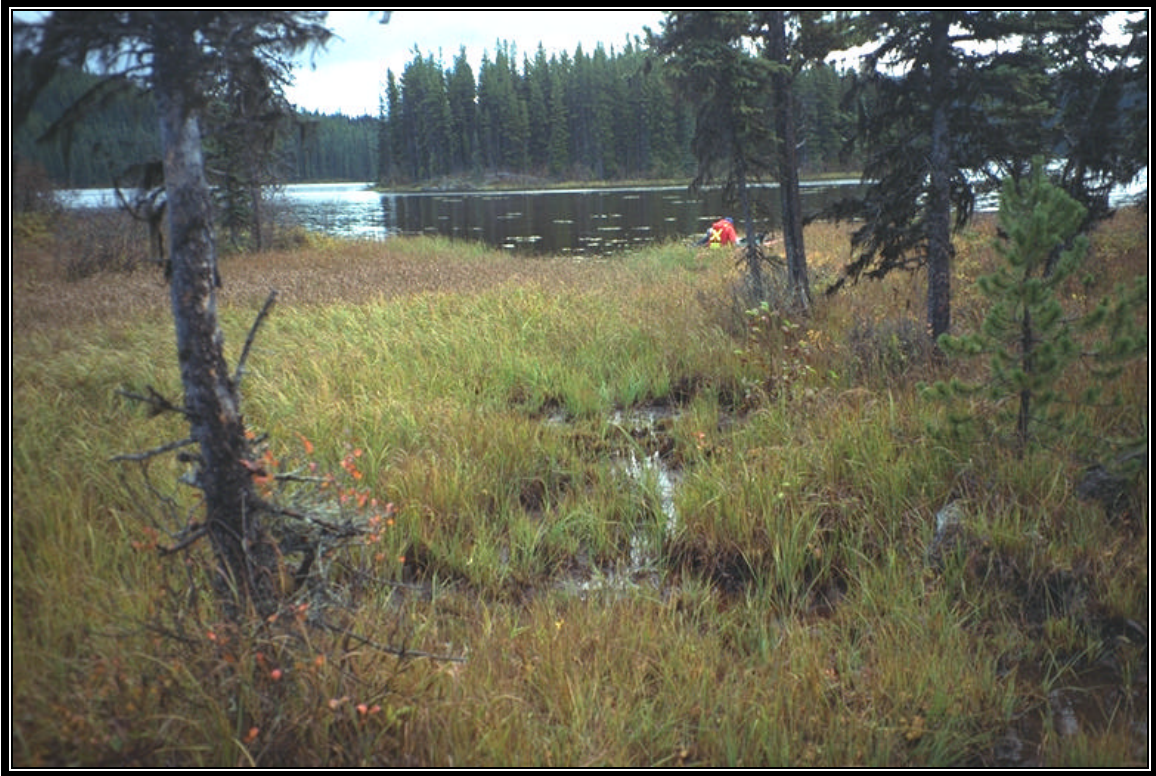
Water is present intermittently along this channel, which drains a marsh. The channel was approximately 0.3 m at the lake. The substrate consists of sand and silt. Suitable fish habitat was not identified close to the lake.

**Plate 1 View looking southeast down inlet stream ILP 81.**

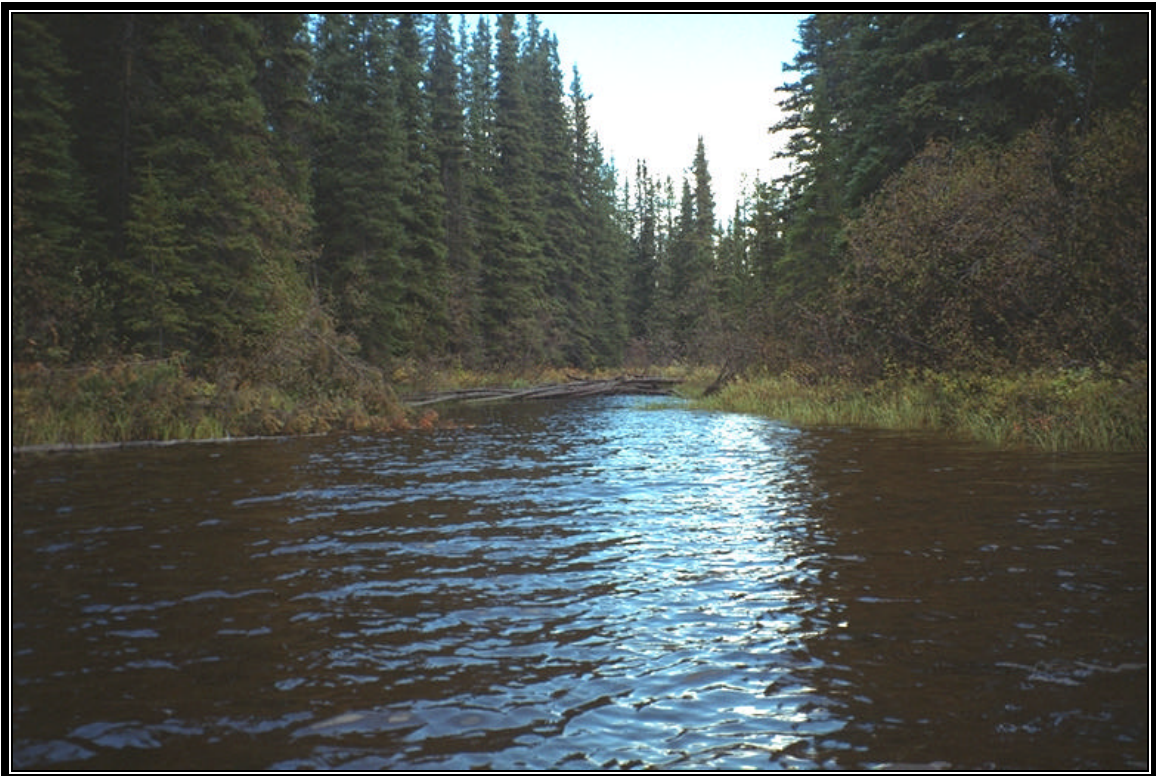
The outlet is a distinct channel, with a strong flow at the time of the survey. The substrate consists primarily of gravel and offers good potential spawning habitat. Stream cover was provided by numerous pools and large woody debris, and offers good rearing habitat.

**Plate 2 View looking north towards lake outlet (460-750400).**
