A RECONNAISSANCE INVENTORY OF CLOTA LAKE

Watershed Code 480-4026

FINAL REPORT

Klohn-Crippen Consultants Ltd.
10200 Shellbridge Way
Richmond, British Columbia
Canada, V6X 2W7

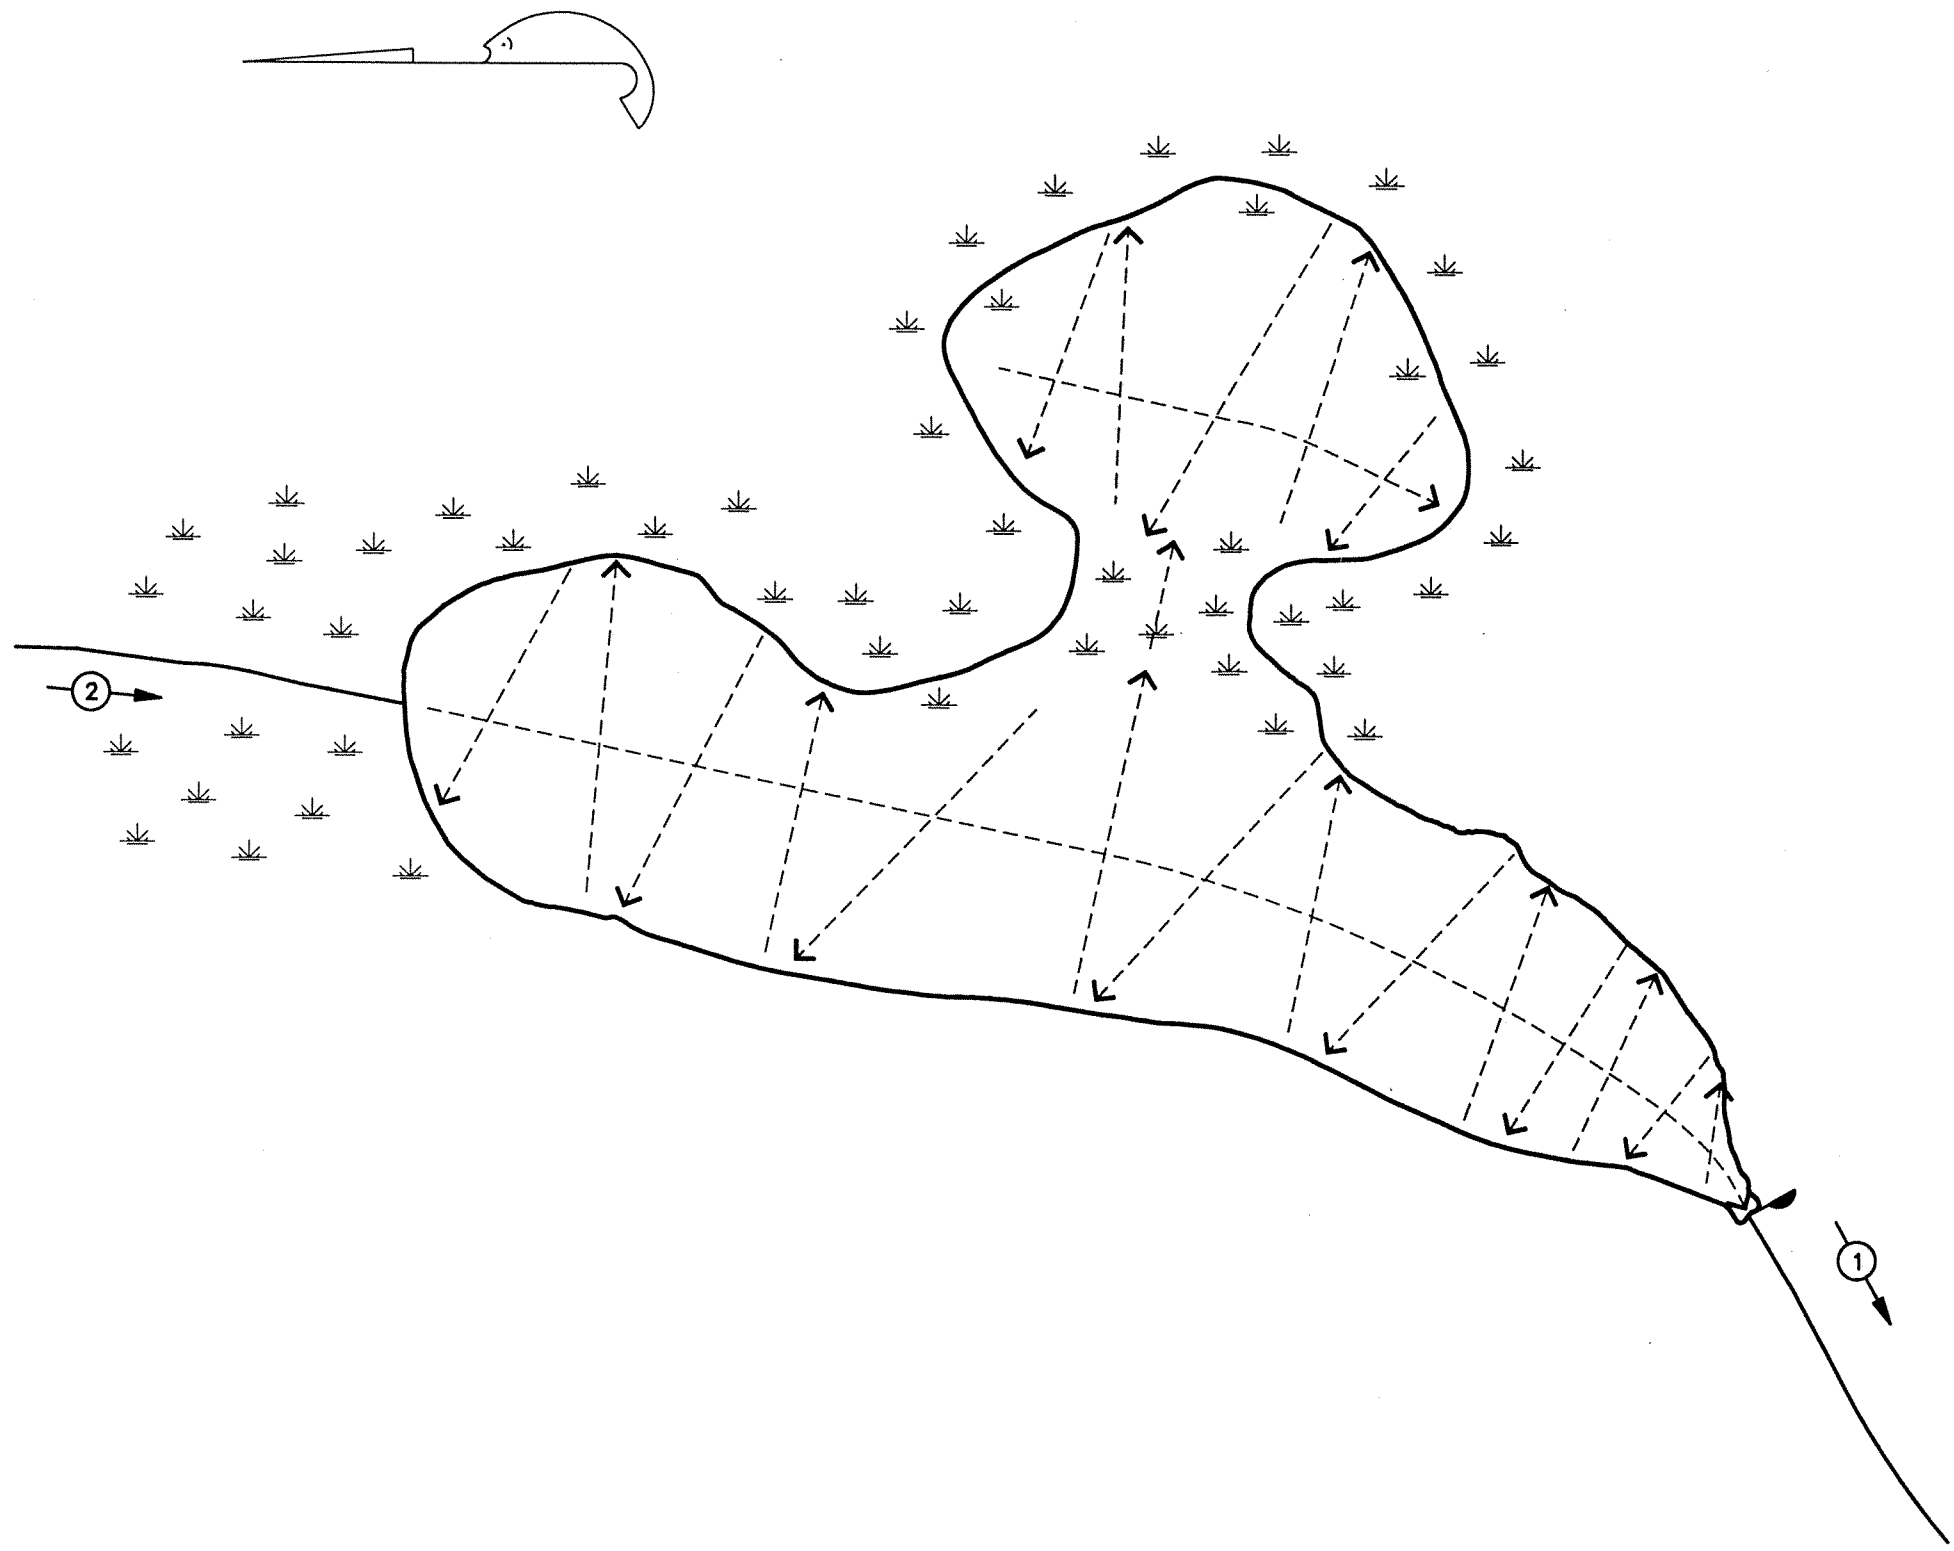
Fisheries Branch Ministry of Environment, Lands, and Parks	DATE OF ISSUE MAR.19, 1997	PROJECT No. PW7507 0105
	FIG. No. FIGURE 2

- LEGEND**
- > SURVEY TRANSECT AND DIRECTION
 - ① → STREAM FLOW DIRECTION AND NUMBER
 - | BEAVER DAM

KLOHN-CRIPPEN	PROJECT RECONNAISSANCE INVENTORY OF CLOTA LAKE	
	TITLE CLOTA LAKE BATHYMETRIC SURVEY TRANSECTS	
CLIENT

Following the perimeter trace, the lake's longest axis (e-line) was traced to illuminate the general depth trends and then transects were made across the shorter axis in directions generally perpendicular to the e-line. These shorter transects were conducted such that the depth sounder was allowed to track depths from shore to opposite shore. Additional depth data were obtained through excursions into small bays along the shoreline. The coordinates for these bathymetric data were then differentially corrected and analyzed along with the corrected perimeter data to generate bathymetric contours via the AdCADD® Civil/Survey software package. The resulting bathymetric map was then

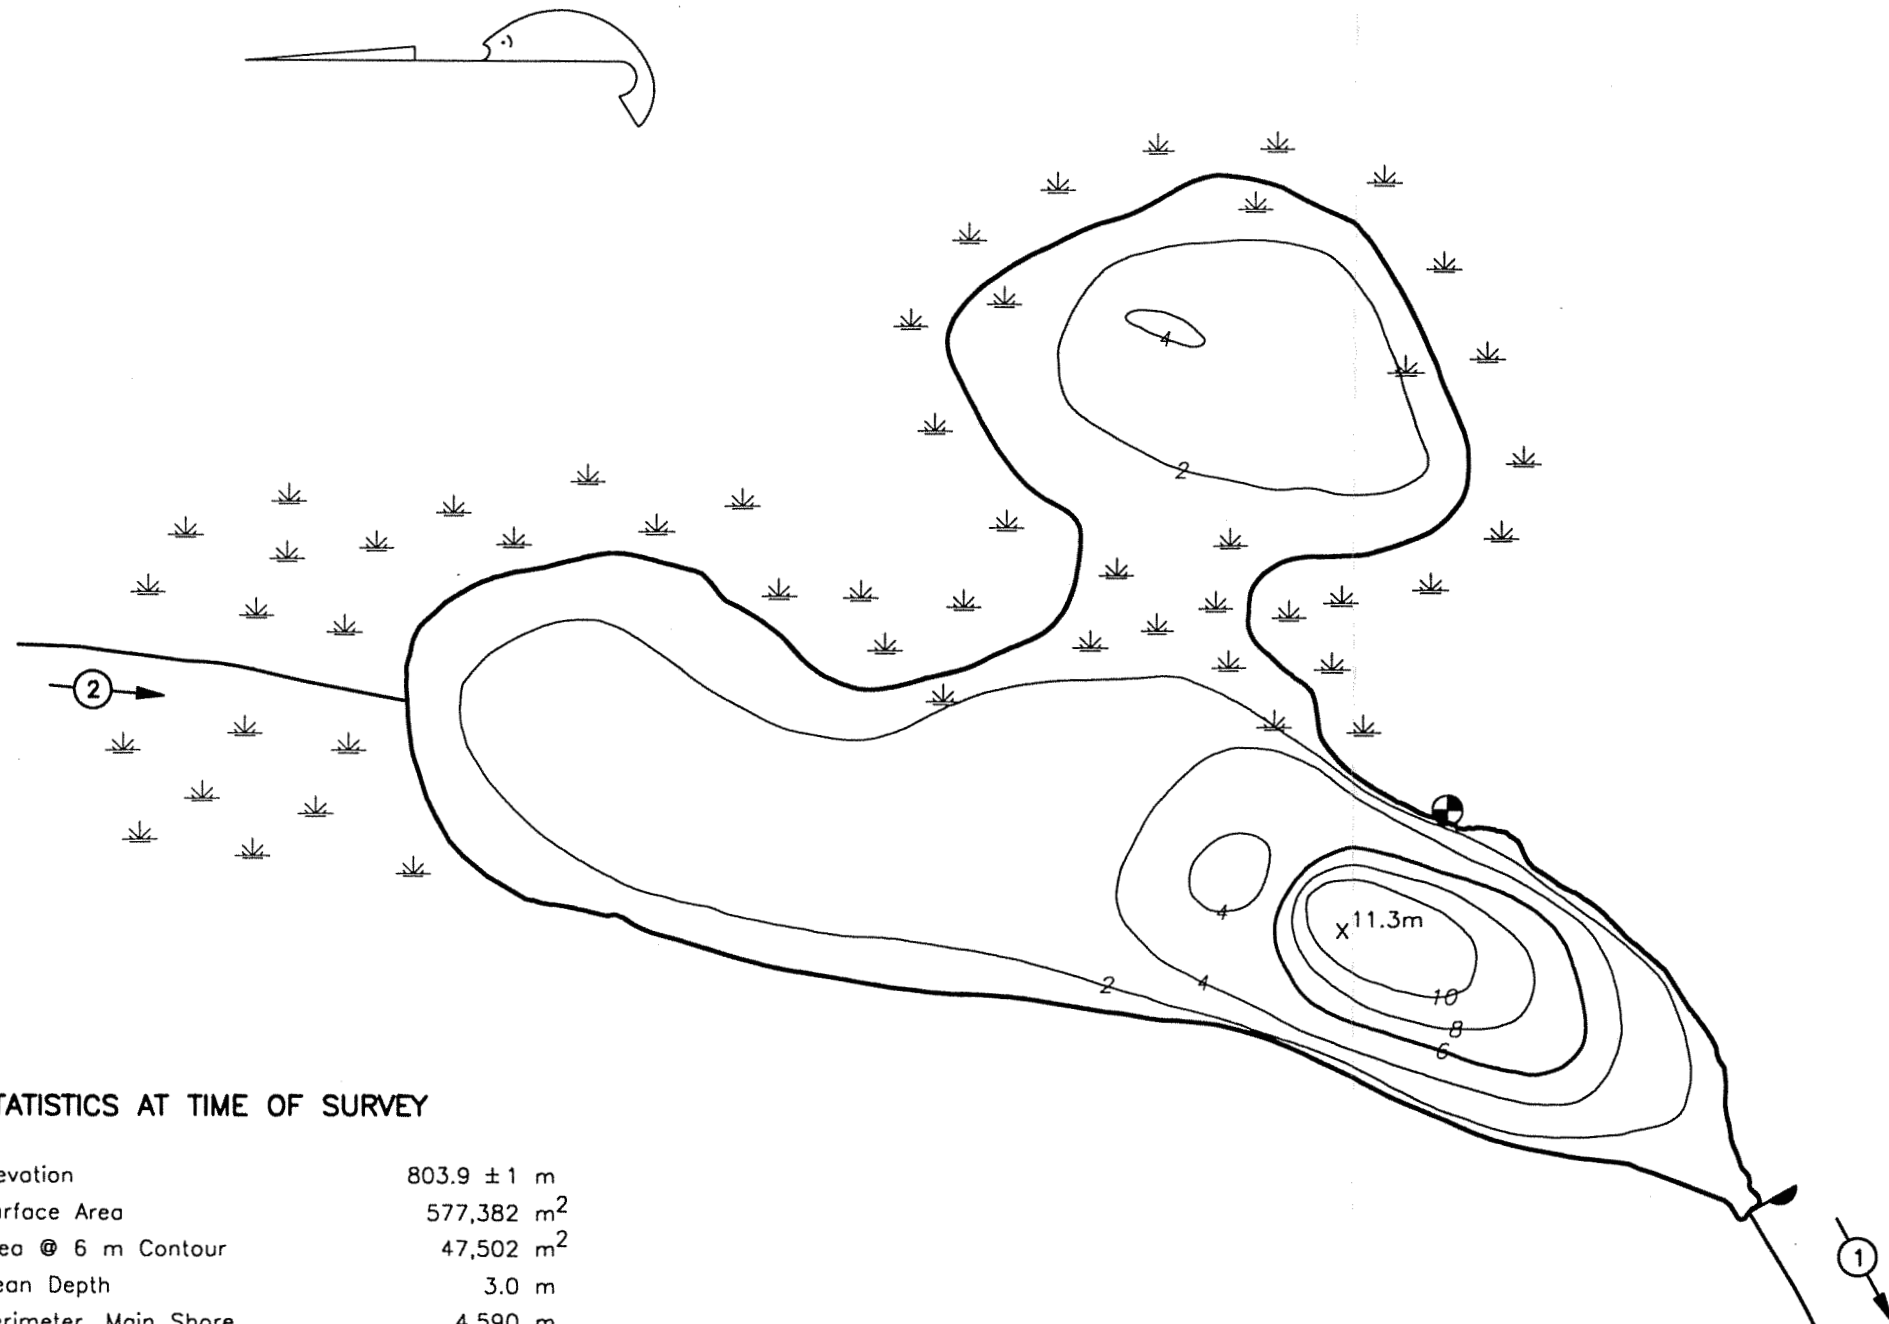
An investigation of Clota Lake's morphometry was conducted on September 24, 1996. This lake has a small sub basin extending from the east side of the main lake so the main basin and the sub-basin were treated separately in this bathymetric survey. For both the sub and main basins, the longest axis was traced. Traces of the shorter axes of this lake resulted in fourteen transects of the main basin and five transects of the sub-basin. Because the survey technique used here involved a GPS unit with post-mission differential correction allowing sub-meter locational accuracy, the standard method for bathymetric surveys was not followed. This resulted in the lack of paper traces, transect calculation sheets and percentage distance along transect determinations (see Anon. 1996a) so these required items are not summarized here. However, the survey transects for assessing Clota Lake's bathymetry have been recorded and are shown in Figure 2. The bathymetric contour map generated from these surveys is shown in Figure 3.

Elevation	803.9 ± 1 m
Surface Area	577,382 m ²
Area @ 6 m Contour	47,502 m ²
Mean Depth	3.0 m
Perimeter, Main Shore	4,590 m
Perimeter, Islands	0 m
Number of Islands	0
Maximum Depth	11.3 m
Type of Benchmark	iron spike
Benchmark Height Above Water Level	0.932 m
Volume by stratum and total (m ³)	
0- 2m	848,657
2- 4m	485,641
4- 6m	161,868
6- 8m	75,093
8-10m	41,038
10-max.depth	8,741
TOTAL	1,721,038

Total surface area:	577,382 m ²
Surface area at 6m contour:	47,502 m ²
Shoreline perimeter:	4,590 m
Maximum depth:	11.3 m
Perimeter of islands:	0
Number of islands:	0
Mean depth:	3.0 m
Secchi depth:	1.6 m
Sounding device:	Meridata depth sounder

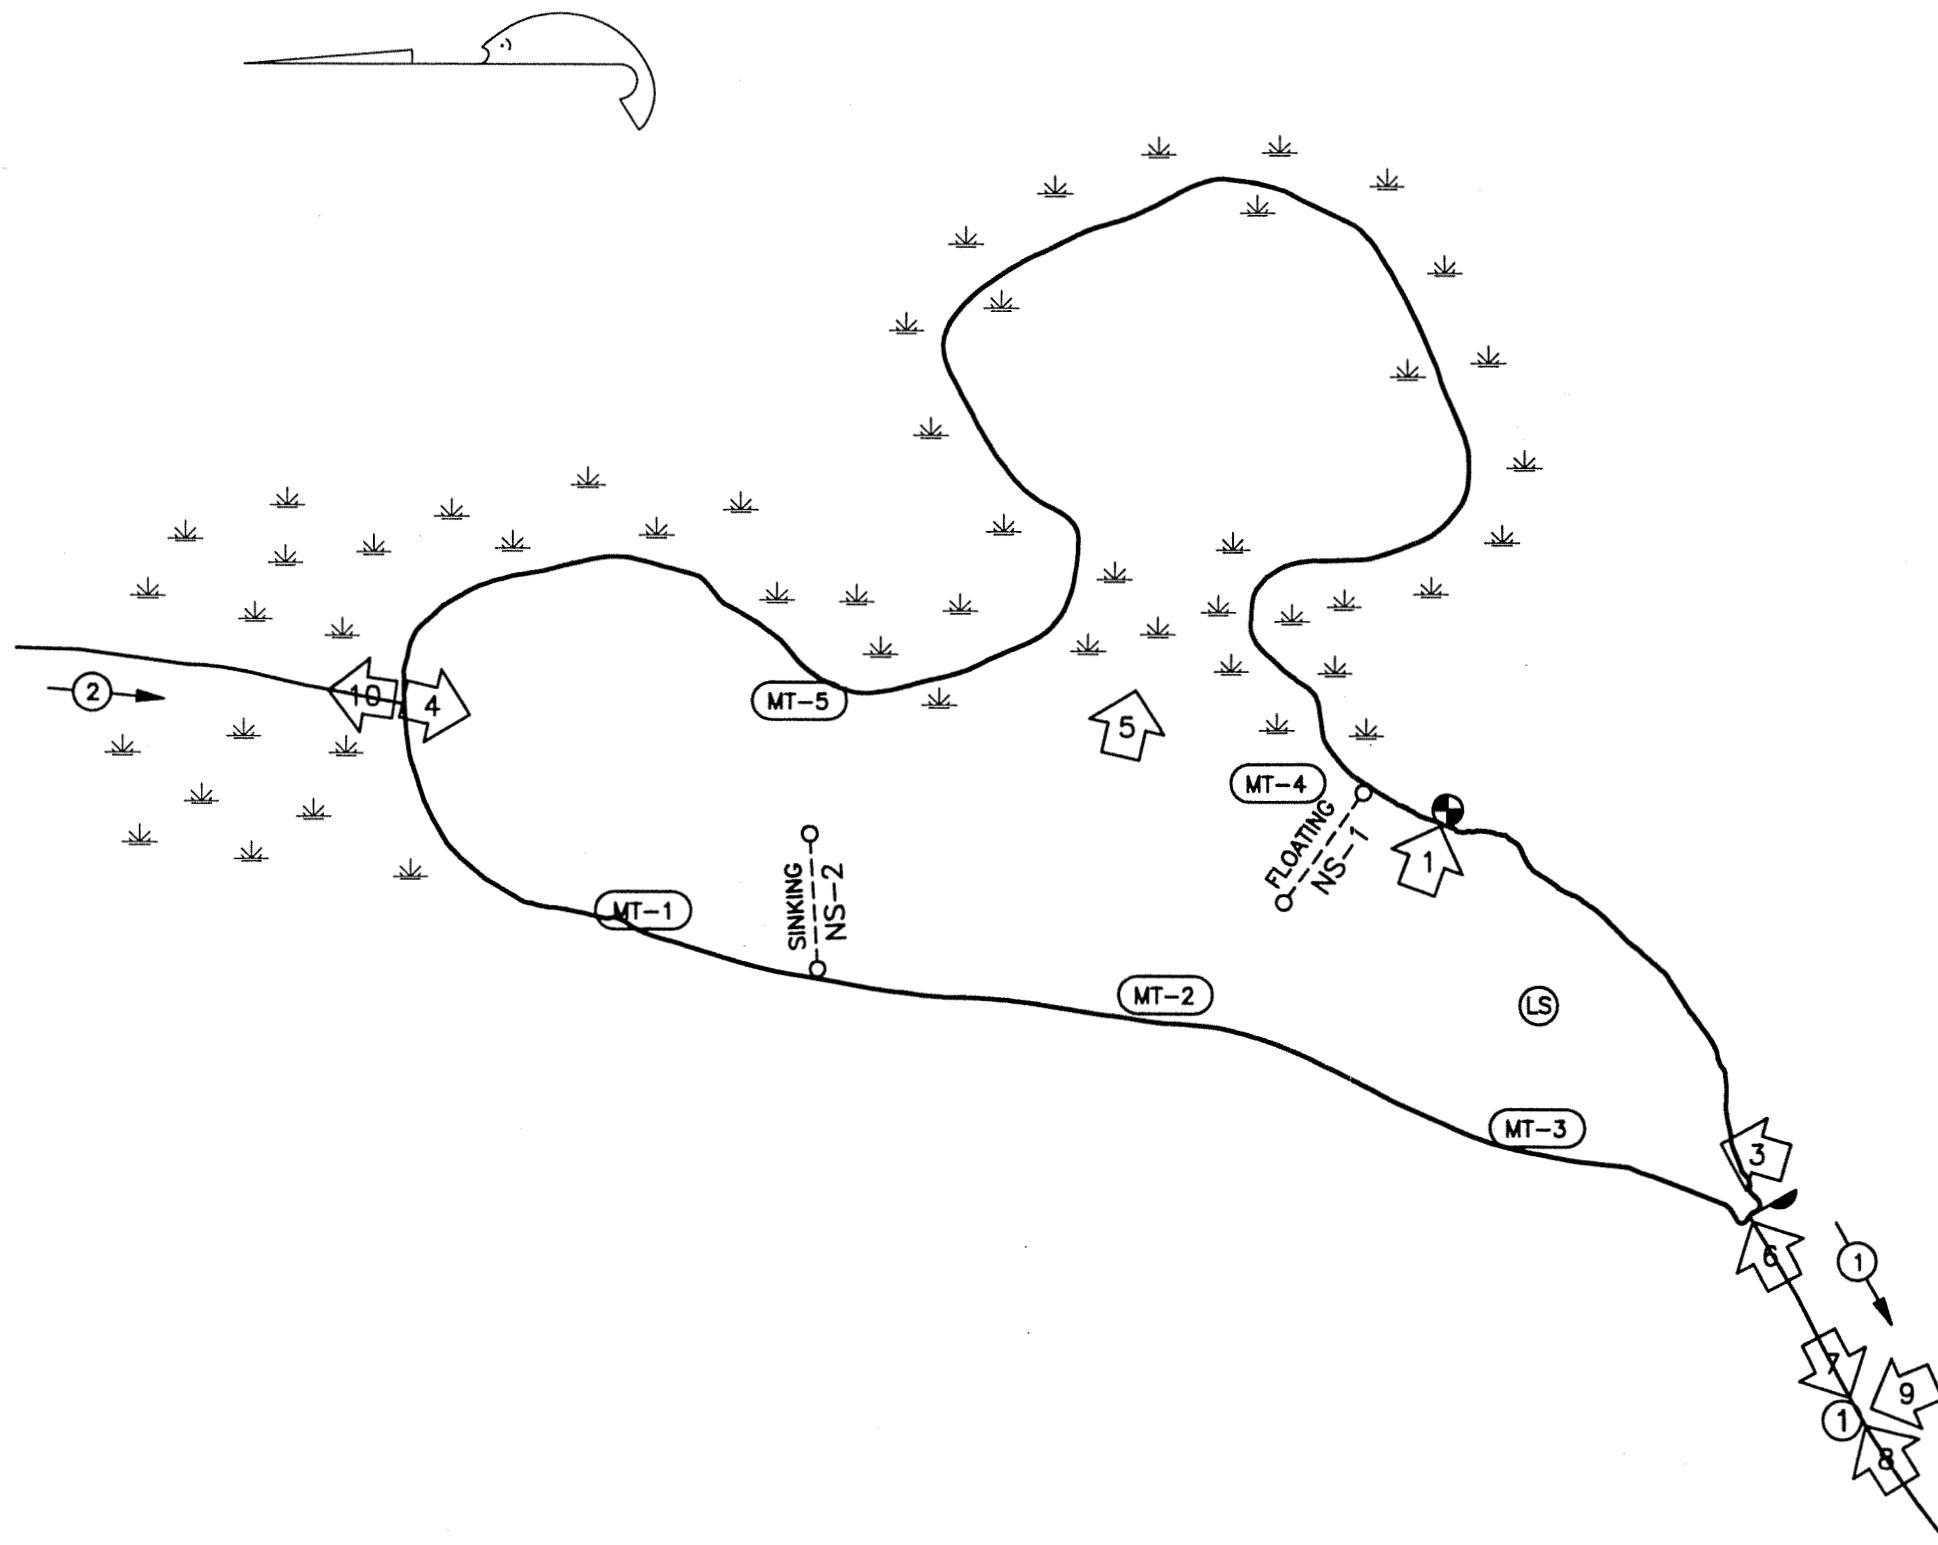
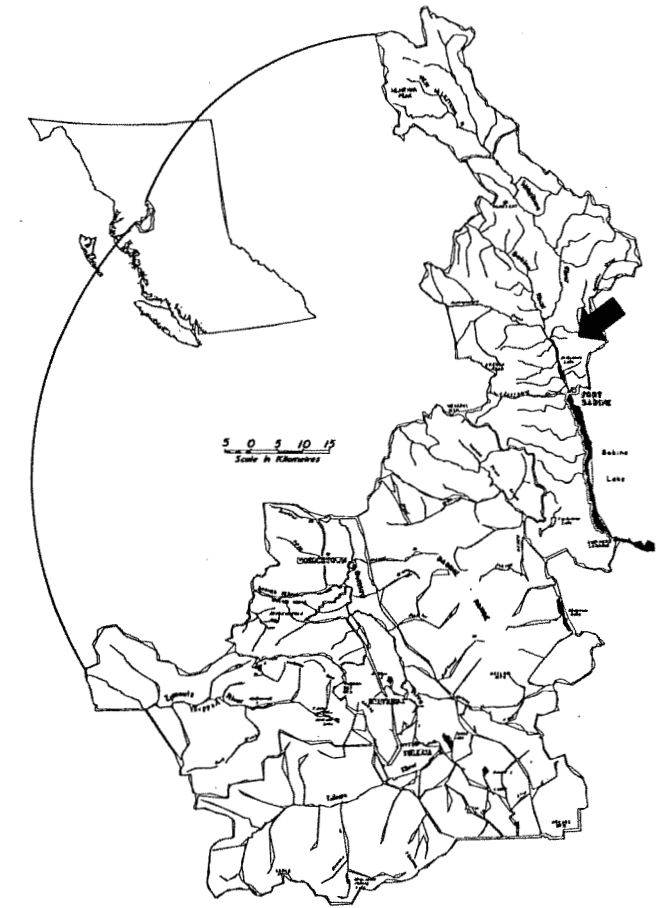
Fisheries Branch Ministry of Environment, Lands, and Parks	DATE OF ISSUE MAR.19, 1997	PROJECT No. PW7507 0105
	FIG. No. FIGURE 4

KLOHN-CRIPPEN	PROJECT RECONNAISSANCE INVENTORY OF CLOTA LAKE	
	TITLE CLOTA LAKE LOCATION OF LAKE SURVEY SITES	
CLIENT

- See Figure 4 for location of gillnet sample sites.
- See Figure 4 for location of gillnet sample sites.
- CPUE-#fish/100m²/ 12- hour period.

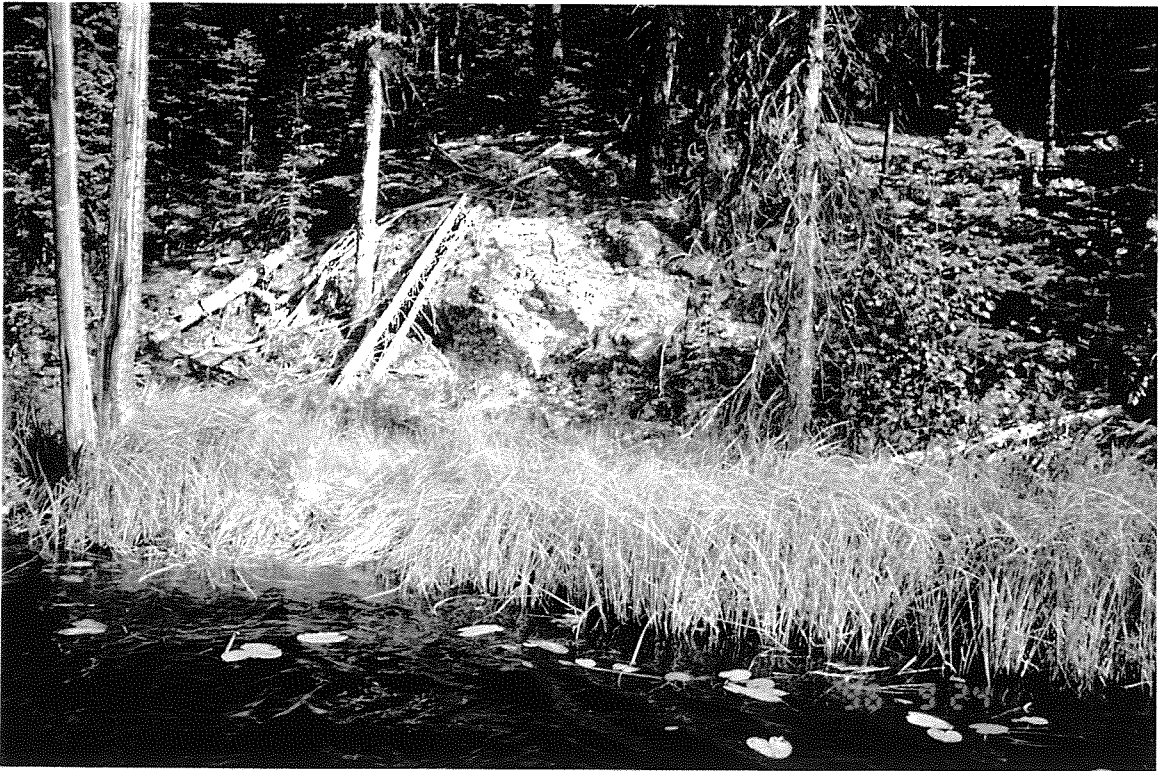
Plate 1 View of benchmark. (Roll #6, Negative #22)

The benchmark in Clota Lake was indicated by an iron spike driven 93.2 cm above the water surface into the base of a small pine tree emerging from bedrock near the lakeshore southwest of the lake's small sub-basin. The spike itself is marked by fluorescent orange flagging tape, as is the surrounding area, for easy re-location (Plate 1). The coordinates for the benchmark, as recorded in the field by GPS, are 9.651606.6140218 (NAD83). The location of the benchmark in relation to the lake is indicated in Figure 4. Figure 5 shows an air photo enlargement of Clota Lake plus the benchmark's location.

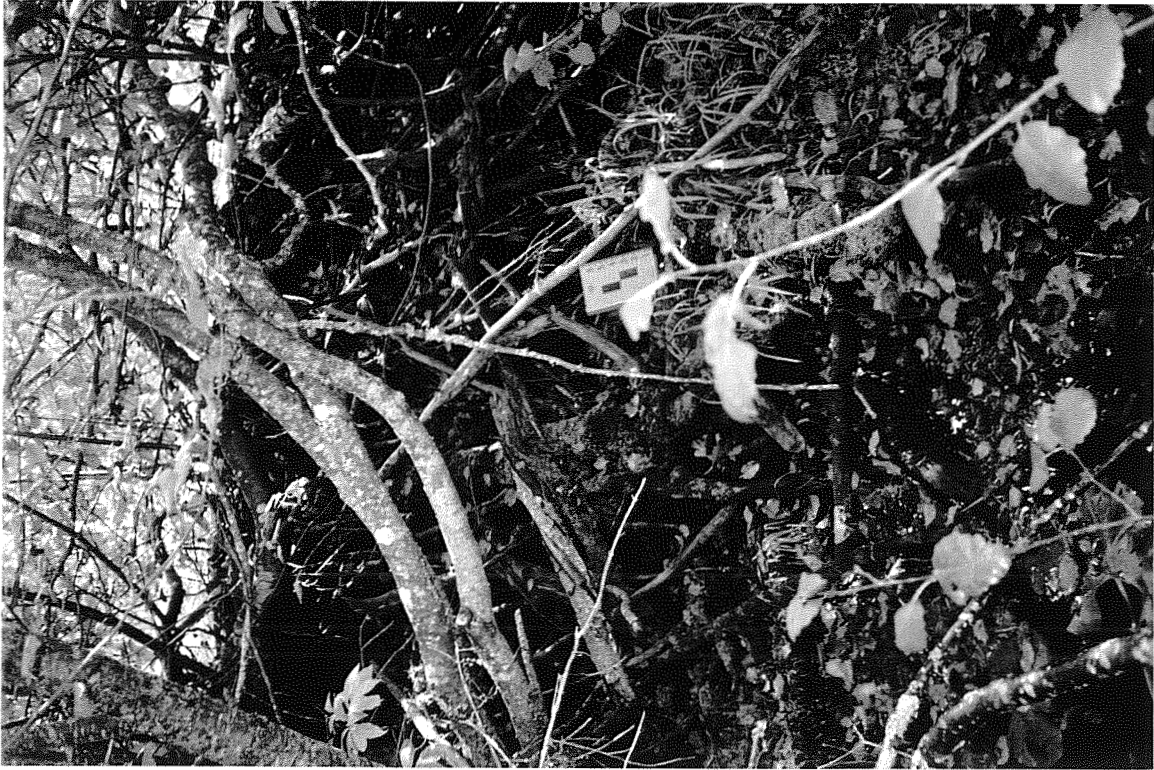
Plate 6 View of beaver dam in Clota Lake outlet. (Roll #6, Negative #18)

Stream #1 is the single obvious outlet of Clota Lake. This stream flows over a large 1.3 metre high beaver dam located immediately at the lake outlet (Plate 6). This dam appeared to be fairly old and contained many pieces of wood that were dry and rotting. A second 0.6 metre high beaver dam was located 12 metre downstream of the first emphasizing the high degree of influence beaver have on both the lake and its outlet. After passing the second beaver dam, this stream passes through a broad, bouldery channel with very low flow. The width of this channel suggests that at one time, the stream possessed a significant discharge but (probably) due to the beaver dam, discharge has since been reduced. The channel width averaged 4.4 metre at the survey site and the stream habitat here was dominated by larger. Boulders and overstream vegetation provided more than half of the available cover in this stream. Only 180 metres of this stream was surveyed. Plates 7, 8 and 9 provide views of the habitat in stream #1.

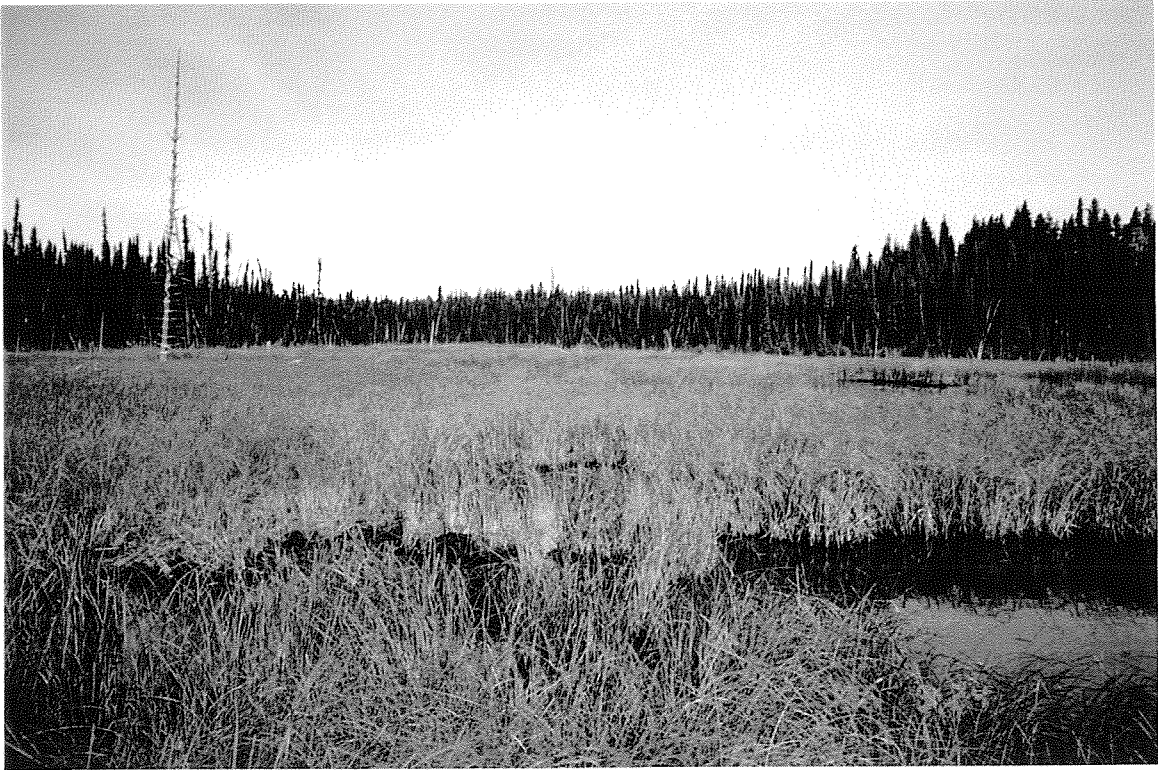
Plate 10 View of inlet and extensive marsh area through which it passes. (Roll #6, Negative #17)

Stream #2 is one of the inlets into Clota Lake. This stream enters the lake through a broad marsh that was not navigable by either boat or on foot (Plate 10). Therefore, a stream card was not completed here.

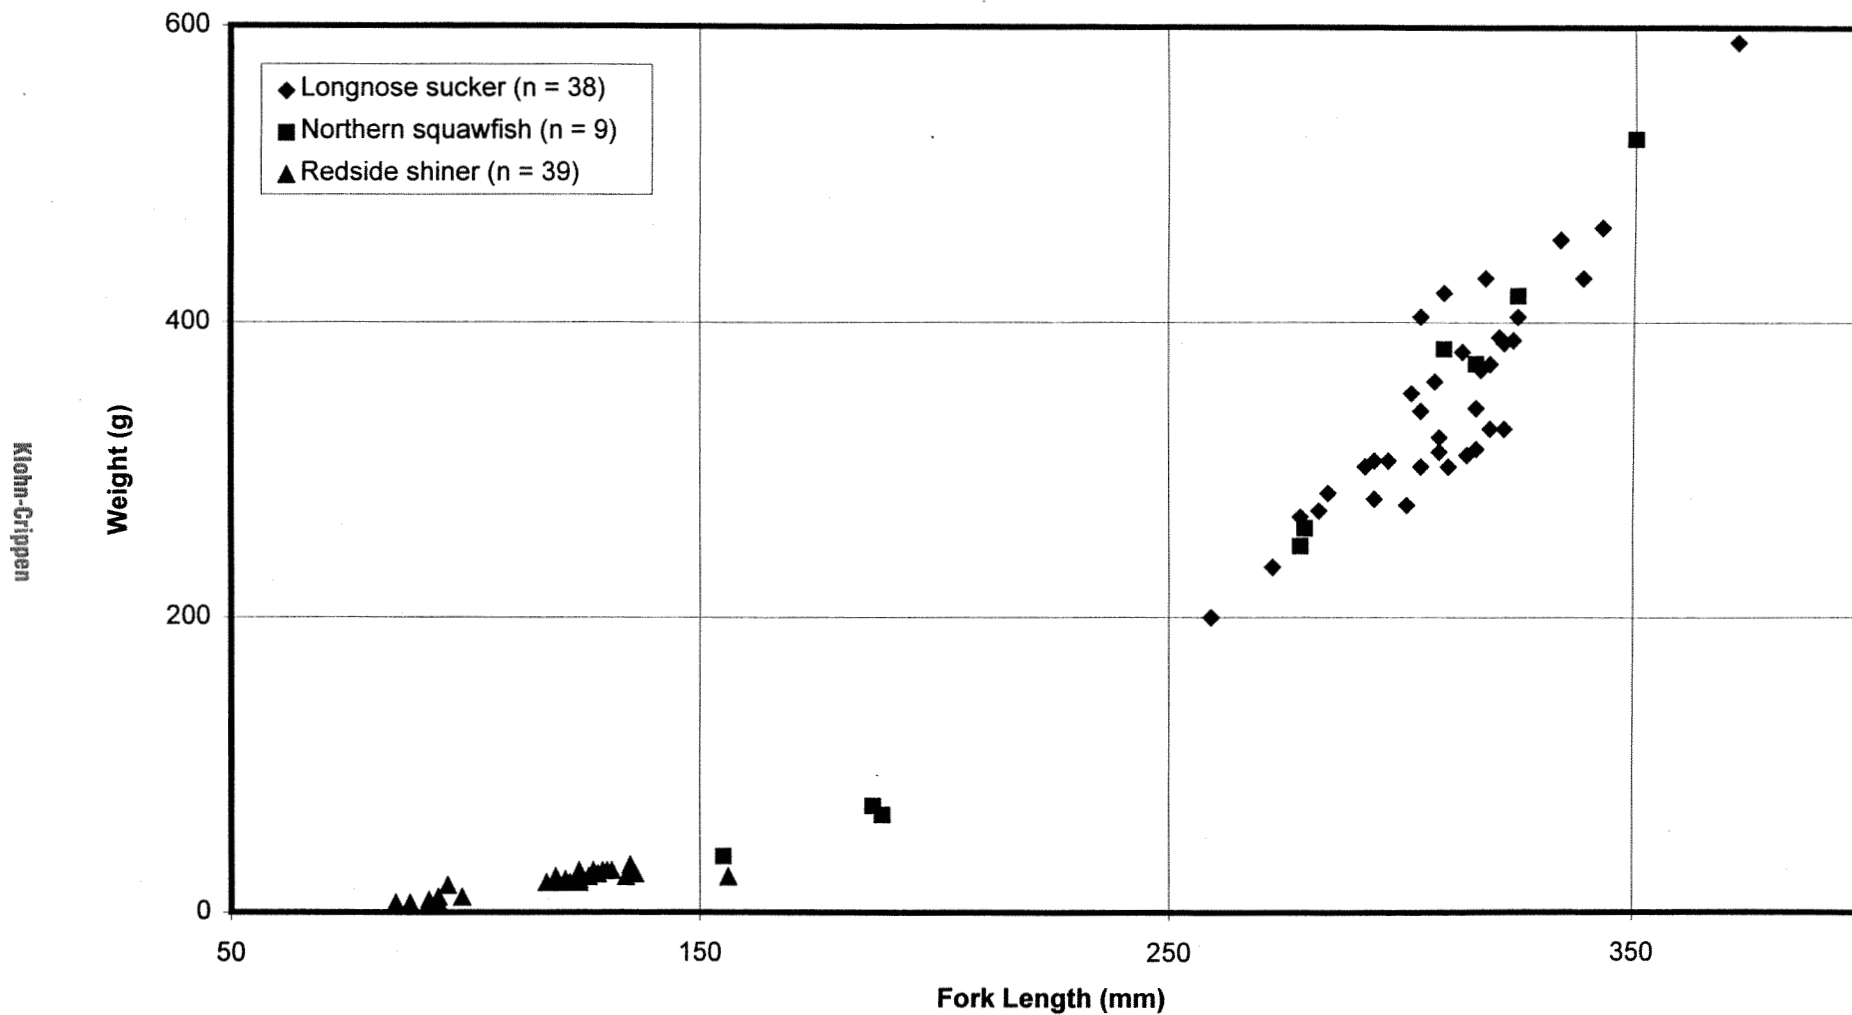
Figure 7 - Fork length versus weight for non-sport fish species.

Figure 7 shows the relationships between fork length and weight for each of the sampled non-sport fish species captured in this lake. The average Fulton's Condition Factor for longnose sucker was 1.19 (SD=0.11), 1.15 (SD=0.1) for northern squawfish and 1.18 (SD=0.23) for redbside shiner. Figure 8 shows the relationship between fork length and weight for the two cutthroat trout captured in this study. This species has an average Fulton's Condition Factor of 1 (SD=0.04). Only one of the scales taken from the cutthroat trout could be aged so a length vs. age relationship could not be determined.

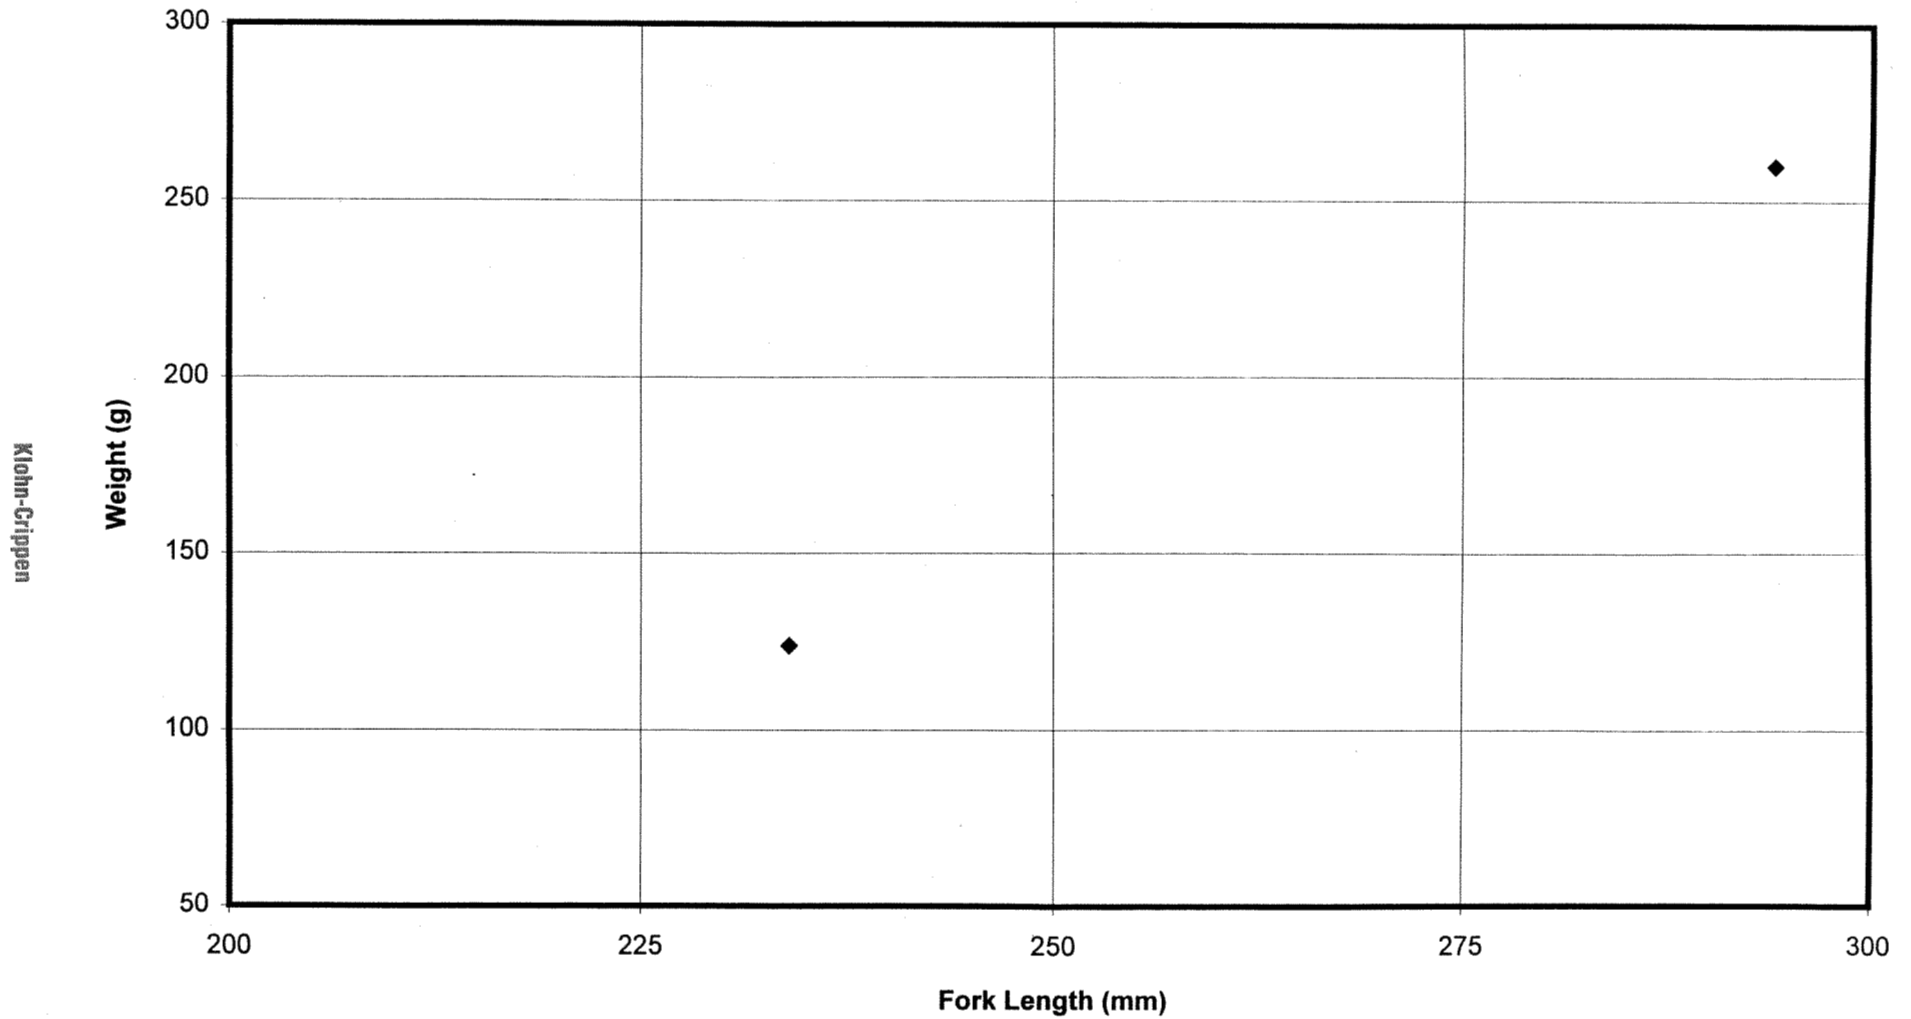
Figure 8 - Cutthroat trout fork length versus weight (n = 2). Fulton's Condition Factor = 1 (SD = 0.04).

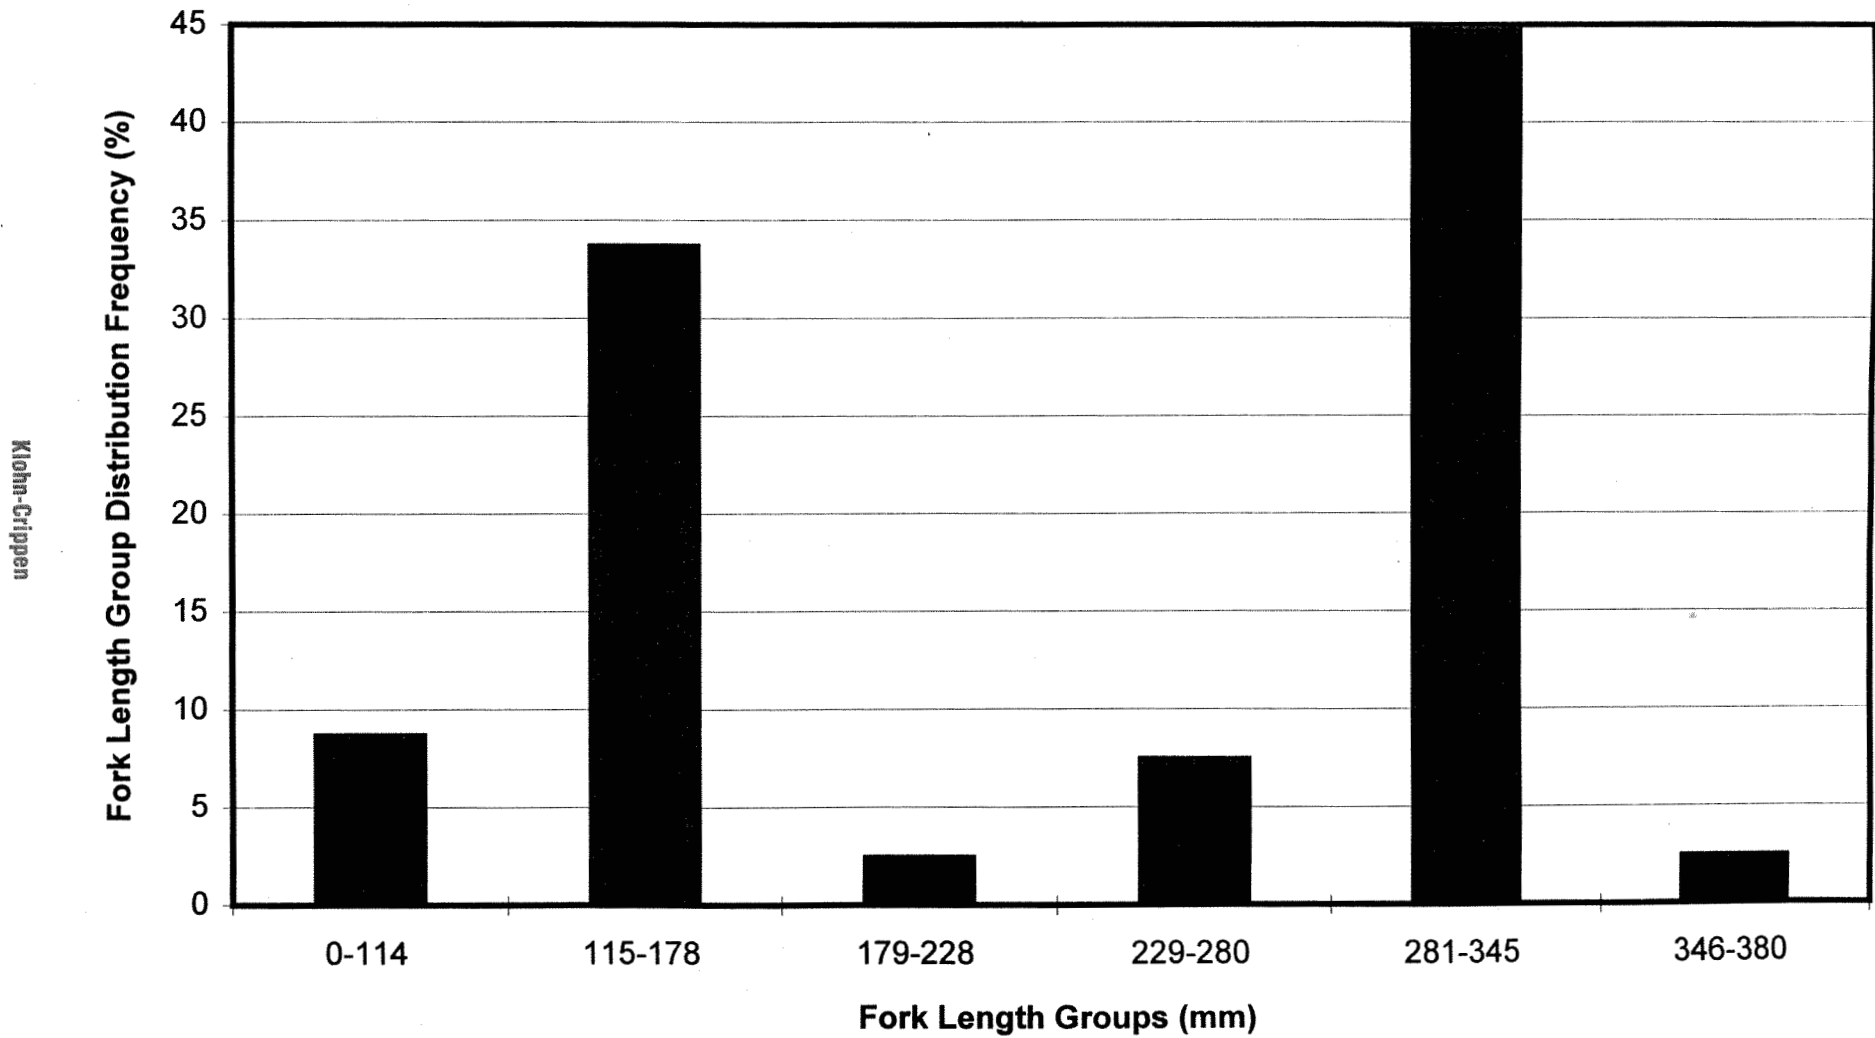
Figure 9 - Frequency distribution of fish fork length groupings (n = 80).

The gillnets Klohn-Crippen employed in this inventory did not have the mesh panels that select for fish in approximately the 179-228 mm and 281-345 mm fork length ranges as suggested by Hamley (1972 op. cit.). These fish groupings are apparently best captured by mesh sizes of 54 and 76 mm, respectively. Figure 9 suggests that the fish in the 179-228 mm range are under-represented but this figure also indicates that the 281-345 mm range group represents the largest proportion (45%) of the total fish catch. However, since the catch from Clota Lake consisted mostly of reidside shiner and longrose sucker, Figure 9 is representative of a binodal distribution in fork lengths that would be expected from these two species. The data suggest that size selection bias due to the absence of the 54 and 76 mm gillnet panels probably did not occur. Additionally, the mesh sizes used in this study targeted the minimum, average and maximum sizes of fish and thus provided data to describe the entire fish population as a whole.

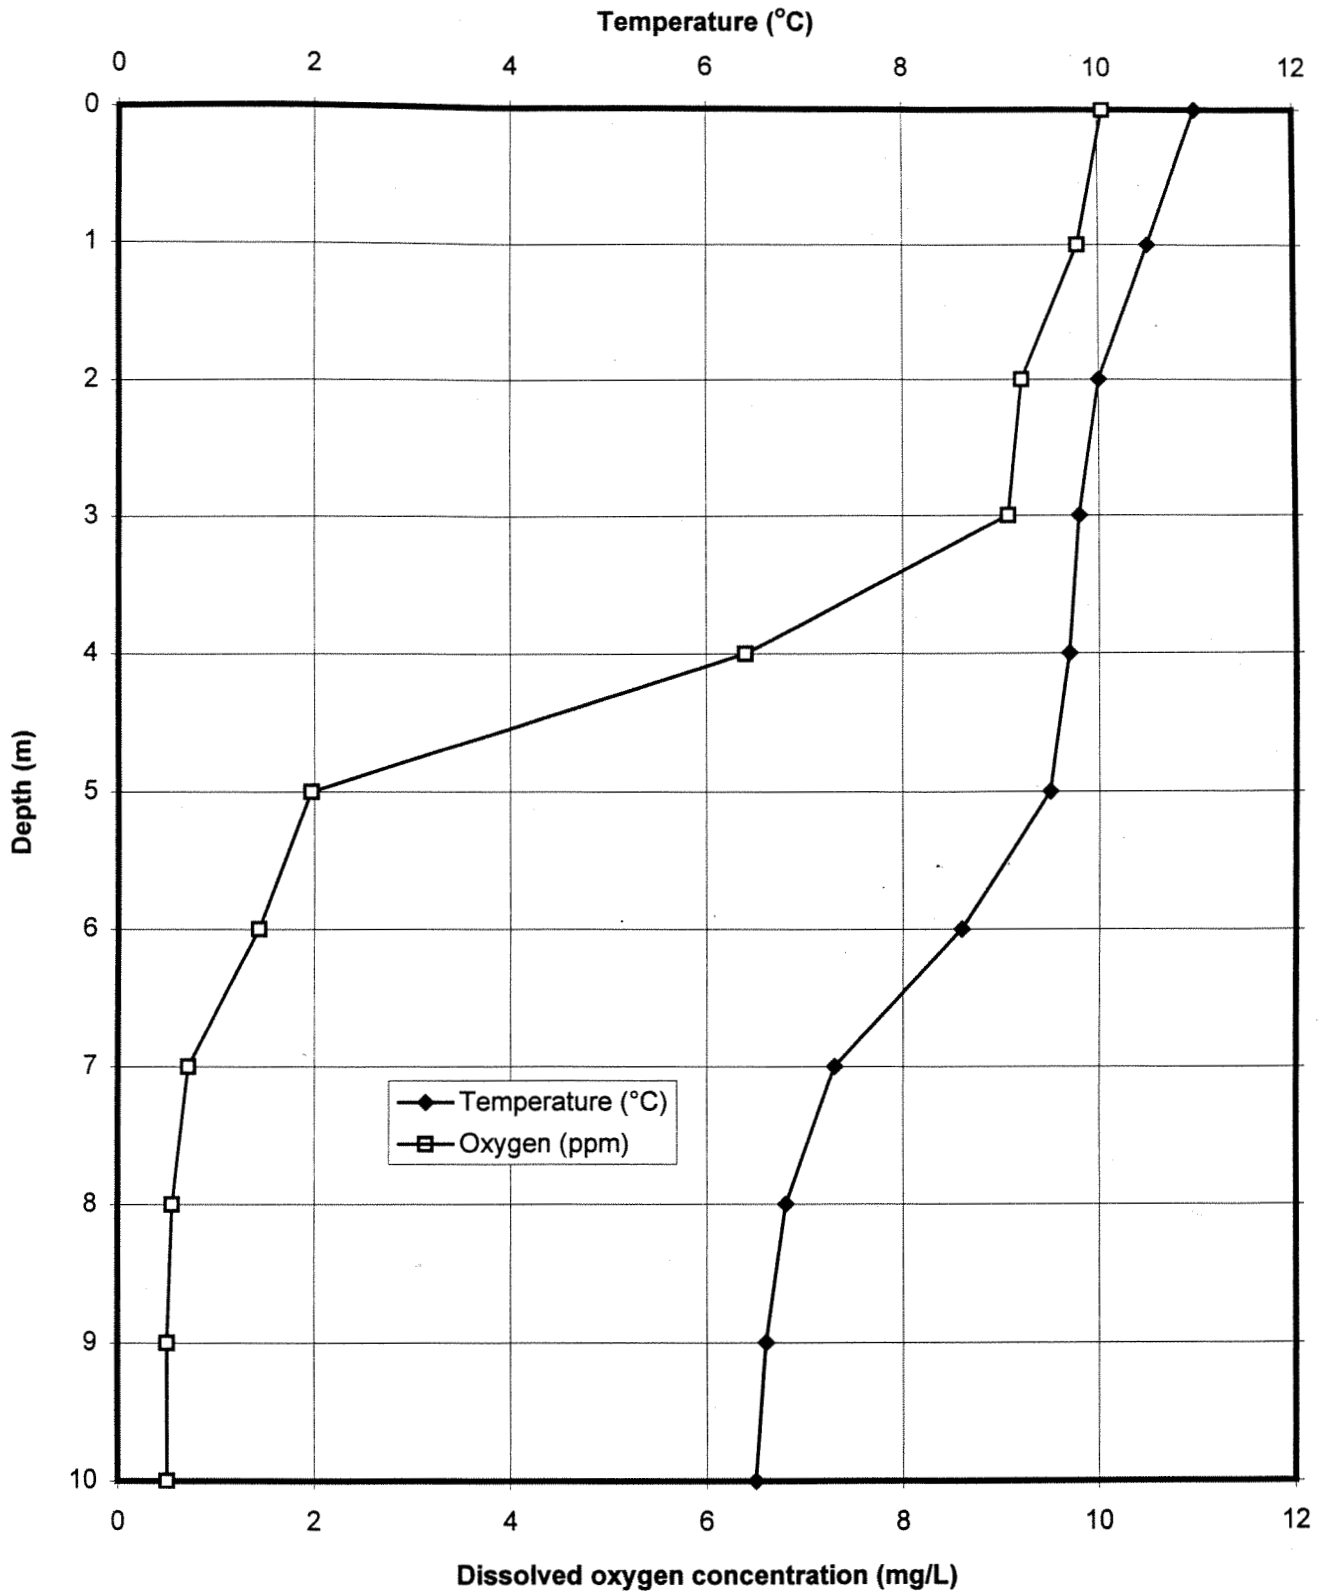
Figure 10 - Dissolved Oxygen and Temperature Profiles.

Depth (m)	Dissolved Oxygen (ppm)	Temperature (°C)
0	10.05	11.0
1	9.79	10.5
2	9.21	10.0
3	9.07	9.8
4	6.40	9.7
5	1.97	9.5
6	1.44	8.6
7	0.72	7.3
8	0.55	6.8
9	0.50	6.6
10	0.50	6.5
