**Old Woman Lake
(460-04)
01634BULK**

**SECONDARY LAKE INVENTORY
1997 STUDIES**

**Ministry of Environment, Lands and Parks
Project No. IVBVS622 (FRBC)**

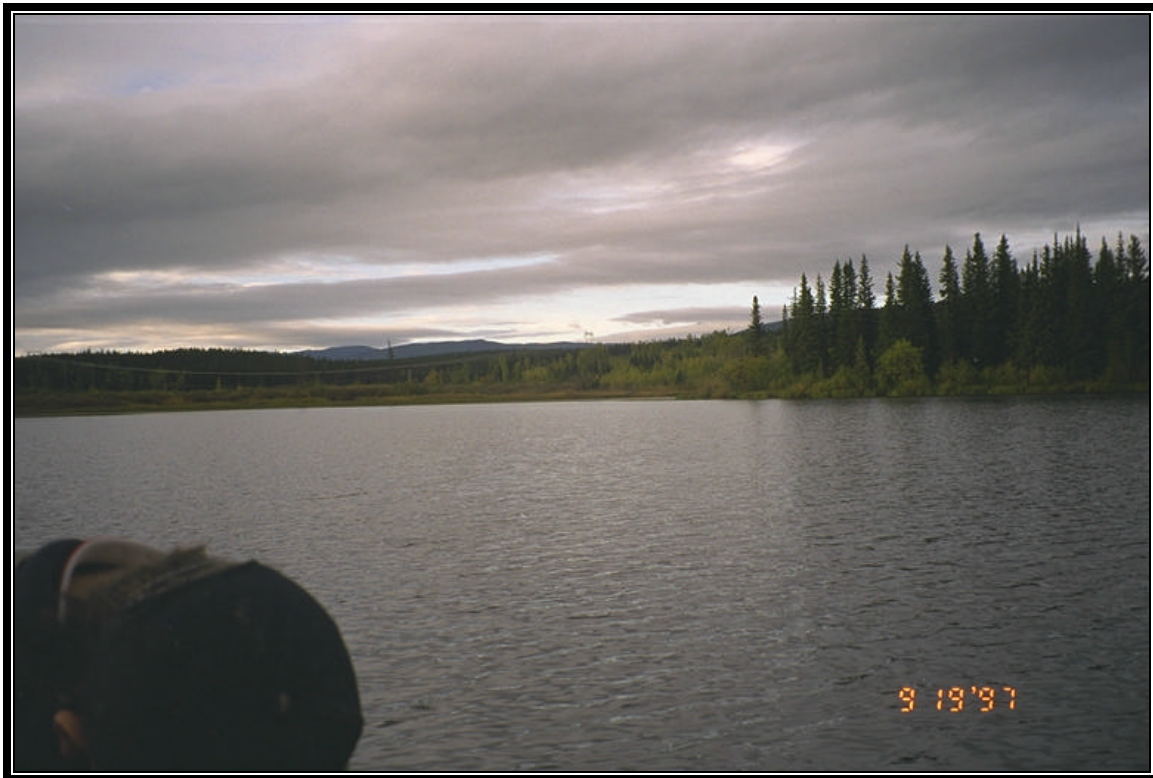
Plate 1 View from limnological station looking north.

The limnological sampling site was located at the deepest recorded point (3.0 m). Dissolved oxygen (mg/l) and temperature (C) were measured with a YSI meter (model 85). A thermocline was not evident. Dissolved oxygen levels were 6-7 mg/l from surface to bottom (for profile results, refer to Appendix D). The Secchi depth was 2.75 m; water was colourless. pH was measured using a hand held Hanna pH meter. Surface and bottom pH were 7.4 and 7.5, respectively. H₂S was not detected.

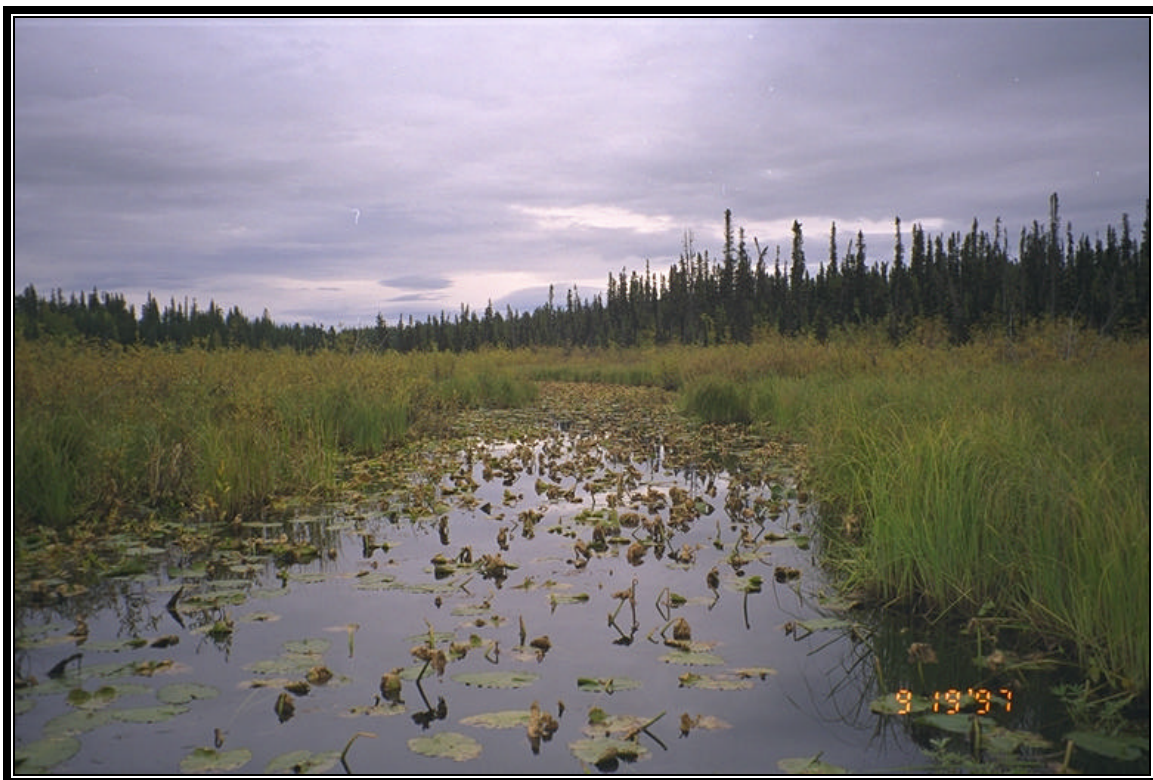
Plate 2 View of outlet (460-04) looking downstream (southeast).

The outlet is a distinct channel approximately 3-4 m wide, narrowing as the channel passes through a marsh/shrub area. The substrate is comprised of primarily sand and silt. Heavy macrophyte growth is evident in this area. Cattle roam freely along the southwest perimeter of the lake and may contribute to nutrient loading. The channel may be used seasonally as rearing habitat.

Rehabilitation/enhancement efforts may include water quality monitoring to establish the potential effects of nutrient loading and, if nutrient levels are high, development of measures to reduce loading.
