A DESIGN BRIEF ON THE
Floodplain Mapping Study
Lakelse River and Lake

An Overview of the Study Undertaken
to Produce Floodplain Mapping for
Lakelse River and Lake

R. W. Nichols, P.Eng.
Senior Hydraulic Engineer
Special Projects Section

Victoria, British Columbia
August, 1989

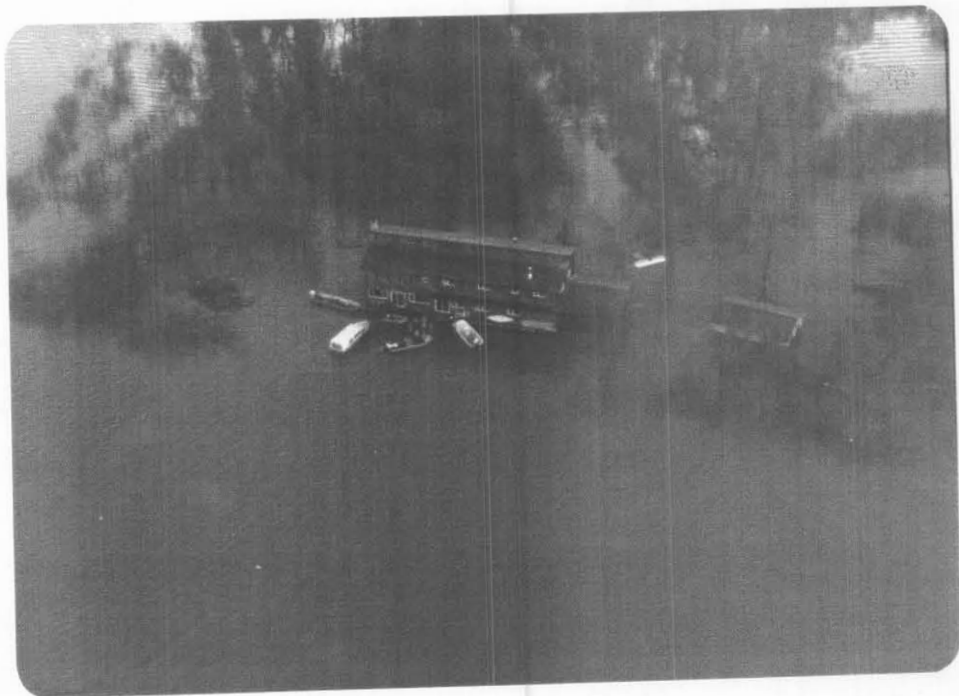
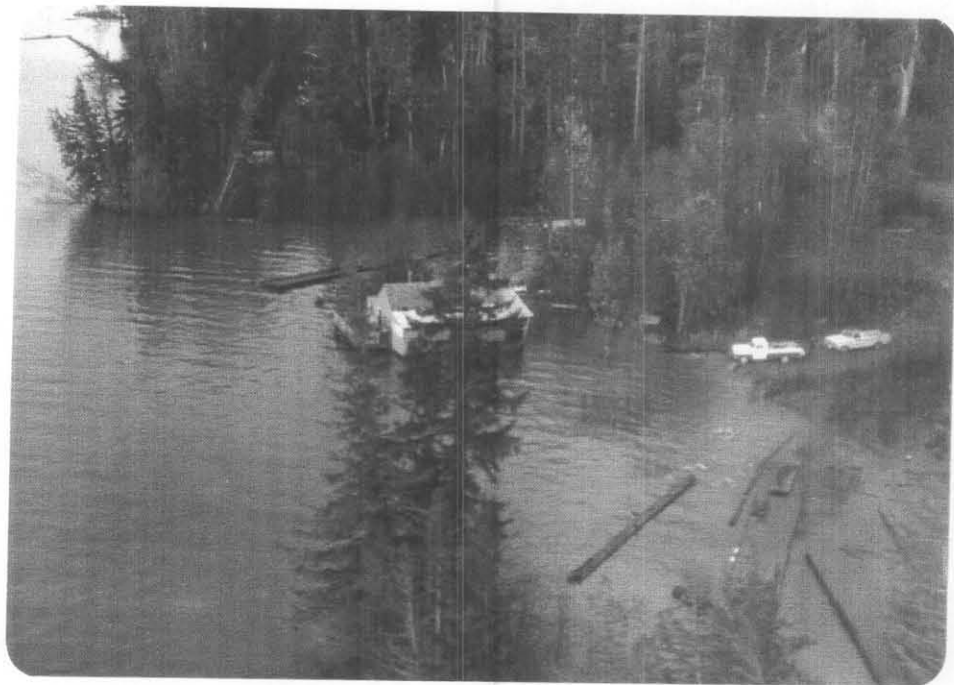
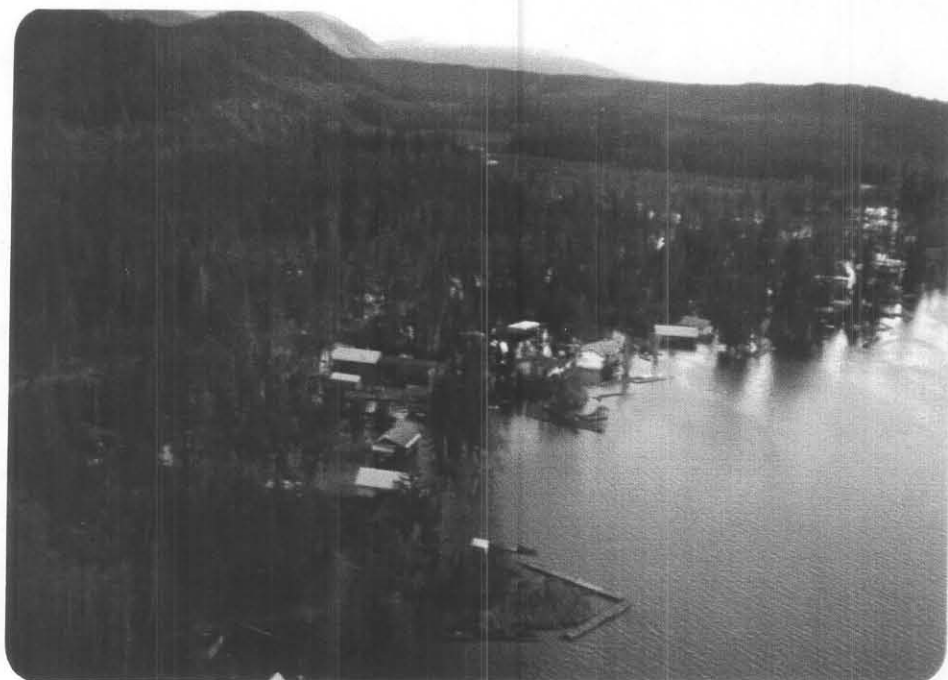
APPENDIX 2

Photos of 1978 Flood

Lakelse Lake

During the November 1978 flood, the lake level increased within 3 days from a normal elevation of approximately 71.5 metres to 74.2 metres by November 2. Approximately 60% of the homes and cottages around the lake were flooded. Appendix 2 provides photos of the 1978 flood event at Lakelse Lake.
