Monitoring the Effectiveness of Riparian Planting Along the Upper Bulkley River

Prepared by LM Forest Resource Solutions Ltd. on behalf of Northwest
Research and Monitoring, 2021

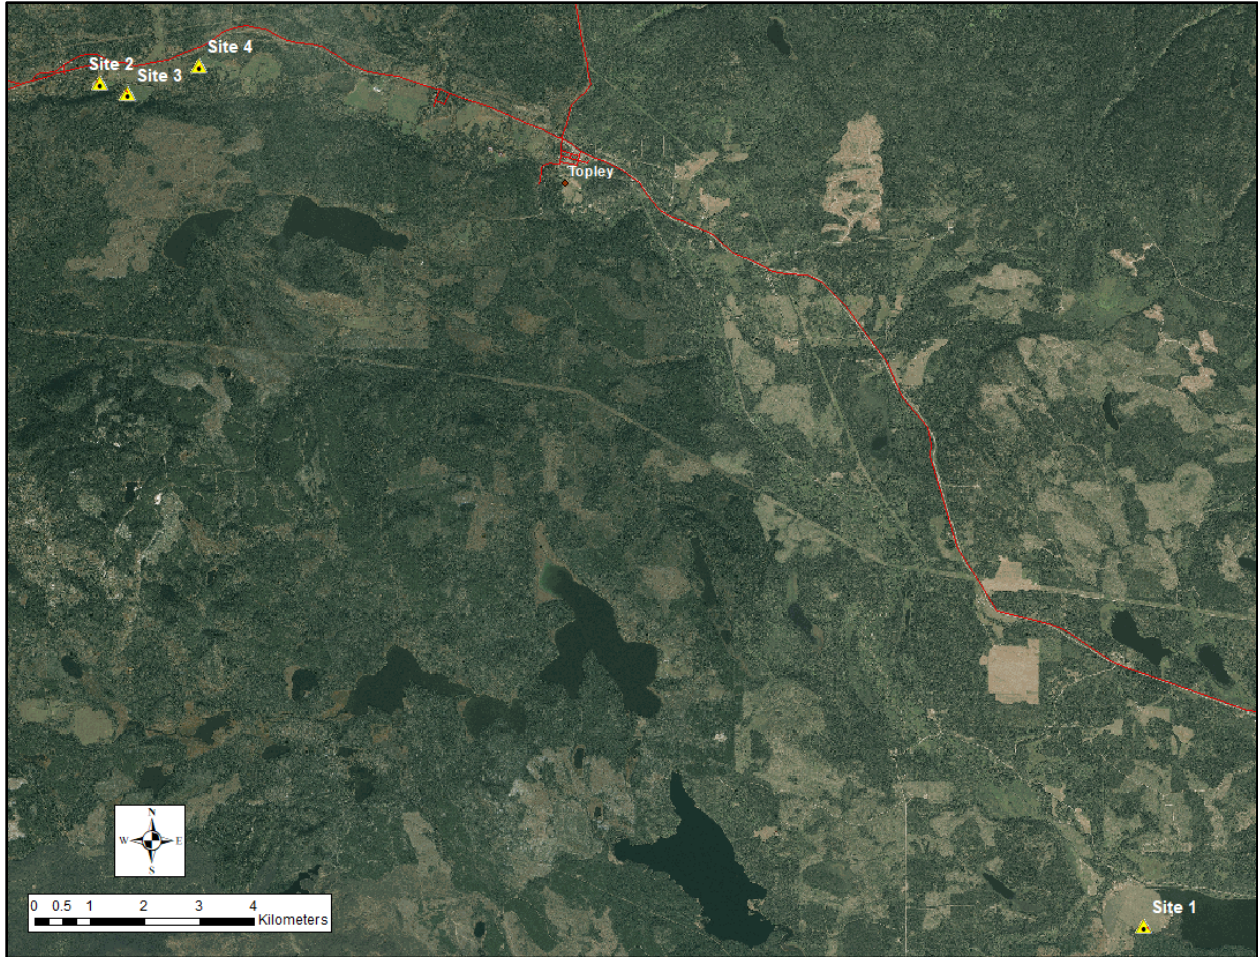
Figure 1: Location of the study sites in relation to Highway 16 and Topley, BC. All sites were located adjacent to the Upper Bulkley River, on private agricultural land.

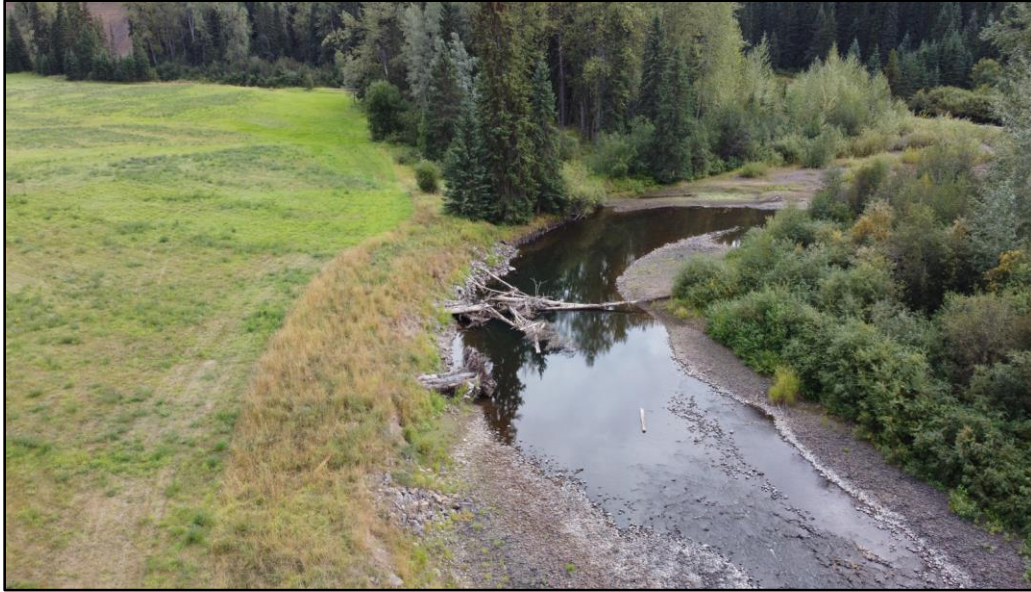
Figure 2: An example of an oblique image, taken at Site 3.

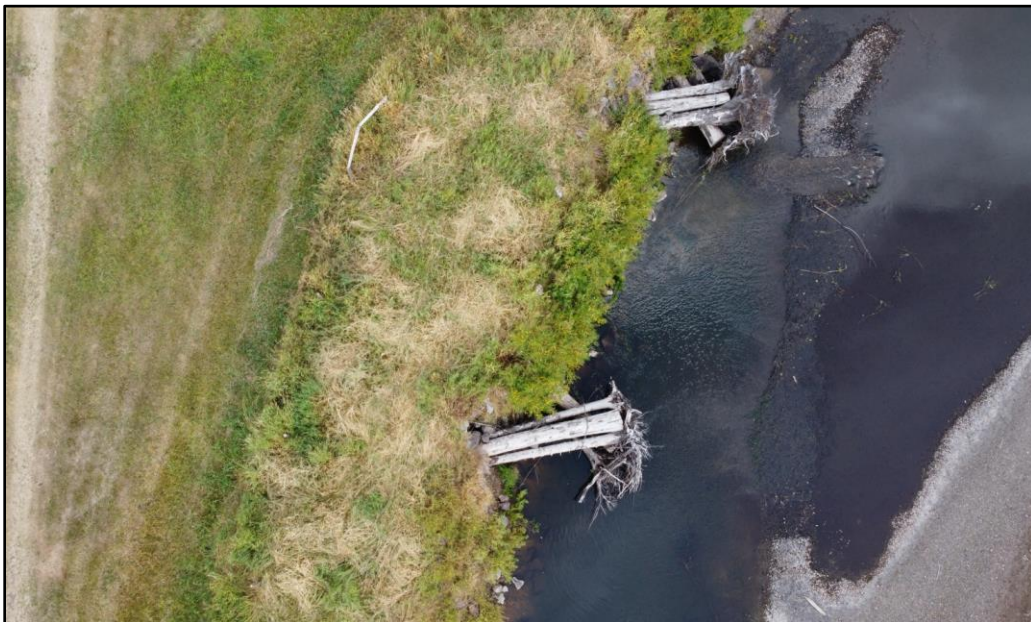
Figure 3: An example of a nadir image, taken at Site 4. The logs protruding from the streambanks installed in an earlier streambank stability project.

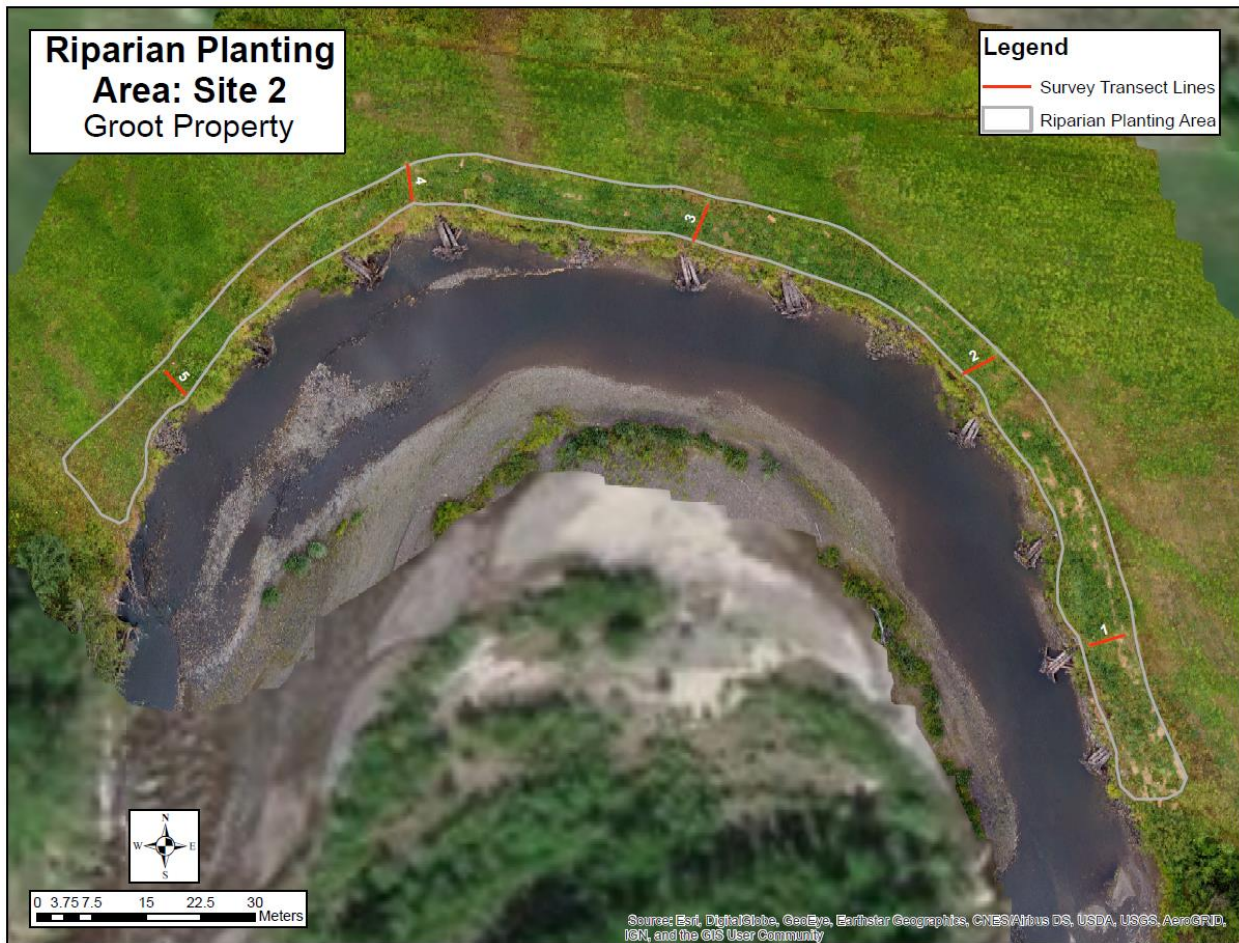
Figure 4: An example of a georeferenced orthomosaic for Site 2, showing the transect locations (red lines), the digitized planting area (grey polygon), and logs that were inserted perpendicular to the streambank as part of an earlier streambank stabilization project.

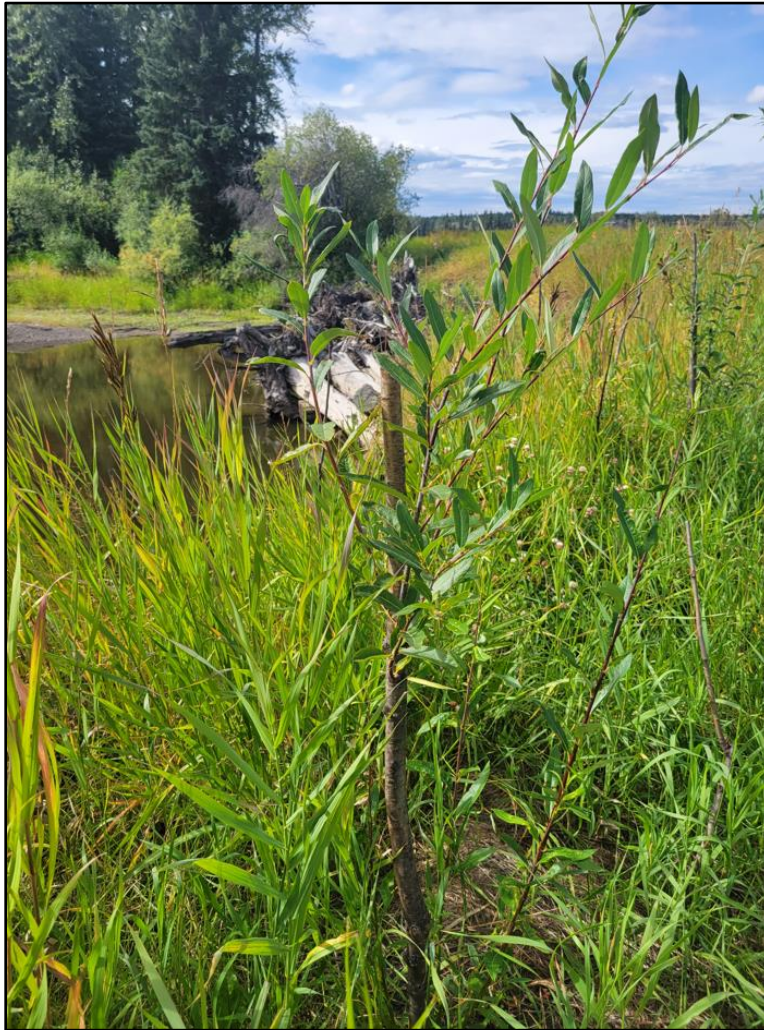
Root egress at this site was good, with average root egress of excavated stems measuring at 5.8 cm. 80% of cuttings were also firmly placed in the ground. Some examples of root growth can be seen in Figures 5 and 6.

Figure 5: An example of good shoot growth one growing season after planting at Site 1 (photo taken in September).

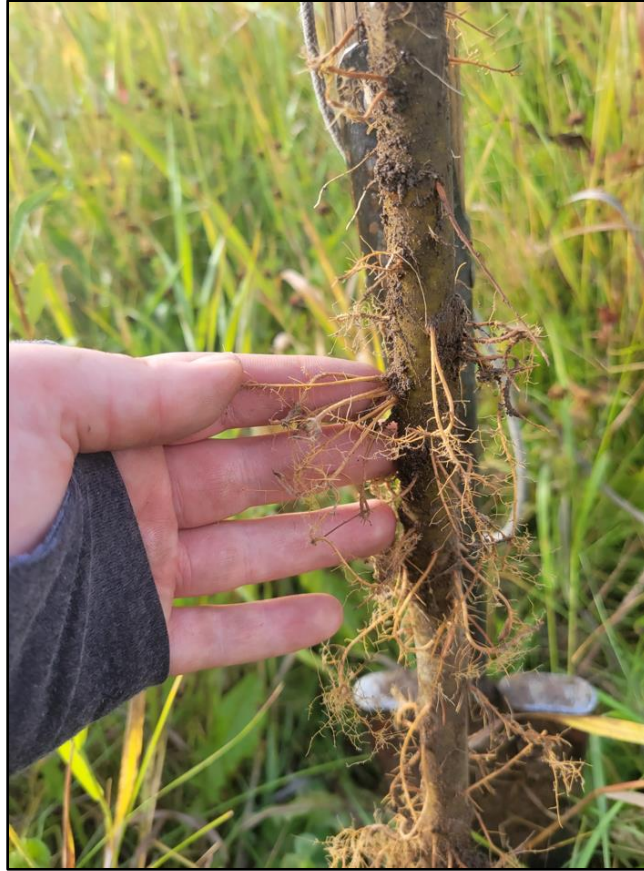
Figure 6: An example showing good lateral root growth at Site 1 (photo taken in September).

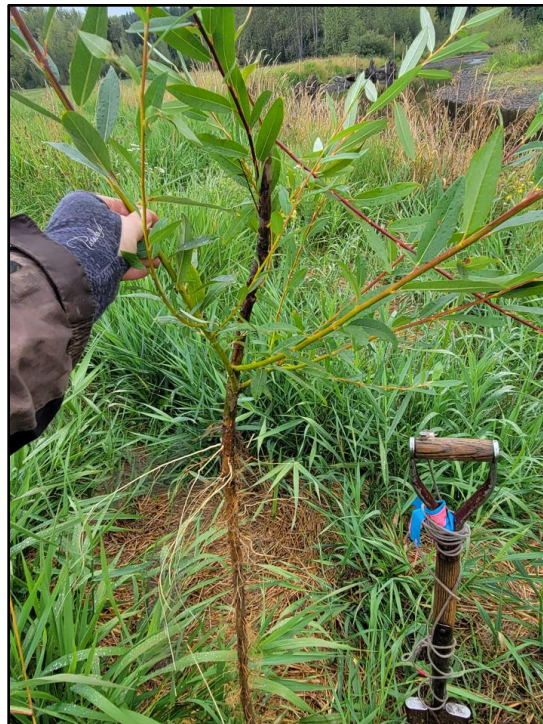
Root egress at this site was good, with average root egress of excavated stems measuring at 4.0 cm. 60% of cuttings were also firmly placed in the ground. An example of root egress and growth characteristics for one of the willow stems is shown in Figure 7.

Figure 7: An example of a willow displaying good shoot growth and good lateral root development at Site 2 after one growing season (photo taken in September).

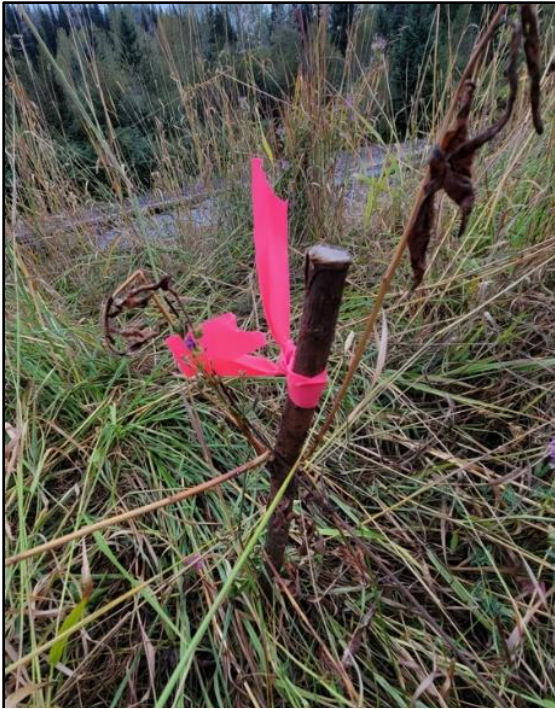
Site 3 (the Groot property) was also planted with a species mix including *Salix* species (48%), *Populus trichocarpa* (Black Cottonwood, Act, 24%), *Picea glauca* (white spruce, Sw, 24%) and *Larix occidentalis* (Western larch, Lw, 4%). This site experienced the highest mortality rates of the 4 sites (41% in September, and 45% in October, cumulatively) (Table 3). One reason for the high rates of mortality observed here may be the relatively stony soils at this site. It is possible that cuttings were not able to penetrate deep enough into the ground here to compensate for the high temperatures and drought conditions experienced in the summer. This site was also planted later than Sites 1 and 2 (early June as opposed to early-mid May), and it is possible that these stems did not have enough time to become well established before the heat dome occurred in late June. Cuttings that were planted earlier would have had more time to develop an effective root system compared to cuttings planted at a later date.

Figure 8: An example of a dead willow stem found at Site 3 in October.

Sites 3 and 4 displayed the highest mortality rates of the four sites that were surveyed. If funding permits, these sites should be replanted next spring to account for the mortality that occurred in the 2021 growing season. Species selection should be limited to Salix and Act, because survival and growth of conifers was relatively poor (possibly because of competing vegetation and much shallower rooting within the soil profile during the drought). One possible way to mitigate replanting costs would be to remove dead stems and use the same locations to plant new cuttings in the same residual holes. Cuttings should be inserted as deep as possible. Also, consider using whips instead of cuttings as whips will maintain the terminal bud at the top of the tree, which may result in improved early shoot growth.

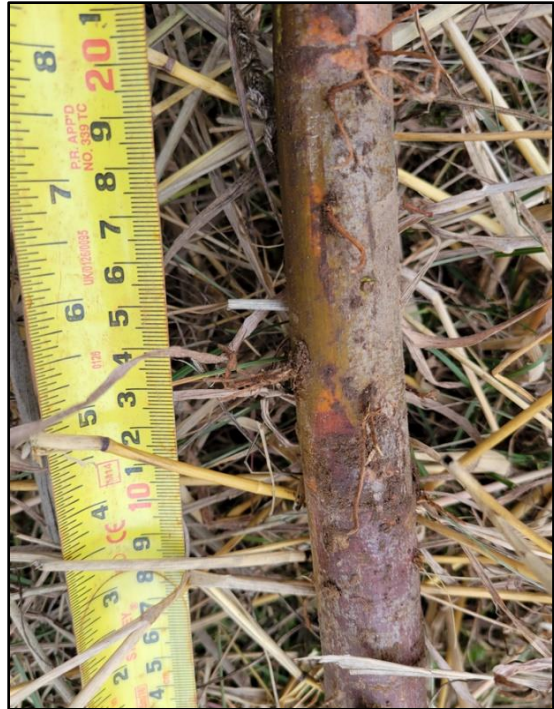
There was no brushing or mulching applied to this site. Root egress was also comparatively low at this site, compared to the other 3 sites (average root egress here was only 2.5 cm, compared

to 5.8 cm at Site 1, 4.0 cm at Site 2, and 3.0 cm at Site 4). Figures 8 and 9 show examples of a dead stem, and a stem with low root egress.

Figure 9: An example of a stem with poor root egress found at Site 3 in October.

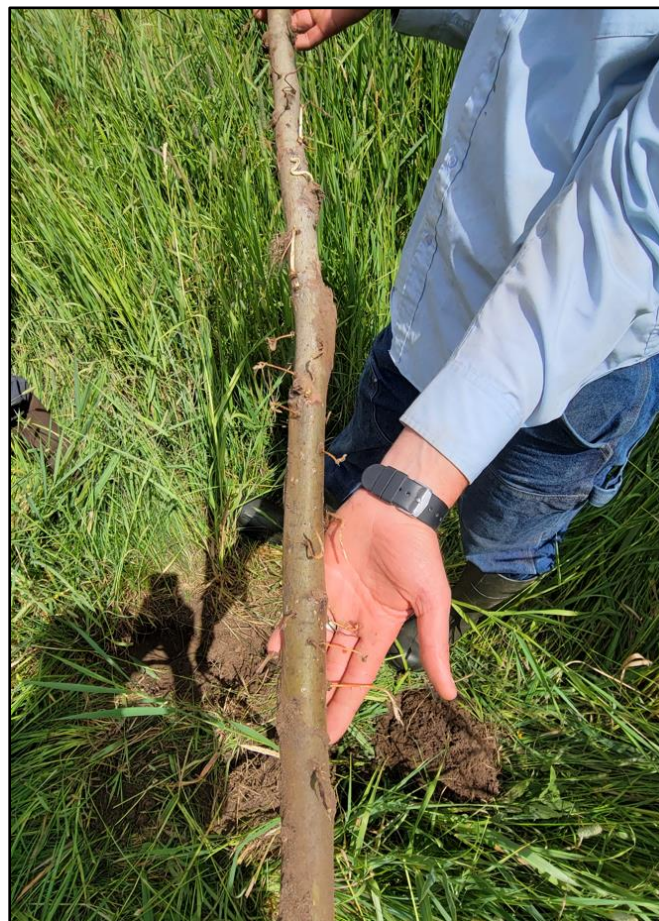
Cattle grazing was observed at this site – between the surveys completed in September and October, four surveyed trees were ripped out of the ground (all Sw stems) by cattle. Evidence of grazing was also noticed at this site, but not at any of the other 3 sites. This site was brushed in late August, immediately prior to when the monitoring surveys began, and the treatment would not have impacted growth and survival in the current year. Treatment at this time of year could influence the amount of snow press that occurs in the winter however. Figure 10 shows an example of a stem with average root egress at this site.

Figure 10: An example of a willow cutting showing average root egress at Site 4 in September.

In order to eliminate the effects of cattle grazing on these riparian planting sites, it may be beneficial to install an enclosure around the planting area at Sites 2, 3, and 4. There was evidence that cattle were ripping conifer stems out of the ground at Site 4, and it is expected that this will not be an isolated incident given that these sites are located on active, working farms.

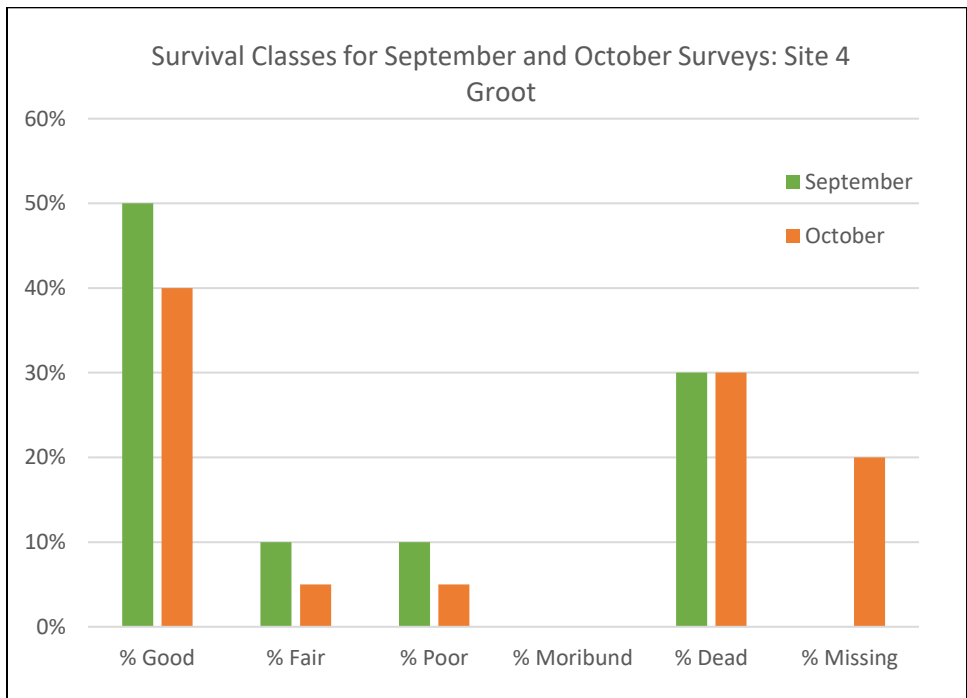
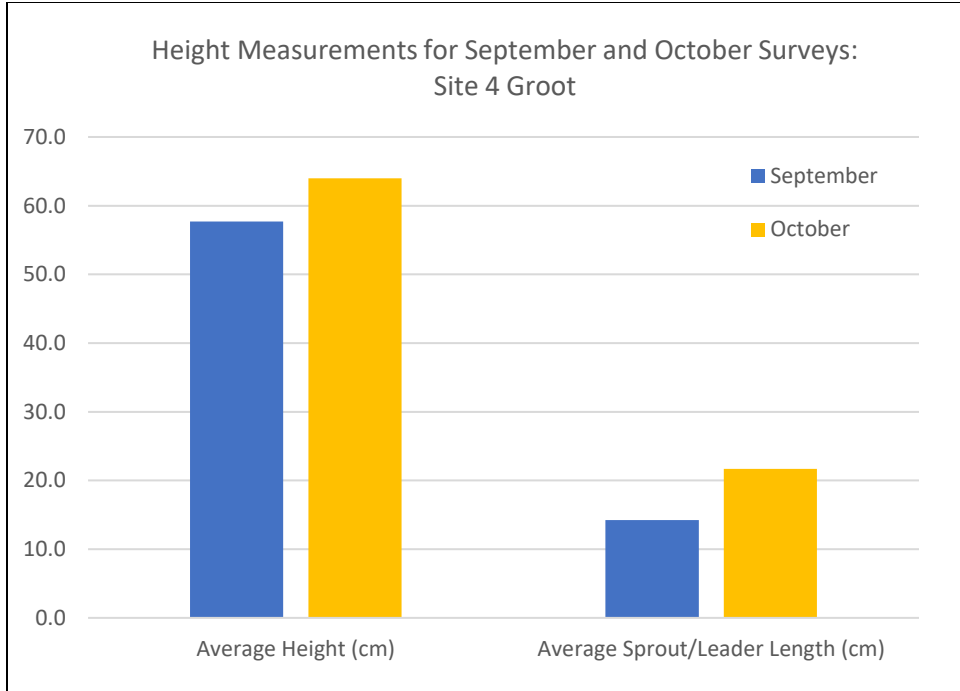
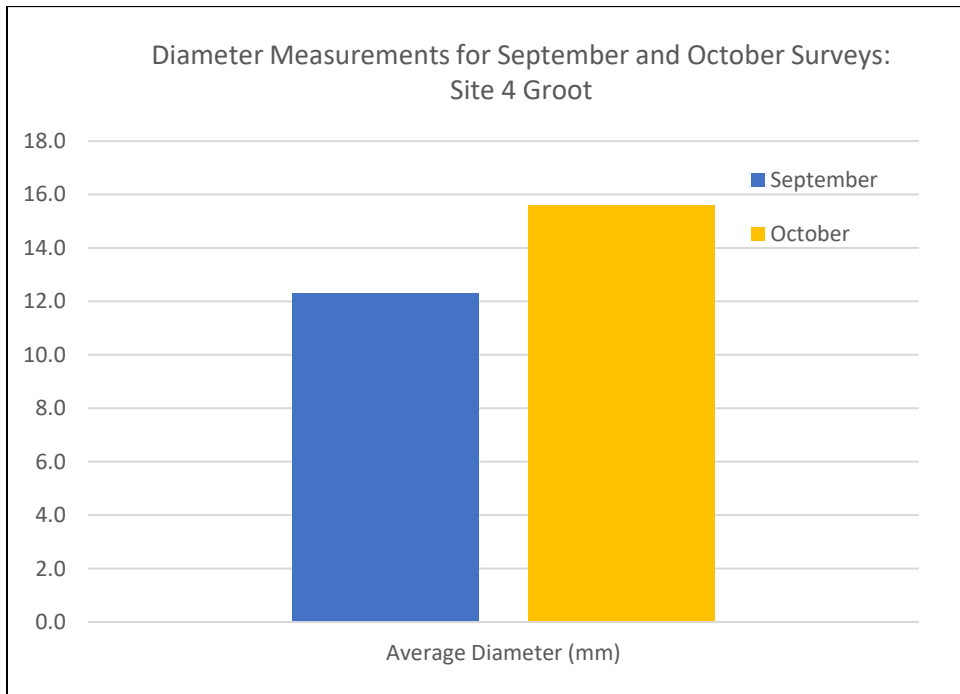
Site 4 Survival And Growth:

Note that the differences in survival, height, and diameter measurements for Site 4 were significantly impacted by missing trees between the two surveys completed in September and October. Twenty stems were surveyed in September, compared to 16 surveyed in October.
