RIPARIAN RESTORATION

2021

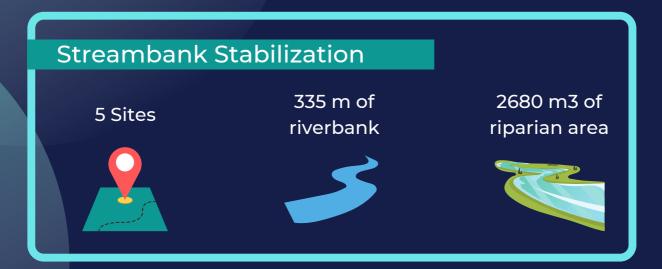
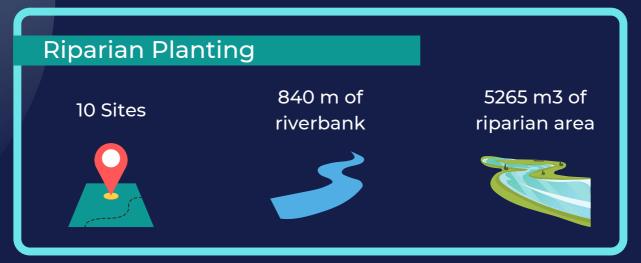
Restoration Completed

In quickly eroding areas, banks were resloped, stems were "pegboarded" (pounded vertically into the bank) at ~1 m spacing with Willow wattle fencing woven between to stabilize banks long enough for vegetation growth.
