**SUMMARY REPORT FOR
TOBOGGAN CREEK STREAM
REHABILITATION
and
SILVERN LAKES
ROAD DEACTIVATION**

Prepared for:
Pacific Inland Resources
(A Division of West Fraser Mills Ltd)

Ed Withers AScT, Watershed Restoration Supervisor
Silvicon Services Inc.
December 2000

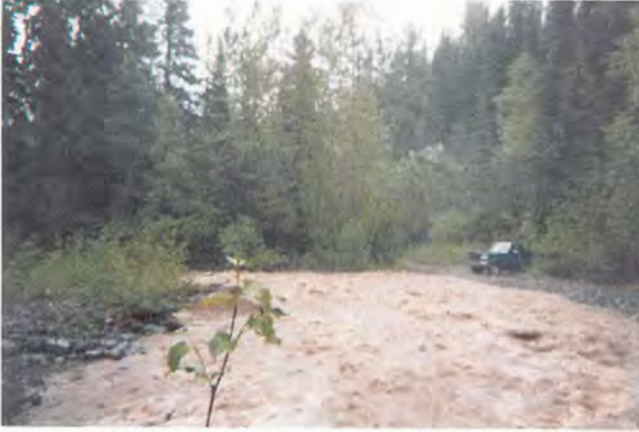
Photo 4. Old bridge washed out causing channel change

A number of years ago an old bridge located at this site collapsed into the creek and seems to have diverted the main stream channel out of its natural course. Due to the new location of the stream channel, the stream washes over its banks and runs down the road surface during high water flows (photo 5 and 6). It is felt that overflowing of the banks at this point could cause excessive siltation and debris accumulations, which may adversely impact important salmon spawning grounds downstream of the crossing.

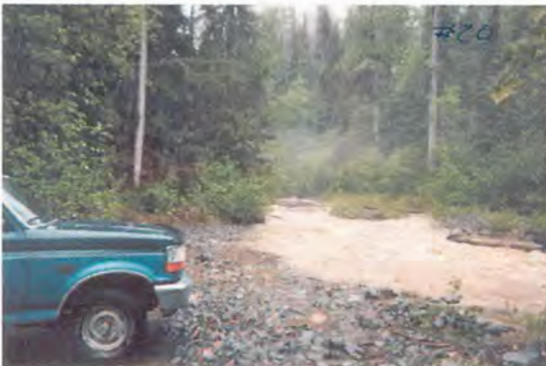
Photo 5. Road approach at nearing high water

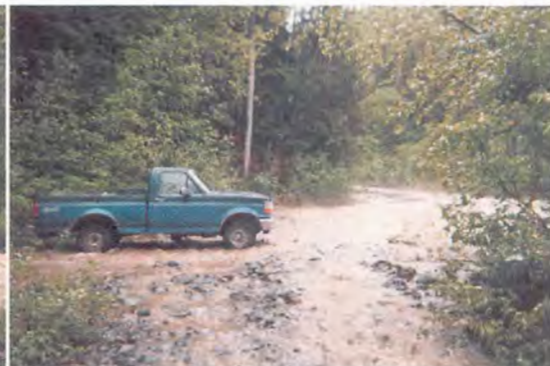
Photo 6. Stream overflowing onto road at high water

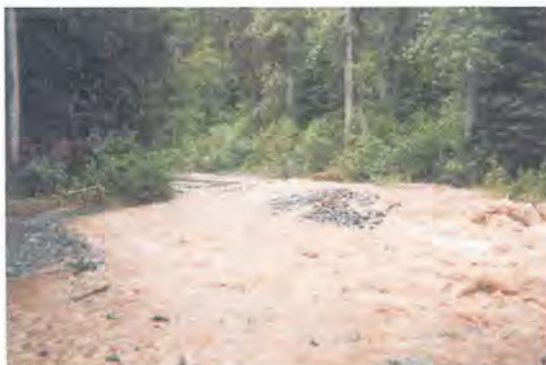
Toboggan Creek has a relatively small watershed area of 1733ha above the Silvern Lakes Road crossing. As close to the headwaters of the stream as the crossing is, it can be expected that Toboggan Creek is quite resilient to disturbance and recovers quickly from streambed damage. Disturbances to the streambed are naturally occurring and quite frequent. This stream rises very quickly from runoff and heavy rainfalls and subsides just as quickly as the weather changes. Evidence of the flashy nature of Toboggan Creek is portrayed in the 35mm photographs of the site, located in Appendix A. Photos 4-9 were shot within a span of 48 hours after a heavy rainstorm in June 1999 and show the dynamics of Toboggan Creek, depicting the stream before, during and after high water. The photograph of the low clear water (photo 9) was taken the second day following the high water event.

Photo 7. Site during high water

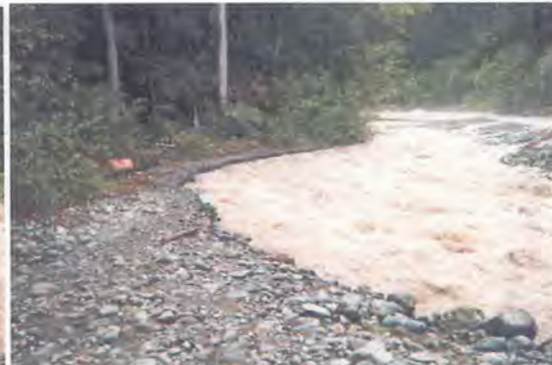
Photo 8. High water is receding

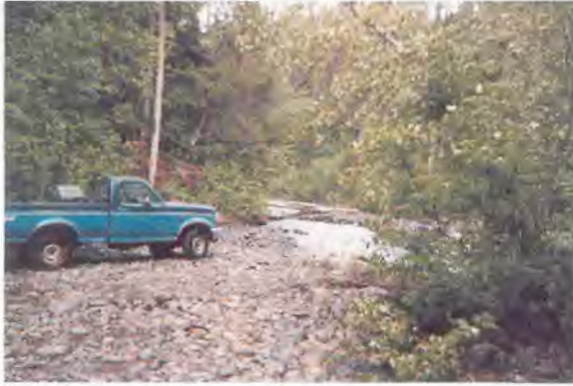
Photo 9. Roughly 48 hours after high water

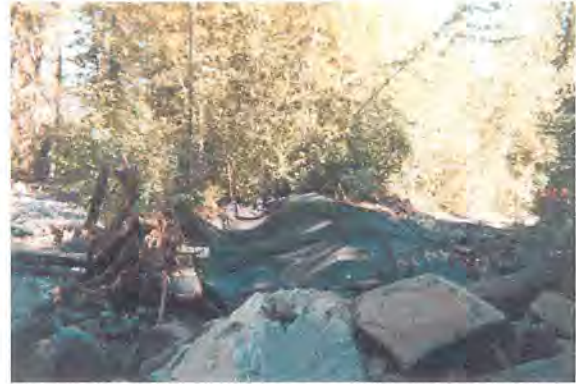
The two root wads of the cottonwood trees were placed at the downstream end of the berm so that the roots would be roughly at the waterline and the stems would extend into the berm. The stumps were left roughly 4m long, buried with the common fill and covered with the filter fabric so that only the root mass was exposed (Figure 1).

Figure 2. Cottonwood root wads buried into berm.

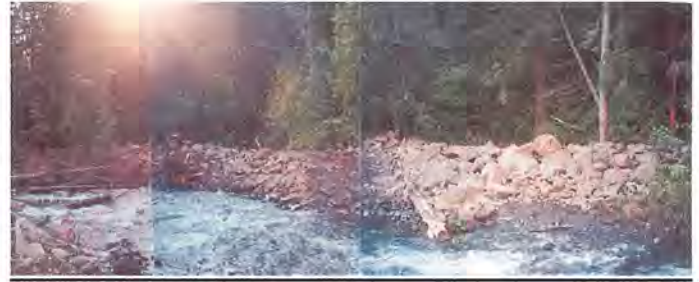
Figure 1. Final constructed berm.

The prescription developed by Silvicon Services Inc. for the rehabilitation of Toboggan Creek at the Silvern Lakes Road crossing site consisted of a riprap berm designed by McElhanney Consulting Services for the protection of the stream banks and including approaches over the berm to maintain four-wheel drive access across the stream, a stream deflector groin to protect the berm and approach from the full force of the stream, placement of cottonwood root wads at the waterline for fish habitat and potential revegetation.

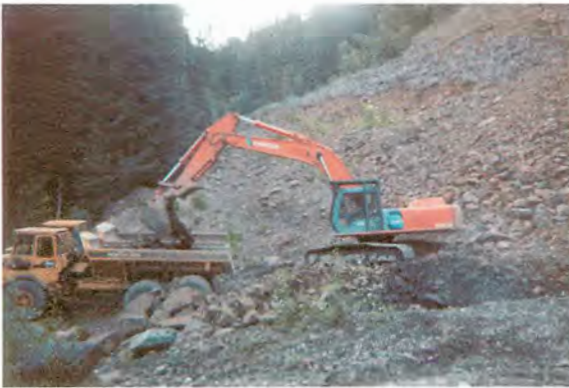
Photo 10. Excavator at rock quarry

- a) The first step was to walk the smaller excavator to the top of the Silvern Lakes Road to begin the road deactivation as per the professional prescription. While walking the machine in, the operator smoothed out a few trouble spots on the road so that a pick up could bring fuel to the excavator.
- b) As the smaller excavator was working the upper elevations, the larger excavator was being utilized to load rock from a quarry located on the Glacier Gulch Road (photo 10). The rock trucks transported the rock to the softer sections of the Silvern Lakes Road to armour the road surface. The loader was used to spread the rock where it was dumped (photo 11).

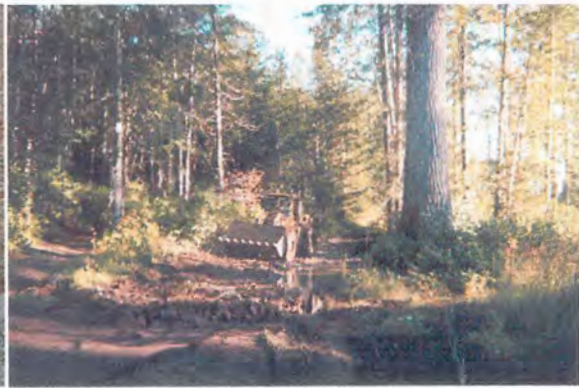
Photo 11. Loader spreading rock in soft road sections

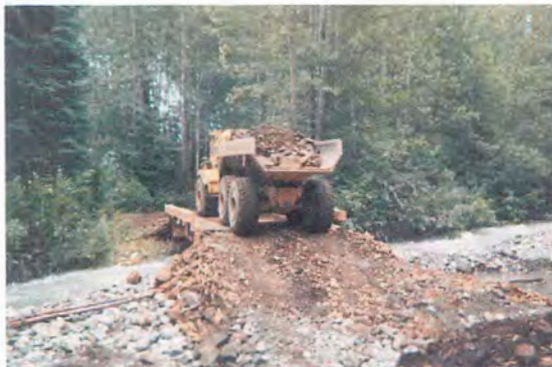
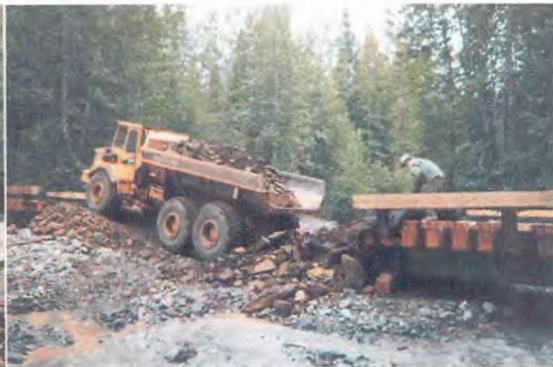
Photo 12. 6m span temporary crossing on Glacier Gulch Creek

Photo 13. Dip between bridges for high flow precaution

- c) Three 6m span temporary bridges were used between the Toboggan Creek crossing and the beginning of the Silvern Lakes Road to protect fish bearing streams while transporting rock to the berm construction site. The first bridge was placed over a stream that feeds into Lake Kathlyn. Two other bridges were used to cross Glacier Gulch Creek. Because of the low water, only two narrow channels flowed within the wetted perimeter of Glacier Gulch Creek. A bridge was placed over each channel and rock from the quarry was hauled in for the approaches. A low gap was left between the bridges as a safety precaution against a high water event (photos 12 and 13).

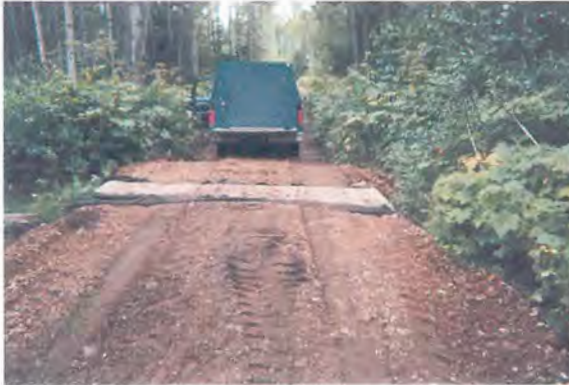
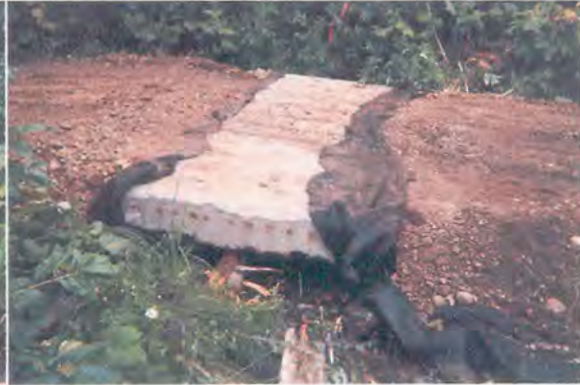
Photo 14. Temporary bridge over TX17

Photo 15. Temporary bridge over TX17

James Cuell, DEO stated as part of his approval that material was not to be placed in the stream labelled in the road deactivation prescription as TX17. He suggested that a temporary span bridge be installed on the stream during the construction. Consequently, a large slab of concrete was placed on sill logs as a temporary bridge over this stream (photos 14 and 15).

- d) A small S4 stream labelled TX17 in the deactivation prescription was crossed using a large concrete slab on sill logs as a temporary bridge (photo 14 and 15).

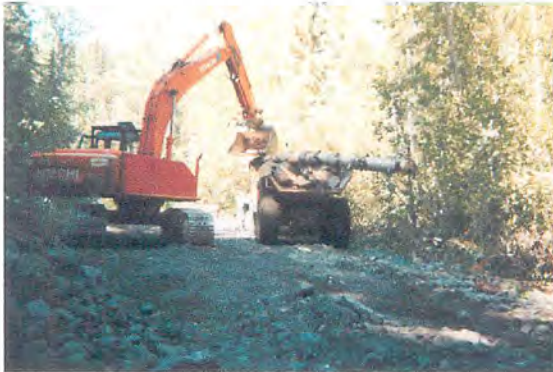
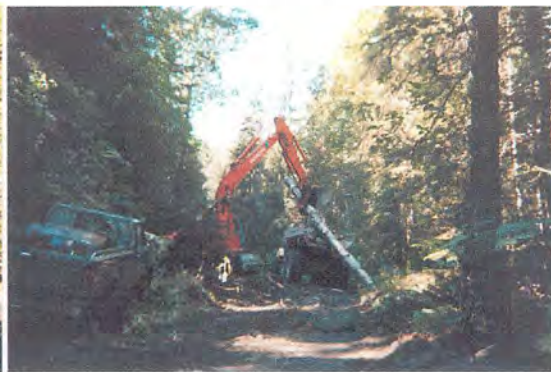
Photo 16. Transporting Cottonwood logs to construction site

Photo 17. Transporting logs

- h) Two young cotton wood trees were pushed over with the excavator, cut up and transferred to the site to be used in the construction of the various structures to be built with the berm (photo 16 and 17).

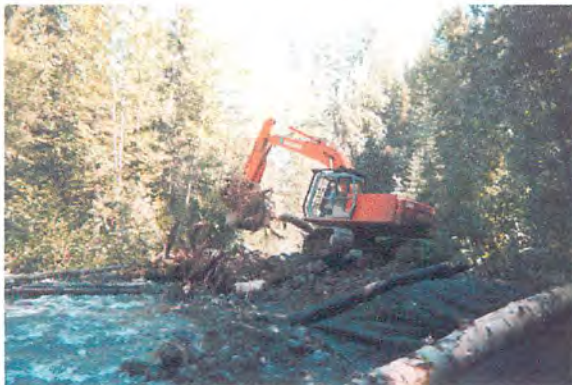
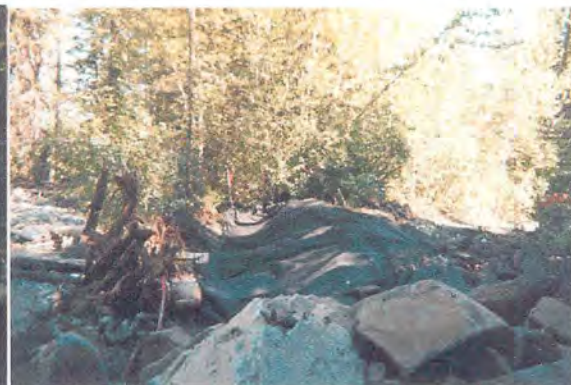
Photo 18. Cottonwood root wads buried into berm

Photo 19. 4m long stumps buried and covered with filter fabric

- i) A log cut from one of the trees was put in place to be part of the groin deflector. A cable was attached to this log and tied back to another log that was then buried below the berm. A layer of filter fabric was rolled out over top of the common fill portion of the berm and beneath the groin deflector log.
- j) The two root wads of the cottonwood trees were placed at the downstream end of the berm so that the roots would be roughly at the waterline and the stems would extend back into the berm (photo 18 and 19). The stumps were left roughly 4m long, buried with the common fill and covered with the filter fabric so that only the root mass was exposed.

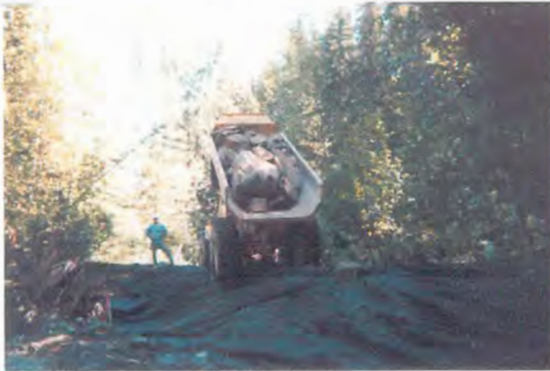
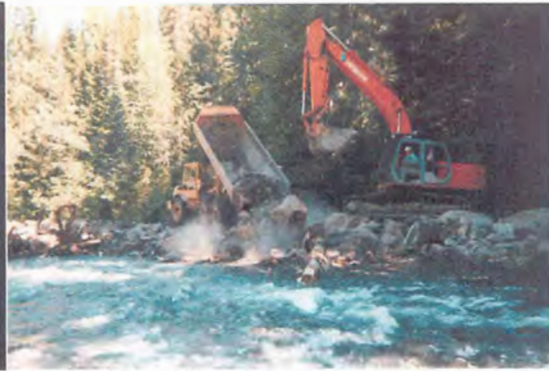
Photo 20. Large rock dumped at the site

Photo 21. Rock was keyed in

- k) Large riprap was then trucked in and dumped at the site. The excavator placed the rock so that it was keyed in to the constructed trench and back over the fill (photo 20 and 21).

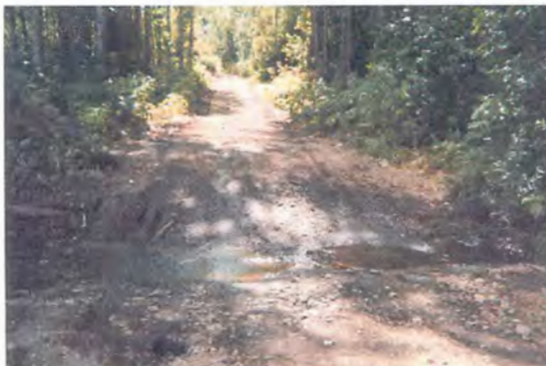
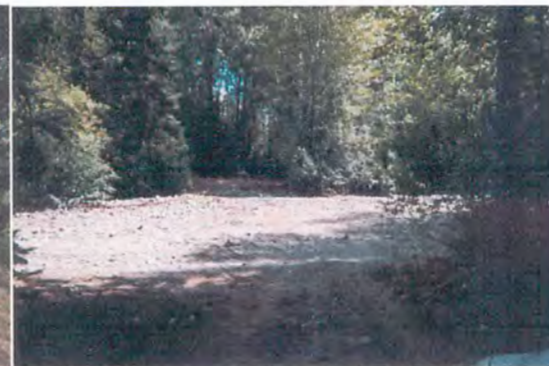
Photo 22. TX17 after bridge has been removed

Photo 23. Glacier Gulch Creek after bridges removed

- l) As the construction of the berm neared completion, high daytime temperatures caused Toboggan Creek to rise slightly and the edge of the stream came up to the edge of the work zone, but even with the rise of the water level, very little of the stream was disturbed during the construction.
- m) Following the completion of the berm, the equipment worked from Toboggan Creek back out to the beginning of the road. The temporary bridges were removed and the material that was used for the approaches loaded onto the rock trucks and removed. The sites where the bridges were placed were re-contoured to put them back as close to their original state as possible (photo 22 and 23). The quarry on Glacier Gulch Road was recontoured and slopes were left in a safe condition.

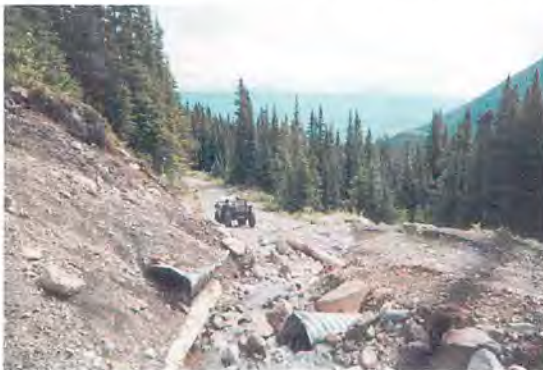
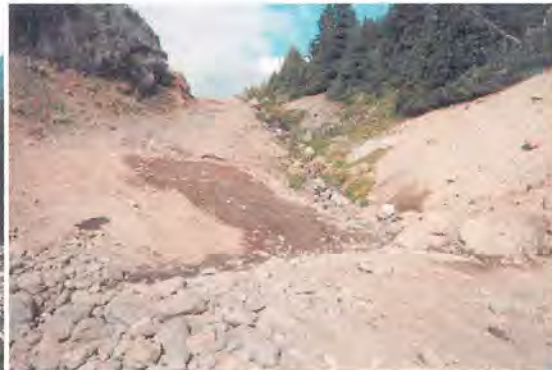
Photo 24. Blown culvert

Photo 25. Same as photo 24 after construction

The deactivation of the road is expected to increase the life expectancy of the road as many of the existing problems with this road have been corrected or improved (photo 24 and 25).

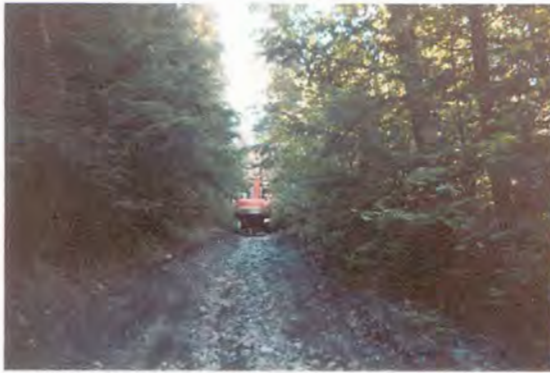
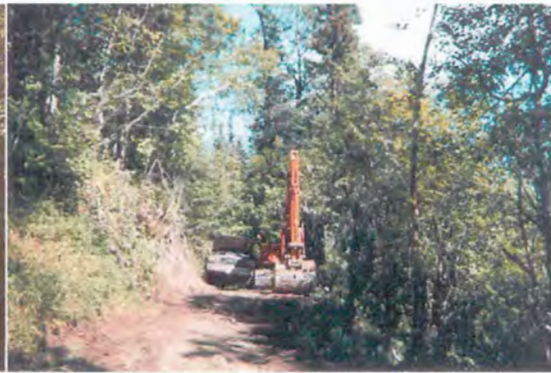
Although most of the drainage areas are now controlled, natural drainage patterns restored and fill slopes stabilized, there are still a few areas where problems could occur. Due to the narrow road width (photo 26 and 27), many of the areas where pullback was prescribed, it was found that the action would reduce the width of the road and possibly cutting off access. In this situation, the berm was removed from the edge of the road and loose fill material was removed to stabilize the slope.

Photo 26. Narrow road width

Photo 27. Narrow road made refuelling difficult

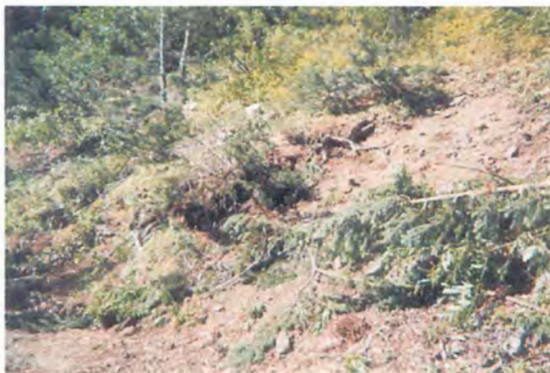
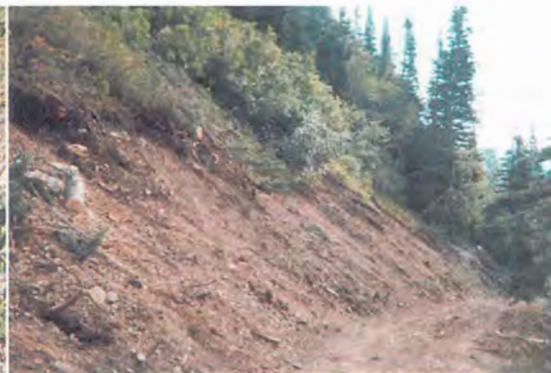
At the site labelled in the professional deactivation prescription as CBS 33 a dry sloughing cut bank may cause future problems. This is probably the most problematic site. The construction at this site was conducted according to an amendment to the original prescription detailed in a letter from Jack Whittles, M.Sc, P.Geo. of Madrone Consultants Ltd. The loose material was removed from the cut slope and the cut slope was recontoured to reduce the steep grade of the cut. The problem is that much of the loose material is out of reach of the excavator and was left above the cut. This material could eventually slough down onto the road blocking access or even transgress the road and slide further down into the valley (photo 28 and 29).

Photo 28. Sloughing cut slope at CBS33

Photo 29. Loose material was removed and slope recontoured

Routine monitoring of this the Silvern Lakes Road and especially at site CBS33, is recommended. It may be necessary to perform a small amount of maintenance to keep four-wheel drive access open. This site should be visited twice a year for the first two years. The first visit should take place immediately following snow melt in the spring.

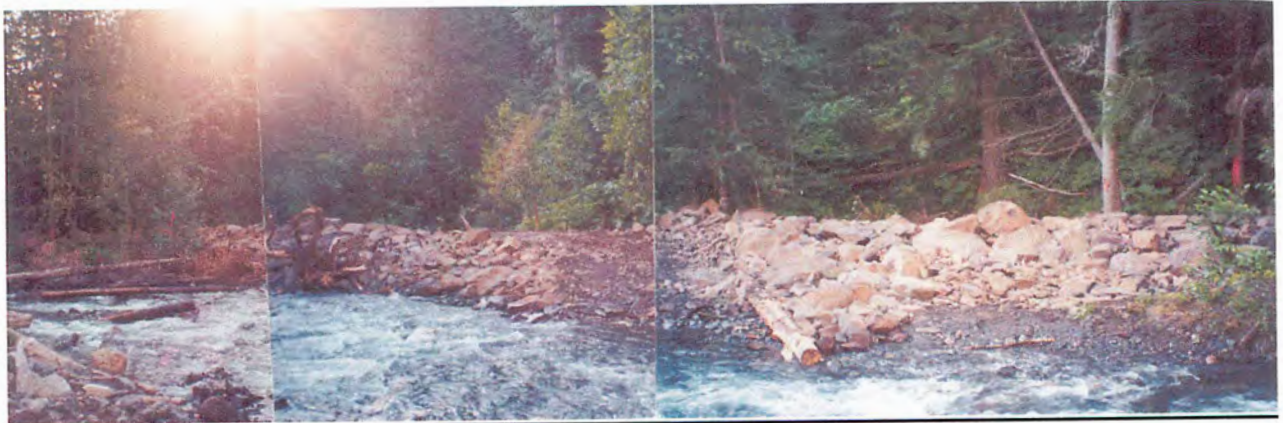
The construction of the berm at the Toboggan Creek crossing on the Silvern Lakes Road is expected to protect the approach of the road from being flooded during high water events (photo 30). It is expected that the constructed berm will withstand any foreseeable natural changes to Toboggan Creek. The western side of Toboggan Creek is still susceptible to severe stream channel changes as is evident from the Prescription Map (Appendix B), but it is expected that downstream values will not be at risk of serious damage if such an event should occur.

Photo 30. Final constructed berm

Routine monitoring of the constructed berm on Toboggan Creek is recommended to ensure the ford crossing provides access for four-wheel drive vehicle. If access becomes blocked the area should be assessed to determine what is required to restore access. The first visit should take place immediately following snow melt in the spring.

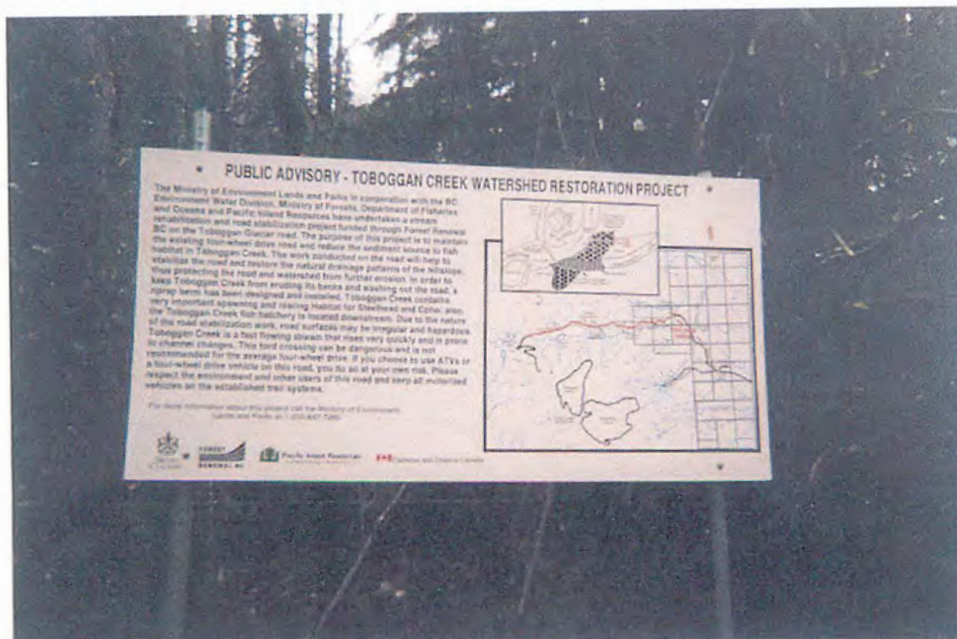
Photo 31. Sign placed at parking lot near constructed berm

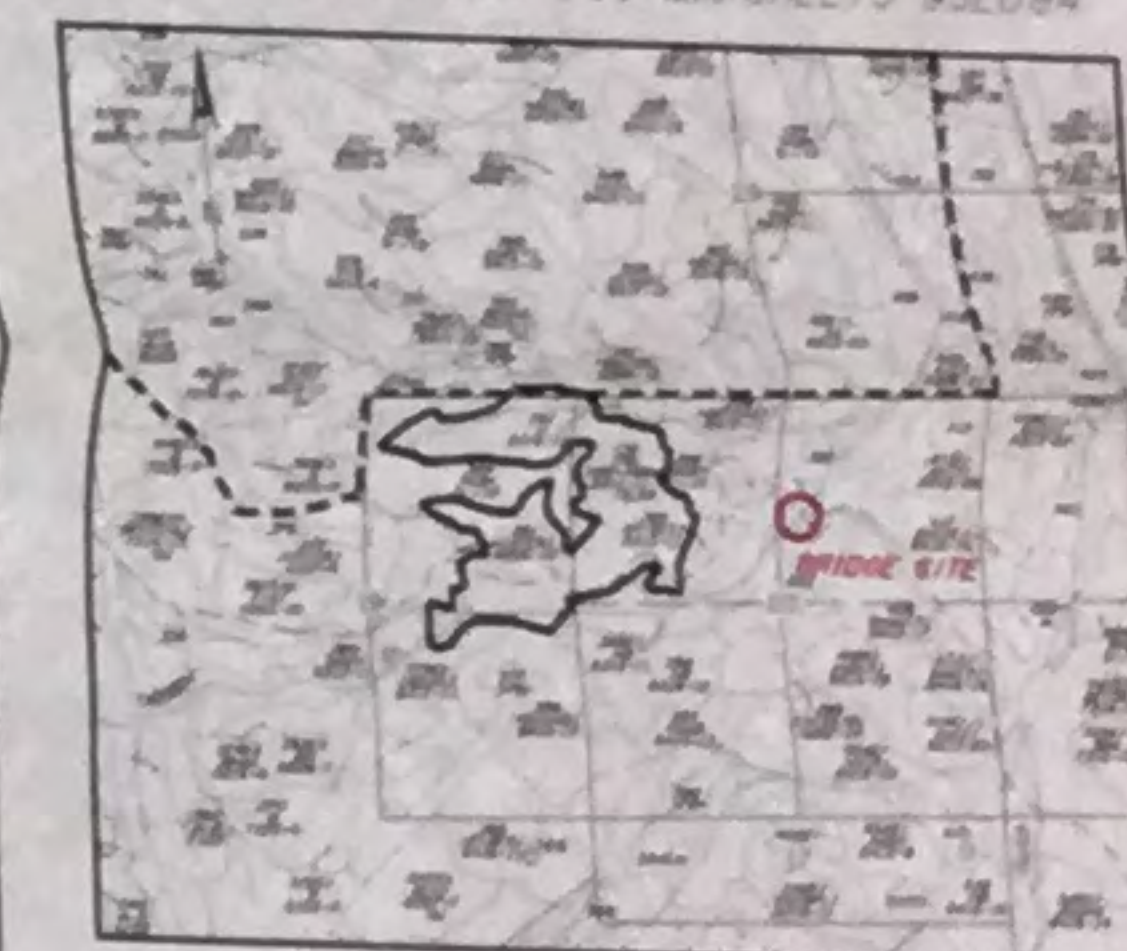
Prescription Map

CHANNEL DESCRIPTION	
ORGANIC	
FINES	
PEBBLES	15%
COBBLES	80%
BULDERS	5%
BEDROCK	
GRADIENT AVG	5%
VELOCITY	Approx. 2.0-3.0 m/s at 1 m/s water

STRUCTURES AND EXCAVATION

- A - posterior designed first crossing
 - B - "split" design

- C - "wing" distal-most/lateral side of design

- D - "wrench" group deflector
 - E - approach to distal-most side of design

- F - "crossover" short placement
