SOCIETY FOR ECOSYSTEM RESTORATION
IN NORTHERN BRITISH COLUMBIA

Bulkley River and Morice River Watershed Groups Fish Passage Restoration Planning

**Version 0.1.2
2021-04-21**

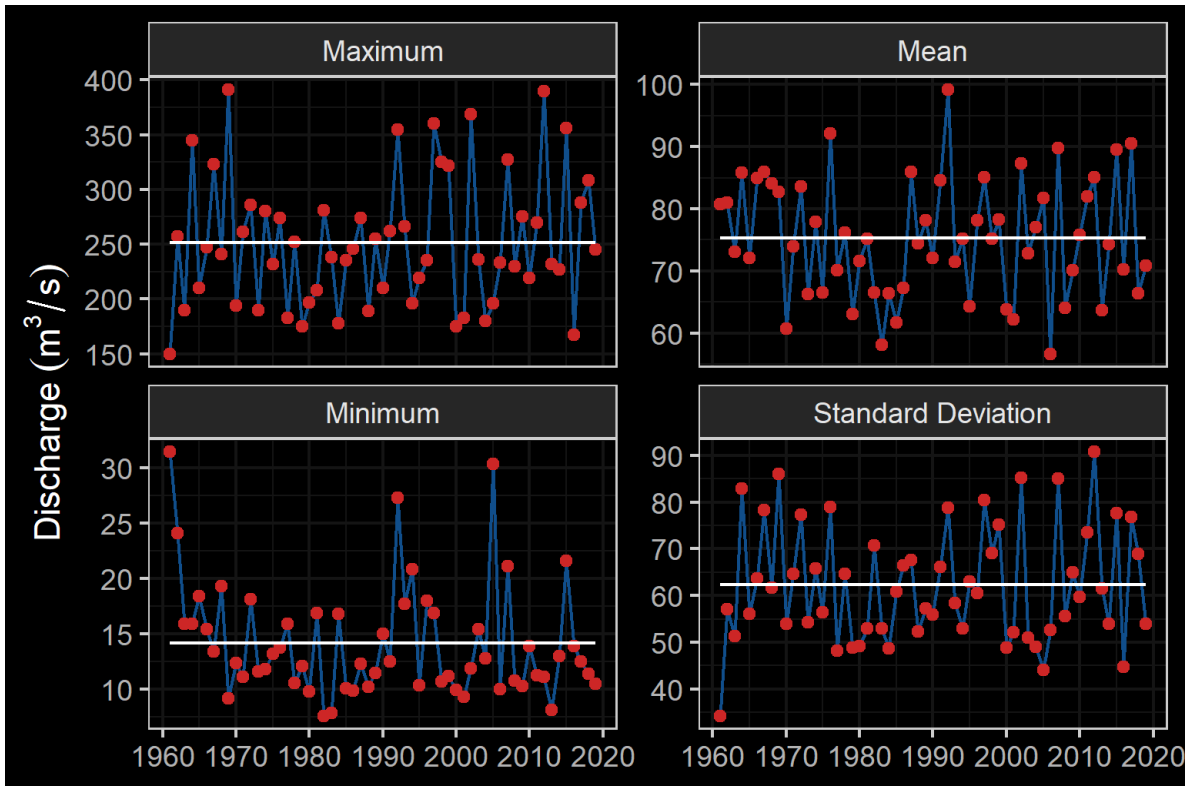
Figure 2.6: Summary of hydrology statistics for Morice River near outlet of Morice Lake (Station #08ED002 - Lat 54.116829 Lon -127.426582). Available daily discharge data from 1961 to 2018.

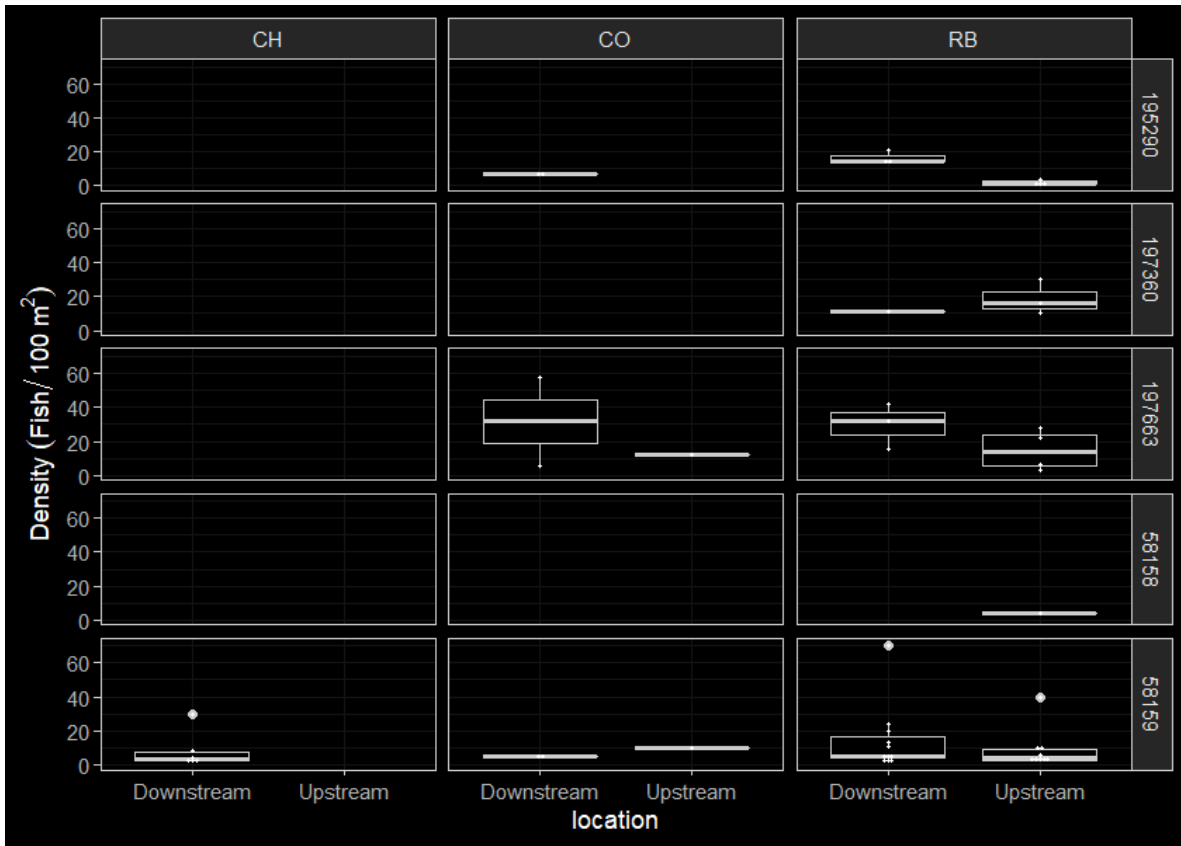
Figure 4.1: Boxplots of densities (fish/100m2) of fish captured by life stage and site for data collected during habitat confirmation assessments.

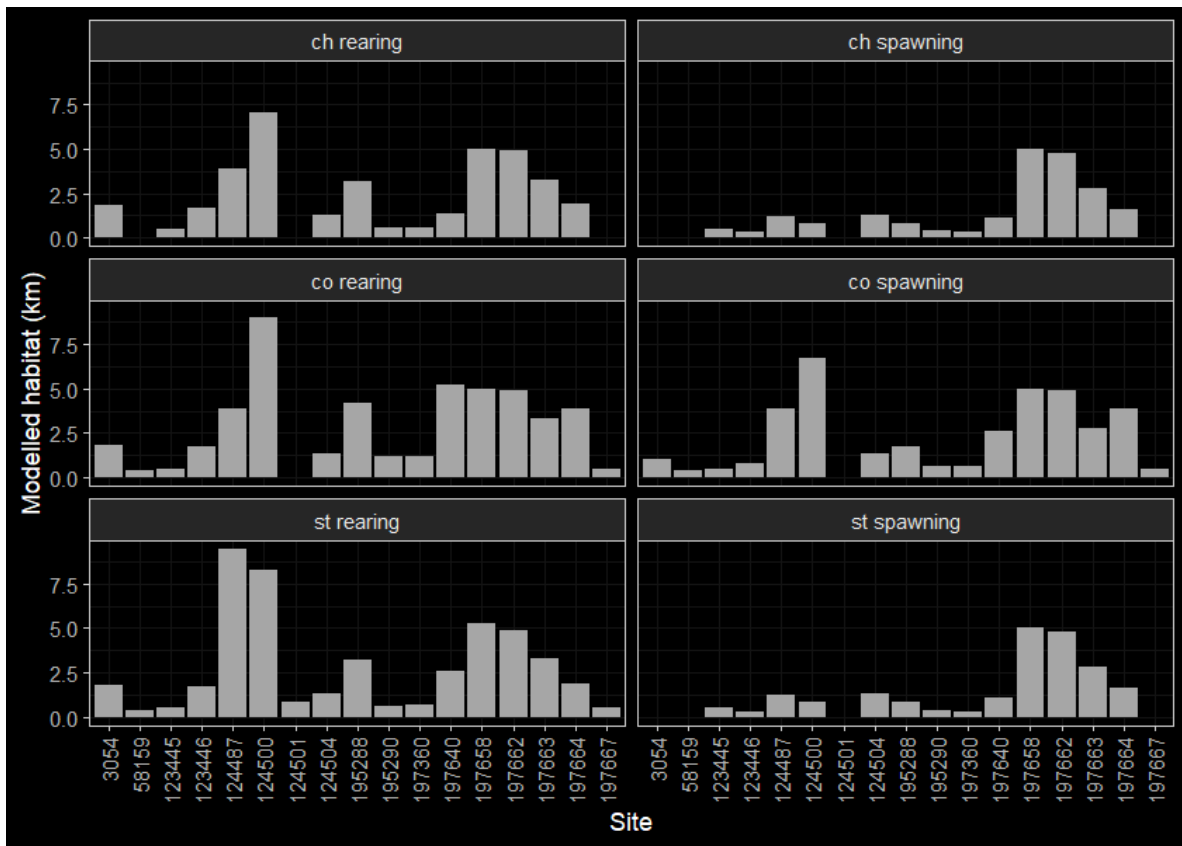
Figure 4.2: Summary of potential habitat upstream of habitat confirmation assessment sites estimated based on modelled channel width and upstream channel length.

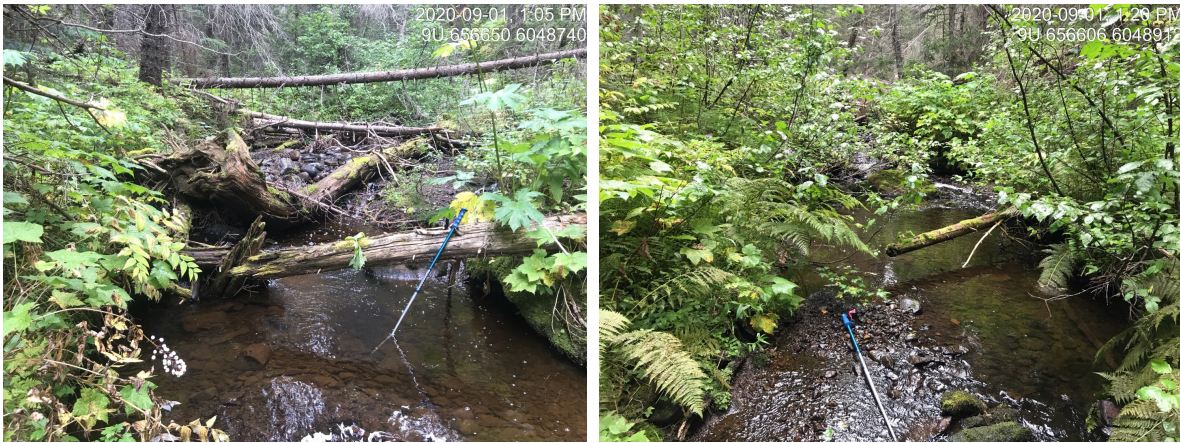
Figure 5.2: Left: Habitat upstream of PSCIS crossing 3139. Right: Habitat upstream of PSCIS crossing 3139.

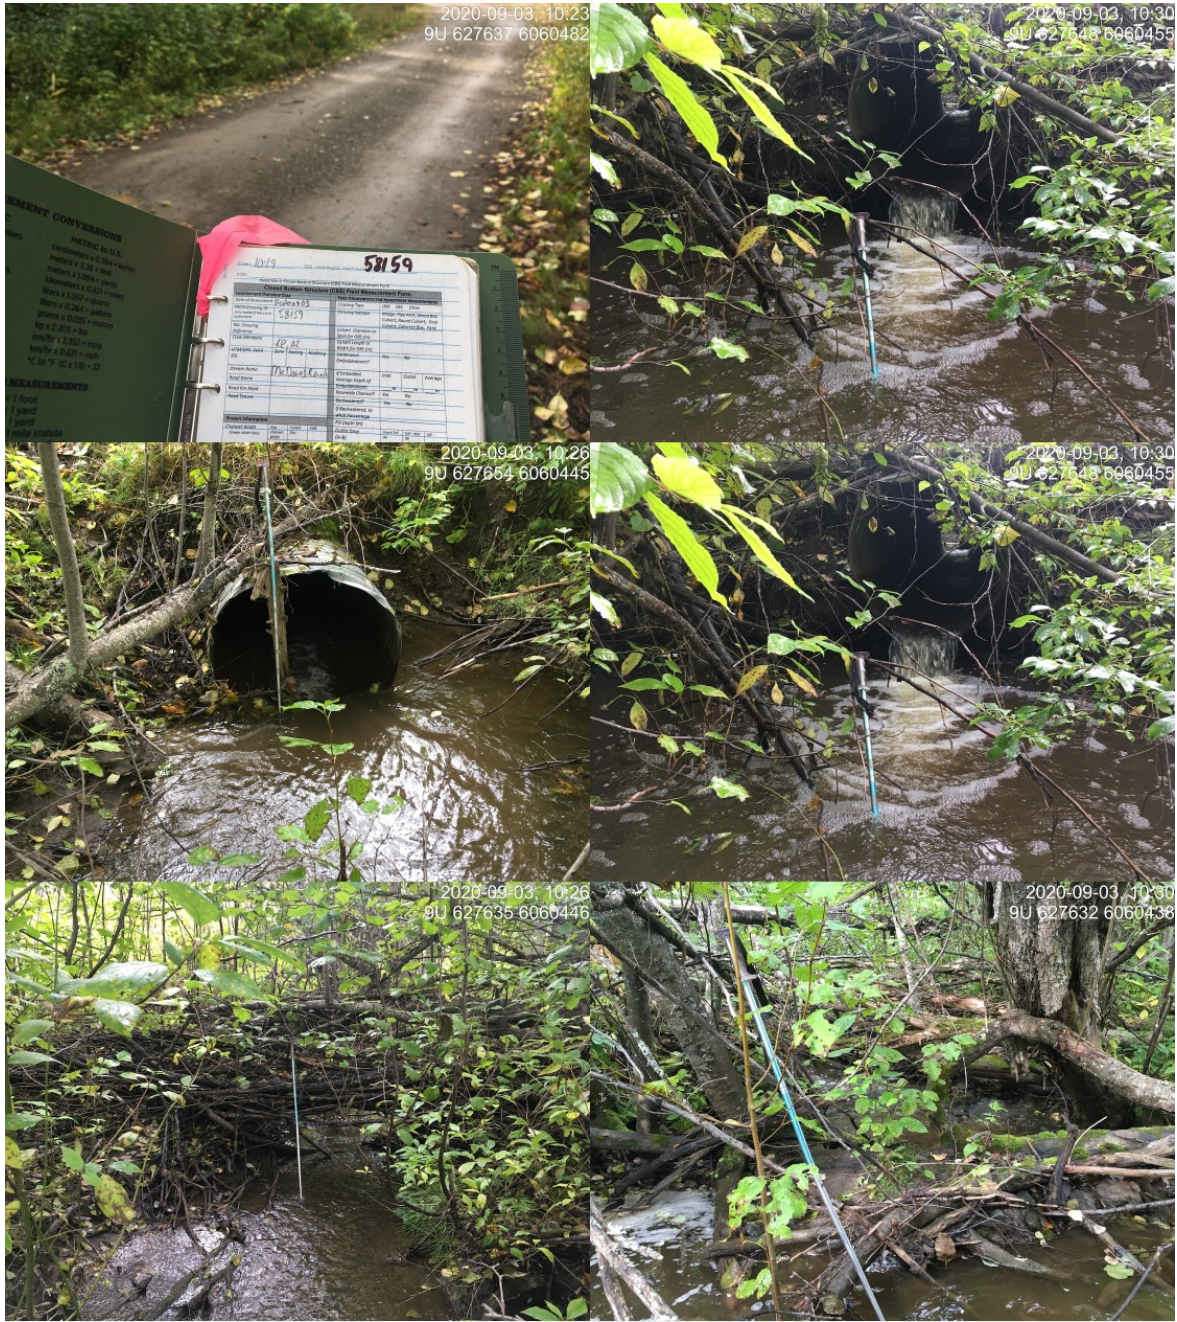
Date	2020-09-03	Crossing Sub Type	Round Culvert
PSCIS ID	58158	Diameter (m)	2.5
External ID	–	Length (m)	53
Crew	AI, KP	Embedded	Yes
UTM Zone	9	Depth Embedded (m)	0.5
Easting	628044	Resemble Channel	Yes
Northing	6060527	Backwatered	No
Stream	McDowell Creek	Percent Backwatered	–
Road	Highway 16	Fill Depth (m)	4
Road Tenure	MoTi highway	Outlet Drop (m)	0.36
Channel Width (m)	2.5	Outlet Pool Depth (m)	0.45
Stream Slope (%)	3	Inlet Drop	Yes
Beaver Activity	No	Slope (%)	5.5
Habitat Value	High	Valley Fill	Deep Fill
Final score	34	Barrier Result	Barrier
Fix type	Replace with New Open Bottom Structure	Fix Span / Diameter	13
Photos: From top left clockwise: Road/Site Card, Barrel, Outlet, Downstream, Upstream, Inlet.

Comments: New culvert horizontally drilled under highway in 2017. Structure has baffles made of ored concrete and boulders. Often deep pools up to 50cm before baffles. Baffles seem sharp and have potential to injure fish ascending?

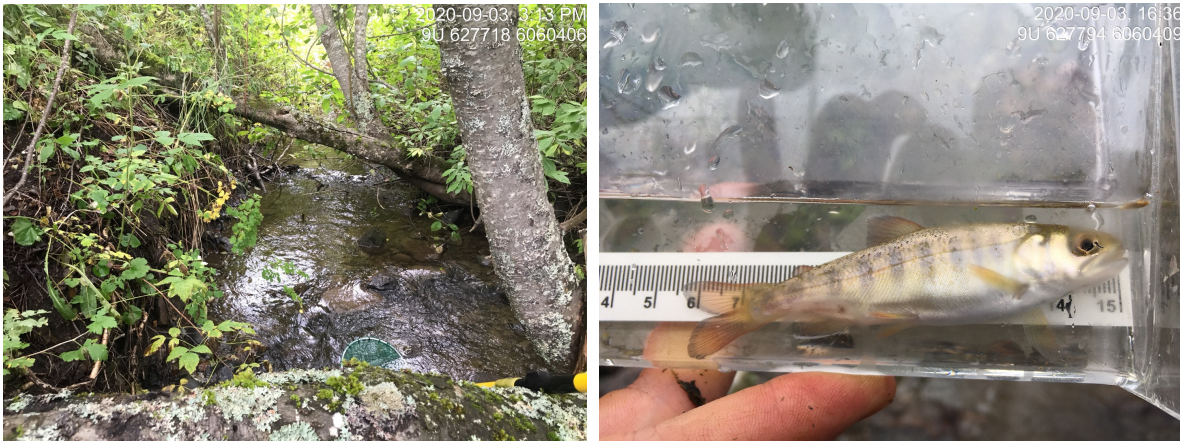
Figure 5.5: Left: Typical habitat upstream of PSCIS crossing 58159. Right: Coho captured upstream of PSCIS crossing 58159.

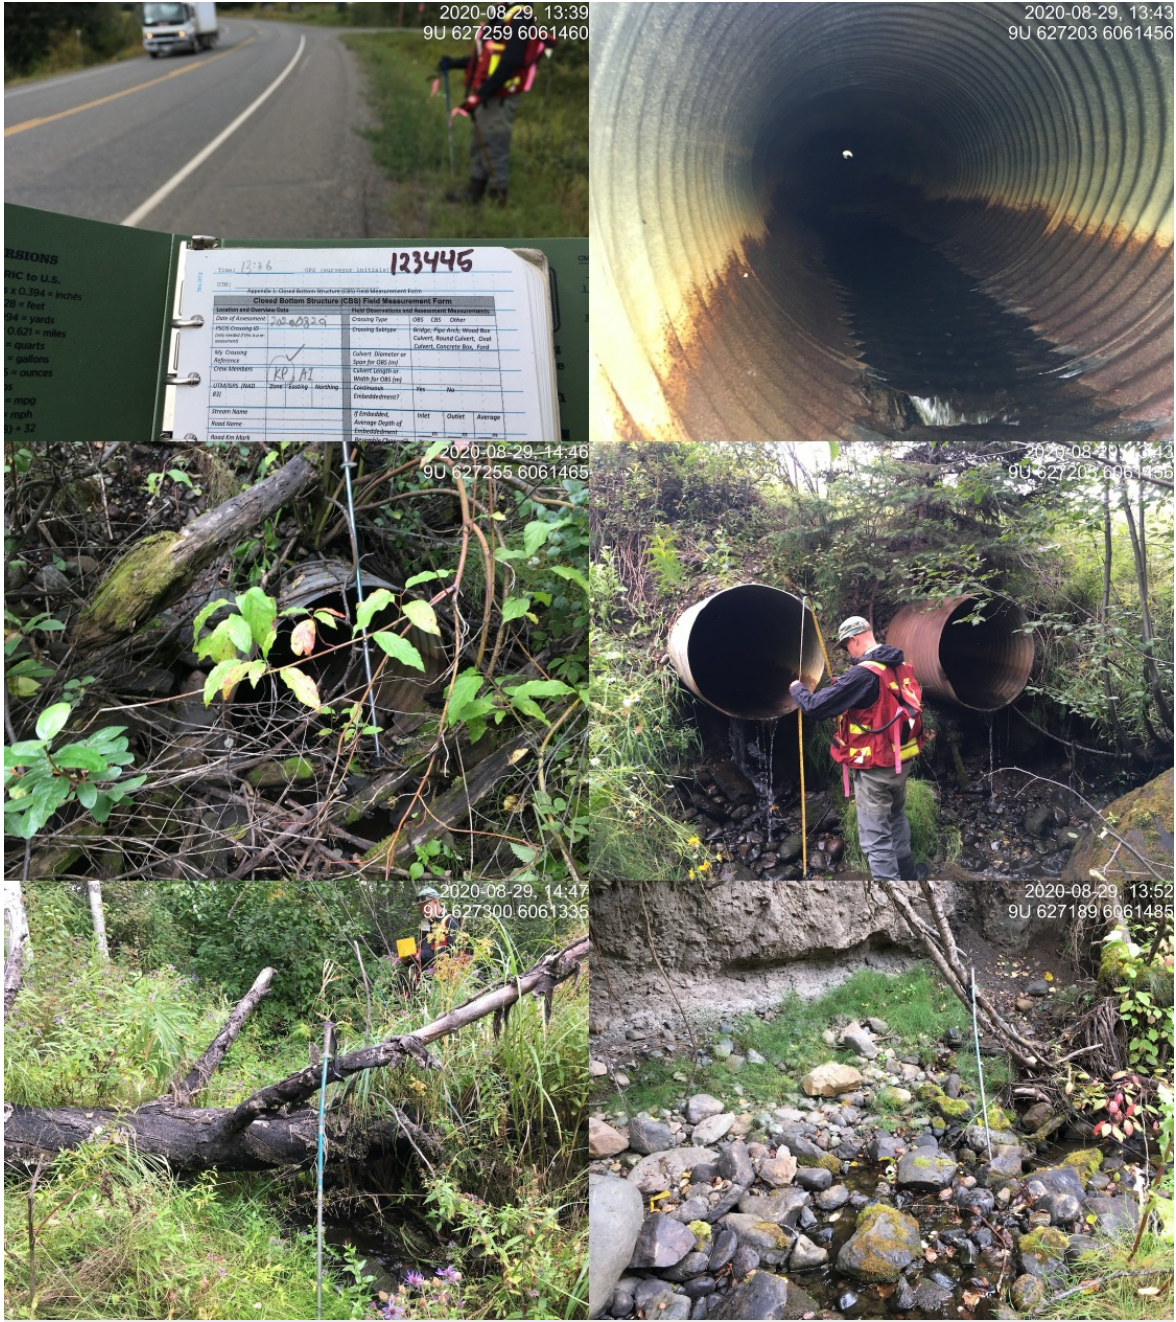
Comments: Important migration corridor to Tye Lake. Large outlet drop seems unlikely passabel by any life stage or species.

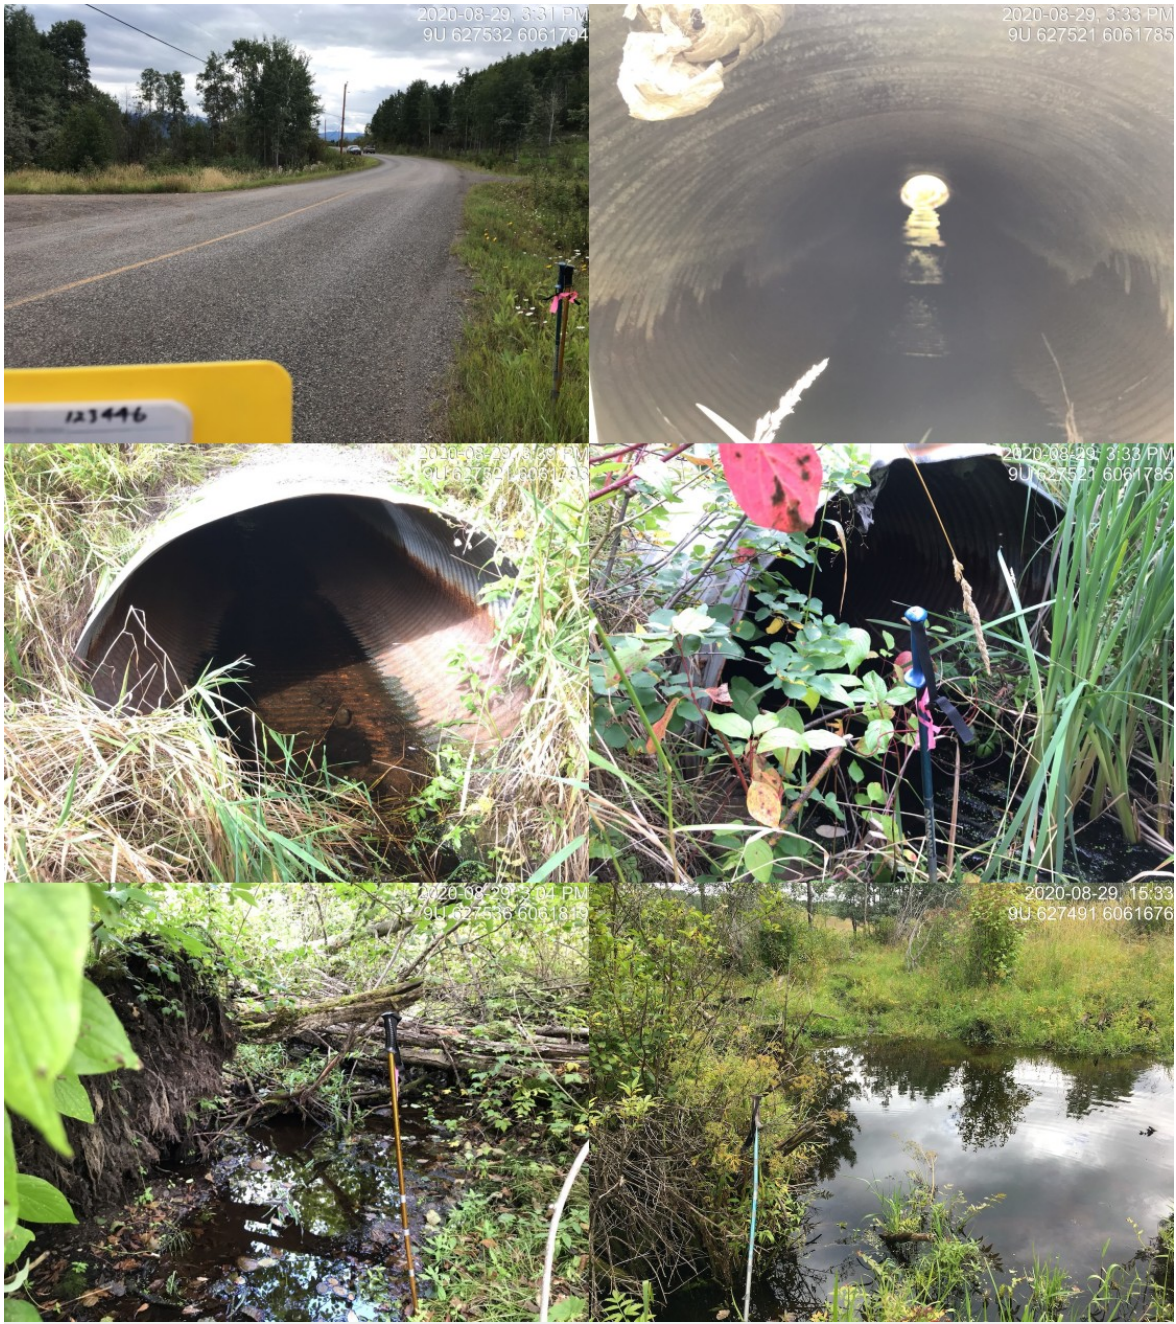
Comments: Important migration corridor to get to Tye Lake from Bulkley River. Crossing does not appear to be barrier to most life stages/species at most flows.

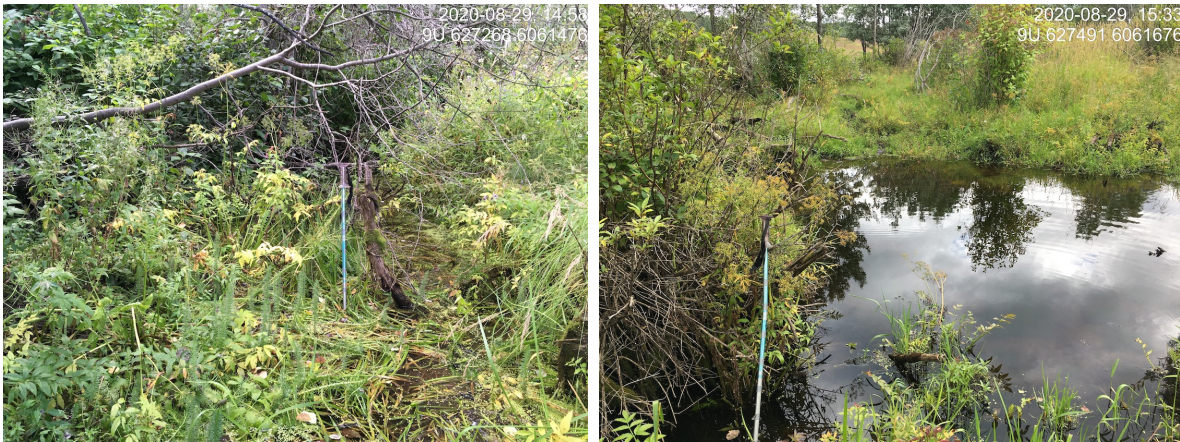
Figure 5.7: Left: Habitat upstream of PSCIS crossing 123445. Right: Habitat upstream of PSCIS crossing 123445.

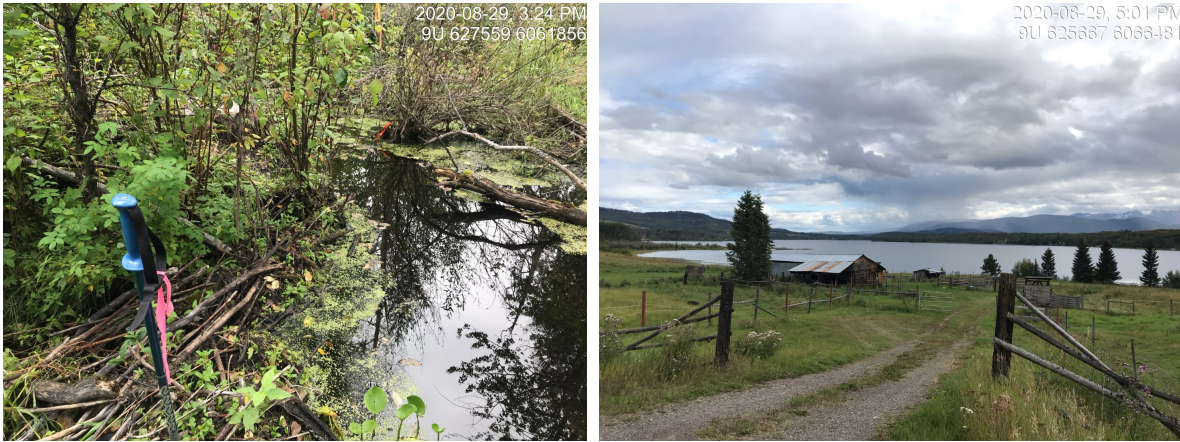
Figure 5.8: Left: Habitat upstream of PSCIS crossing 123446. Right: Habitat upstream of PSCIS crossing 123446.

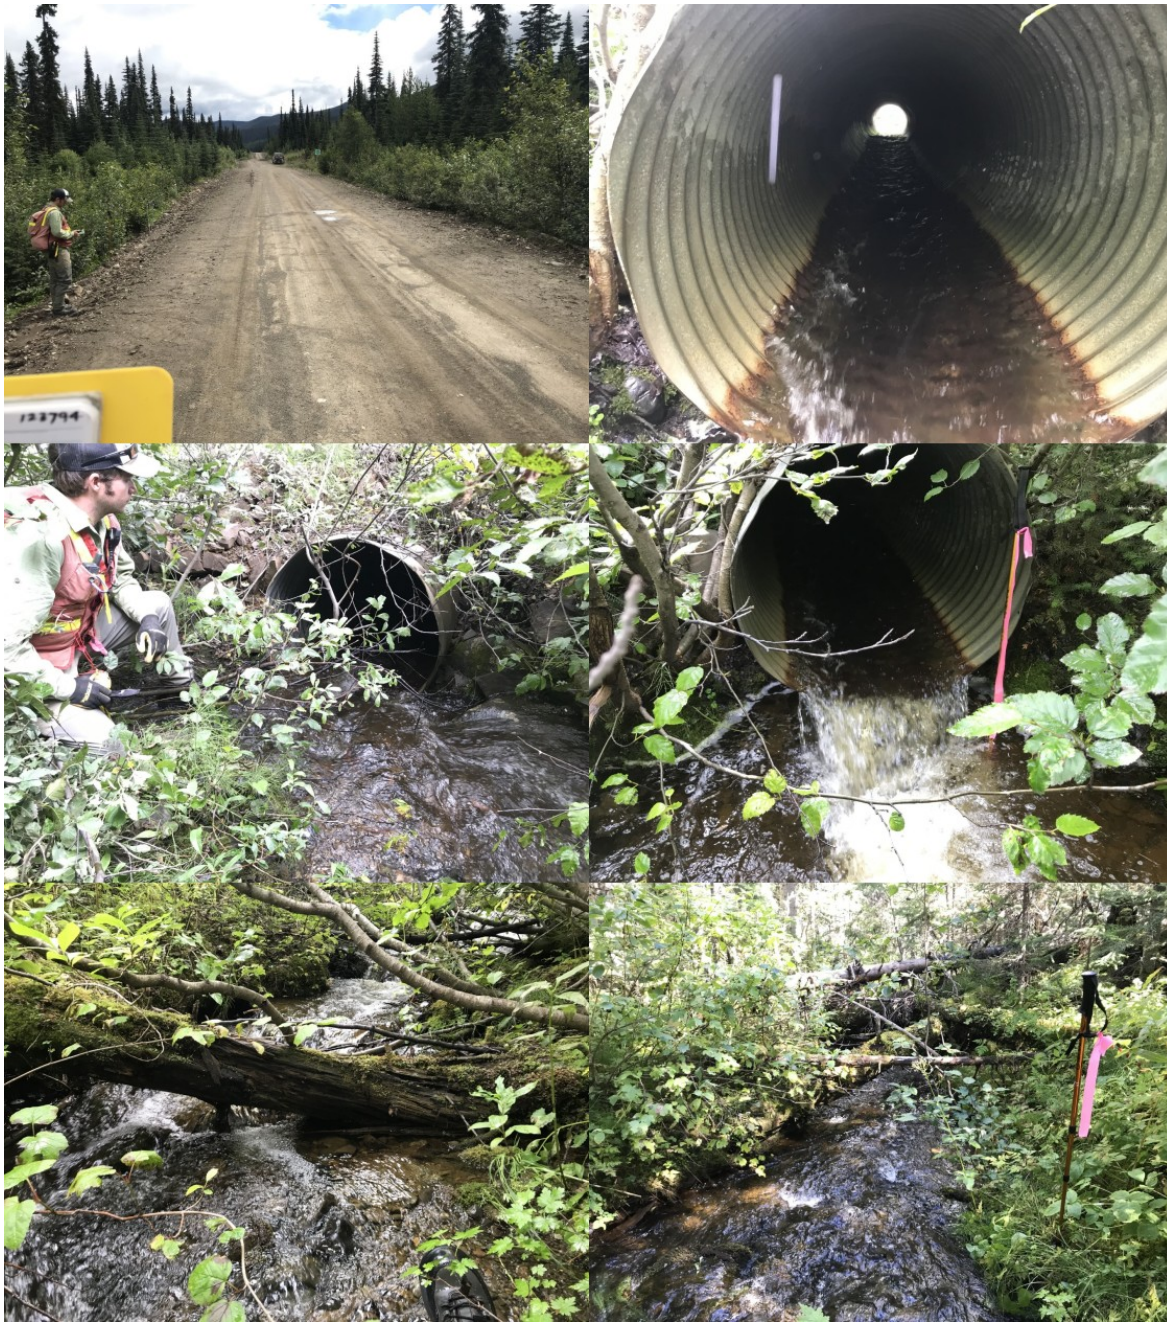
Photos: From top left clockwise: Road/Site Card, Barrel, Outlet, Downstream, Upstream, Inlet.

Comments: Smaller stream with good flow. Salmon points noted in adjacent stream. Recommend sampling upstream and downstream and habitat assessment of stream at associated PSCIS crossing 123785.

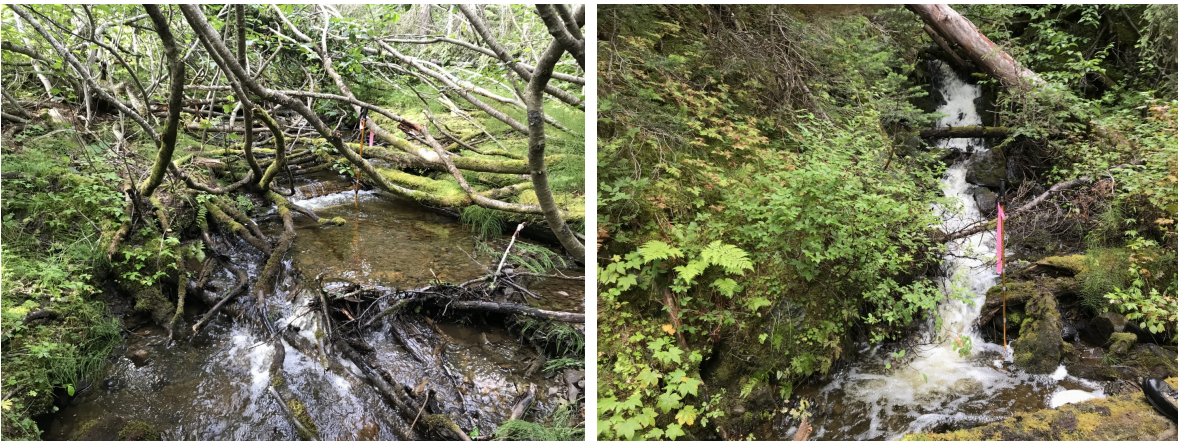
Figure 5.10: Left: Habitat upstream of PSCIS crossing 123794. Right: Cascade upstream of PSCIS crossing 123794.

The stream was surveyed immediately upstream from 123794 for approximately 525m (Figure 5.10). Within the area surveyed, total cover amount was rated as moderate with undercut banks dominant. Cover was also present as small woody debris, large woody debris, deep pools, and overhanging vegetation (Table 5.16). The average channel width was 1.9m, the average wetted width was 1.6m and the average gradient was 9.6%. The dominant substrate was gravels with cobbles subdominant. The channel was noted as having good complexity and abundant gravels suitably sized for both coho and resident salmonid spawning. Some small woody debris/large woody debris steps (30-50cm in height) were present intermittently starting approximately 400m above the culvert. A fish (~120mm) was observed 500m upstream of the culvert. A 4m high falls was noted at the top end of the site and represents an impassable barrier to upstream migration. Habitat value was rated as moderate for salmonid spawning and rearing.

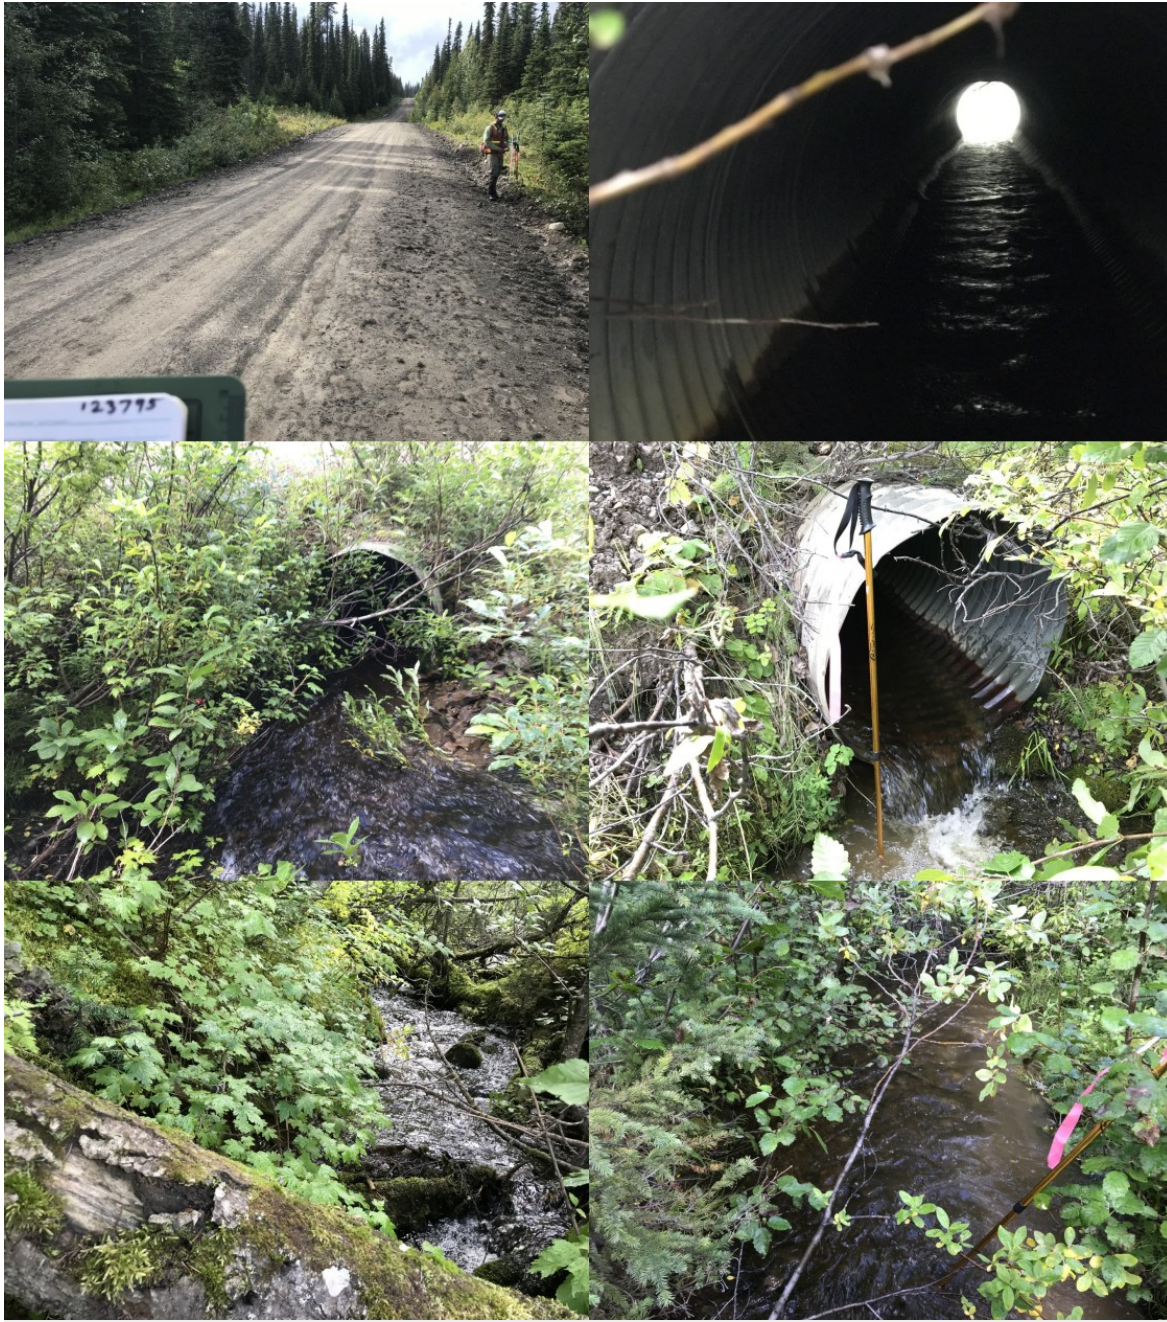
Photos: From top left clockwise: Road/Site Card, Barrel, Outlet, Downstream, Upstream, Inlet.

Comments: Smaller stream with good flow. Salmon point (juvenile) noted upstream. Recommend sampling upstream and downstream and habitat assessment of stream at associated PSCIS crossing 123785.

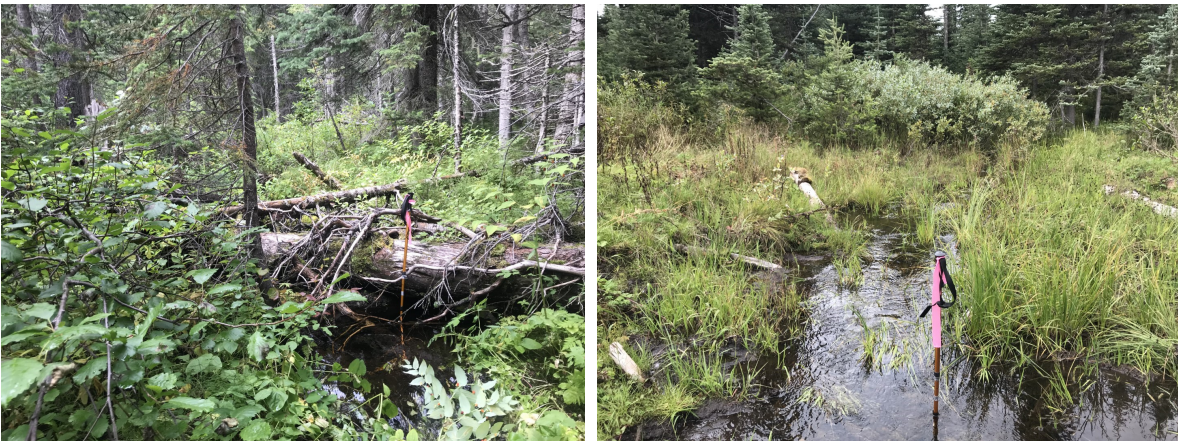
Figure 5.12: Left: Habitat upstream of PSCIS crossing 123795. Right: Cascade upstream of PSCIS crossing 123795.

The stream was surveyed immediately upstream from 123795 for approximately 650m to the location of a ford (PSCIS123796).(Figure 5.12). Within the area surveyed, total cover amount was rated as abundant with undercut banks dominant. Cover was also present as small woody debris, large woody debris, deep pools, overhanging vegetation, and instream vegetation (Table 5.19). The average channel width was 1.4m, the average wetted width was 1.3m and the average gradient was 7.2%. The dominant substrate was fines with cobbles subdominant. Deep glide habitat was noted as prevalent in the area surveyed. Gradients leveled out at top end of site, with primarily shrub and wetland riparian area present. Very occasional pockets of gravel suitable for resident and adfluvial salmonid spawning were noted. Habitat value was rated as moderate for salmonid spawning and rearing.

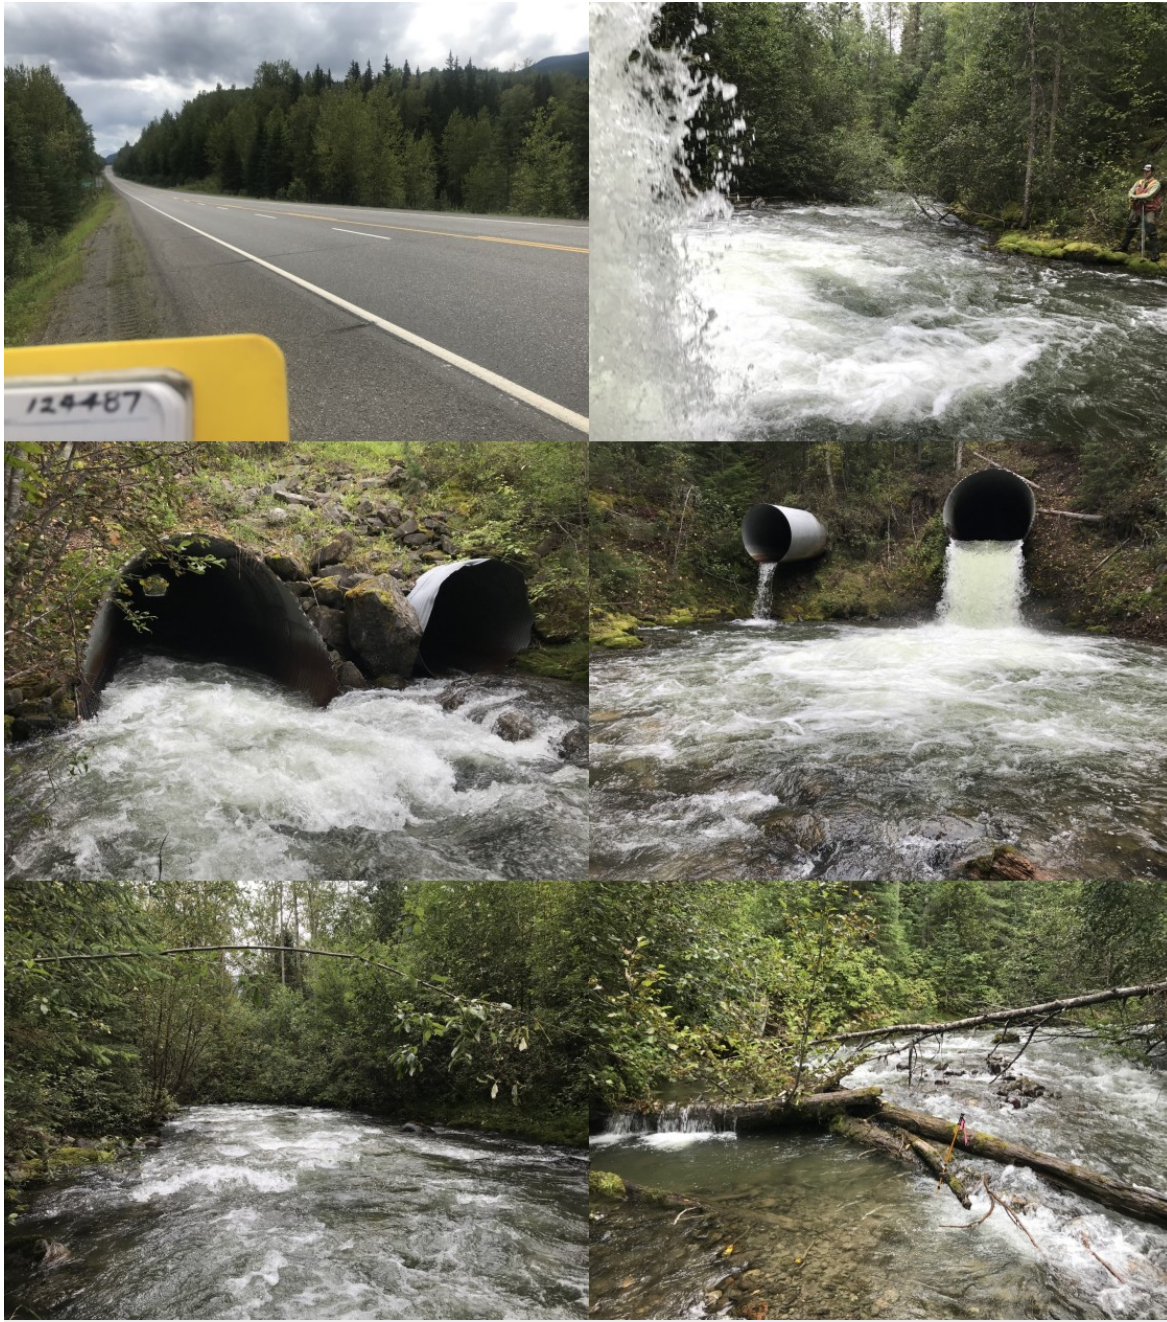
Location and Stream Data		Crossing Characteristics	
Date	2020-08-25	Crossing Sub Type	Round Culvert
PSCIS ID	124487	Diameter (m)	5
External ID	–	Length (m)	99
Crew	AI, KP	Embedded	No
UTM Zone	9	Depth Embedded (m)	–
Easting	603073	Resemble Channel	No
Northing	6113363	Backwatered	No
Stream	Porphyryr Creek	Percent Backwatered	–
Road	Highway 16	Fill Depth (m)	9.99
Road Tenure	FLNR Nadina 7543	Outlet Drop (m)	2.5
Channel Width (m)	11.2	Outlet Pool Depth (m)	4
Stream Slope (%)	2.8	Inlet Drop	Yes
Beaver Activity	No	Slope (%)	4
Habitat Value	High	Valley Fill	Deep Fill
Final score	42	Barrier Result	Barrier
Fix type	Replace with New Open Bottom Structure	Fix Span / Diameter	31
Photos: From top left clockwise: Road/Site Card, Barrel, Outlet, Downstream, Upstream, Inlet.

Comments: Unpassable to all life stages and species. Fill depth is approximately 35m. Salomid (50cm) observed trying to ascend to outlet of main pipe.

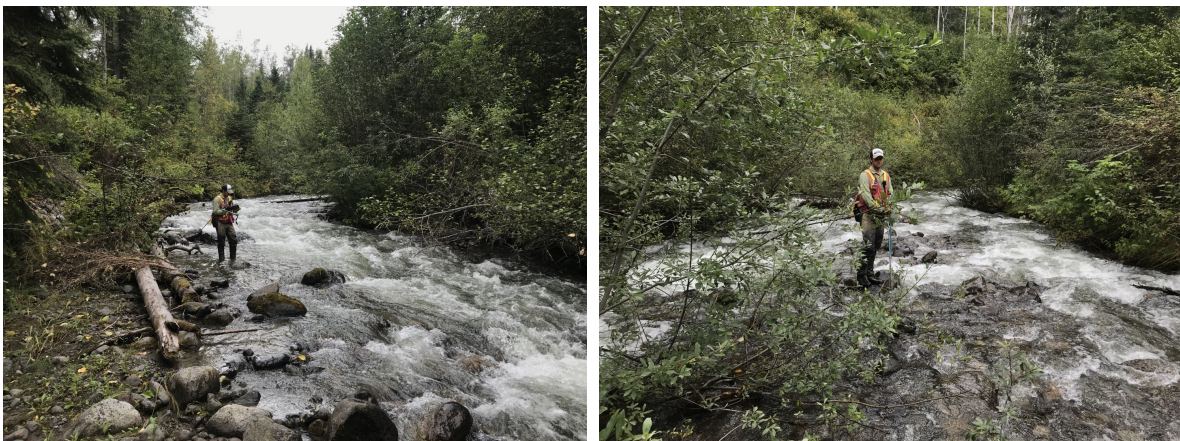
Figure 5.14: Left: habitat upstream of PSCIS crossing 124487. Right: Habitat upstream of PSCIS crossing 124487.

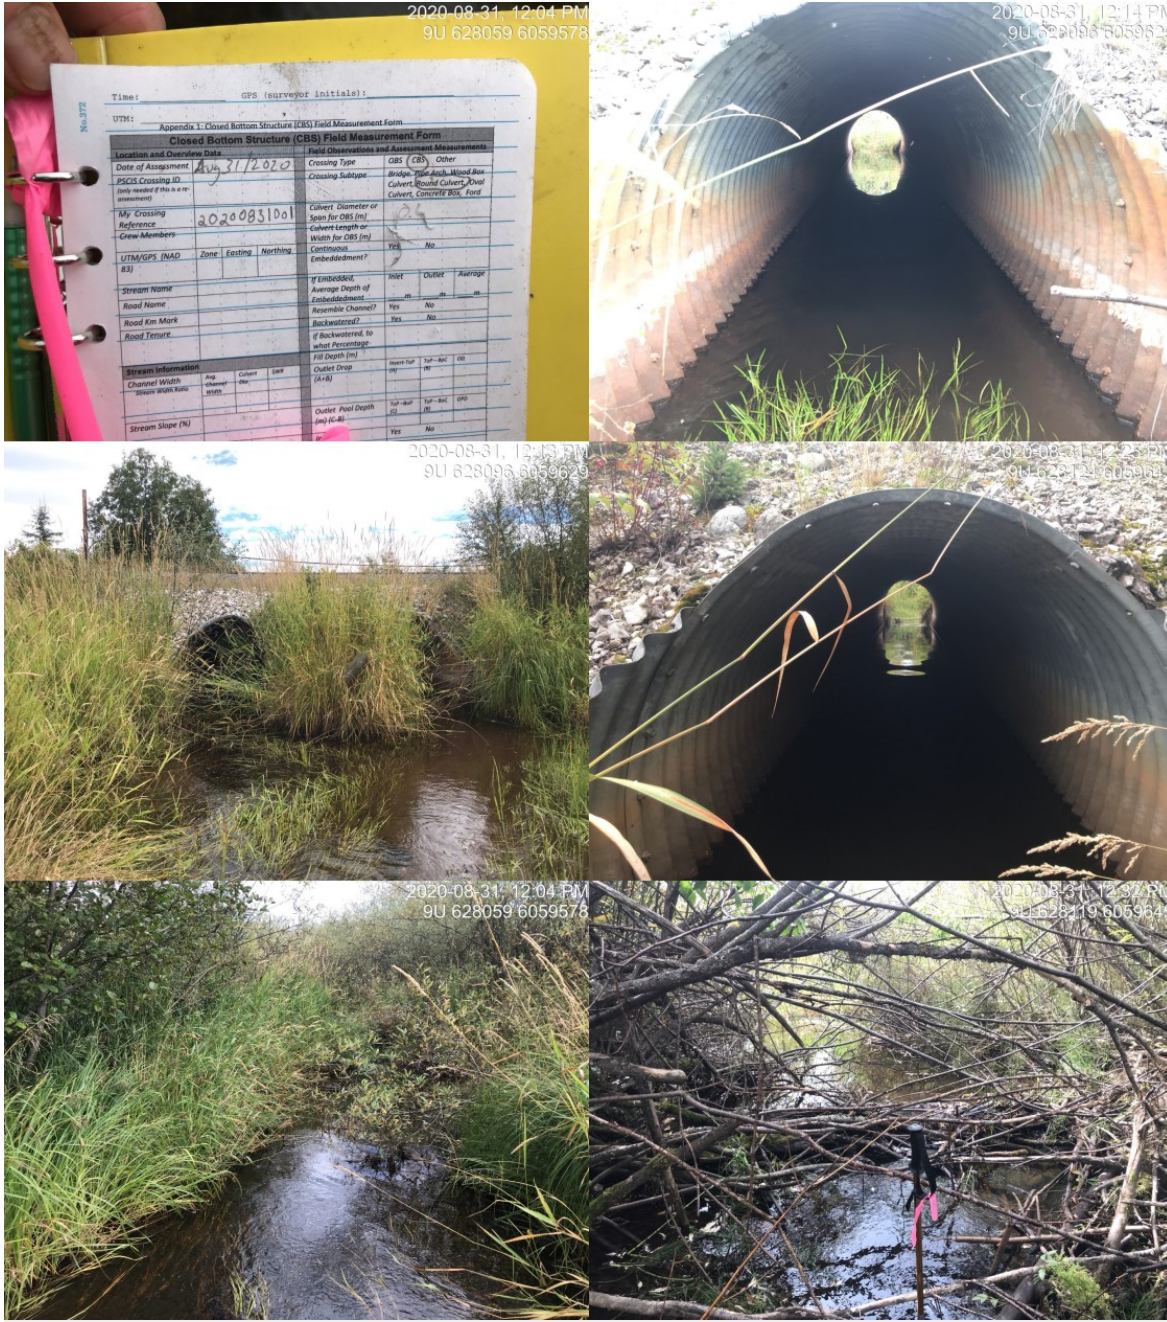
Photos: From top left clockwise: Road/Site Card, Barrel, Outlet, Downstream, Upstream, Inlet.

Comments: Passable and fully backwatered structure. Landowner reports that lamprey (~40cm x 20) at crossing inside of the culvert in the past.

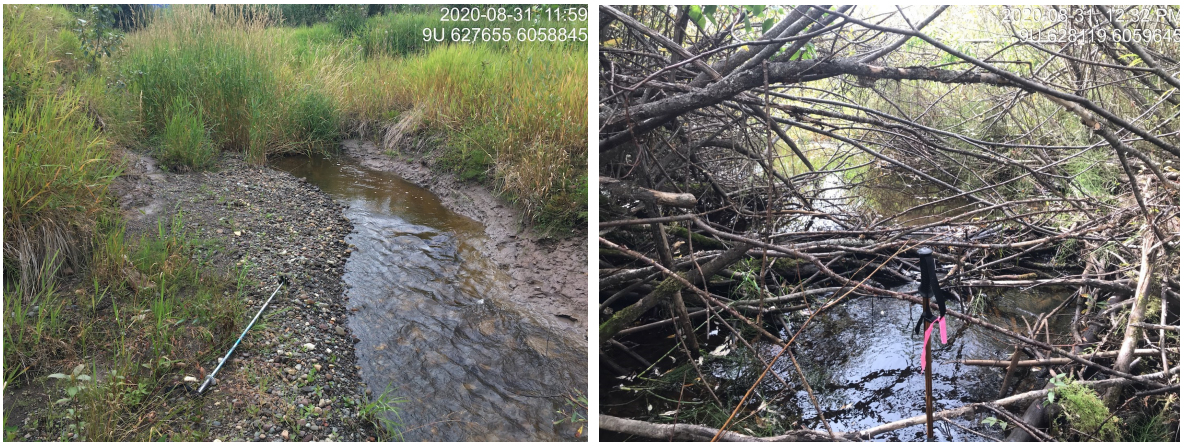
Figure 5.15: Left: Habitat downstream of PSCIS crossing 124500. Right: Habitat downstream of crossing 124500 below the railway culverts.

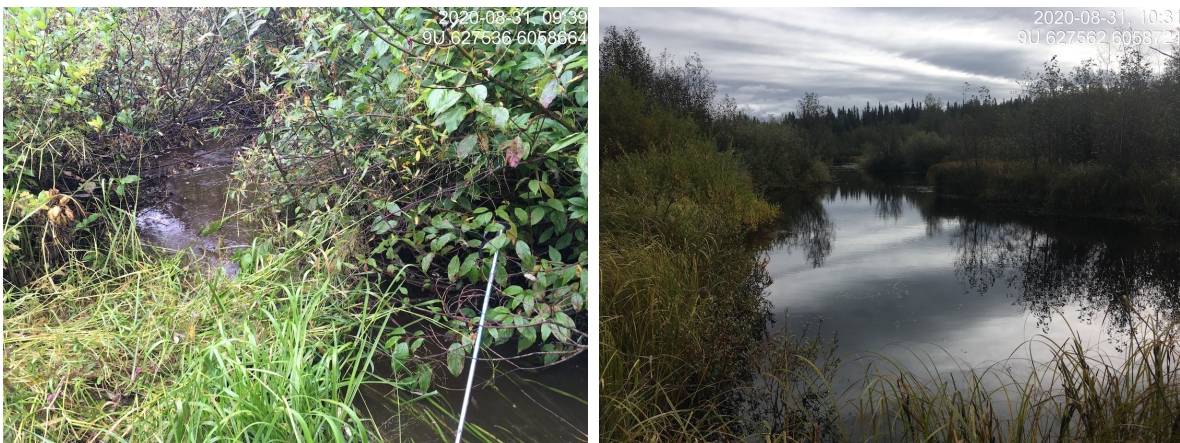
Figure 5.16: Left: Habitat upstream of PSCIS crossing 124500. Right: Habitat upstream of PSCIS crossing 124500.

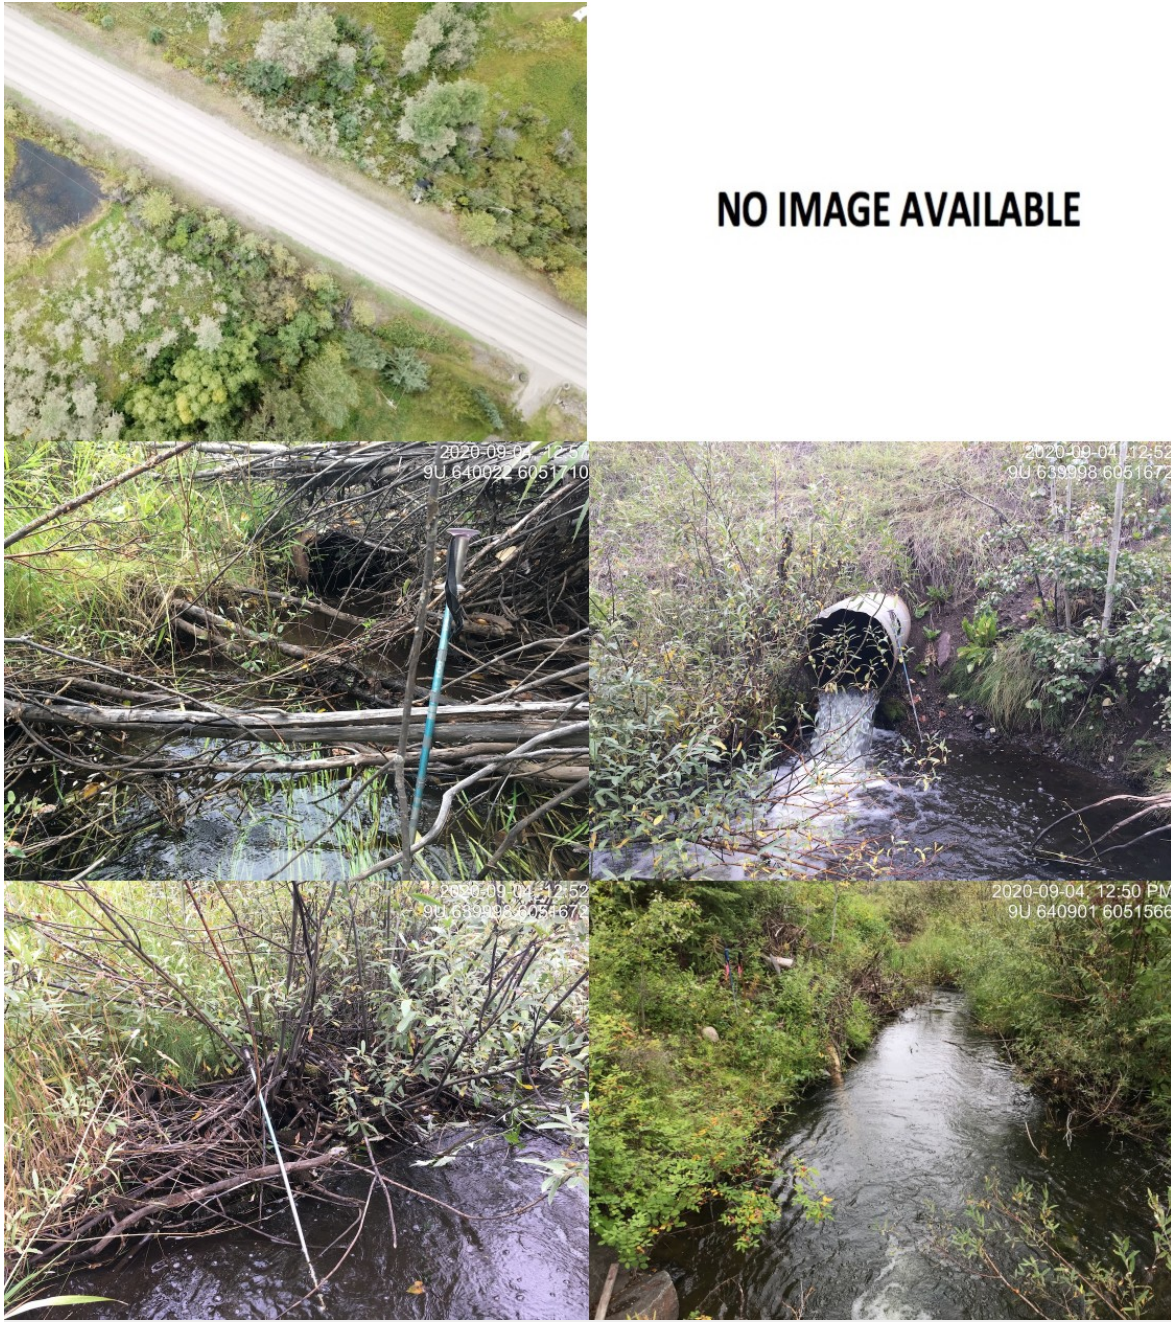
Comments: Flows into Deep Creek downstream. Electrofished upstream and downstream. Wetland type habitat upstream with CO captured below only. Candidate for backwatering?
