SOCIETY FOR ECOSYSTEM RESTORATION
IN NORTHERN BRITISH COLUMBIA

Bulkley River and Morice River Watershed Groups Fish Passage Restoration Planning

**Version 0.1.2
2021-04-21**

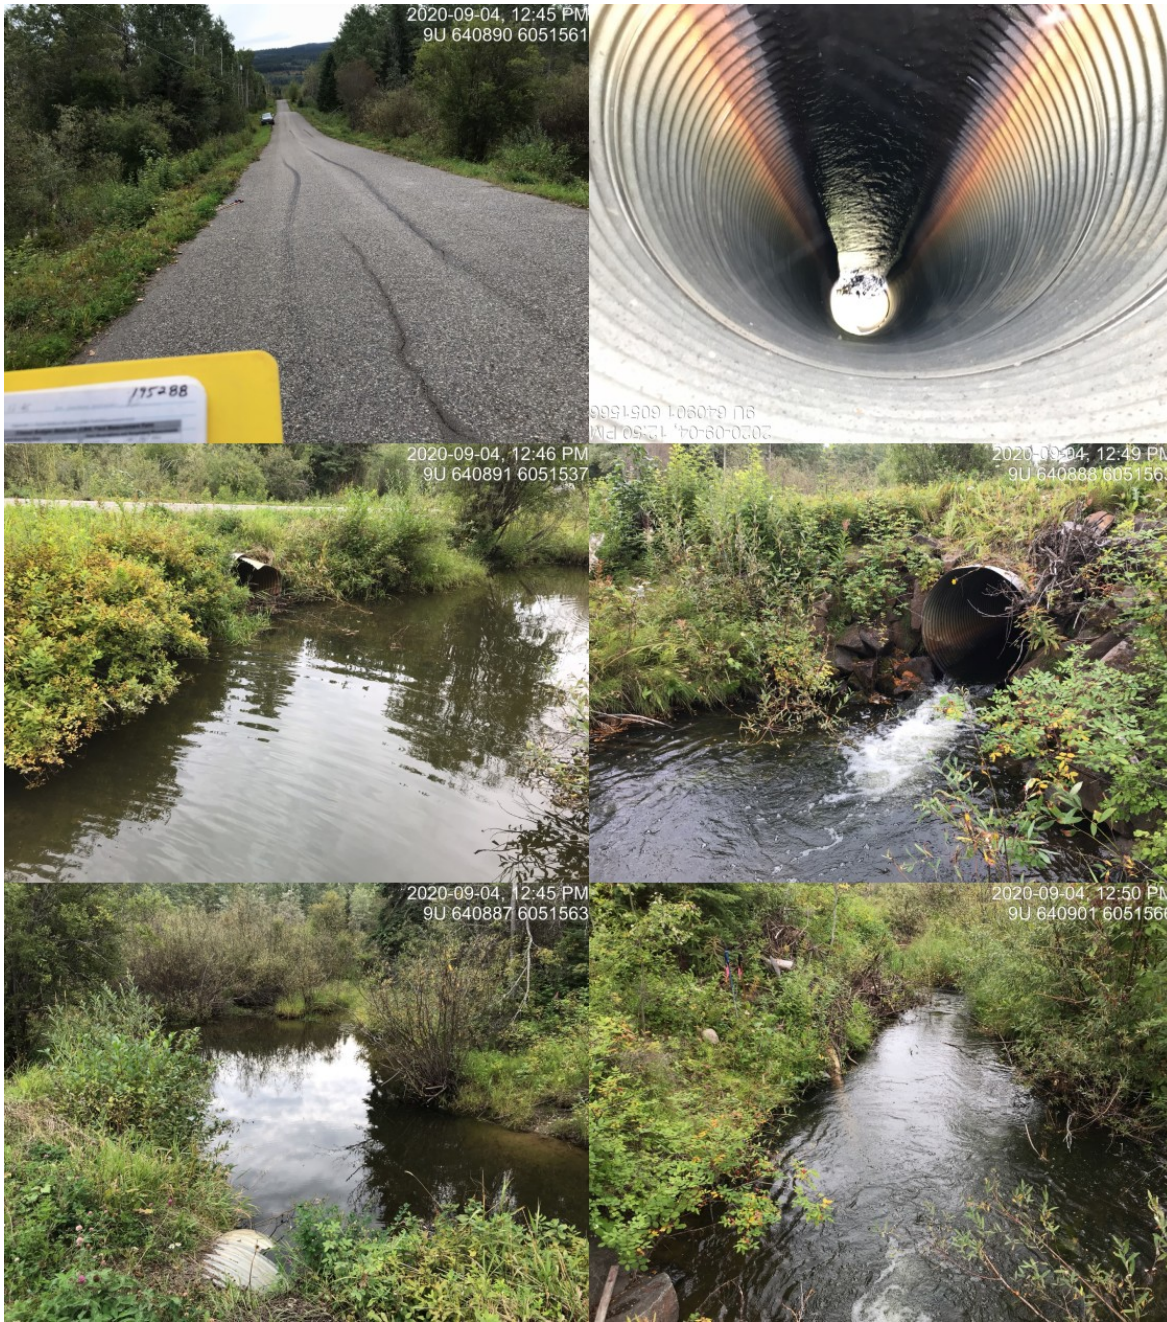
Comments: Wetland type habitat upstream and downstream. Drone flight conducted upstream to map immediate area upstream.

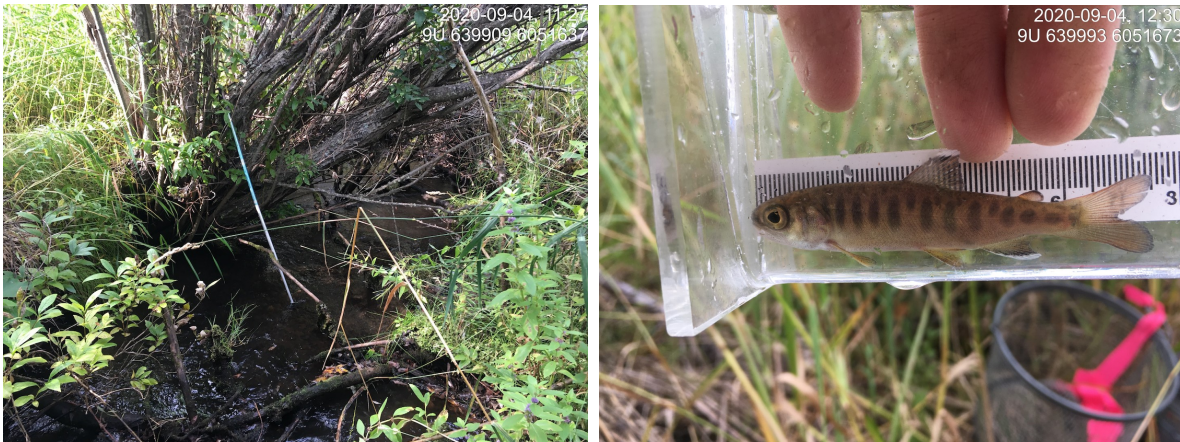
Figure 5.18: Left: Typical habitat downstream of PSCIS crossing 195290. Right: Coho captured downstream of PSCIS crossing 195290.

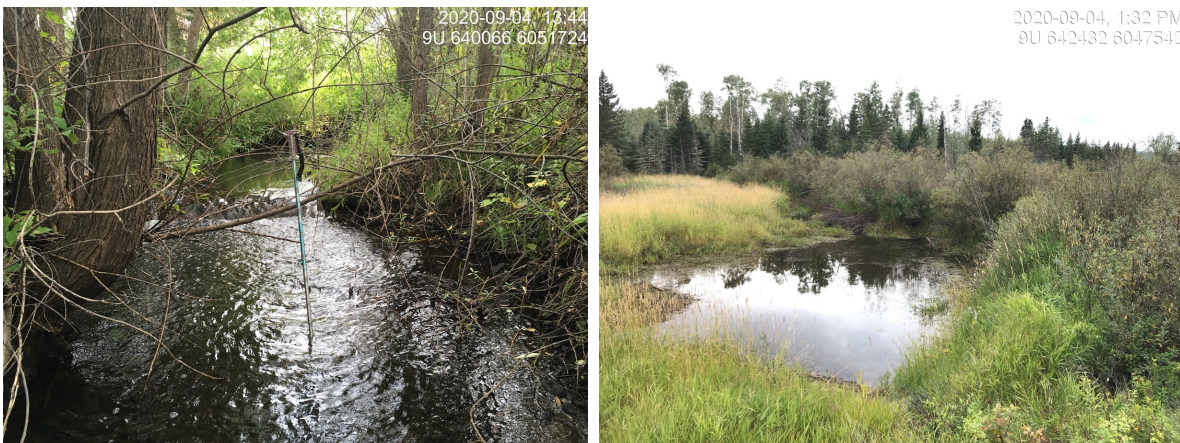
Figure 5.19: Left: Typical habitat upstream of PSCIS crossing 195290. Right: Wetland habitat upstream of PSCIS crossing 195290.

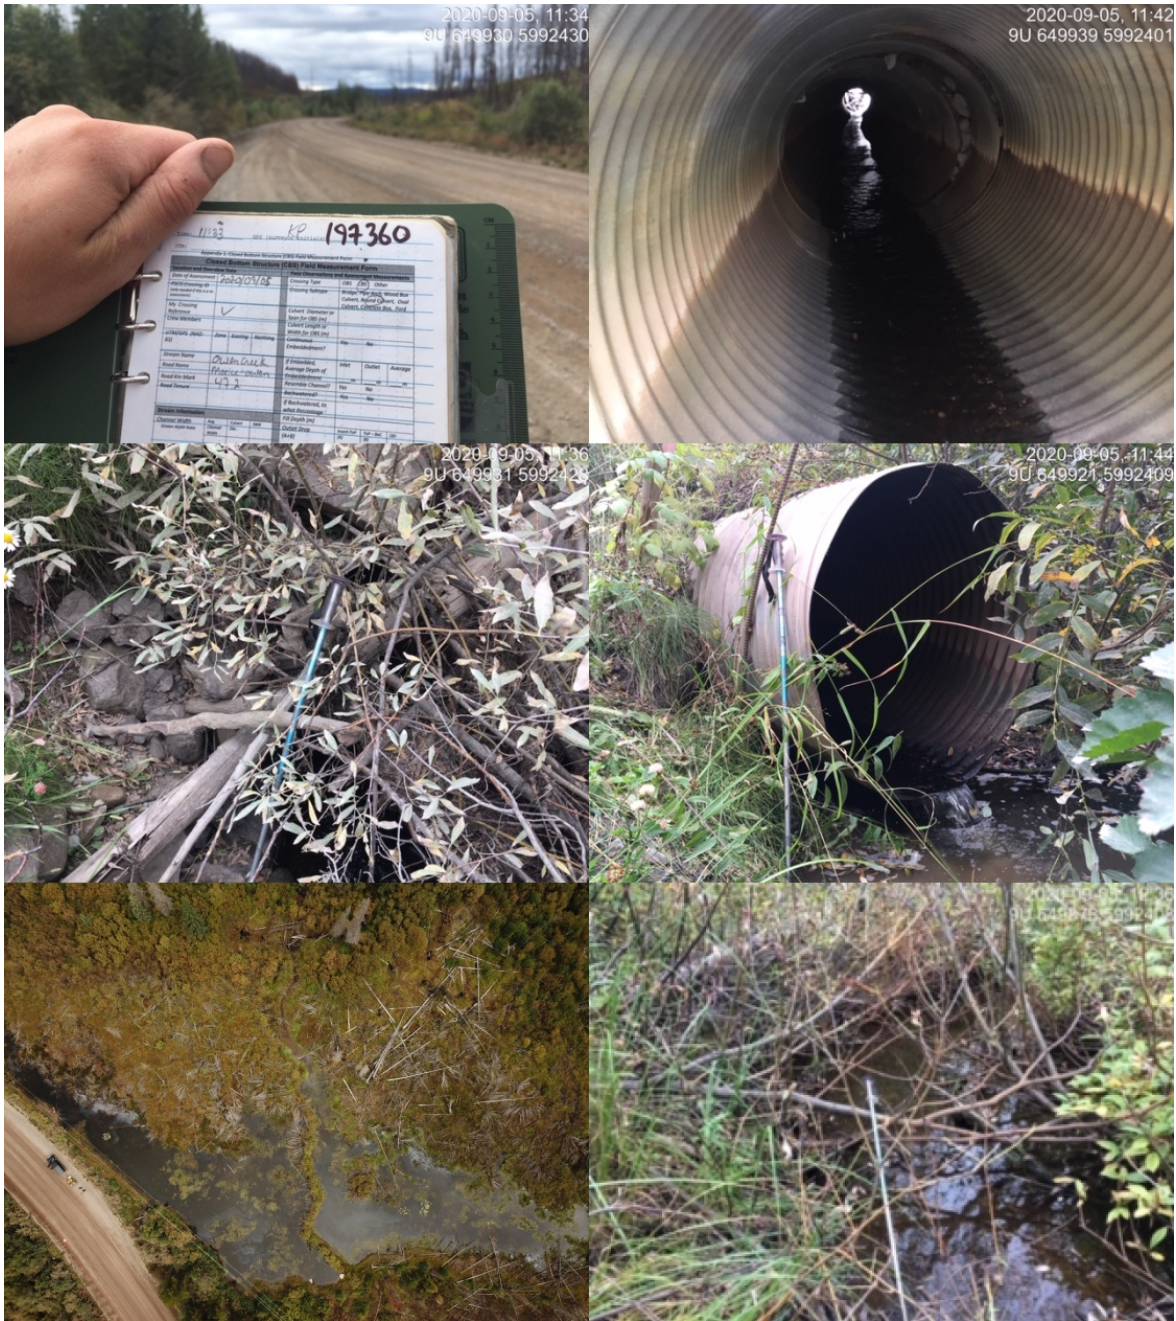
Comments: Wetland type habitat for first 300m upstream then 3m wide channel with cover available in all forms with pools suitable for juvenile RB and CO overwintering. Abundant gravels and small cobbles through suitable for CO or RB/ST spawning.

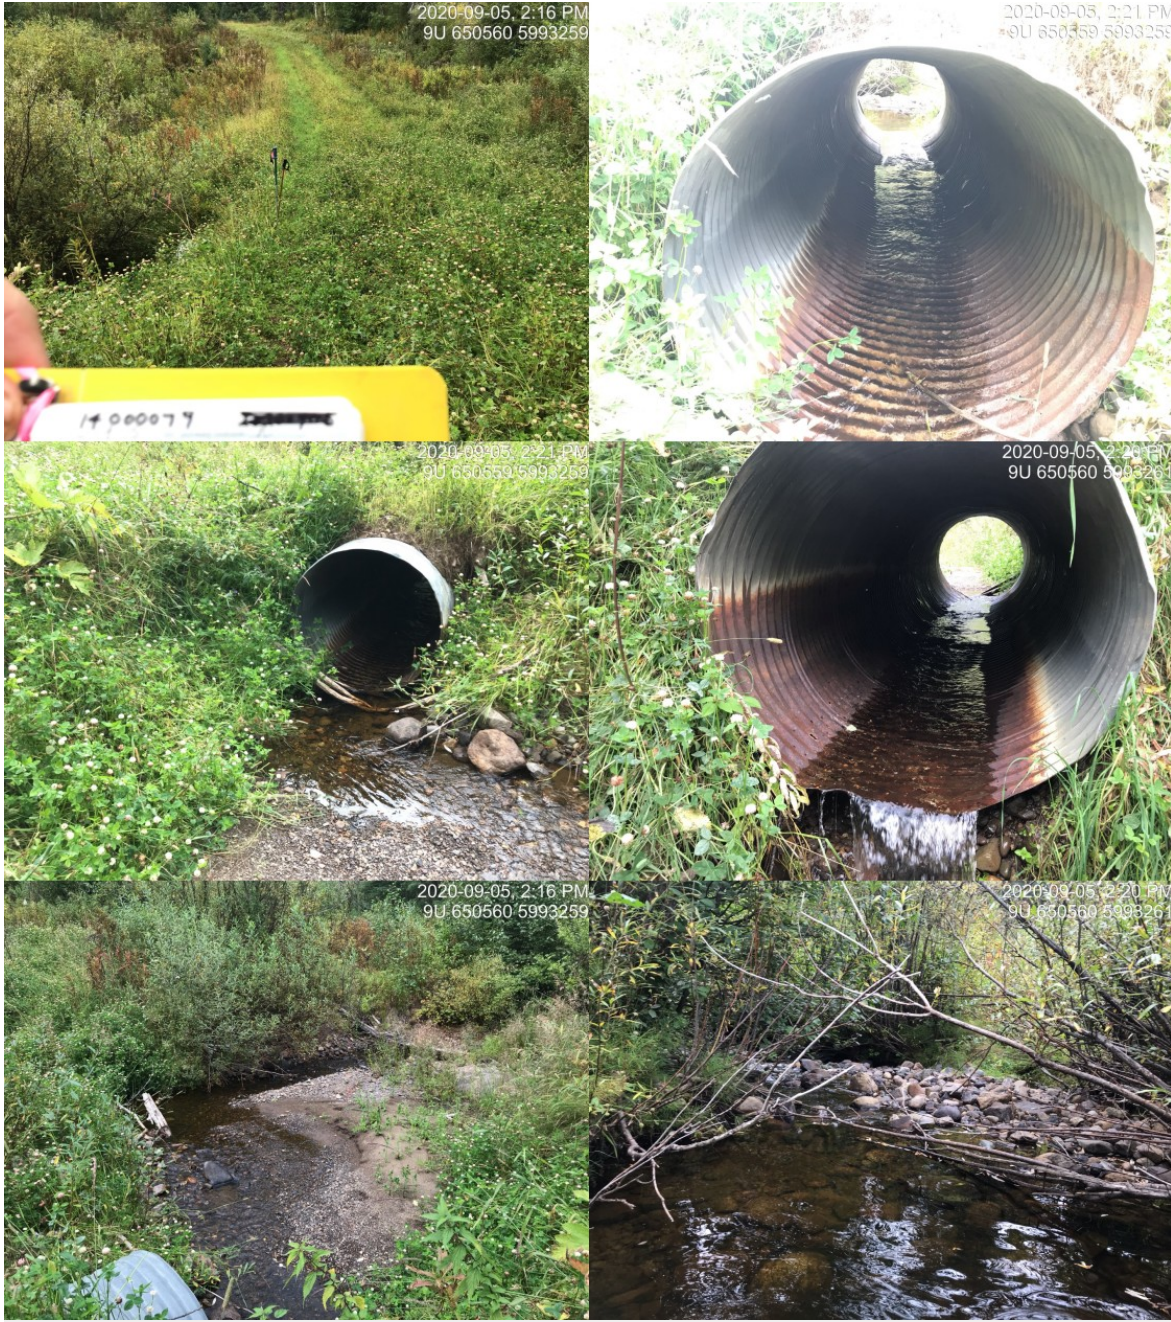
Comments: Extensive rearing habitat and gravels suitable for spawning. Stream eventually flows into top end of Owen Lake.

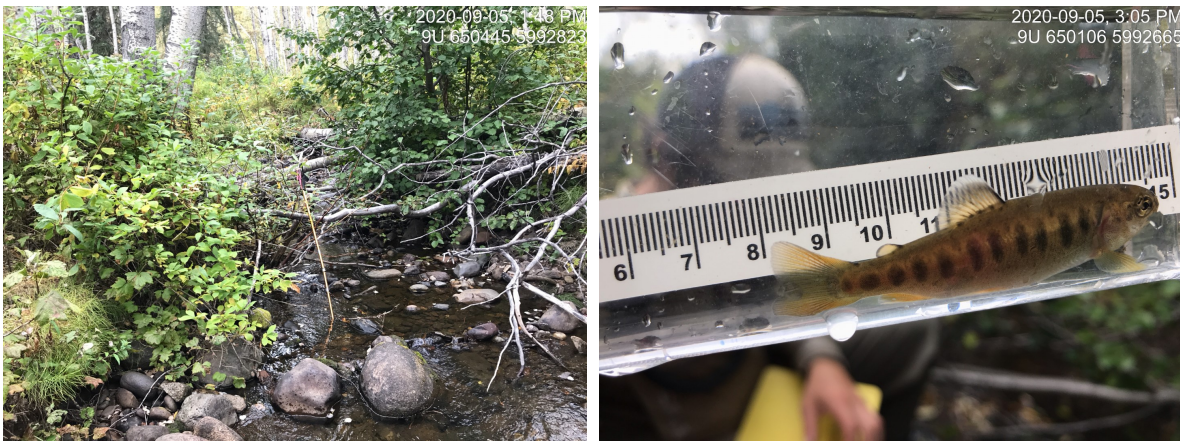
Figure 5.23: Left: Typical habitat upstream of PSCIS crossing 197360. Right: Rainbow trout captured upstream of PSCIS crossing 197360.

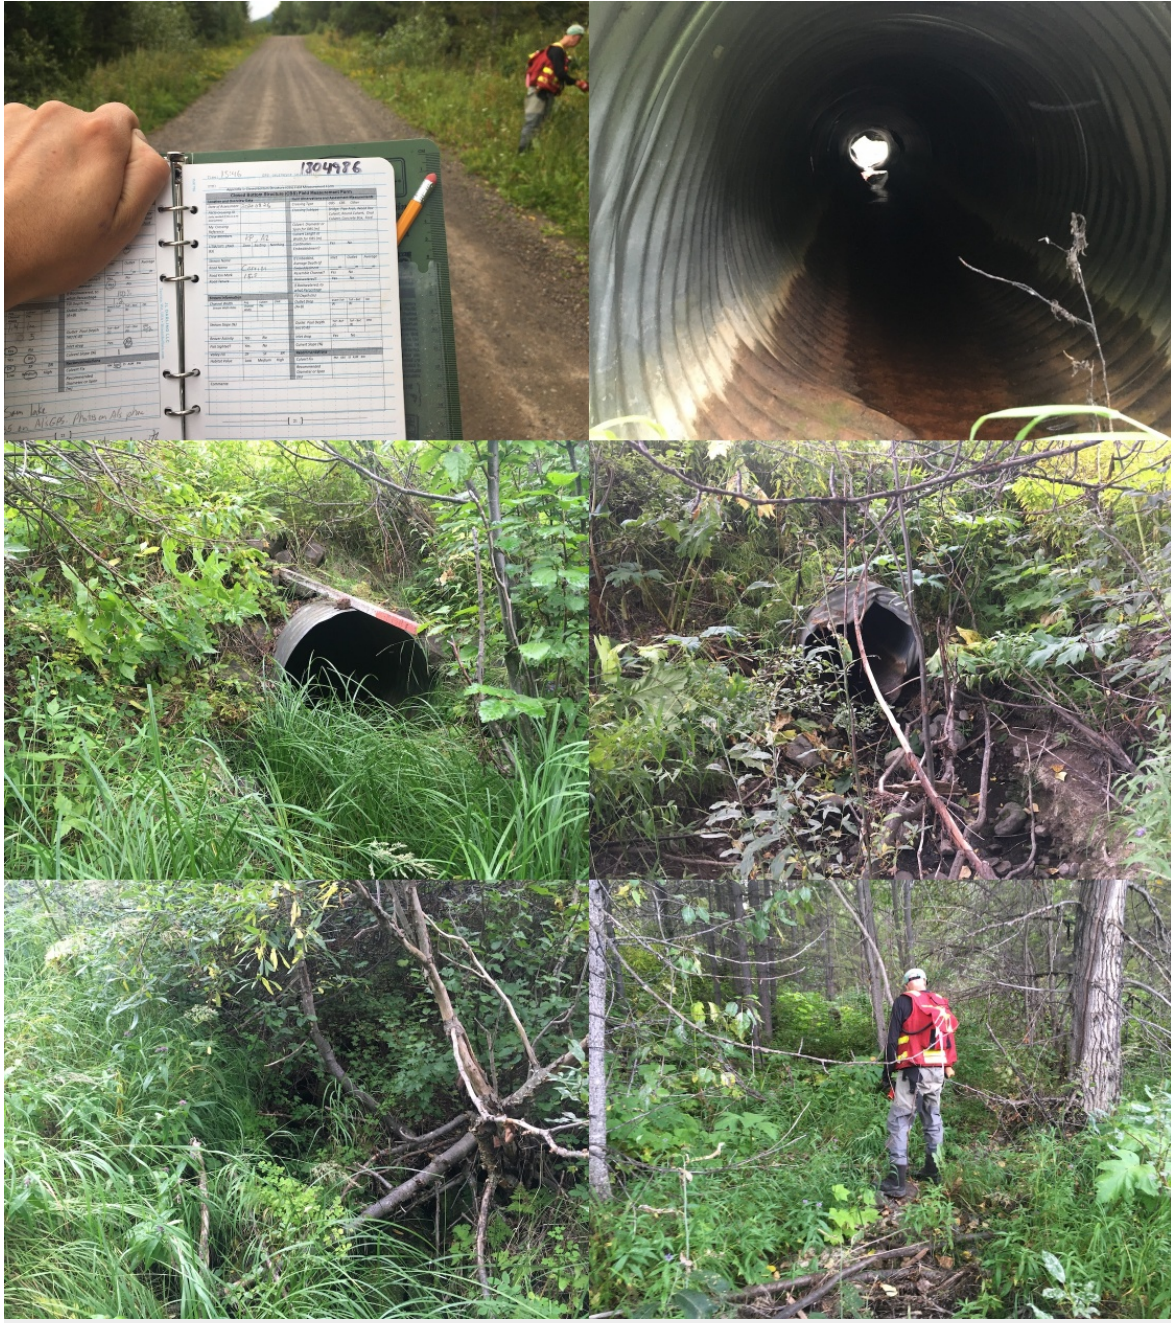
Crew	KP, AI	Embedded	No
UTM Zone	9	Depth Embedded (m)	–
Easting	651263.5	Resemble Channel	No
Northing	6012508	Backwatered	No
Stream	Tributary to Buck Creek	Percent Backwatered	–
Road	Carrier FSR	Fill Depth (m)	1.8
Road Tenure	FLNR Nadina 9772	Outlet Drop (m)	0.3
Channel Width (m)	1.5	Outlet Pool Depth (m)	0
Stream Slope (%)	2	Inlet Drop	No
Beaver Activity	No	Slope (%)	1.5
Habitat Value	Low	Valley Fill	Deep Fill
Final score	34	Barrier Result	Barrier
Fix type	Replace Structure with Streambed Simulation CBS Fix Span / Diameter		3
Photos: From top left clockwise: Road/Site Card, Barrel, Outlet, Downstream, Upstream, Inlet.

Comments: Suspect no fish. Multiple fish survey sites located downstream. Dry at time of survey.

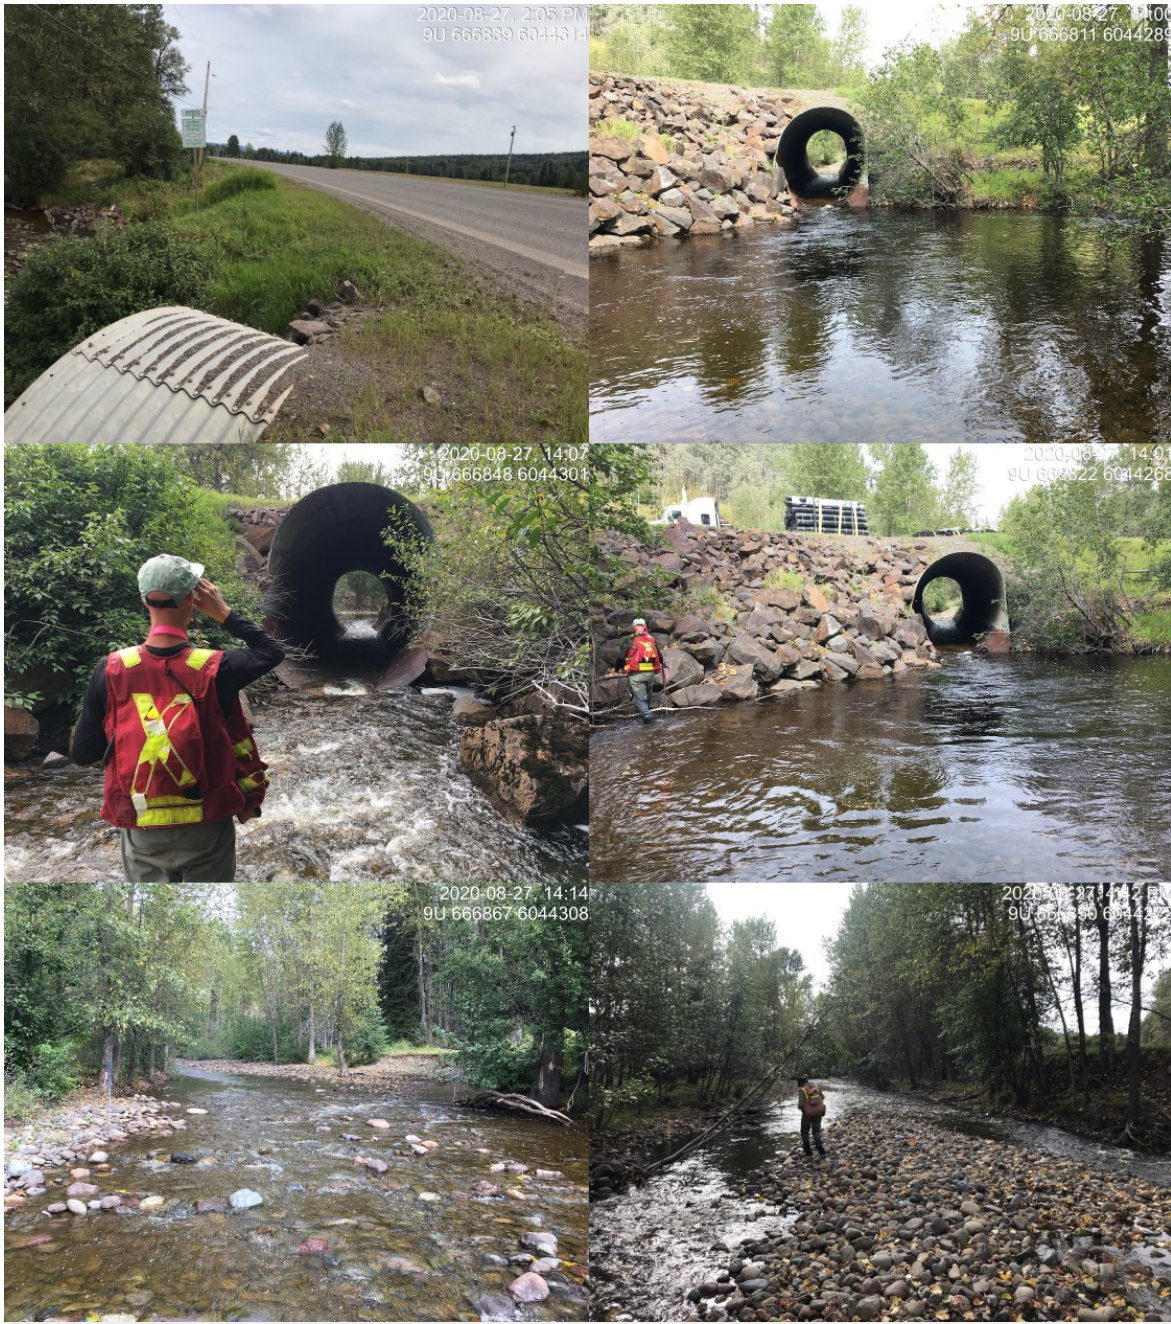
Comments: Culvert is likely as passable for most species and life stages at most non-peak and non-lowest flows. Streamkeepers have observed fry moving through culvert in overwintering studies.

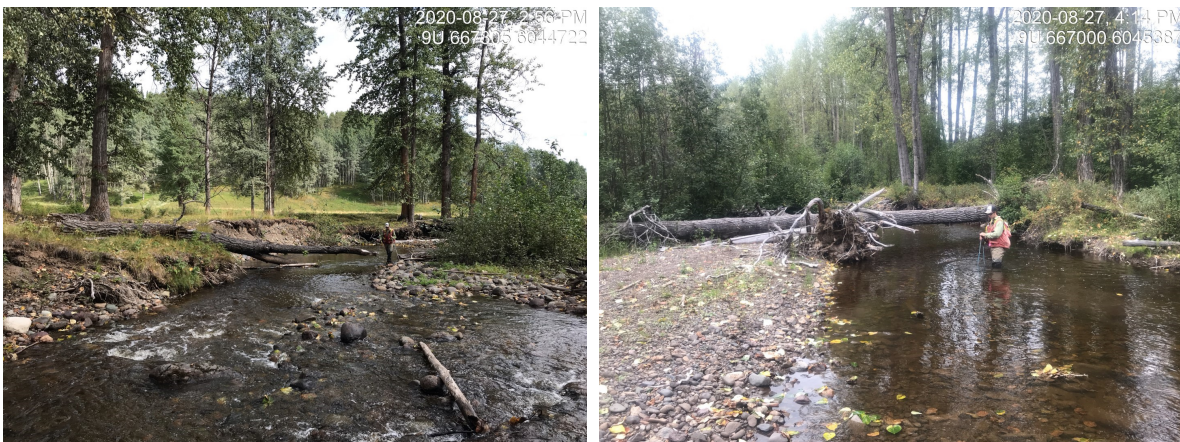
Figure 5.27: Left: habitat upstream of PSCIS crossing 197658. Right: Habitat upstream of PSCIS crossing 197658.

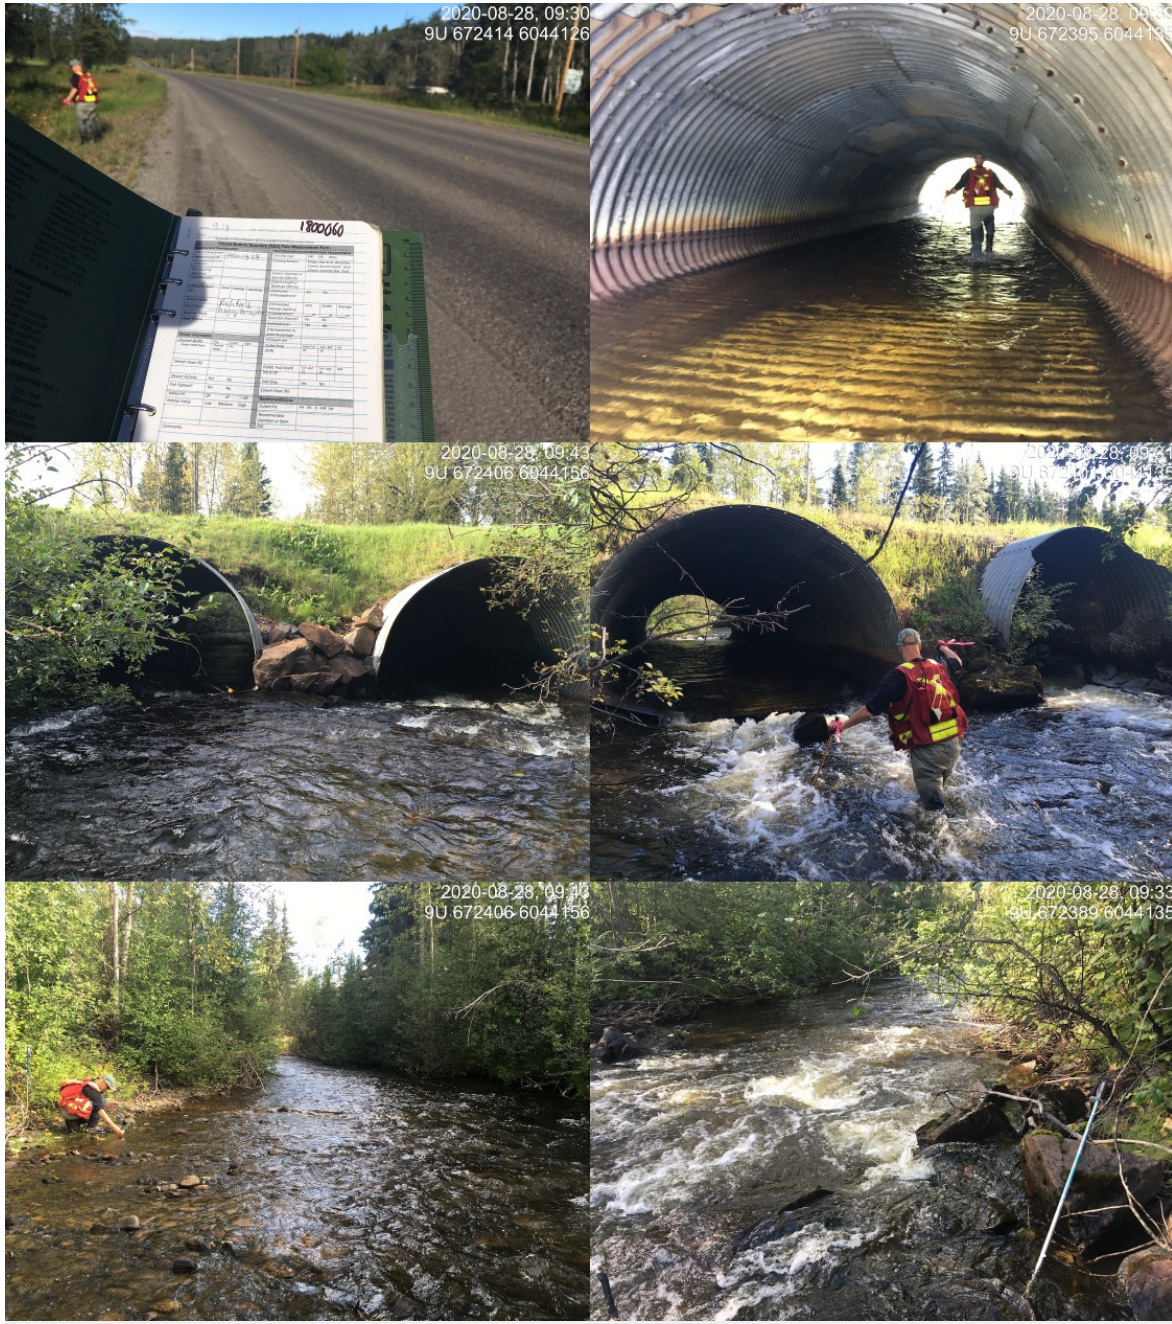
Easting	672404.7	Resemble Channel	No
Northing	6044146	Backwatered	No
Stream	Richfield Creek	Percent Backwatered	–
Road	Highway 16	Fill Depth (m)	1
Road Tenure	MoTi highway	Outlet Drop (m)	0.2
Channel Width (m)	12.5	Outlet Pool Depth (m)	1
Stream Slope (%)	1.5	Inlet Drop	No
Beaver Activity	No	Slope (%)	2
Habitat Value	High	Valley Fill	Deep Fill
Final score	29	Barrier Result	Barrier
Fix type	Replace with New Open Bottom Structure	Fix Span / Diameter	16.5
Photos: From top left clockwise: Road/Site Card, Barrel, Outlet, Downstream, Upstream, Inlet.

Comments: Habitat confirmation and minnowtrapping completed.

Structure replacement with a bridge (16.5m span) is recommended to provide access to the habitat located upstream of PSCIS crossing 197662. The cost of the work is estimated at \$8,250,000 for a cost benefit of 0.2 linear m/\$1000 and 3.2m²/\$1000.

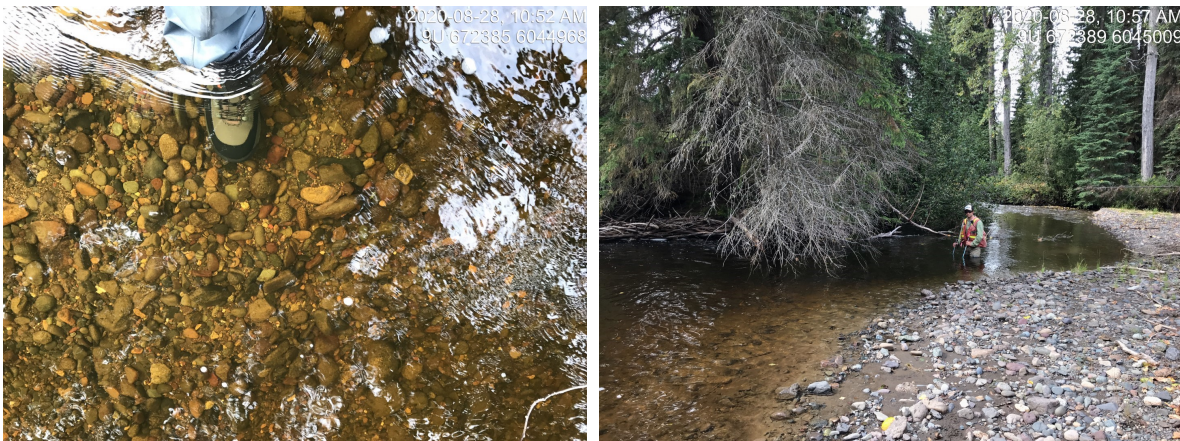
Figure 5.30: Left: Gravel and cobble substrate upstream of PSCIS crossing 197662. Right: Typical habitat upstream of PSCIS crossing 197662.

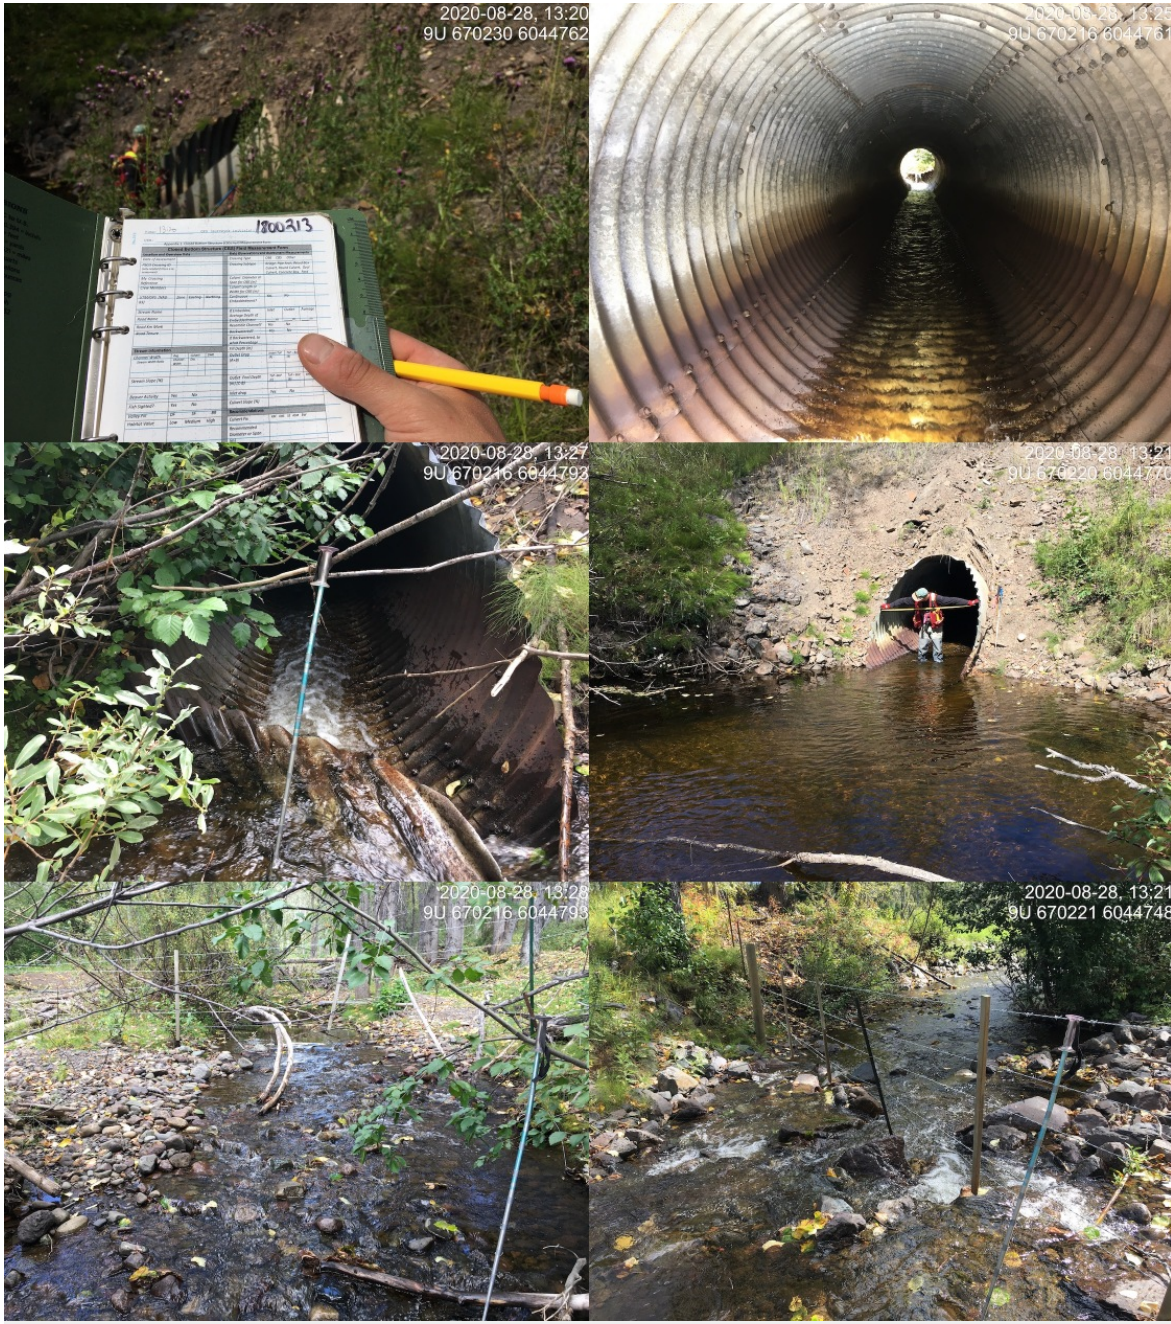
At the time of the survey, the 197663 on Highway 16 was un-embedded, non-backwatered and considered a barrier to upstream fish passage according to the provincial protocol. The pipe was 1.75m in diameter with a length of 25m, a culvert slope of 2%, a stream width ratio of 3.6 and an outlet drop of 0m (Table [5.54](#)). The inlet of the culvert was damaged with the metal folded up by incoming debris. Water temperature was 11°C, pH was 8.1 and conductivity was 186uS/cm.

Northing	6044772	Backwatered	No
Stream	Johnny David Creek	Percent Backwatered	–
Road	Highway 16	Fill Depth (m)	3
Road Tenure	MoTi highway	Outlet Drop (m)	0
Channel Width (m)	6.3	Outlet Pool Depth (m)	1.35
Stream Slope (%)	5.5	Inlet Drop	Yes
Beaver Activity	No	Slope (%)	2
Habitat Value	High	Valley Fill	Deep Fill
Final score	24	Barrier Result	Barrier
Fix type	Replace with New Open Bottom Structure	Fix Span / Diameter	10.3
Photos: From top left clockwise: Road/Site Card, Barrel, Outlet, Downstream, Upstream, Inlet.

Comments: Habitat confirmation and sampling completed.

Structure replacement with bridges for 197663 (10.3m span) and 3054 (31m span) are recommended to provide access to the habitat located upstream. An estimate of cost for replacement of 197663 is \$5,150,000 resulting in cost benefits of 1.9 linear m/\$1000 and 12.8m²/\$1000. An estimate of cost for replacement of 3054 is \$388,000 resulting in cost benefits of 19.3 linear m/\$1000 and 50.3m²/\$1000.

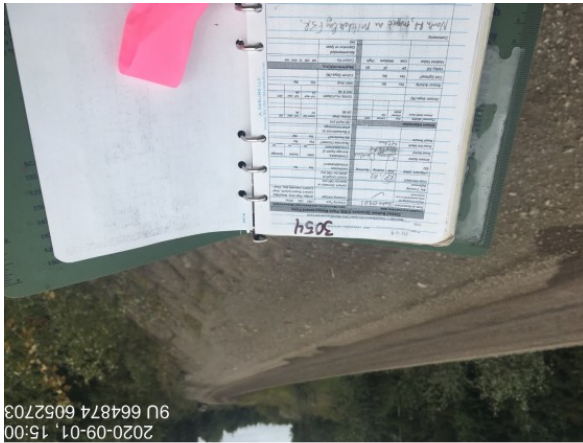
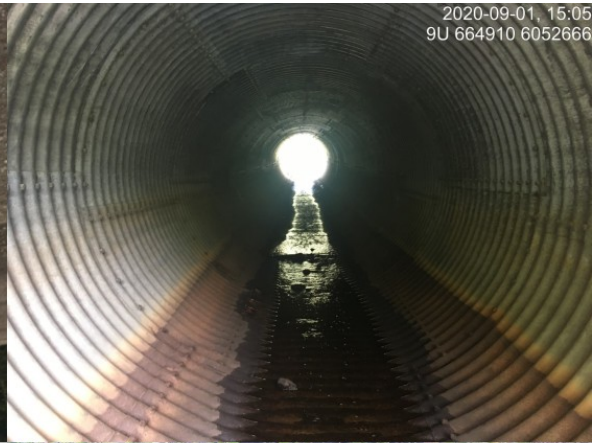
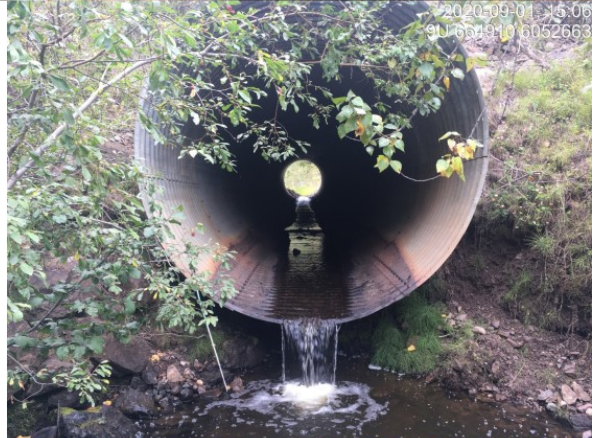
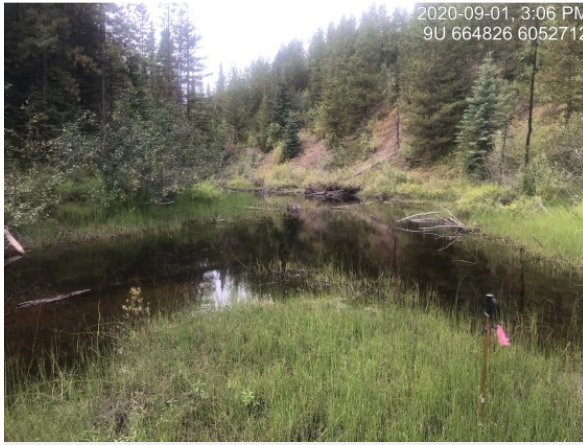
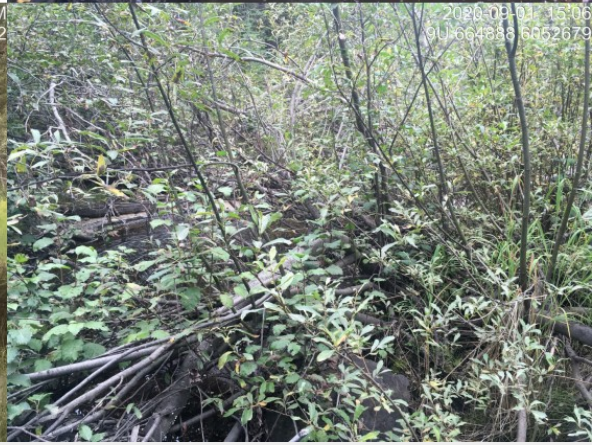
Table 5.55: Summary of fish passage assessment for PSCIS crossing 3054.

External ID	–	Length (m)	40
Crew	KP, AI	Embedded	No
UTM Zone	9	Depth Embedded (m)	–
Easting	664881	Resemble Channel	No
Northing	6052688	Backwatered	No
Stream	Johnny David Creek	Percent Backwatered	–
Road	North road	Fill Depth (m)	9.99
Road Tenure	MoTi local	Outlet Drop (m)	0.76
Channel Width (m)	3.5	Outlet Pool Depth (m)	0.8
Stream Slope (%)	3.3	Inlet Drop	No
Beaver Activity	Yes	Slope (%)	2
Habitat Value	Medium	Valley Fill	Deep Fill
Final score	34	Barrier Result	Barrier
Fix type	Replace with New Open Bottom Structure	Fix Span / Diameter	31
Photos: From top left clockwise: Road/Site Card, Barrel, Outlet, Downstream, Upstream, Inlet.

Comments: Fill depth approximatley 12m. Fish observed upstream of crossing.

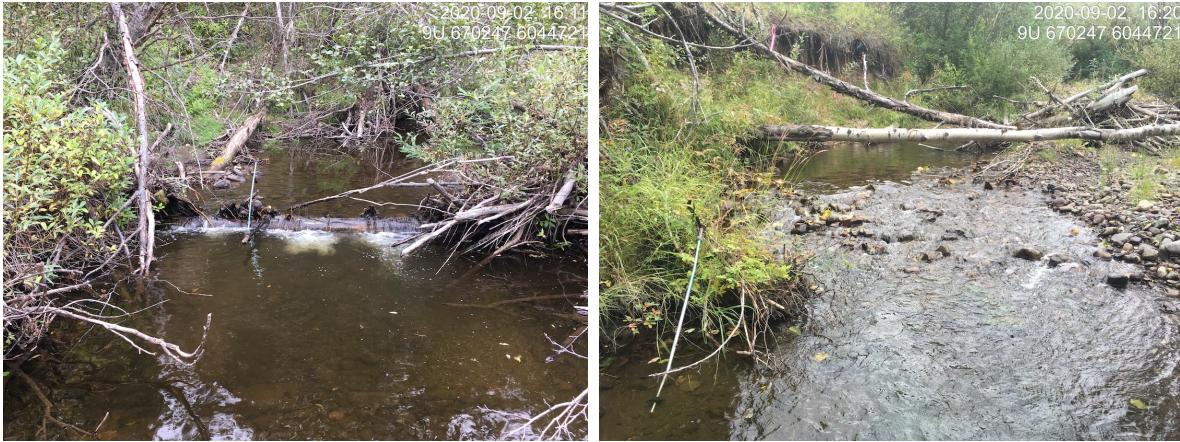
Figure 5.33: Left: Typical habitat downstream of PSCIS crossing 197663. Right: Typical habitat downstream of PSCIS crossing 197663.

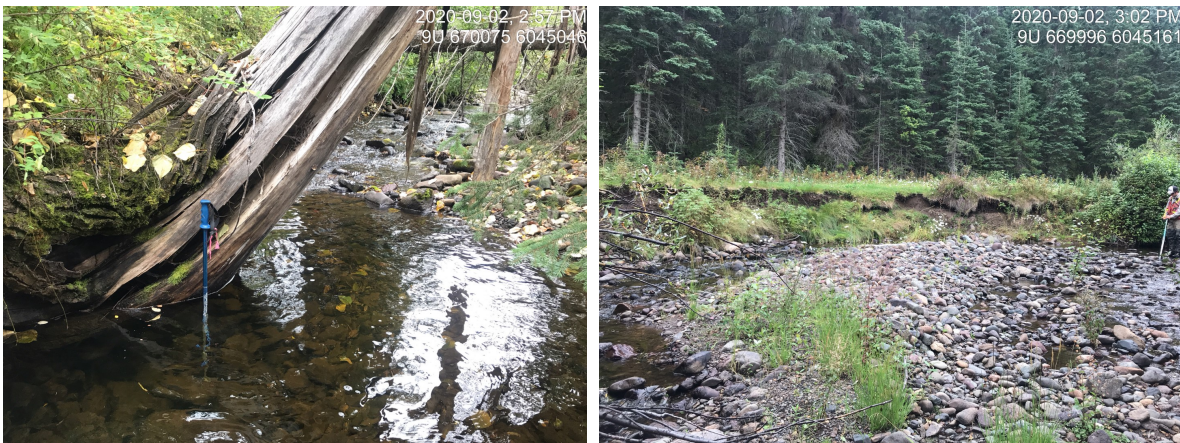
Figure 5.34: Left: Habitat upstream of PSCIS crossing 197663. Right: Habitat upstream of PSCIS crossing 197663.

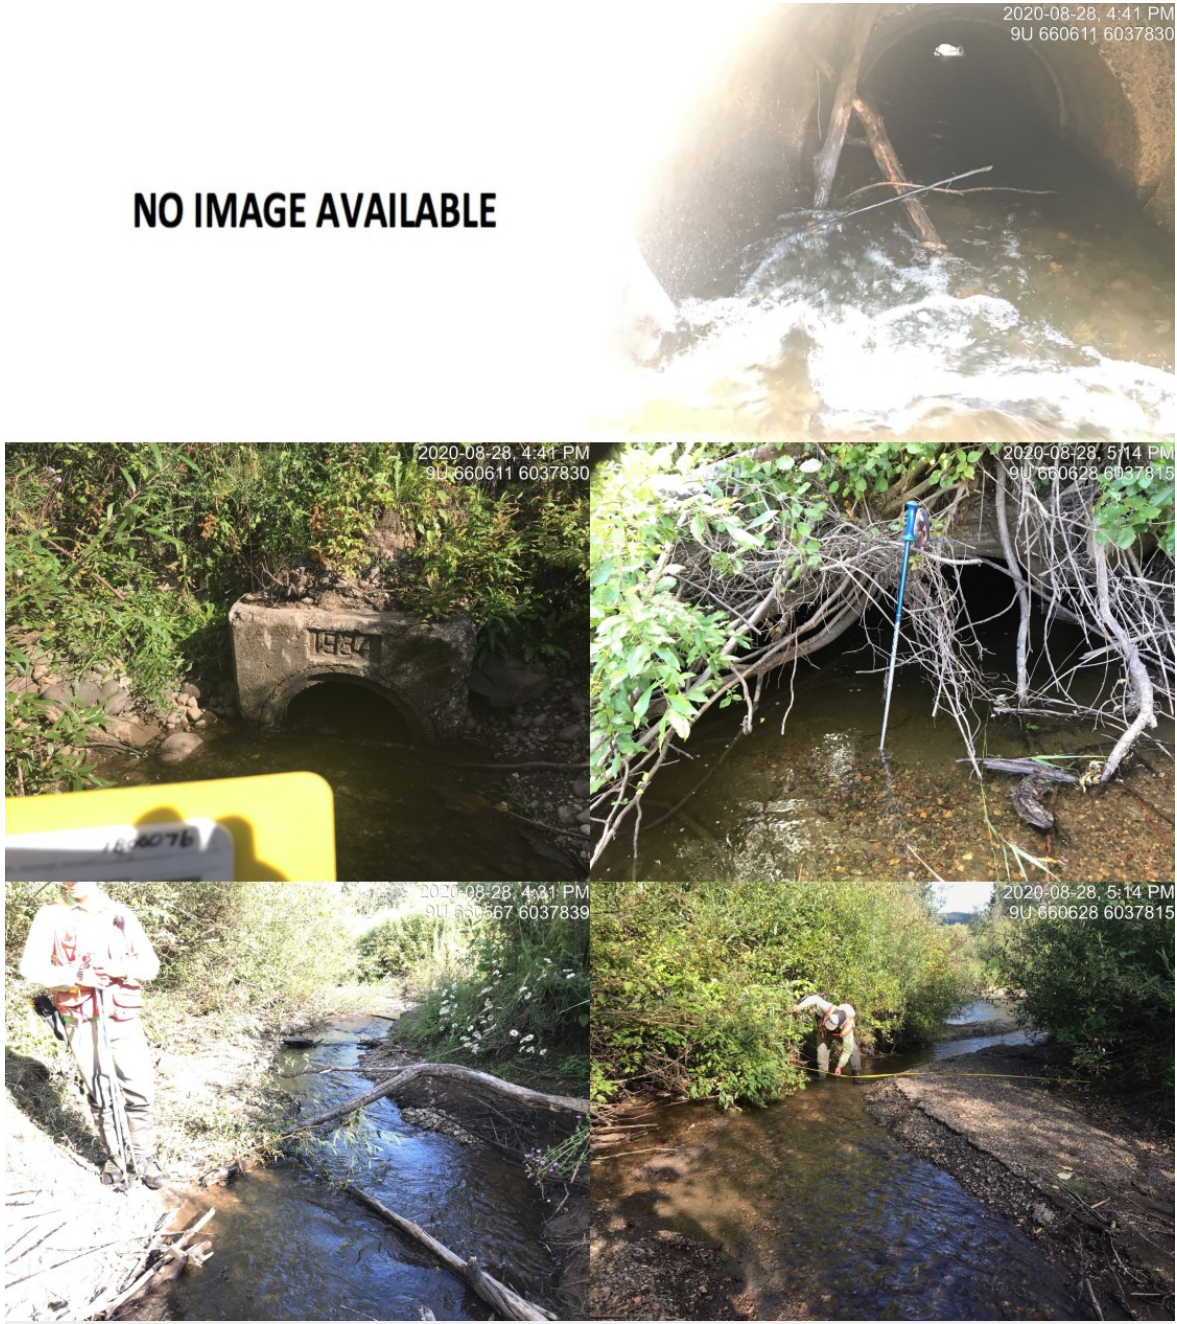
Comments: Targeted for habitat confirmation due to upstream aggradation and dredging associated impacts on coho

Costs to replace 197665 and 197664 with bridges are estimated at \$5,000,000 per crossing. Structure replacement with an embedded culvert is recommended for 3042 (streambed simulation - 3m span) with an estimated cost of \$25,000 resulting in cost benefits of 68 linear m/\$1000 and 156.4m²/\$1000.

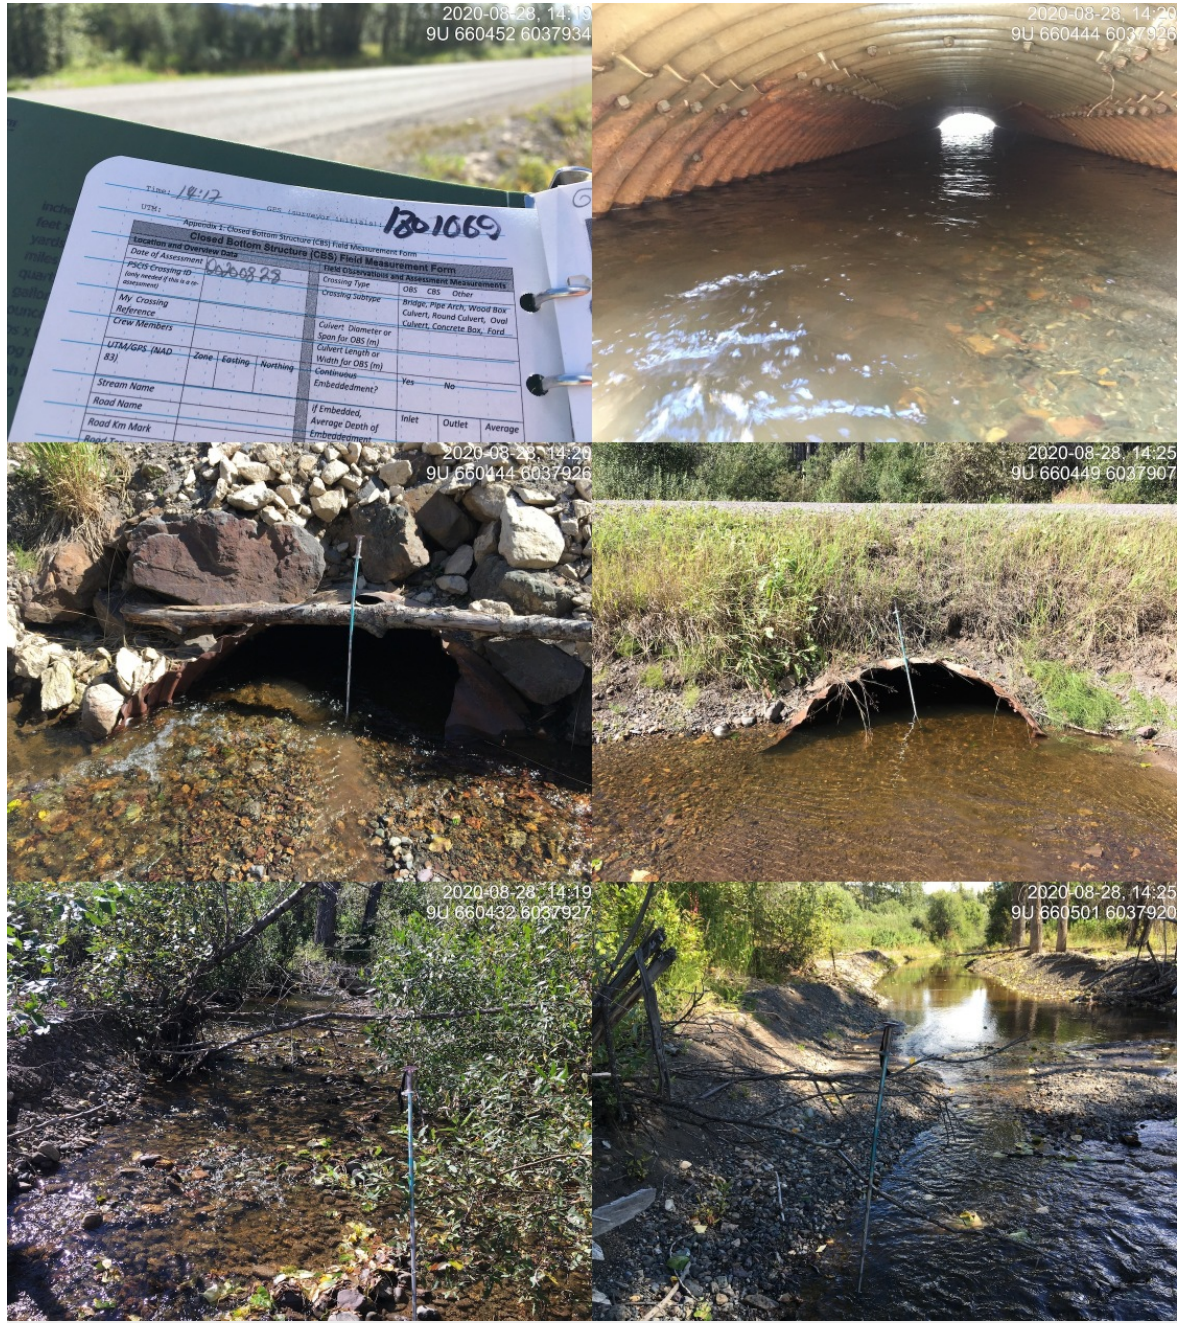
Comments: Habitat confirmation completed.

Comments: Targeted for habitat confirmation due to aggradation and dredging associated impacts on coho.

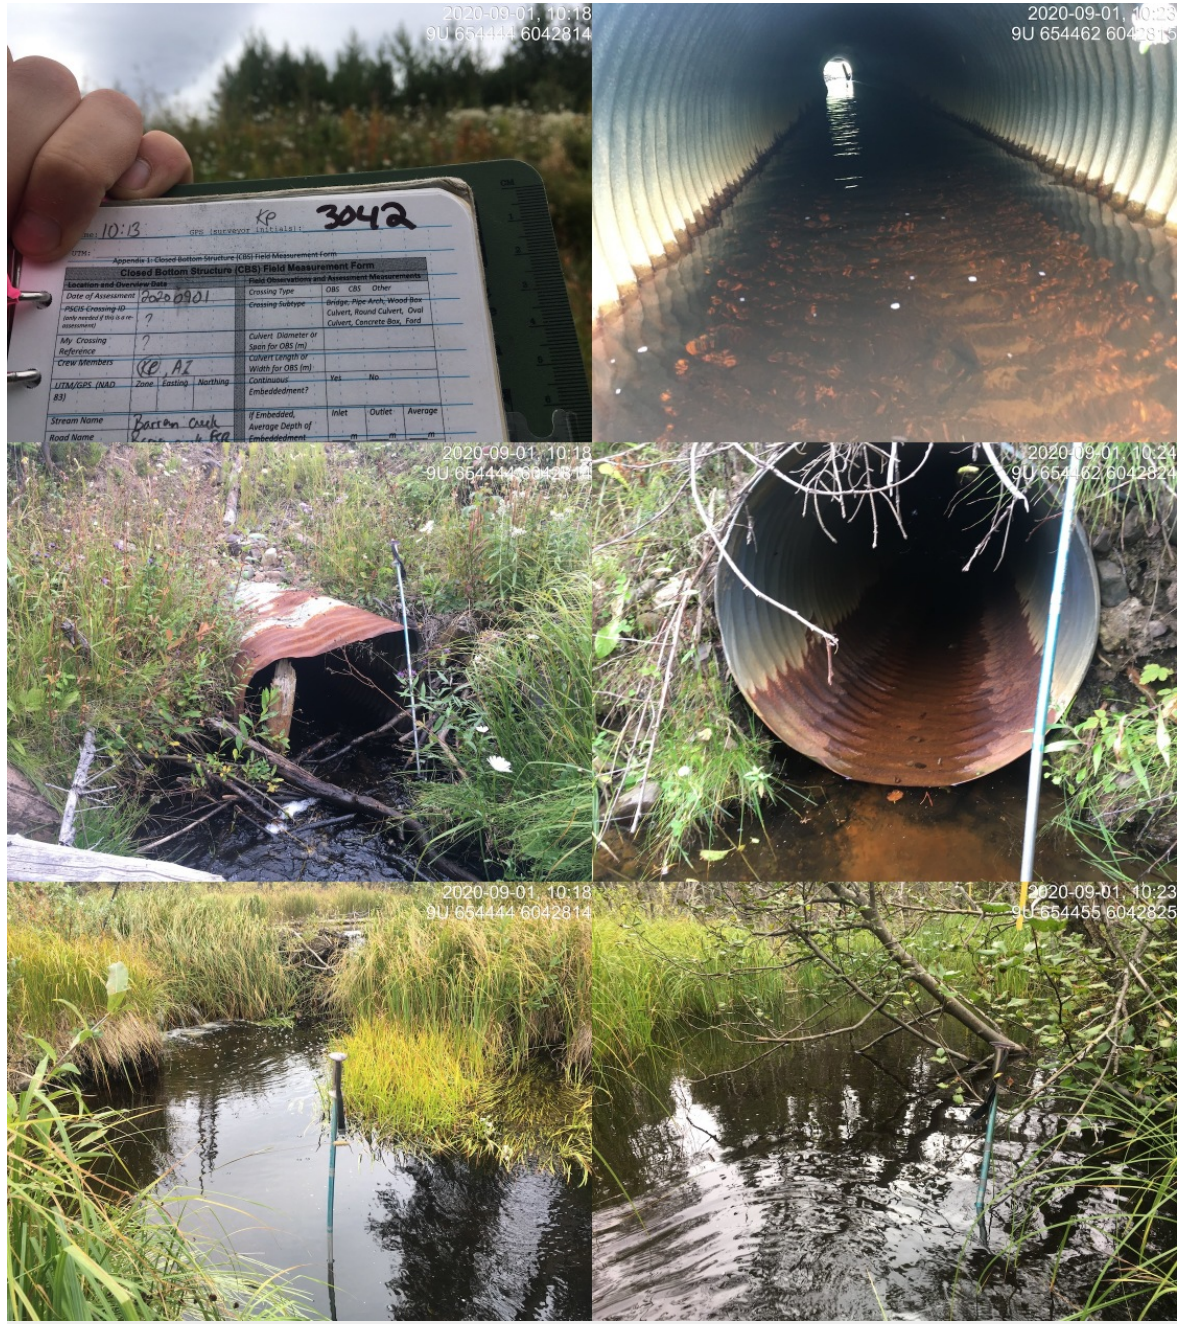
Table 5.64: Summary of fish passage assessment for PSCIS crossing 3042.

Photos: From top left clockwise: Road/Site Card, Barrel, Outlet, Downstream, Upstream, Inlet.

Comments: Beaver influenced stream with lake upstream.

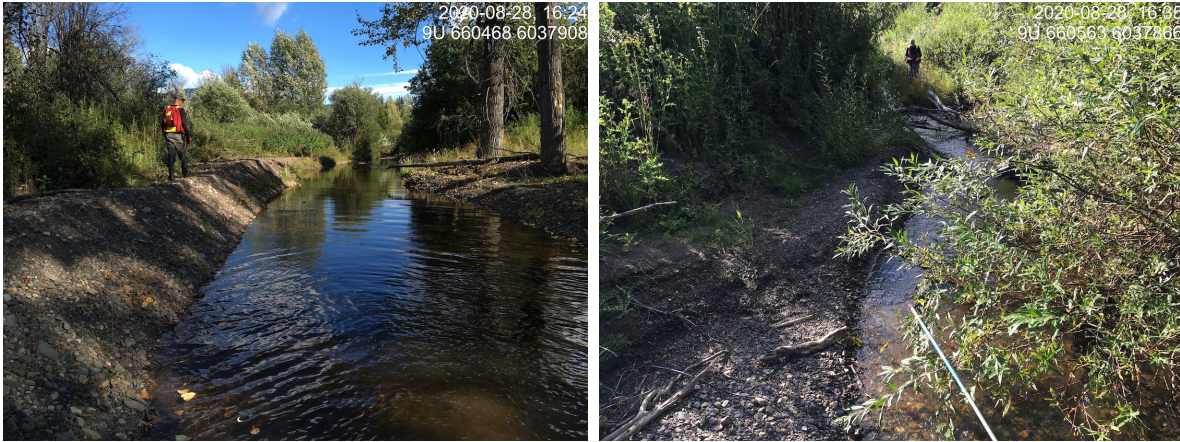
Figure 5.37: Left: Typical habitat downstream of PSCIS crossing 197664. Right: Typical habitat downstream of PSCIS crossing 197664.
