SOCIETY FOR ECOSYSTEM RESTORATION
IN NORTHERN BRITISH COLUMBIA

Bulkley River and Morice River Watershed Groups Fish Passage Restoration Planning

**Version 0.1.2
2021-04-21**

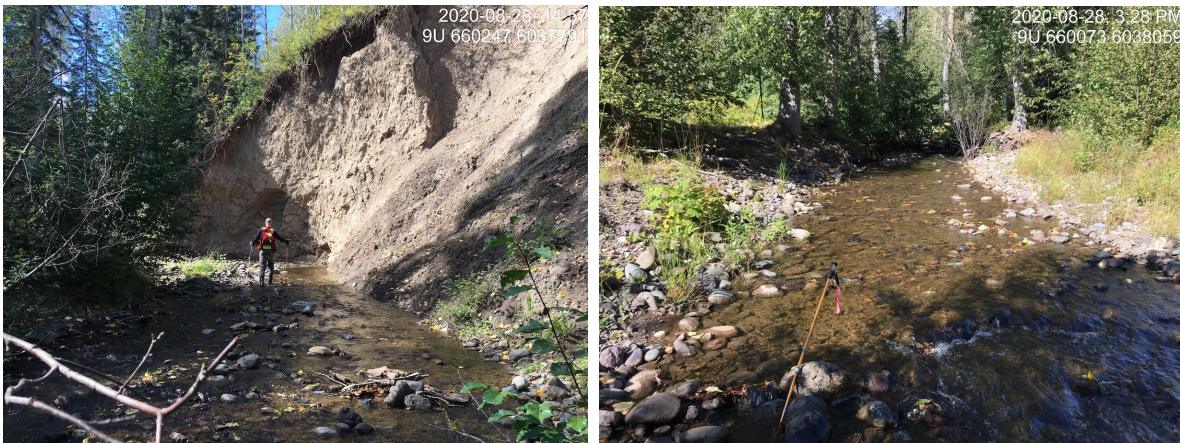
Figure 5.38: Left: Habitat upstream of PSCIS crossing 197664 and location of cutslope. Right: Habitat upstream of PSCIS crossing 197664.

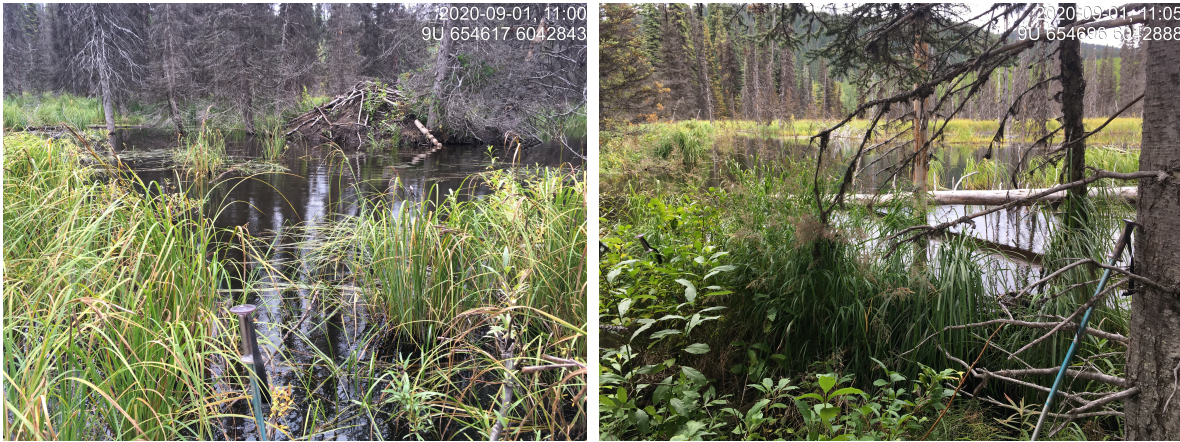
Figure 5.39: Left: Habitat downstream of PSCIS crossing 3042. Right: Habitat downstream of PSCIS crossing 3042.

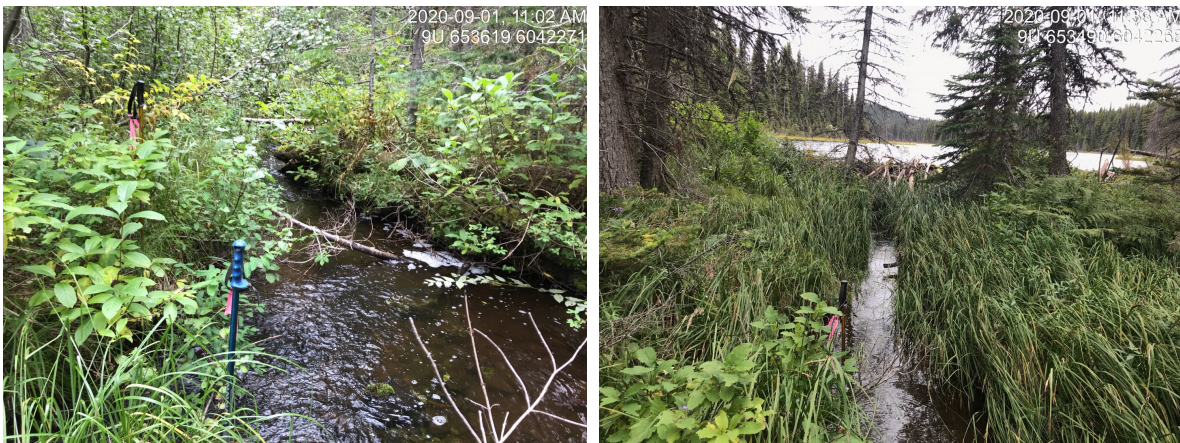
Figure 5.40: Left: Habitat upstream of PSCIS crossing 3042. Right: Habitat upstream of PSCIS crossing 3042.

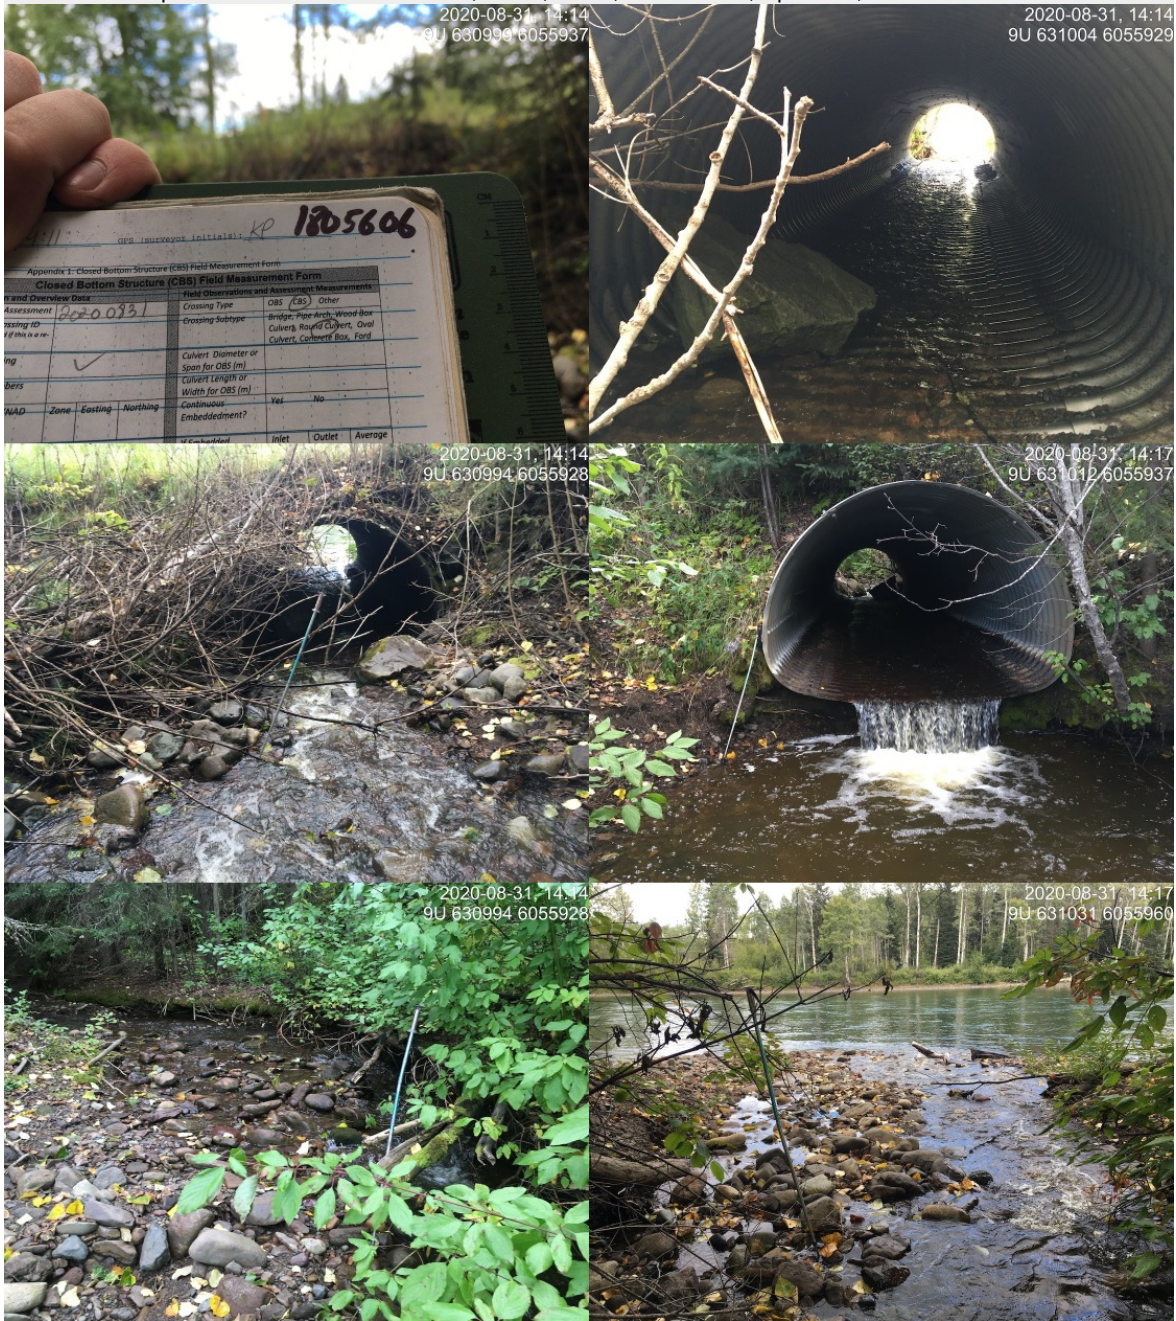
Road Tenure	Canadian National	Outlet Drop (m)	0.58
Channel Width (m)	3.8	Outlet Pool Depth (m)	0.57
Stream Slope (%)	4.5	Inlet Drop	No
Beaver Activity	No	Slope (%)	4
Habitat Value	High	Valley Fill	Deep Fill
Final score	39	Barrier Result	Barrier
Fix type	Replace with New Open Bottom Structure	Fix Span / Diameter	10

Comments: Approximately 17m from the outlet to the Bulkley River.

Photos: From top left clockwise: Road/Site Card, Barrel, Outlet, Downstream, Upstream, Inlet.

A cost estimate for replacing 197667 with a bridge (10m span) is \$5,000,000, resulting in cost benefits of 0.7 linear m/\$1000 and 3m²/\$1000. Although 124501 on Lawson Road was considered passable for most species/life stages during most flows, an estimate of cost for replacement (10m span) is \$500,000 resulting in cost benefits of 5.6 linear m/\$1000 and 26.9m²/\$1000.

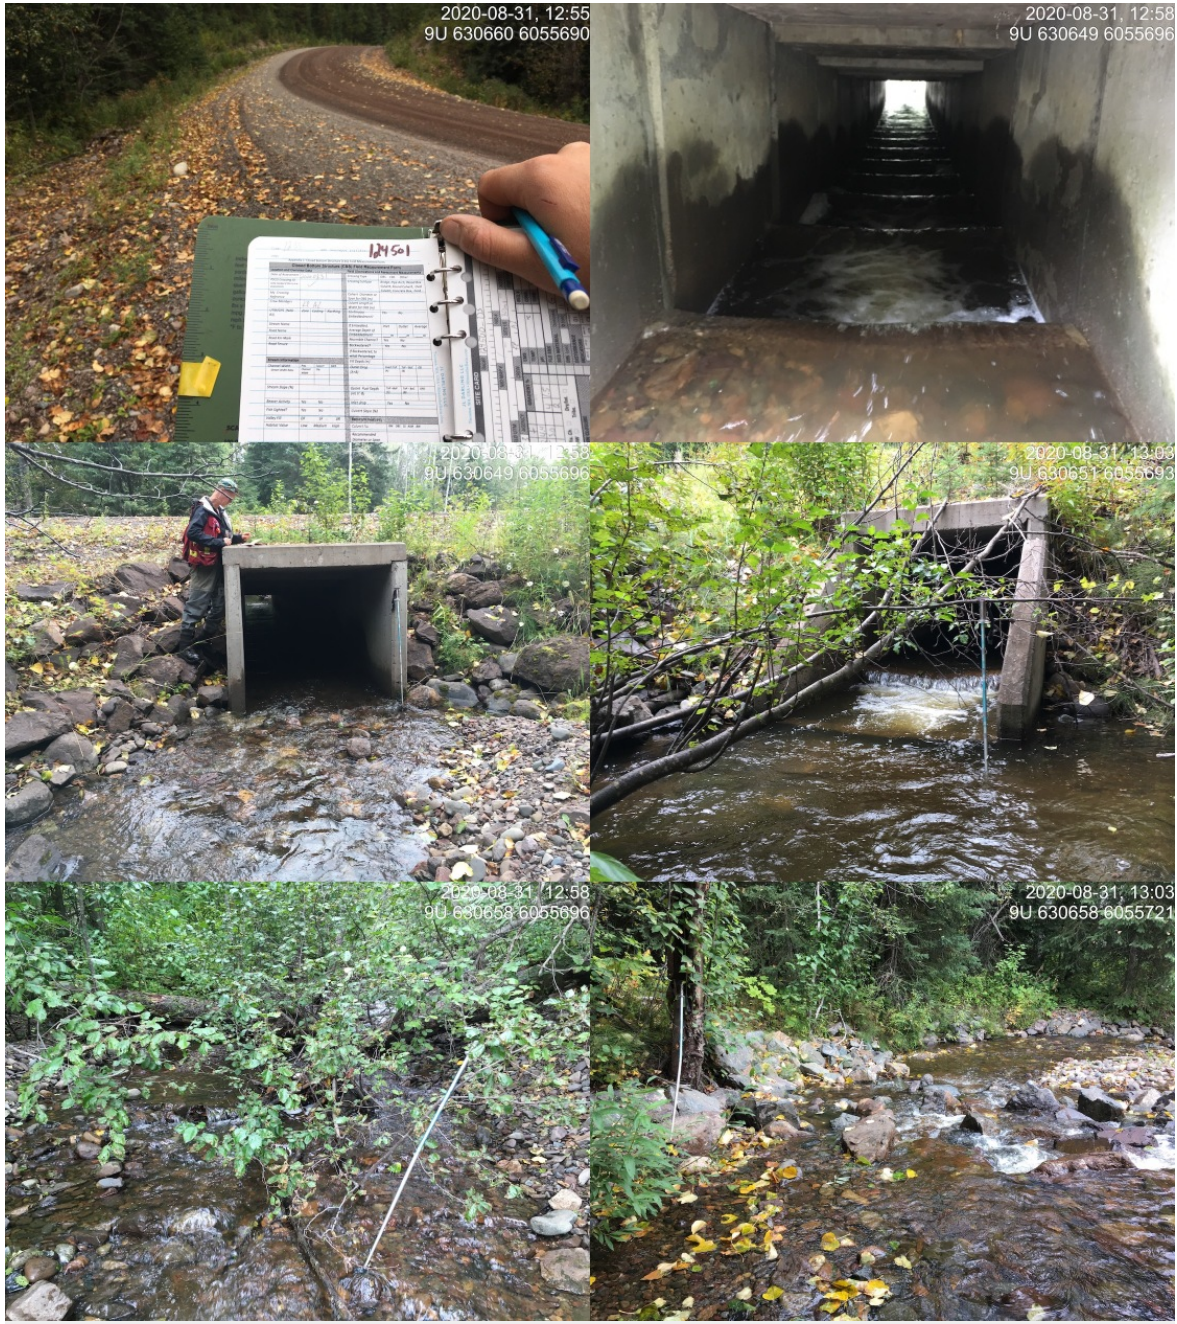
Table 5.68: Summary of fish passage assessment for PSCIS crossing 124501.

Photos: From top left clockwise: Road/Site Card, Barrel, Outlet, Downstream, Upstream, Inlet.

Comments: Fully embedded and baffled culvert. Likely passable for all salmonid adults.

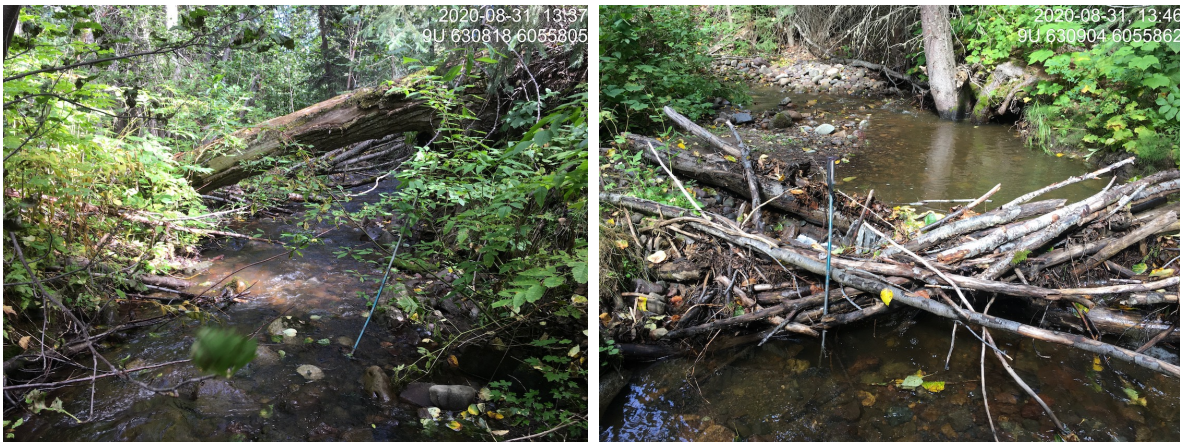
Figure 5.41: Left: Typical habitat upstream of PSCIS crossing 197667. Right: Typical habitat upstream of PSCIS crossing 197667.

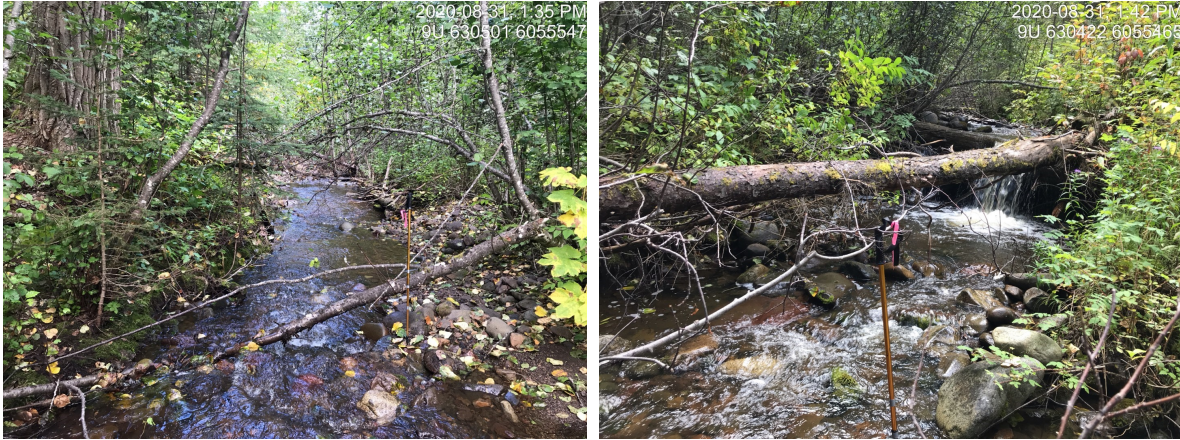
Figure 5.42: Left: Habitat upstream of PSCIS crossing 124501. Right: Habitat upstream of PSCIS crossing 124501.

Moan Creek was surveyed upstream from 124501 for 520m (Figure [5.42](#)). Within the area surveyed, total cover amount was rated as moderate with deep pools dominant. Cover was also present as small woody debris, large woody debris, boulders, undercut banks, and overhanging vegetation (Table [5.69](#)). The average channel width was 4.8m, the average wetted width was 3.1m and the average gradient was 6.3%. There were multiple debris jams present upstream from 350m above Larson Road with heights ranging from 0.4 - 1m high. Habitat was noted as complex with abundant gravels suitable for resident, fluvial and anadromous salmonid spawning. Habitat was rated as high value.

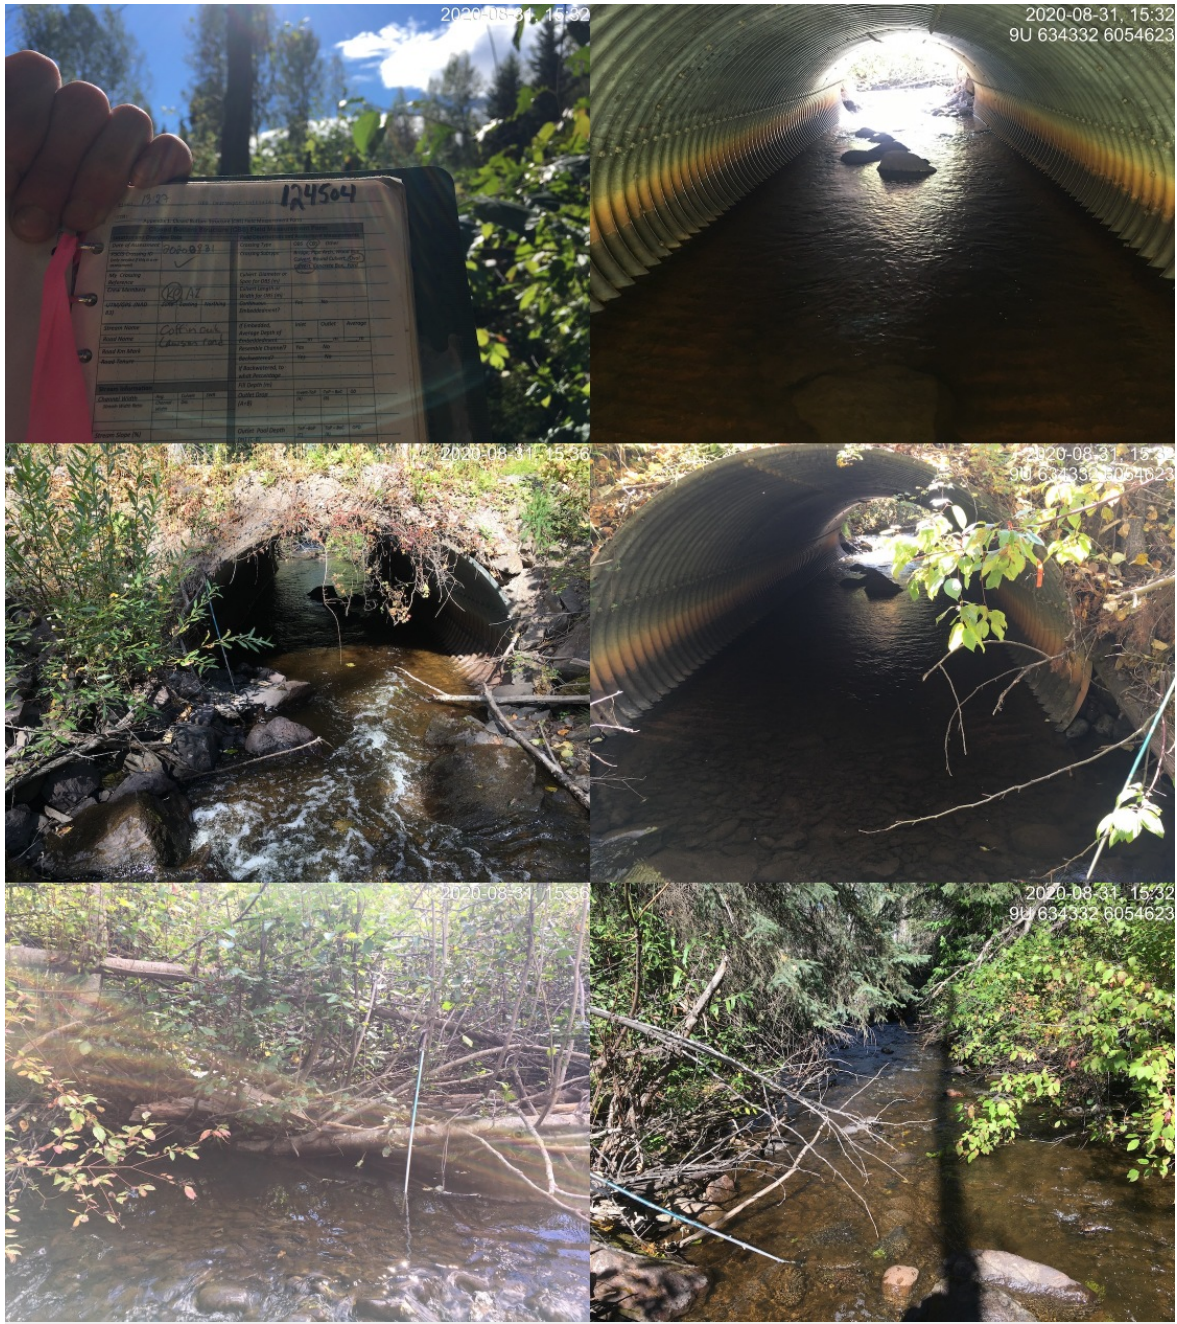
Comments: Partially embedded with several large boulders (30 - 50cm) in culvert. No outlet drop at the time of survey but there may be at lowest flow levels.

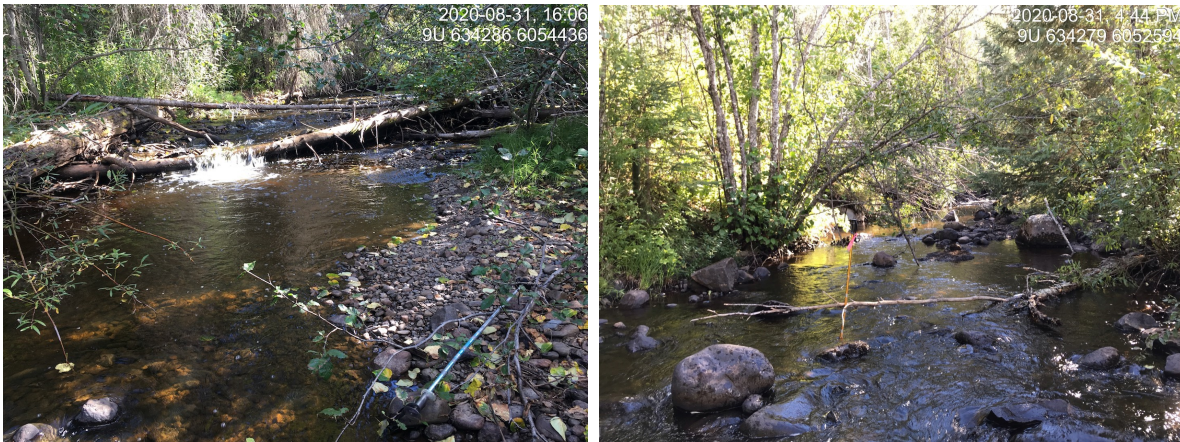
Figure 5.44: Left: Habitat upstream of PSCIS crossing 124504. Right: Habitat 2.1km upstream of PSCIS crossing 124504.
