Lakelse Lake Sockeye Rehabilitation Program
Upper Williams Creek Spawning Channel

Project completed: June 2011

The excavation of the Upper Williams Creek Spawning Channel was carried out from May 30 to June 16, 2011. 470 lineal meters of spawning channel was excavated with an average slope of 1.2%, an average width of 3.5m, and an average depth from ground level of 2.5m. Channel complexities included large woody debris placement, boulder placement, pool and riffle construction, and three constructed undercut banks. The depth of the excavation was below ground water for much of the length of the channel. The excavation of the remaining 200m of channel and installation of an intake structure, pipeline and valve system to supply river water from Williams Creek main stem to the newly created off-channel spawning habitat is expected to begin in August of 2012.

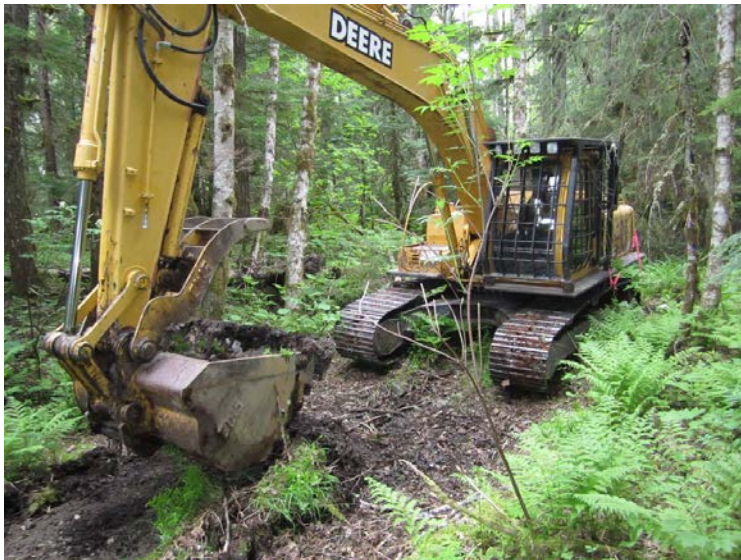
Photo 1. The Beginning of Channel Excavation.

Depth and width of excavation varied from 1.5m deep and 5 meters wide at 0+5 meters to almost 3 meters deep and 2.5 meters wide at ~0+100. Attempts to keep stream banks to a 1:2 slope were made, however spoiling material on site and trying to maintain as much riparian vegetation as possible resulted in more vertical banks in some areas.

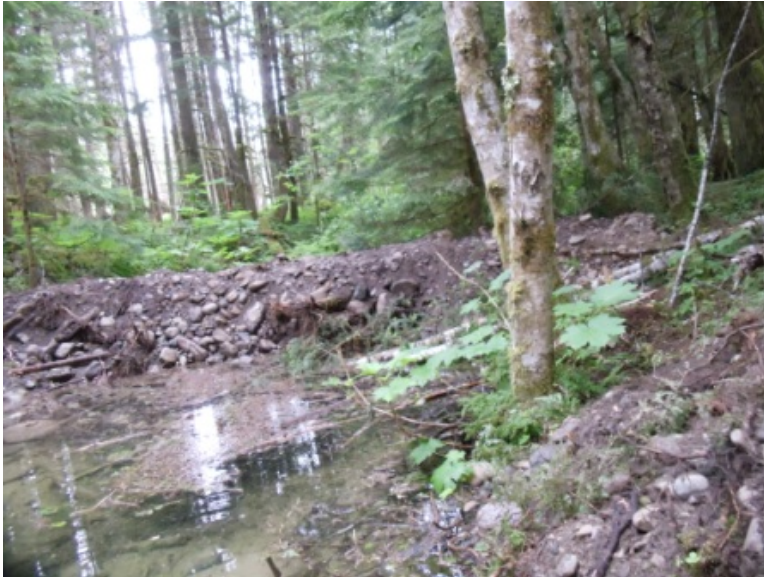
Photo 2. Re-constructed Earthen dam @ 0+0m.

Excavation of the spawning channel proceeded upstream to 0+110m., including construction of an undercut bank at 0+85m. The undercut bank consisted of the excavation and complexing of an alcove pool adjacent to the channel. Horizontal logs were then placed just above water level on top of the alcove and material was backfilled over top of the logs. On June 2nd, the downstream earthen dam was reinforced due to the amount of ground water encountered upstream and the possibility of heavy rains causing overflow to downstream fish habitat. The excavator returned to the earthen dam site following existing cat tracks, excavated a deeper pool and utilised side-cast materials to build up the dam to a level above

surrounding ground elevations. This would ensure that in the unlikely event of extreme high water, silt-laden water from the newly excavated channel would be filtered by the surrounding forest duff before reaching fish habitat downstream.

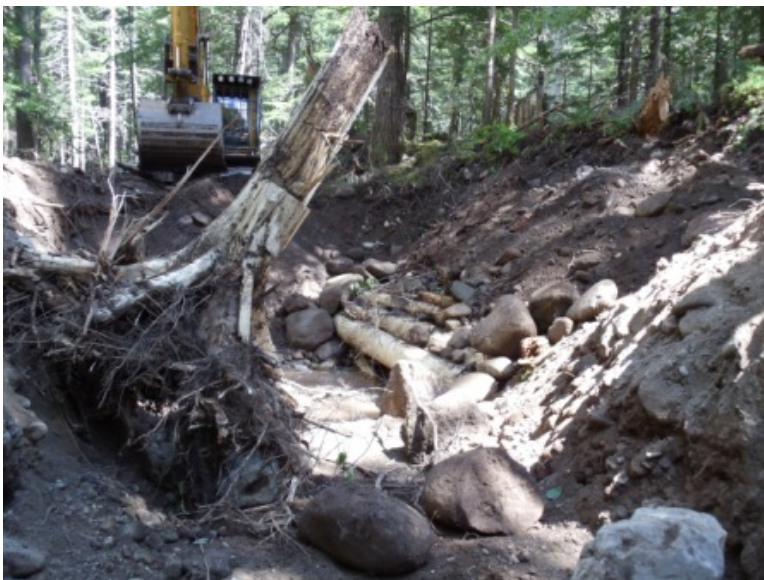
Photo 3. Undercut bank @ 0+190m.

The excavator returned to the main channel construction on the afternoon of June 2nd. The excavation continued upstream until June 9th to 0+250m, including a second undercut bank at 0+190m adjacent to the second channel access point. In order to maintain access to the 0+230m access point while minimizing stream bank disturbance, the excavator was moved to the upstream end of the channel (0+470m) and excavation continued in a downstream direction.

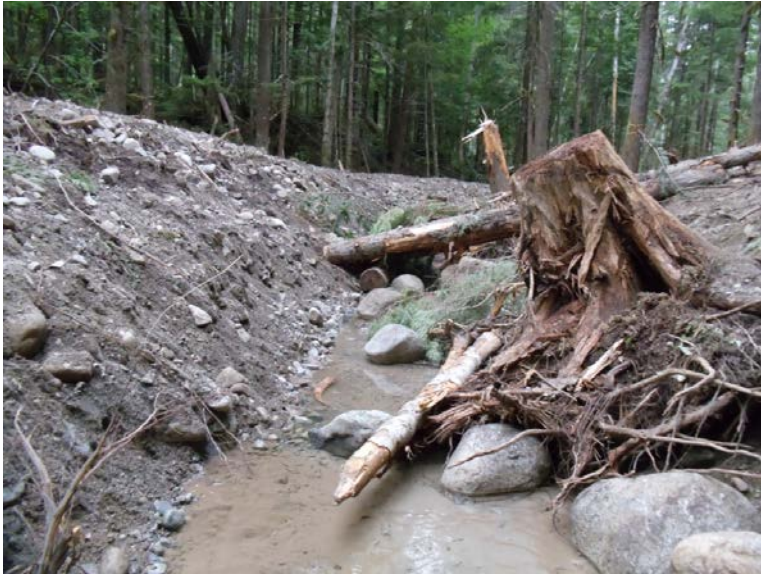
Photo 4. Looking Downstream @ 0+320m.

Excavation continued until June 11 from 470m to 360m when excavation slowed due to the large amount of ground water being encountered and stored. This was due to the lack of downstream drainage resulting from working in an upstream-to-downstream direction. An access route was laid out along the south side of the channel and the excavator was walked back to 0+250m where excavation continued in an upstream direction until the channel was completed on June 13th, 2011.

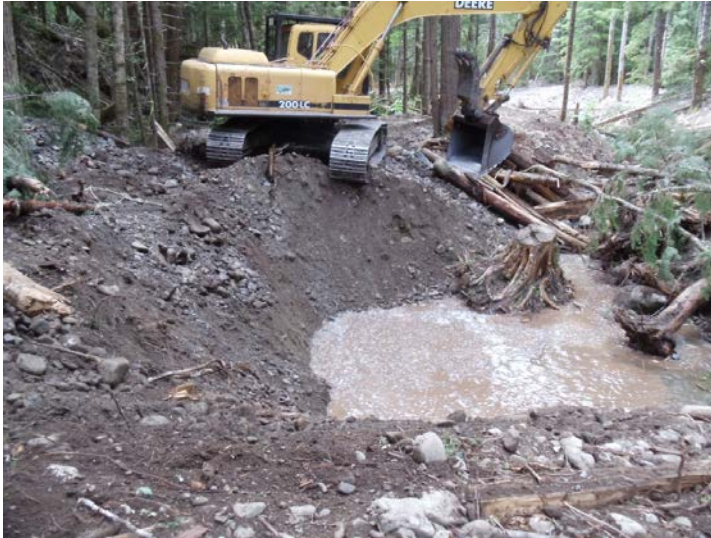
Photo 5. Construction of Undercut Bank @ 0+305m.

On June 16th, lock blocks were delivered to the earthen dam site to be used in the construction of the downstream weir and a third undercut bank was constructed at 0+305m.

The channel construction included the creation of many features intended to optimise the spawning and rearing capacity of the channel and to ensure sufficient spawner protection from predators such as bears. These features included pools, riffles, bends, large woody debris and boulder placements consistent with structures described in the Watershed Restoration Technical Circular No. 9 (Slaney and Zaldokas, 1997). Three undercut banks were also constructed by excavating pools of ~6m² at a depth of 0.5m below the ground water level. These pools were armoured with large boulders and logs were placed across the boulders and backfilled with material from the excavation.

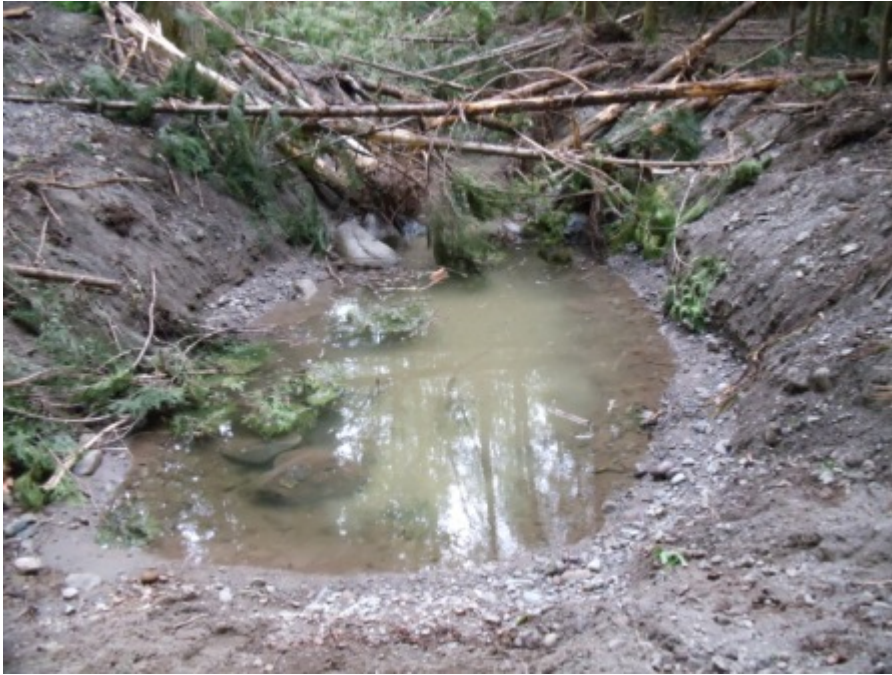
Photo 7: Upstream end of 2011 channel construction at 470m. Lots of groundwater evident.

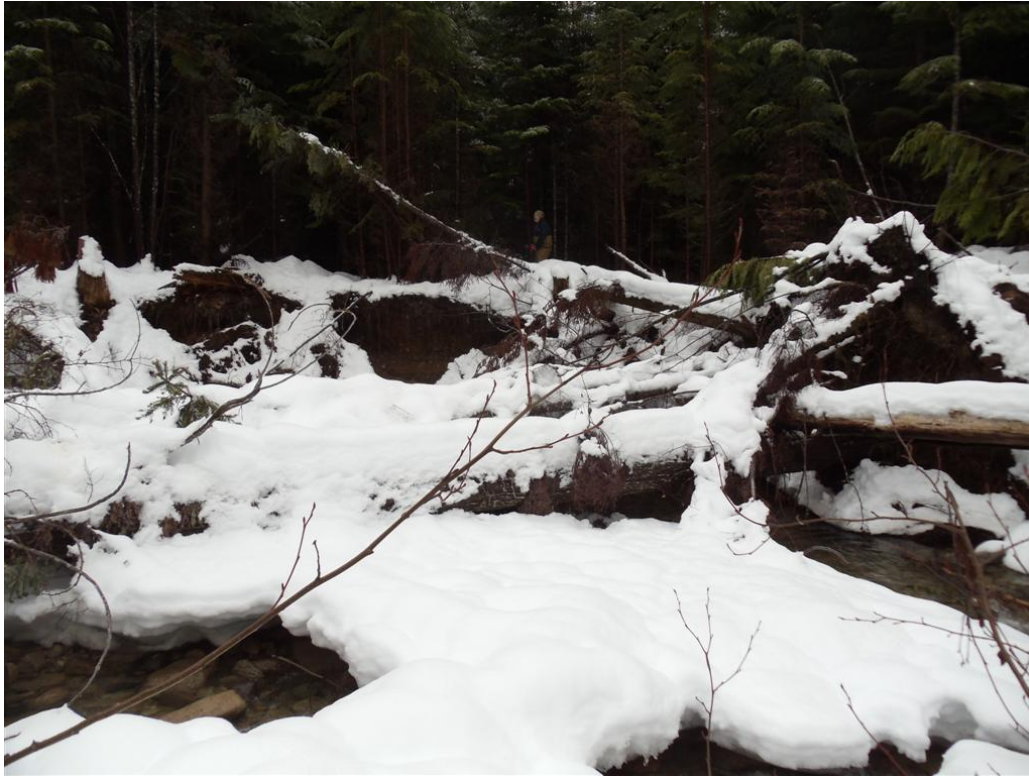
Limited funds in 2010/2011 lead to a focus on the Williams Creek project and less attention on the Scully Creek Flow Augmentation/Diversion Feasibility Study. A site visit was conducted in December 2010 and recent gravel and woody debris accumulations in the channel were noted. The stream walk revealed significant channel instability at the proposed diversion site near the fan apex. This occurrence would require the diversion site to be moved upstream above the area of instability to a bedrock section of channel which would be cost prohibitive. No further investigations are planned for a diversion near the Scully fan apex at this time. See appendix 7 for a memo provided by Don Hjorth, former RRU Engineer. There is some interest in exploring a diversion further downstream in a stable reach near Highway 37 South. This may be explored in future years.

Photo 6. Proposed Scully Channel Diversion Location - unstable streambed and banks

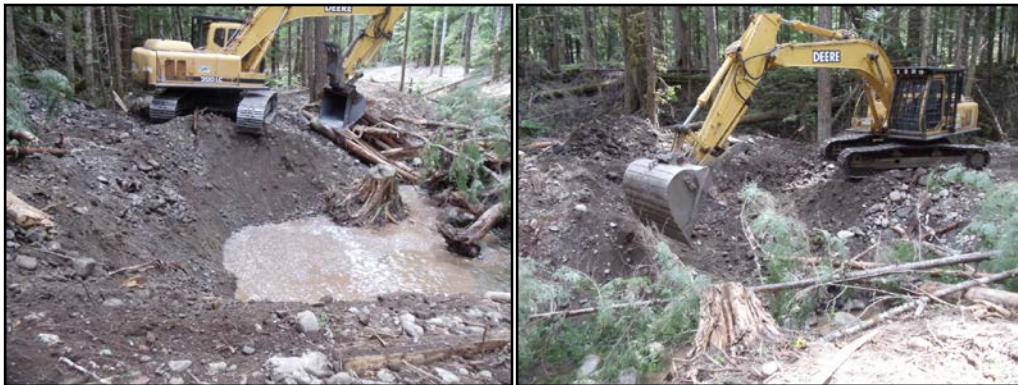
Construction of Undercut Bank @ 0+305m.

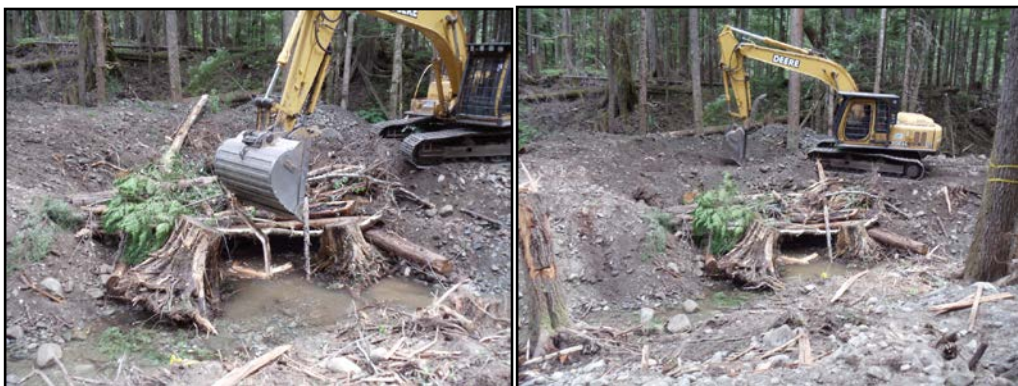
Construction of Undercut Bank @ 0+305m.

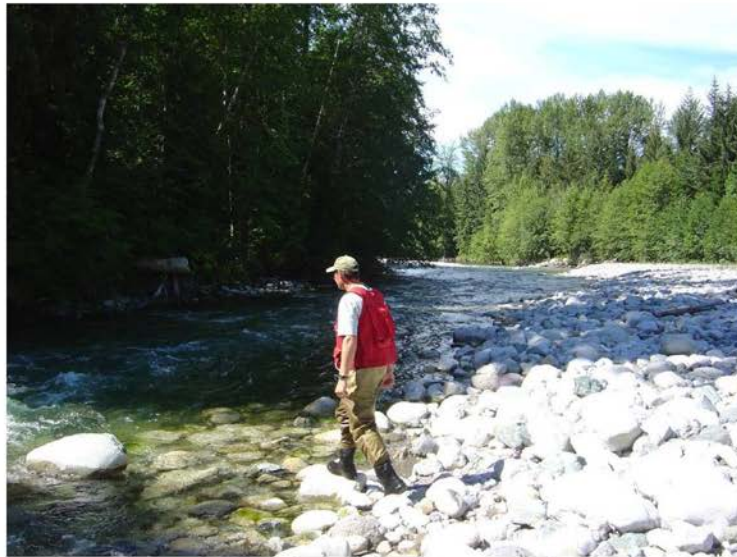
Reach 3 used to support sockeye spawning is highly unstable and dominated by braided channels, cobble-boulder substrate and a lack of riparian vegetation (BioLith, 1998). In the past 13 years since the BioLith report, however, I would note that the area is rehabilitating to some extent, somewhat less braided and regeneration of riparian vegetation (per comm Miller 2011).

Photograph 1. Reach 3: Immediately downstream of the Old Lakelse Lake Bridge, downstream view (DFO August 2005).
