## 2023 Completed Activities

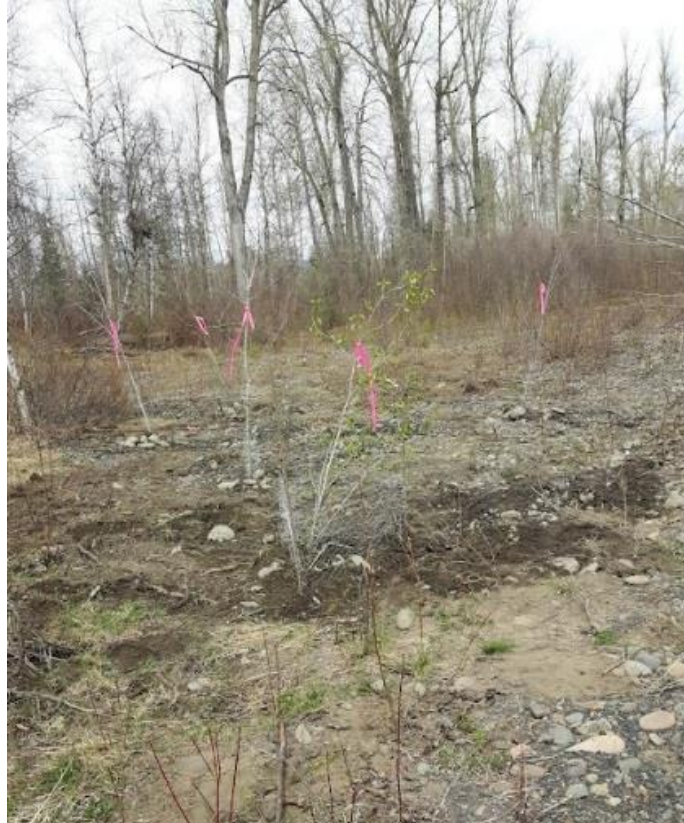
**Figure 1.** Cottonwood plants (6 to 10 ft tall) planted on the river left bank in the fan area.

1. **May 3, 2023- Cottonwood planting (6 plants) in the McCully fan area.** These cottonwood plants were purchased from Upland Nursery, Terrace BC. The cottonwood plants were between 6 and 10 feet and had established roots. These were planted behind the area which is now the emergency bank structure area. The idea was to add some diversity to the creek banks in this area. These plants will also seed the banks downstream when they mature.

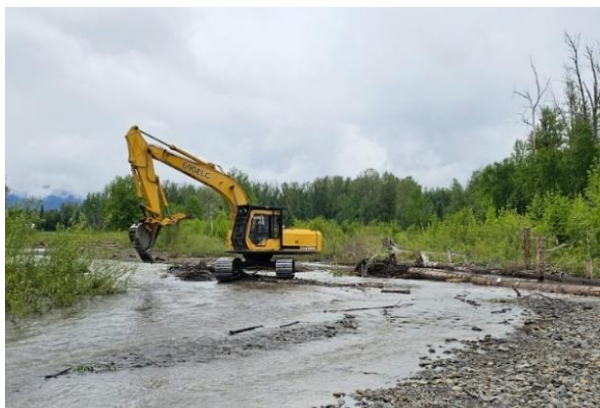
**Figure 2.** Emergency creek diversion to prevent the main stem of the creek from flowing directly into MC1. June 5, 2023.

2. **May 17, 2023-** AGAT Laboratories high water sampling and analysis (with an emphasis on particle size distribution of the Total Suspended Solids during peak flood stage).
3. **June 5, 2023-**Emergency creek diversion in the fan area with fish salvage.

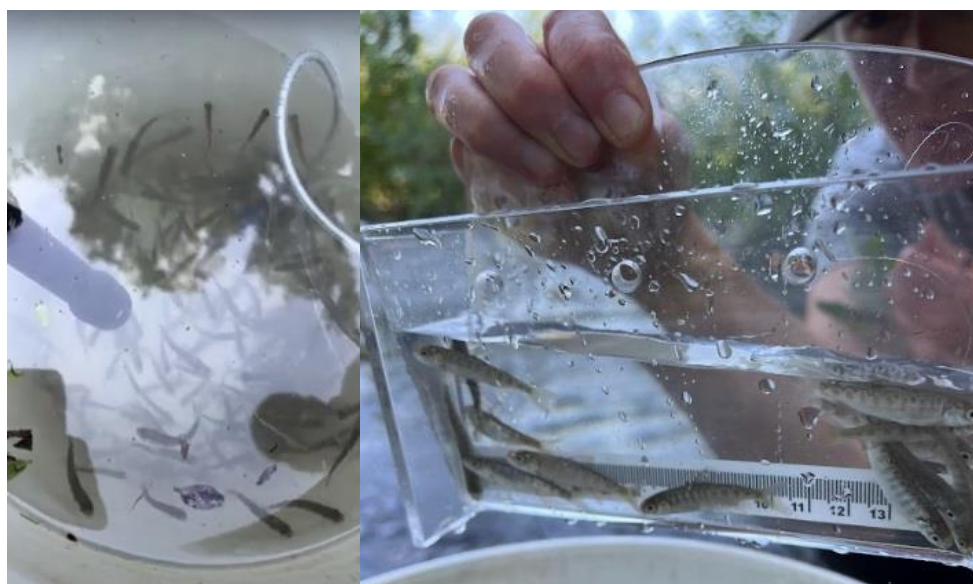
**Figure 3.** Fish relocation from MC1 into MC2. The fish were identified and counted.

4. **June 5, 2023- Fish salvage efforts.** The fish salvage operation was also carried out on June 8, 2023, June 23, and July 13. Approximately 500 coho (with 1 steelhead fry and 1 Dolly Varden fry) were salvaged from the McCully MC1 & MC3 reaches, with another 150 (unidentified) from the Kispiox river gravel bar at the bottom of MC2.

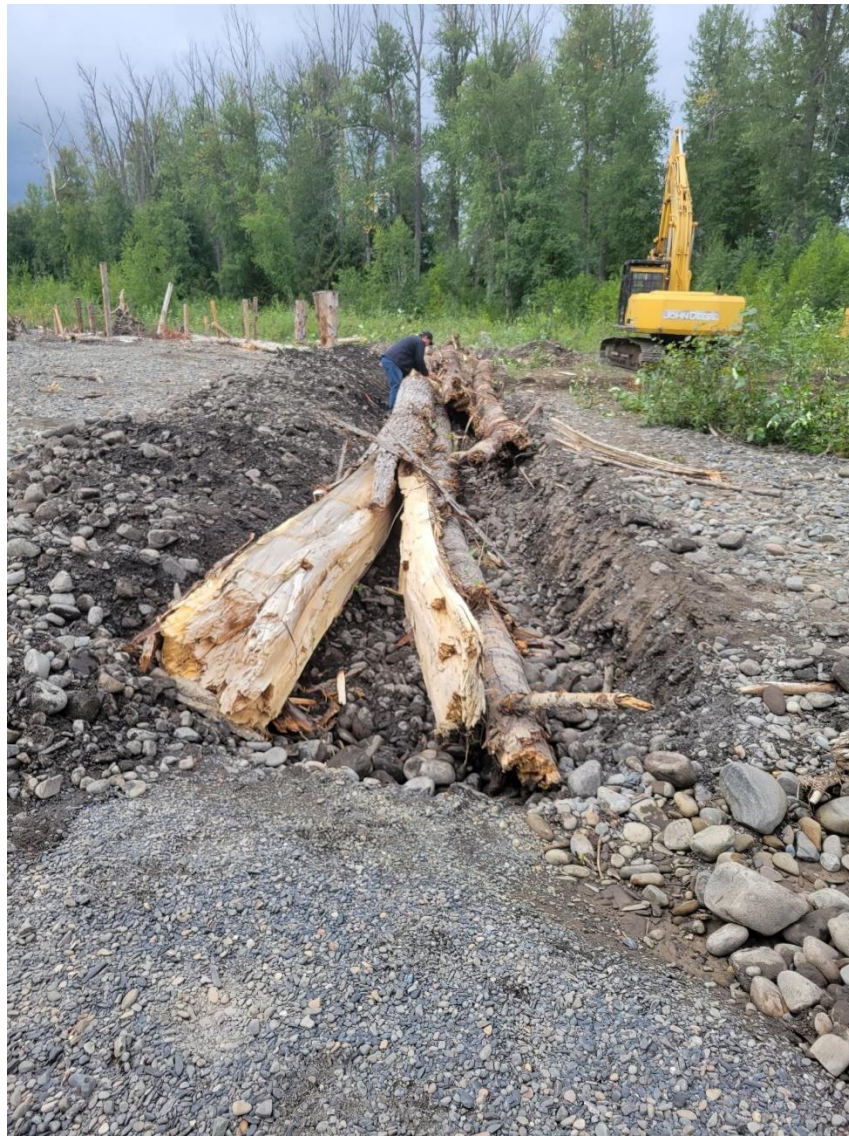
**Figure 4.** Bank structure put in place to prevent flood waters from channelizing towards MC1. The structure was created by roping 5 cottonwoods together and burying them with rock and gravel approximately 3-4 ft down into the streambed.

5. **July 31, 2023- Bank stabilization/channel diversion prevention in the fan area.** In this activity we re-organized some of the components of the emergency bank structure, and as well, we added a whole new structure. The new structure was put in place to prevent the creek from carving out a new channel towards MC1 in the next spring flood. **Figure 4** is an image of the new structure. A similar structure was built immediately above the emergency bank structure (no

photo); it was built at roughly the same angle (perpendicular to anticipated flow direction) as the structure below.

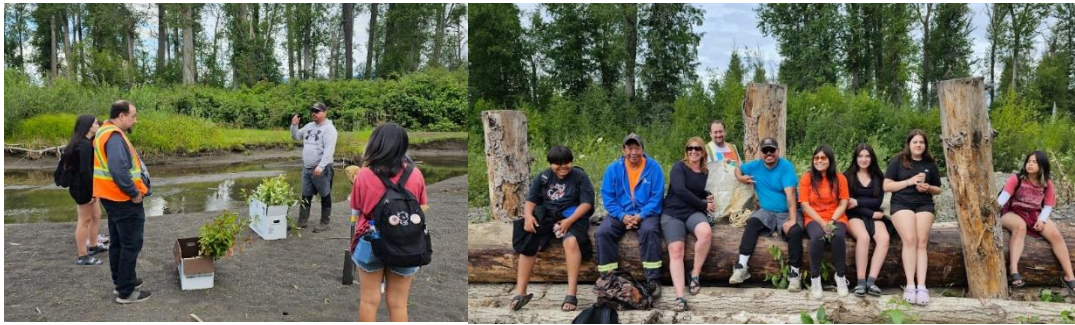
**Figure 5.** The youth took part in cottonwood and red osier planting in the MC1 reach. The principals of plant restoration were discussed and the youth learned about how their actions will affect this reach in a positive manner. The key concept introduced was **stewardship**.

6. **August 2, 2023- Kispiox school youth field trip.** Amongst other activities the kids took part in the re-vegetation of the MC1 banks with 75 cottonwoods and 20 red osier plants. The idea here was to add some plant diversity to the channel banks, while at the same time, adding bank stabilization. The seedlings were purchased from Woodmere Nursery.

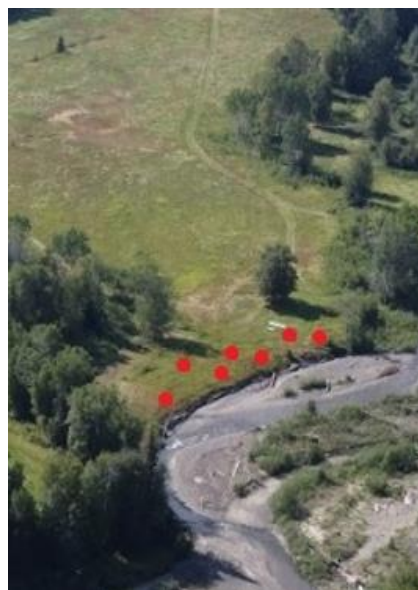
**Figure 6.** This image illustrates the section of bank which was planted with two rows of spruce seedlings (80 total). The seedlings were planted to prevent bank erosion/land loss.

**7. August 3, 2023- Conifer planting on river right banks on Clint Larson's property.**

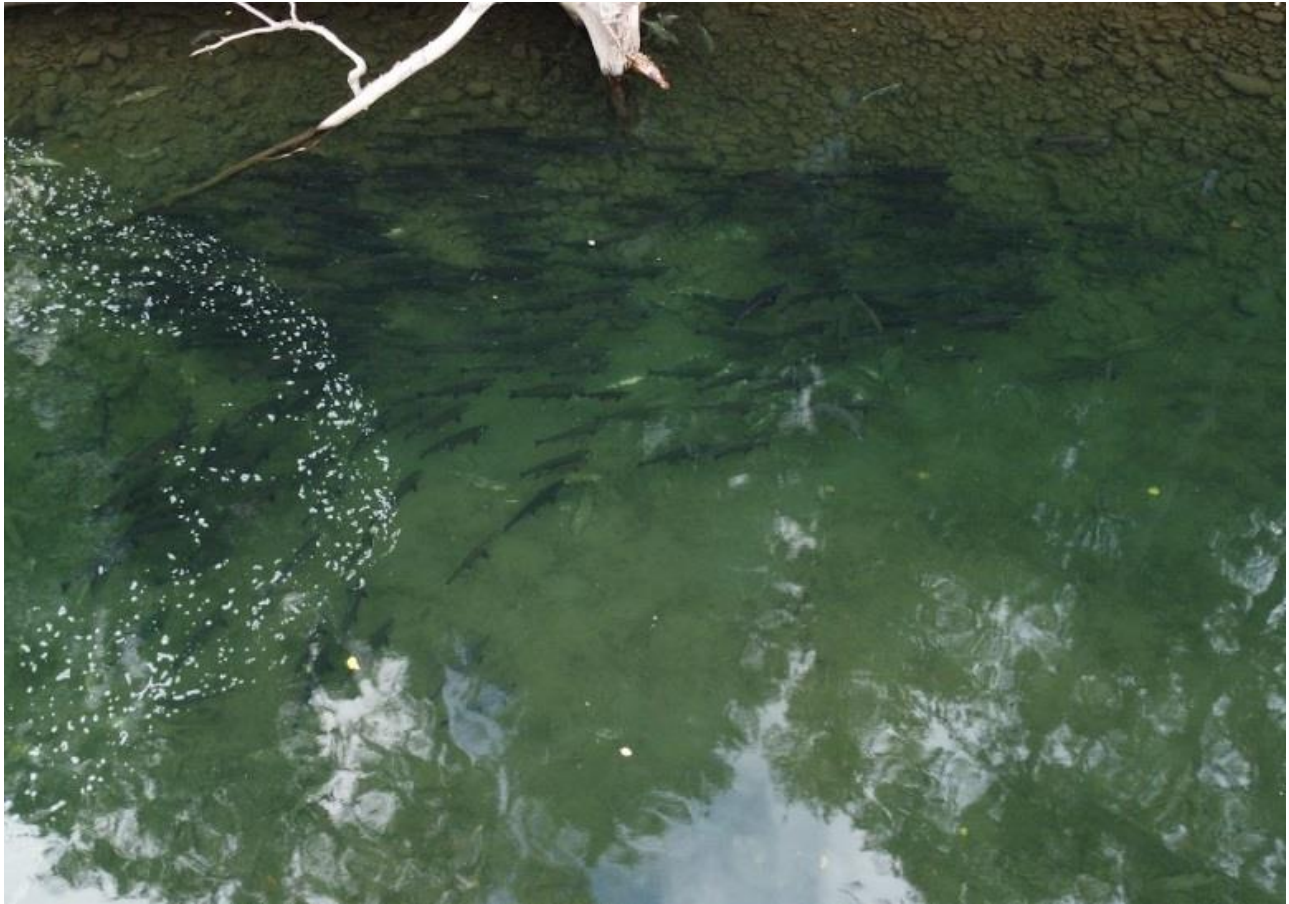
**Figure 7.** This image illustrates coho holding 200 yards below the old MC2 mouth. This is the confluence of the McCully creek and Kispiox river in 2023. Approximately 90-120 of these coho moved into McCully at different times with the fall surges in water levels.

**8. August-November 2023-Creek walks.** This year we observed pink salmon and coho salmon (and 1 steelhead), and as well, we observed 1 mortality each of Chinook and chum salmon. Towards the end of October, we had 1 large count of coho (94), which were mostly found in the MC2 reach; with about 15 above the new beaver dam at MC7 (above the bridge). In the first week of November, another 30 coho may have moved into the McCully creek as these were lively still

and fighting each other to spawn. In the weeks prior to this observation, the coho activity slowed down since the big count of 94. One point of interest is that we observed a large school of coho which was pooled up ~200 yards below the old MC2 mouth of McCully creek. I say old, because in the two previous years the Kispiox would drain McCully directly at the MC2 mouth. This year the Kispiox jumped to the other side of the gravel bar at the bottom of McCully, and now the McCully needs to travel an additional 200 yards to drain into the Kispiox. The coho held in this pool and they moved up periodically with the surges in high water that came sparsely throughout the fall.

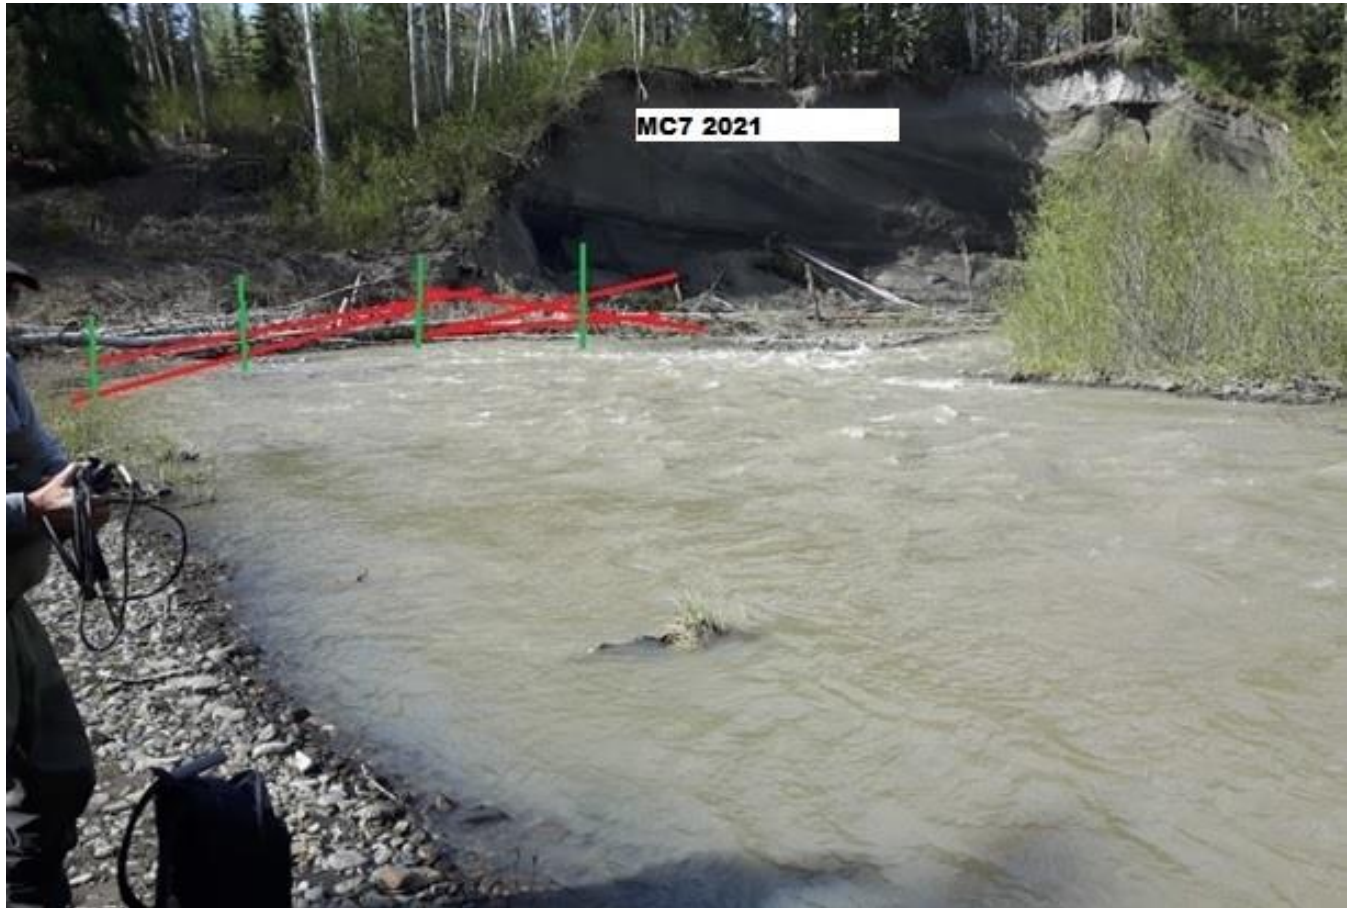
#### MC7

**Figure 8.** This image was taken at MC7 in 2021, where bank stabilization structures were placed in 2018-2019. The structures have subsided slightly and this site needs to be refurbished as of 2023. The red and green lines represent how the original structure looked when it was first built in 2018-2019. The green lines represent upright logs and the red lines represent horizontal logs.

Some of the activities we had planned for this year we could not get around to. These activities include bank stabilization refurbishing at the large cutbank in the MC7 area, bank stabilization on the cutbank on Clint Larson's property, bank stabilization in the low-tech stream in the upper fan area, and plant reclamation in the lower fan. As we proceed, I would like to note that we should also plan to protect the

vegetation in the upper fan area with strategically placed large woody debris. Below are images which illustrate areas we had planned to carry out these activities.

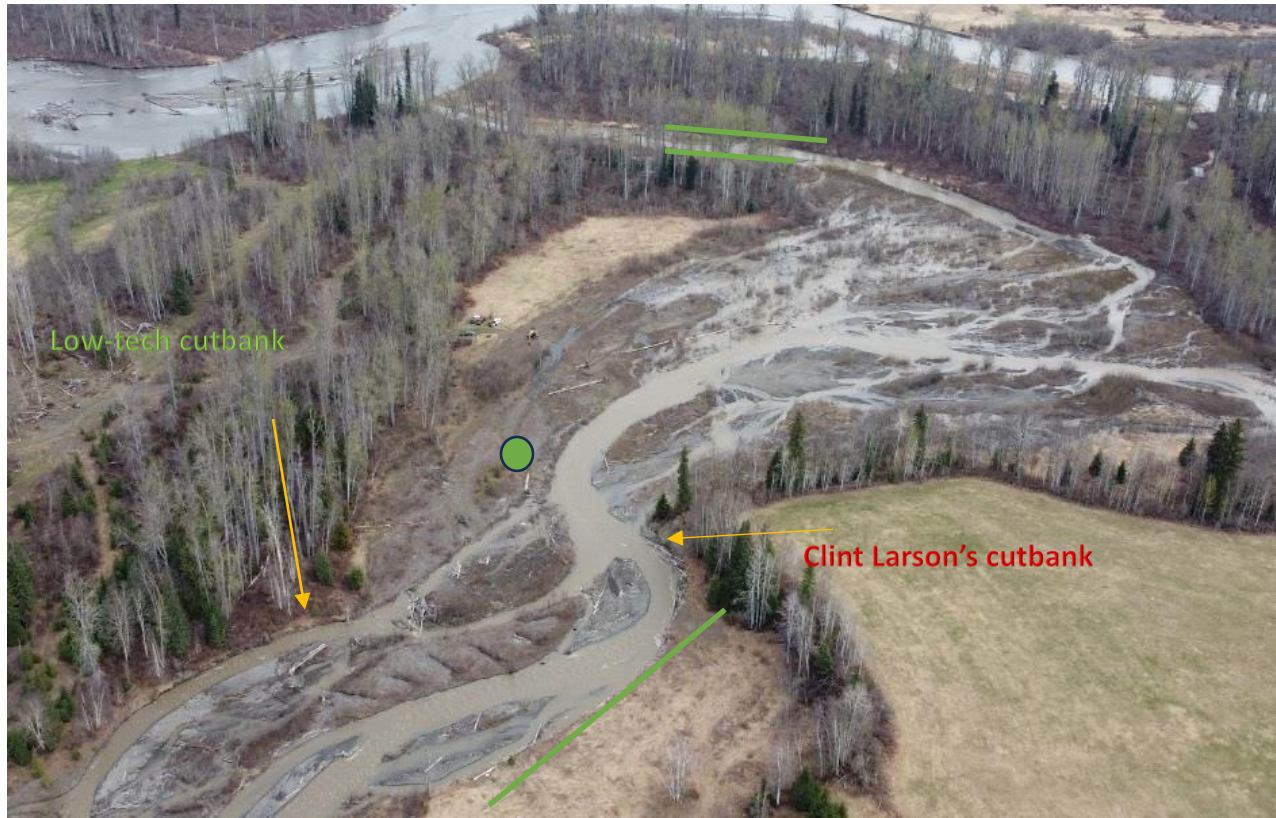
## Clint Larson's Cutbank/Low-Tech Cutbank Stabilization

**Figure 9.** An aerial image of the fan area. On the left side of the image, you can see the 'Low-tech cutbank' which may benefit from some bank protection structures, and on the right, you can see 'Clint Larson's cutbank', which also needs some bank protection re-furbishing. As a side note, the green lines at the top of the image illustrates where cottonwood and red osier were planted in August. The green circle in the bottom middle area illustrates where 6 large cottonwoods were planted in early May. The green line in the bottom middle illustrates the section of bank which was seeded with spruce seedlings in mid-August.
