## **Skeena Watershed Fish Passage Restoration Planning 2022**

**Prepared for**  
**Habitat Conservation Trust Foundation - CAT23-6-288**  
**BC Fish Passage Remediation Program**  
**Ministry of Transportation and Infrastructure**

**Prepared by**  
**Al Irvine, B.Sc., R.P.Bio. and Mateo Wintersheidt, B.Sc.**  
**New Graph Environment Ltd.**  
**on behalf of**  
**Society for Ecosystem Restoration in Northern British Columbia**

**Version 0.1.2 2024-06-25**

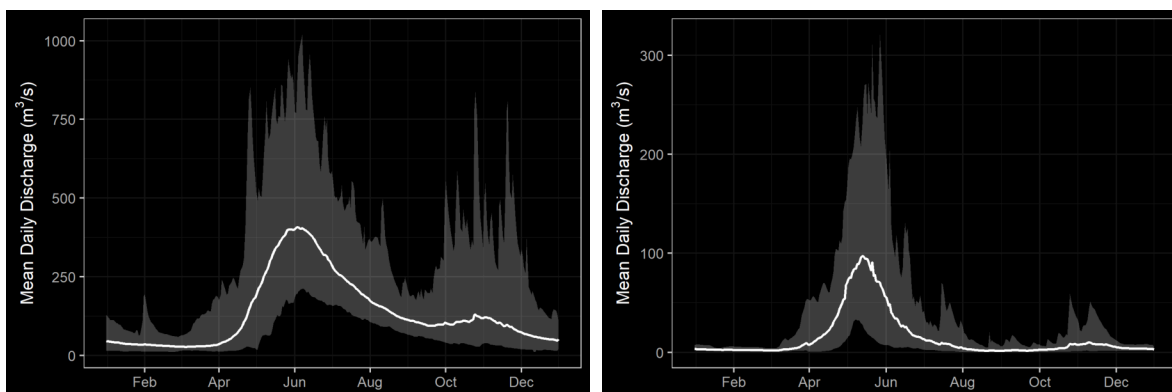
Figure 2.2: Hydrograph for Bulkley River at Quick (Station #08EE004) and near Houston (Station #08EE003).

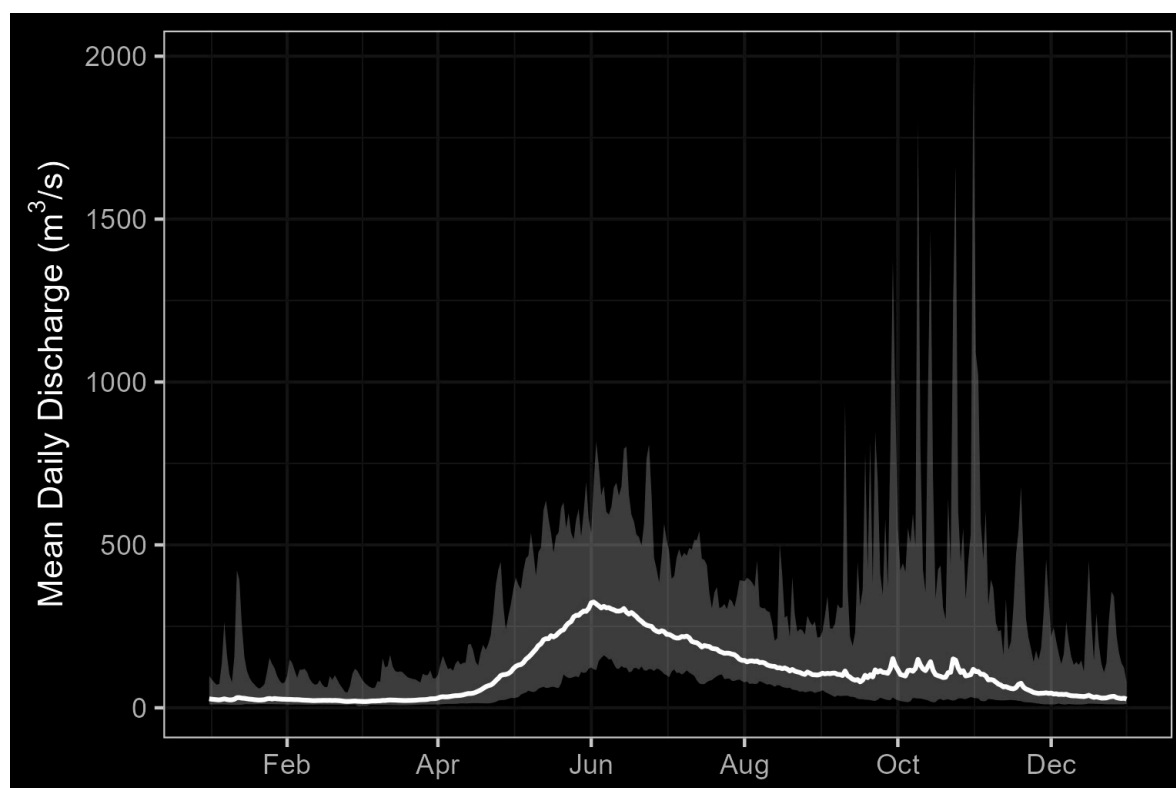
Figure 2.7: Hydrograph for Zymoetz River (Station #08EF005).

The Zymoetz River (known locally as the Copper River) watershed is an eighth order stream that drains an area of 3,028 km<sup>2</sup> in a generally westerly direction. It is considered a major tributary of the Skeena River, as it contributes approximately 10% of the flow. The headwater lakes are located approximately 20km southwest of Smithers, and they include Aldrich, Dennis and McDonell Lakes. The upper and lower portions of the watershed are accessed via logging roads off of Highway 16 from Smithers and Terrace, respectively. Access to the middle watershed is difficult due to road wash out. The Zymoetz River flows roughly 120km, starting just west of Hudson Bay mountain near Smithers and ending at the confluence of the Skeena River, approximately 8km north-east of Terrace. Elevations in the watershed range from 120m at the confluence, to 2740m in the Howson Range. The lower end of the Zymoetz watershed has seen a significant reduction in riparian habitat due to fires, forest development practices, pipe line and road construction (Allen Gottesfeld, Rabnett, and Hall 2002). Snowmelt plays a big role in controlling the stream hydrology, with a mean annual discharge estimated at 105.5 m<sup>3</sup>/s at station 08EF005 located near Smithers. Peak discharge happens in May to early June, which is typical of a high elevation watershed like this (Figures [2.7](#) - [2.8](#)).

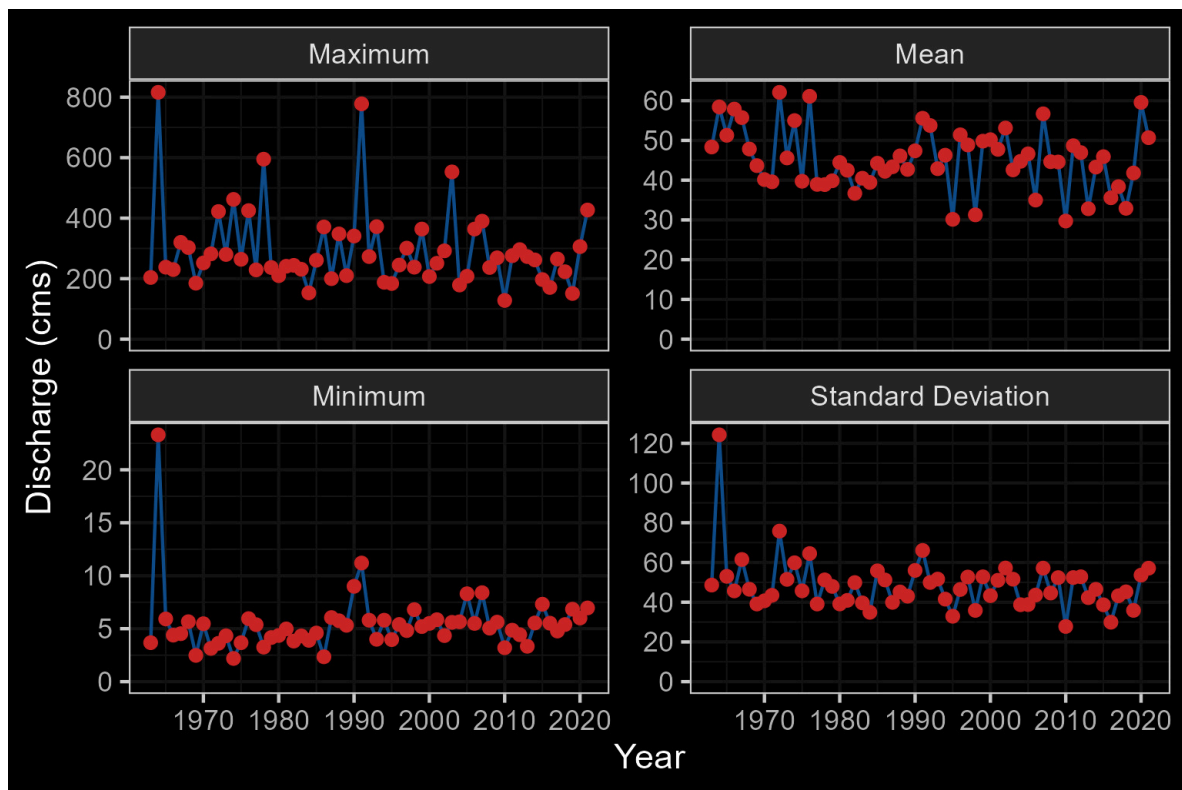
Figure 2.10: Summary of hydrology statistics for Kispiox River near Hazelton (Station #08EB004). Available daily discharge data from 1963 to 2021.

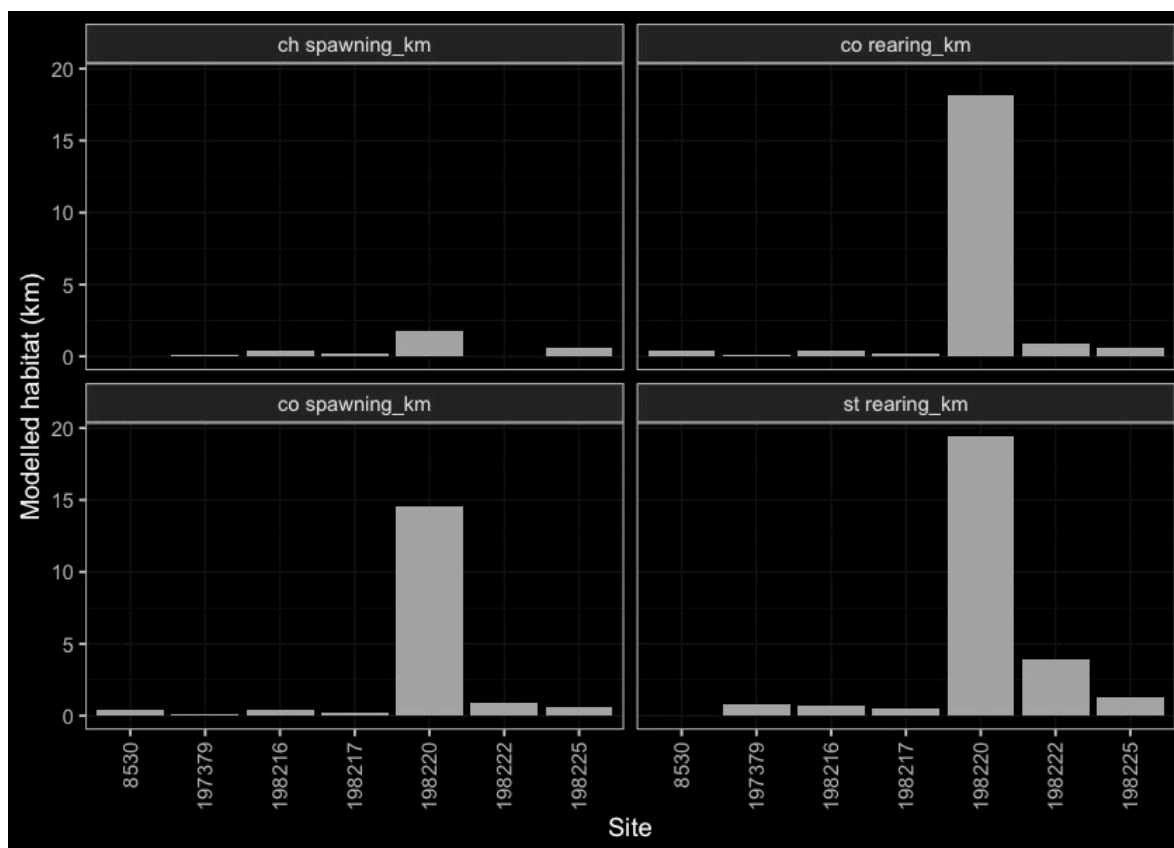
Figure 4.1: Summary of potential habitat upstream of habitat confirmation assessment sites estimated based on modelled channel width and upstream channel length.

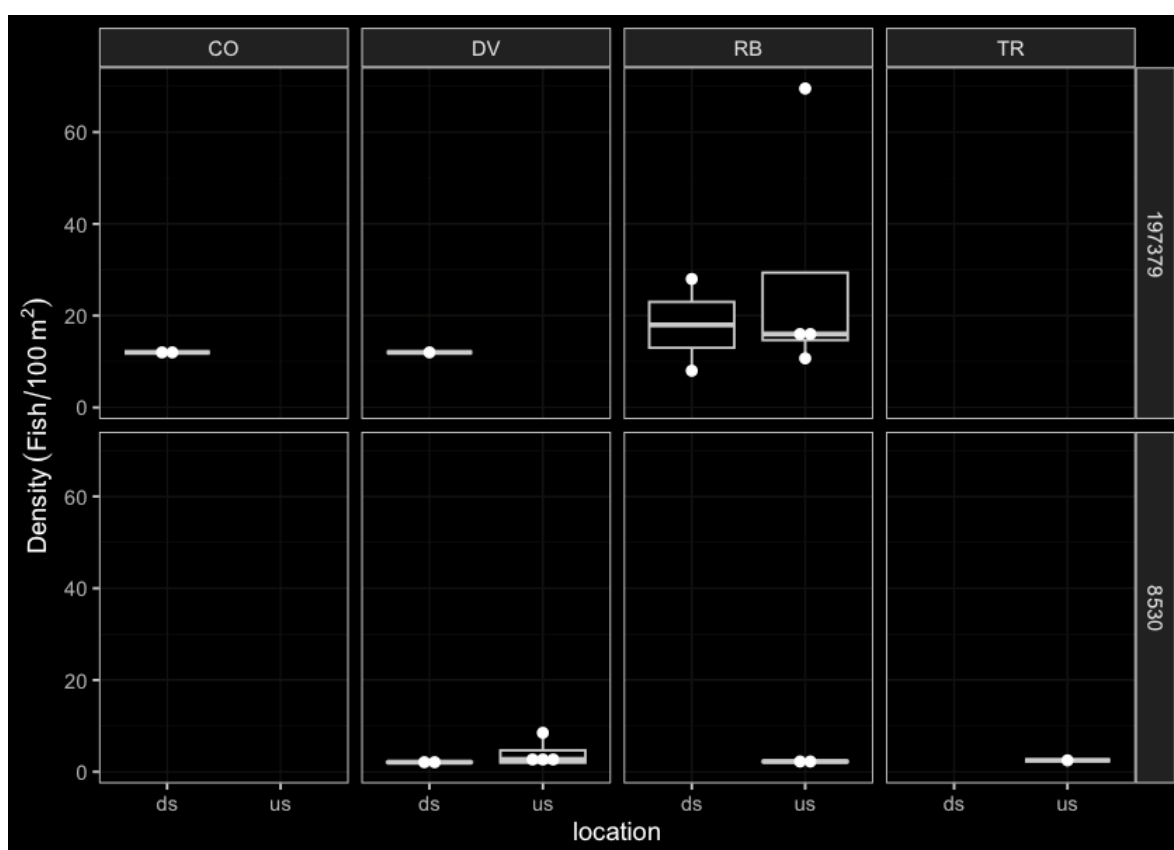
Figure 4.3: Boxplots of densities (fish/100m2) of fish captured by electrofishing during habitat confirmation assessments.

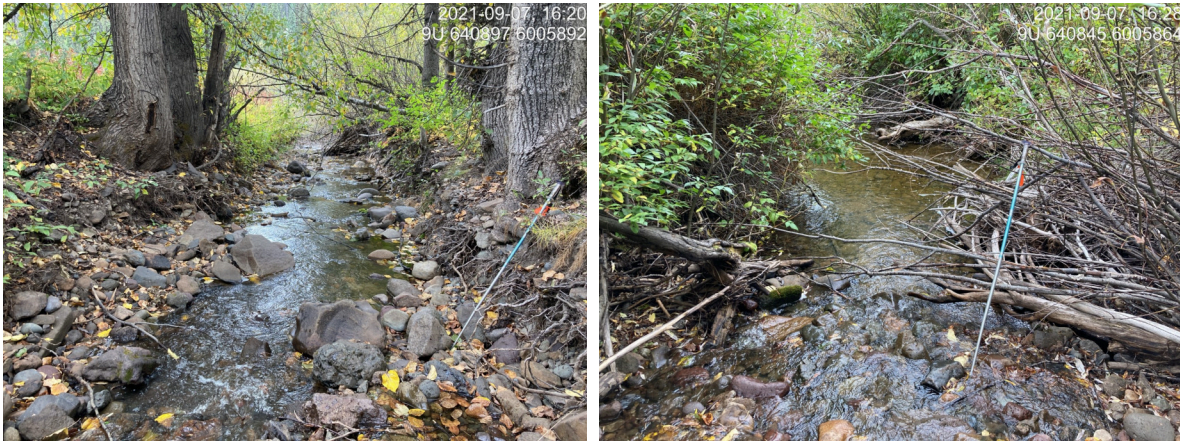
Figure 5.2: Left: Typical habitat downstream of PSCIS crossing 197379. Right: Typical habitat downstream of PSCIS crossing 197379.

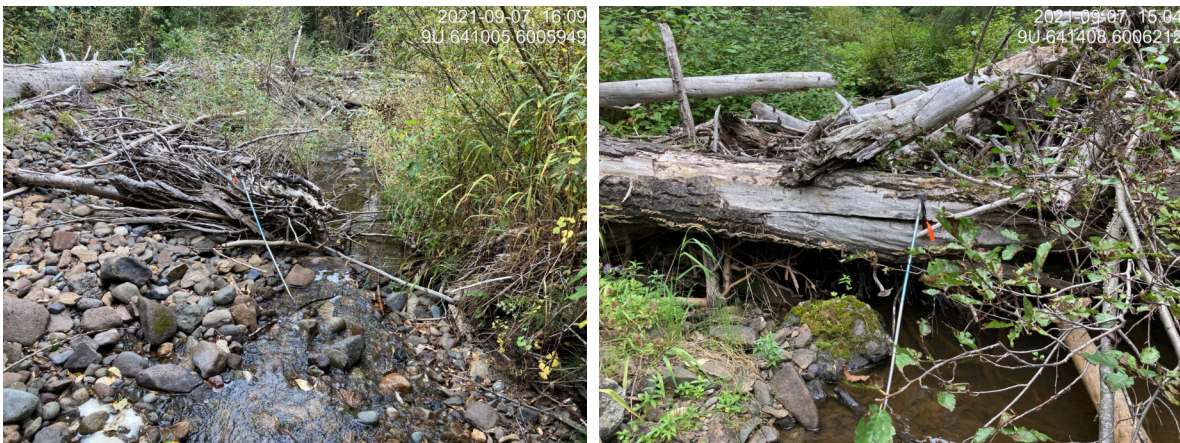
Figure 5.3: Left: Typical habitat upstream of PSCIS crossing 197379. Right: Large woody debris jam upstream of PSCIS crossing 197379.

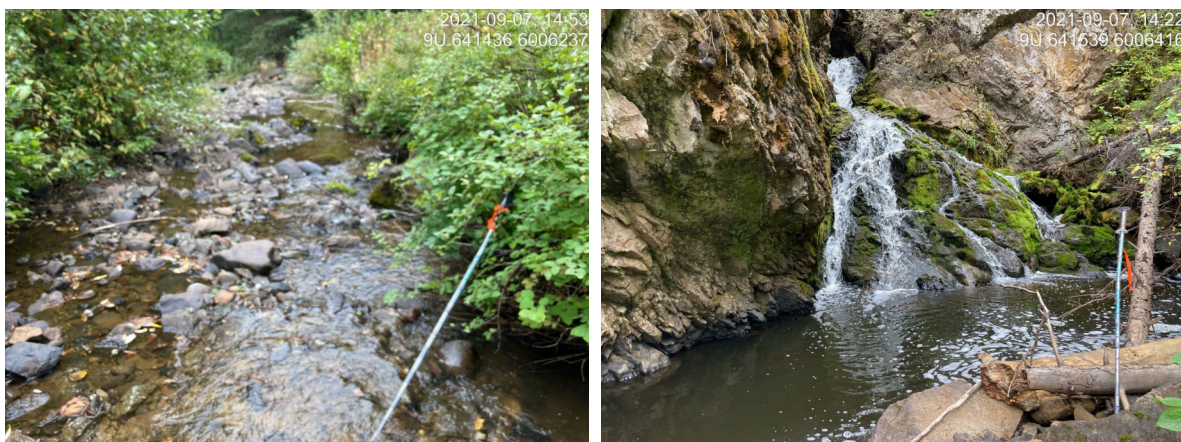
Figure 5.4: Left: Typical habitat upstream of PSCIS crossing 197379. Right: Waterfall upstream of PSCIS crossing 197379.

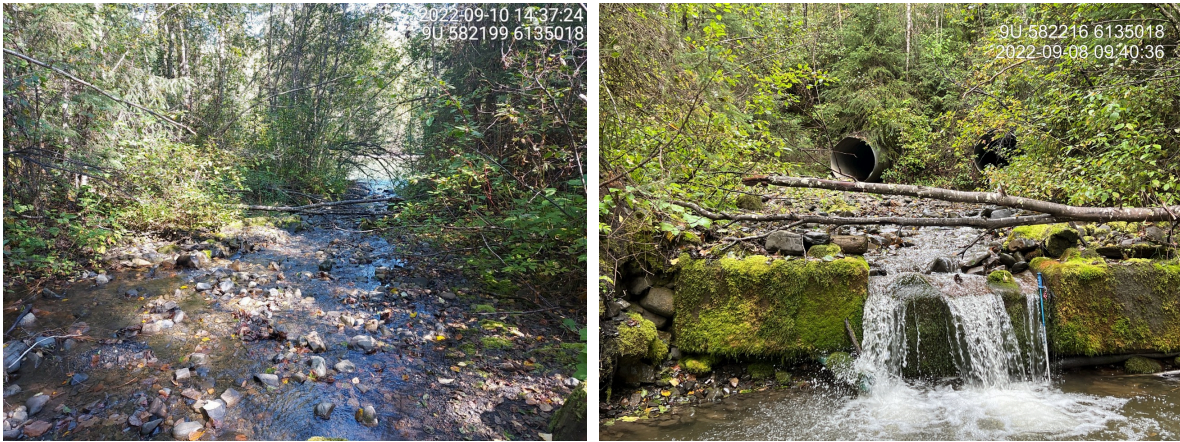
Figure 5.7: Left: Typical habitat downstream of PSCIS crossing 198215. Right: Lock block step downstream of PSCIS crossing 198215.

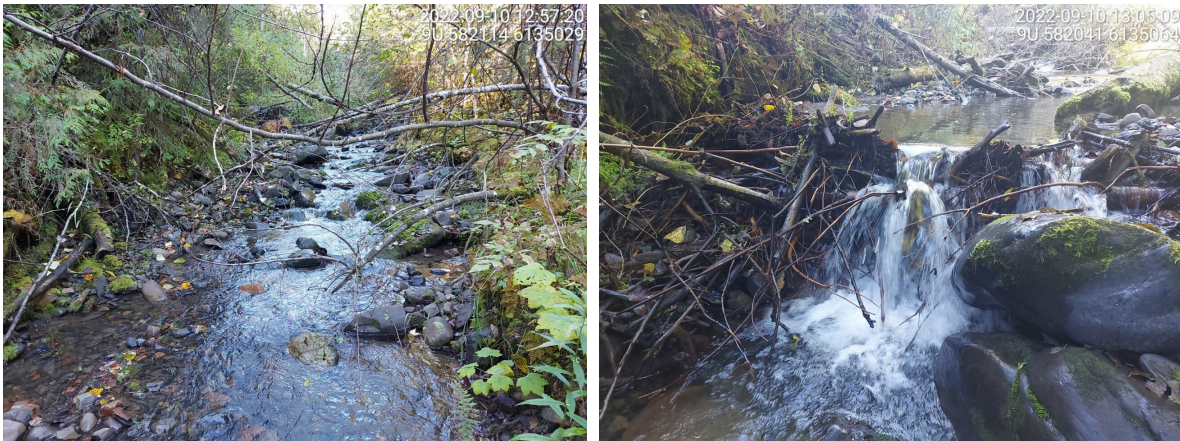
Figure 5.8: Left: Typical habitat upstream of PSCIS crossing 198215. Right: Typical habitat upstream of PSCIS crossing 198215.

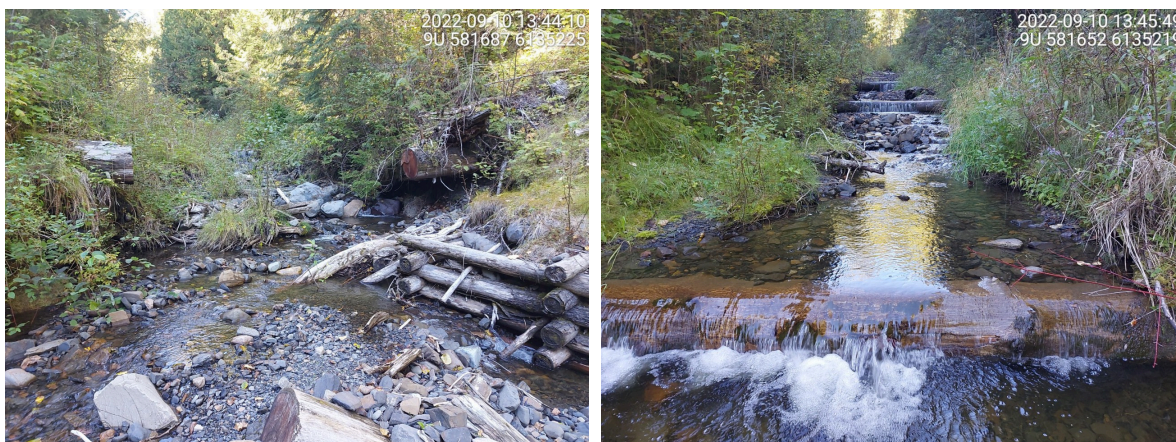
Figure 5.9: Left: Location of old historic dam, upstream of PSCIS crossing 198215. Right: Typical habitat upstream of PSCIS crossing 198215.

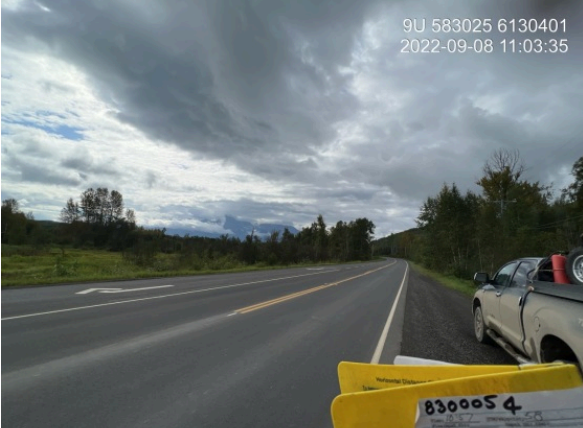
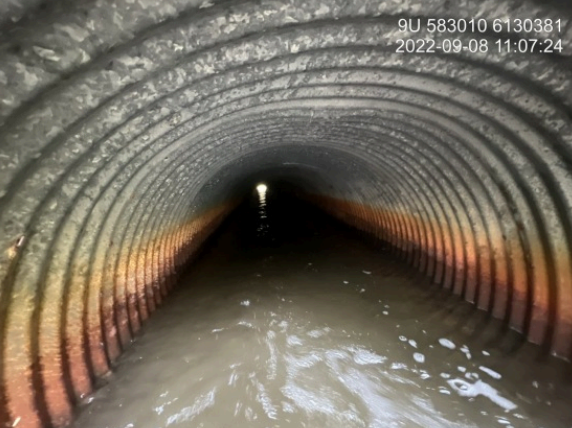
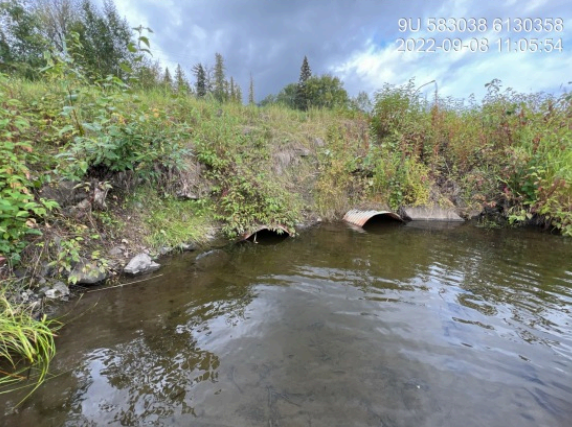
Location and Stream Data	•	Crossing Characteristics	-
Comments: Culvert appears very old and near end of life. Nice gravels upstream. Flow is moving between the two 1 m pipes. Trash rack on inlet could be barrier to adult coho migrating upstream. 10:57			
Photos: From top left clockwise: Road/Site Card, Barrel, Outlet, Downstream, Upstream, Inlet.

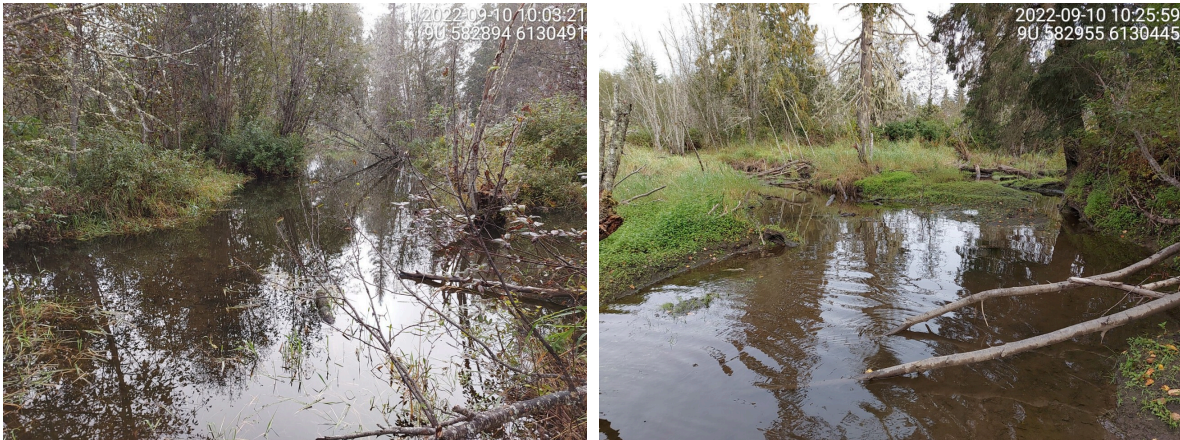
Figure 5.13: Left: Typical habitat downstream of PSCIS crossing 198217. Right: Typical habitat downstream of PSCIS crossing 198217.

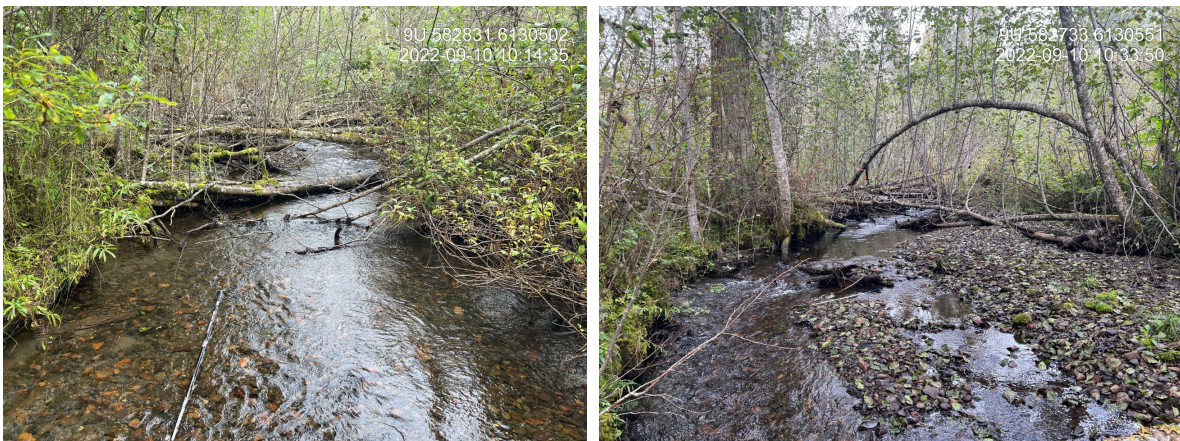
Figure 5.14: Left: Typical habitat upstream of PSCIS crossing 198217. Right: Typical habitat upstream of PSCIS crossing 198217.

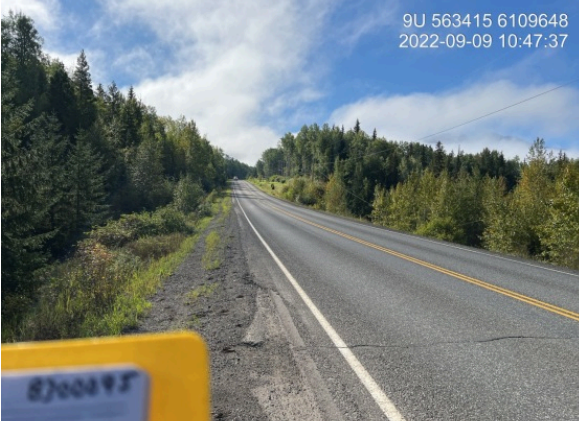
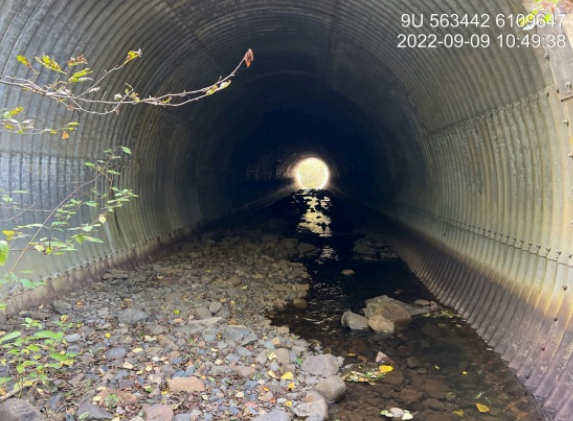
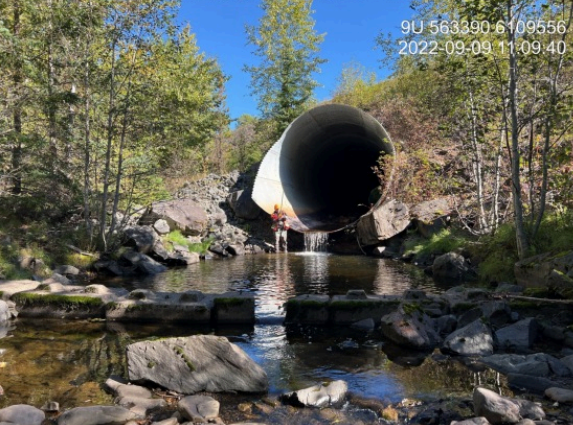
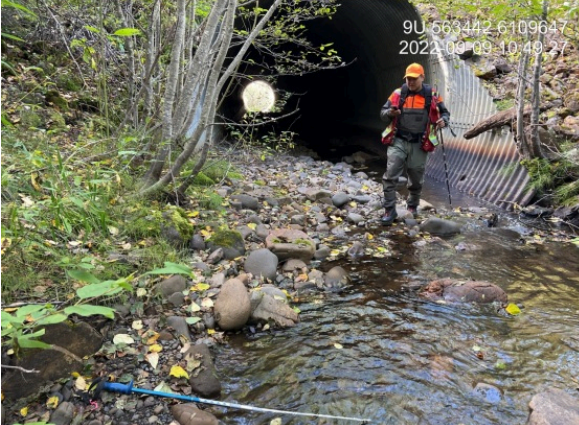
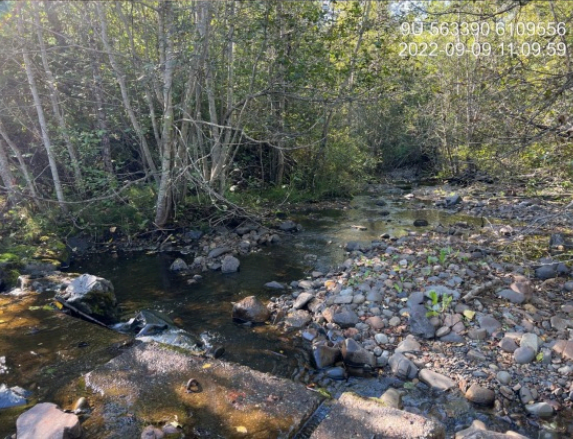
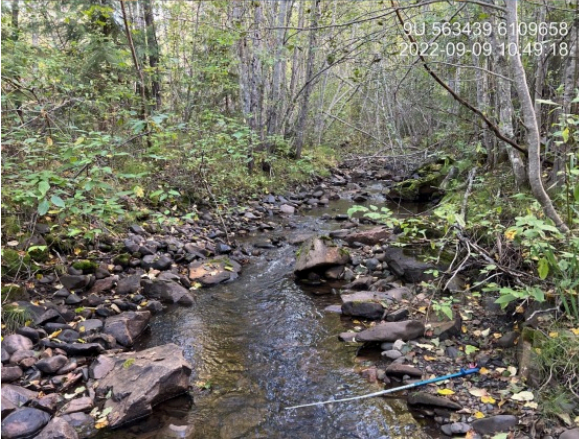
Location and Stream Data	•	Crossing Characteristics	-
Comments: Historic backwatering with 6 downstream lock block weirs. Skeena Fisheries Commission has assessed site in past. Very large system, pipe embedded until downstream 10m. Large outlet drop. Abundant algae. 10:46			
Photos: From top left clockwise: Road/Site Card, Barrel, Outlet, Downstream, Upstream, Inlet.

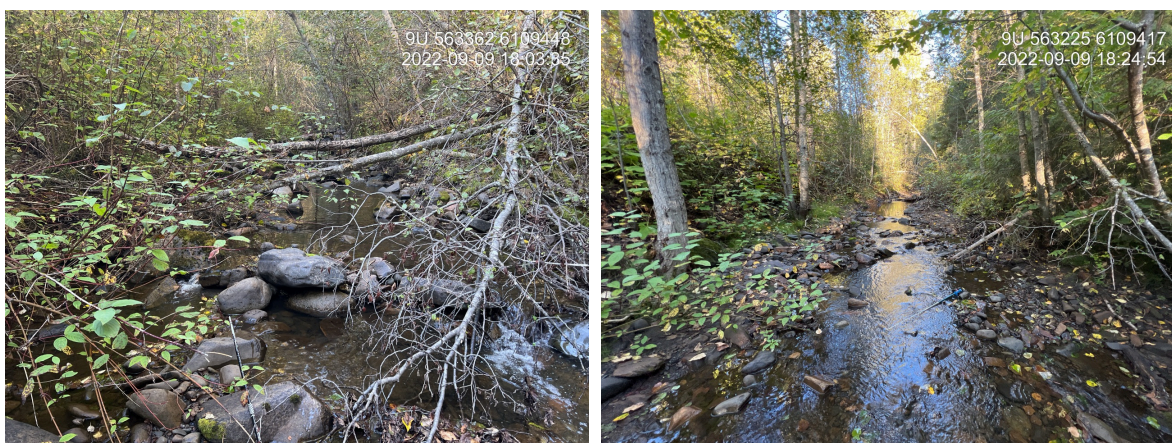
Figure 5.16: Left: Typical habitat downstream of PSCIS crossing 198220. Right: Typical habitat downstream of PSCIS crossing 198220.

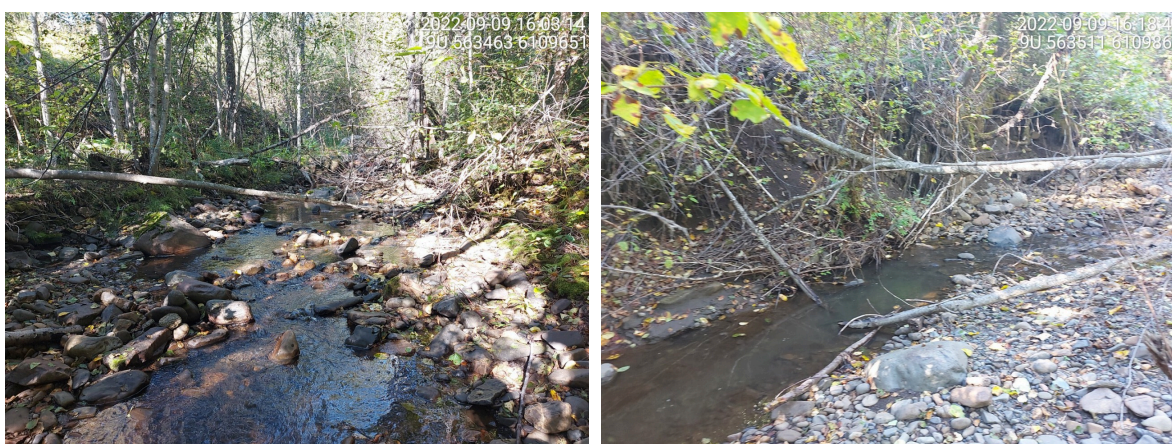
Figure 5.17: Left: Typical habitat upstream of PSCIS crossing 198220. Right: Typical habitat upstream of PSCIS crossing 198220.

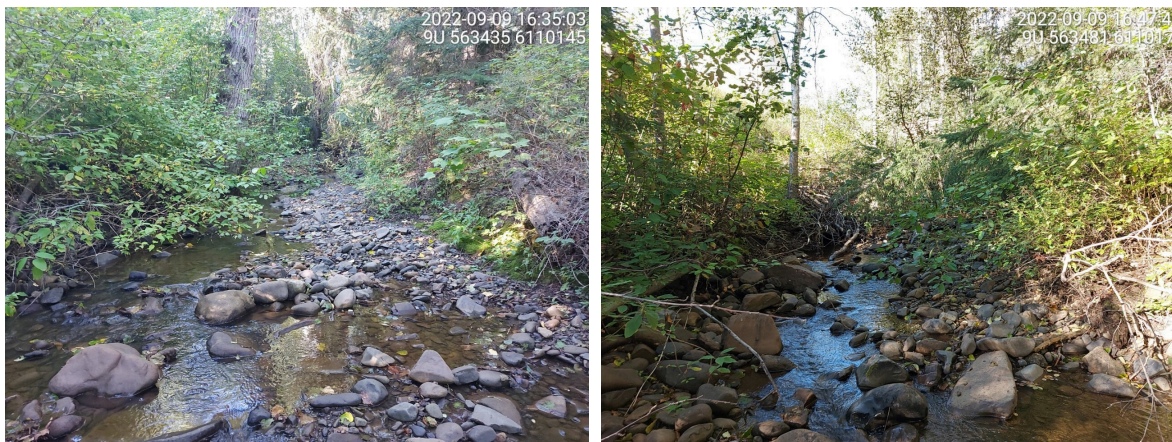
Figure 5.18: Left: Typical habitat upstream of PSCIS crossing 198220. Right: Typical habitat upstream of PSCIS crossing 198220.

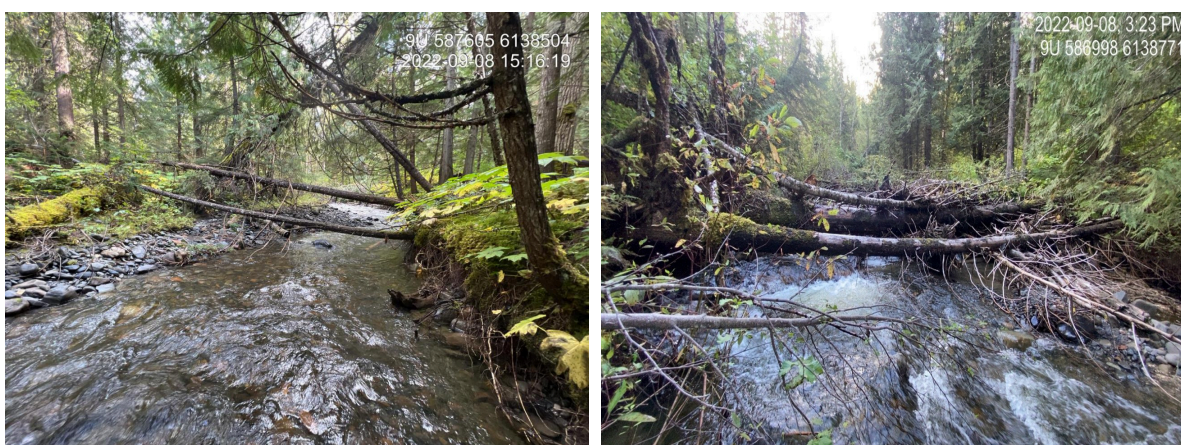
The stream was surveyed downstream from crossing 198222 for 150m (Figure 5.20). The dominant substrate was cobbles with gravels sub-dominant. The average channel width was 8.1m, the

Figure 5.20: Left: Typical habitat downstream of PSCIS crossing 198222. Right: Typical habitat downstream of PSCIS crossing 198222.

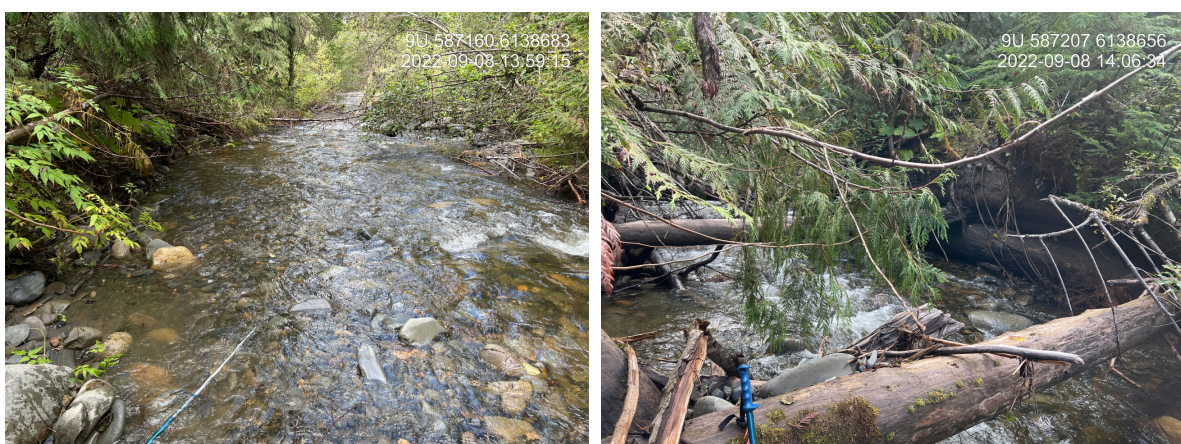
Figure 5.21: Left: Typical habitat upstream of PSCIS crossing 198222. Right: Collapsed bridge upstream of PSCIS crossing 198222.

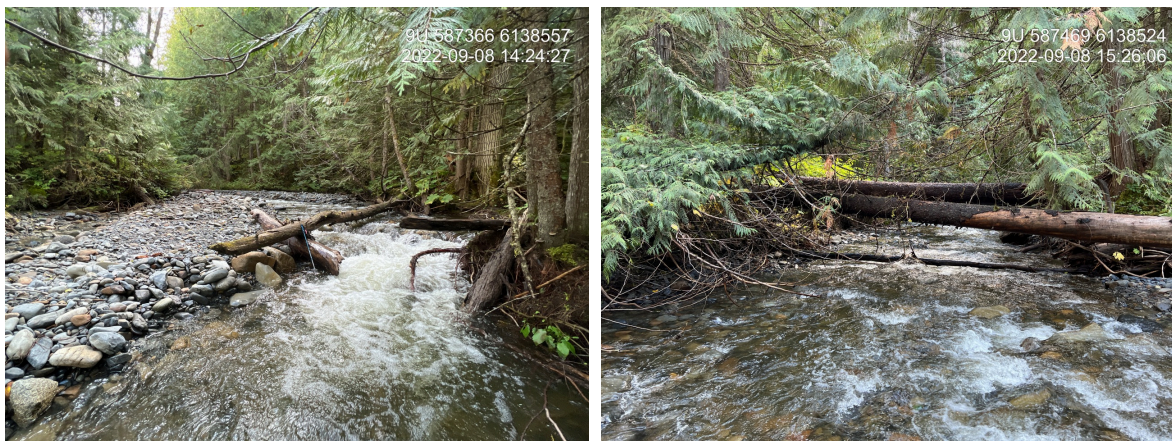
Figure 5.22: Left: Typical habitat upstream of PSCIS crossing 198222. Right: Typical habitat upstream of PSCIS crossing 198222.

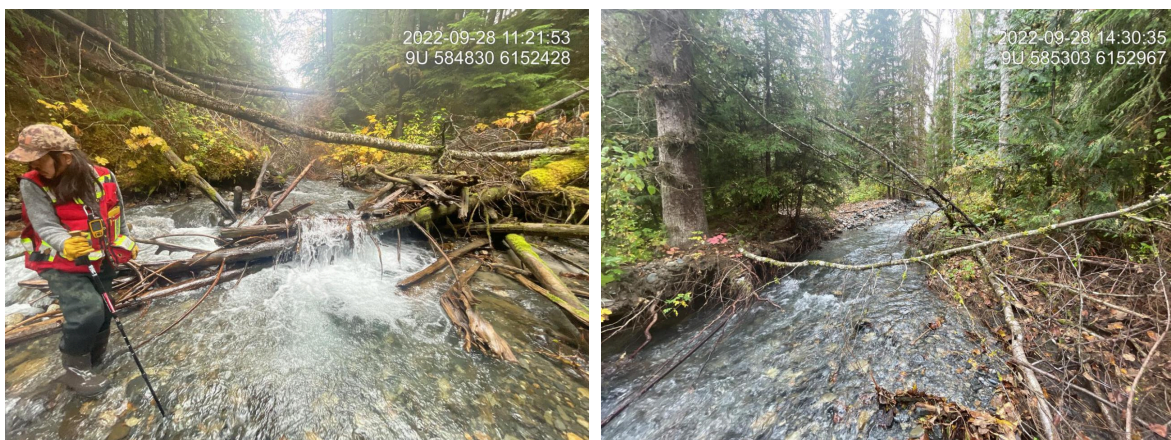
The stream was surveyed downstream from crossing 198225 for 260m in 2022 (Figure 5.24). The average channel width was 7.5m, the average wetted width was 5.6m, and the average gradient

Figure 5.24: Left: Typical habitat downstream of PSCIS crossing 198225. Right: Typical habitat downstream of PSCIS crossing 198225.

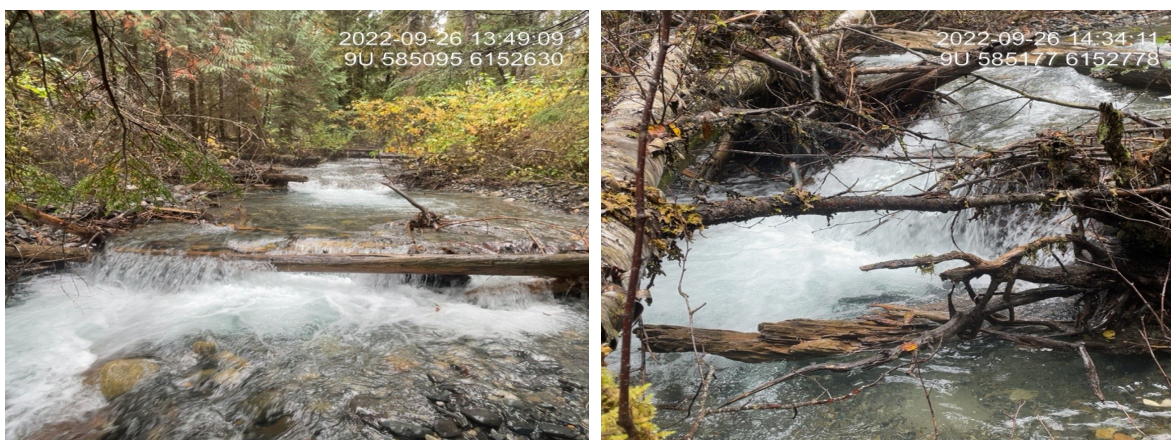
The stream was surveyed upstream from crossing 198225 for 500m (Figure 5.25). The dominant substrate was cobbles with gravels sub-dominant. The average channel width was 12.2m, the average wetted width was 5.5m, and the average gradient was 4.4%. Total cover amount was rated as abundant with large woody debris dominant. Cover was also present as small woody debris. This stream has the potential to be fish bearing but the gradient is steep. The bank full depth is very high, with a measured average of 0.8m. There was an abundance of large woody debris that provided functionality to the stream habitat by diverting flow and providing cover. The habitat was rated as medium value as an important migration corridor containing suitable rearing habitat.

Figure 5.25: Left: Typical habitat upstream of PSCIS crossing 198225. Right: Typical habitat upstream of PSCIS crossing 198225.

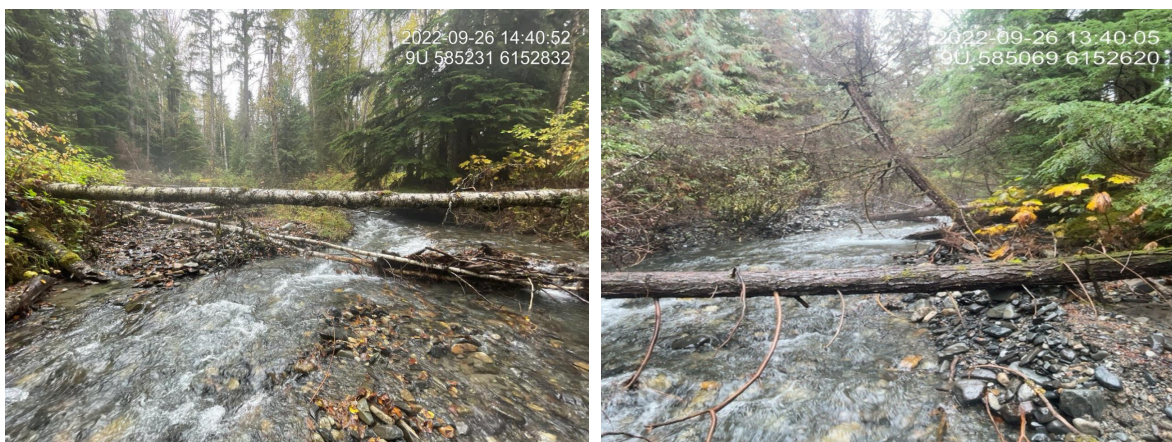
Figure 5.26: Left: Typical habitat upstream of PSCIS crossing 198225. Right: Typical habitat upstream of PSCIS crossing 198225.

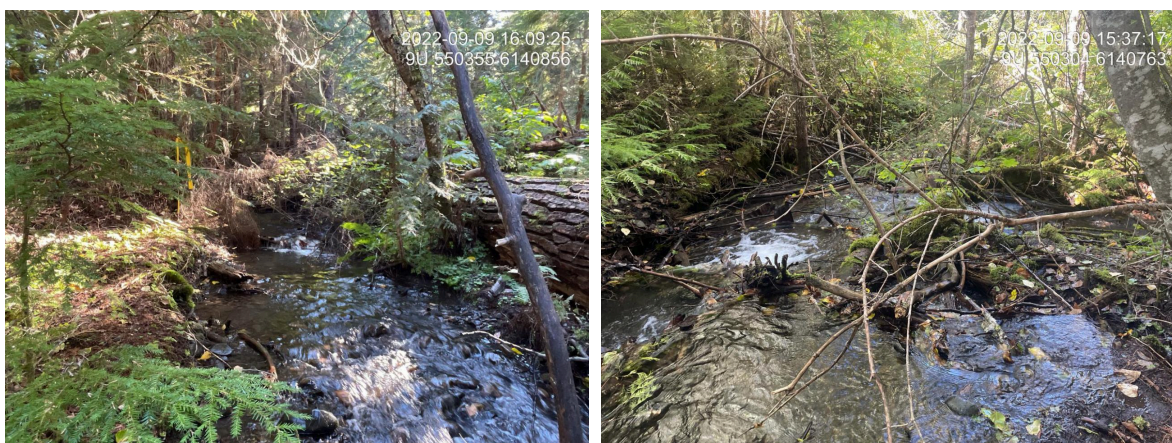
The stream was surveyed downstream from crossing 198236 for 200m (Figure 5.27). The dominant substrate was cobbles with gravels sub-dominant. Total cover amount was rated as moderate with

Figure 5.27: Left: Typical habitat downstream of PSCIS crossing 198236. Right: Typical habitat downstream of PSCIS crossing 198236.

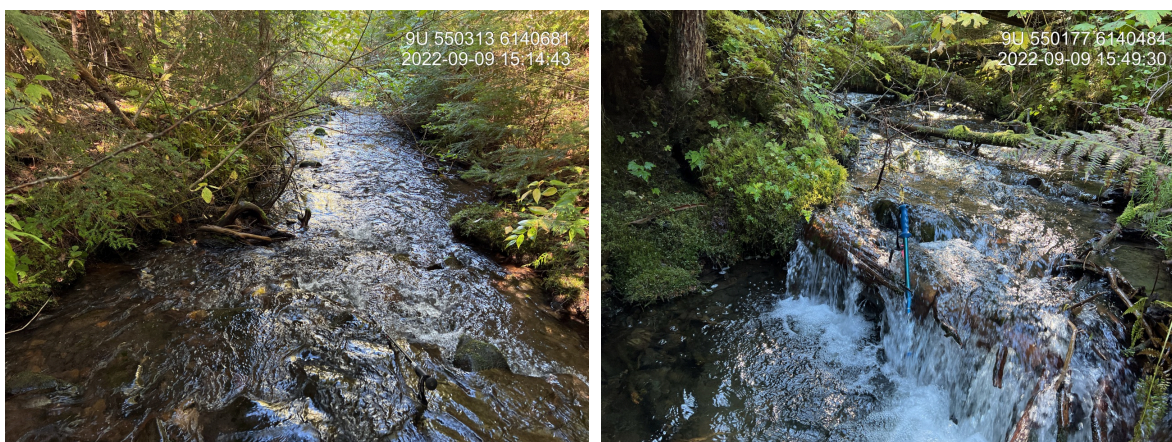
Figure 5.28: Left: Typical habitat upstream of PSCIS crossing 198236. Right: Typical habitat upstream of PSCIS crossing 198236.

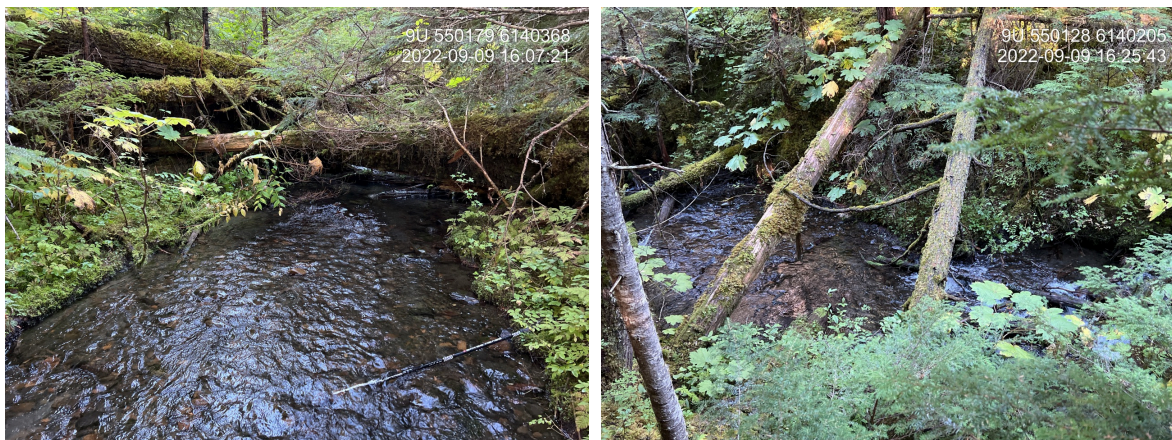
Figure 5.29: Left: Typical habitat upstream of PSCIS crossing 198236. Right: Typical habitat upstream of PSCIS crossing 198236.

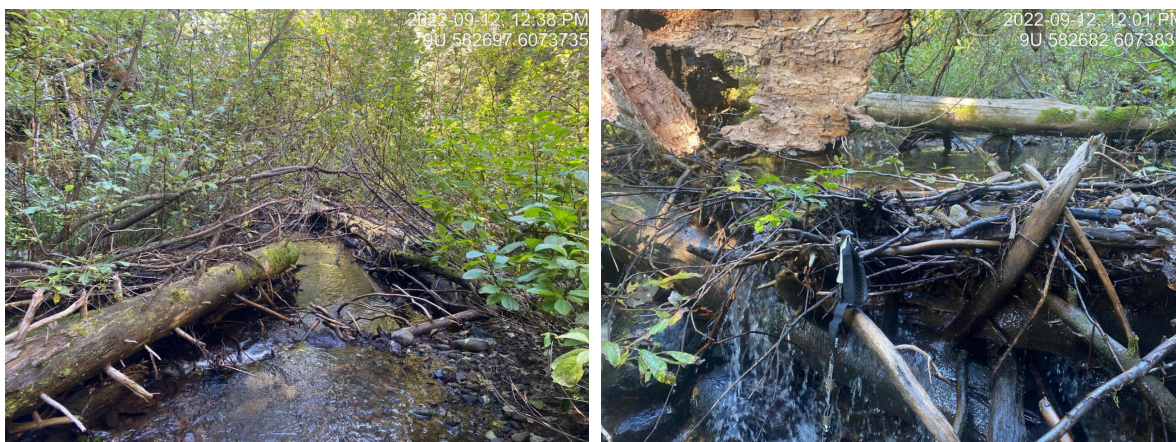
The stream was surveyed downstream from crossing 8530 for 275m (Figure 5.32). The average channel width was 4m, the average wetted width was 3.2m, and the average gradient was

Figure 5.32: Left: Typical habitat downstream of PSCIS crossing 8530. Right: Large woody debris jam downstream of PSCIS crossing 8530.

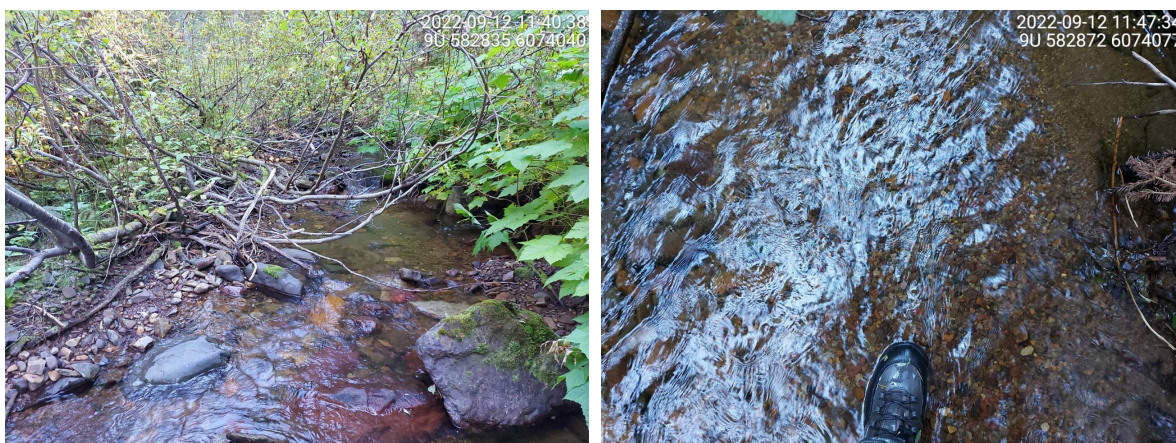
Figure 5.33: Left: Typical habitat upstream of PSCIS crossing 8530. Right: Area with suitable spawning gravels, upstream of PSCIS crossing 8530.

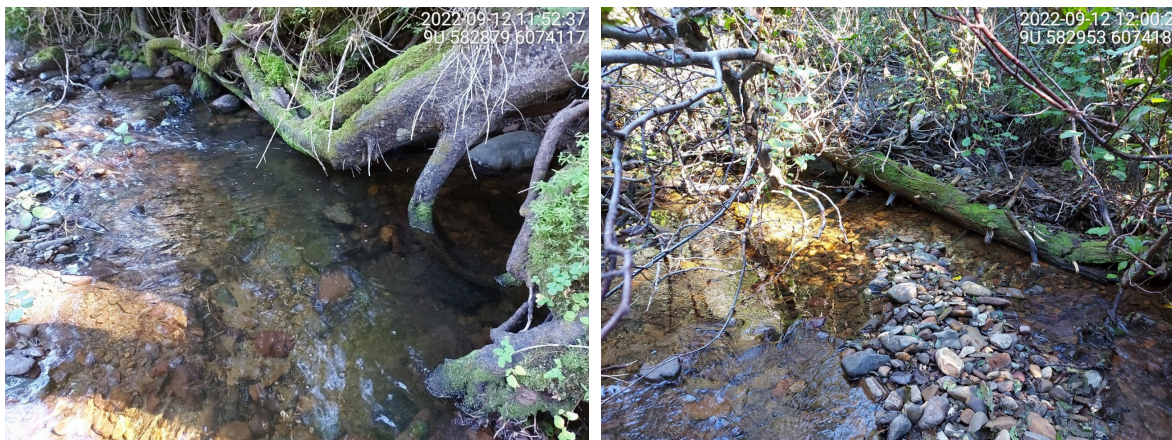
Figure 5.34: Left: Typical habitat upstream of PSCIS crossing 8530. Right: Typical habitat upstream of PSCIS crossing 8530.
