## **Skeena Watershed Fish Passage Restoration Planning 2023**

**Prepared for**  
**Habitat Conservation Trust Foundation - CAT23-6-288**  
**BC Fish Passage Remediation Program**  
**Ministry of Transportation and Infrastructure**

**Prepared by**  
**Al Irvine, B.Sc., R.P.Bio and Lucy Schick, B.Sc.**  
**New Graph Environment Ltd.**  
**on behalf of**  
**Society for Ecosystem Restoration in Northern British Columbia**

**Version 0.0.3 2024-06-27**

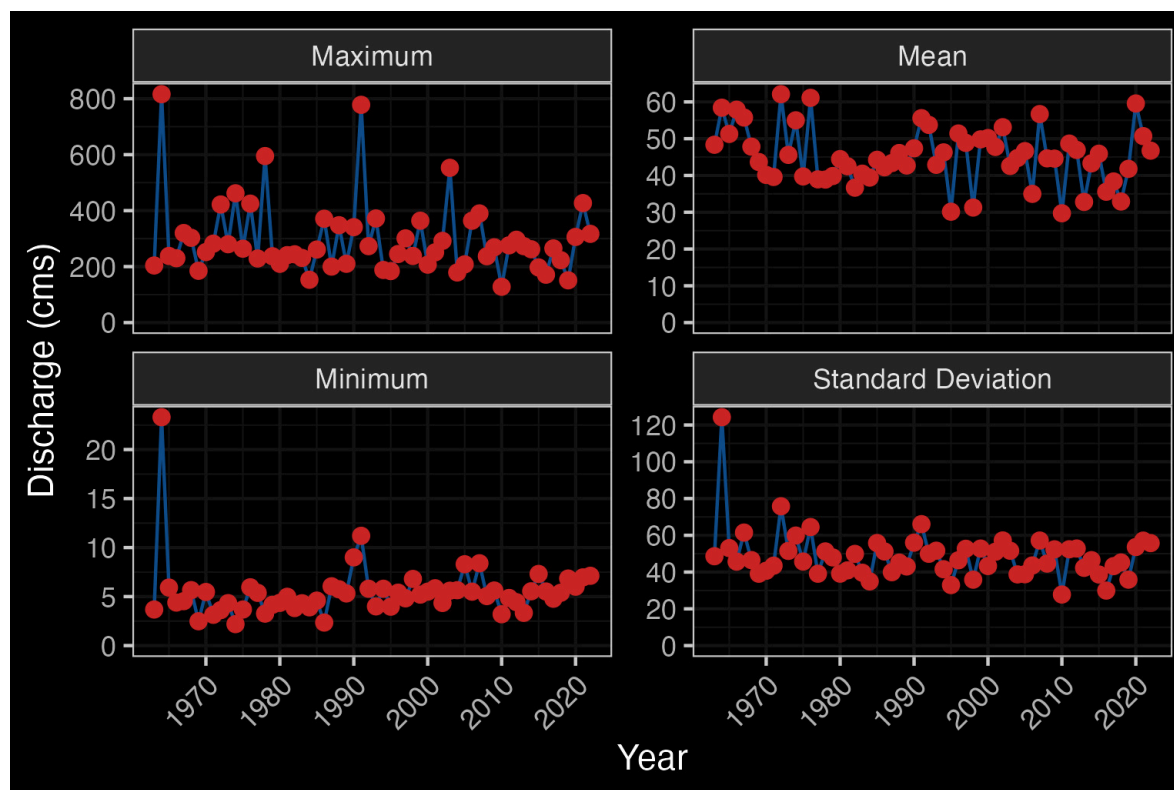
Figure 2.10: Kispiox River Near Hazelton (Station #08EB004 - Lat 55.43385 Lon -127.71616). Available daily discharge data from 1963 to 2022.

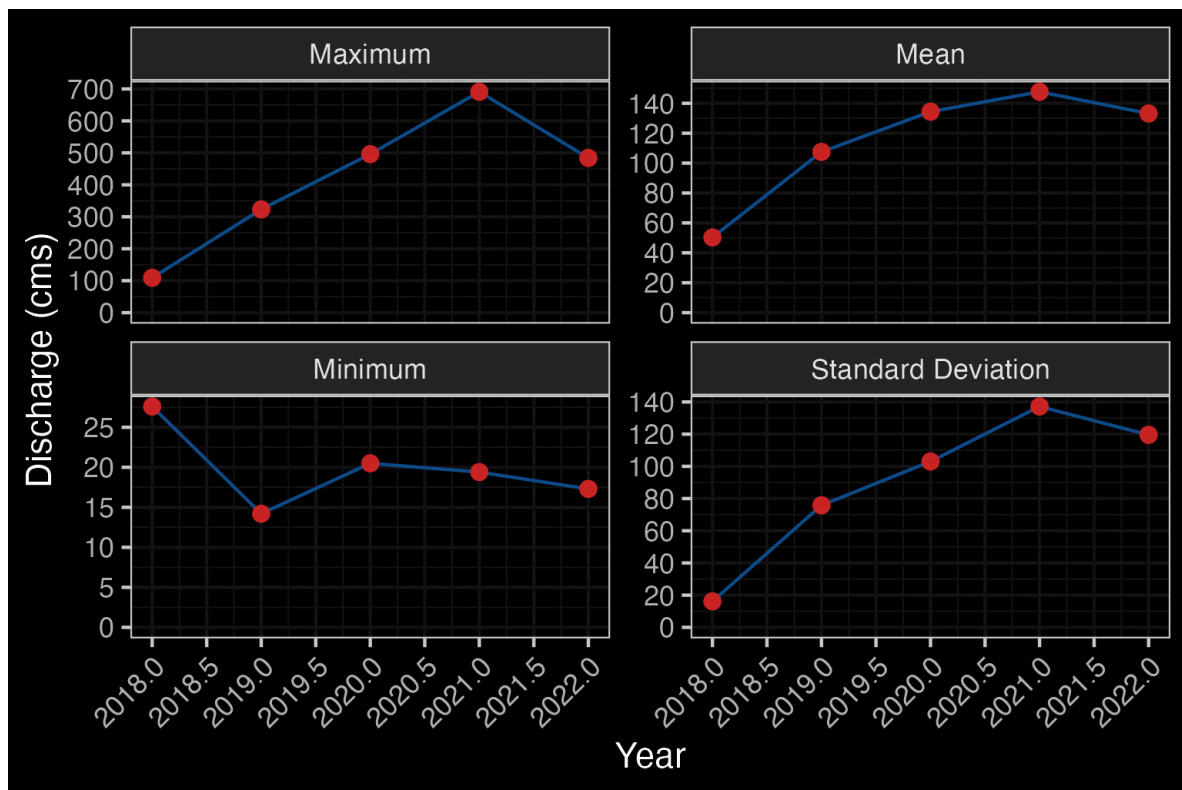
Figure 2.12: Kitsumkalum River Below Alice Creek (Station #08EG019 - Lat 54.6793 Lon -128.74396). Available daily discharge data from 2018 to 2022.

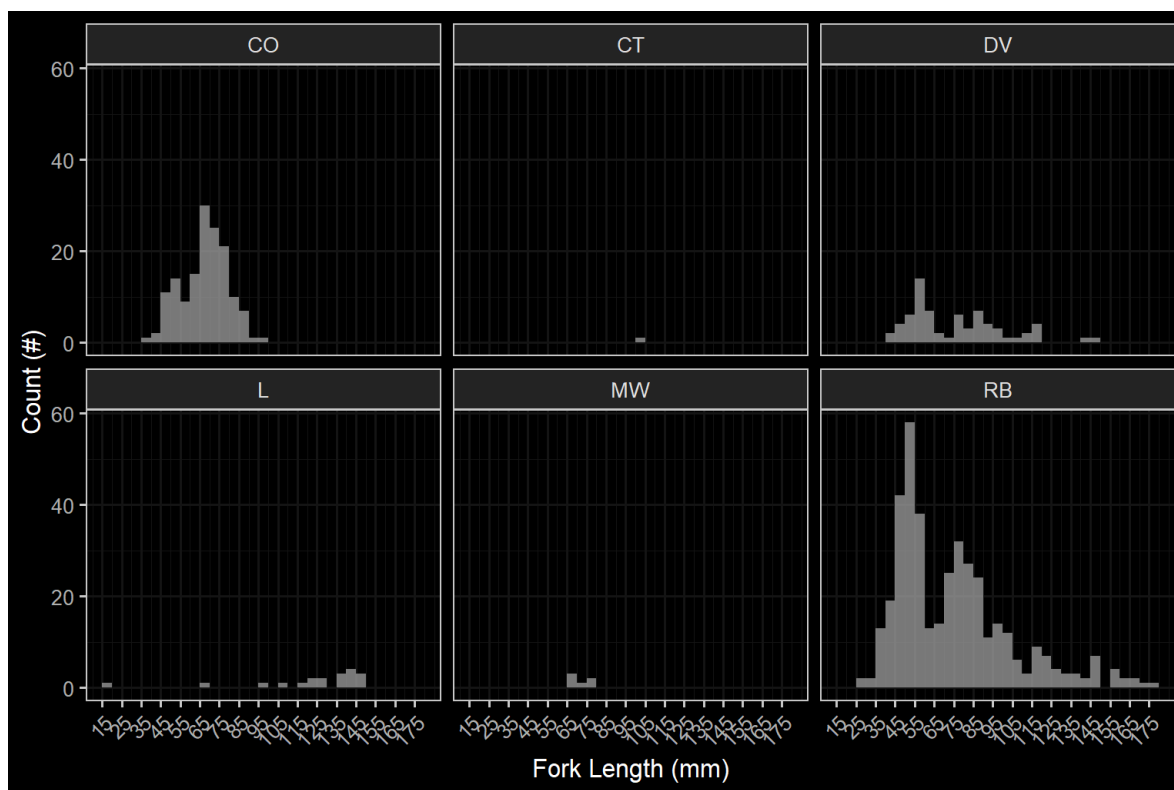
Figure 4.2: Histograms of fish lengths by species. Fish captured by electrofishing during habitat confirmation assessments.

Fish sampling was conducted at 49 sites within 10 streams a total of 416 fish captured. At all electrofishing sites, salmonids with fork lengths >60mm were tagged with PIT tags to facilitate the tracking of health and movement over time. Fork length data was used to delineate salmonids based on life stages: fry (0 to 65mm), parr (>65 to 110mm), juvenile (>110mm to 140mm) and adult (>140mm) by visually assessing the histograms presented in Figure 4.2. A summary of sites assessed are included in Table 4.7 and raw data is provided in Attachment 3. A summary of density results for all life stages combined of select species is also presented in Figure 4.3. Results are presented in greater detail within individual habitat confirmation site appendices.

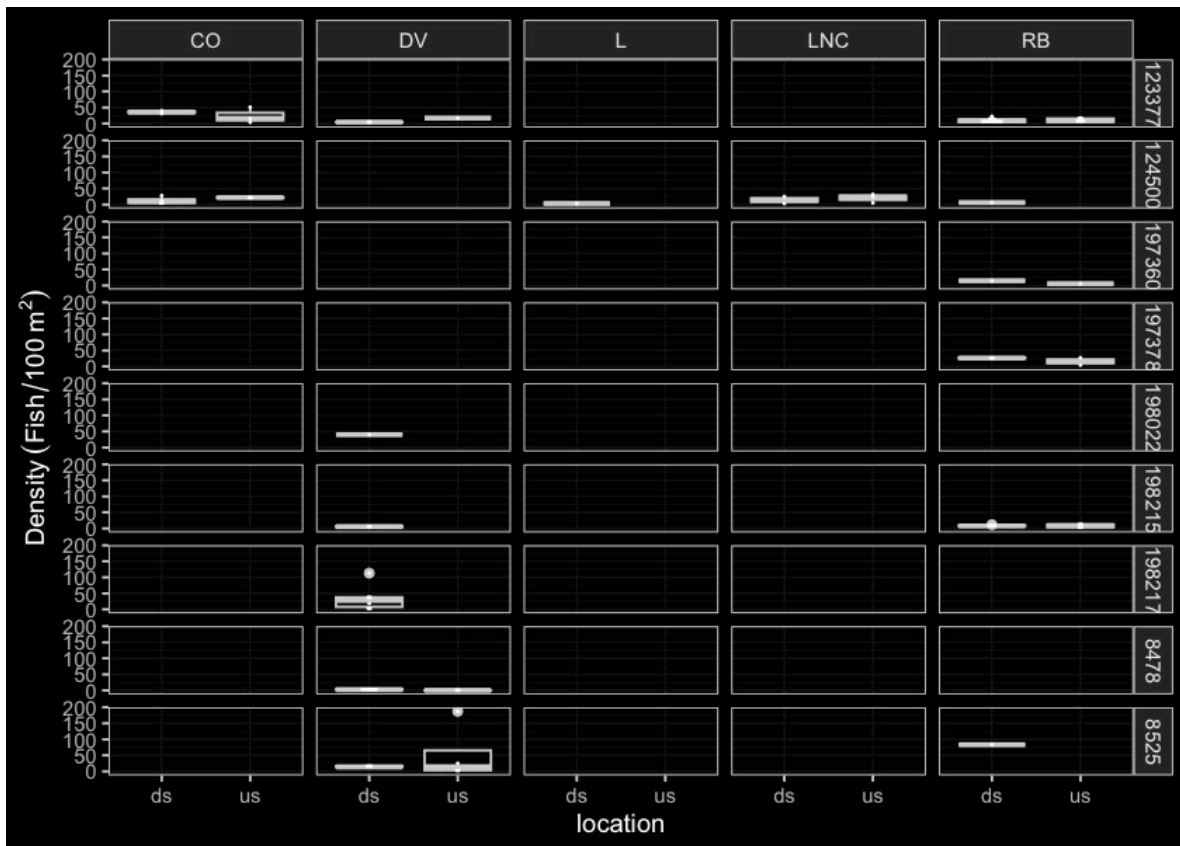
Figure 4.3: Boxplots of densities (fish/100m<sup>2</sup>) of fish captured by electrofishing during habitat confirmation assessments.

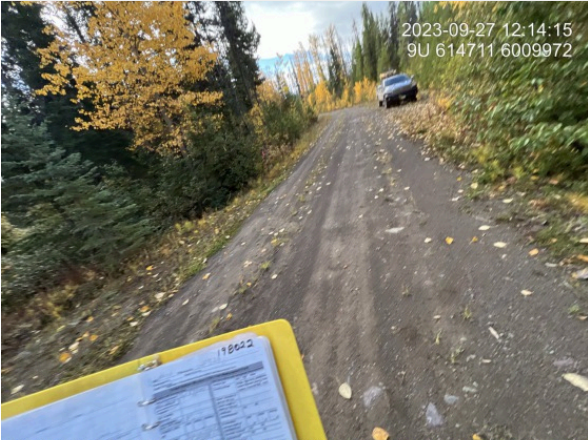
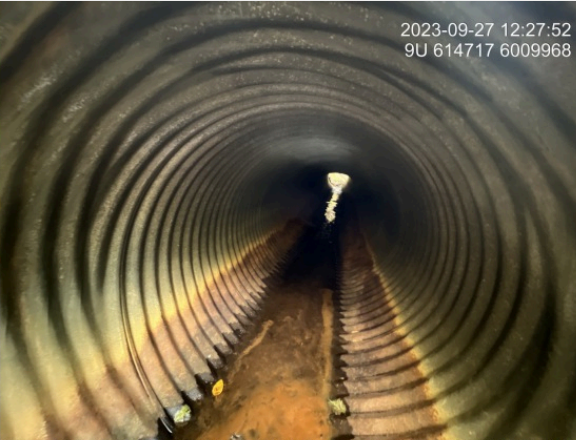
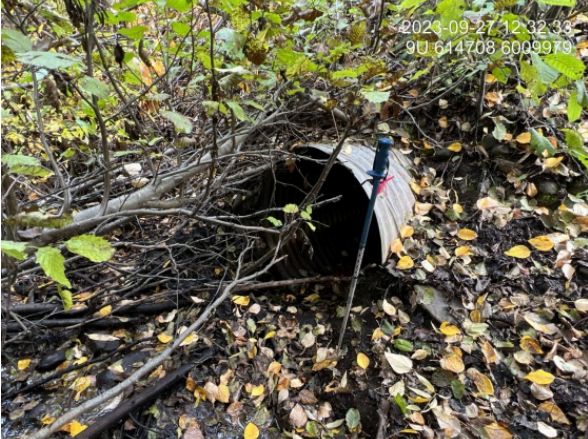
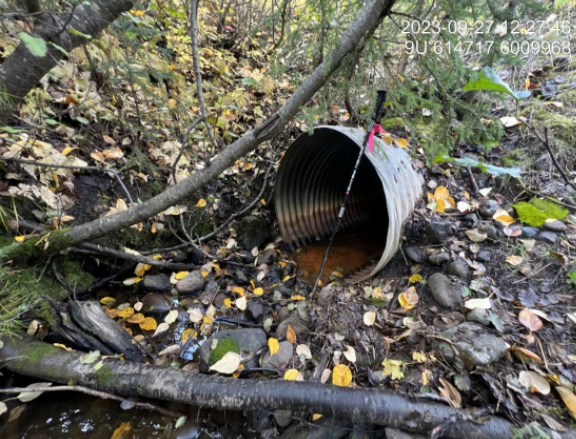
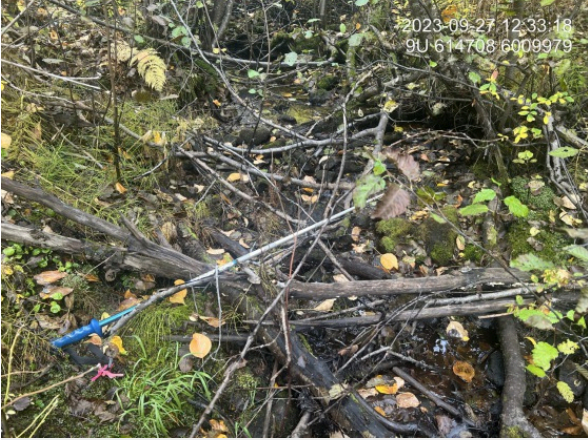
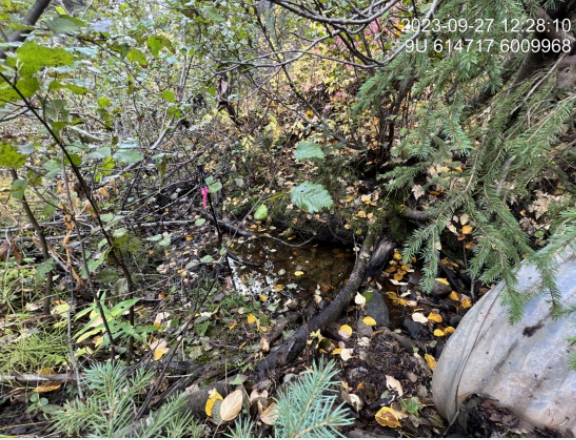
Location and Stream Data		Crossing Characteristics	
Road Tenure	West Fraser Mills Ltd.	Outlet Drop (m)	0
Channel Width (m)	2.4	Outlet Pool Depth (m)	0
Stream Slope (%)	2	Inlet Drop	No
Beaver Activity	Yes	Slope (%)	2
Habitat Value	Medium	Valley Fill	Deep Fill
Final score	21	Barrier Result	Barrier
Fix type	Replace with New Open Bottom Structure	Fix Span / Diameter	15

Location and Stream Data	Crossing Characteristics	—
<p>Comments: Moderate value habitat. Habitat confirmation conducted on stream, walked from upstream crossing down through wetland type area to culvert. Mostly dewatered besides small section above this crossing and below the upper crossing. Surveyed from upstream to down and ended up on road approximately 40 m to the north. Stream seems to merge with wetland type area just upstream of the road. Fish sampling conducted with dolly varden captured in small (2.5m2) outlet pool. Cutthroat are known to be upstream of crossing.. 12:12:45</p> <p>Photos: From top left clockwise: Road/Site Card, Barrel, Outlet, Downstream, Upstream, Inlet.</p>

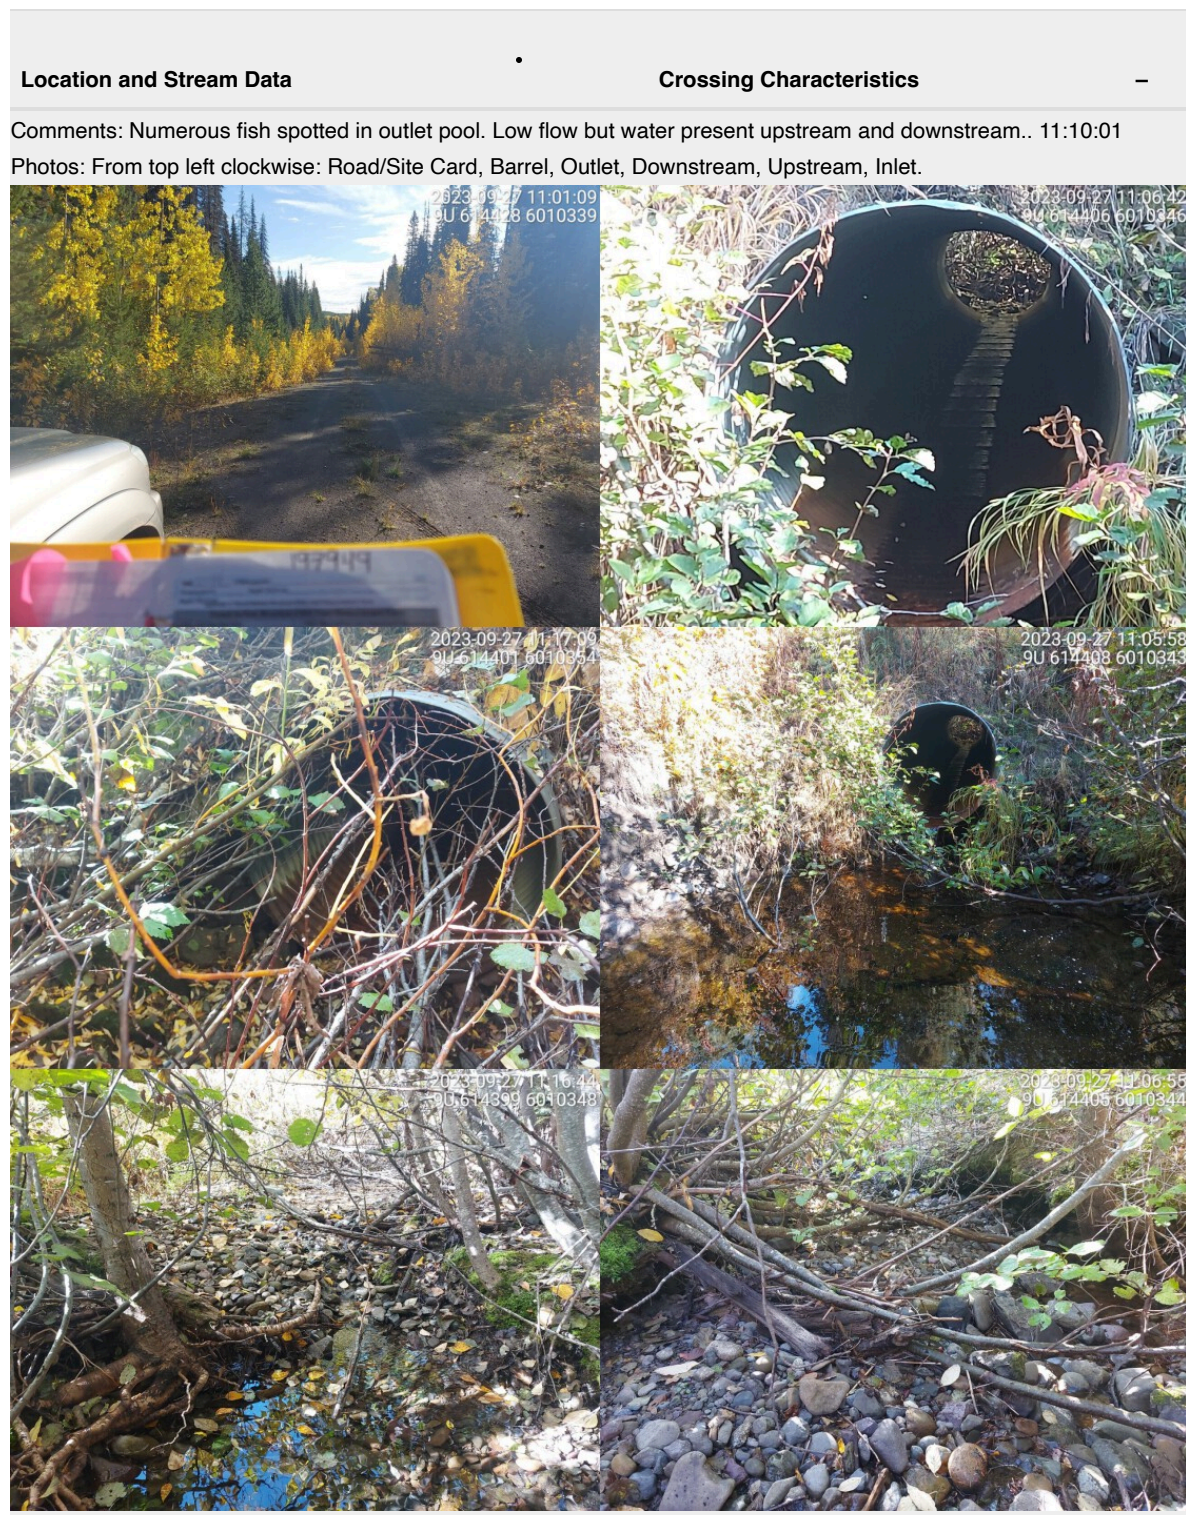
Table 5.4: Summary of fish passage assessment for PSCIS crossing 197949.

Location and Stream Data		Crossing Characteristics	
Date	2023-09-27	Crossing Sub Type	Round Culvert
PSCIS ID	197949	Diameter (m)	1.2
External ID	–	Length (m)	14
Crew	MW	Embedded	No
UTM Zone	9	Depth Embedded (m)	–
Easting	614404	Resemble Channel	No
Northing	6010346	Backwatered	No
Stream	Tributary to Tagit Creek	Percent Backwatered	–
Road	Spur	Fill Depth (m)	1.2
Road Tenure	MOF 9946	Outlet Drop (m)	0.5
Channel Width (m)	2.3	Outlet Pool Depth (m)	0.6
Stream Slope (%)	2	Inlet Drop	No
Beaver Activity	No	Slope (%)	2
Habitat Value	High	Valley Fill	Deep Fill
Final score	31	Barrier Result	Barrier
Fix type	Replace with New Open Bottom Structure	Fix Span / Diameter	15

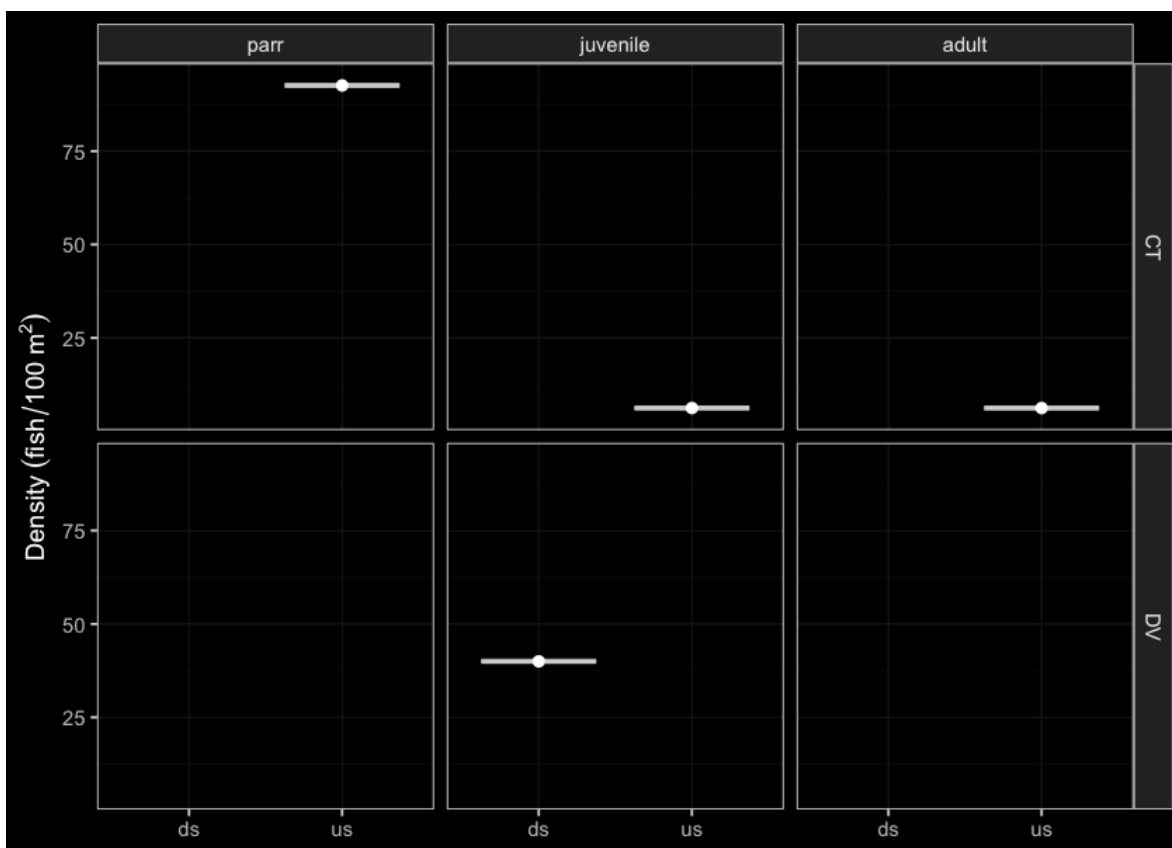
Figure 5.1: Densities of fish (fish/100m<sup>2</sup>) captured upstream and downstream of PSCIS crossing 198022.

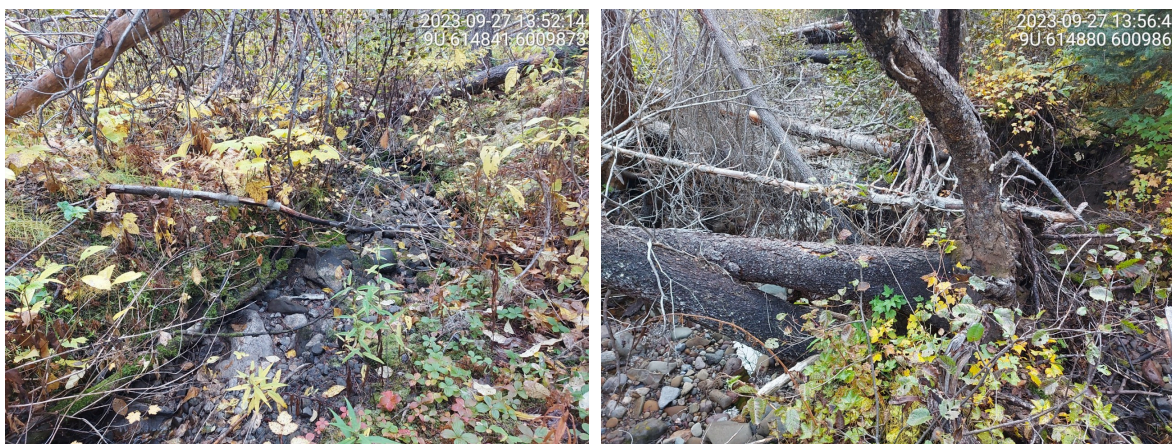
Figure 5.2: Left: Typical habitat downstream of PSCIS crossing 198022. Right: Log jam at the confluence with Tagit Creek.

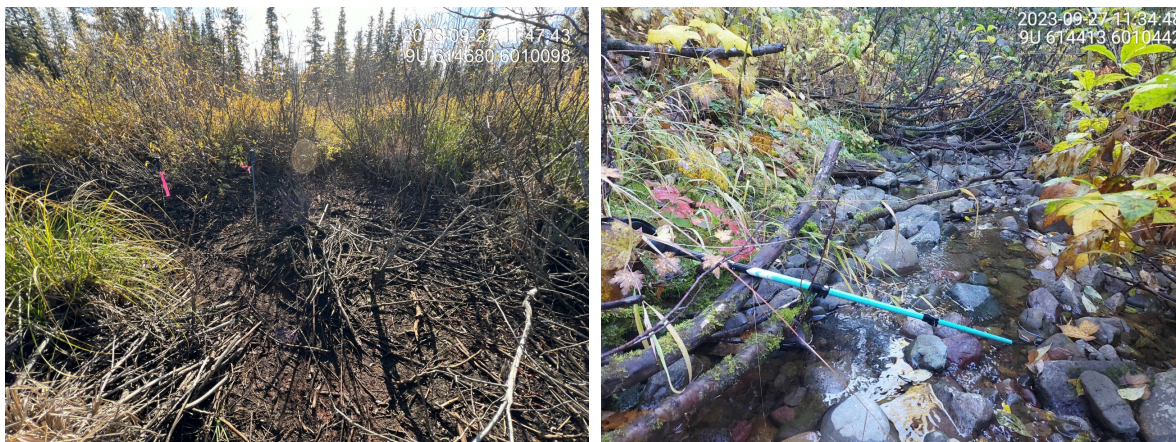
Figure 5.3: Left: Typical habitat upstream of PSCIS crossing 198022 and downstream of crossing 197949. Right: Typical habitat upstream of PSCIS crossing 197949.

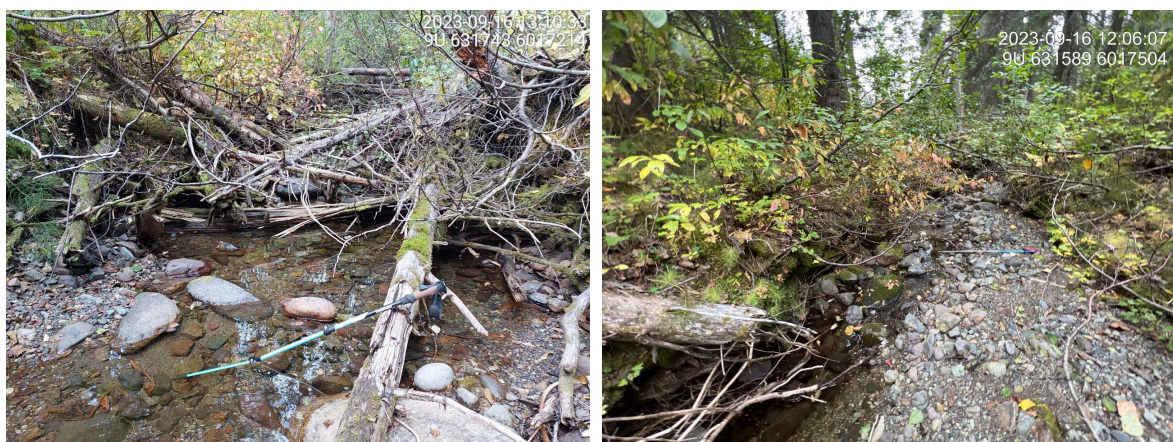
Figure 5.5: Left: Typical habitat downstream of PSCIS crossing 198934. Right: Typical habitat upstream of PSCIS crossing 198934 and downstream of PSCIS crossing 198942.

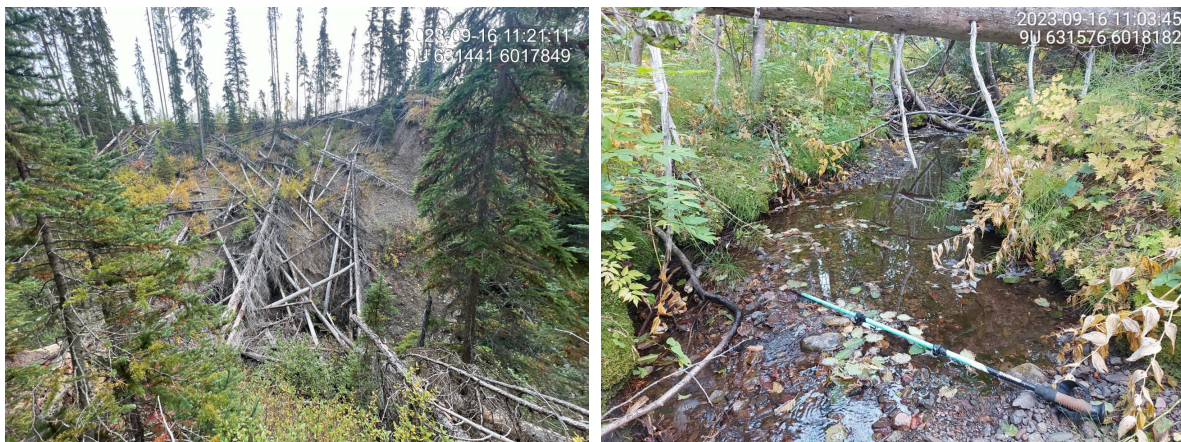
Figure 5.6: Left: Landslide located 300m downstream of crossing 198942. Right: Typical habitat upstream of PSCIS crossing 198942.

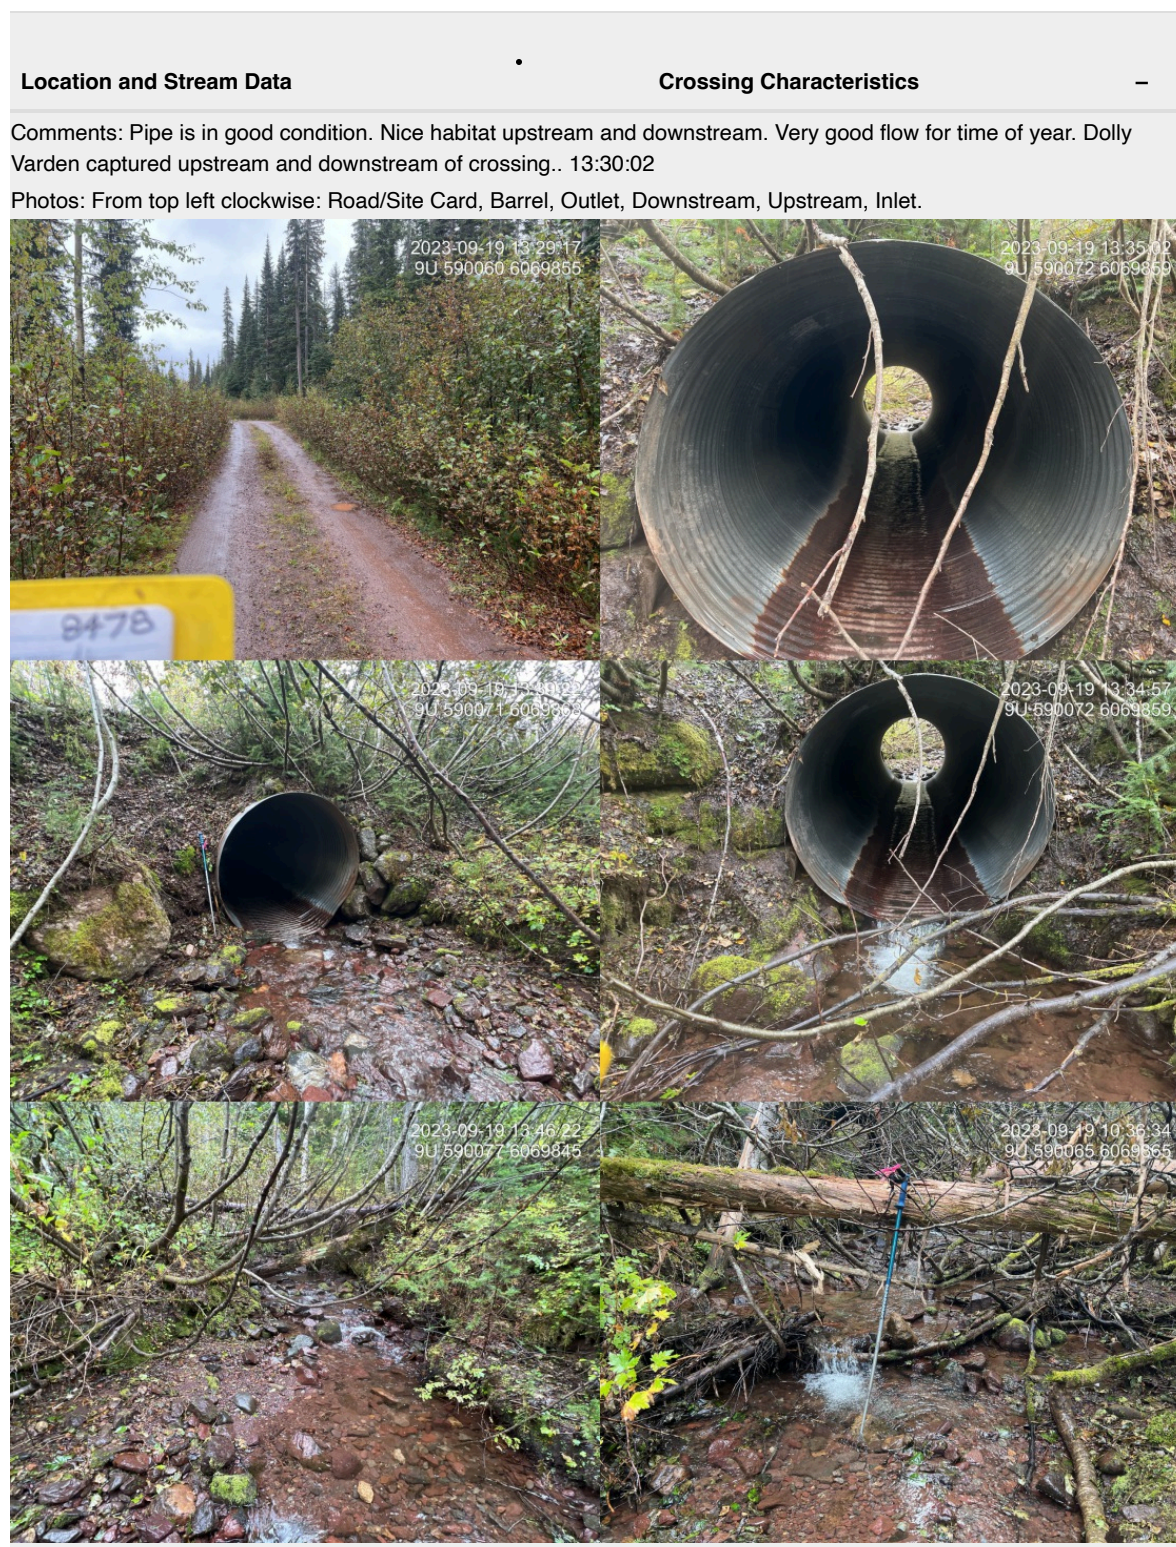
Table 5.15: Summary of fish passage assessment for PSCIS crossing 8478.

Location and Stream Data		Crossing Characteristics	
Date	2023-09-19	Crossing Sub Type	Round Culvert
PSCIS ID	8478	Diameter (m)	1.9
External ID	–	Length (m)	12
Crew	AI	Embedded	No
UTM Zone	9	Depth Embedded (m)	–
Easting	590065	Resemble Channel	No
Northing	6069867	Backwatered	No
Stream	Tributary to McDonell Lake	Percent Backwatered	–
Road	Dennis West FSR	Fill Depth (m)	1.5
Road Tenure	BCTS R22433	Outlet Drop (m)	0.2
Channel Width (m)	2.5	Outlet Pool Depth (m)	0.25
Stream Slope (%)	8	Inlet Drop	Yes
Beaver Activity	No	Slope (%)	4
Habitat Value	Medium	Valley Fill	Deep Fill
Final score	31	Barrier Result	Barrier
Fix type	Replace with New Open Bottom Structure	Fix Span / Diameter	15

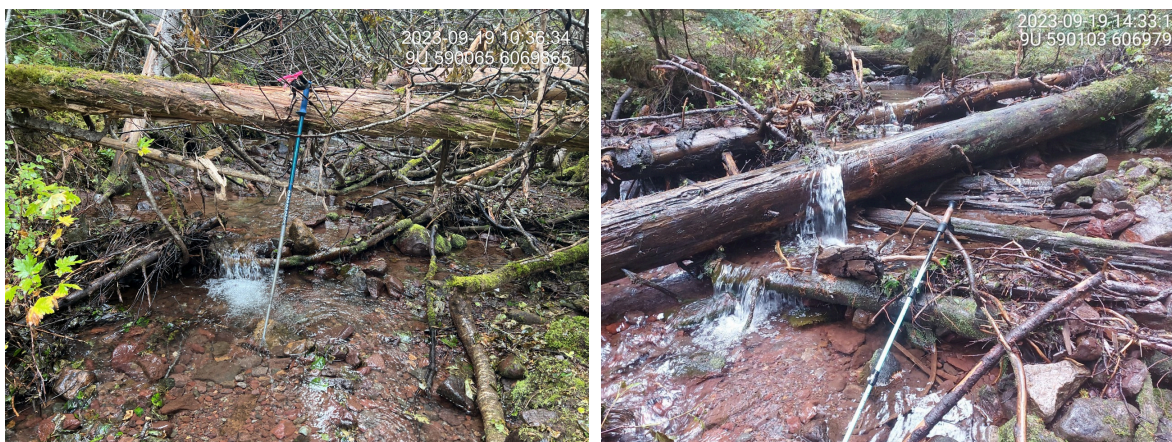
The stream was surveyed downstream from crossing 8478 for 200m . Total cover amount was rated as moderate with large woody debris dominant. Cover was also present as small woody debris, undercut banks, and overhanging vegetation. The average channel width was 3m, the average wetted width was 2.2m, and the average gradient was 8.3%. The dominant substrate was gravels with cobbles sub-dominant. The stream was noted as having good flow and containing pockets of gravel suitable for spawning (Figure [5.8](#)). Deep pools were infrequent and the morphology was step-pool cobble. The habitat was rated as medium value suitable for salmonid rearing and spawning.

Figure 5.8: Left: Typical habitat downstream of PSCIS crossing 8478. Right: Typical habitat upstream of PSCIS crossing 8478.

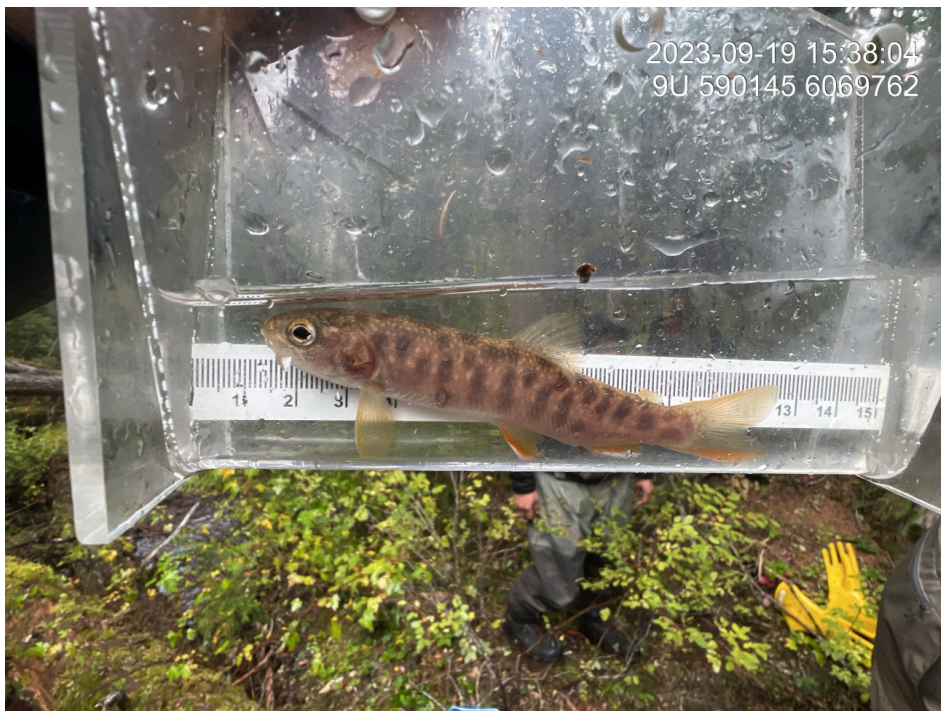
Figure 5.9: Dolly varden with deteriorating purple gill plates and unusual black spots captured upstream of crossing 8478.

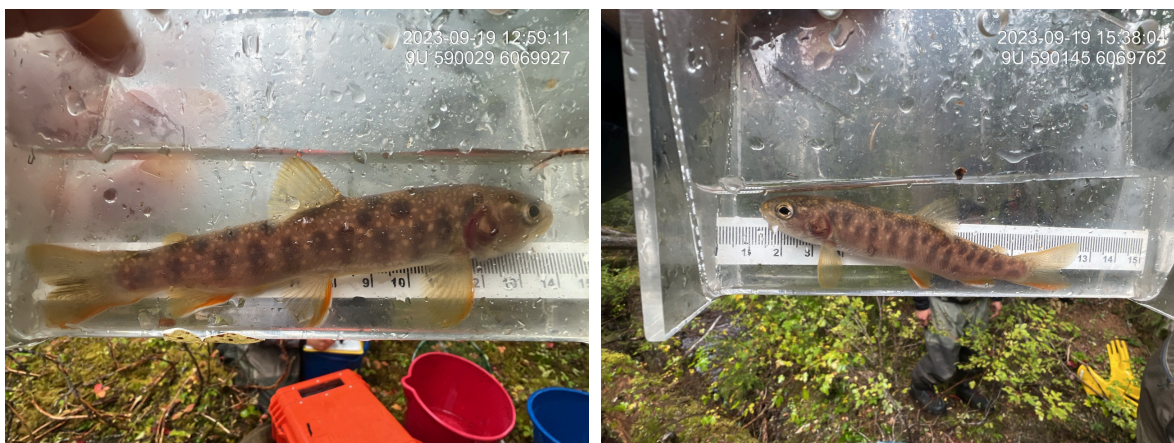
Figure 5.10: Left: Dolly varden with deteriorating purple gill plates and unusual black spots captured downstream of crossing 8478. Right: Dolly varden with deteriorating purple gill plates and unusual black spots captured upstream of crossing 8478.

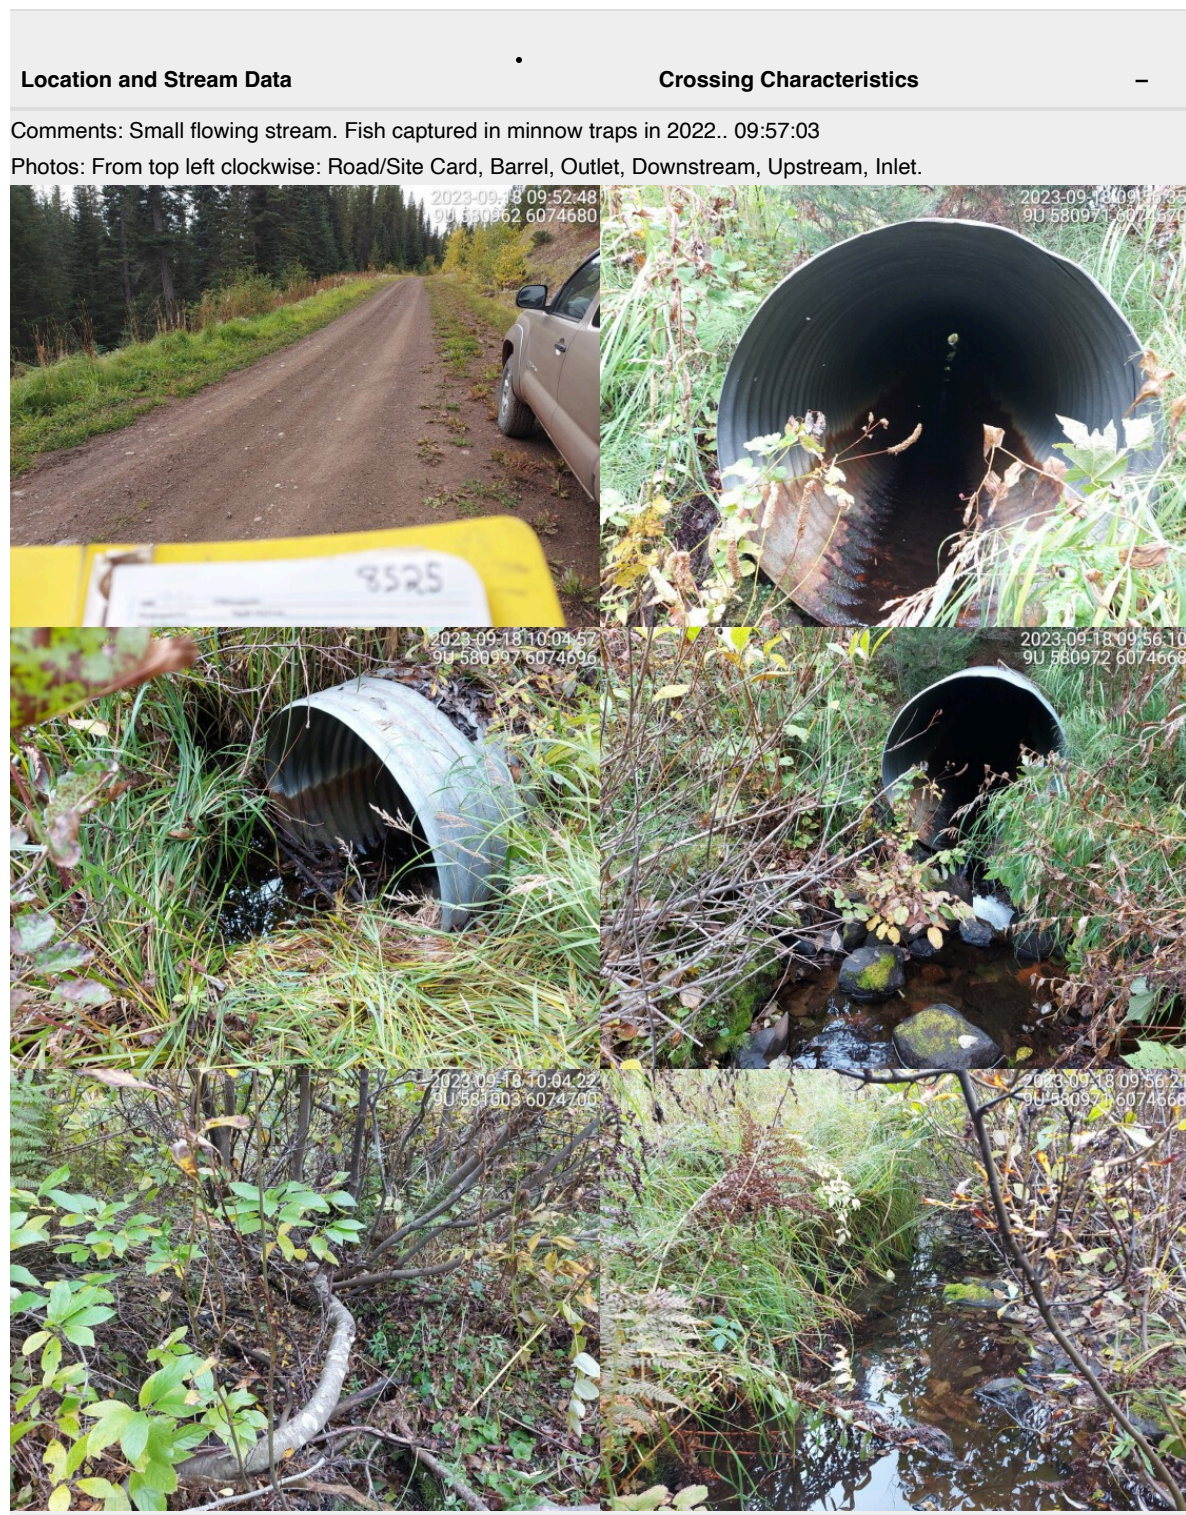
Table 5.21: Summary of fish passage assessment for PSCIS crossing 8525.

Location and Stream Data		Crossing Characteristics	
Date	2023-09-18	Crossing Sub Type	Round Culvert
PSCIS ID	8525	Diameter (m)	0.9
External ID	–	Length (m)	28
Crew	MW TP VJ	Embedded	No
UTM Zone	9	Depth Embedded (m)	–
Easting	580998	Resemble Channel	No
Northing	6074681	Backwatered	No
Stream	Tributary to Coal Creek	Percent Backwatered	–
Road	McDonell FSR	Fill Depth (m)	2
Road Tenure	MOF 7552	Outlet Drop (m)	0.5
Channel Width (m)	1.9	Outlet Pool Depth (m)	0.2
Stream Slope (%)	4	Inlet Drop	No
Beaver Activity	No	Slope (%)	1
Habitat Value	Medium	Valley Fill	Deep Fill
Final score	34	Barrier Result	Barrier
Fix type	Replace Structure with Streambed Simulation CBS	Fix Span / Diameter	3

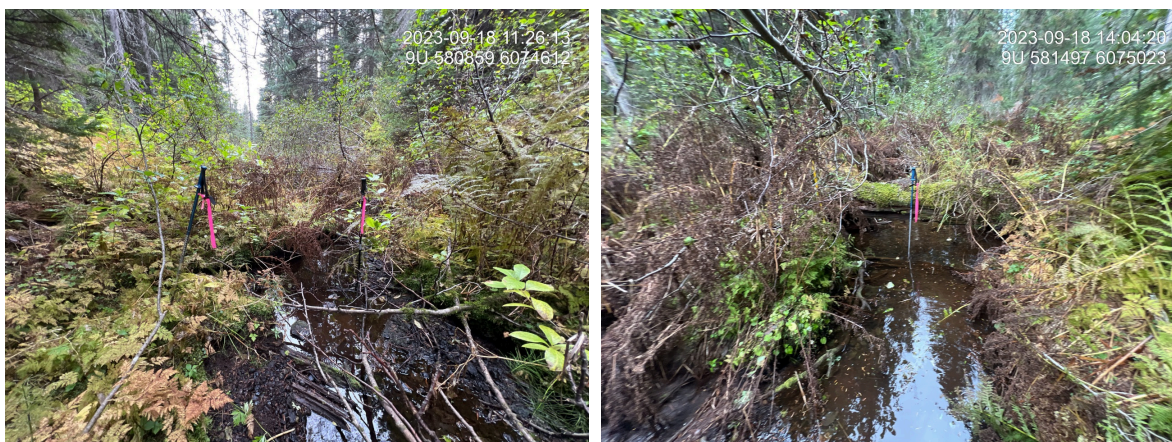
The stream was surveyed downstream from crossing 8525 for 400m . The stream was noted to have intermittent dewatering, but good flow relative to other streams in the area given it was a very dry year. Water was noted as relatively turbid (Figure [5.12](#)). There were few deep pools and abundant small gravels present throughout the area surveyed. The dominant substrate was gravels with cobbles sub-dominant. The average channel width was 1.8m, the average wetted width was 1.5m, and the average gradient was 6.2%. Total cover amount was rated as moderate with undercut banks dominant. Cover was also present as small woody debris, large woody debris, and overhanging vegetation. The habitat was rated as medium value for salmonid rearing and spawning.

Figure 5.12: Left: Typical habitat downstream of PSCIS crossing 8525. Right: Typical habitat upstream of PSCIS crossing 8525.

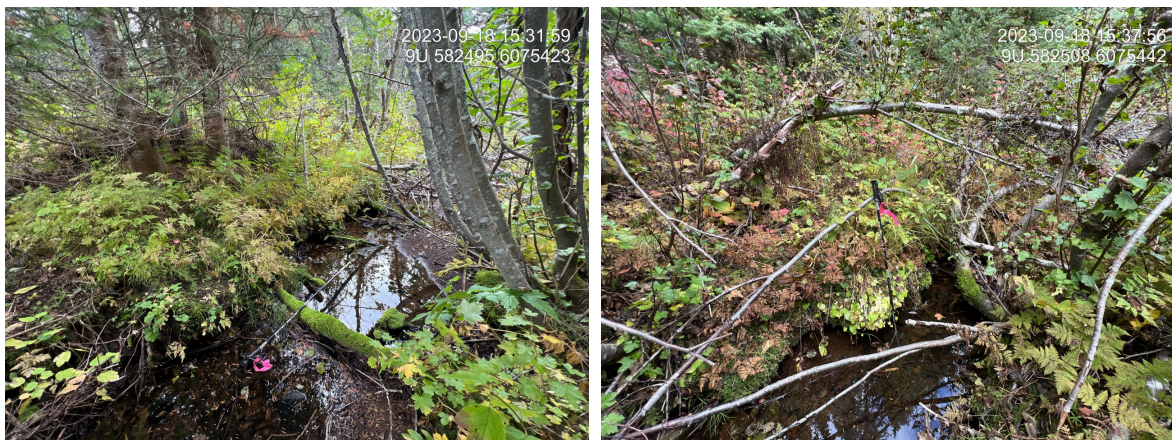
Figure 5.13: Left: Typical habitat upstream of PSCIS crossing 8529. Right: Typical pool habitat at PSCIS crossing 8529.

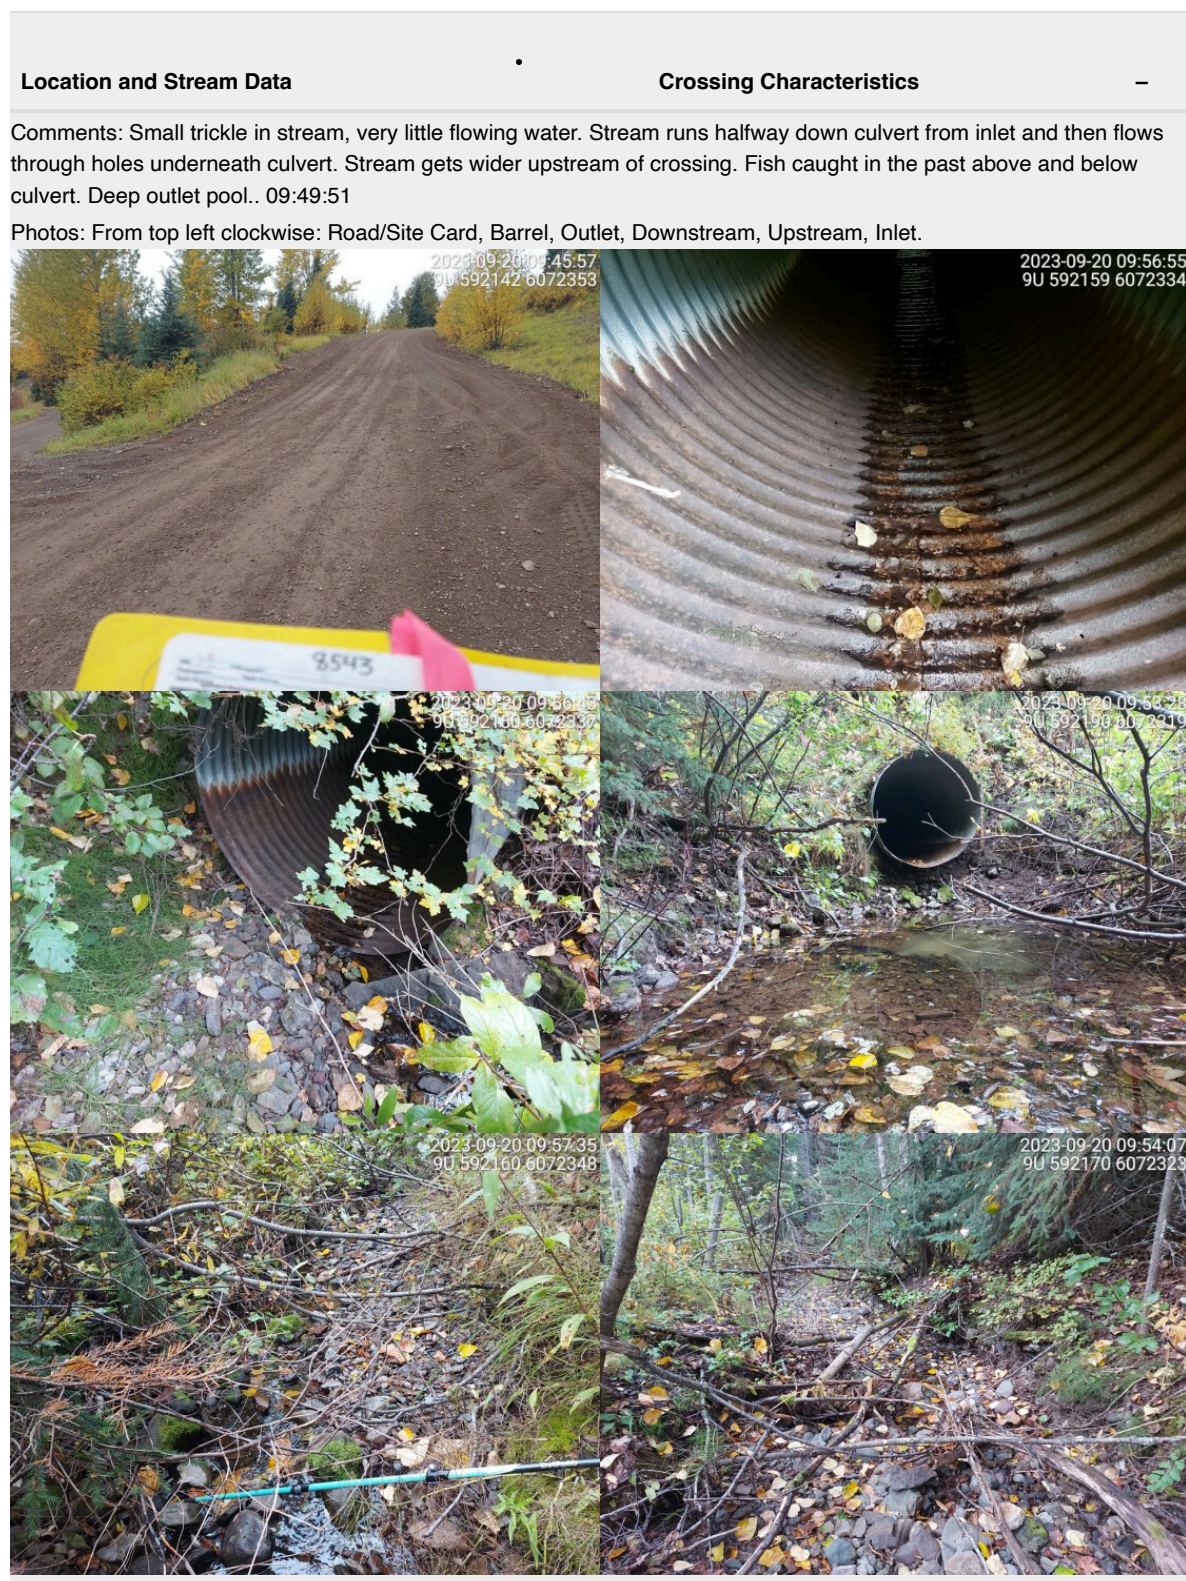
Table 5.27: Summary of fish passage assessment for PSCIS crossing 8543.

Location and Stream Data		Crossing Characteristics	
Date	2023-09-20	Crossing Sub Type	Round Culvert
PSCIS ID	8543	Diameter (m)	1.2
External ID	–	Length (m)	14
Crew	MW JO RB	Embedded	No
UTM Zone	9	Depth Embedded (m)	–
Easting	592142	Resemble Channel	No
Northing	6072357	Backwatered	No
Stream	Tributary to McDonell Lake	Percent Backwatered	–
Road	McDonell Lake FSR	Fill Depth (m)	1
Road Tenure	Wetzinkwa Community Forest Corporation	Outlet Drop (m)	0.5
Channel Width (m)	1.8	Outlet Pool Depth (m)	0.8
Stream Slope (%)	5	Inlet Drop	No
Beaver Activity	No	Slope (%)	3
Habitat Value	Medium	Valley Fill	Deep Fill
Final score	36	Barrier Result	Barrier
Fix type	Replace Structure with Streambed Simulation CBS	Fix Span / Diameter	3

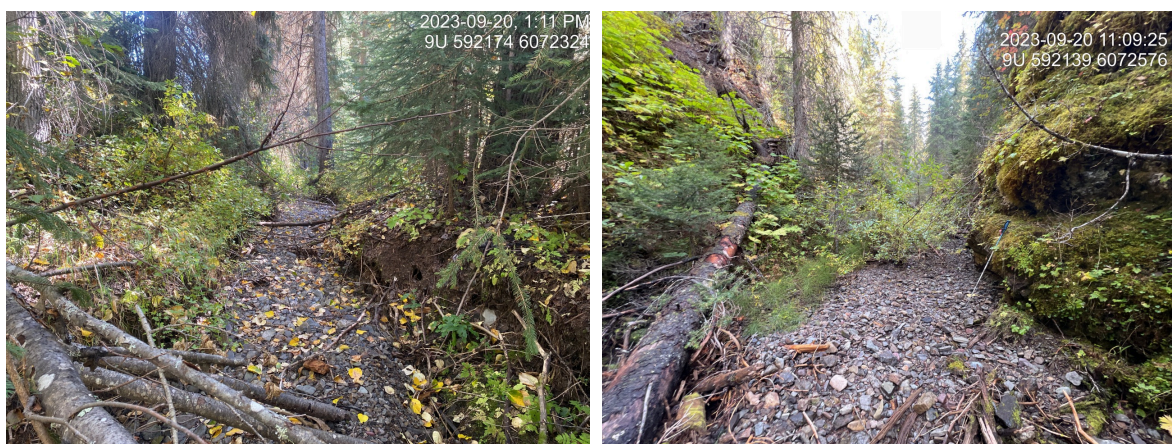
The stream was surveyed downstream from crossing 8543 for 160m (Figure [5.15](#)). The stream was dry at the time of the survey. Total cover amount was rated as moderate with overhanging vegetation dominant. Cover was also present as small woody debris, large woody debris, undercut banks, and deep pools. The dominant substrate was cobbles with gravels sub-dominant. The average channel width was 2.4m, the average wetted width was 0.7m, and the average gradient was 2.8%. There are historic dolly varden and rainbow trout observations just downstream of the crossing in the FISS database. The habitat was rated as low value for salmonid rearing and spawning.

Figure 5.15: Left: Typical habitat downstream of PSCIS crossing 8543. Right: Typical habitat upstream of PSCIS crossing 8543.
