## **Skeena Watershed Fish Passage Restoration Planning 2023**

**Prepared for**  
**Habitat Conservation Trust Foundation - CAT23-6-288**  
**BC Fish Passage Remediation Program**  
**Ministry of Transportation and Infrastructure**

**Prepared by**  
**Al Irvine, B.Sc., R.P.Bio and Lucy Schick, B.Sc.**  
**New Graph Environment Ltd.**  
**on behalf of**  
**Society for Ecosystem Restoration in Northern British Columbia**

**Version 0.0.3 2024-06-27**

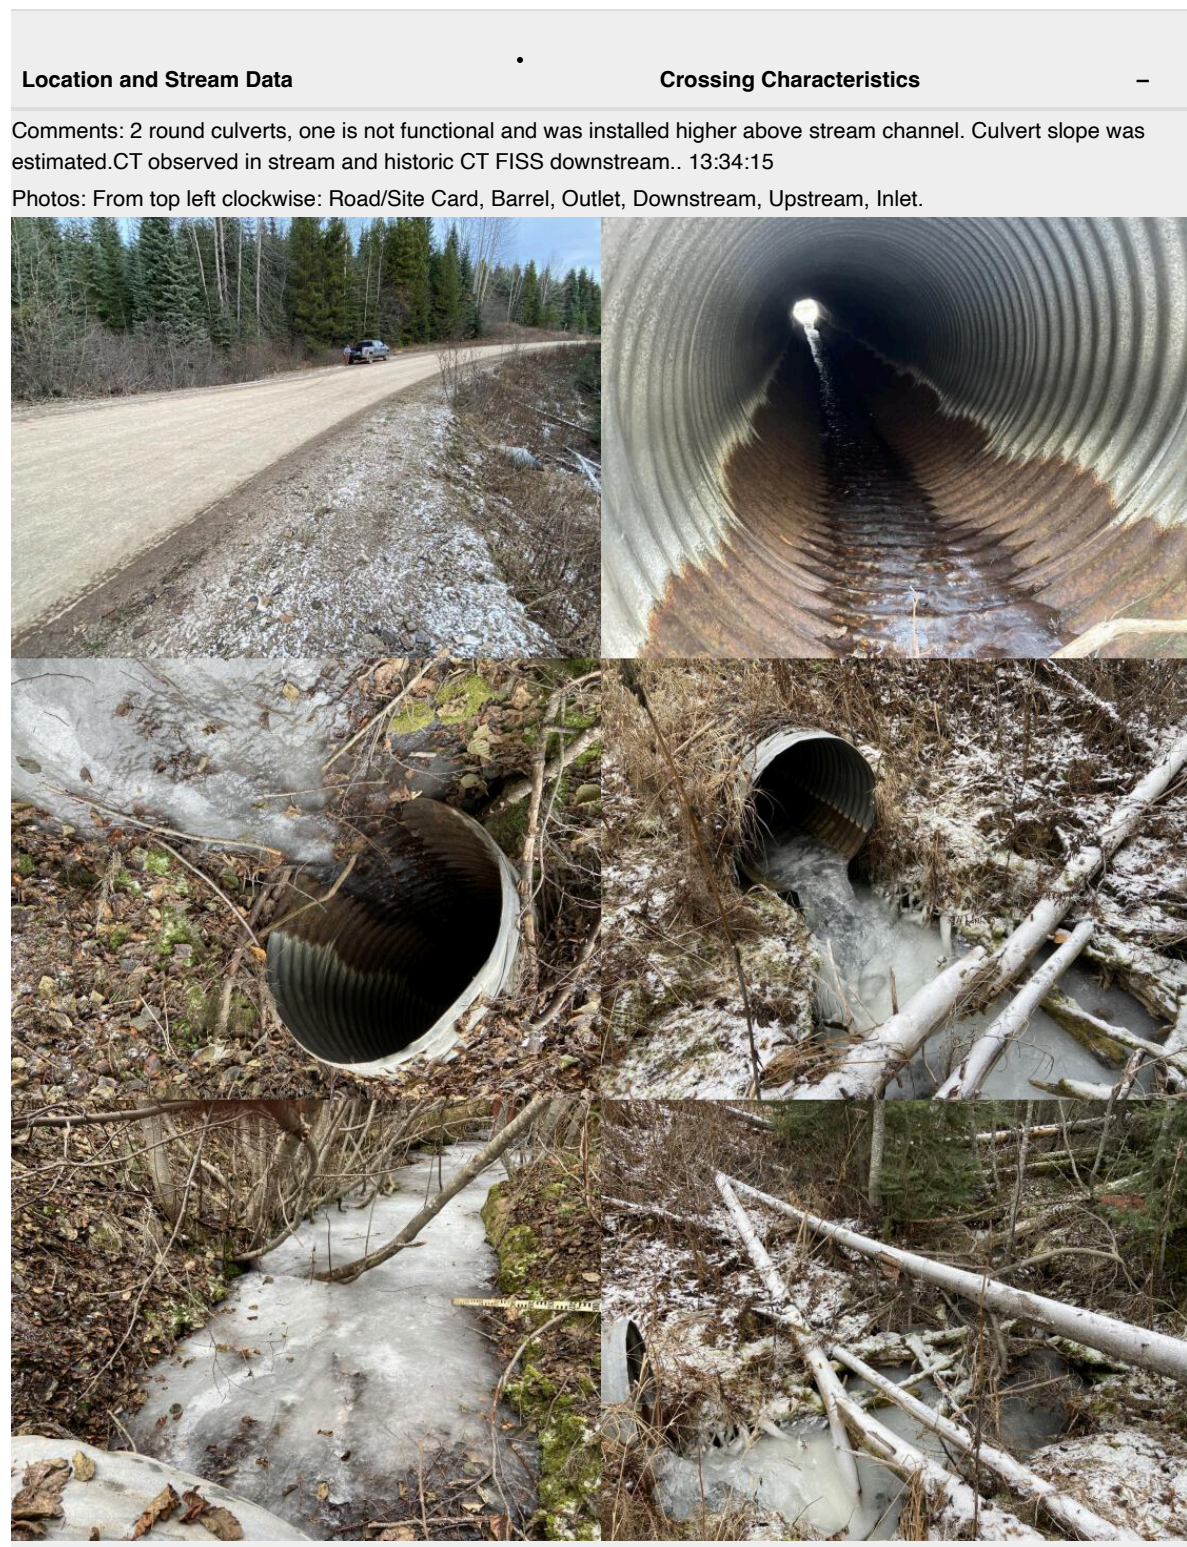
Table 5.31: Summary of fish passage assessment for PSCIS crossing 8547.

Location and Stream Data		Crossing Characteristics	
Date	2023-11-01	Crossing Sub Type	Round Culvert
PSCIS ID	8547	Diameter (m)	0.9
External ID	–	Length (m)	20
Crew	AR AF	Embedded	No
UTM Zone	9	Depth Embedded (m)	–
Easting	589988	Resemble Channel	No
Northing	6072657	Backwatered	No
Stream	Tributary to McDonell Lake	Percent Backwatered	–
Road	McDonell Lake FSR	Fill Depth (m)	3
Road Tenure	Wetzinkwa Community Forest Corporation	Outlet Drop (m)	0.7
Channel Width (m)	1.9	Outlet Pool Depth (m)	0.5
Stream Slope (%)	3	Inlet Drop	No
Beaver Activity	No	Slope (%)	3
Habitat Value	High	Valley Fill	Deep Fill
Final score	39	Barrier Result	Barrier
Fix type	Replace Structure with Streambed Simulation CBS	Fix Span / Diameter	3

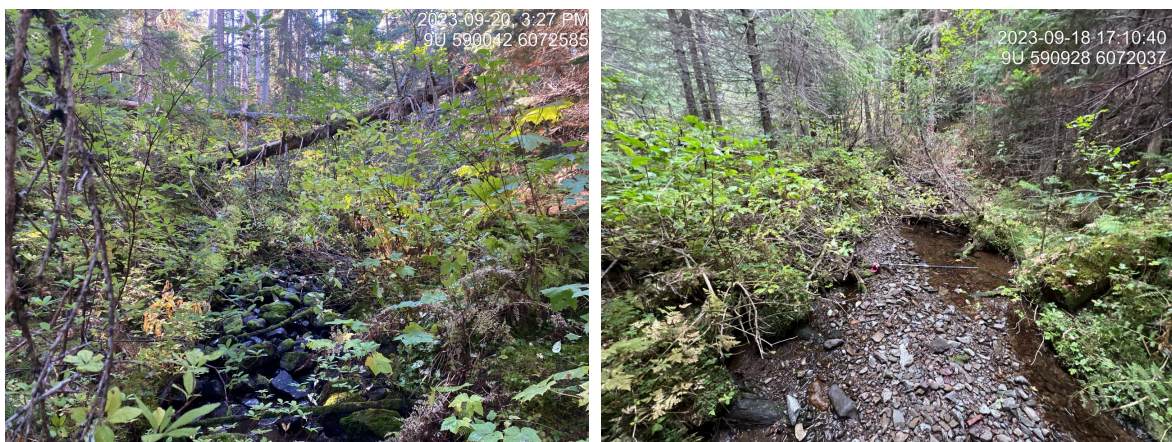
The stream was surveyed downstream from crossing 8547 for 220m . This section of stream was shallow with slow moving water and had some shallow pools with large rocks for fish shelter. (Figure [5.17](#)). Total cover amount was rated as moderate with large woody debris dominant. Cover was also present as small woody debris, boulders, undercut banks, and overhanging vegetation. The dominant substrate was boulders with cobbles sub-dominant. The average channel width was 2m, the average wetted width was 0.7m, and the average gradient was 11%. The habitat was rated as Medium value for salmonid rearing and spawning.

Figure 5.17: Left: Typical habitat downstream of PSCIS crossing 8547. Right: Typical habitat downstream of PSCIS crossing 24600461.

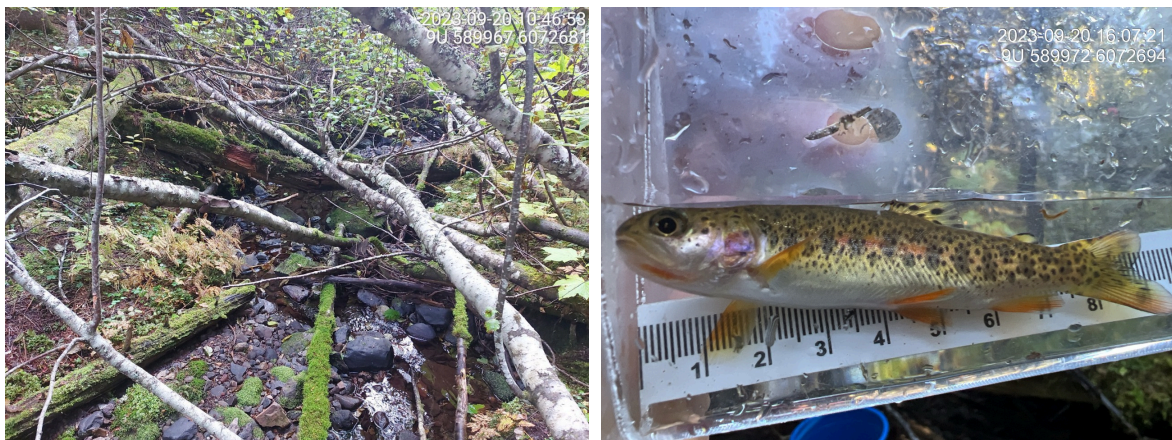
Figure 5.18: Left: Typical habitat upstream of PSCIS crossing 8547. Right: Cutthroat trout captured upstream of crossing 8547.
