## 2021 Fish Habitat Assessments for Lake Babine Nations

Prepared for:  
**Capacity Forest Management Ltd.**  
1761 Redwood St.  
Campbell River, BC, V9W 3K7

Prepared by:  
**Mac Jedrzejczyk, M.Sc., R.P.Bio.**  
**FINS Consulting Ltd.**  
4206 Eby St.  
Terrace, BC, V8G 2E5

December 2021

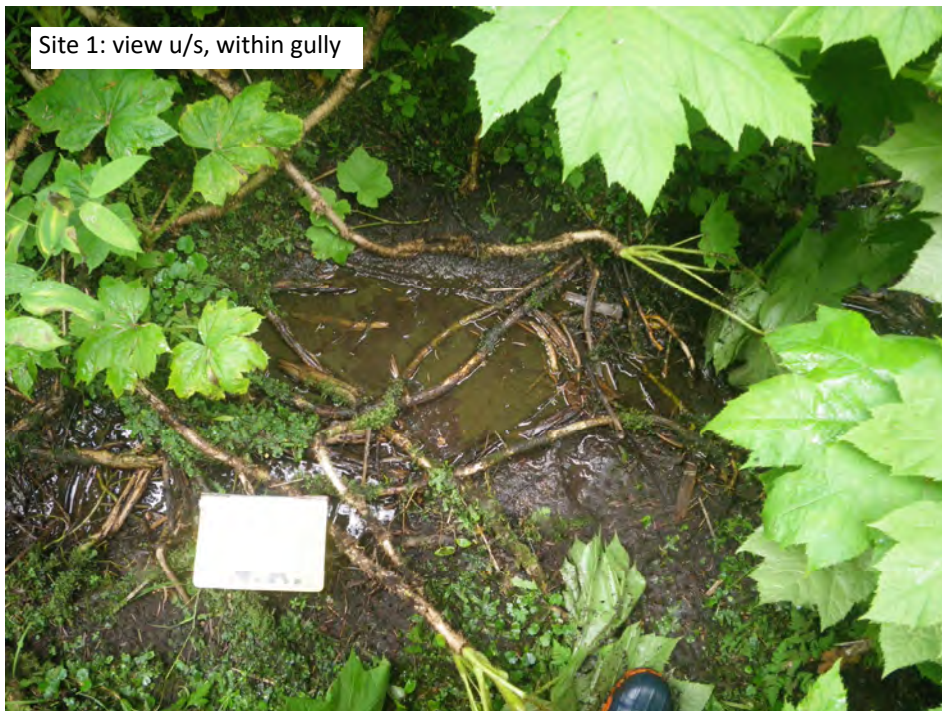
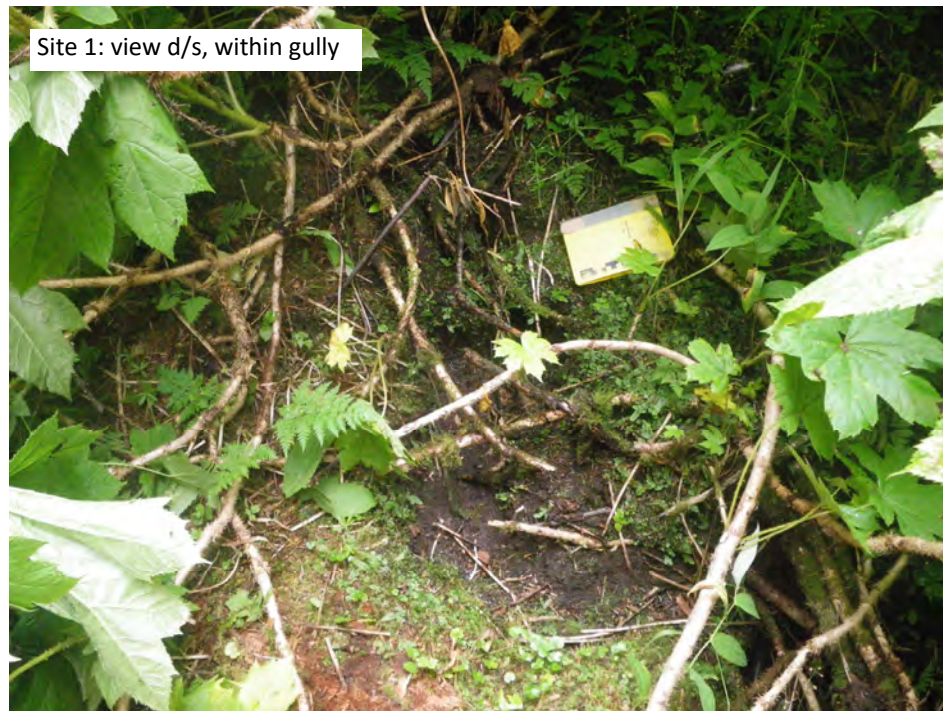
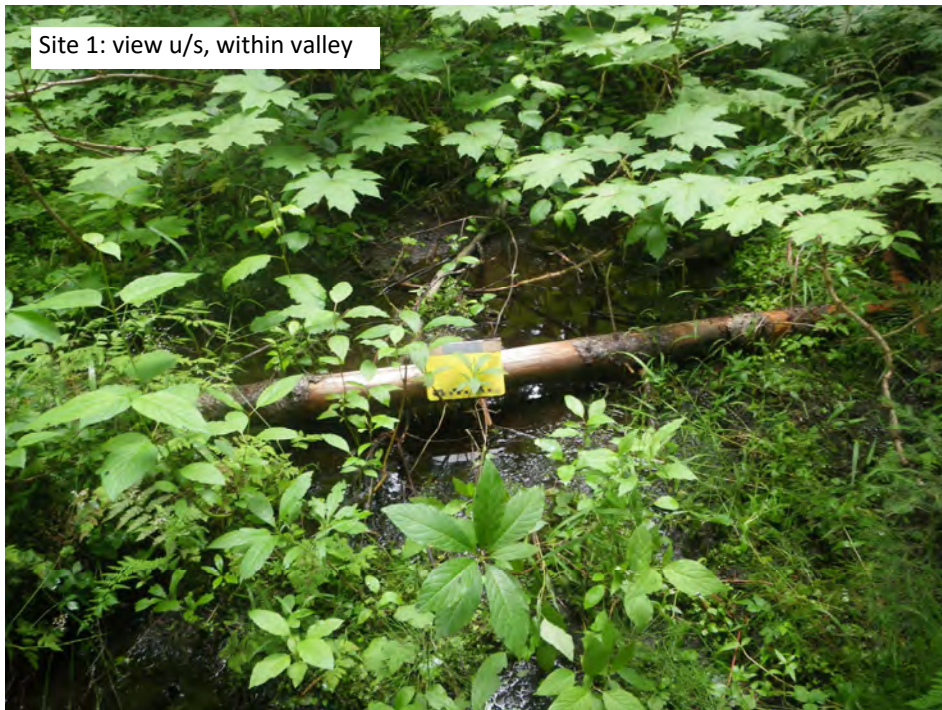
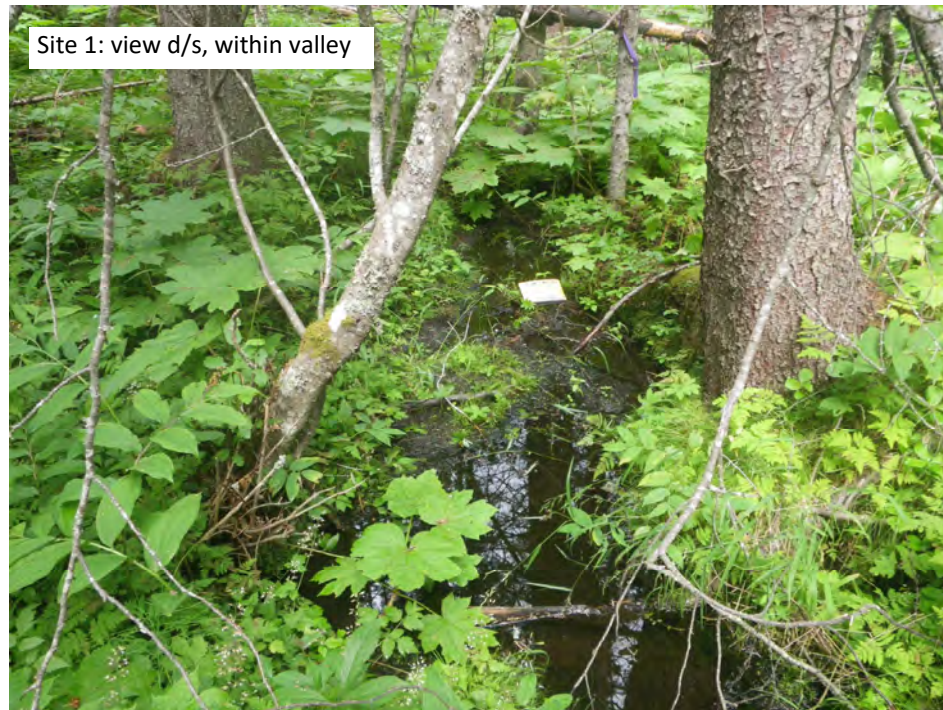
| SITE REFERENCE | | | | | | | | | | | | | | | |
|---|---|---|---|---|---|---|---|---|---|---|---|---|---|---|---|
| Comm 2 | ~60m u/s from site gradient rises and drainage flows through 10-12% gully with overland flows; surface scour, no alluvium, some protruding cobbles from the ground observed. | | | | | | | | | | | | | | |

Site 1: view u/s, within gully

Site 1: view d/s, within gully

Site 1: view u/s, within valley

Site 1: view d/s, within valley

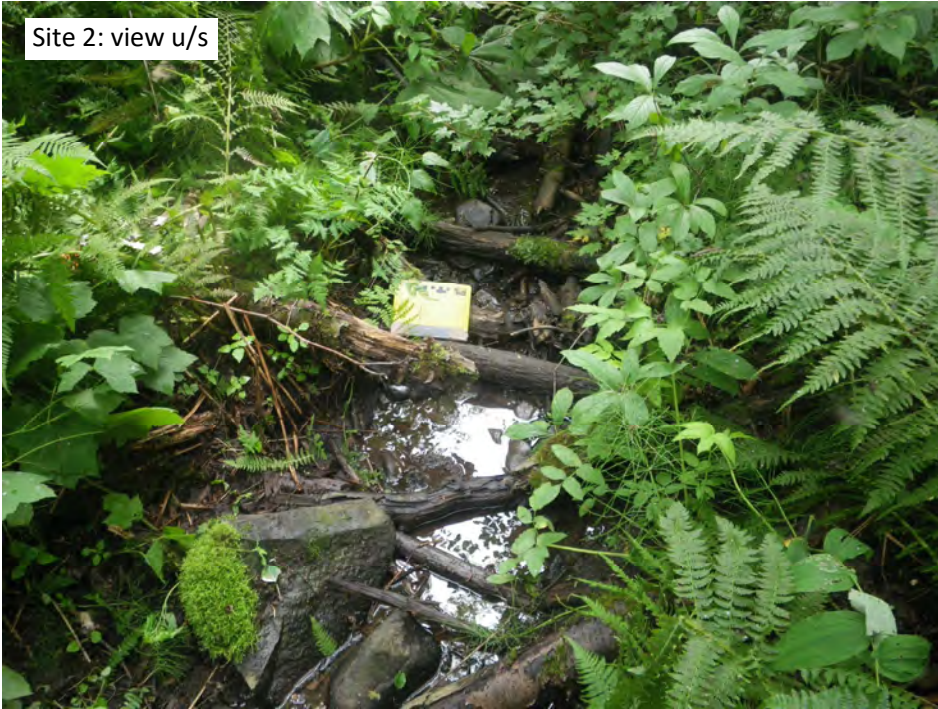
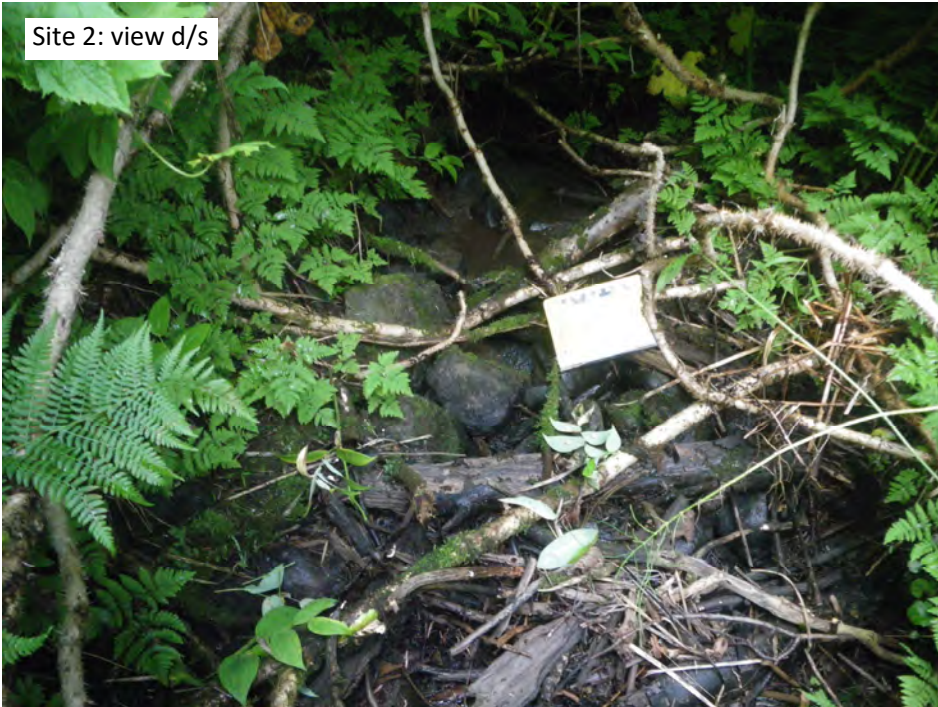
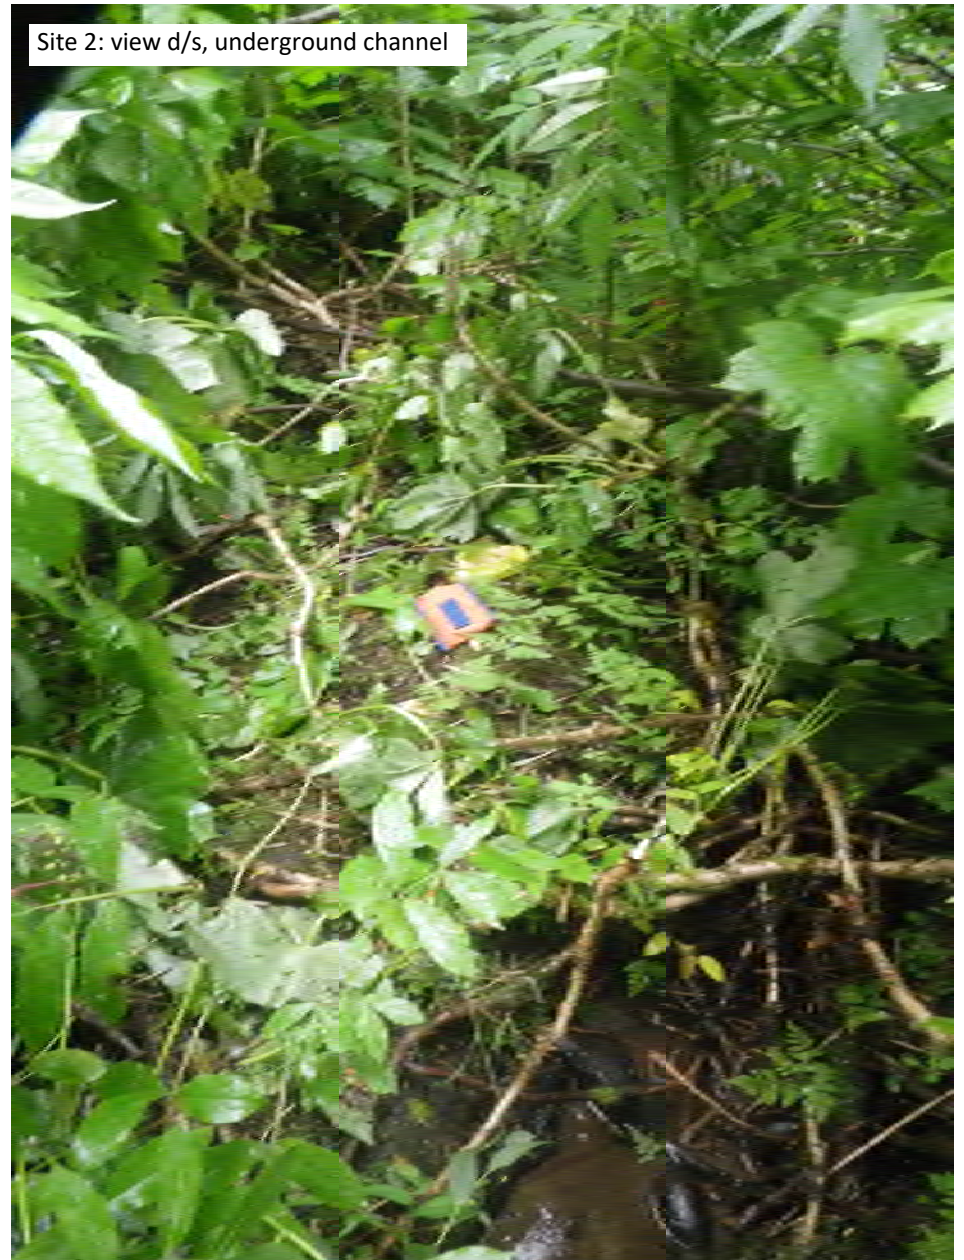
| SITE REFERENCE | | | | | | | | | | | | | | | |
|---|---|---|---|---|---|---|---|---|---|---|---|---|---|---|--|
| Comm 2 | No SHAB or OHAB observed. | | | | | | | | | | | | | | |

Site 2: view u/s

Site 2: view d/s

Site 2: view d/s, underground channel

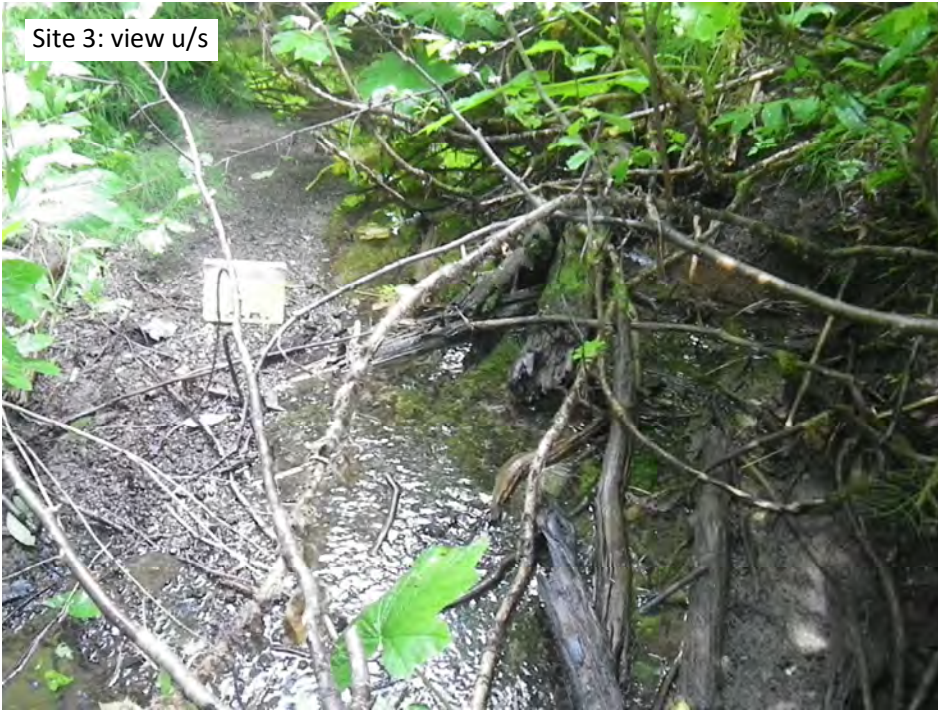
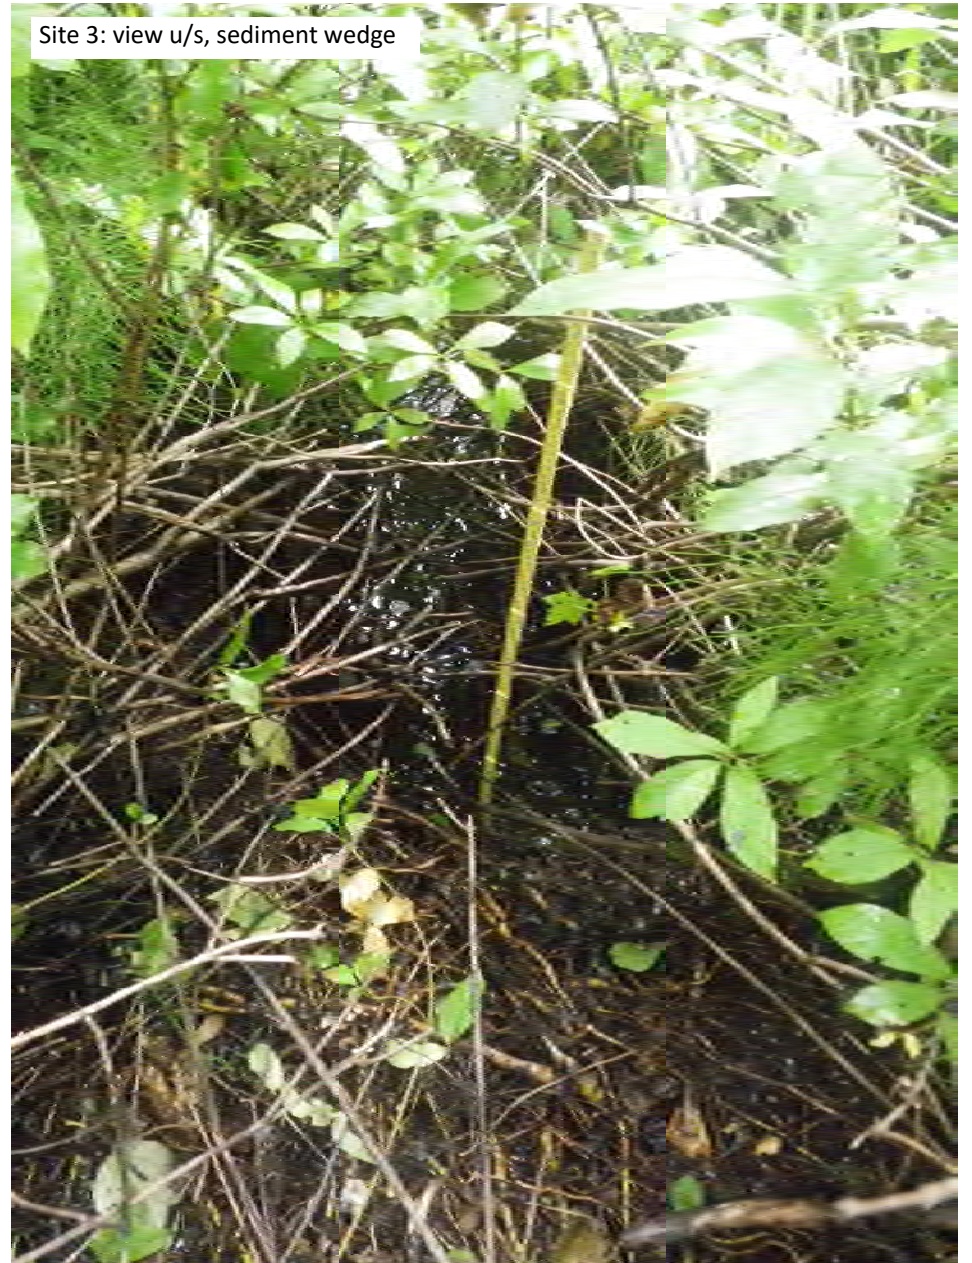
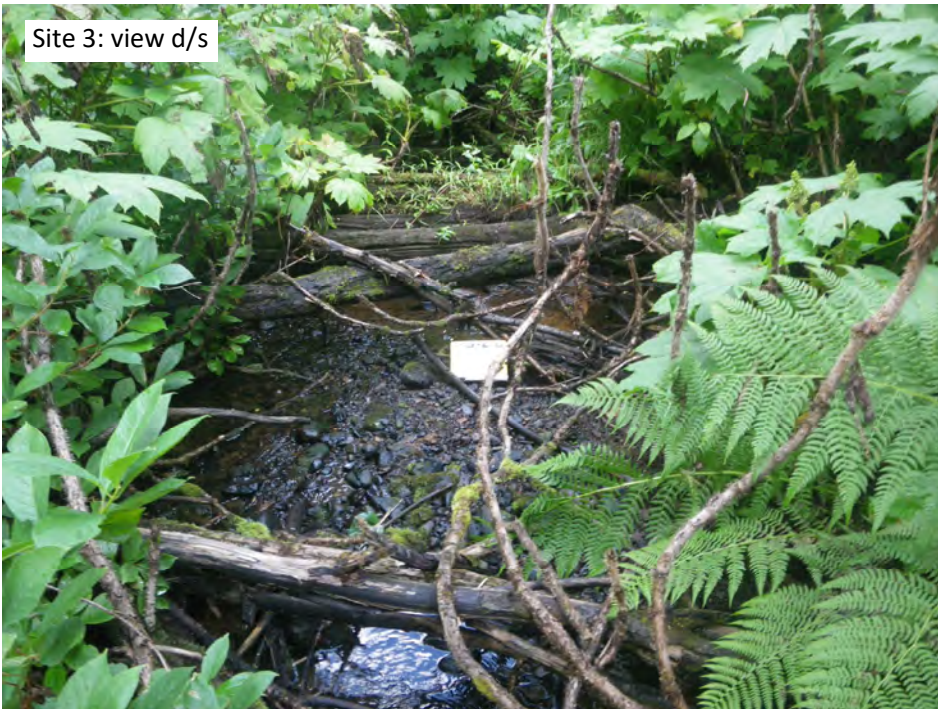
| SITE REFERENCE | | | | | | | | | | | | | | | |
|---|---|---|---|---|---|---|---|---|---|---|---|---|---|---|--|
| Comm 1 | Stream with usable RHAB and potential SHAB - 1-2cm gravel patches for a few meters observed and OK holding areas (overstream vegetation and some undercut banks). | | | | | | | | | | | | | | |

Site 3: view u/s

Site 3: view u/s, sediment wedge

Site 3: view d/s

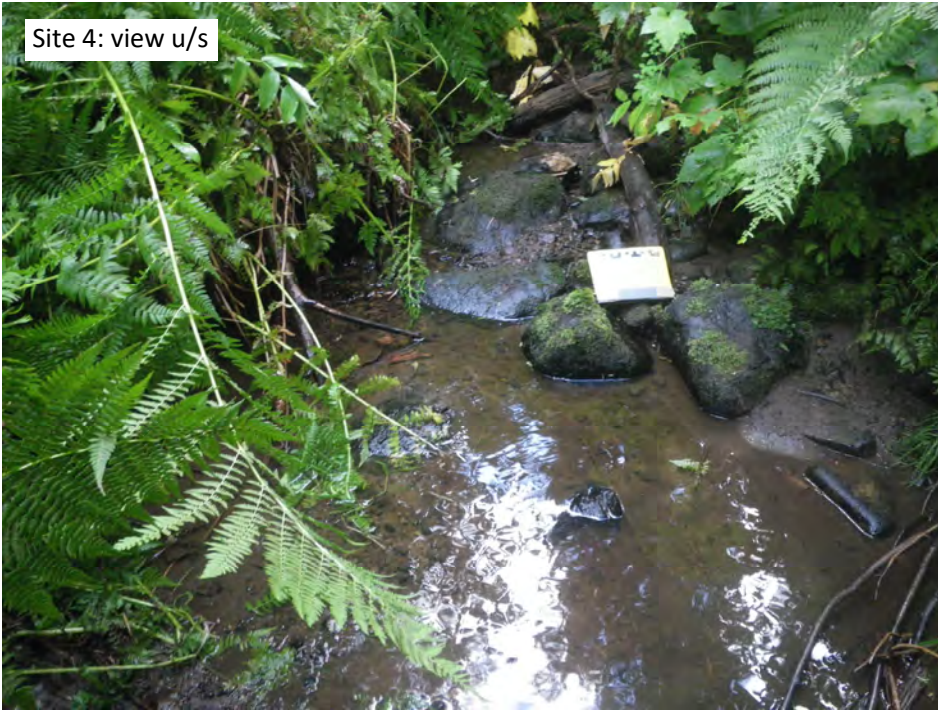
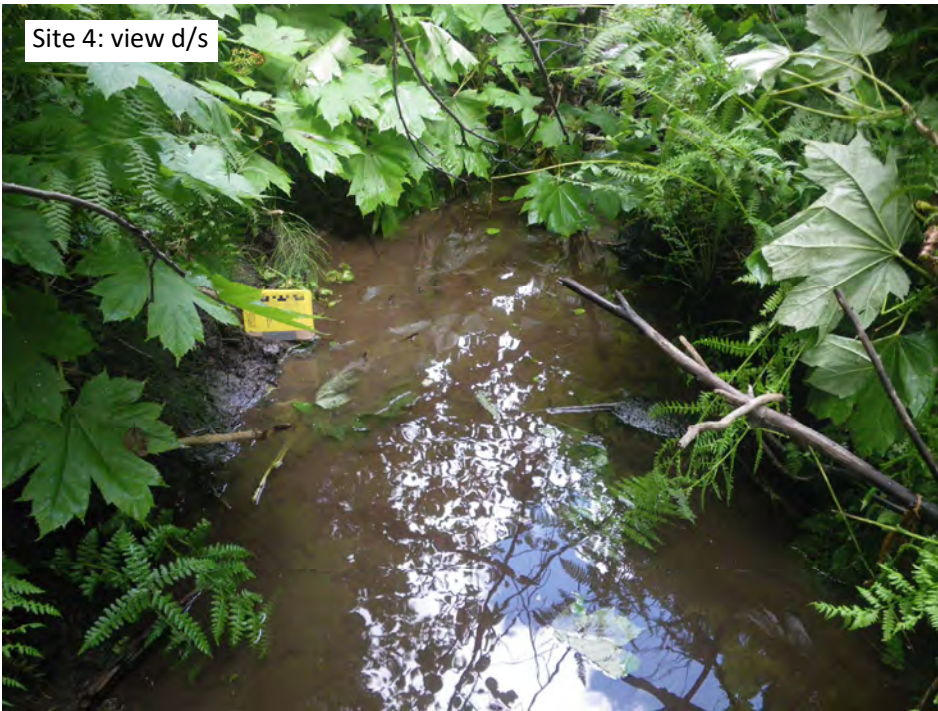
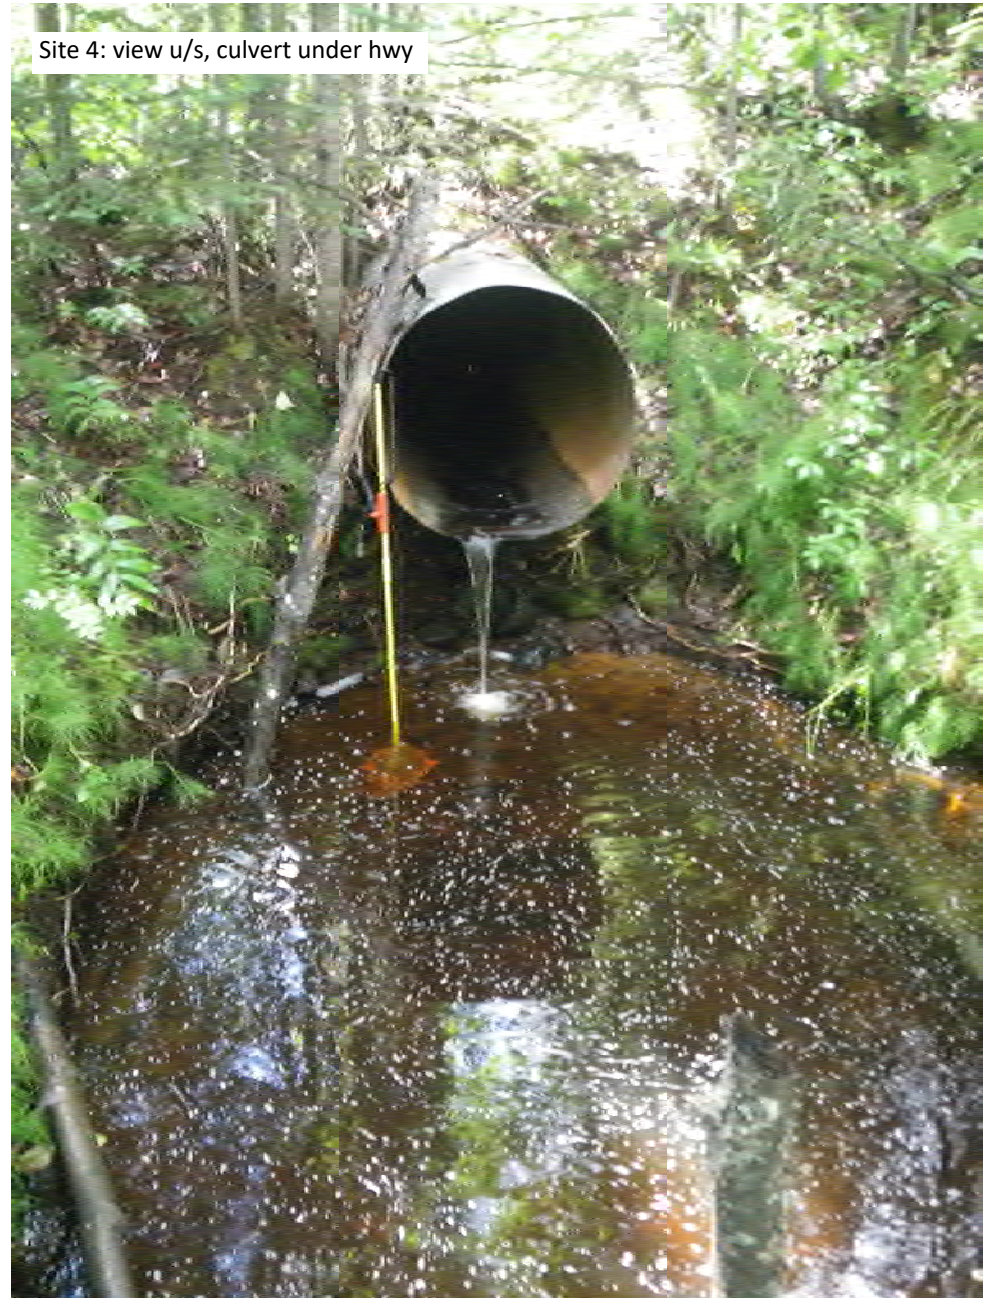
Site 4: view u/s

Site 4: view d/s

Site 4: view u/s, culvert under hwy

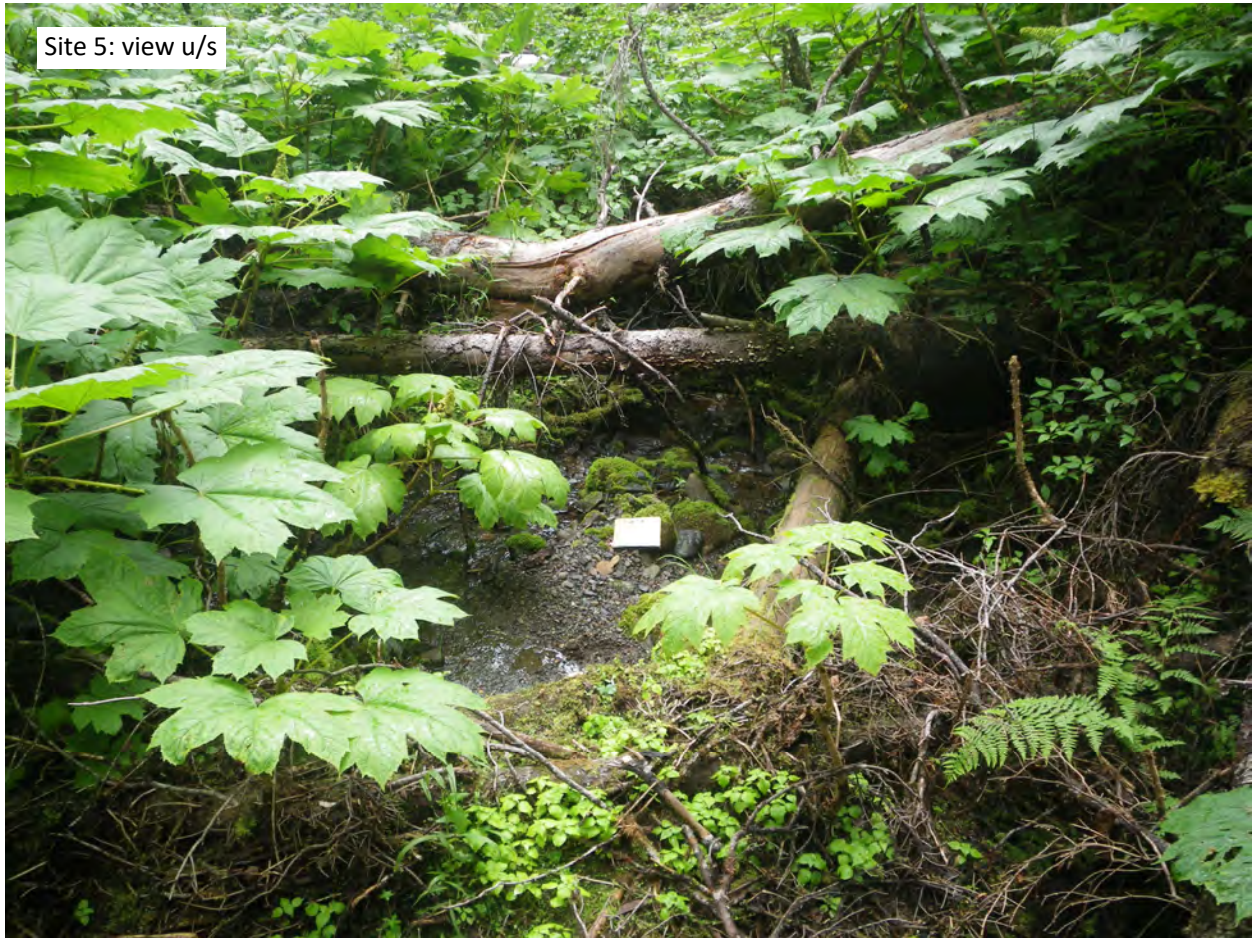
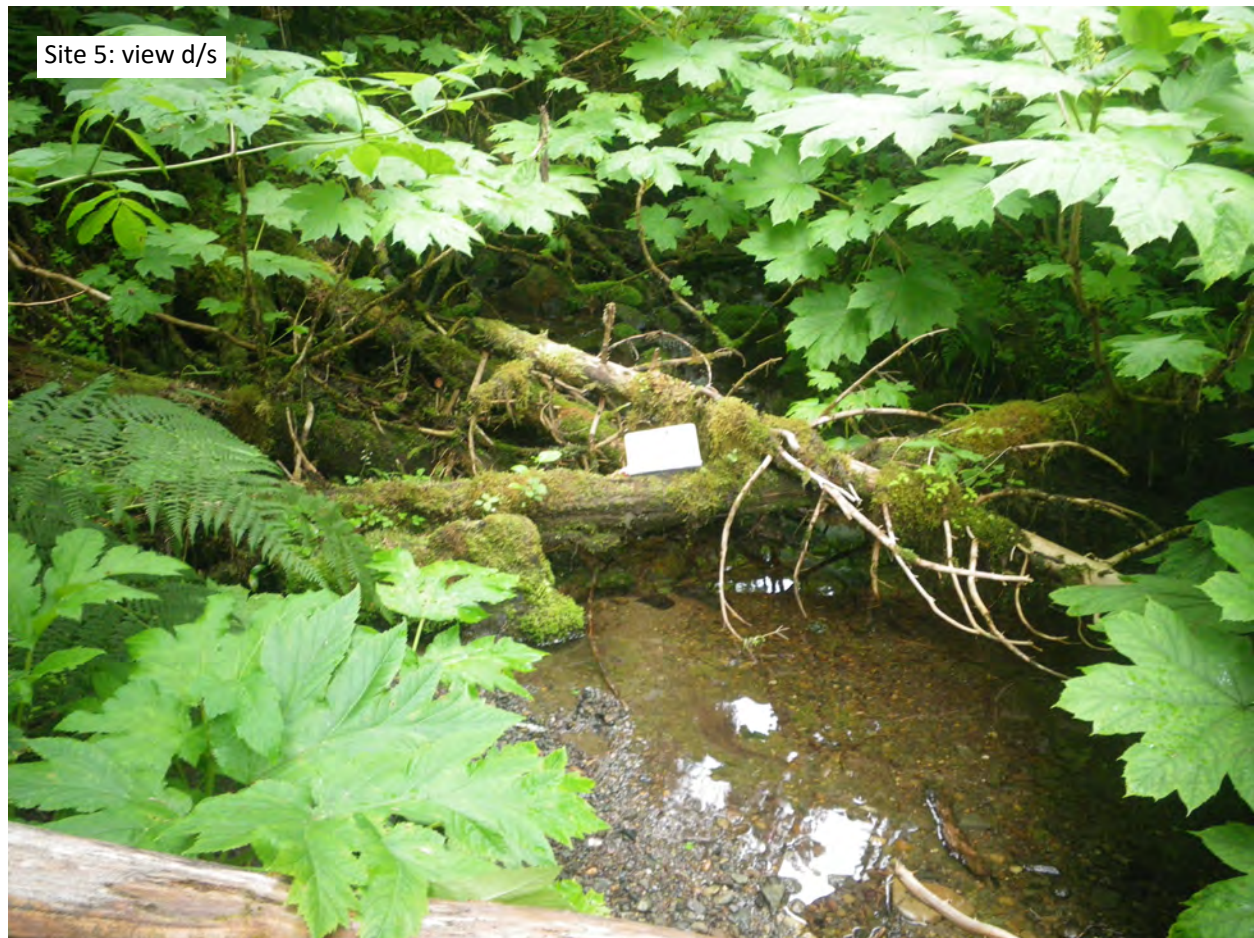
| SITE REFERENCE | | | | | | | | | | | | | | |
|---|---|---|---|---|---|---|---|---|---|---|---|---|---|---|
| Comm 3 | Walked stream u/s of bridge to site UTM and d/s to mouth to verify fish access - no barriers present; many salmonids observed near mouth (~70m section from Babine L.). | | | | | | | | | | | | | |

Site 5: view u/s

Site 5: view d/s

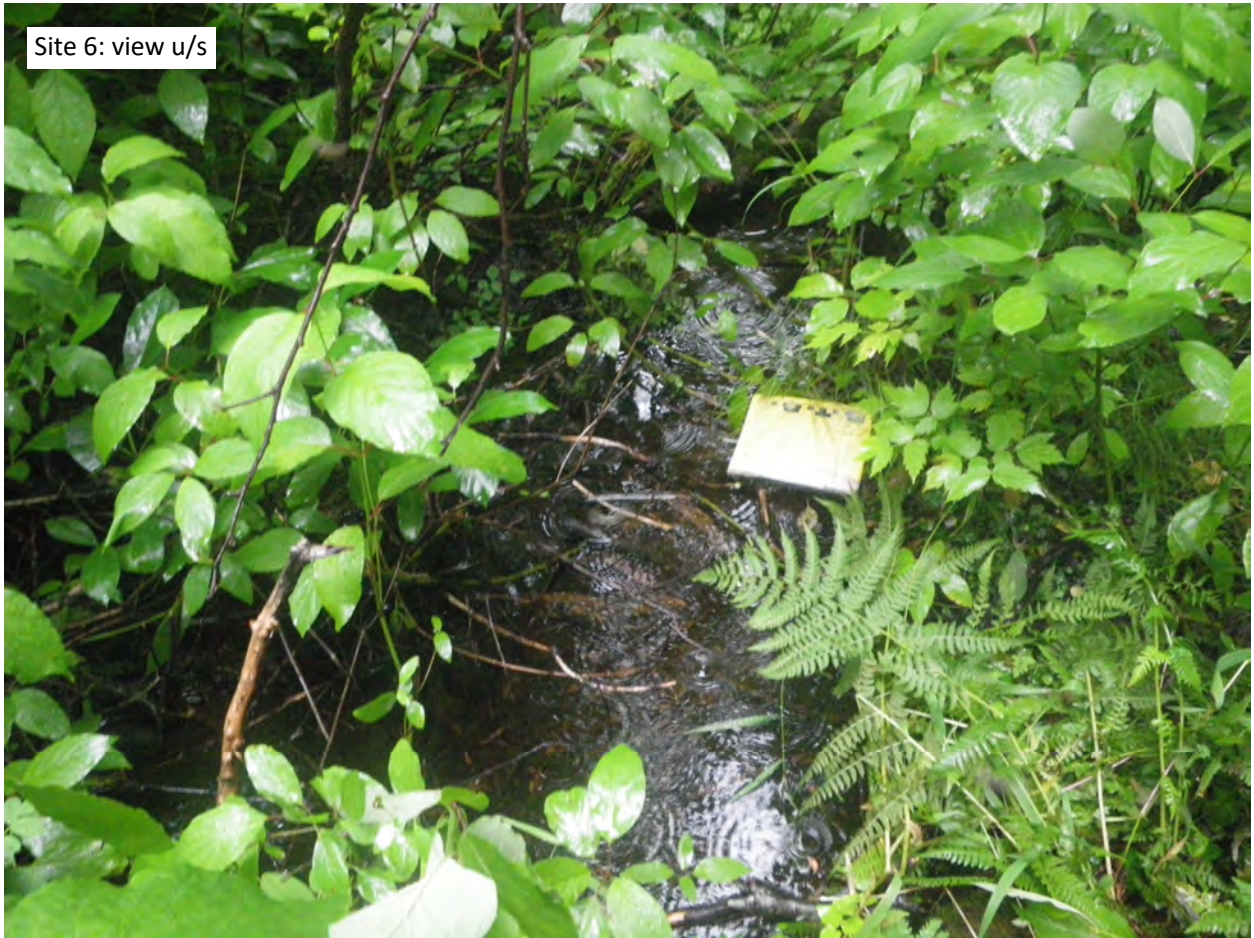
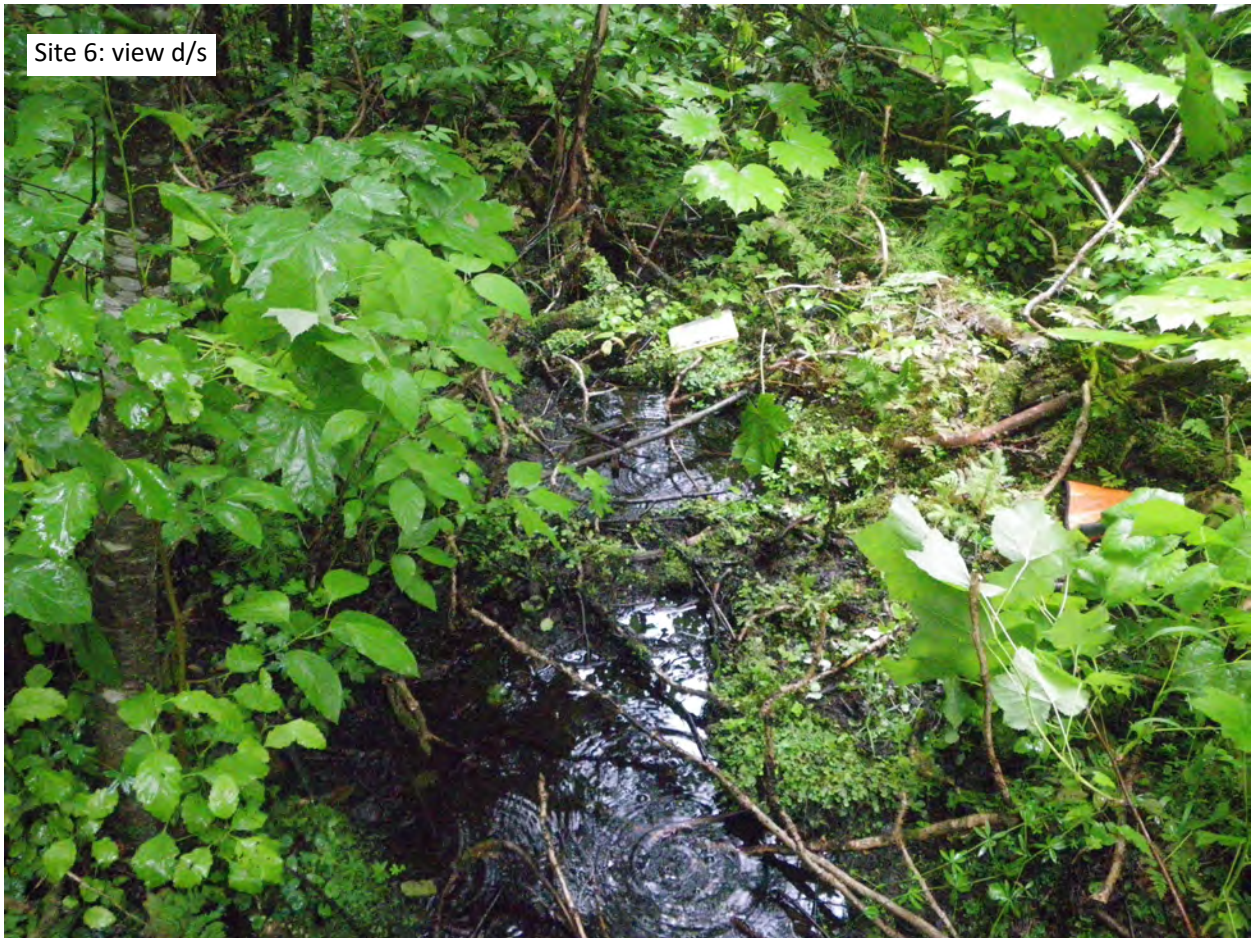
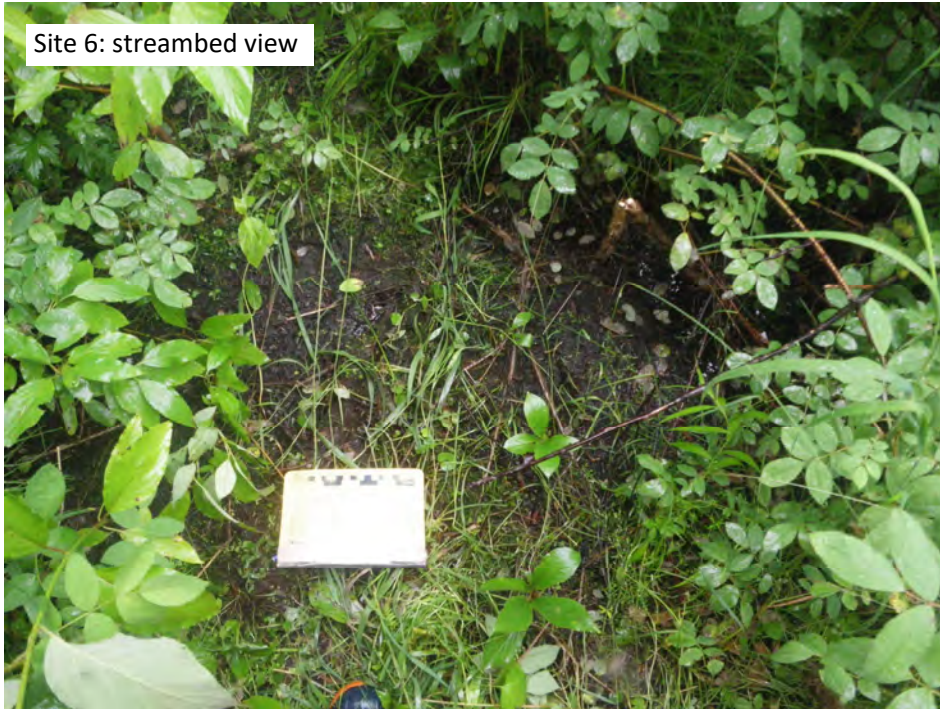
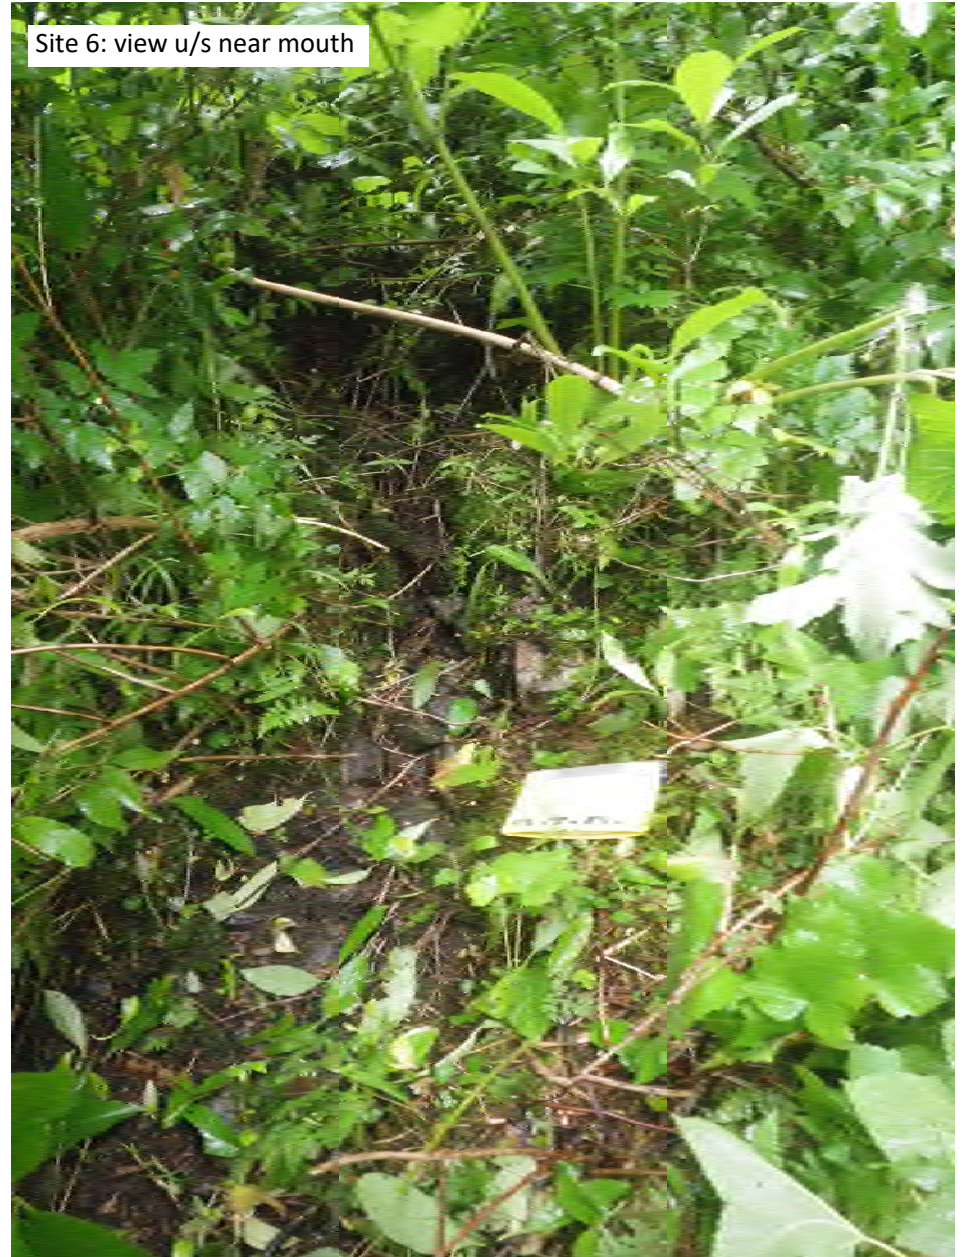
| SITE REFERENCE | | | | | | | | | | | | | | | |
|---|---|---|---|---|---|---|---|---|---|---|---|---|---|---|--|
| Comm 1 | No fish habitat - watercourse with alternating overland flows, surface scour, and some puddles; overland flow sections 10-20m long. No alluvium throughout, although a few boulders and large cobbles protruding from the ground observed. | | | | | | | | | | | | | | |
| Comm 3 | Alluvium noted for ~15-20m d/s from an old road crossing. | | | | | | | | | | | | | | |

Site 6: view u/s

Site 6: view d/s

Site 6: streambed view

Site 6: view u/s near mouth

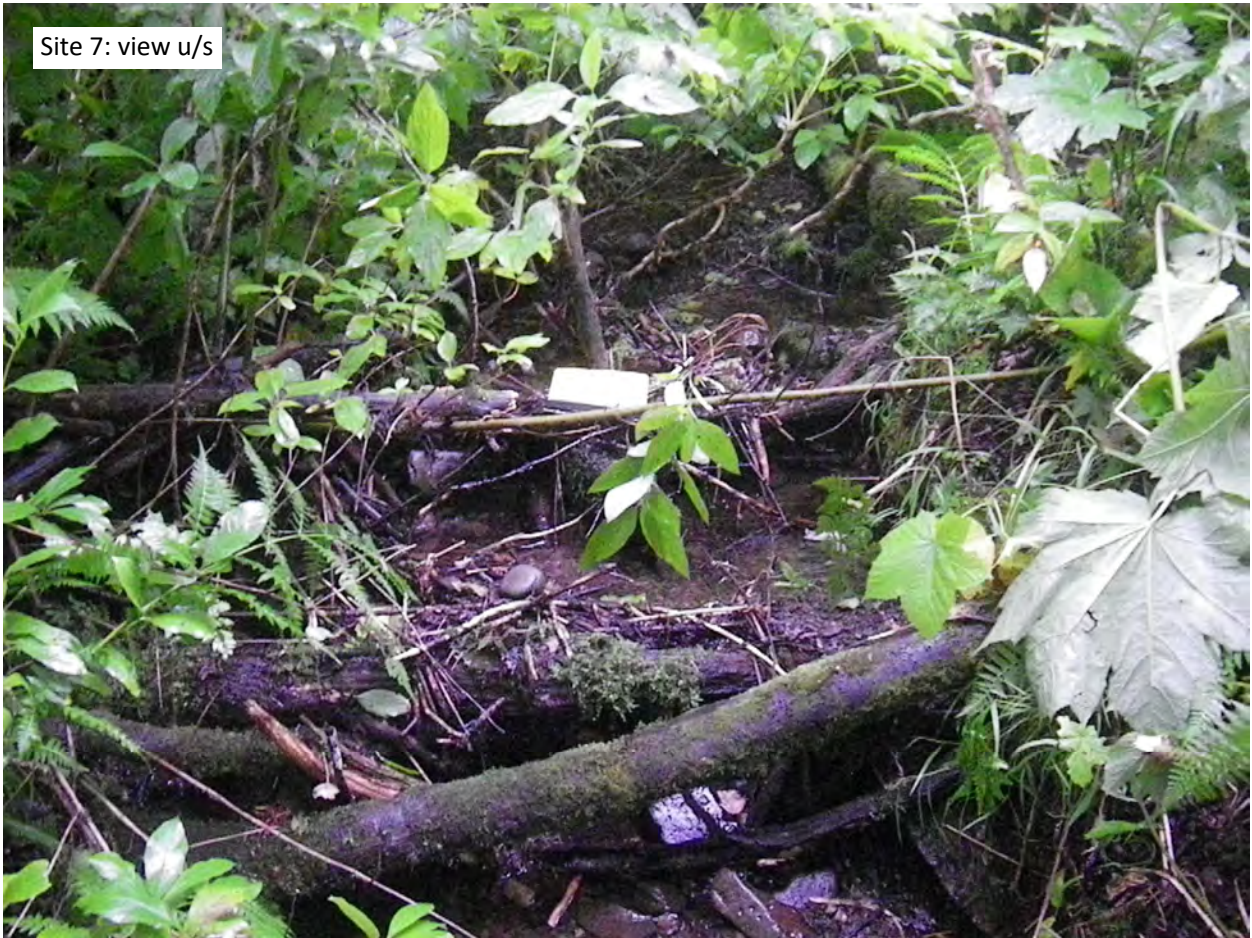
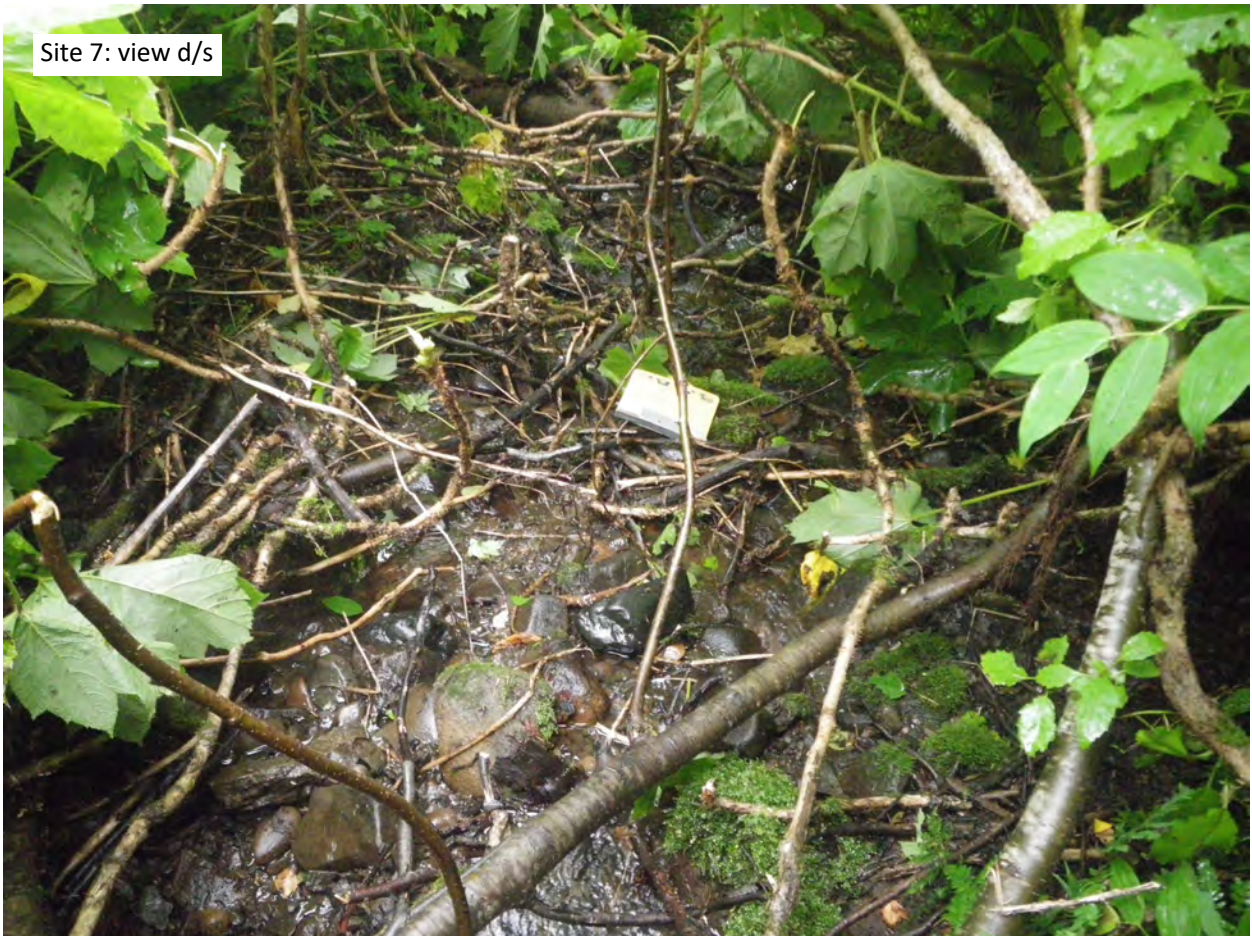
| SITE REFERENCE | | | | | | | | | | | | | | | |
|---|---|---|---|---|---|---|---|---|---|---|---|---|---|---|--|
| Comm 1 | No fish habitat - steep stream with no instream cover, no channel complexity, highly movable bed material during high flows, only one small pool found over 100m length. | | | | | | | | | | | | | | |

Site 7: view u/s

Site 7: view d/s

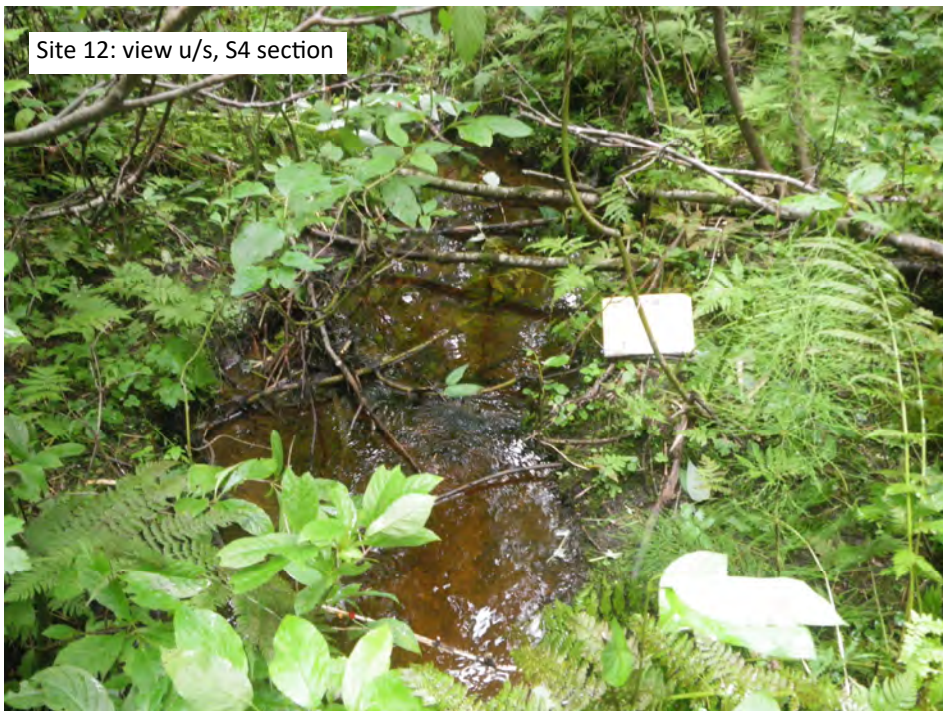
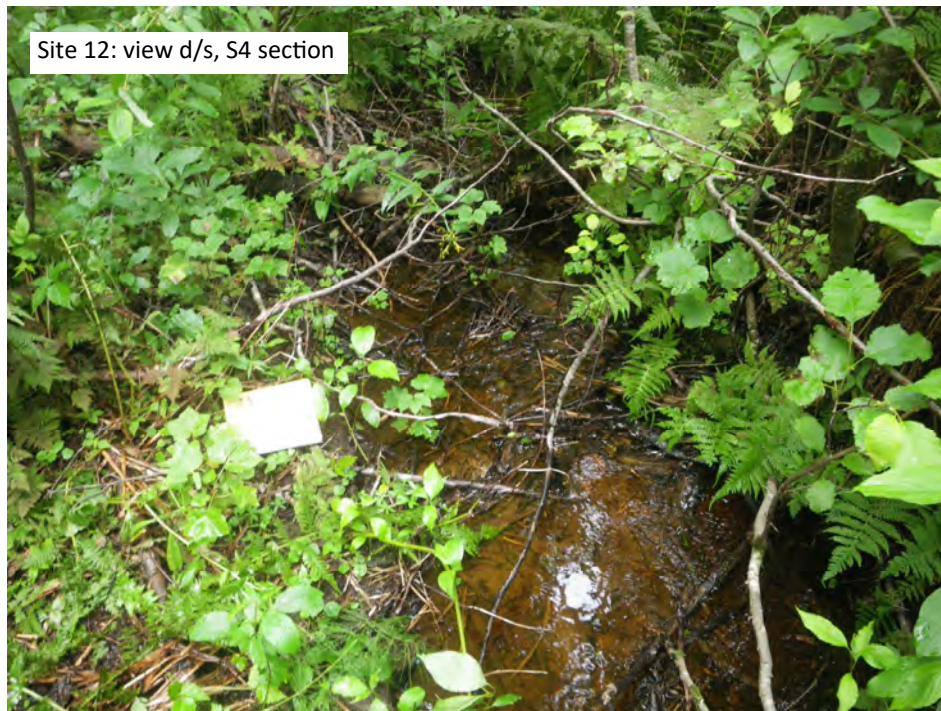
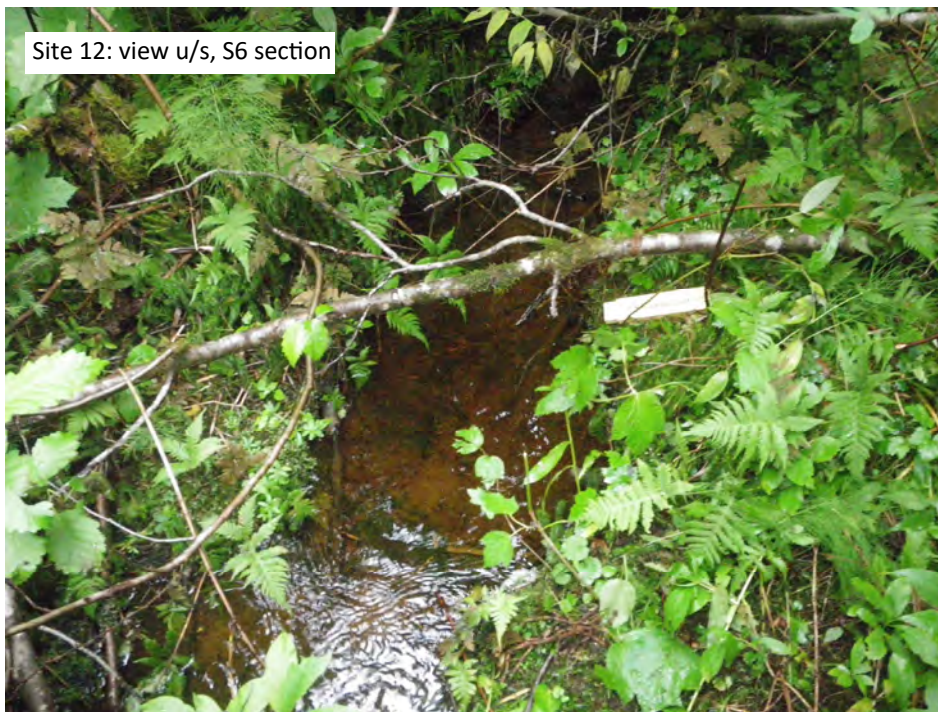
Site 12: view u/s, S4 section

Site 12: view d/s, S4 section

Site 12: view u/s, S6 section
