## 2021 Fish Habitat Assessments for Lake Babine Nations

Prepared for:  
**Capacity Forest Management Ltd.**  
1761 Redwood St.  
Campbell River, BC, V9W 3K7

Prepared by:  
**Mac Jedrzejczyk, M.Sc., R.P.Bio.**  
**FINS Consulting Ltd.**  
4206 Eby St.  
Terrace, BC, V8G 2E5

December 2021

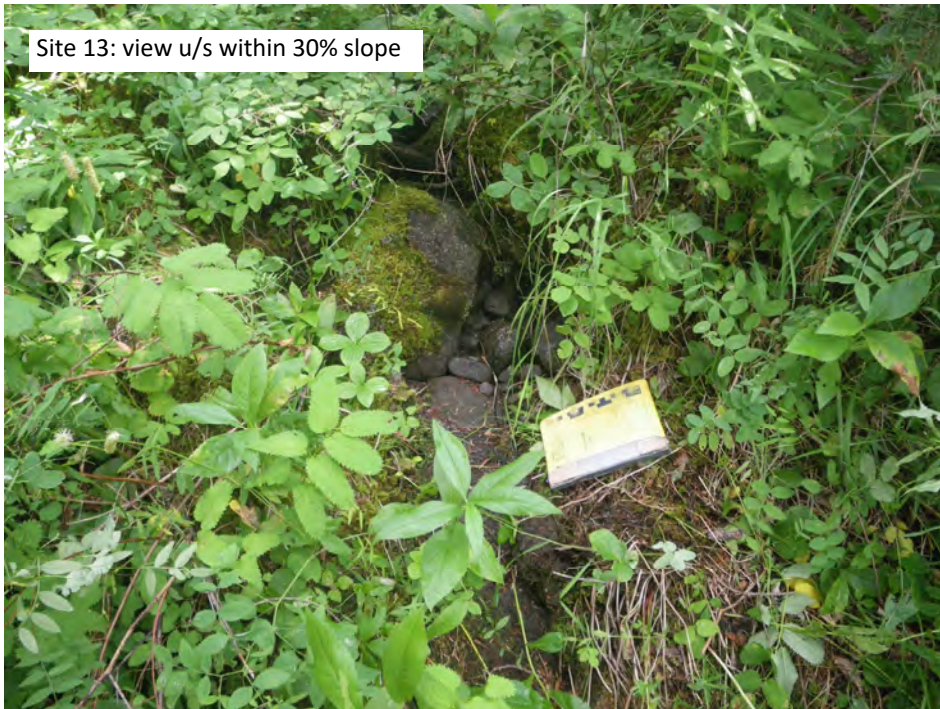
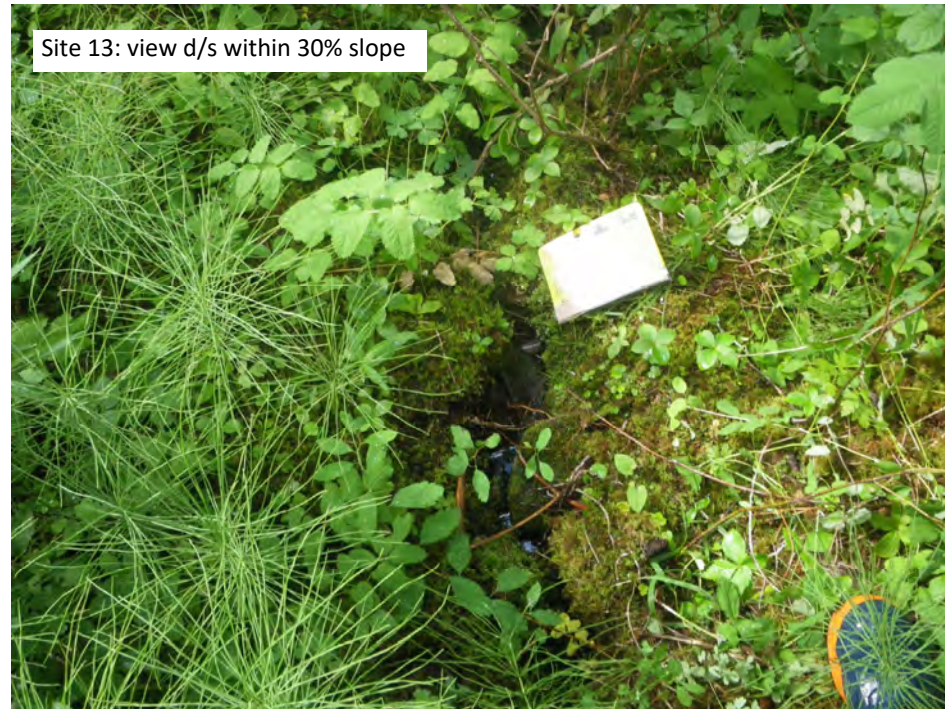
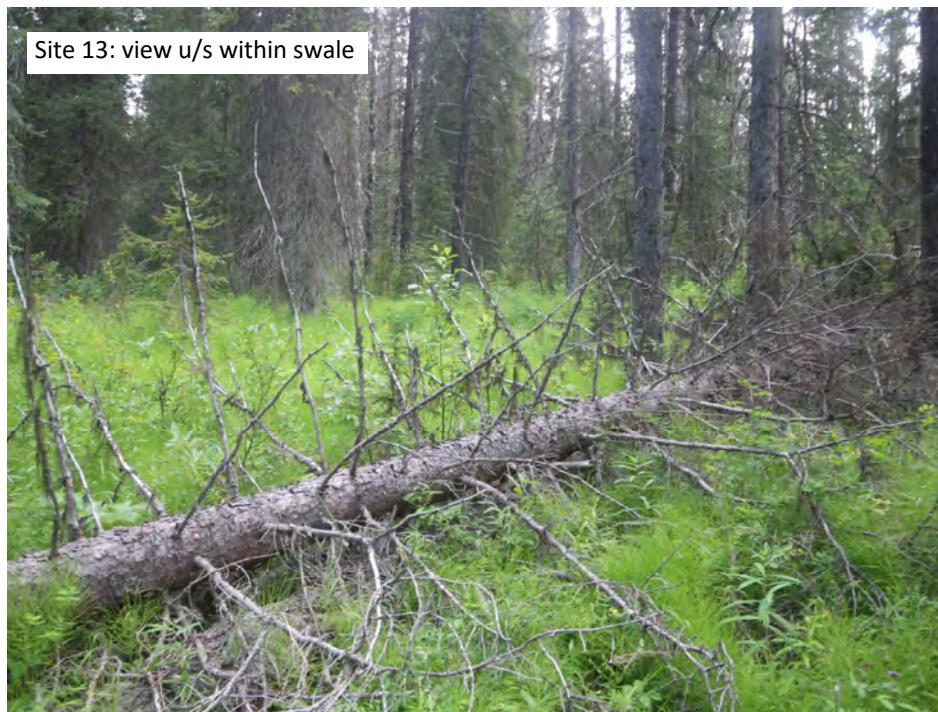
Site 13: view u/s within 30% slope

Site 13: view d/s within 30% slope

Site 13: view u/s within swale

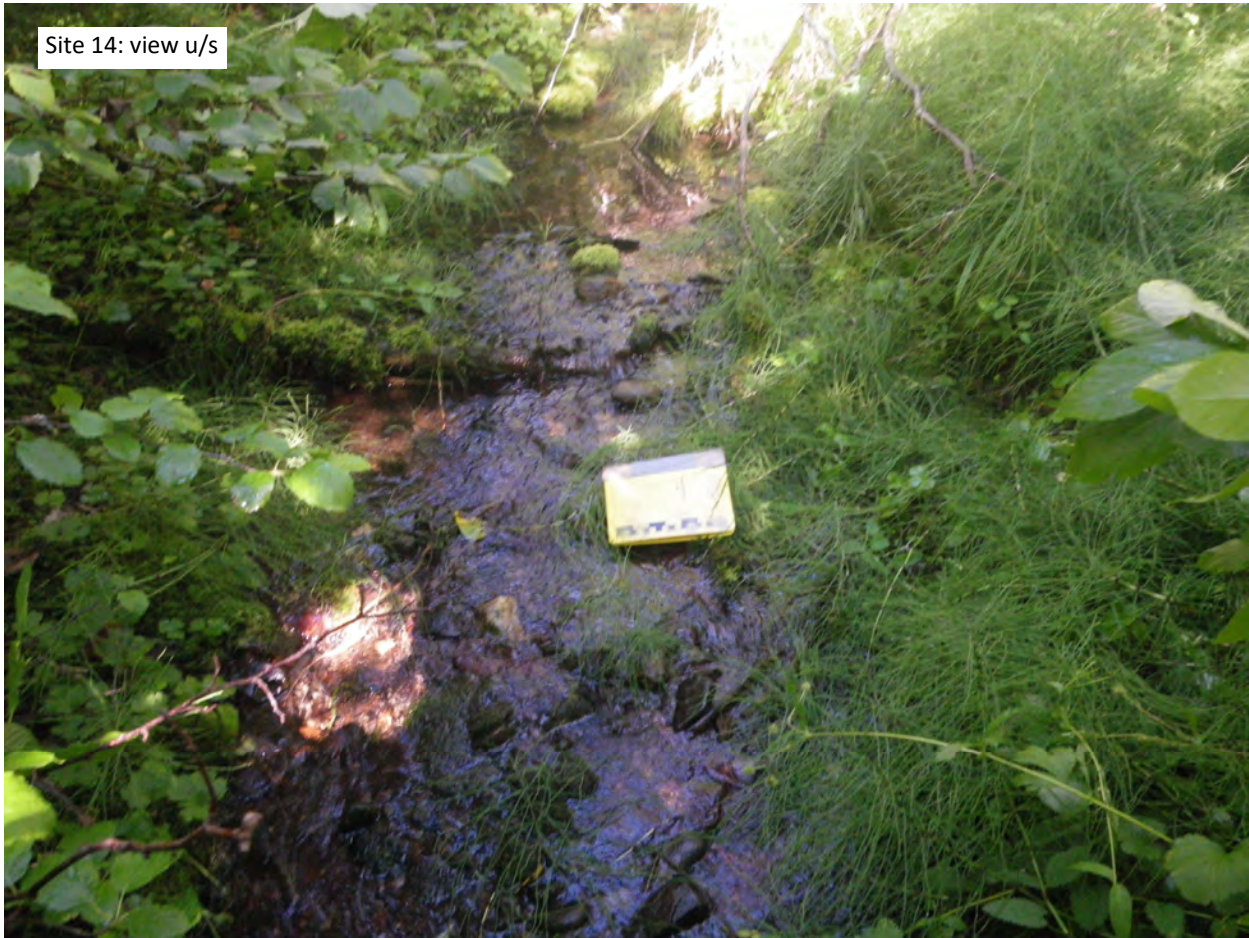
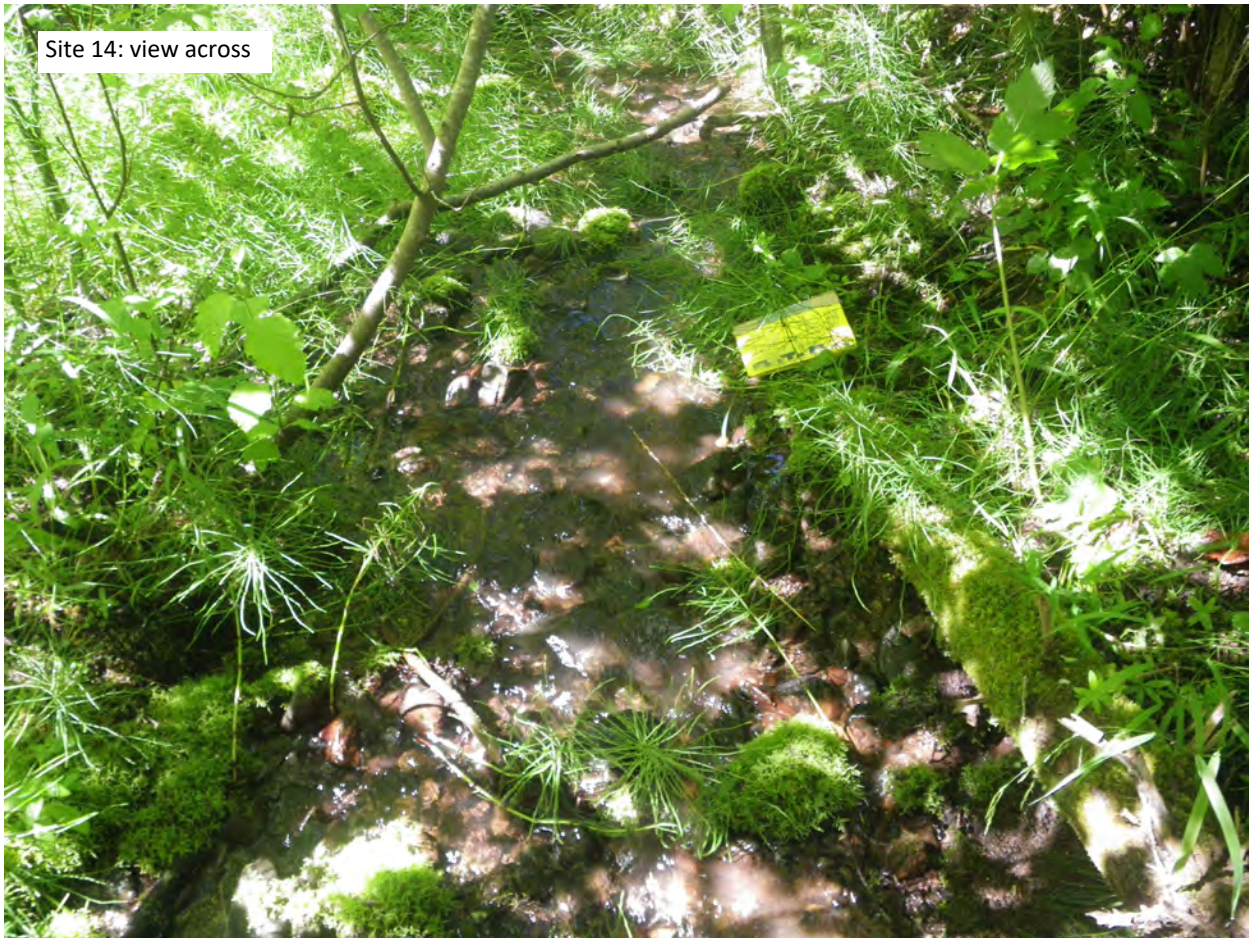
| SITE REFERENCE | | | | | | | | | | | | | | | |
|---|---|---|---|---|---|---|---|---|---|---|---|---|---|---|--|
| Comm 1 | No fish habitat - stream is extremaly shallow and has nothing to offer to fish; channel lacks complexity and instream cover for any flow conditions. | | | | | | | | | | | | | | |

Site 14: view u/s

Site 14: view across

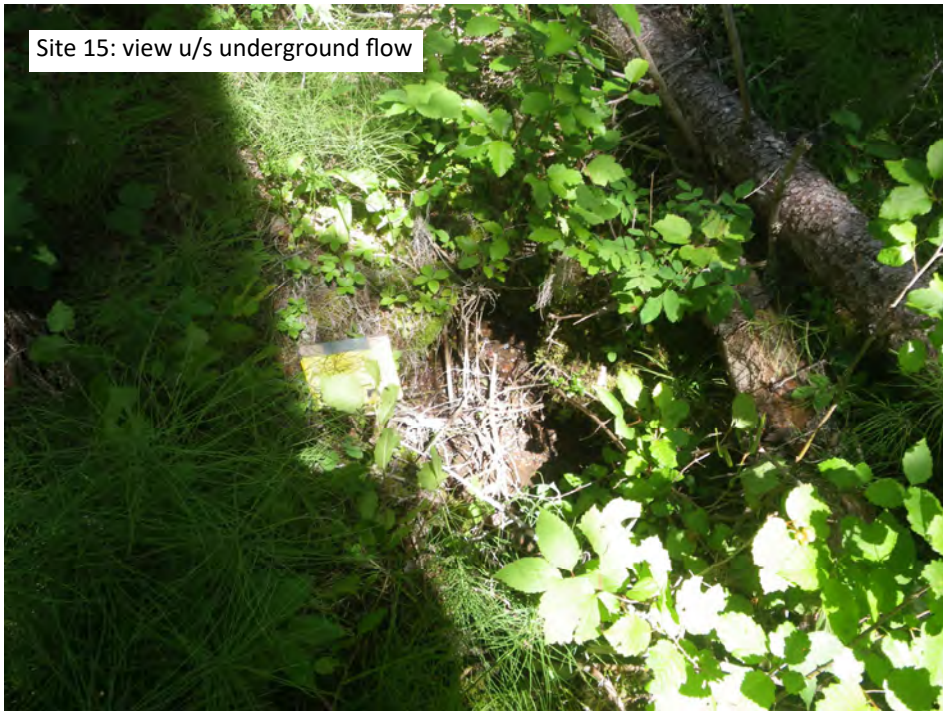
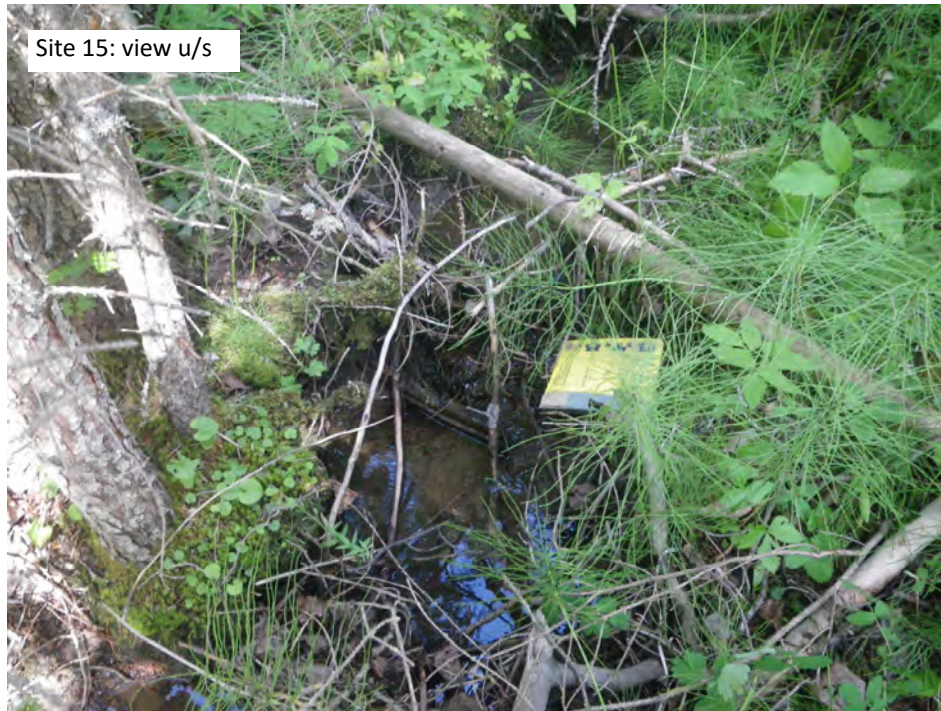
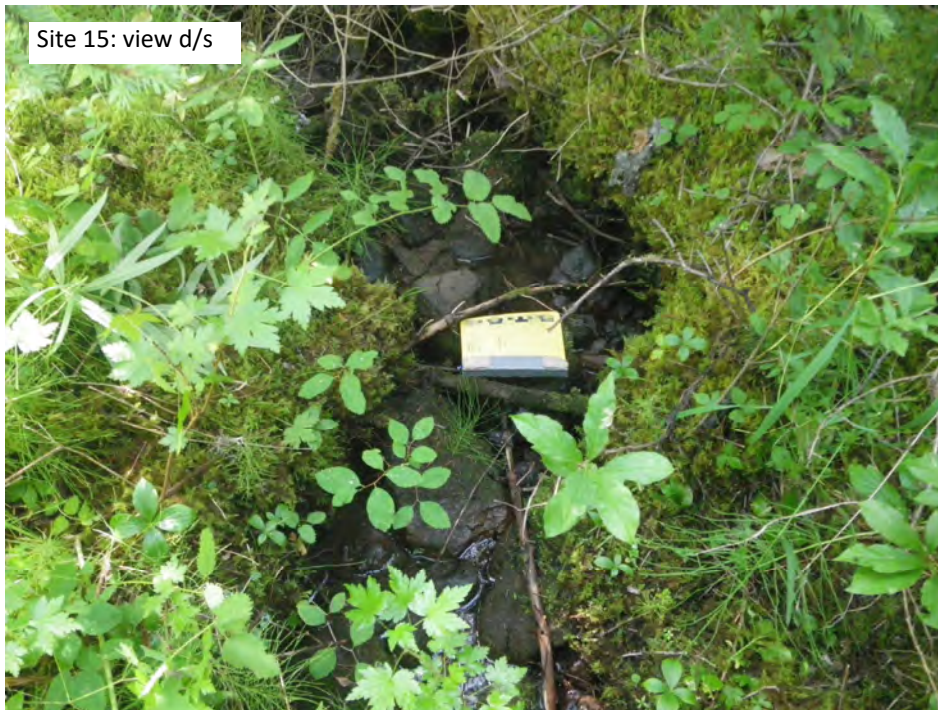
Site 15: view u/s underground flow

Site 15: view u/s

Site 15: view d/s

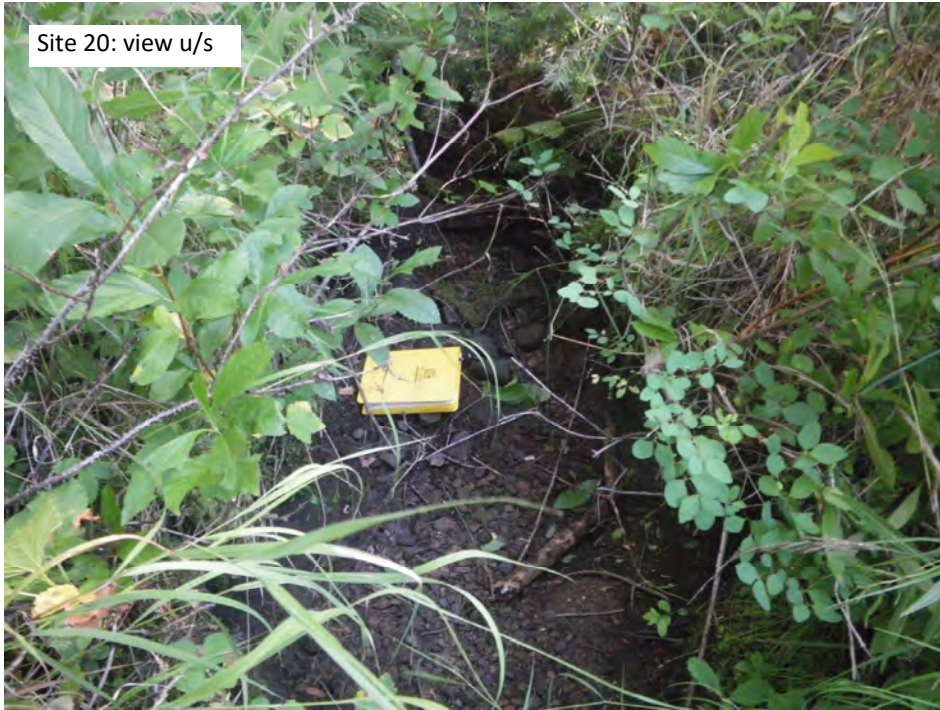
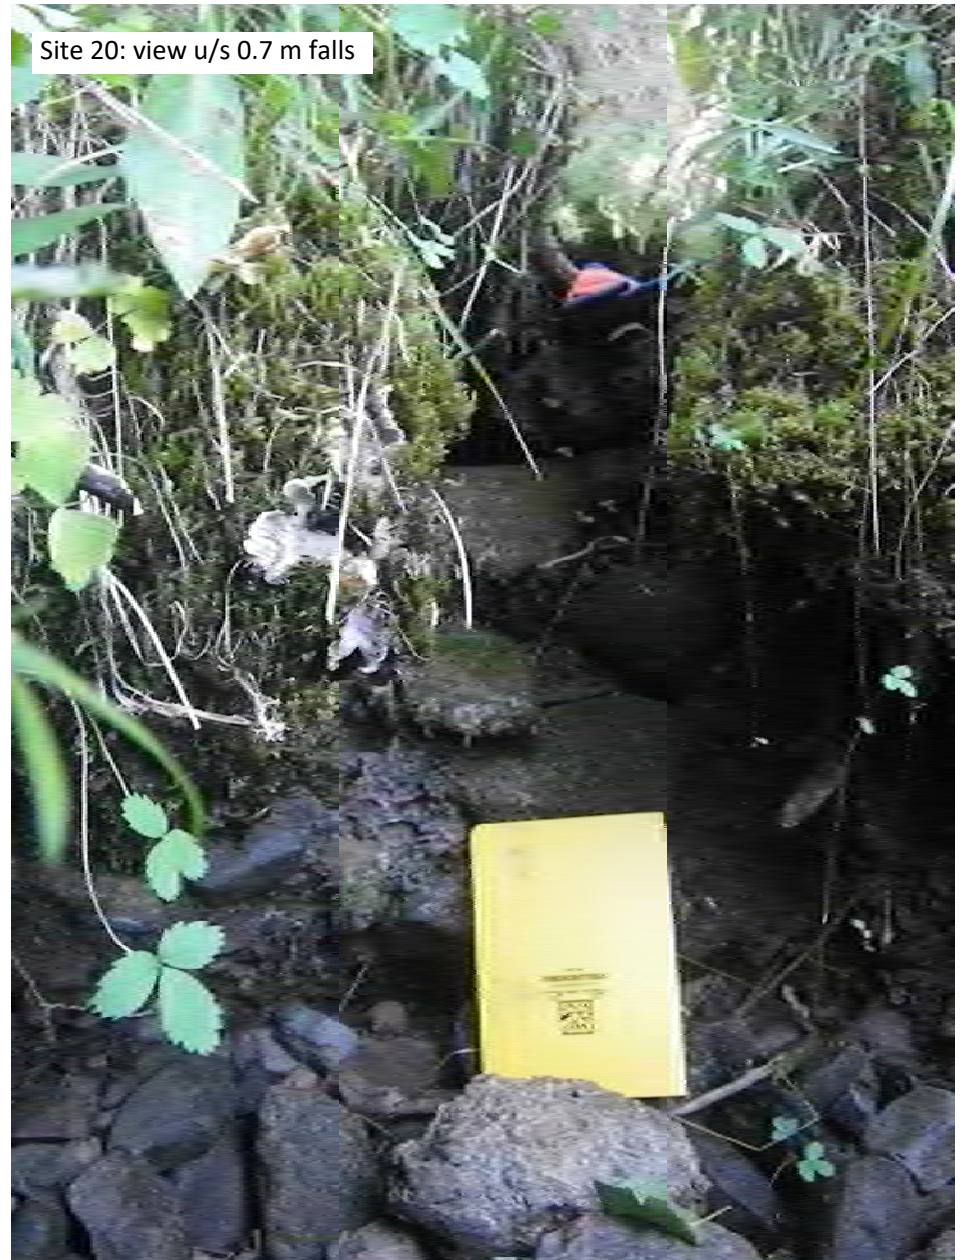
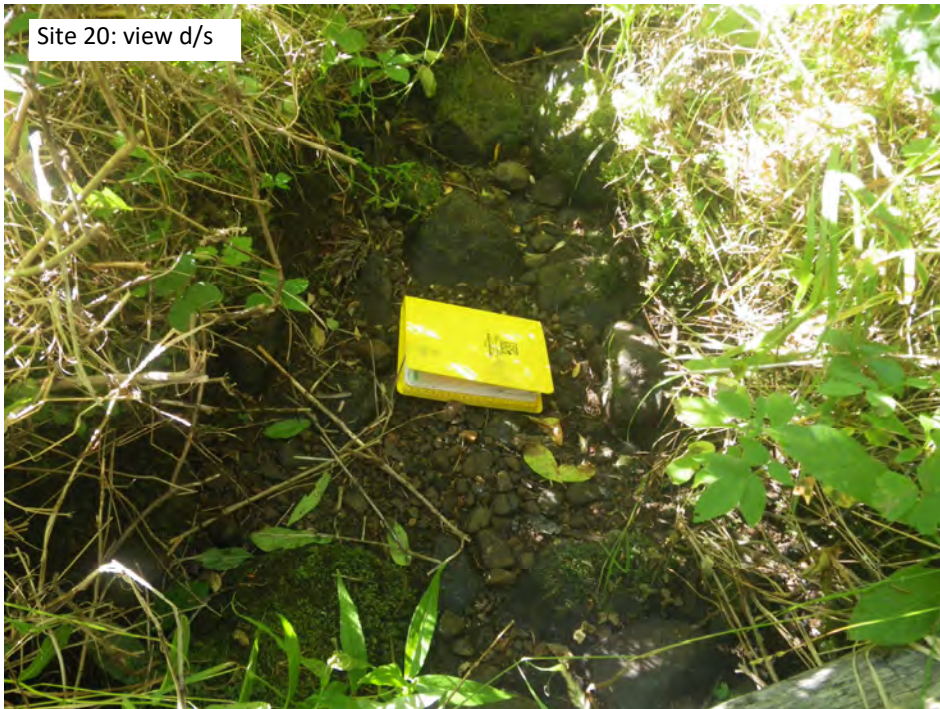
Site 20: view u/s

Site 20: view u/s 0.7 m falls

Site 20: view d/s
