# **2020 Fish Habitat Assessments for Lake Babine Nations in the Granisle Area**

Prepared for:  
**Capacity Forest Management Ltd.**  
1761 Redwood St.  
Campbell River, BC, V9W 3K7

Prepared by:  
**Mac Jedrzejczyk, M.Sc., R.P.Bio.**  
**FINS Consulting Ltd.**  
4206 Eby St.  
Terrace, BC, V8G 2E5

**November 2020**

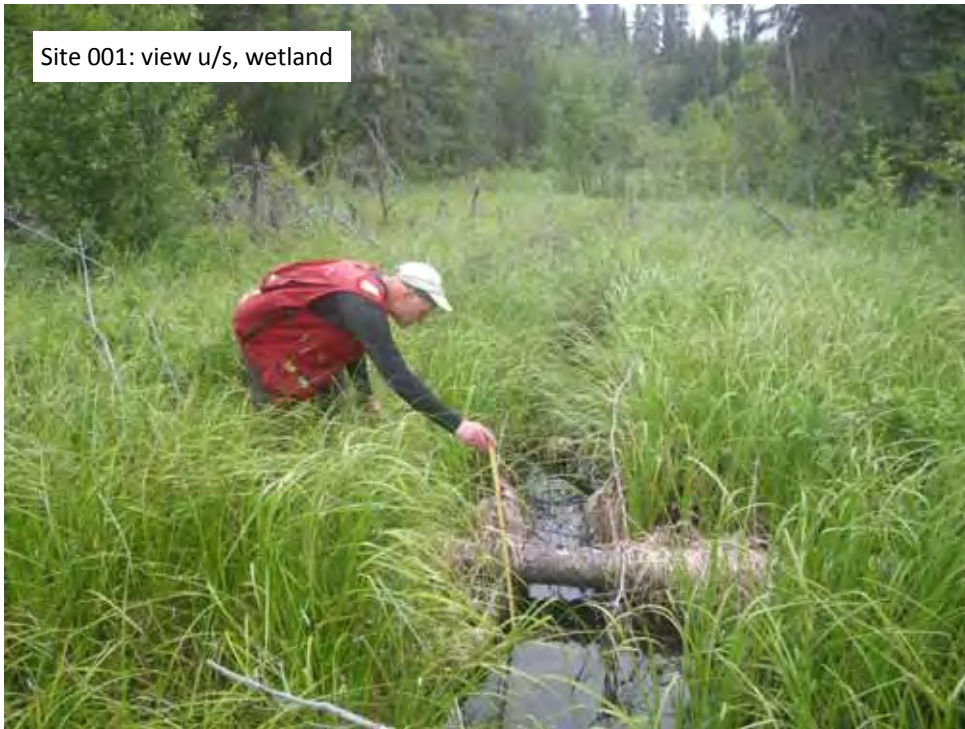
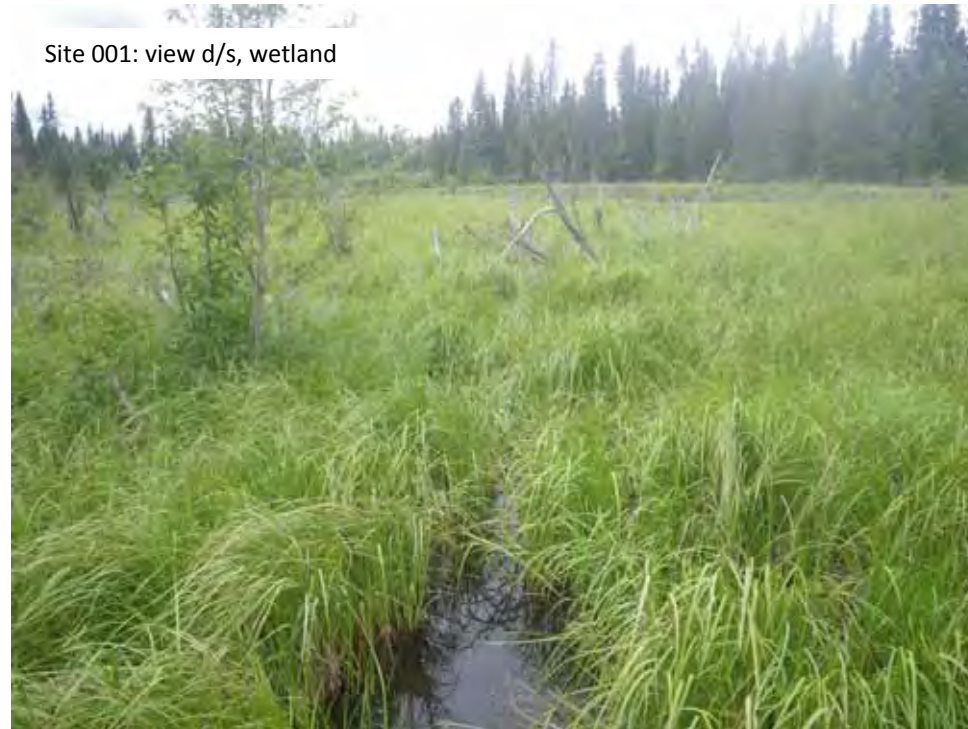
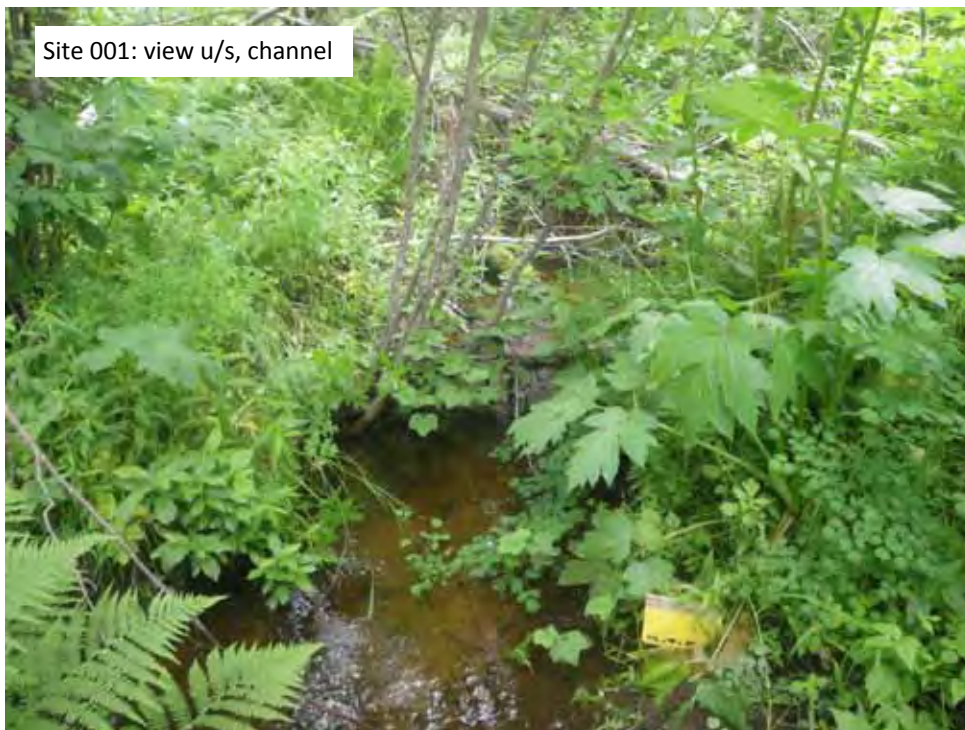
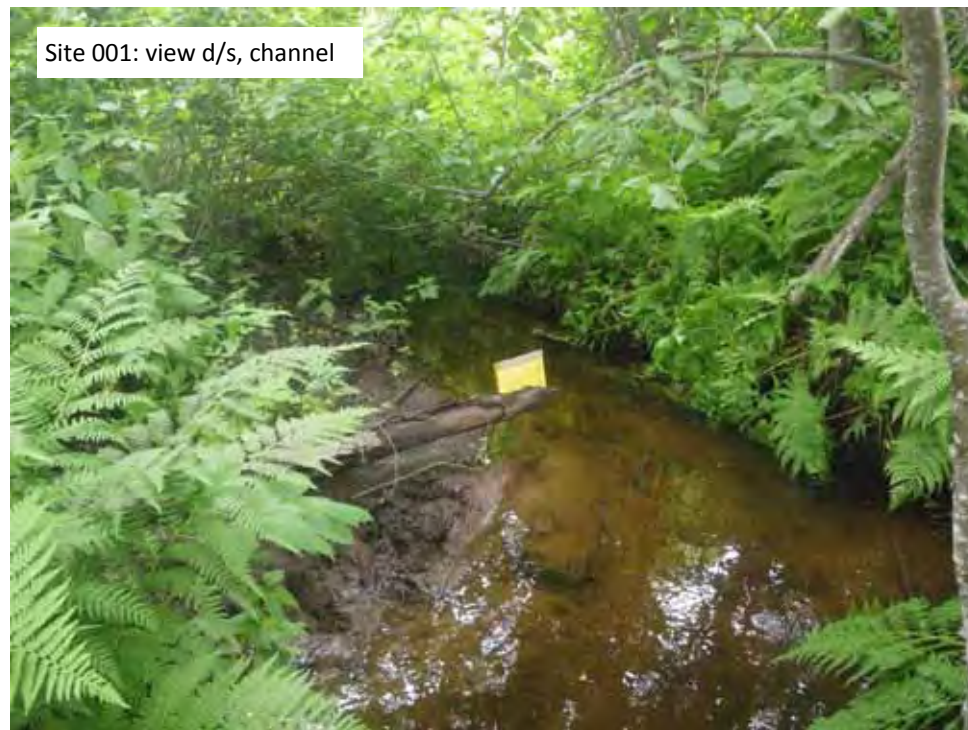
Site 001: view u/s, wetland

Site 001: view d/s, wetland

Site 001: view u/s, channel

Site 001: view d/s, channel

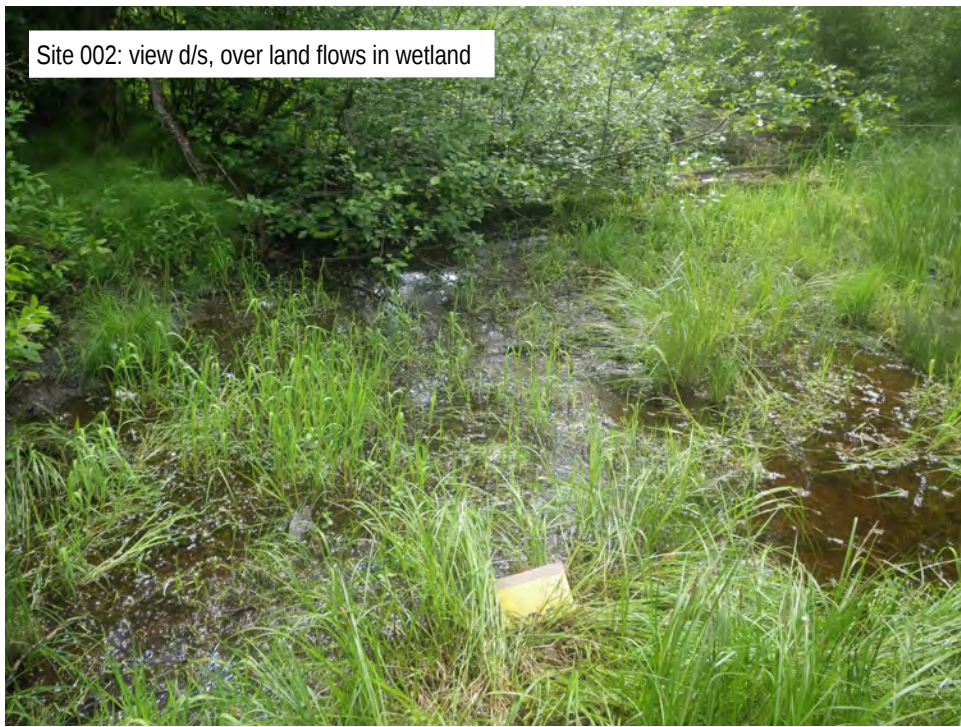
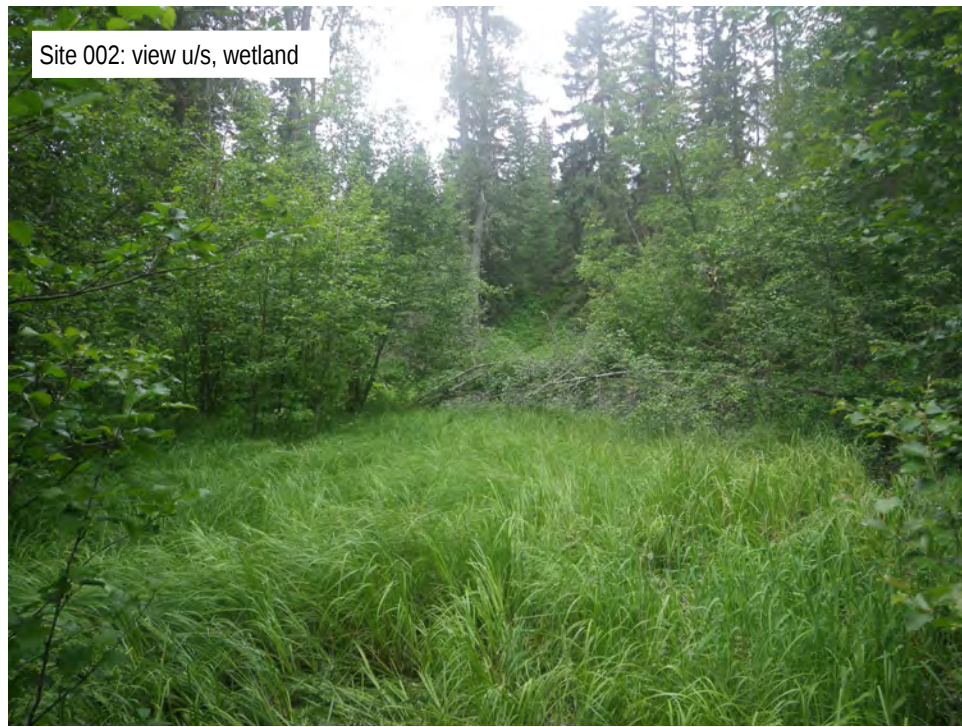
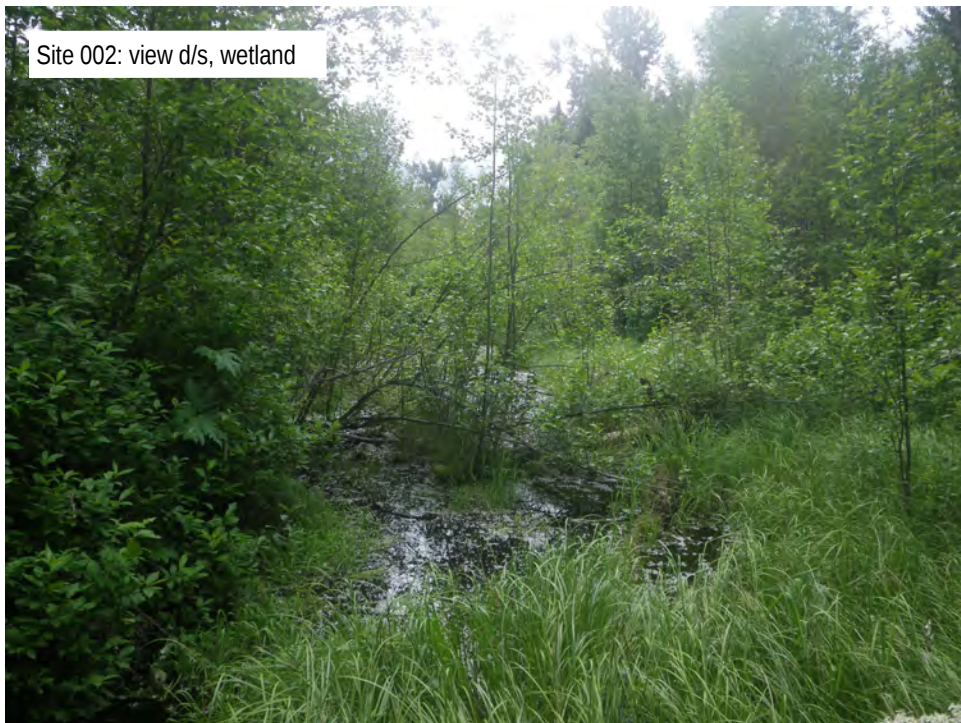
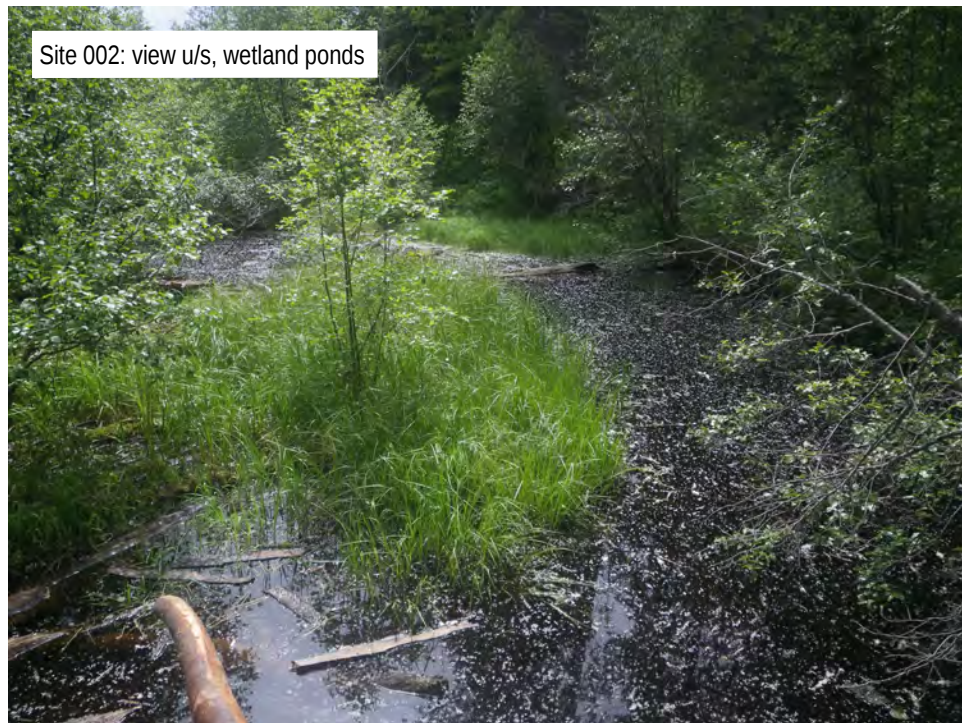
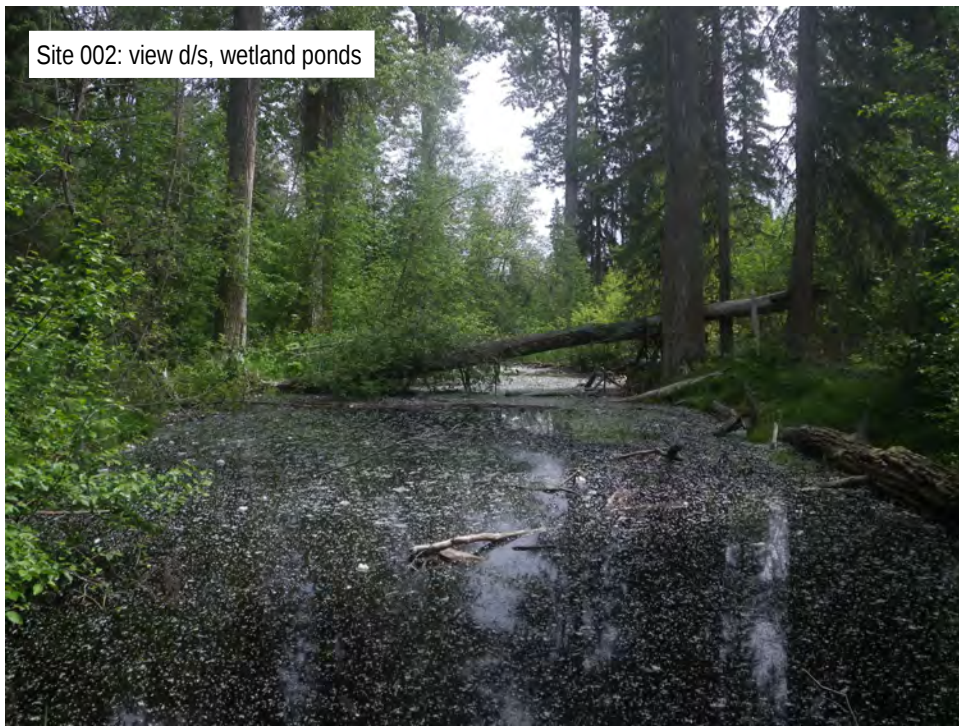
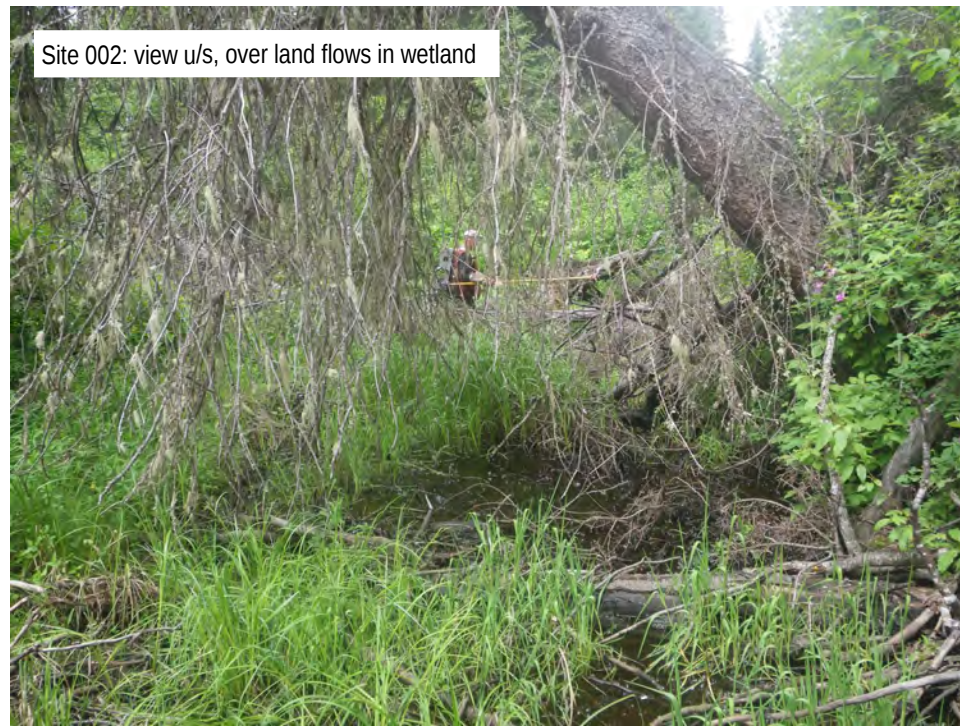
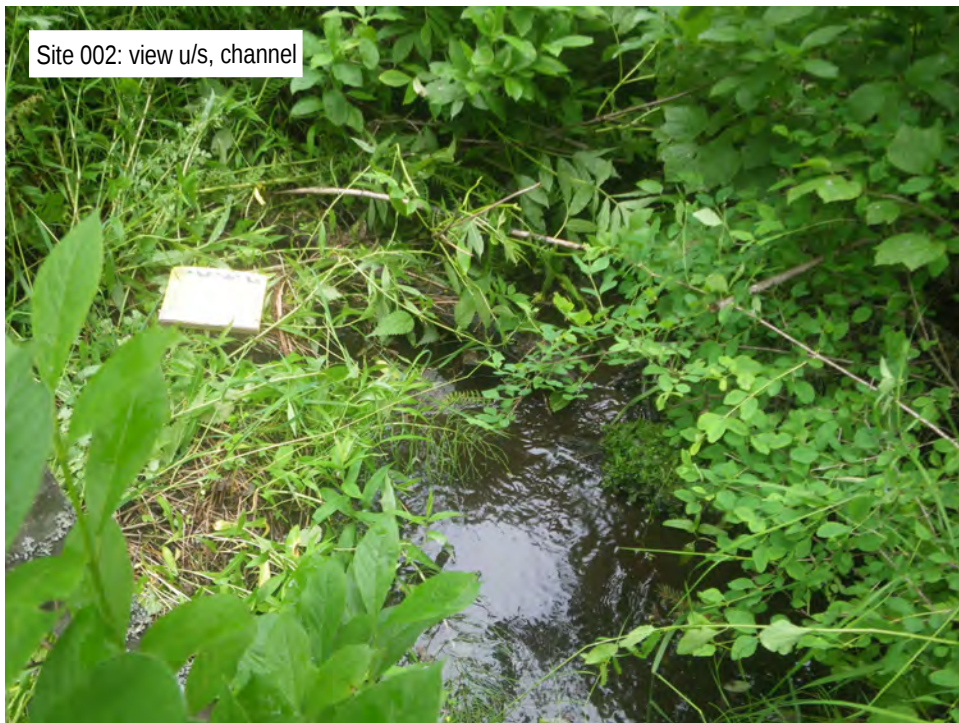
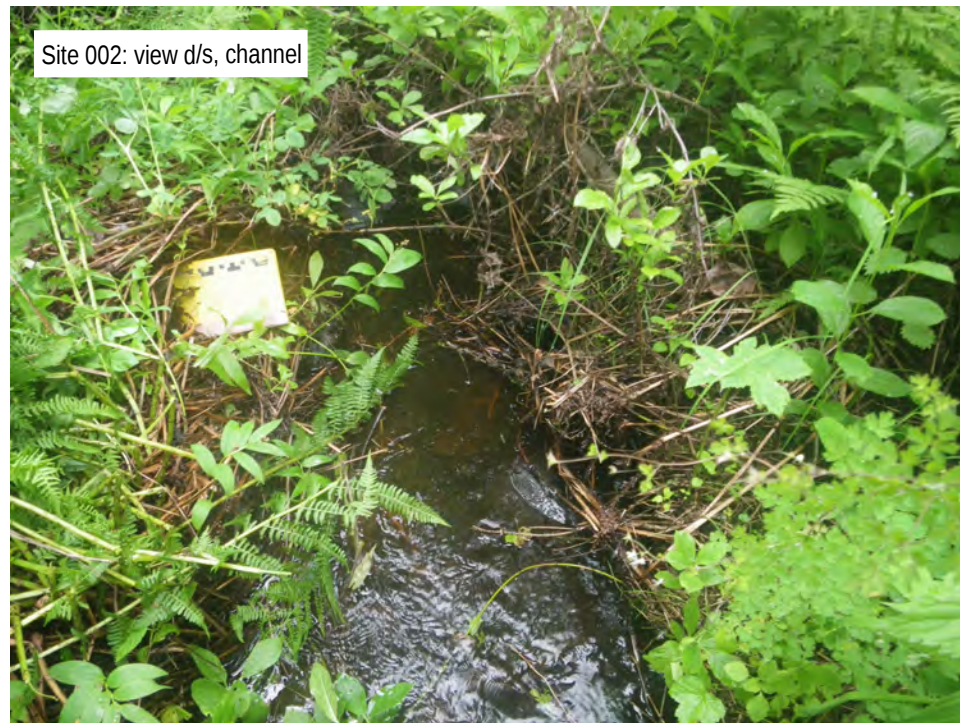
Site 002: view d/s, over land flows in wetland

Site 002: view u/s, wetland

Site 002: view d/s, wetland

Site 002: view u/s, wetland ponds

Site 002: view d/s, wetland ponds

Site 002: view u/s, over land flows in wetland

Site 002: view u/s, channel

Site 002: view d/s, channel

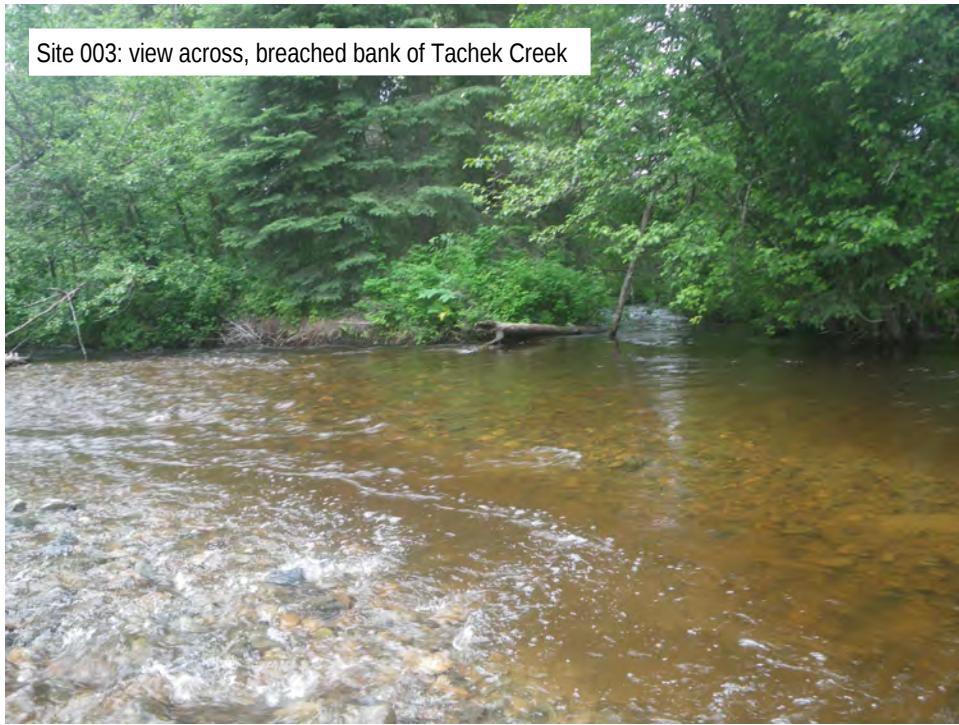
| AREA | Stream ID<br>(Name, TWC<br>or WSC) | Reach<br># | Site # | UTM<br>zone | UTM<br>Easting | UTM<br>Northing | Riparian<br>Class | Habitat Value<br>Rating | Channel<br>Slope (%) | Channel<br>Width (m) | Channel<br>Depth(m) | Sampling<br>Results | Site Length<br>(m) | Follow-up<br>Sampling | Comments |
|---|---|---|---|---|---|---|---|---|---|---|---|---|---|---|---|
| | 480-705800 | 1.1 &<br>1.2 | 3 | 9 | 685259 | 6075293 | S3 | IM | 1 | 3.67 | * | CO | 1600 | N | The right bank of Tachek Creek was breached several years ago at UTM 9.684665.6074965 (~100 m d/s of the bridge). Currently, this new distributary dissects proposed blocks DAN001. It carries ~25% of the Tachek C. flow and is still in the process of forming a channel. It is characterized by mostly overland flows with some sections scoured and channelized, occasionally water floods ~40-50m wide valley. CO was captured d/s of wetland where the confluence of stream 480-704490 is located. It was impossible to obtain full channel measurements or determine complete morphology due to flooding and continuing channel formation; therefore, the channel width was estimated. Numerous BDs were observed in ~300m section u/s of Babine L. Another forming distributary (branch) flowing South was noted ~250m u/s of Babine Lake at UTM 9.686059.6075433 (the east side of DAN001). When completely established in the near future, both branches will create good rearing and overwintering habitat for CO fry. |

Site 003: view across, breached bank of Tachek Creek

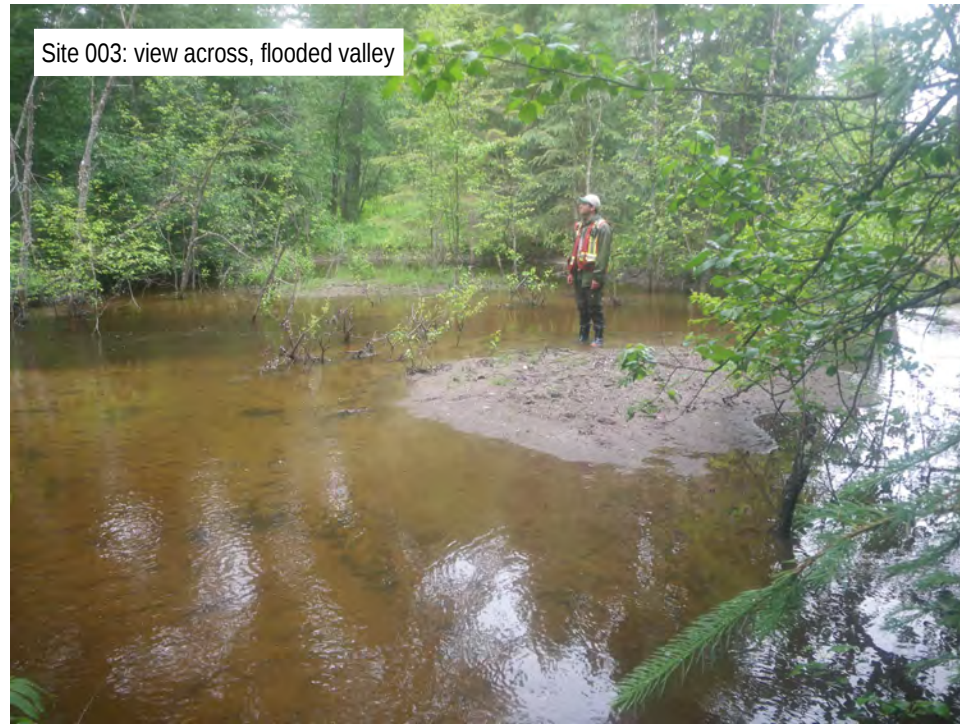
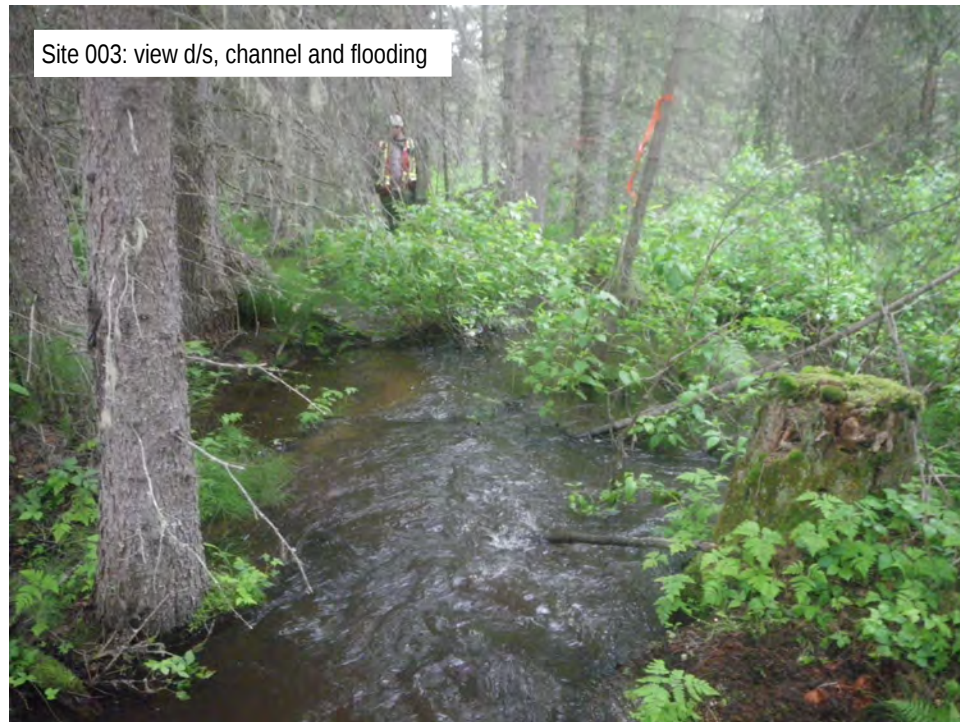
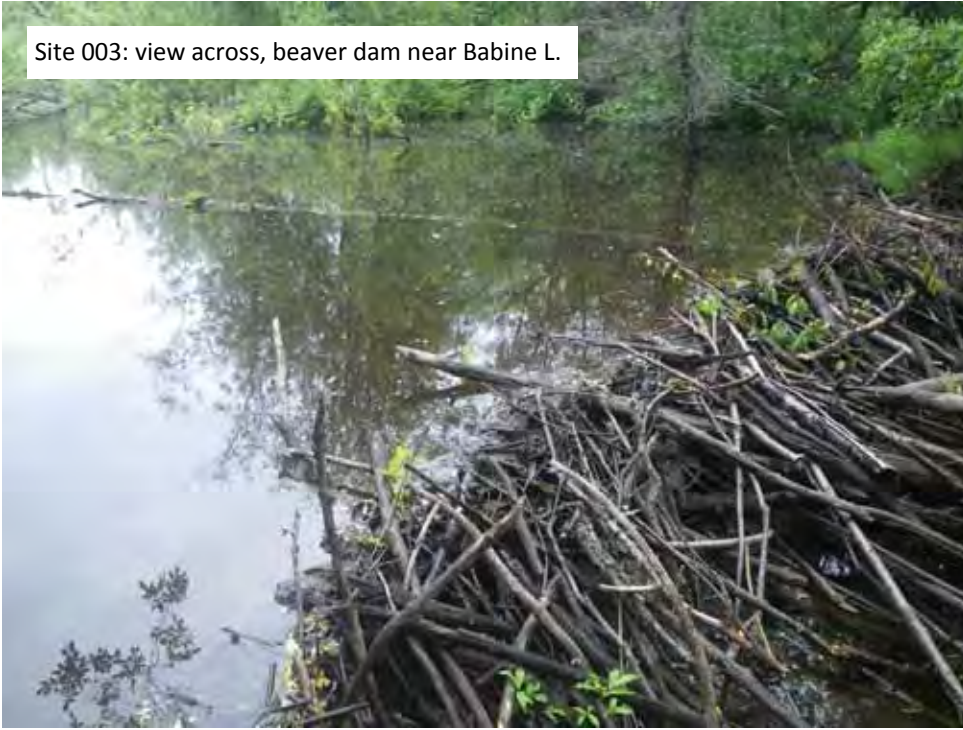
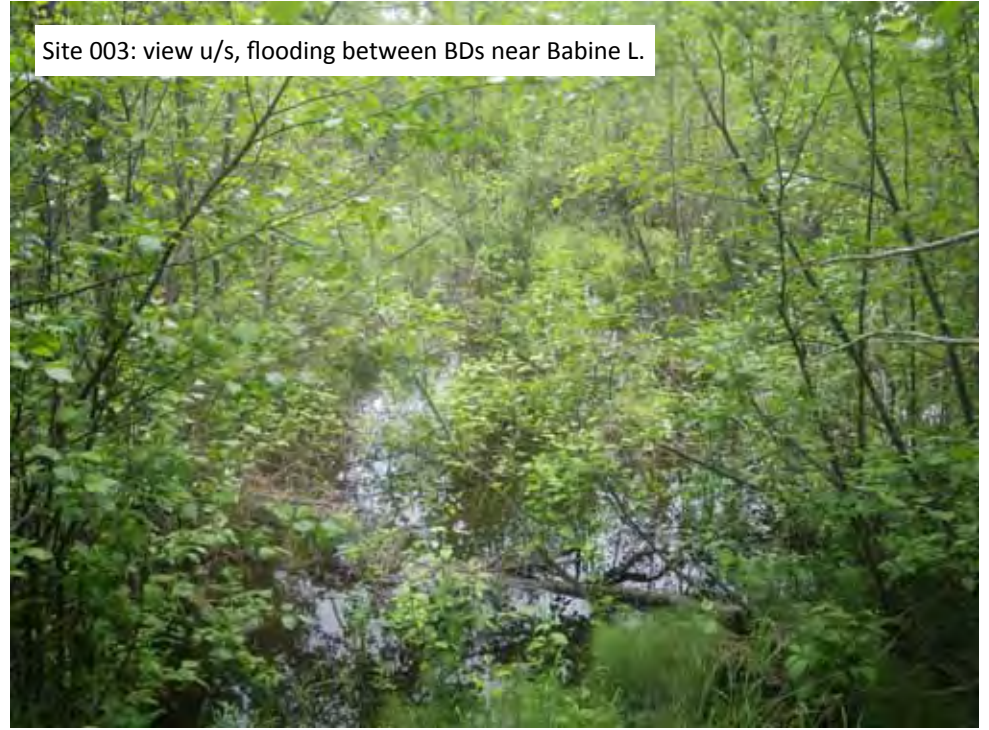
Site 003: view across, flooded valley

Site 003: view u/s, channel

Site 003: view d/s, channel and flooding

Site 003: view across, beaver dam near Babine L.

Site 003: view u/s, flooding between BDs near Babine L.

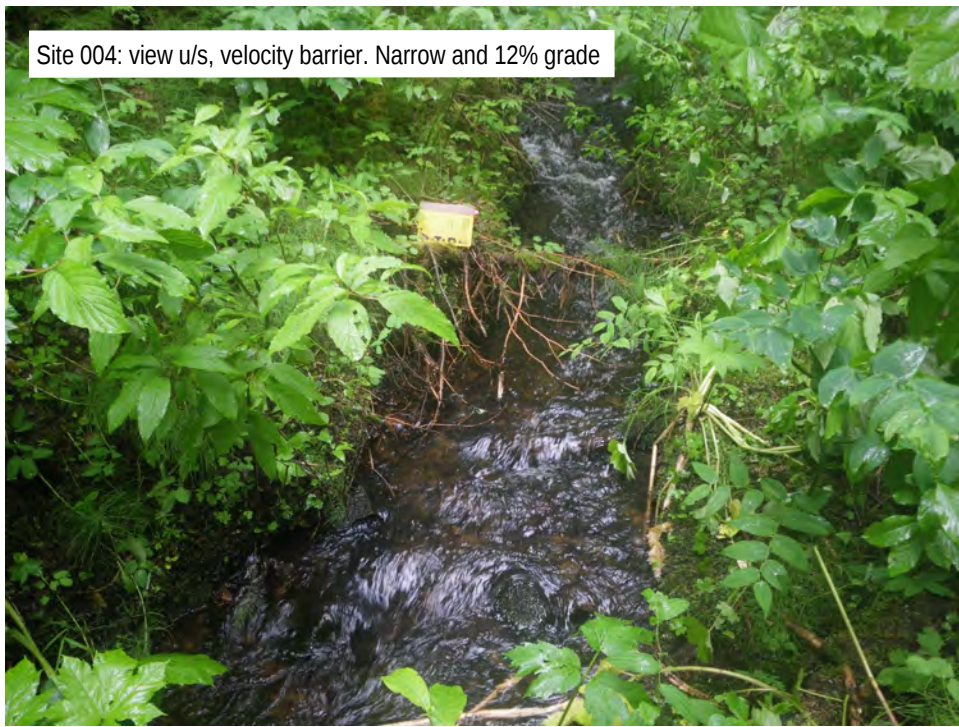
| AREA | Stream ID<br>(Name, TWC<br>or WSC) | Reach<br># | Site # | UTM<br>zone | UTM<br>Easting | UTM<br>Northing | Riparian<br>Class | Habitat Value<br>Rating | Channel<br>Slope (%) | Channel<br>Width (m) | Channel<br>Depth(m) | Sampling<br>Results | Site Length<br>(m) | Follow-up<br>Sampling | Comments |
|---|---|---|---|---|---|---|---|---|---|---|---|---|---|---|---|
| | | 6.1 | 4 | 9 | 683161 | 6070601 | S3 | MG | 2 | 1.87 | 0.33 | NFC (RB) | 700 | N | Stream with only usable rearing habitat d/s of velocity barrier (UTM 9.682926.6070433), but beaver dams in R4 and R5 temporarily obstruct the fish use. No spawning or overwintering habitat was observed. <b>The start of the barrier marks the upper RB distribution and transition between fish-bearing and non-fish bearing reach.</b> |

Site 004: view u/s, velocity barrier. Narrow and 12% grade

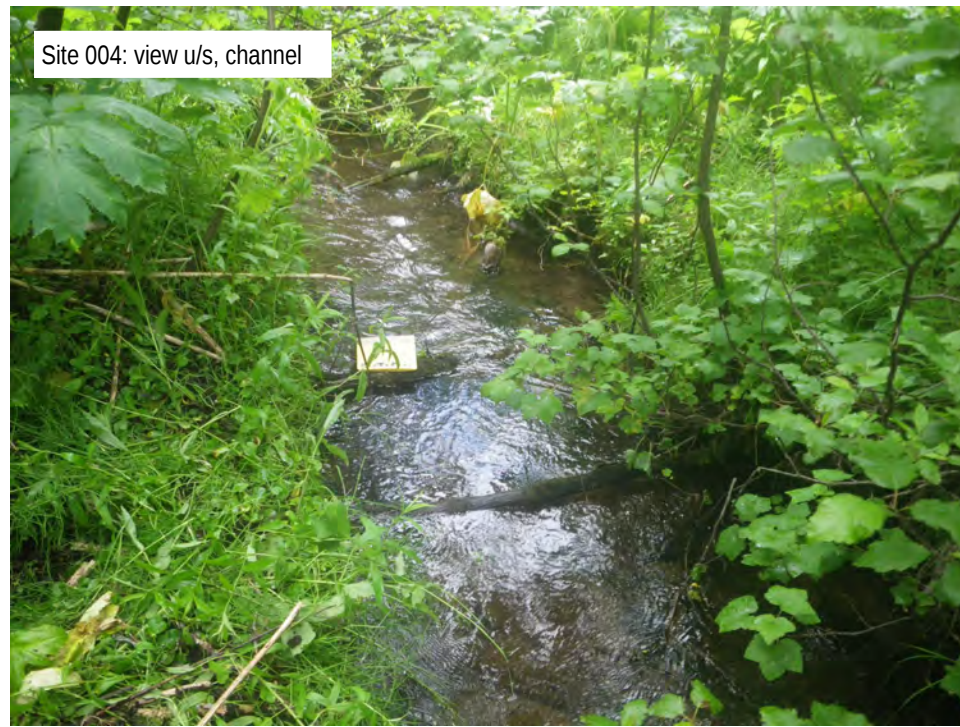
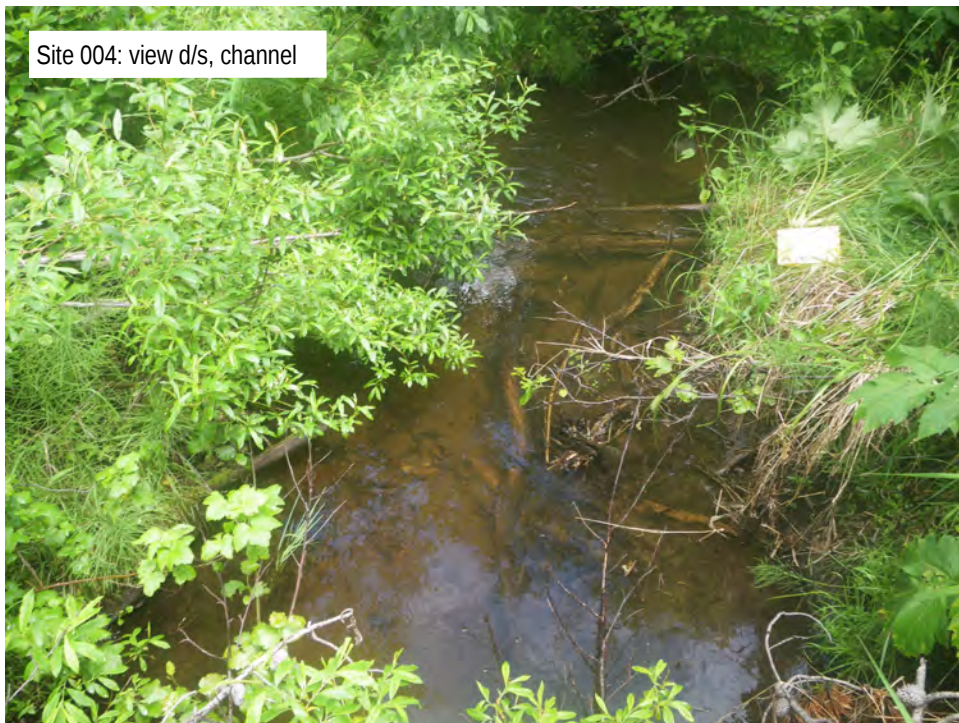
Site 004: view u/s, channel

Site 004: view d/s, channel

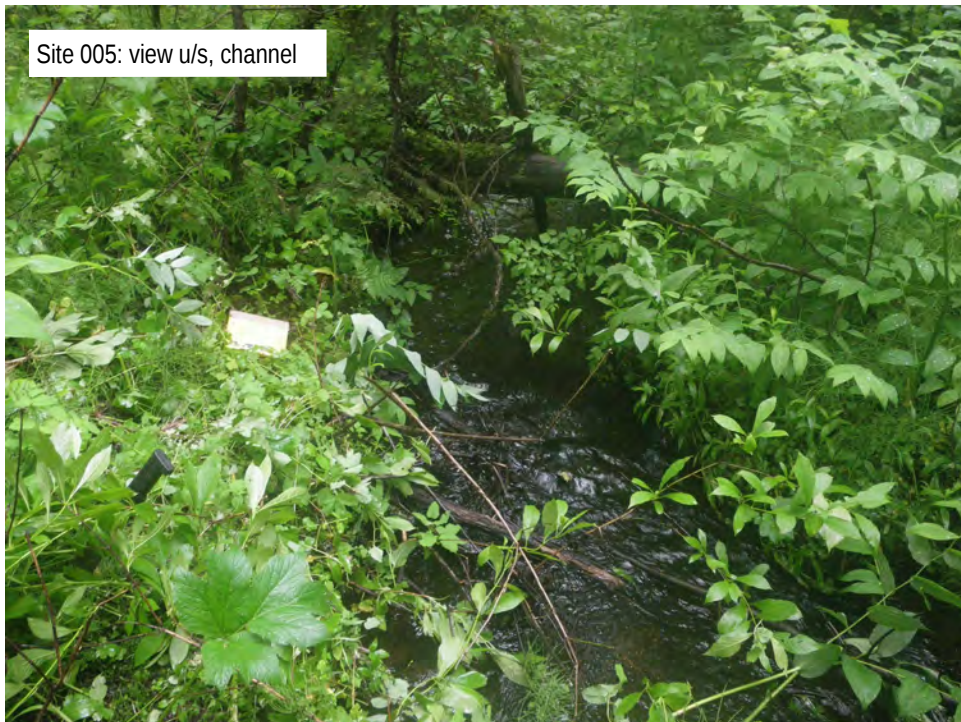
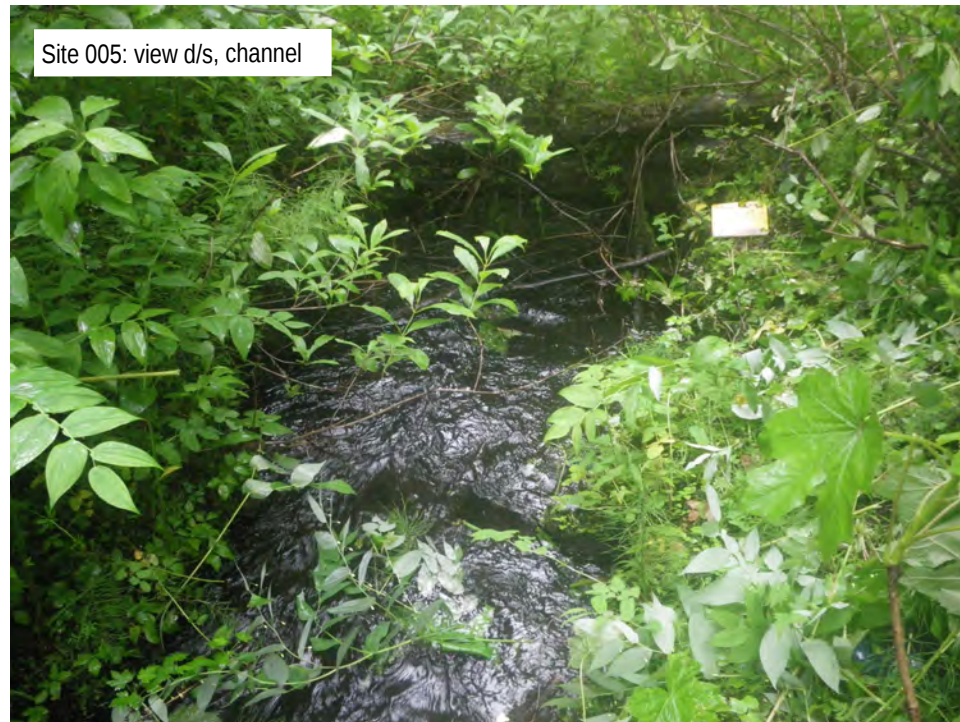
| AREA | Stream ID<br>(Name, TWC<br>or WSC) | Reach<br># | Site # | UTM<br>zone | UTM<br>Easting | UTM<br>Northing | Riparian<br>Class | Habitat Value<br>Rating | Channel<br>Slope (%) | Channel<br>Width (m) | Channel<br>Depth(m) | Sampling<br>Results | Site Length<br>(m) | Follow-up<br>Sampling | Comments |
|---|---|---|---|---|---|---|---|---|---|---|---|---|---|---|---|
| TAC007 | 480-718600 | 4 | 5 | 9 | 684091 | 6071294 | S3 | MG | 2 | 2.00 | 0.40 | RB | 1000 | N | Overall good rearing habitat for RB, but stream lacks deep pools. No spawning habitat present - mostly fines with a few surface gravel deposits. No suitable overwintering pools were observed other than beaver ponds, which may be too shallow. Stream with several BDs in the upper 300 m of reach impeding RB access. Some BDs breached with the flow away from the original channel. |

Site 005: RB

Site 005: view u/s, beaver dam

Site 005: view u/s, channel

Site 005: view d/s, channel

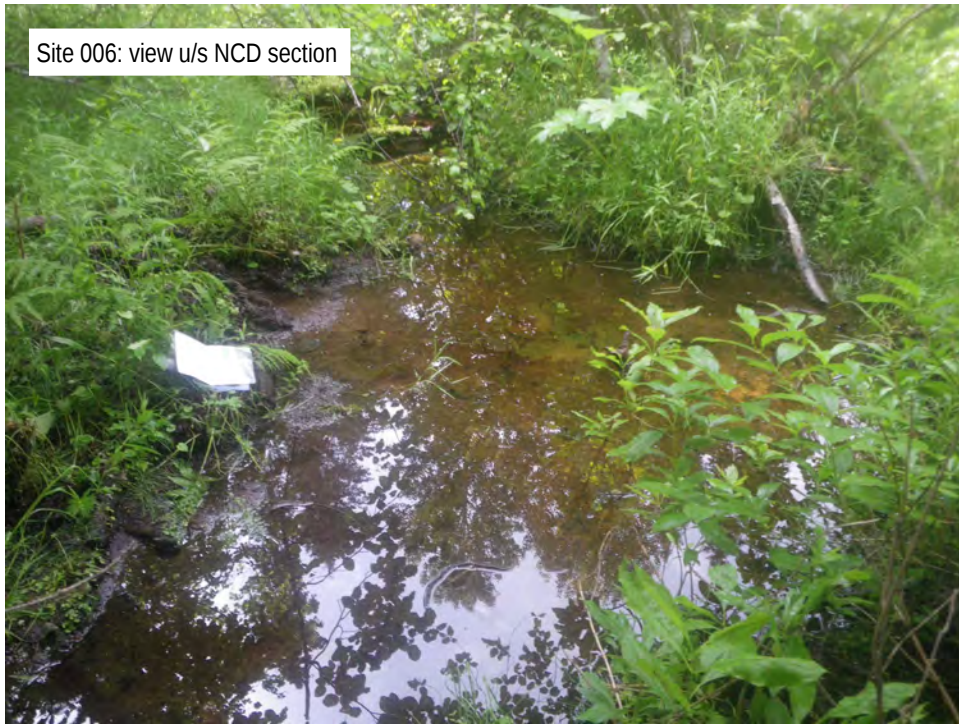
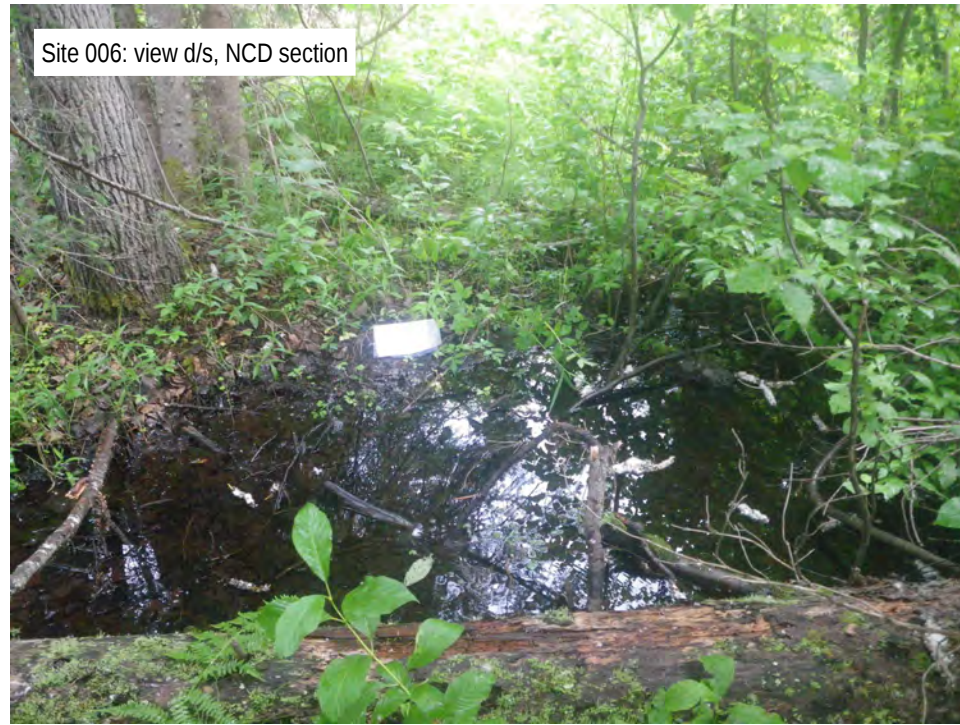
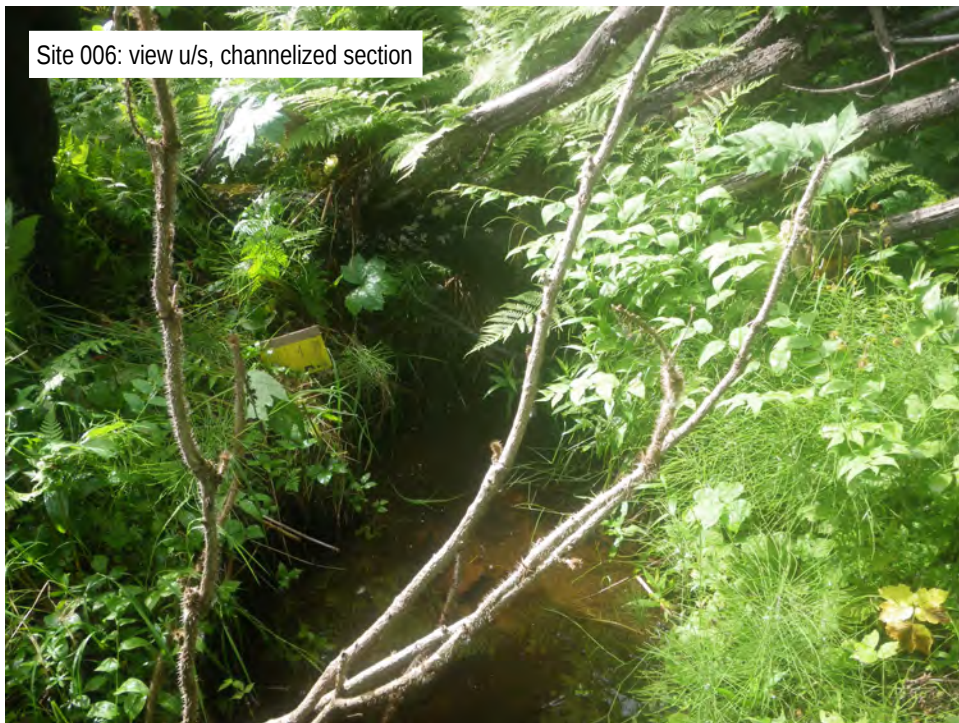
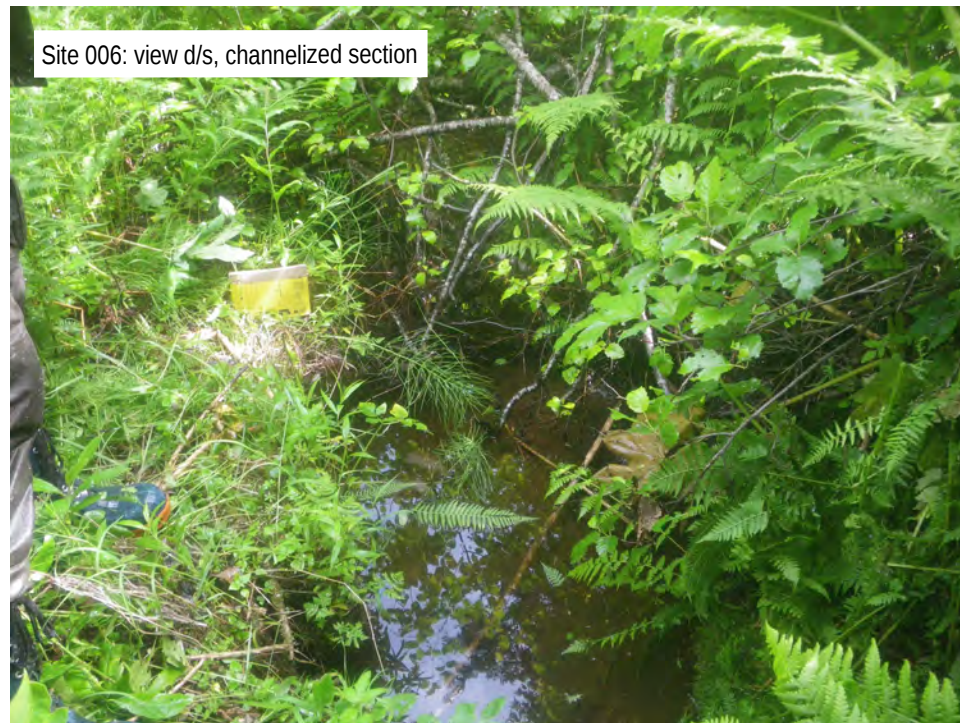
| Area | Stream ID<br>(Name, TWC<br>or WSC) | Reach # | Site # | Date | Riparian Class | Channel Slope (%) | Channel Width (m) | Channel Depth (m) | Flow Stage | Water Temperature<br>(°C) | Conductivity (µS/cm) | Turbidity | Sampling Method | Sampling Results | Effort (EF - sec/ dist.;<br>MT #/Hrs) | EF Specs (V/ Hz/ µs) | Comments |
|---|---|---|---|---|---|---|---|---|---|---|---|---|---|---|---|---|---|
| TAC008 | 480-718600-18048 | 2 | 6 | 8-Jul-20 | NCD | * | * | * | L | 10.6 | 182 | C | NS | * | * | * | <b>No fish habitat</b> - the stream becomes NCD at UTM 9.686094.6073533. No continuous scoured channel was observed upstream of this point. The watercourse is composed of mostly overland flows through approx. 10 m wide swampy swale with terrestrial and aquatic plants. The length of a continuously scoured channel was no greater than 30 m above the coordinates. |

Site 006: view u/s NCD section

Site 006: view d/s, NCD section

Site 006: view u/s, channelized section

Site 006: view d/s, channelized section

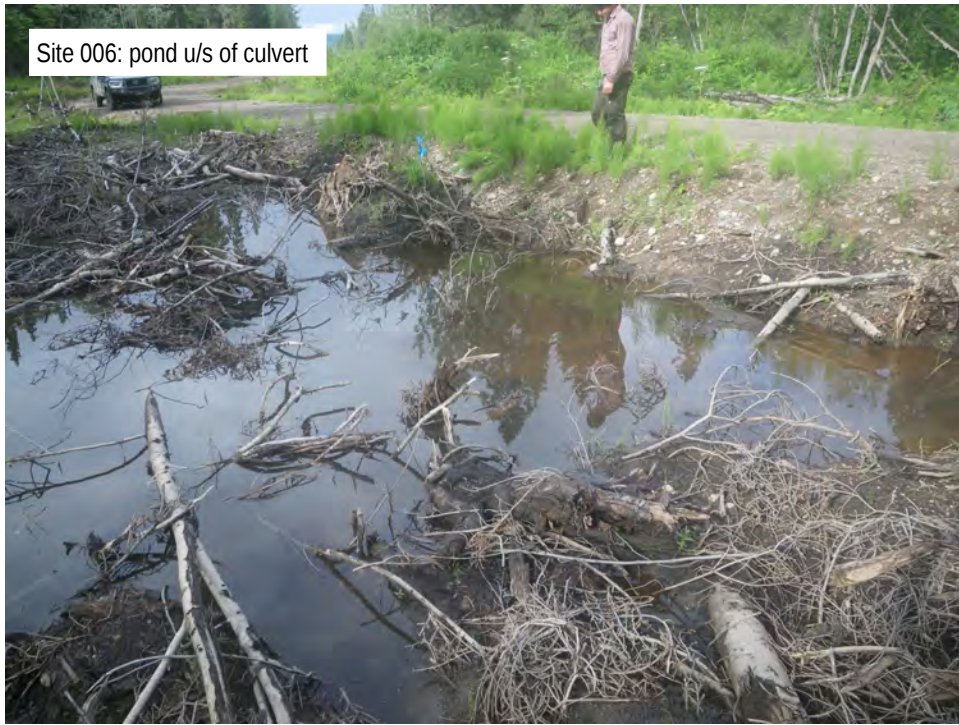
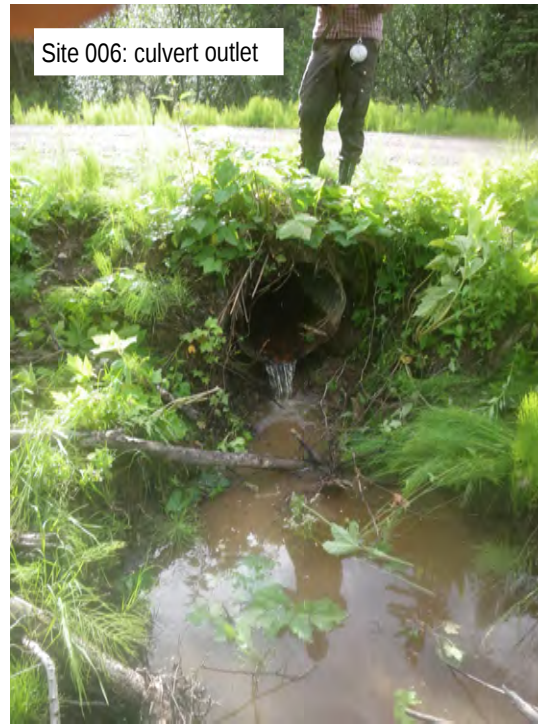
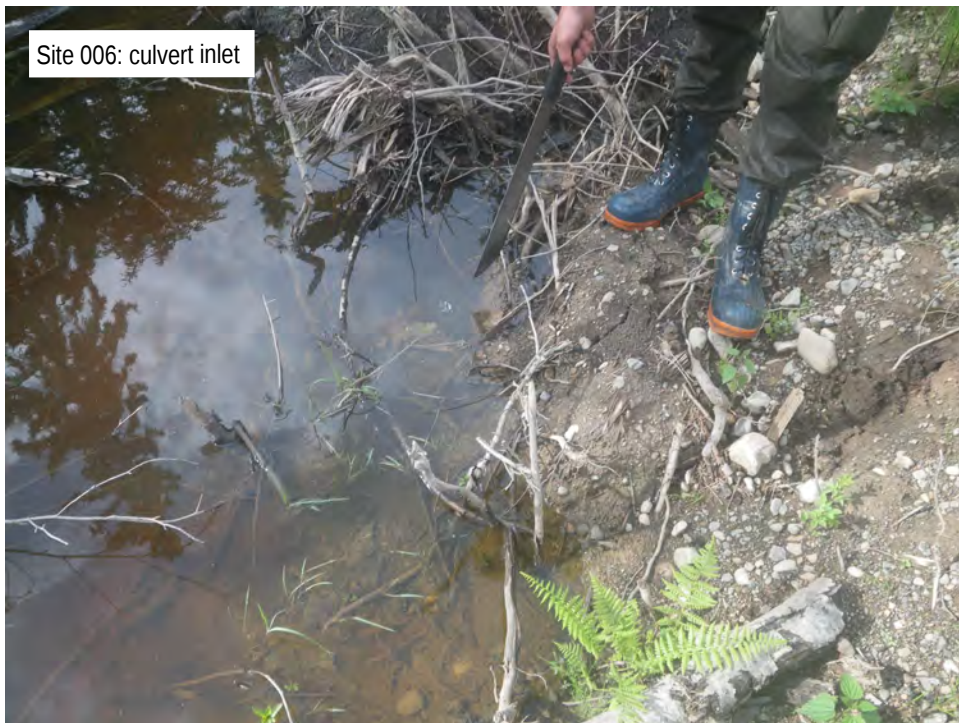
| AREA | Stream ID<br>(Name, TWC<br>or WSC) | Reach<br># | Site # | UTM<br>zone | UTM<br>Easting | UTM<br>Northing | Riparian<br>Class | Habitat Value<br>Rating | Channel<br>Slope (%) | Channel<br>Width (m) | Channel<br>Depth(m) | Sampling<br>Results | Site Length<br>(m) | Follow-up<br>Sampling | Comments |
|---|---|---|---|---|---|---|---|---|---|---|---|---|---|---|---|
| | | 2 | 6 | 9 | 686298 | 6073386 | S4 | MG | 3 | 1.05 | 0.27 | NS | | N | Stream with usable habitat for RB or CT; however, no spawning or overwintering habitat was observed. The culvert blocks access to the reach at the road crossing. The stream is potentially accessible from the parent stream but becomes NCD at UTM 9.686094.6073533. <b>The start of NCD marks the upper CT or RB distribution and transition between fish-bearing and non-fish bearing reach.</b> |

Site 006: pond u/s of culvert

Site 006: culvert outlet

Site 006: culvert inlet
