# **2020 Fish Habitat Assessments for Lake Babine Nations in the Granisle Area**

Prepared for:  
**Capacity Forest Management Ltd.**  
1761 Redwood St.  
Campbell River, BC, V9W 3K7

Prepared by:  
**Mac Jedrzejczyk, M.Sc., R.P.Bio.**  
**FINS Consulting Ltd.**  
4206 Eby St.  
Terrace, BC, V8G 2E5

**November 2020**

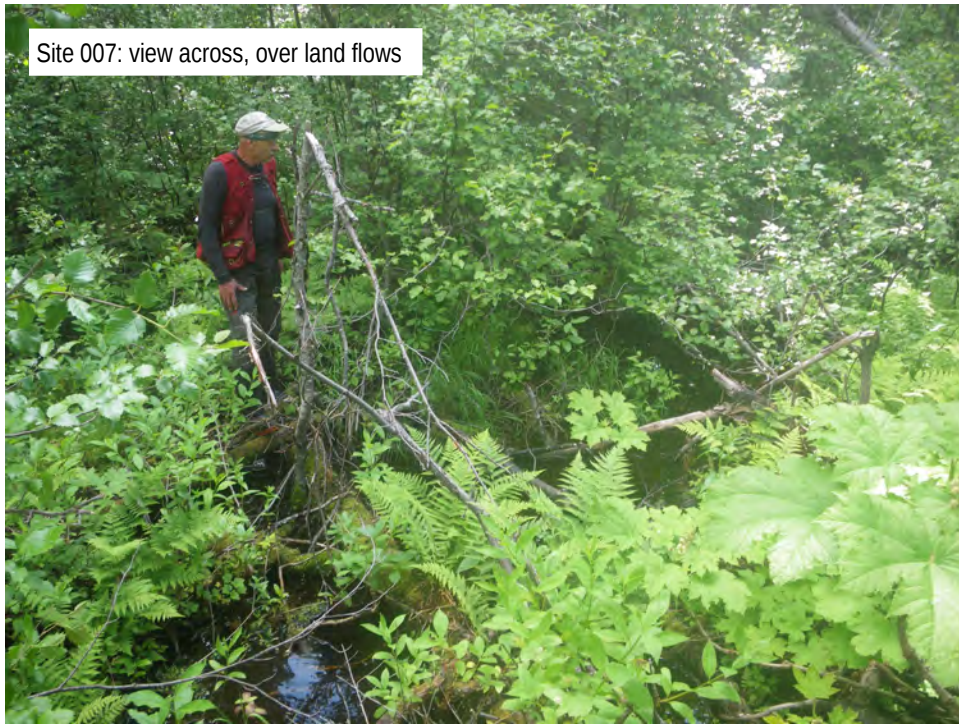
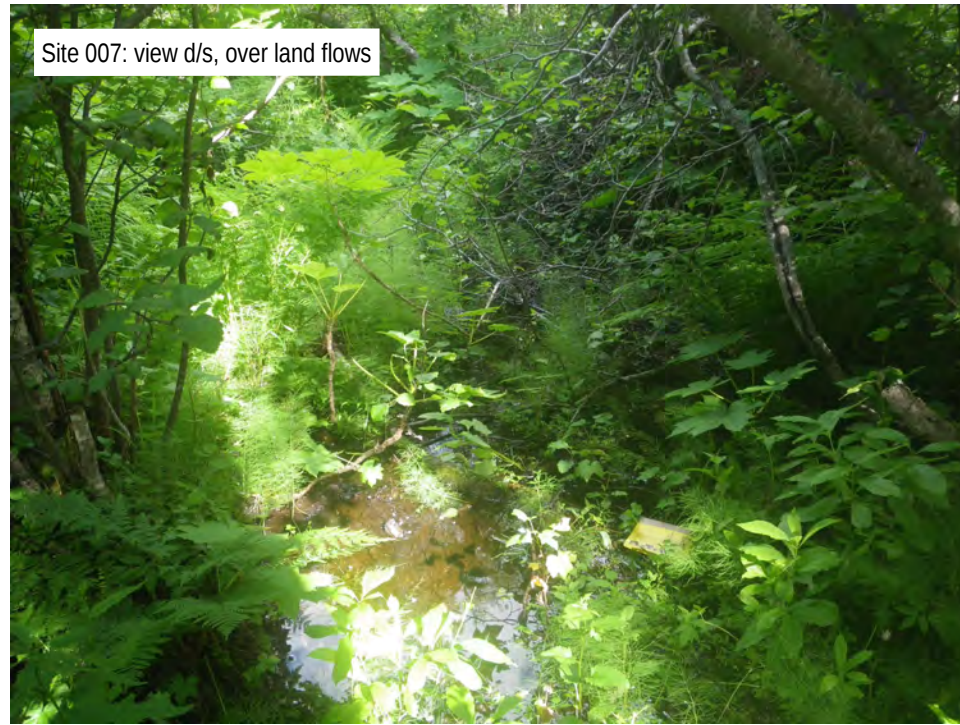
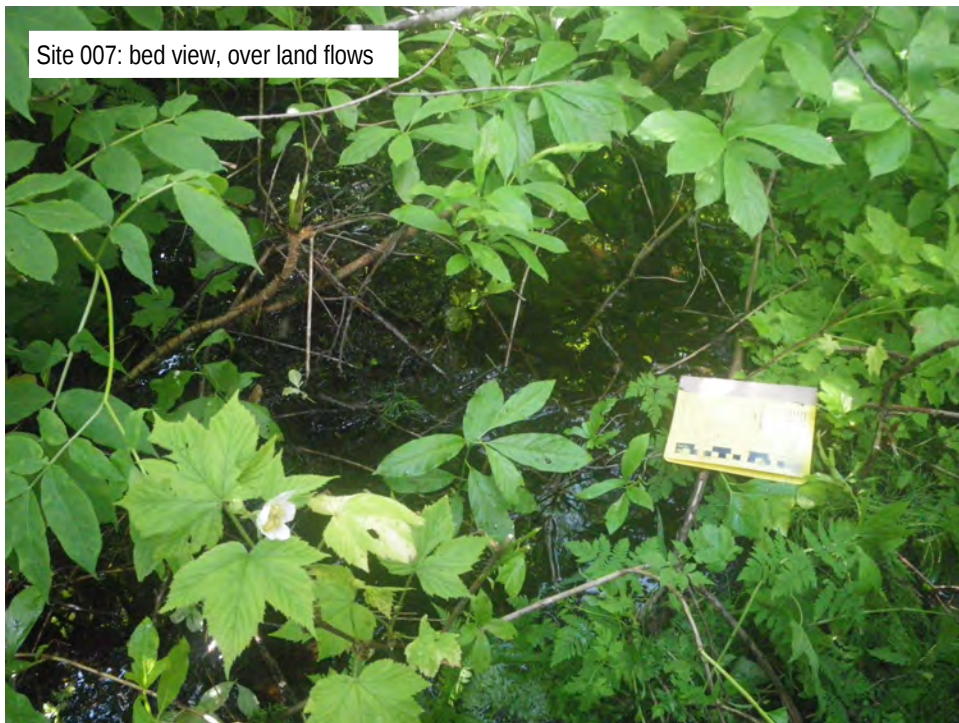
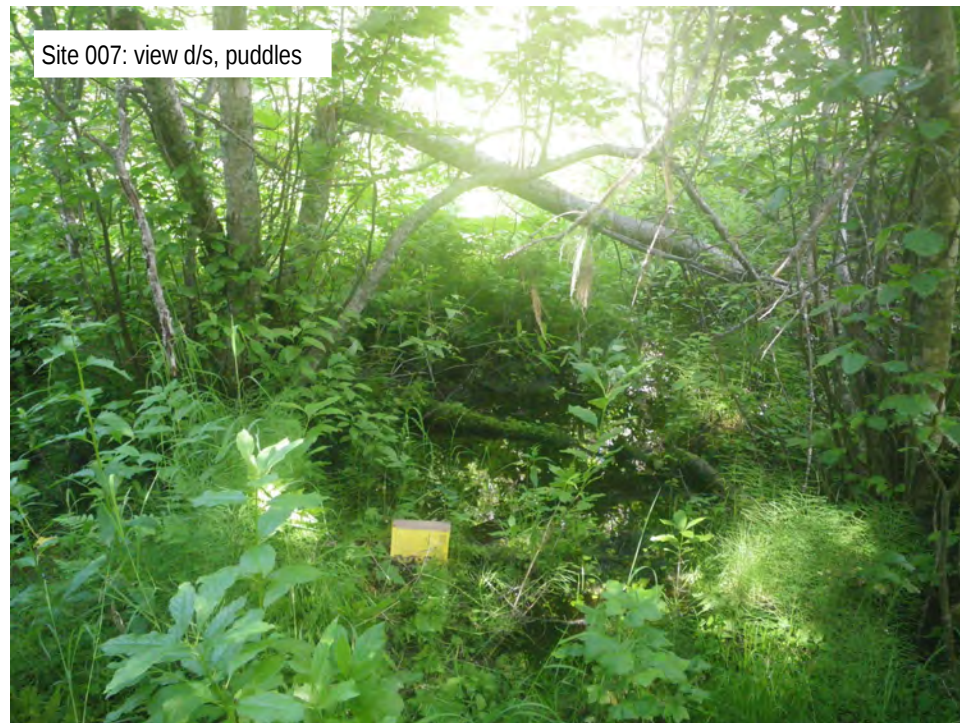
Site 007: view across, over land flows

Site 007: view d/s, over land flows

Site 007: bed view, over land flows

Site 007: view d/s, puddles

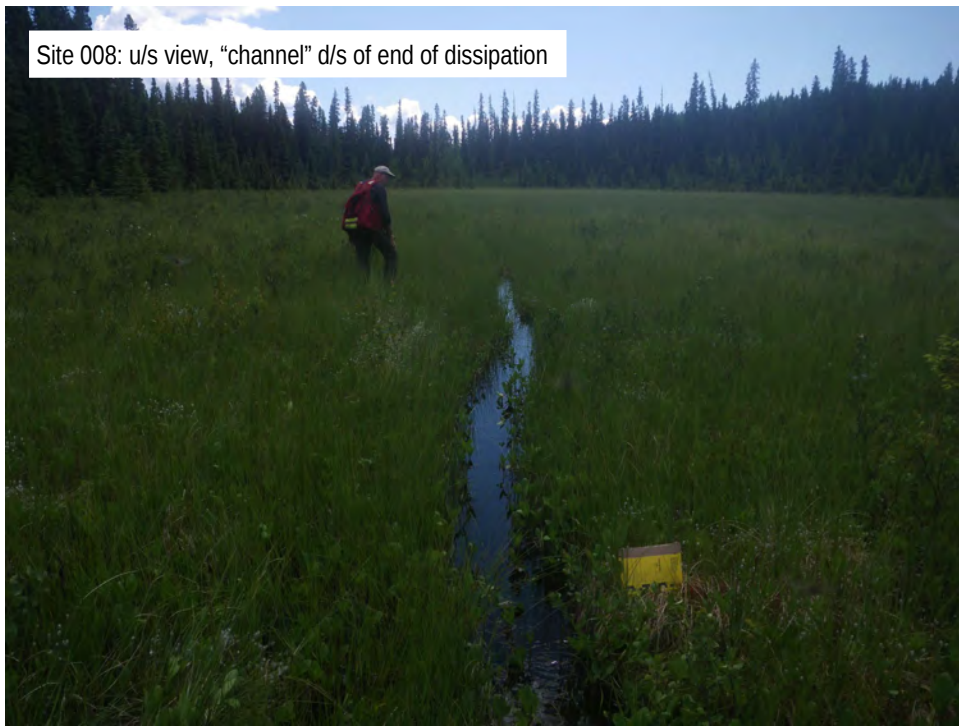
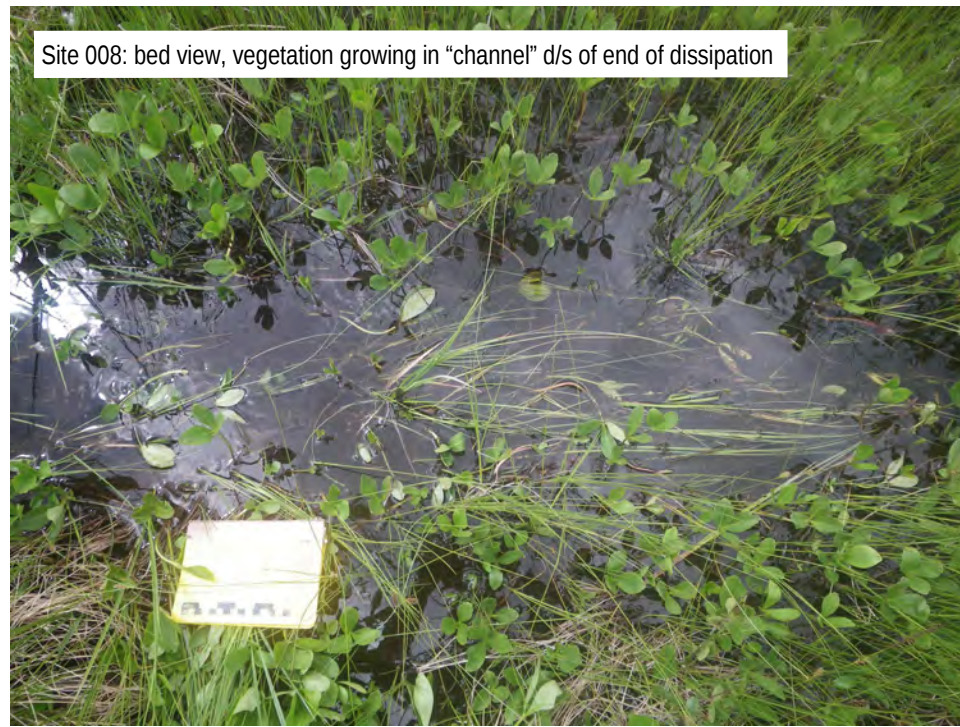
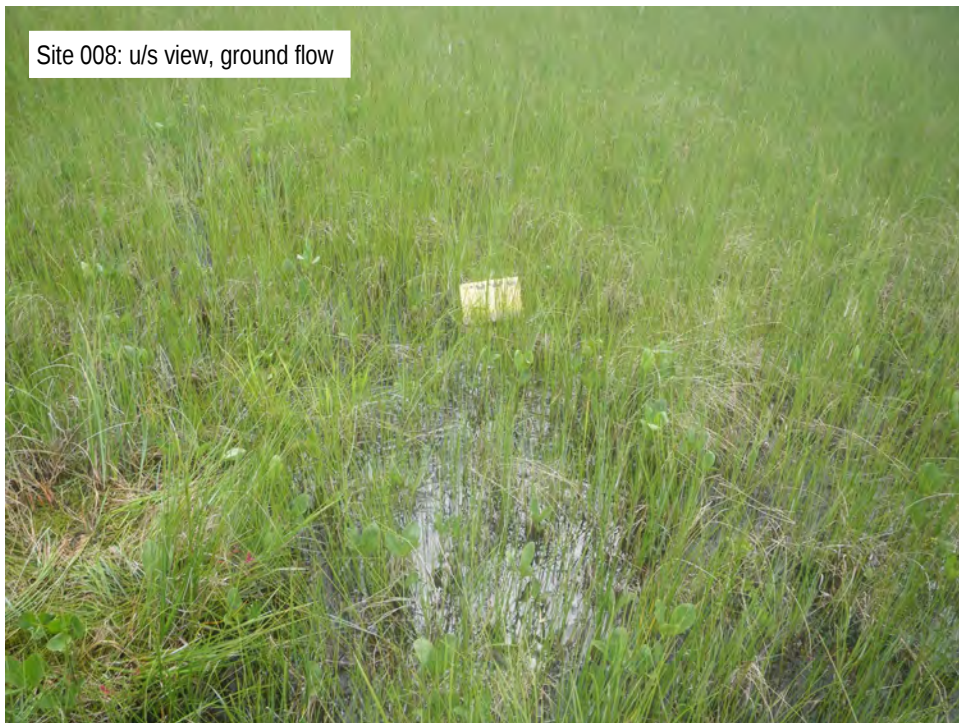
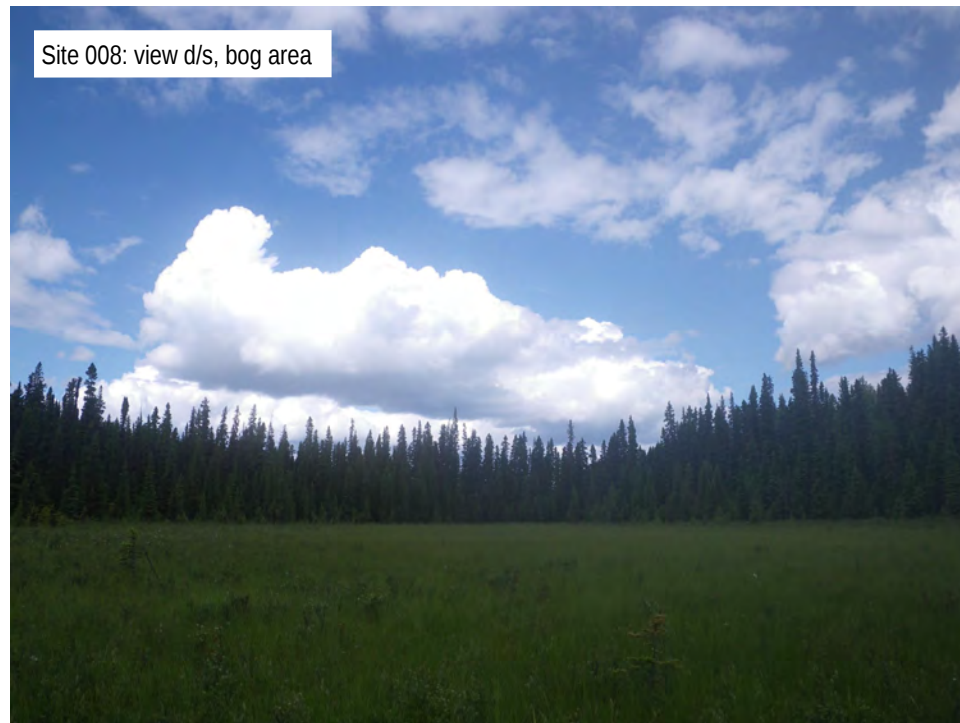
| Area | Stream ID<br>(Name, TWC<br>or WSC) | Reach # | Site # | Date | Riparian Class | Channel Slope (%) | Channel Width (m) | Channel Depth (m) | Flow Stage | Water Temperature<br>(°C) | Conductivity (µS/cm) | Turbidity | Sampling Method | Sampling Results | Effort (EF - sec/ dist.;<br>MT #/Hrs) | EF Specs (V/ Hz/ µs) | Comments |
|---|---|---|---|---|---|---|---|---|---|---|---|---|---|---|---|---|---|
| FUL003 | 480-697200-02900 | 8 | 8 | 9-Jul-20 | NCD | * | * | * | * | * | * | * | NS | * | * | * | <b>No fish habitat</b> - no channel through bog was observed u/s from the point UTM 9.680668.6074641, and there is no access to fish from the lake downstream. The watershed upstream of the site is too small and has no lakes to provide perennial fish habitat for any isolated population. |

Site 008: u/s view, "channel" d/s of end of dissipation

Site 008: bed view, vegetation growing in "channel" d/s of end of dissipation

Site 008: u/s view, ground flow

Site 008: view d/s, bog area

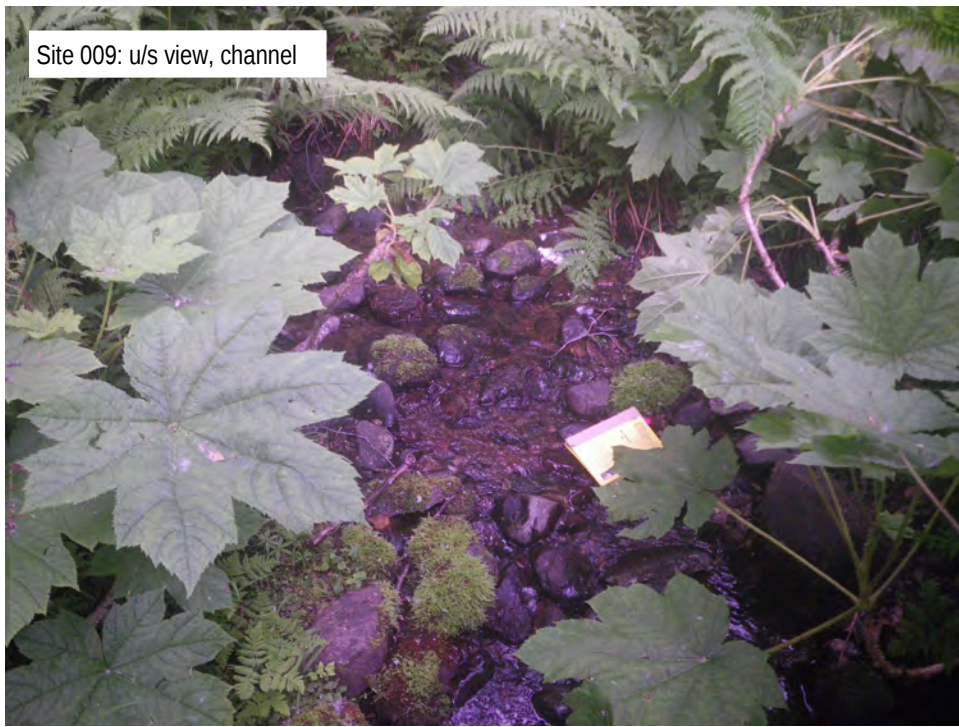
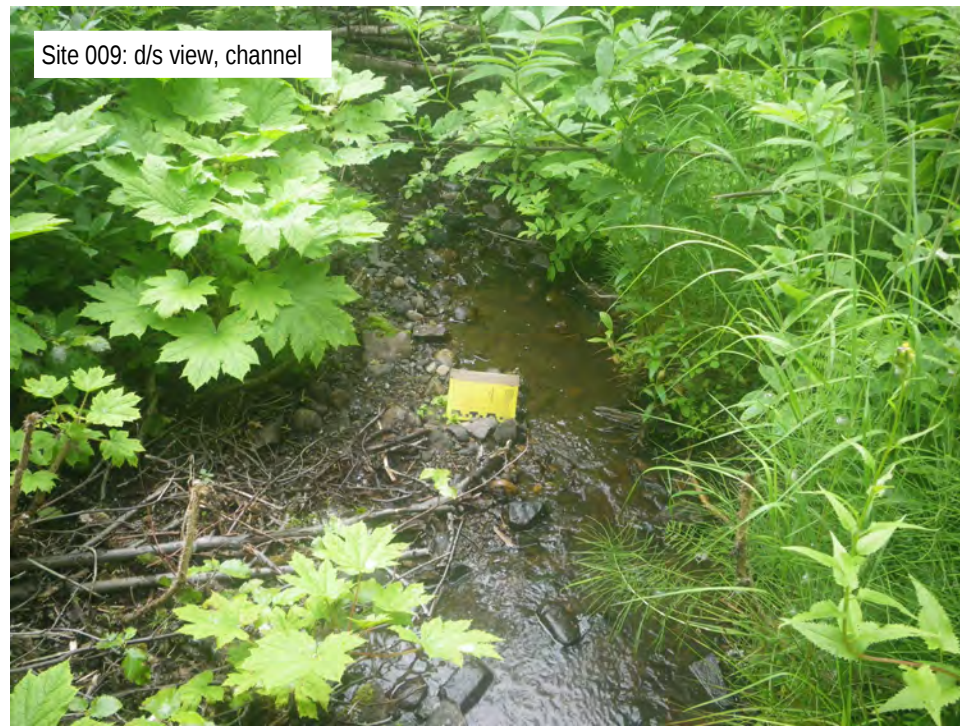
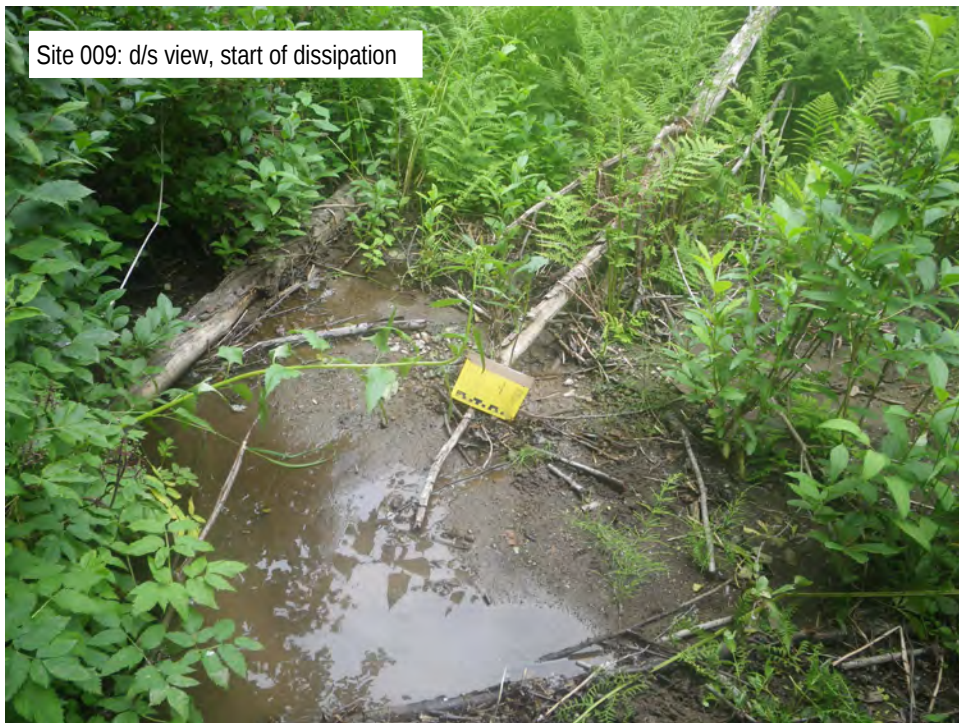
| Area | Stream ID<br>(Name, TWC<br>or WSC) | Reach # | Site # | Date | Riparian Class | Channel Slope (%) | Channel Width (m) | Channel Depth (m) | Flow Stage | Water Temperature<br>(°C) | Conductivity (µS/cm) | Turbidity | Sampling Method | Sampling Results | Effort (EF - sec/ dist.;<br>MT #/Hrs) | EF Specs (V/ Hz/ µs) | Comments |
|---|---|---|---|---|---|---|---|---|---|---|---|---|---|---|---|---|---|
| OLF003 | 480-612957 | 1 | 9 | 7-Jul-20 | S6 | 13 | 1.38 | 0.12 | L | 9.9 | 126 | C | NS | * | * | * | <b>No fish habitat</b> - shallow stream with no perennial habitat to support any isolated fish population. It is inaccessible to fish from Babine Lake due to dissipation into the ground at UTM 9.672299.6097541 (40 m away from the lake). No fish was captured by Triton in 2000 in Reach 2 upstream. |

Site 009: u/s view, channel

Site 009: d/s view, channel

Site 009: d/s view, start of dissipation

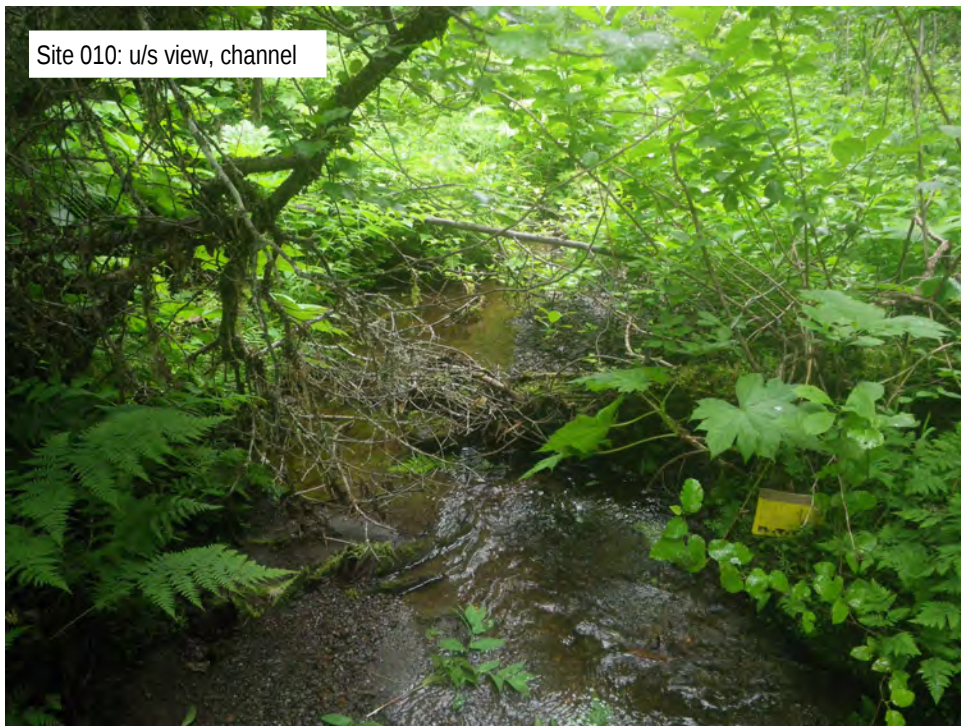
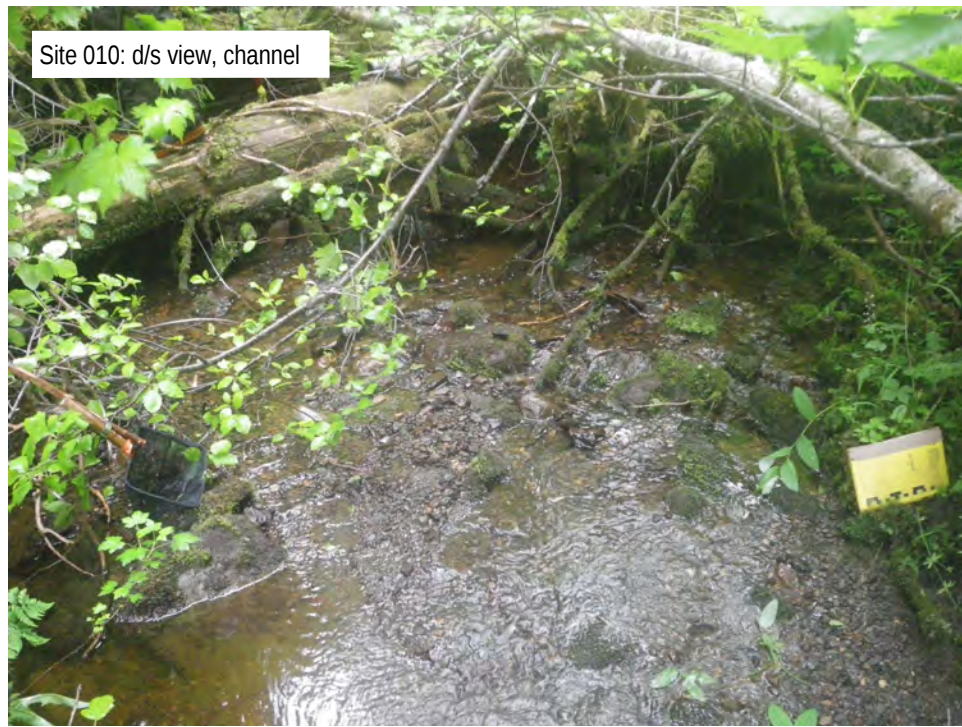
| AREA | Stream ID<br>(Name, TWC<br>or WSC) | Reach<br># | Site # | UTM<br>zone | UTM<br>Easting | UTM<br>Northing | Riparian<br>Class | Habitat Value<br>Rating | Channel<br>Slope (%) | Channel<br>Width (m) | Channel<br>Depth(m) | Sampling<br>Results | Site Length<br>(m) | Follow-up<br>Sampling | Comments |
|---|---|---|---|---|---|---|---|---|---|---|---|---|---|---|---|
| OLF005 | 480-575000-<br>22400 | 1 | 10 | 9 | 665666 | 6099961 | S3 | MG | 6 | 3.50 | 0.50 | RB | 350 | N | A seasonal stream with use limited to approximately two months of the year as indicated by algae coatings on the stream bed substrate. Numerous sediment wedges impede access to fish. No spawning habitat was observed; the stream is too steep and has a too short watered period for fry to develop. The stream is too shallow for overwintering. Fish presence is sparse and only was captured near the mouth. The stream is relatively volatile during high flows as indicated by parallel large woody debris, mid-channel bars, and sediment wedges. |

Site 010: u/s view, channel

Site 010: d/s view, channel
