WATERSHED REVIEW

OBJECTIVE CREEK WATERSHED

BIOPHYSICAL CHARACTERISTICS OF WATERSHED

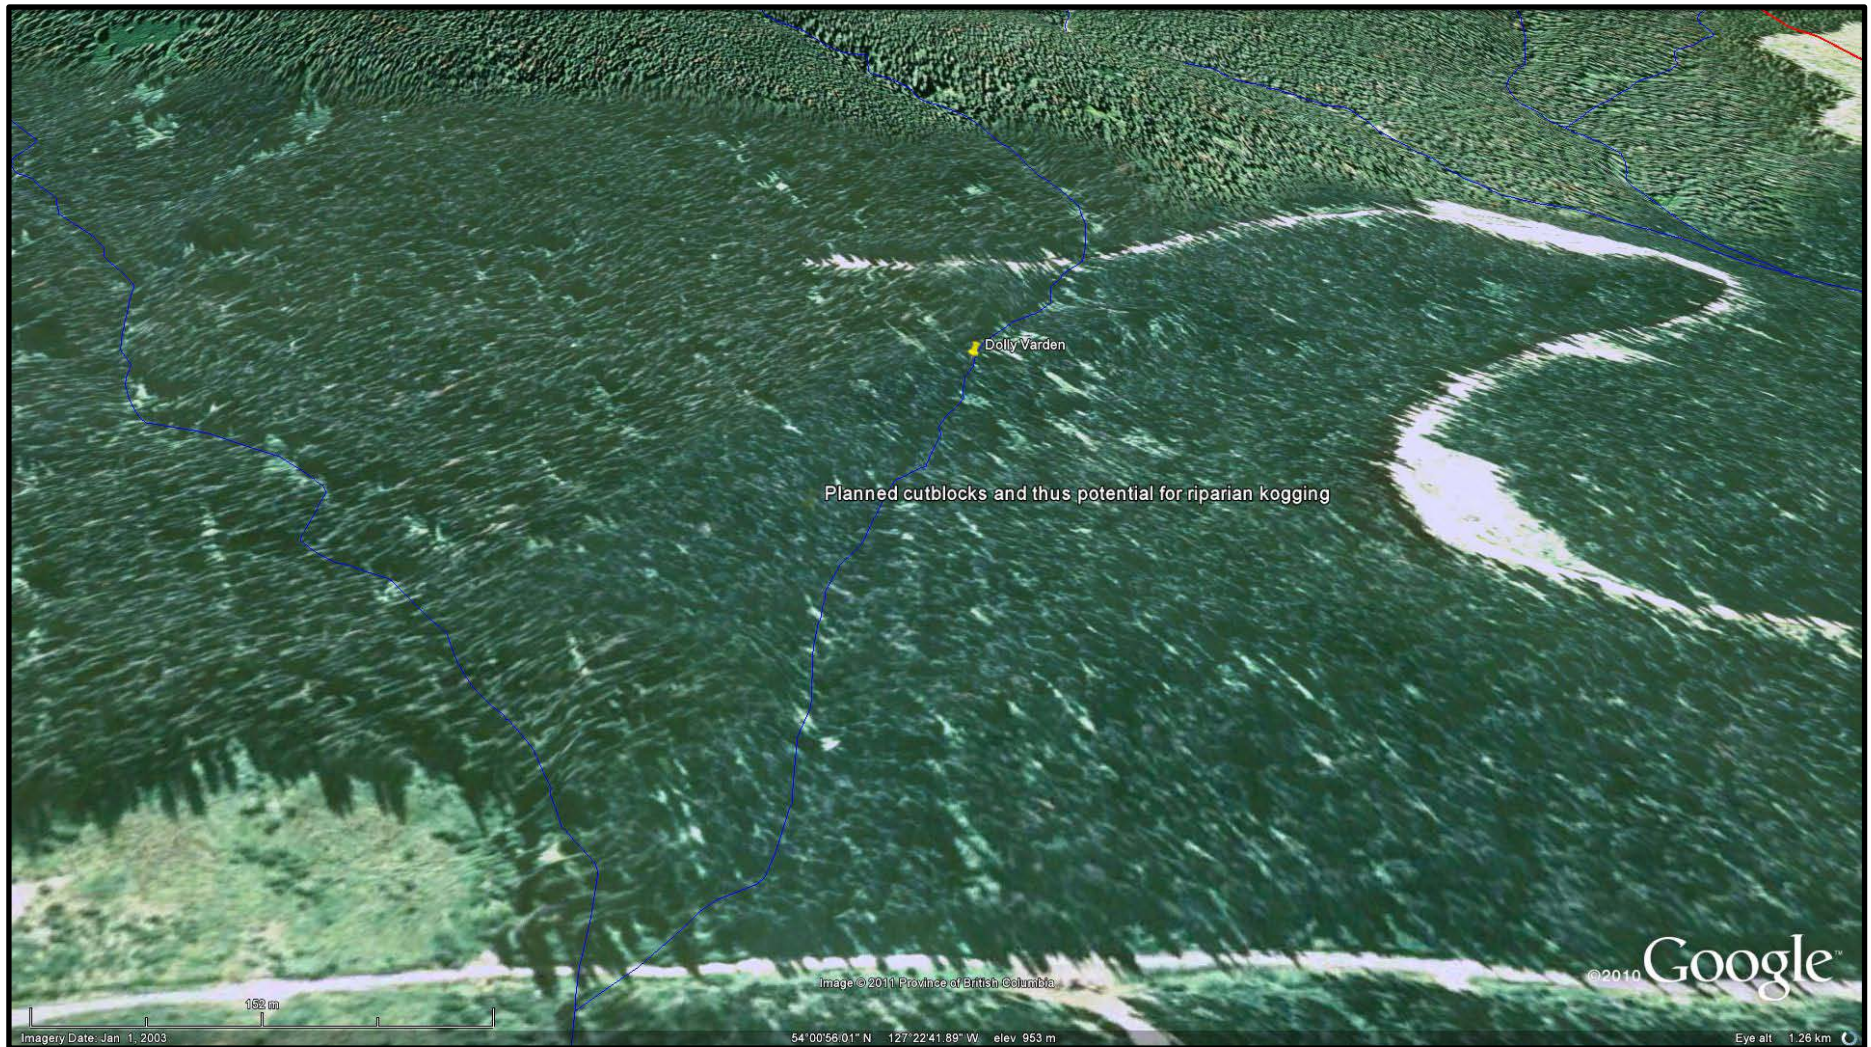
Figure 12. General location of planned cutblocks and with it comes the potential for further riparian logging along these small streams.

The FSW objectives for Objective Creek should focus on providing effective riparian protection to the small streams flowing down the north side of Tableland Mountain to maintain channel integrity and riparian function (Figure 12). This objective could be achieved by implementing the following practice along all S4 and S6 streams flowing down the north side of Tableland Mountain:

- 1) Maintain long term recruitment of large woody debris (LWD), shade and bank stability to the stream channel by retaining at least 90% of the riparian area in a state undisturbed by primary forest activities.

Riparian Area – For the purposes of riparian protection objective below, riparian area refers to the management area measured from the closest streambank to a distance 15m upslope from the streambank on:

- iii. S4 streams that are 0.5 m or greater in stream channel width, or
- iv. S6 streams that are 0.5 m or greater in stream channel width that flow directly into a fish stream.
