**Sediment Source Mapping, Detailed Channel Assessment, and
Reconnaissance Sediment Budget for Williams Creek
for the Period 1949 to 2001**

Weiland Terrain Sciences
Irene Weiland, P.Geol.
7-3731 1st Avenue
Smithers, B.C. V0J 2N0

Fluvial Systems Research Inc.
Steve Bird, P.Geol.
No. 179, 106-1656 Martin Drive
White Rock, B.C. V4A 6E7

March 2007

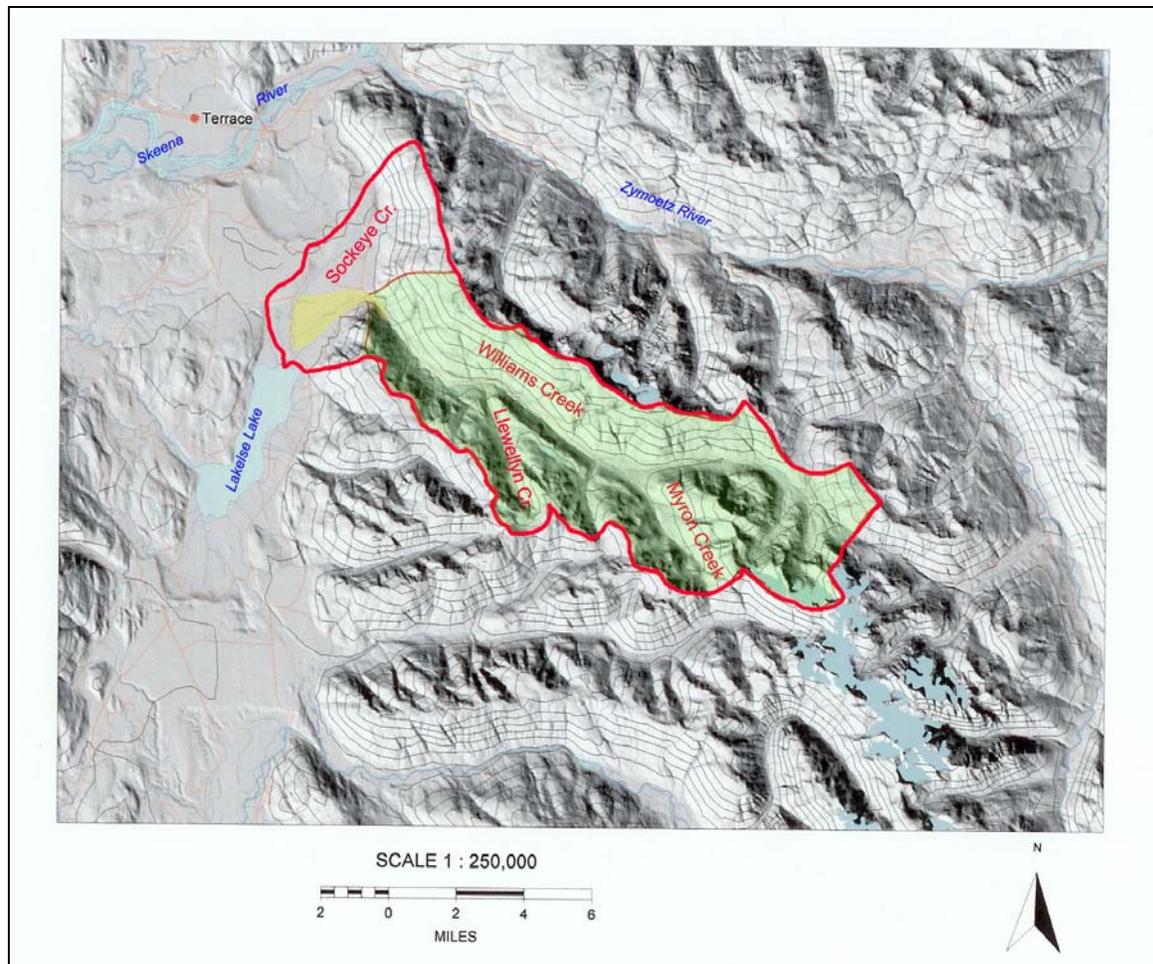
Figure 2-1. Study area overview map. Green shading: area covered by sediment source mapping. Yellow shading: area covered by detailed channel assessment.

The study area comprises the Williams Creek valley and the alluvial stream reaches (Figure 2-1) on the fluvial fan at the mouth of Williams Creek valley. The mountainous valley of Williams Creek covers an area of 17,002 ha. Including the area covered by the large alluvial fan and the drainage basins of the two tributaries, Sockeye Creek and Blackwater Creek, the total watershed area of Williams Creek is 21,007 ha.

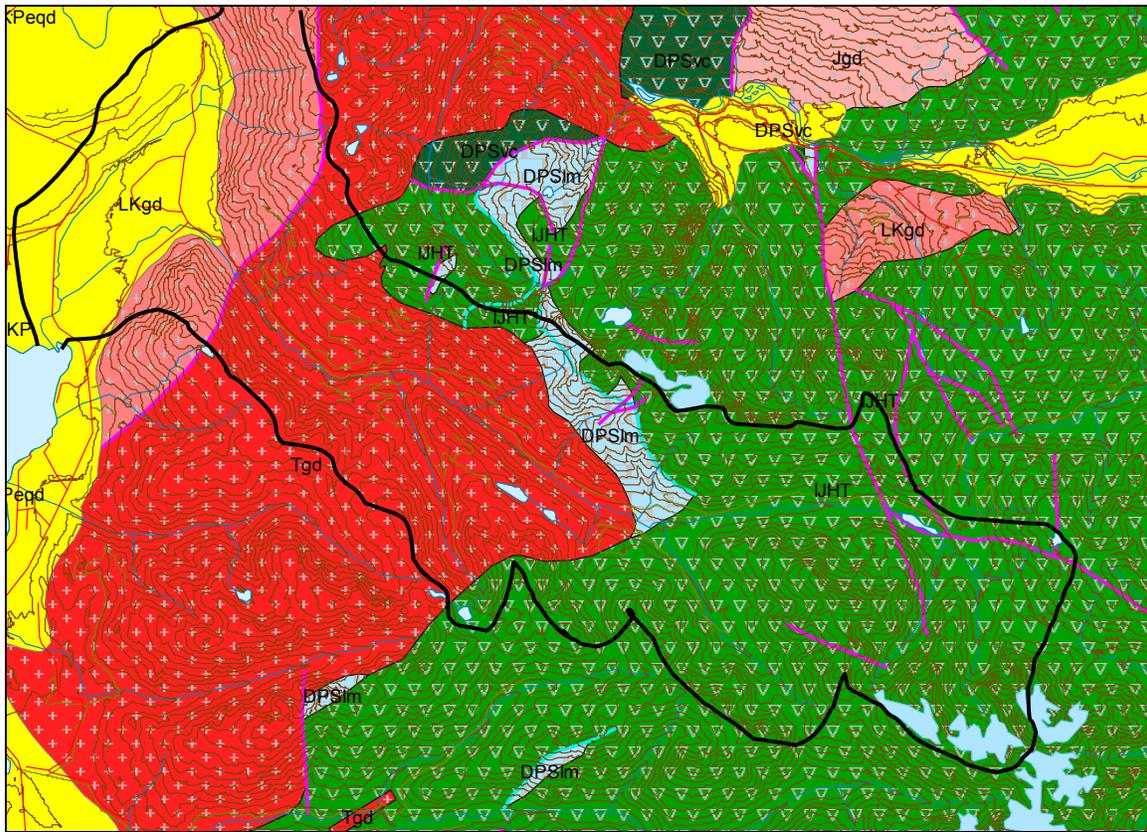
Figure 2-2. Bedrock Geology in Williams Creek. DPSlm: Stikine Assemblage of Devonian to Permian age; limestone, marble, calcareous sedimentary rocks. IJHT: lower Jurassic Hazelton Group -Telkwa Formation; calc-alkaline volcanic rocks. LKgd: late Cretaceous unnamed granodioritic intrusive rocks. Tgd: Tertiary unnamed granodioritic intrusive rocks. Yellow: Quaternary sediments. Williams Creek watershed outline shown in black.

Bedrock (Figure 2-2) in the western (lower) part of the Williams Creek valley consists of granodiorite of late Cretaceous and Tertiary age (Ministry of Energy, Mines and Petroleum Resources 2005). These light-coloured, medium to coarse-grained rocks intruded into older volcanic rocks, the Telkwa Formation of the Jurassic Hazelton Group, which underlies the eastern (upper) part of the valley. Rocks of the Telkwa Formation are typically red, maroon, and grey-green, fine-grained to aphanitic volcanic breccias, tuffs, and flows, of basaltic to rhyolitic composition (Tipper 1976). A narrow band of older rocks, limestone, marble, and calcareous sedimentary rocks is exposed on the alpine ridge along the north side of the valley, between the granodiorite and the volcanic rocks of the Telkwa formation. These sedimentary rocks are of Devonian to Permian age and are overthrust onto the volcanic rocks of the Telkwa formation (Ministry of Energy, Mines and Petroleum Resources, 2005).

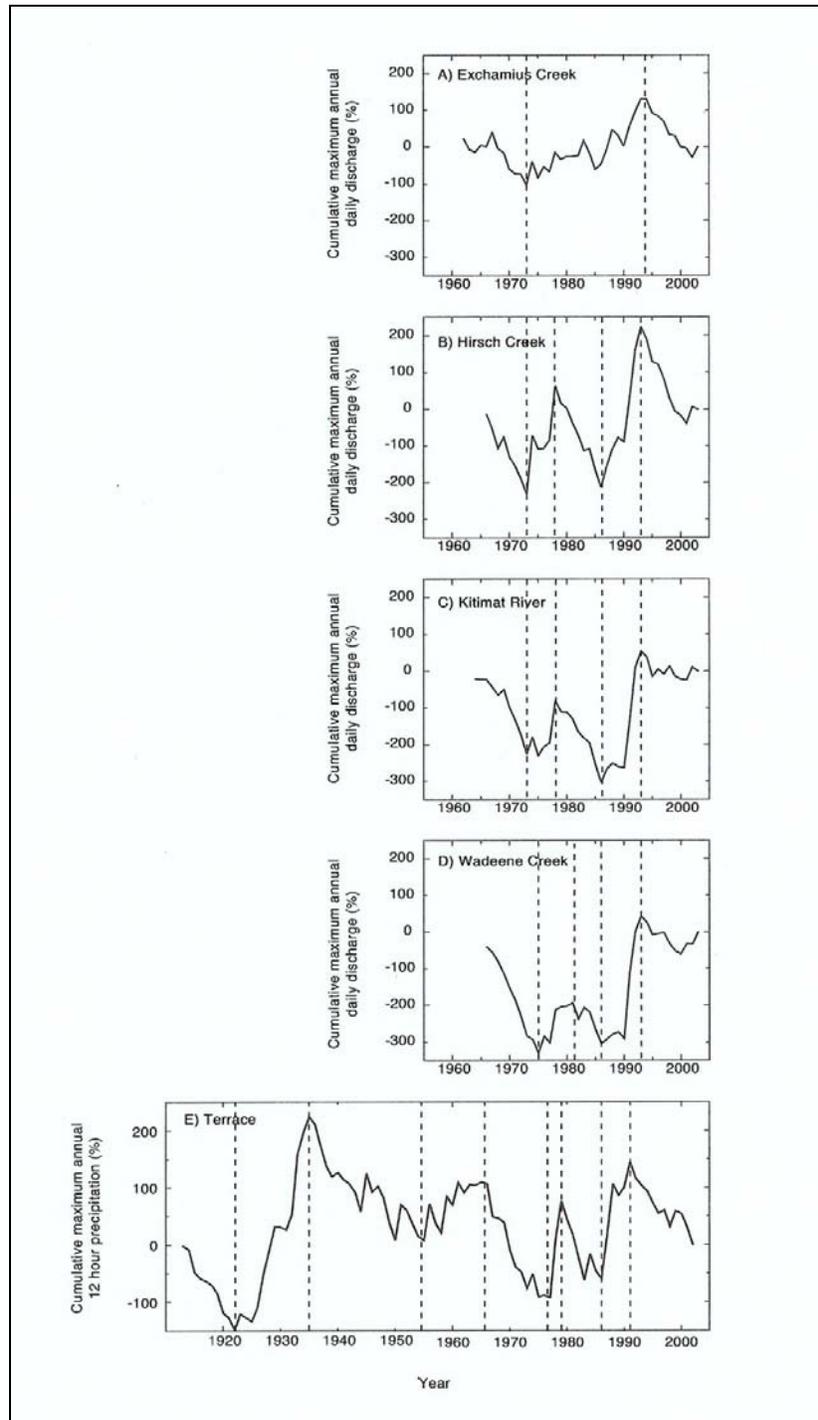
Figure 2-3. Cumulative departure plots of maximum annual daily discharge for Exchamsiks Creek, Hirsch Creek, Kitimat River, Wedeene Creek, and cumulative departure plot for maximum annual 12 hour precipitation for Terrace. The dashed lines delimit periods of broad regional (and generally uniform) climate conditions. Periods with a positive trend indicate flood flows and/or intense precipitation events were generally above average in magnitude, while periods with a negative trend indicate flood flows and/or intense precipitation events were generally below average in magnitude.

Cumulative departure plots of the annual maximum daily discharge of the four nearby gauging stations used above and maximum annual 12-hour precipitation for Terrace are in Figure 2-3. Assuming that changes in the record reflect broad, regional changes in climate and not local changes in land use or streamflow generation, it is assumed here that Williams Creek followed a similar pattern to the other stations over the entire period of record (1913 to 2003). Inflection points between broad and sustained changes in the record are assumed to indicate points where river behaviour may have changed as well. The analysis shows nine distinct hydrologic periods for the Williams Creek region since 1913. Of relevance to this study, the magnitude of discharge events was generally below average from 1935 to 1955, and remaining above average until 1966. The record fluctuated from 1967 to 1993 with four relatively short phases (below average discharges from 1967 to 1973; above average from 1974 to 1978; below average from 1979 to 1986; above average from 1987 to 1993). Currently, Williams Creek region has been in a period of below average discharge since 1994.

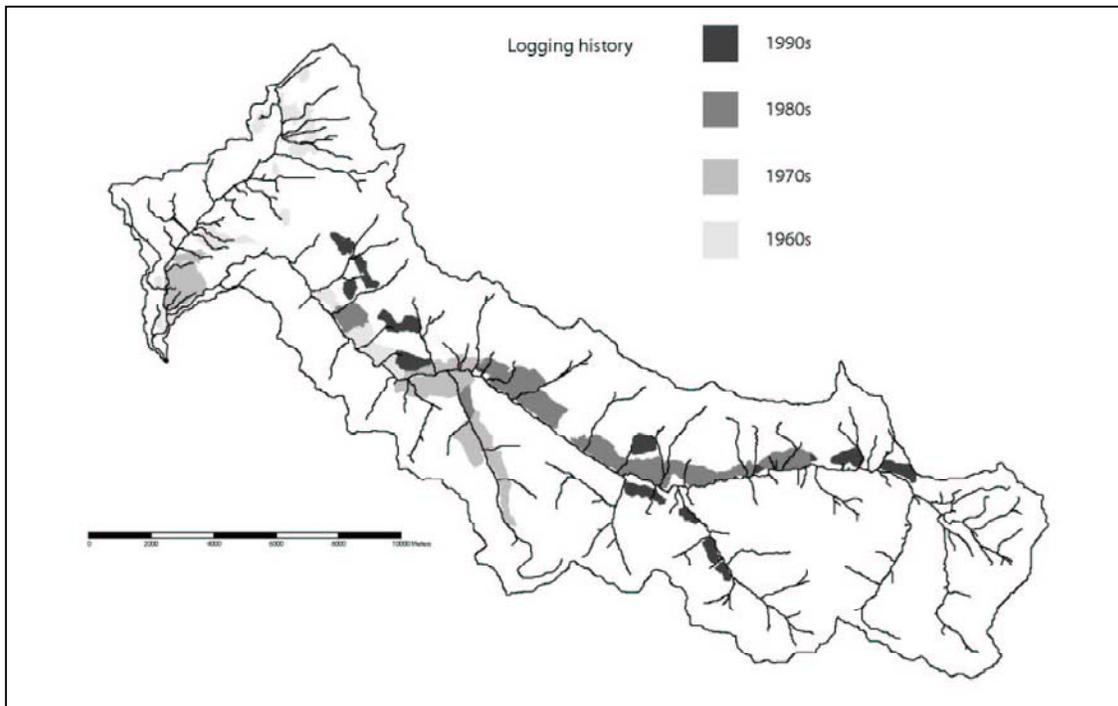
Figure 2-4. Logging history in Williams Creek watershed, 1960-2000

Most forest development (Figure 2-4) on the fan occurred between 1960 and 1975, with streambank logging along reaches 1 through 3. This included roads and trails through the riparian forest and wetlands, occasionally crossing into the active channel. Recent forest harvesting (1975–2001) has been limited to a small area along reach 3, often in association with residential development. Overall, development on the fan has been relatively extensive, with the largest changes to forest cover occurring between 1960 and 1975. Although not all streambanks were initially logged in any given period, the channel often occupied the previously logged riparian area, as the channel shifted laterally across the fan surface, following the path of an old road or trail on at least one occasion.

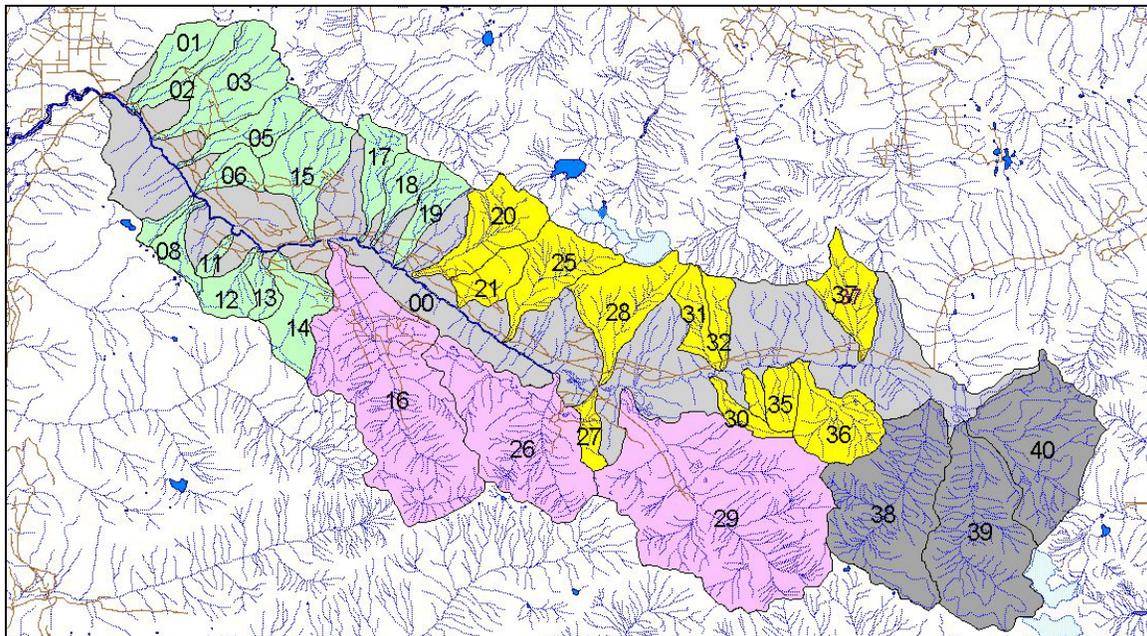
Figure 4-1. Location of subbasins in Williams Creek Valley.

- Lower Williams Creek valley including minor tributaries, between Old Lakelse Lake Drive and Sub-basin 19 (Figure 4-1, green shading);
- Mid valley section and small, steep tributary basins (Figure 4-1, yellow shading);
- Larger tributary valleys entering mid-valley from the south side (Figure 4-1, pink shading);
- Headwater tributary basins (Figure 4-1, dark grey shading).

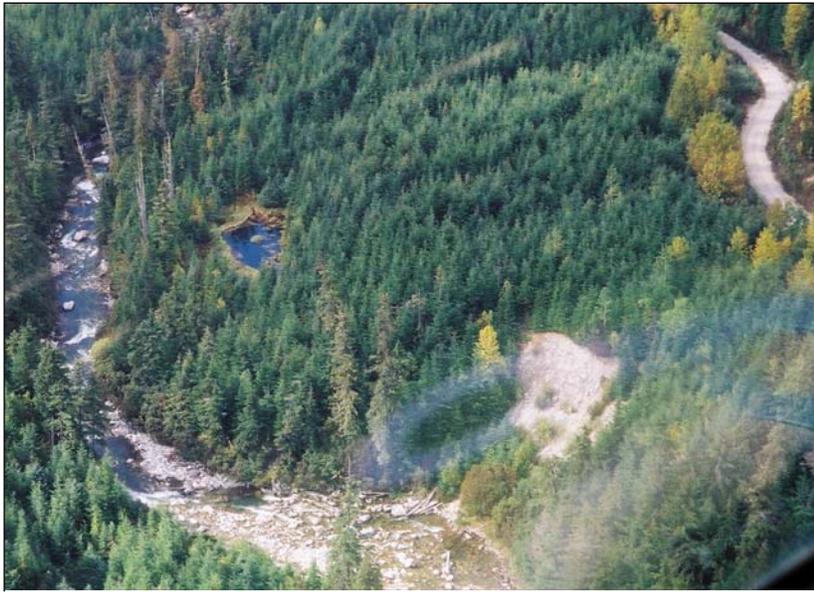
Figure 4-2. Natural sediment source on the stream side embankment along Williams Creek (#00-25).

failures (Figure 4-2) apparently occurred post-1968 and prior to 1988. Several open slope debris slides (#00-16, 17, 19, 32) occurred post-1988 in clearcut areas. These slides did not reach a stream and did not contribute sediment to Williams Creek. A large natural debris slide (#00-28) initiated on the forested open slope above a clearcut area between 1968 and 1988 and ran to the valley floor. Landslide debris was partially deposited on the valley floor and partially delivered to Williams Creek.

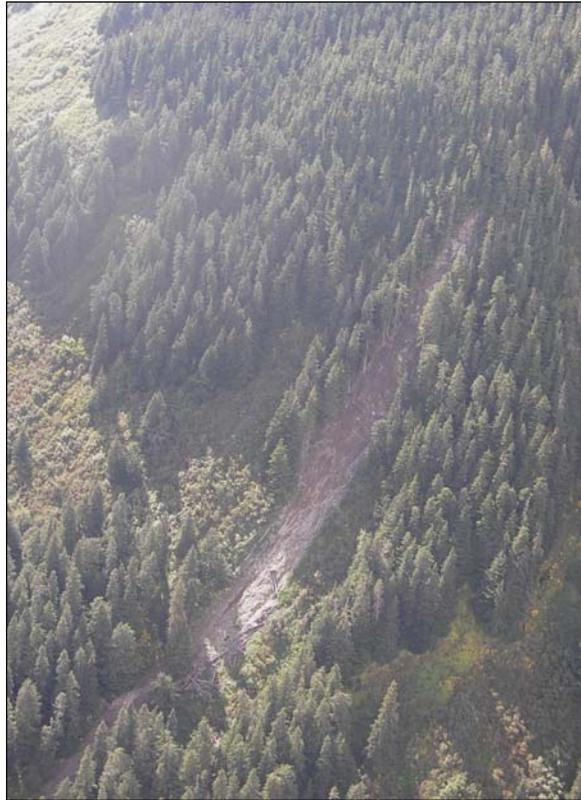
Figure 4-3. Debris slide in upper Williams Creek valley (#00-47)

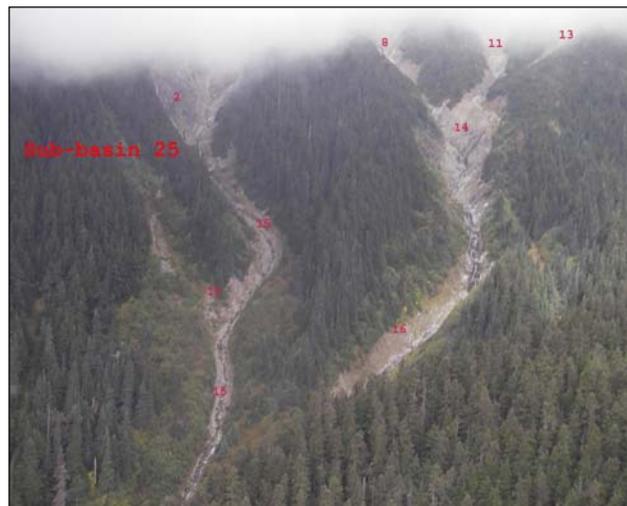
Figure 4-4. Scoured bedrock gullies in subbasin 25

Sub-basin 25 (SB25, 348 ha): The sub-basin comprised a steep-sided, subalpine to alpine basin adjacent to SB20. Several scoured gullies were deeply incised into bedrock on the north side of the basin (Figure 4-4). Sediment transport out of the dendritic gully system (#25-11 to #25-15) into the basin floor and beyond into stream 25 appeared to have increased significantly during a pre-1988 event. In 1968, the stream channel draining from the basin floor appeared undisturbed under closed forest

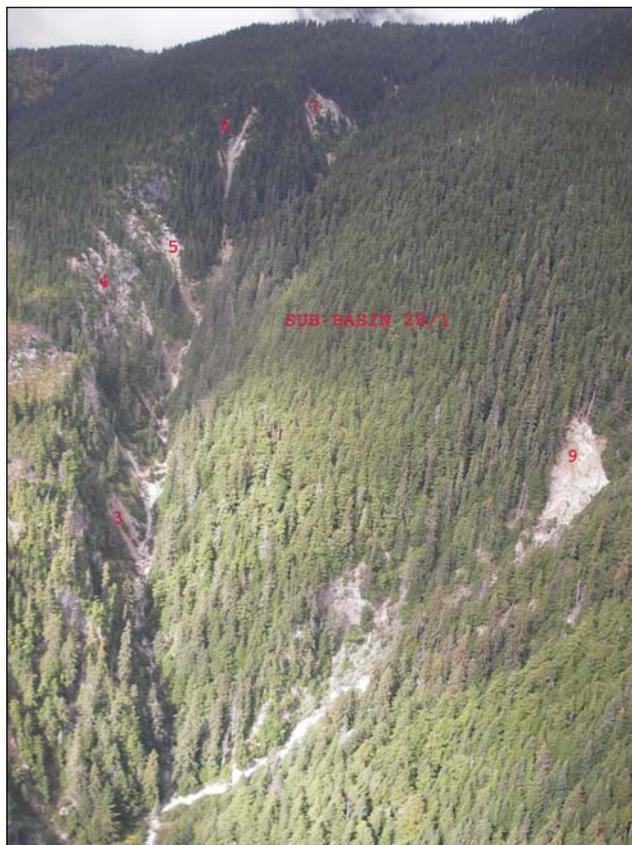
Figure 4-5. Actively failing gully sidewalls in subbasin 28/1.

Sub-basin 28 (SB28, 407.1 ha): Two steep gully systems joined at the road crossing of stream 28. Both gullies have generated considerable amounts of coarse sediment from gully wall failures since pre-1949. Sediment entrainment by, and throughput through the gully floor stream varied from slow to occasionally rapid. Both gully floor streams have been disturbed (scour and aggradation) since pre-1949, and sediment was deposited on the valley floor fan. Evidence of channel disturbance on the fan extended from the fan apex to the confluence with Williams Creek, indicating that a considerable amount of sediment entered Williams Creek. Pre-1968, a new gully sidewall failure (#28-7) added a moderate to large amount of sediment to the western branch of the gully system (Figure 4-5). Little change appeared to have occurred by 1988. By 2001, several of the subalpine gully sidewall sources had started to revegetate, while

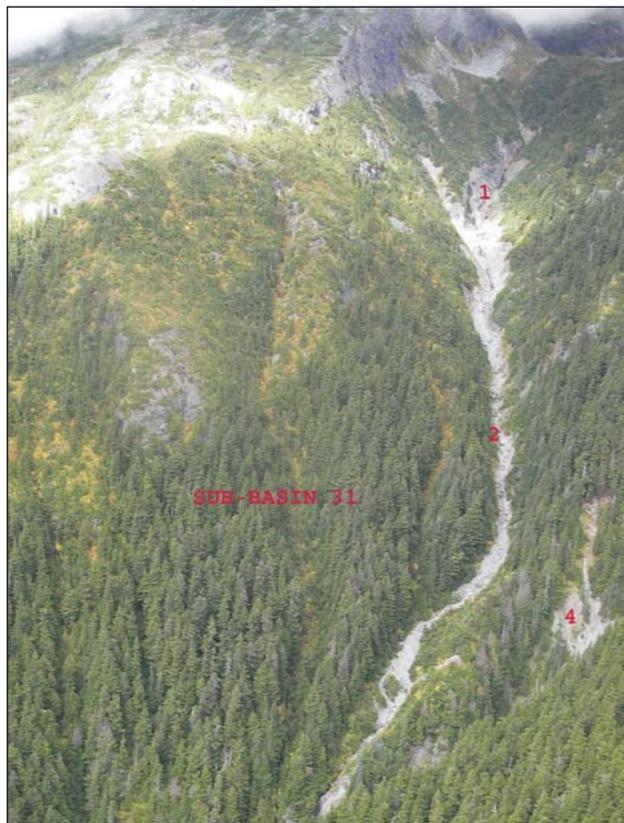
Figure 4-6. Debris flow track #31-2 in subbasin 31

Sub-basin 31 (SB31, 158.3 ha): The sub-basin drained hummocky, subdued alpine terrain upslope of steep forested valley wall slopes. Starting in the subalpine, a two-branch gully system was deeply incised into the steep, forested slope. Sediment was generated from bedrock exposure at site #31-3. A considerable amount of blocky and rubbly sediment was generated from gully walls at site #31-1 and transported along the debris flow track (Figure 4-6). The lower debris flow track (#31-2) is currently loaded with sediment, as transport out of the reach is slower than accumulation from upstream sources. Transport through the lower steep reaches of Stream 31 occurred at a steady, slow rate. Deposition on the valley floor fan has been in equilibrium with scour since 1949. Over the past 52 years, and possibly longer, sediment output from SB31 to Williams Creek has been lower than input from active upslope sediment sources. The sediment stored in the debris flow track could be mobilized by an extreme run-off event at any time, causing a large debris flow which would run to the valley floor and partially enter Williams Creek.

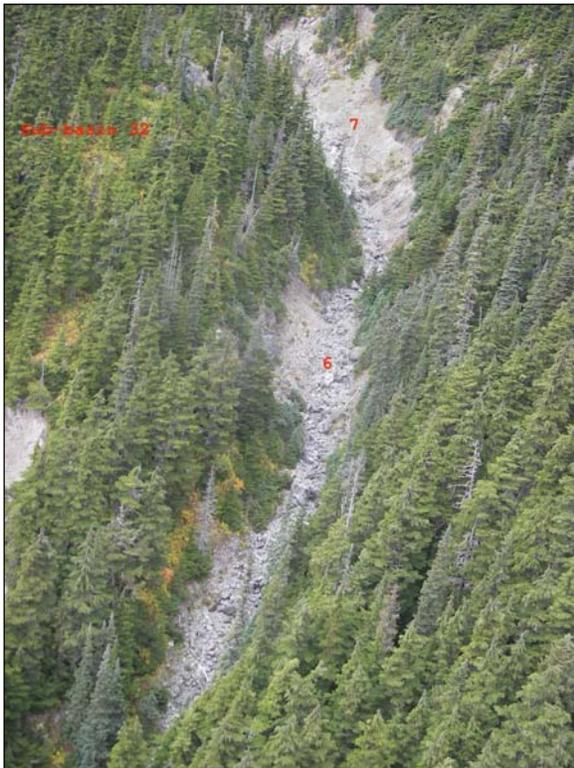
Figure 4-7. Subbasin 32, gully floor is loaded with sediment.

Sub-basin 32 (SB32, 111.1 ha): The gully system received coarse-textured sediment from gully sidewall failures in fractured bedrock in steep, subalpine reaches (Figure 4-7). Transport through the steep bedrock gully to the valley floor fan was direct and has occurred at a steady rate since 1949. However, transport was less than input from subalpine gully sidewall sources. This has left the gully floor channel at 32-7 loaded with coarse sediment.

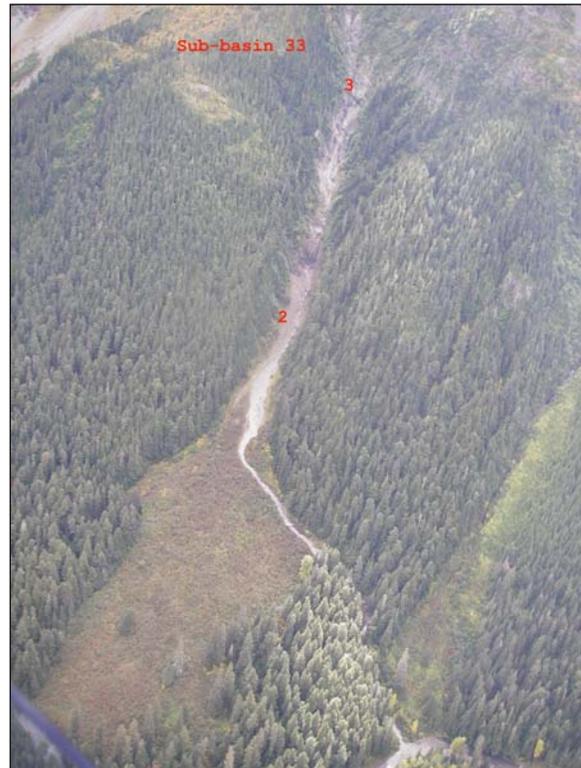
Figure 4-8. Erosion into cone apex at the mouth of gully 33, and sediment transport to Williams Creek.

Sub-basin 33 (SB33, 47.6 ha): Weathering bedrock along the upper gully reaches produced a slow supply of blocky-rubby sediment. Throughput through the steep, narrow bedrock gully to the valley floor cone was direct. The cone apex was eroding and little or no sediment is stored on the cone. Throughput to Williams Creek was immediate (Figure 4-8).

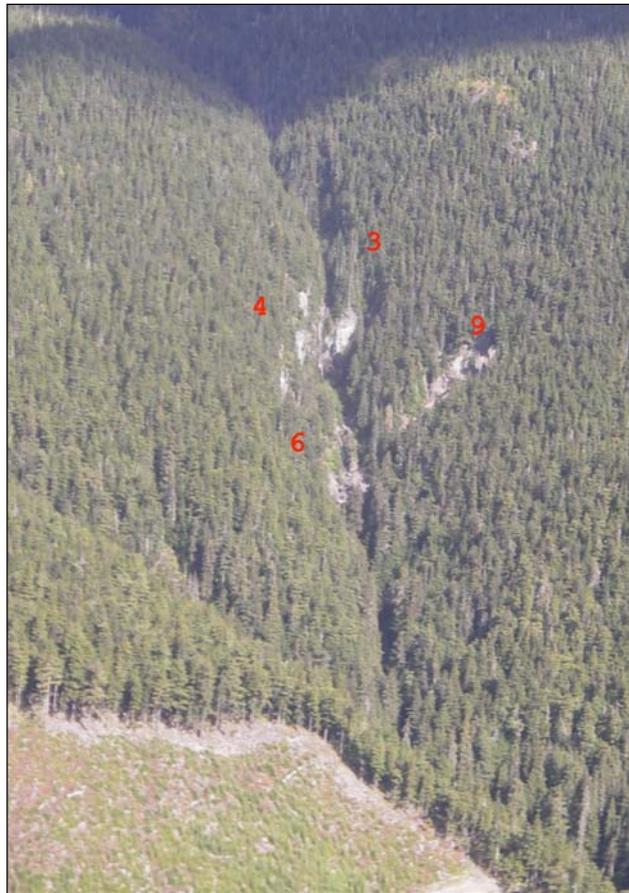
Figure 4-9. Subbasin 37, mid-elevation valley wall.

Sub-basin 37 (SB37, 263.5 ha): The main gully in SB37 started in the alpine on moderately steep slopes. No sediment sources were identified in the alpine. As the gully stream reached the steep subalpine and forested valley side slopes, it became incised into bedrock (Figure 4-9). Several gully sidewall failures (#37-3 to #37-6 and #37-9) existed in bedrock along the forested, mid-elevation gully reaches. They have been active since pre-1949, slowly producing sediment. Sediment entering the gully stream has been transported along the narrow, incised channel and was partially deposited on the valley floor fan. Some of the sediment reached Williams Creek. The sediment regime in Sub-basin 37 has changed little over the 52 years since 1949.

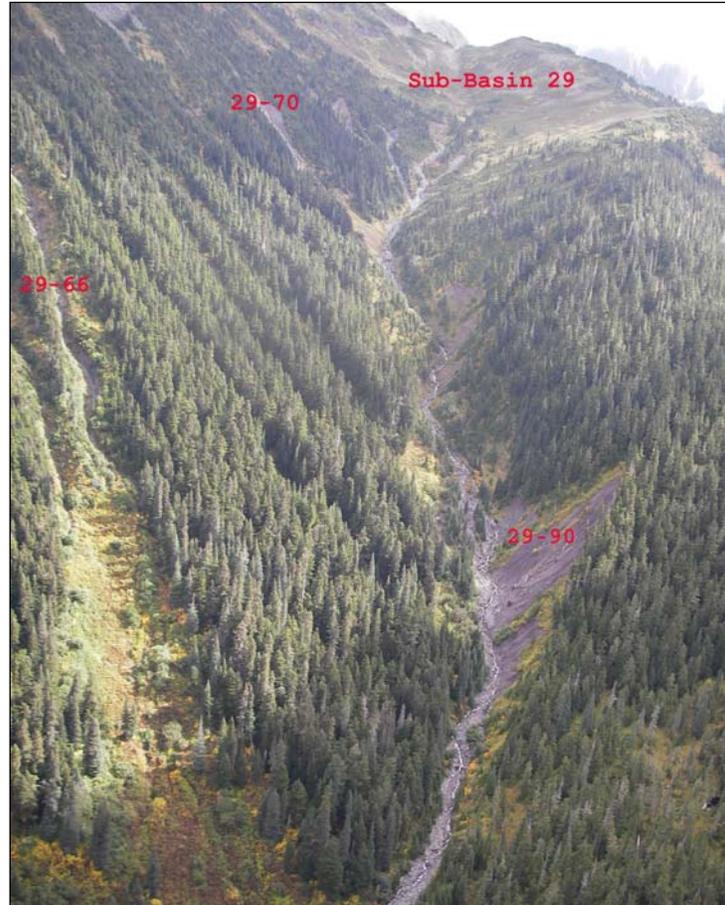
Figure 4-10. Headwaters of subbasin 29 (Myron Creek).

Sub-basin 29 (SB29, Myron Creek, 2086.4 ha): The sub-basin was a long tributary valley draining the alpine and subalpine divide on the south side of Williams Creek. Eastern headwater slopes consisted of gullied glacial till and colluvium. Gully erosion was active (#29-60 to #29-76), particularly in glacial till. A 50 m high and 30–40 m wide debris slide (#29-90) occurred along the stream bank escarpment in the headwater reach of stream 29 (Figure 4-10). This significant sediment source has been active since 1949, depositing fine- and coarse-textured sediment in the stream, causing local aggradation.

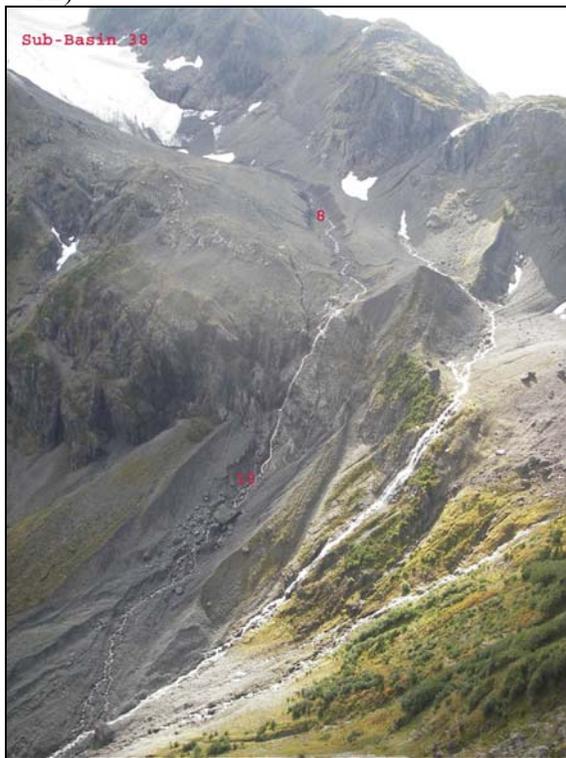
Figure 4-11. Headwaters of subbasin 38.

Sub-basin 38 (SB38, 993.7 ha): Sub-basin 38 was a glaciated tributary valley, which entered Williams Creek from the south. The U-shaped valley was flanked by steep valley walls and several alpine cirques. The valley head consisted of a 150 m-tall bedrock cliff - talus cone complex, which formed a steep step between the tributary valley floor and the glaciated hanging valley above. Considerable ice retreat in the hanging valley since the end of the little ice age (1860 DC) exposed approximately 500 m of neoglacial basal moraine in the lowest part of the hanging valley. Prior to 1949, a meltwater outburst flow eroded a 350 m-long, 20–30m wide, 5–10 m deep pre-glacial channel (#38-8 and #38-10) into the neoglacial basal moraine (Figure 4-11). Some of this substantial sediment volume was partially deposited at the very edge of the hanging valley, but most of the volume was transported down the hanging valley step to the SB38 valley floor. Additional sediment was derived from the rugged valley sidewalls in form of rock fall and debris flows (Figure 4-12).

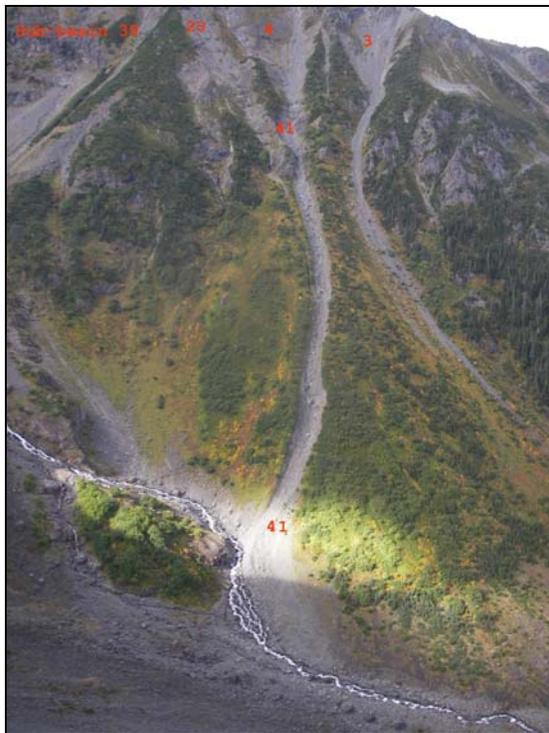
Figure 4-13. Subbasin 39, valley wall debris flow track

Sediment delivery to stream 39 was mainly from several debris flow tracks (#39-14, #39-41), which were located on the valley sidewalls (Figure 4-13) and fed sediment into the

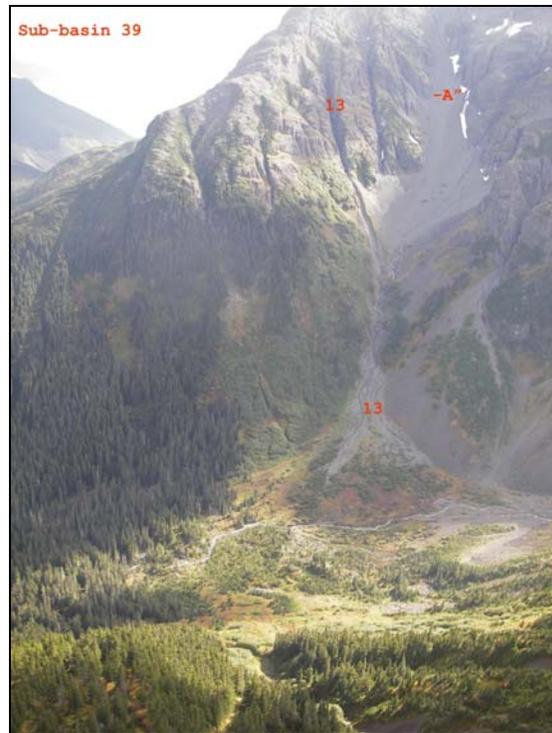
Figure 4-14. Subbasin 39, snow avalanche track and valley head basin.

flat-bottomed, slowly revegetating valley-head basin. Sediment from snow avalanche and debris flow track #39-13 was deposited on a valley floor cone (Figure 4-14), and did not enter stream 39. The channel in the valley head basin had a gentle gradient and appeared to be aggrading slowly, trapping a large proportion of the sediment that was generated on the valley walls and the hanging valley. Sediment output from sub-basin 39 to Williams Creek has been steady since 1949.

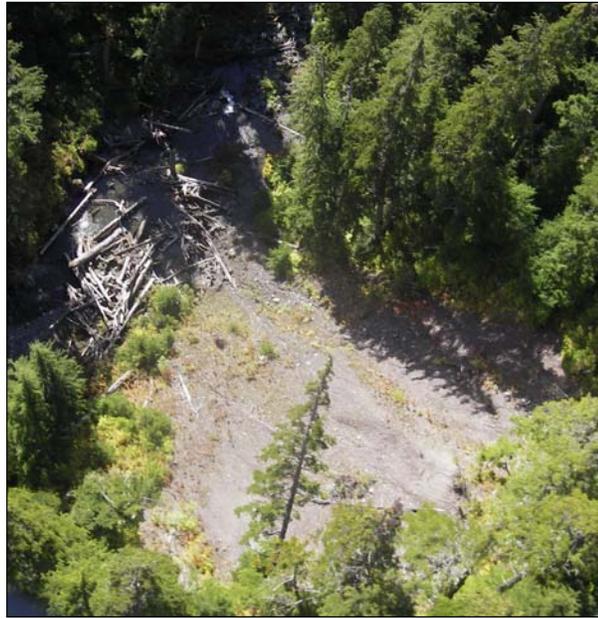
Figure 4-15. Subbasin 40, site #40-51. Stream side escarpment failure in glacial till.

Sub-basin 40 (SB40, 828 ha): The sub-basin covered mostly subdued forested slopes, drained by several deeply incised streams. Sediment was generated from failing 15–20 m-high streamside escarpments in bedrock (#40-55 to #40-62) and in glacial till (#40-51 to #40-54, Figure 4-15). These sediment sources have been active with little change since pre-1949, producing a small amount of sediment annually due to weathering of the exposed rock and mineral soil surfaces. Sediment output to Williams Creek has been low and steady since 1949.

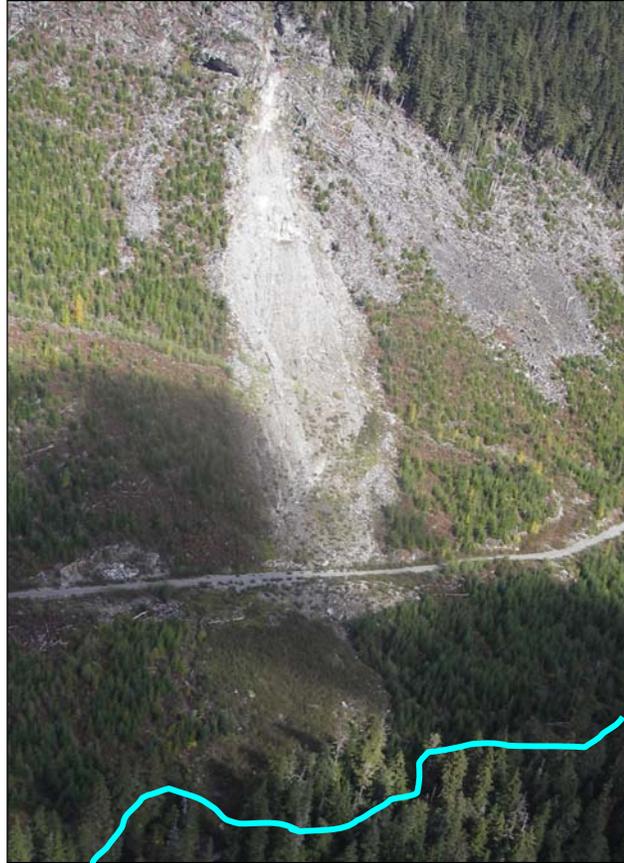
Figure 4-16. Debris slide initiating in a clearcut (site #00-35). The blue line marks the approximate location of Williams Creek

Numerous small debris slides occurred in clearcuts along Williams Creek mainline, identified during field work in 1998 and during air photo interpretation. These narrow slides generally ran out on the open slope and were disconnected from the stream network. Between 1988 and 2001, sediment from debris slide #00-35 in sub-basin 00/2 ran to the valley floor, covered Williams Creek mainline, and may have deposited some sediment in Williams Creek (Figure 4-16).

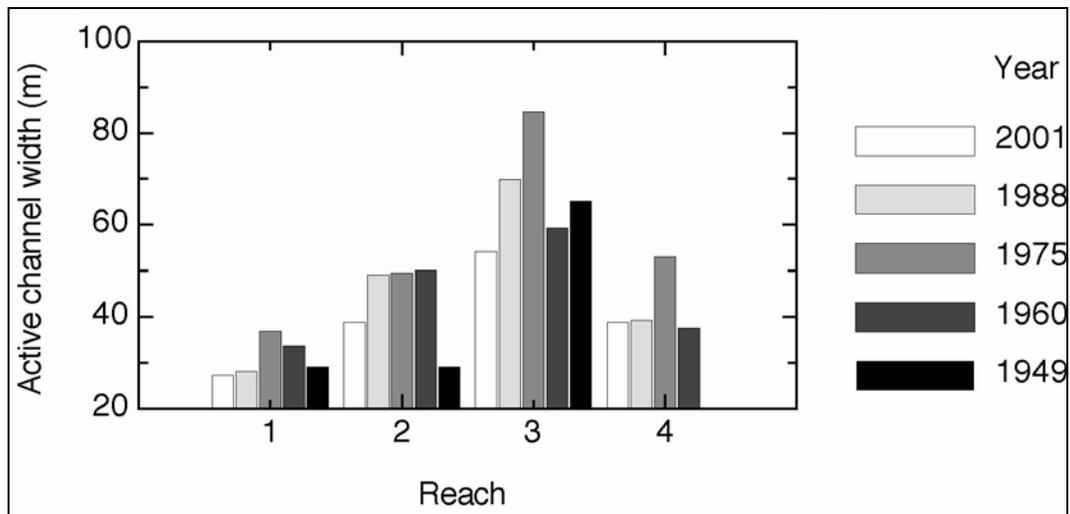
Figure 5-1. Active channel widths in lower Williams Creek: 1949 to 2001

The lower 6 km of Williams Creek flows across a low gradient fan and onto an unconfined valley bottom before reaching Lakelse Lake. The planimetric adjustment of the channel from 1949 to 2001 is shown in Map 1. The channel follows a wandering to irregular pattern amongst islands and wetlands. Reach 4 marks the apex of the fan and is largely confined by the valley walls (valley bottom width \approx twice the undisturbed channel width) and channel gradient averages 0.013 (Table 3-2). The channel followed a relatively straight pattern in 1960 with few bars or islands. However, by 1975 the channel had widened from 37.6 to 53.1 m (Figure 5-1), and large side- and mid-channel bars had developed as the channel began to wander across the valley bottom, eroding the riparian area. By 1988, the reach had begun to recover, with relatively large portions of the active rtrions of the active channel colonized by riparian vegetation (mapped as mixed vegetation and sediment). Channel width was 39.2 m, close to the value recorded for 1960. This recovery continued until 2001, although areas of mixed vegetation and sediment remained, suggesting that the channel had not completely returned to the form observed in 1960.

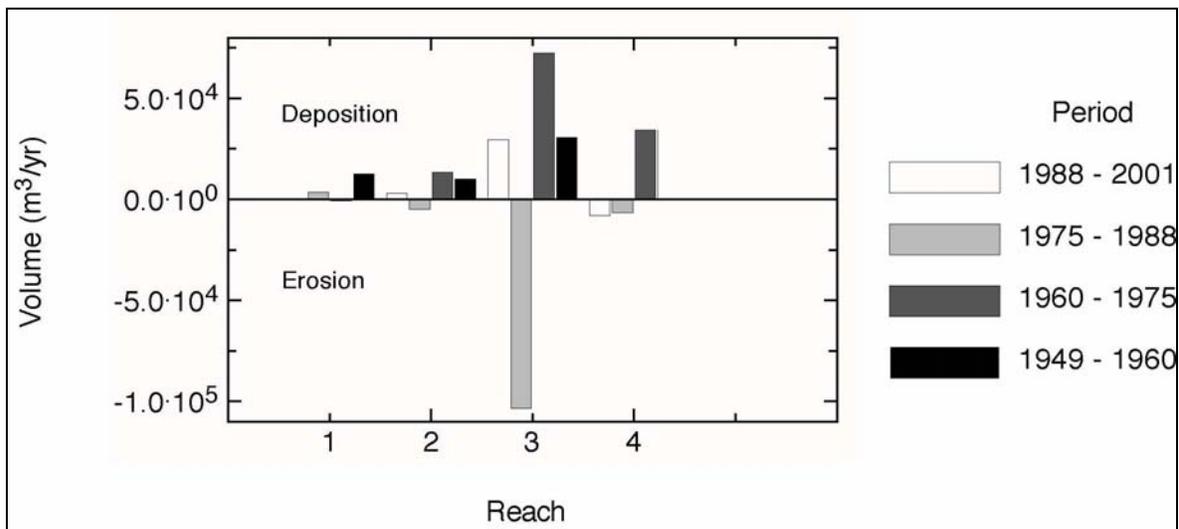
Figure 5-2. Change in sediment storage in lower Williams Creek

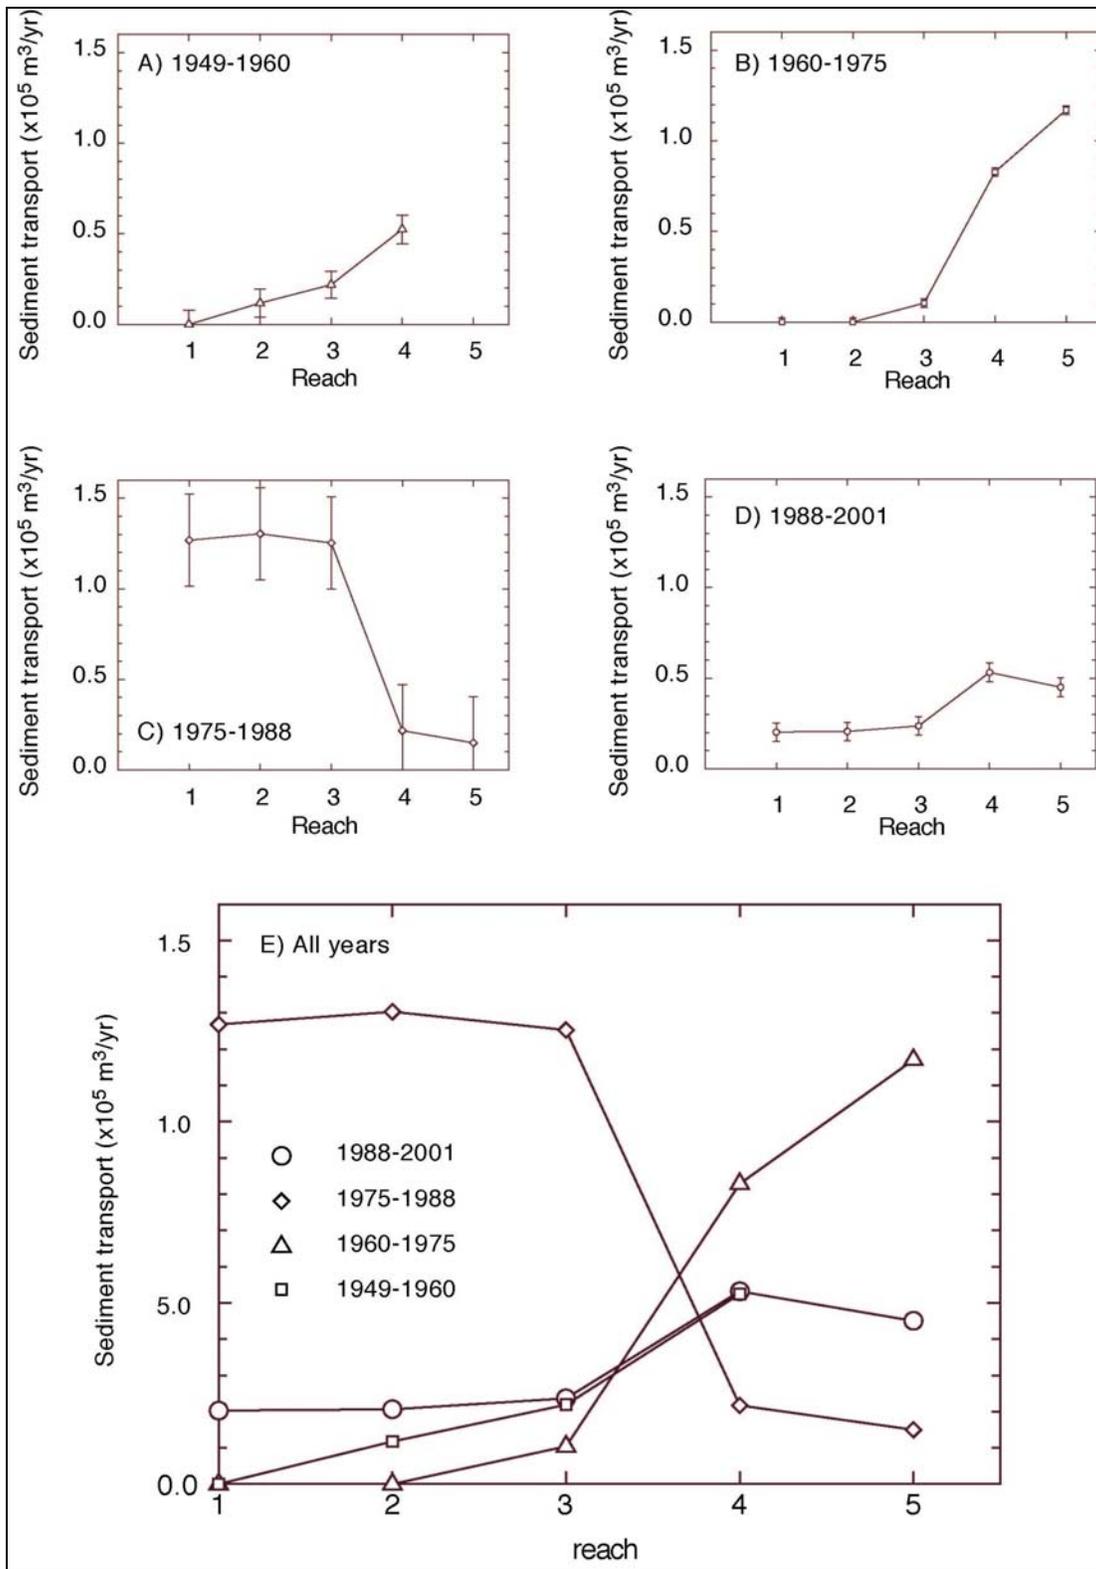
Figure 5-3. Sediment transport rates in lower Williams Creek

The trend observed prior to 1975 is reversed in the period 1975 to 1988. Sediment delivery from reach 5 to the fan declined by $100,000 \pm 30,000 \text{ m}^3/\text{yr}$ compared to rates observed between 1960 to 1975, while transport in reaches 1 through 3 increased by an average of $120,000 \pm 10,000 \text{ m}^3/\text{yr}$. Most of this sediment was derived from storage along reaches 3 and 4 (Figure 5-2), as sediments deposited prior to 1975 were remobilized as supply from upstream declined. Between 1988 and 2001, average transport rates in reaches 1 through 3 declined by $100,000 \pm 20,000 \text{ m}^3/\text{yr}$ but remained about $14,000 \pm 4,000 \text{ m}^3/\text{yr}$ higher than the average rates observed between 1949 and 1975. This suggests that the channel was still reworking sediments delivered to reaches 3 and 4 prior to 1975, and that channel recovery processes were still ongoing in 2001.

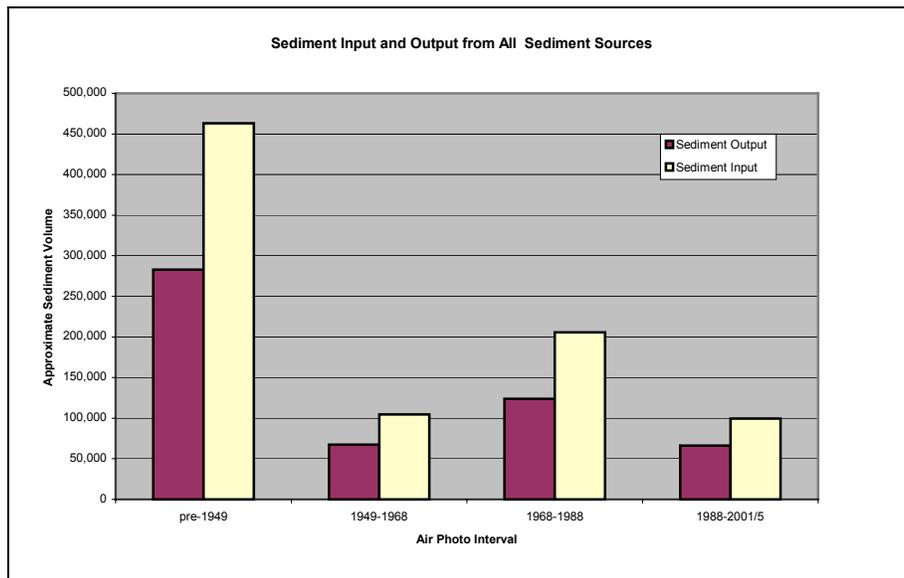
Figure 6-1. Sediment output and sediment input volume from all subbasins since 1949

Figure 6-1 shows an approximation of sediment production per observation period. Many small, long-term sediment sources were active prior to 1949, and the majority of the volume generated from these sources was assumed to have entered the stream network during the initial slope failure, prior to 1949. However, the sediment volume allocated to the pre-1949 period was probably overestimated as a result of applying standard reconnaissance scour depths to all sediment sources.

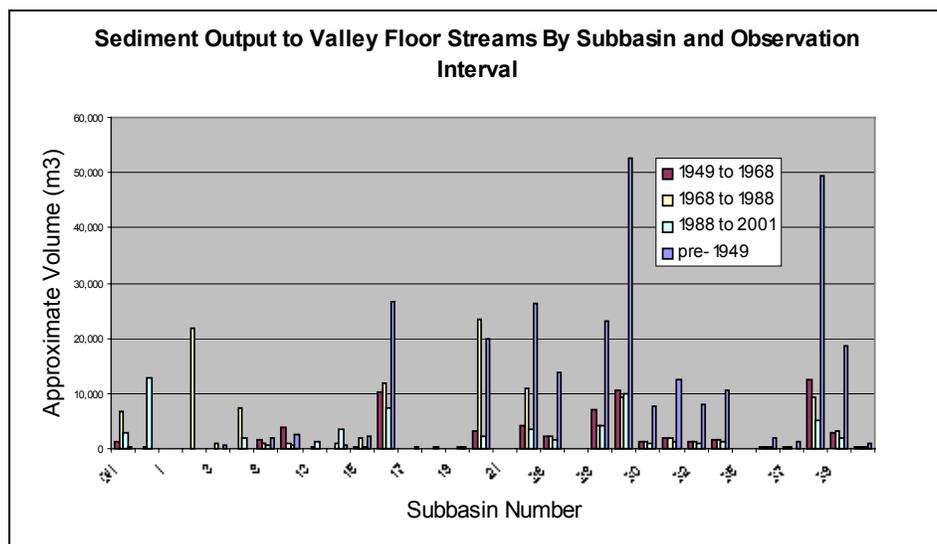
Figure 6-2. Sediment output by subbasin and observation period.

Sub-basin 38 showed a different trend (Figure 6-2). Estimated sediment output to the valley floor stream was greater between 1949 and 1968 than after 1968. This corresponds with significant aggradation and channel change on the gravelly fluvial fan at the mouth of sub-basin 38 during a flood event between 1949 and 1968.

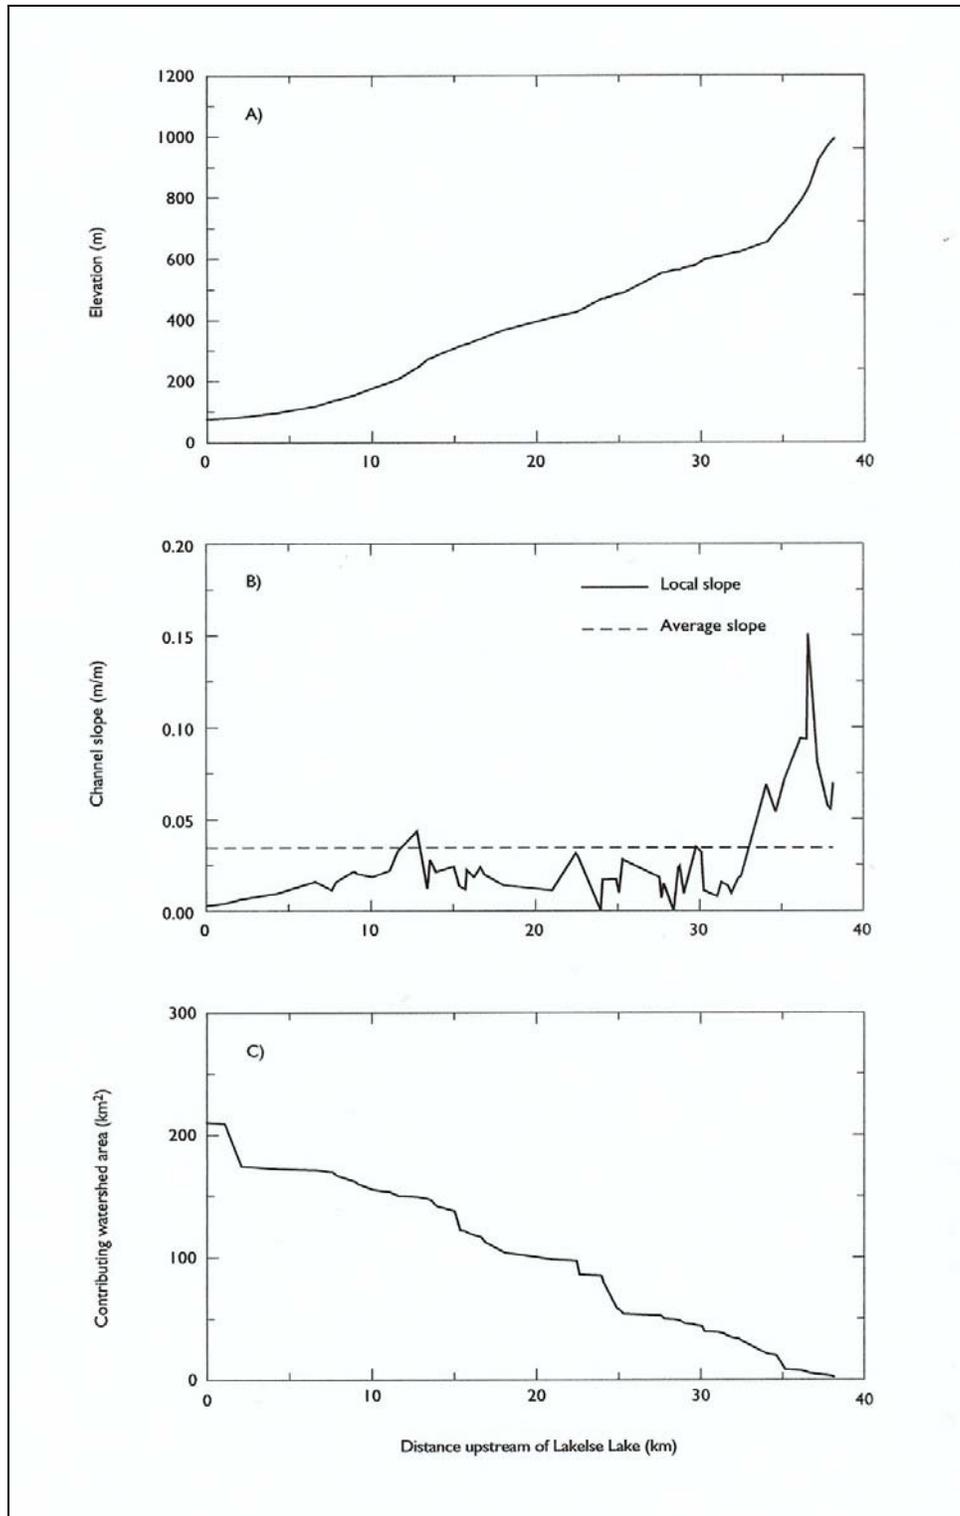
Figure 6-3. Longitudinal profile of the main channel of Williams Creek: A) channel elevation, B) channel gradient, C) contributing watershed area. Data was derived from 1:20,000 TRIM maps and 1:50,000 DEM.

An estimate of the temporal link between an input of sediment to the rapid section of channel at km 24 of the longitudinal profile, and the time it takes to reach the fan, was made with reference to the analysis presented in Section 5. Assuming average channel conditions of $D_{50} = 256$ mm, $d = 1$ m, $s = 0.03$, $\theta = 0.06$, and $n = 0.08$, the average L_t for the channel is about 2 km per flood event. Given that we assumed $Q_{1.5}$ was exceeded about 1.1 times per year in Williams Creek (Table 2-1), the D_{50} of sediment transferred to km 24 may take approximately 8 years to reach the apex of the fan at km 6 of the longitudinal profile. Finer-size fractions may require only a few years to reach the fan, while coarser fractions may take several decades.
