THE B.C. FOREST SERVICE
1990-1991
TELKWA RIVER WATERSHED
SUSPENDED SEDIMENT DATA REPORT

Suspended Sediment
Telkwa River Watershed

Data Report
April to October, 1990.

B.C. Forest Service
Forest Sciences Section
Smithers B.C.

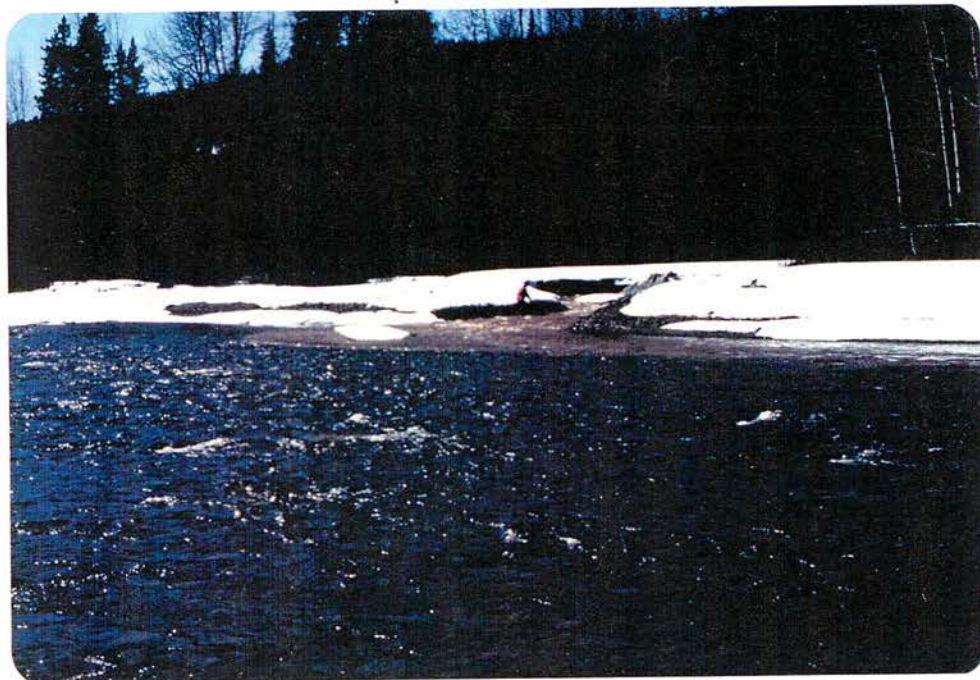
Photo 1. Pine Creek plume entering the Telkwa River April 5, 1990.

The sampling commenced on April 5, 1990. At that time, the Telkwa River was crystal clear above Pine Creek containing sediment concentrations of 3 mg/L. Pine Creek was already chocolate brown (42 mg/L) which provided a significant amount of sediment to the Telkwa River, as evidenced by a distinct sediment plume that entered the main stem from Pine Creek (Photo appendix 2). The Telkwa River at the gauge site was light brown(4 mg/L); representative of a dilution or mixing of sediment delivered from Pine Creek into the higher volume Telkwa River. Visual records indicate that Tenas Creek started to become dirty on April 12.

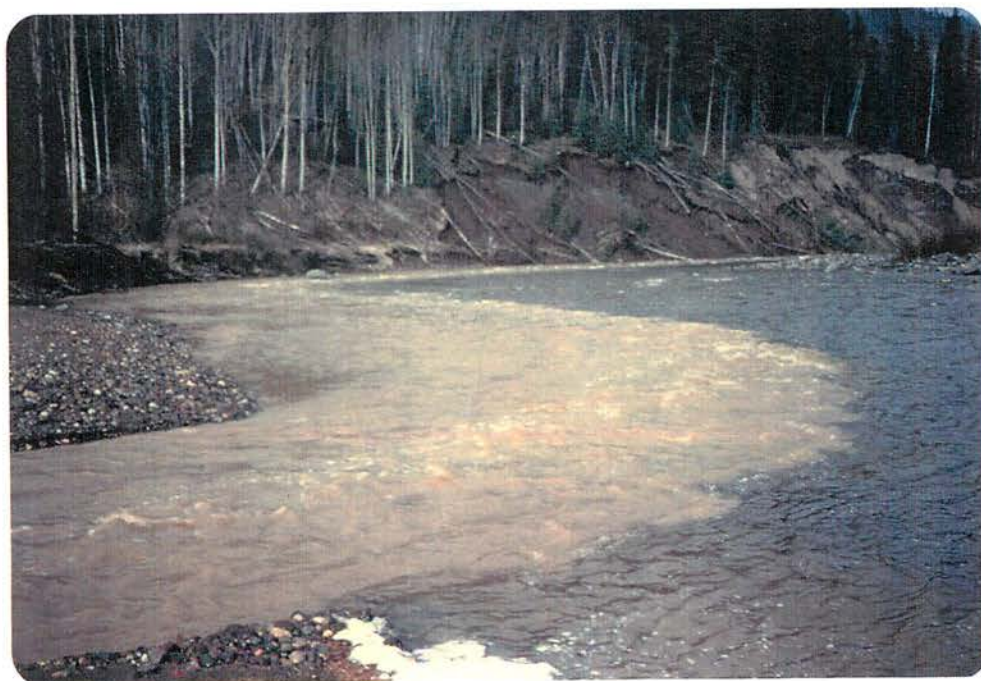
Photo 2. Pine Creek plume entering the Telkwa River April 20, 1990.

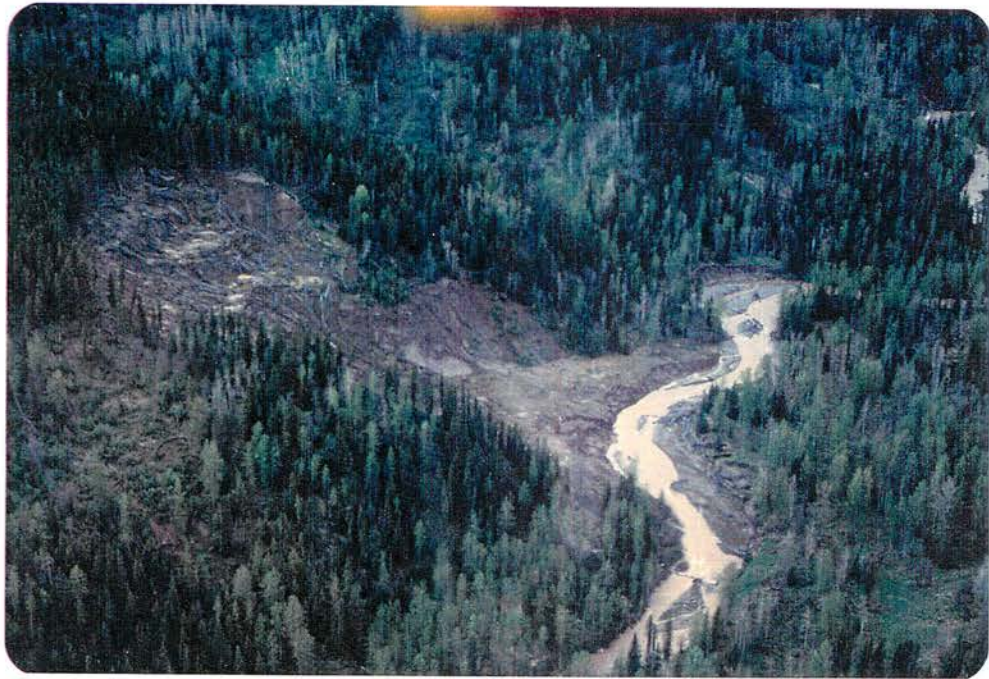
Photo 3. Slump earth flow terrain Pine Creek May 28, 1990.

The source of the large sediment loads carried by the Telkwa River during spring runoff are dominated by natural sources in all of the major tributaries to the river. These sources from natural erosion are large active slump earth flows, gully erosion in alpine and subalpine areas, and stream bank undercutting. Man related activities in the watershed no doubt do contribute sediment to the river. This is evident by some of the man caused erosion related to roads, pipelines and hydro right of ways in the watershed. However, the natural sources of sediment overwhelmingly dominated the sediment input to the Telkwa River during the 1990 spring freshet.

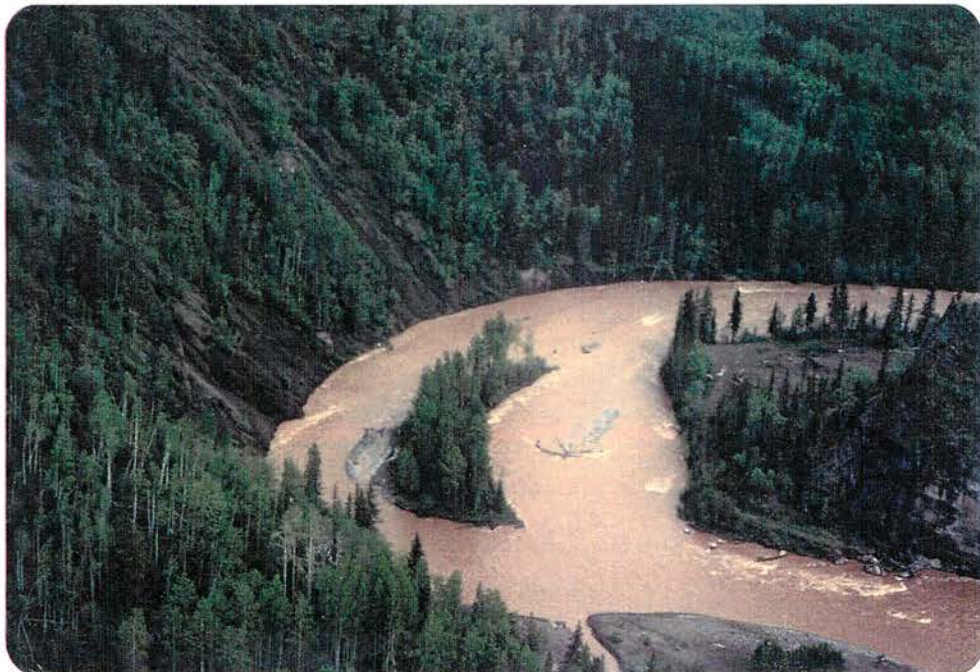
Photo 4. Telkwa River flow May 28, 1990.

Peak spring flow on the Telkwa River occurred on May 28, 1990. Sediment concentrations in the Telkwa River, at that time, increased to levels of 900 mg/L despite the increased flow. The peak flow effect is discussed separately in the next section.

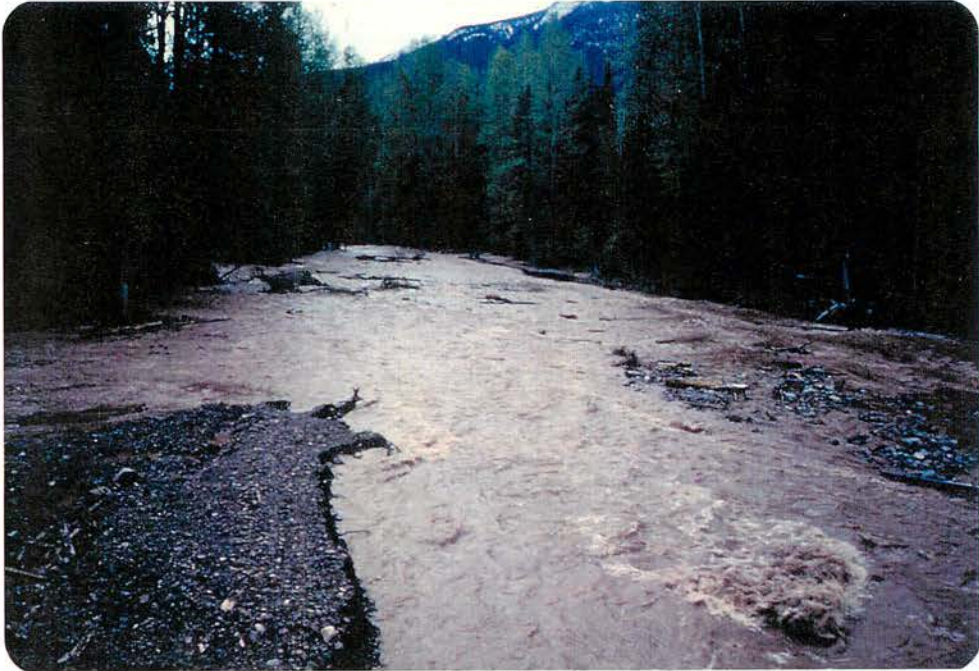
Photo 5. Windfield Creek May 28, 1990.

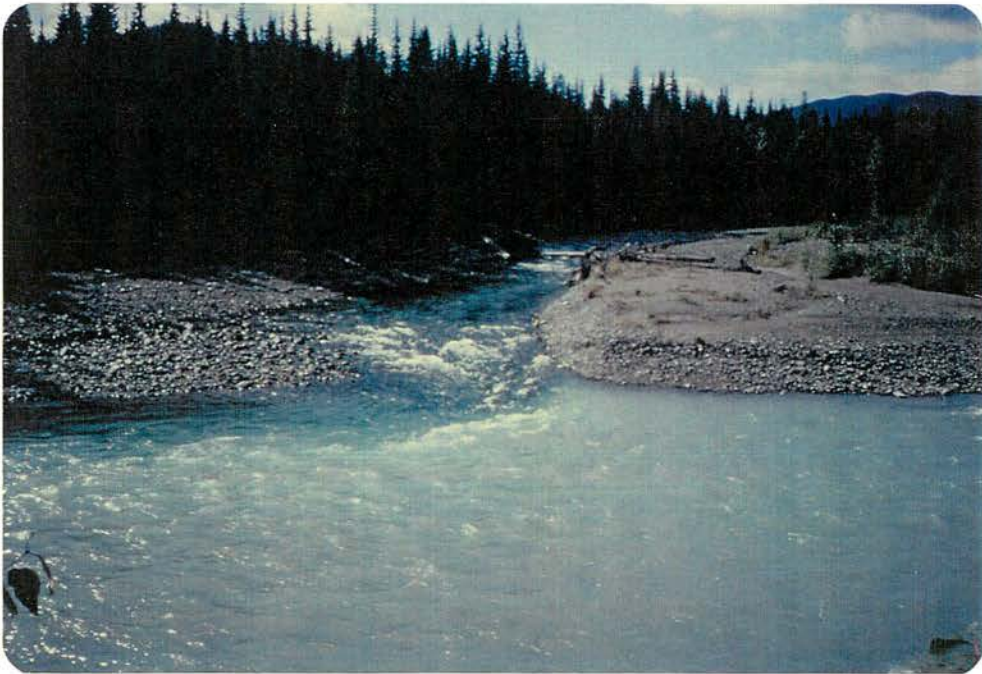
Photo 6. Howson entering the Telkwa River August 9, 1990 (note milky color of the Telkwa River)
