STREAM INVENTORY
TAGIT CREEK AND ADJACENT
TRIBUTARIES
1997

WATERSHED CODE: 460-6006-445

DAVID BUSTARD AND ASSOCIATES LTD.

HOUSTON FOREST PRODUCTS LTD.
(Funded by Forest Renewal BC)

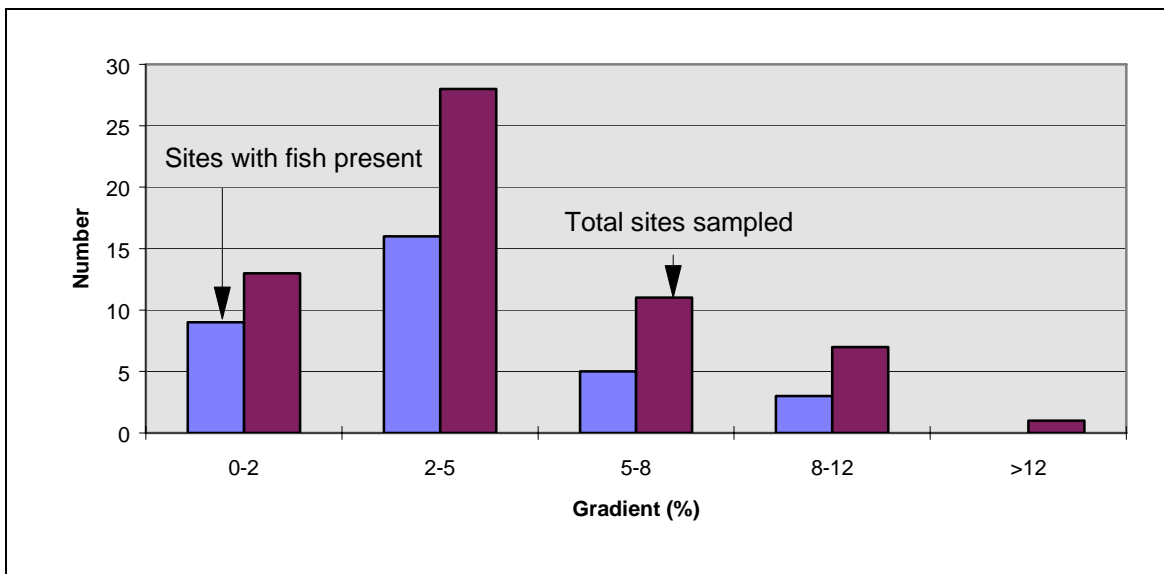
Figure 2. Summary of Fish Sample Sites by Gradient.

Number of sites sampled	Fish present	Fish not present	Cutthroat Trout	Dolly Varden	Coho	Steelhead
Unnamed	1	0	1	0	0	0	0
False Tagit	23	12	11	12	1	0	1
Tagit ²	27	15	12	12	9	1	1
O'Dine	6	4	2	4	0	1	1
Swamp	3	2	1	2	0	1	0
Total	60	33	27	30	10	3	3

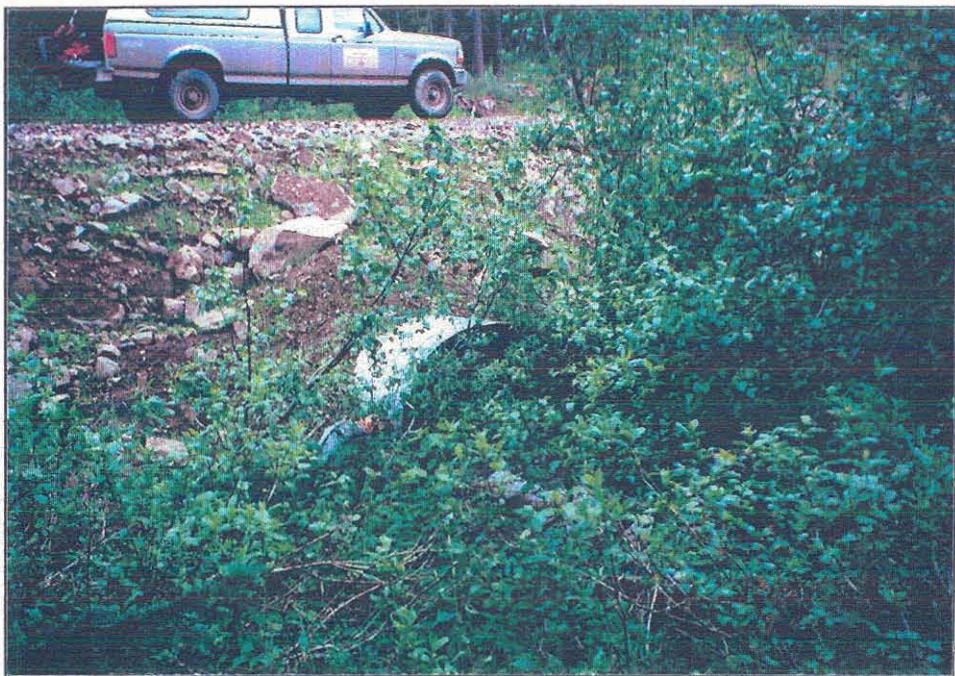
Site 3 Reach 4. A large oval culvert 18 m long and 1.5 m in diameter with a 3 m fill is present at this site. This culvert is installed at a 6% slope with a 15 cm drop at the outlet. We suspect that this culvert restricts cutthroat movements upstream in this section of False Tagit Creek. It should be noted that there are several small bedrock chutes approximately 1 km upstream that also restrict movements between the lake and this section of stream.

- C1 Electrofished 28 m length of stream d/s from the culvert for 440 s. with a lower net. CT were caught. Electrofished ~10 m length of stream above the culvert with no lower net; 4 fish were observed.
- C2 Steep creek with large angular bed material. Very limited potential spawning habitat. Excellent parr rearing habitat.
- C3 Problem culvert at road: 18 m long x 1.5 m diameter (oval) with a 15 cm drop at the outlet and ~6% gradient (photo B1/16).
- C4 R4 is classed as S4 habitat.

Photo 9. False Tagit C., R4, Site 3 - Road culvert.

Fish passage difficulties were identified at three locations in the study area. These sites should be assessed to determine whether the culverts can be removed or replaced with structures that allow for fish access.

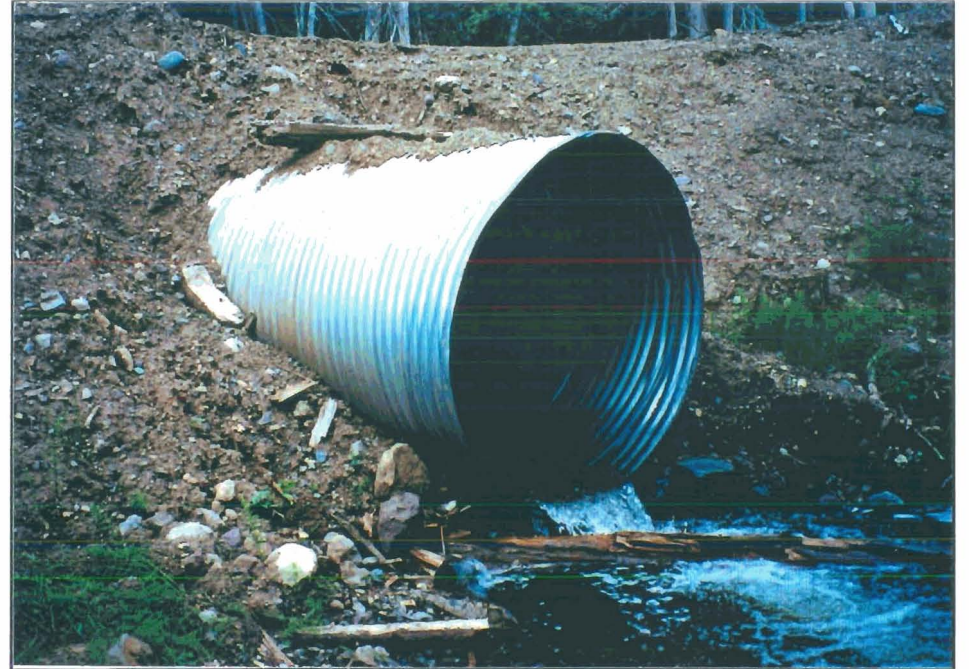
- C1 Electrofished 100 m length of stream for 950 s. with a lower net. DV were caught. Also sampled 20 m above the culvert; no fish were caught/observed in this section.
- C2 Problem culvert: 1.8 m diameter x 12.2 m length with a 10% gradient (photo A8/3). Similar habitat above the road as below; suspect culvert is acting as a migration barrier.
- C3 Dynamic creek with and abundance of log stepping and pools. Boulder/cobble bed material.
- C4 Hiked u/s from culvert for 200 m: gradient is 10-13%; a large, unstable bank is present on R. right at 160 m. Surveyed upper extent of fish use by air: potential fish use up to impassable chutes and creek is classed as S3 up to these barriers.

Photo 74. Tagit C., R6, Site 7, Road culvert.

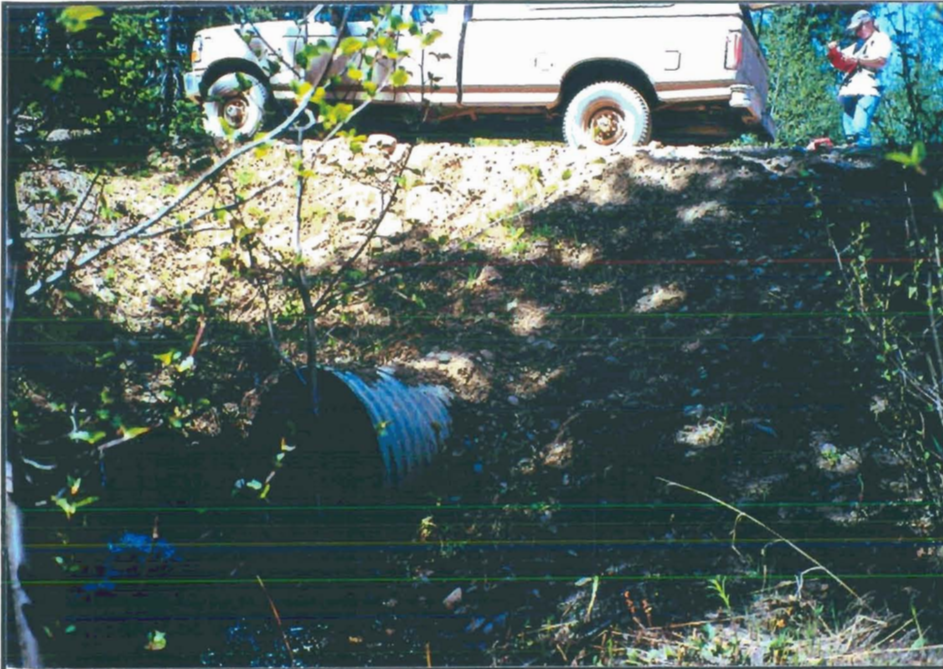
- C1 Electrofished 100 m length of stream below the road with a lower net. CT were caught. Very low fish densities.
- C2 Problem culvert at the road: 12 m length x 1 m diameter, no drop at the outlet, and ~2.5 m high road fill over top (photo A1/20). Gradient was not obtained but the high water velocities observed through the culvert restrict fish passage. Some adult CT must pass through the culvert because CT fry were caught in Site 19 u/s. This culvert should be removed.
- C3 LOD abundant within channel and dense brush lines the creek.
- C4 Some pockets of fine gravel are present above the debris steps. Assume CT adults spawn here; creek is too steep below the road for fry to migrate u/s.
- C5 Channel is confined and at these flow levels, the water velocities are very high.
- C6 R1 and R2 are classed as S3 habitat.

Photo 97. Tagit C. Tributary Ta7, R1, Road culvert.

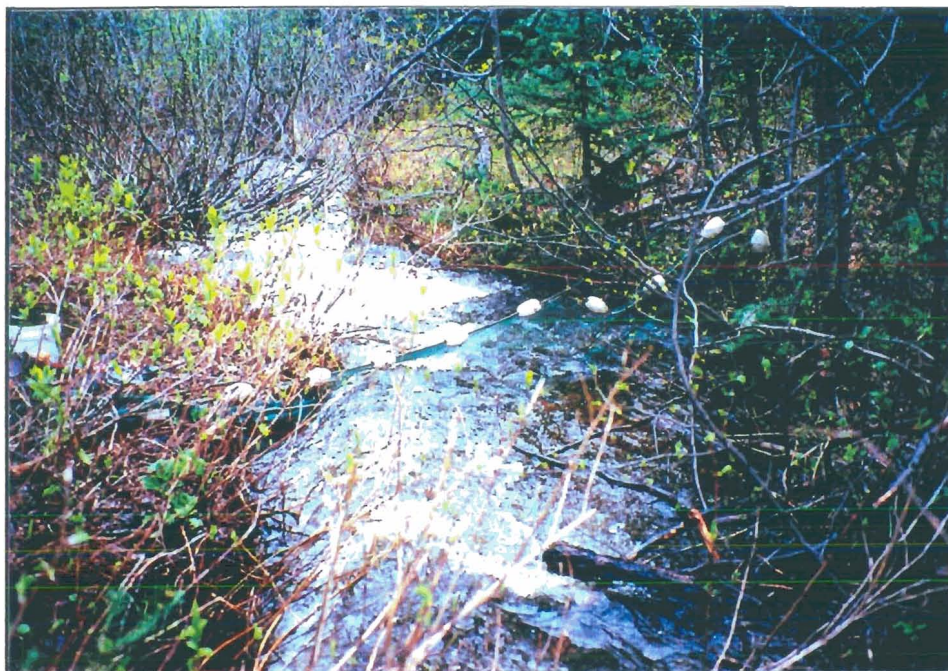
Photo 101. Tagit C. Tributary Ta7, R3, Site 20, At high flows - Downstream
