Lakelse Lake Sockeye Rehabilitation Program:

Scully Creek Off-channel Habitat & Flow Augmentation Project

August 2007

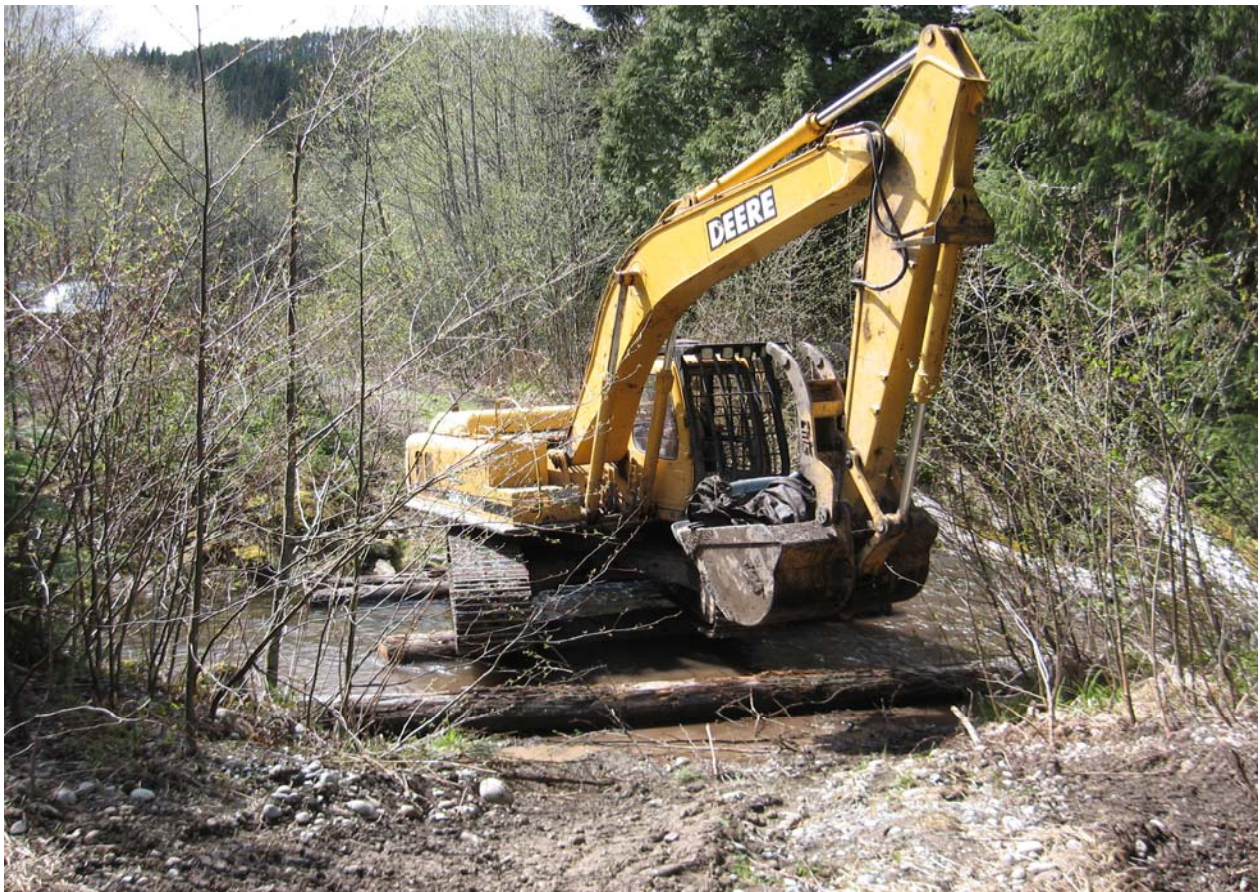
Figure 3. An excavator crosses Scully South on three access logs for May 2007 construction work.

In late October and early November 2006, equipment and supplies were mobilised to the project site from the nearest community, Terrace, BC. A John Deere 200 CL excavator from Nechako Northcoast was walked into the site from Highway 37 South on an old logging road (~1km long). The excavator transported supplies such as the sheet pile weir and creek crossing logs from the highway to the project site. Three large logs (>1m in diameter and 6m long) were placed on the streambed of Scully South in order to facilitate a stream crossing by the excavator on top of the logs to access the project site. Equipment and supplies (sheet pile, straw bales, filter cloth, pumps) were delivered to the left bank of the creek at the stream crossing site and the excavator moved them across the channel. Equipment and supplies were then walked up to the project site along the continuation of the old logging road (~200m).

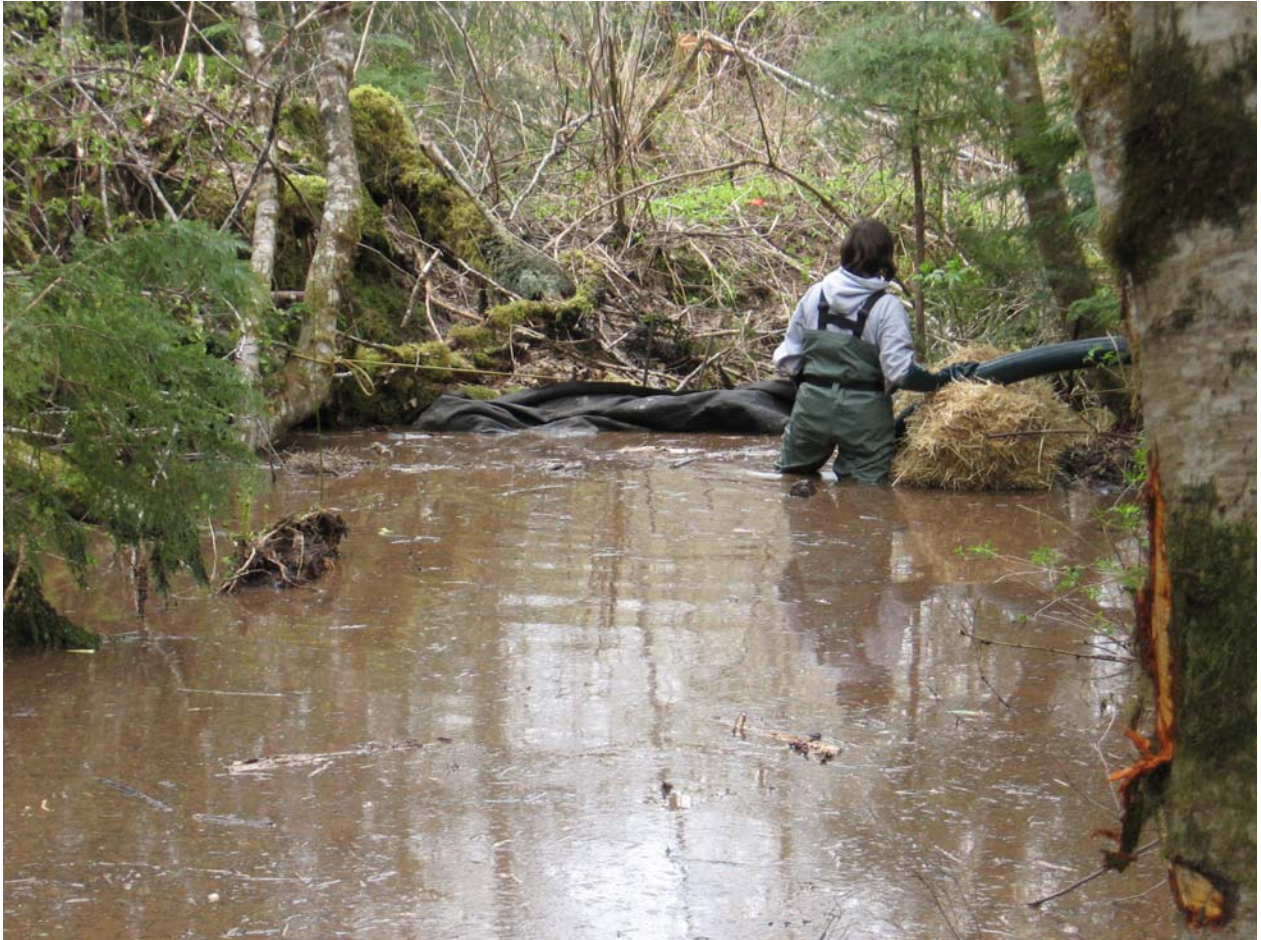
Figure 4. Installation of a silt fence to trap sediment during construction.

David Taft from Cambria Gordon Ltd. provided environmental monitoring services for the project. At the downstream end of the excavated channel, three silt dams were constructed from straw bales with rebar supports and filter cloth covering in order to prevent sediment-laden water from

entering Scully South and to exclude fish from the site during construction. Each silt dam was placed approximately 10m downstream from each other with the final dam located approximately 20m upstream from the confluence of the channel with Scully South. Two - 3 inch pumps were employed in a pool created upstream from the first silt dam to pump silt-laden water into the adjacent forest and away from the creek. Pumps and silt dams were maintained throughout construction and the dams were left in the creek at the end of the November excavation to collect any remaining silt that might be mobilised during winter/spring high water events.

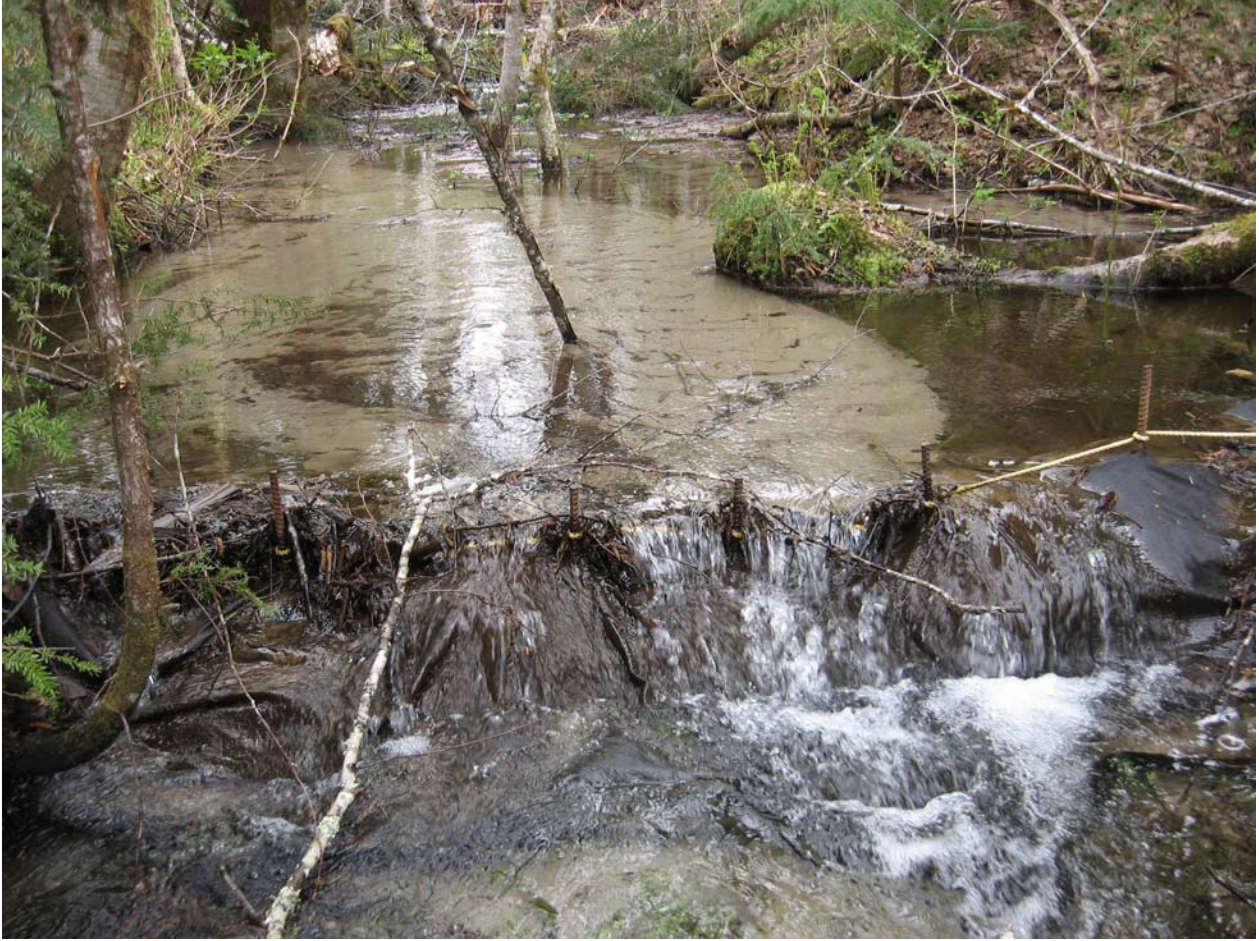
Figure 5. One of three silt fences installed with accumulated sediment Trapped upstream.

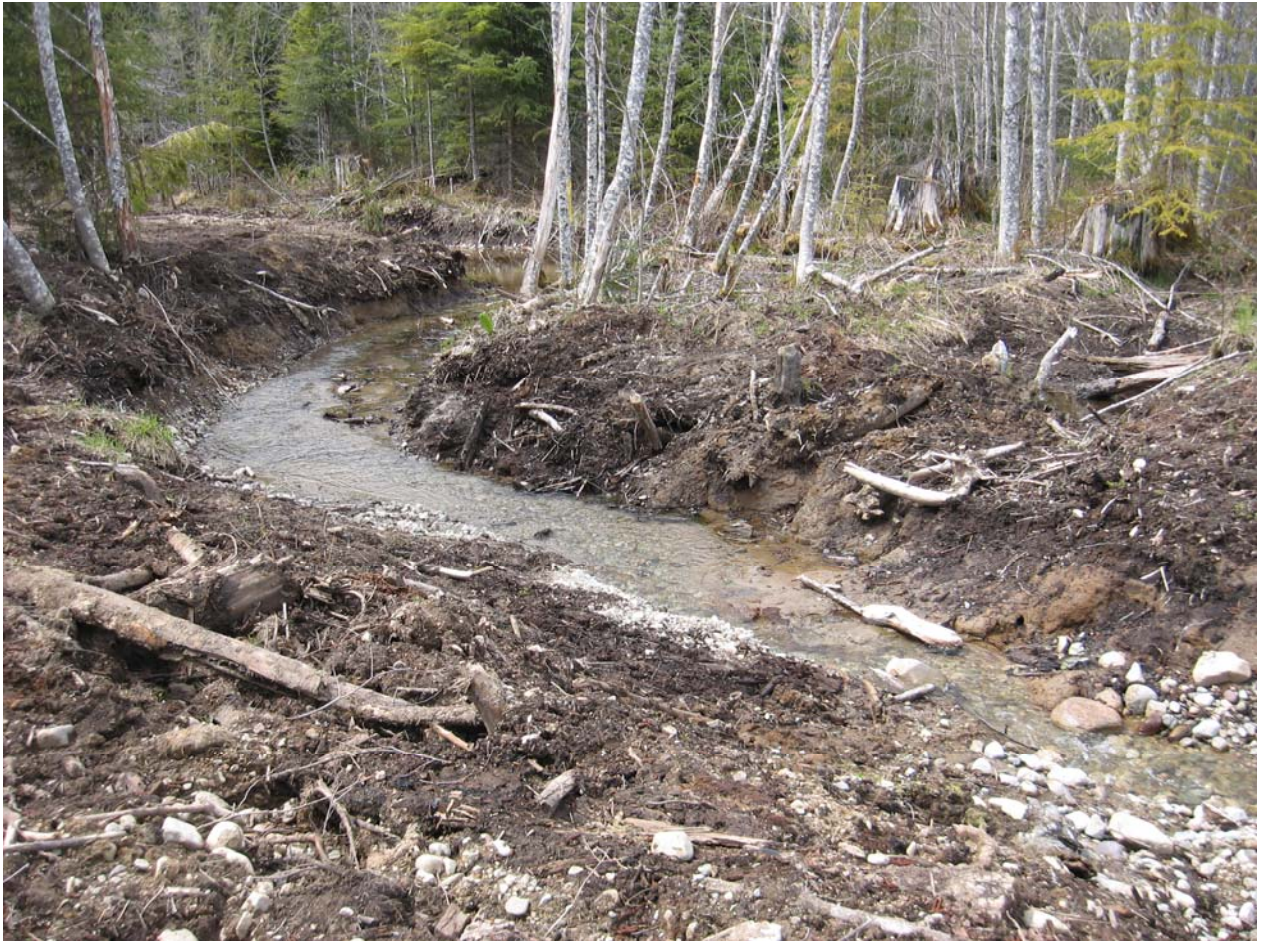
Figure 6. Excavated channel with disturbed banks requiring seeding and planting.

After dam installation, a ~200m long channel was constructed from the dam opening to Scully South using a John Deere 200 CL excavator from Nechako Northcoast. The channel was excavated 2-3 meters deep and 1-4 meters wide. Three pools were excavated in the channel to provide varied habitat. Excavated materials were side-cast into the adjacent forest and onto the existing old logging road and stream banks were sloped 1:1.5 to try to prevent sloughing. The

excavator walked down the constructed channel as it was excavated in order to preserve the greatest amount of riparian vegetation. The site was then left for the winter with plans to complete environmental work such as silt dam removal, planting, seeding and site clean-up work in the spring.

Native grass seed mix and conifers have been purchased; however, the disturbed areas still need to be seeded and planted. This will be completed by DFO and volunteers from the Lakelse Watershed Society in the summer of 2007.

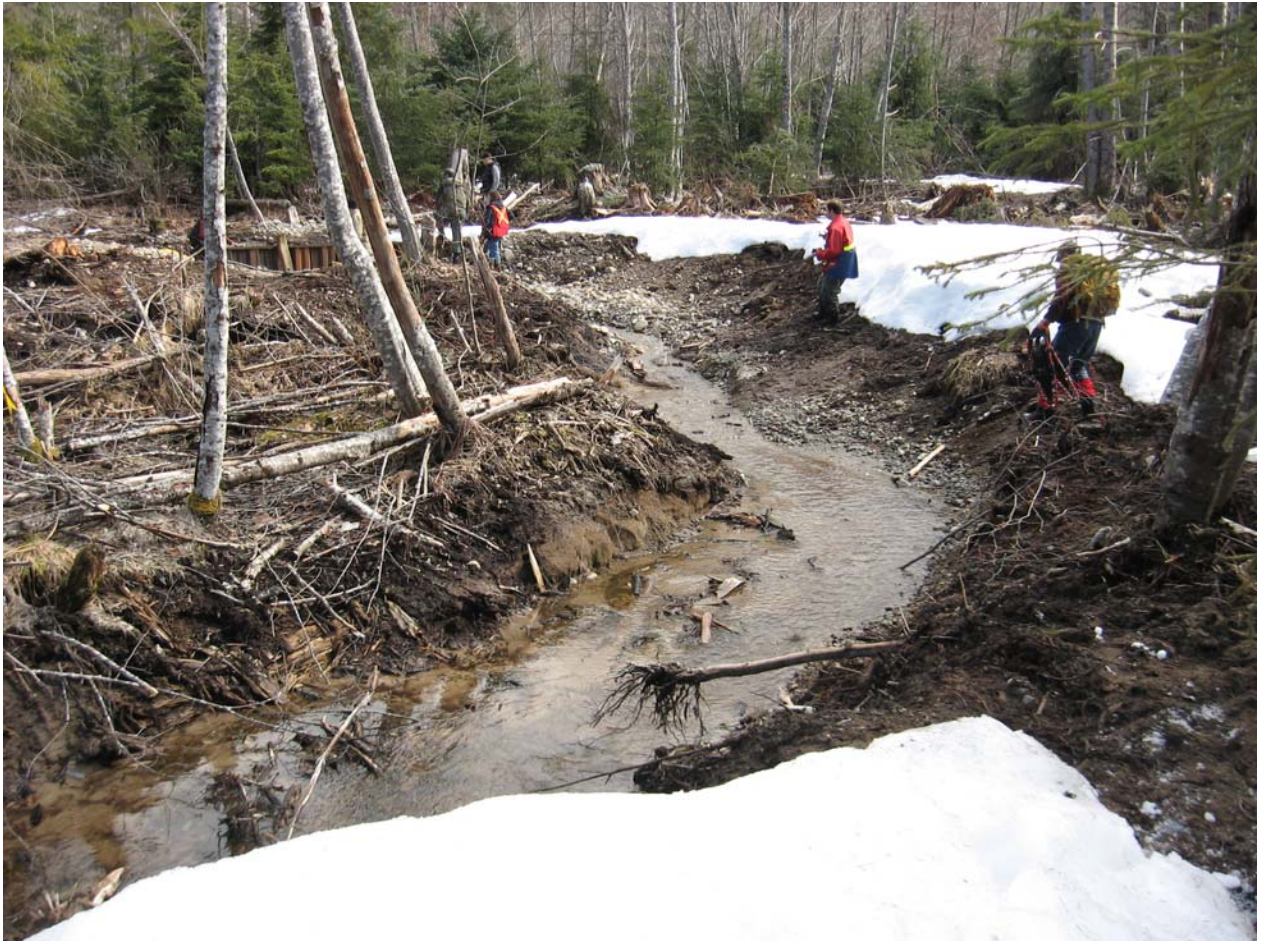
***Figure 7. April 2007 site visit with DFO, LWS and Cambria Gordon Ltd staff.
Upper groundwater channel.***

In April 2007, a site visit with the DFO Resource Restoration staff, members of the Lakelse Watershed Society and Cambria Gordon Ltd. was conducted to determine the remaining tasks required to complete the project. Several items were identified and the project budget and scope were reviewed and discussed with PSC.

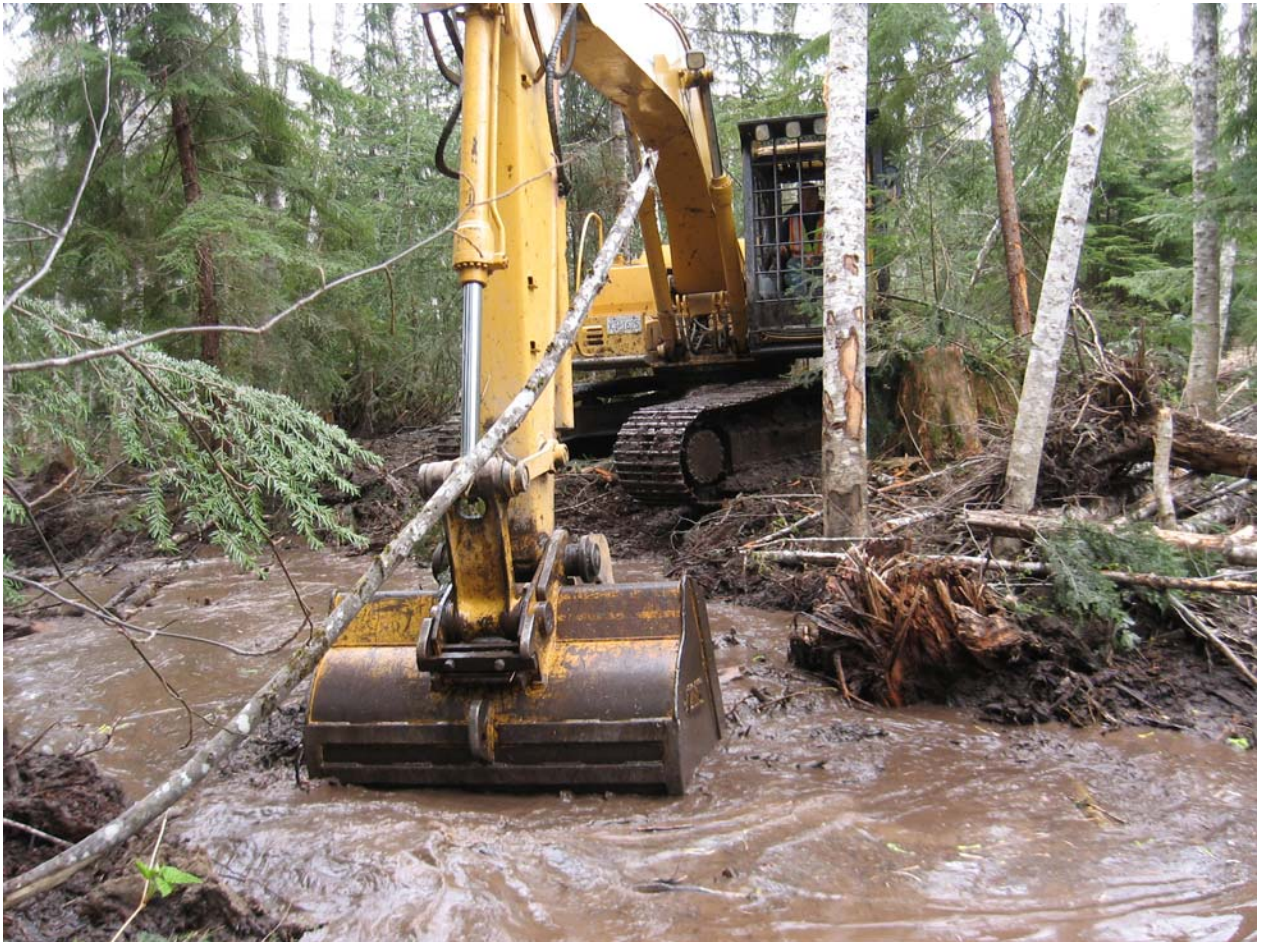
Figure 8. Fine sediment removal in the downstream end of the groundwater channel.

In May 2007, a second channel approximately 30 meters in length was excavated to capture additional groundwater flows and to connect an old established spring to the channel excavated in November, 2006. A fourth silt dam was installed downstream from the three that remained from the November construction. The three upstream dams and accumulated fine sediment were removed with the excavator in May 2007. A leak through which high water flows escaped from the excavated channel and flowed through the old logging road was contained. Large logs were placed at the ford to discourage/prevent All Terrain Vehicle (ATV) disturbance to the spawning areas near or at the ford.

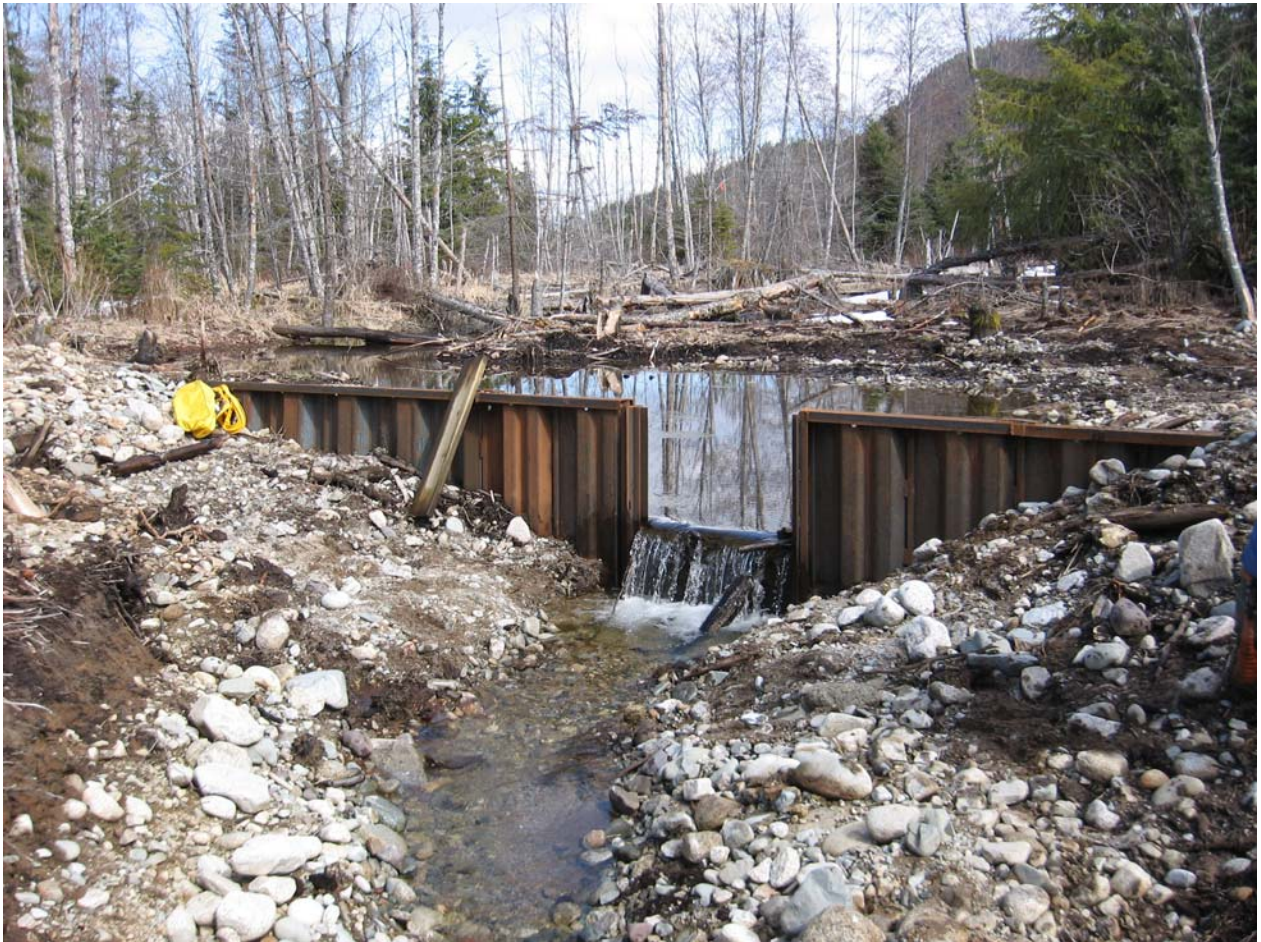
Figure 9. Installed sheet pile dam with two stop logs in place.

In the fall of 2006, a 3mm thick sheet pile dam was fabricated at Johnny's Welding in Terrace, BC. The piling was purchased from Armtec in 1/2 X 5meter sheets and delivered from Langley, BC, by Bandstra Transportation to Johnny's Welding in Terrace, BC. The sheets were welded together to form the dam with a finishing piece of steel welded across the top and a stop log slot welded in place for an outlet. The final dam was approximately 18m wide by 5m deep with a notch for stop log control approximately 1m wide by 1.2m deep. The excavator carried the finished dam from the highway to the dam site at the upstream end of the excavated channel within the wetland area of the Scully Creek fan. A trench was dug and the dam was lowered into the trench and braced laterally. The dam top was set with a survey level and then back filled with local material.

In November 2006, a sheet pile dam with a stop log outlet was installed to store water and control flow from a portion of the wetland area in the Scully Creek watershed.

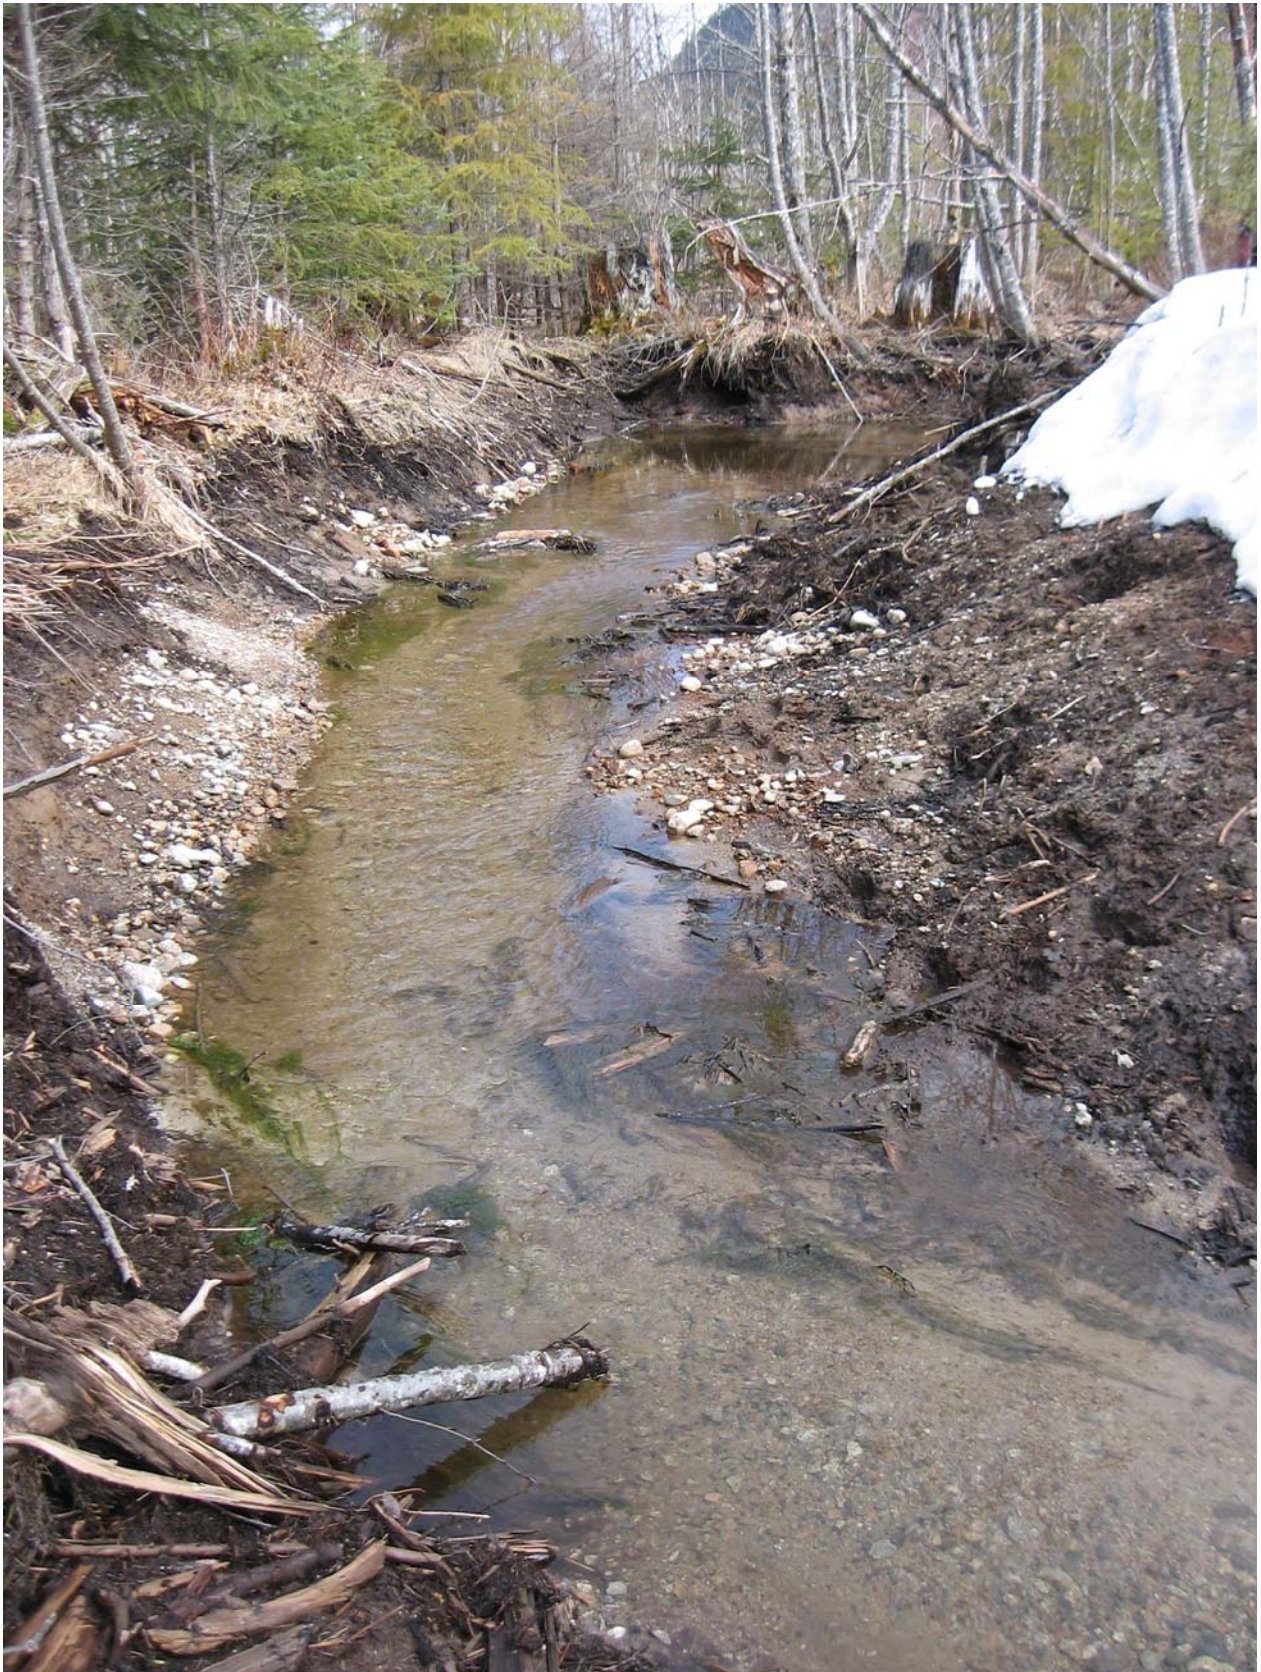
Significant groundwater and some suitable spawning gravels were accessed during the excavation of a 200m long channel from the dam to Scully South.

Figure 10. This photo shows natural gravel deposits encountered during channel excavation.

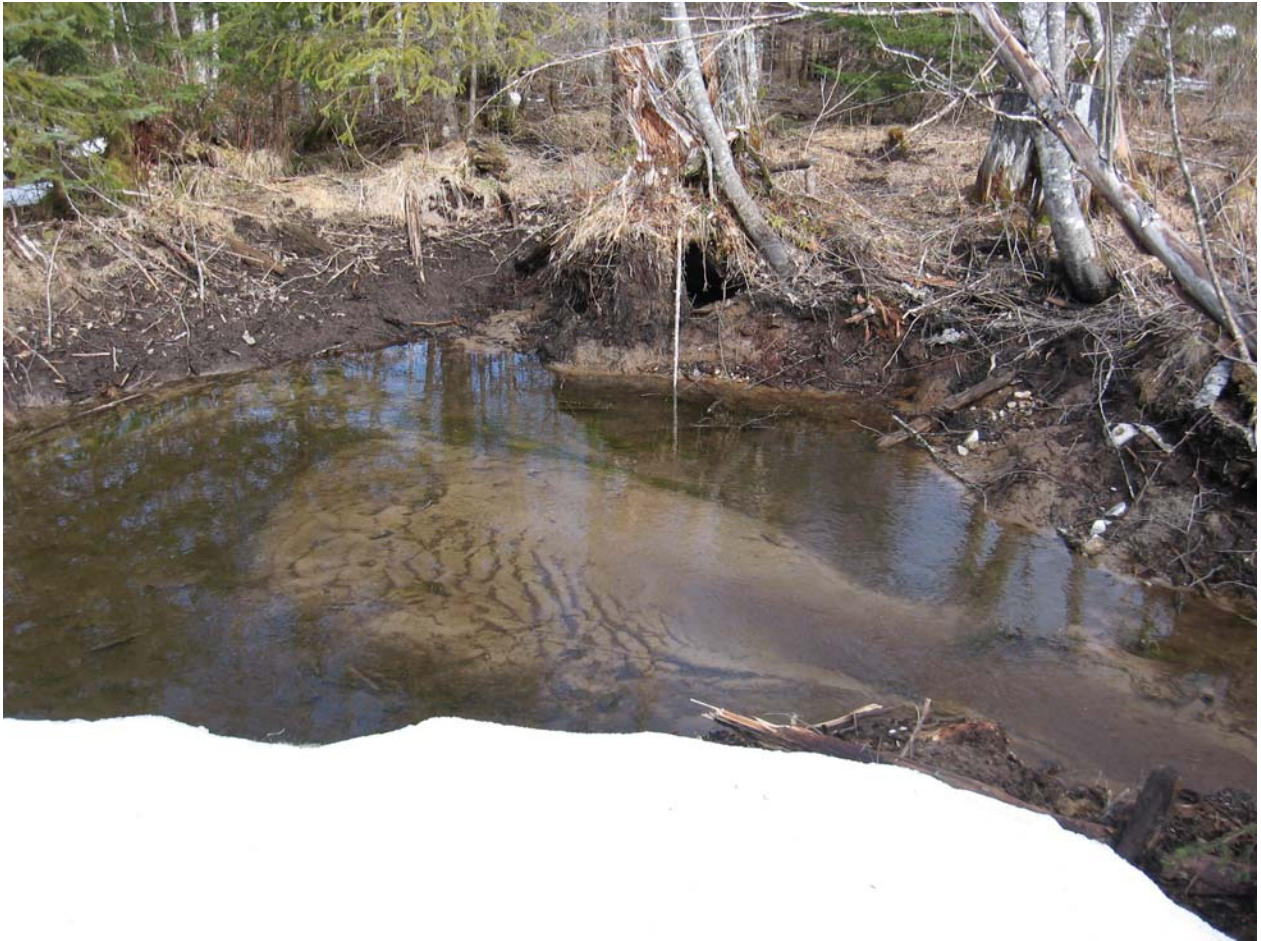
Some areas of fine sediment were also encountered, making it difficult for channel features such as pools and stable stream banks to be created and also for the excavator to manoeuvre. The delayed construction timing coincided with heavy fall rains and a high water table, which made channel excavation and water management difficult and contributed to the decision to only install one of the sheet pile weirs.

Figure 11. A pool constructed in an area of fine sediment in November, 2007, has infilled with sediment.

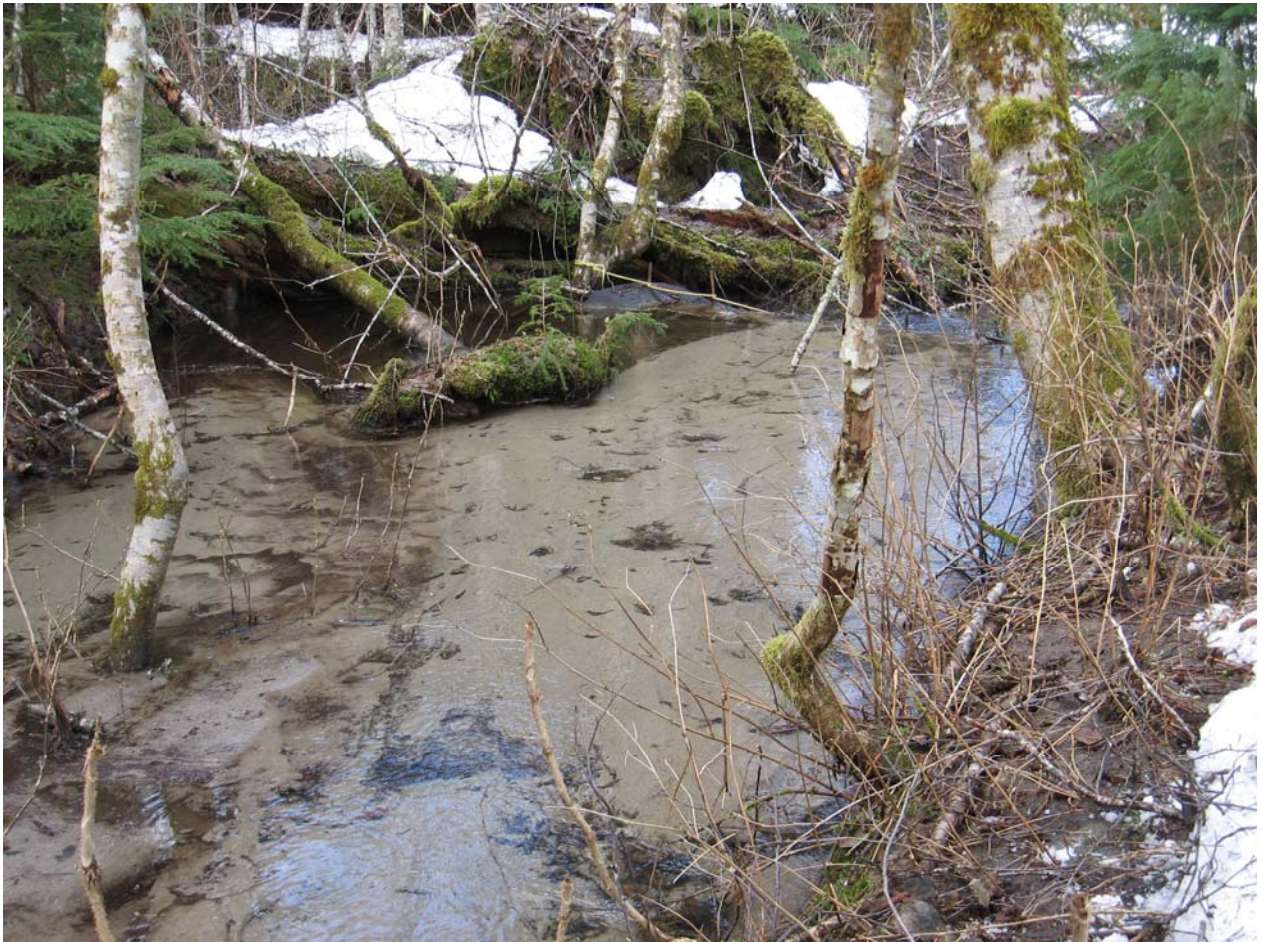
Figure 12. April 2007 site visit. Accumulated sediment upstream from the three sediment fences at the downstream end of the groundwater channel.

In April 2007, a site visit with the DFO Resource Restoration staff, members of the Lakelse Watershed Society and Cambria Gordon Ltd. was conducted to determine the remaining tasks required to complete the project. Several items were identified, including:

- the mechanical removal of silt that had accumulated upstream of each of the three silt dams at the downstream end of the project;
- removal of the silt dams;
- plugging a leak through which high water flows escaped from the excavated channel and flowed through the old logging road;
- connecting an upstream wetland 'spring' to the excavated channel to increase flows; and,
- planting and seeding the disturbed area with native seed and conifers.

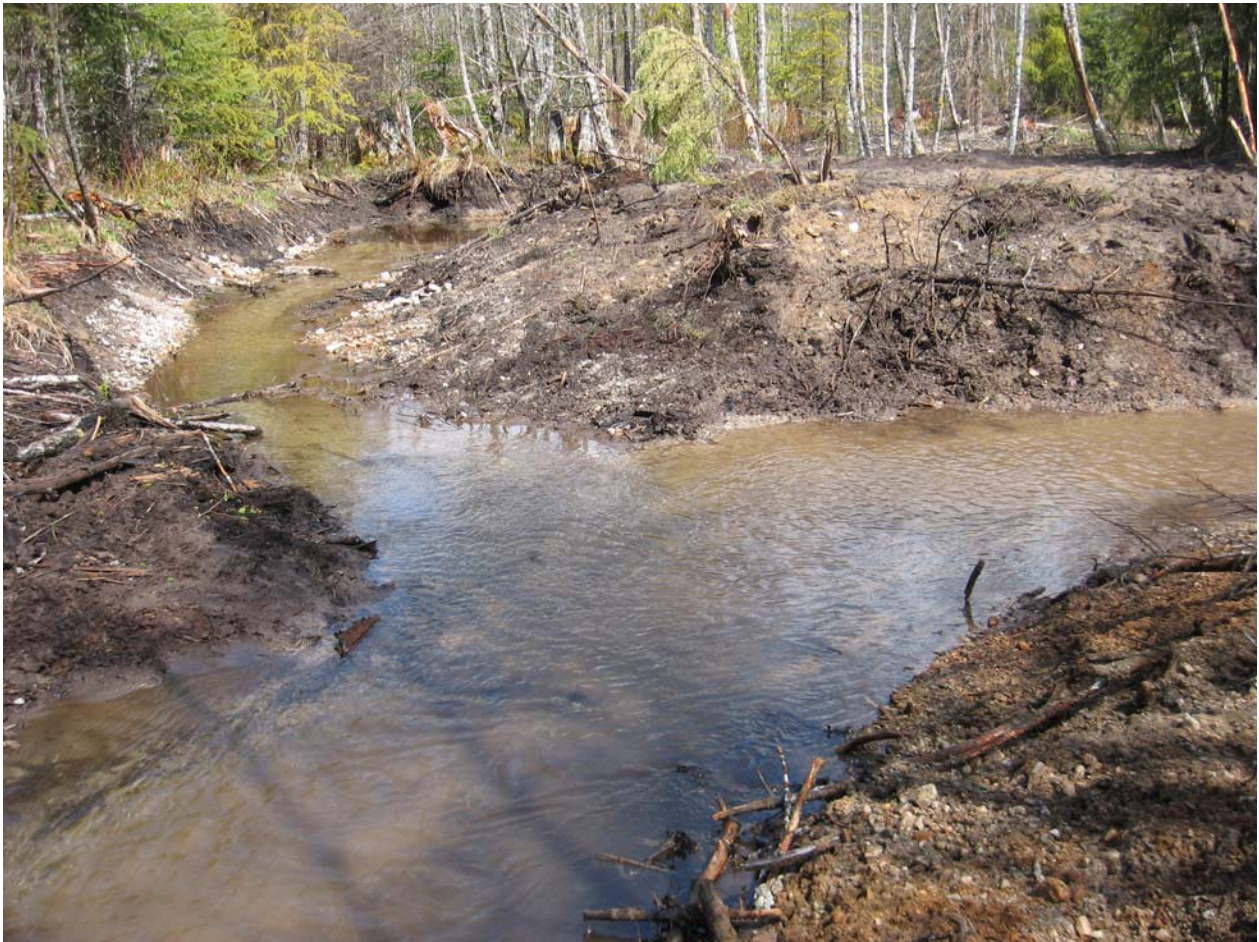
Figure 13. The newly excavated channel (May 2007) flows in the groundwater channel excavated in November 2006, doubling flows.

The project proceeded to complete final components in May 2007. A second channel approximately 30 meters in length was constructed in order to harness additional groundwater flows and to connect an old established spring to the channel excavated in November, 2006. This second channel doubled the water flow in the constructed channel to Scully South. The fine sediment that had accumulated at the downstream end of the channel constructed in November was removed. The site was trimmed and prepared for planting. The high water 'leak' from the main channel under the existing road was blocked off and as the excavator demobilised, the large logs used from the stream crossing were placed at the ford to discourage/prevent ATV disturbance to the spawning areas at the ford.

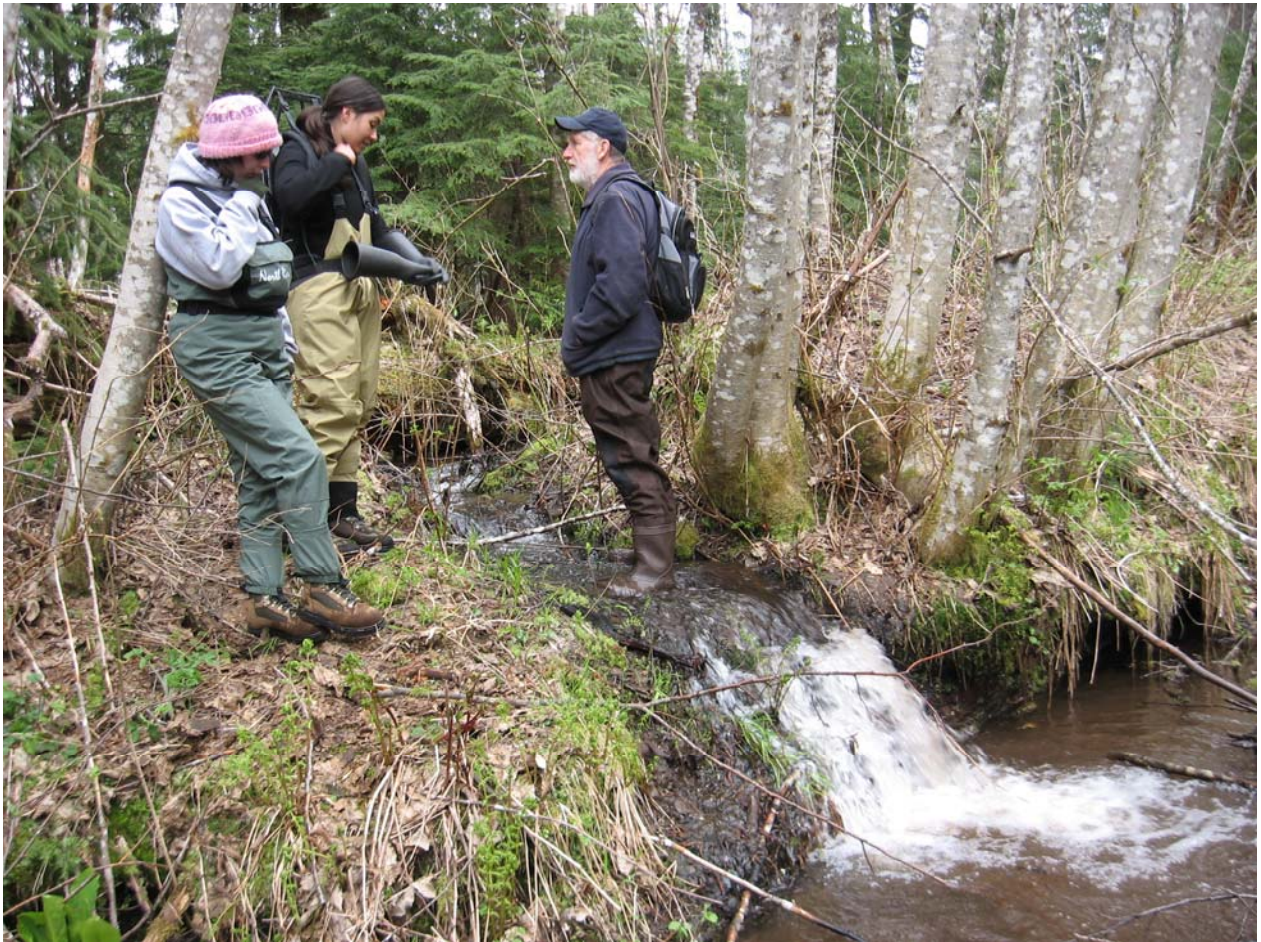
**Figure 14. The excavated groundwater channel outlet to Scully South.
Access to the channel will be improved in 2008.**

Fish access to the channel will be improved by hand work after the banks have had a season to rehabilitate and year-round flows have been assessed.
