## Variations in Success of Eelgrass Transplants over a Five-years' Period

PAUL G. HARRISON, PhD (Dalhousie)

Department of Botany, University of British Columbia, 3529-6270 University Boulevard,  
Vancouver, British Columbia V6T 2B1,  
Canada.

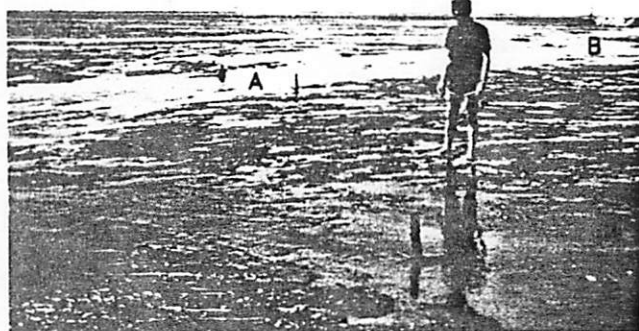
FIG. 1. Dendritic erosion channels in the Eelgrass bed at Robert Bank. The single stake in the foreground and the pair marked A indicate the landward extent of the channels in 1981. B marks the head of one channel in 1983. Distance from A to B is 20 m.

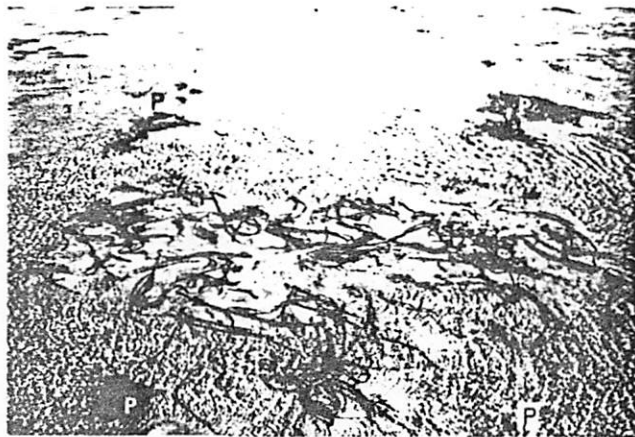
FIG. 4. A newly-established transplant plot marked by four posts (P). Distance between adjacent posts is 2 m.

rhizomes and roots (Fig. 3). At the transplant site, plots (1 x 2 m) were subdivided into 32 sections, and a hole was dug in each section to accommodate one core. The core was gently shaken out of the can into a hole, and packed securely in place with the excavated sediment (Fig. 4).
