# Fish Passage Assessment of Highway 16 and CN Rail in the Bulkley Watershed

**Tim Wilson & Ken Rabnett**  
**Skeena Fisheries Commission**  
**March 2007**

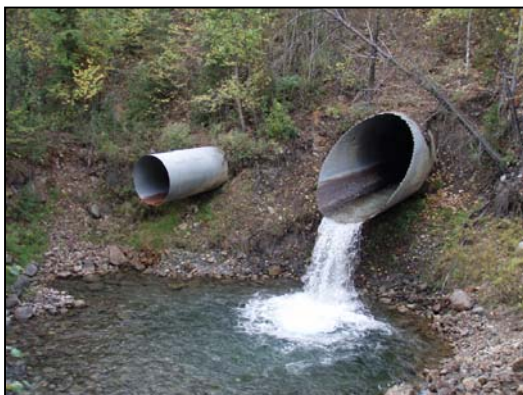
**Figure 2. View upstream of Porphyry Creek culvert outlet**

Channelization and installation of culverts blocking or hindering fish passage are seen at numerous locations along the rail line and highway. An example of a perched culvert can be found at the Highway 16 crossing of Porphyry Creek. Both Waterfall and Station Creeks near New Hazelton have had a history of habitat alterations related to railroad and highway construction, and more recently to changes in New Hazelton's water supply and sewage disposal systems (Remington 1996). Coho salmon and steelhead passage up Station Creek is blocked by the poorly installed Highway 16 culvert about 1.6 km above the Bulkley River; a subsequent 5 km of potential coho rearing upstream is inaccessible (DFO 1991c).

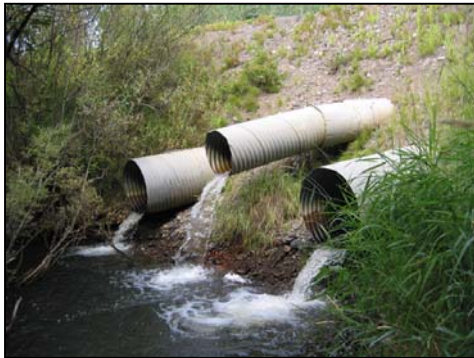
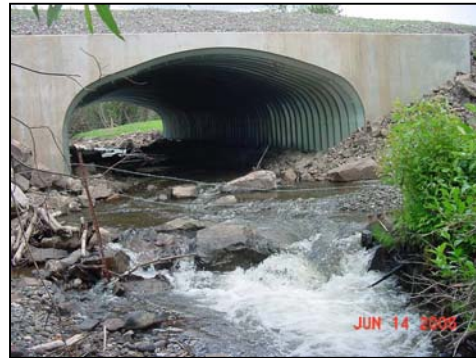
**Figures 3 & 4. Thompson Creek – Highway #16 crossing.**  
View on the left shows the Thompson Creek culvert outlets, which were replaced in 2004 with the steel plate arch on the right.

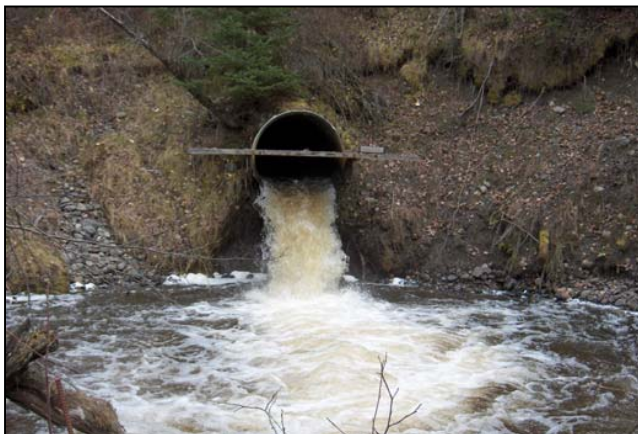
**Figure 7. Station Creek culvert with a 1.5 m outfall drop. This culvert passing under Highway 16 does not allow fish passage.**

Station Creek is the highest priority culvert to rehabilitate on Highway #16 within the Bulkley Watershed. This culvert issue has been noted by DFO as a serious hindrance to fish passage since at least 1975. The culvert is undersized according to Ministry of Transportation guidelines. In the event of an extreme flood, washout of the culvert and/or the adjacent CN Rail line would severely damage fish habitat downstream from the highway.

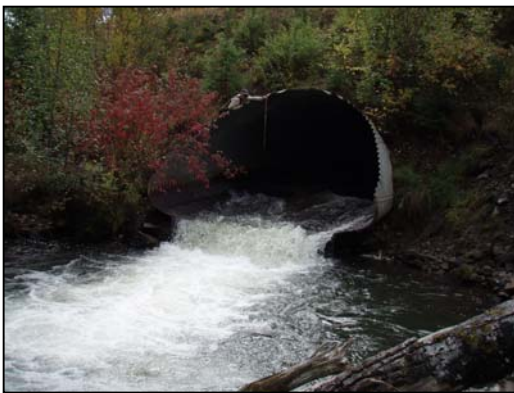
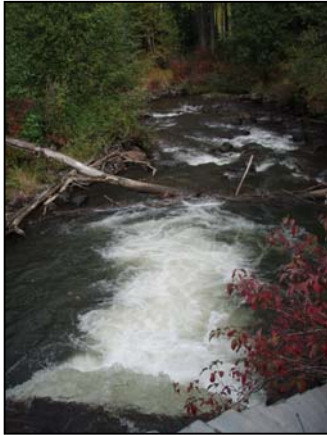
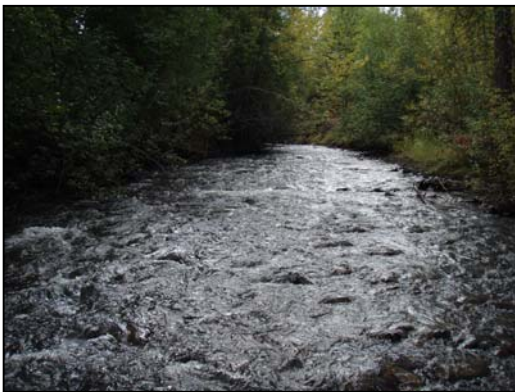
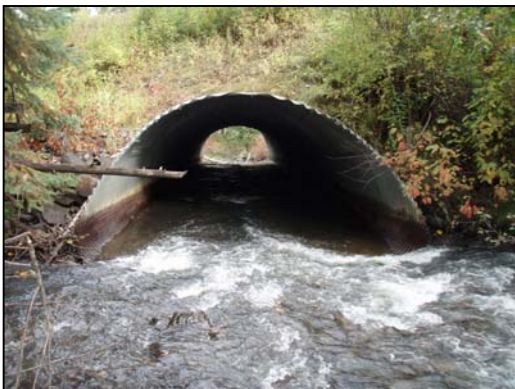
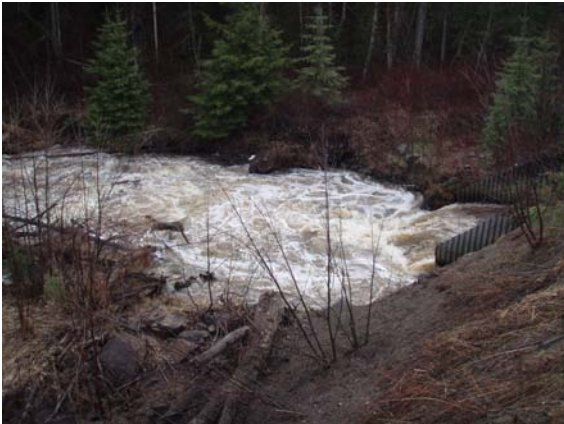
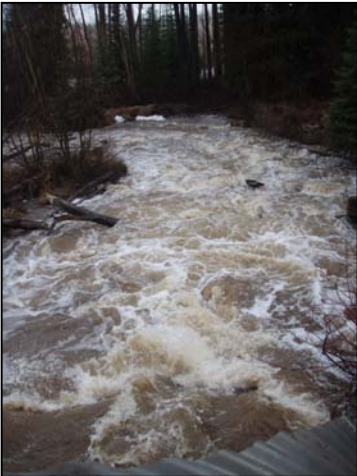
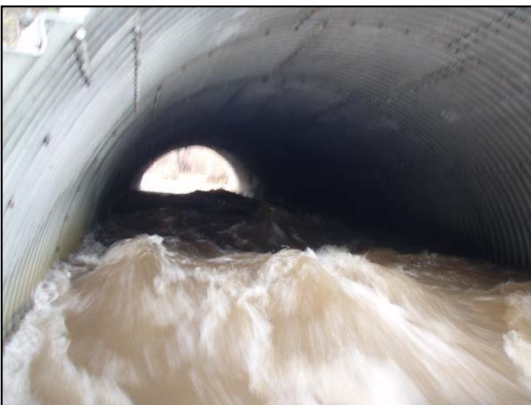
**Figure 23. View upstream of Toboggan Creek culvert outlet. Photo shows low flow conditions September 21, 2006.**

**Figure 24. View of Toboggan Creek culvert downstream.  
Photo shows low flow conditions September 21, 2006.**

**Figure 25. View of Toboggan Creek culvert upstream.  
Photo shows low flow conditions September 21, 2006.**

**Figure 26. View of Toboggan Creek culvert inlet downstream.  
Photo shows low flow conditions September 21, 2006.**

**Figure 27. View of Toboggan Creek culvert outlet. Photo shows high flow conditions May 04, 2007.**

**Figure 28. View of Toboggan Creek culvert outlet. Photo shows high flow conditions May 04, 2007.**

**Figure 29. View of Toboggan Creek culvert inside. Photo shows high flow conditions May 04, 2007. Culvert water velocity averaged 3.37 m/s.**

Toboggan Creek culvert rehabilitation is rated as a high priority fish passage restoration site due to its matrix score of 46 and the significant fisheries values. An open bottom arch or bridge structure is recommended to alleviate fish passage problems.

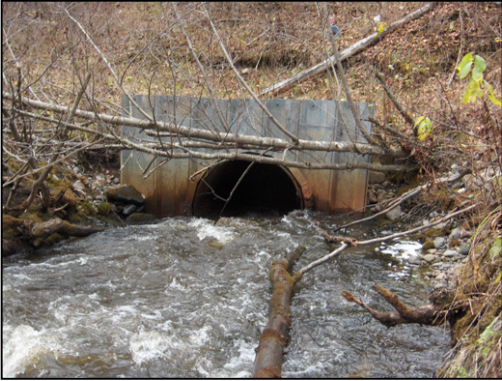
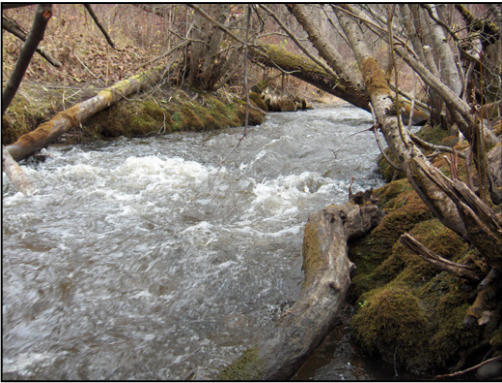
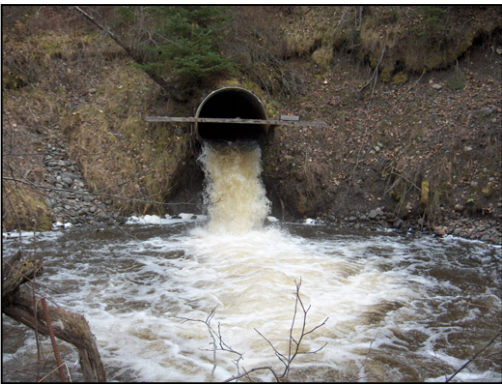
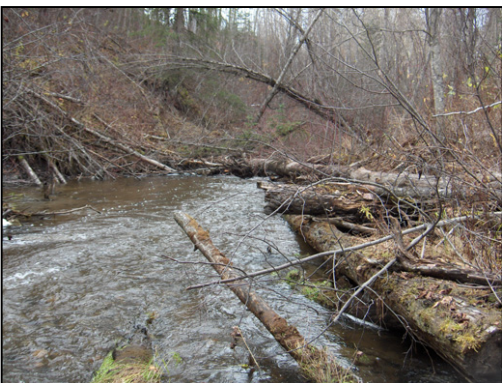
**Figure 30. Station Creek culvert inlet.  
View downstream to inlet.**

**Figure 31. Station Creek culvert inlet.  
View upstream from inlet.**

**Figure 32. Station Creek culvert outlet.  
View upstream of outlet.**

**Figure 33. Station Creek culvert outlet.  
View downstream from outlet.**

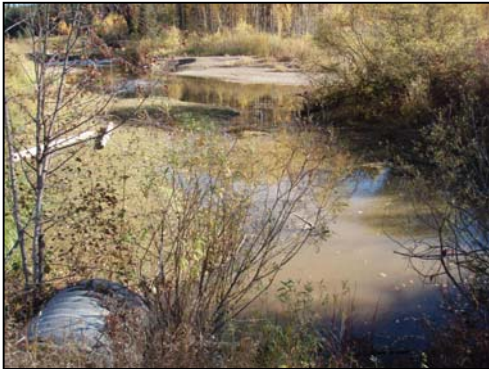
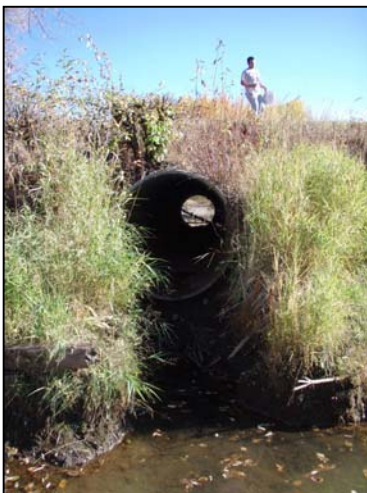
**Figure 34. Bulkley Oxbow 1 culvert inlet.  
View upstream.**

**Figure 36. Bulkley Oxbow 1 culvert outlet.  
View upstream of culvert outlet.**

Bulkley Oxbow 1 is an approximately 800 m in length abandoned channel that lies between Highway #16 and CN Rail. It is located 100 m east of the Raspberry Creek - CN Rail crossing. Coho and steelhead presence within the oxbow has been confirmed and chinook presence is inferred. The oxbow potentially represents high quality and productive overwintering habitat. The only culvert passing under the CN Rail grade is positioned at the eastern end of the oxbow. The 1700 mm culvert was 1.35 m in height above the Bulkley River during low flows. A habitat and juvenile presence/absence assessment needs to be conducted to determine the extent of productive habitat and the nature and stability of the flow regime. The results of these assessments will then determine if restoration work is appropriate.

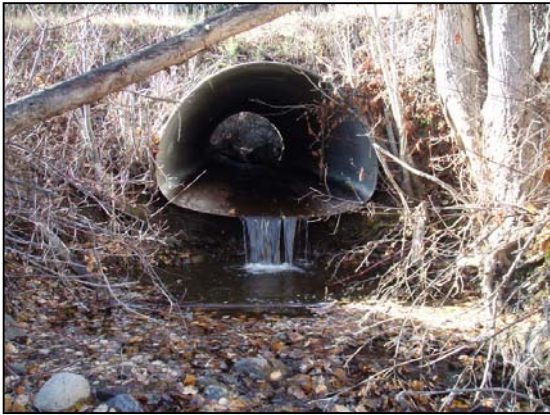
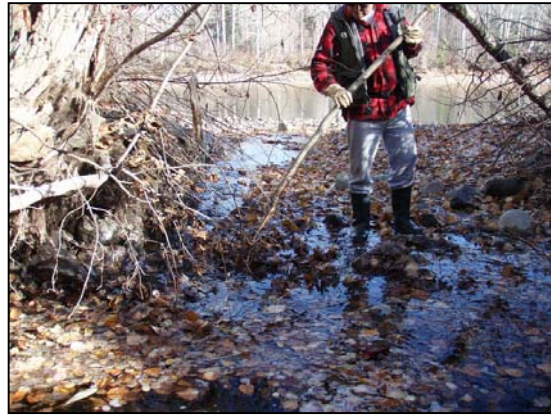
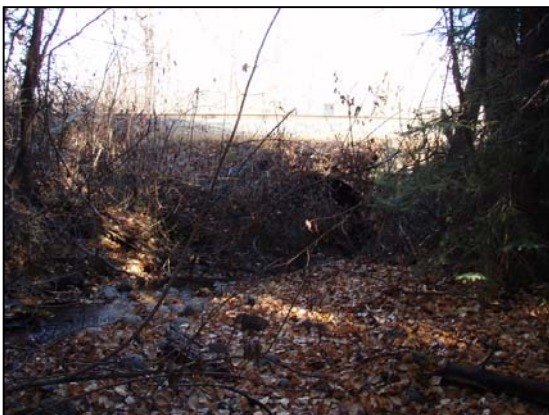
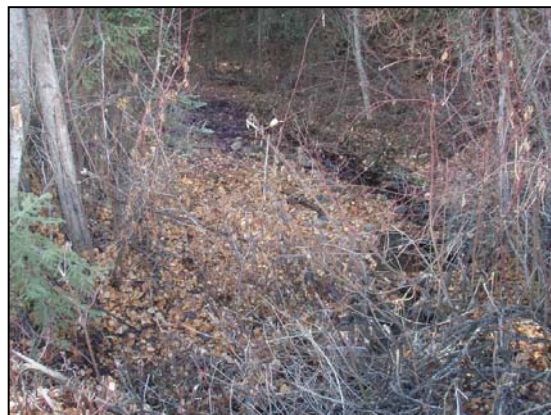
**Figure 37. Moan Creek culvert outlet.  
View upstream of culvert outlet.**

**Figure 38. Moan Creek culvert outlet.  
View downstream from culvert outlet with  
Bulkley River in the background.**

**Figure 39. Moan Creek culvert inlet.  
View downstream to culvert inlet**

**Figure 40. Moan Creek culvert inlet.  
View upstream from culvert inlet**

The site was visited twice due to low flow conditions. The 2700 mm elliptical multiplate culvert is located 15 m from the Bulkley River, has an outfall drop of 57 cm and an outfall pool depth of 34 cm at low flow conditions. This is limiting to juvenile and adult fish. It is suspected that spring snowmelt freshets generate excessive culvert discharge with high flow velocities that have contributed to scouring downstream of the culvert. Installation of an open bottom structure is recommended. The site is rated a high restoration priority.

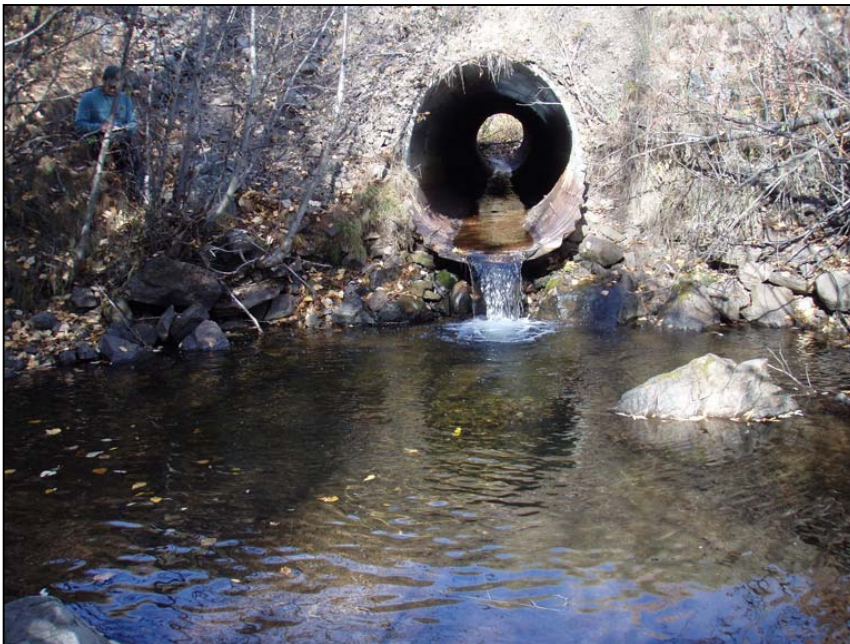
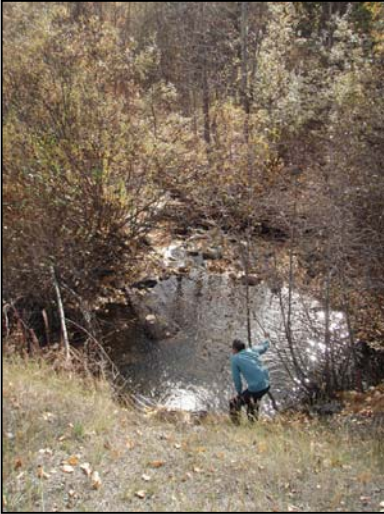
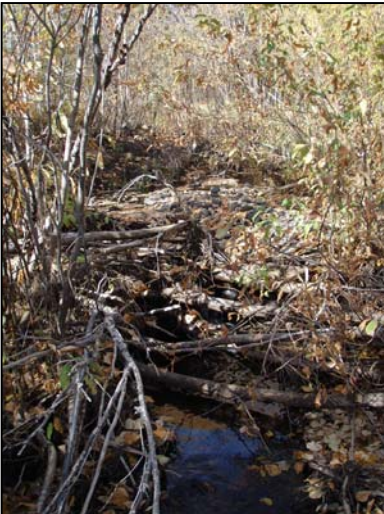
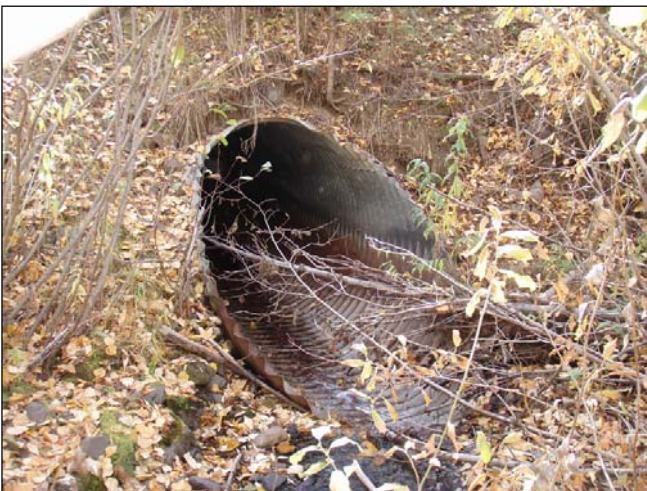
**Figure 41. Johnny David Creek culvert outlet.  
View upstream of culvert outlet.**

**Figure 42. Johnny David Creek culvert outlet.  
View downstream from culvert outlet.**

**Figure 43. Johnny David Creek culvert inlet.  
View upstream from culvert inlet.**

**Figure 44. Johnny David Creek culvert inlet.  
View downstream to culvert inlet.**

In addition, backwater steps could potentially infill with sediment transported in high flows. Overall, the Johnny David crossing is a partial barrier to adult and juvenile fish passage due to the outfall drop and high velocity at various flow regimes. Johnny David Creek culvert restoration is rated high priority with a matrix score of 46. Establishing a series of pools to step up to a deep outfall pool that acts to backwater the culvert is recommended.

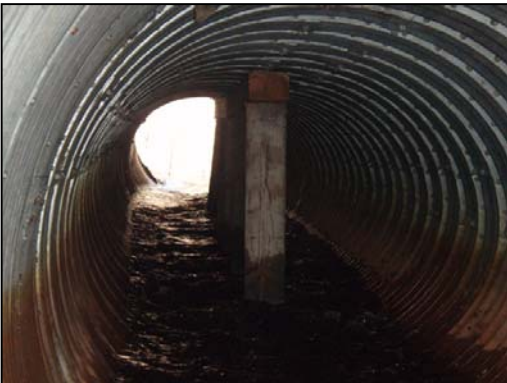
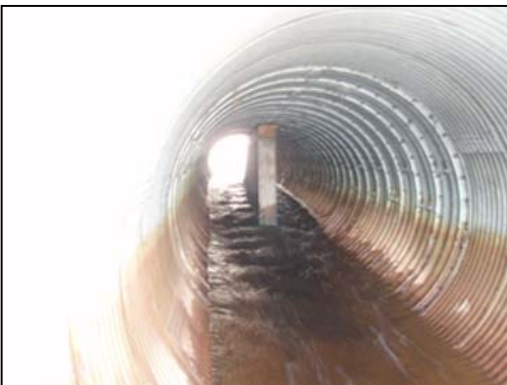
**Figure 49. Glass Creek culvert interior.  
View downstream from culvert inlet  
showing sag and support beams.**

**Figure 50. Glass Creek culvert interior.  
View upstream from culvert outlet  
showing support beams.**

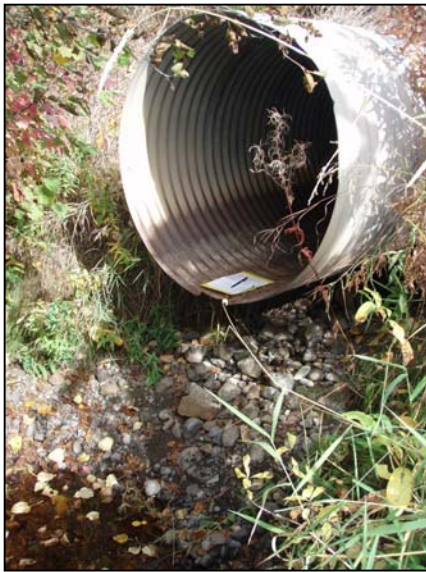
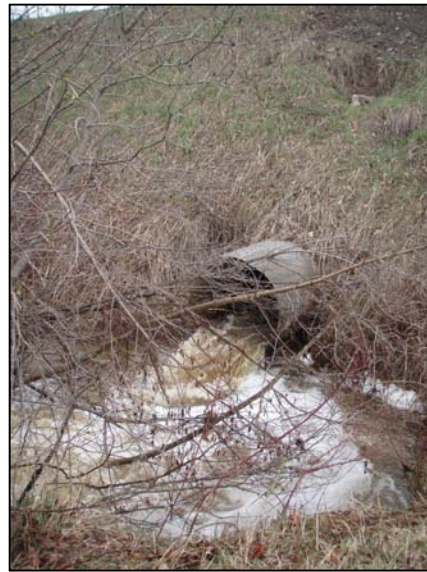
Figure 51. McDowell Creek culvert outlet. Photo shows late summer dry flows.

Figure 52. McDowell Creek culvert outlet in high flows. Note hillslope slump above culvert.

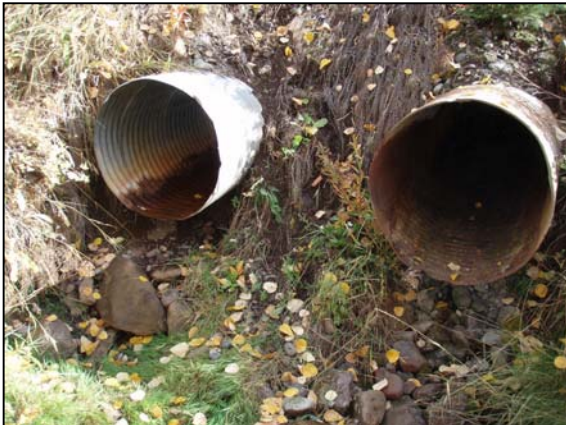
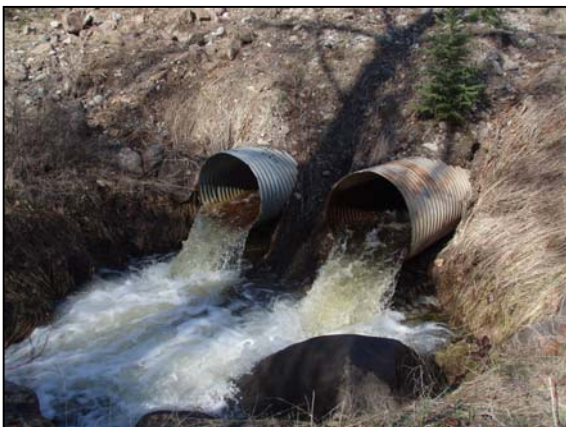
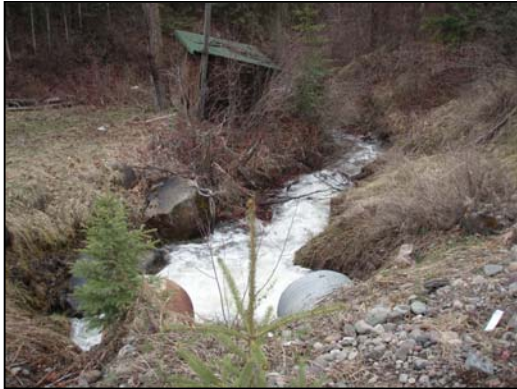
**Figure 57. Tyhee Creek culvert outlets.  
Outlets in late September, 2006.**

**Figure 58. Tyhee Creek culvert outlets.  
View upstream of outlets in spring, 2007.**

**Figure 59. Tyhee Creek culvert outlets.  
View downstream to outlets in high water, spring, 2007.**
