**Reconnaissance (1:20,000)**  
**Fish and Fish Habitat Inventory**  
**of Unnamed Tributaries to the**  
**Southwest Shore of Babine Lake,**  
**South of Topley Landing**  
**(South Fulton Planning Area)**

**WSC 480-705800 to 480-776600**  
**Volume 2 of 2**

### **Reach Cards/Site Cards/Fish Collection Forms and Photographs**

**(Sites 366 to 953)**

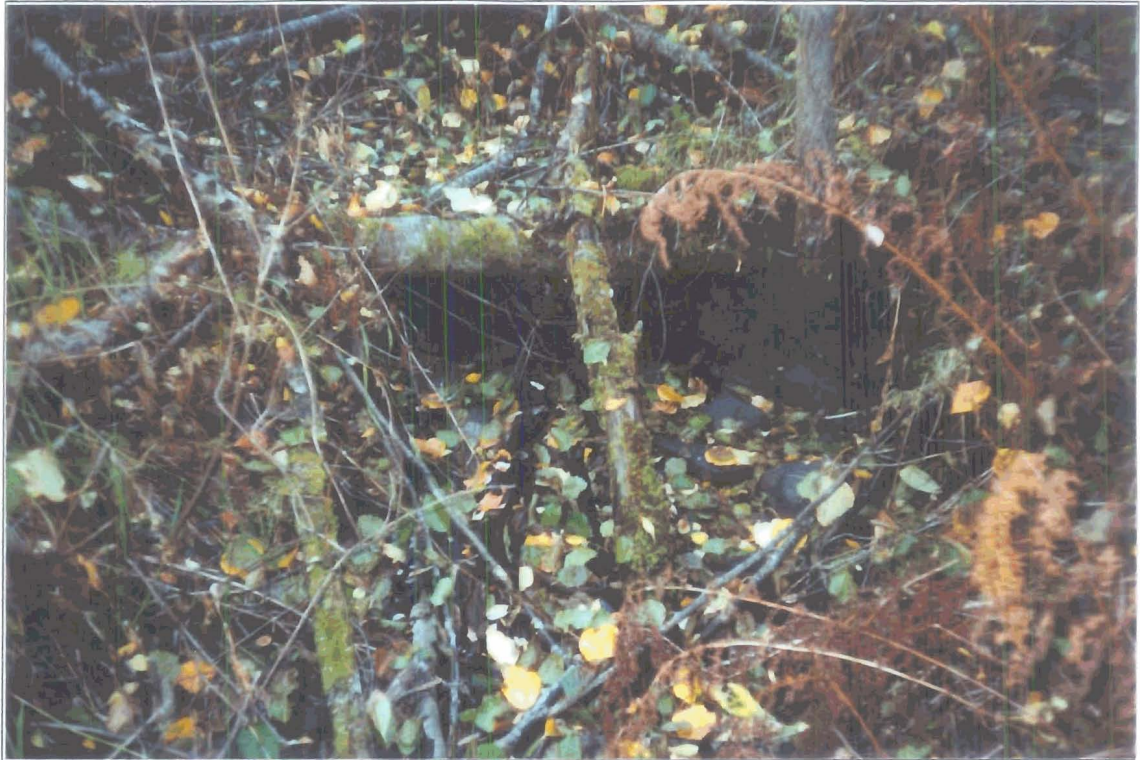
Site #366, upstream photo of typical habitat within site.  
Roll #91, Frame #13, Date: 2001/10/04

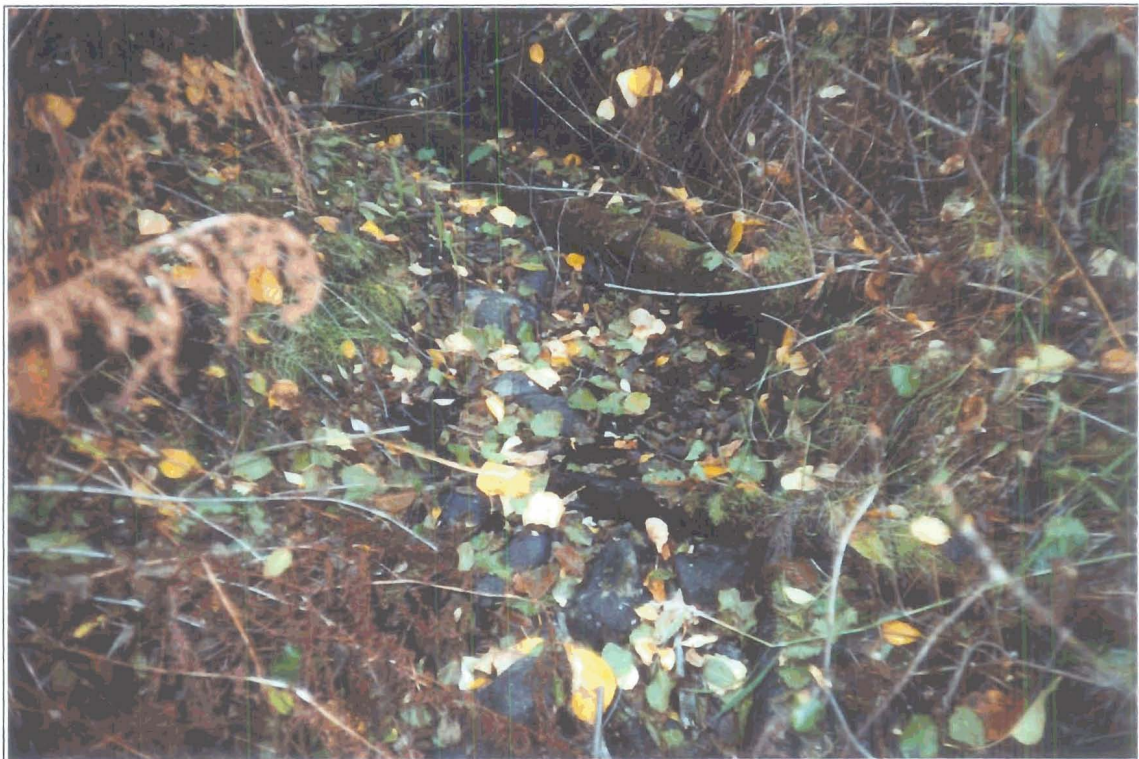
Site #366, downstream photo of typical habitat within site.  
Roll #91, Frame #14, Date: 2001/10/04

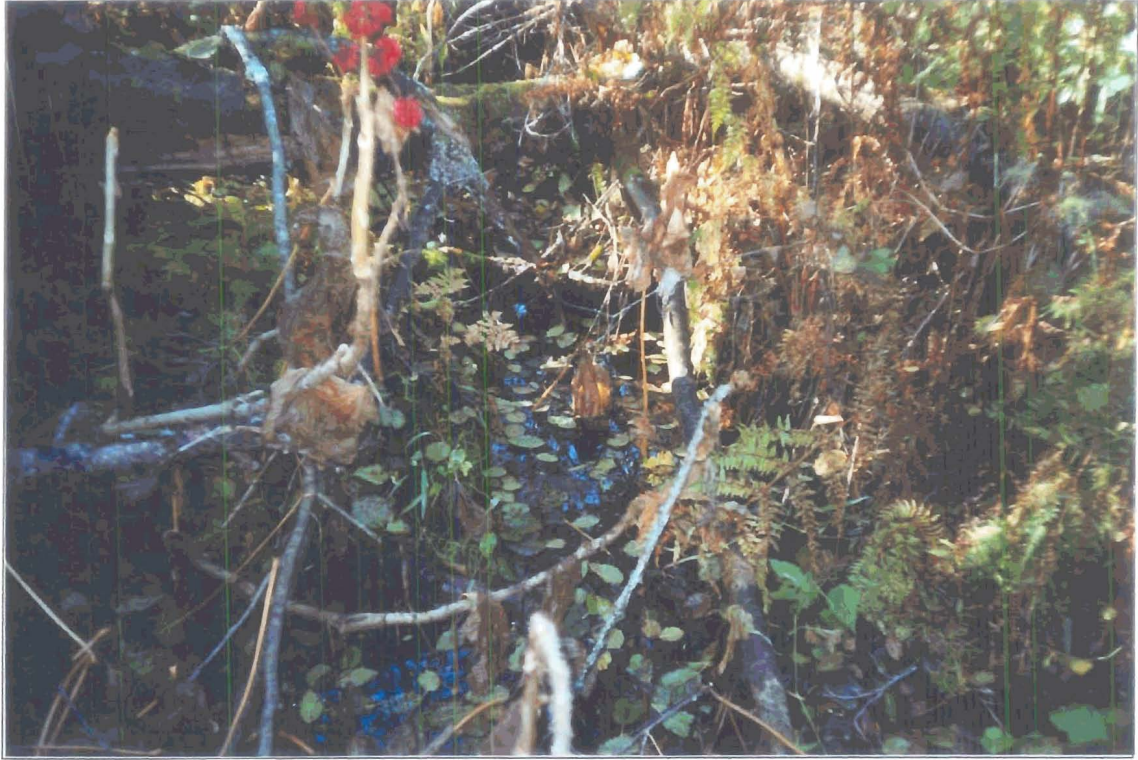
Site #367, upstream photo of overhanging vegetation observed within sample site.  
Roll #91, Frame #11, Date: 2001/10/04

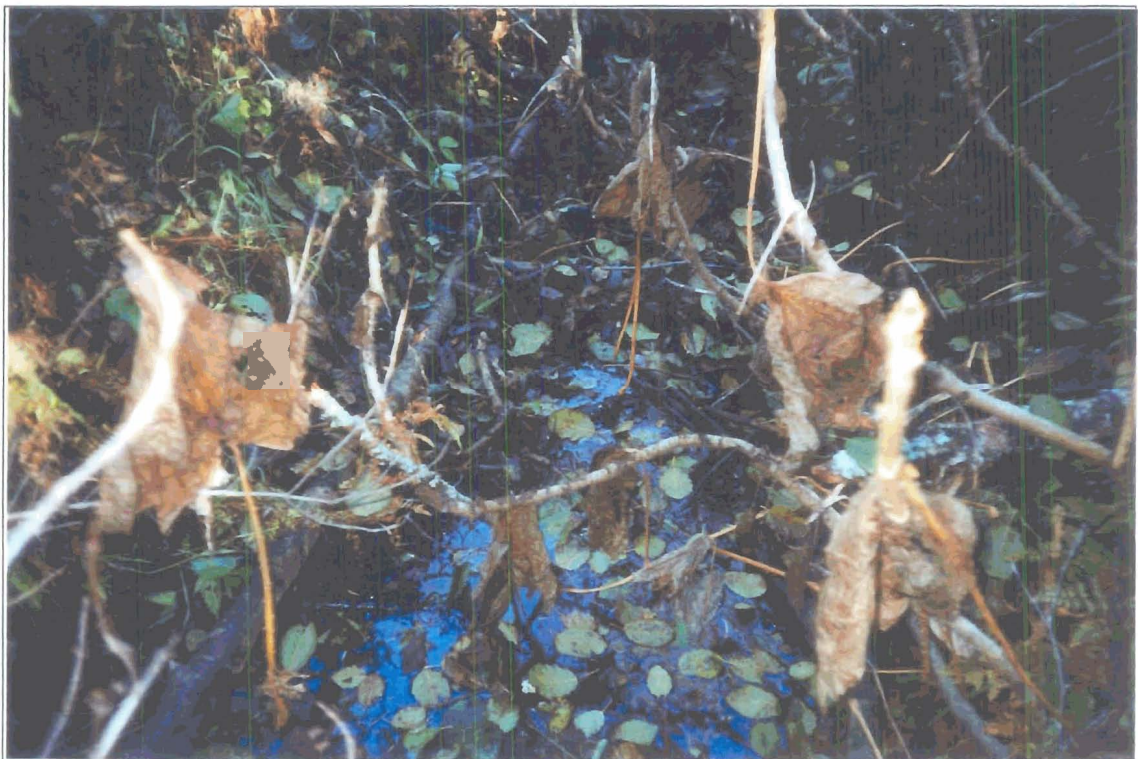
Site #367, downstream photo of typical channel observed within sample site.  
Roll #91, Frame #12, Date: 2001/10/04

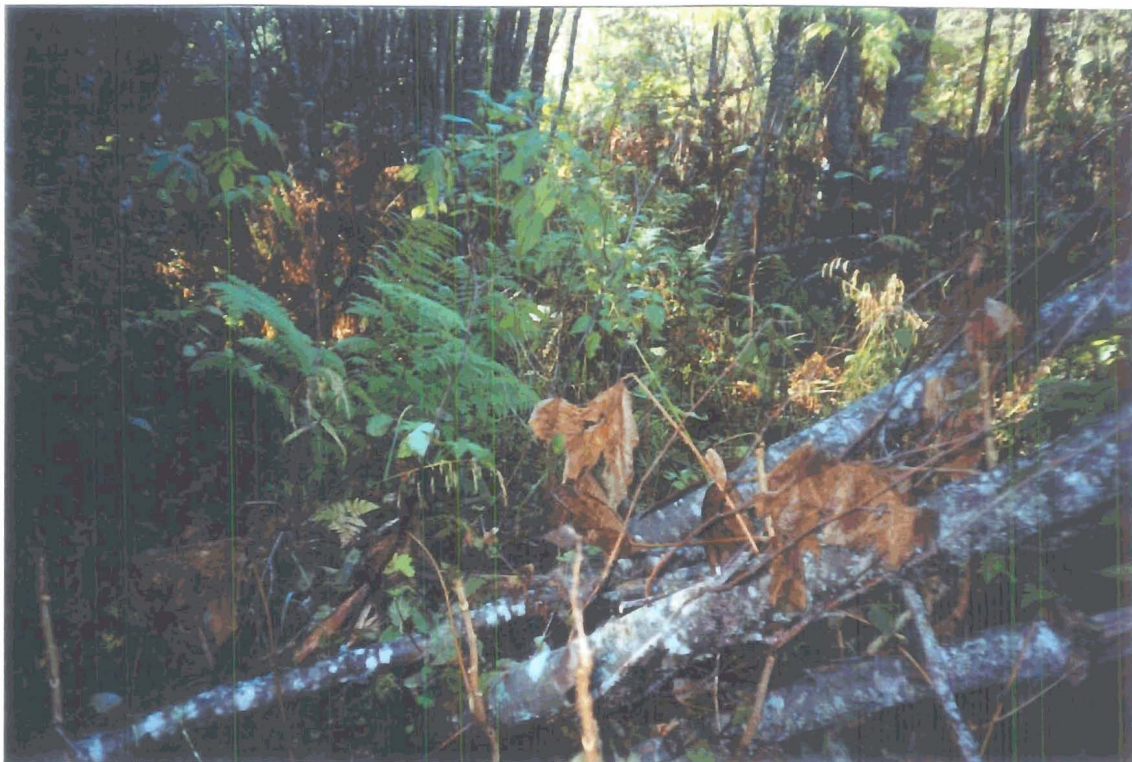
| COMMENTS | |
|---|---|
| CHANNEL | alder swirls were observed |

Site #368, upstream photo of vegetated depression within site.  
Roll #91, Frame #09, Date: 2001/10/04

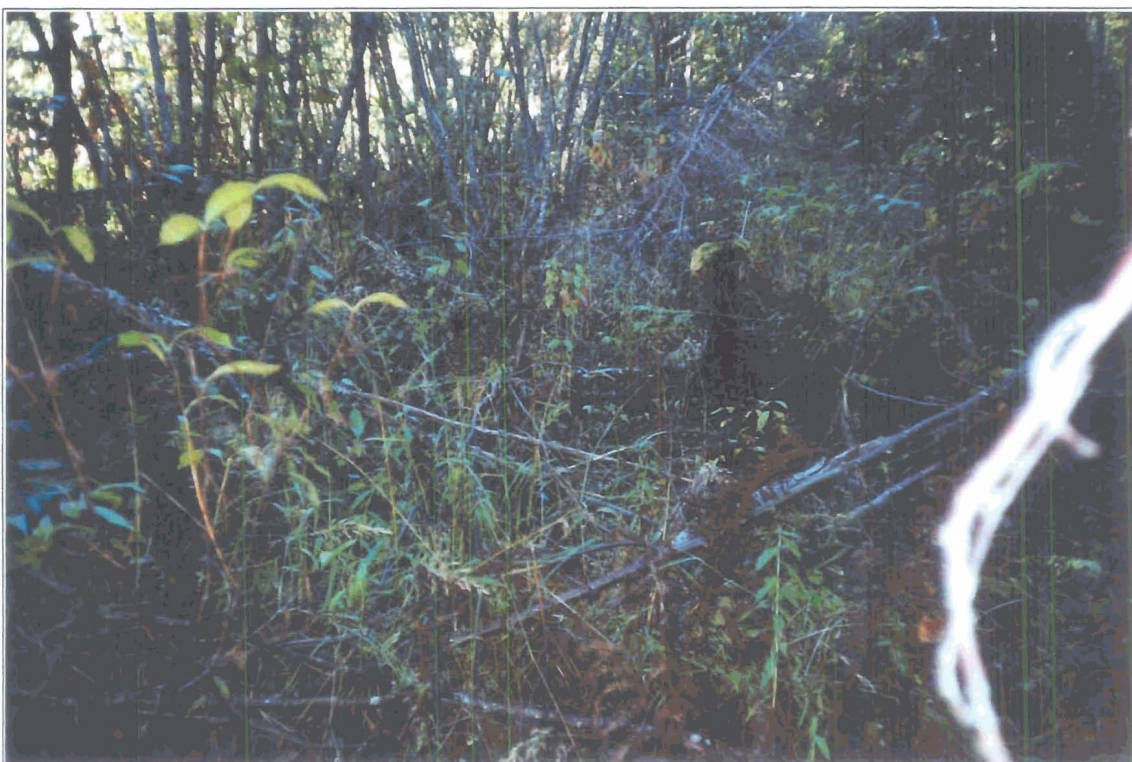
Site #368, downstream photo of typical vegetation observed within sample site.  
Roll #91, Frame #10, Date: 2001/10/04

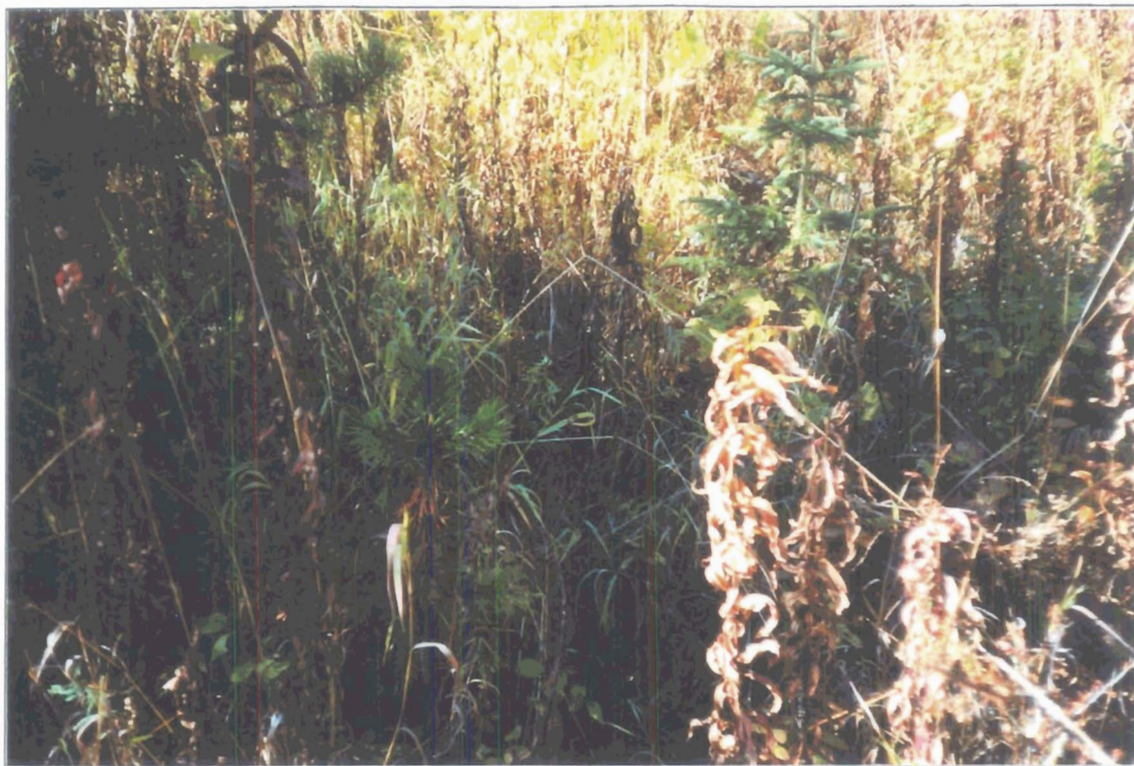
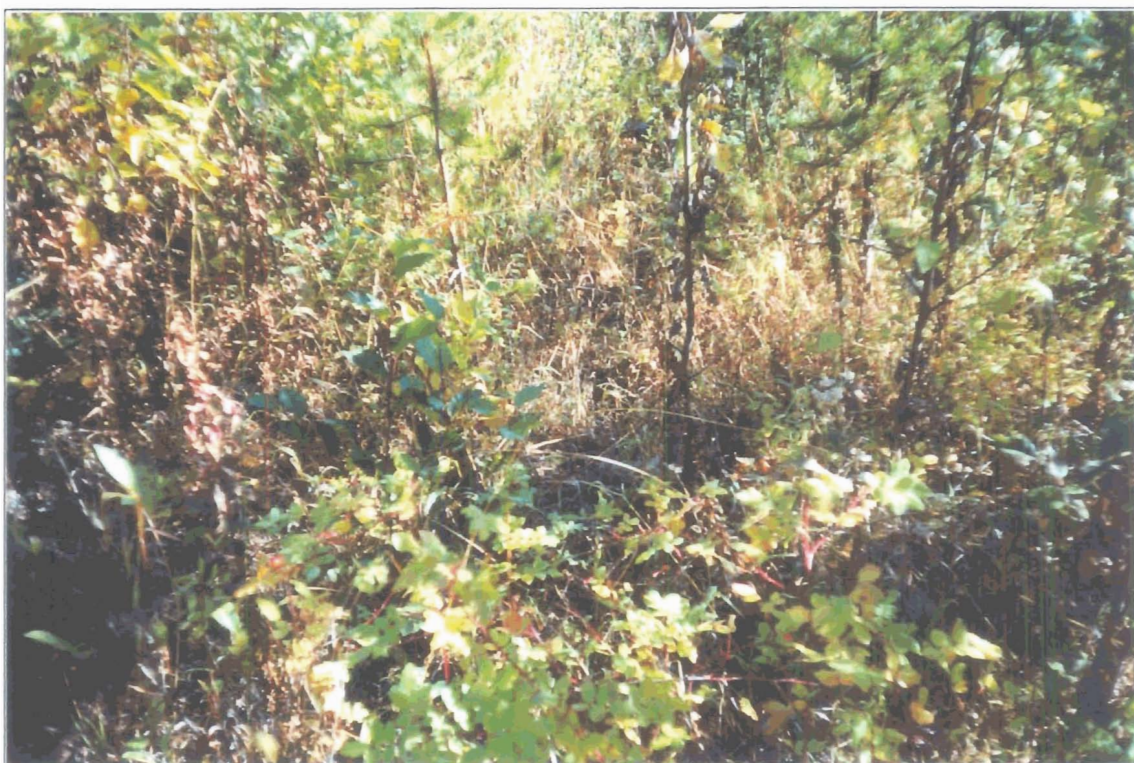
| COMMENTS | |
|---|---|
| CHANNEL | depression cuts through an old logging block |
| CHANNEL | immature pine, alder and twisted stalk was observed within depression |

Site #369, upstream photo of vegetated depression.  
Roll #91, Frame #07, Date: 2001/10/04

Site #369, downstream photo of vegetated depression.  
Roll #91, Frame #08, Date: 2001/10/04

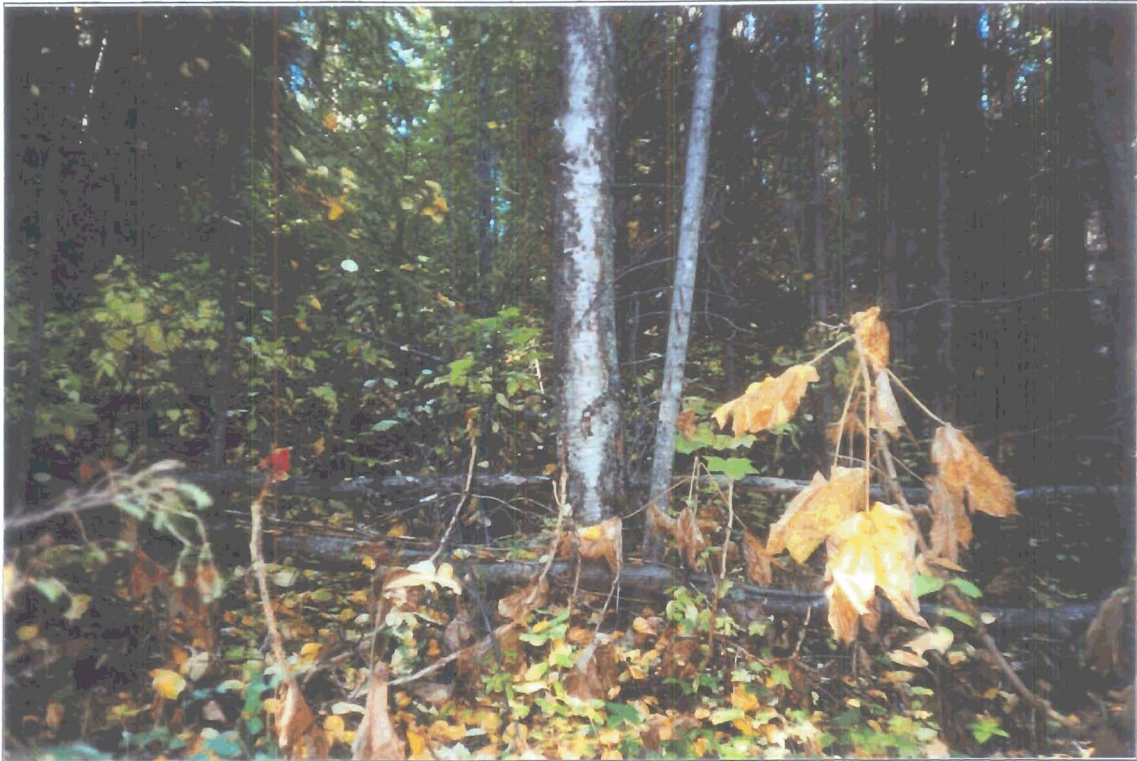
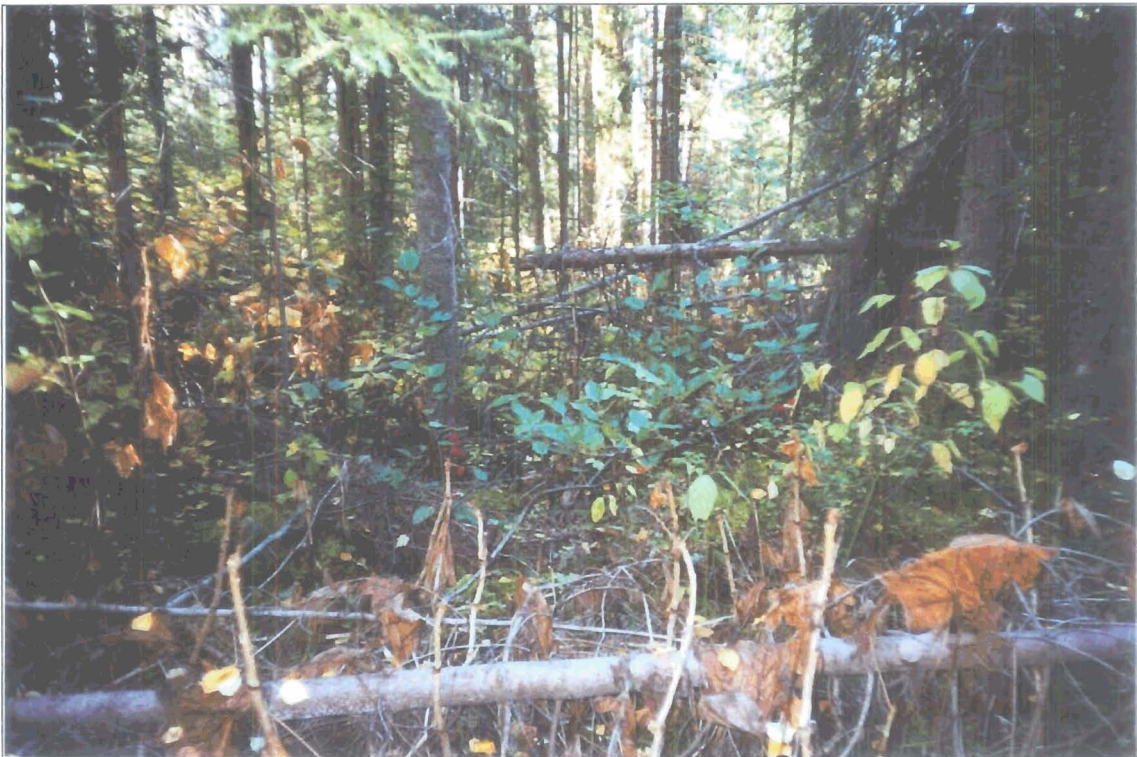
| COMMENTS | |
|---|---|
| CHANNEL | Heavily vegetated depression with devil's club, twisted stalk found in abundance |

Site #370, upstream photo of typical vegetated depression found within site.  
Roll #91, Frame #05, Date: 2001/10/04

Site #370, downstream photo of typical vegetated depression found within site.  
Roll #91, Frame #06, Date: 2001/10/04

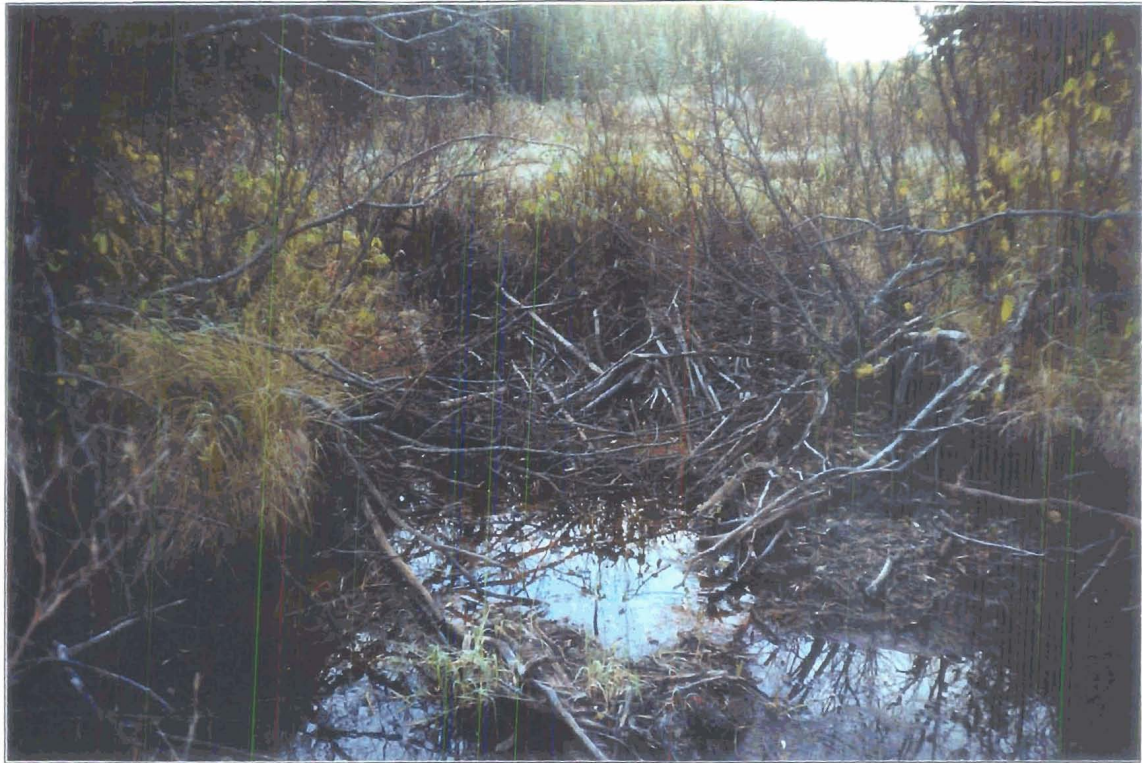
Site #371, photo towards beaver dam.  
Roll #91, Frame #21, Date: 2001/10/05

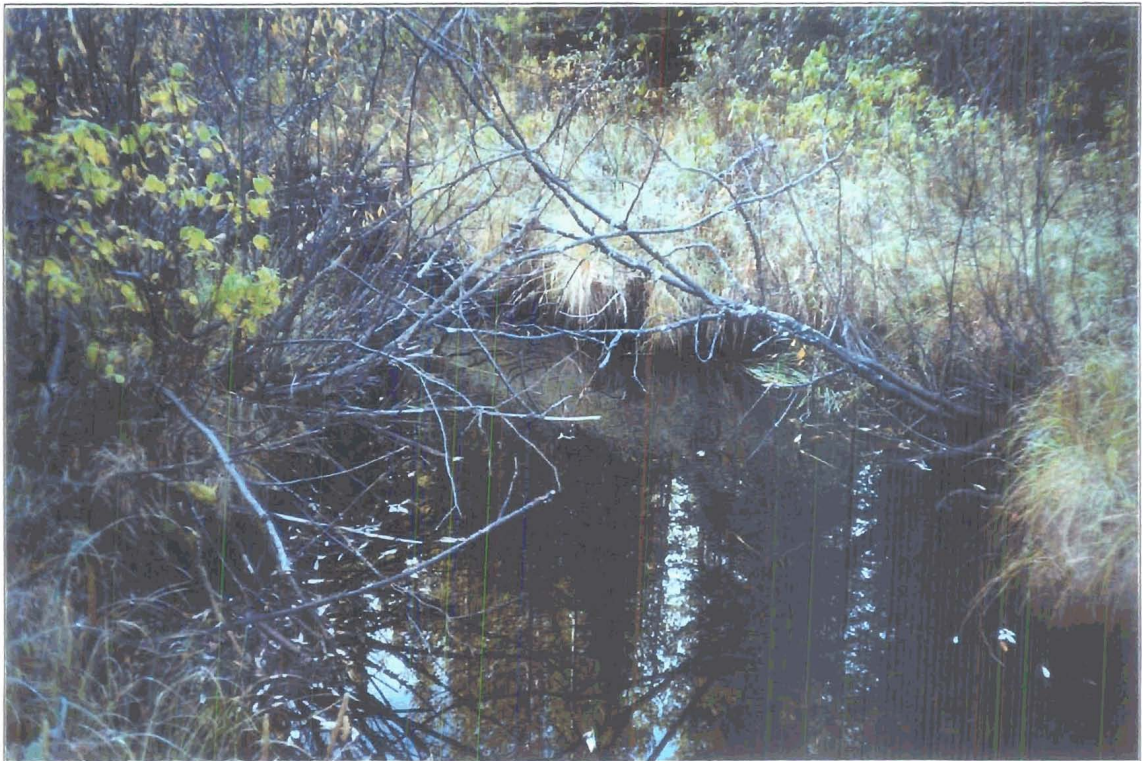
Site #371, upstream photo of typical channel found within site.  
Roll #91, Frame #22, Date: 2001/10/05

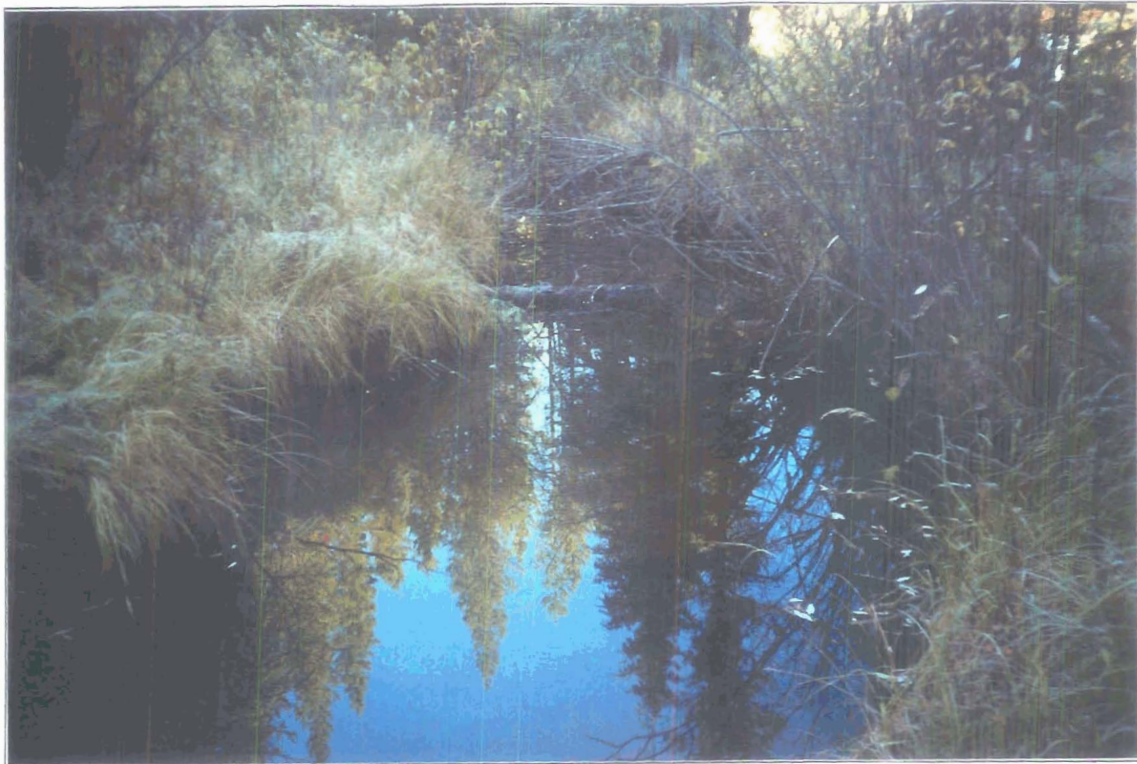
Site #371, downstream photo includes typical riparian vegetation within sample site.  
Roll #91, Frame #23, Date: 2001/10/05

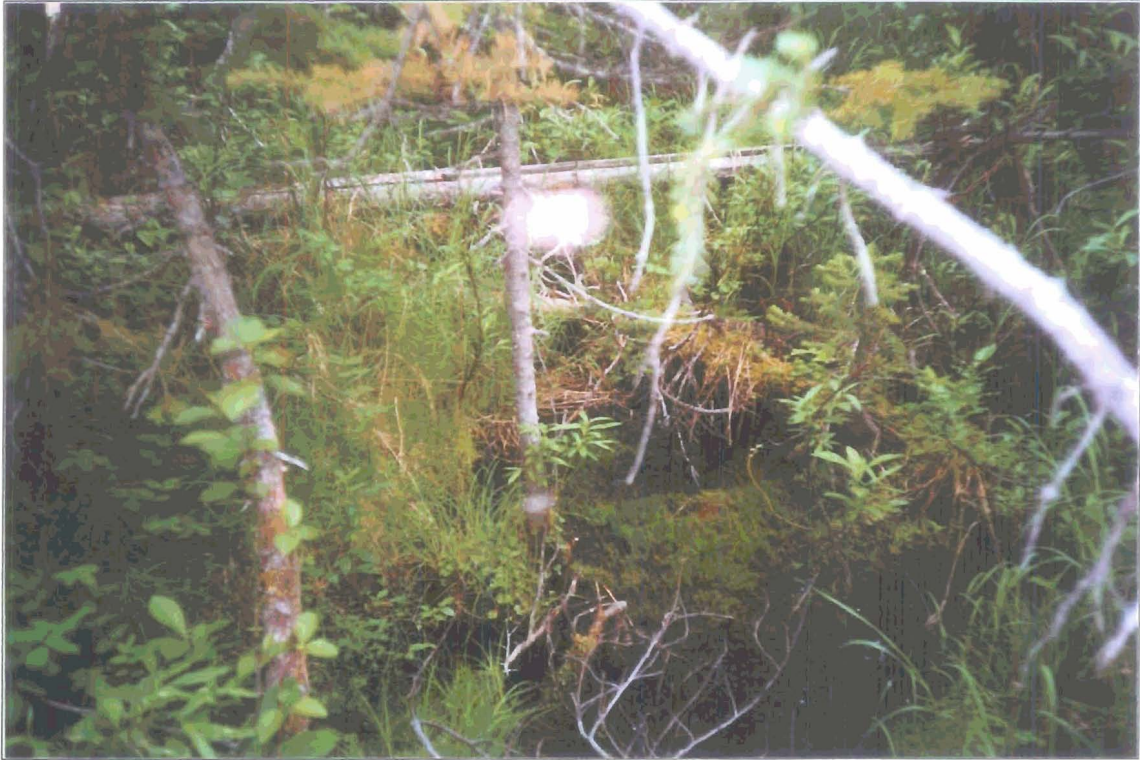
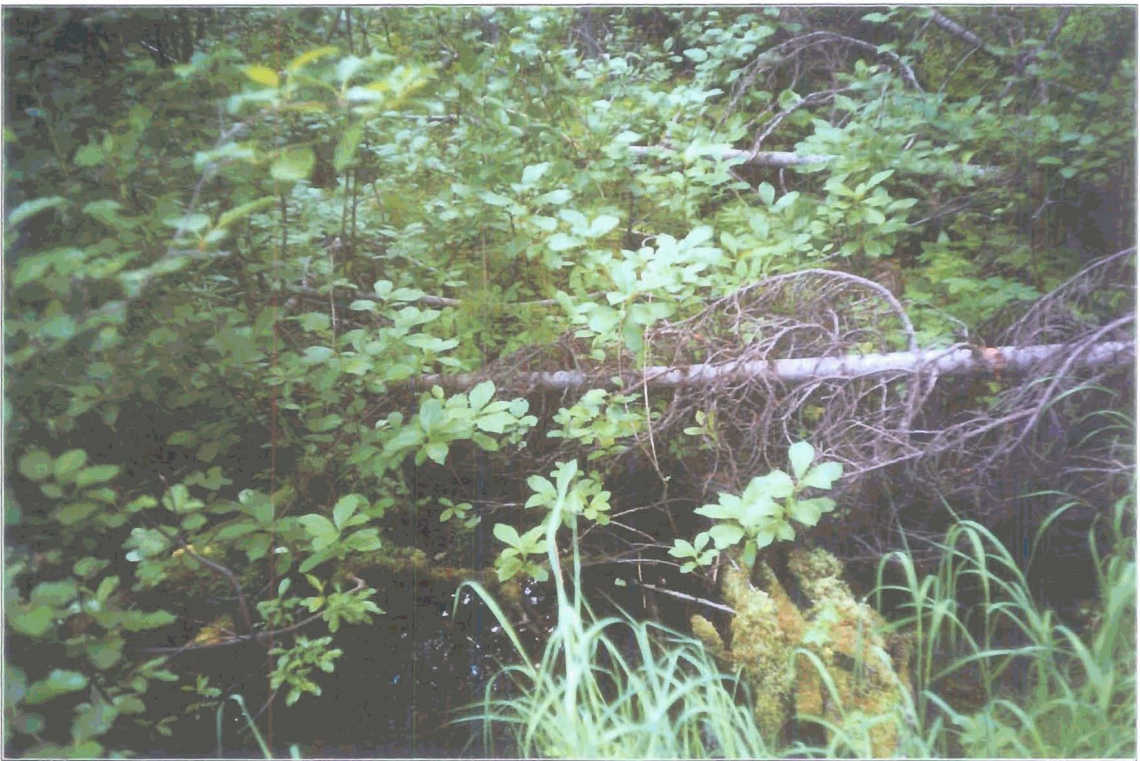
| COMMENTS | |
|---|---|
| CHANNEL | First site, dropped off by helicopter, bead chain, discontinued pockets and puddles |

Site #501, upstream photo of typical habitat within site.  
Roll #21, Frame #01, Date: 2001/07/31

Site #501, downstream photo of typical habitat within site.  
Roll #21, Frame #02, Date: 2001/07/31

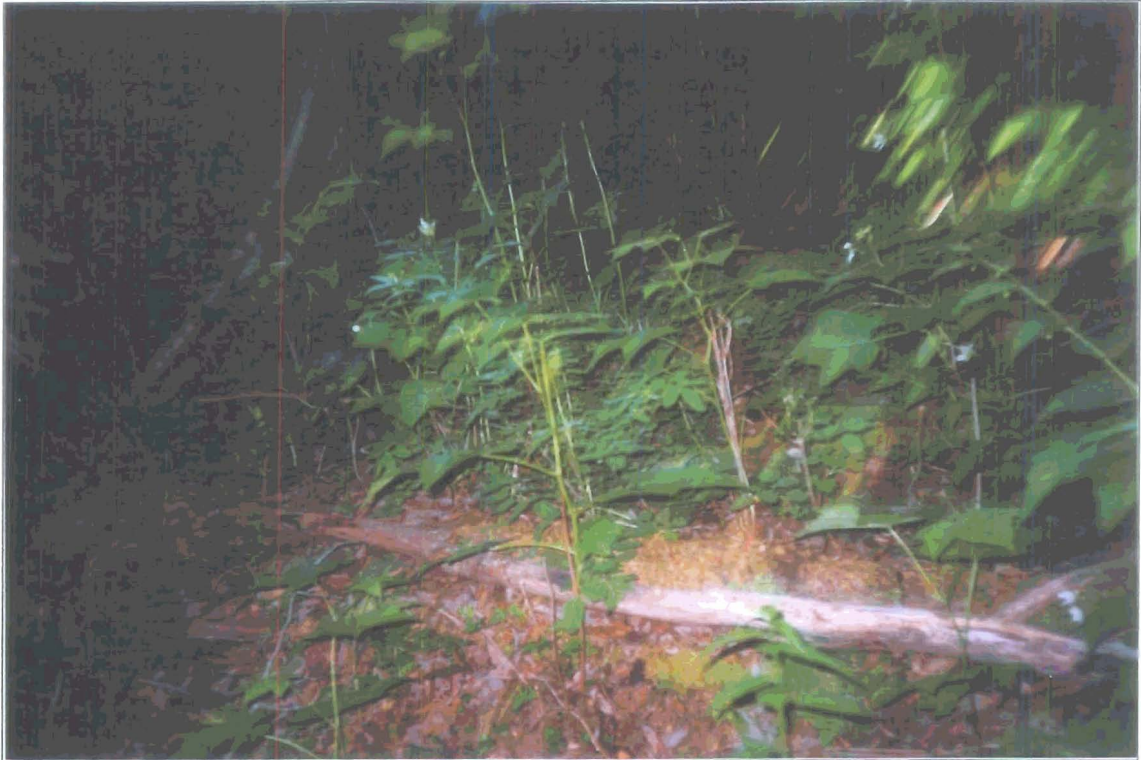
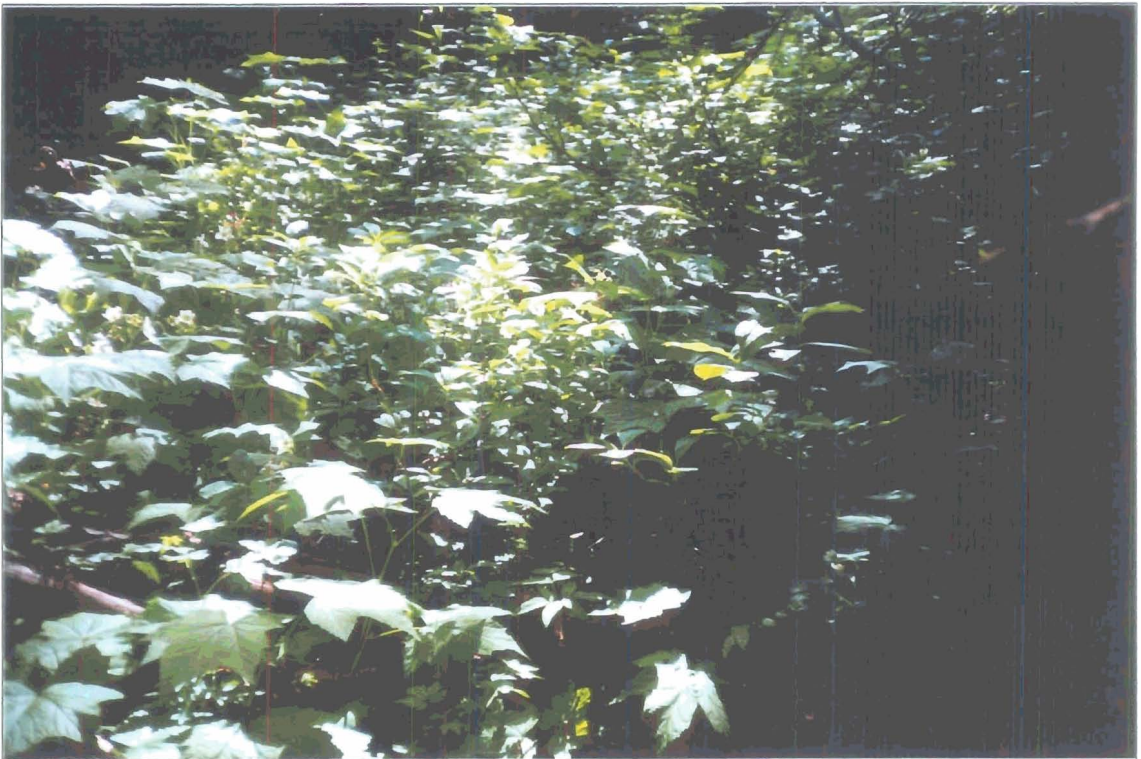
Site #502, upstream photo taken of No Visible Channel.  
Roll #21, Frame #03, Date: 2001/07/31

Site #502, downstream photo taken of No Visible Channel.  
Roll #21, Frame #04, Date: 2001/07/31

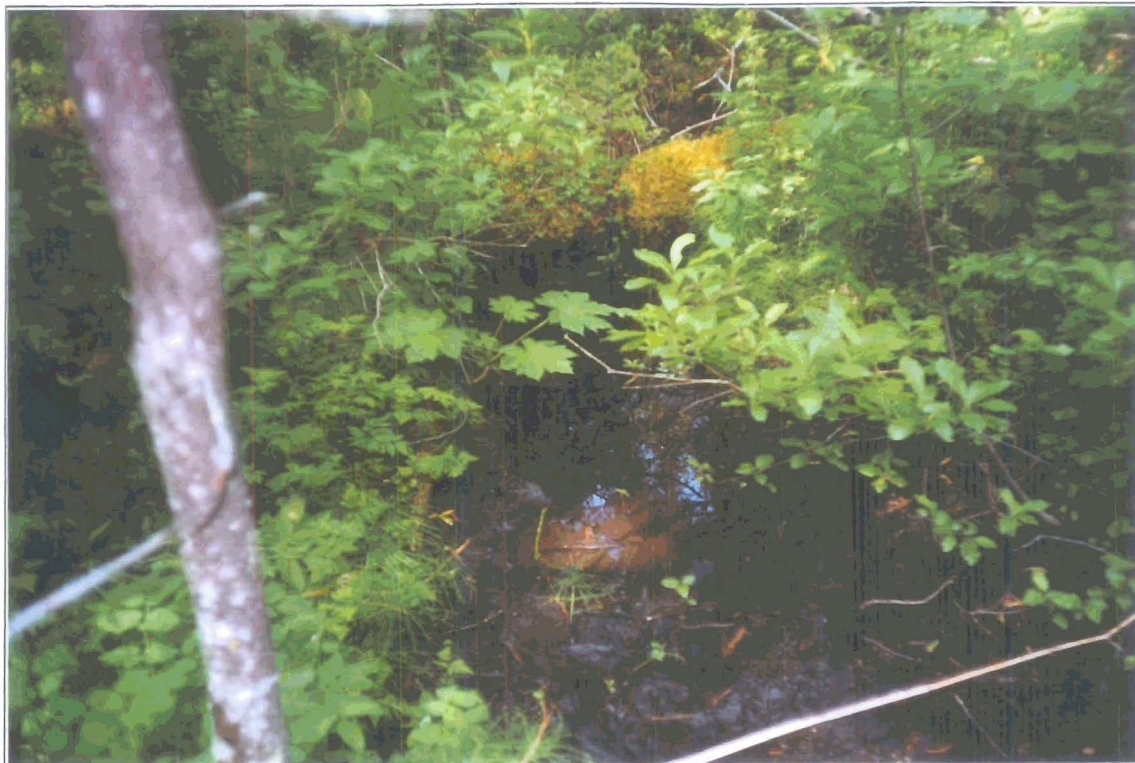
Site #503, upstream photo of typical habitat.  
Roll #21, Frame #05, Date: 2001/07/31

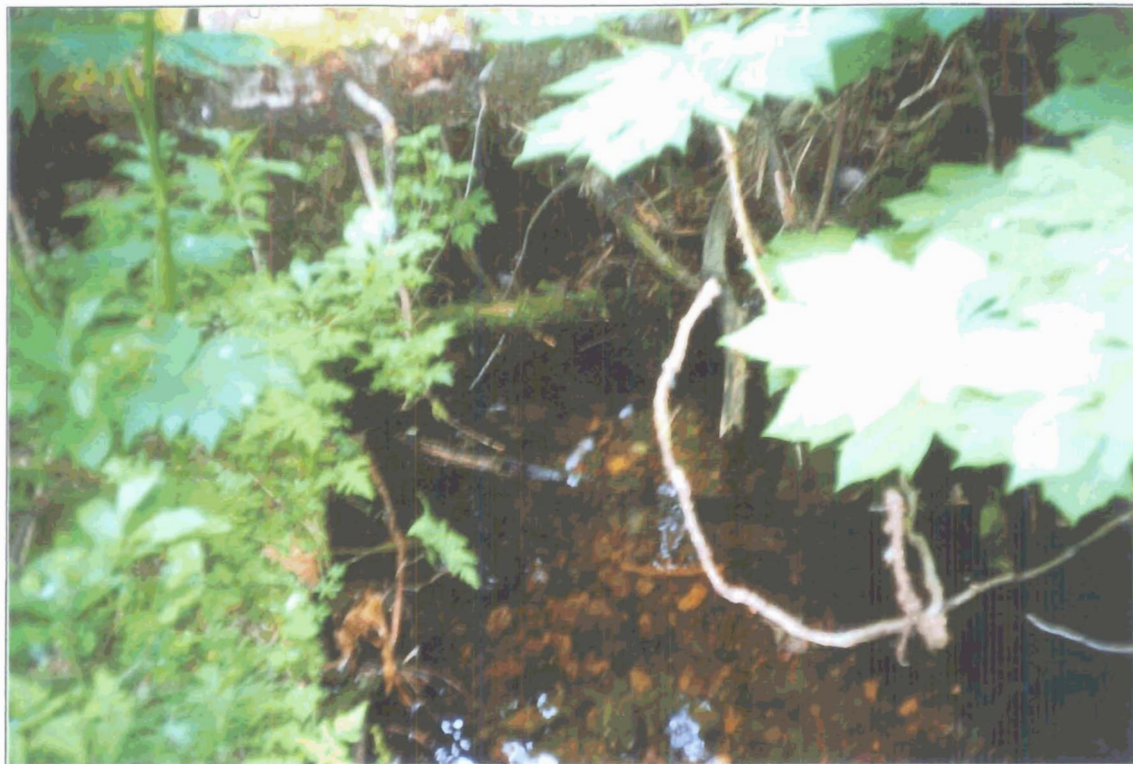
Site #505, upstream photo of cobble/gravel substrates typical within sample site.  
Roll #21, Frame #09, Date: 2001/07/31

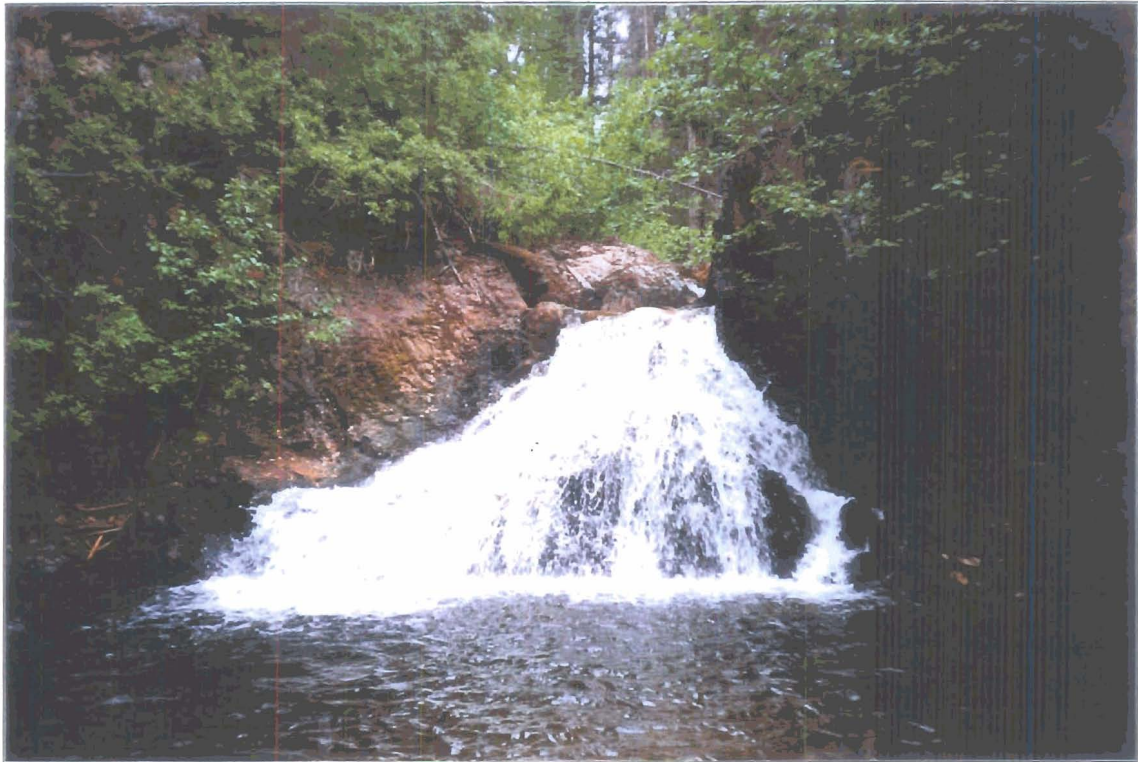
Site #509, photo of waterfall.  
Roll #21, Frame #15, Date: 2001/08/01

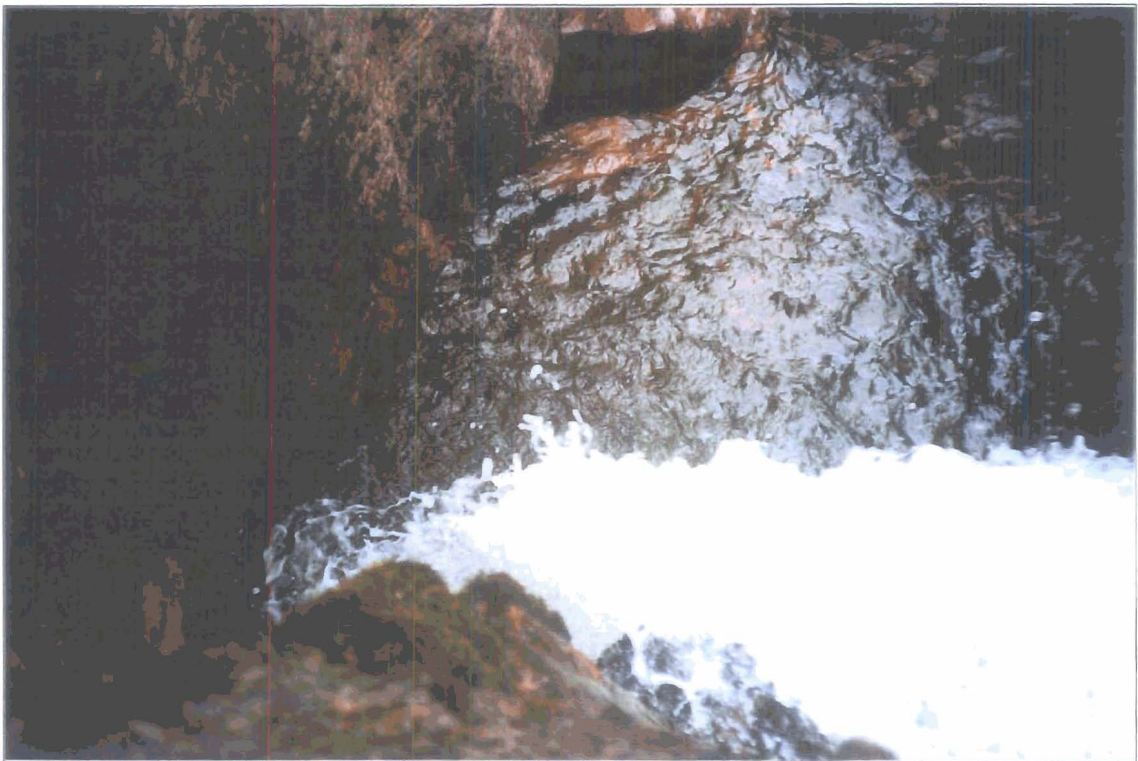
Site #509, photo over waterfall.  
Roll #21, Frame #16, Date: 2001/08/01

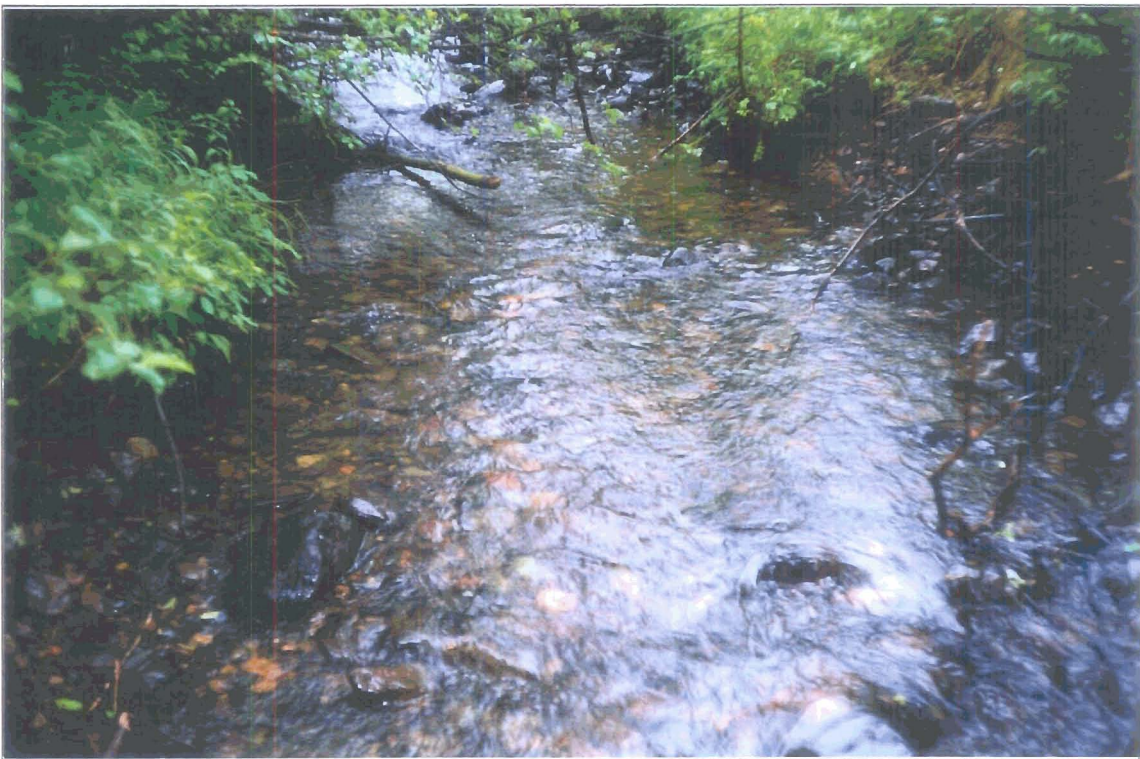
Site #513, upstream photo of typical habitat within site - riffle pool morphology.  
Roll #22, Frame #X, Date: 2001/08/02

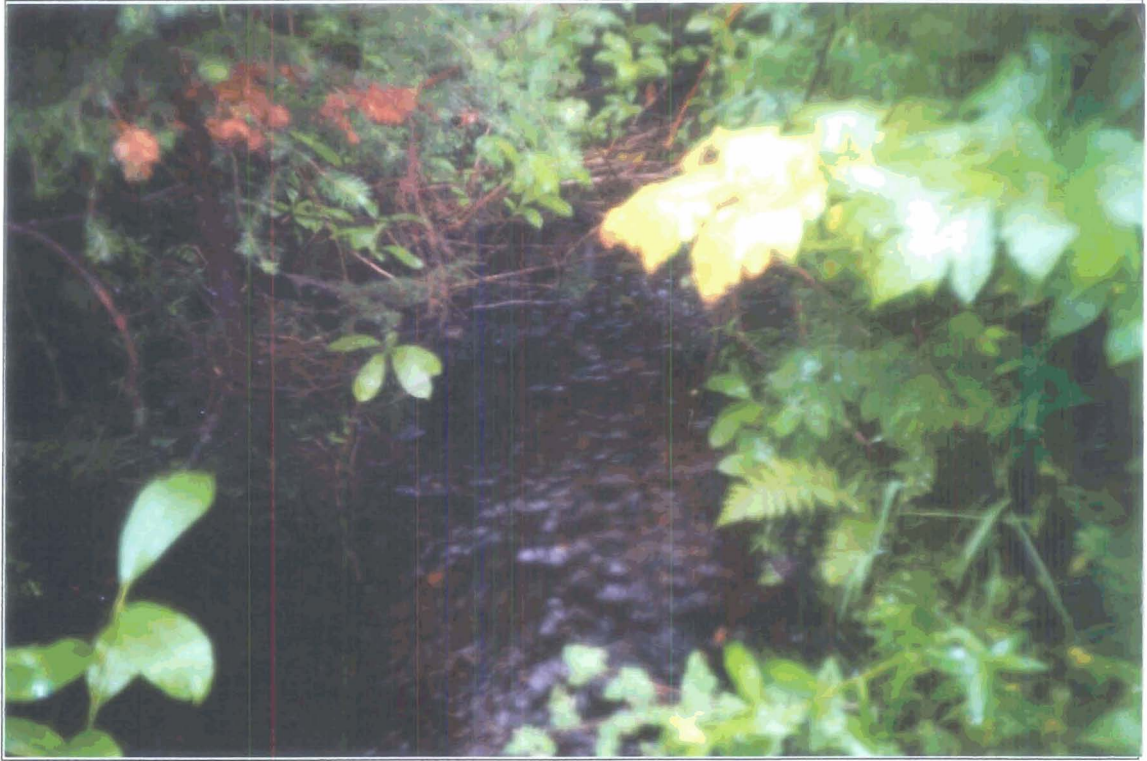
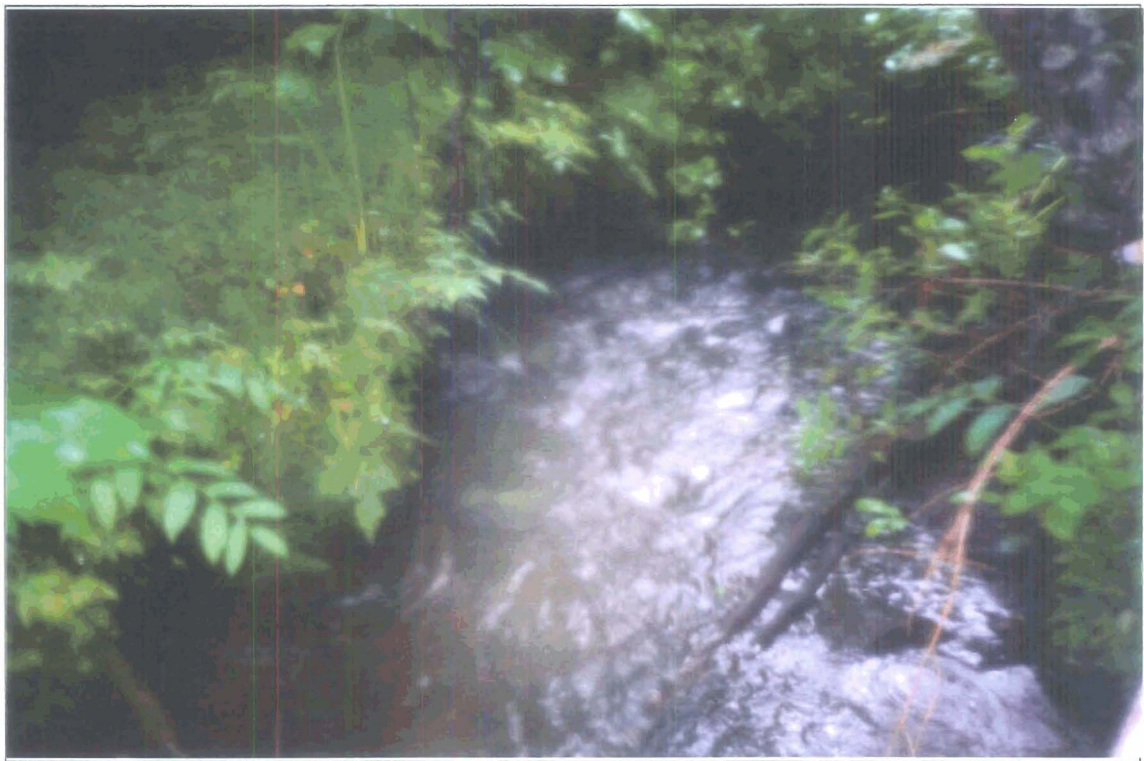
Site #517, upstream photo of riffle pool habitat.  
Roll #22, Frame #06, Date: 2001/08/03

Site #517, downstream photo of riffle pool habitat.  
Roll #22, Frame #08, Date: 2001/08/03

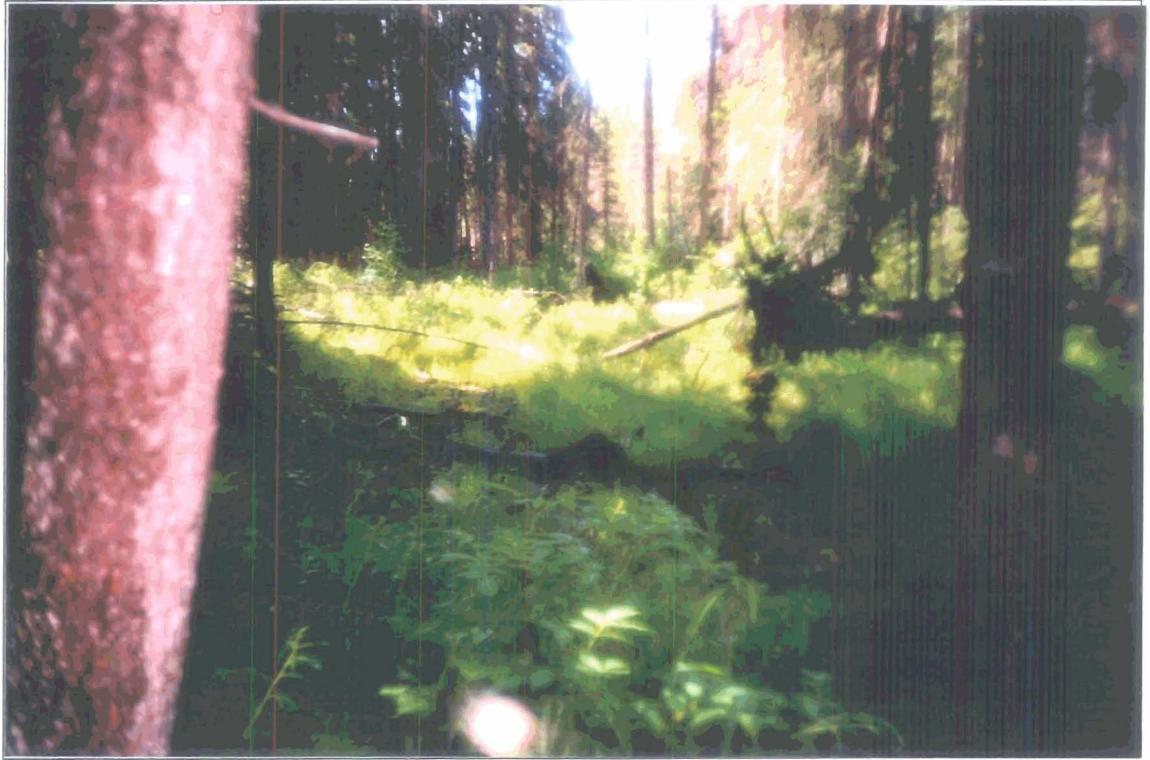
Site #519, downstream photo from wetland.  
Roll #22, Frame #12, Date: 2001/08/03
