**Reconnaissance (1:20,000)**  
**Fish and Fish Habitat Inventory**  
**of Unnamed Tributaries to the**  
**Southwest Shore of Babine Lake,**  
**South of Topley Landing**  
**(South Fulton Planning Area)**

**WSC 480-705800 to 480-776600**  
**Volume 2 of 2**

### **Reach Cards/Site Cards/Fish Collection Forms and Photographs**

**(Sites 366 to 953)**

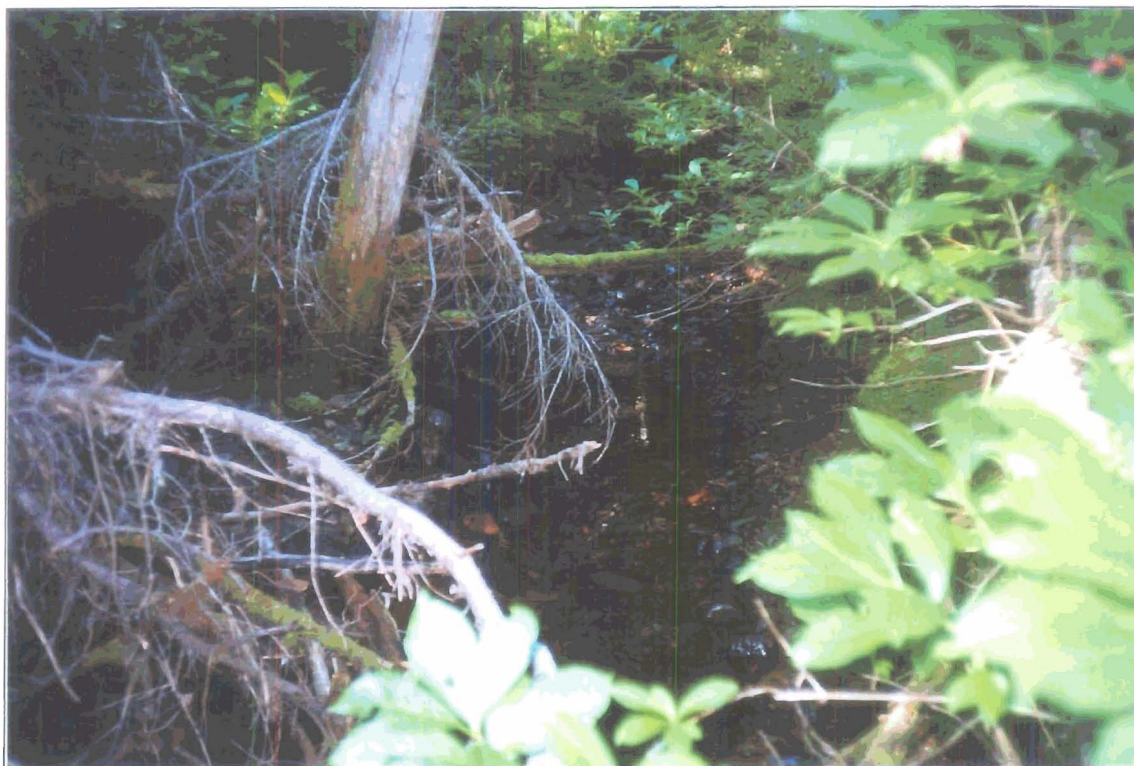
Site #527, upstream photo taken of SWD and overhanging vegetation, typical habitat within sample site.  
Roll #23, Frame #11, Date: 2001/08/15

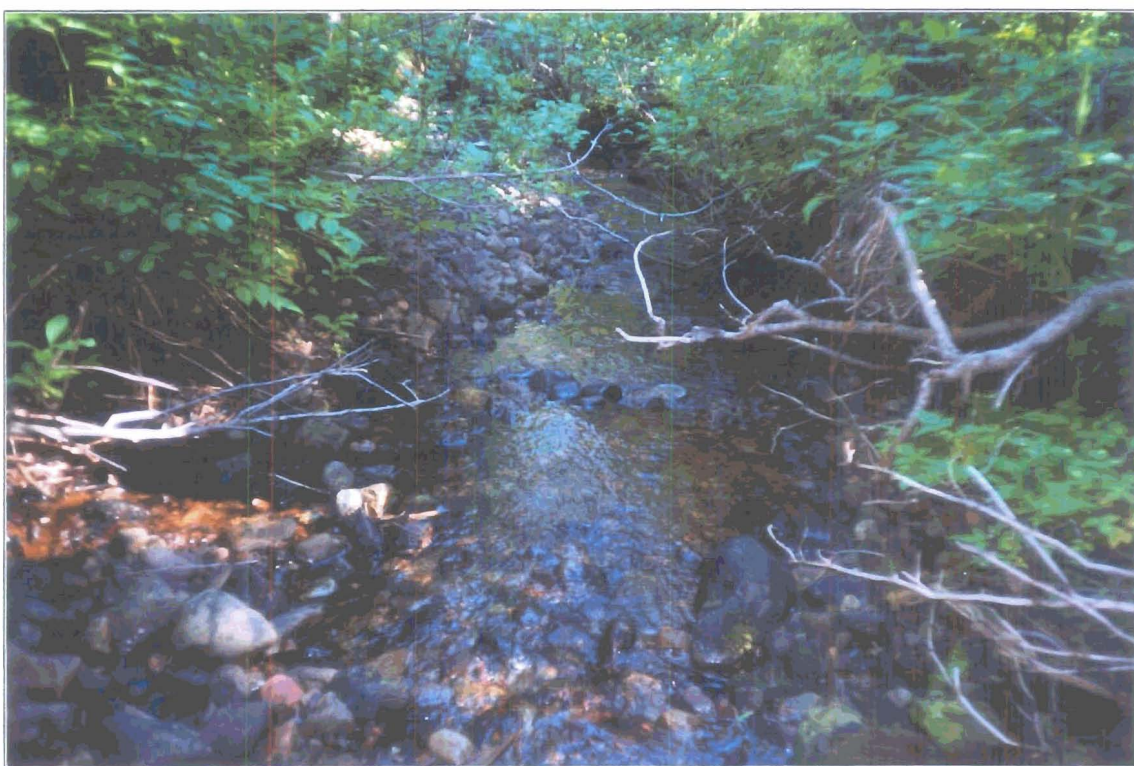
Site #527, downstream photo taken of cobble substrates found within sample site.  
Roll #23, Frame #12, Date: 2001/08/15

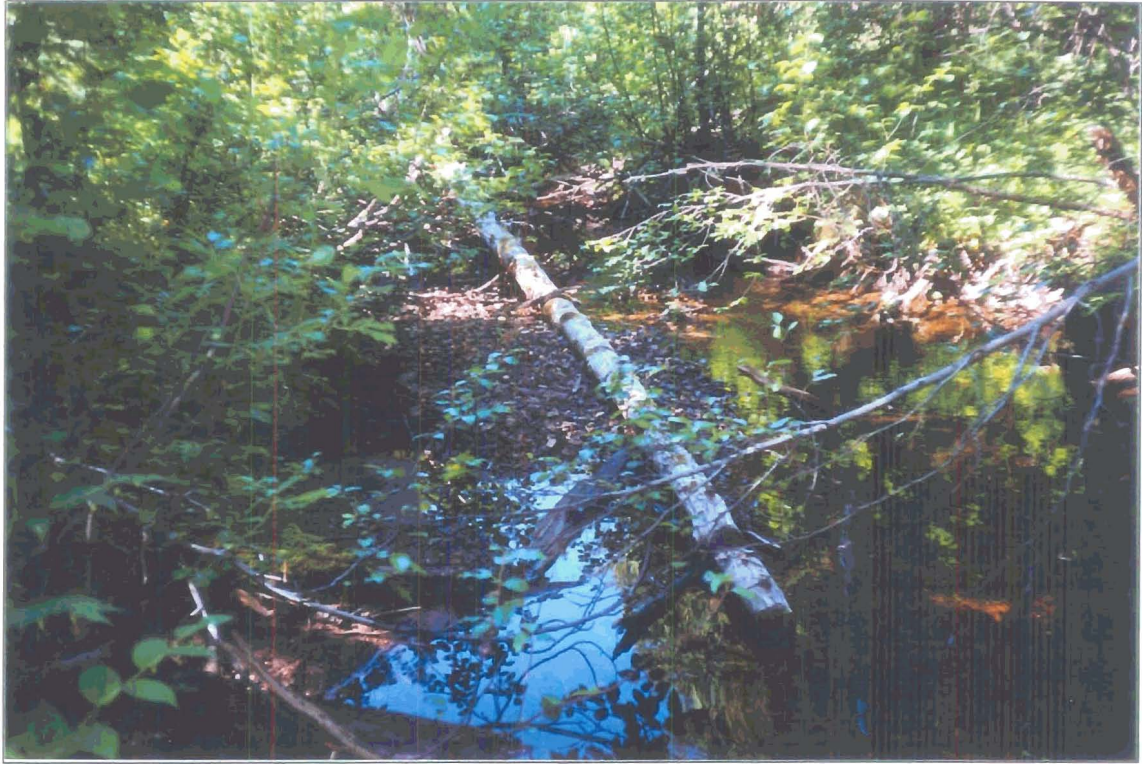
Site #530, upstream photo taken of cobble islands typical within sample site.  
Roll #23, Frame #13, Date: 2001/08/15

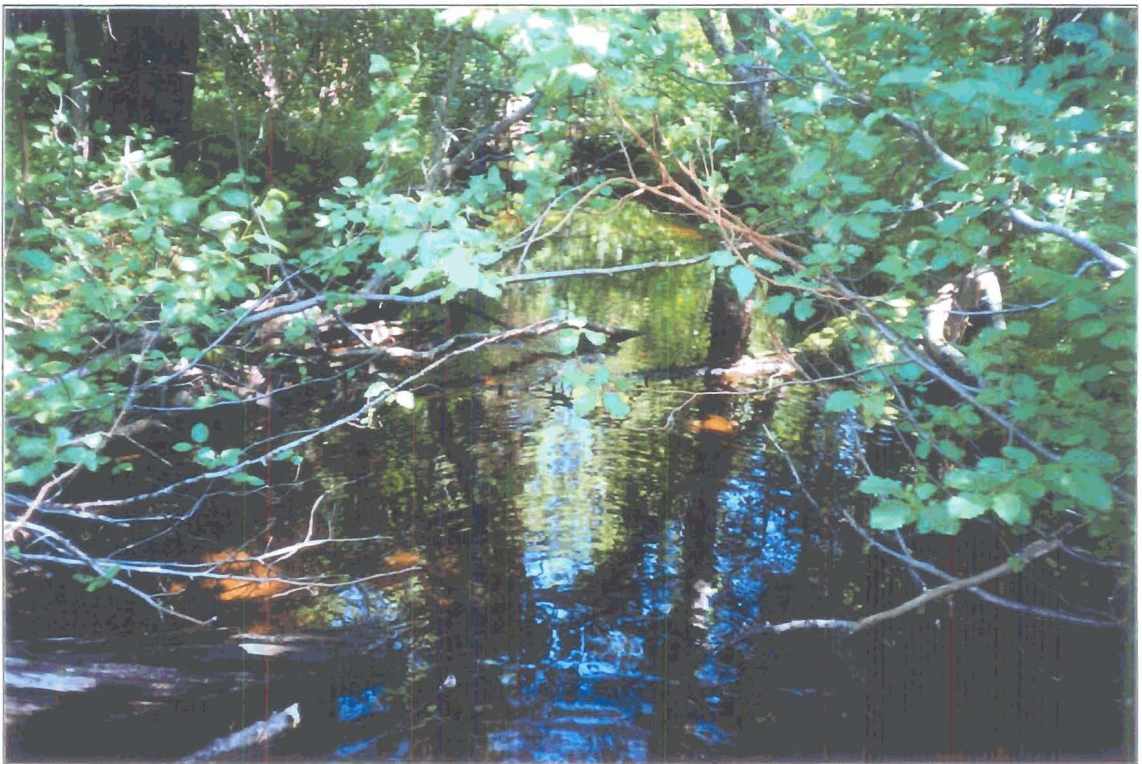
Site #530, downstream photo taken of overhanging vegetation typical within sample site.  
Roll #23, Frame #14, Date: 2001/08/15

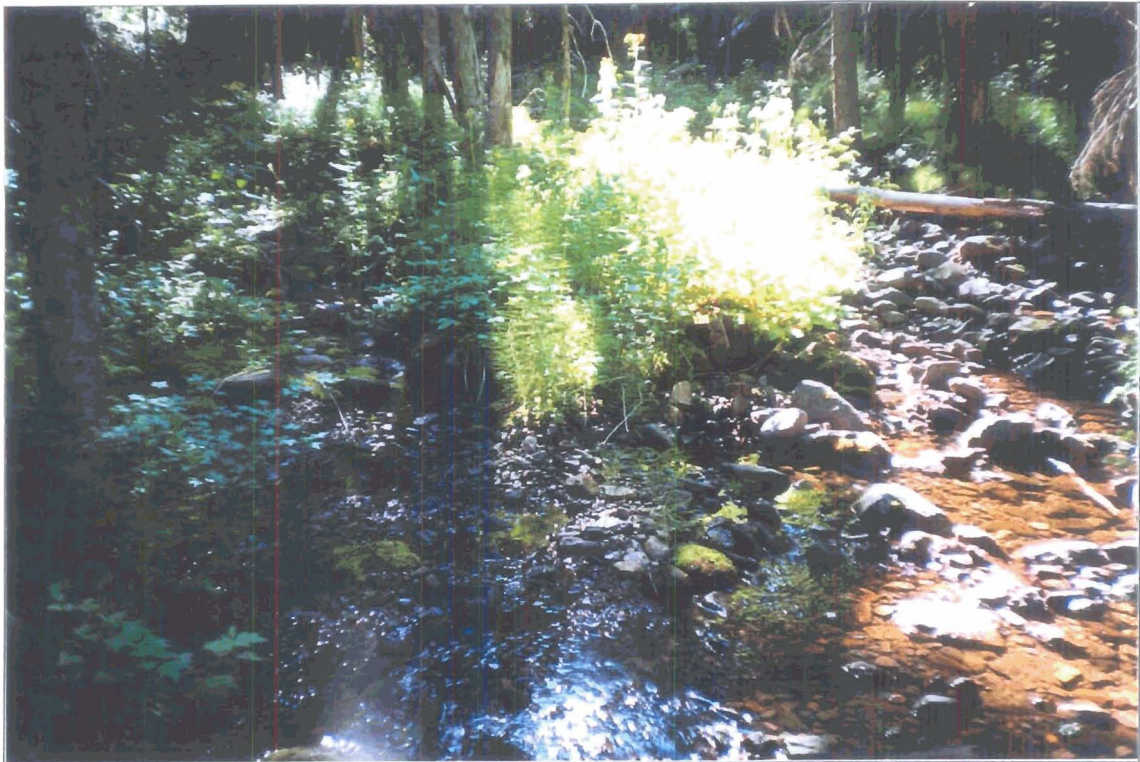
Site #532, upstream photo taken of braided channel within site.  
Roll #23, Frame #17, Date: 2001/08/15

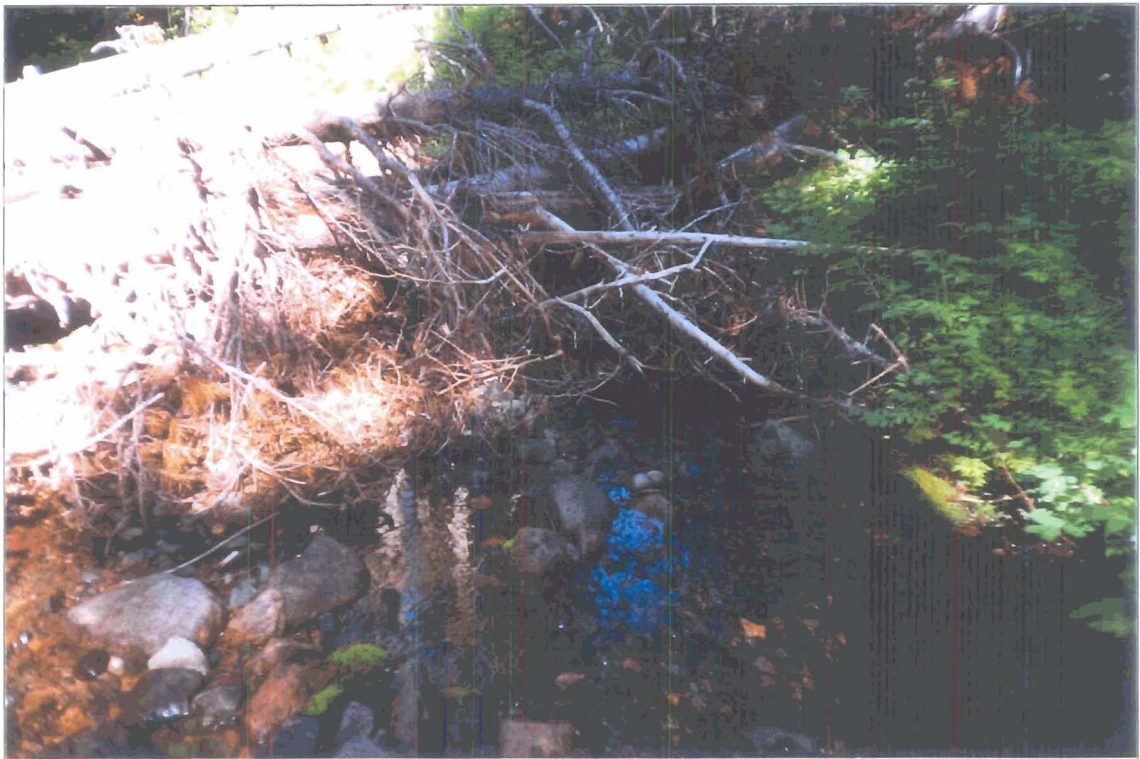
Site #532, downstream photo taken of typical LWD within sample site.  
Roll #23, Frame #18, Date: 2001/08/15

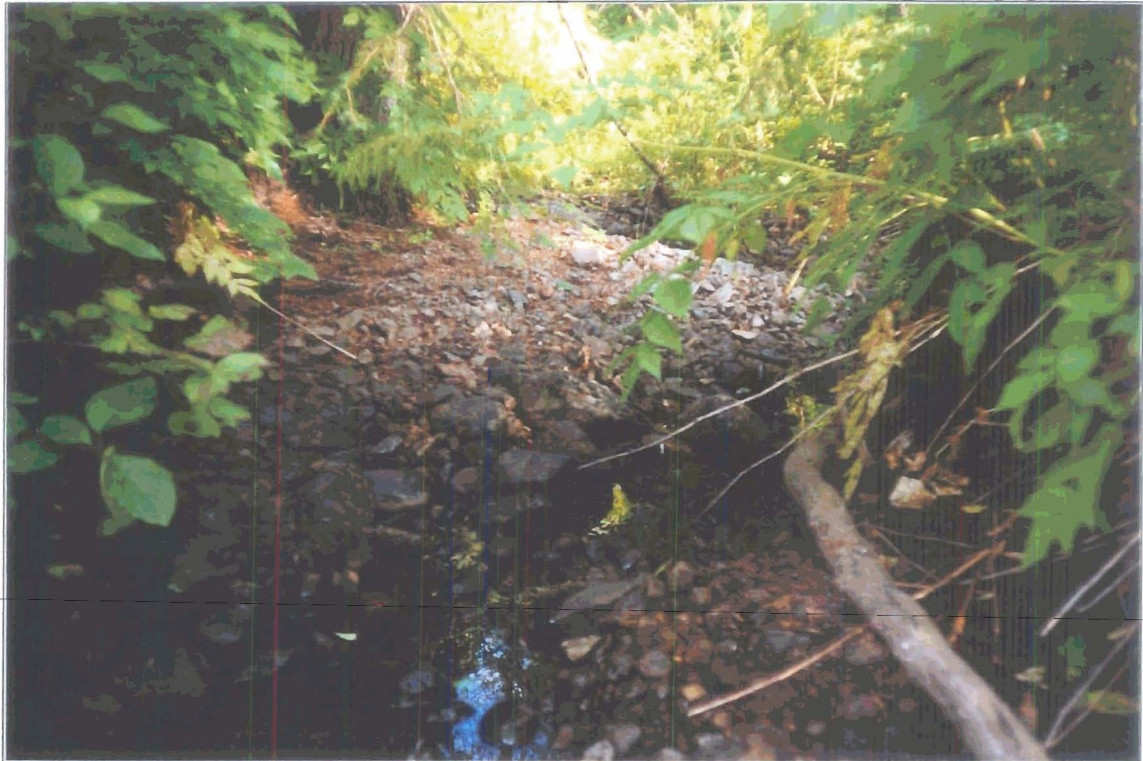
Site #533, upstream photo taken of Dry/Int flow typically found within sample site.  
Roll #23, Frame #19, Date: 2001/08/16

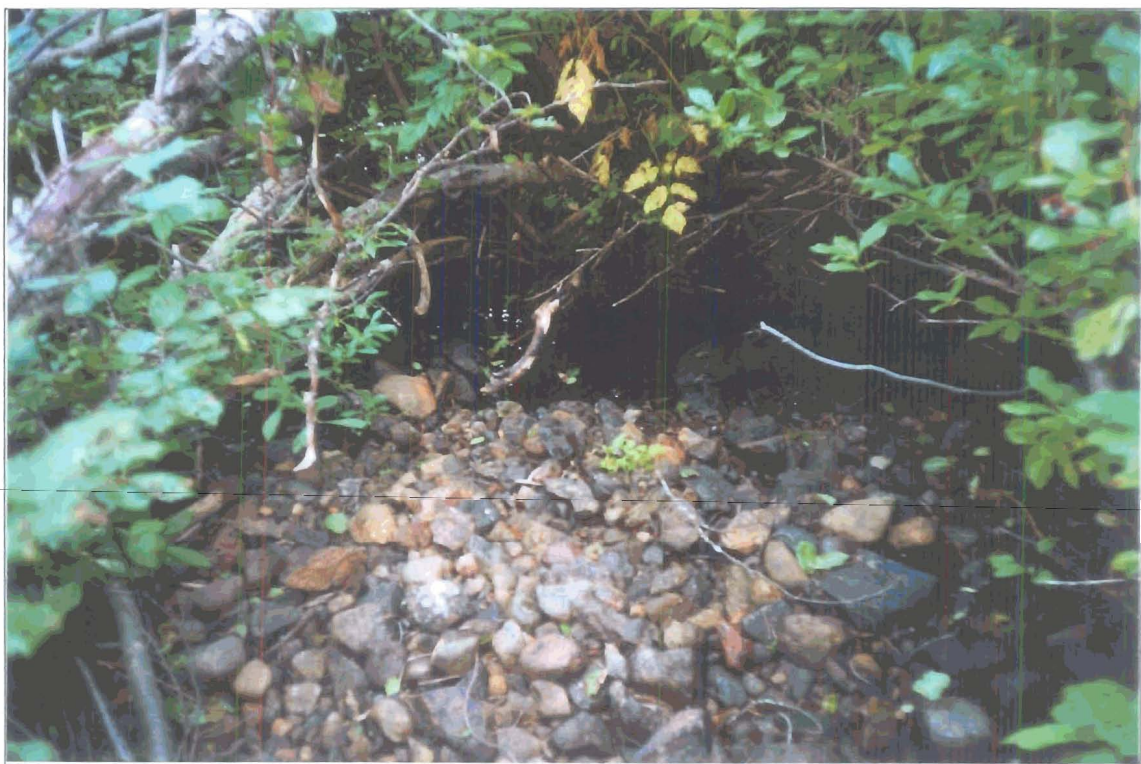
Site #533, downstream photo of cobble substrates found within sample site.  
Roll #23, Frame #20, Date: 2001/08/16

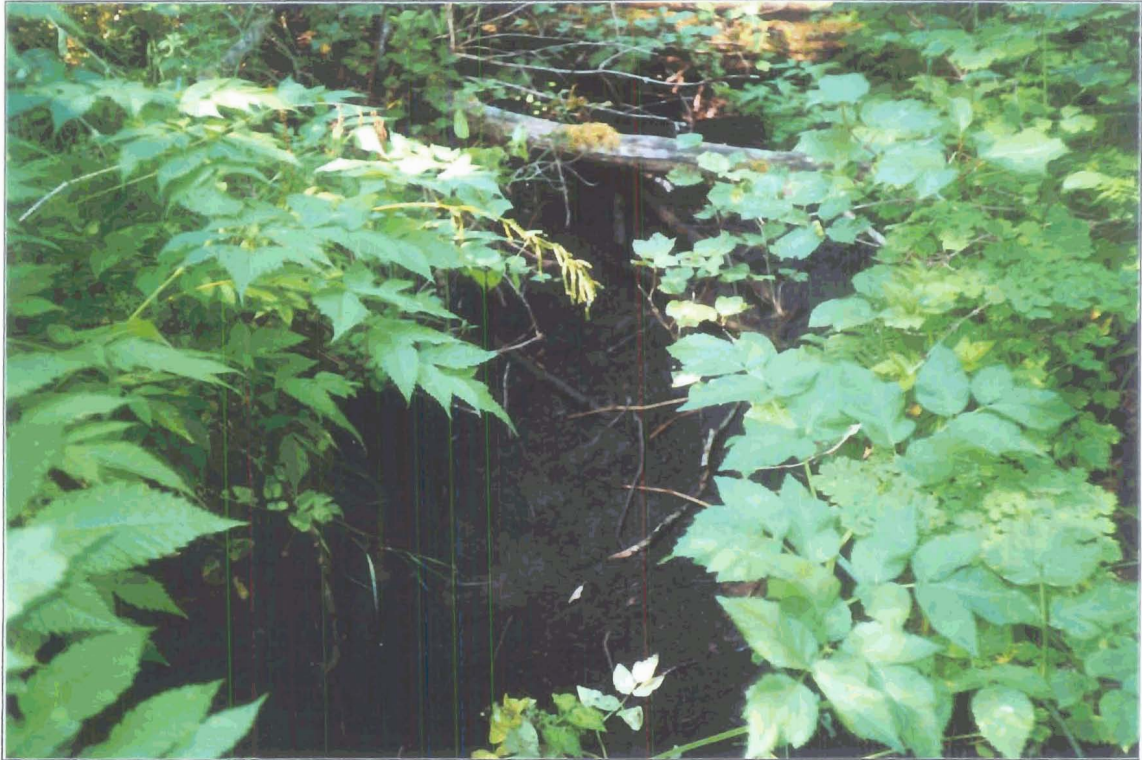
Site #535, upstream photo taken shows dominant cover of overhanging vegetation.  
Roll #23, Frame #21, Date: 2001/08/16

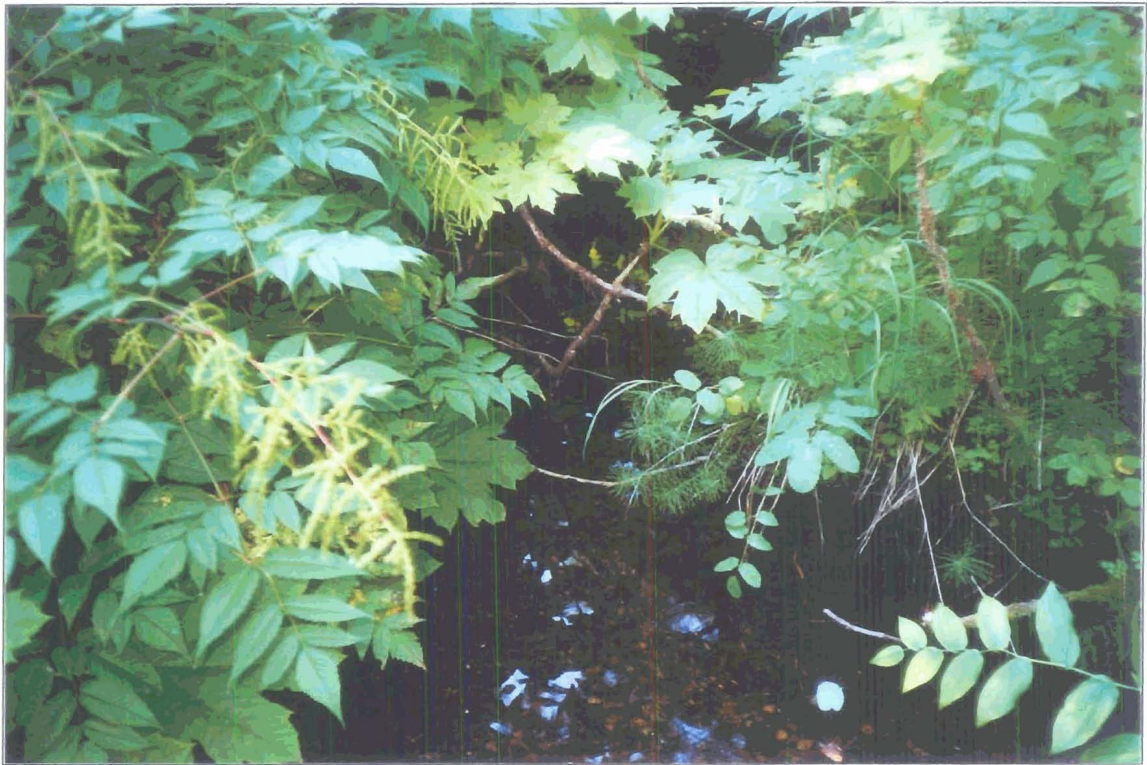
Site #536, upstream photo of overhanging vegetation above stream typical within site.  
Roll #23, Frame #23, Date: 2001/08/16

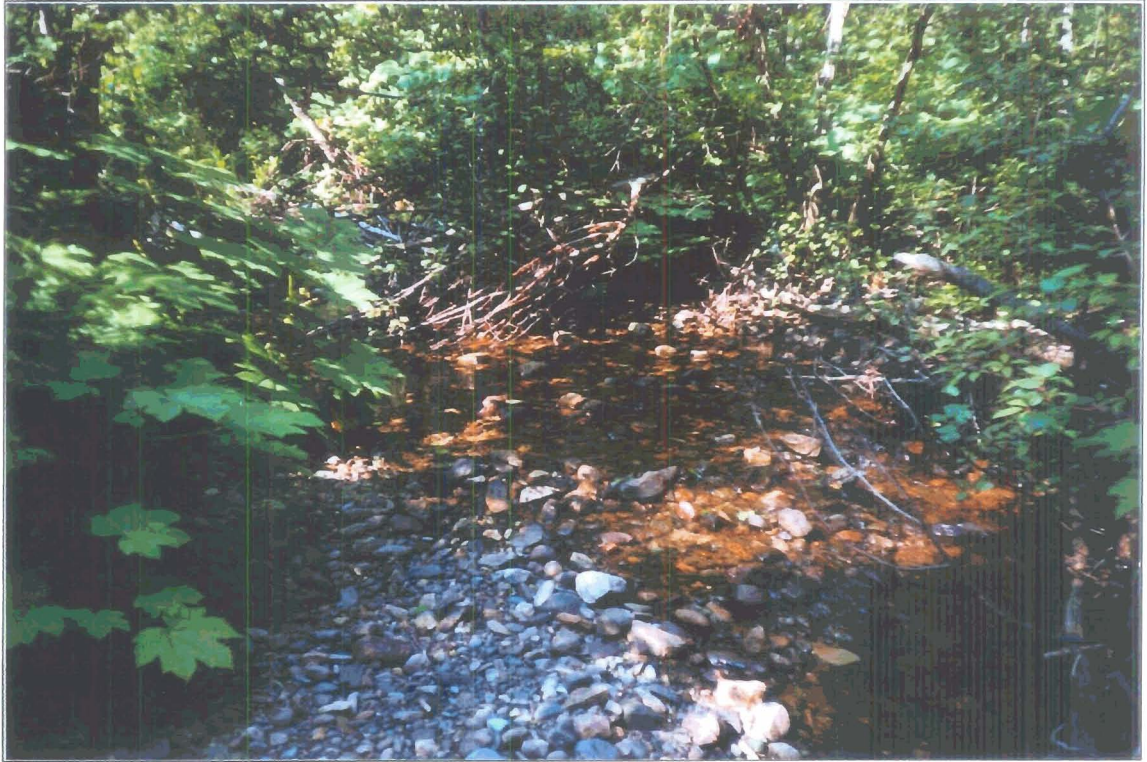
Site #538, upstream photo of cobble substrates found within site.  
Roll #24, Frame #01, Date: 2001/08/16

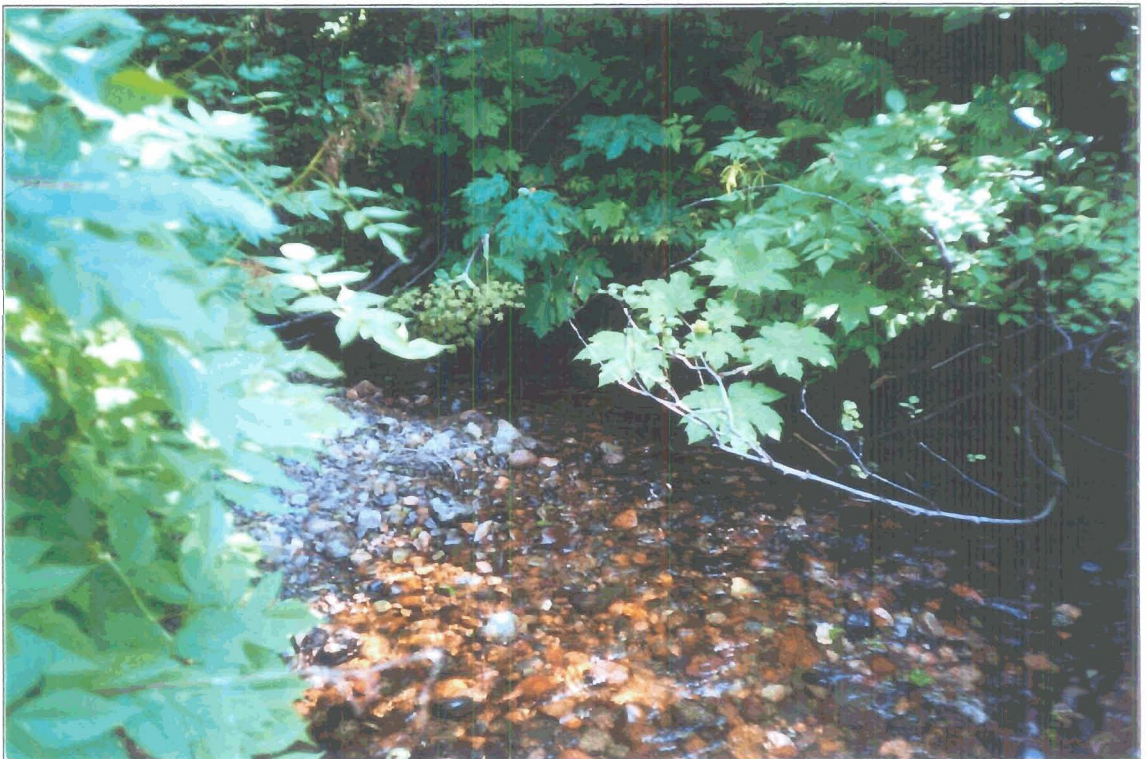
Site #538, downstream photo of overhanging vegetation found within site.  
Roll #24, Frame #02, Date: 2001/08/16

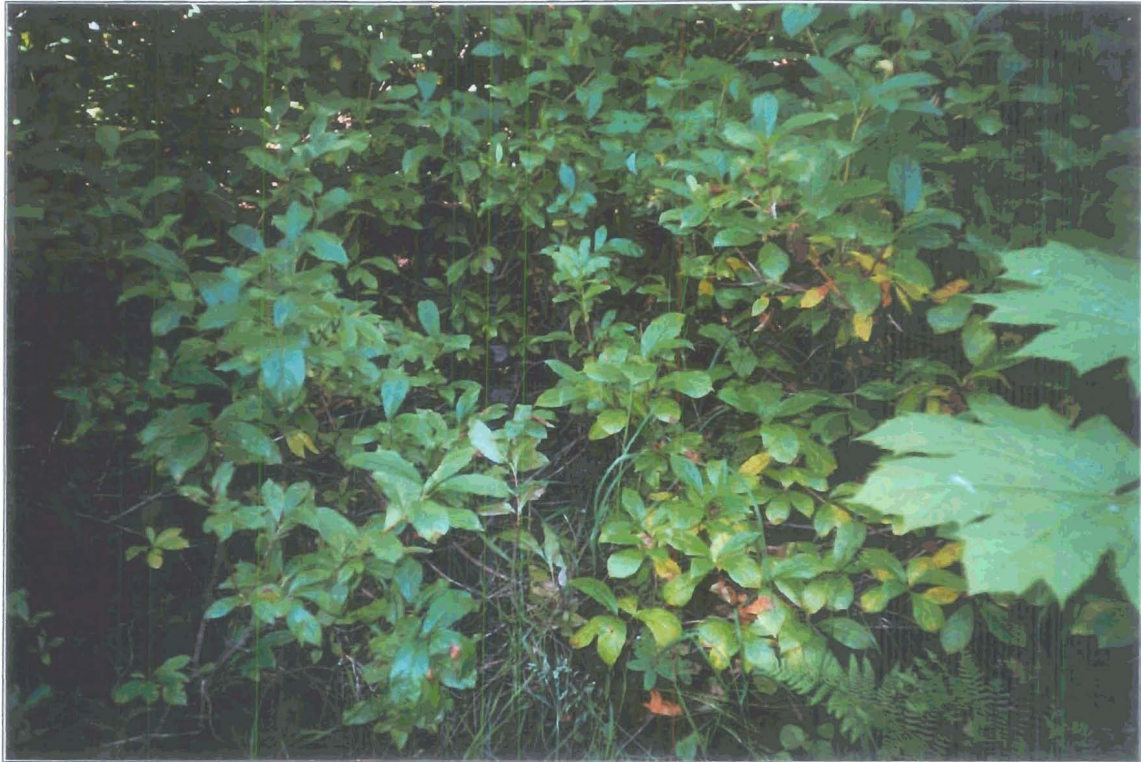
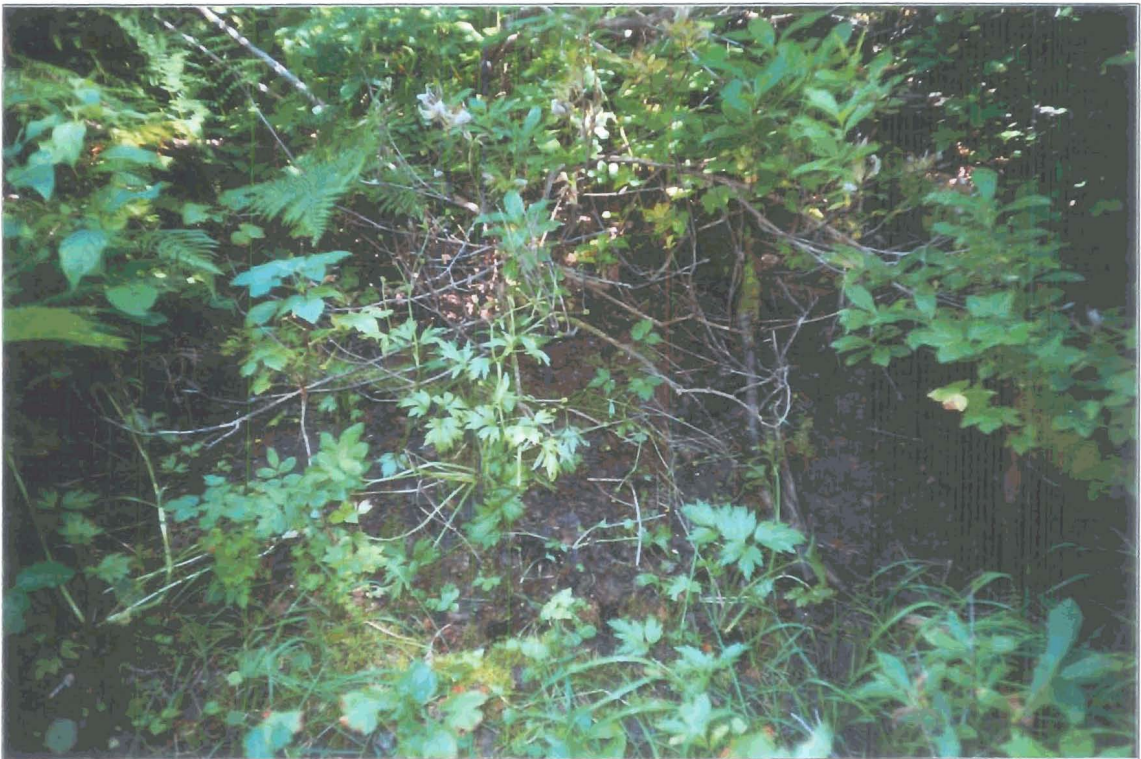
| COMMENTS | |
|---|---|
| CHANNEL | No Visible Channel |

Site #542, upstream photo of vegetated gully.  
Roll #24, Frame #05, Date: 2001/08/17

Site #542, downstream photo of vegetated gully.  
Roll #24, Frame #06, Date: 2001/08/17

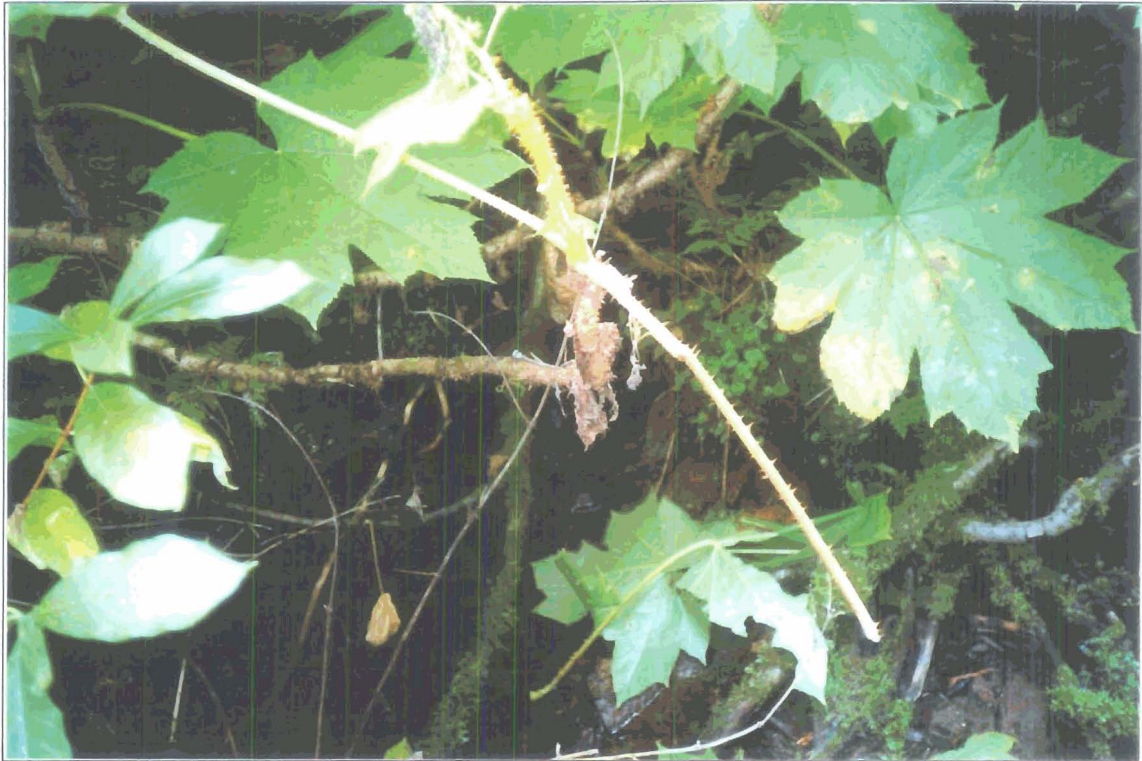
Site #543, upstream photo of dense overhanging vegetation.  
Roll #24, Frame #07, Date: 2001/08/17

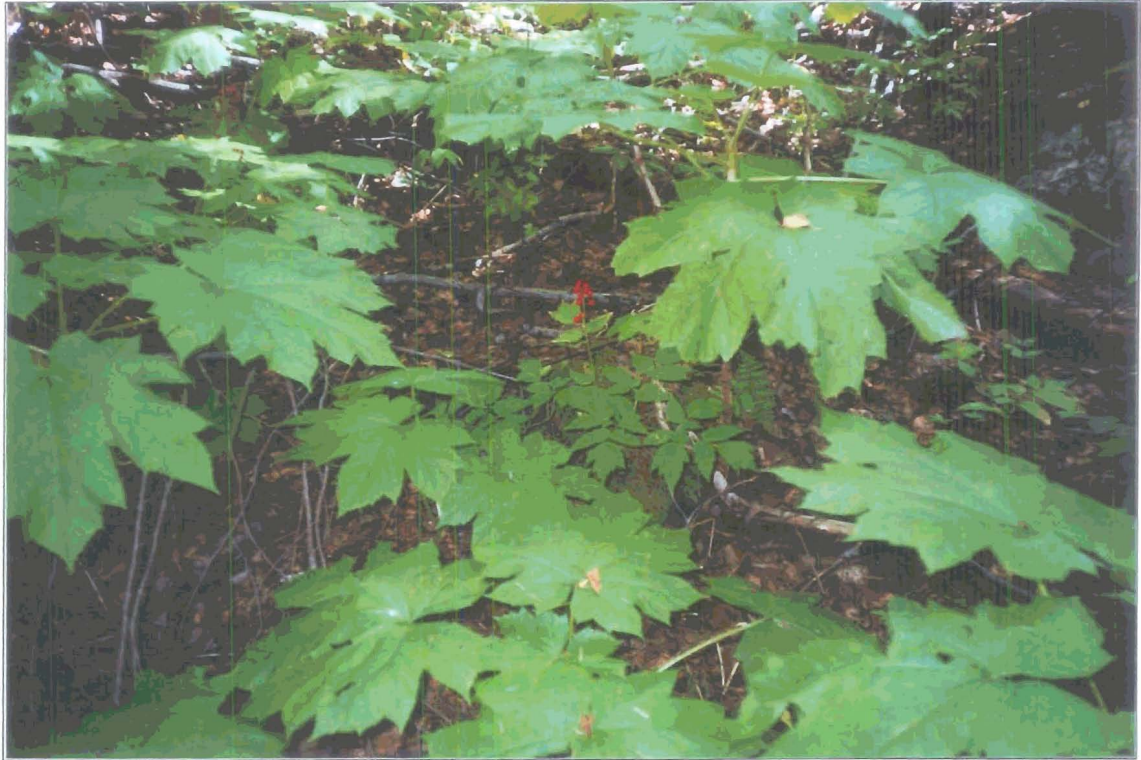
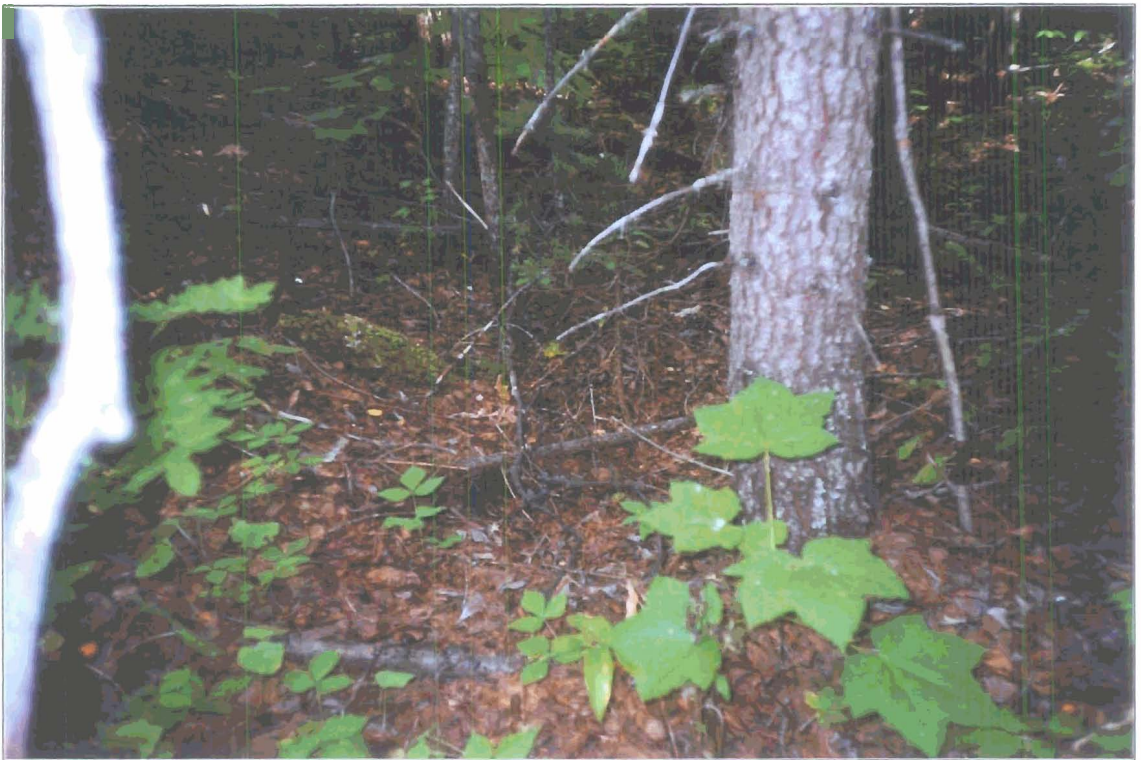
Site #545, upstream photo of vegetated depression.  
Roll #24, Frame #09, Date: 2001/08/17

Site #545, downstream photo of vegetated depression.  
Roll #24, Frame #10, Date: 2001/08/17

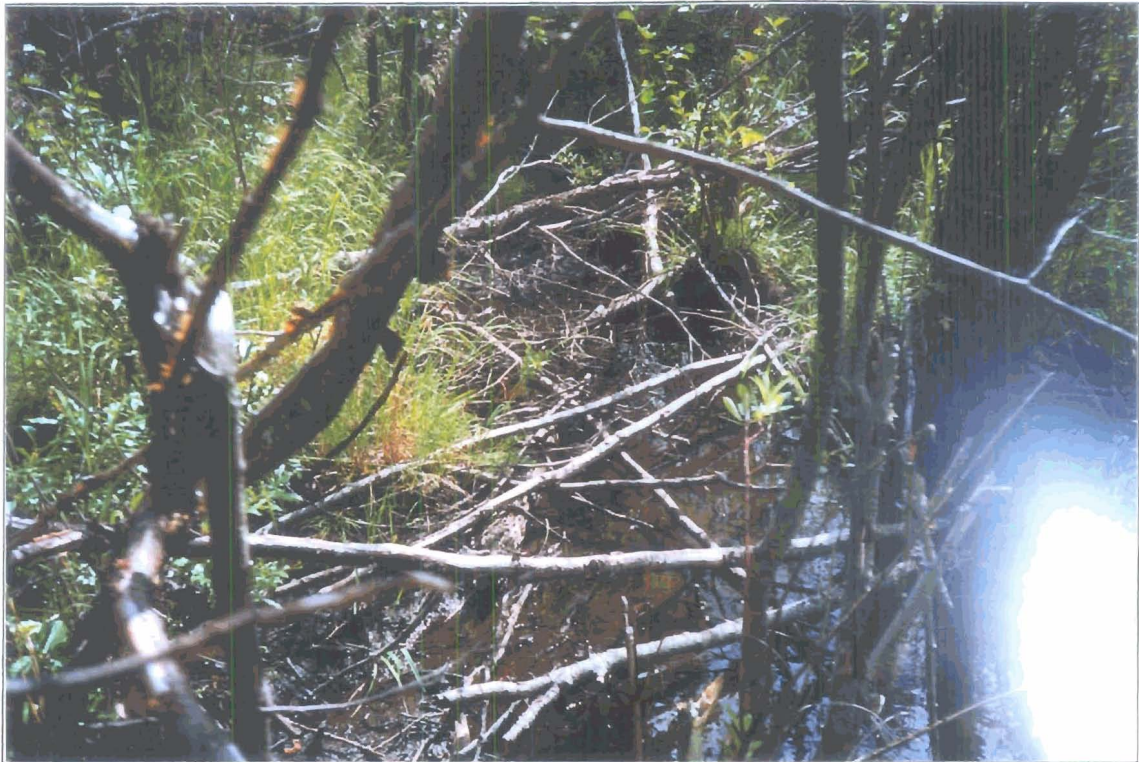
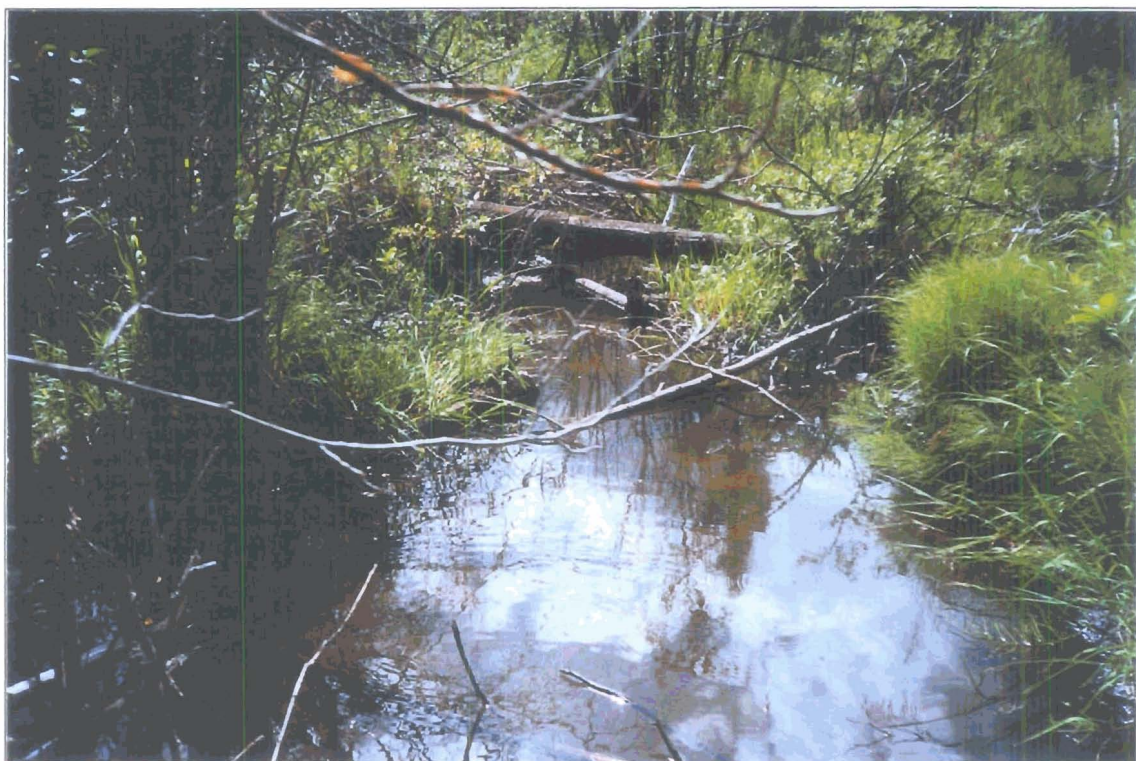
Site #548, upstream photo of sloughy area with stagnant water.  
Roll #24, Frame #11, Date: 2001/08/18

Site #548, downstream photo of sloughy area with stagnant water.  
Roll #24, Frame #12, Date: 2001/08/18

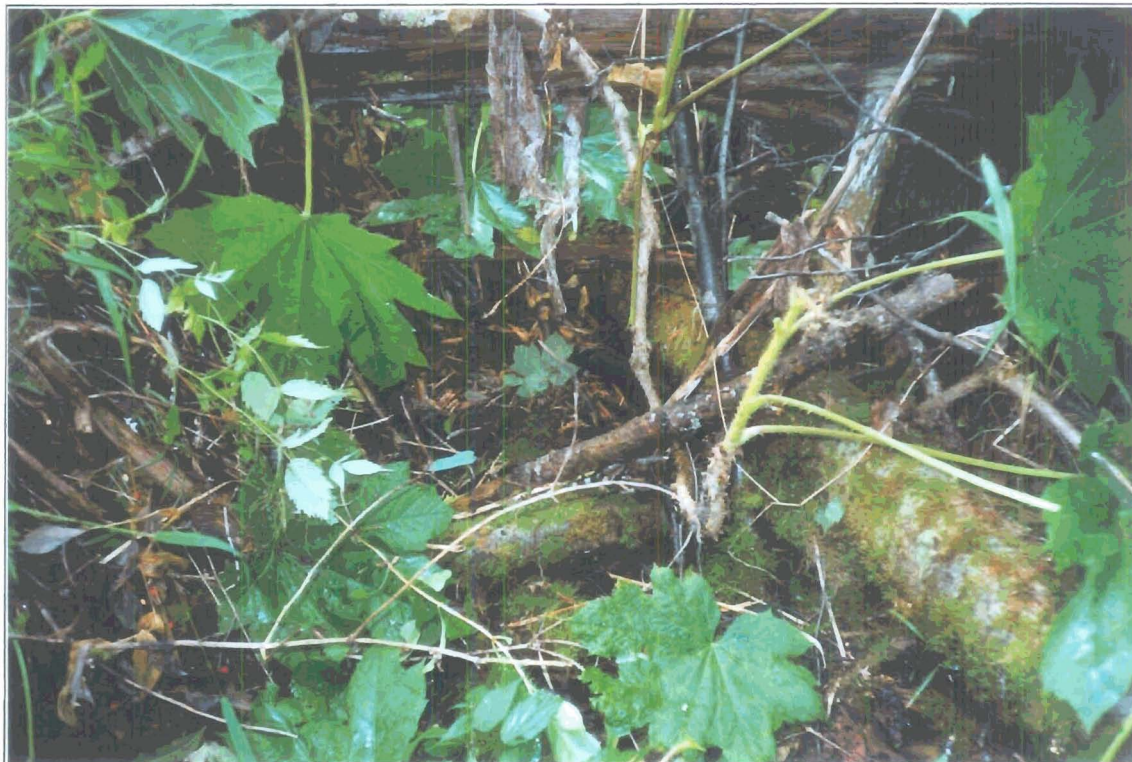
| COMMENTS | |
|---|---|
| CHANNEL | stream has a high amount of vascular plants within stream bed |

Site #791, upstream photo of overhanging vegetation which is the dominant cover throughout sample site.  
Roll #24, Frame #13, Date: 2001/08/19

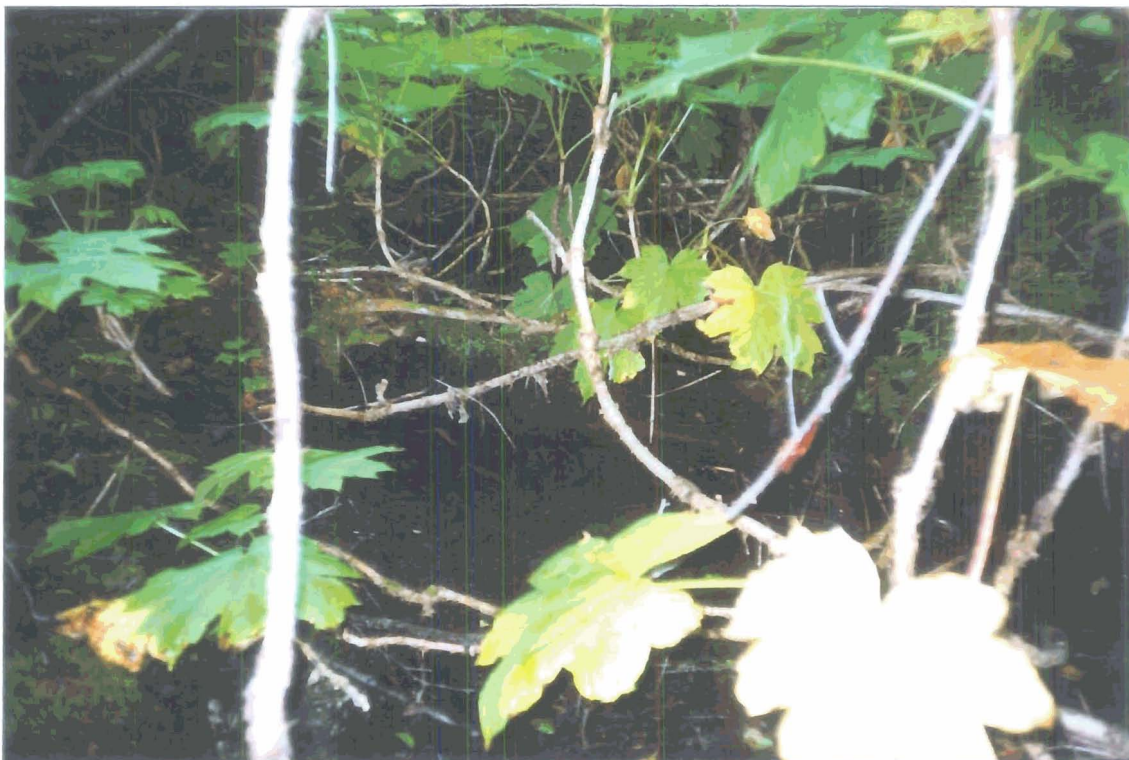
Site #792, upstream photo of fine substrate and the high overhanging vegetation found within sample area.  
Roll #24, Frame #15, Date: 2001/08/19

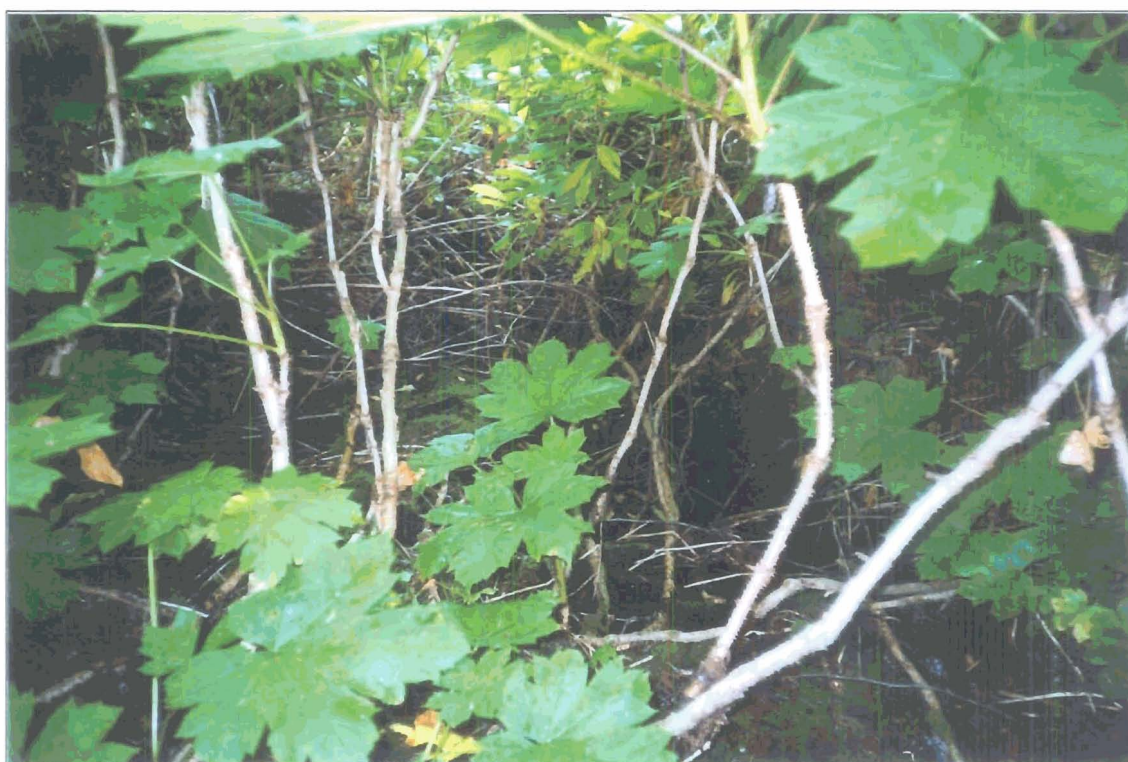
| COMMENTS | |
|---|---|
| CHANNEL | high distribution of vascular plants were observed in stream bed |

Site #792, downstream photo of high vascular plant distribution within stream bed.  
Roll #24, Frame #16, Date: 2001/08/19

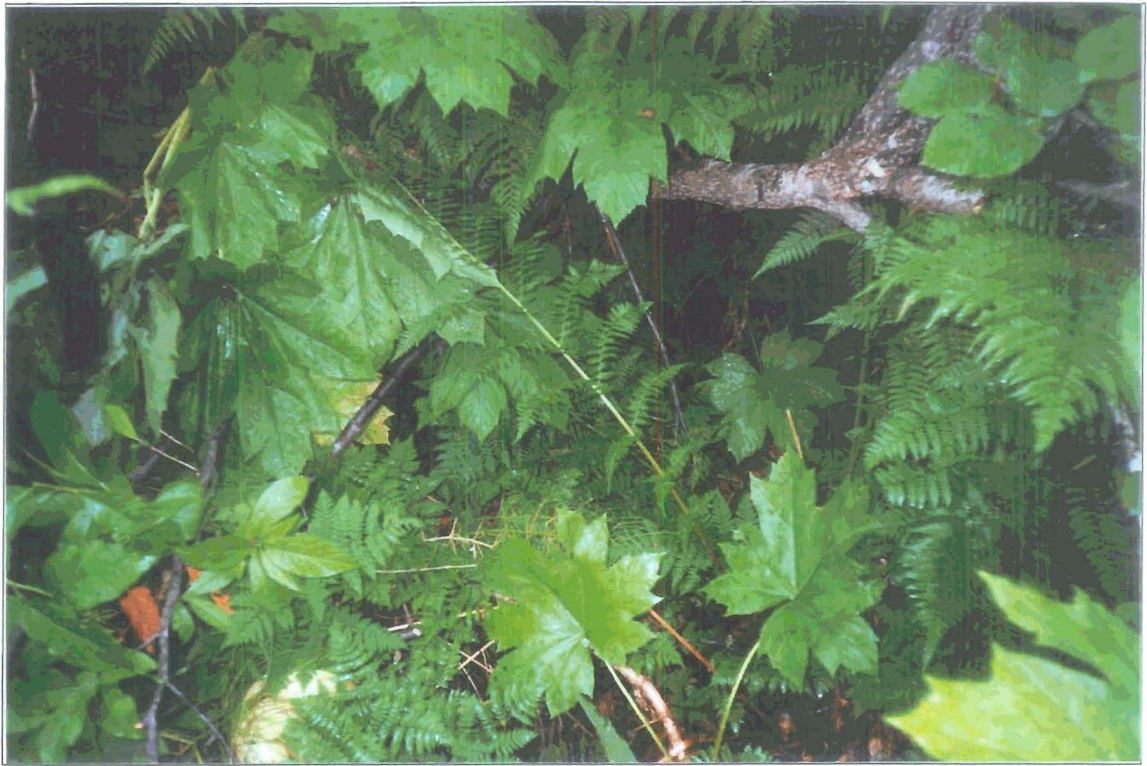
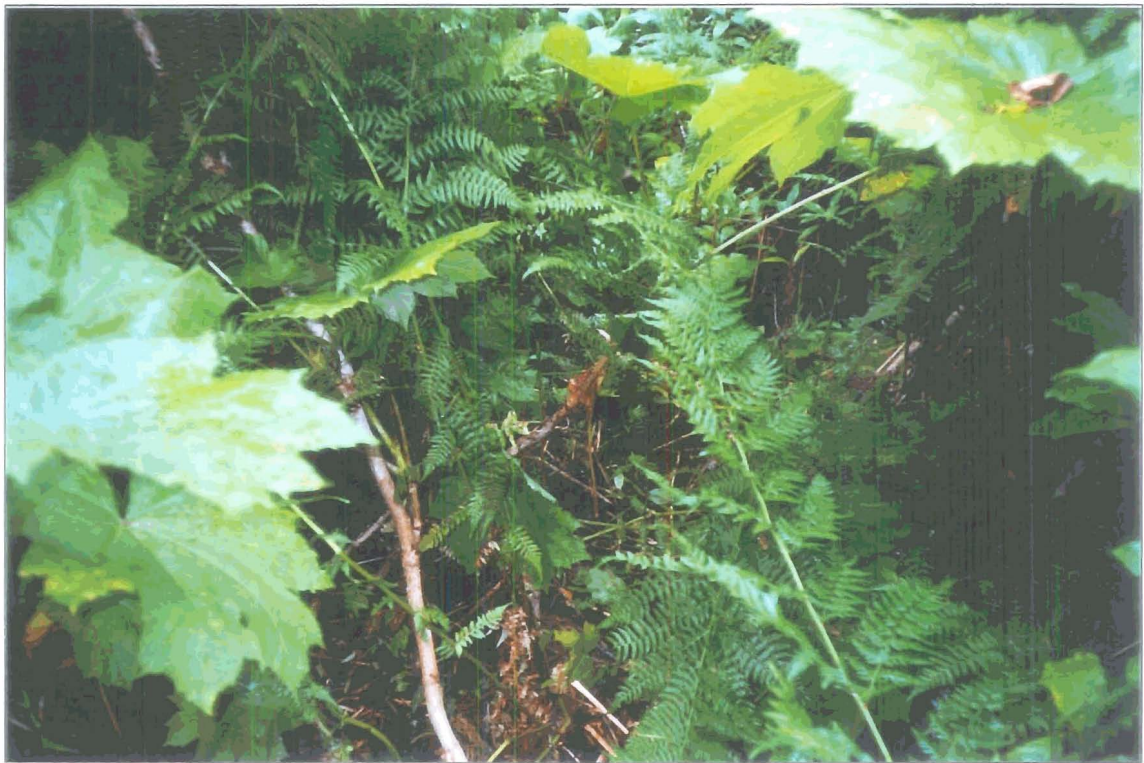
| COMMENTS | |
|---|---|
| CHANNEL | No stream or channel observed |

Site #793, upstream photo of vegetated gully.  
Roll #24, Frame #17, Date: 2001/08/19

Site #793, downstream photo of vegetated gully.  
Roll #24, Frame #18, Date: 2001/08/19

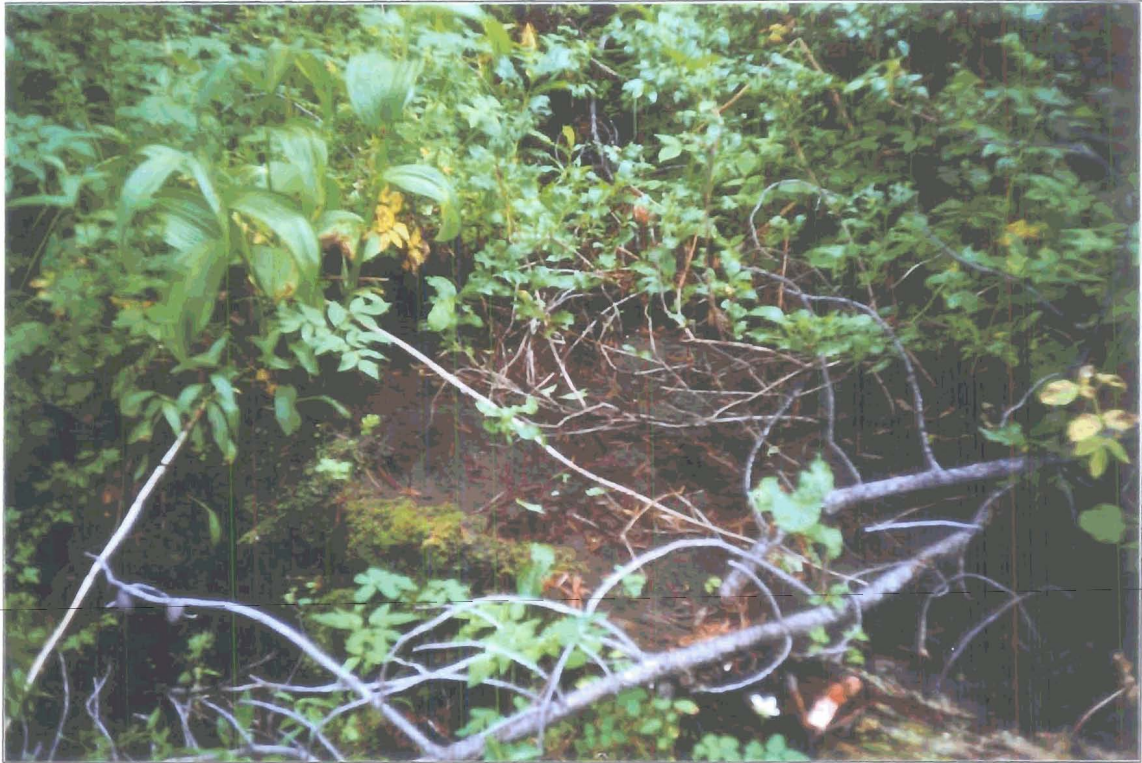
Site #794, upstream photo of de-watered section common throughout sample site.  
Roll #24, Frame #19, Date: 2001/08/19
