**Reconnaissance (1:20,000)**  
**Fish and Fish Habitat Inventory**  
**of Unnamed Tributaries to the**  
**Southwest Shore of Babine Lake,**  
**South of Topley Landing**  
**(South Fulton Planning Area)**

**WSC 480-705800 to 480-776600**  
**Volume 2 of 2**

### **Reach Cards/Site Cards/Fish Collection Forms and Photographs**

**(Sites 366 to 953)**

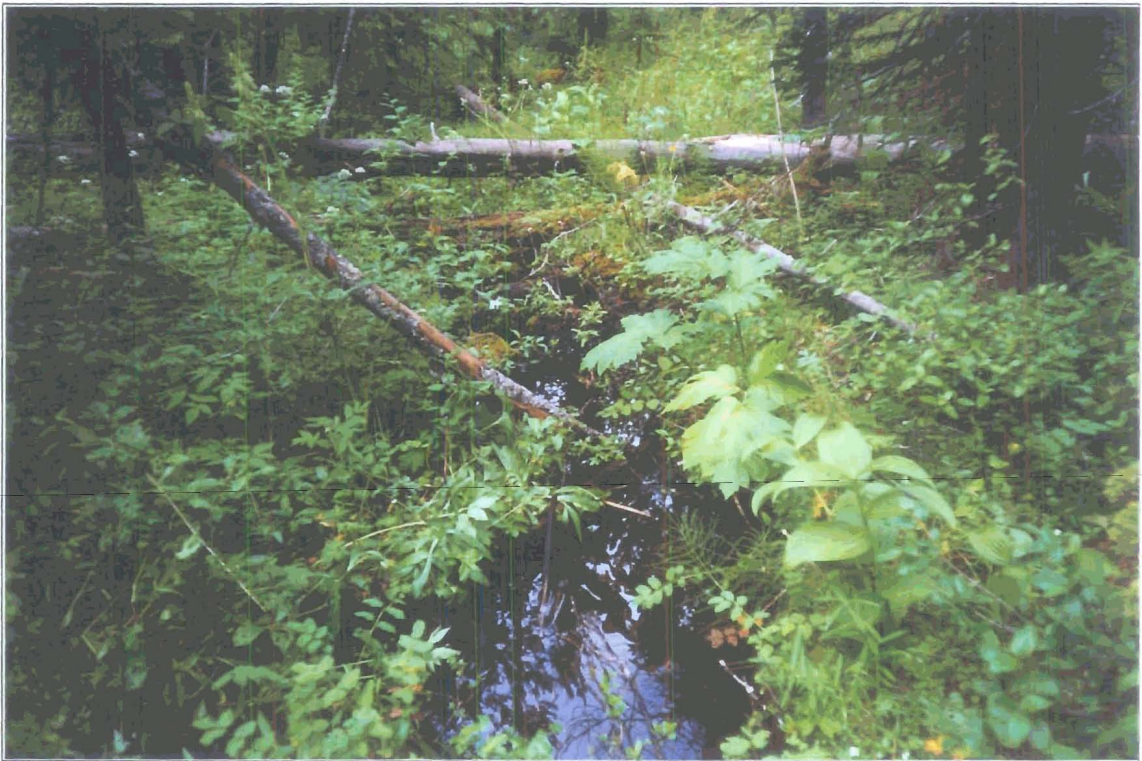
Site #794, downstream photo of typical morphology found within sample site.  
Roll #24, Frame #20, Date: 2001/08/19
