**Reconnaissance (1:20,000)
Fish and Fish Habitat Inventory of
Tributaries to West Shore of Babine Lake
Between Newman Island and the Fulton River
and an Unnamed Inlet stream to the
North Shore of Fulton Lake
East of Broughton Creek**

Watershed Code: 480, 480-697200-08100

Houston Forest Products Co.

SKR Consultants Ltd.

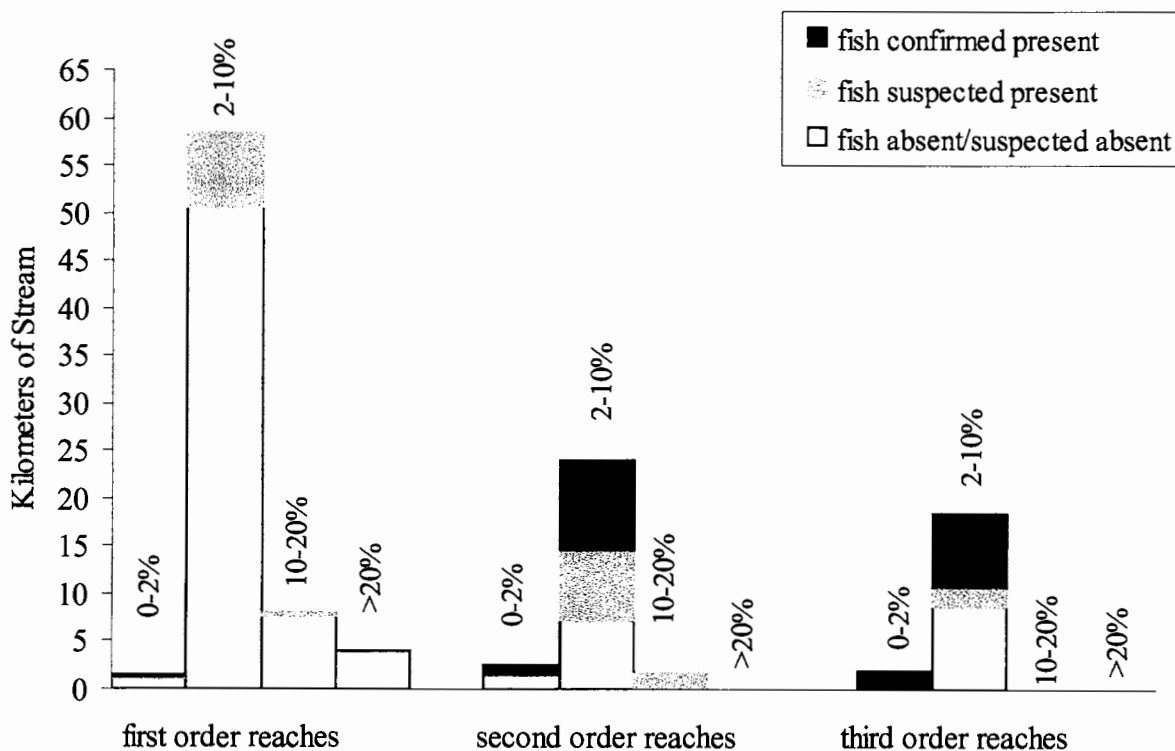
Figure 2. Distribution of fish presence in different order and gradient classes of stream reaches within Sub-basins II and VII. Data labels represent the gradient classes (%) within each stream order.

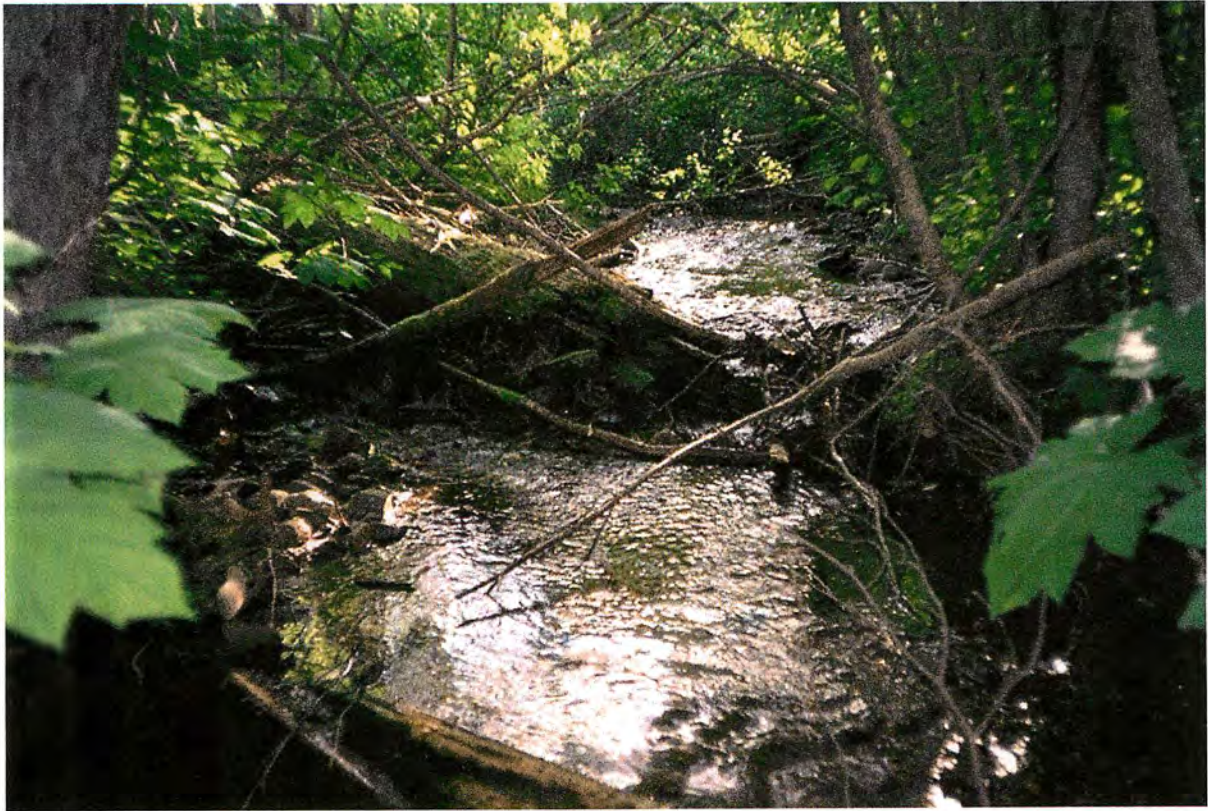
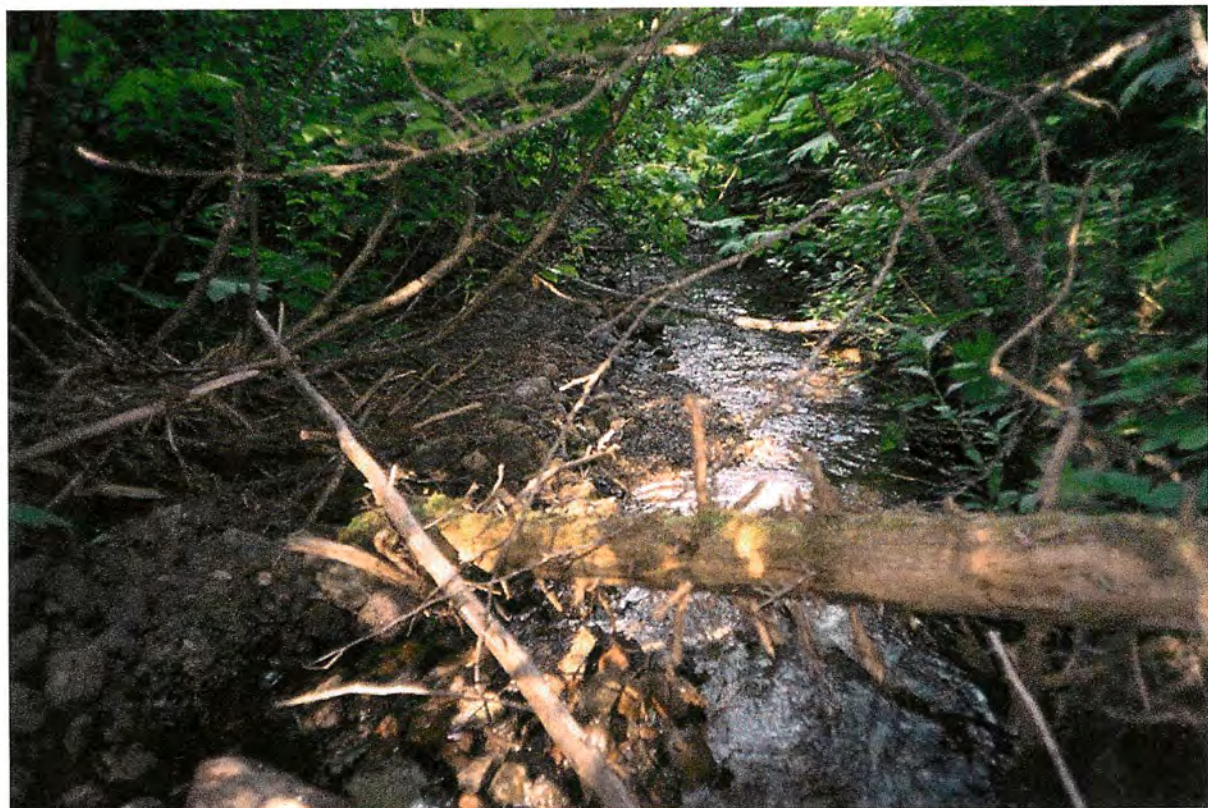
Site # 1
ILP # 40208 ILP Map # 093L.099
Reach # 1.0
Watershed Code: 000-000000-00000-00000-0000-0000-000-000-000-000-000-000

COMMENTS	
Section	Comments
SITE LOCATION	3 minnow traps set upstream of North Road crossing and 2 downstream.
SITE DESCRIPTION	Electrofishing over best habitat above and below culvert (1 DV was captured above the culvert), 1 DV was captured shocking in the same pool that one of the unsuccessful minnow traps was set in.

Direction of Photo: U CD #: 1 Image #: 46 Roll #: TC1 Frame #: 21
Comment: 520 metres upstream of Babine Lake.

Direction of Photo: D CD #: 1 Image #: 47 Roll #: TC1 Frame #: 22
Comment: 520 metres upstream of Babine Lake.

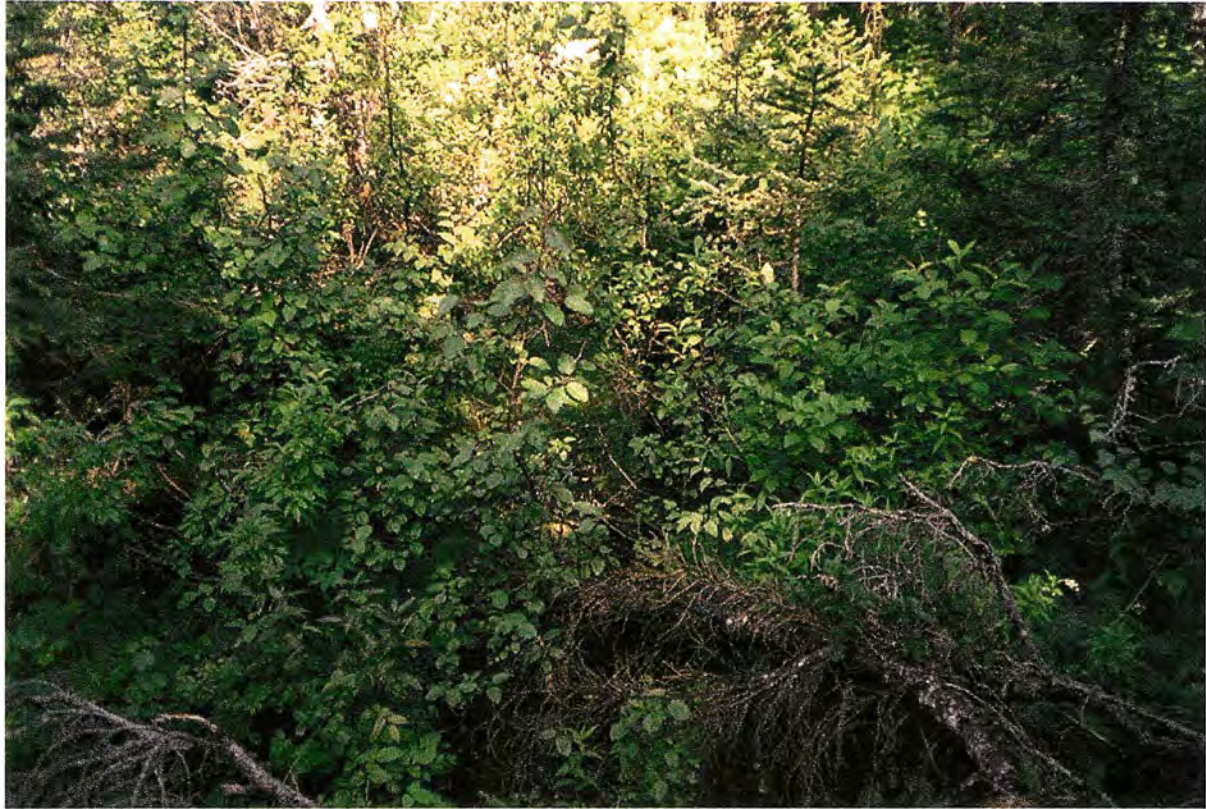
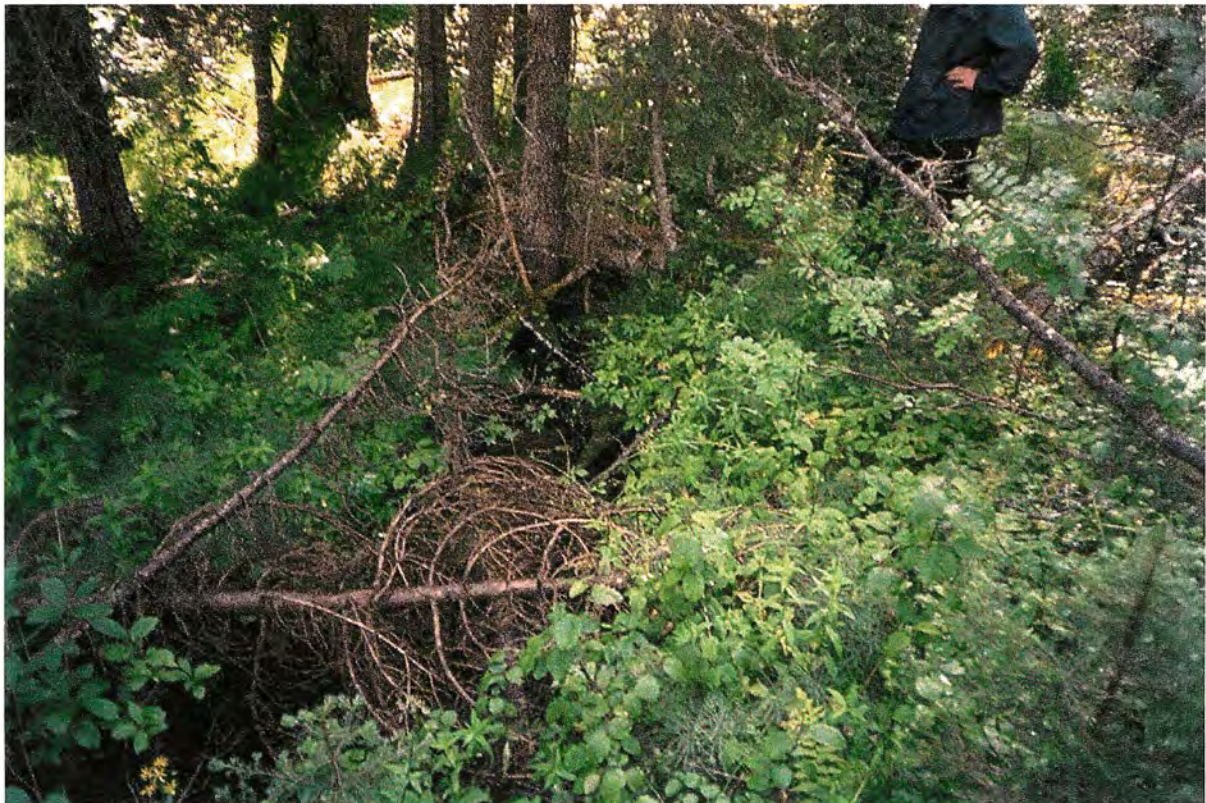
Site # 2
ILP # 40208 ILP Map # 093L.099
Reach # 3.0
Watershed Code: 000-000000-00000-00000-0000-0000-000-000-000-000-000-000

Section	Comments
SITE LOCATION	Approximately 50 m downstream of tributary ILP40399.
COMMENTS	
Section	Comments
SURVEY LOCATION	Surveyed entire reach in helicopter in search of barriers but no definite barriers were observed in reaches 1-3 via helicopter.
COMMENTS	
Section	Comments
SURVEY DESCRIPTION	Channel appeared to have better qualities in reach 2.
COMMENTS	
Section	Comments
RIPARIAN VEGETATION	3-5 m band on both sides consisting of alder ,willow, horsetail, and ferns.
COMMENTS	
Section	Comments
FISH PRESENCE	No fish captured but resampling and a ground search to identify a likely barrier in a deep rock canyon in reach 2 is required.

Direction of Photo: U CD #: 1 Image #: 68 Roll #: TC4 Frame #: 12
Comment: Approximately 50 metres downstream of tributary (ILP 40399).

Direction of Photo: D CD #: 1 Image #: 69 Roll #: TC4 Frame #: 13
Comment: Approximately 50 metres downstream of tributary (ILP 40399).

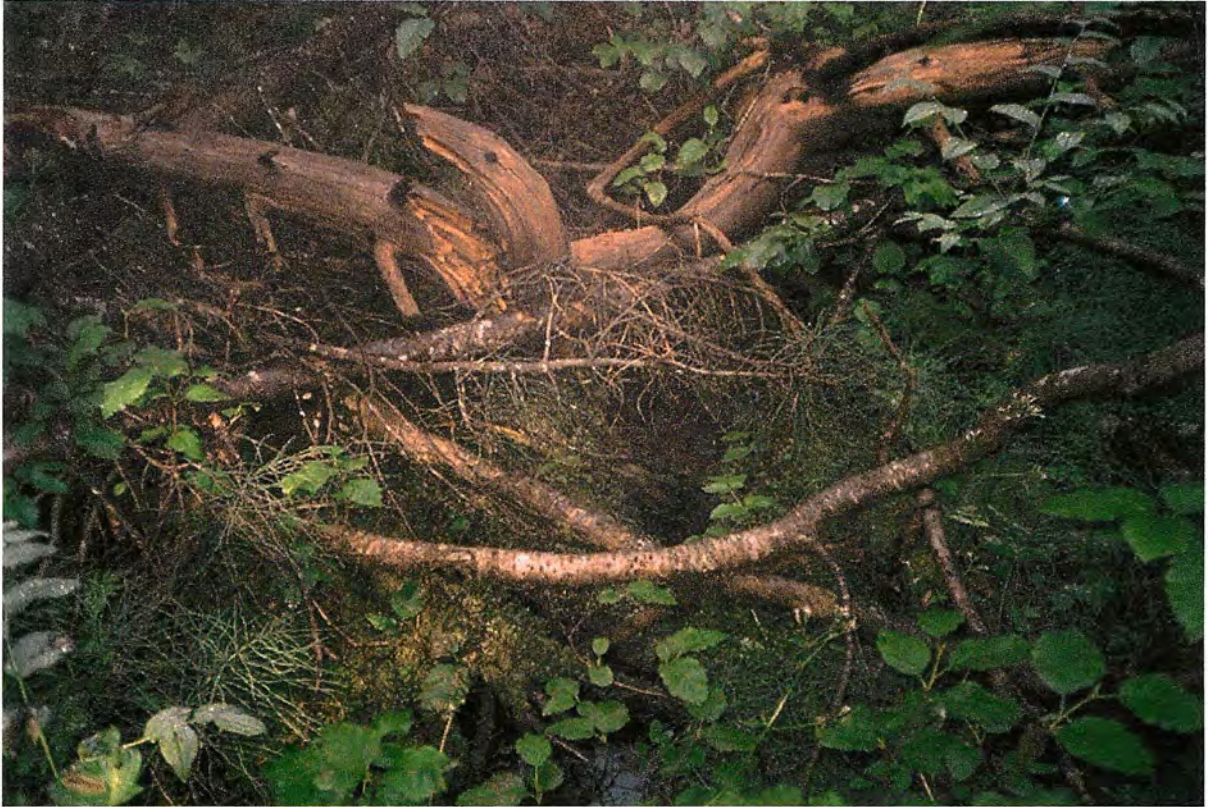
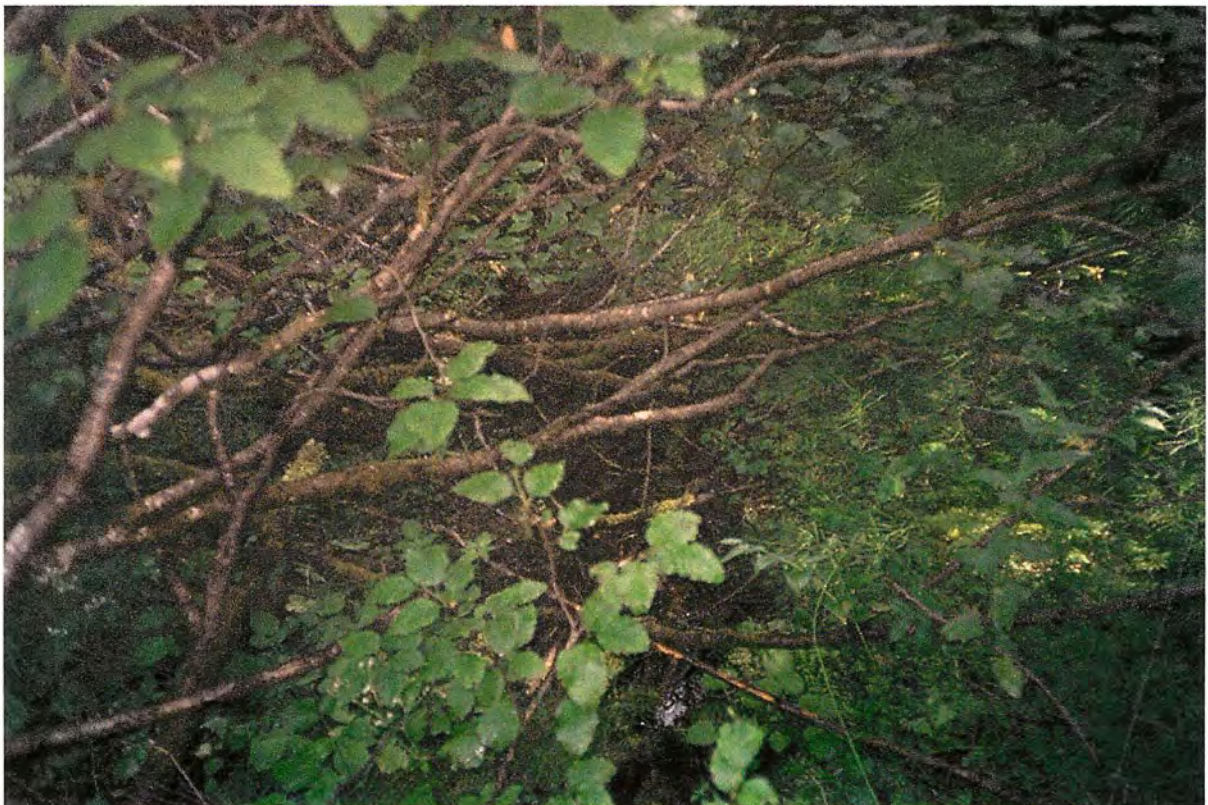
Site # 3
ILP # 40399 ILP Map # 093L.099
Reach # 1.0
Watershed Code: 000-000000-00000-00000-0000-0000-000-000-000-000-000-000

PHOTOS				
Photo	Foc Lg	Dir	Comments	
R: TC4	F: 10	STD	U	150 metres upstream of confluence of mainstem (ILP 40208).
R: TC4	F: 11	STD	D	150 metres upstream of confluence of mainstem (ILP 40208).
COMMENTS				
Section	Comments			
SITE LOCATION	150 m upstream of confluence with mainstem (ILP40208).			
COMMENTS				
Section	Comments			
SITE DESCRIPTION	Site was representative of reach observed by helicopter.			
COMMENTS				
Section	Comments			
SURVEY LOCATION	Surveyed entire reach by helicopter.			
COMMENTS				
Section	Comments			
RIPARIAN VEGETATION	1-4 m band on both sides of alder, horsetail, twisted stalk, and oak fern.			
COMMENTS				
Section	Comments			
FISH PRESENCE	No fish present upstream of 8C40 and 22% gradient section at confluence or in mainstem.

Direction of Photo: U CD #: 1 Image #: 66 Roll #: TC4 Frame #: 10
Comment: 150 metres upstream of confluence of mainstem (ILP 40208).

Direction of Photo: D CD #: 1 Image #: 67 Roll #: TC4 Frame #: 11
Comment: 150 metres upstream of confluence of mainstem (ILP 40208).

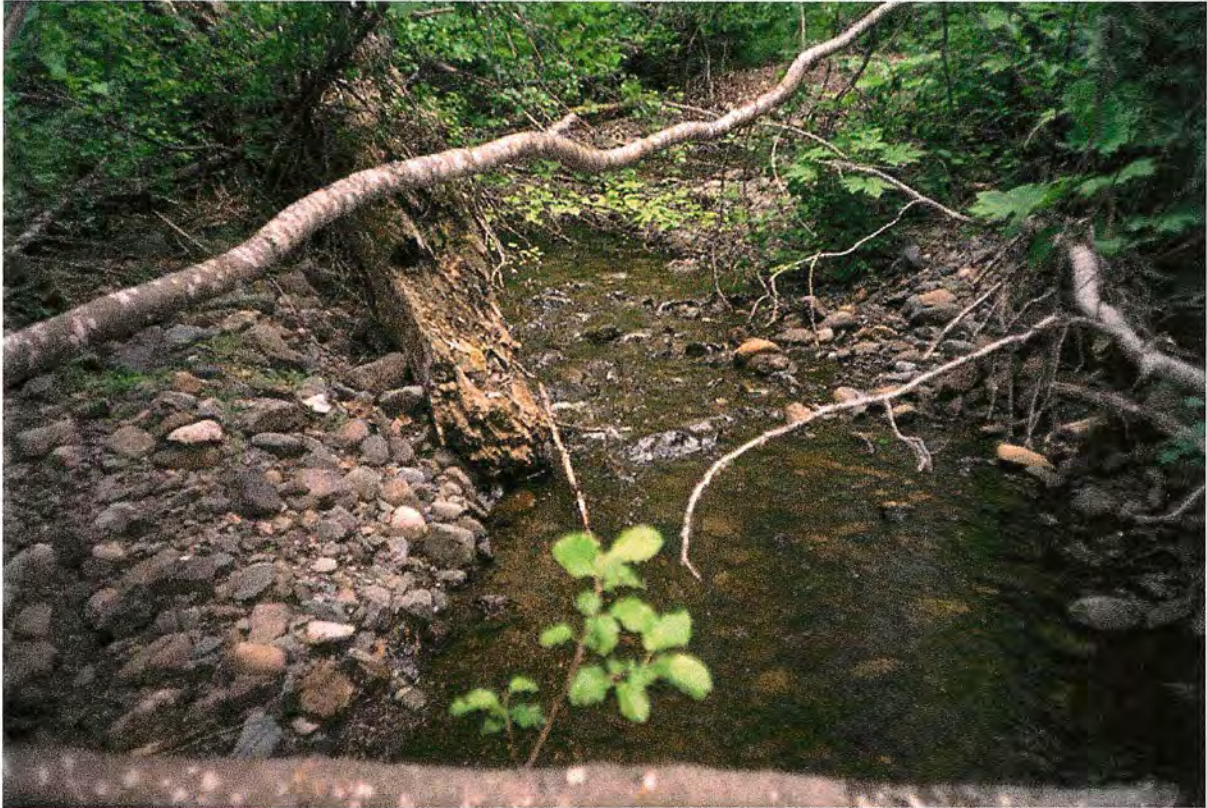
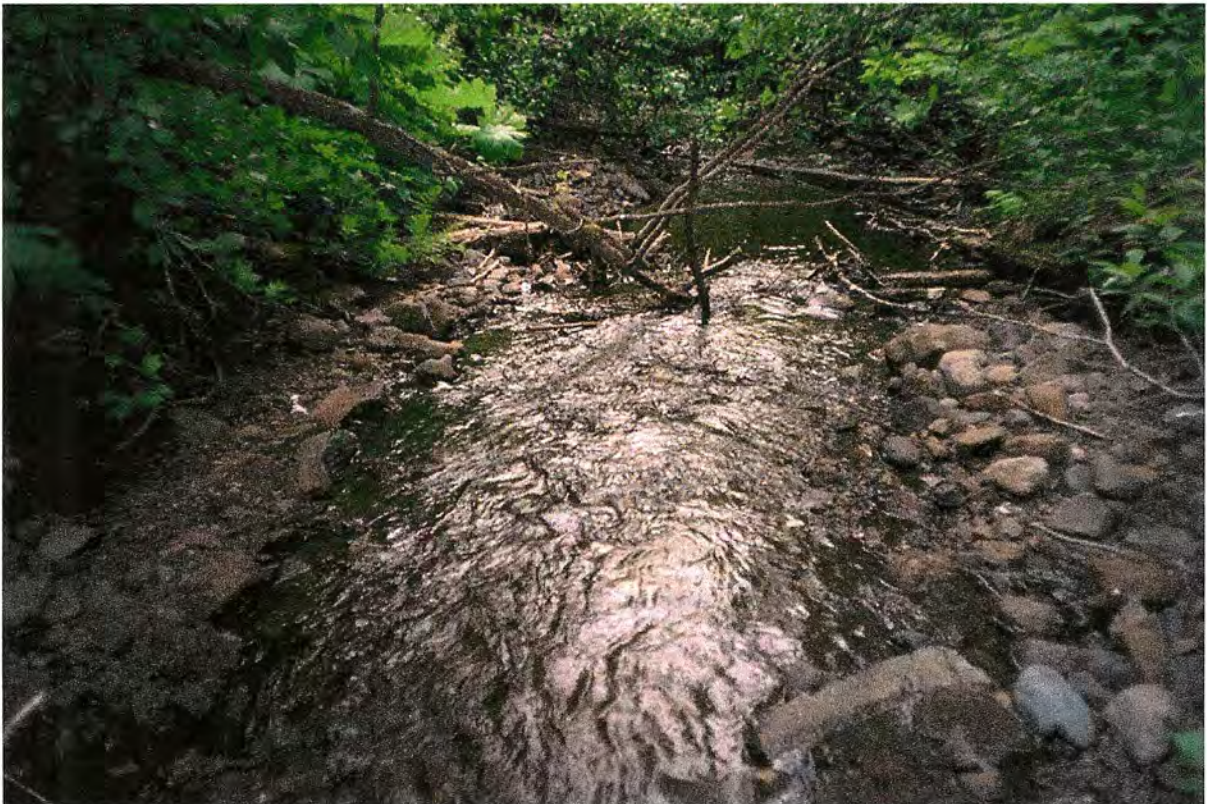
Site # 4
ILP # 40216 ILP Map # 093L.099
Reach # 1.0
Watershed Code: 000-000000-000000-000000-0000-0000-000-000-000-000-000

Section	Comments
SITE DESCRIPTION	Set 3 MT's upstream of North Road crossing and 2 downstream. A large log across the front of the culvert has accumulated alluvium under it and created a "step" into the front of the culvert, allowing a pool to build here. 1 MT was set here.

Direction of Photo: U CD #: 1 Image #: 48 Roll #: TC1 Frame #: 23
Comment: 650 metres upstream of Babine Lake.

Direction of Photo: D CD #: 1 Image #: 49 Roll #: TC1 Frame #: 24
Comment: 650 metres upstream of Babine Lake.

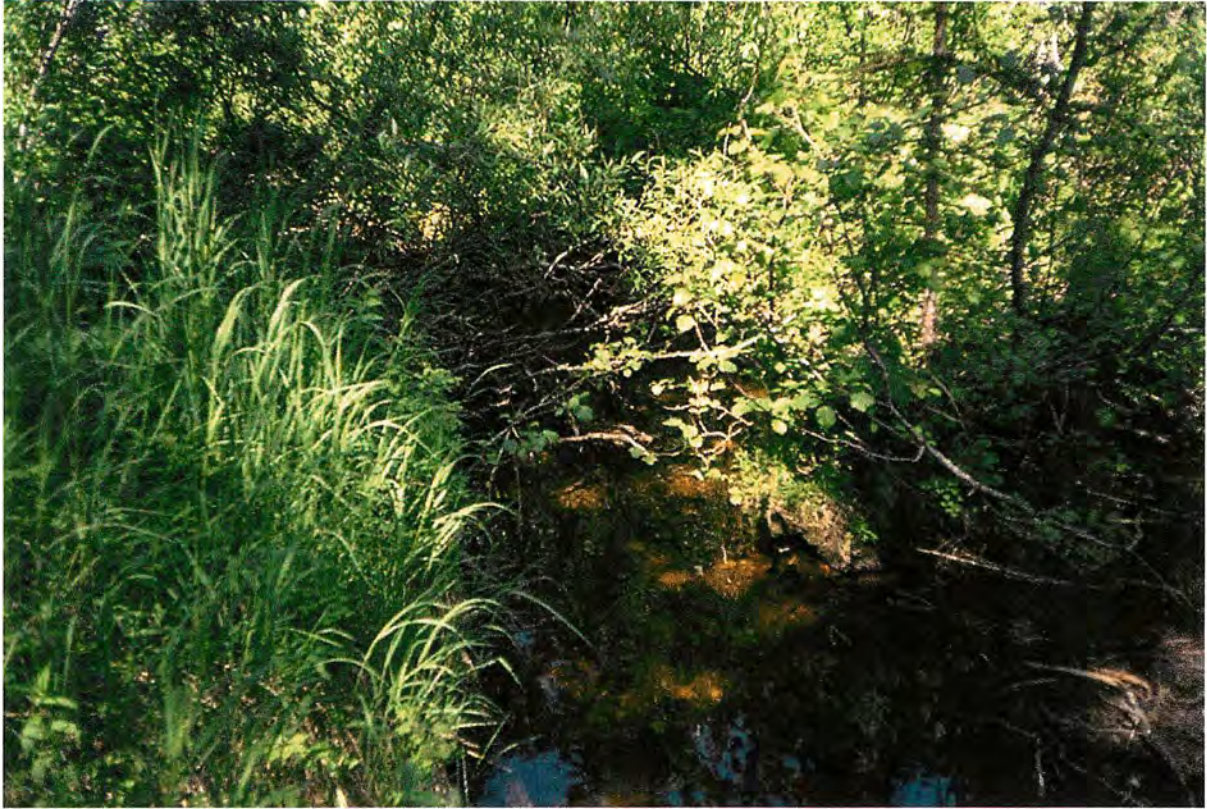
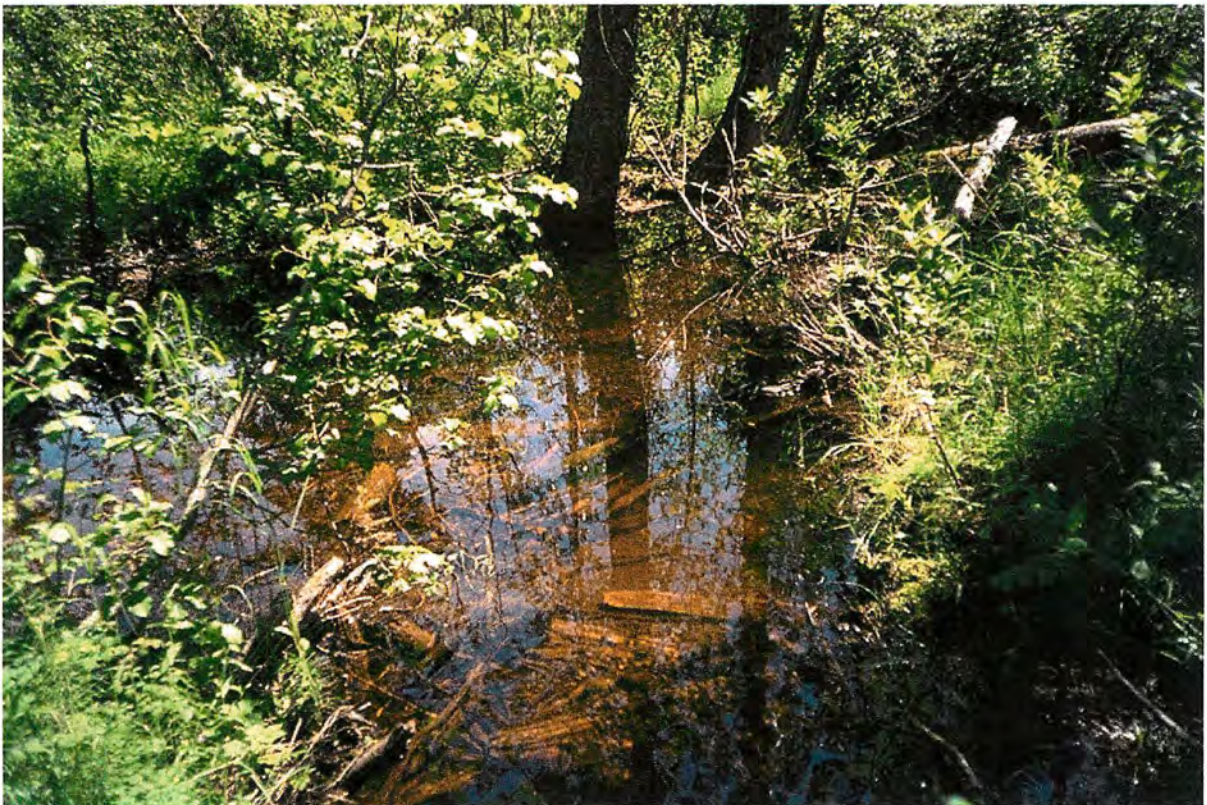
Site # 5
ILP # 40216 ILP Map # 093L.099
Reach # 3.0
Watershed Code: 000-000000-00000-00000-0000-0000-000-000-000-000-000-000

Section	Comments
PERCENT HABITAT SHOCKED	EF over 40% pool (some beaver pond at lower end of site), 30% glide, 30% riffle, over some excellent habitat. Efficiency was good (excellent visibility and access) but would have been better with large anode ring.

Direction of Photo: U CD #: 1 Image #: 51 Roll #: TC3 Frame #: 2
Comment: 250 metres upstream of confluence of ILP 40219.

Direction of Photo: D CD #: 1 Image #: 52 Roll #: TC3 Frame #: 3
Comment: 250 metres upstream of confluence of ILP 40219.

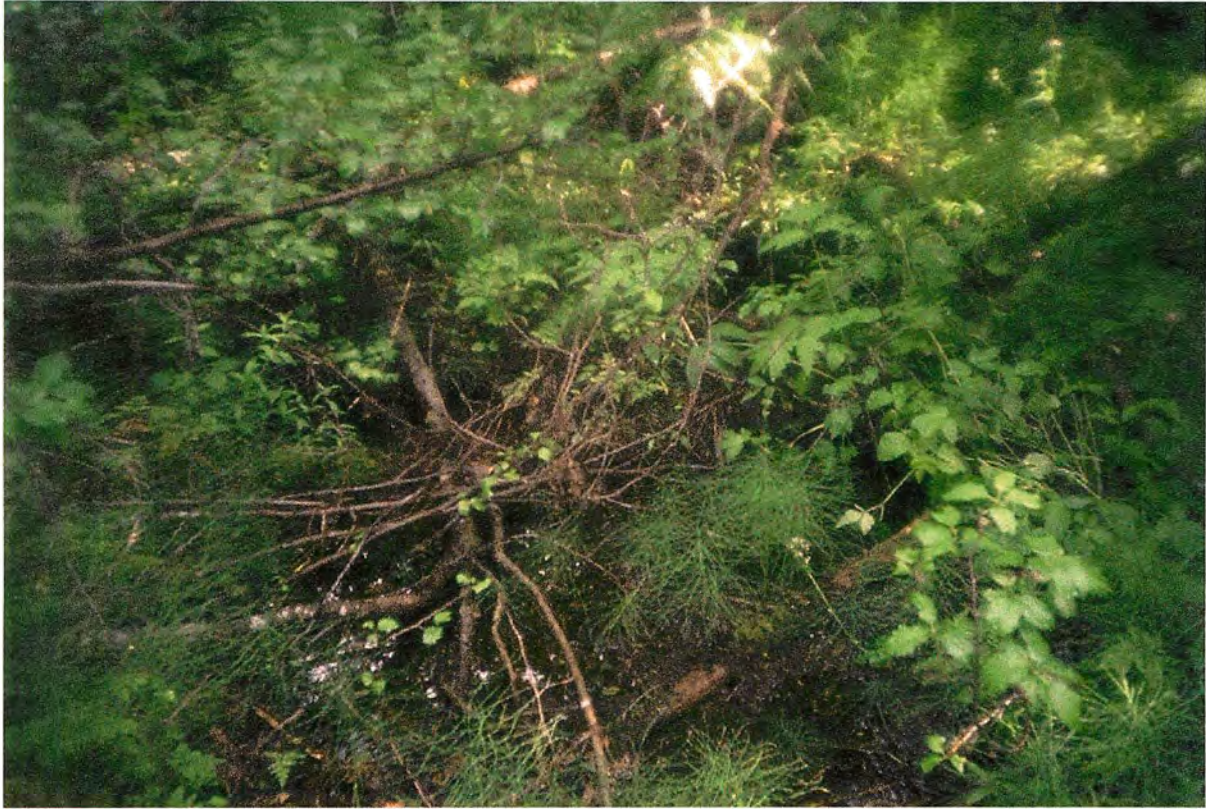
Site # 6
ILP # 40216 ILP Map # 093L.099
Reach # 4.0
Watershed Code: 000-000000-00000-00000-0000-0000-000-000-000-000-000-000

Section	Comments
SITE LOCATION	Approximately 500 m upstream of mapped confluence with tributary ILP 40225.
COMMENTS	
Section	Comments
SURVEY LOCATION	Surveyed 200 m starting at site location and going upstream.
COMMENTS	
Section	Comments
SURVEY DESCRIPTION	Stream has only enough momentum to scour away surface vegetation and debris. Substrate was entirely fines. Many short seepage steps (approximately 1.5 m) were also observed. Stream may be ephemeral.
COMMENTS	
Section	Comments
FISH PRESENCE	Not suspected due to poor habitat quality and barrier downstream in reach 2. This stream was not sampled.
COMMENTS	
Section	Comments
RIPARIAN VEGETATION	Riparian band on both banks consisting of horsetail, arrow leafed groundsel, alpine fir, oak fern, willow.
COMMENTS	
Section	Comments
BARRIER	A 5 m falls was observed from the helicopter in reach 2, 680 m upstream of tributary ILP 40217.

Direction of Photo: U CD #: 1 Image #: 79 Roll #: TC5 Frame #: 1
Comment: View of site approximately 520 metres upstream of tributary ILP 40225.

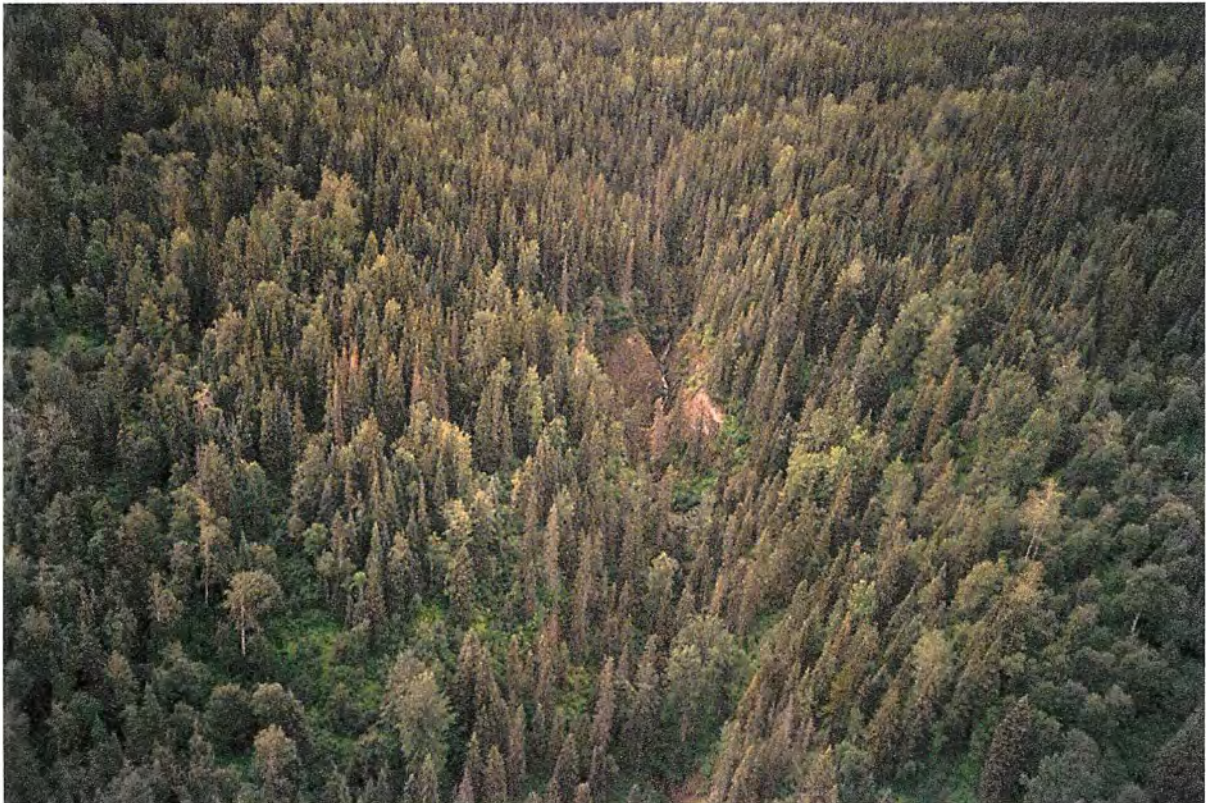
Direction of Photo: X CD #: 1 Image #: 70 Roll #: TC4 Frame #: 14
Comment: Aerial view of 5 metres falls located downstream in reach 2.

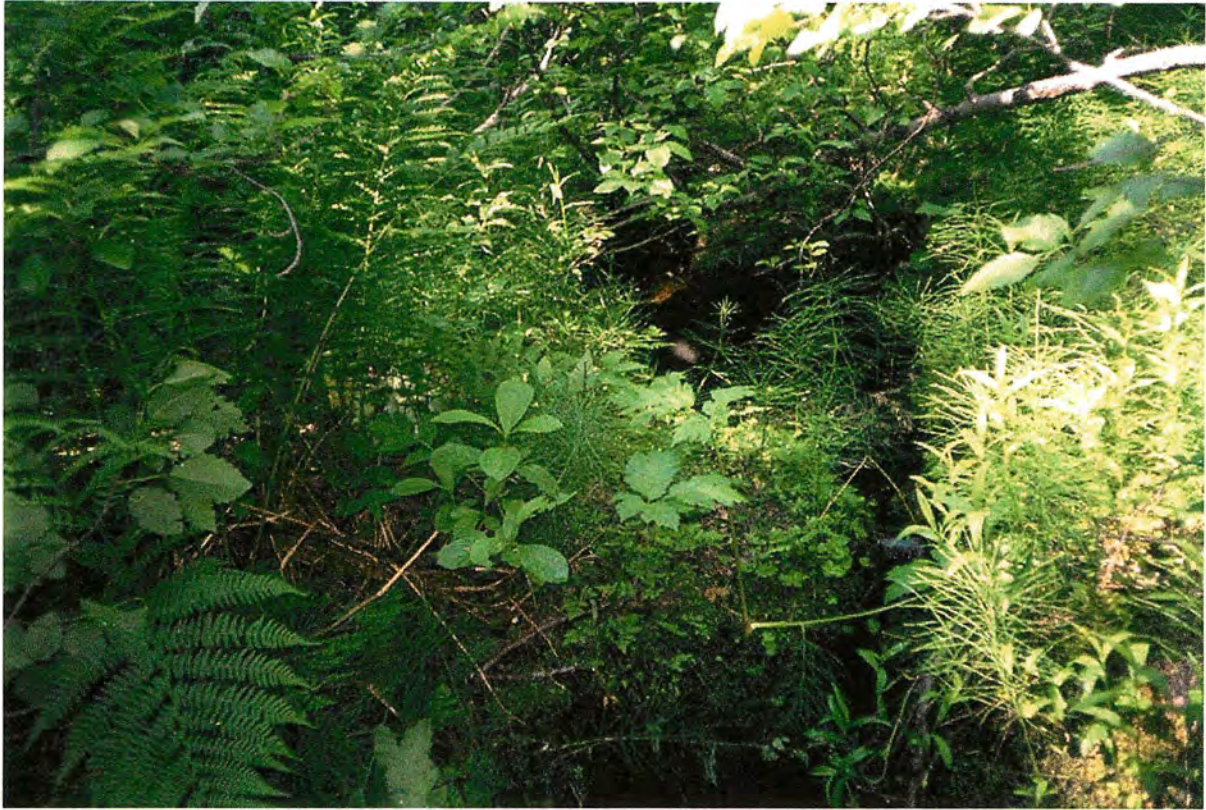
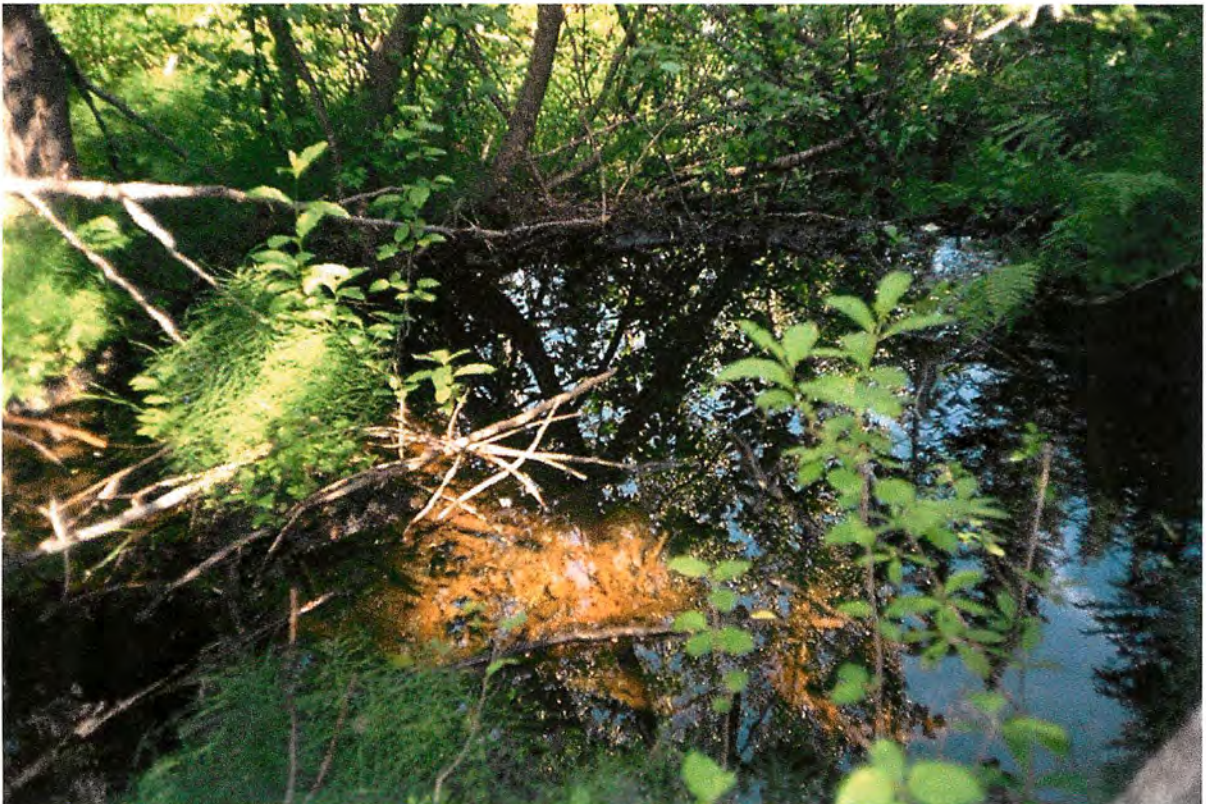
Site # 7
ILP # 40219 ILP Map # 093L.099
Reach # 1.0
Watershed Code: 000-000000-00000-00000-0000-0000-000-000-000-000-000-000

A. GEAR SETTINGS													
Site#	MTD/NO	H/P	Date In	Time In	Date Out	Time Out	Comment						
7	EF	1	2001/07/20	11:34	2001/07/20	12:00							
C. ELECTROFISHER SPECIFICATIONS													
Site#	MTD/NO	H/P	Encl	Sec	Length	Width	Voltage	Frequency	Pulse	Make	Model		
7	EF	1	O	614	100.0	0.5	600	60	6	SR	15C		
FISH SUMMARY													
Site#	MTD/NO	H/P	Species	Stage	Age	Total #	Lgth (Min/Max)	FishAct	Comment				
7	EF	1	NFC			0							
COMMENTS													
Section			Comments										
PERCENT HABITAT SHOCKED			Shocked 70% of pool (30 % step-pool, 40% beaver pool), 20% glide, 10% riffle. Efficiency was good but somewhat reduced by dark substrate.

Direction of Photo: U CD #: 1 Image #: 25
Comment: 50 metres upstream of confluence with mainstem.

Direction of Photo: D CD #: 1 Image #: 50
Comment: 50 metres upstream of confluence with mainstem.

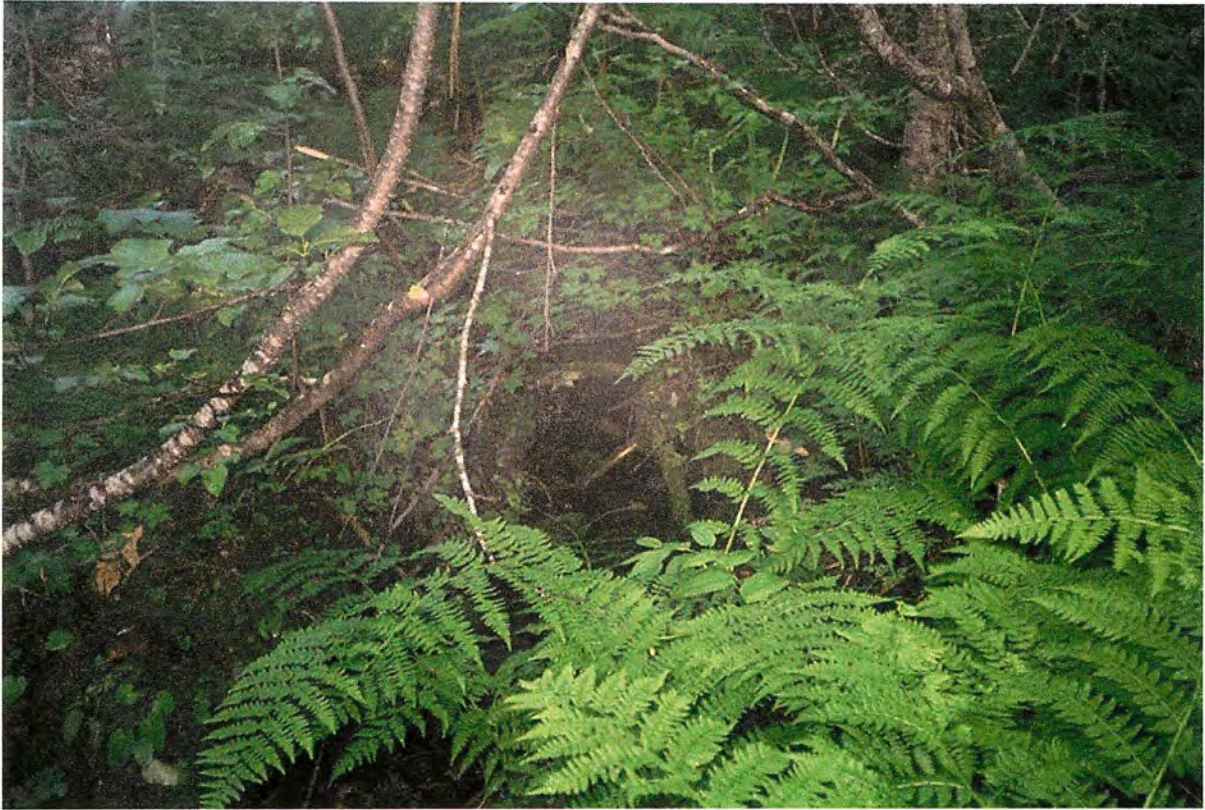
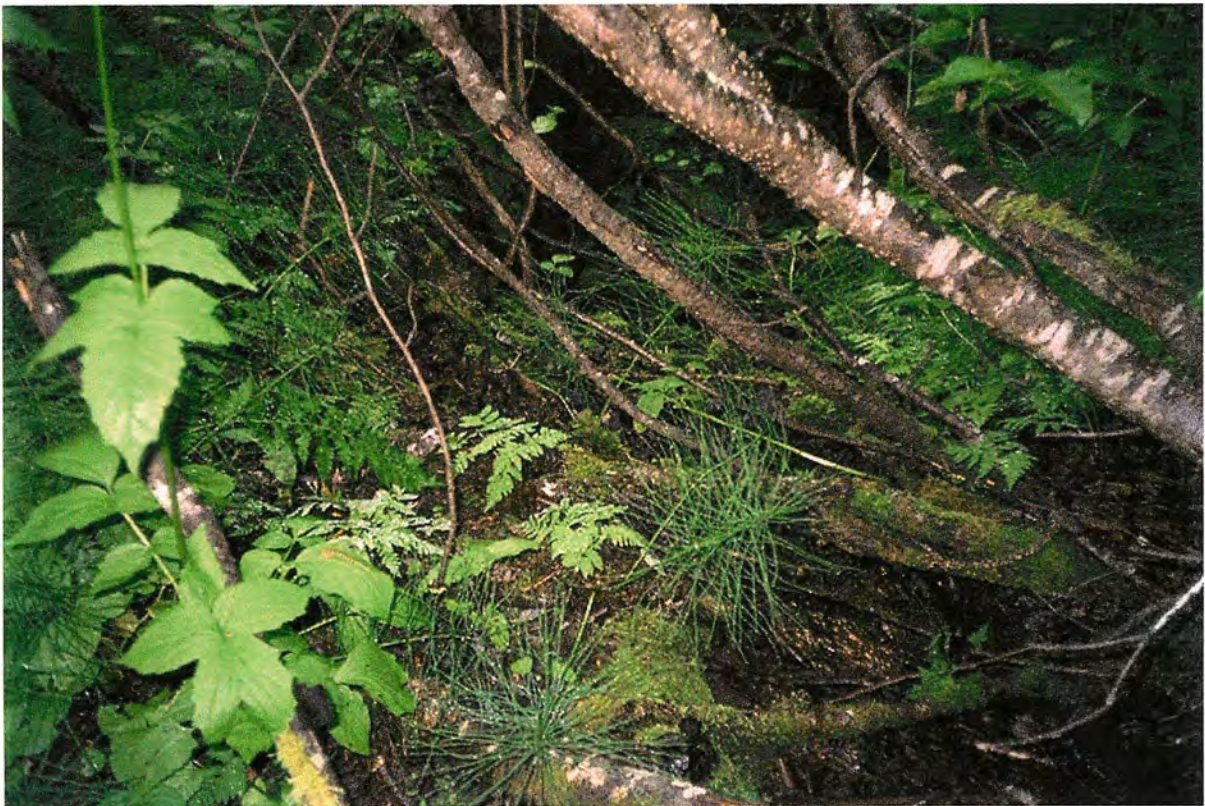
Site # 8
ILP # 40222 ILP Map # 093L.099
Reach # 2.0
Watershed Code: 000-000000-00000-00000-0000-000-000-000-000-000-000

Section	Comments
SITE LOCATION	Approximately 1400 m upstream of confluence with mainstem (ILP40222).
COMMENTS	
Section	Comments
SURVEY LOCATION	Surveyed lower 250 m of the reach.
COMMENTS	
Section	Comments
RIPARIAN VEGETATION	Alder and horsetail, but mature fir to stream bank.
COMMENTS	
Section	Comments
FISH PRESENCE	Not sampled due to no fish captured downstream in mainstem and very low discharge at time of survey. No fish present due to no fish present in mainstem.

Direction of Photo: U CD #: 1 Image #: 62 Roll #: TC4 Frame #: 6
Comment: Approximately 1400 metres upstream of confluence with mainstem (ILP 40222).

Direction of Photo: D CD #: 1 Image #: 63 Roll #: TC4 Frame #: 7
Comment: Approximately 1400 metres upstream of confluence with mainstem (ILP 40222).

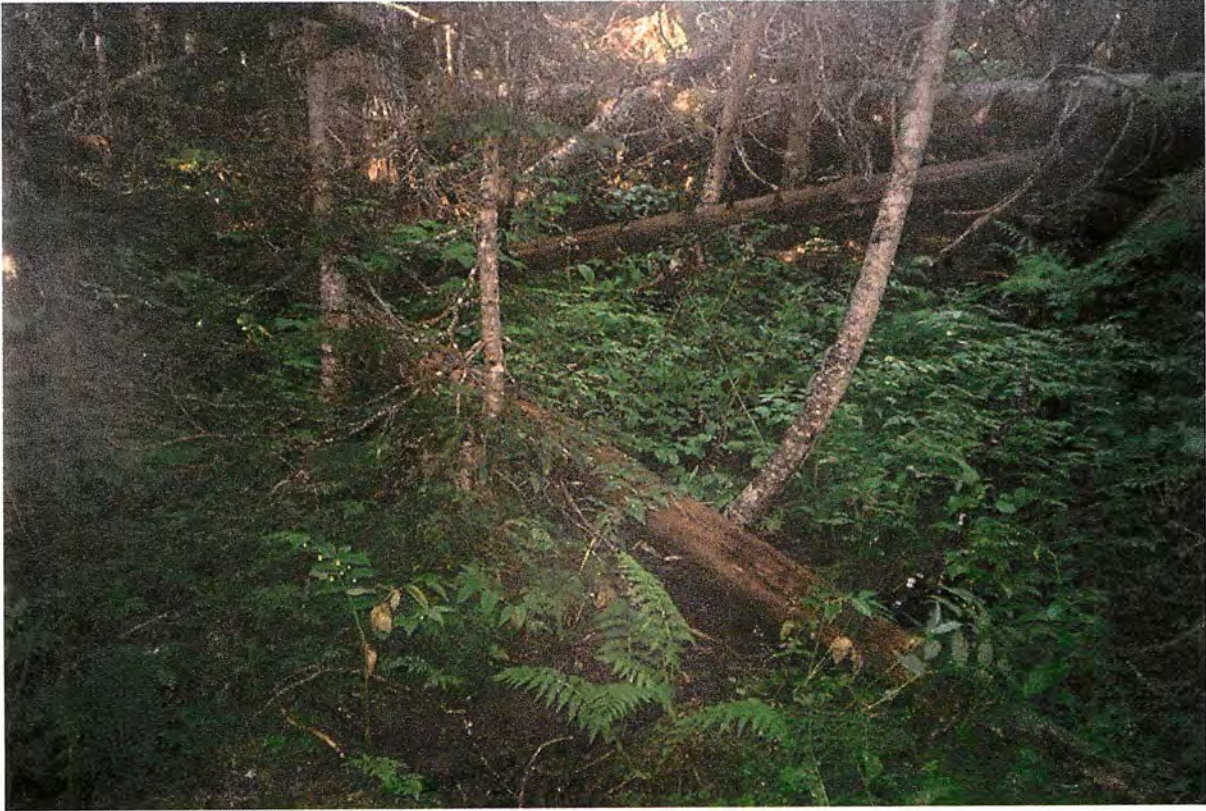
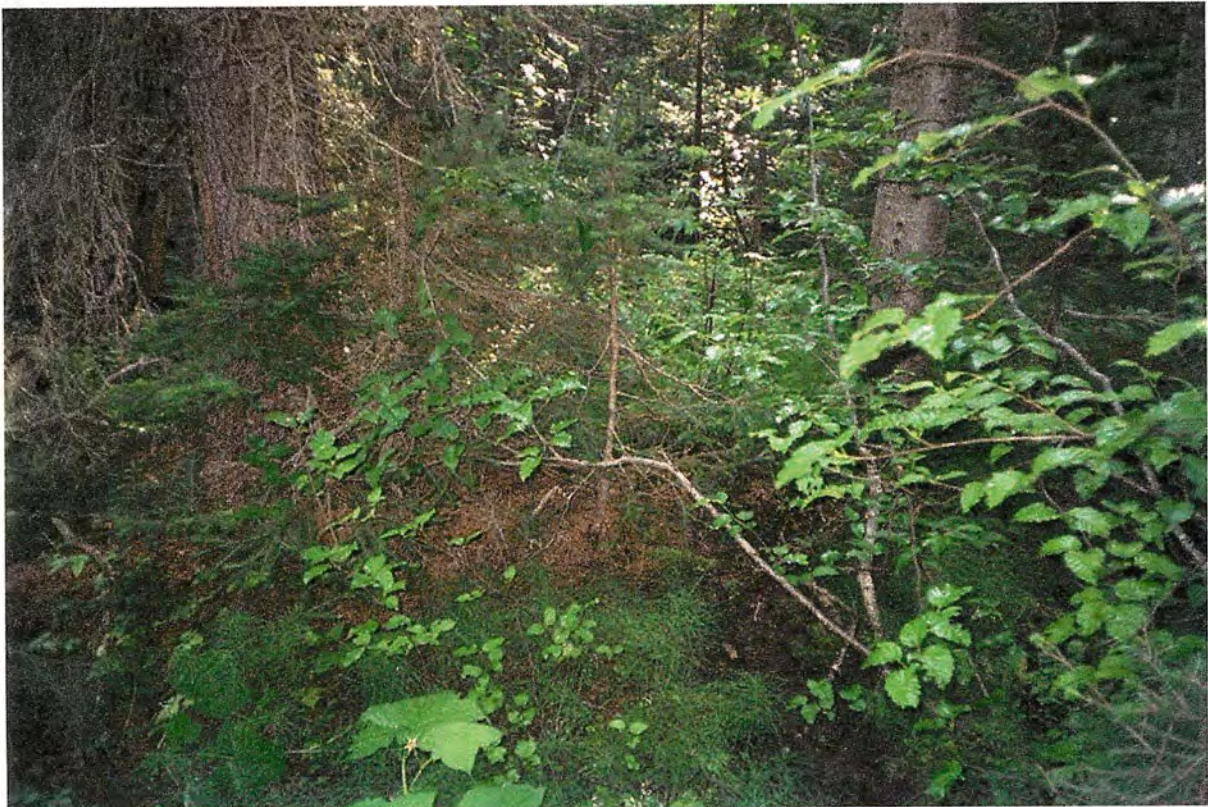
Site # 9
ILP # 40223 ILP Map # 093L.099
Reach # 1.0
Watershed Code: 000-000000-00000-00000-00000-0000-000-000-000-000-000-000

SITE LOCATION	Approximately 250 m upstream of confluence with mainstem ILP 40222.
COMMENTS	
Section	Comments
SITE DESCRIPTION	Channel consists of short sections of defined channel and 3-10 m sections of seepage.
COMMENTS	
Section	Comments
RIPARIAN VEGETATION	Stream runs through mature fir forest with little riparian vegetation.
COMMENTS	
Section	Comments
FISH PRESENCE	No fish present and no potential for fish habitat further upstream due to high gradient in reach 2.

Direction of Photo: U CD #: 1 Image #: 58 Roll #: TC4 Frame #: 2
Comment: 150 metres upstream of confluence with mainstem (ILP 40222).

Direction of Photo: D CD #: 1 Image #: 59 Roll #: TC4 Frame #: 3
Comment: 150 metres upstream of confluence with mainstem (ILP 40222).

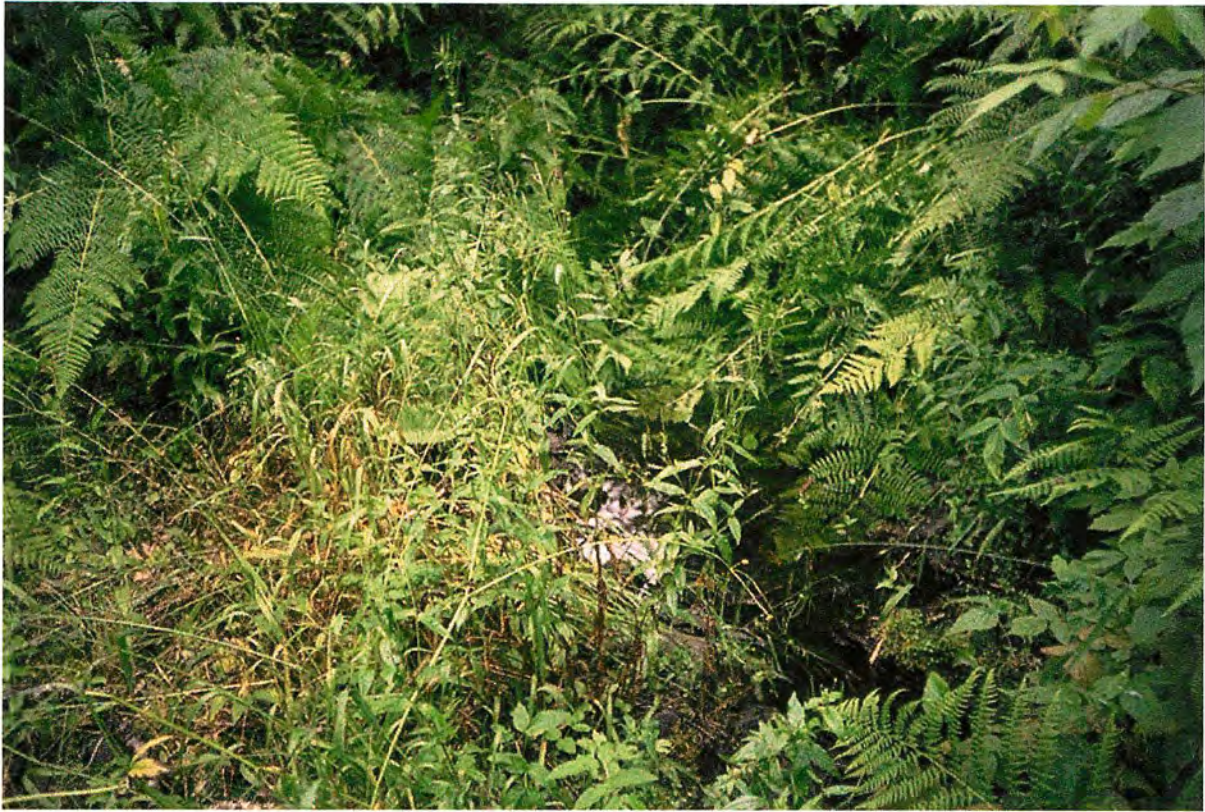
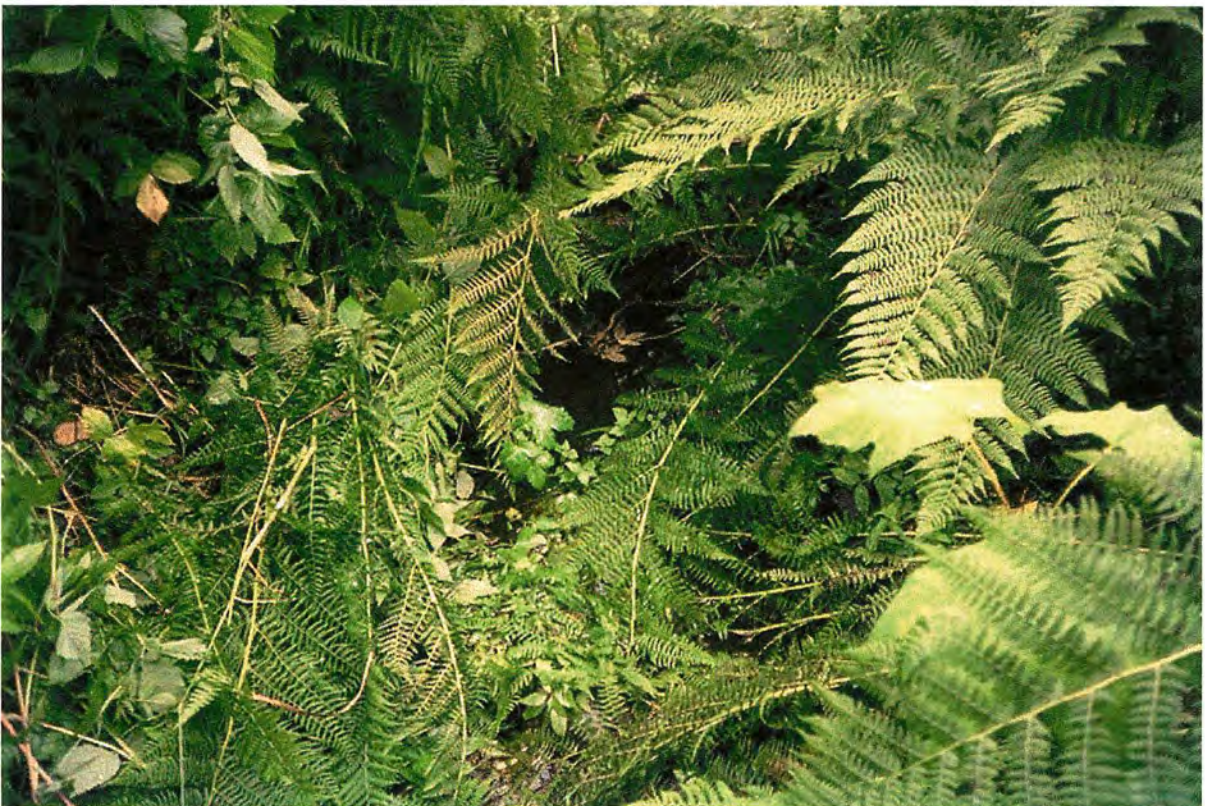
Site # 10
ILP # 40327 ILP Map # 093L.099
Reach # 2.0
Watershed Code: 000-000000-00000-00000-0000-0000-000-000-000-000-000-000

A. GEAR SETTINGS												
Site#	MTD/NO	H/P	Date In	Time In	Date Out	Time Out	Comment					
10	EF	1	2001/08/23	12:10	2001/08/23	12:21						
C. ELECTROFISHER SPECIFICATIONS												
Site#	MTD/NO	H/P	Encl	Sec	Length	Width	Voltage	Frequency	Pulse	Make	Model	
10	EF	1	O	601	100.0	0.6	500	60	6	SR	12B	
FISH SUMMARY												
Site#	MTD/NO	H/P	Species	Stage	Age	Total #	Lgth (Min/Max)	FishAct	Comment			
10	EF	1	NFC			0						
COMMENTS												
Section			Comments									
PERCENT HABITAT SHOCKED			Shocked 40% riffle, 35% pool, 25% glide over some good habitat, but many large steps were present.									
SAMPLING EFFICIENCY			Efficiency was reduced by thick lady fern overhanging vegetation.

Direction of Photo: U CD #: 1 Image #: 71 Roll #: TC4 Frame #: 15
Comment: Approximately 1700 metres upstream of Babine Lake.

Direction of Photo: D CD #: 1 Image #: 72 Roll #: TC4 Frame #: 16
Comment: Approximately 1700 metres upstream of Babine Lake.
