**Reconnaissance (1:20,000)
Fish and Fish Habitat Inventory of
Tributaries to West Shore of Babine Lake
Between Newman Island and the Fulton River
and an Unnamed Inlet stream to the
North Shore of Fulton Lake
East of Broughton Creek**

Watershed Code: 480, 480-697200-08100

Houston Forest Products Co.

SKR Consultants Ltd.

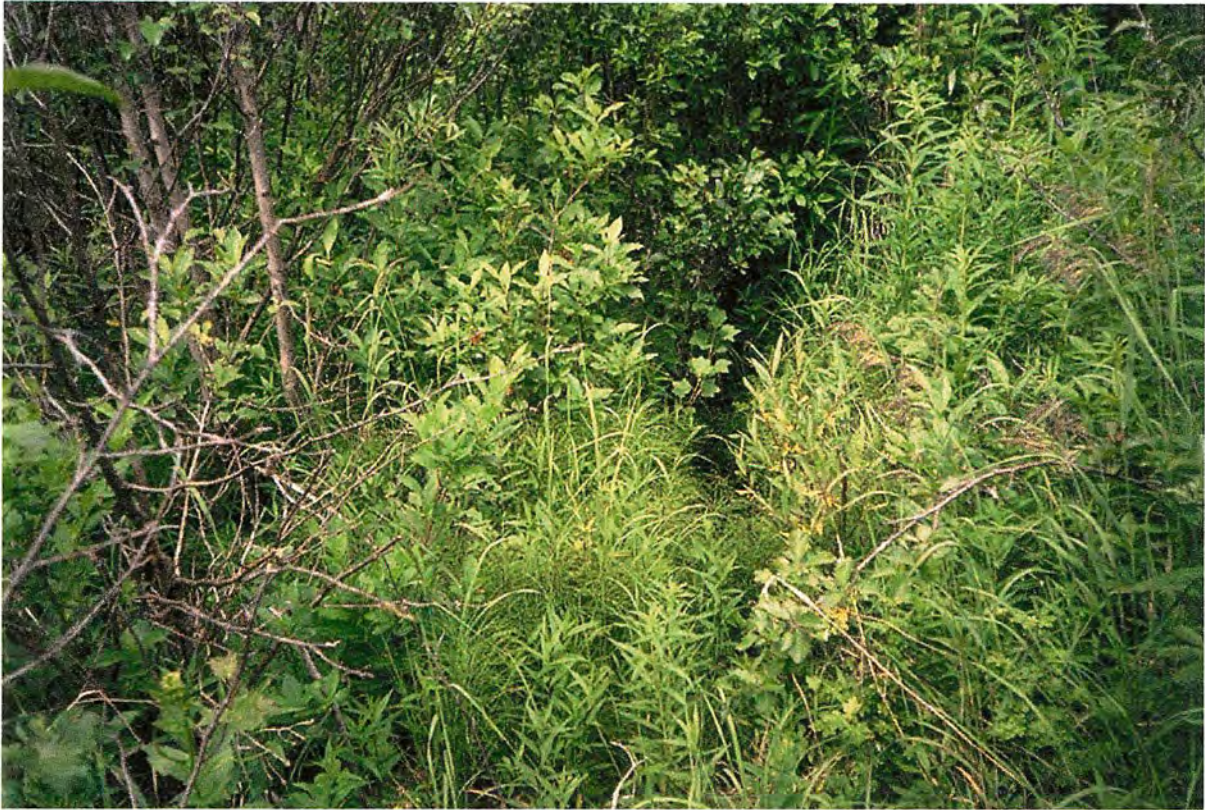
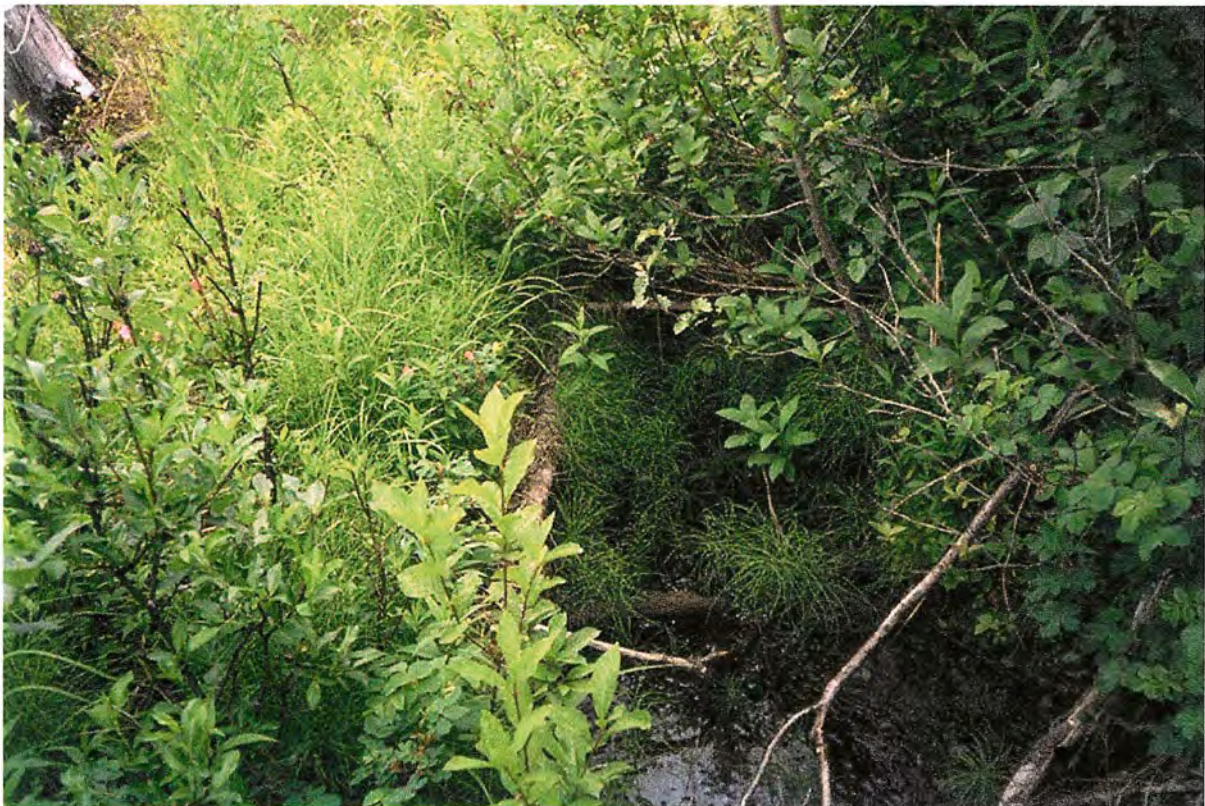
Site # 11
ILP # 40327 ILP Map # 093L.099
Reach # 11.0
Watershed Code: 000-000000-00000-00000-0000-0000-000-000-000-000-000-000

COMMENTS	
Section	Comments
SITE LOCATION	700 m upstream of inlet to lake in reach 9.
COMMENTS	
Section	Comments
SURVEY LOCATION	Surveyed lower 600 m of reach.
COMMENTS	
Section	Comments
SURVEY DESCRIPTION	Reach consisted of a riparian band in shallow gully with no sign of alluvium or fluvial deposits; reach over section surveyed was NCD.
COMMENTS	
Section	Comments
RIPARIAN VEGETATION	40 m band of willow, alder, twinberry, and grasses between replanted spruce and pine.

Direction of Photo: U CD #: 1 Image #: 5 Roll #: TC2 Frame #: 5
Comment: 750 metres upstream of inlet to lake in reach 9.

Direction of Photo: D CD #: 1 Image #: 6 Roll #: TC2 Frame #: 6
Comment: 750 metres upstream of inlet to lake in reach 9.

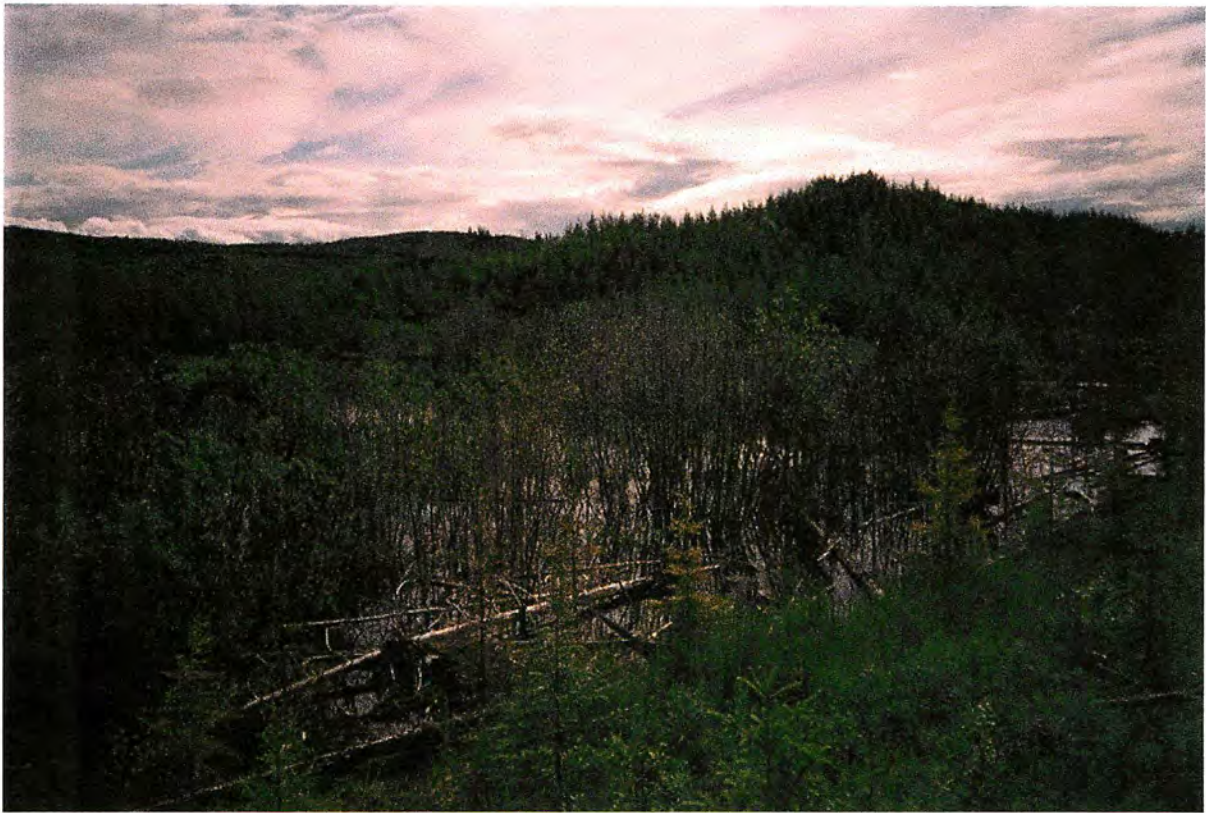
Direction of Photo: NS CD #: 1 Image #: 3 Roll #: TC2 Frame #: 3
Comment: View of large beaver dam.

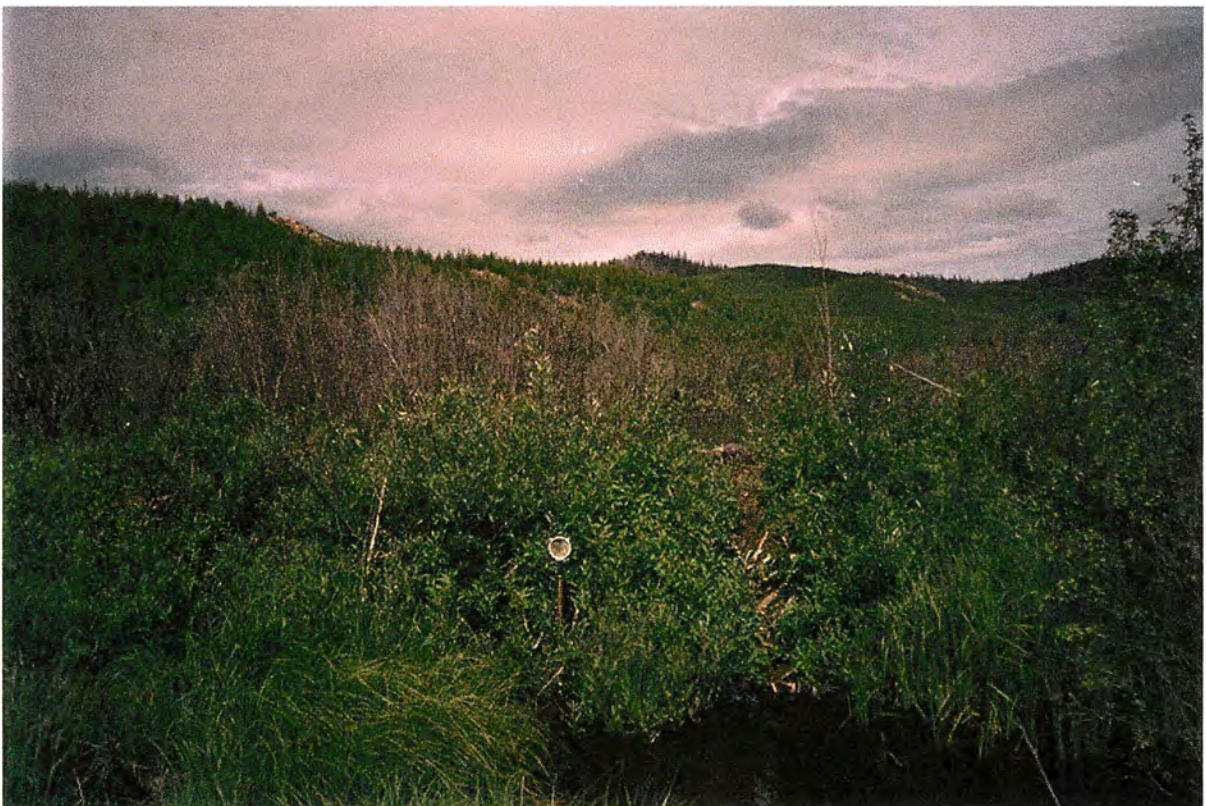
Direction of Photo: U CD #: 1 Image #: 4 Roll #: TC2 Frame #: 4
Comment: View of 2 metres high beaver dam, 135 metres upstream of lake ILP 40327, R7.

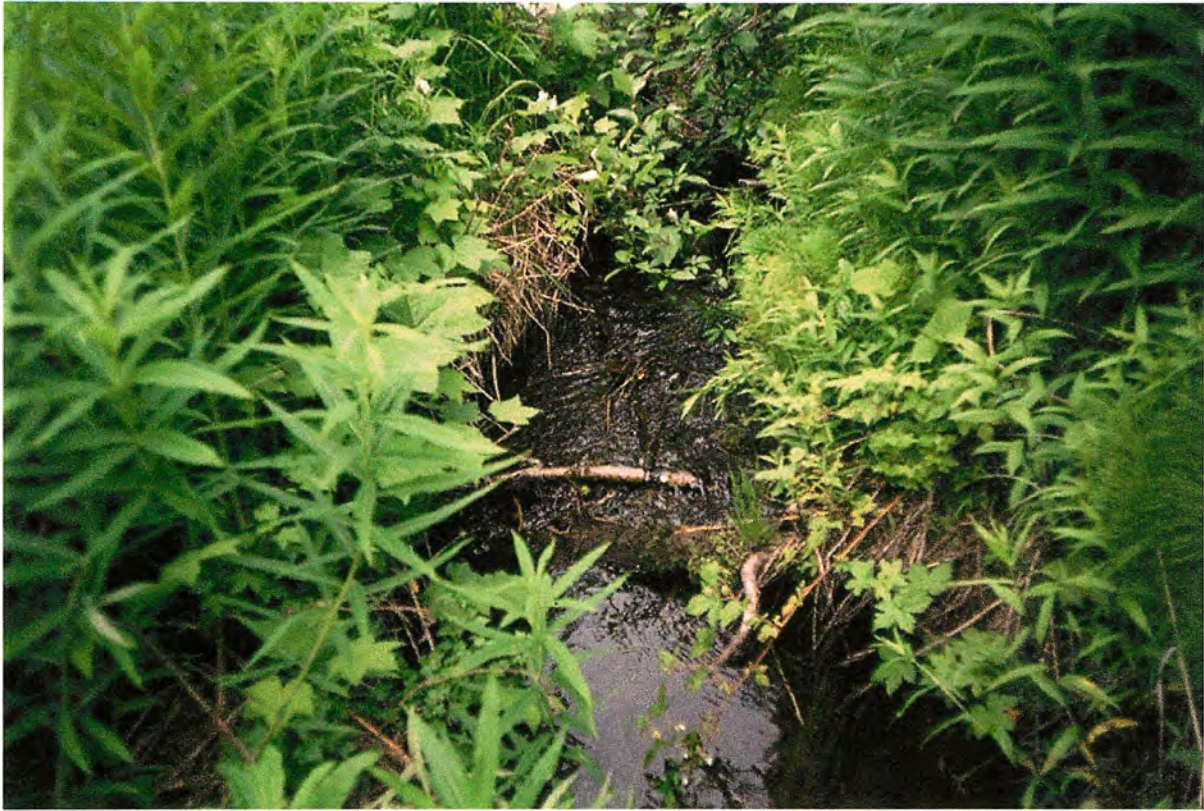
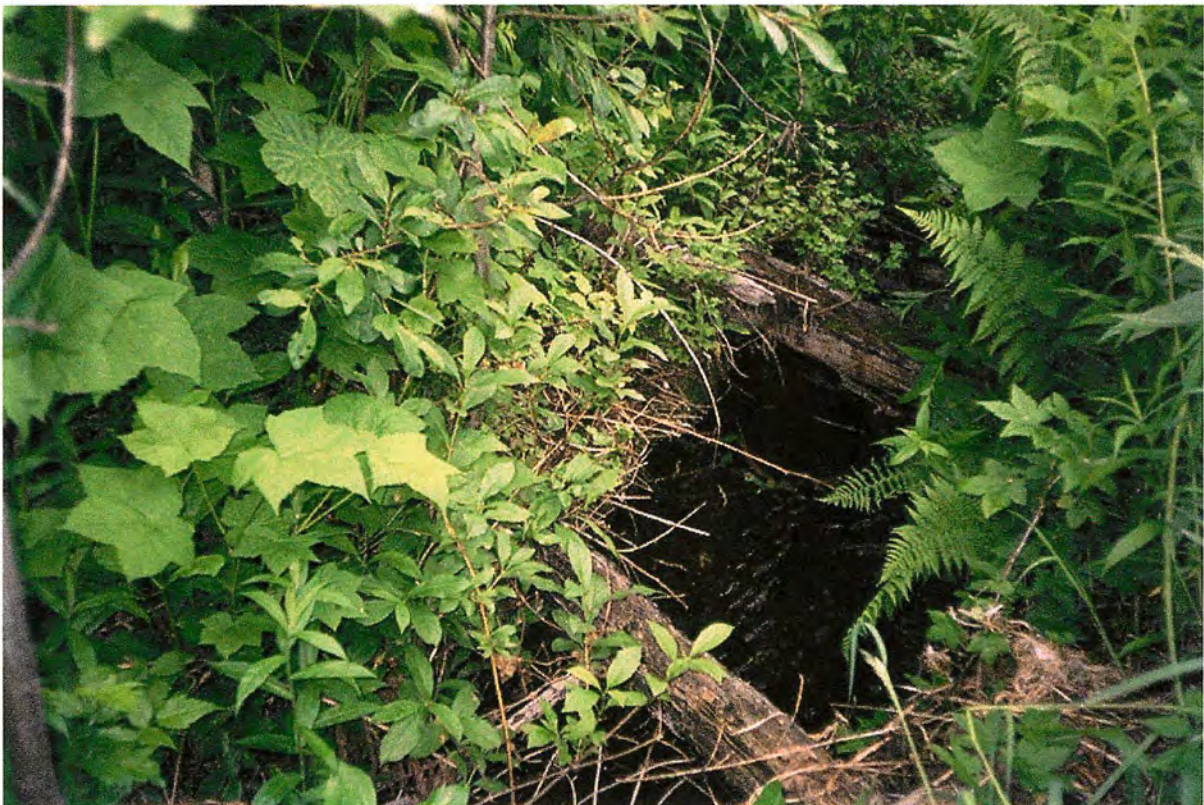
Site # 12
ILP # 40334 ILP Map # 093L.089
Reach # 1.0
Watershed Code: 000-000000-00000-00000-0000-0000-000-000-000-000-000-000

Direction of Photo: U CD #: 1 Image #: 1 Roll #: TC2 Frame #: 1
Comment: View of site 570 metres upstream of lake ILP 40327, R7.

Direction of Photo: D CD #: 1 Image #: 2 Roll #: TC2 Frame #: 2
Comment: View of site 570 metres upstream of lake ILP 40327, R7.

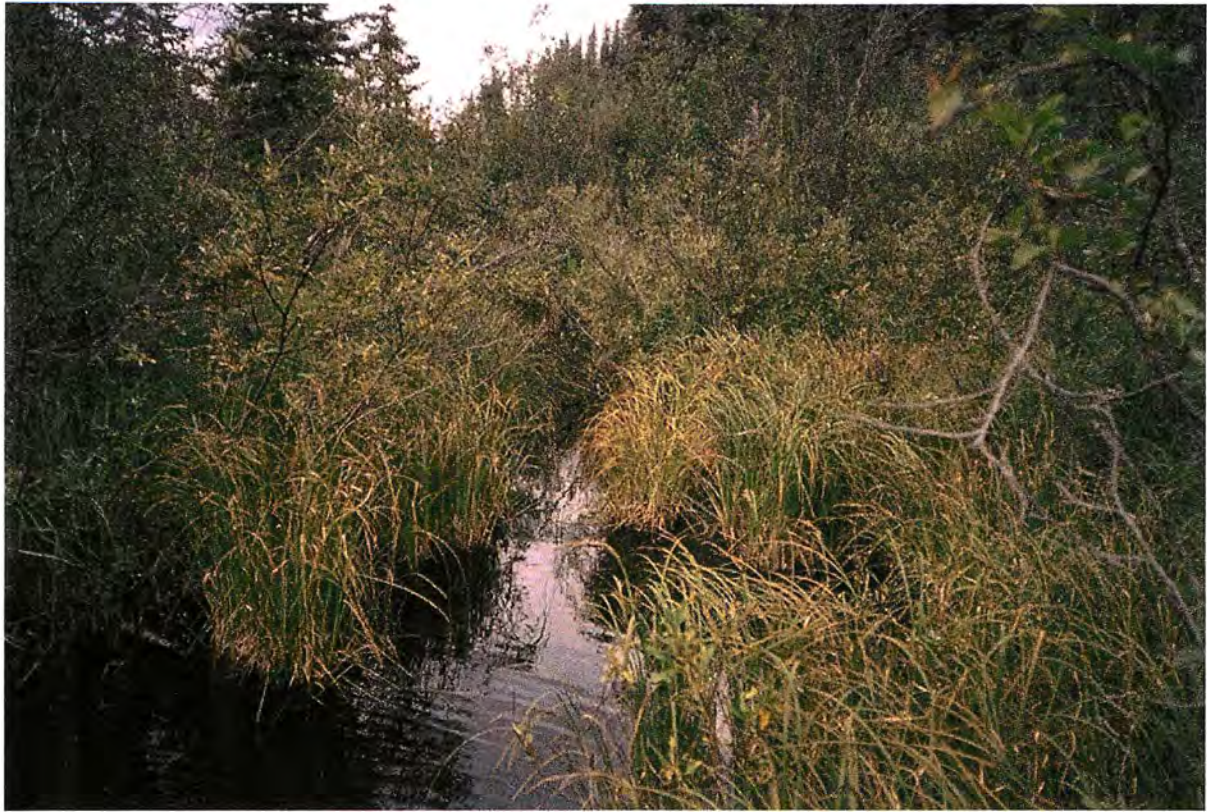
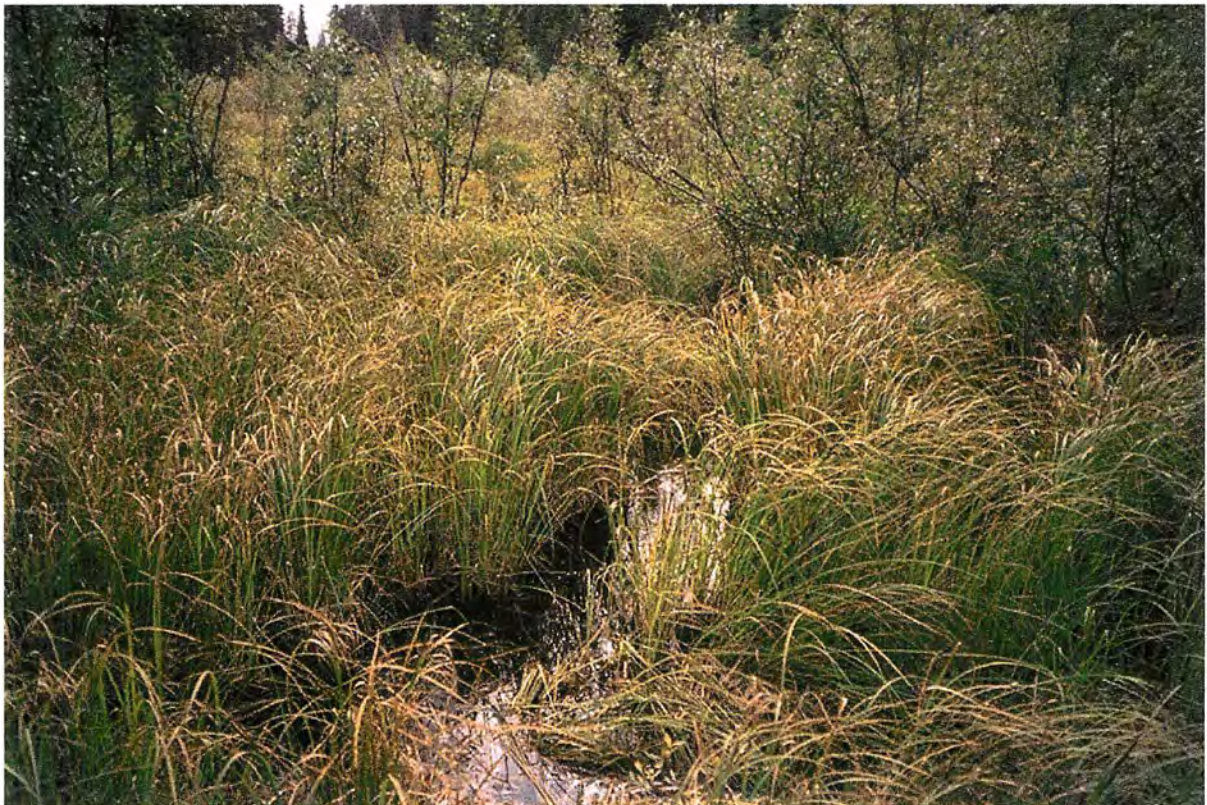
Site # 13
ILP # 40334 ILP Map # 093L.089
Reach # 3.0
Watershed Code: 000-000000-00000-00000-0000-0000-000-000-000-000-000-000

A. GEAR SETTINGS													
Site#	MTD/NO	H/P	Date In	Time In	Date Out	Time Out	Comment						
13	EF 1	1	2001/08/23	13:32	2001/08/23	13:41							
C. ELECTROFISHER SPECIFICATIONS													
Site#	MTD/NO	H/P	Encl	Sec	Length	Width	Voltage	Frequency	Pulse	Make	Model		
13	EF 1	1	O	823	100.0	1.5	500	60	6	SR	12B		
FISH SUMMARY													
Site#	MTD/NO	H/P	Species	Stage	Age	Total #	Lgth (Min/Max)	FishAct	Comment				
13	EF 1	1	NFC			0							
COMMENTS													
Section			Comments										
PERCENT HABITAT SHOCKED			Shocked 100% beaver influenced large channel morphology.										
SAMPLING EFFICIENCY			Efficiency very poor due to large channel morphology, wide channel, (lots of room to escape), difficult access and small anode ring.

Direction of Photo: U CD #: 1 Image #: 73 Roll #: TC4 Frame #: 17
Comment: Approximately 200 metres upstream of lake in reach 2 of ILP 40334.

Direction of Photo: D CD #: 1 Image #: 74 Roll #: TC4 Frame #: 18
Comment: Approximately 200 metres upstream of lake in reach 2 of ILP 40334.

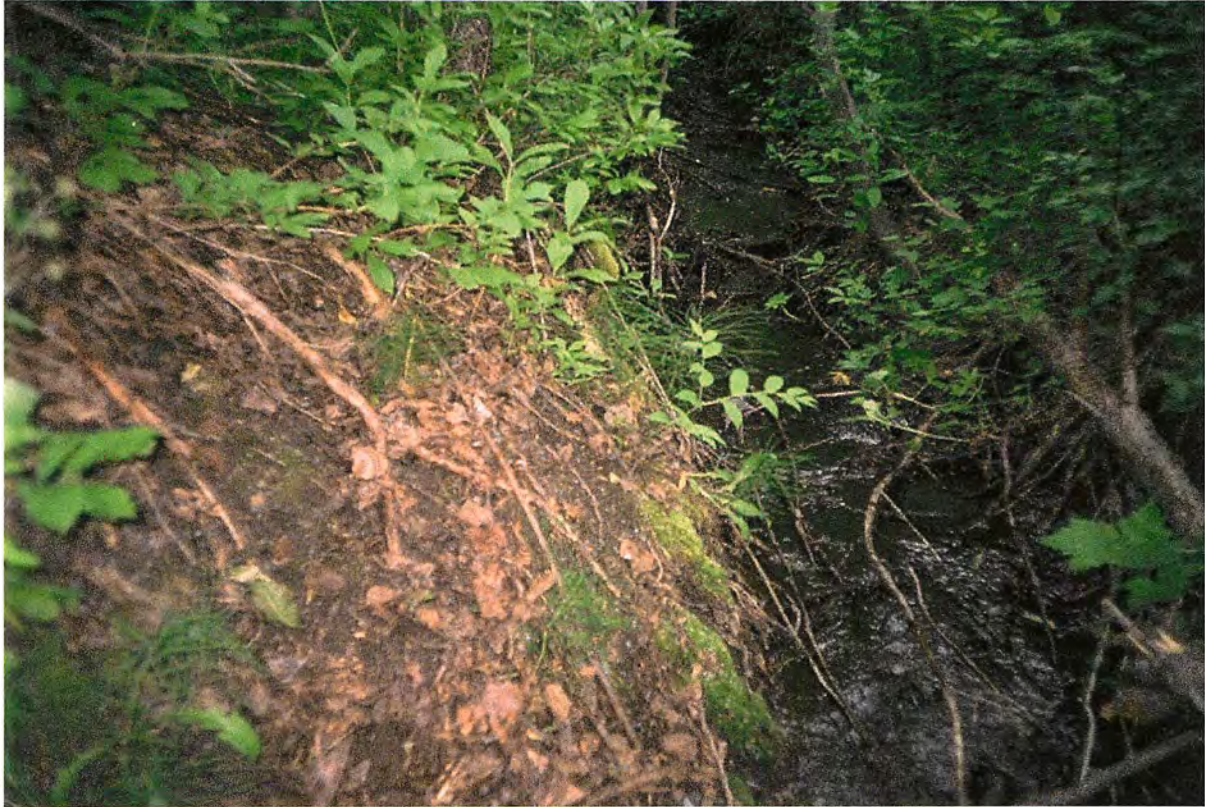
Site # 14
ILP # 40347 ILP Map # 093L.089
Reach # 1.0
Watershed Code: 000-000000-00000-00000-0000-000-000-000-000-000-000

Section	Comments
SITE DESCRIPTION	Shocked for 470 seconds approximately 220 m upstream of Babine Lake at second road crossing unsuccessfully. Further shocking below culvert on Bell Mine road captured fish.
SAMPLING EFFICIENCY	Efficiency was excellent : good visibility and access.

Direction of Photo: U CD #: 1 Image #: 20 Roll #: TC2 Frame #: 20
Comment: 60 metres upstream of Babine Lake.

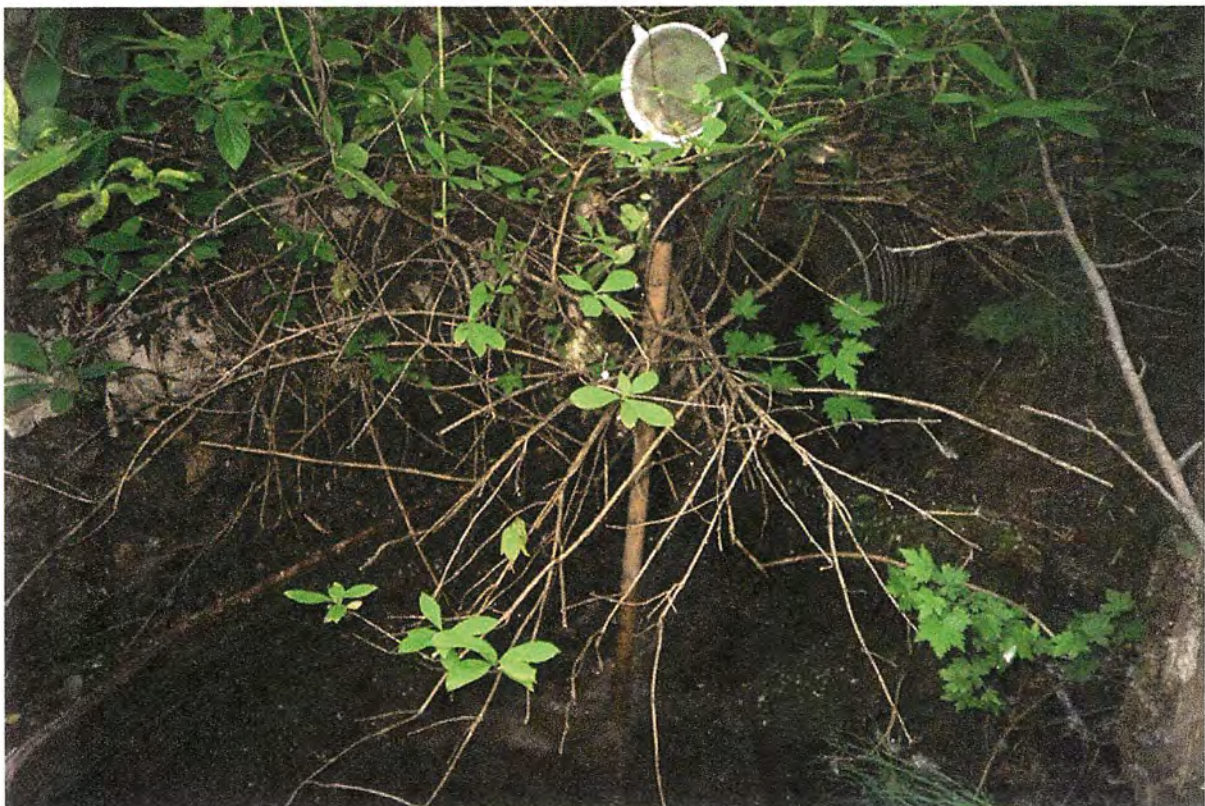
Direction of Photo: U CD #: 1 Image #: 22 Roll #: TC2 Frame #: 22
Comment: View of 0.7 metres hanging culvert.

Restoration and rehabilitation opportunities identified in sub-basins II and VII concentrated along the Granisle Highway, since road crossing on this section of the road commonly consisted of perched culverts which were found to restrict or prevent fish access. A 1.5 m perched culvert in reach 1 of ILP 40353 (site 16), and a 0.8 m perched culvert in reach 1 of ILP 40363 (site 24) were noted as barriers to fish passage. A 0.7 m perched culvert in reach 1 of ILP 40347 (site 14) is an obstruction of fish passage, but this culvert may be passable at some flows. Fish were captured downstream of these structures, but no fish were captured upstream.

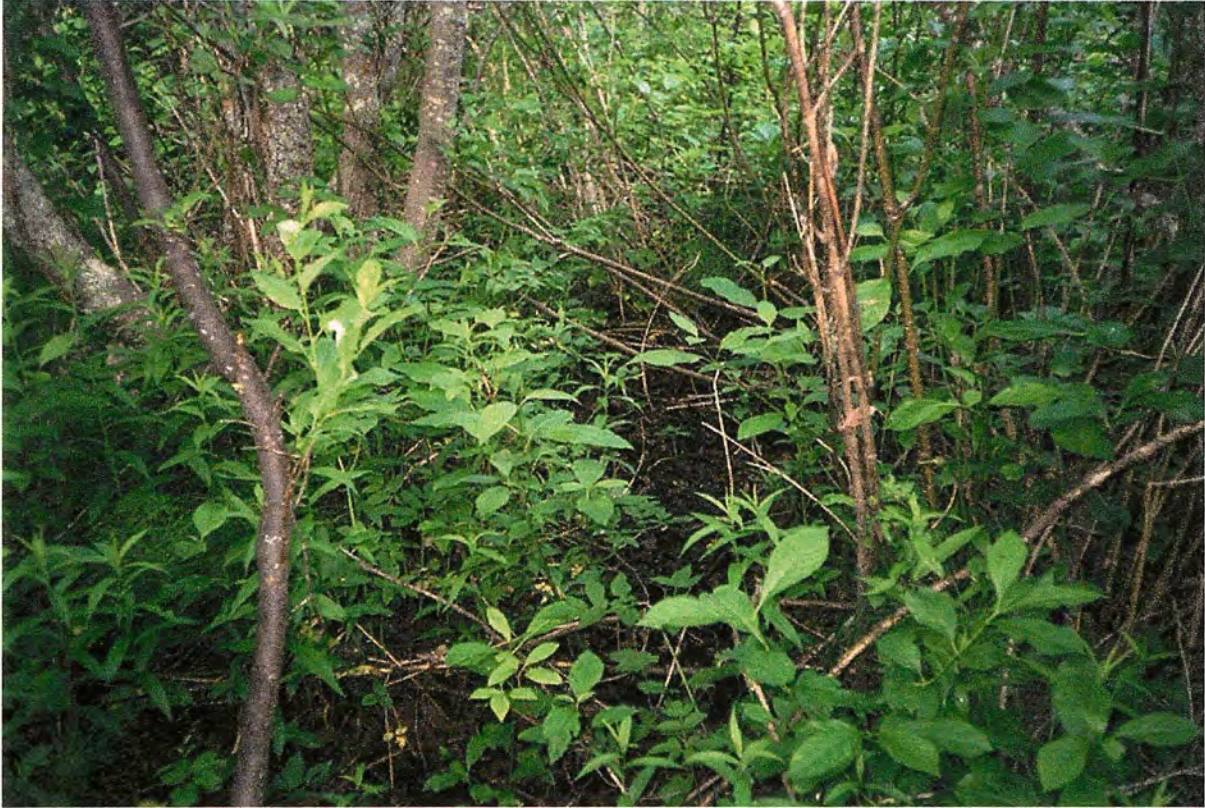
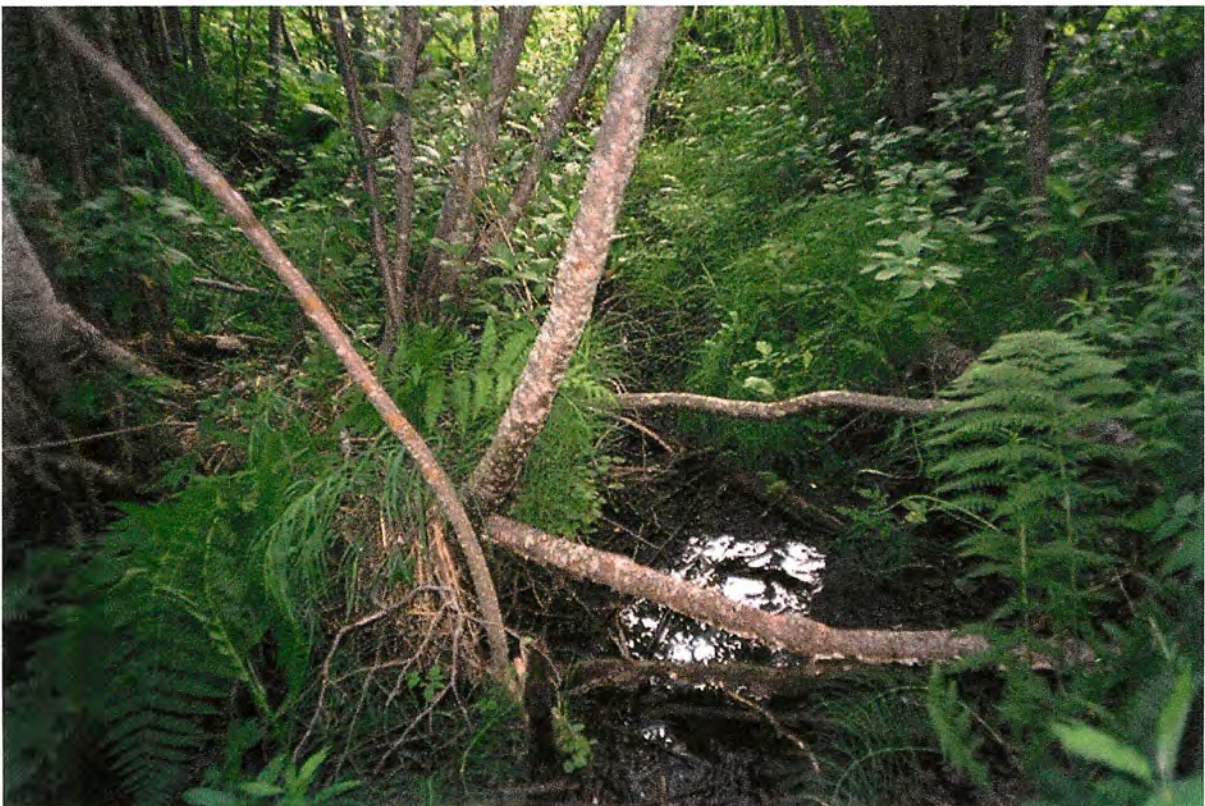
Site # 15
ILP # 40351 ILP Map # 093L.099
Reach # 1.0
Watershed Code: 000-000000-00000-00000-0000-0000-000-000-000-000-000-000

Section	Comments
SITE LOCATION	Started at confluence with ILP 40347.
COMMENTS	
Section	Comments
SURVEY LOCATION	Surveyed lower 300 m.
COMMENTS	
Section	Comments
SURVEY DESCRIPTION	Channel contained little or no water over entire section surveyed; habitat quality would only improve marginally during periods of higher flow due to lack of well functioning structures in the channel to scour pools and provide cover.
COMMENTS	
Section	Comments
RIPARIAN VEGETATION	40-50 m band of alder, willow, twinberry, ferns, and horsetail.

Direction of Photo: U CD #: 1 Image #: 23
Comment: 50 metres upstream of confluence with ILP 40347.

Direction of Photo: D CD #: 1 Image #: 24
Comment: 50 metres upstream of confluence with ILP 40347.

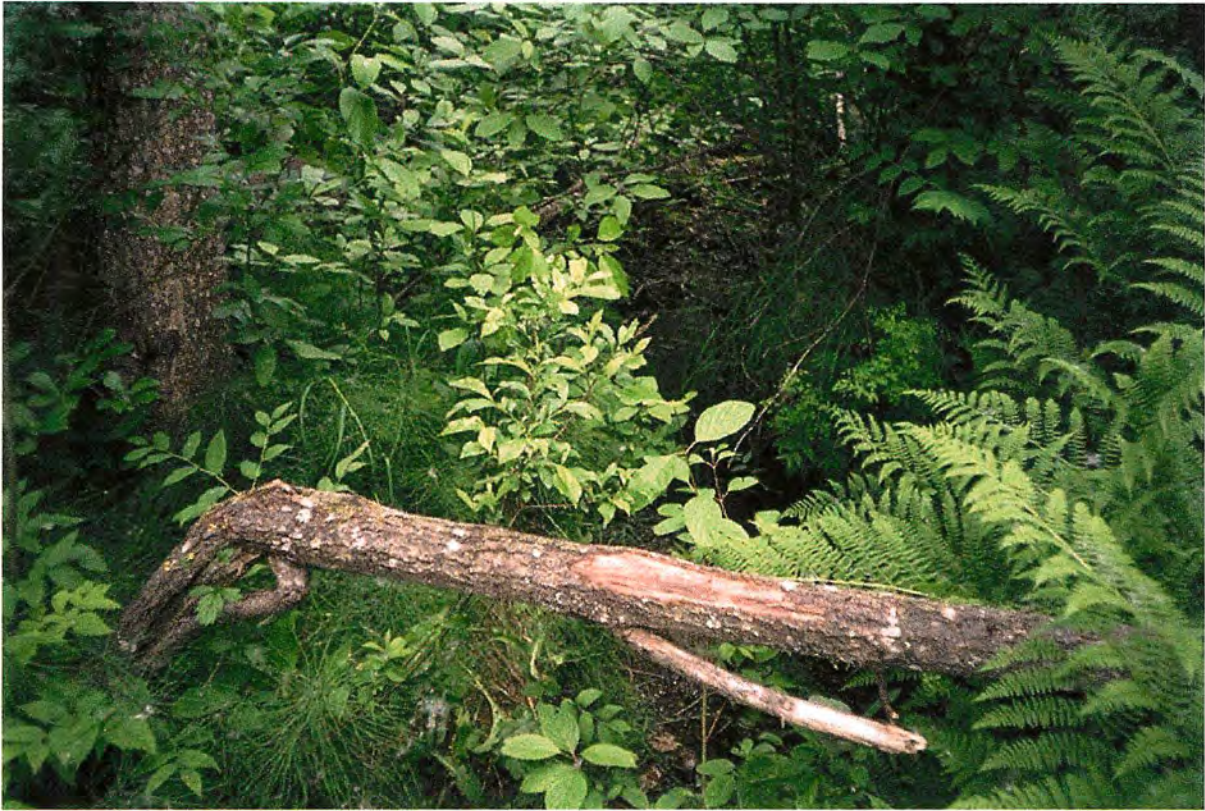
Site # 16
ILP # 40353 ILP Map # 093L.089
Reach # 1.0
Watershed Code: 000-000000-00000-00000-0000-0000-000-000-000-000-000-000

Section	Comments
PERCENT HABITAT SHOCKED	Shocked mostly glide habitat with cobble / boulder cover (80%). Also shocked some past riffle and LWD pool.

Direction of Photo: D CD #: 1 Image #: 18 Roll #: TC2 Frame #: 18
Comment: 250 metres upstream of Babine Lake.

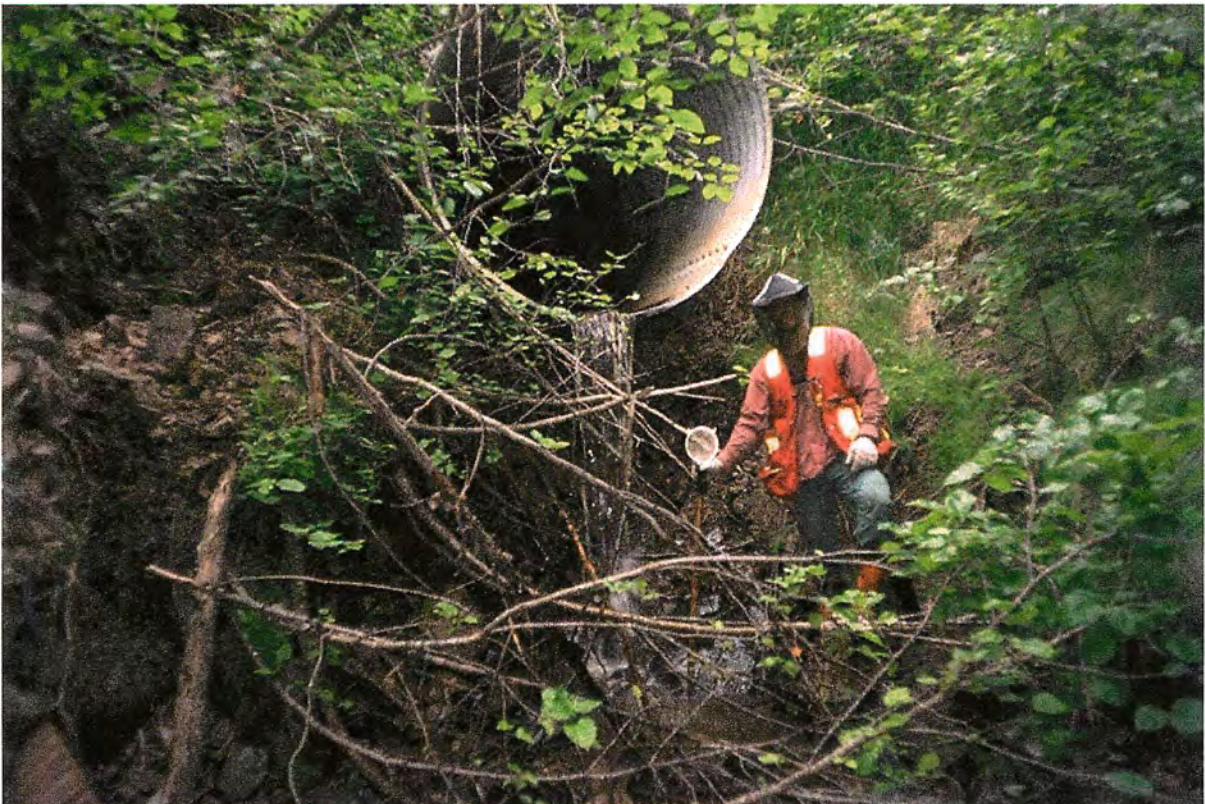
Direction of Photo: U CD #: 1 Image #: 19 Roll #: TC2 Frame #: 19
Comment: Culvert at Granisle Highway road crossing.

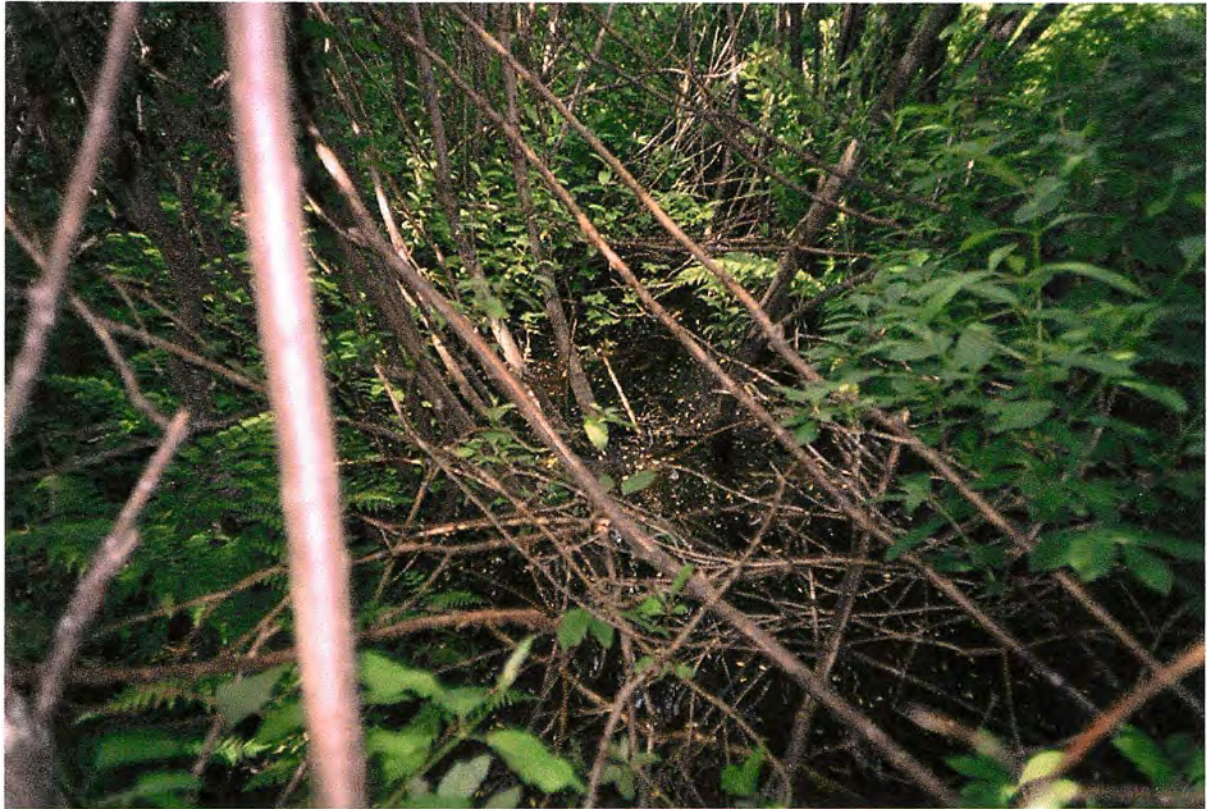
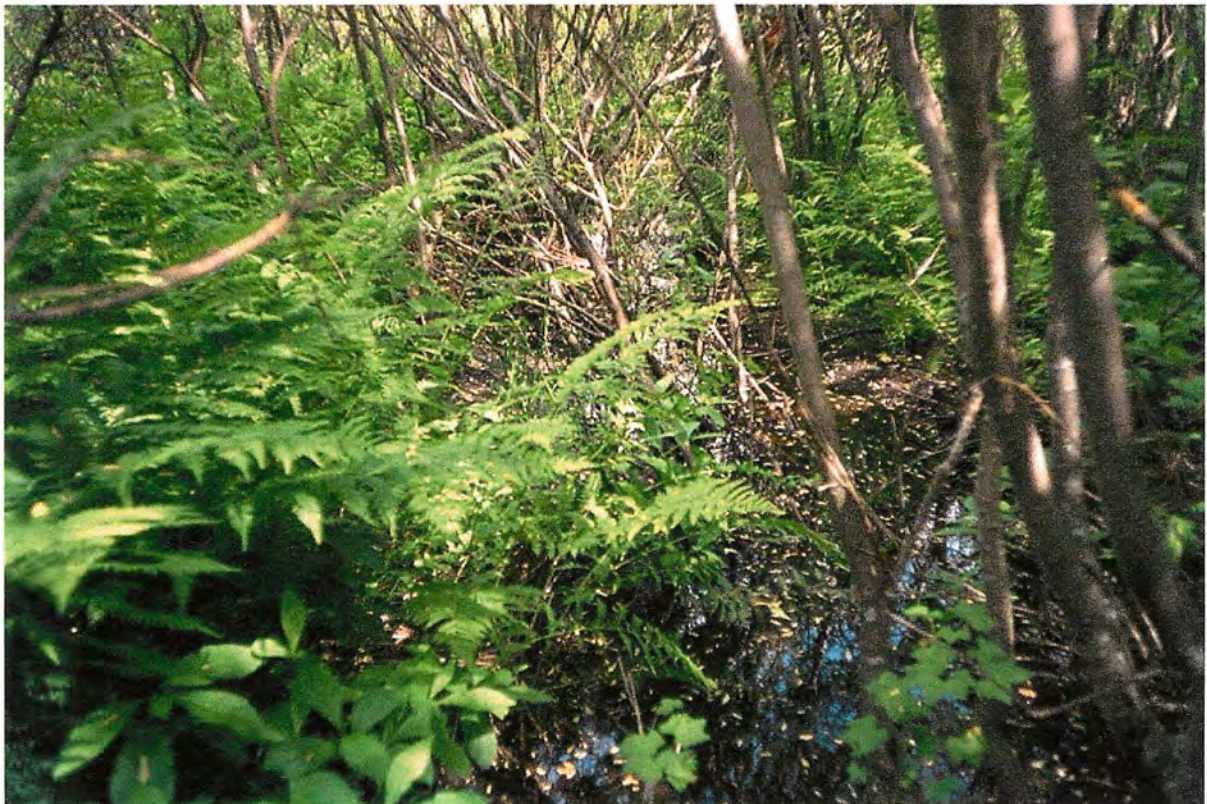
Site # 17
ILP # 40353 ILP Map # 093L.089
Reach # 3.0
Watershed Code: 000-000000-00000-00000-0000-0000-000-000-000-000-000-000

A. GEAR SETTINGS													
Site#	MTD/NO	H/P	Date In	Time In	Date Out	Time Out	Comment						
17	EF 1	1	2001/07/18	14:15	2001/07/18	14:35							
C. ELECTROFISHER SPECIFICATIONS													
Site#	MTD/NO	H/P	Encl	Sec	Length	Width	Voltage	Frequency	Pulse	Make	Model		
17	EF	1	1	O	614	100.0	1.0	700	60	6	SR 15C		
FISH SUMMARY													
Site#	MTD/NO	H/P	Species	Stage	Age	Total #	Lgth (Min/Max)	FishAct	Comment				
17	EF	1	NFC			0							
COMMENTS													
Section			Comments										
PERCENT HABITAT SHOCKED			EF through 80% LC morph. With fine substrate and average water depth of 10 cm; 20% of channel had some riffle over SWD and overgrown shrubs.

Direction of Photo: U CD #: 1 Image #: 40 Roll #: TC1 Frame #: 15
Comment: 3250 metres upstream of Babine Lake.

Direction of Photo: D CD #: 1 Image #: 41 Roll #: TC1 Frame #: 16
Comment: 3250 metres upstream of Babine Lake.

Site #	ILP/Stream name	Reach	TRIM map	Channel Width (m)	Timing	Methods	Proposed Riparian Class	Comments
17	40353	3	093L.089	1.75	After culvert removal	EF	S3	No fish were captured in this reach after 614 seconds of electrofishing over 100 lineal meters (18/07/01); a 1.5 m perched culvert in reach 1 of this stream is an anthropogenic barrier to fish passage (Table 6), and prevents fish access to marginal rearing habitat in this reach; this reach should be managed as fish bearing, and re-sampling is not recommended until fish access to the reach has been re-established
18	40353	5	093L.089	0.60	After culvert removal	EF	S4	No fish were captured in this reach after 399 seconds of electrofishing over 100 lineal meters (19/07/01); a 1.5 m perched culvert in reach 1 of this stream is an anthropogenic barrier to fish passage (Table 6), and prevents fish access to moderate rearing habitat in this reach; this reach should be managed as fish bearing, and re-sampling is not recommended until fish access to the reach has been re-established

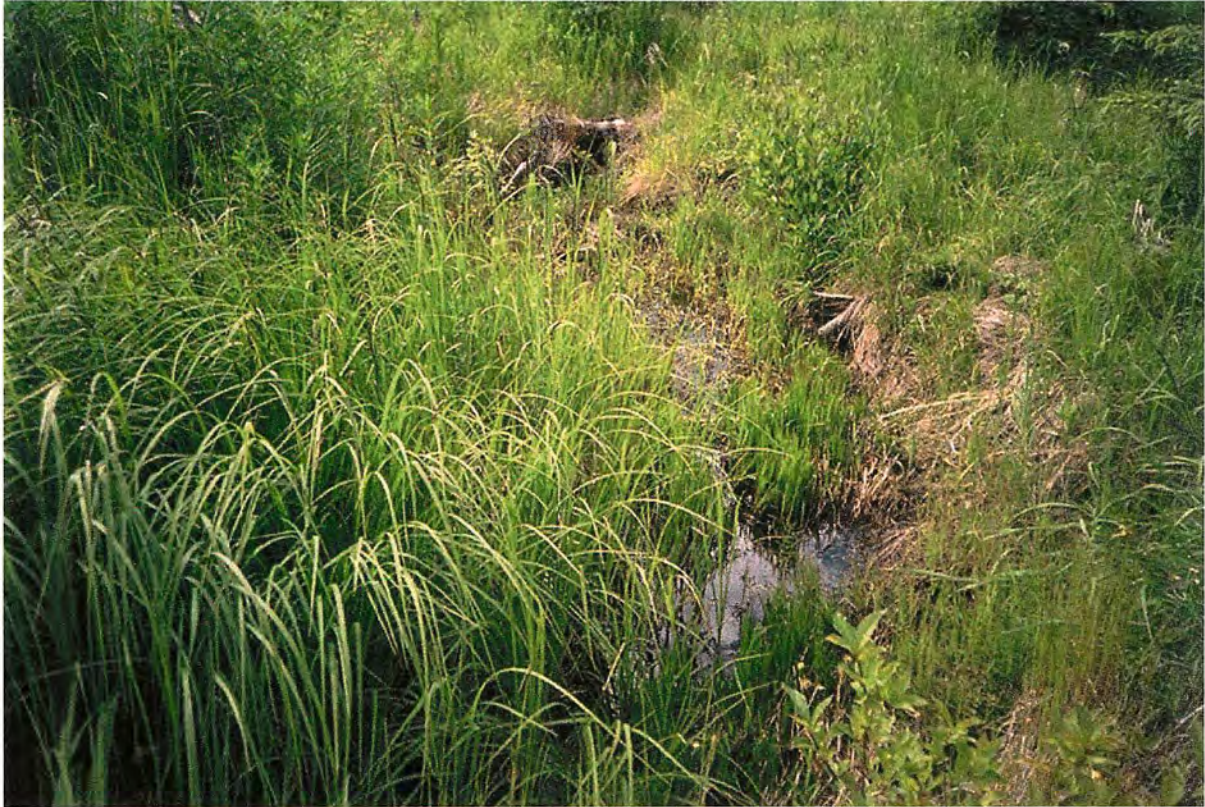
Site # 18
ILP # 40353 ILP Map # 093L.089
Reach # 5.0
Watershed Code: 000-000000-00000-00000-0000-0000-000-000-000-000-000-000

A. GEAR SETTINGS												
Site#	MTD/NO	H/P	Date In	Time In	Date Out	Time Out	Comment					
18	EF	1	2001/07/19	16:35	2001/07/19	17:00						
C. ELECTROFISHER SPECIFICATIONS												
Site#	MTD/NO	H/P	Encl	Sec	Length	Width	Voltage	Frequency	Pulse	Make	Model	
18	EF	1	1	O	399	100.0	0.4	600	60	6	SR 15C	
FISH SUMMARY												
Site#	MTD/NO	H/P	Species	Stage	Age	Total #	Lgth (Min/Max)	FishAct	Comment			
18	EF	1	1	NFC		0						
COMMENTS												
Section			Comments									
SAMPLING EFFICIENCY			Efficiency was good but somewhat reduced by dark pine substrate in LC section.									
PERCENT HABITAT SHOCKED			Shocked all available habitat: 35% pool, 35% glide, 10% large channel glide, 20% riffle.

Direction of Photo: U CD #: 1 Image #: 15 Roll #: TC2 Frame #: 15
Comment: 50 metres upstream of inlet to lake in reach 4.

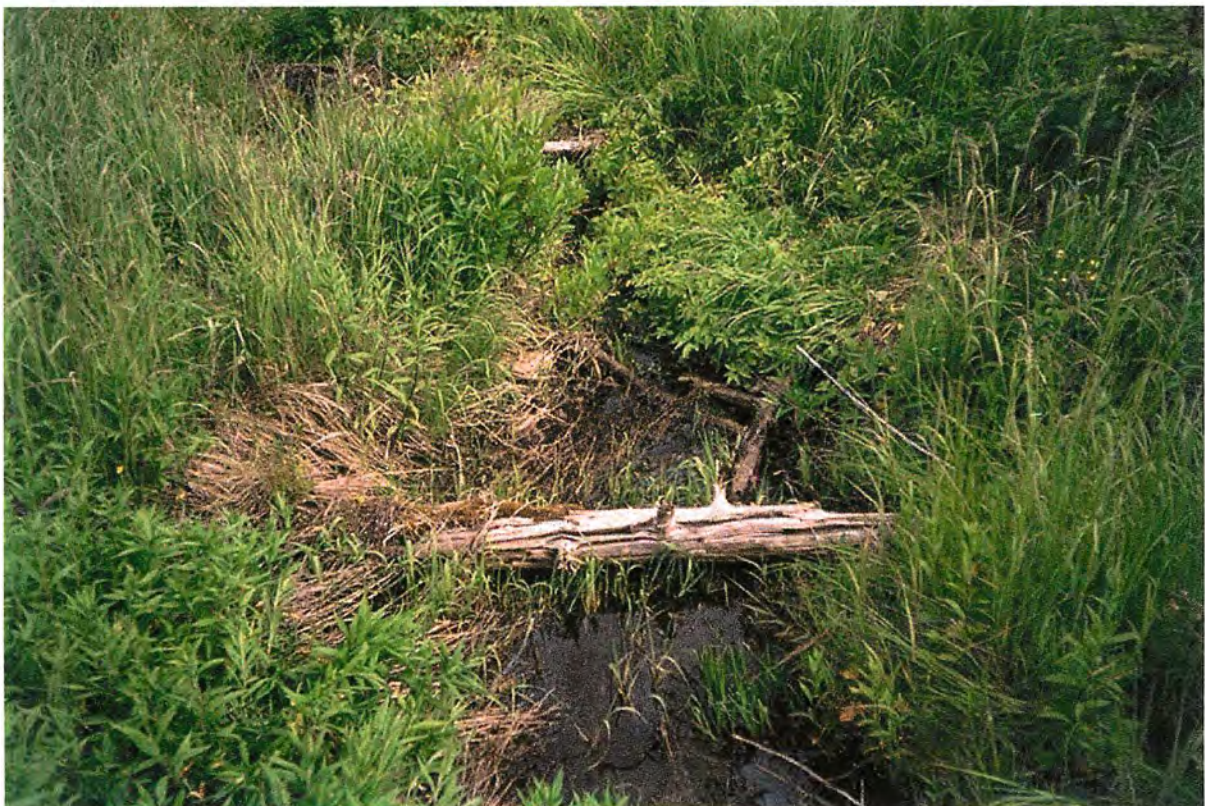
Direction of Photo: D CD #: 1 Image #: 16 Roll #: TC2 Frame #: 16
Comment: 50 metres upstream of inlet to lake in reach 4.

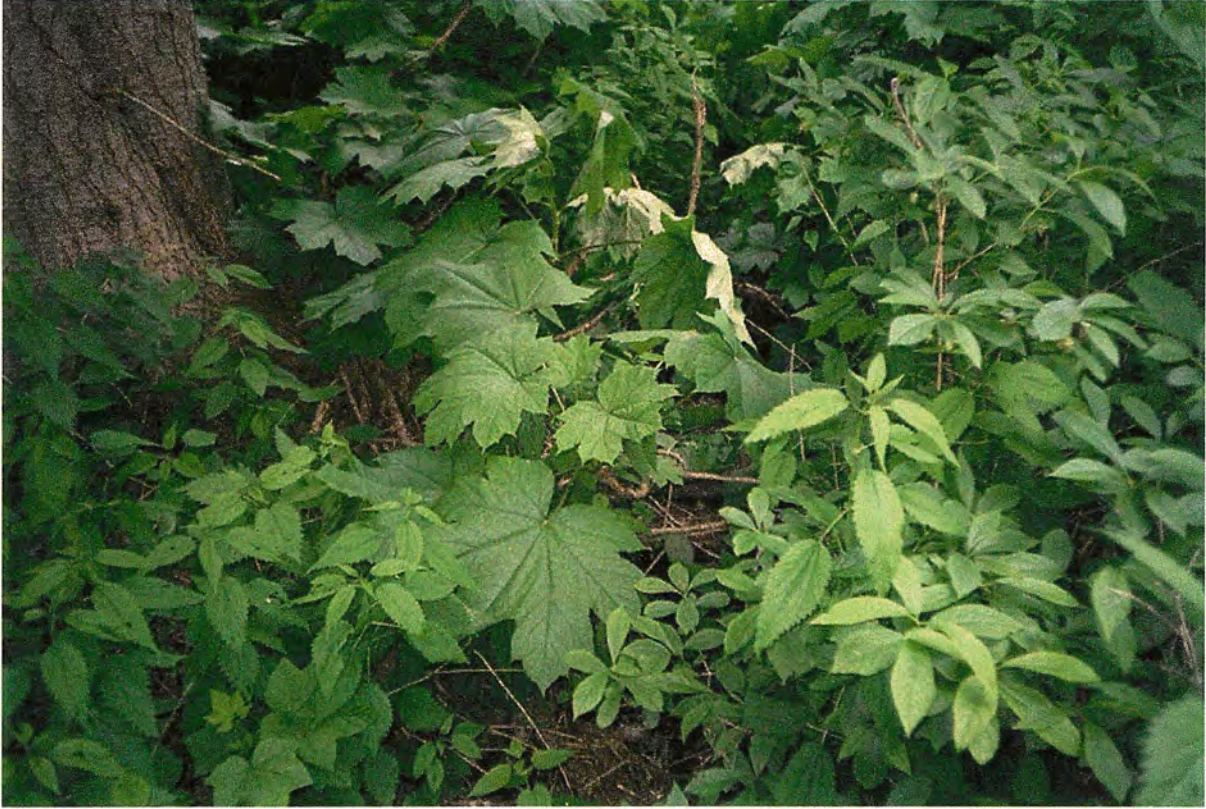
Site # 19
ILP # 40354 ILP Map # 093L.089
Reach # 1.0
Watershed Code: 000-000000-00000-00000-0000-0000-000-000-000-000-000-000

Direction of Photo: U CD #: 1 Image #: 34 Roll #: TC1 Frame #: 9
Comment: 250 metres upstream of confluence with ILP 40353.

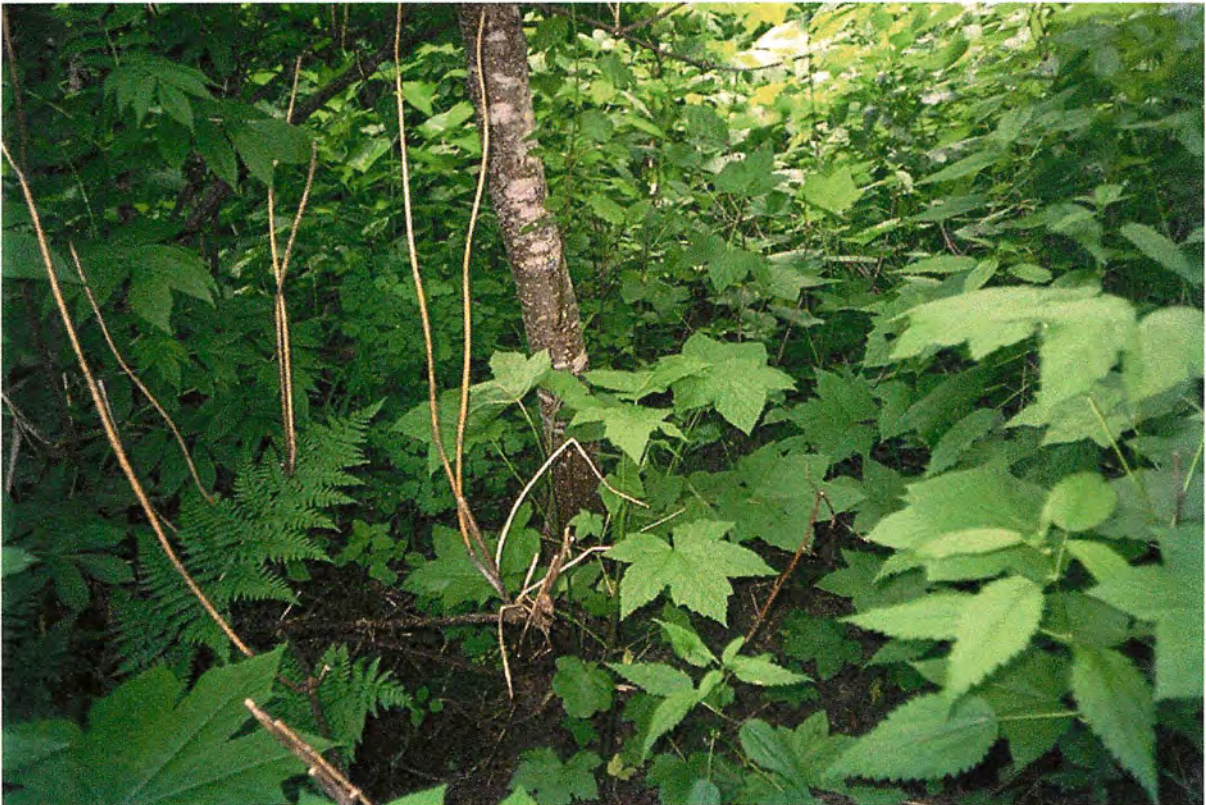
Direction of Photo: D CD #: 1 Image #: 35 Roll #: TC1 Frame #: 10
Comment: 250 metres upstream of confluence with ILP 40353.

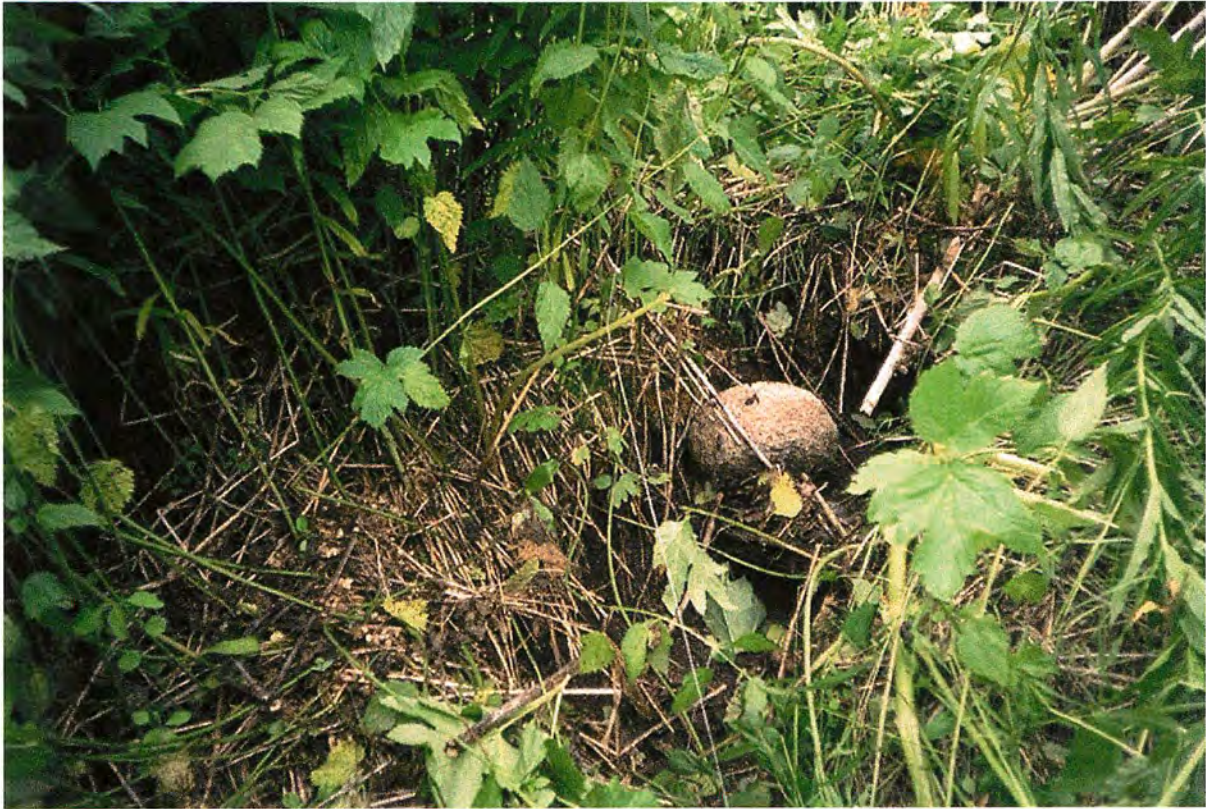
Site # 20
ILP # 40354 ILP Map # 093L.089
Reach # 2.0
Watershed Code: 000-000000-00000-00000-0000-0000-000-000-000-000-000-000

Direction of Photo: U CD #: 1 Image #: 36
Comment: 575 metres upstream of confluence with ILP 40353.
