**Reconnaissance (1:20,000)
Fish and Fish Habitat Inventory of
Tributaries to West Shore of Babine Lake
Between Newman Island and the Fulton River
and an Unnamed Inlet stream to the
North Shore of Fulton Lake
East of Broughton Creek**

Watershed Code: 480, 480-697200-08100

Houston Forest Products Co.

SKR Consultants Ltd.

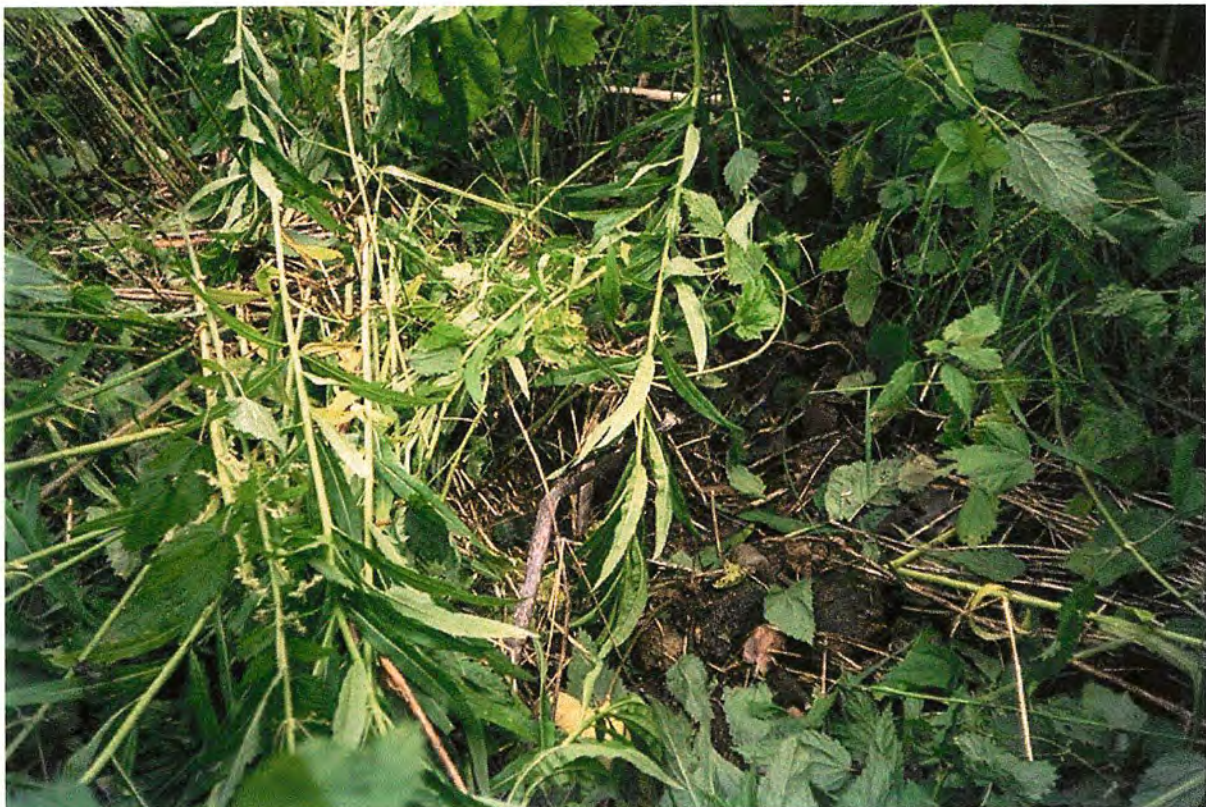
Direction of Photo: D CD #: 1 Image #: 37
Comment: 575 metres upstream of confluence with ILP 40353.

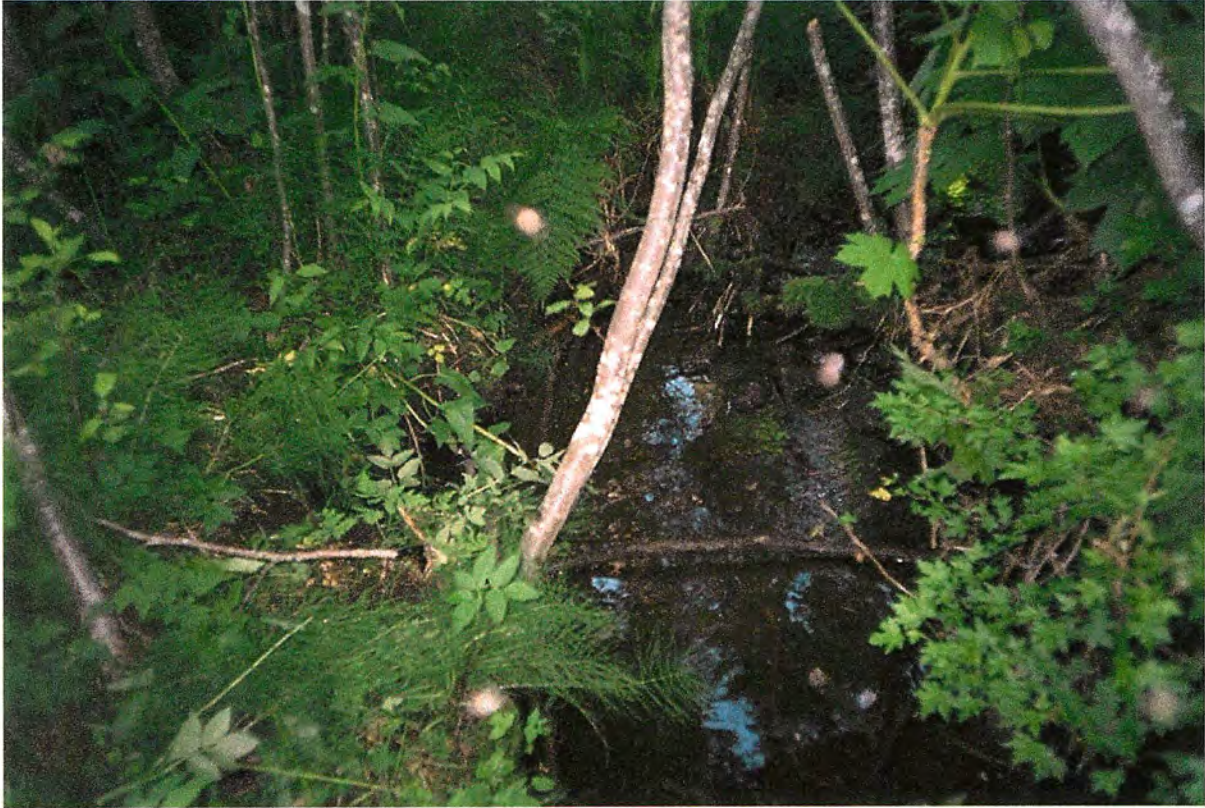
Site # 21
ILP # 40402 ILP Map # 093L.089
Reach # 1.0
Watershed Code: 000-000000-00000-00000-0000-0000-000-000-000-000-000-000

Direction of Photo: U CD #: 1 Image #: 42
Comment: 60 metres upstream of confluence with mainstem.

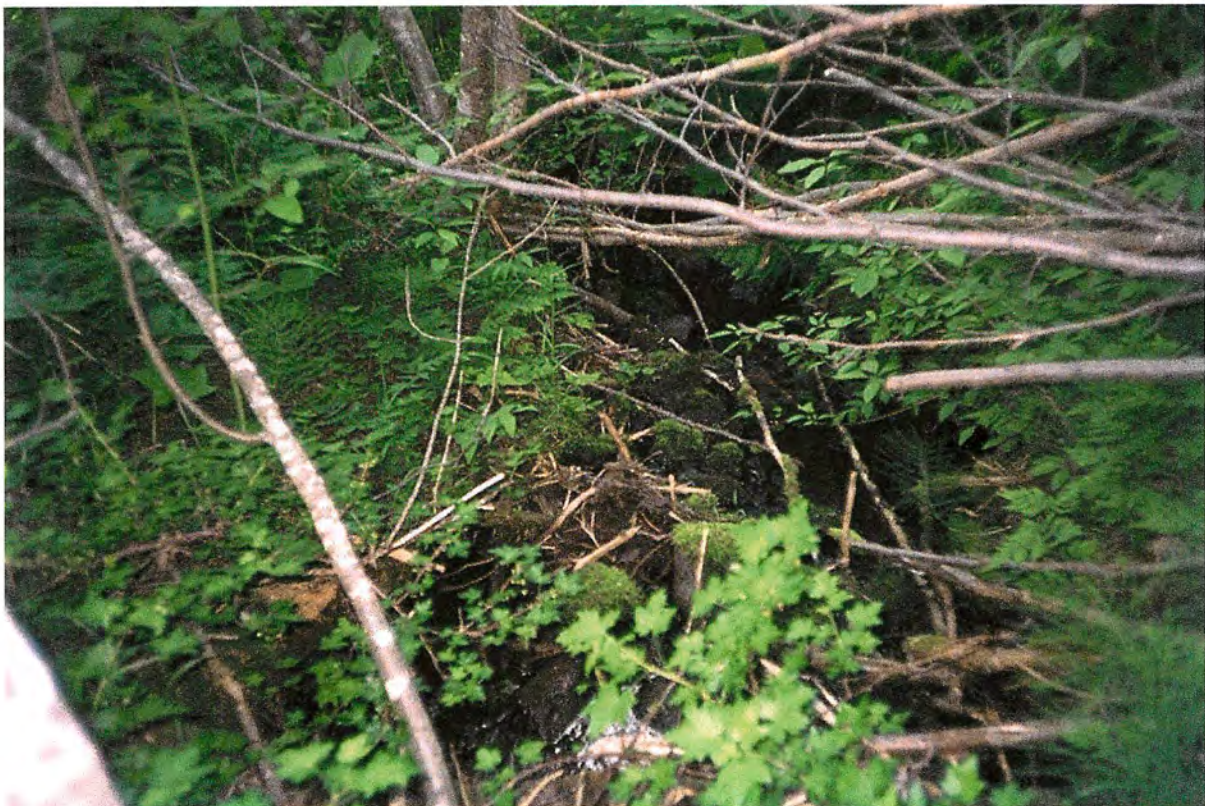
Direction of Photo: D CD #: 1 Image #: 43
Comment: 60 metres upstream of confluence with mainstem.

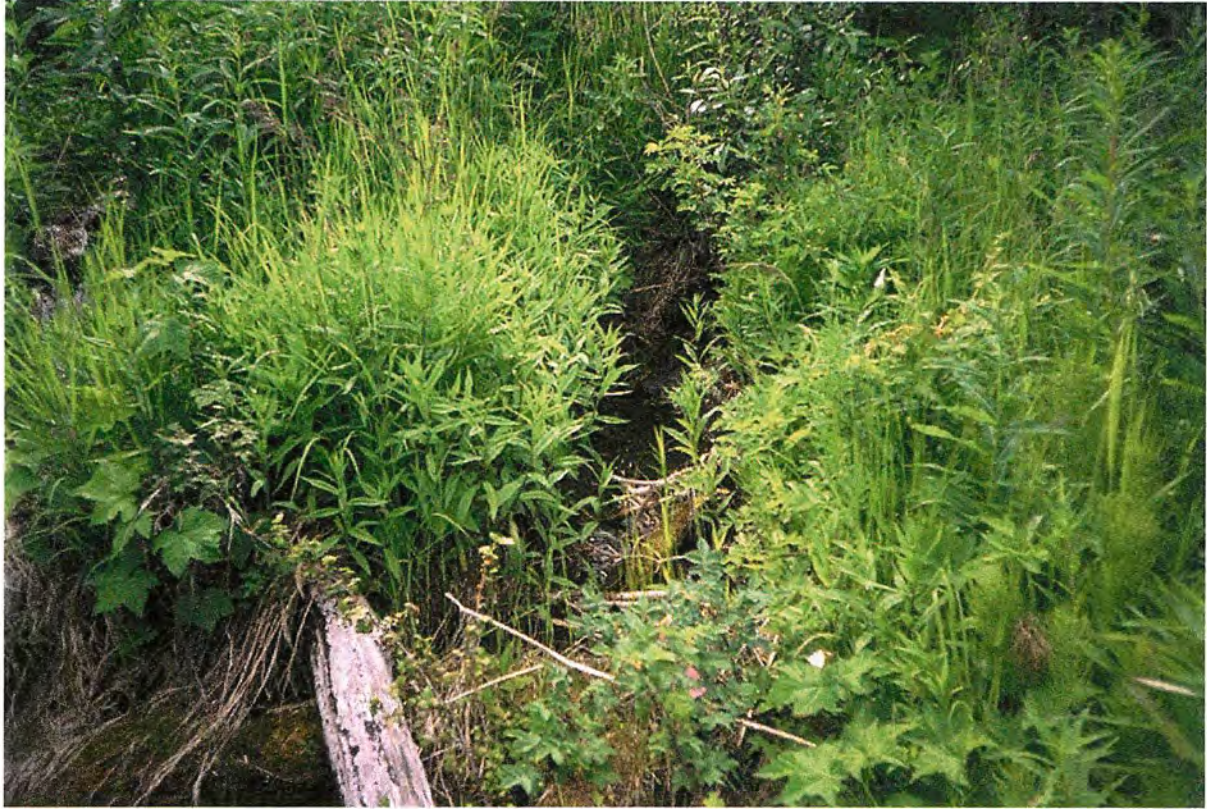
Site # 22
ILP # 40359 ILP Map # 093L.089
Reach # 1.0
Watershed Code: 000-000000-00000-00000-0000-0000-000-000-000-000-000-000

Direction of Photo: U CD #: 1 Image #: 44 Roll #: TC1 Frame #: 19
Comment: View of site 95 metres upstream of confluence with ILP 40402.

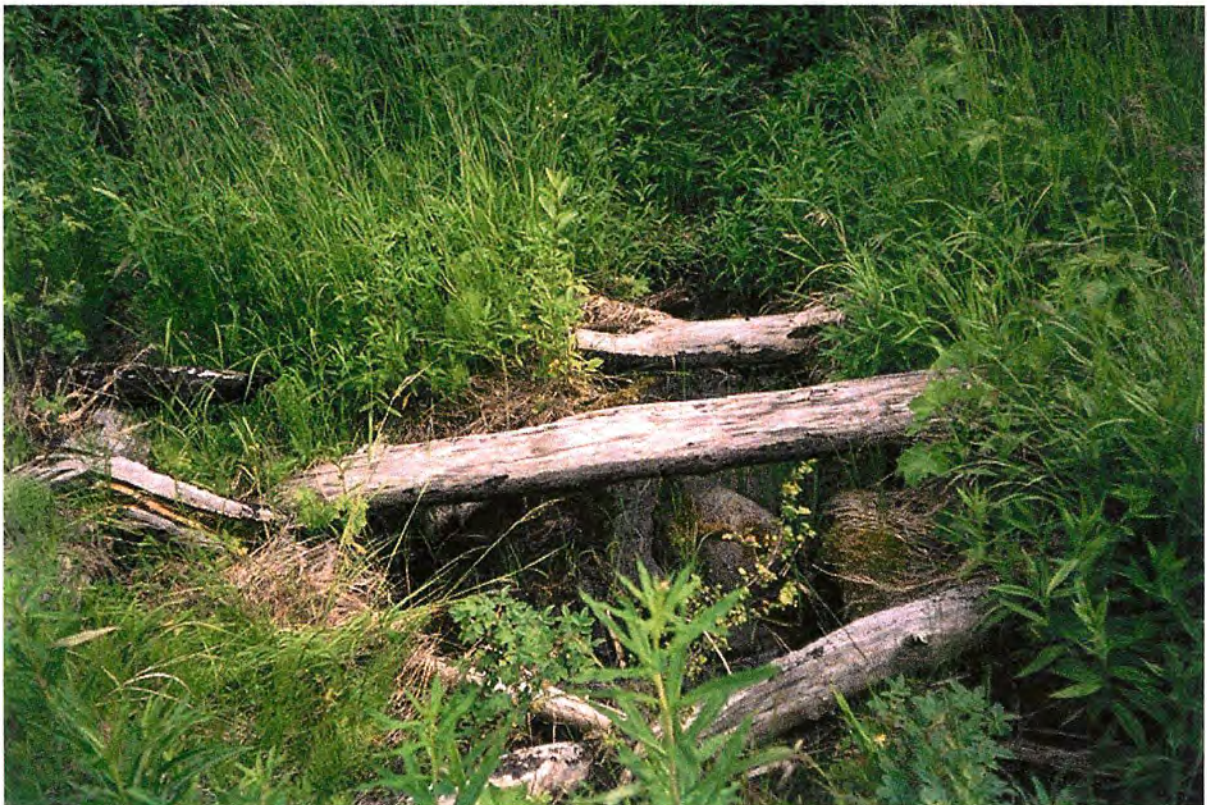
Direction of Photo: D CD #: 1 Image #: 45 Roll #: TC1 Frame #: 20
Comment: View of site 95 metres upstream of confluence with ILP 40402.

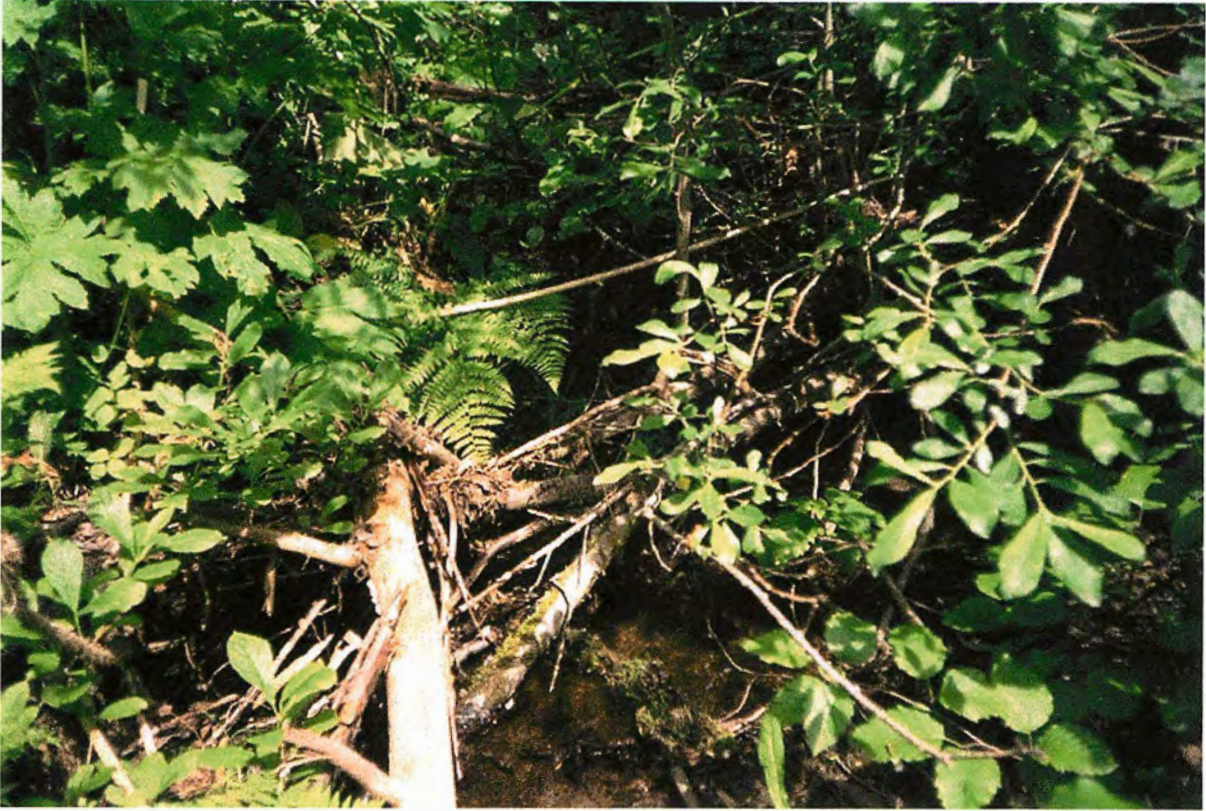
Site # 23
ILP # 40356 ILP Map # 093L.090
Reach # 1.0
Watershed Code: 000-000000-00000-00000-0000-0000-000-000-000-000-000-000

Direction of Photo: U CD #: 1 Image #: 32 Roll #: TC1 Frame #: 7
Comment: 250 metres upstream of Babine Lake.

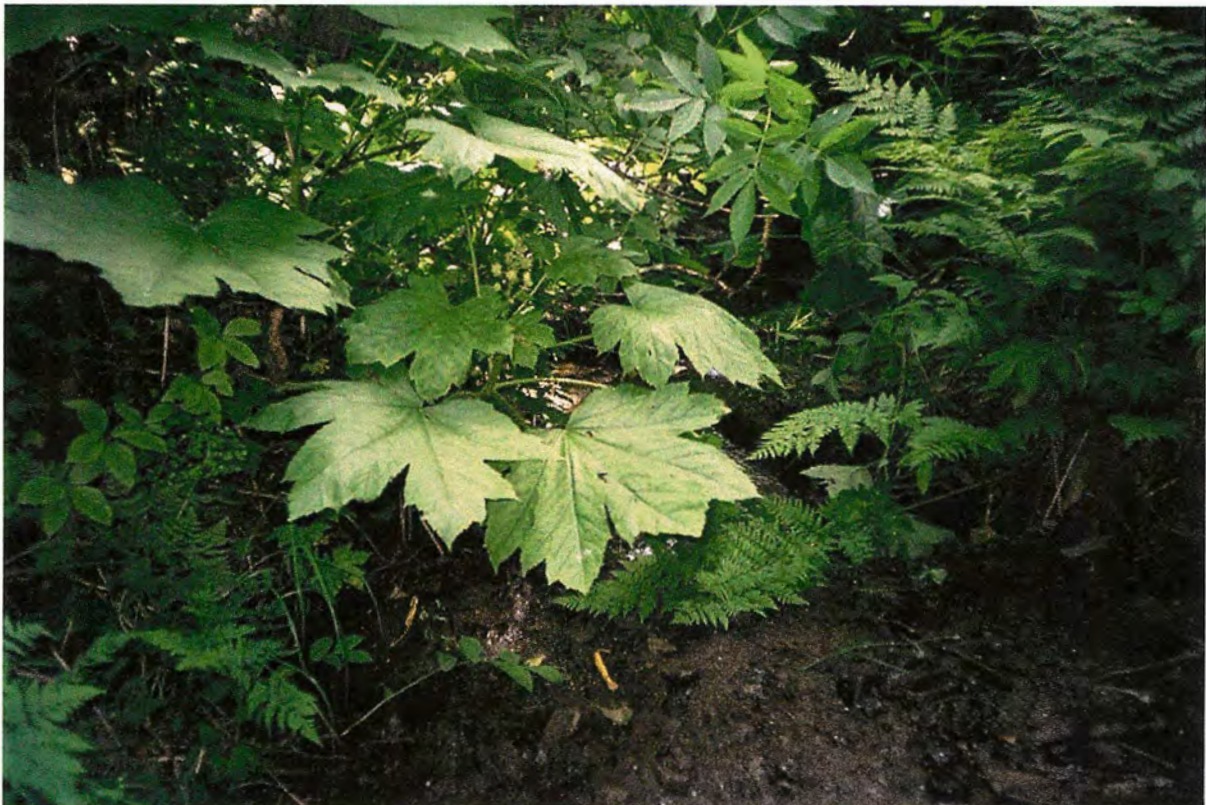
Direction of Photo: D CD #: 1 Image #: 33 Roll #: TC1 Frame #: 8
Comment: 250 metres upstream of Babine Lake.

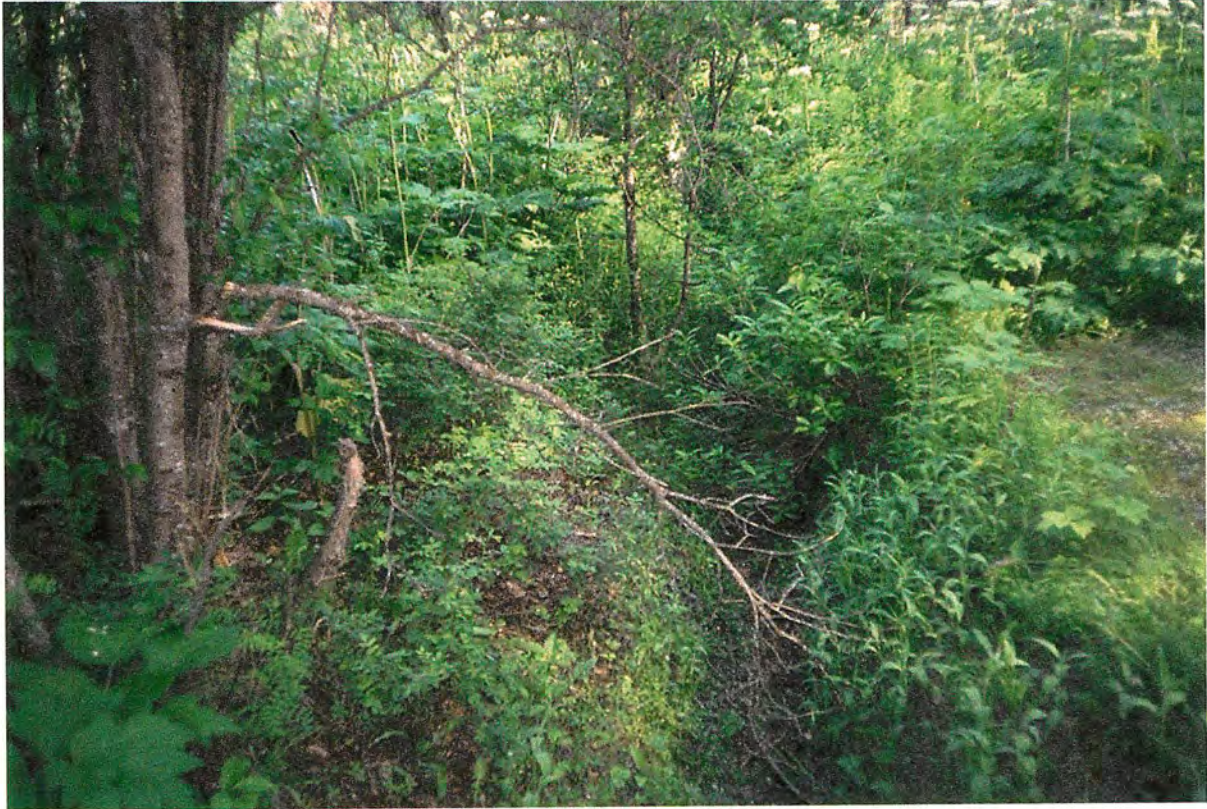
Site # 24
ILP # 40363 ILP Map # 093L.090
Reach # 1.0
Watershed Code: 000-000000-00000-00000-0000-000-000-000-000-000-000-000

Direction of Photo: U CD #: 1 Image #: 26 Roll #: TC1 Frame #: 1
Comment: View in Red Bluff Park approximately 40 metres upstream of Babine Lake.

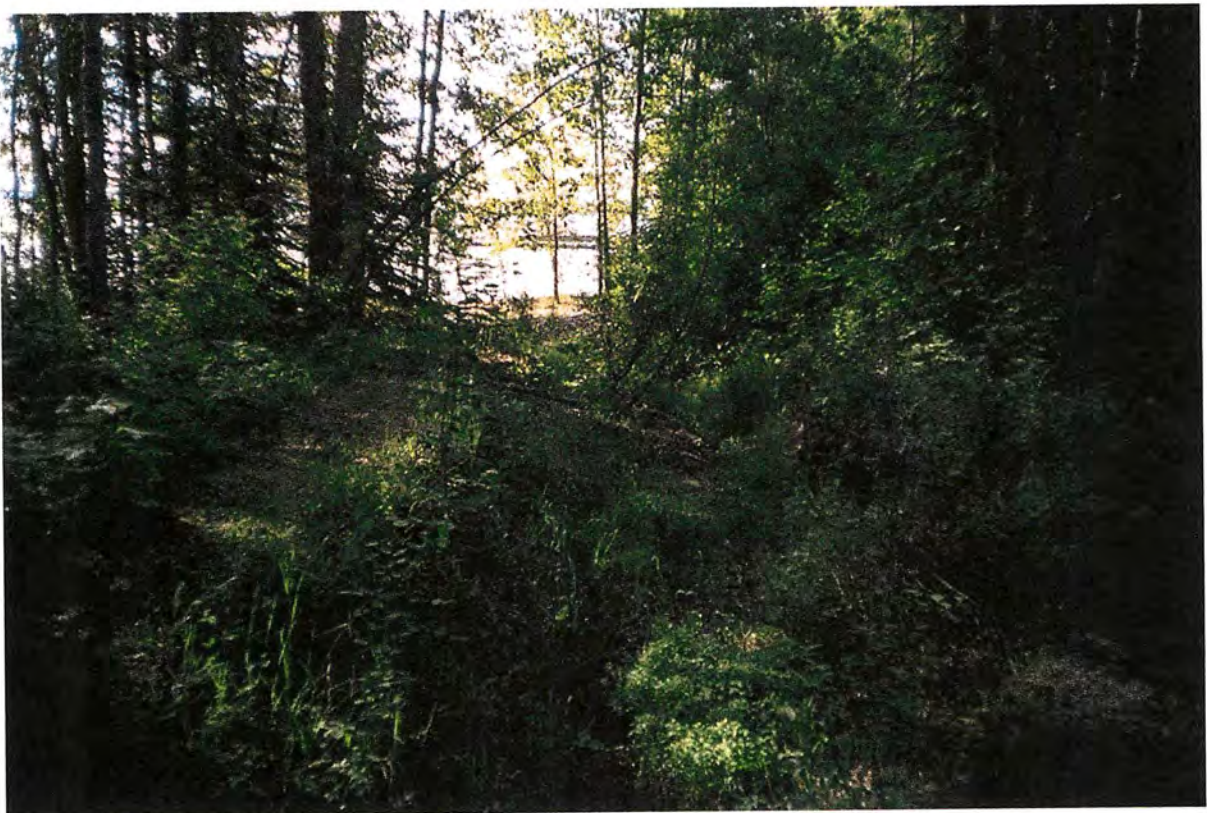
Direction of Photo: D CD #: 1 Image #: 27 Roll #: TC1 Frame #: 2
Comment: View in Red Bluff Park approximately 40 metres upstream of Babine Lake.

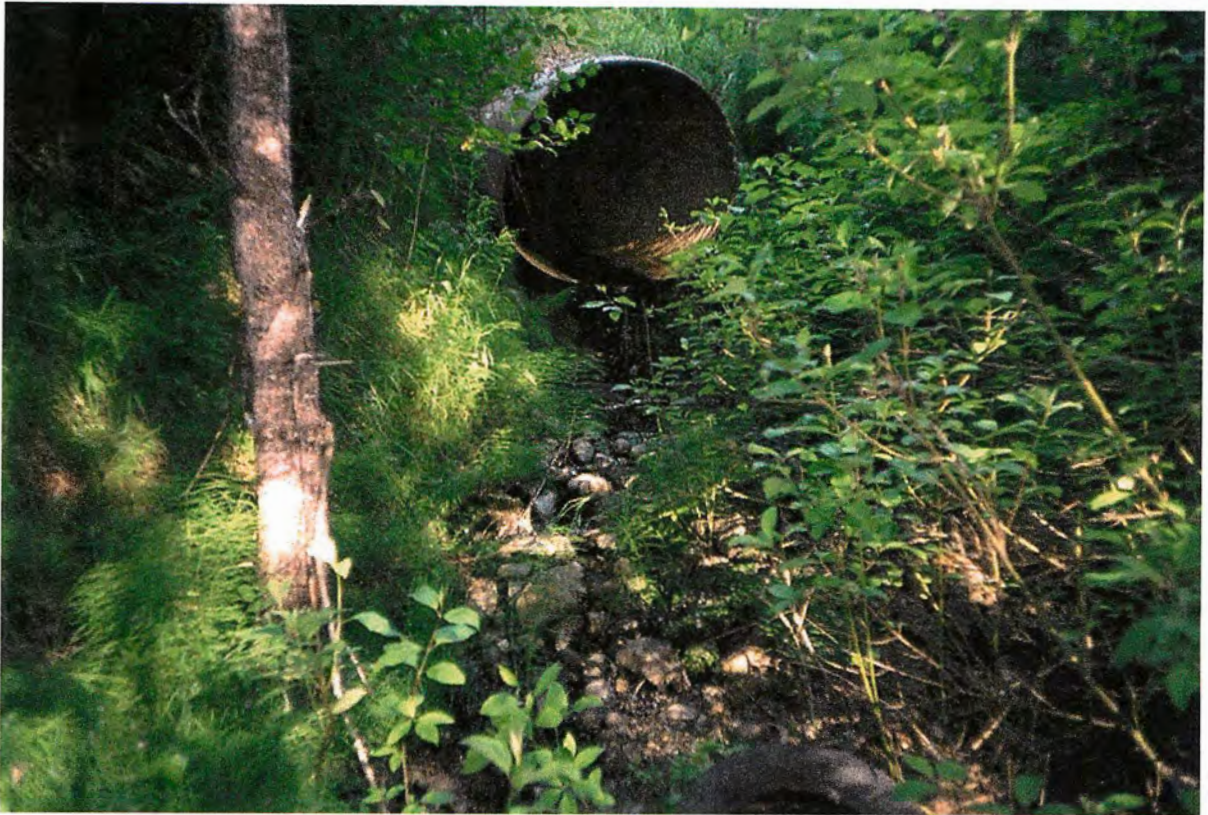
Direction of Photo: U CD #: 1 Image #: 28 Roll #: TC1 Frame #: 3
Comment: View at sample site approximately 40 metres downstream of Granisle Highway (shows culvert).

Restoration and rehabilitation opportunities identified in sub-basins II and VII concentrated along the Granisle Highway, since road crossing on this section of the road commonly consisted of perched culverts which were found to restrict or prevent fish access. A 1.5 m perched culvert in reach 1 of ILP 40353 (site 16), and a 0.8 m perched culvert in reach 1 of ILP 40363 (site 24) were noted as barriers to fish passage. A 0.7 m perched culvert in reach 1 of ILP 40347 (site 14) is an obstruction of fish passage, but this culvert may be passable at some flows. Fish were captured downstream of these structures, but no fish were captured upstream.

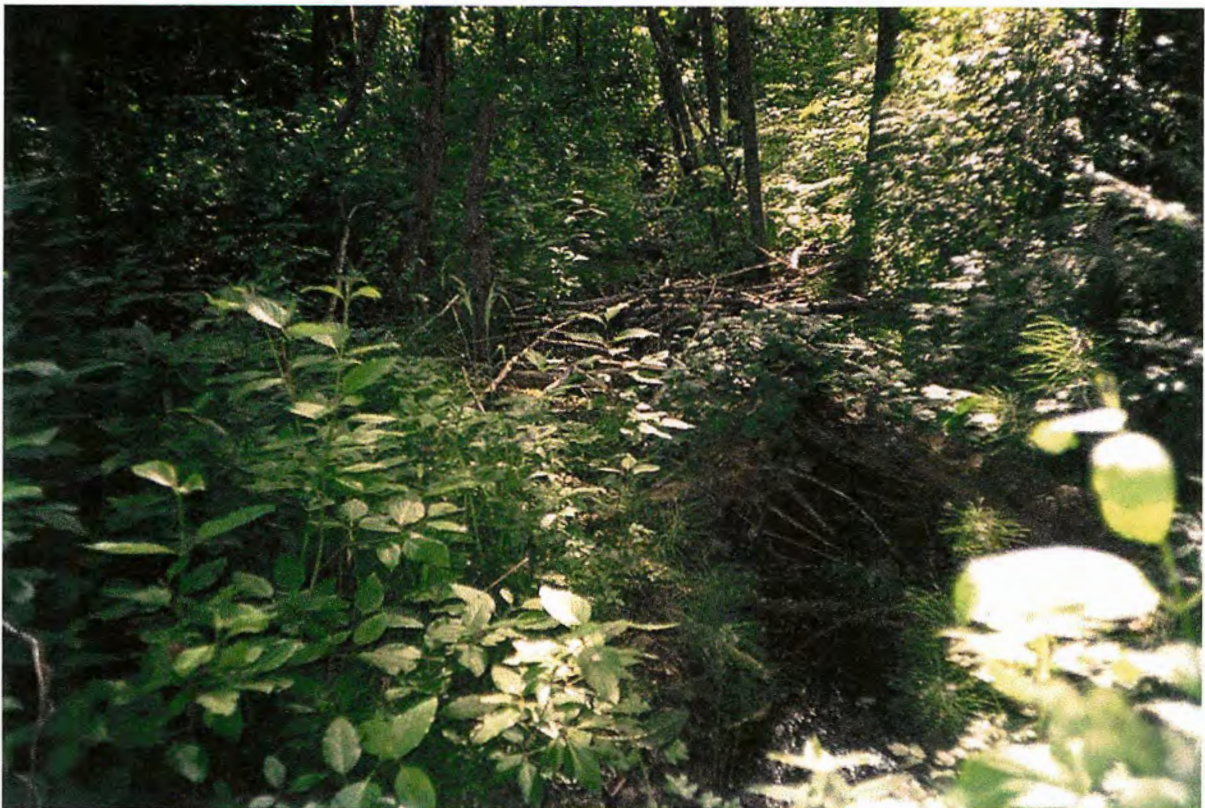
Direction of Photo: D CD #: 1 Image #: 29 Roll #: TC1 Frame #: 4
Comment: View at sample site, approximately 40 metres downstream of Granisle Highway.

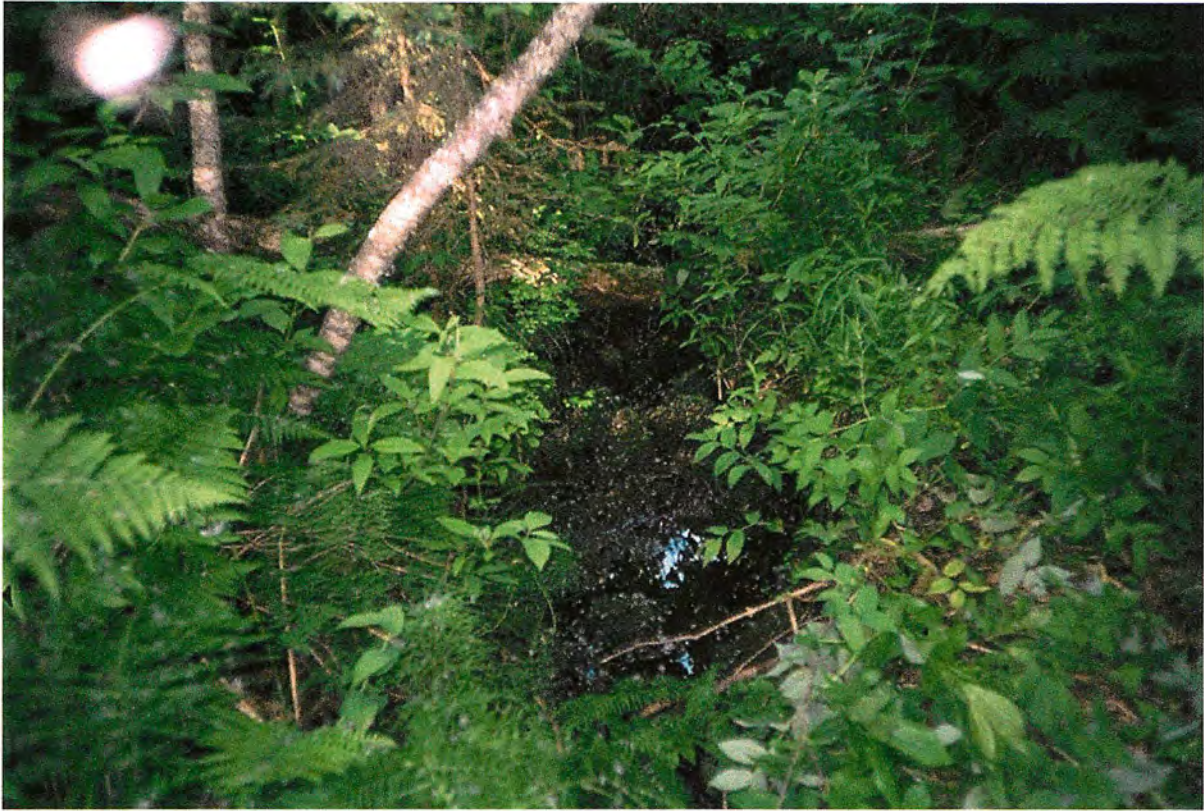
Site # 25
ILP # 40363 ILP Map # 093L.090
Reach # 2.0
Watershed Code: 000-000000-00000-00000-0000-000-000-000-000-000-000

Direction of Photo: U CD #: 1 Image #: 30 Roll #: TC1 Frame #: 5
Comment: View at site location (approximately 1220 metres upstream from Babine Lake).

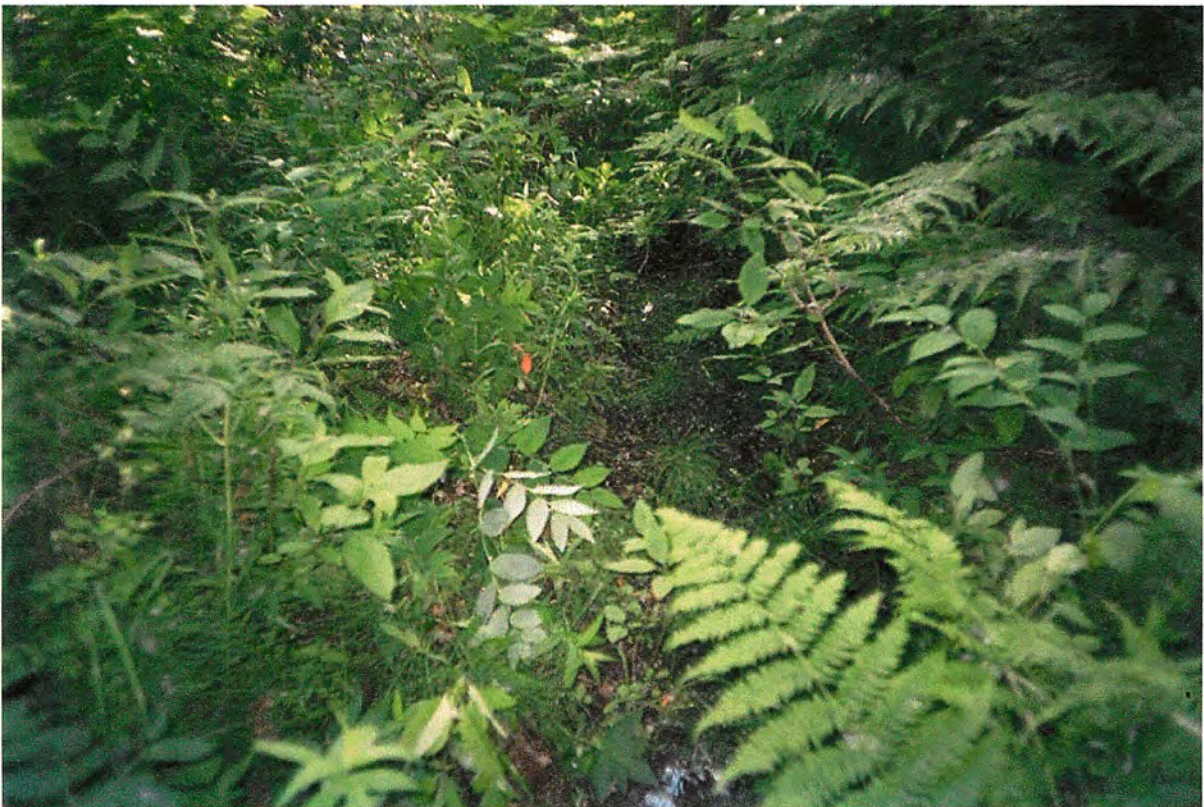
Direction of Photo: D CD #: 1 Image #: 31 Roll #: TC1 Frame #: 6
Comment: View at site location (approximately 1220 metres upstream from Babine Lake).

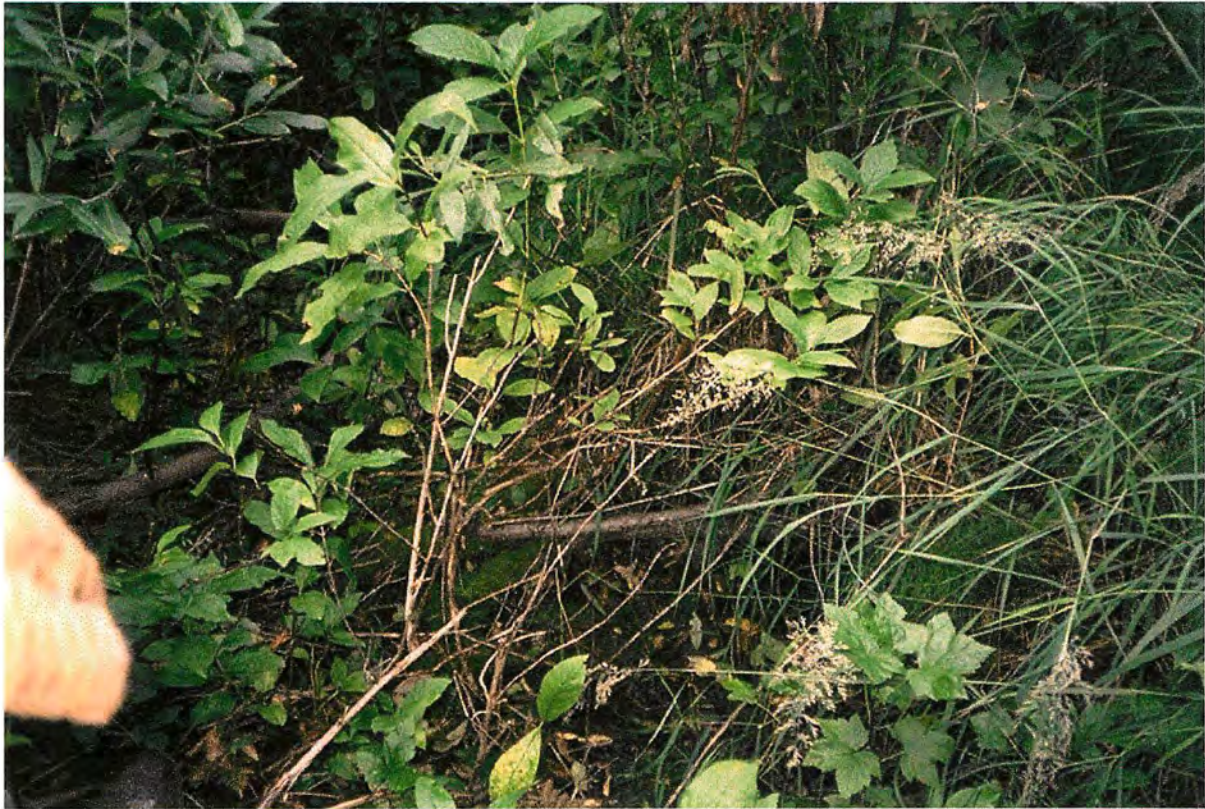
Site # 26
ILP # 40314 ILP Map # 093L.089
Reach # 1.0
Watershed Code: 000-000000-00000-00000-0000-000-000-000-000-000-000

Direction of Photo: U CD #: 1 Image #: 75 Roll #: TC4 Frame #: 19
Comment: Approximately 1350 metres upstream of Babine Lake.

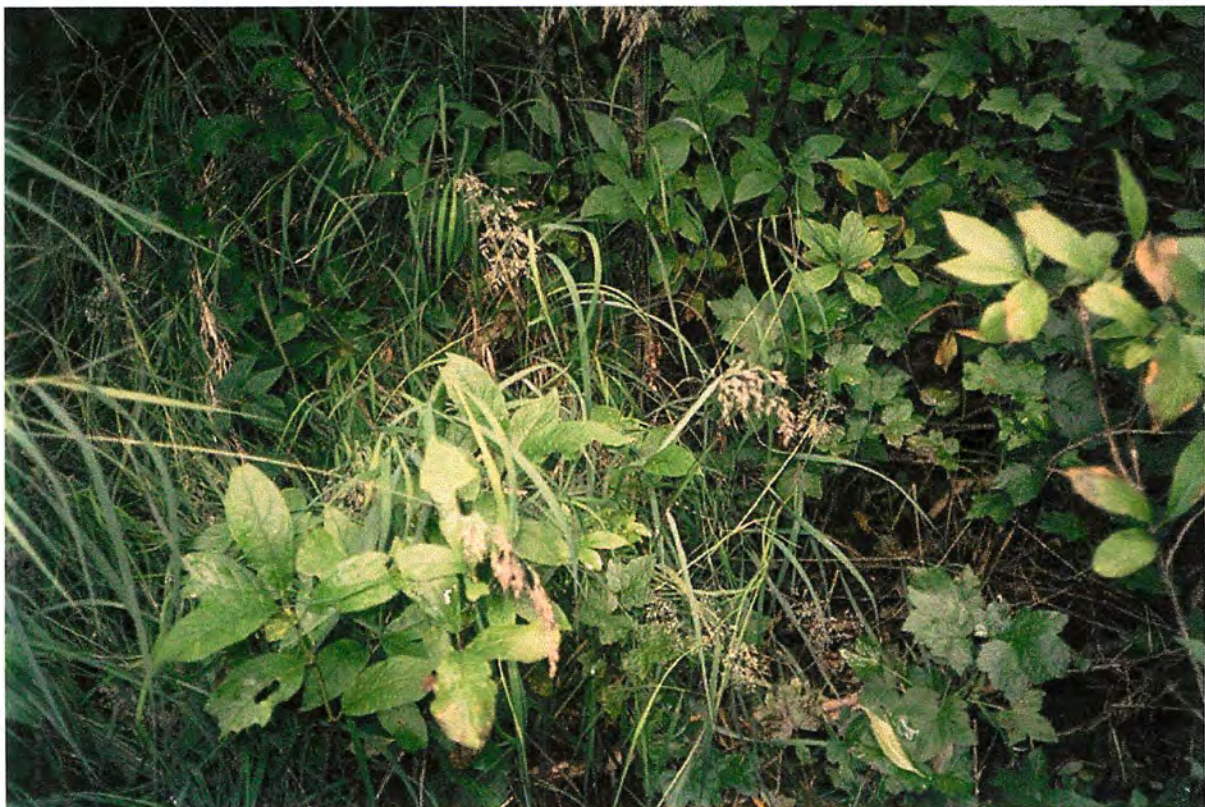
Direction of Photo: D CD #: 1 Image #: 76 Roll #: TC4 Frame #: 20
Comment: Approximately 1350 metres upstream of Babine Lake.

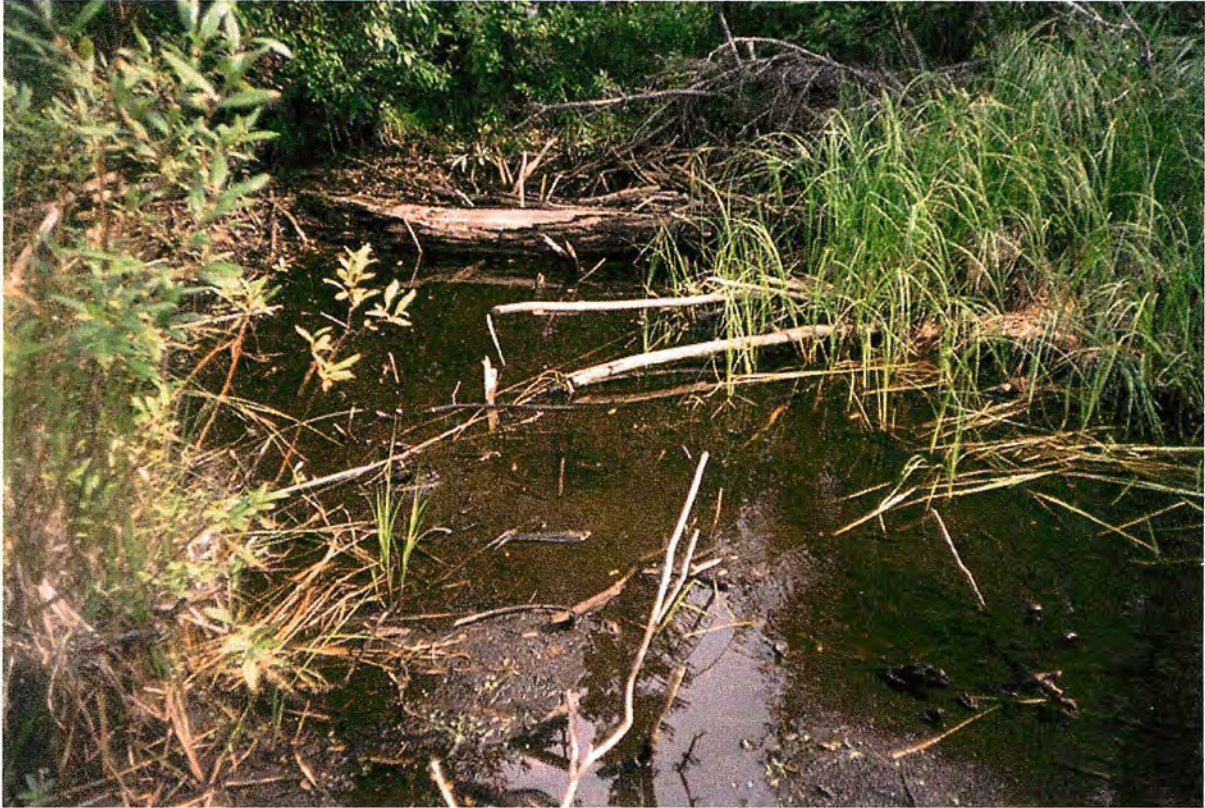
Site # 27
ILP # 40314 ILP Map # 093L.089
Reach # 3.0
Watershed Code: 000-000000-00000-00000-0000-000-000-000-000-000-000

Direction of Photo: U CD #: 1 Image #: 81 Roll #: TC5 Frame #: 3
Comment: View of the most defined braid, approximately 70 metres upstream from wetland.

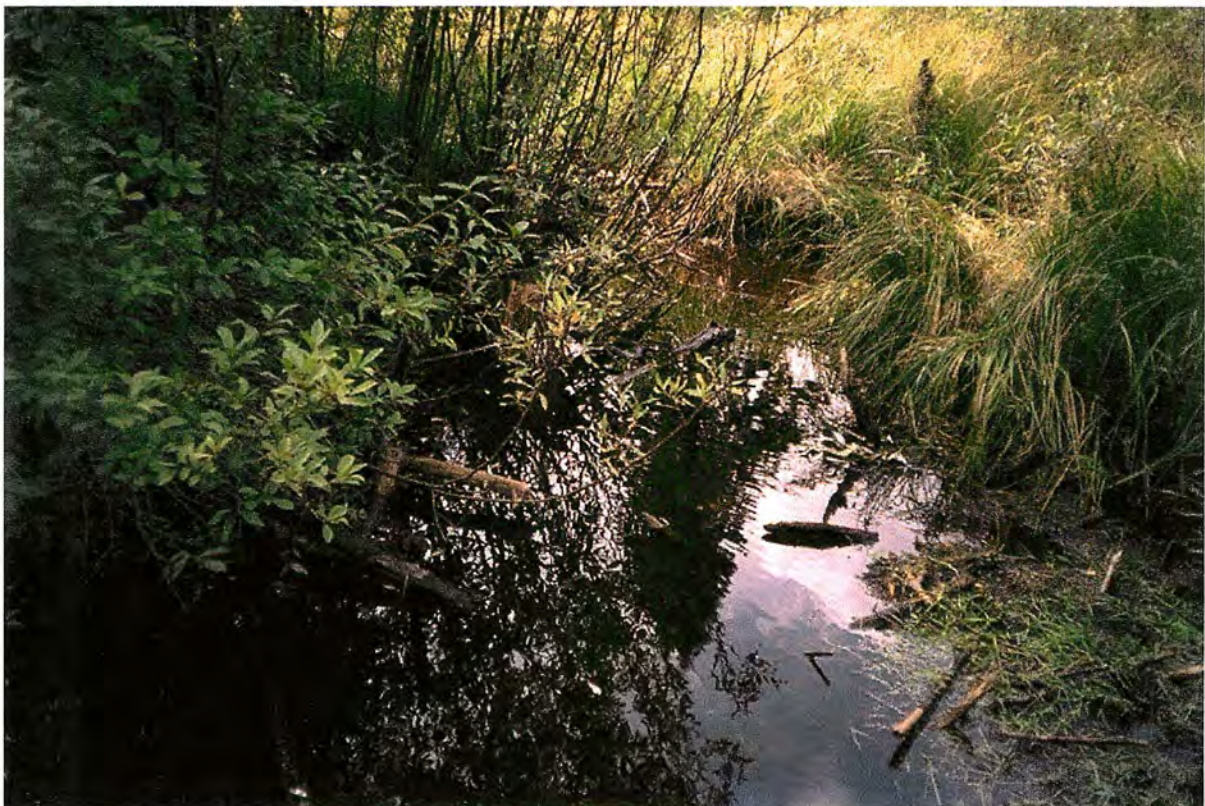
Direction of Photo: D CD #: 1 Image #: 82 Roll #: TC5 Frame #: 4
Comment: View of the most defined braid, approximately 70 metres upstream from wetland.

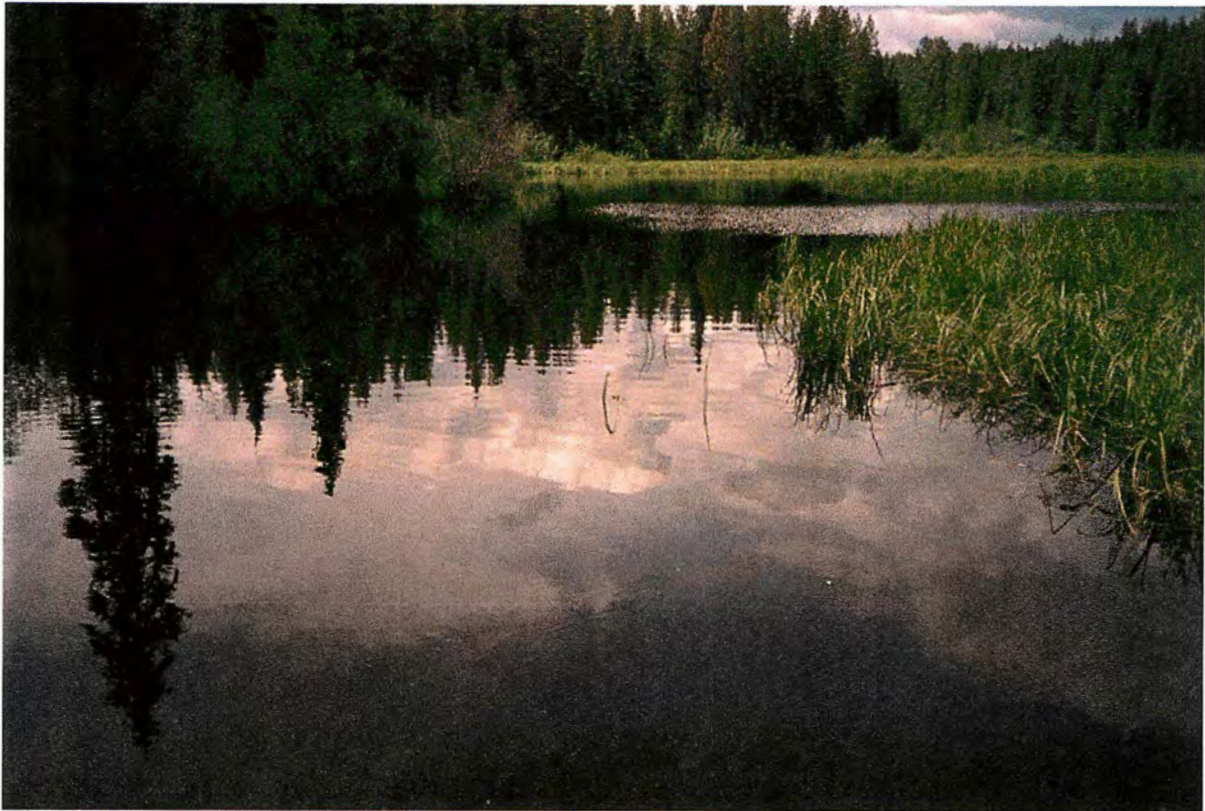
Site # 28
ILP # 40314 ILP Map # 093L.089
Reach # 8.0
Watershed Code: 000-000000-00000-00000-0000-0000-000-000-000-000-000-000

Direction of Photo: U CD #: 1 Image #: 11 Roll #: TC2 Frame #: 11
Comment: 400 metres upstream of lake in reach 6.

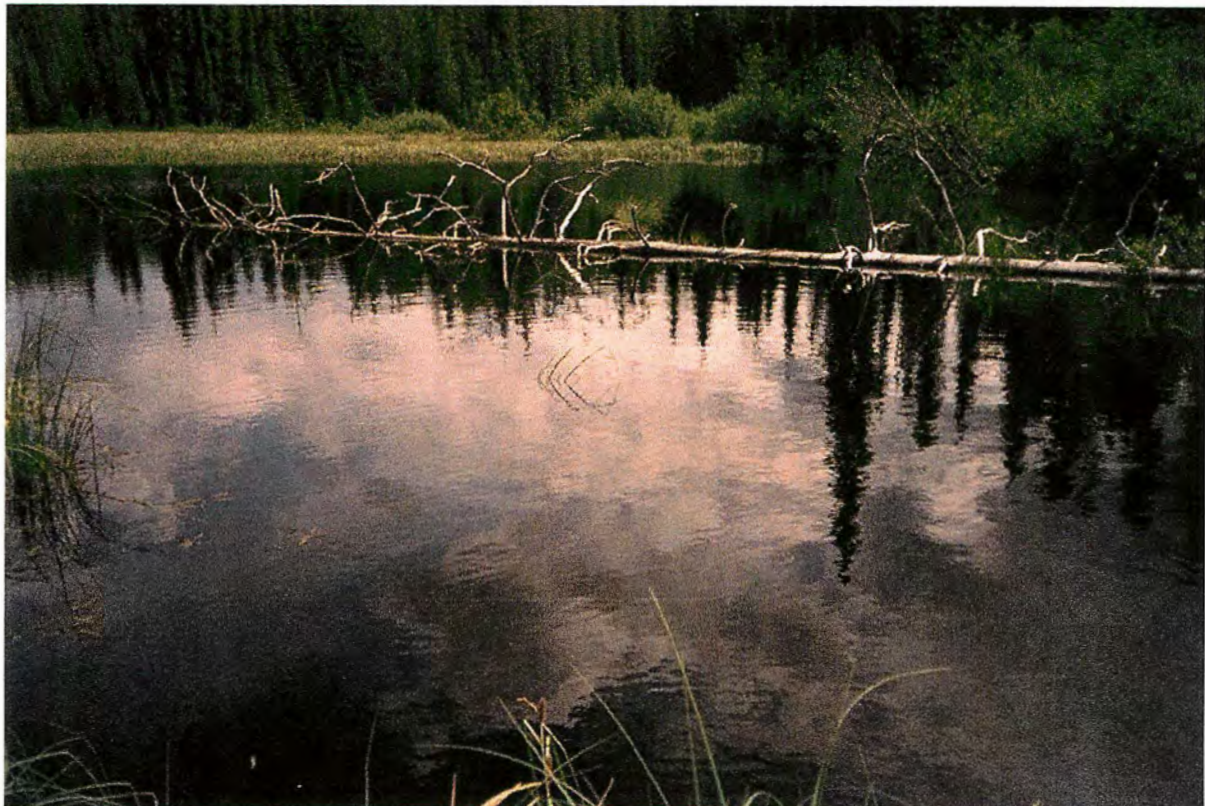
Direction of Photo: D CD #: 1 Image #: 12 Roll #: TC2 Frame #: 12
Comment: 400 metres upstream of lake in reach 6.

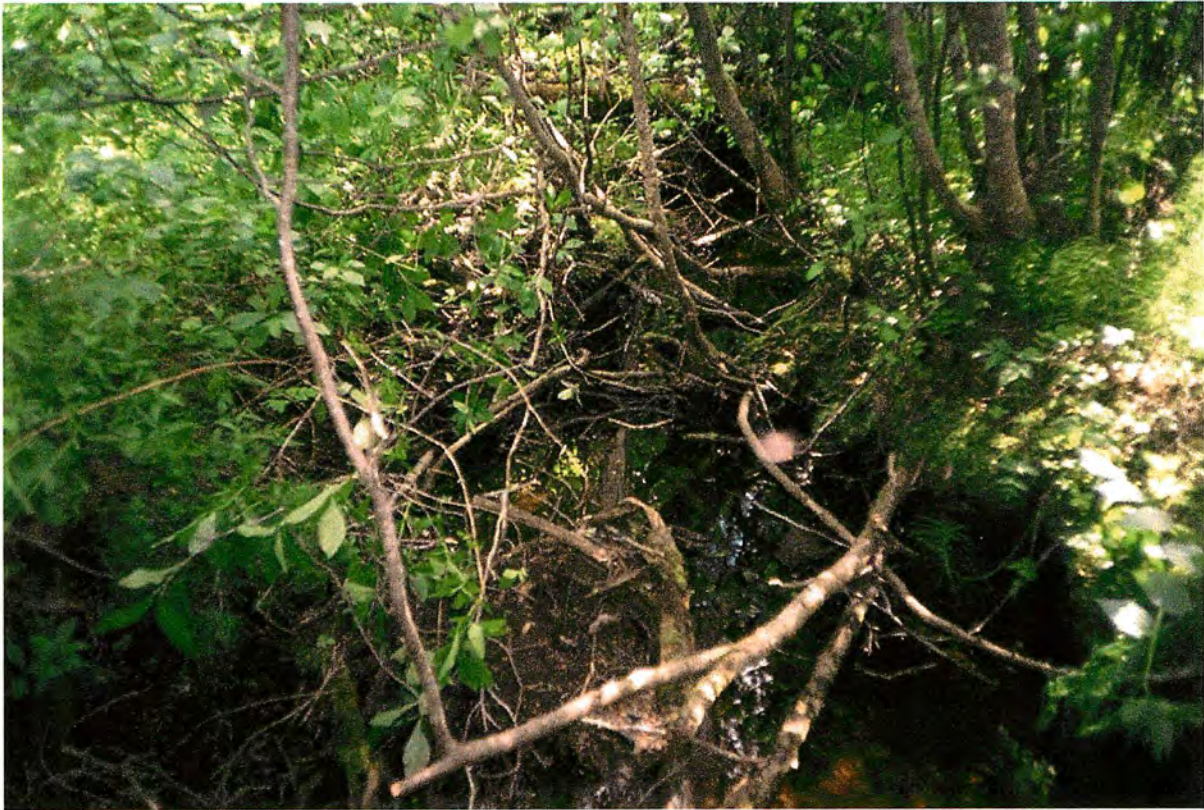
Site # 29
ILP # 40314 ILP Map # 093L.089
Reach # 9.0
Watershed Code: 000-000000-00000-00000-0000-0000-000-000-000-000-000-000

Direction of Photo: D CD #: 1 Image #: 10
Comment: 100 metres upstream of confluence of ILP 40307.

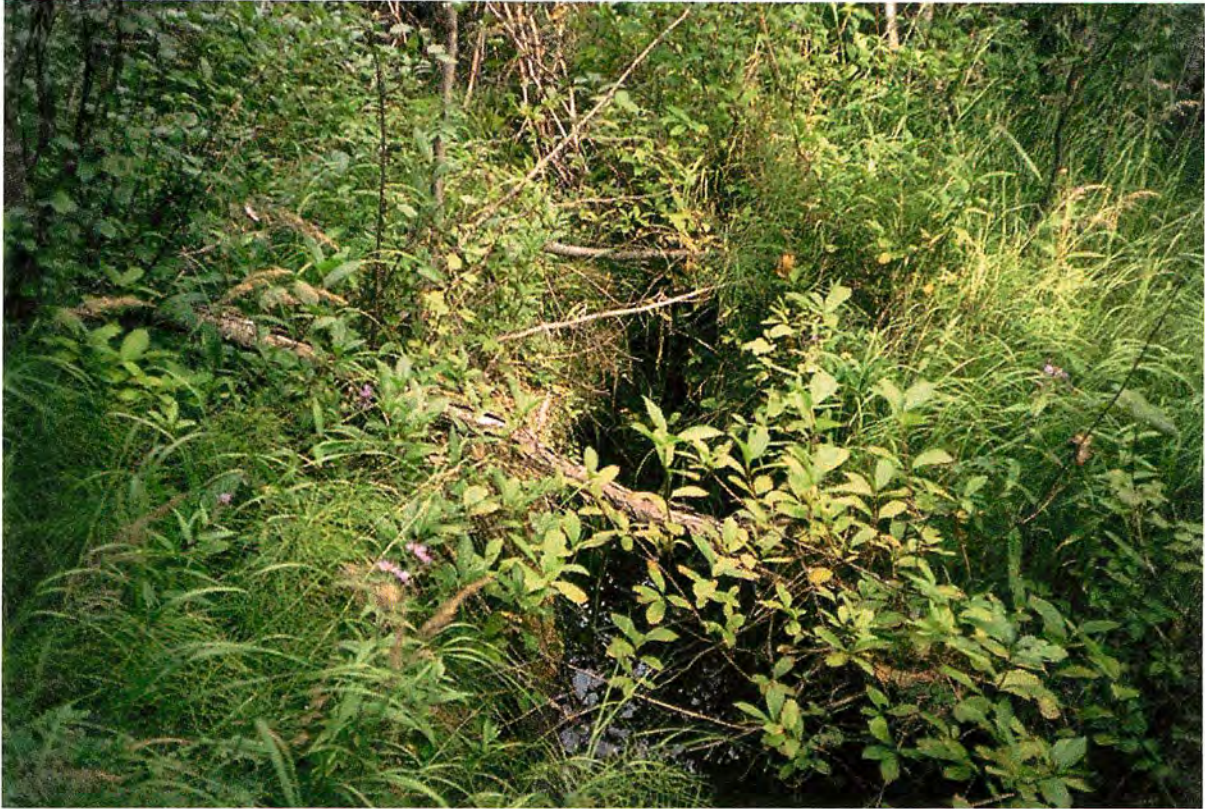
Site # 30
ILP # 40403 ILP Map # 093L.089
Reach # 1.0
Watershed Code: 000-000000-00000-00000-0000-0000-000-000-000-000-000-000

Direction of Photo: U CD #: 1 Image #: 77 Roll #: TC4 Frame #: 21
Comment: Approximately 75 metres upstream of wetland reach 2 of ILP 40314.

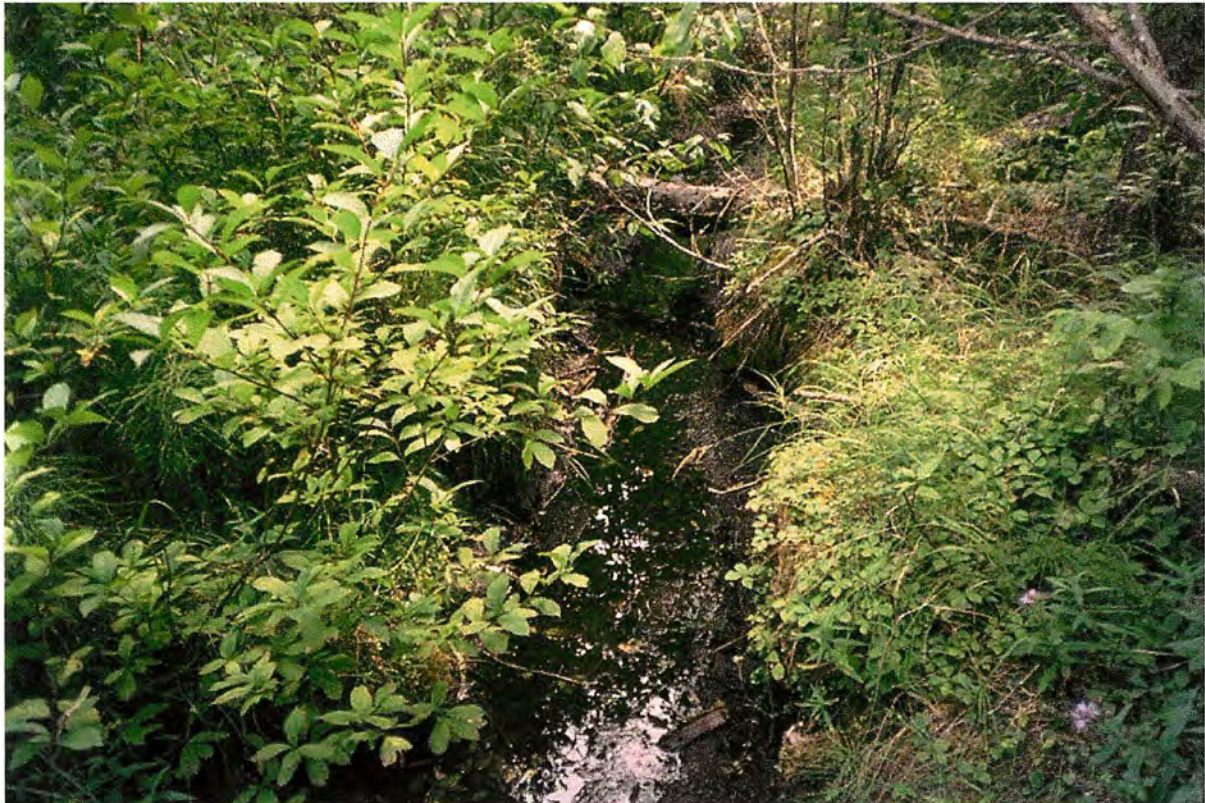
Direction of Photo: D CD #: 1 Image #: 78 Roll #: TC4 Frame #: 22
Comment: Approximately 75 metres upstream of wetland reach 2 of ILP 40314.
