**Reconnaissance (1:20,000)
Fish and Fish Habitat Inventory of
Tributaries to West Shore of Babine Lake
Between Newman Island and the Fulton River
and an Unnamed Inlet stream to the
North Shore of Fulton Lake
East of Broughton Creek**

Watershed Code: 480, 480-697200-08100

Houston Forest Products Co.

SKR Consultants Ltd.

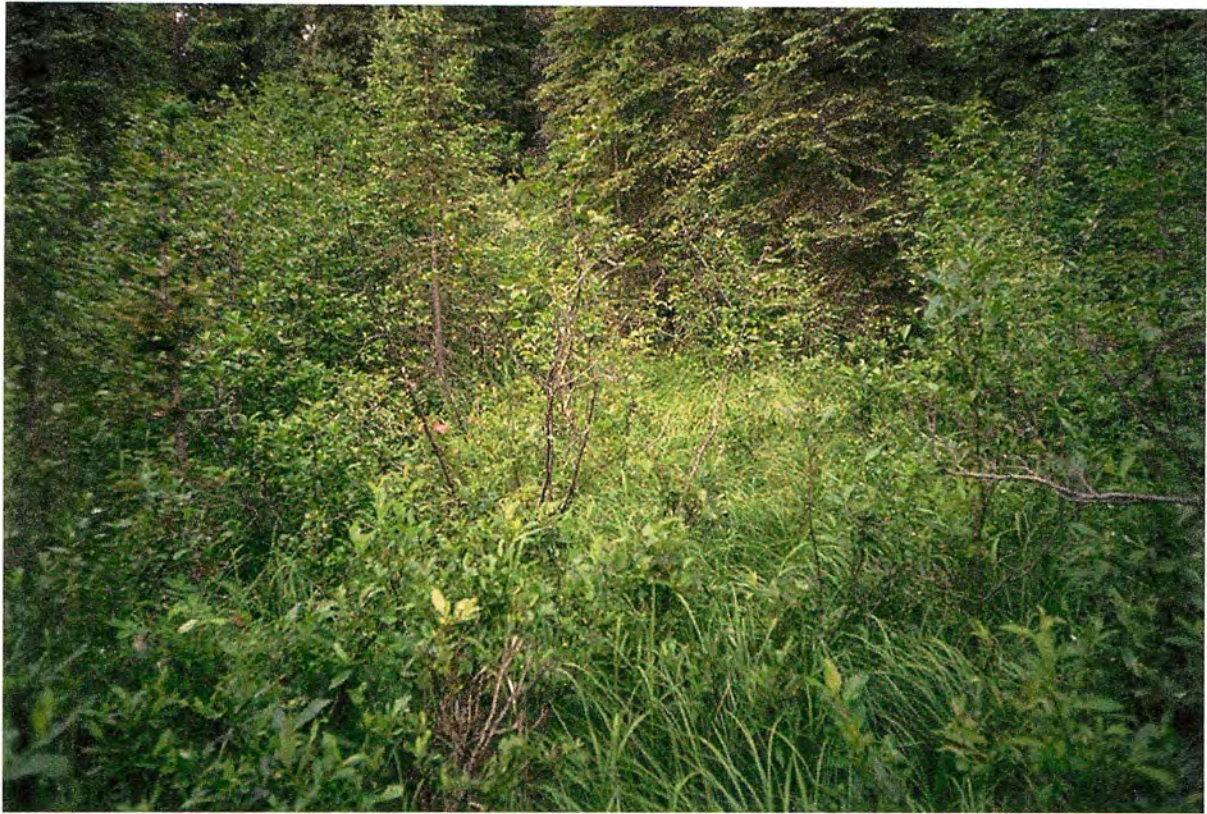
Site # 31
ILP # 40310 ILP Map # 093L.089
Reach # 1.0
Watershed Code: 000-000000-00000-00000-0000-0000-000-000-000-000-000

Direction of Photo: U CD #: 1 Image #: 13 Roll #: TC2 Frame #: 13
Comment: View in riparian band 40 metres upstream of Lake ILP 40314, R6.

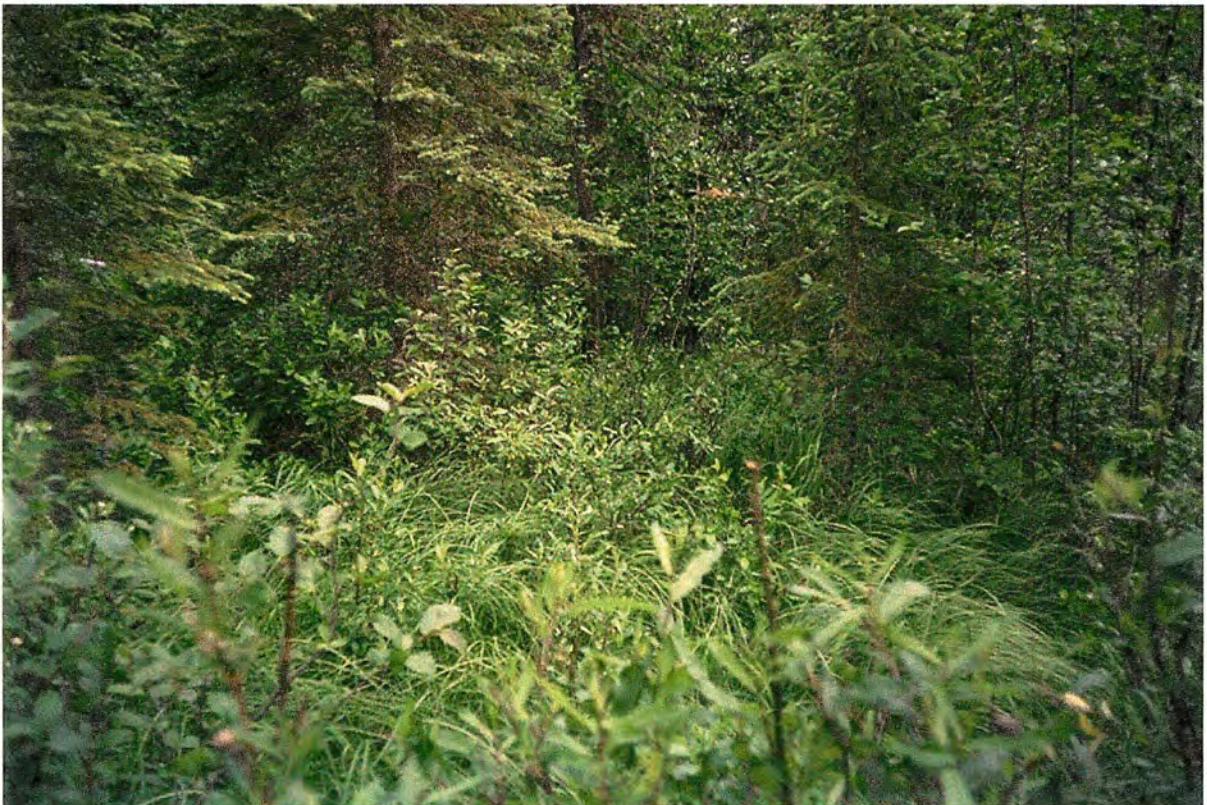
Direction of Photo: D CD #: 1 Image #: 14 Roll #: TC2 Frame #: 14
Comment: View in riparian band 40 metres upstream of Lake ILP 40314, R6.

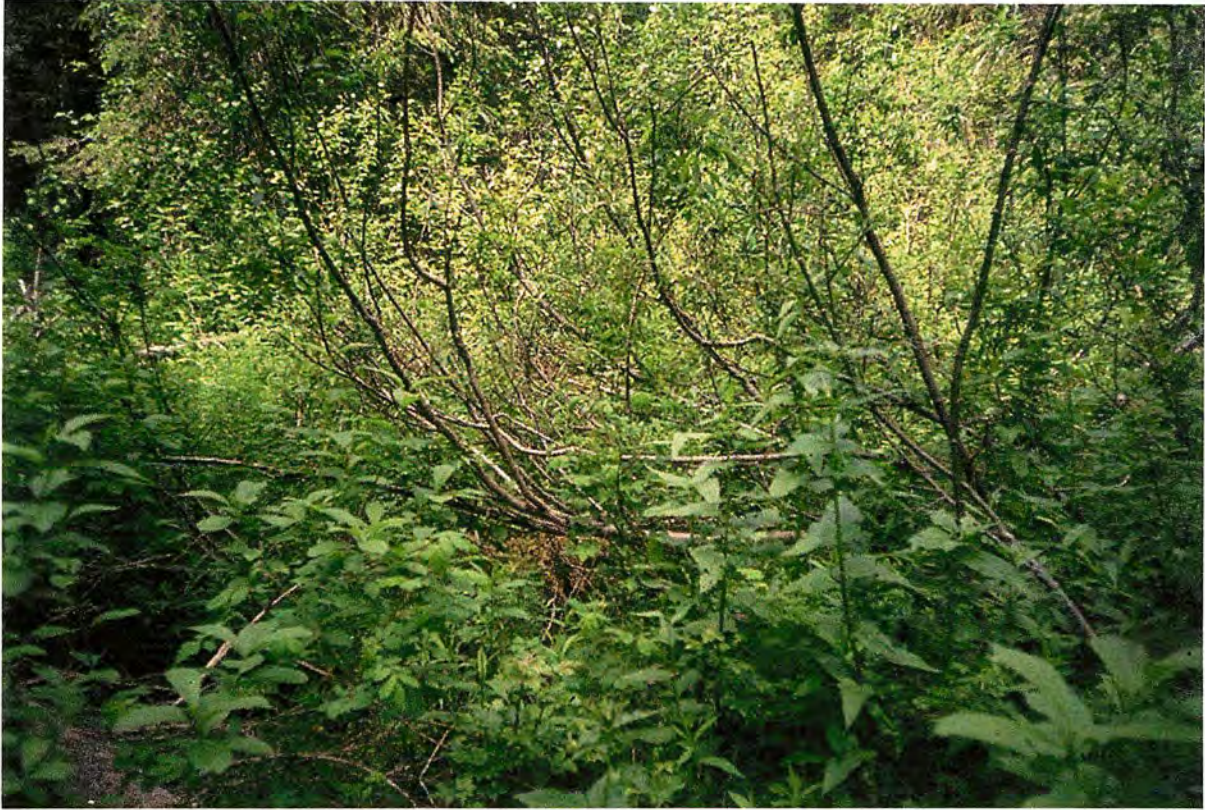
Site # 32
ILP # 40307 ILP Map # 093L.089
Reach # 1.0
Watershed Code: 000-000000-00000-00000-0000-0000-000-000-000-000-000-000

Direction of Photo: U CD #: 1 Image #: 7 Roll #: TC2 Frame #: 7
Comment: 210 metres upstream of confluence with ILP 40314.

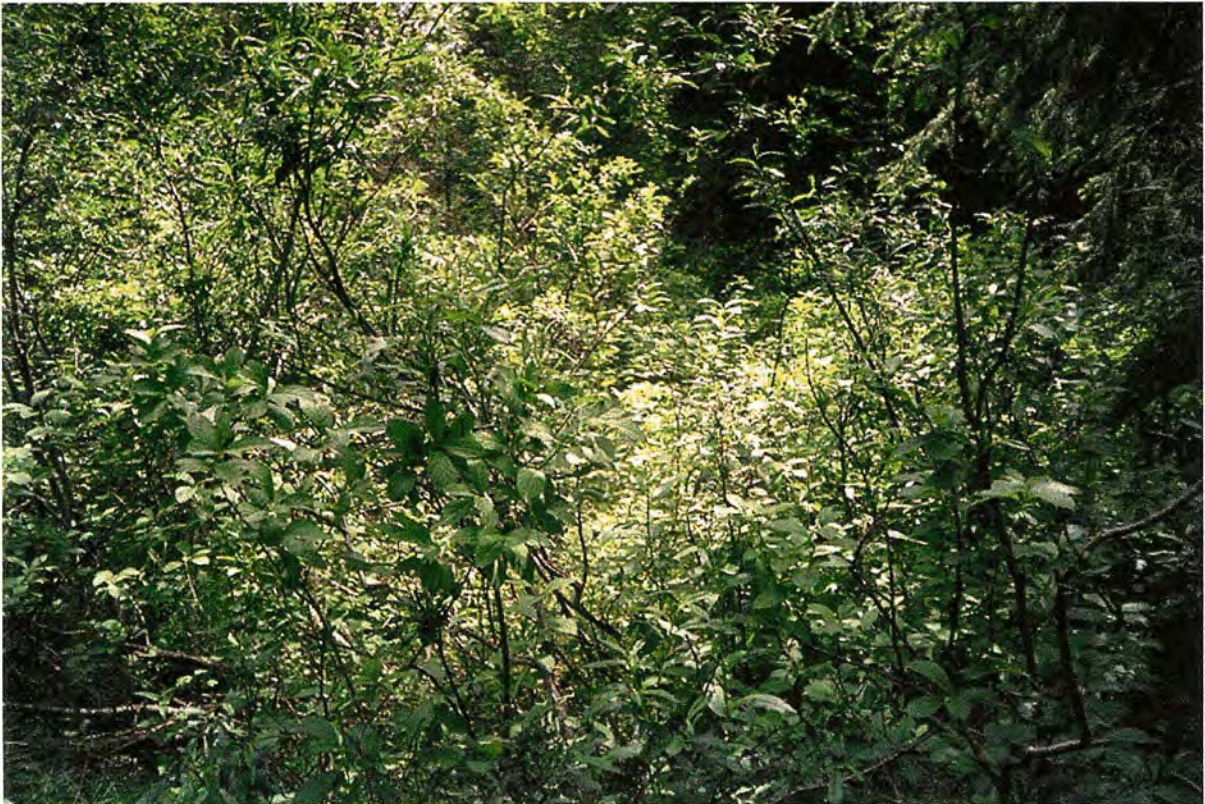
Direction of Photo: D CD #: 1 Image #: 8 Roll #: TC2 Frame #: 8
Comment: 210 metres upstream of confluence with ILP 40314.
