**An Inventory of Lars Lake
and its
Inlet and Outlet Streams**

**B.C. Fish and Wildlife Branch
Smithers, B.C.**

October, 1993

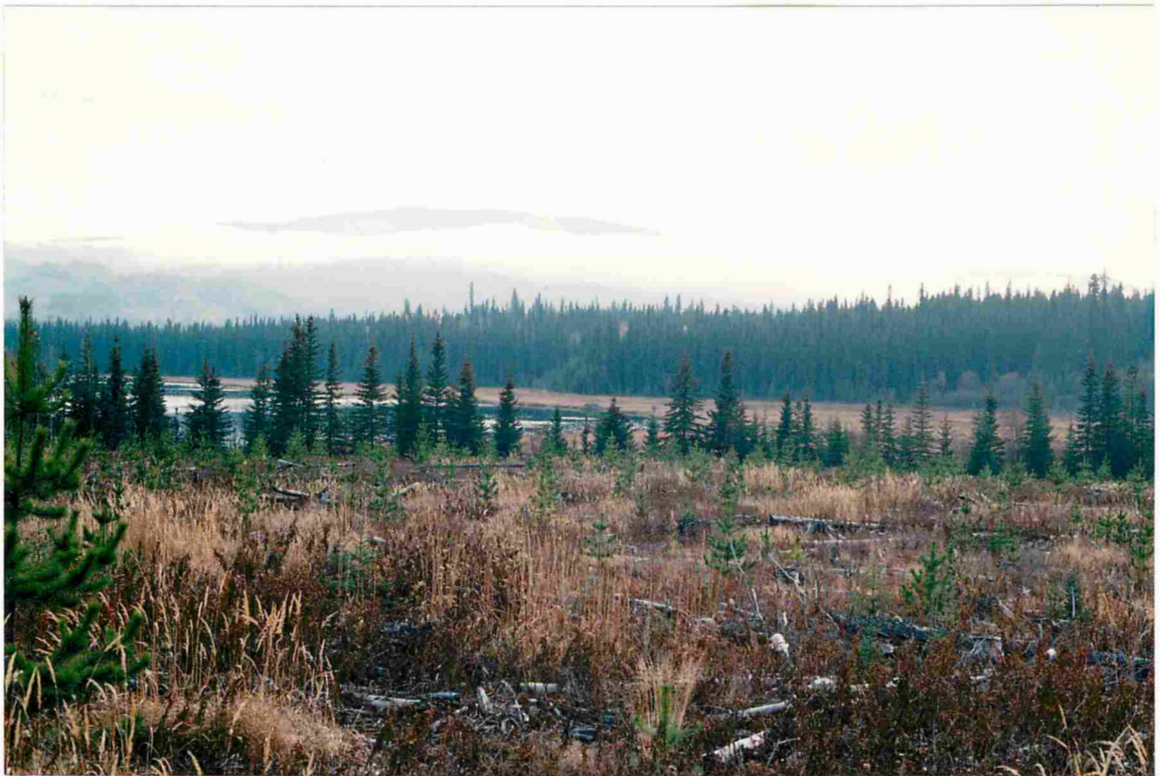
Figure 2. View of Lars Lake, looking south.

The large shoreline area on the west and north side of the lake has been clear cut in the last 10 - 15 years (Figure 2).

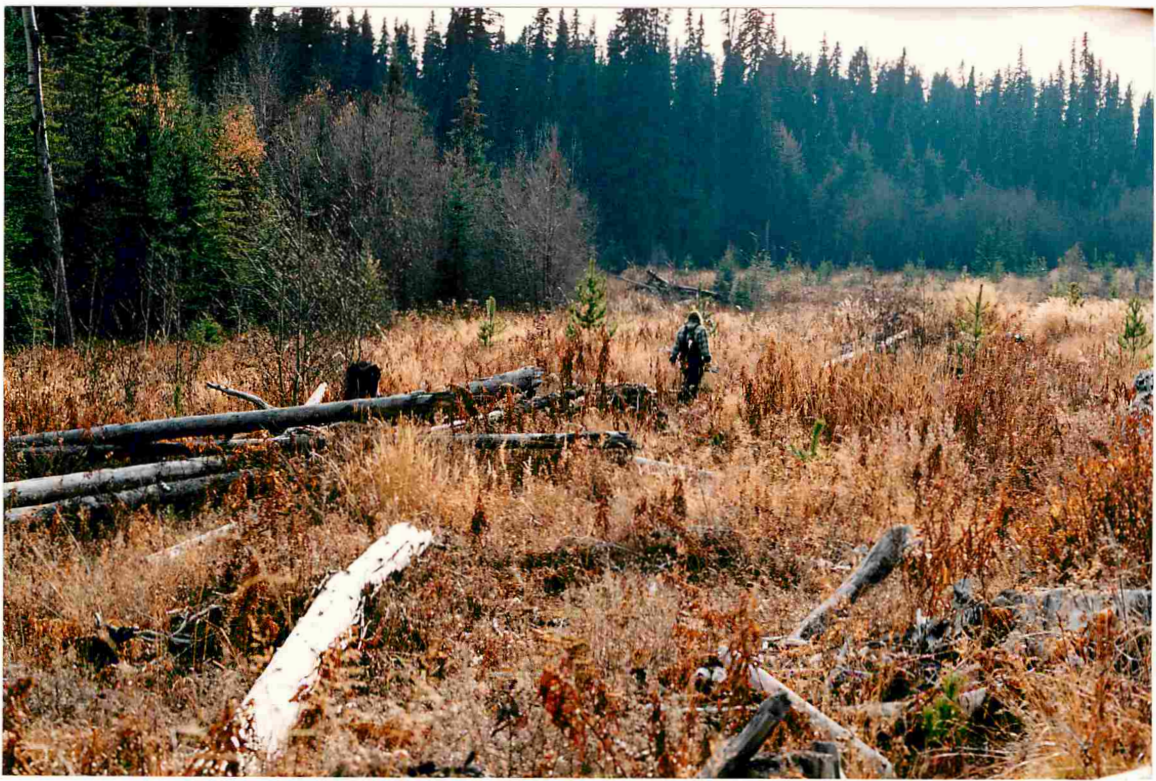
Figure 3. West side of Lars Lake where the reforestation was inadequate.

Much of this logged area around the lake is not satisfactorily replanted (Figure 3). A band of vegetation has been left directly surrounding this lake to give some protection from run off and erosion.

5.1 It is recommended that official requests be made to the logging company responsible for the present environmental damage at Lars Lake. The culprit company should supply sufficient rehabilitation of this location. The area surrounding this lake should be thoroughly replanted, and the road across the stream should be either blocked or a suitable culvert should be installed.

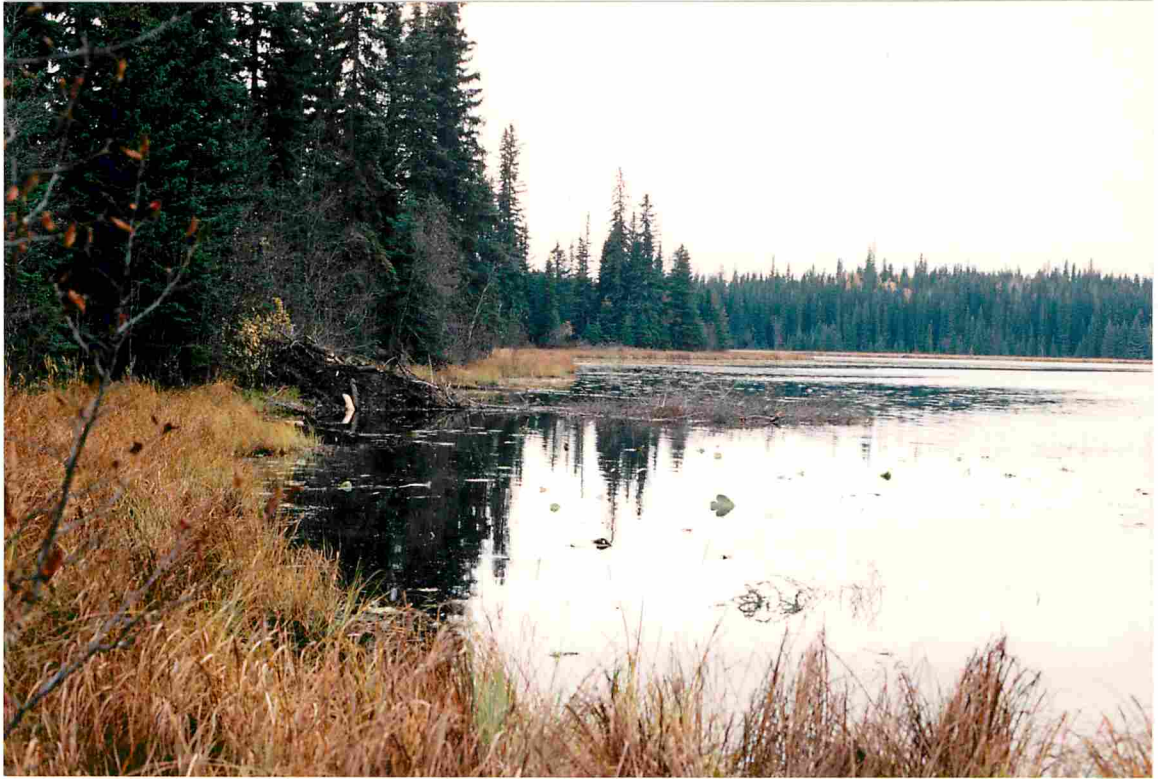
Figure 4. Active beaver house on the east side of Lars Lake.

Two minnow traps were set along the east shore of the lake within 30 m of one of the two beaver houses that were found at this lake (Figure 4). Traps were set overnight (22 hours), but caught only one large scale sucker (*Catostomus macrocheilus*) with a fork length of 94 mm.

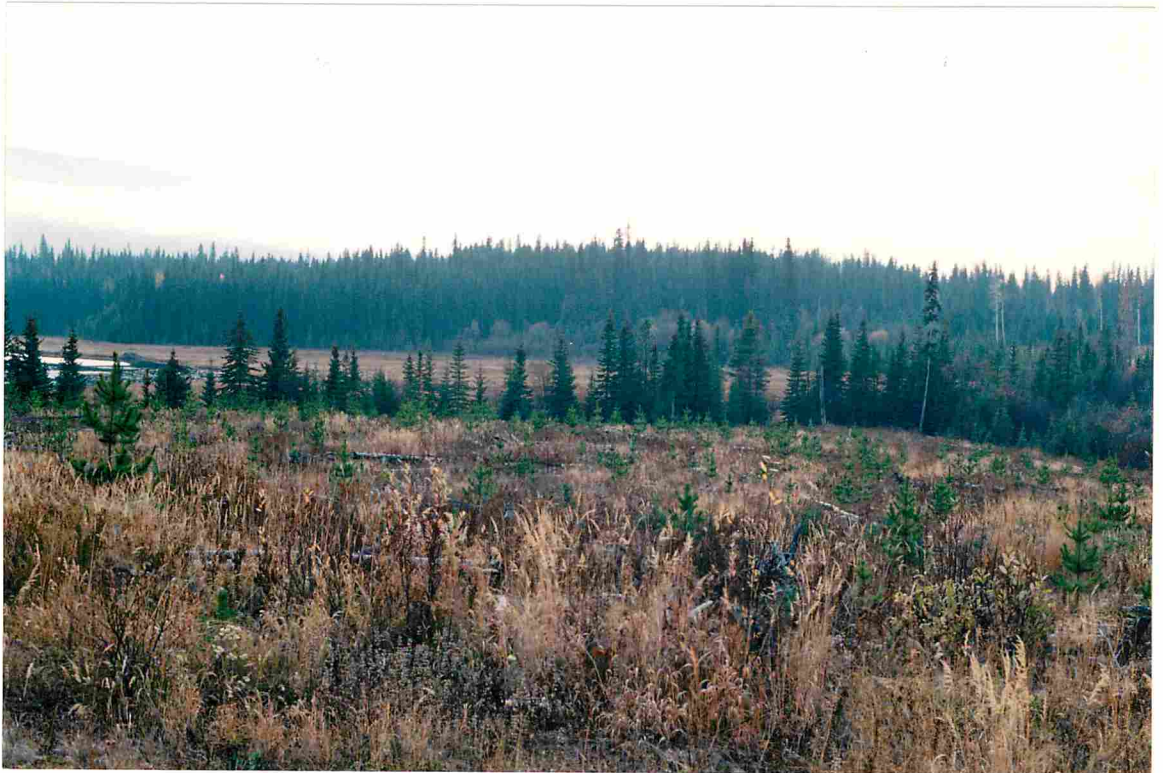
Figure 5. Looking at southwest corner of Lars Lake where a narrow band of trees gives some protective cover over the lower 250 meters of the main inlet stream.

The main inlet stream to Lars Lake was on the northwest corner, and wound through the clear cut area. A very narrow stand of trees and bushes was left around this stream for 250 m down to the lake (Figure 5). For the lower 80 m of this inlet

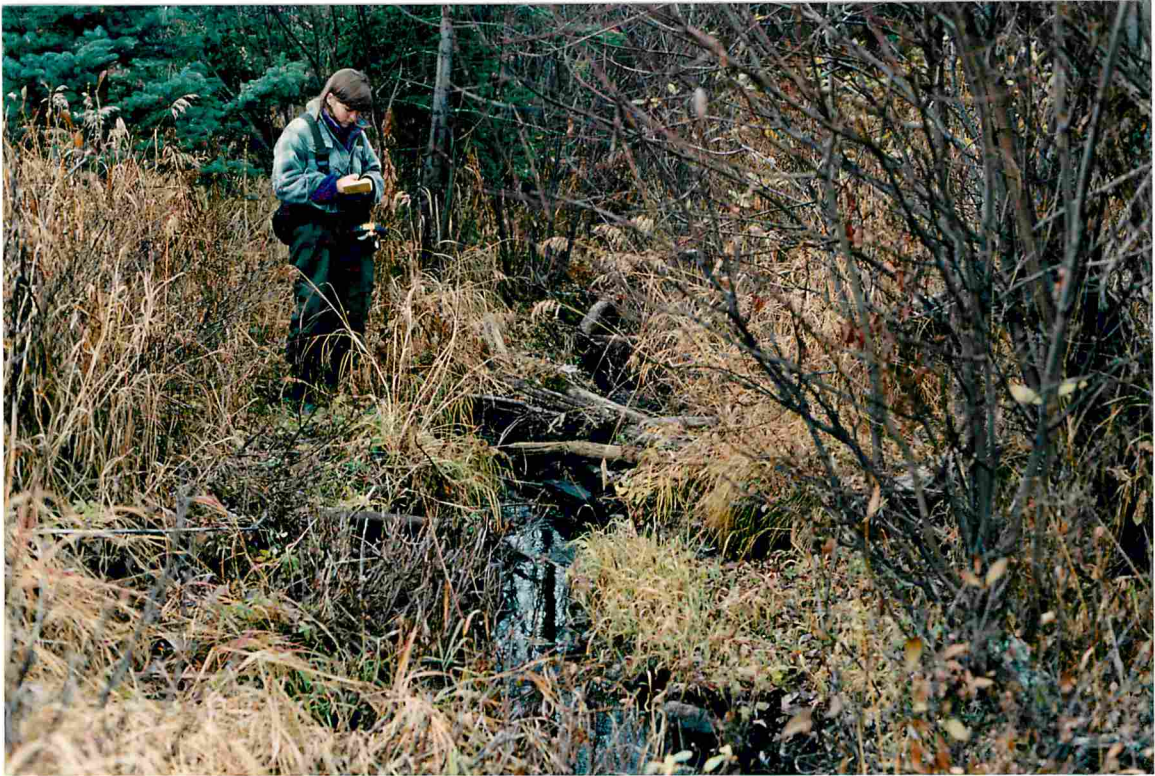
Figure 6. The main Lars Lake inlet stream where it is narrow, but fairly deep with good water flow.

stream there was no notable flow in this 5 - 10 m wide stretch with a mud bottom; this lower reach is surrounded by marsh. Above this 80 m stretch the stream narrows to 1 - 3 m wide and flow is faster. The stream becomes consistently broken into pools and runs and includes suitable spawning sites for rainbow trout. The narrower stretches of stream ranges from 20 - 80 cm deep and the wider areas are primarily large pools that range in depth from 10 - 60 cm (Figures 6 & 7). There was some evidence of minor beaver activity but the stream remains passable by fish through this entire lower section. Overhead protection was good with 90 % cover and thick willow bushes surrounding large lengths of the stream appeared to supply additional protection from terrestrial predators. Debris cover for fish was approximately 10 %.

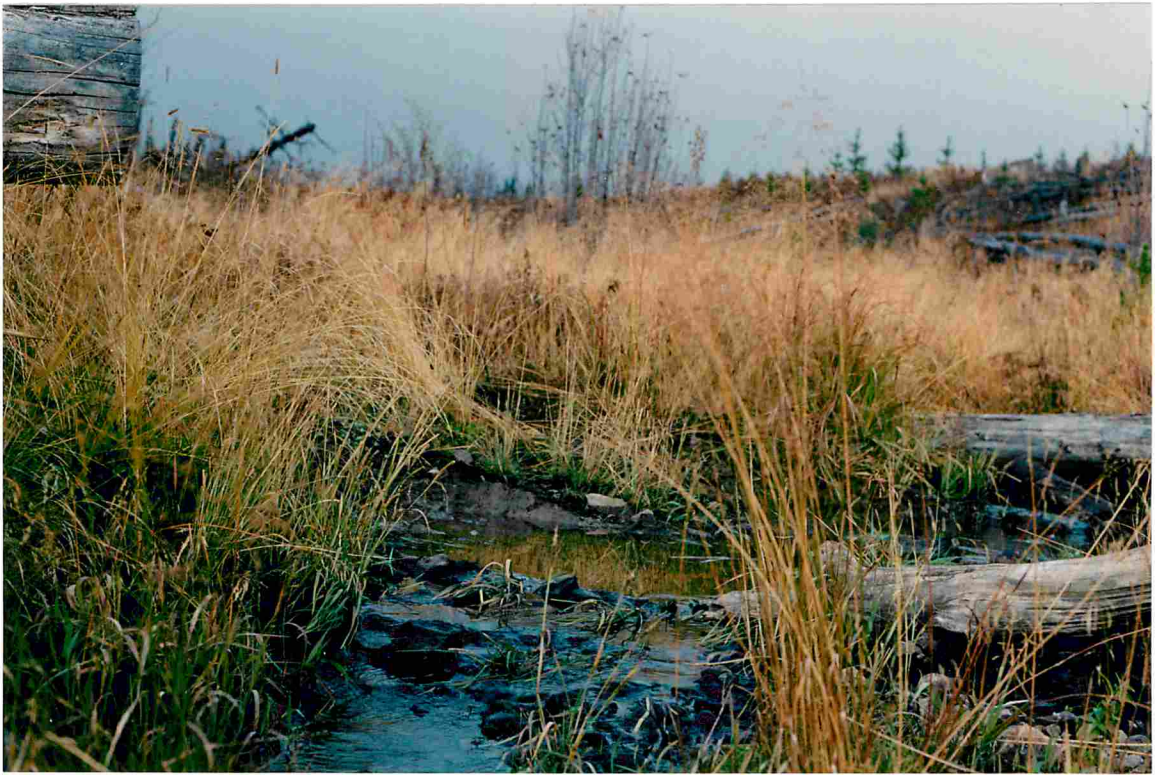
Figure 8. A view, looking up the inlet stream. The pool of water in view is the road crossing and the open area in the background is where the stream winds through the clear cut.

An old logging road, that is presently well used by off road vehicles (hunters), crosses the stream approximately 250 m up from the lake. A culvert was never installed at this road crossing. At this location, vehicles are constantly disturbing the stream beds by causing increased siltation downstream into suitable spawning habitat for rainbow trout. In addition, there was no protective band of vegetation left upstream of this site by the loggers to protect against natural erosion or to give cover from aerial predators (Figure 8). Steep embankments on the east side of this stream were clear cut to within 10 cm of the stream bed. This is discernable, although not clearly, in Figure 8.

logging road crossing. Six rainbow trout parr were captured. Fork lengths of these six parr were 66, 59, 73, 65, 69, and 68 mm. The presence of parr in this stream above and below the road crossing emphasizes the need for rehabilitation at this site.

5.2 If the company responsible for this damage is not identified, it is suggested that a volunteer project be organized to at least install a culvert to protect the inlet stream from excess siltation in future years.

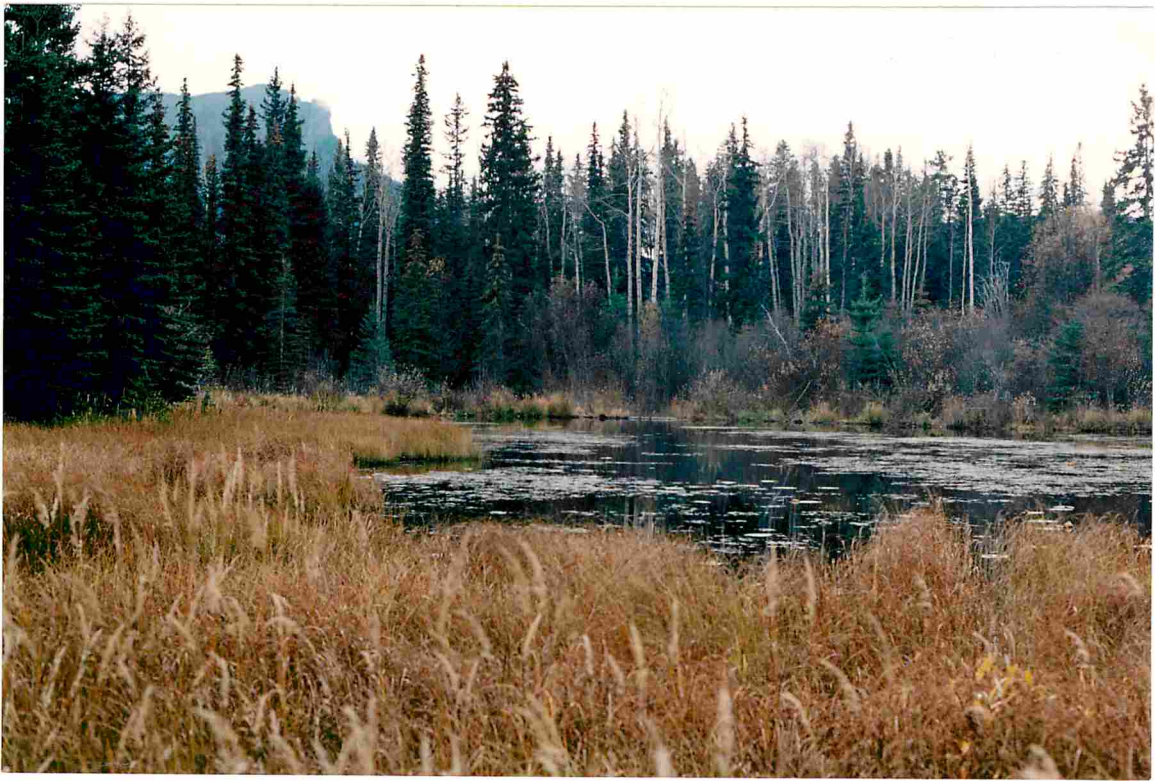
Figure 9. Looking downstream at the beaver dam which blocks the only outlet from Lars Lake.

The outlet of Lars Lake is at the south end of the lake. Directly at the outlet there is a 25 m long beaver dam; at the time of this survey, this dam was only 5 cm above the lake water height (Figure 9). Well used trails and fresh tree cuts in the area surrounding this outlet gave clear evidence of current beaver activity. The dam had some growth on it, but also had evidence of weak points that are vulnerable to annual break through. Although small leaks were present in this dam, fish passage was not possible at the time of observation; it is possible that fish may get past this location during spring floods.

The dam at the outlet to Lars Lake does not appear to be stable and does not threaten the rainbow trout in this lake. It is more probable that this dam is limiting invasion by other fish species which can allow better survival and physical condition of this lake's rainbow trout stock. Access to the outlet is presently too difficult for any major habitat enhancement.

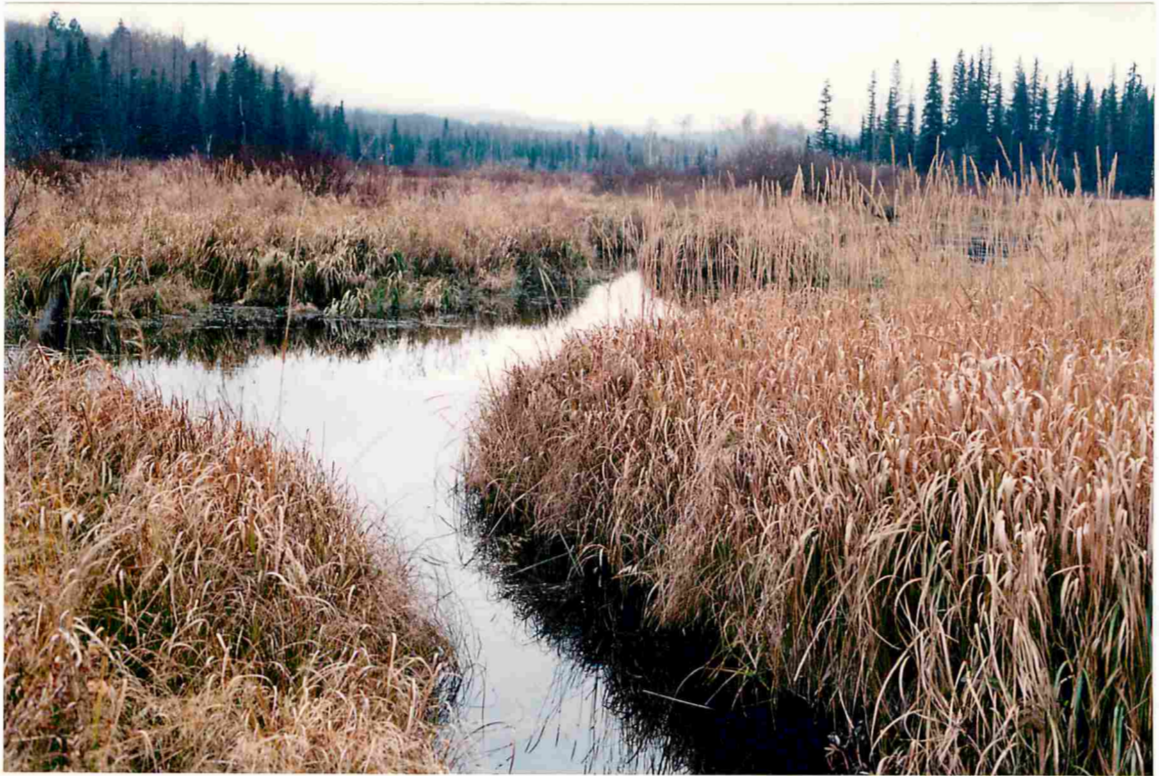
Figure 10. Junction of Swans Lake and Lars Lake outlet streams.

approximately 1 m deep. Below this point the outlet stream exhibits good flow for approximately 250 m down to its confluence with the Swans Lake outlet stream. The stream below the outlet dam has no other beaver dams blocking it. The stream is 1 -2 m wide and consistently changes from pools to runs; substrate varies with different combinations of sand, gravel and muddy debris. Depths range from 10 - 40 cm at the runs, to 30 - 100 cm at pools. This stream winds through dense bush and then through a meadow. Habitat through the willows has 5 - 10 % debris cover. Through the meadow, tall overhanging grass offers 20 % cover for fish as the stream is deep and narrow; large fallen trees across the stream in several locations also offer ideal cover. The lowest 15 m of this stream then slows and becomes approximately 1 m deep where it joins the Swans Lake

outlet stream (Figure 10).
